TOTAL COMPONENT RATING	
------------------------	--

29. SMOKE DETECTORS: <input type="checkbox"/> YES <input type="checkbox"/> NO	30. CARBON MONOXIDE DETECTORS: <input type="checkbox"/> YES <input type="checkbox"/> NO	
PARKING

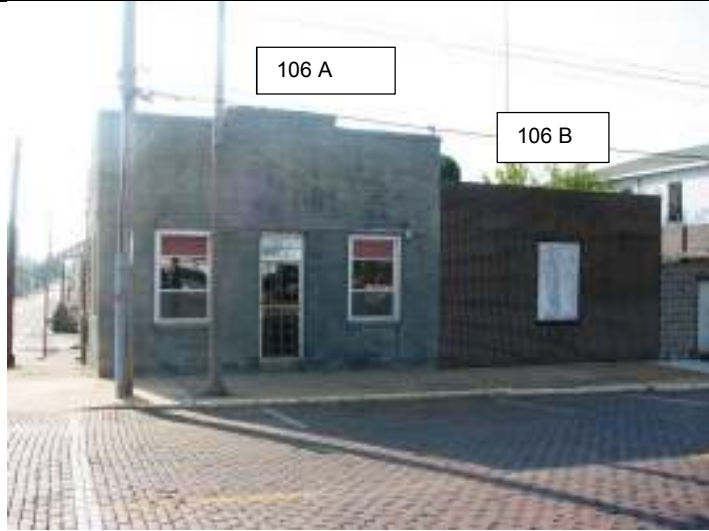
Façade (west), showing deterioration of mortar and damaged window screen.

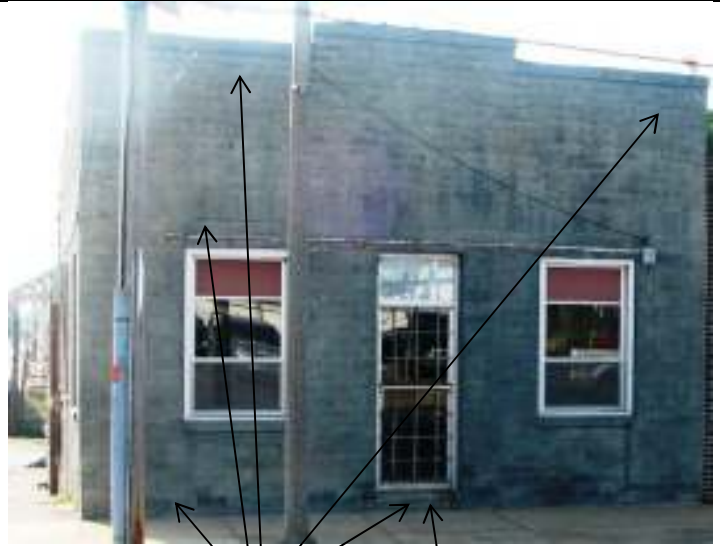
Façade, showing mortar issues, missing step and damaged screens.

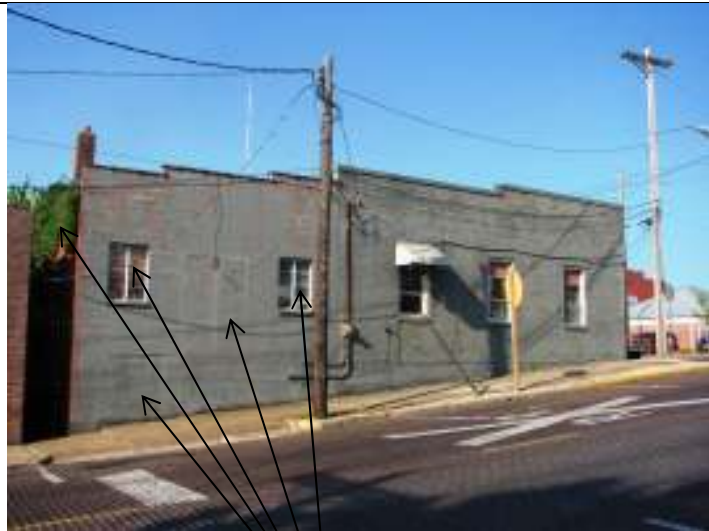
North elevation, showing infilled openings, and broken windows; vegetation on east wall surface

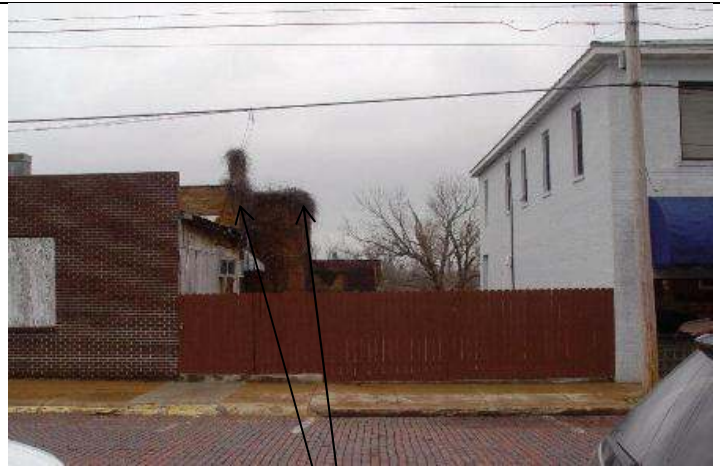
West and east elevation showing vegetation growth

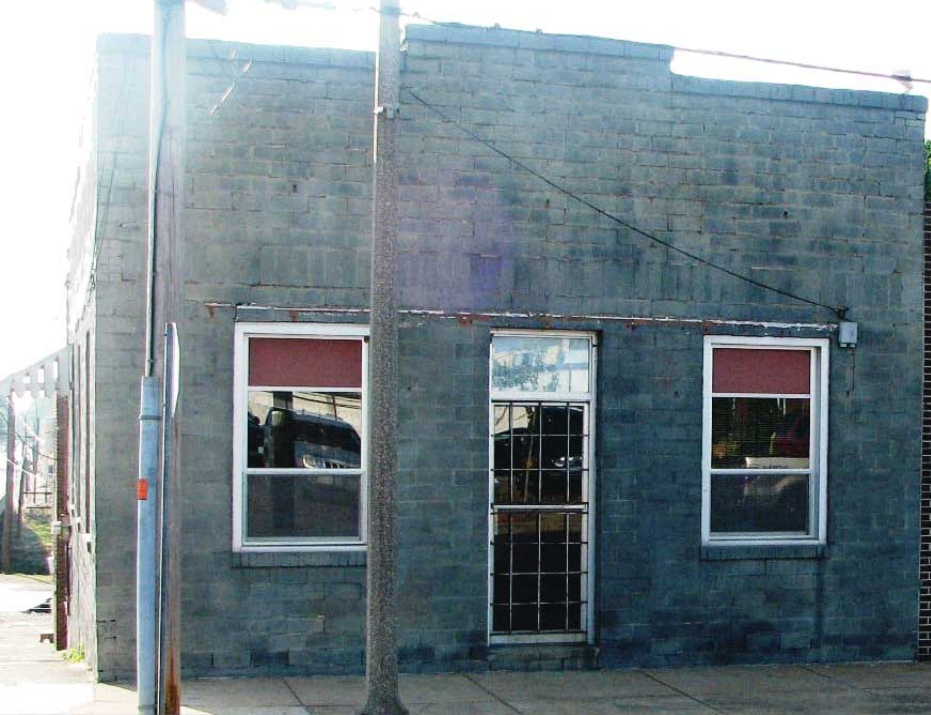
SURVEY NO. BU-AS-005-LUBC-019	
TOTAL SCORE OF OVERALL INTERIOR BUILDING CONDITION:	LOCATION: L1 – 1 ST FLOOR; L2- 2 ND FLOOR; L3 -3 RD FLOOR
12- EXCELLENT 6-8 – FAIR 0-4 - DILAPIDATED	
9-11 – GOOD 1-3 - POOR

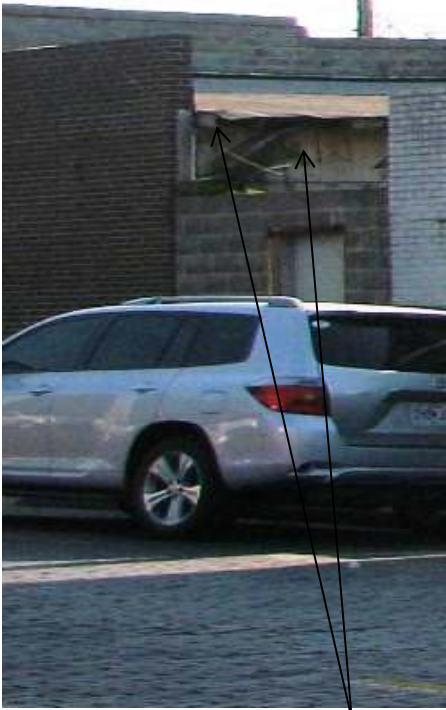
South elevation, showing the deterioration of the expose roof rafters and wall surface

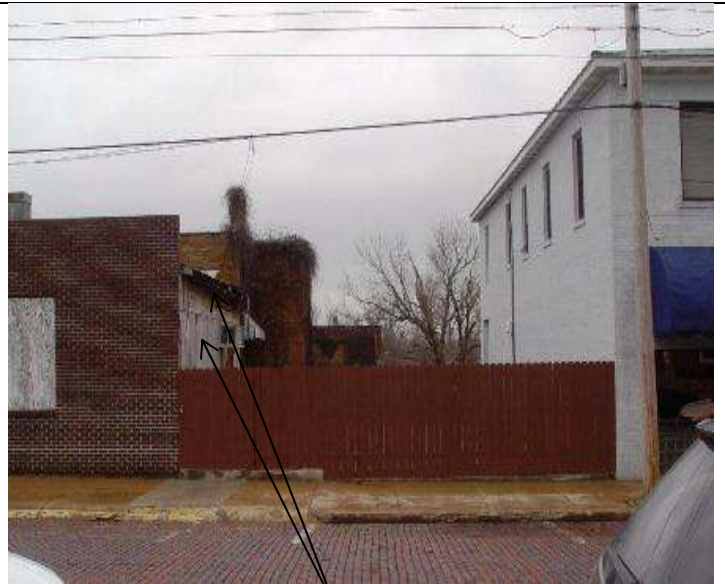
South elevation, deterioration of wood siding and roof rafters.

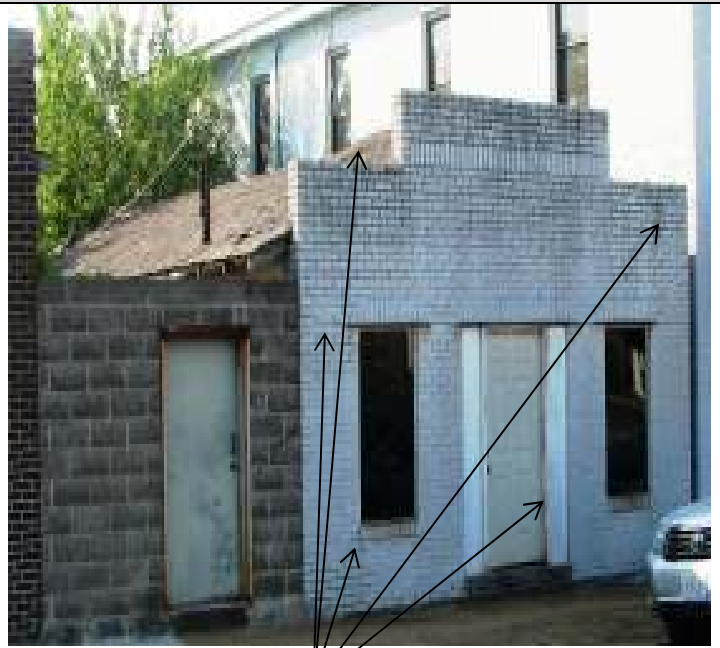
Façade (west) and north elevation, showing worn roof, deteriorated rafters, missing mortar, cracked brick, and weather door surround

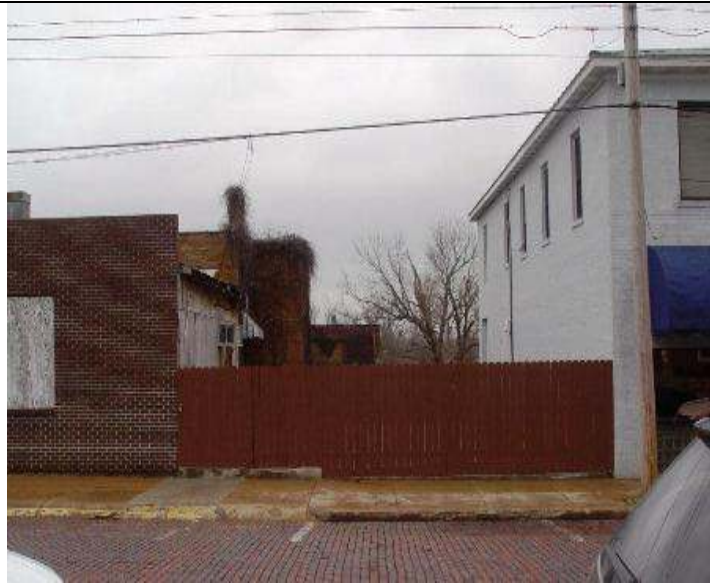
Showing lot where building once stood

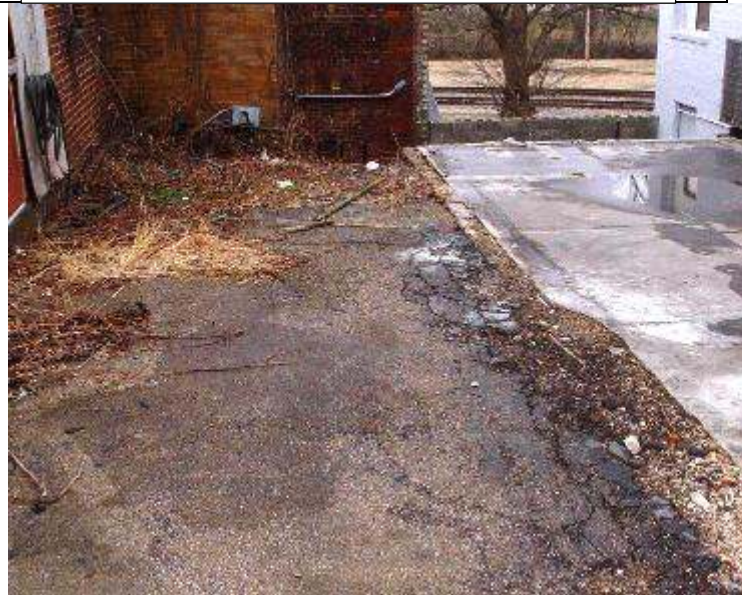
Showing the foundation and lot where building once stood

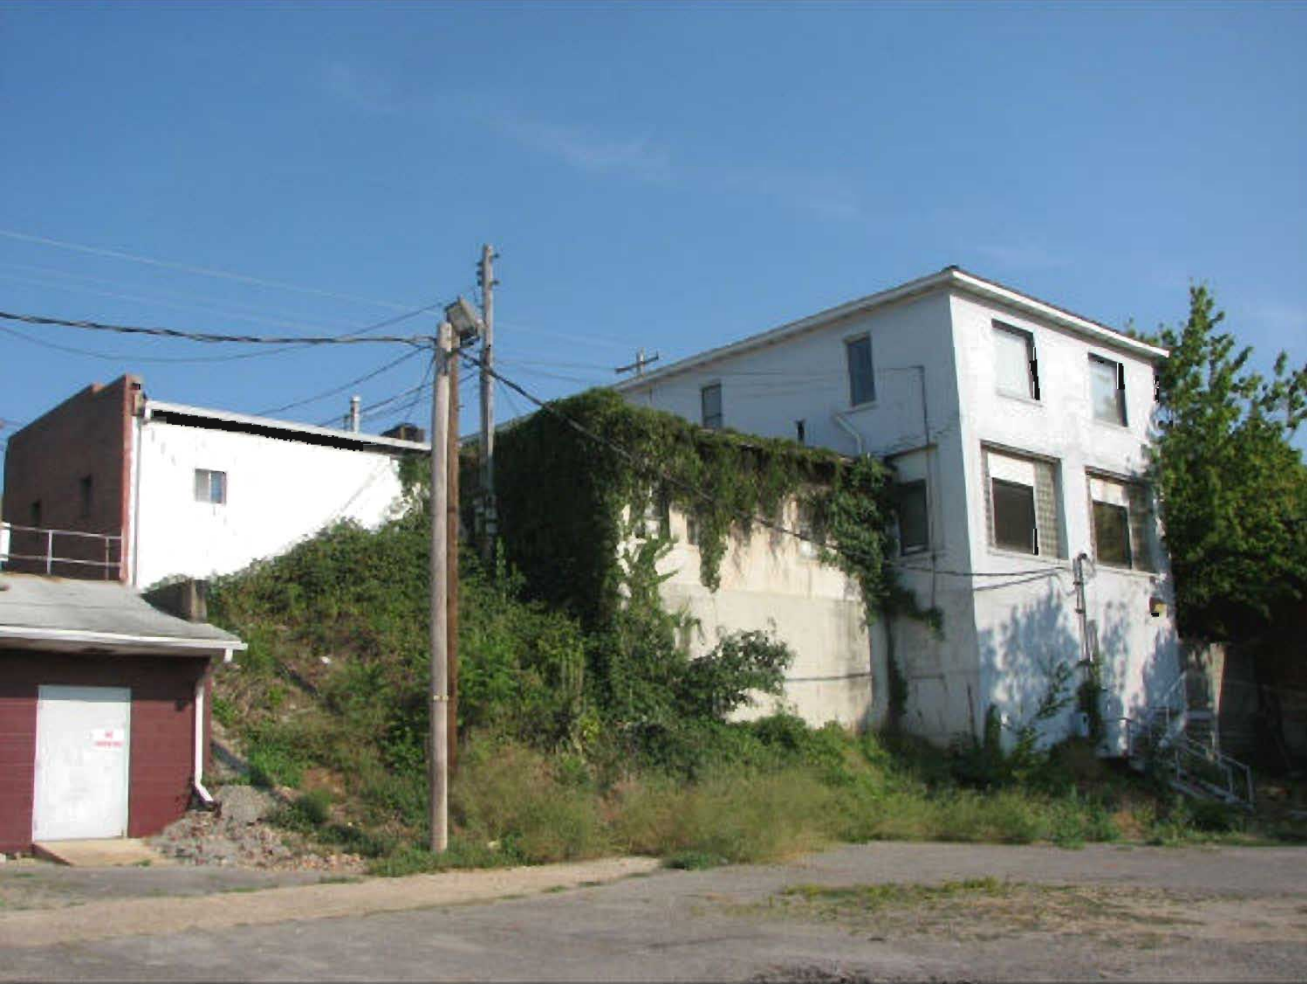
SURVEY NO. BU-AS-005-LUBC-022	
TOTAL SCORE OF OVERALL INTERIOR BUILDING CONDITION:	LOCATION: L1 – 1 ST FLOOR; L2- 2 ND FLOOR; L3 -3 RD FLOOR
12- EXCELLENT	6-8 – FAIR 0-4 - DILAPIDATED
9-11 – GOOD	1-3 - POOR

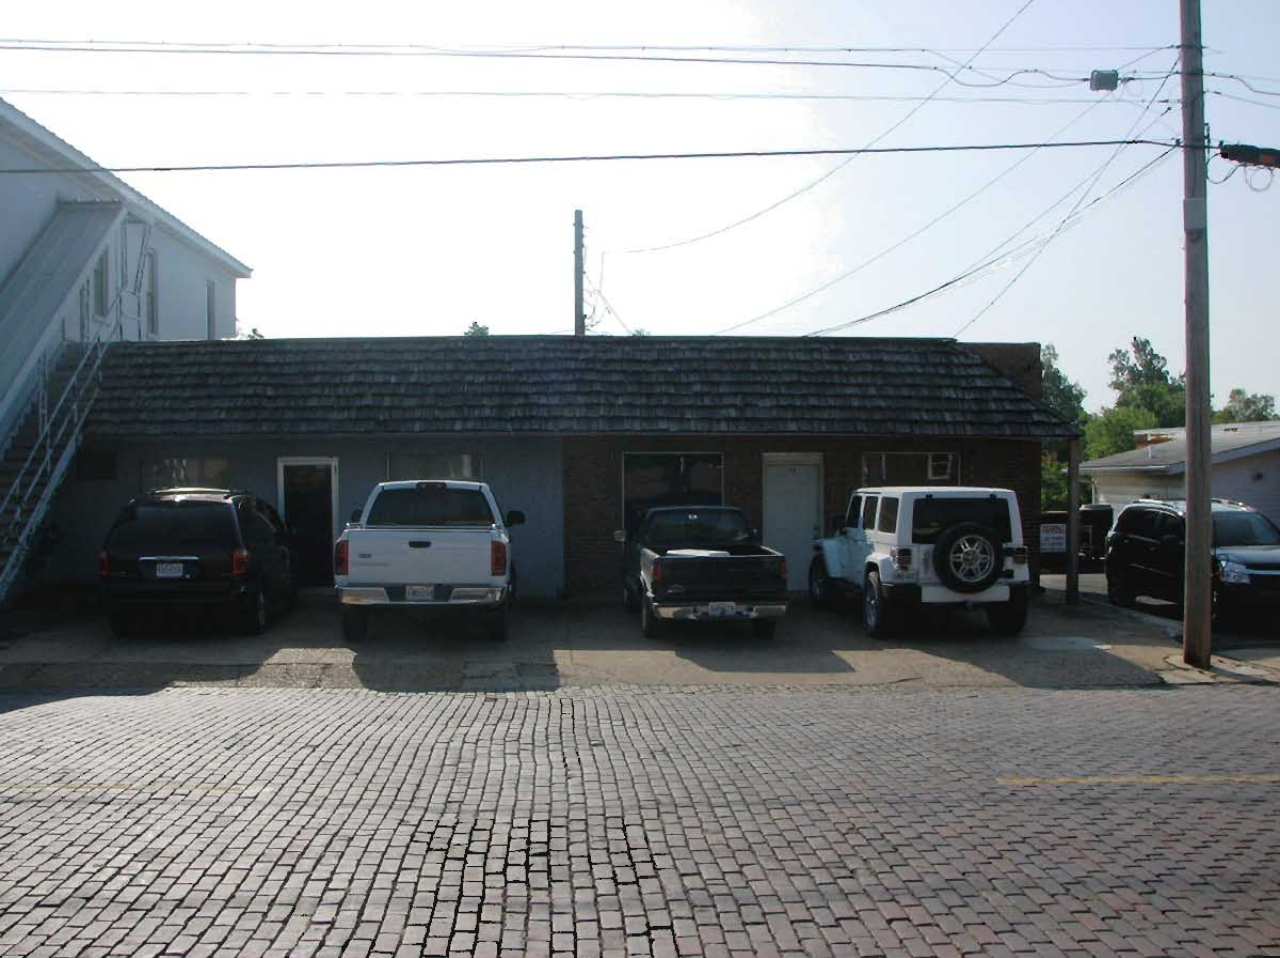
SURVEY NO. BU-AS-005-LUBC-023	
TOTAL SCORE OF OVERALL INTERIOR BUILDING CONDITION:	LOCATION: L1 – 1 ST FLOOR; L2- 2 ND FLOOR; L3 -3 RD FLOOR
12- EXCELLENT 6-8 – FAIR 0-4 - DILAPIDATED	
9-11 – GOOD 1-3 - POOR

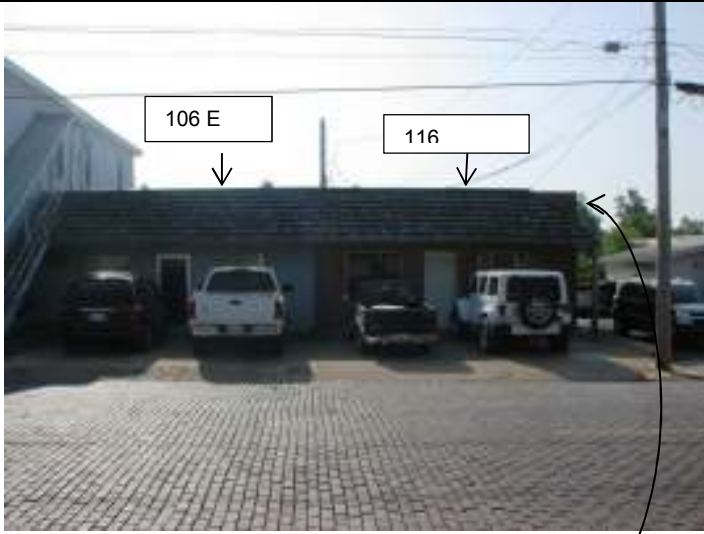
Façade (west) – showing crack in brick in upper corner

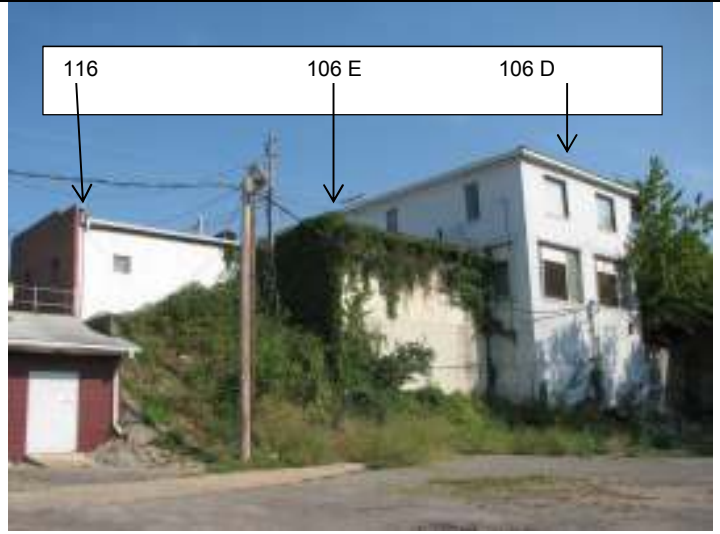
[Empty rectangular box for notes]

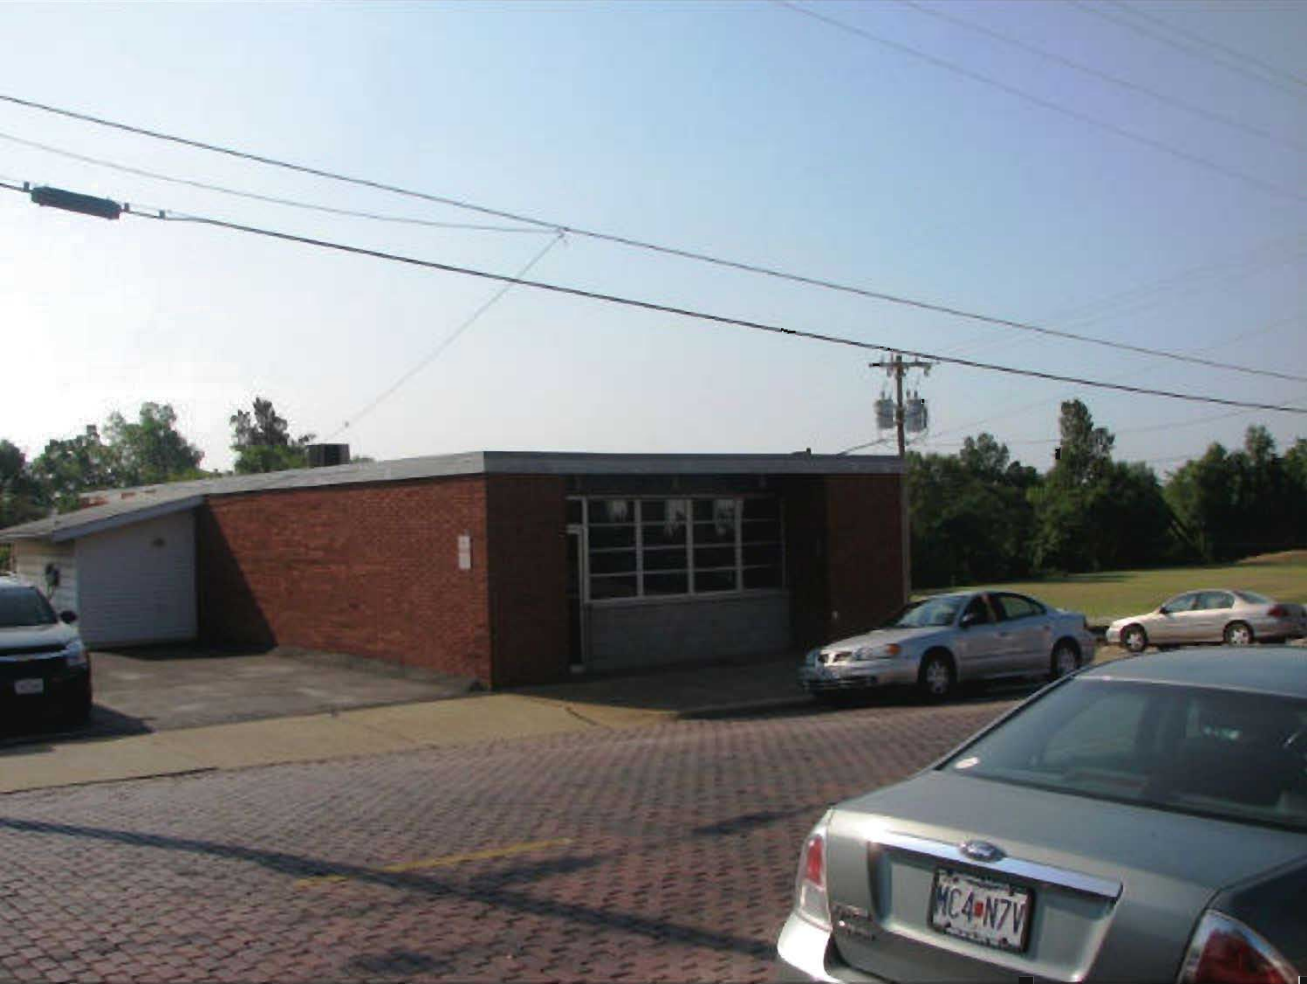
SURVEY NO. BU-AS-005-LUBC-044

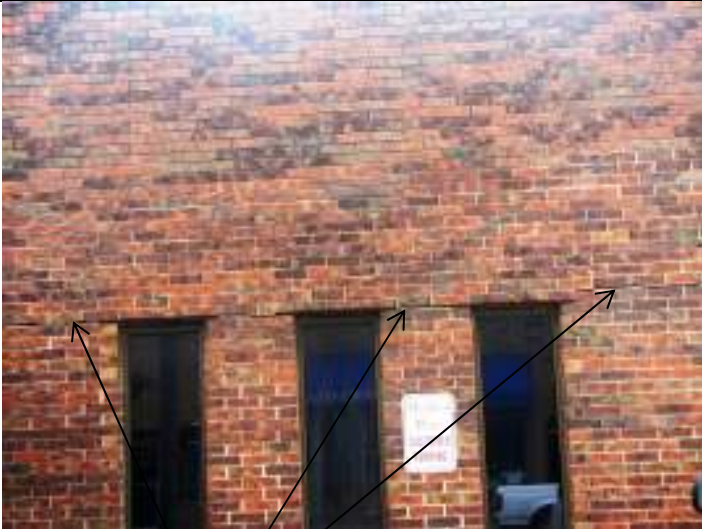
Showing missing mortar

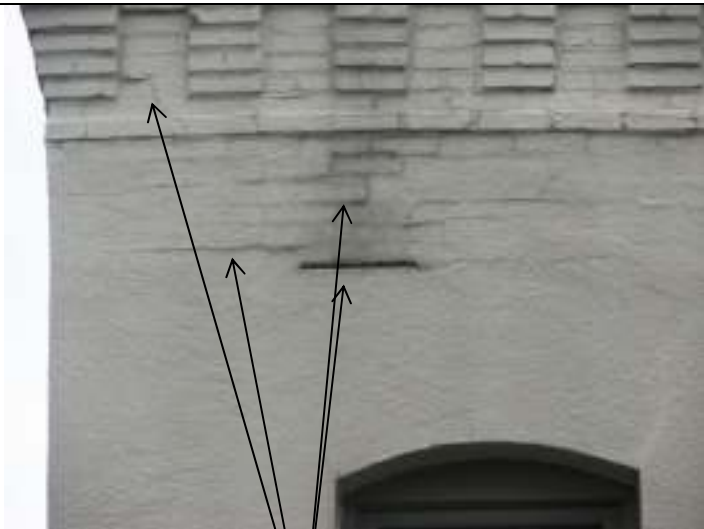
North elevation showing cracked stucco and missing stucco, with possible missing mortar

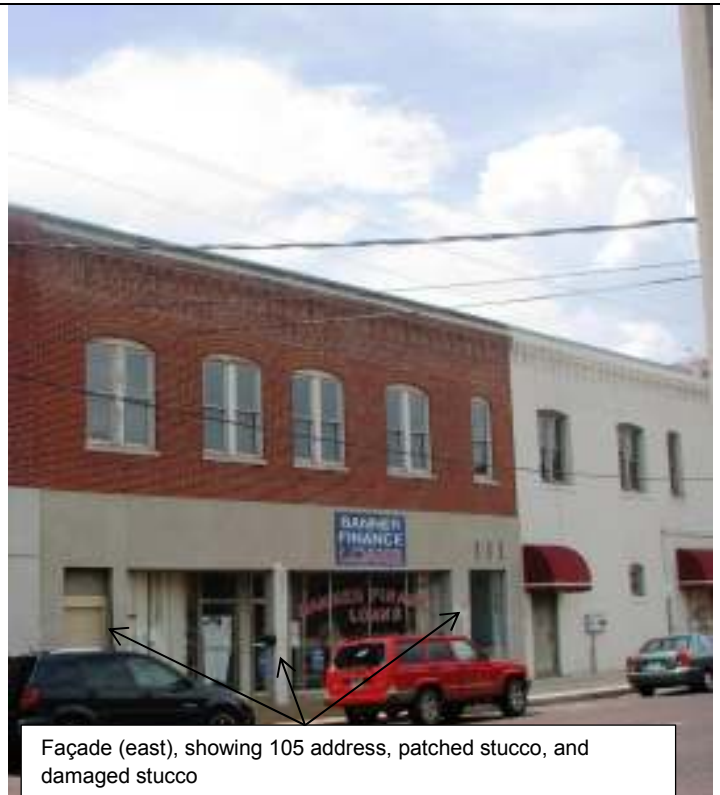
Façade (east), showing 105 address, patched stucco, and damaged stucco

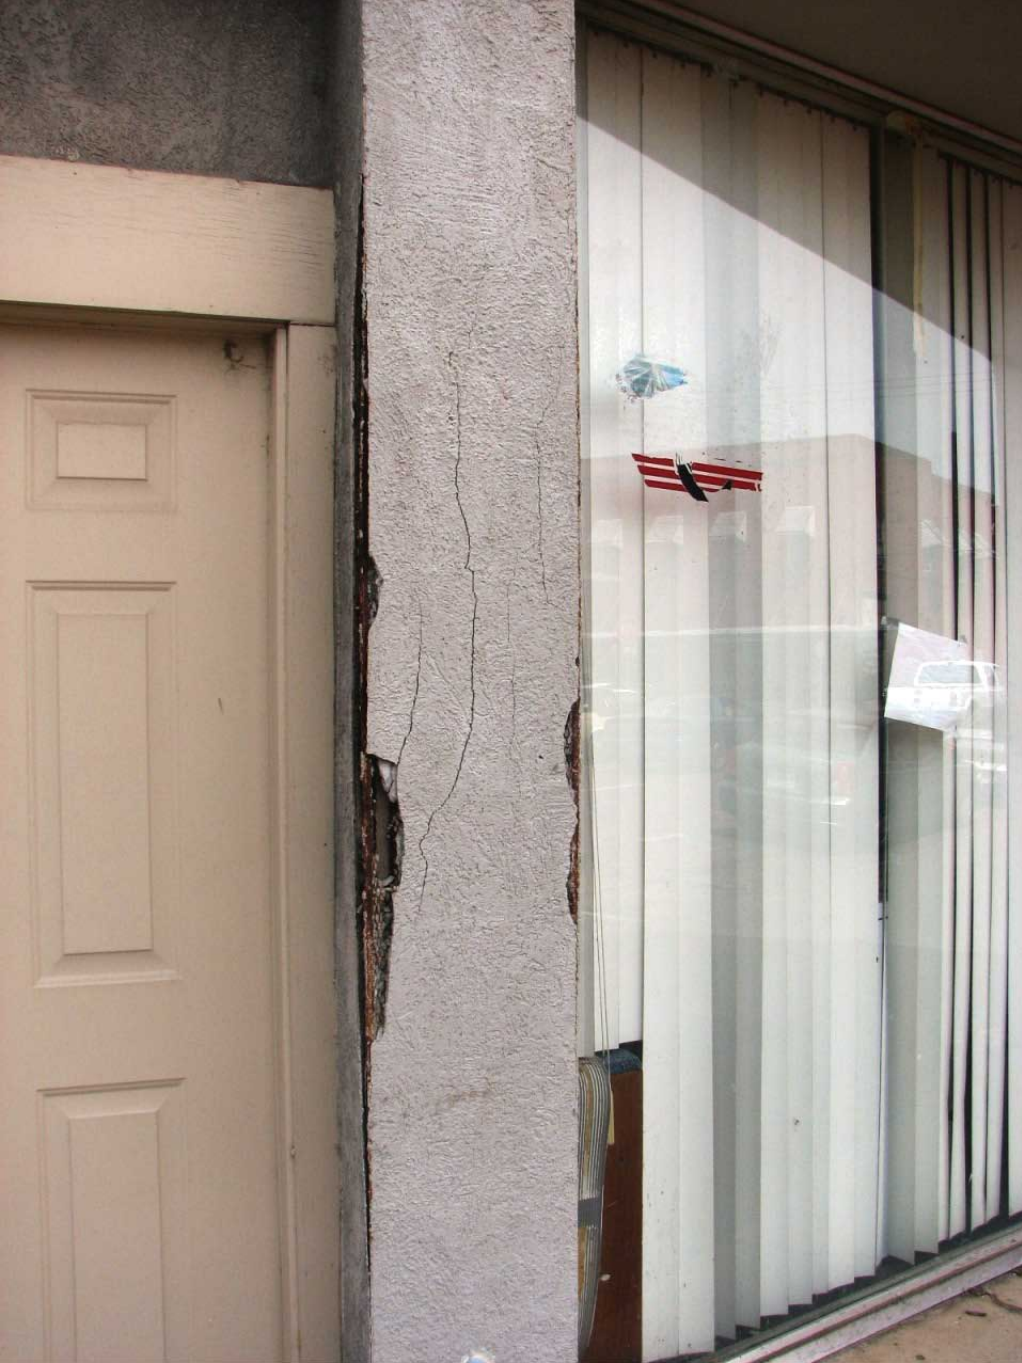
SURVEY NO. BU-AS-005-LUBC-042

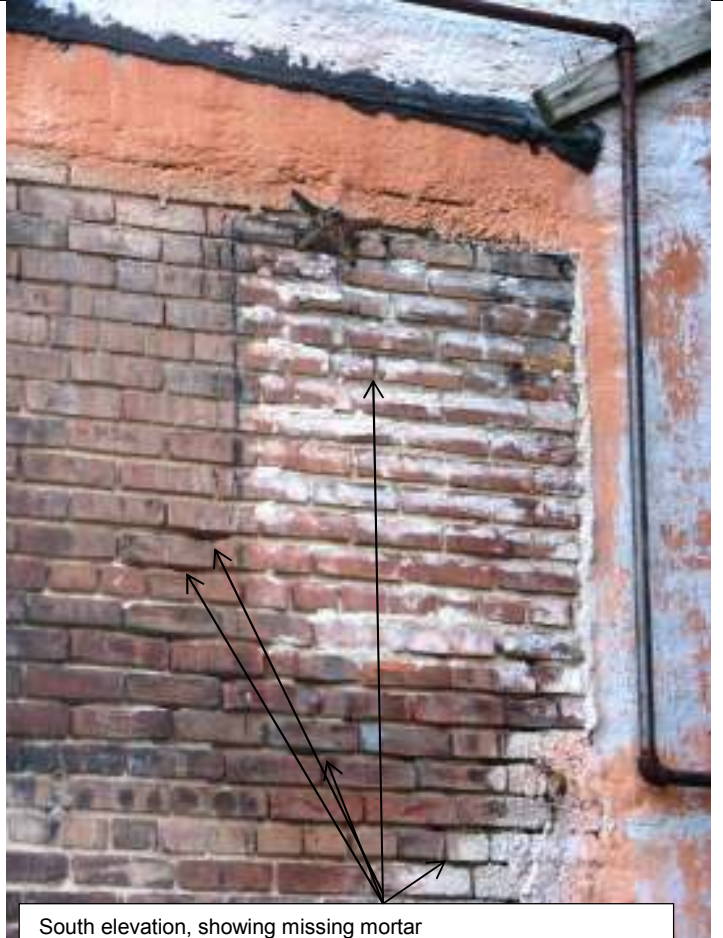
South elevation, showing missing mortar

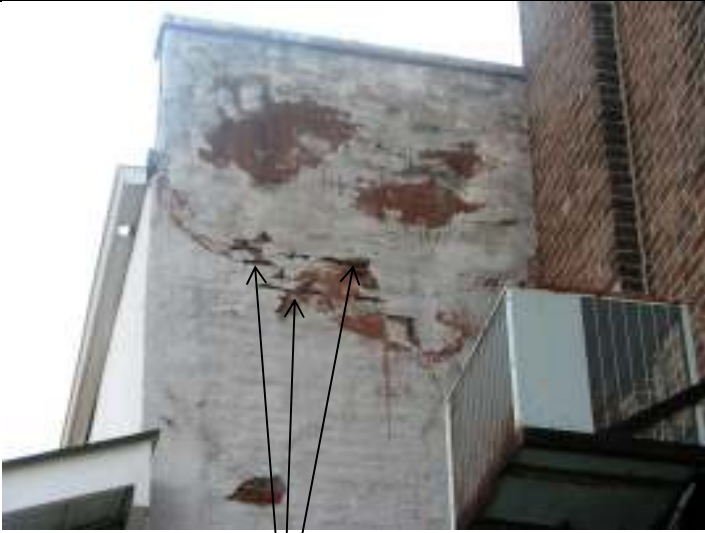
South elevation, missing mortar

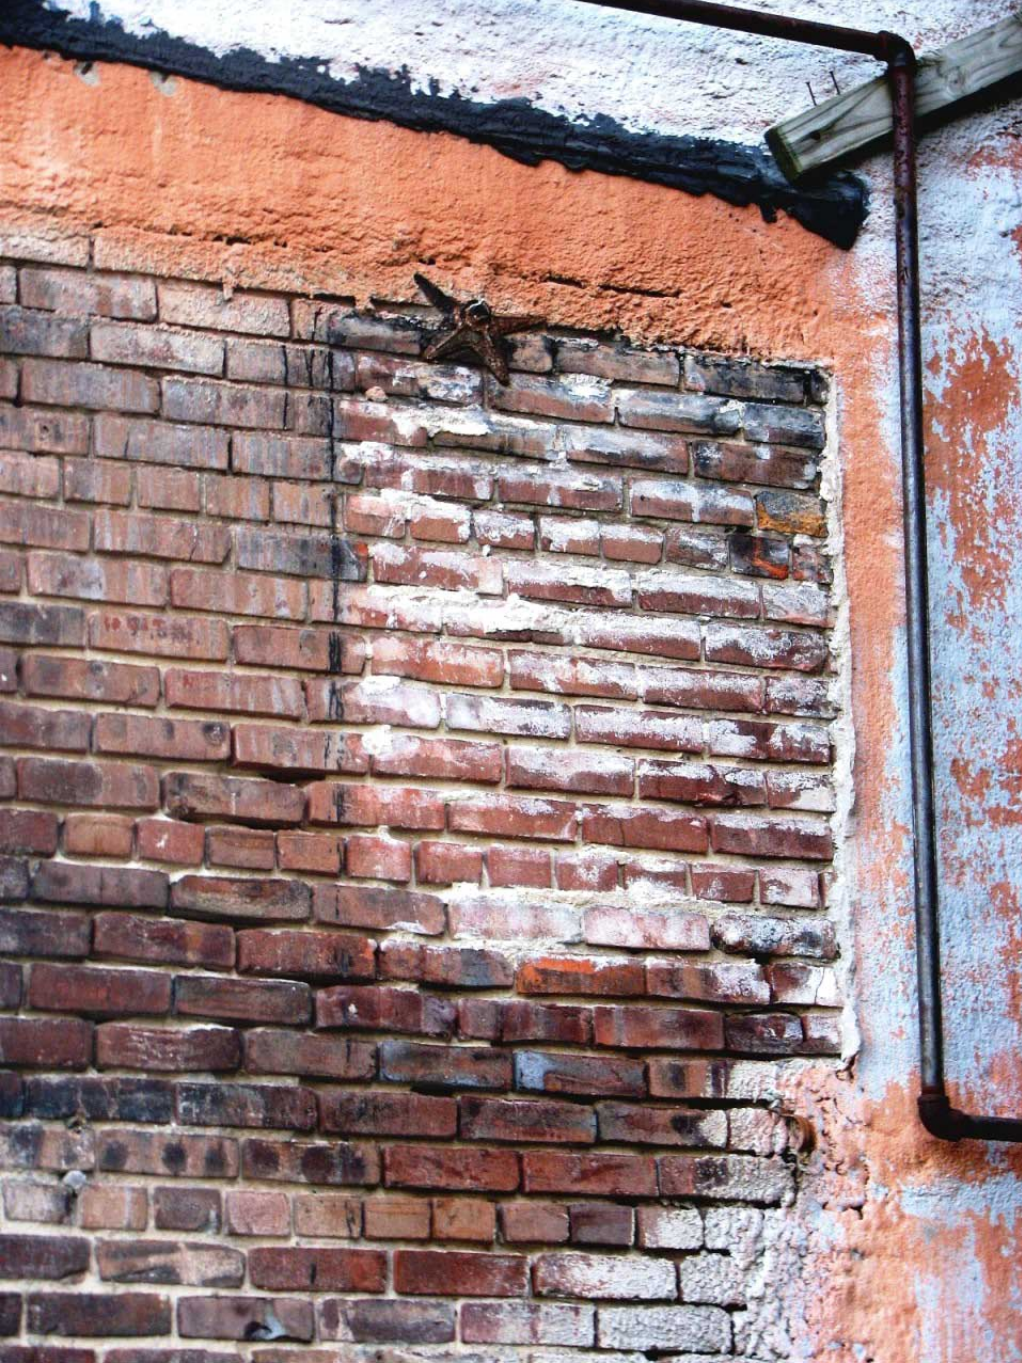
SURVEY NO. BU-AS-005-LUBC-041

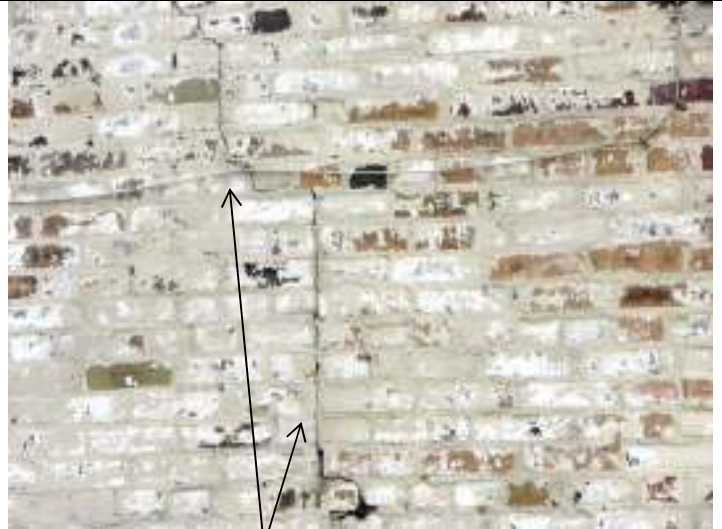
West elevation, showing crack in brick wall surface

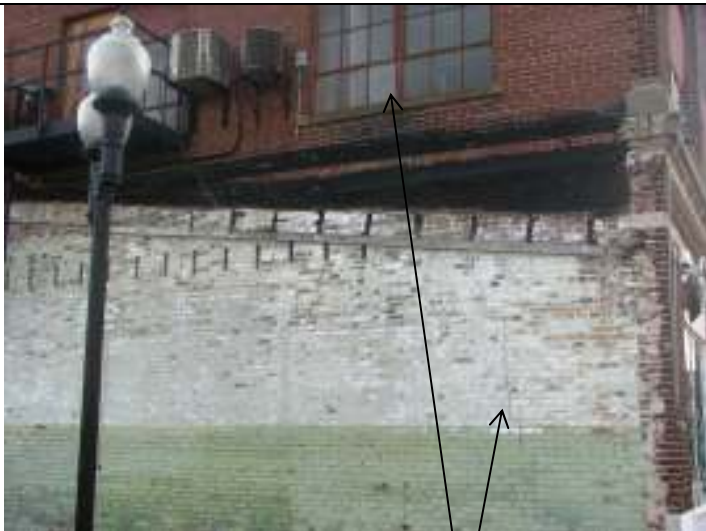
West elevation, showing area of crack, and worn/weathered metal window frame

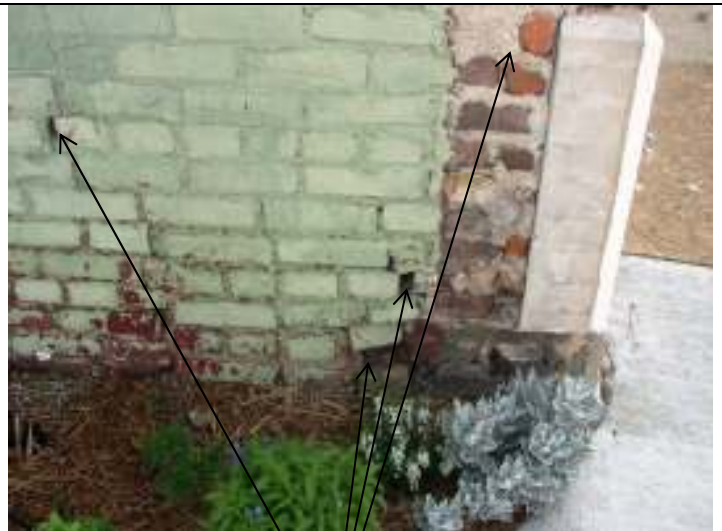
Southwest corner, showing missing and loose brick, improper mortar repair

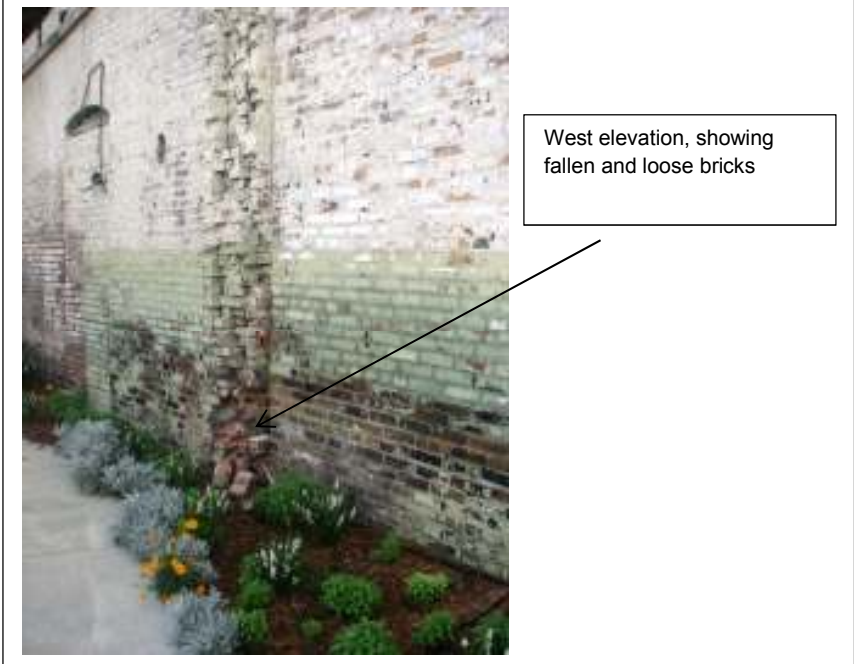
SURVEY NO. BU-AS-005-LUBC-041

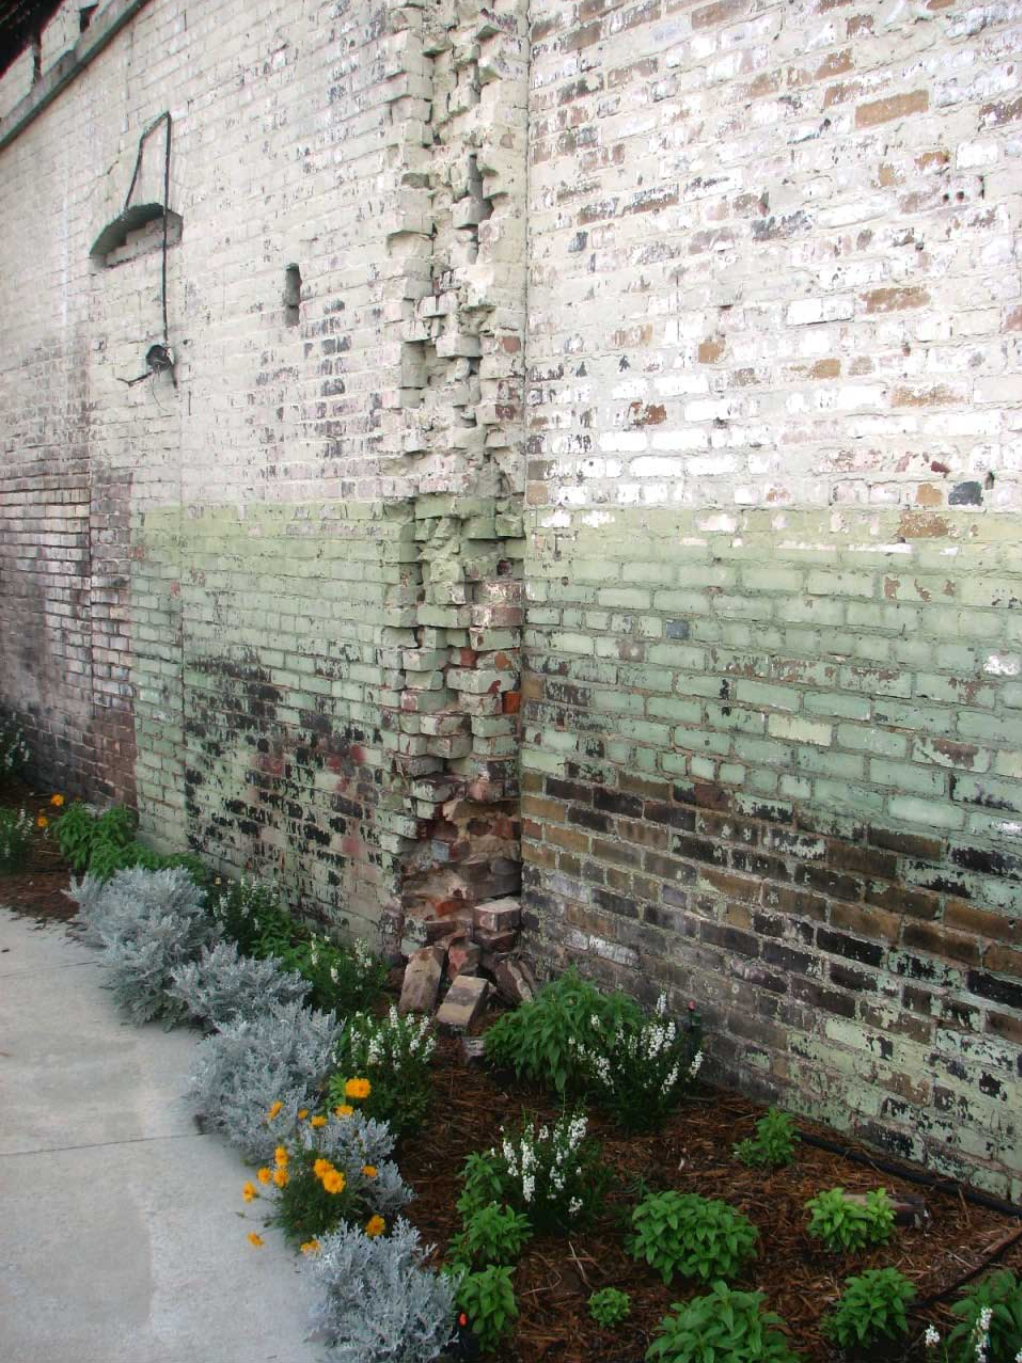
SURVEY NO. BU-AS-005-LUBC-040

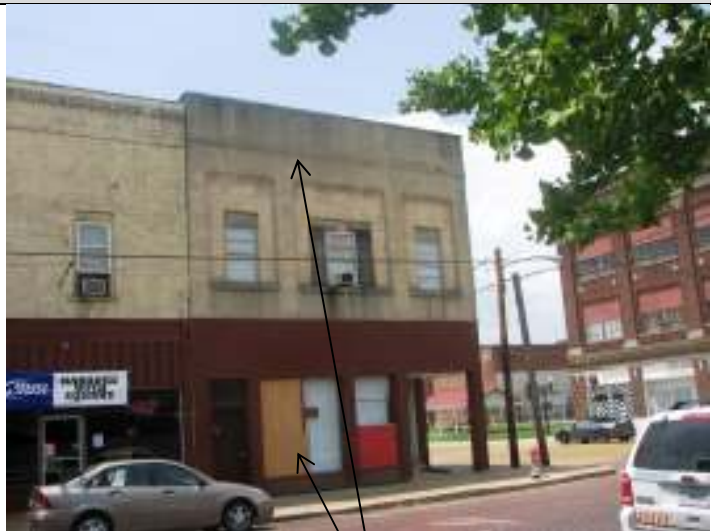
Façade (east), showing weathered stucco, and missing windows

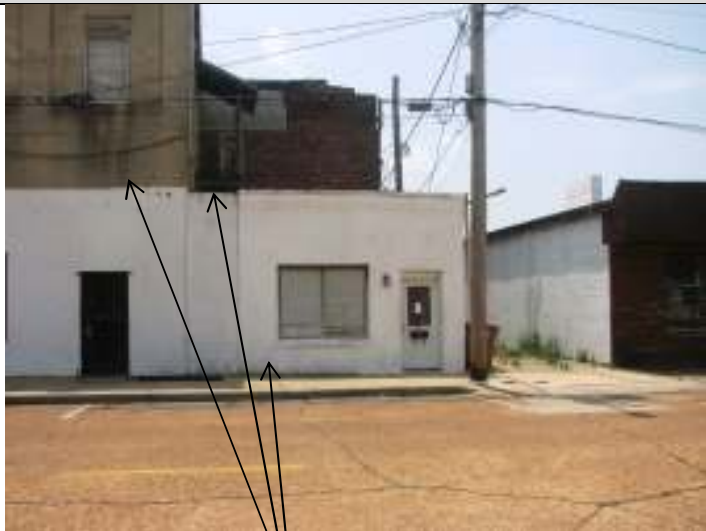
North and west elevation, showing weathered stucco and porch; attached building with address of 408 Poplar St.

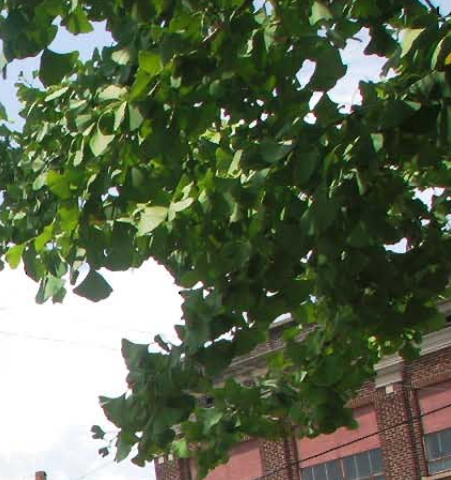
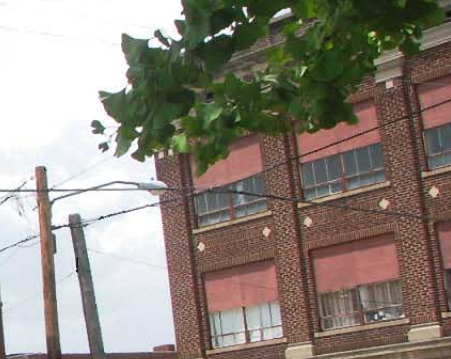
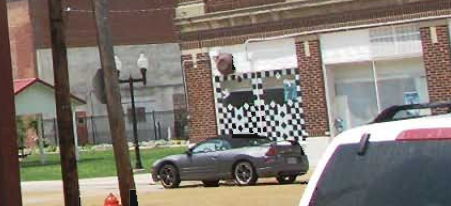
SURVEY NO. BU-AS-005-LUBC-039

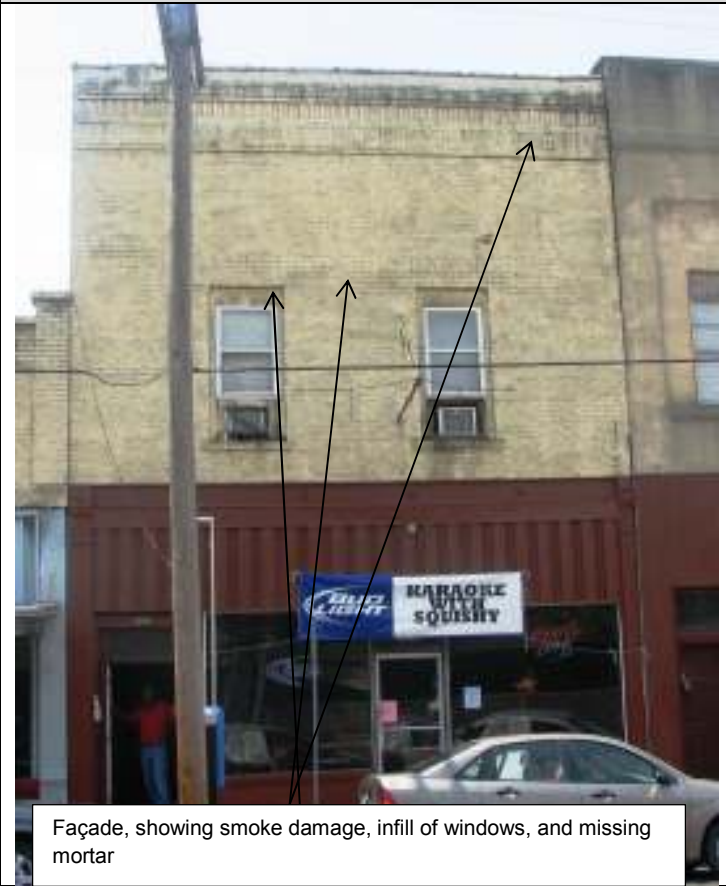
Façade, showing smoke damage, infill of windows, and missing mortar

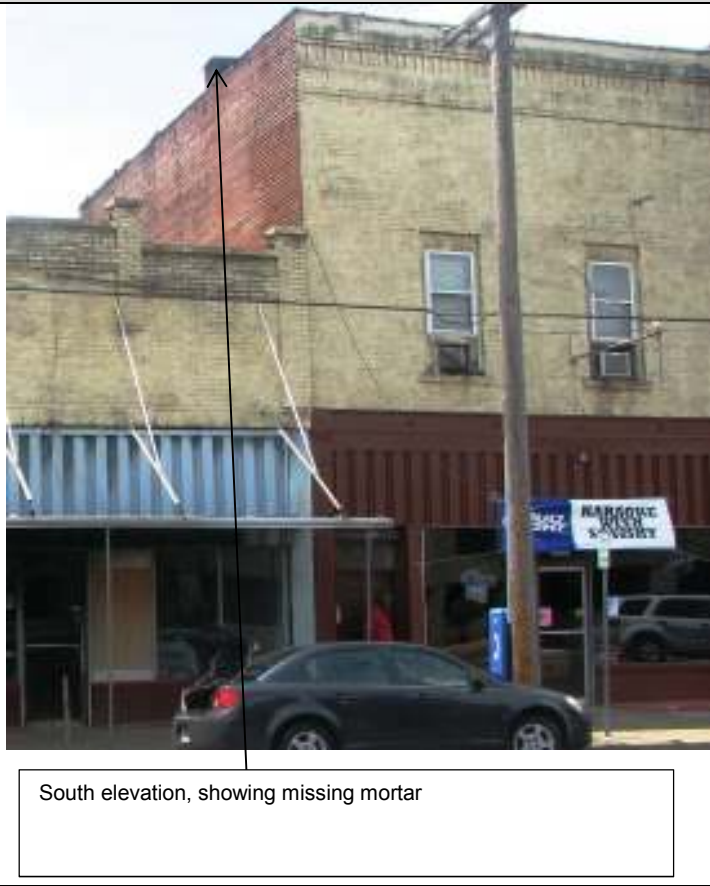
South elevation, showing missing mortar

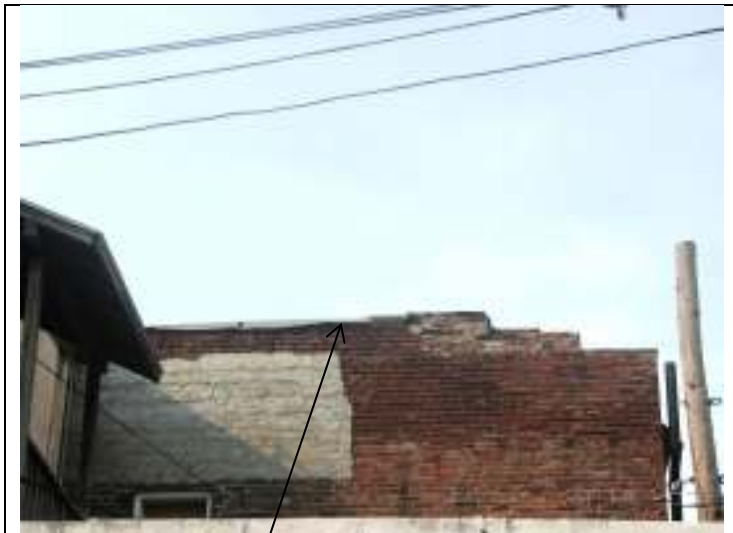
North, showing bend and loose metal coping

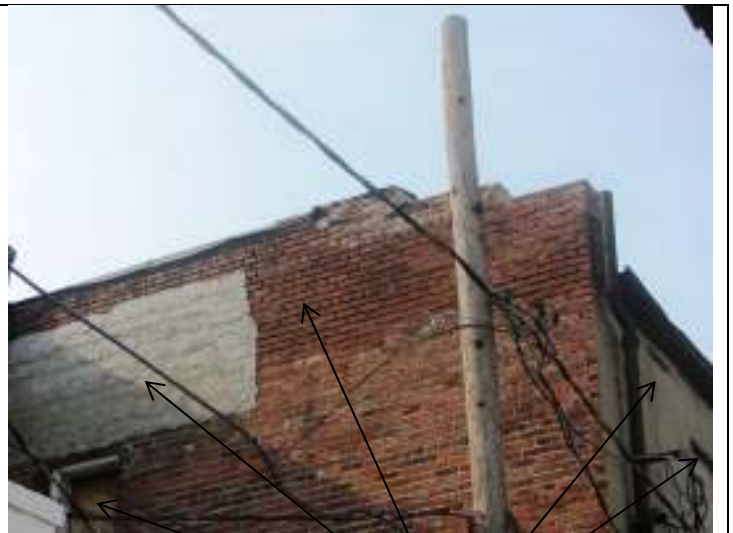
North and west elevation, showing missing mortar, missing window, infilled window, repair of brick with concrete and missing brick

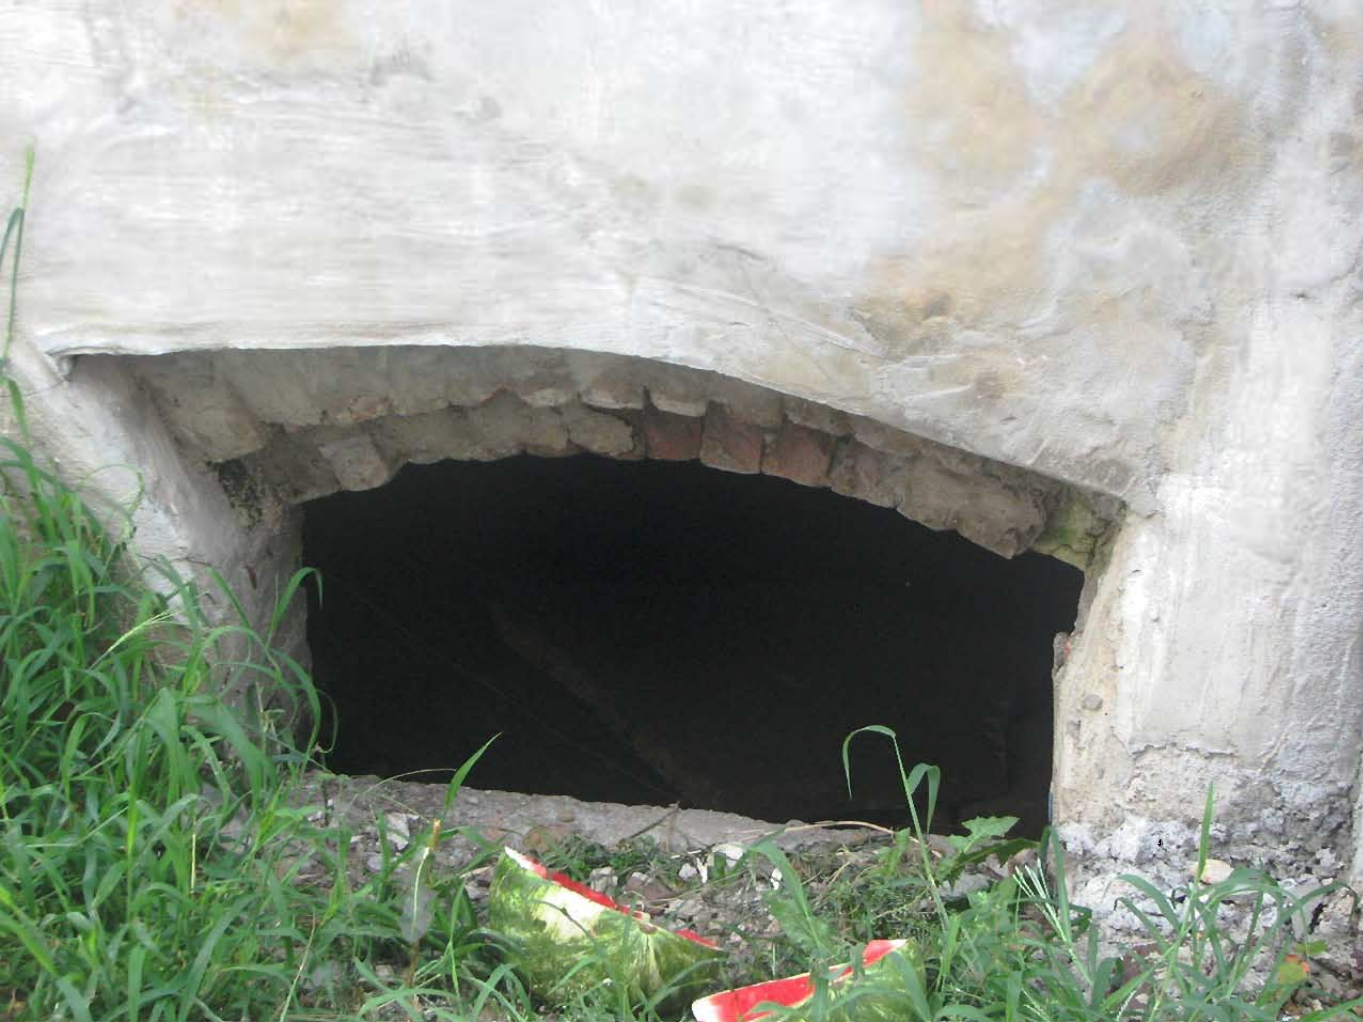
SURVEY NO. BU-AS-005-LUBC-038

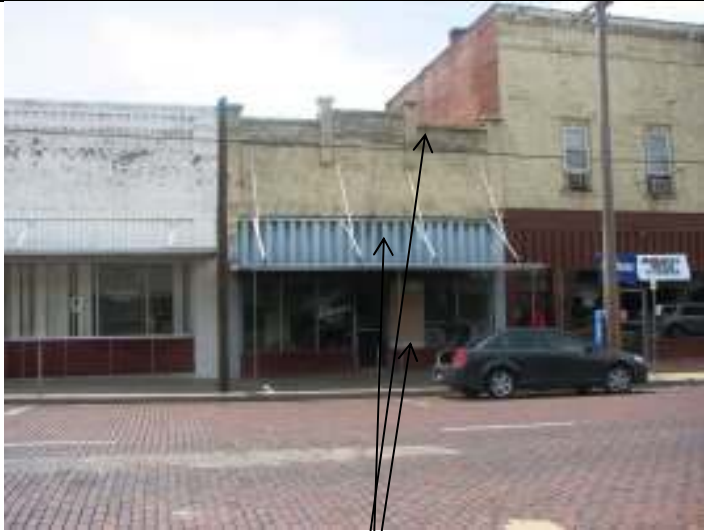
Façade (east), showing smoke damage on brick wall surface and awning, and missing store front window

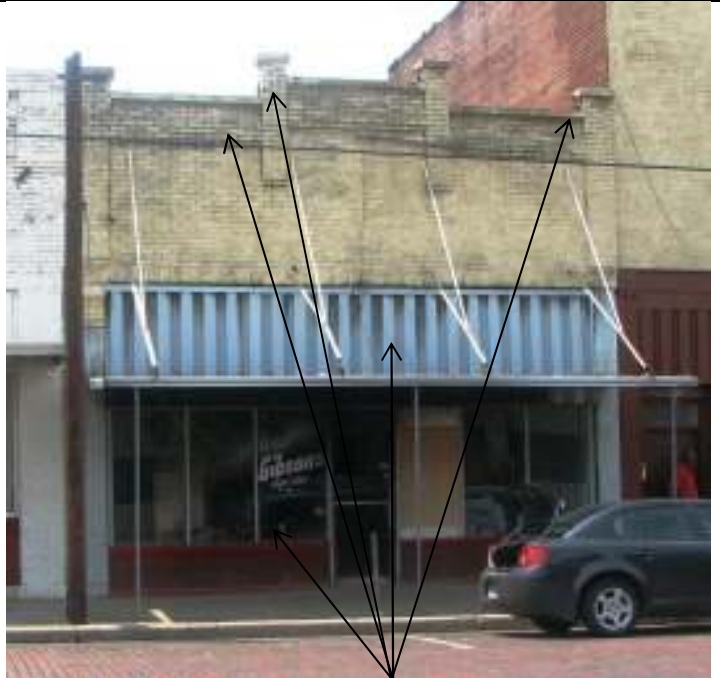
Façade, showing cracked window, missing mortar, and loose wires
