TOTAL COMPONENT RATING	
------------------------	--

29. SMOKE DETECTORS: <input type="checkbox"/> YES <input type="checkbox"/> NO	30. CARBON MONOXIDE DETECTORS: <input type="checkbox"/> YES <input type="checkbox"/> NO	
PARKING

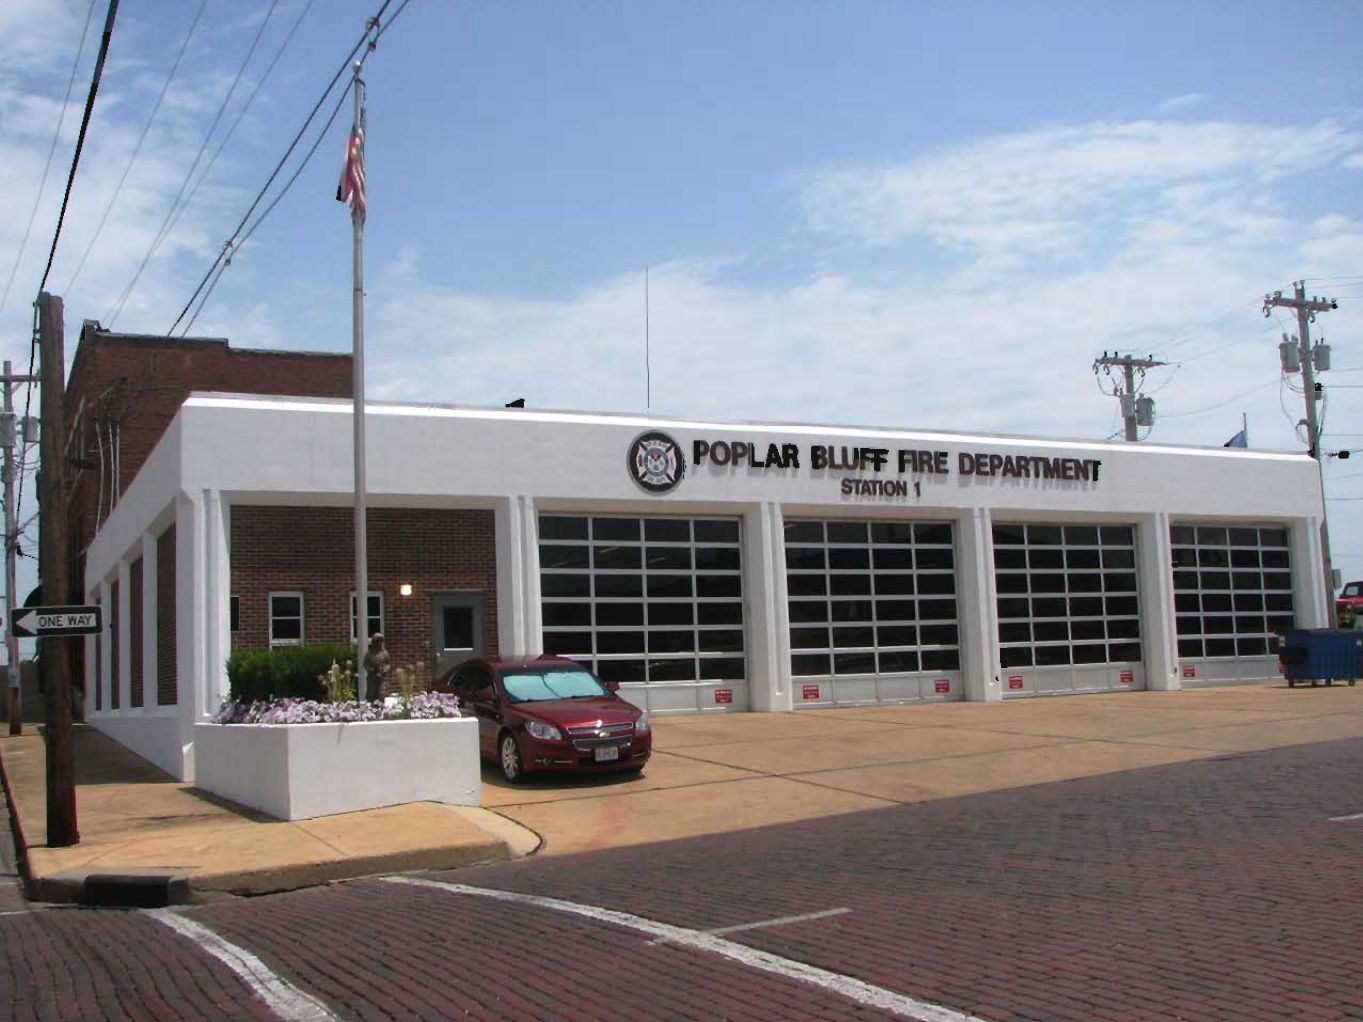
SURVEY NO. BU-AS-005-LUBC-036

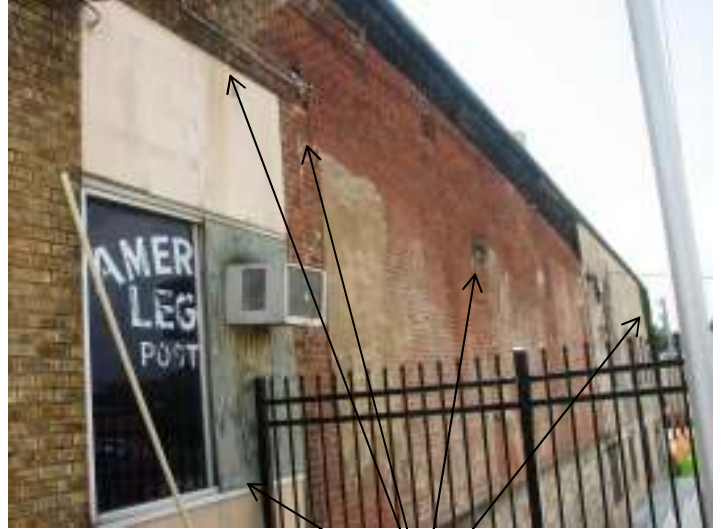
North elevation, showing crack in brick wall, boarded window, mortar issues, and vegetation on wall surface

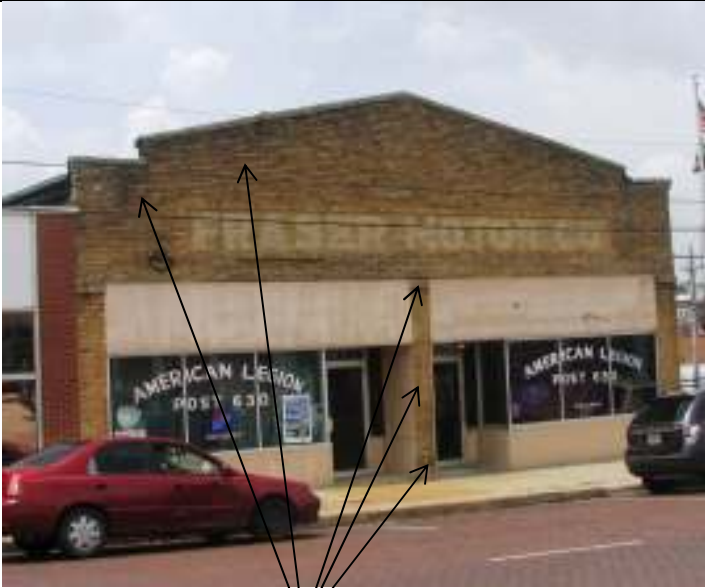
Façade, showing mortar issues

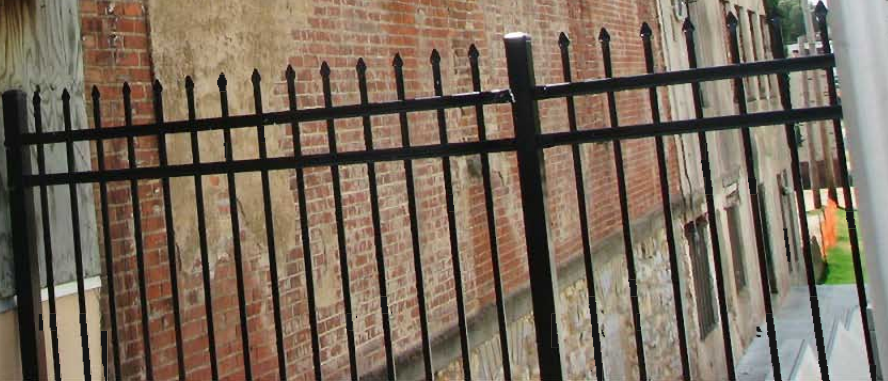
SURVEY NO. BU-AS-005-LUBC-035

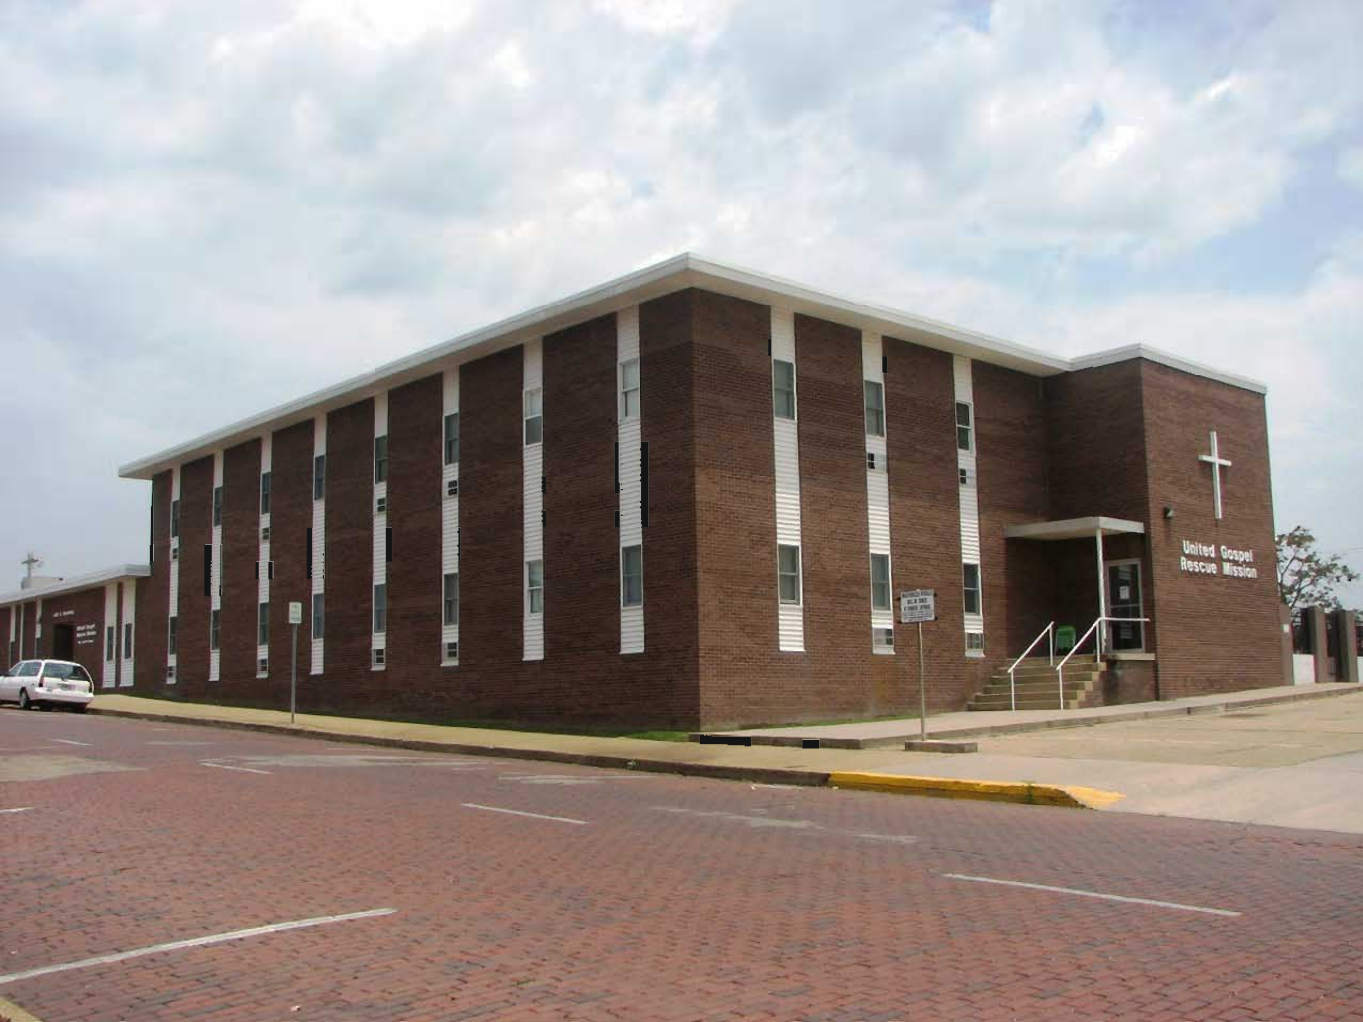
United Gospel
Rescue Mission

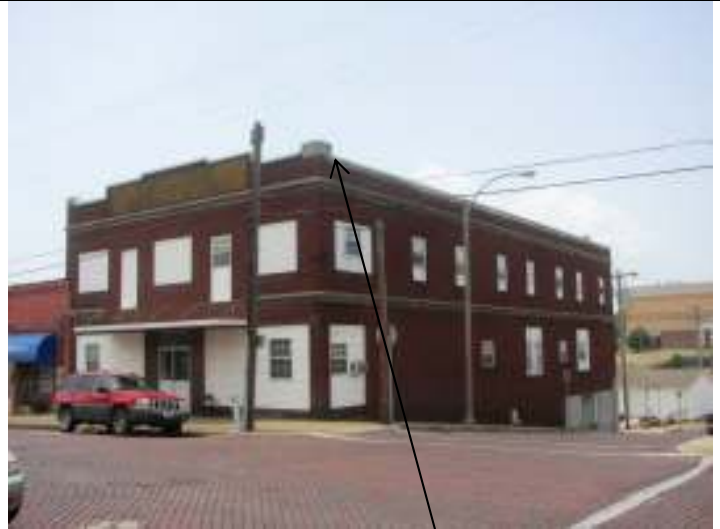
Façade and north elevation, showing improper re-pointing of brick and infill of windows

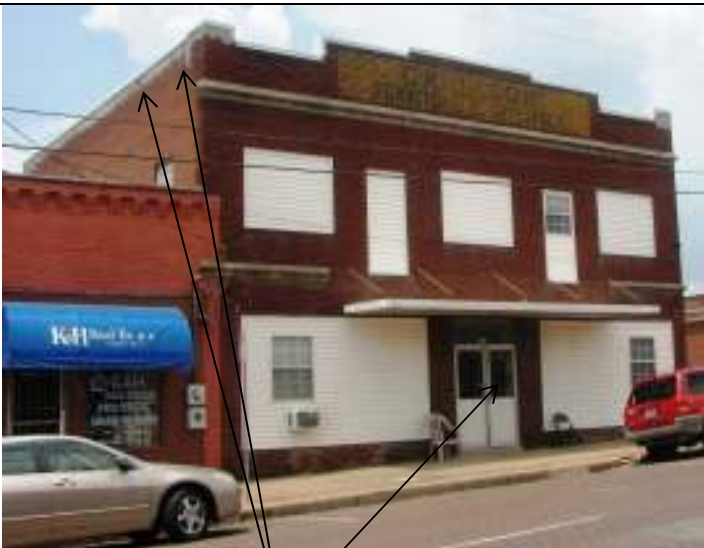
Façade and south elevation, showing improper re-pointing of the brick, missing brick, broken window in door, and enclosed window openings

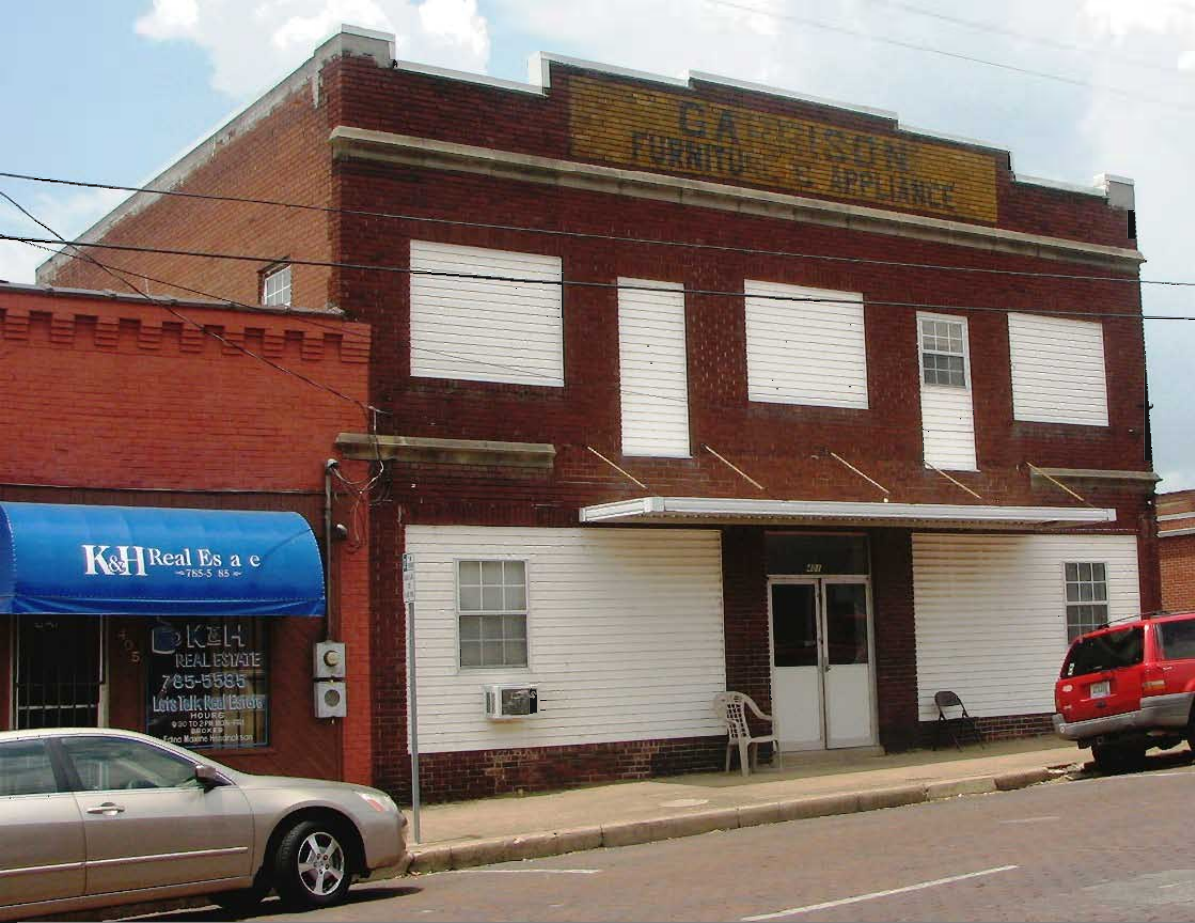
SURVEY NO. BU-AS-005-LUBC-033

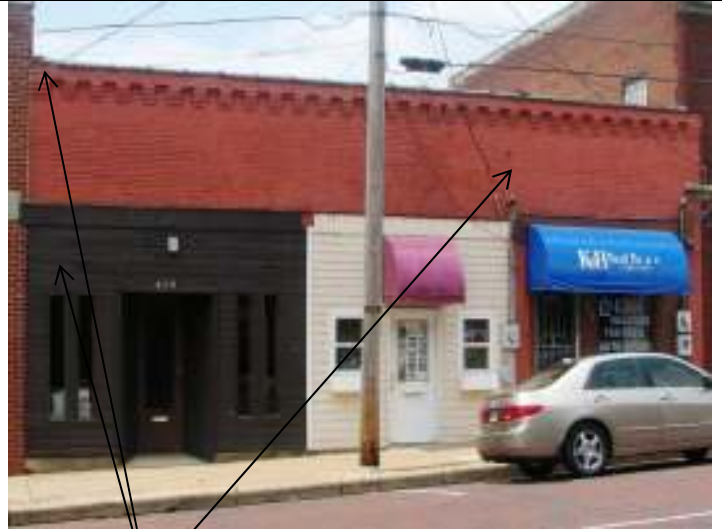
Façade, showing loose wood siding, loose (trim) coping, and areas of cracks in mortar

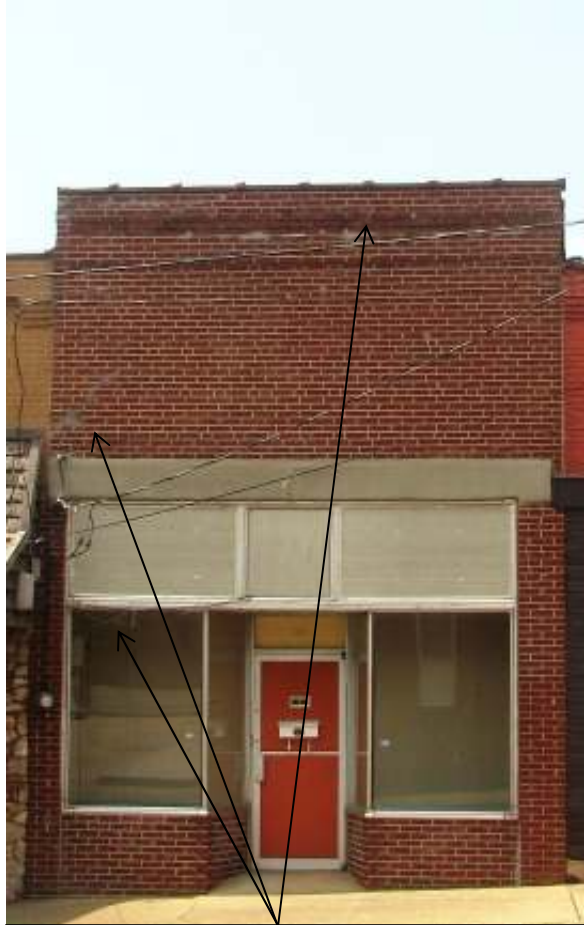
Façade, showing hanging wire, mortar repair of crack, and weathering of mortar

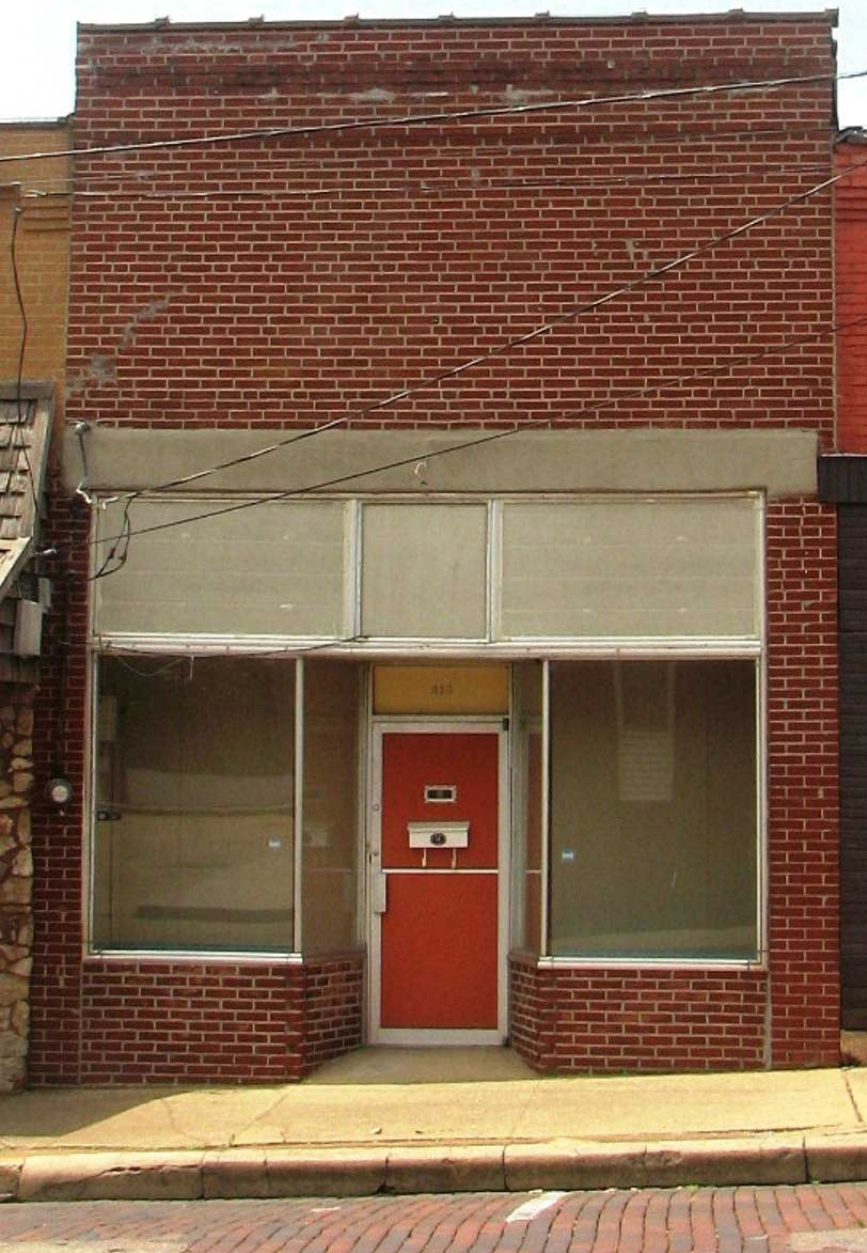
SURVEY NO. BU-AS-005-LUBC-031

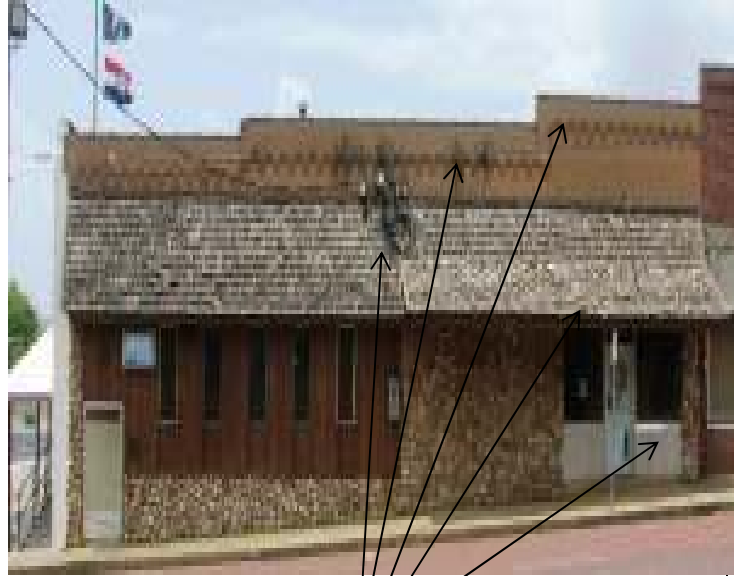
Façade, showing dent in bulkhead, loose/missing shingles, discolored bricks, wires/cables and cracks in brick wall surface.

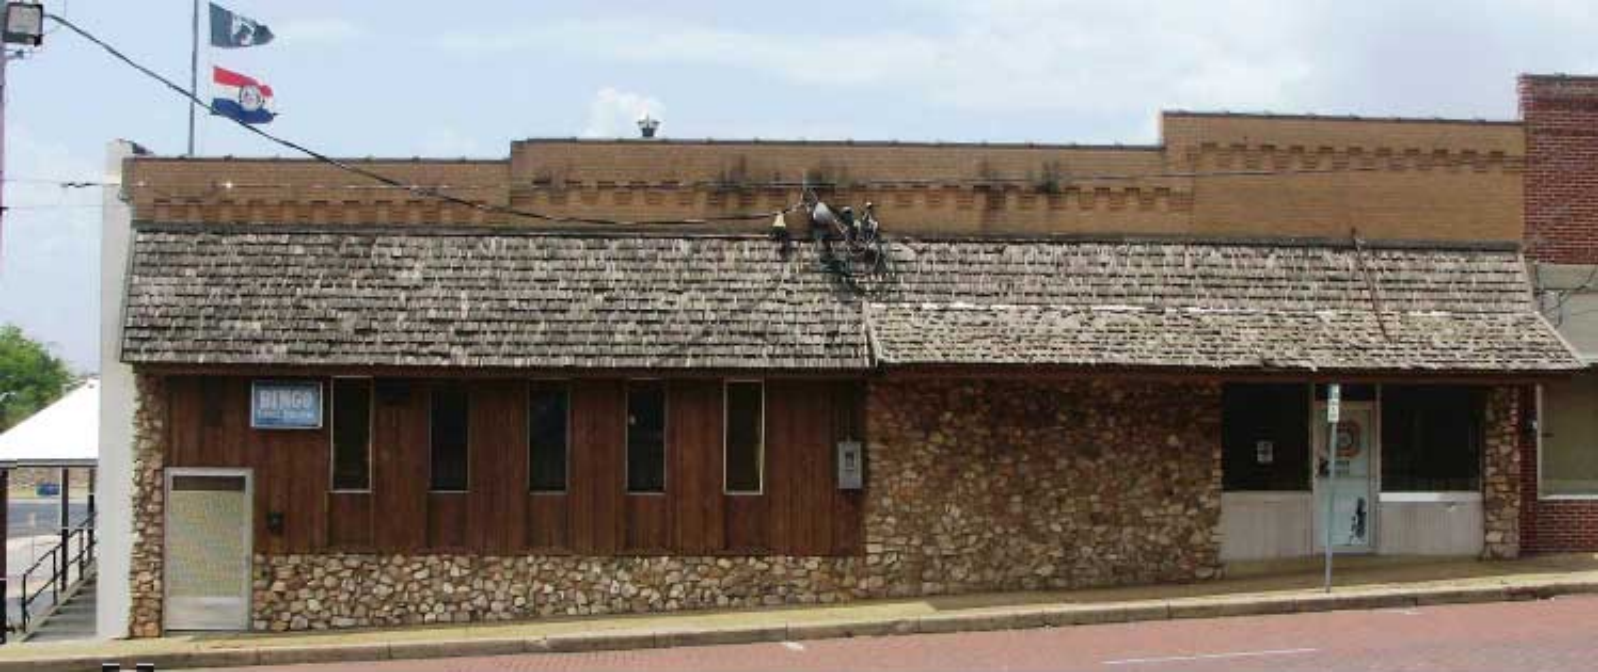
SURVEY NO. BU-AS-005-LUBC-062

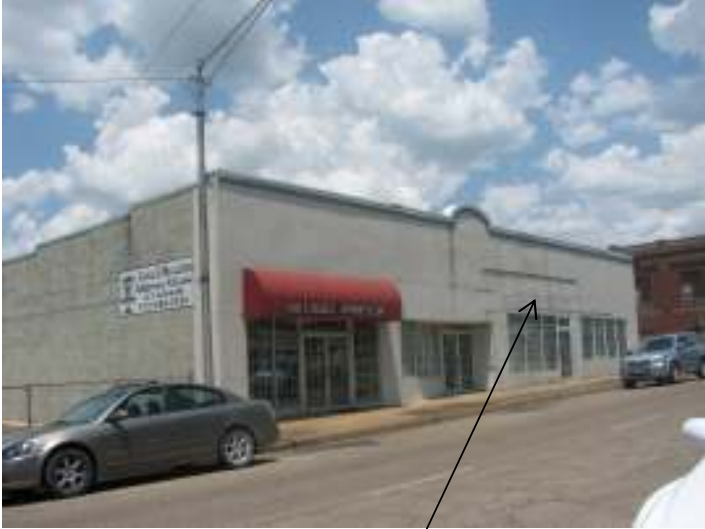
Façade (east), showing missing awning cover

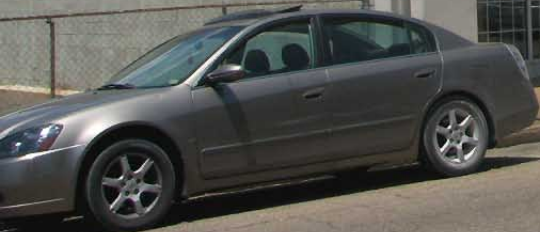
SURVEY NO. BU-AS-005-LUBC-065

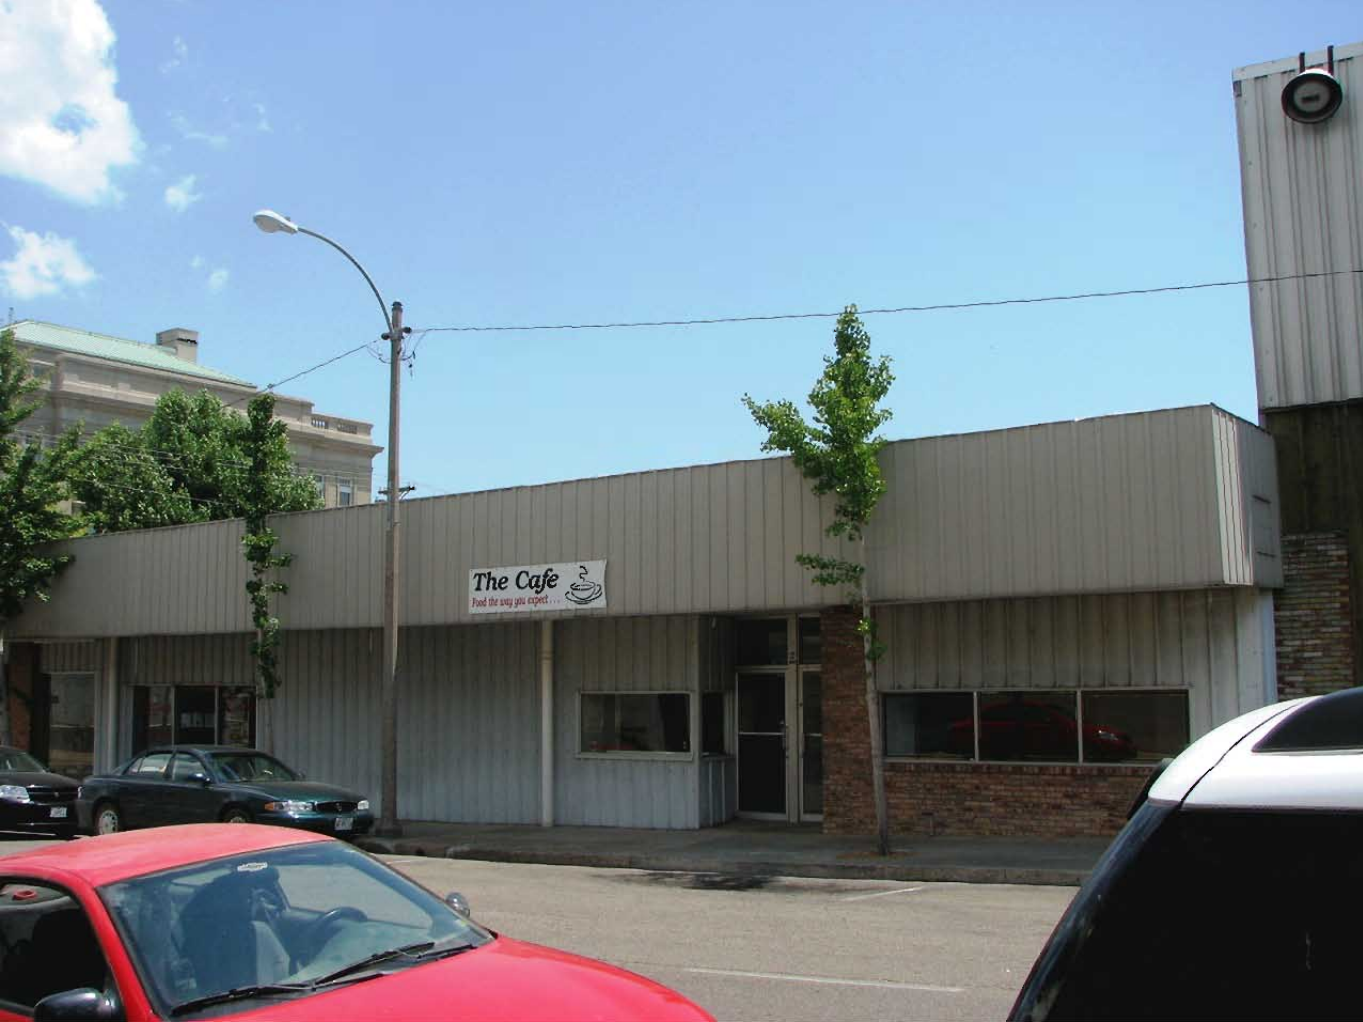
SURVEY NO. BU-AS-005-LUBC-062

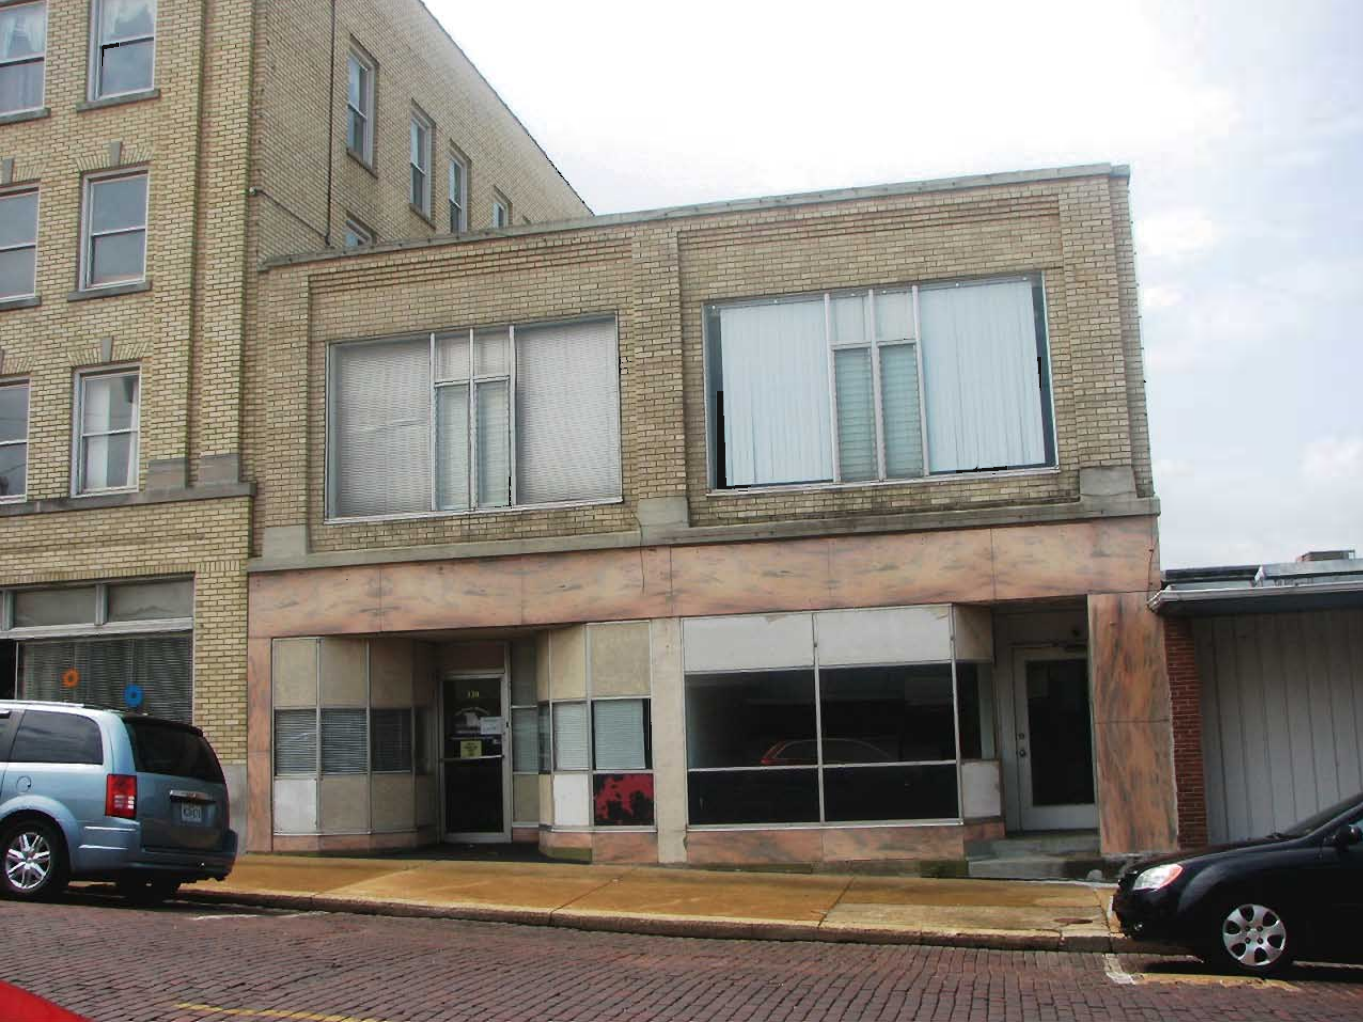
SURVEY NO. BU-AS-005-LUBC-061

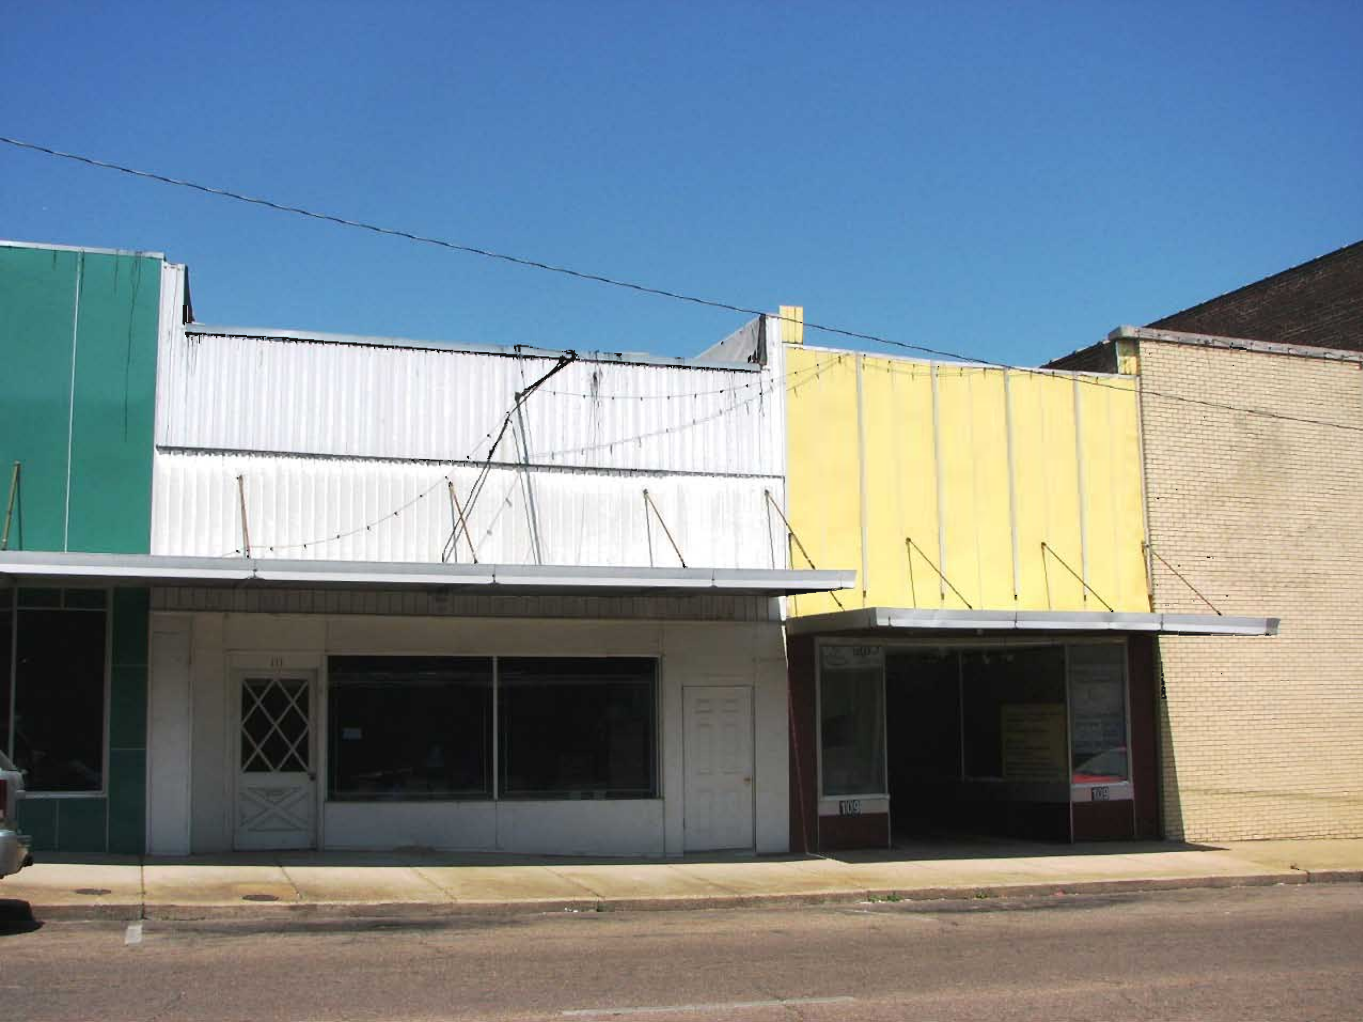
SURVEY NO. BU-AS-005-LUBC-060

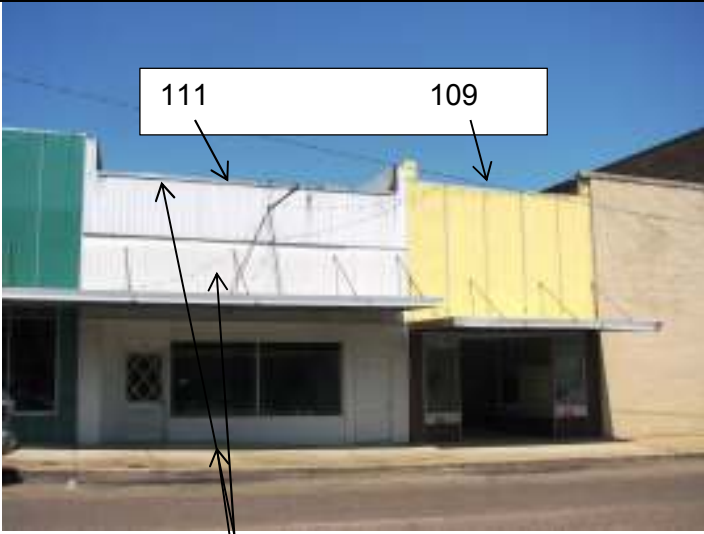
Façade (east), showing weathered wood siding, bent metal coping, loose hanging lights

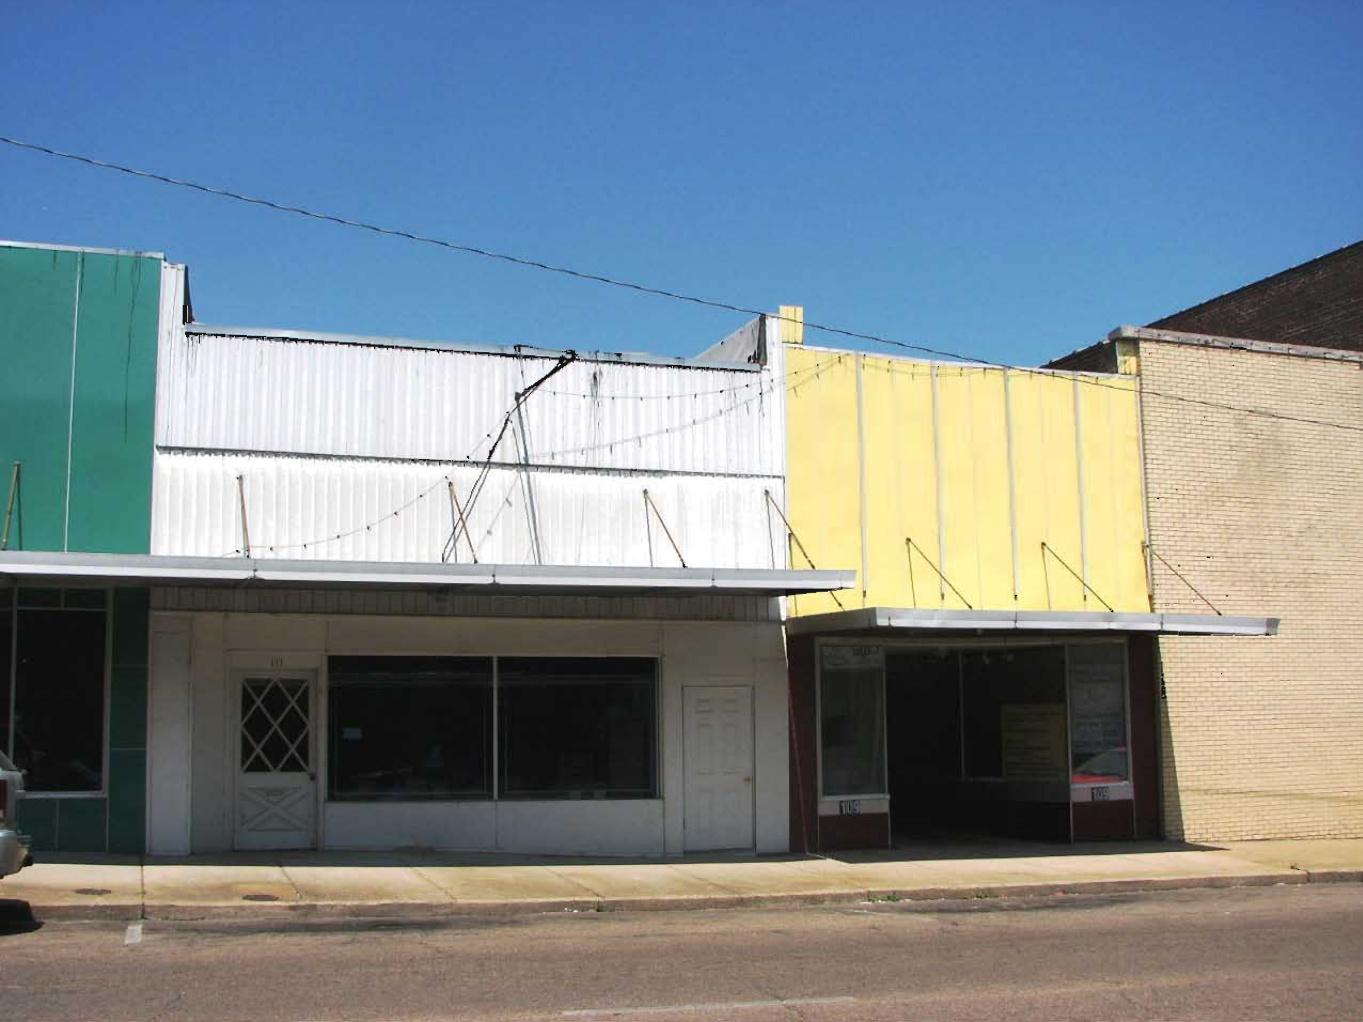
SURVEY NO. BU-AS-005-LUBC-066

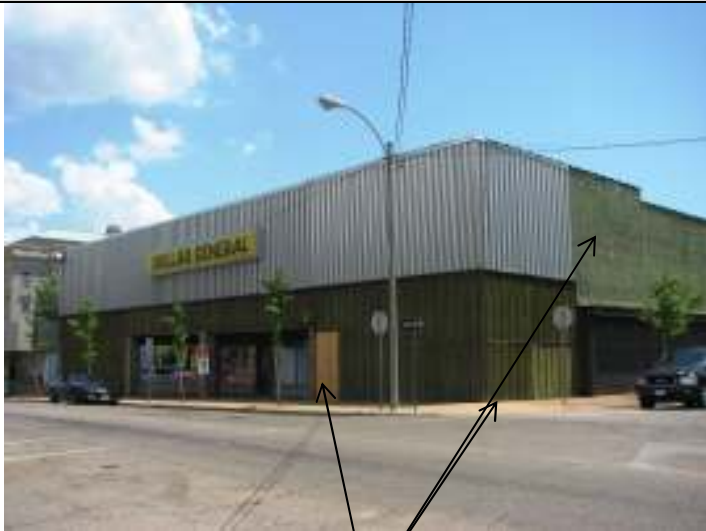
Façade (west) and south elevation, showing missing storefront window, deteriorated wood siding, and peeling paint

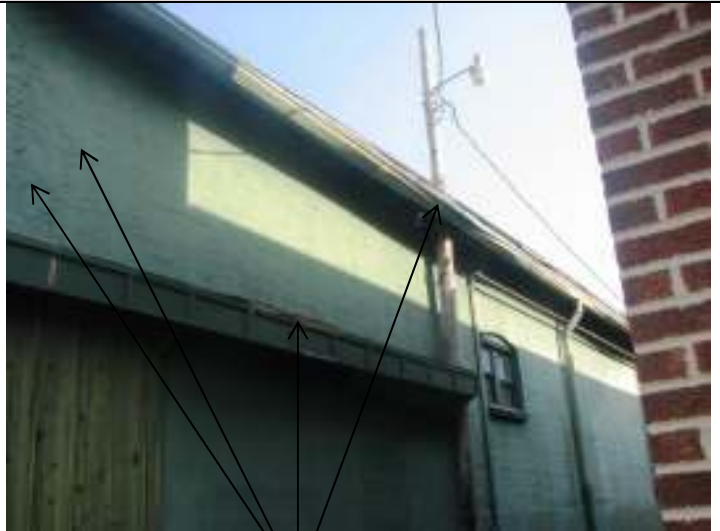
East elevation, showing bent gutter, deteriorated trim, and cracked brick wall surface

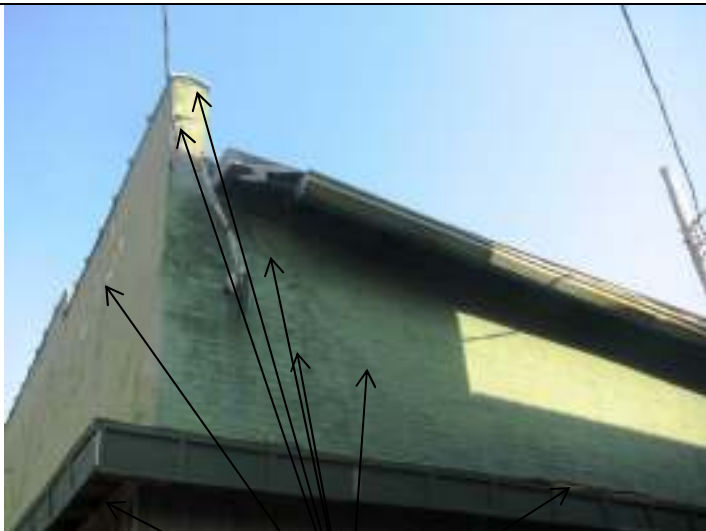
Southeast corner showing cracked brick wall surface, partial missing brick, bend coping, missing trim, deteriorated trim and peeling paint

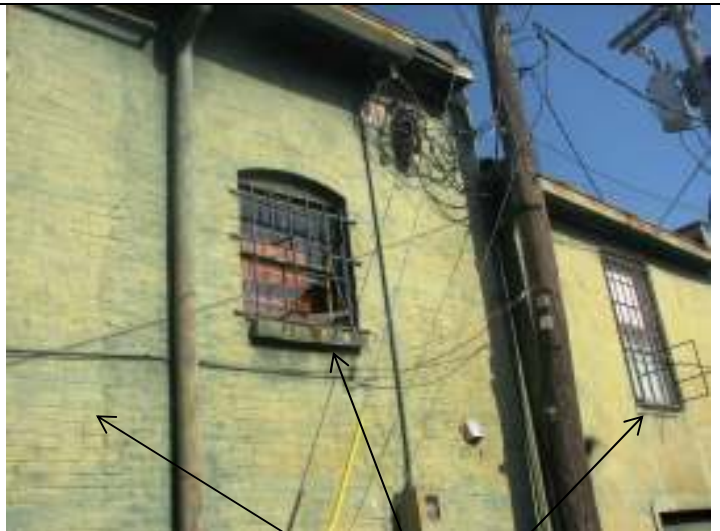
South elevation, showing security bars, and cracks in the mortar

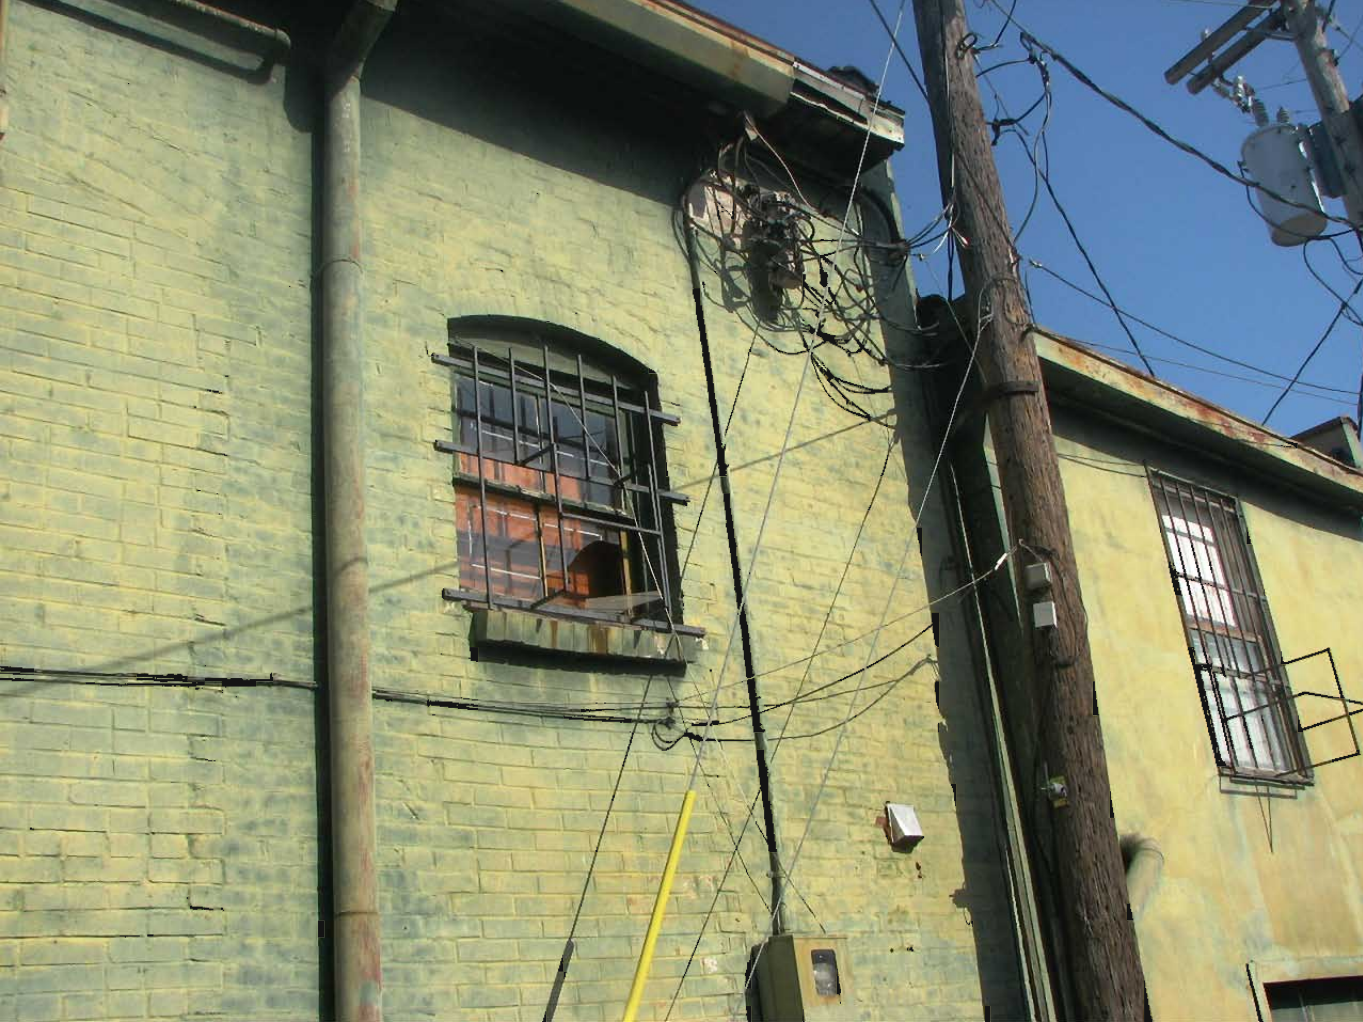
SURVEY NO. BU-AS-005-LUBC-059

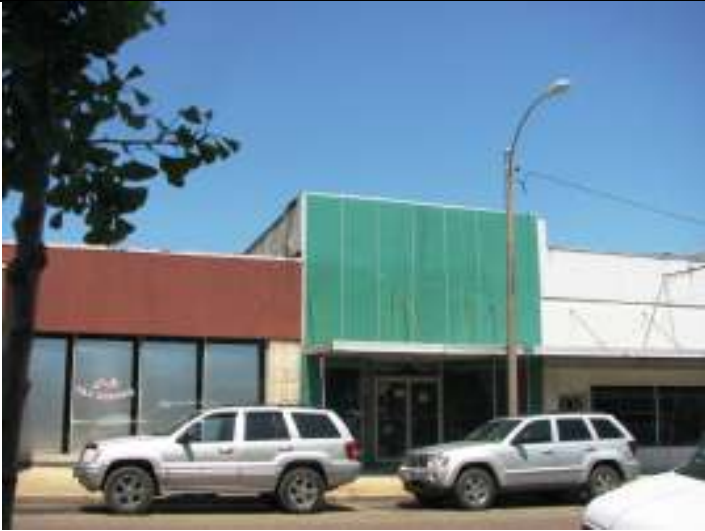
Façade (east) , some of the porcelain enamel panels are loose

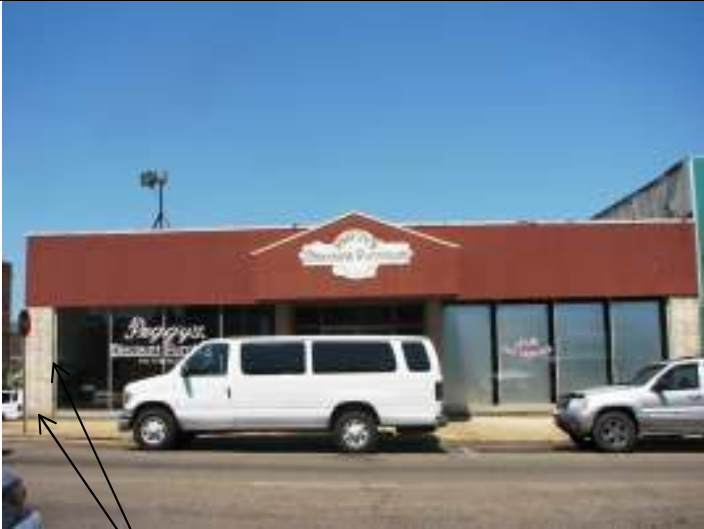
Façade, showing chip bricks, cracked foundation, and weathered sign.

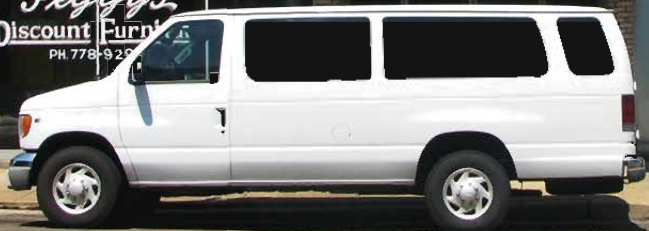
SURVEY NO. BU-AS-005-LUBC-067

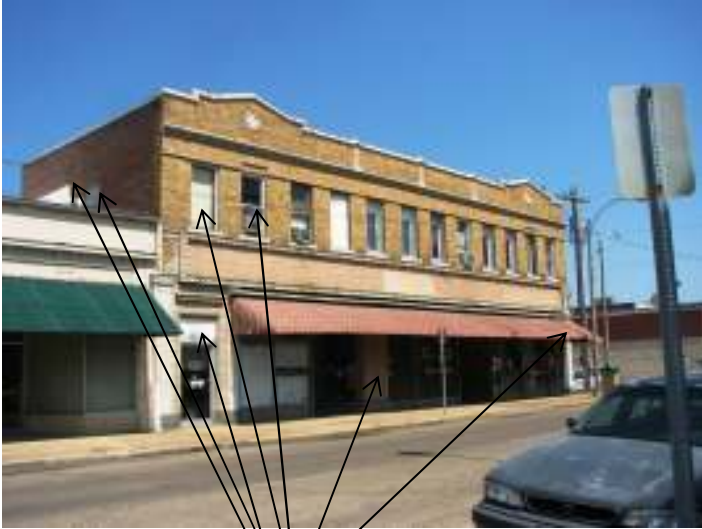
Façade (east) and south elevation showing bent awning, boarded up windows, missing windows

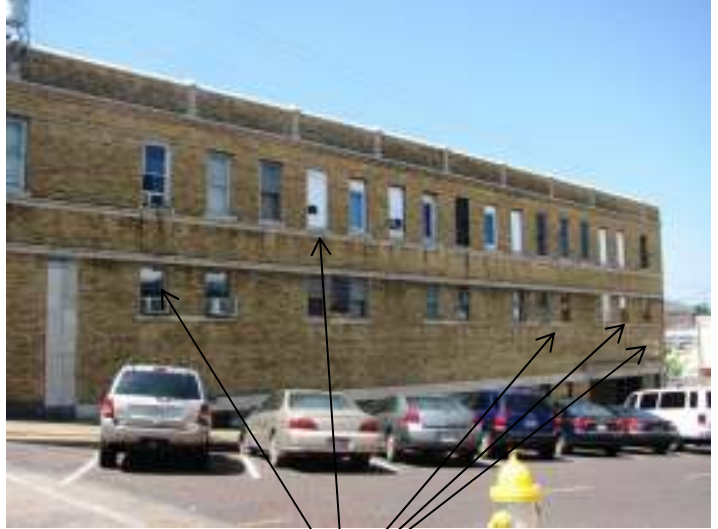
North elevation, showing boarded up windows, and missing windows, and vacant sign frame

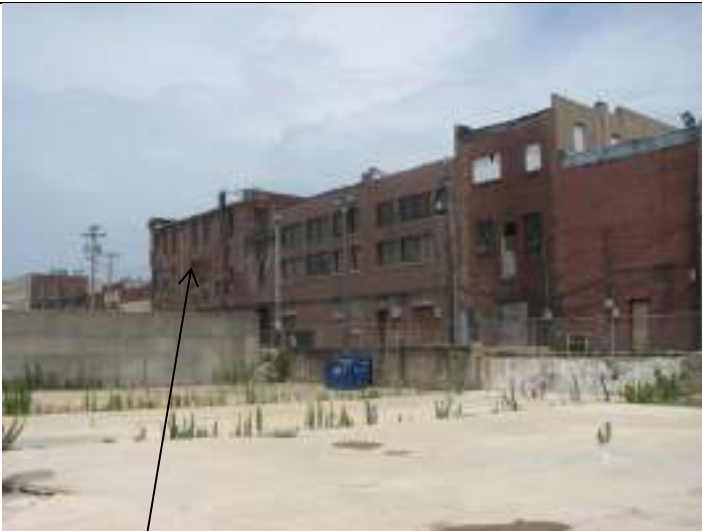
West elevation (rear)

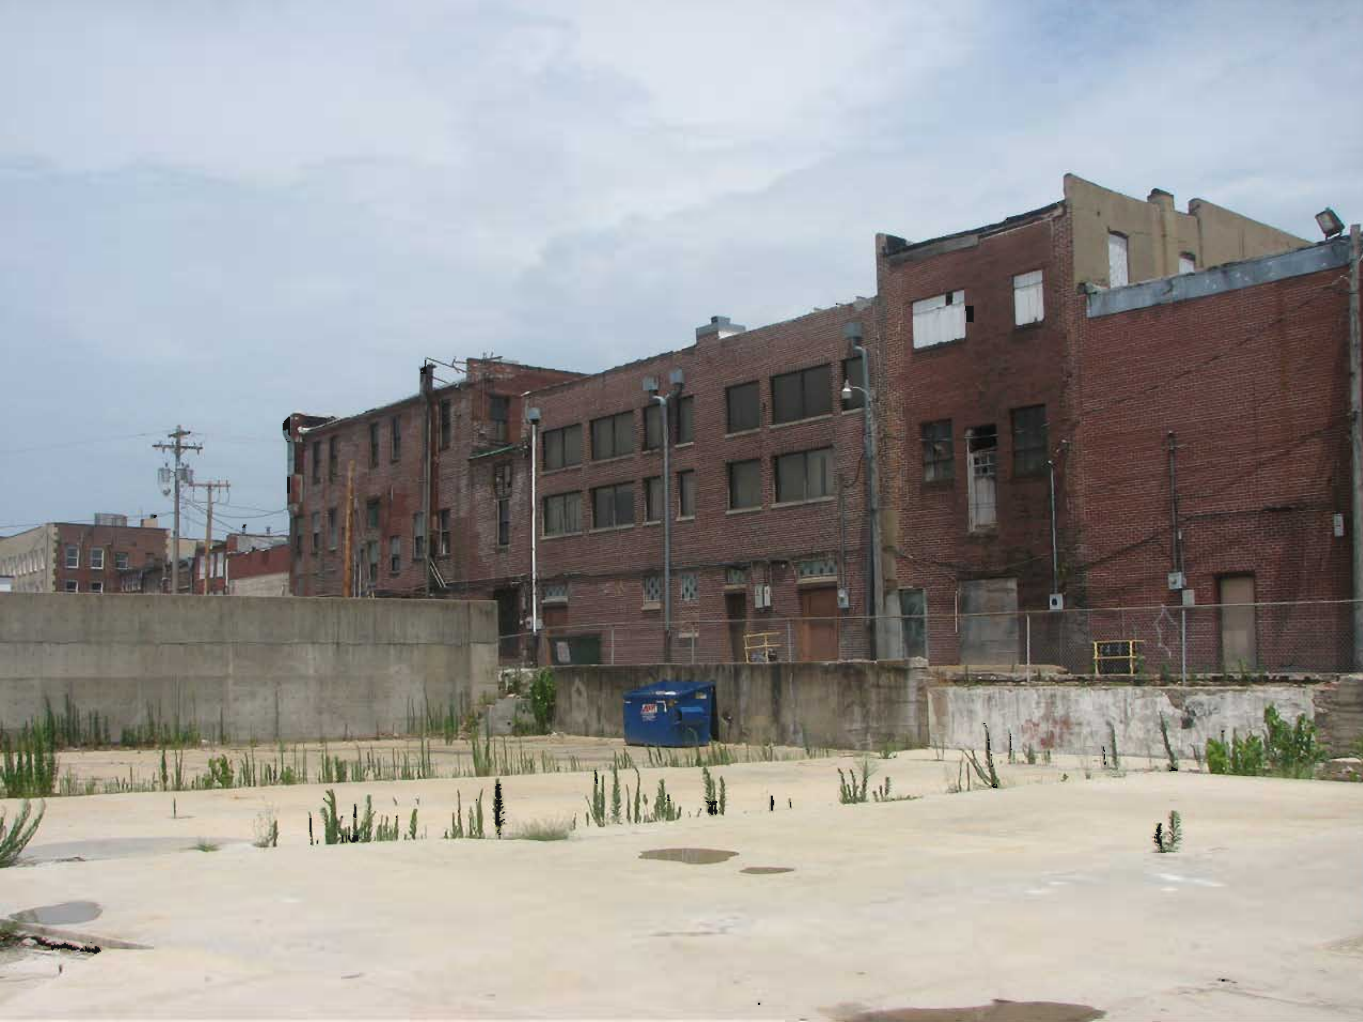
SURVEY NO. BU-AS-005-LUBC-056

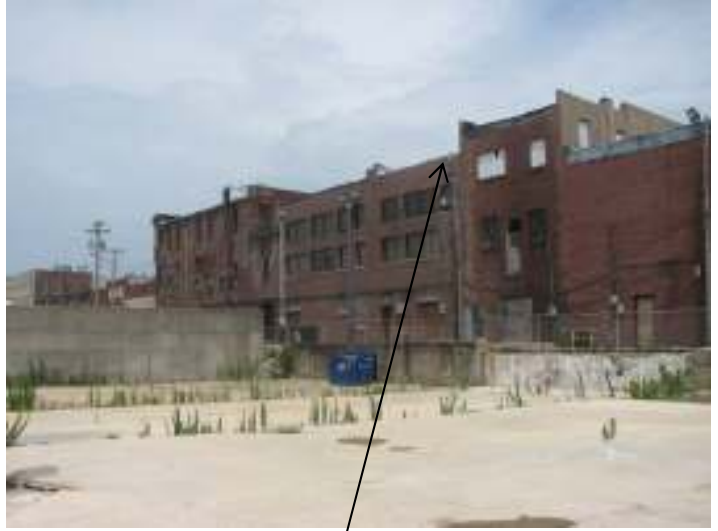
West elevation, showing previous brick work repair
