TOTAL COMPONENT RATING	
------------------------	--

29. SMOKE DETECTORS: <input type="checkbox"/> YES <input type="checkbox"/> NO	30. CARBON MONOXIDE DETECTORS: <input type="checkbox"/> YES <input type="checkbox"/> NO	
PARKING

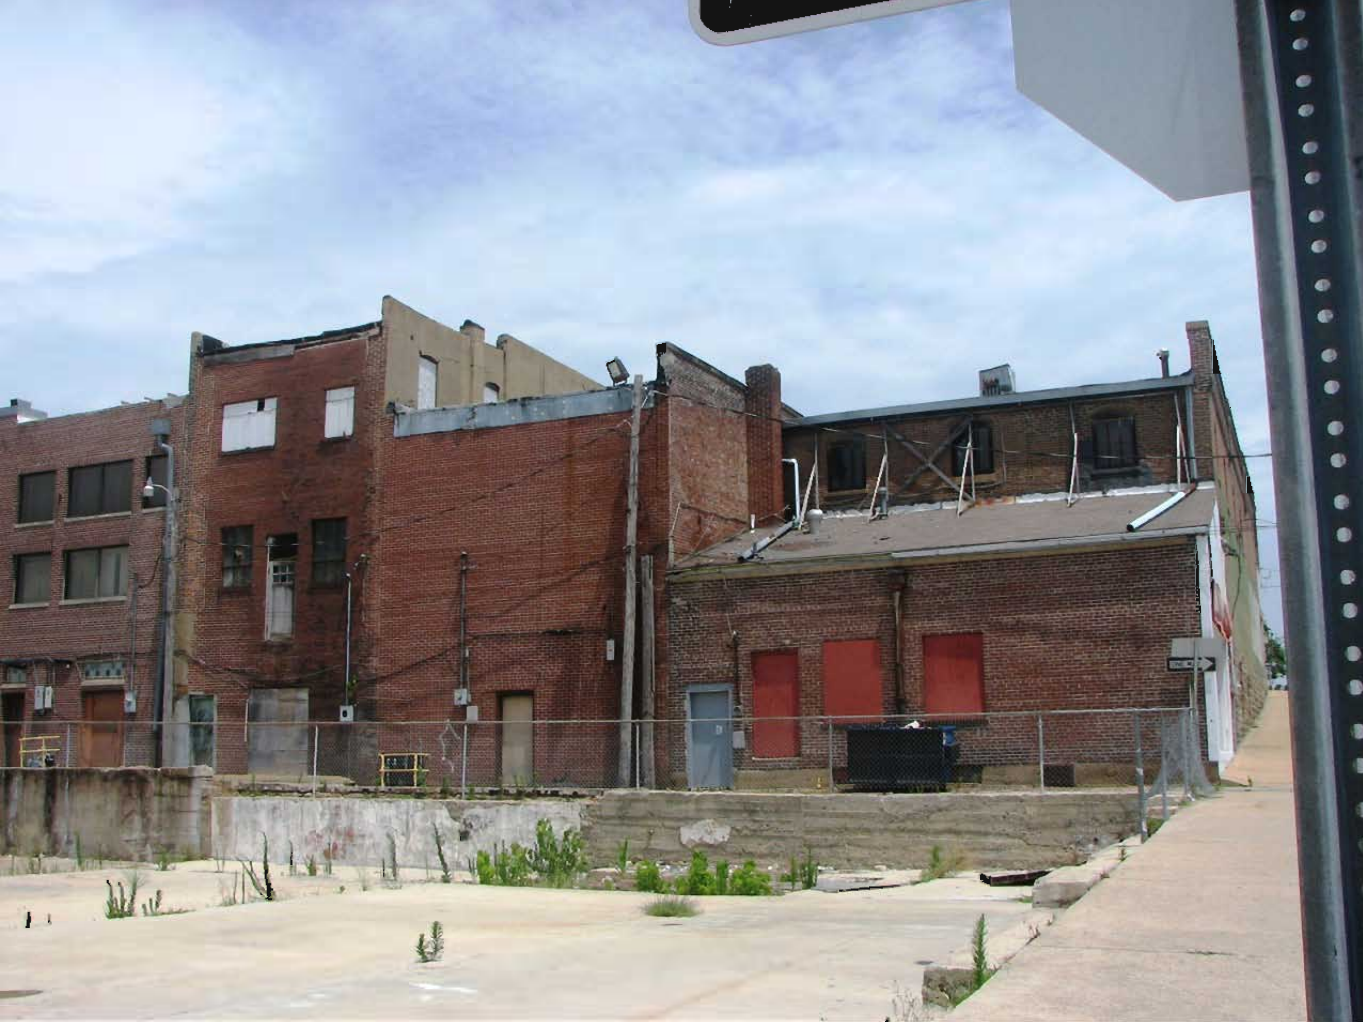
SURVEY NO. BU-AS-005-LUBC-055

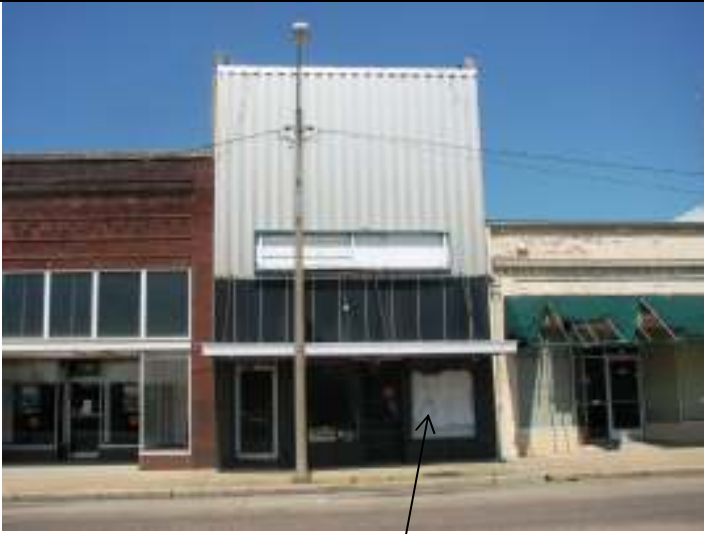
Façade (east), showing cracked storefront window

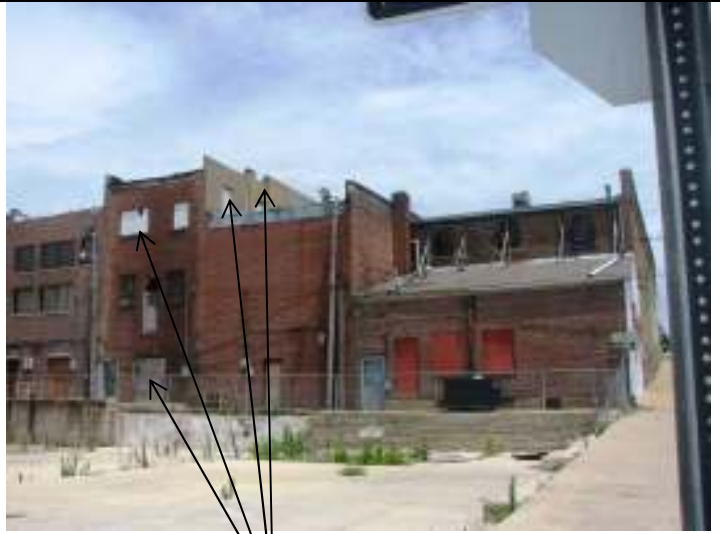
West and south elevations, showing boarded up windows and doors, and cracked stucco

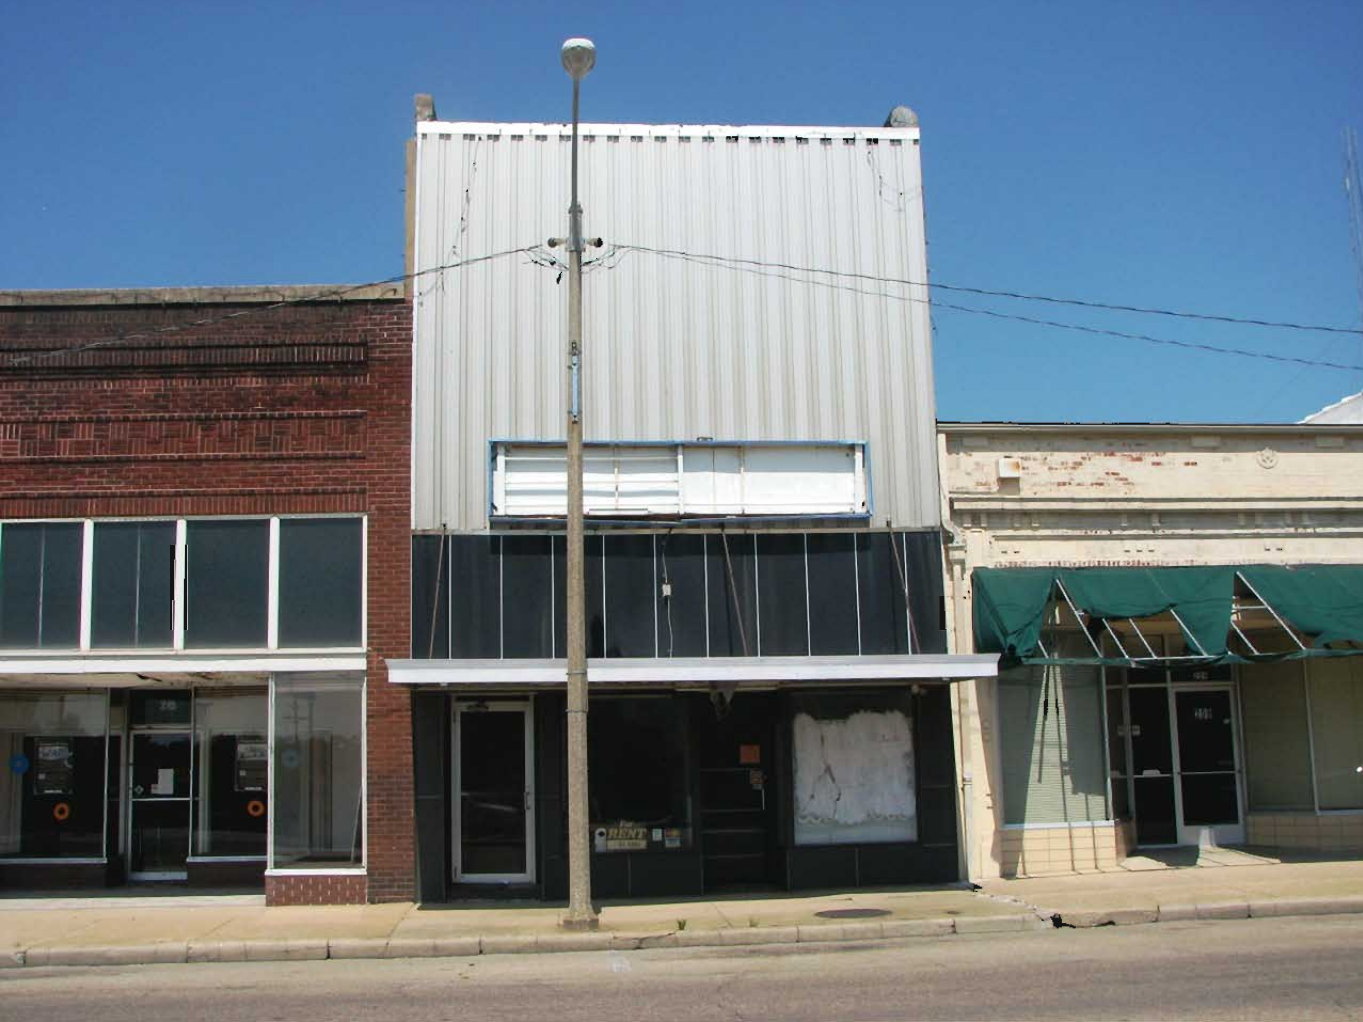
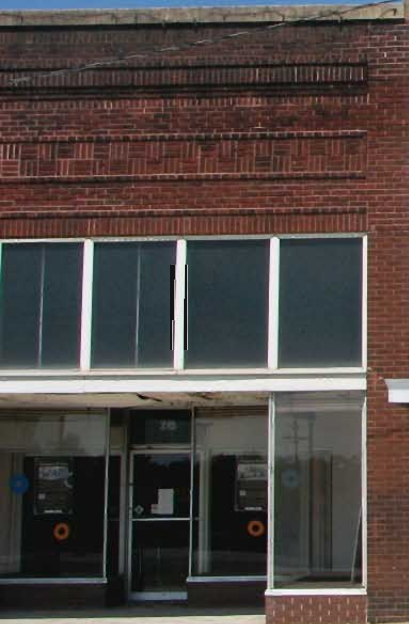
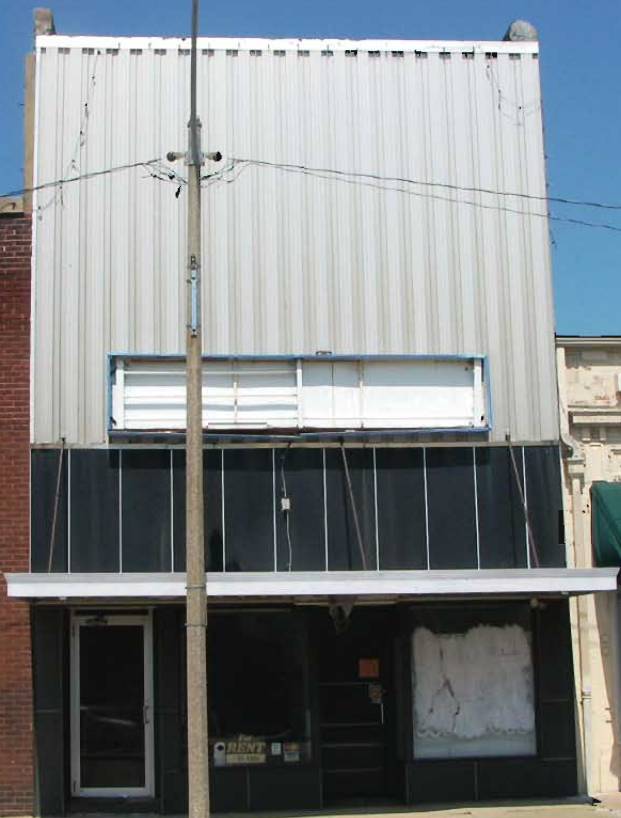
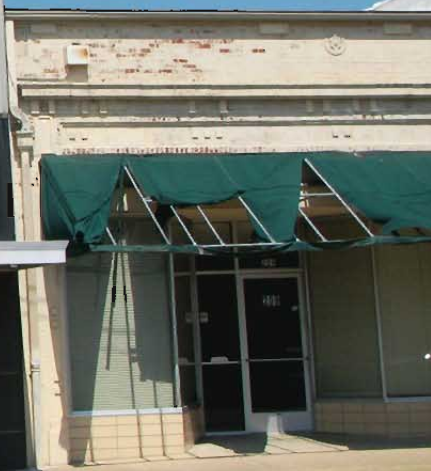
SURVEY NO. BU-AS-005-LUBC-054

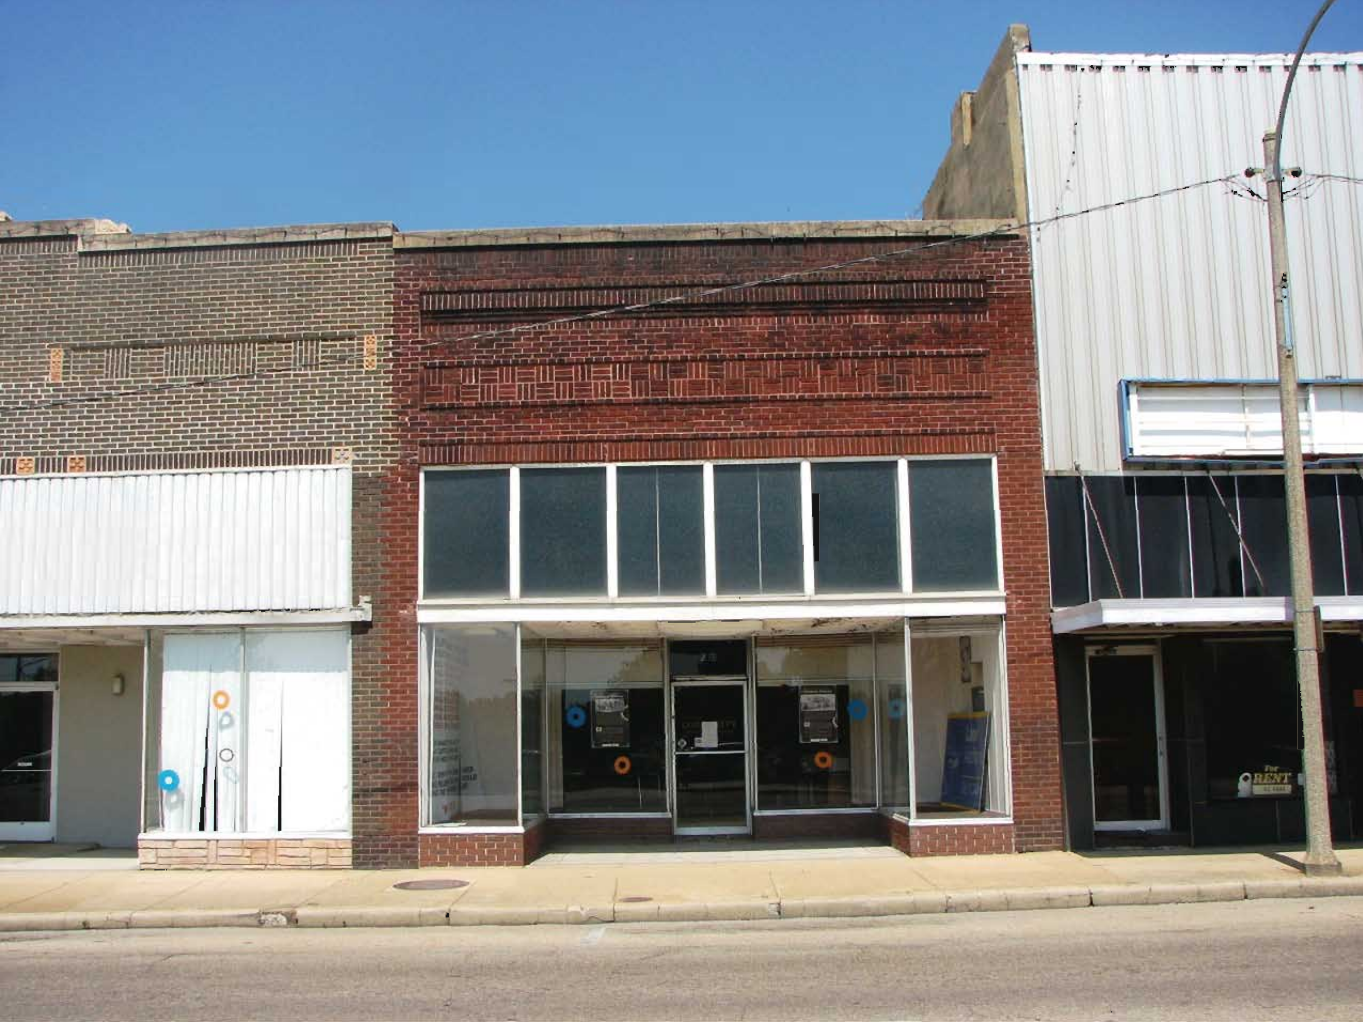
SURVEY NO. BU-AS-005-LUBC-053

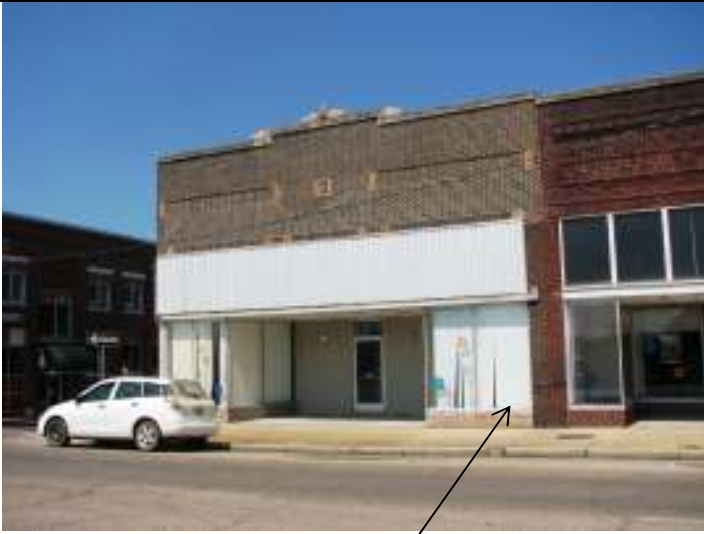
Façade (east), showing cracked window

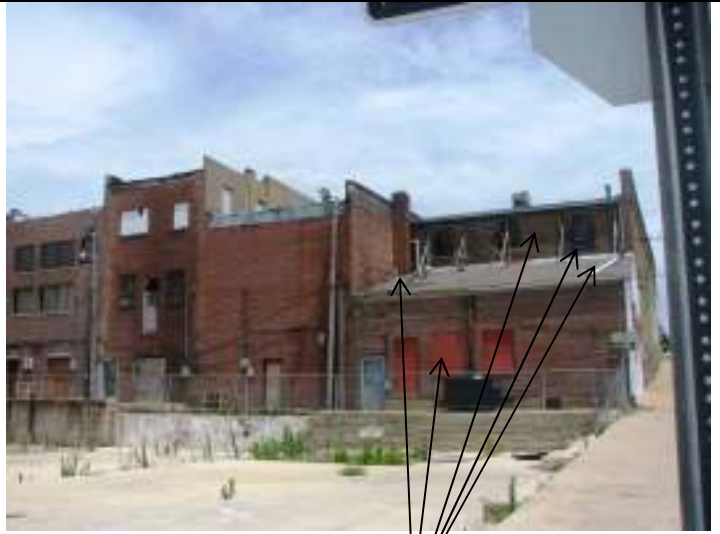
West elevation, showing boarded up windows, gutters but no downspouts, and mortar issues

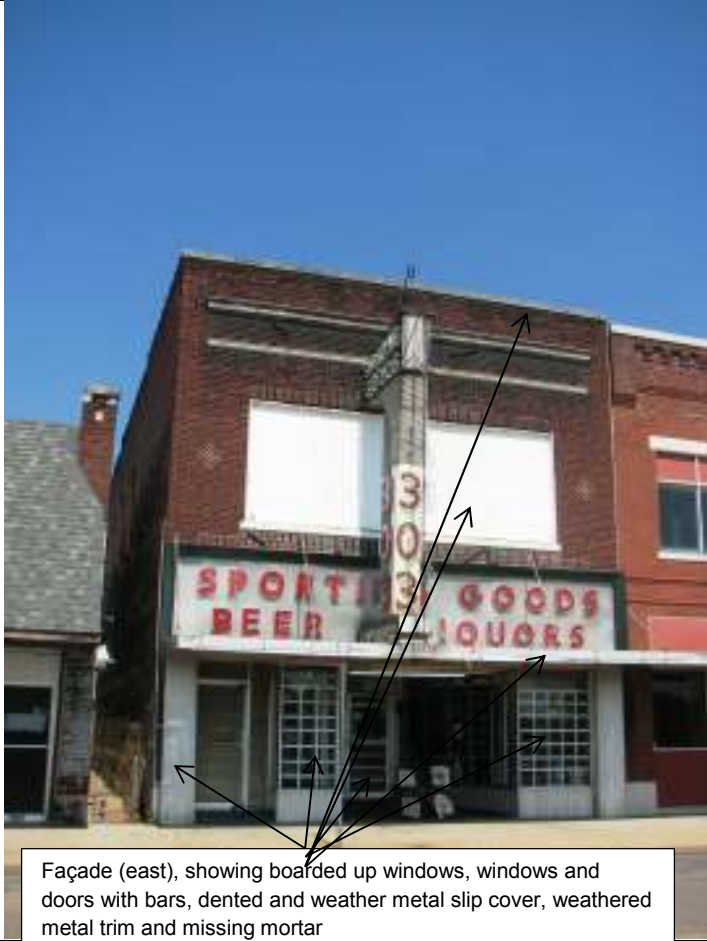
Façade (east), showing boarded up windows, windows and doors with bars, dented and weather metal slip cover, weathered metal trim and missing mortar

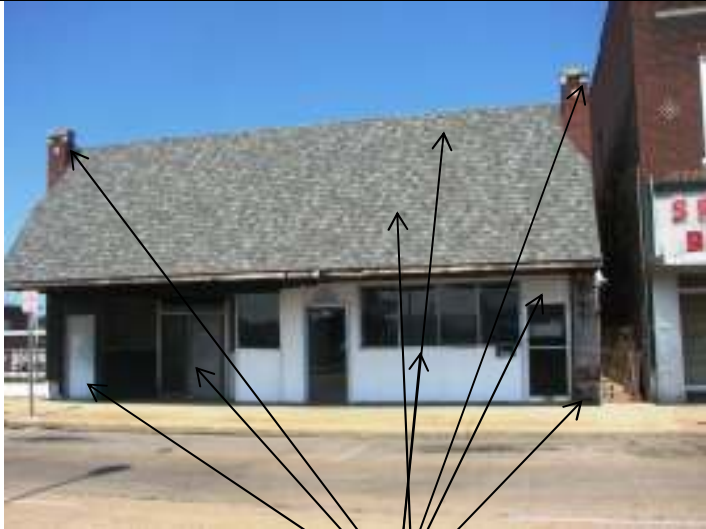
Façade (east), showing loose and weathered trim, weather window frames and doors, inappropriate doors for commercial building, missing brick, mortar issues, loose shingles and boarded up transom

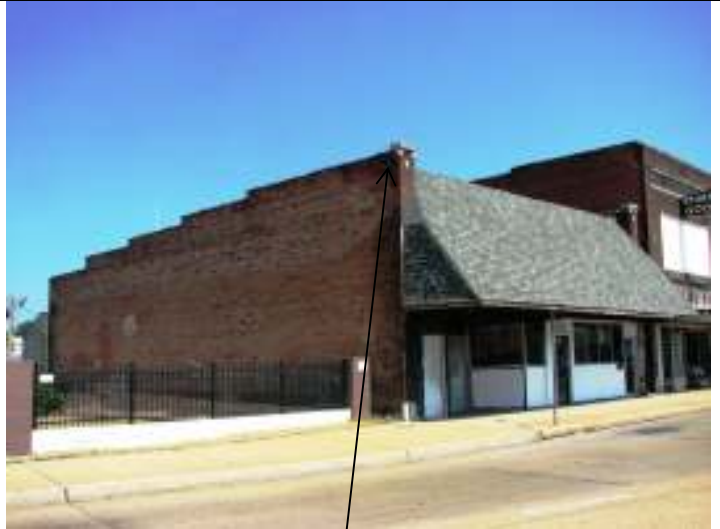
South elevation, showing loose brick

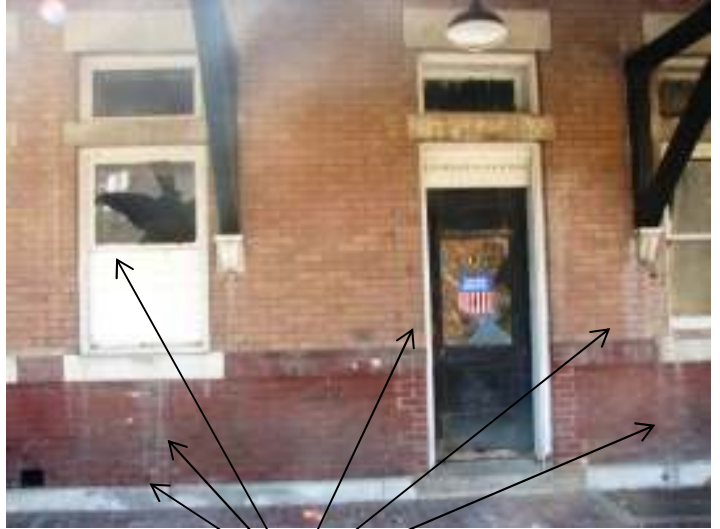
Façade (west), showing broken windows/glass, boarded up windows, missing mortar, and water damage to wall surface.

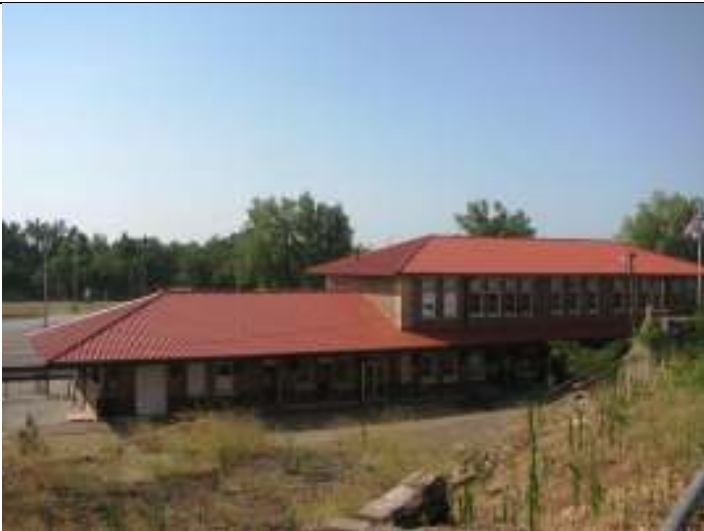
Façade (west), showing overall view

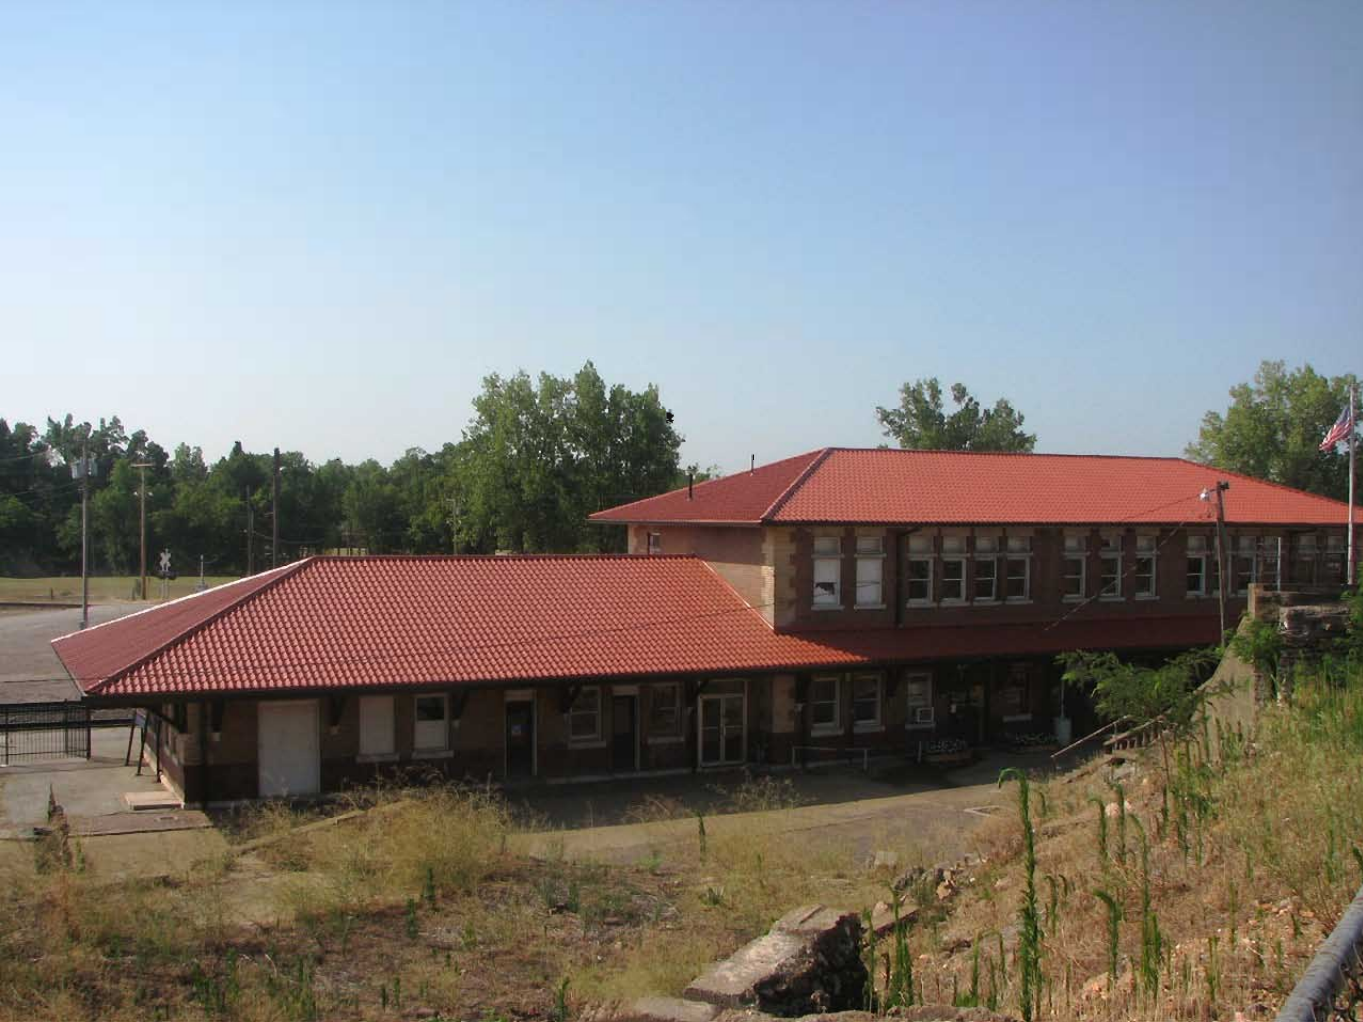
SURVEY NO. BU-AS-005-LUBC-030

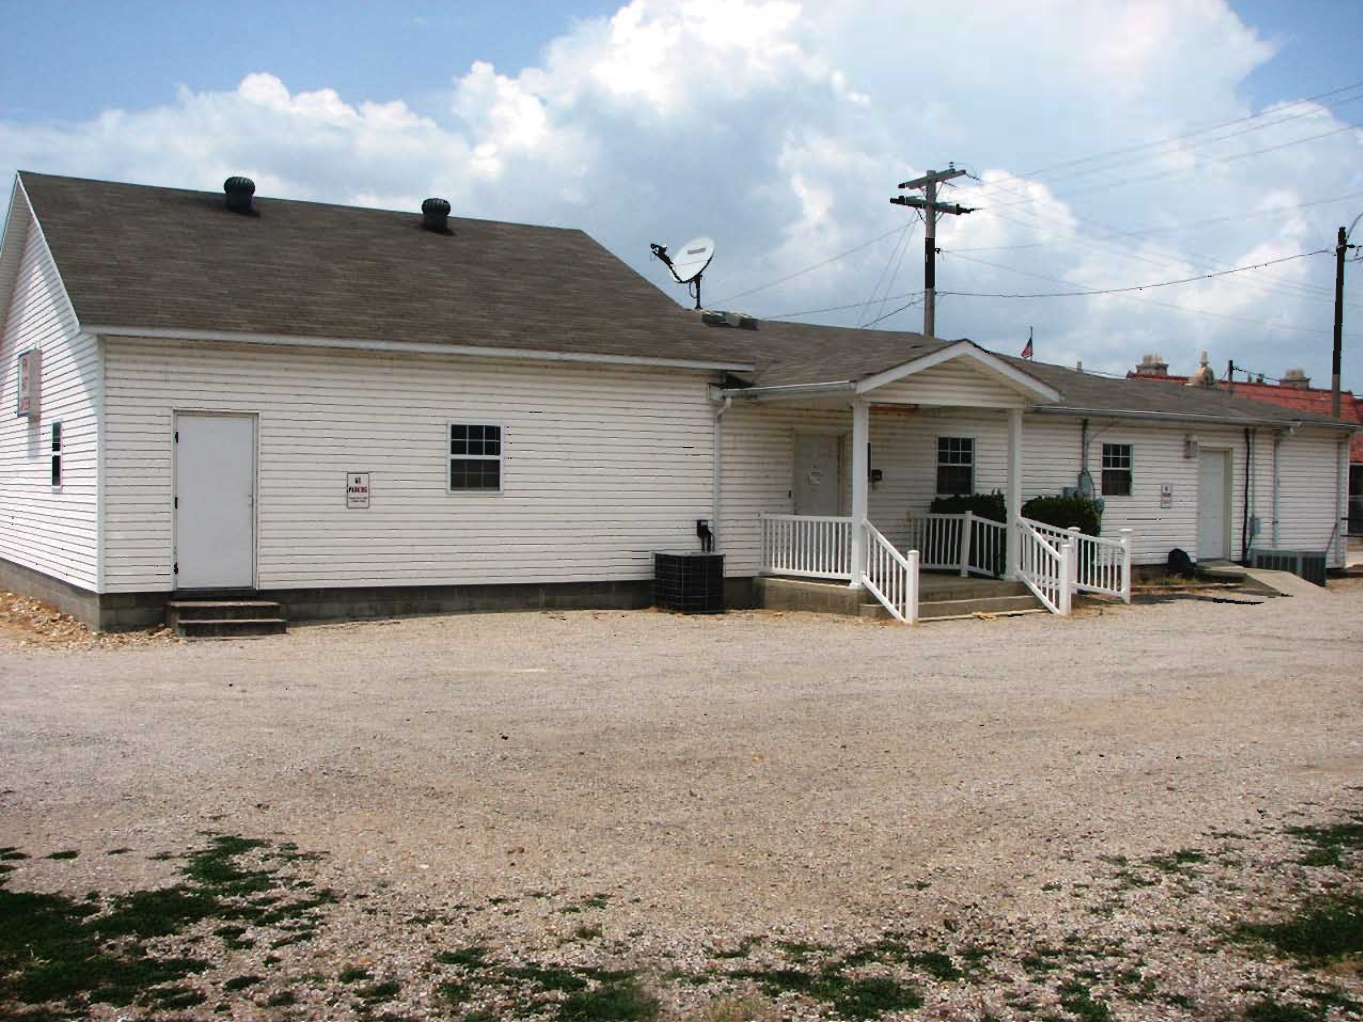
SURVEY NO. BU-AS-005-LUBC-029

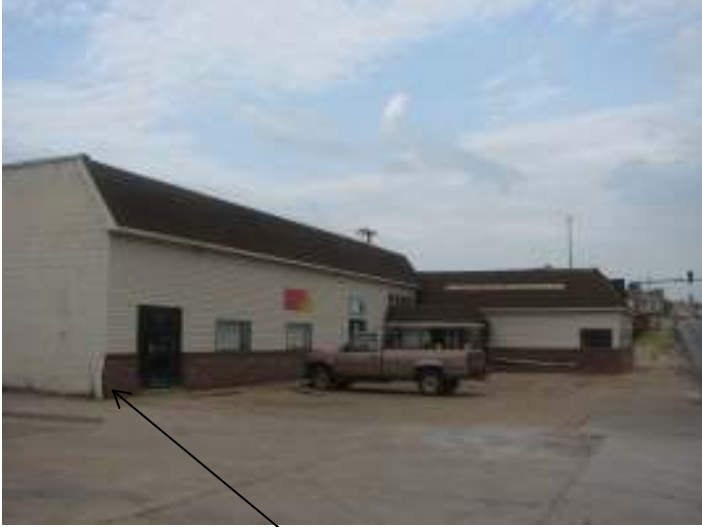
Façade and east elevation; showing damaged downspout

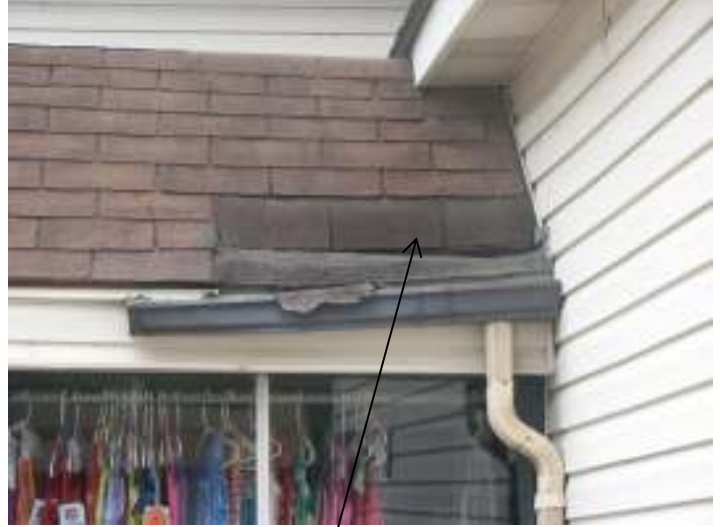
Façade; showing damaged roof

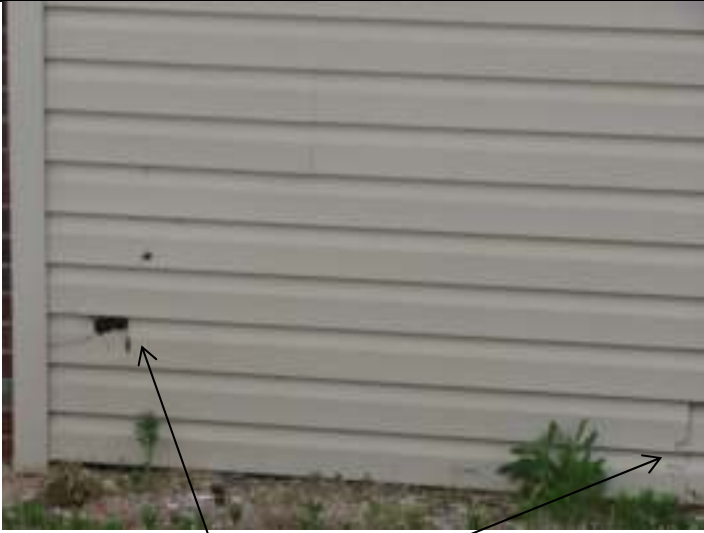
West elevation; showing hole in siding

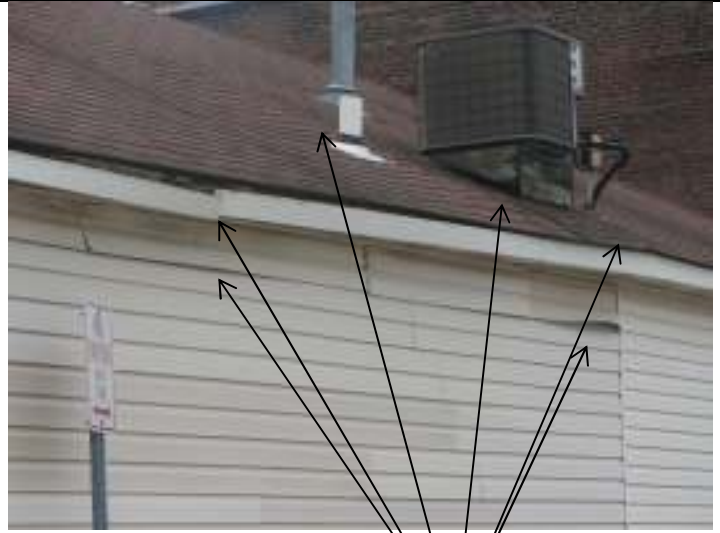
West elevation; showing loose and buckled siding, loose trim, and worn roof appears to have some buckling

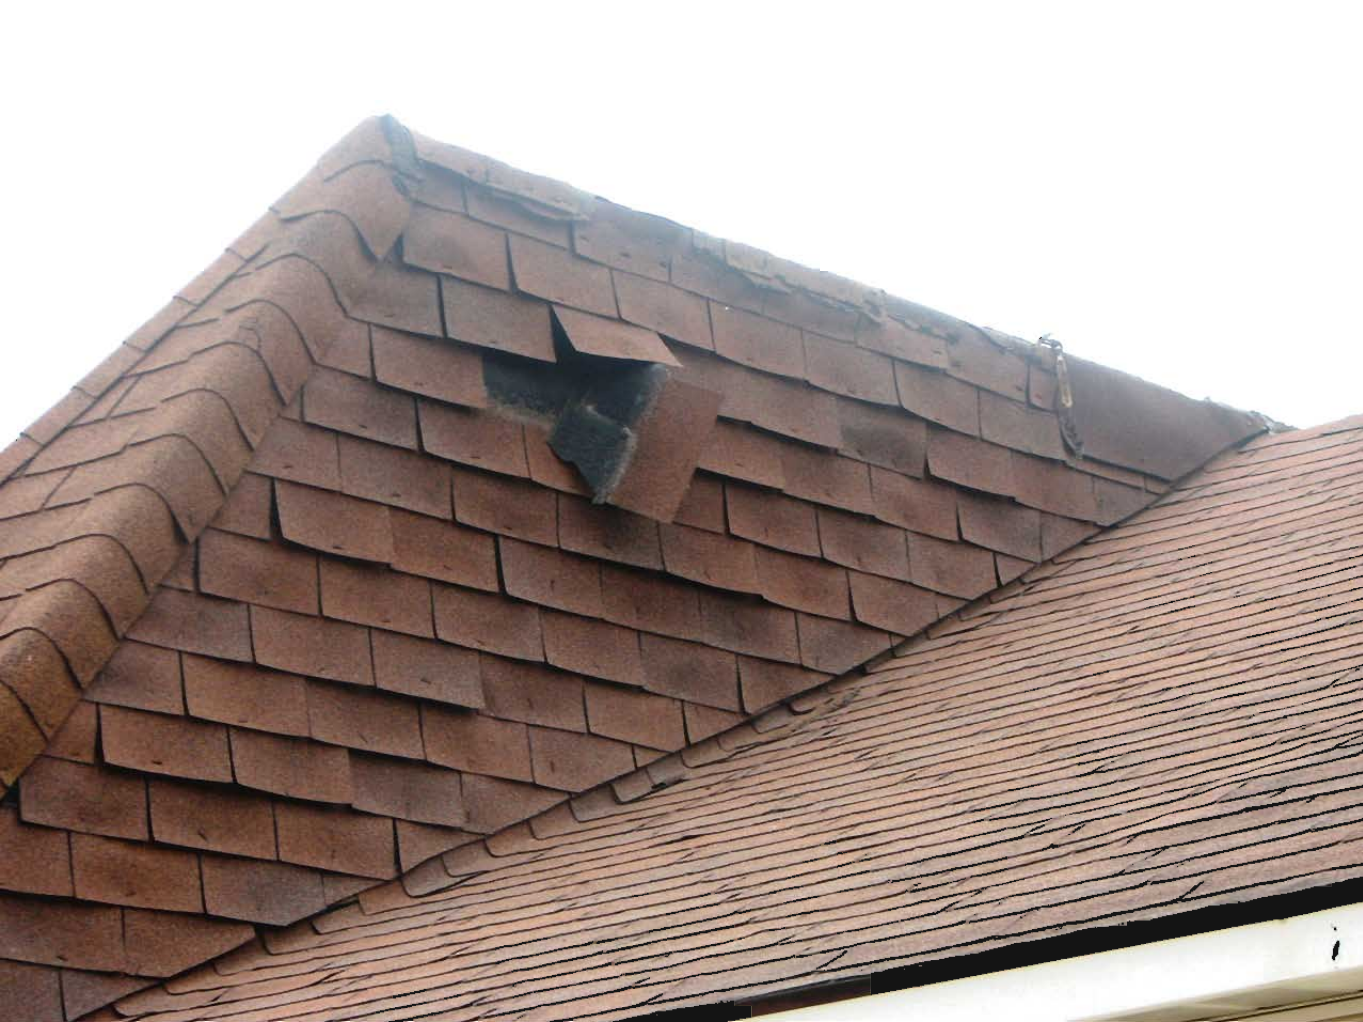
SURVEY NO. BU-AS-005-LUBC-002	
TOTAL SCORE OF OVERALL INTERIOR BUILDING CONDITION: 12- EXCELLENT 6-8 - FAIR 0-4 - DILAPIDATED	LOCATION: L1 - 1 ST FLOOR; L2- 2 ND FLOOR; L3 -3 RD FLOOR
9-11 - GOOD 1-3 - POOR

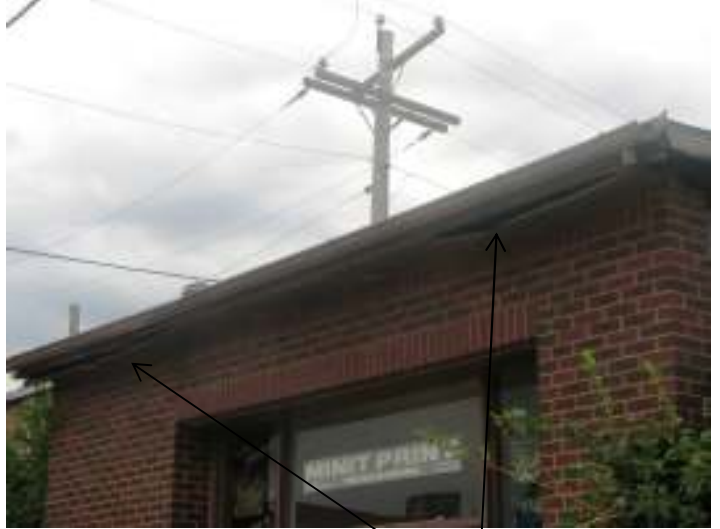
Façade, showing loose trim on the northeast and northwest corner of roofline

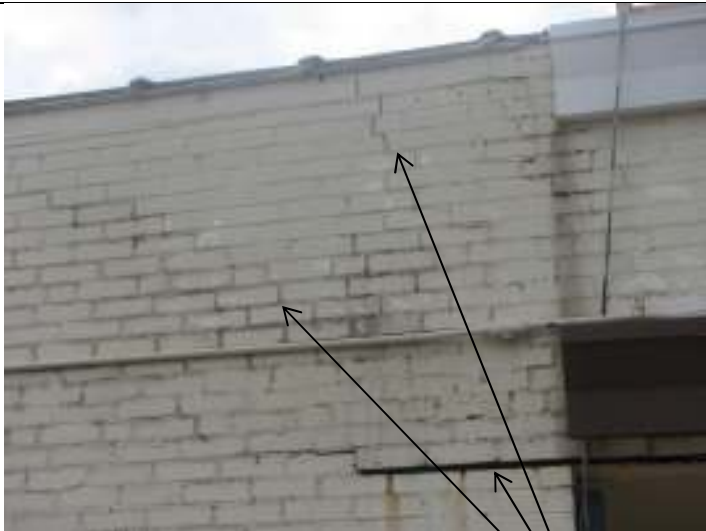
South elevation – southwest corner, showing cracks in brick, cracking mortar and missing mortar.

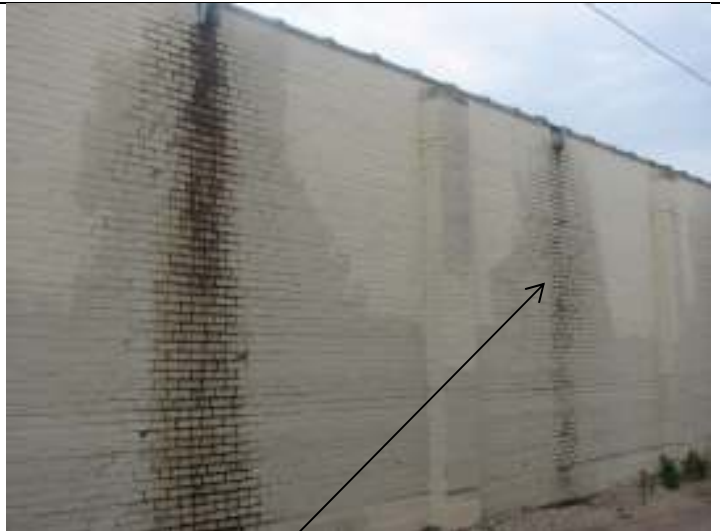
East elevation, showing water damage caused by missing downspouts.

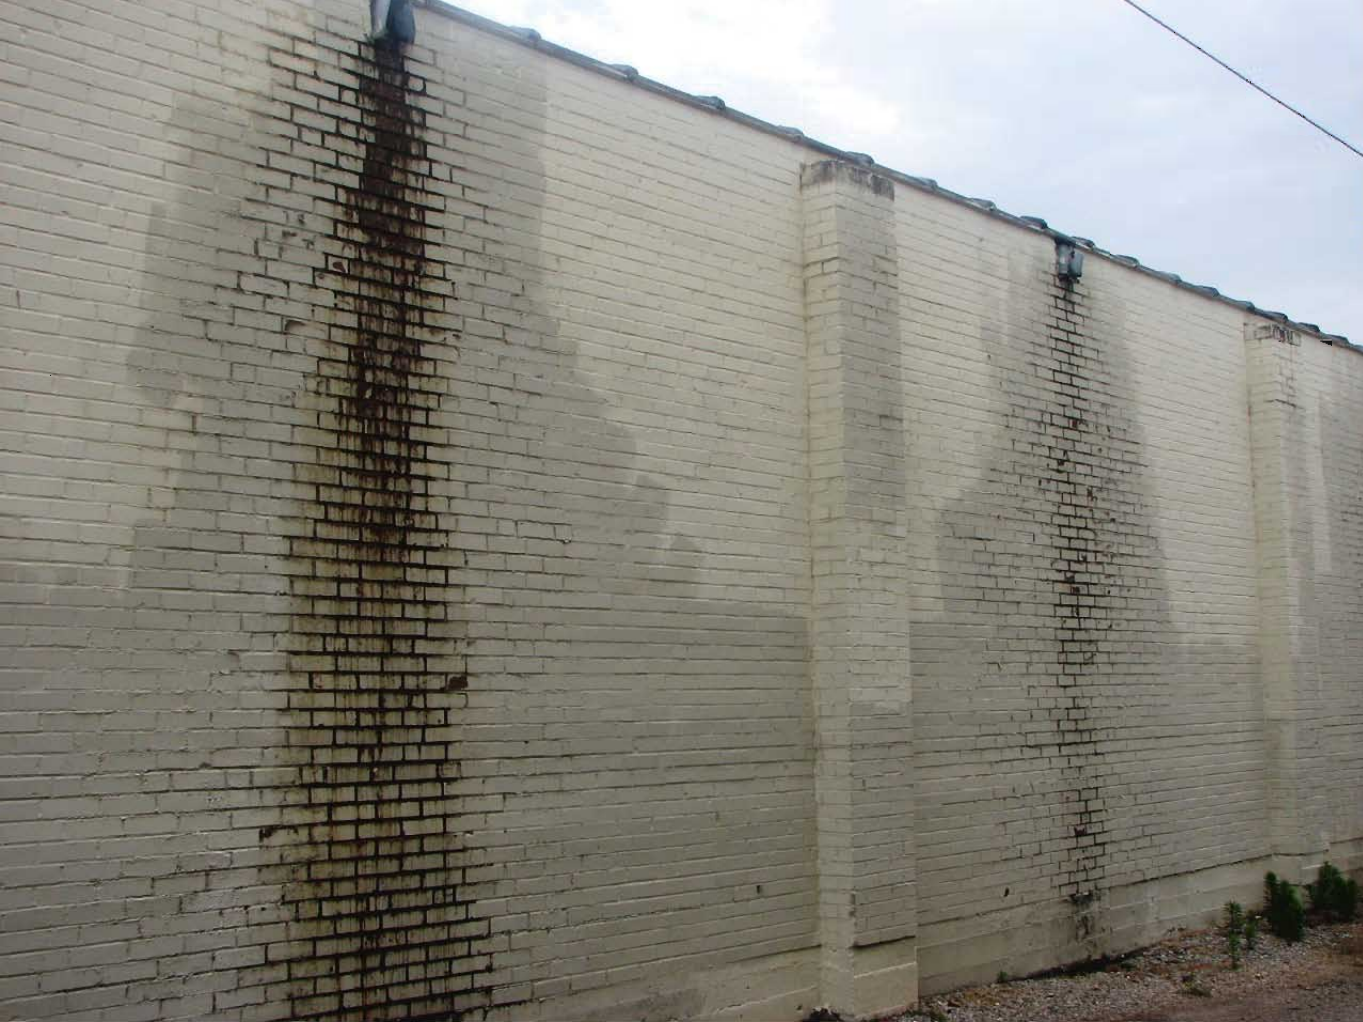
SURVEY NO. BU-AS-005-LUBC-025	
TOTAL SCORE OF OVERALL INTERIOR BUILDING CONDITION: FLOOR 12- EXCELLENT 6-8 - FAIR 0-4 - DILAPIDATED 9-11 - GOOD 1-3 - POOR	LOCATION: L1 - 1 ST FLOOR; L2- 2 ND FLOOR; L3 -3 RD

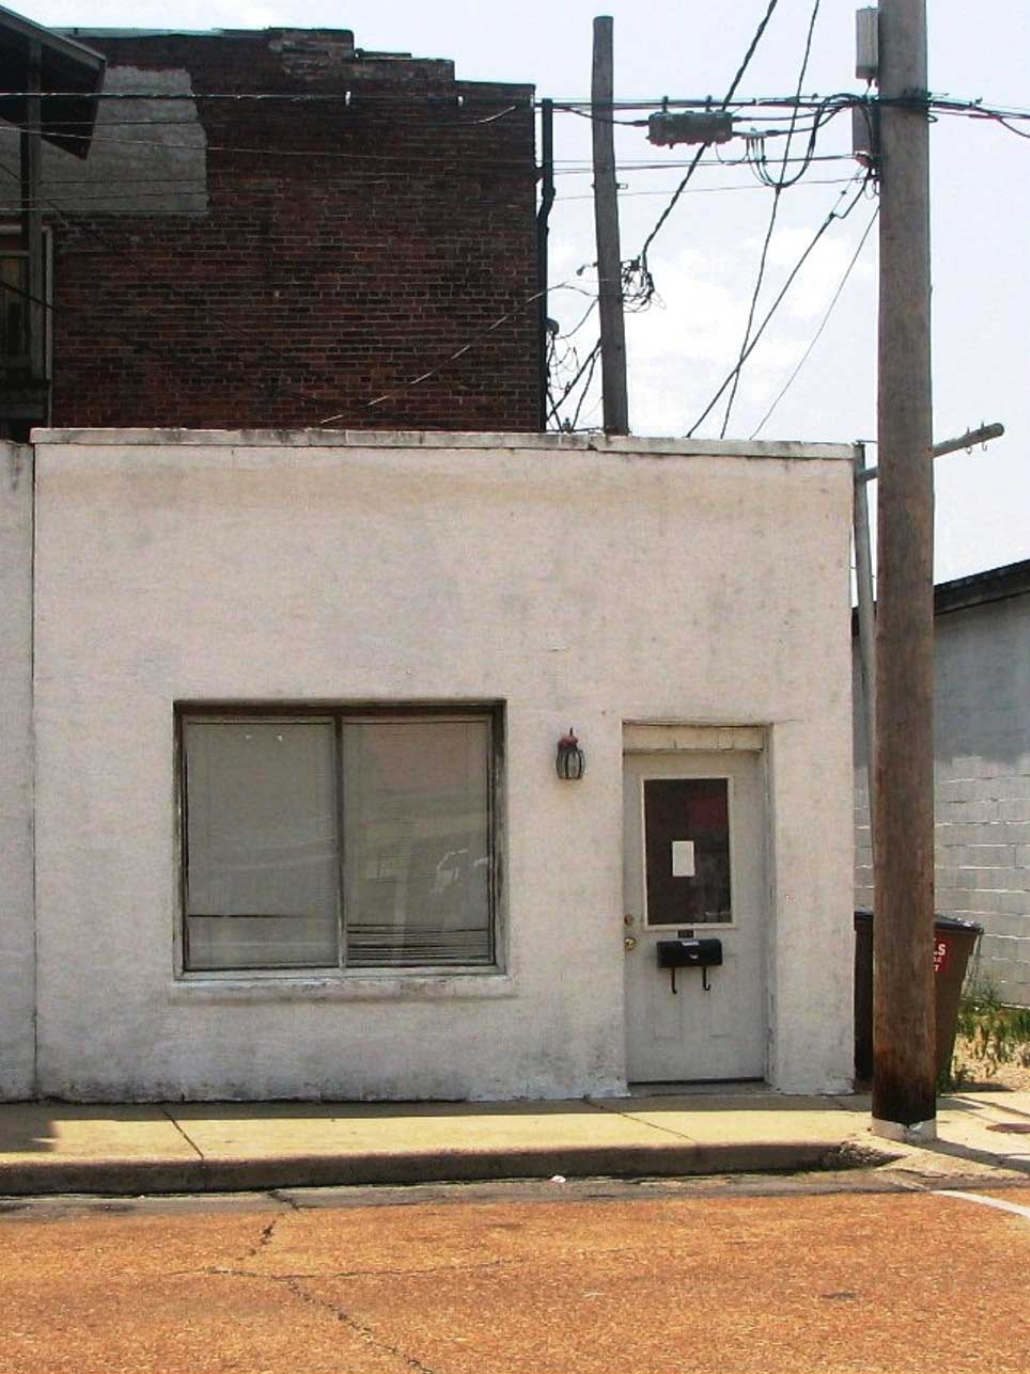
SURVEY NO. BU-AS-005-LUBC-027

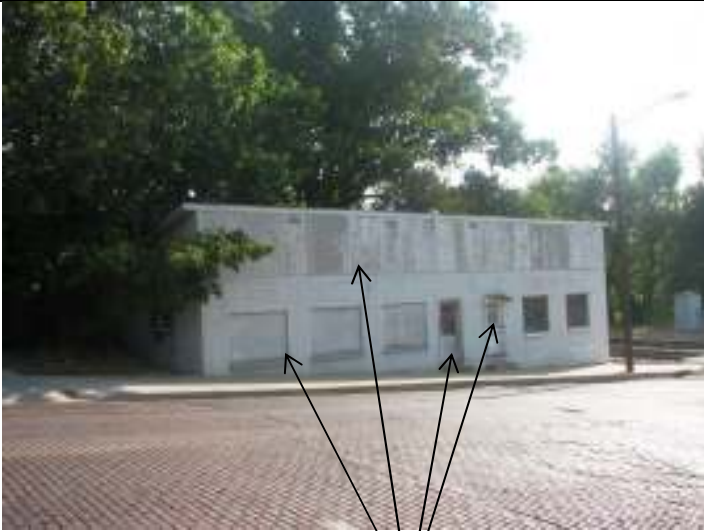
Façade and south elevation, showing boarded windows, missing glass panels in doors, and worn metal slip cover.

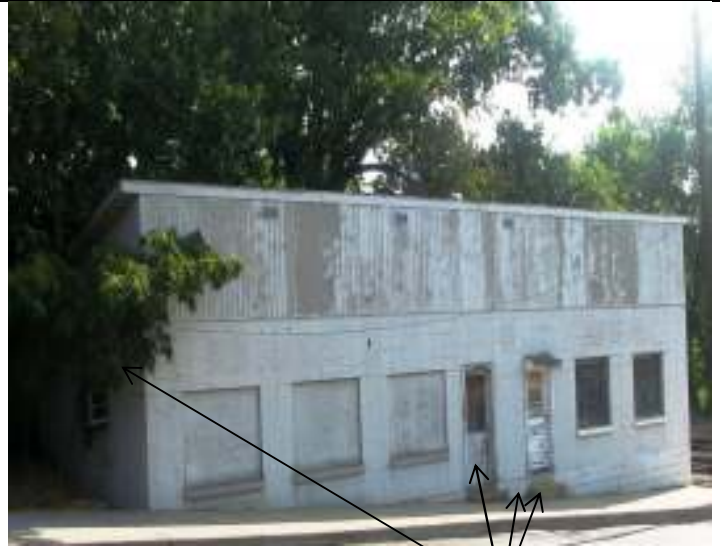
Façade, showing missing step, crack in foundation, deteriorated doors and overgrown vegetation

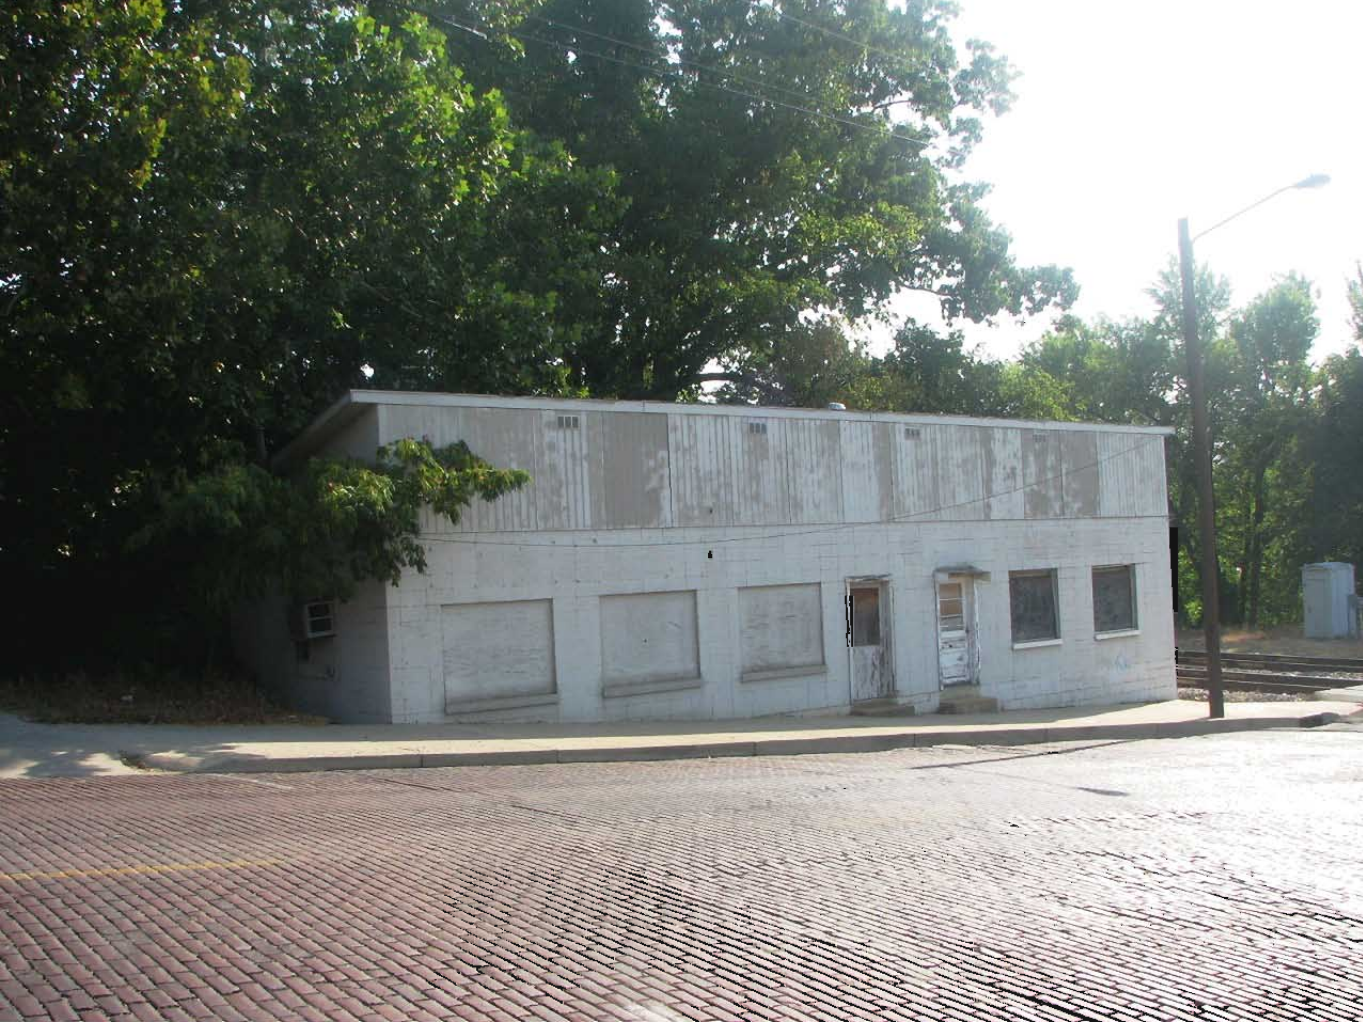
Resource for footprint: Butler County Tax Assessor. Website: <http://butler.villagis.net/>

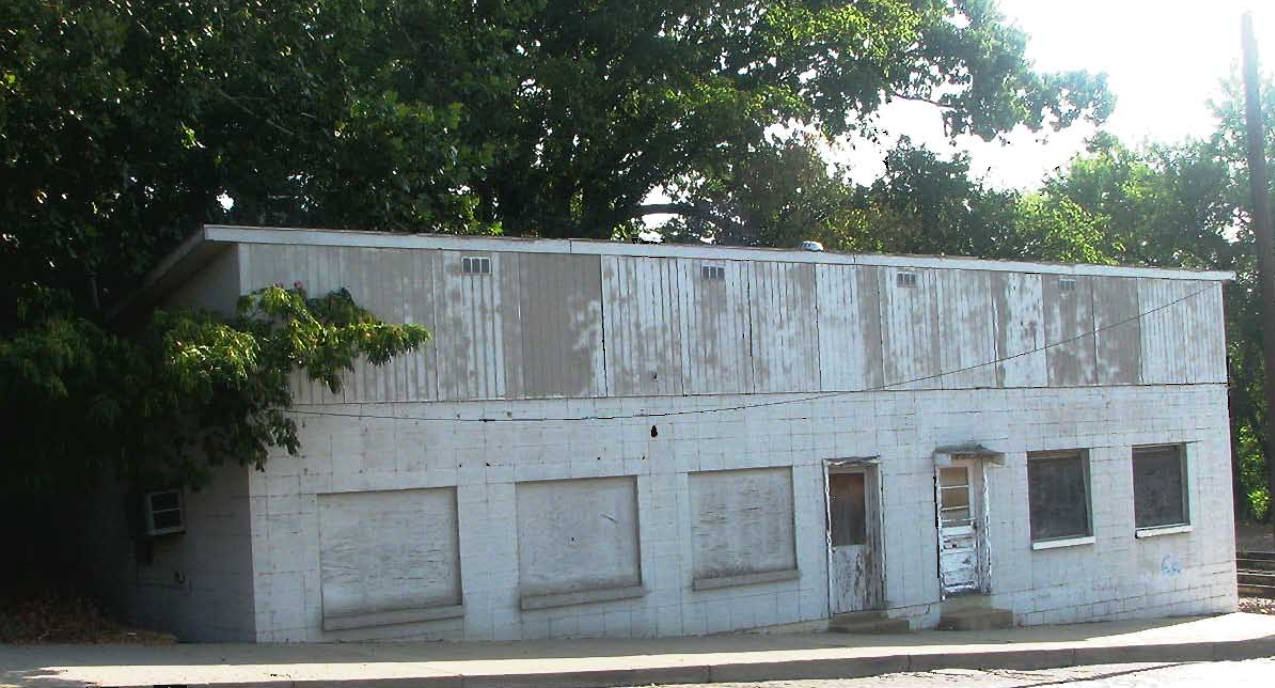
SURVEY NO. BU-AS-005-LUBC-004	
TOTAL SCORE OF OVERALL INTERIOR BUILDING CONDITION: LOCATION: L1 – 1 ST FLOOR; L2- 2 ND FLOOR; L3 -3 RD FLOOR	
12- EXCELLENT	6-8 – FAIR 0-4 - DILAPIDATED
9-11 – GOOD	1-3 - POOR

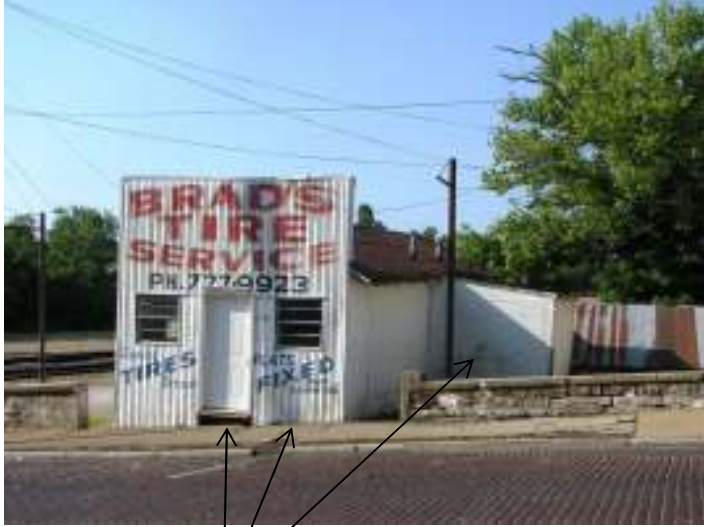
Façade (north) and west elevation, showing missing entrance step, worn siding, and metal slip cover

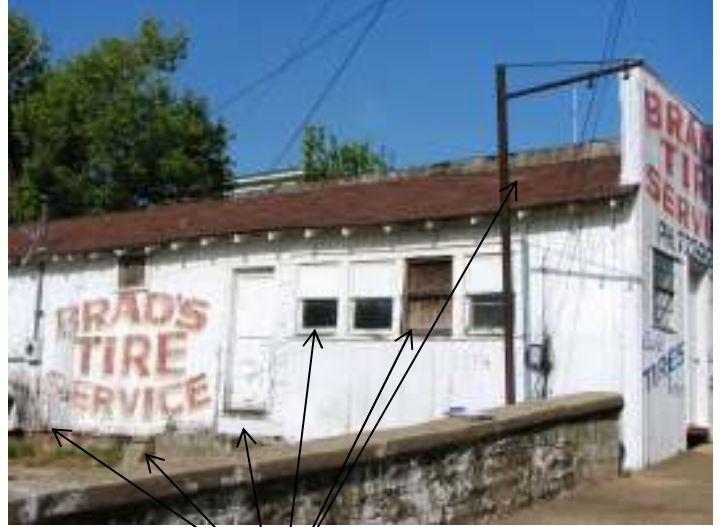
East elevation, showing boarded window, missing entrance step, loose siding and missing shingles
