TOTAL COMPONENT RATING	
------------------------	--

29. SMOKE DETECTORS: <input type="checkbox"/> YES <input type="checkbox"/> NO	30. CARBON MONOXIDE DETECTORS: <input type="checkbox"/> YES <input type="checkbox"/> NO	
PARKING

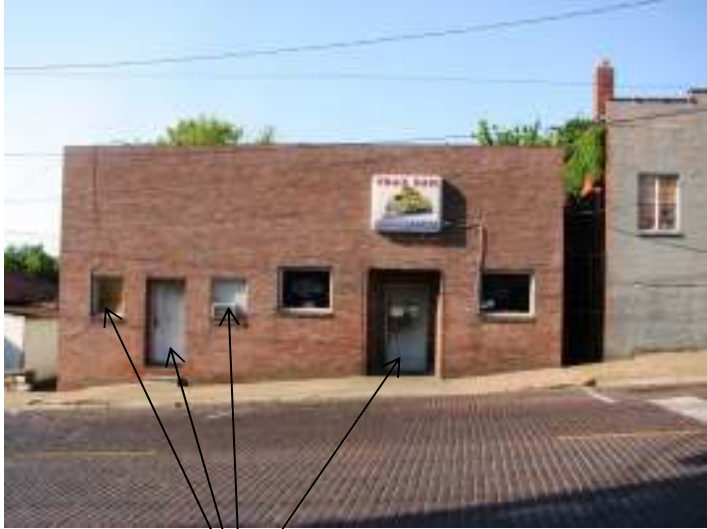
Façade (north), showing boarded up windows, and worn entrance doors.

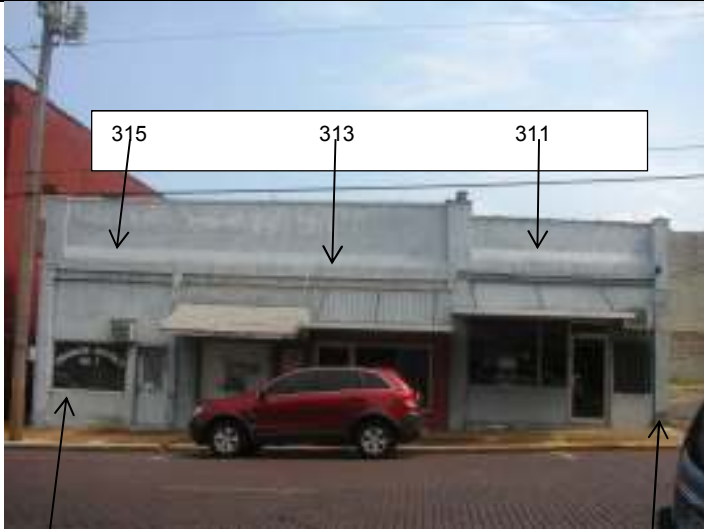
Façade (south), showing missing stucco on the southeast corner exposing brick and missing mortar, cracked window, and cracked stucco

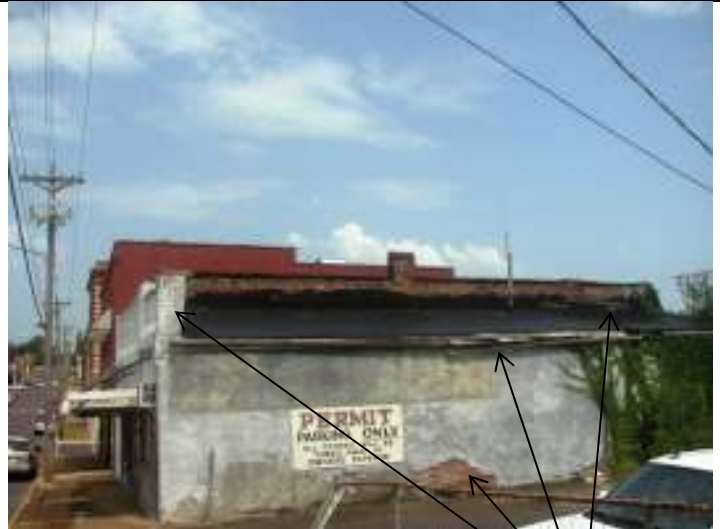
East elevation, showing missing stucco, leaning parapet, sagging roof, loose gutter, and cracks in brick roof ridge line

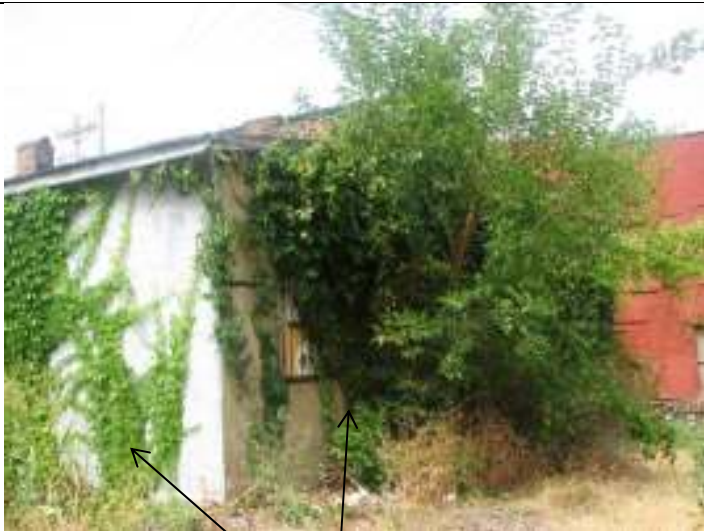
North and east elevation, showing over grown vegetation on building

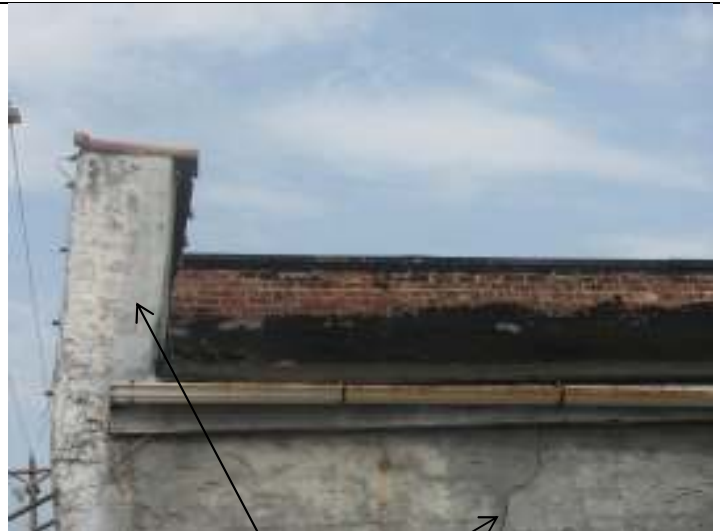
East elevation showing leaning parapet and cracks in stucco

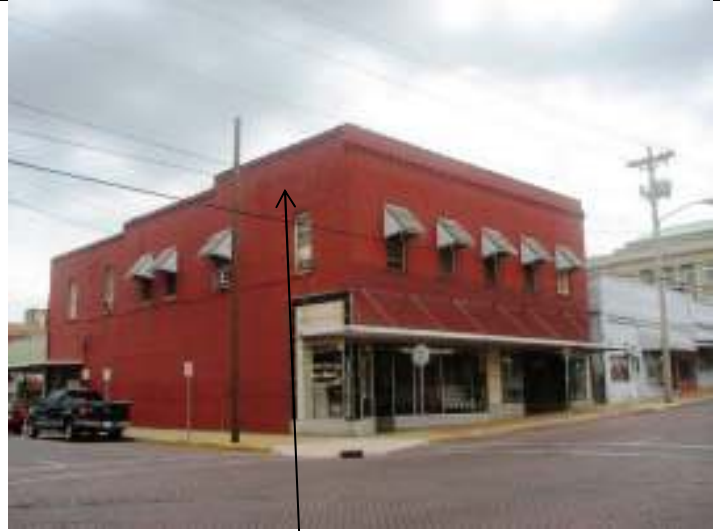
West elevation and façade, showing some peeling painting and spalling of brick

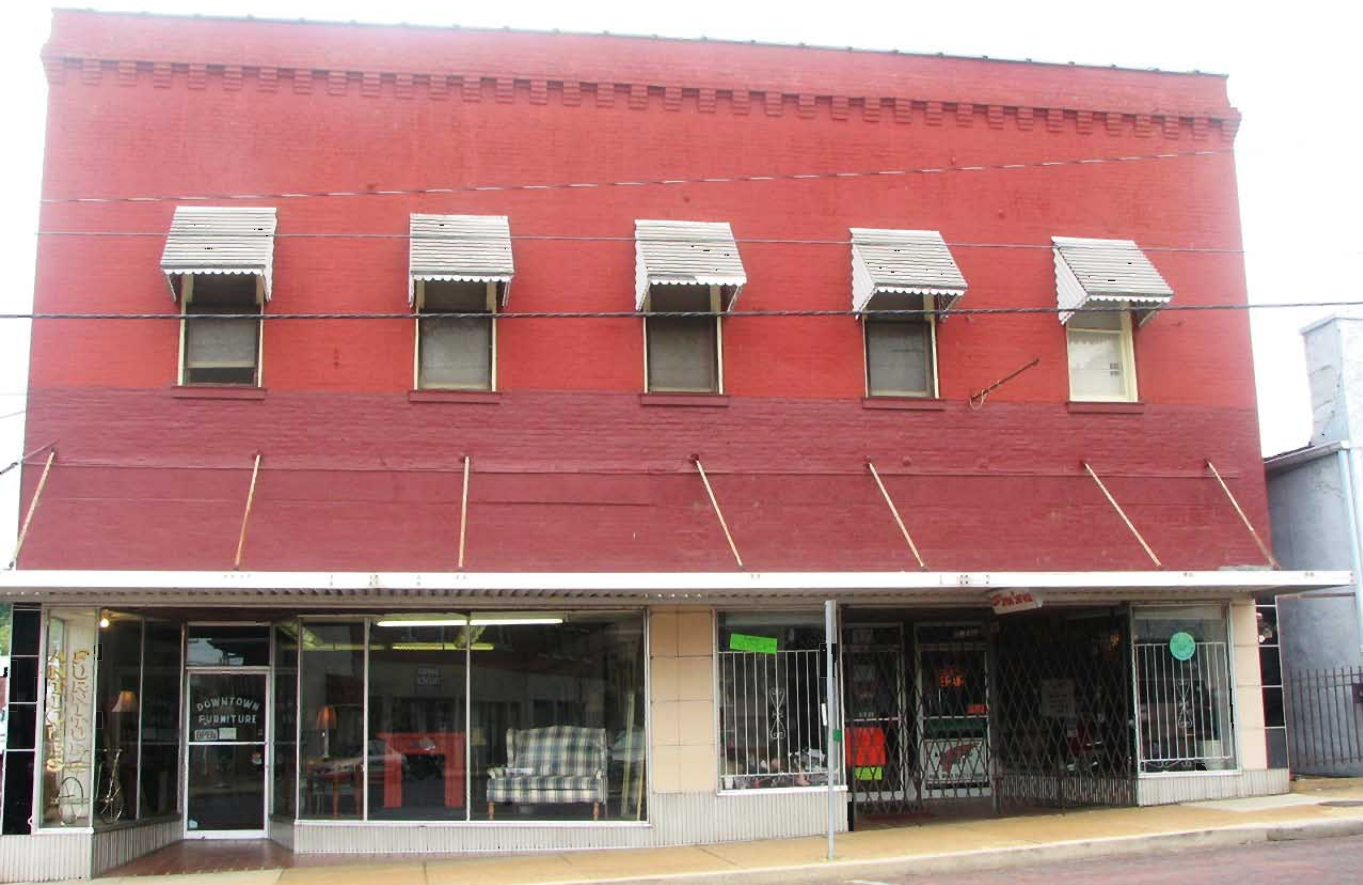
SURVEY NO. BU-AS-005-LUBC-017	
TOTAL SCORE OF OVERALL INTERIOR BUILDING CONDITION:	LOCATION: L1 – 1 ST FLOOR; L2- 2 ND FLOOR; L3 -3 RD
12- EXCELLENT	6-8 – FAIR 0-4 - DILAPIDATED
9-11 – GOOD	1-3 - POOR

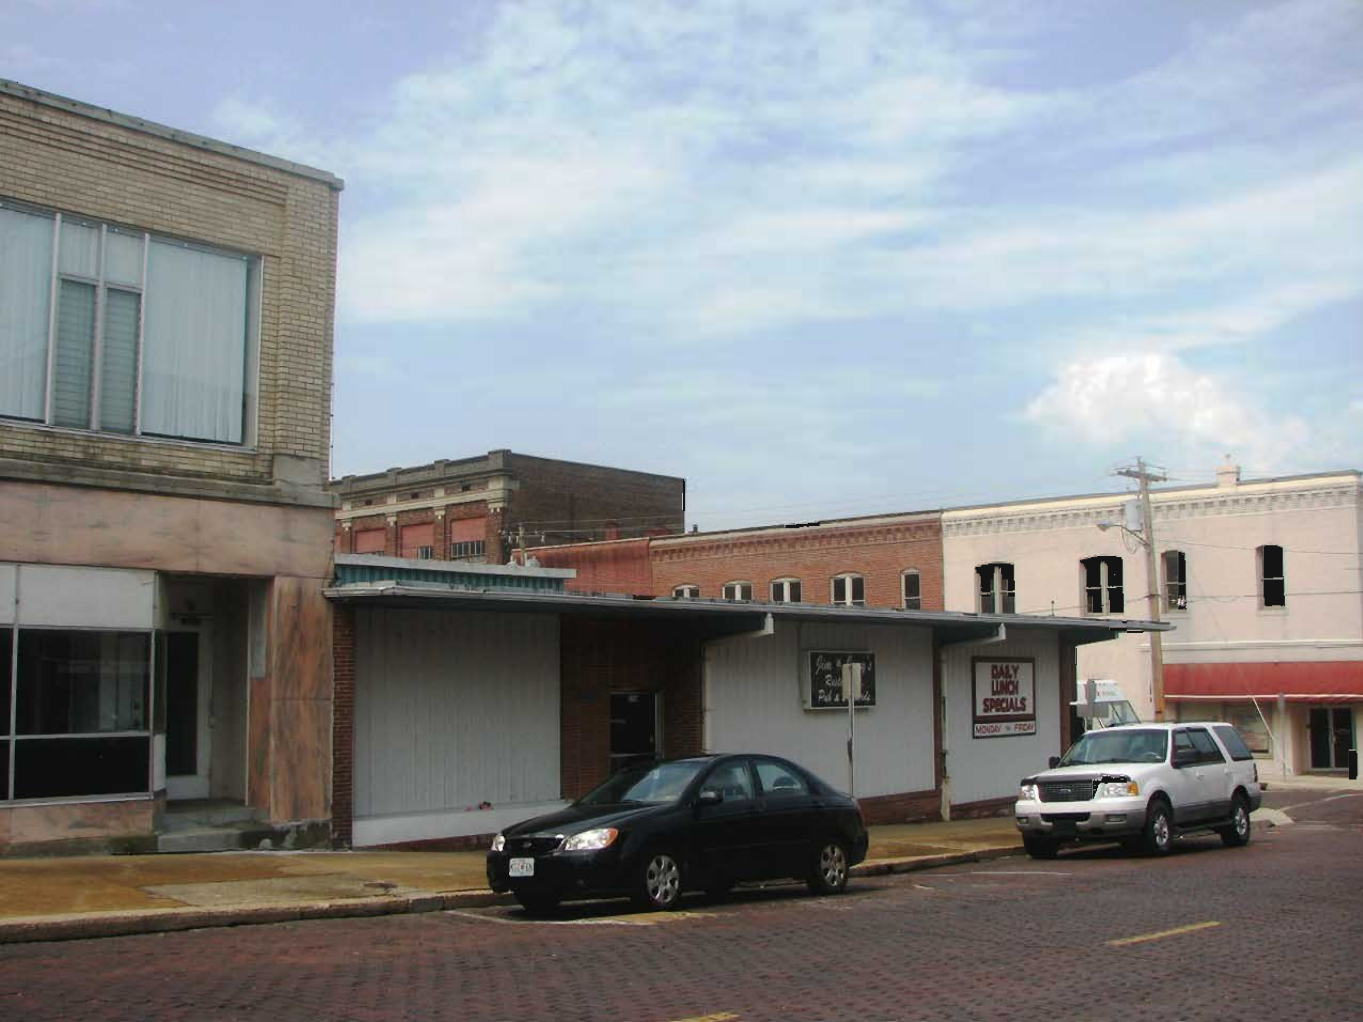
DAILY
LUNCH
SPECIALS
MONDAY - FRIDAY

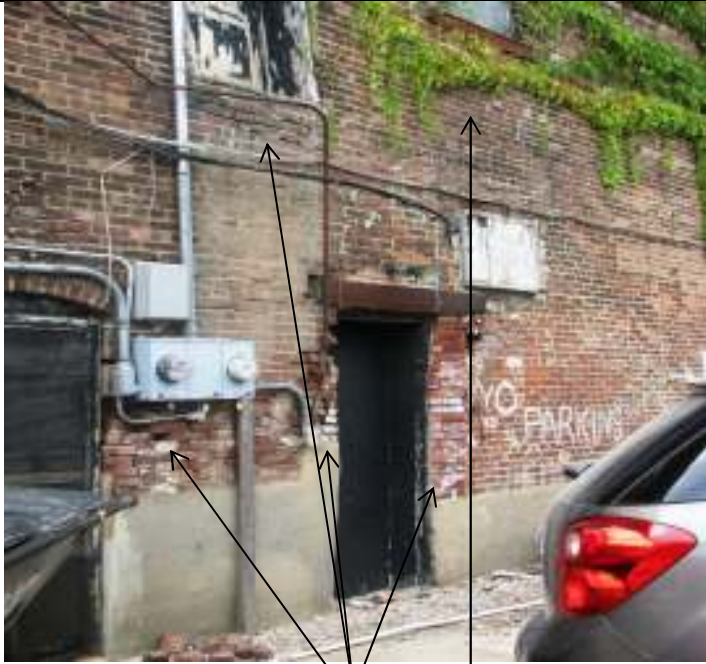
Rear (north) elevation, showing loose and fallen bricks, mortar issues, and vegetation on wall surface.

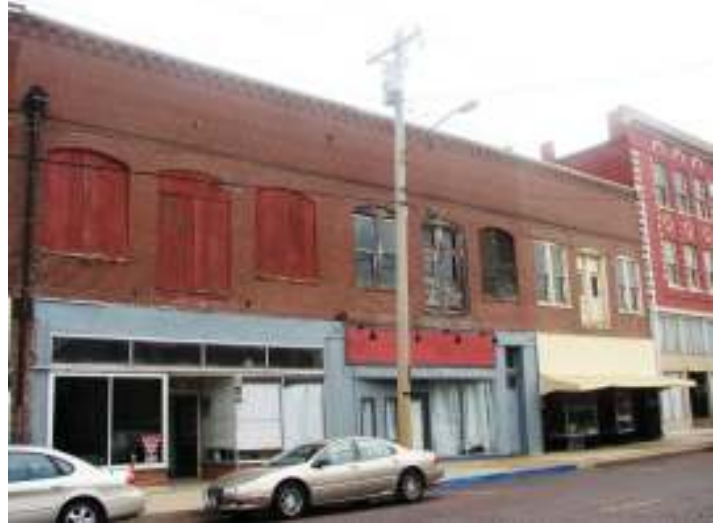
403-405 Vine St. has the light yellow awning. Photo shows the weathered windows and doors on the second level.

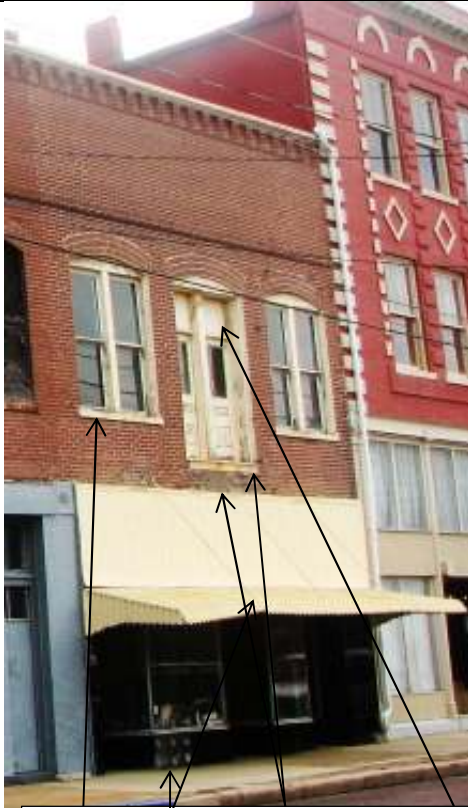
Façade, showing missing Carrara glass panels, bent awning, deteriorated brick/mortar, and doors/windows

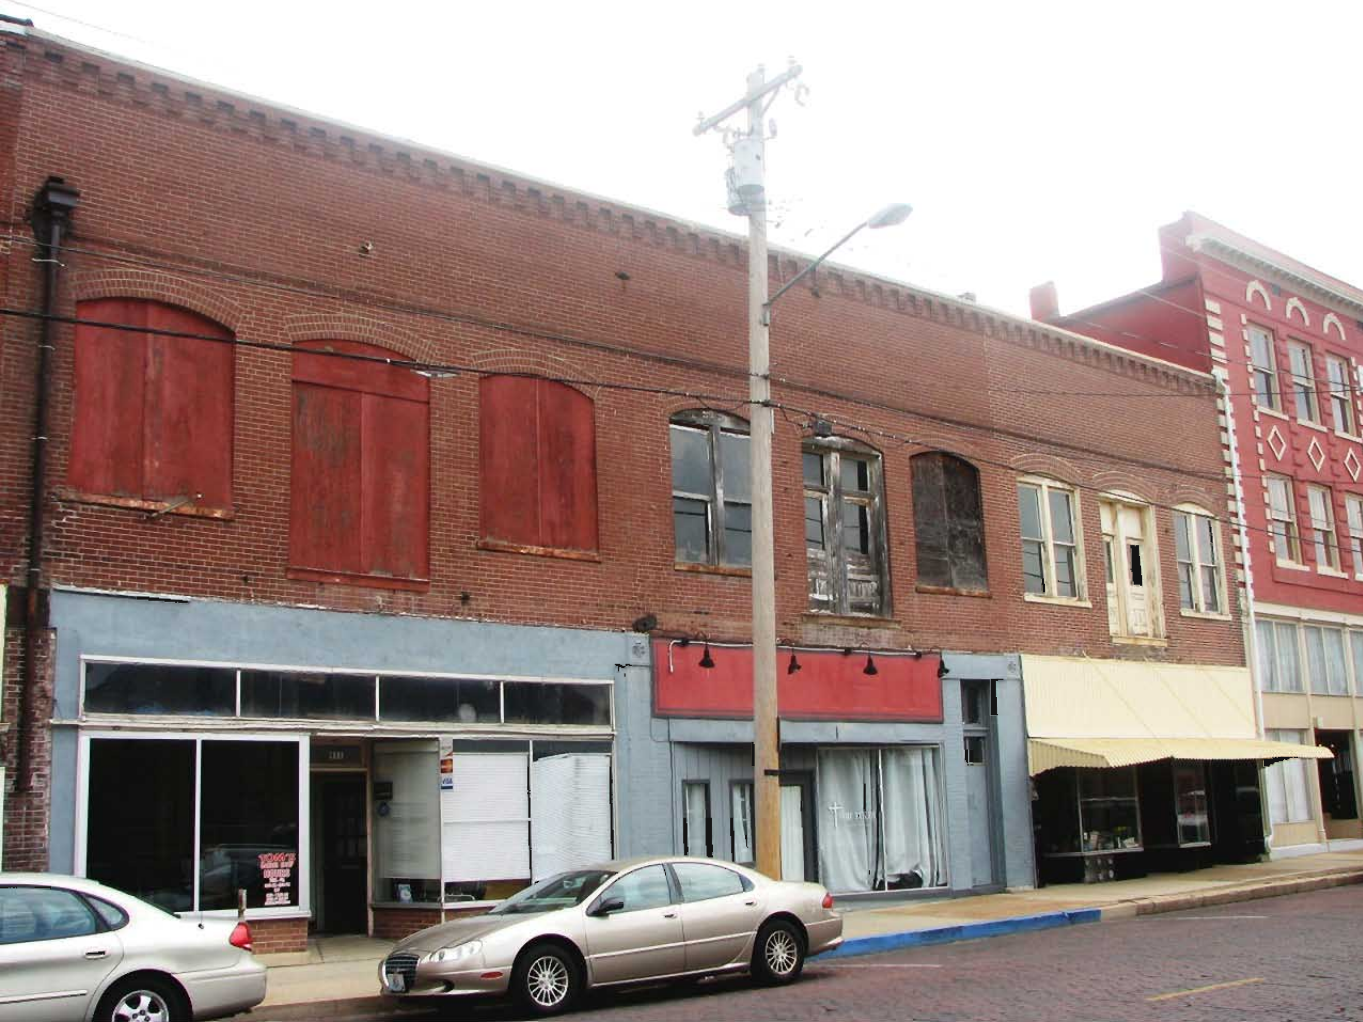
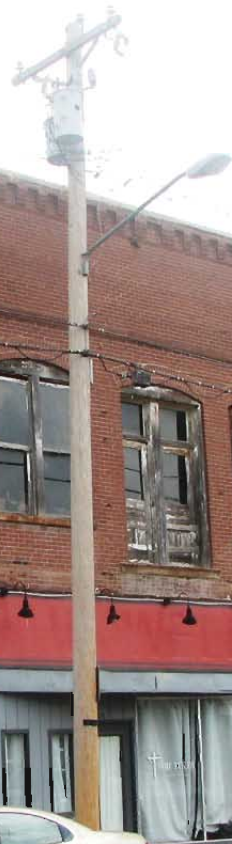
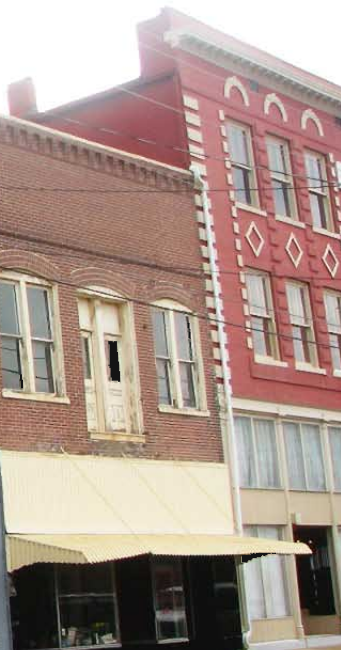
SURVEY NO. BU-AS-005-LUBC-016	
TOTAL SCORE OF OVERALL INTERIOR BUILDING CONDITION: FLOOR 12- EXCELLENT 6-8 - FAIR 0-4 - DILAPIDATED 9-11 - GOOD 1-3 - POOR	LOCATION: L1 - 1 ST FLOOR; L2- 2 ND FLOOR; L3 -3 RD

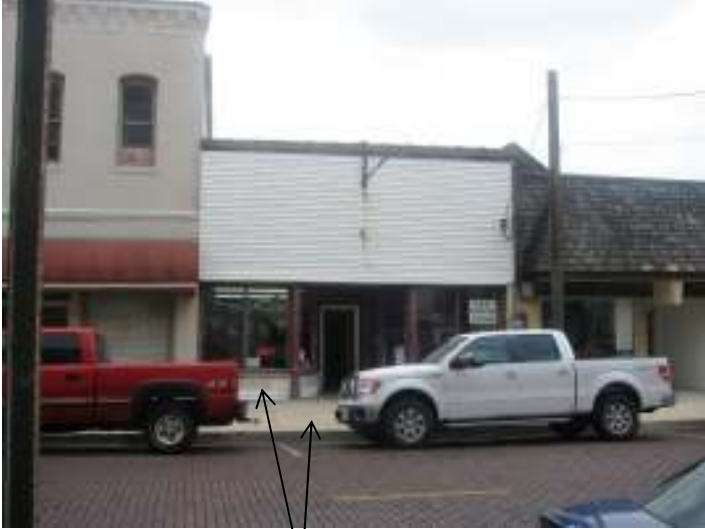
Façade (north), showing missing vinyl siding panel

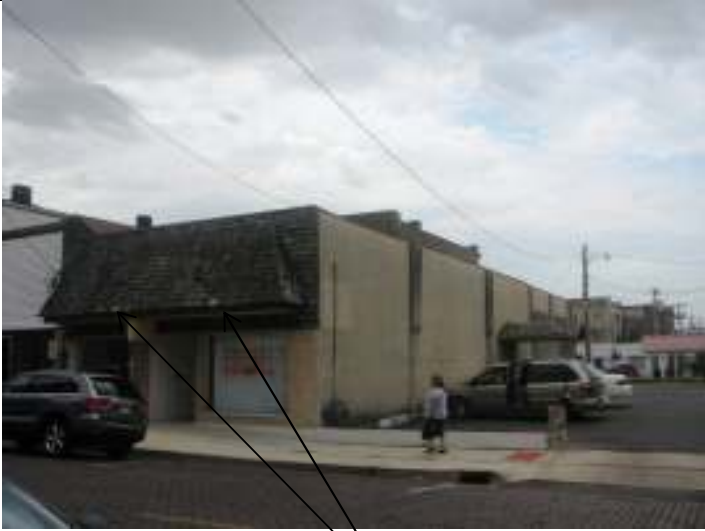
Facade (north), showing missing wood shingles

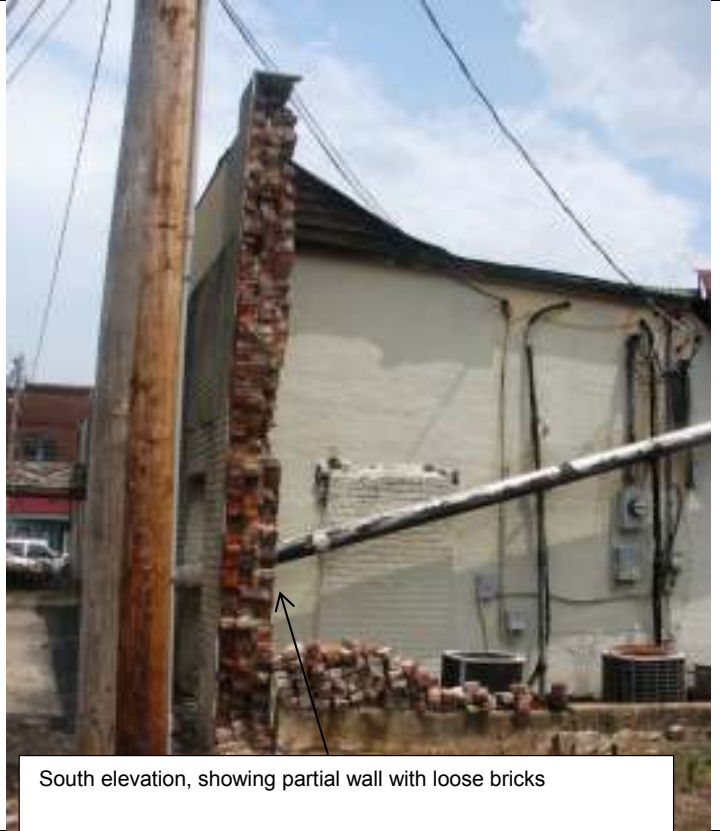
South elevation, showing partial wall with loose bricks

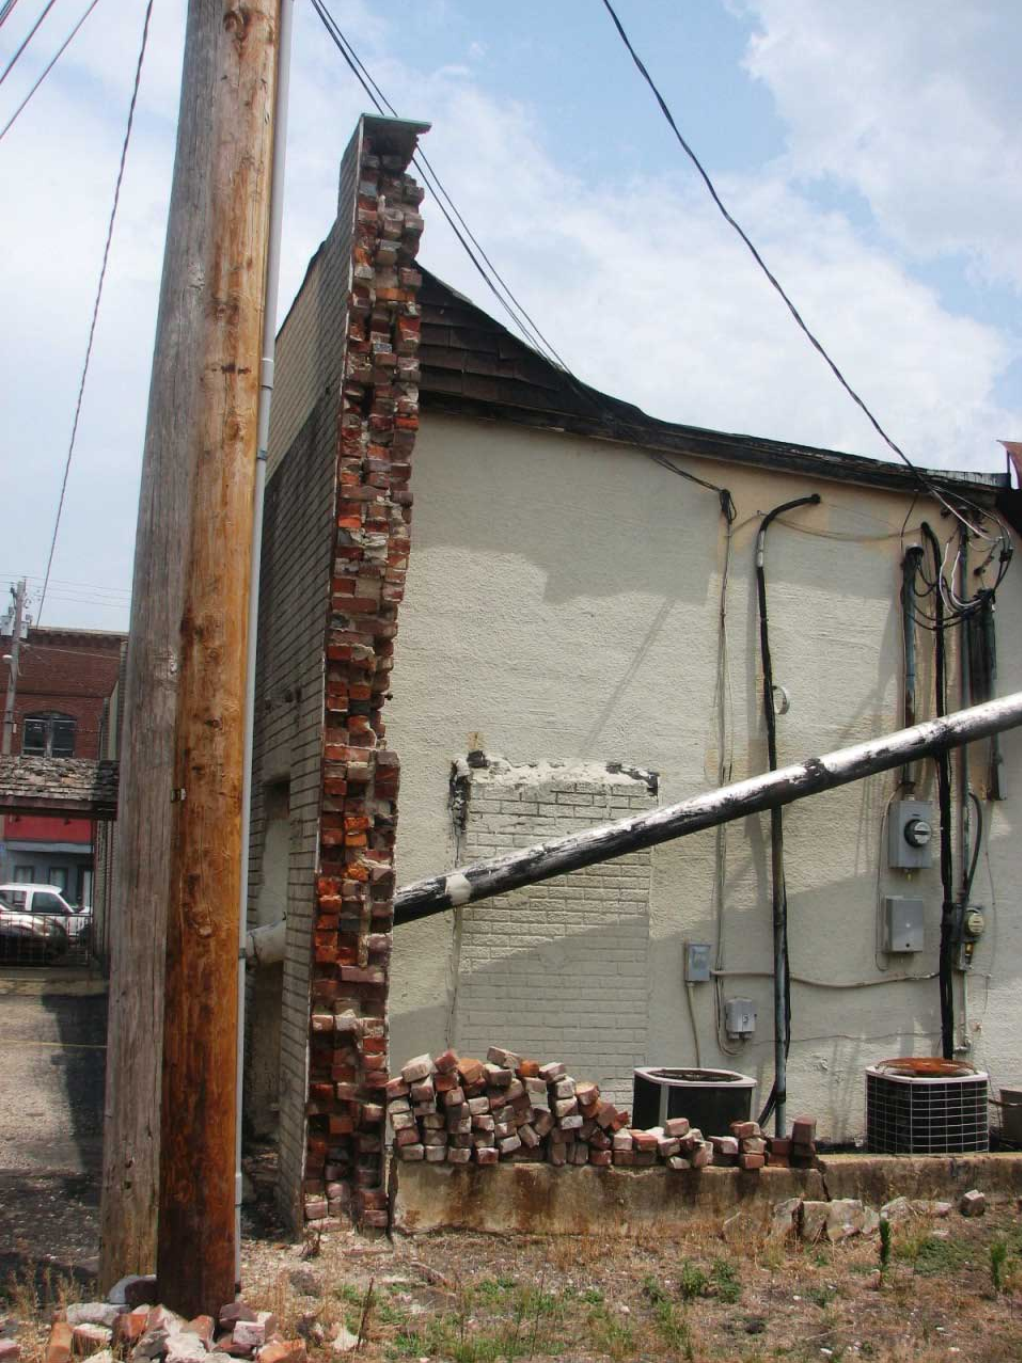
SURVEY NO. BU-AS-005-LUBC-010	
TOTAL SCORE OF OVERALL INTERIOR BUILDING CONDITION:	LOCATION: L1 – 1 ST FLOOR; L2- 2 ND FLOOR; L3 -3 RD FLOOR
12- EXCELLENT	6-8 – FAIR 0-4 - DILAPIDATED
9-11 – GOOD	1-3 - POOR

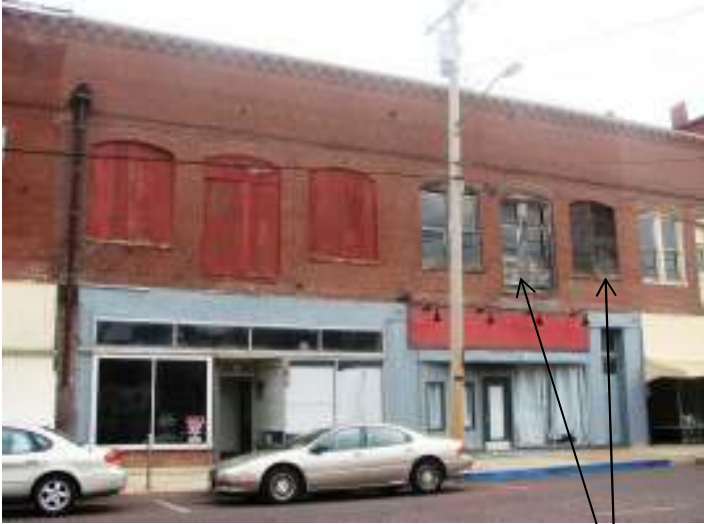
Façade (south) – showing boarded windows, deteriorated windows and doors

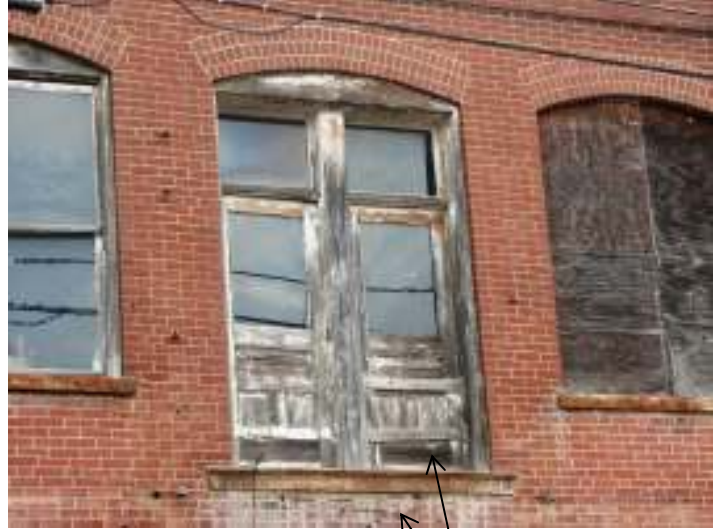
Upper level doors on façade and water damaged brick/mortar bellows doors

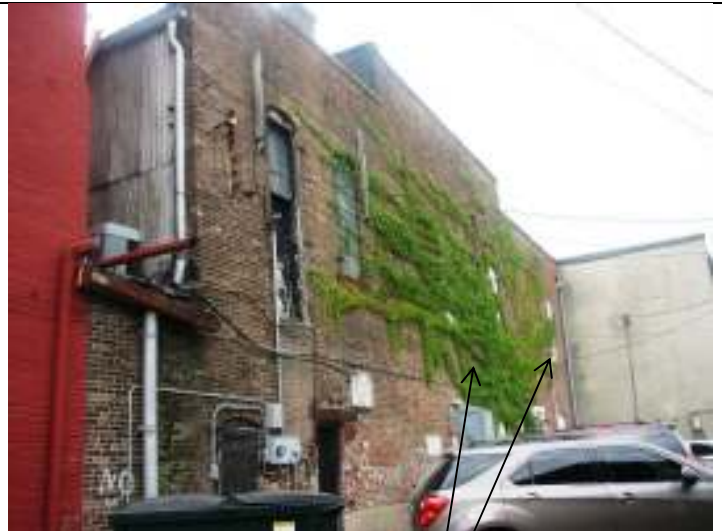
Rear (north) elevation showing vine covered wall surface and covered over window openings

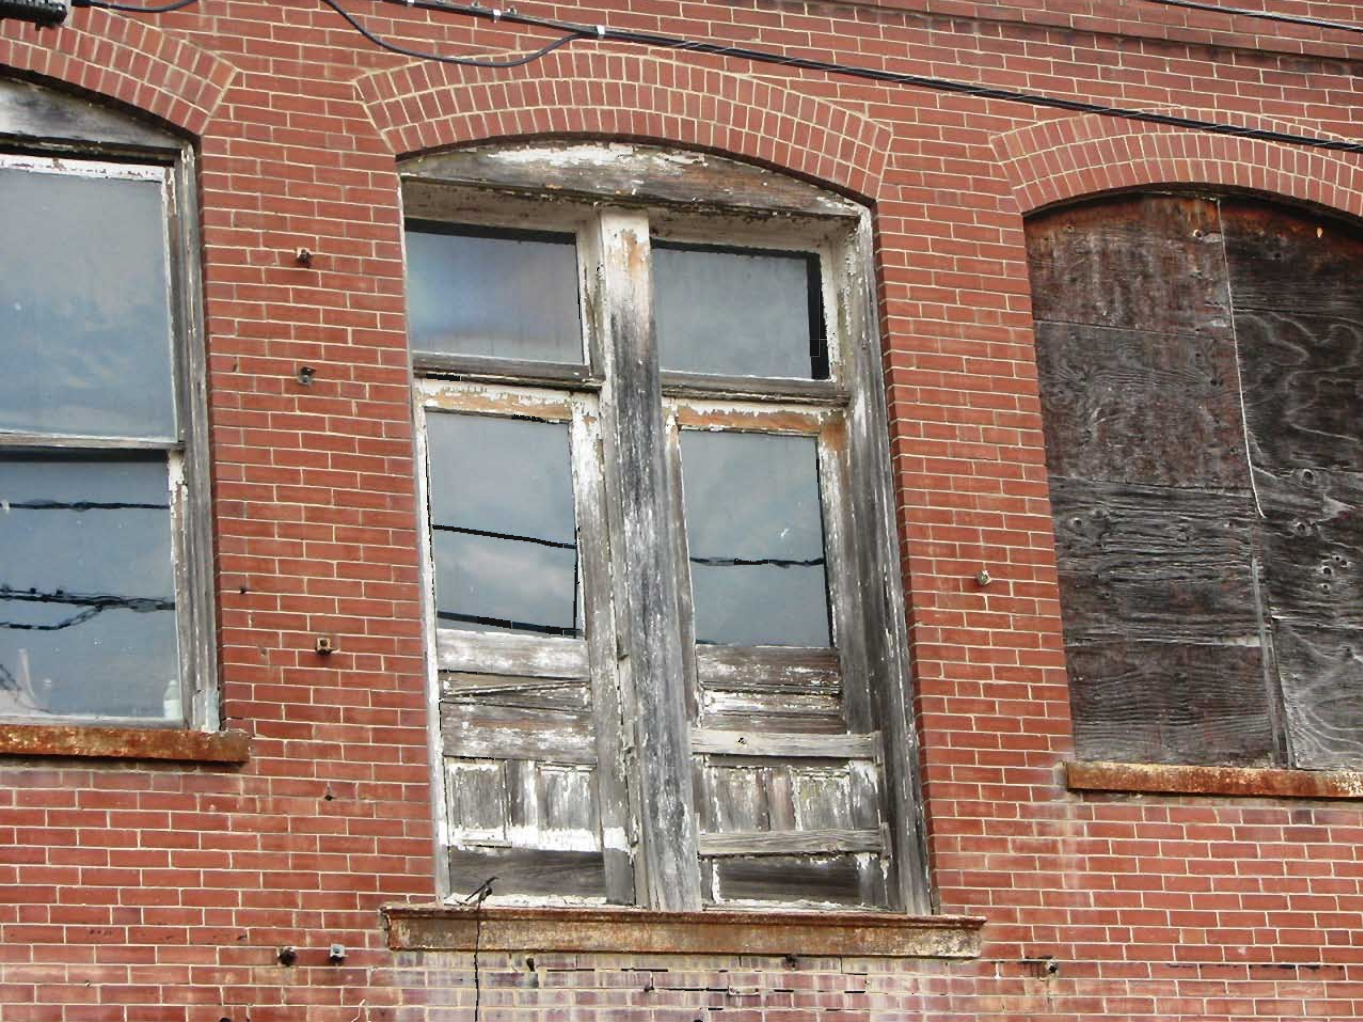
SURVEY NO. BU-AS-005-LUBC-011	
TOTAL SCORE OF OVERALL INTERIOR BUILDING CONDITION:	LOCATION: L1 – 1 ST FLOOR; L2- 2 ND FLOOR; L3 -3 RD FLOOR
12- EXCELLENT 6-8 – FAIR 0-4 - DILAPIDATED	
9-11 – GOOD 1-3 - POOR

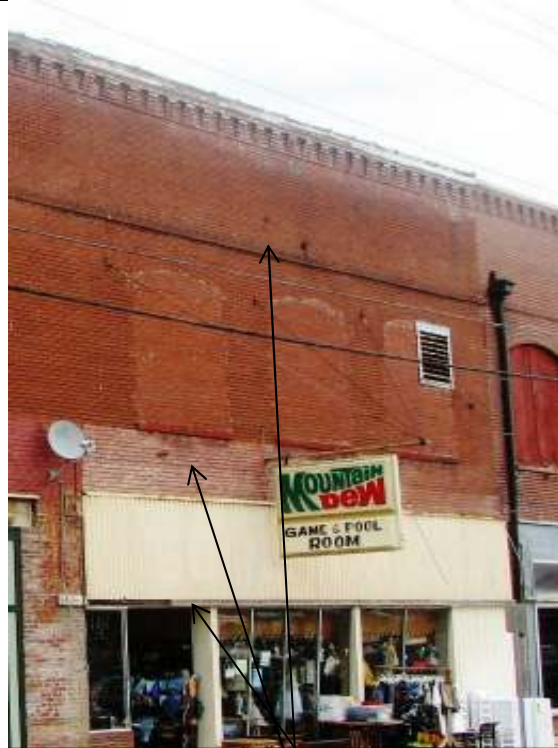
Façade – showing cracks in mortar, missing trim from metal slip cover and mortar issues

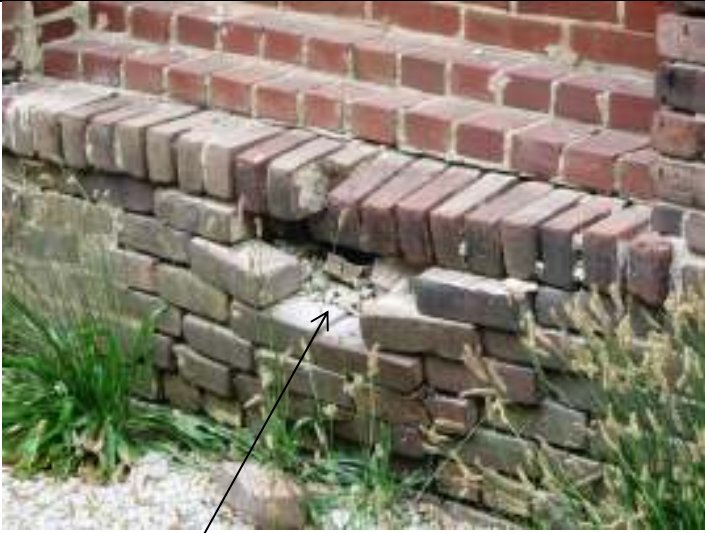
Loose and fallen brick on rear (north) elevation

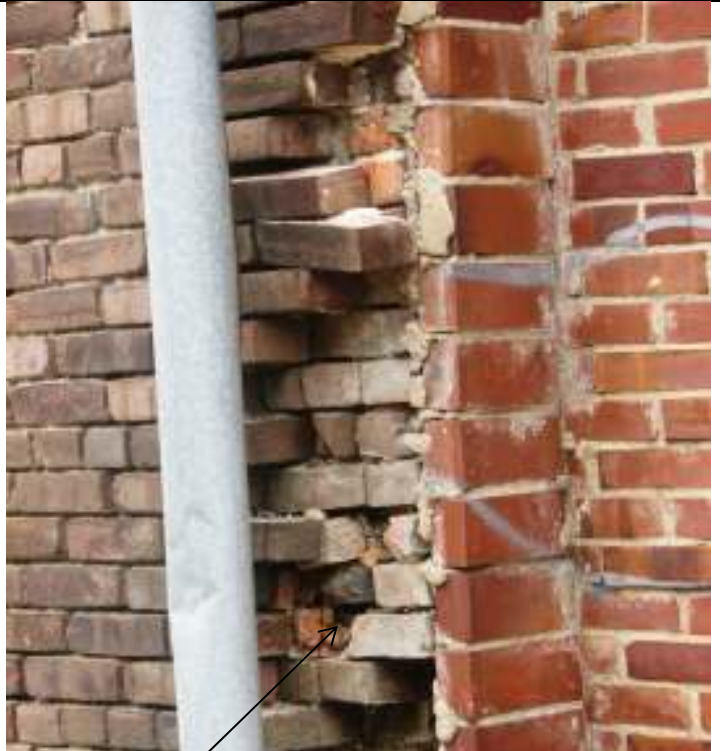
Loose and fallen brick on rear (north) elevation

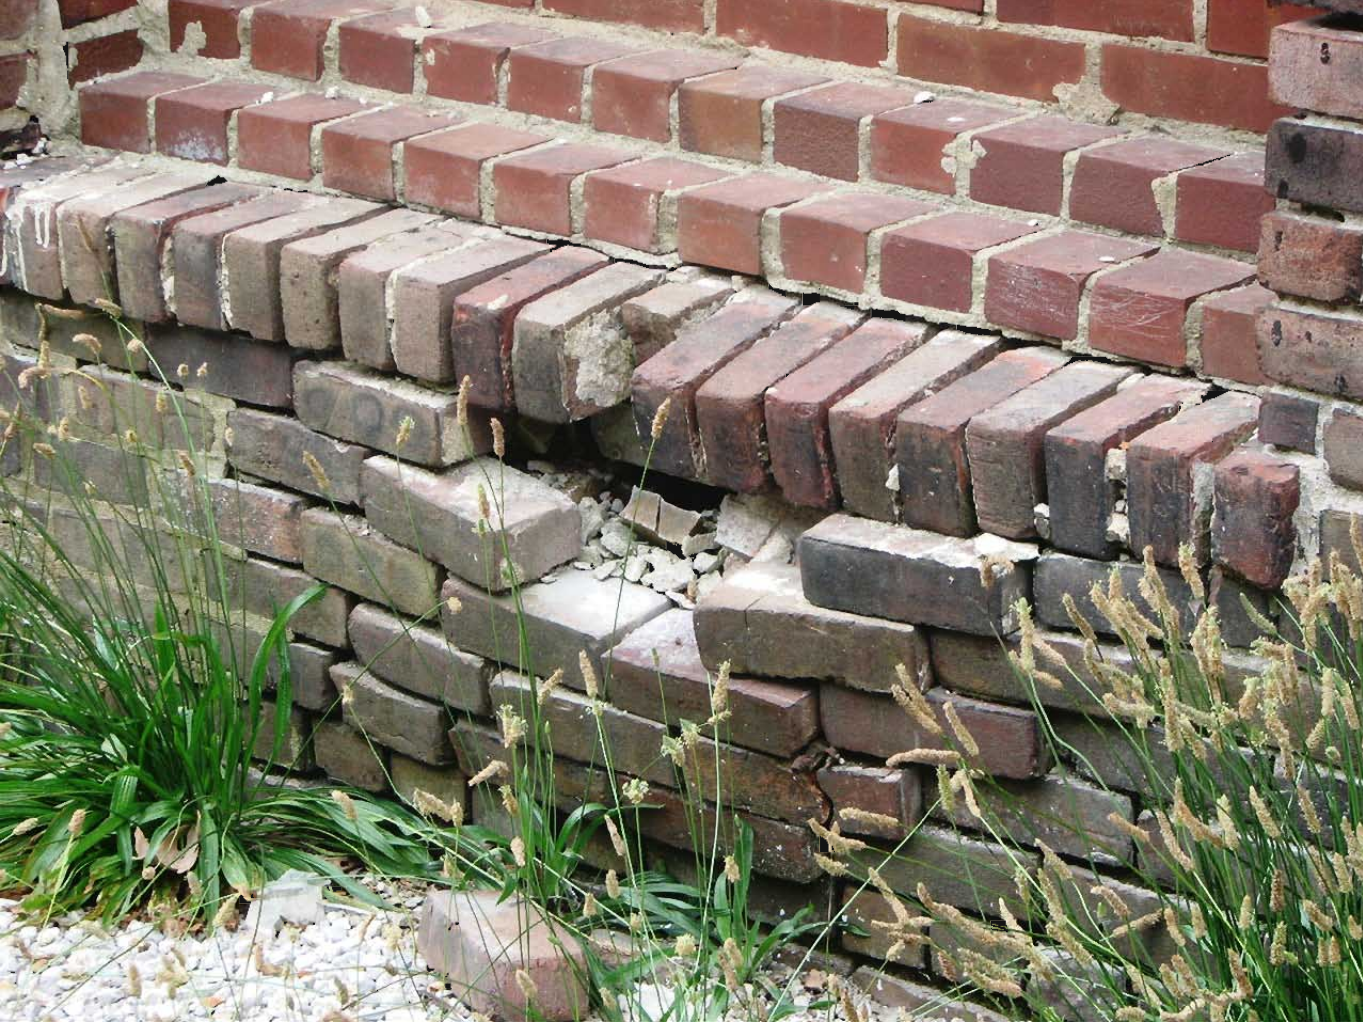
Mountain Dew
GAME & POOL
ROOM

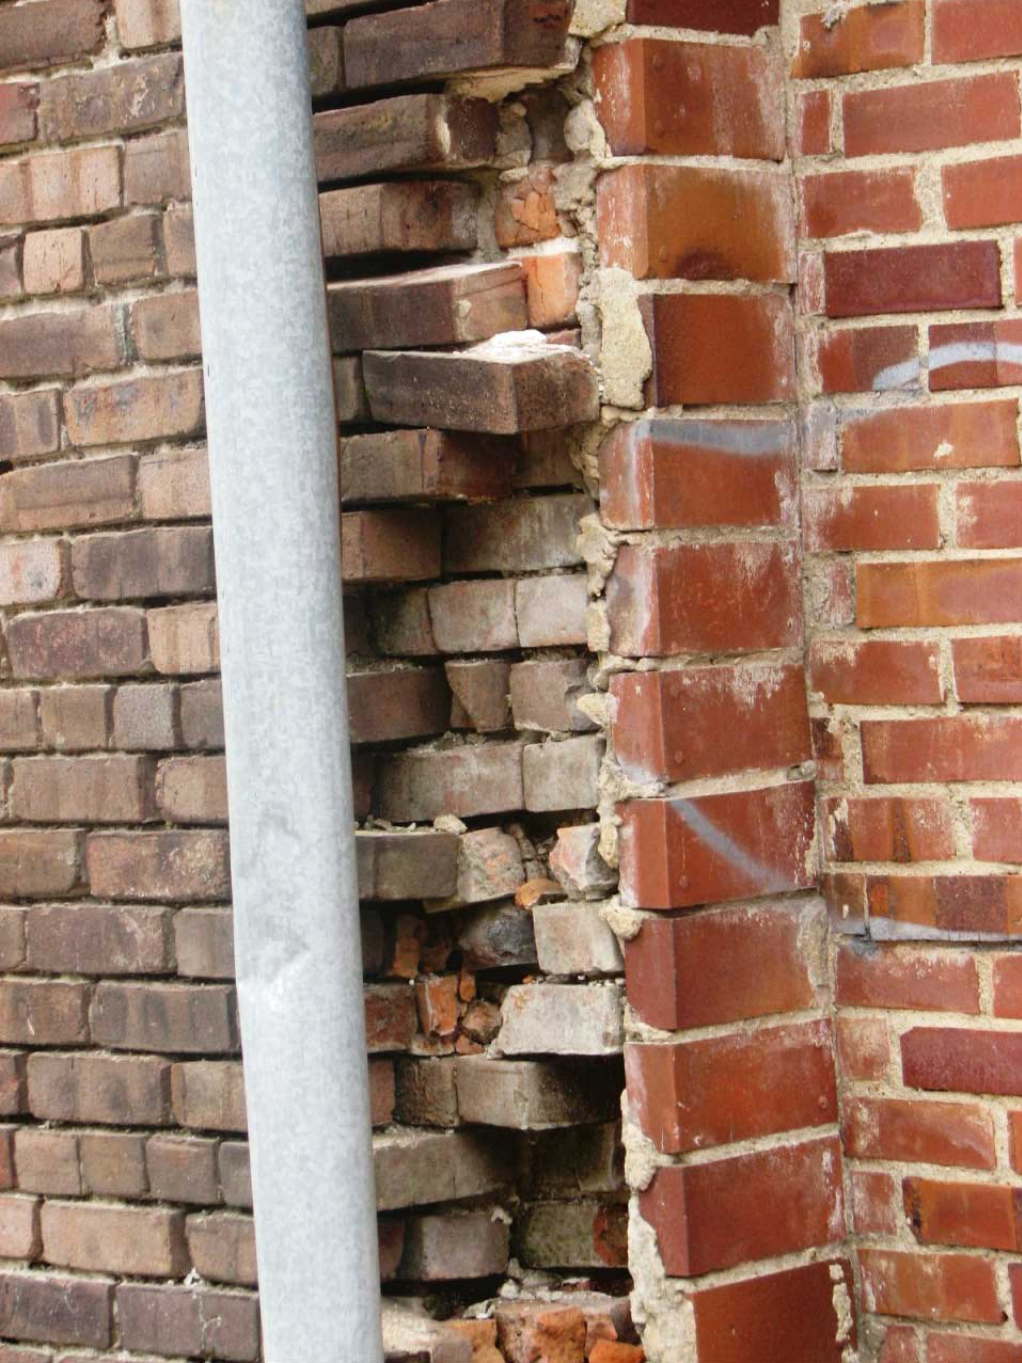
SURVEY NO. BU-AS-005-LUBC-012	
TOTAL SCORE OF OVERALL INTERIOR BUILDING CONDITION:	LOCATION: L1 – 1 ST FLOOR; L2- 2 ND FLOOR; L3 -3 RD FLOOR
12- EXCELLENT 6-8 – FAIR 0-4 - DILAPIDATED	
9-11 – GOOD 1-3 - POOR

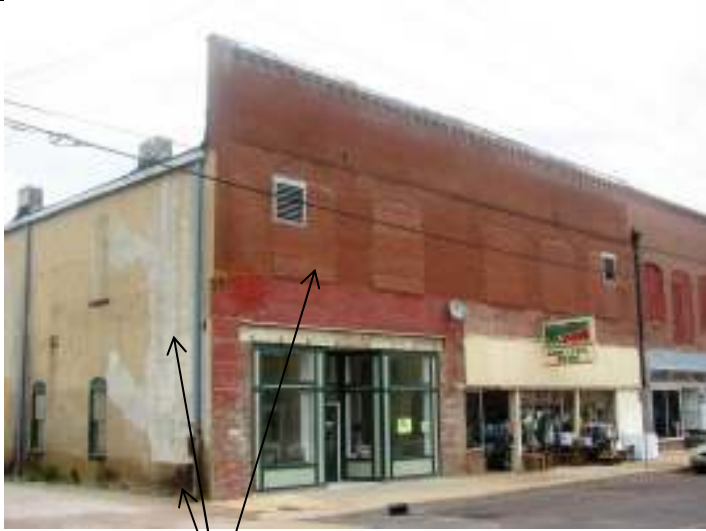
Façade (south) and west elevations – 415 is storefront on the left (end) – showing brick infilled windows, and deteriorated stucco. Water damage on lower section of west elevation

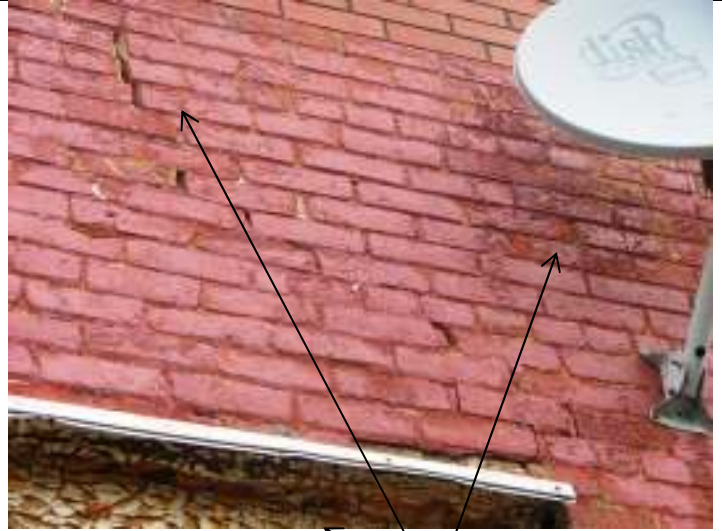
Upper façade, showing cracked brick and missing mortar, peeling paint

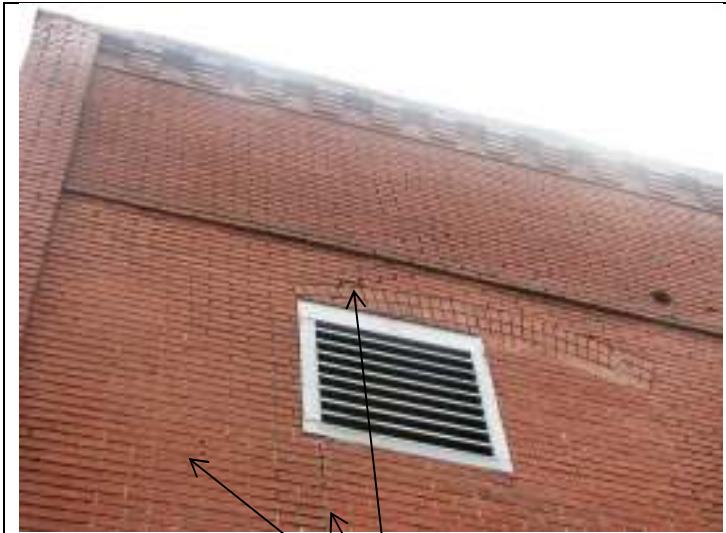
Upper façade showing cracked brick and missing mortar

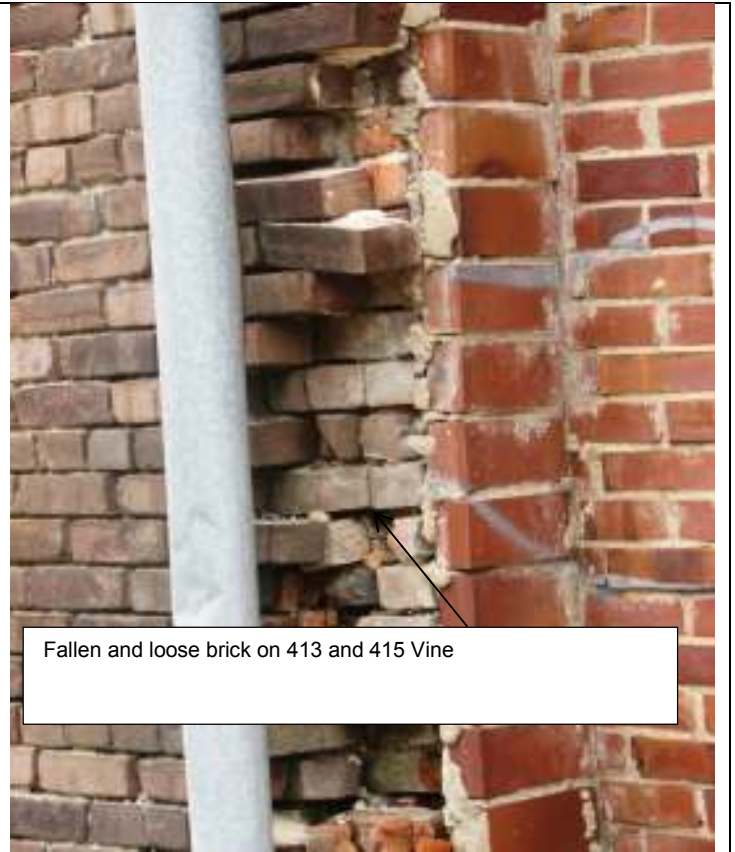
Fallen and loose brick on 413 and 415 Vine

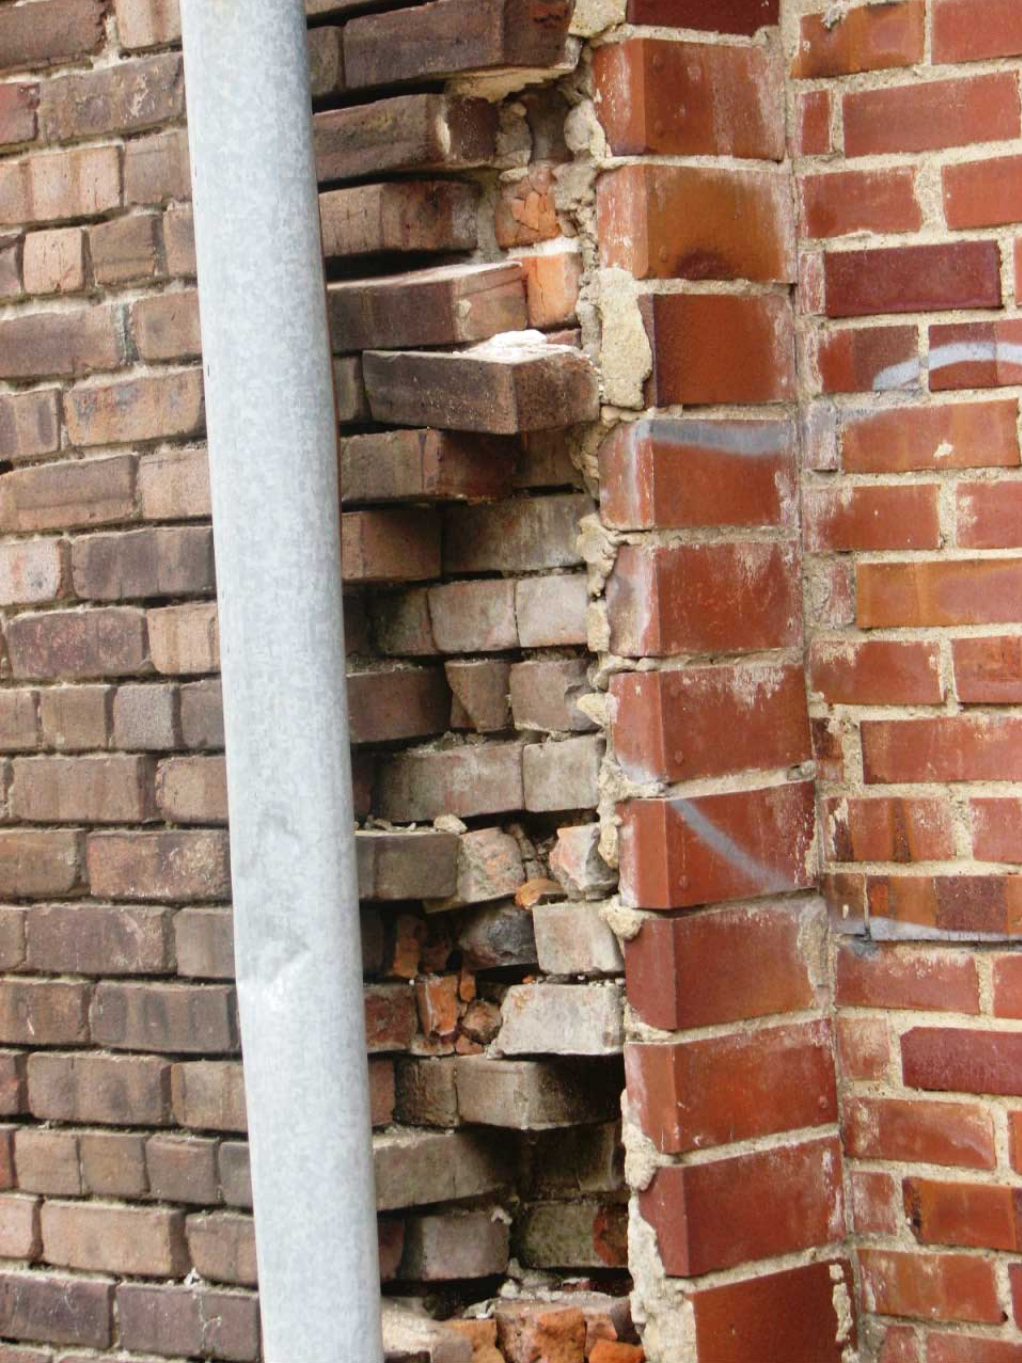
SURVEY NO. BU-AS-005-LUBC-014	
TOTAL SCORE OF OVERALL INTERIOR BUILDING CONDITION:	LOCATION: L1 – 1 ST FLOOR; L2- 2 ND FLOOR; L3 -3 RD FLOOR
12- EXCELLENT	6-8 – FAIR 0-4 - DILAPIDATED
9-11 – GOOD	1-3 - POOR

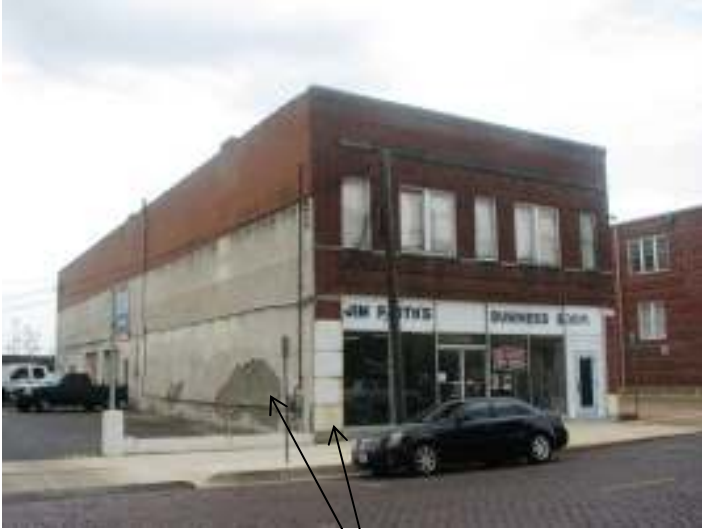
Façade (north) and east elevation, showing damaged concrete wall covering, weathered panels
