Reconnaissance Survey of the Depot District and Old Town Neighborhoods

Kirksville, Adair County, Missouri

Owen & Eastlake Ltd

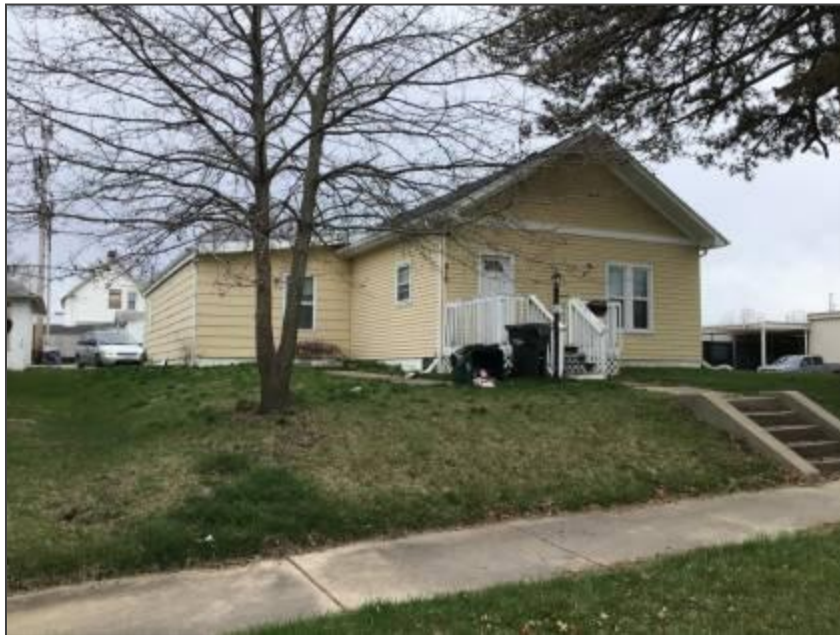
The gable front type is a simple housing form found in many regions of the United States. This type arose as a folk housing form earlier in the nineteenth century and remained popular as railroads brought mass production and standardization to the building industry. In Kirksville, earlier subtypes include simple one-story gable-front houses or two-story examples. Kirksville examples commonly have a front porch with a shed, hipped, or gabled roof. Kirksville also has examples with a recessed front porch incorporated into the main roofline. In Kirksville, before about 1905, smaller one-story examples of this house type either had little or no stylistic detail, or had modest classically-inspired or Victorian/Queen Anne detailing. Larger two-story examples were larger and more expensive homes, and were often adorned with more detail. After 1910, the one-story version of this house in Kirksville often takes on forms and detailing of the Craftsman style, including lower roof pitches, overhangs, exposed rafter tails, and knee braces. A small gable-fronted Craftsman bungalow, usually with a gabled front porch, is probably the most common pre-1930 Kirksville housing type, appearing all over the city's older residential areas.

Figure 17. A gable front house at 615 North Elson Street.

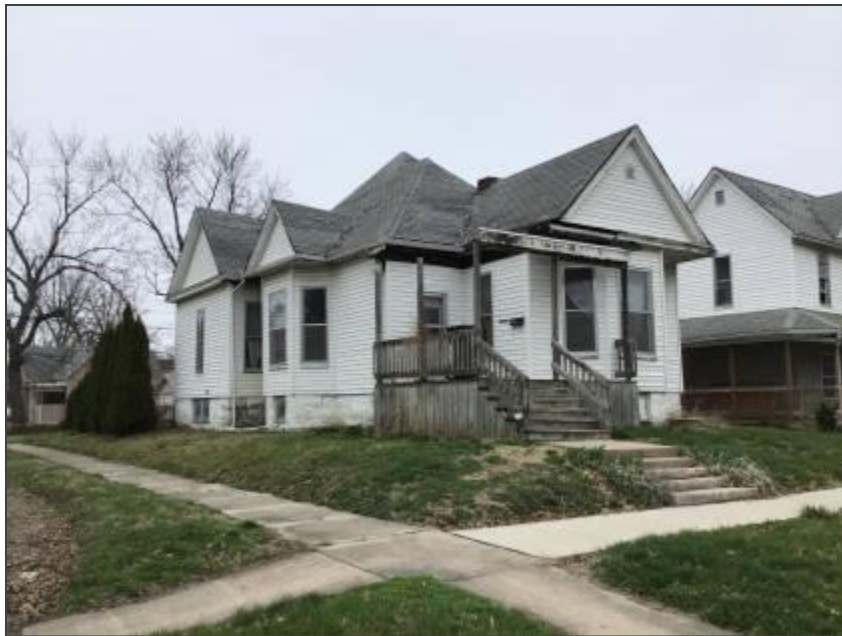
Queen Anne represents both an architectural style and an approach to house planning and layout. The style and form are inspired by Medieval architecture and emphasize complexity and asymmetry. The house facades often feature elements such as three-sided bays, turrets/towers, and varied window shapes and sizes. Ornament consists of contrasting textures and shapes, including use of both wood siding and shingles, as well as shaped claddings like fishscale shingles. Other ornament includes porch ornaments like spindles, scroll-saw tracery, and turned posts. Examples can be one or two stories tall. Kirksville has a number of typical asymmetrical examples with turrets, bays, and gables projecting out from a central hipped roof. The city also has a number of distinctive examples that have symmetrical facades with multiple three-sided bay windows and diagonal angles at the corners, giving an octagon-like effect.

Figure 19. A Queen Anne form house at 501 East Washington Street.

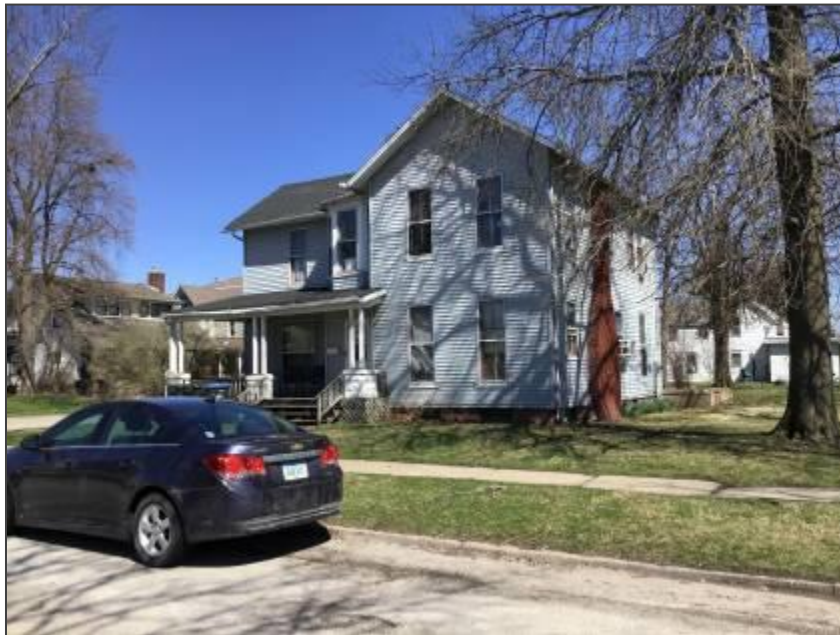
This type of house is typically two stories in height, and has a wider section of roof, often hipped or cross-gabled, at the rear, and a narrower section of gabled roof on the front. The facade is then composed of the main gabled section and a recessed area on one side. A porch is often placed in front of the recessed area. These houses are common in densely developed cities in the Midwest. The format was used by builders at the end of the nineteenth century and in the early twentieth. Stylistically, these houses may be plain folk-style examples or reflect a range of historical styles from Italianate to Queen Anne to Colonial Revival. Kirksville examples tend to be plain in design or reflect Queen Anne, Neoclassical, or Colonial Revival stylistic influence. In Kirksville, this format becomes less common after about 1910, supplanted by newer housing formats like the American Foursquare.

Figure 20. Gabled-ell form house at 301 South Florence Street.

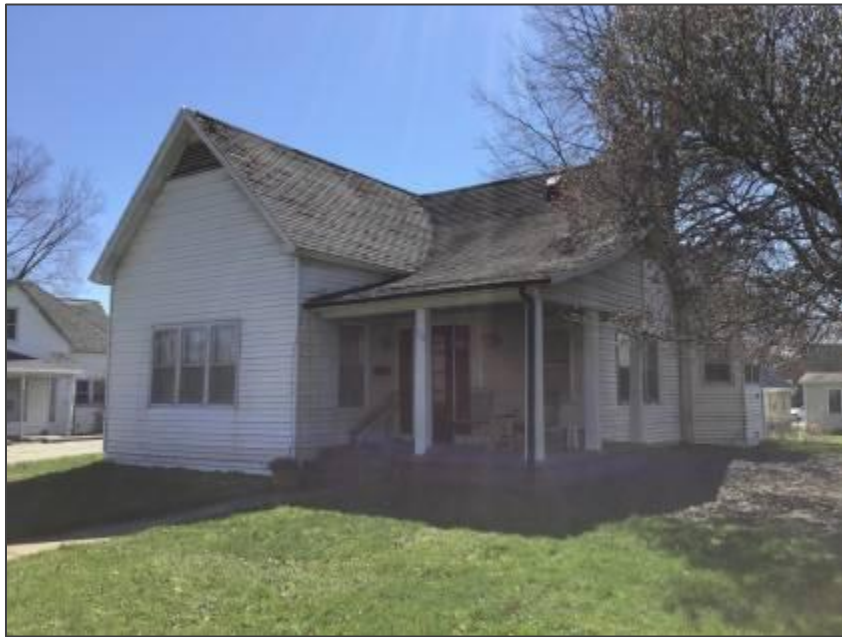
Like the gable front housing form, the gable and wing type also had origins in pre-industrial times and appears in many locations throughout the United States. The form consists of a typical gable-front house that also has a side-gabled wing, placed to the right or left. This is one of the most common housing types for pre-1910 Kirksville, with examples seen throughout the project survey area. Kirksville examples commonly have a front porch with a gabled, hipped, or shed roof. Examples tend to have little or no stylistic detail, or have somewhat sparse elements of Victorian/Queen Anne detailing, which often takes the form of porch features such as spindles or turned posts. However, Kirksville also has several examples of this housing form with more elaborate high-style Queen Anne or Carpenter Gothic detailing. Pre-1915 Kirksville housing features both one-story and two-story examples of the form, although the one-story format seems especially common. In Kirksville after about 1915, it appears that the one-story version of this small house type was largely replaced by the gable-front Craftsman bungalow as the favored small house type.

Figure 21. Gable and wing form house at 701 East Harrison Street.

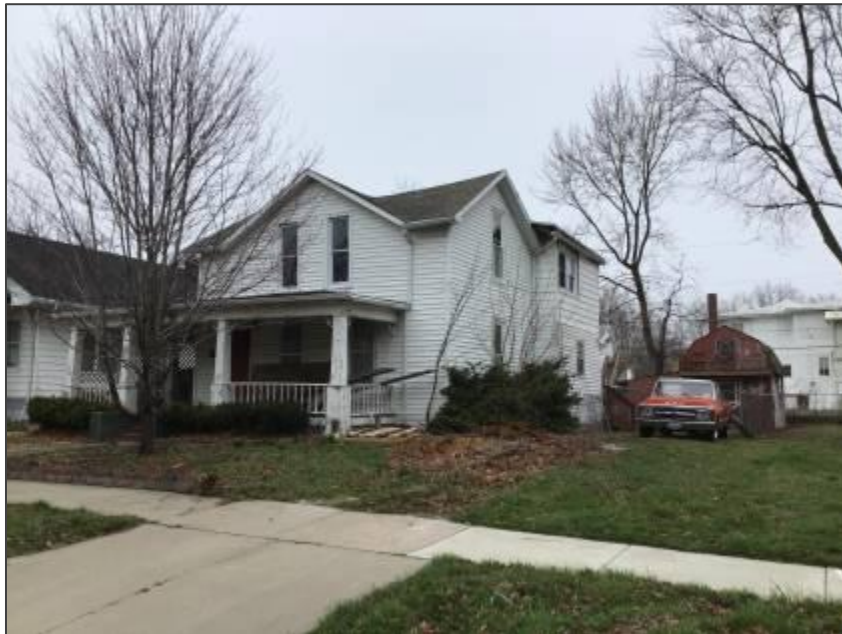
This type is related to the gable and wing type, and consists of a side-gabled house with a symmetrically-placed front-facing gable, and a central entrance under the gable. The gable can either be a simple roof gable or can be part of a projecting central front wing. Like the front gable and gable and wing types, it has origins in pre-industrial folk housing. This type was mostly built before 1920 in Kirksville and is not as common as the much-favored gable and wing format. There are two major Kirksville variants of this type. The first variant is a full two-story side-gabled house with a gable and entrance in the center of the facade. The second common variant is a house with a full first story and a shorter second story partially or fully accommodated under the roofline. The central roof gable provides additional space for the partial second story. Examples of both subtypes are plain or have modest Victorian/Queen Anne detail. The one-story version of this format was largely supplanted after 1915 in Kirksville by the gable-front Craftsman bungalow.

Figure 22. Center gable form house with Craftsman porch details.

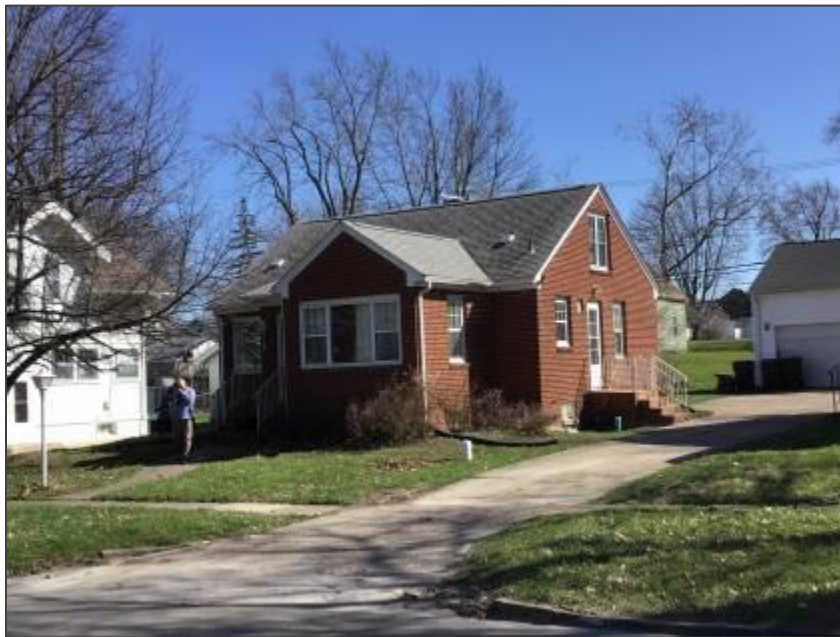
This type of house originated with the need for budget-cutting in house construction during the lean years of the 1930s and World War II. These houses are typically simplified and stripped-down versions of the Colonial Revival and Tudor Revival houses popular in the 1920s. The homes usually feature relatively low roof pitches, and the roof designs tend to lack the broad overhangs seen in earlier Craftsman and Prairie housing stock. These features give the Minimal Traditional style a somewhat clipped, boxy appearance. The houses are usually side-gabled or cross-gabled in format, although Kirksville also has a few hipped-roof versions. These houses are usually plain with very little stylistic ornament, although a few simple details such as Colonial porch columns are sometimes included. Kirksville examples of this style typically date from 1945 into the 1950s, and are similar to examples found in other areas of the United States that experienced postwar-era development. The format was a slightly more traditional alternative to the Modernist-inspired postwar Ranch house.

Figure 23. Minimal traditional form house at 904 East Washington Street.

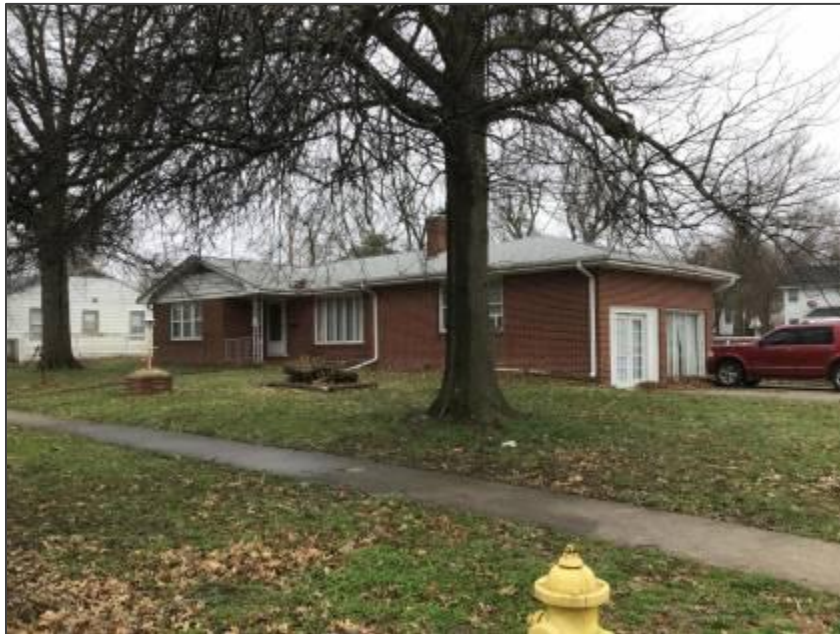
The ranch house is a one-story home characterized by plain design with little ornament, low rooflines of hipped, side gabled, or cross-gabled design, and a low, horizontal, sprawling format. The ranch house evolved in the 1930s from a combination of Modernist influences and western vernacular house types. Its simplicity, informal character, and ease of construction made it a favorite housing type for postwar real estate developers. A modest number of ranch houses are found in the survey area, and many were infill houses that occupied vacant lots left over in older residential subdivisions after World War II. Kirksville's ranch house examples in the survey area are fairly typical of ranch house construction in the postwar Midwest. Both brick and wood frame ranches exist in Kirksville. Although most examples are plain and fairly utilitarian in design, sometimes a few Colonial Revival or Mediterranean features were incorporated into the exteriors.

Figure 24. Ranch house form at 907 East Washington Street.

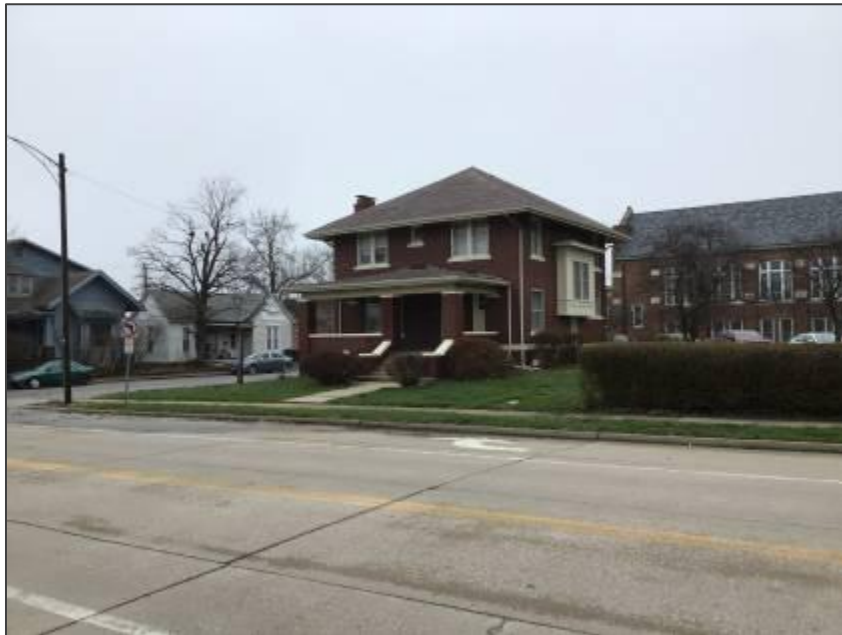
This housing type is common all across the United States in areas that saw development from about 1900–20. Examples of the type are two-story houses with box-like proportions, low horizontal lines, overhanging roofs with dormers, broad one-story hipped-roof front porches, and largely symmetrical facades. The foursquare form was influenced by the simplicity and horizontality of Frank Lloyd Wright’s early Prairie-style architecture, and this housing format is considered distinctly American due to its Wrightian origins. Examples in Kirksville sometimes have little or no ornament, or a few subtle Craftsman details, in sympathy with Wright’s emphasis on simplicity. However, Kirksville examples also exist that have more stylistic detailing, often taking the form of cornice brackets and various designs of porch supports.

Figure 25. An American Foursquare at 301 East Jefferson Street.

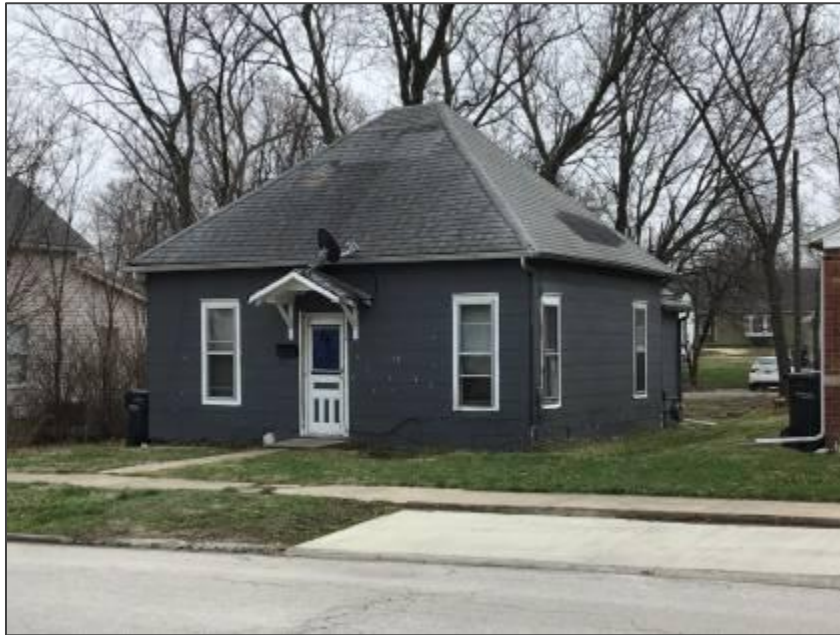
The pyramid-roof housing format usually involves a small house with nearly square proportions, allowing for the roof to take a pyramidal or near-pyramidal form. This is in contrast to the more conventional hipped roof that would cover a house with a longer rectangular shape. This house form originated in the pre-industrial era, but persisted into the twentieth century. The form is most common in the American south and is not seen as much in the northeast and upper Midwest. Its presence in Kirksville may indicate some degree of southern influence in the city's pre-1910 residential architecture. Most Kirksville examples are very small cottages of simple design with little or no stylistic detail and were built before 1920. A few examples were built ca. 1910–30, and they often reflect influence of the prevailing bungalow/Craftsman aesthetic of that era. The pyramid roof form exists in Kirksville but is much less common than the dominant gable front and gable and wing formats seen throughout the city's older residential areas.

Figure 26. Pyramidal roof form at 714 East McPherson Street.

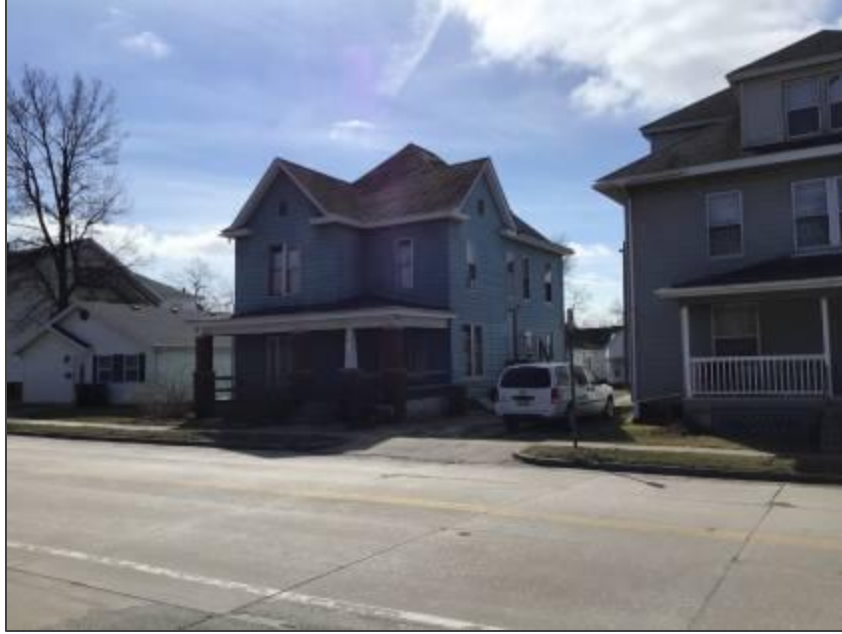
Changes to this style often result in the wrap-around porch being removed. Porch supports and columns are also often switched out, although some high-style examples remain. High-style examples would have turned wood supports, although in some instances classical columns are present.

Figure 32. This Queen Anne style at 308 Jefferson Street has a subsequently added Craftsman porch.

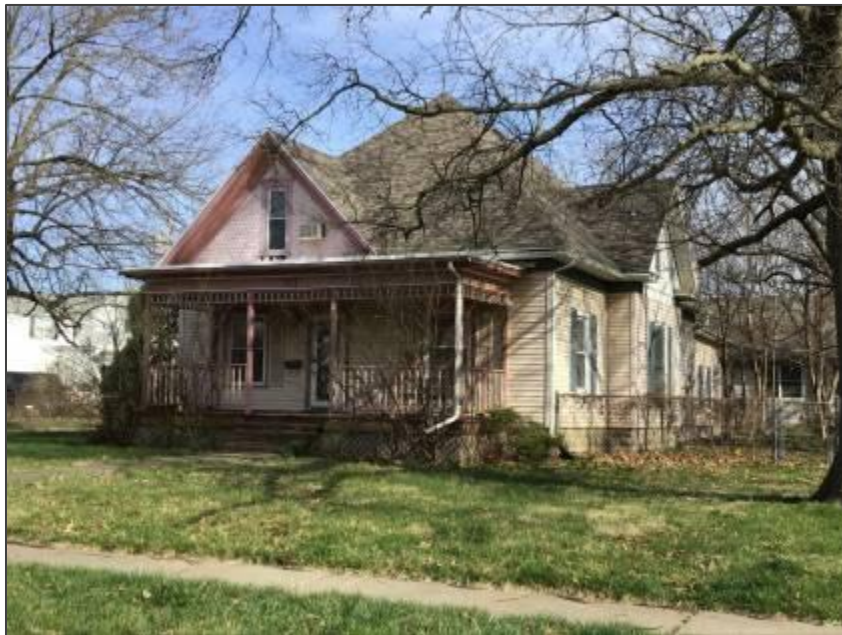
Figure 33. This high-style Queen Anne at 701 E. Harrison Street features an irregular shape and hip and gable roof. The porch features turned wood posts and spindlework.

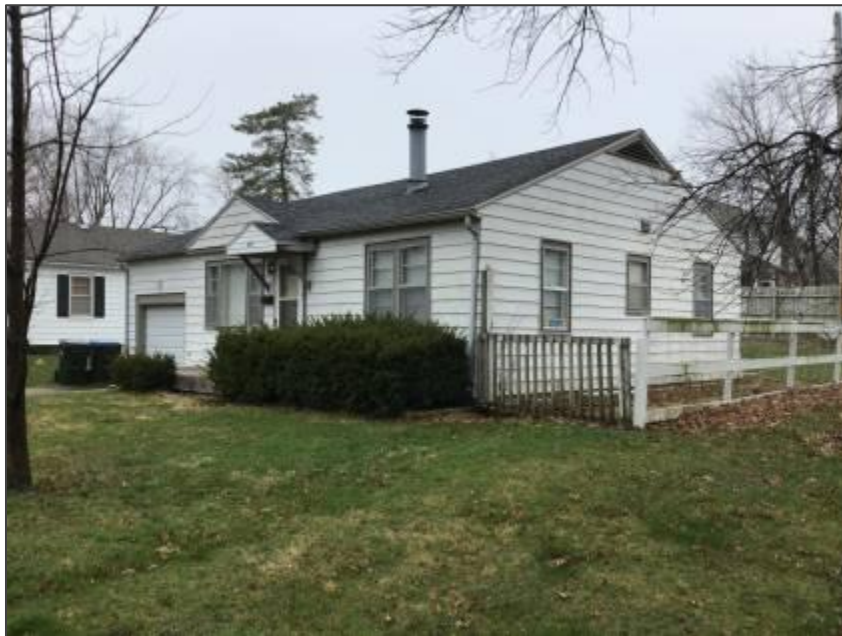
Minimal Traditional house forms are based on Federal Home Administration small house designs from the 1930s. The form was popular from 1935–50. Predominant designs include the Cape Cod and gable and wing forms. The houses sometimes have Colonial-inspired elements and forms, but do not have enough Colonial detailing to be classified as examples of the Colonial Revival style. In Kirksville survey area the Minimal Traditional house was used as the major infill design during the 1940s and 1950s. In Kirksville houses of this vintage often have horizontal two-over-two windows. Porch supports are decorative metal and the porch deck is often poured concrete. The design was aimed at easing production and cost. In some examples the design is based on four-foot increments to allow for less cutting of sheet material.

Figure 34. Minimal Traditional design located at 903 E. Washington Street.

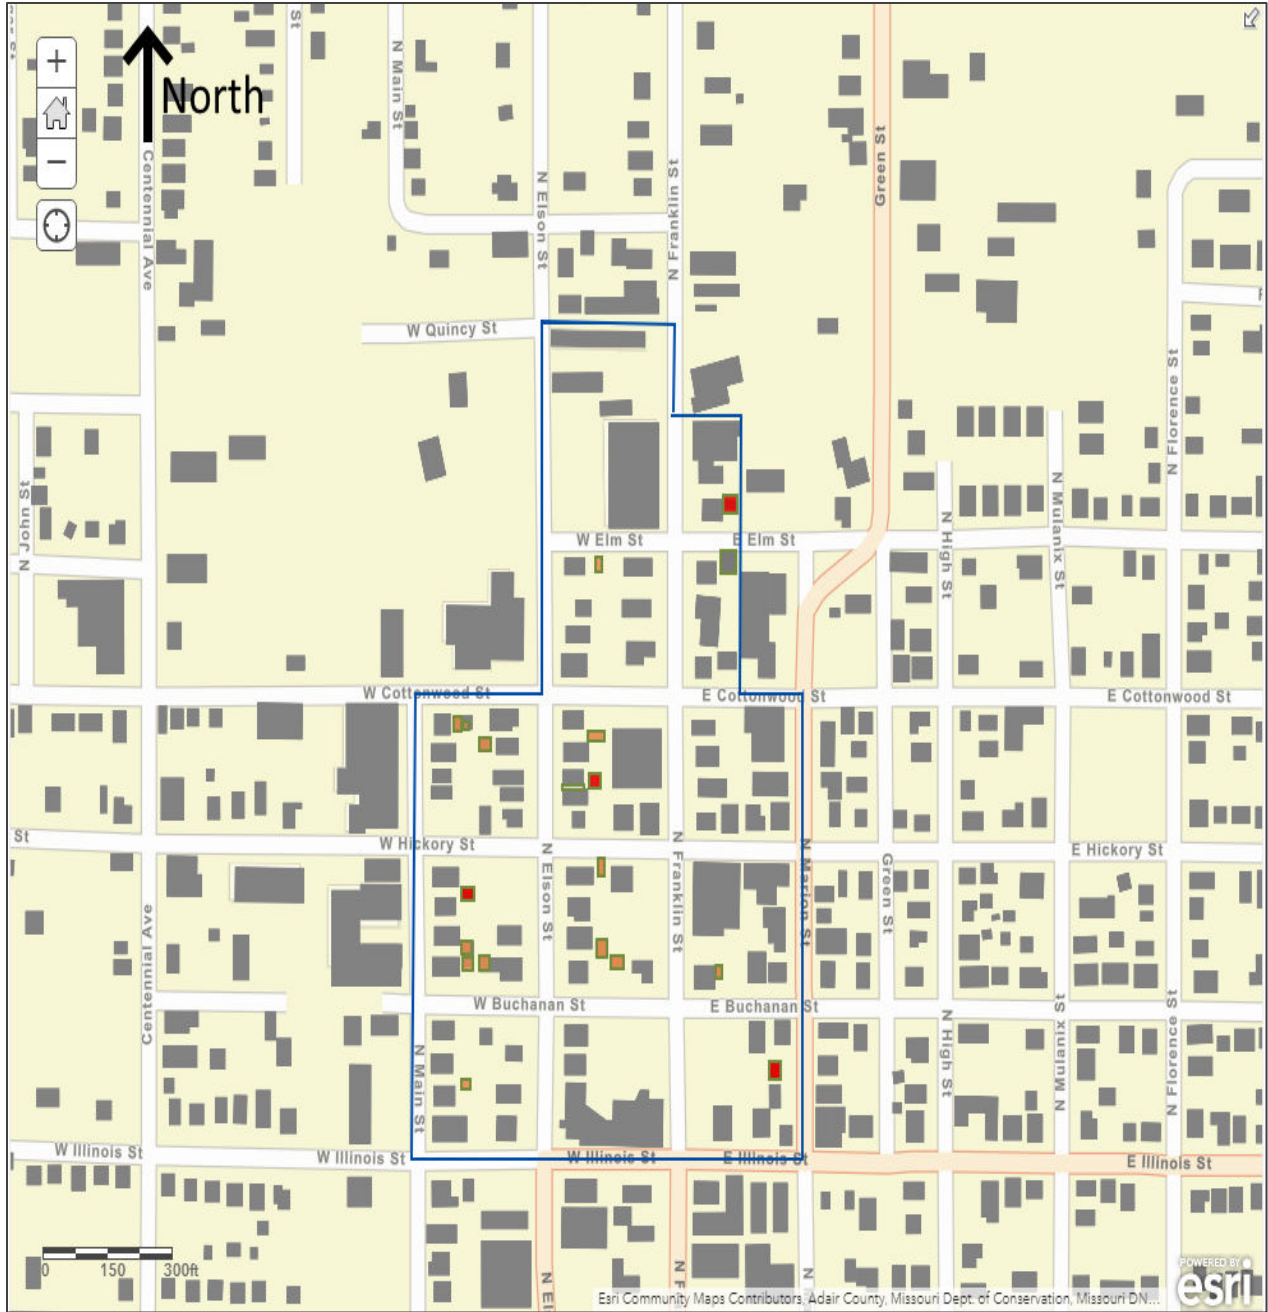
Figure 52. Inventoried outbuildings in the Depot District. Orange outbuildings are historic. Red outbuildings are modern or altered.

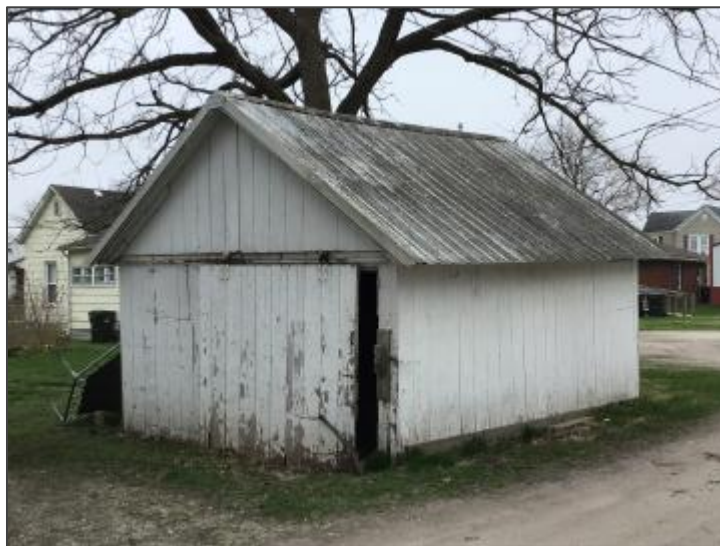
Kirksville garages fall into three broad categories. Some garages are based on agricultural buildings and feature vertical, barn-type siding, with or without windows.

Figure 54. Pre-1925 vertical sided garage at 615 East Jefferson Street.

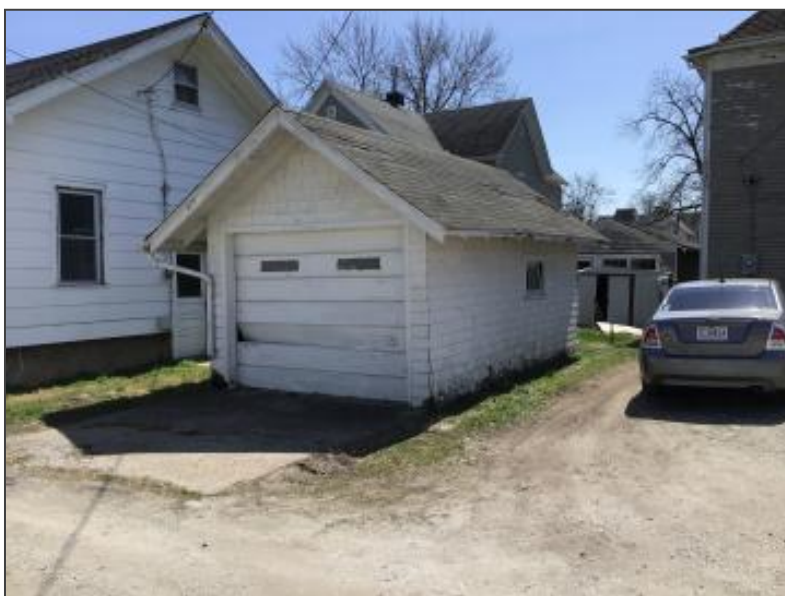
Figure 55. Garage at 210 South Davis Street with exposed rafter tails.
