MISSOURI OFFICE OF HISTORIC PRESERVATION

Architectural/Historic Inventory Survey Form

Community of Bonnots Mill Survey

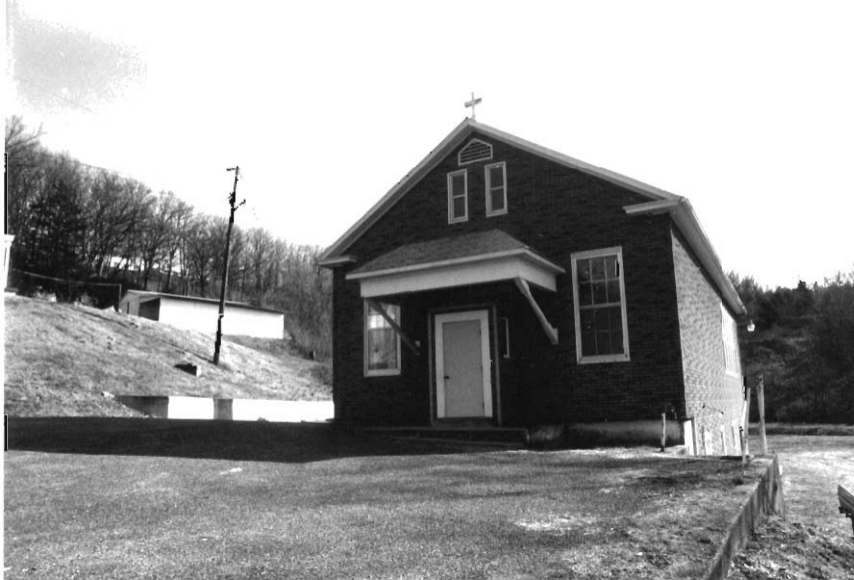
Address: Church Hill Street Roll/Frame: 1/34

Modern solid door off-center to left of facade (northwest) in front projection with horizontal 1/1 window above. Oversized hip roof door hood with wide wood frieze supported by turned posts set as angled braces; concrete stoop slightly above grade. 6/6 sash to south of front entrance and 4/4 sash to north with aluminum frame storm sash. Gable with two narrow 1/1 sash and louvered vent in apex; small wood cross on ridge. Narrow overhanging eaves return on front gable. Southwest elevation with exposed at-grade basement with pedestrian door at west end and sash to east. First story with four grouped sash at east end. Interior brick chimney on northeast elevation toward rear. Eight adjoining 4/4 windows on northeast elevation toward front of building with stepped wing toward rear. 3/1 window faces southeast in wing of rear elevation with two paired 4/4 windows on first floor of main building block. Boarded window and gable returns in rear gable. 2/2 window in basement off center to left with basement door off center to right.

Important building to the social and education development of the village. Building is part of St. Louis Catholic church complex and is situated on an imposing site overlooking village which adds credence to its important role in village life. This building was constructed c. 1916 as a parochial school, one of only two school buildings in the town. The parish school was closed in 1966.

This building would contribute to a potential National Register historic district (1C).

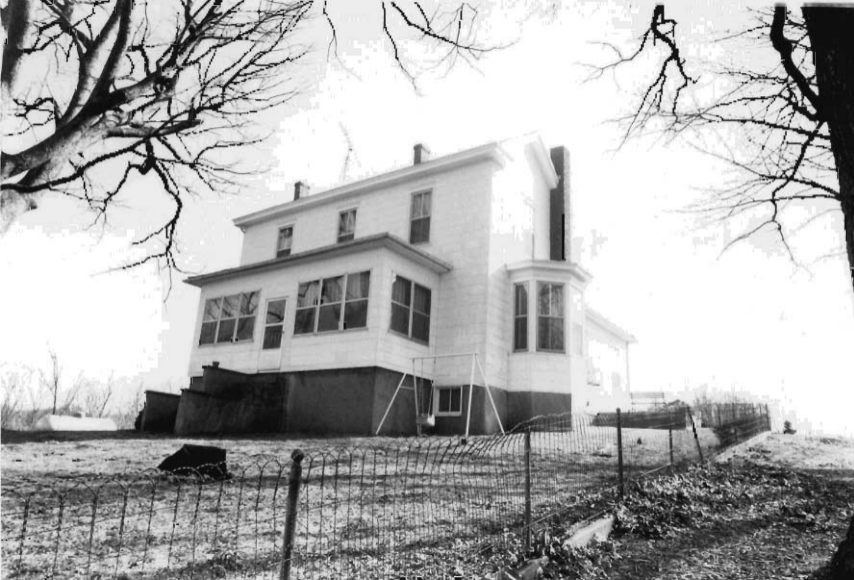
Pre-Classical (three bay) I-House. Rectangular plan dwelling with standing seam metal, gable roof. Gable extension with shed wing at rear. All gables have returns. Symmetrical facade (northwest). Broad, central enclosed porch with metal roof, an early twentieth century alteration. Front entrance in center of facade, with sets of 1/1 storm sash on either side. Three 2/2 windows with drip molds on second floor of facade. Main block of building has 2/2 windows with plain drip molds. Semi-octagonal bay with 2/2 windows on southwest elevation. Toward rear of dwelling on southwest elevation, exterior end brick chimney. Rear gable extension has brick chimney at center of ridge, 2/2 window in gable, and two northeast facing windows. Shed wing with rear entrance and 1/1 window facing southeast and four windows facing northeast.

This two story, rectangular plan I-House was constructed c. 1855 and is one of the oldest houses in Bonnots Mill. The presence of brick-nogged walls indicates Germanic building traditions, and this house is the only known extant example of this technique in Bonnots Mill. Lucine Bonnot deeded the residence and the accompanying property to her son, Victor on June 10, 1881. Lucine Bonnot was the wife of Felix Bonnot who laid out Bonnots Mill in 1852. He operated a lumber mill in the village and Bonnots Mill is named after him. Felix Bonnot may have resided in this dwelling prior to his death in 1880. Mr. and Mrs. Victor Bonnot deeded the same property to L. J. Boillot on December 23, 1883. By 1890, Henry Meyer was the owner and occupant of the residence. He also owned the flour mill in the village. In 1917, Francis Wallner, daughter of Henry Meyer, assumed occupancy of the dwelling. The house remained in the Meyer family until 1988. Frank and Susan Wesley currently reside here.

This building and its four remaining outbuildings retain a high degree of integrity and would contribute to a potential National Register historic district (1C; 4C).

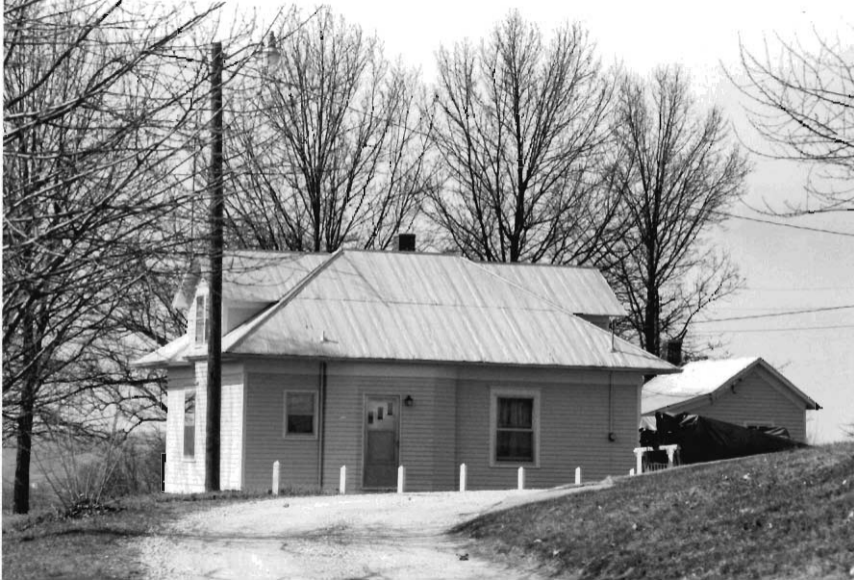
Square floor plan. Hipped, corrugated metal roof. Frame construction with artificial siding. Gable front, wall dormers with pairs of 1/1 windows face northeast and southwest. Front entrance faces southeast in semi-hexagonal "bay", off center to the left of the facade. Smooth wood cornice band below eave of roof and dormers.

The house retains its overall integrity despite artificial siding, and clearly conveys a sense of time and place. This building and the summer kitchen would contribute to a potential National Register historic district (1C; 1C).

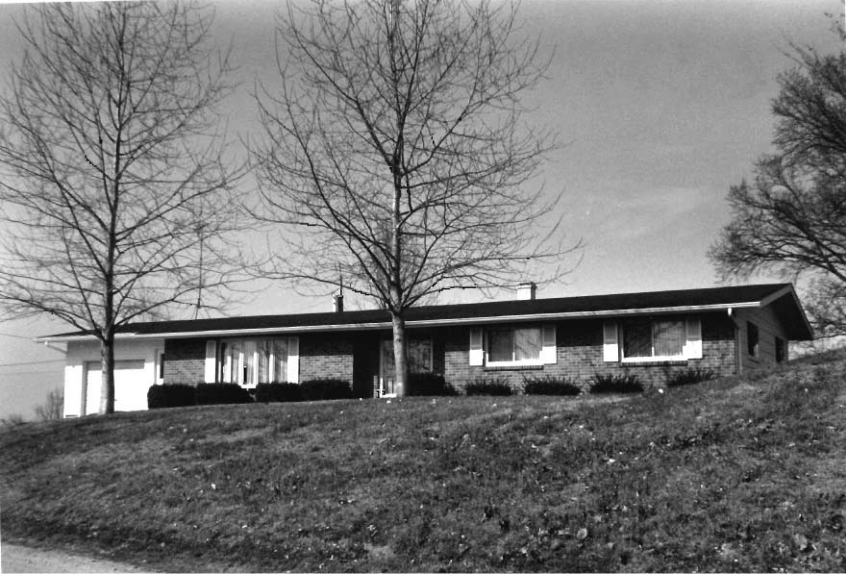
Ranch house with rectangular floor plan. Low pitch, asphalt shingle, gable roof. Two adjoining front doors in recess off center to the left. Two 2-light sliding sash windows in right bay of facade (south) and a 5-light casement bay window in the left bay. Shutters on all facade fenestration. Garage addition to west elevation. Accommodates one car and has modern overhead car door. A pedestrian door also faces south in the garage addition. Two windows face east and one faces west. Stuccoed chimney to right of facade center at roof ridge.

This building is within the boundaries of a potential National Register historic district, but would be non-contributing (INC).

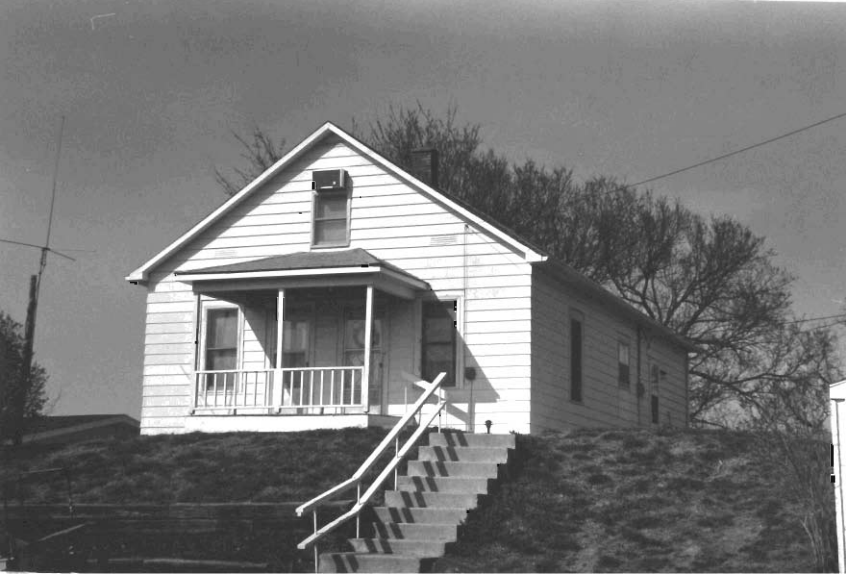
Address: Highway A Roll/Frame: 2/5, 3/19A

Rectangular floor plan. Gable roof with asphalt shingle. Front entrances to right and left of facade center. 1/1 window below narrow vent in gable facing front (south). Three simple wooden posts extending from wooden porch base support asphalt shingle, hipped, porch roof. Plain wooden balustrade. 1/1 windows on all elevations. Door on east elevation at rear. Similar to building #18.

The house retains a good degree of historic integrity, despite artificial siding. This building and its garage would contribute to a potential National Register historic district (1C; 1C).

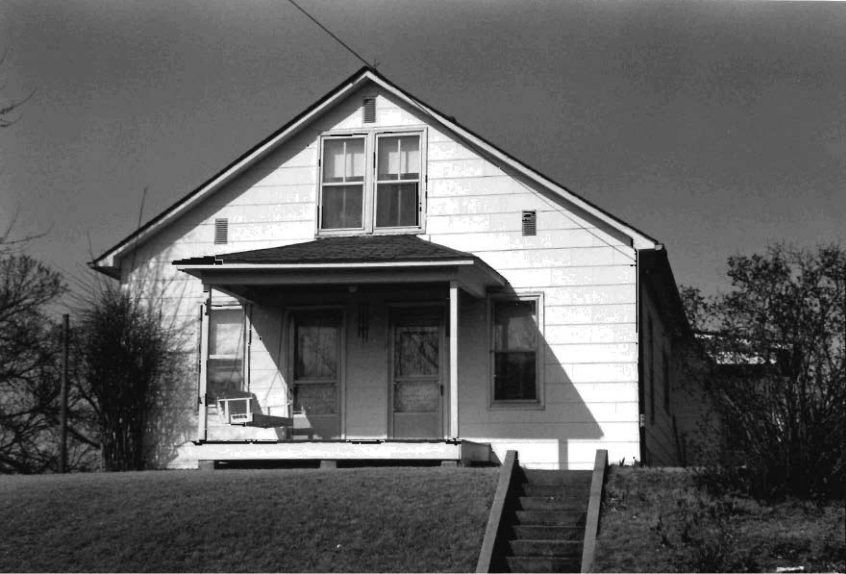
Address: Highway A Roll/Frame: 2/4, 3/18A

Rectangular floor plan. Gable front, asphalt shingle roof with shed extension at rear. Brick chimney at roof ridge toward facade. Front entrances to left and right of facade center. Windows in left and right bays of facade. Three small vents in gable. Central bay entrance porch. Hipped roof supported by two narrow wooden posts. Wooden porch floor on stone base supports. Door with awning overhead faces front (south) in rear extension. Door on west elevation at rear. Awning over door supported by wooden posts rests on stoop. Storm cellar entrance also faces west. Similar to the adjacent building (#17).

Retains a high degree of integrity. Good example of an early twentieth century Open Gable house type. This building would contribute to a potential National Register historic district (1C).

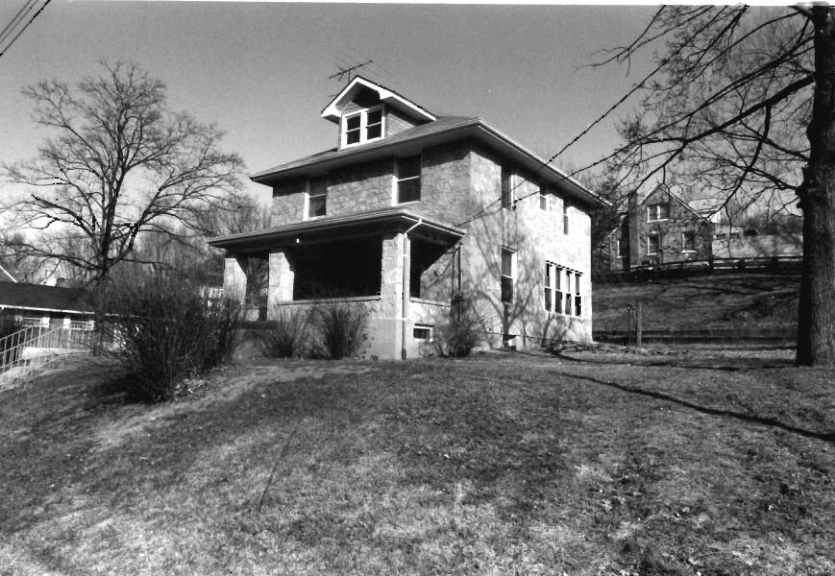
An excellent example of the Four Square house type with the Craftsman stylistic influence of Native Rock wall treatment. This building would contribute to a potential National Register historic district (1C).

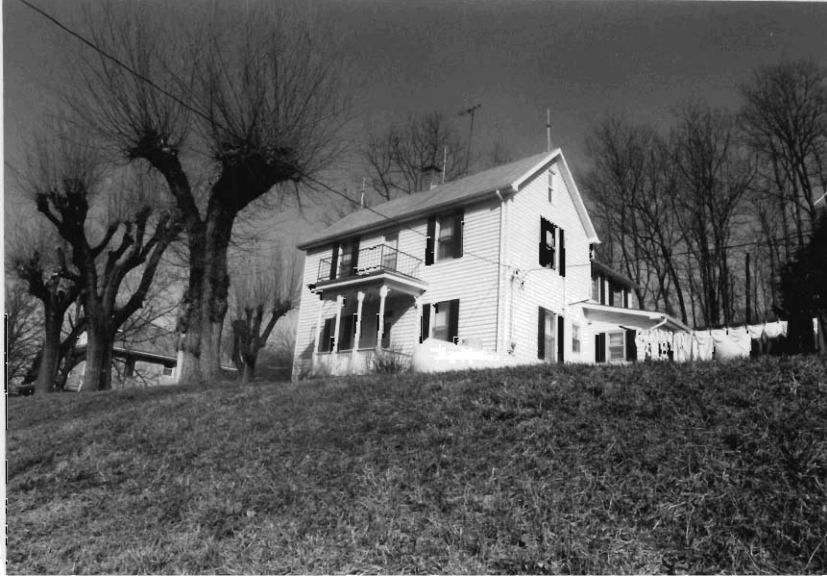
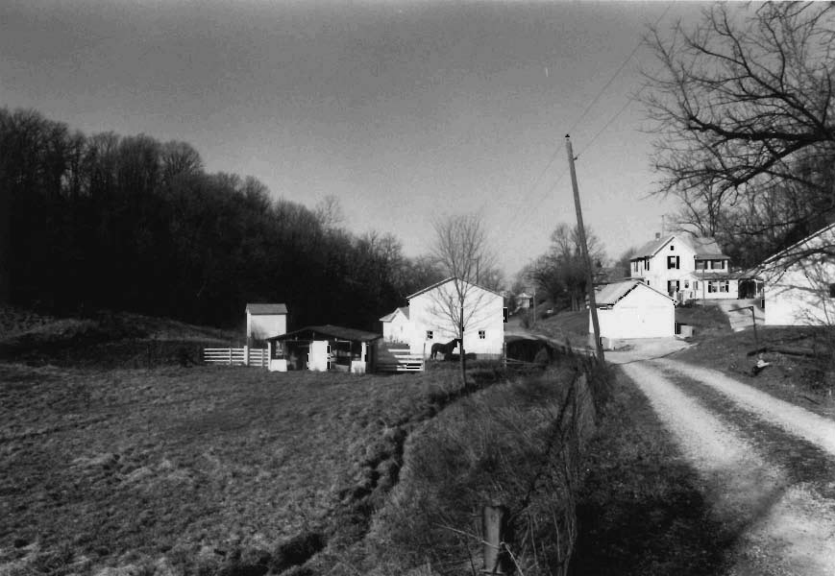
I-House (Pre-Classical) with wings. Italianate influenced porch. Two-story with overall square plan. Corrugated metal side gable main roof with one story gable roof wing at rear. Shed extension on southeast and northwest elevations. Rear additions accommodate kitchen and family room. Brick chimneys at ridge to left of facade center and at rear of dwelling in gable extension. Symmetrical facade. Front entrance in center of facade. Balcony with iron railing on second floor with access via door on second floor. Turned posts and engaged columns support balcony. Ornate wooden brackets. Porch on east corner of shed extension on southeast elevation. Rear hipped porch with turned posts.

Stone retaining wall faces front (southwest). Steps lead diagonally to porch on raised ground. Gravel drive to southeast of house. Land slopes from northeast to southwest. Trees at rear of dwelling on uphill slope. Summer kitchen behind dwelling. Frame construction with corrugated metal, gable roof. Pedestrian door faces southwest. Brick chimney toward rear of outbuilding. Shed addition to southeast elevation. Gable front, one-car garage to southeast of dwelling on the northwest corner of Iris Avenue and access lane to house. Corrugated metal, gable roof with two corrugated metal swing doors facing southeast. Modern double car garage with gable roof oriented north-south on northeast corner of Iris Avenue and access road to house. Concrete foundation; wide clapboard wall treatment with two overhead car doors in north gable facing house. On southwest side of Iris Avenue, four outbuildings and wood and wire fences form an enclosure. One 2 story barn parallel to Iris Avenue with corrugated metal, gable roof; oriented northwest-southeast. Concrete foundation; vertical wood siding and vertical wood swing doors on first and second floors. 2/2 windows with wooden sills. 1 story three-car garage to northwest with asphalt shingle, gable roof and rear, gable wing. Frame construction with wide vertical wood siding. Two 3-light, wooden car doors in left and center bays of facade (northeast). One modern, overhead car door in right facade bay. 3/3 window in northwest and southeast elevation. Tall 1 story, asphalt shingle, gable roof smoke house at rear of lot behind 1 story barn. 2/2 window on west elevation with horizontal 1/1 window on north elevation below vent in gable. Pedestrian door faces east. 1 story outbuilding with low pitched, asphalt, gable roof to south of 2 story barn. Vertical wood siding with wire mesh in openings facing southeast. Pedestrian, wood swing door on northwest gable with boarded rectangular window in gable.

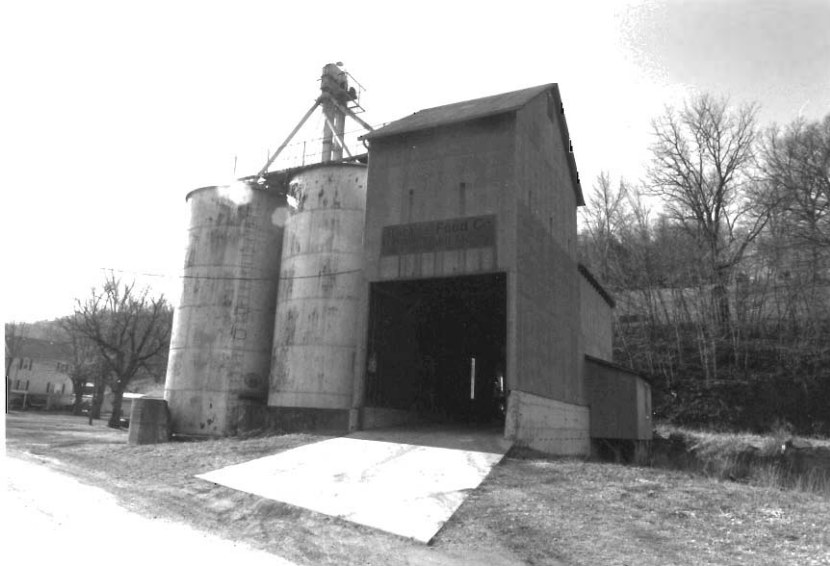
Side gable, oversized (basically 2-story) delivery building set on concrete foundation. Two silos to southeast with modern loading equipment on top. Rear with lower, corrugated metal shed roof section; small, corrugated metal, shed roof appendage supported on posts attached to north elevation of rear section. Two 2/2 windows on southeast elevation and one 2/2 window on first floor. Double, wood swing doors in basement of northwest elevation on shed appendage.

Occupies the site of the original Meyer-Morfeld Milling Company mill; the mill burned c. 1950, and was replaced with this agricultural building.

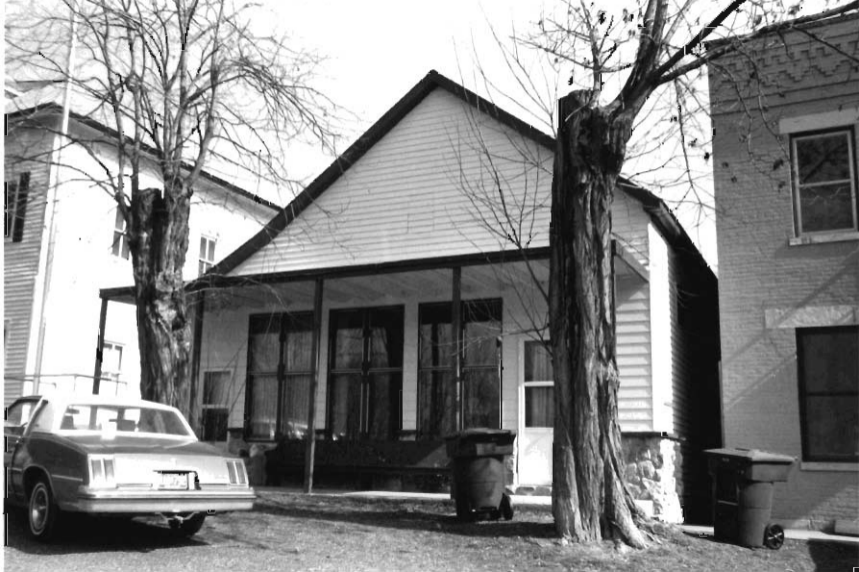
Double single light and wood doors to south of facade with three very large 2/2 sash in center. Small single light wood pedestrian door to north of facade. Flat roof porch with five simple 2 x 4 posts; at-grade concrete pad. Watertable above elevated random limestone foundation. Main front gable with narrow wood siding, shallow overhang; gable roof continues over small 1-story addition on northeast elevation now integrated into main building by artificial siding. Concrete block chimney on northeast slope of roof. Northeast elevation with single small 1/1 sash in center; southwest elevation with three small sash set high on wall. Most original detailing obscured by siding.

Building is located in center of intact row of early commercial buildings and contributes to this fine grouping. Building is important to the commercial development of village.
