ARCHITECTURAL/HISTORIC INVENTORY FORM

1. Survey No. SCAS001-0014		2. Survey Name: City of Cottleville Architectural/ Historic Resource Survey	
3. County: St. Charles		4. Address: 5209 4 th Street	
5. City: Cottleville	Vicinity: <input type="checkbox"/>	6. UTM: 15 /704000/ 4290982	7. Township/Range/Section: T: 43 R: 03 S: 00
8. Historic Name (if known): Schulte Brother's Store		9. Present/Other name (if known): The Flower Stop	
10. Ownership: <input checked="" type="checkbox"/> Private <input type="checkbox"/> Public		11. Historic Use (if known): Domestic/ Commercial	11. Current Use: Commercial

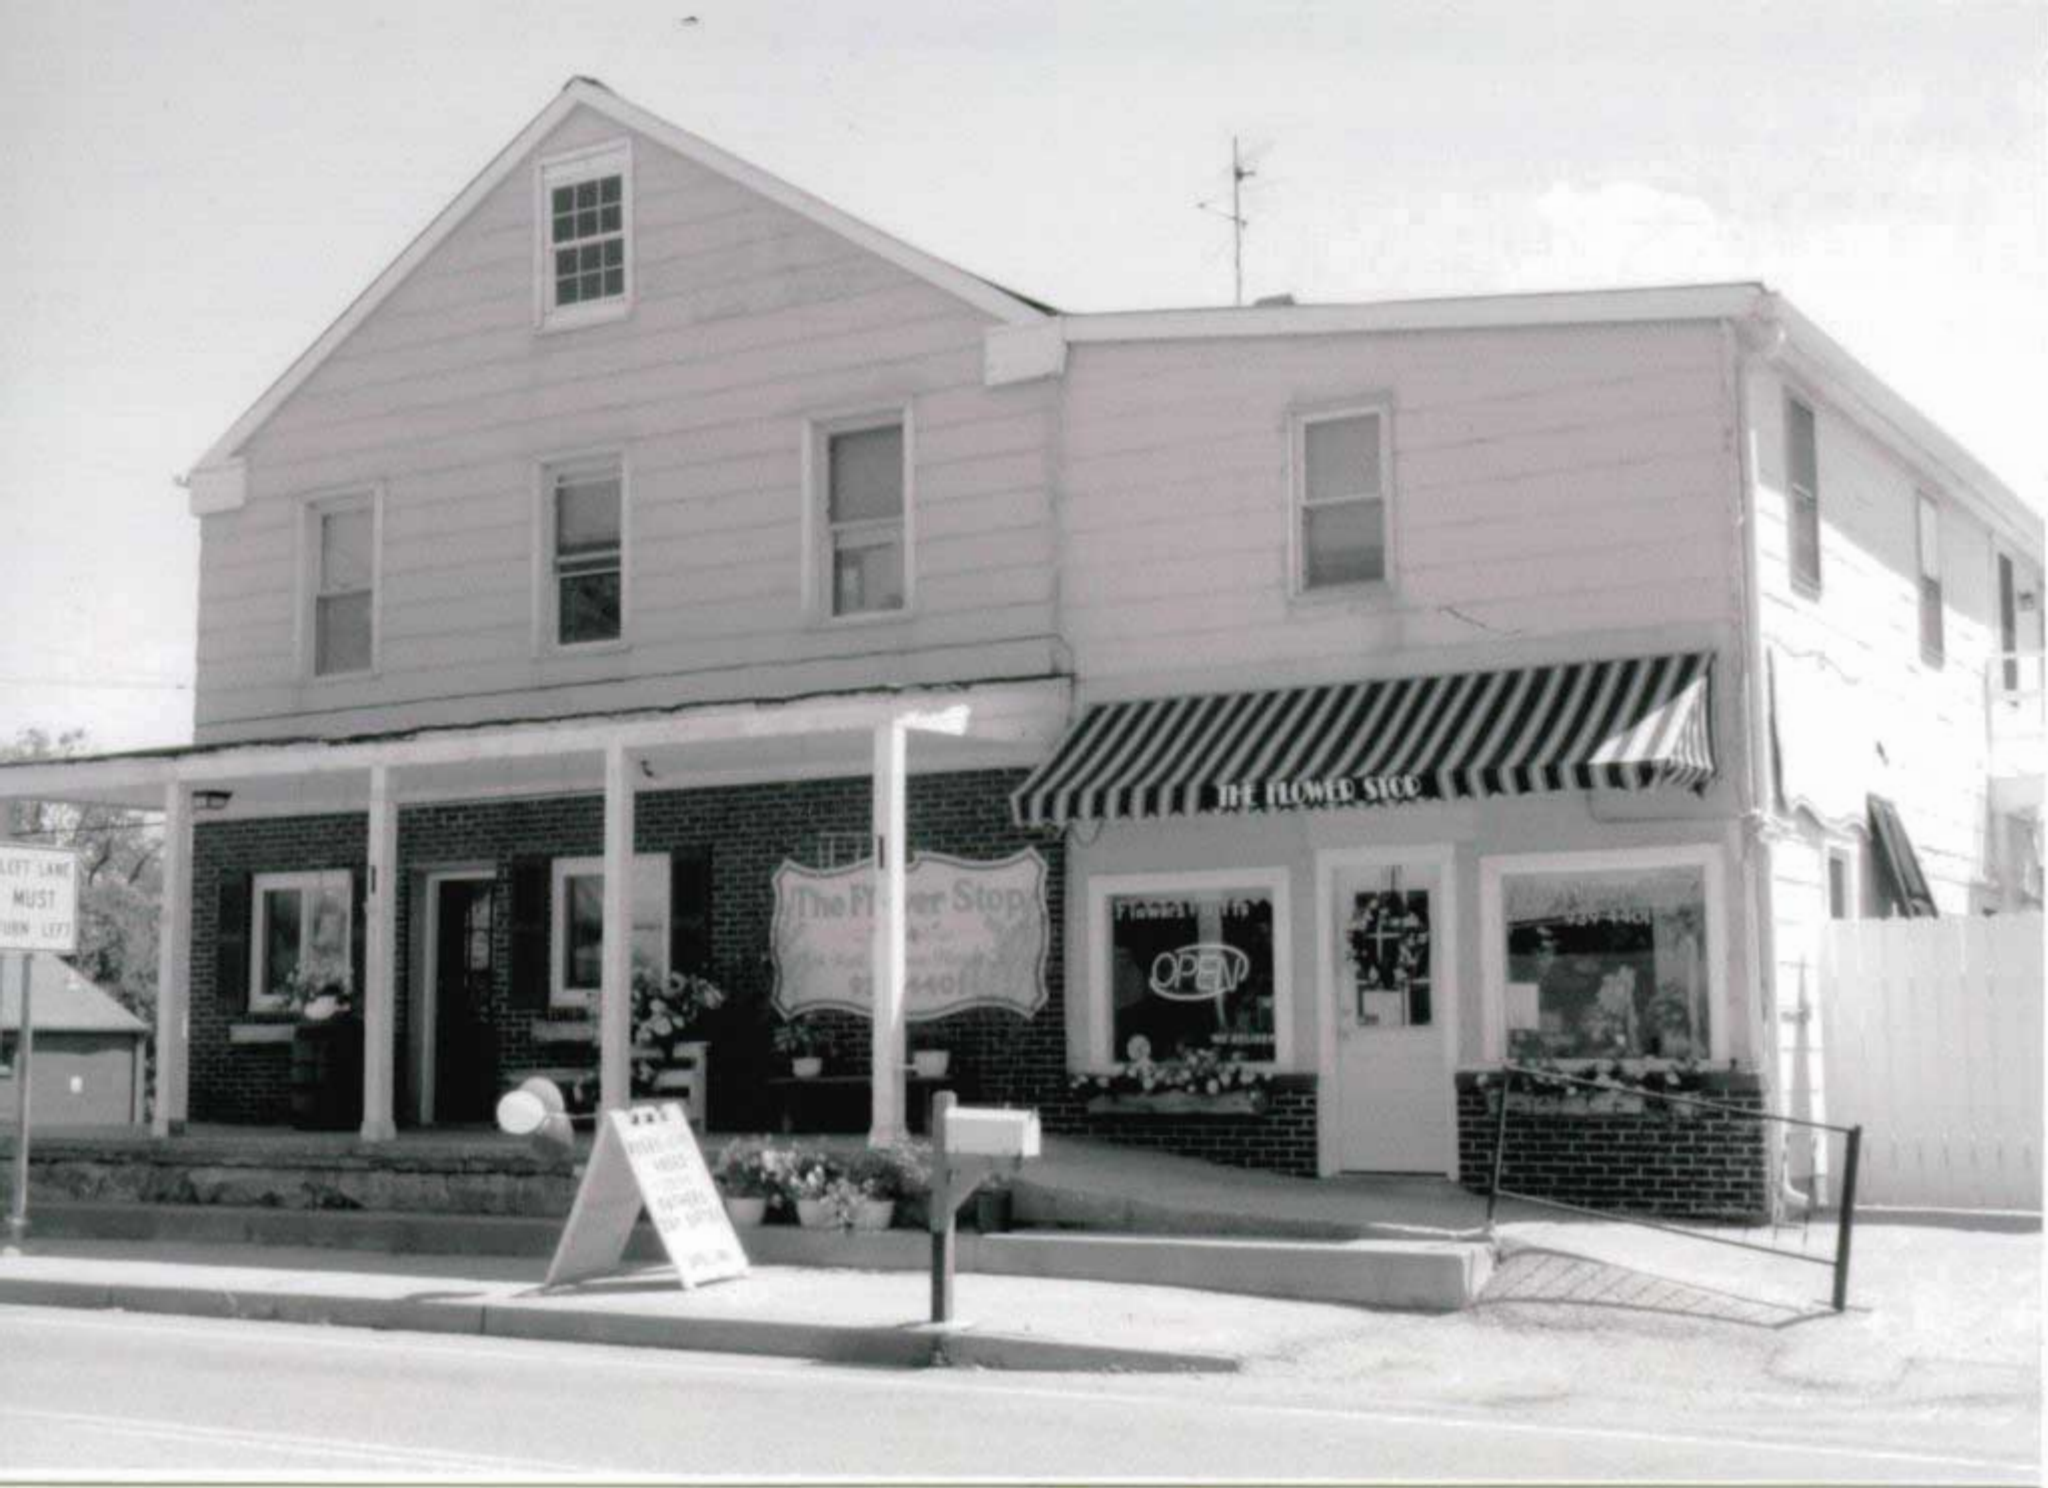
Two-story, frame, front gabled two-part commercial structure clad in brick and aluminum siding and a stone foundation. The first level features two store fronts: the north storefront is composed of sliding one-by-one windows on either side of the off center modern glass and wood door and an open porch; the southern storefront features a large display window on either side of a glass and wood entrance. The second level features four 1/1 sash windows. A 6/6 wood window is found in the gable. The southern portion of the building appears to have been constructed after 1905.

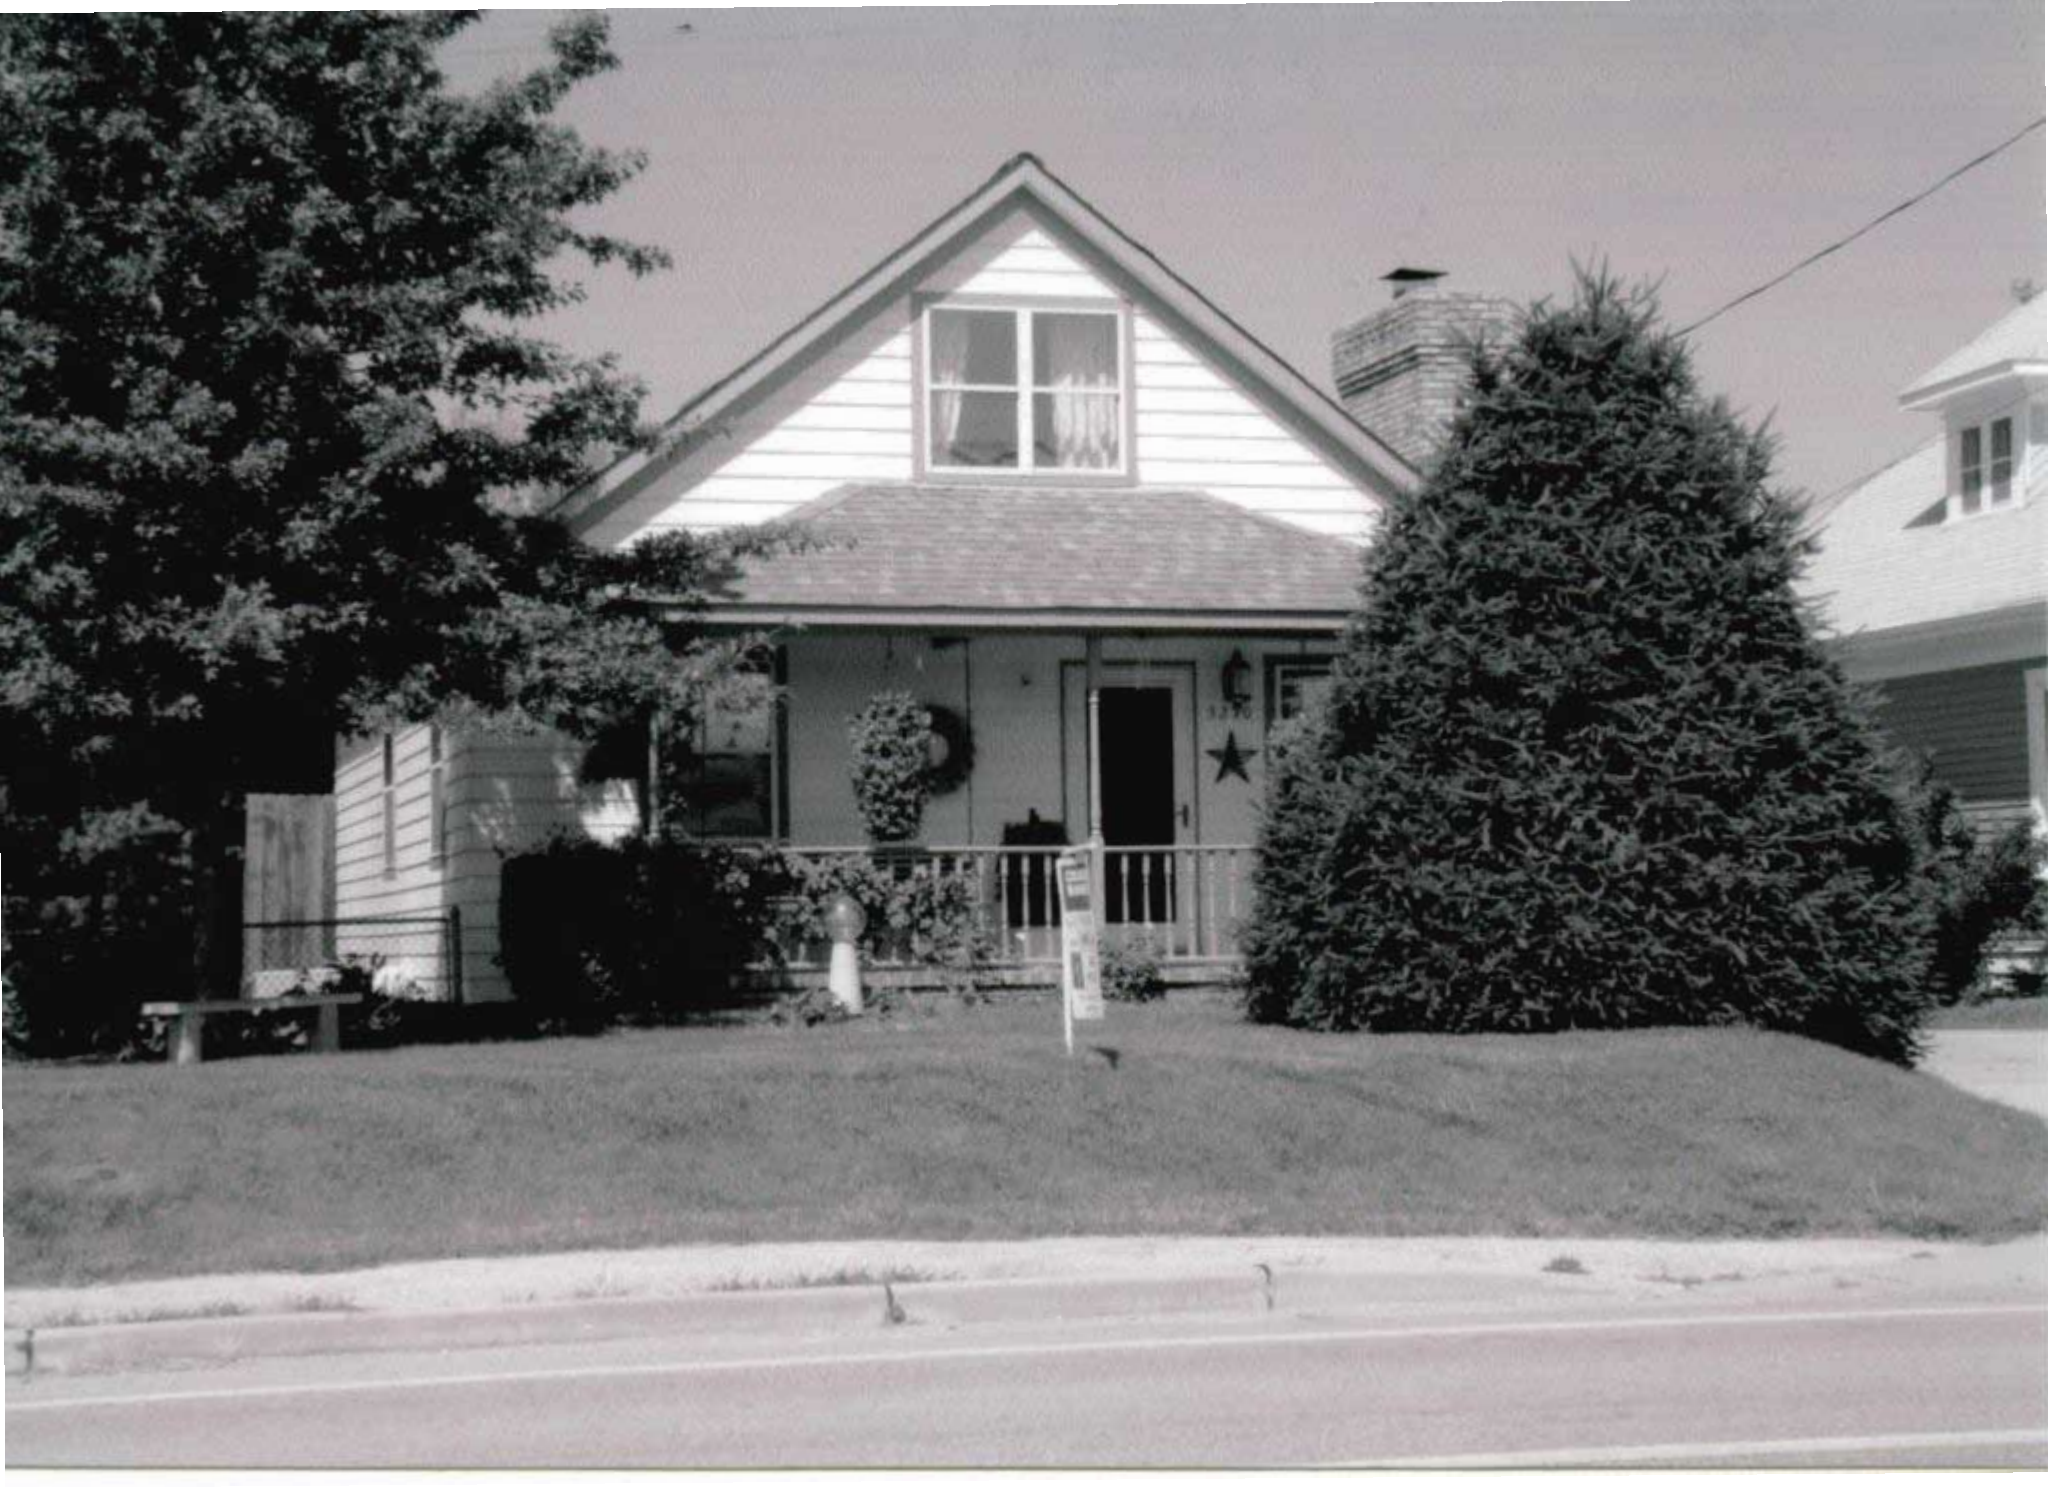
One-and-a-half-story, frame, front gable residence clad in aluminum siding. A 1/1 sash window is found on either side of the off-center entrance. A paired one-over-one sash window is found in the gable above the shed roof of the open porch.

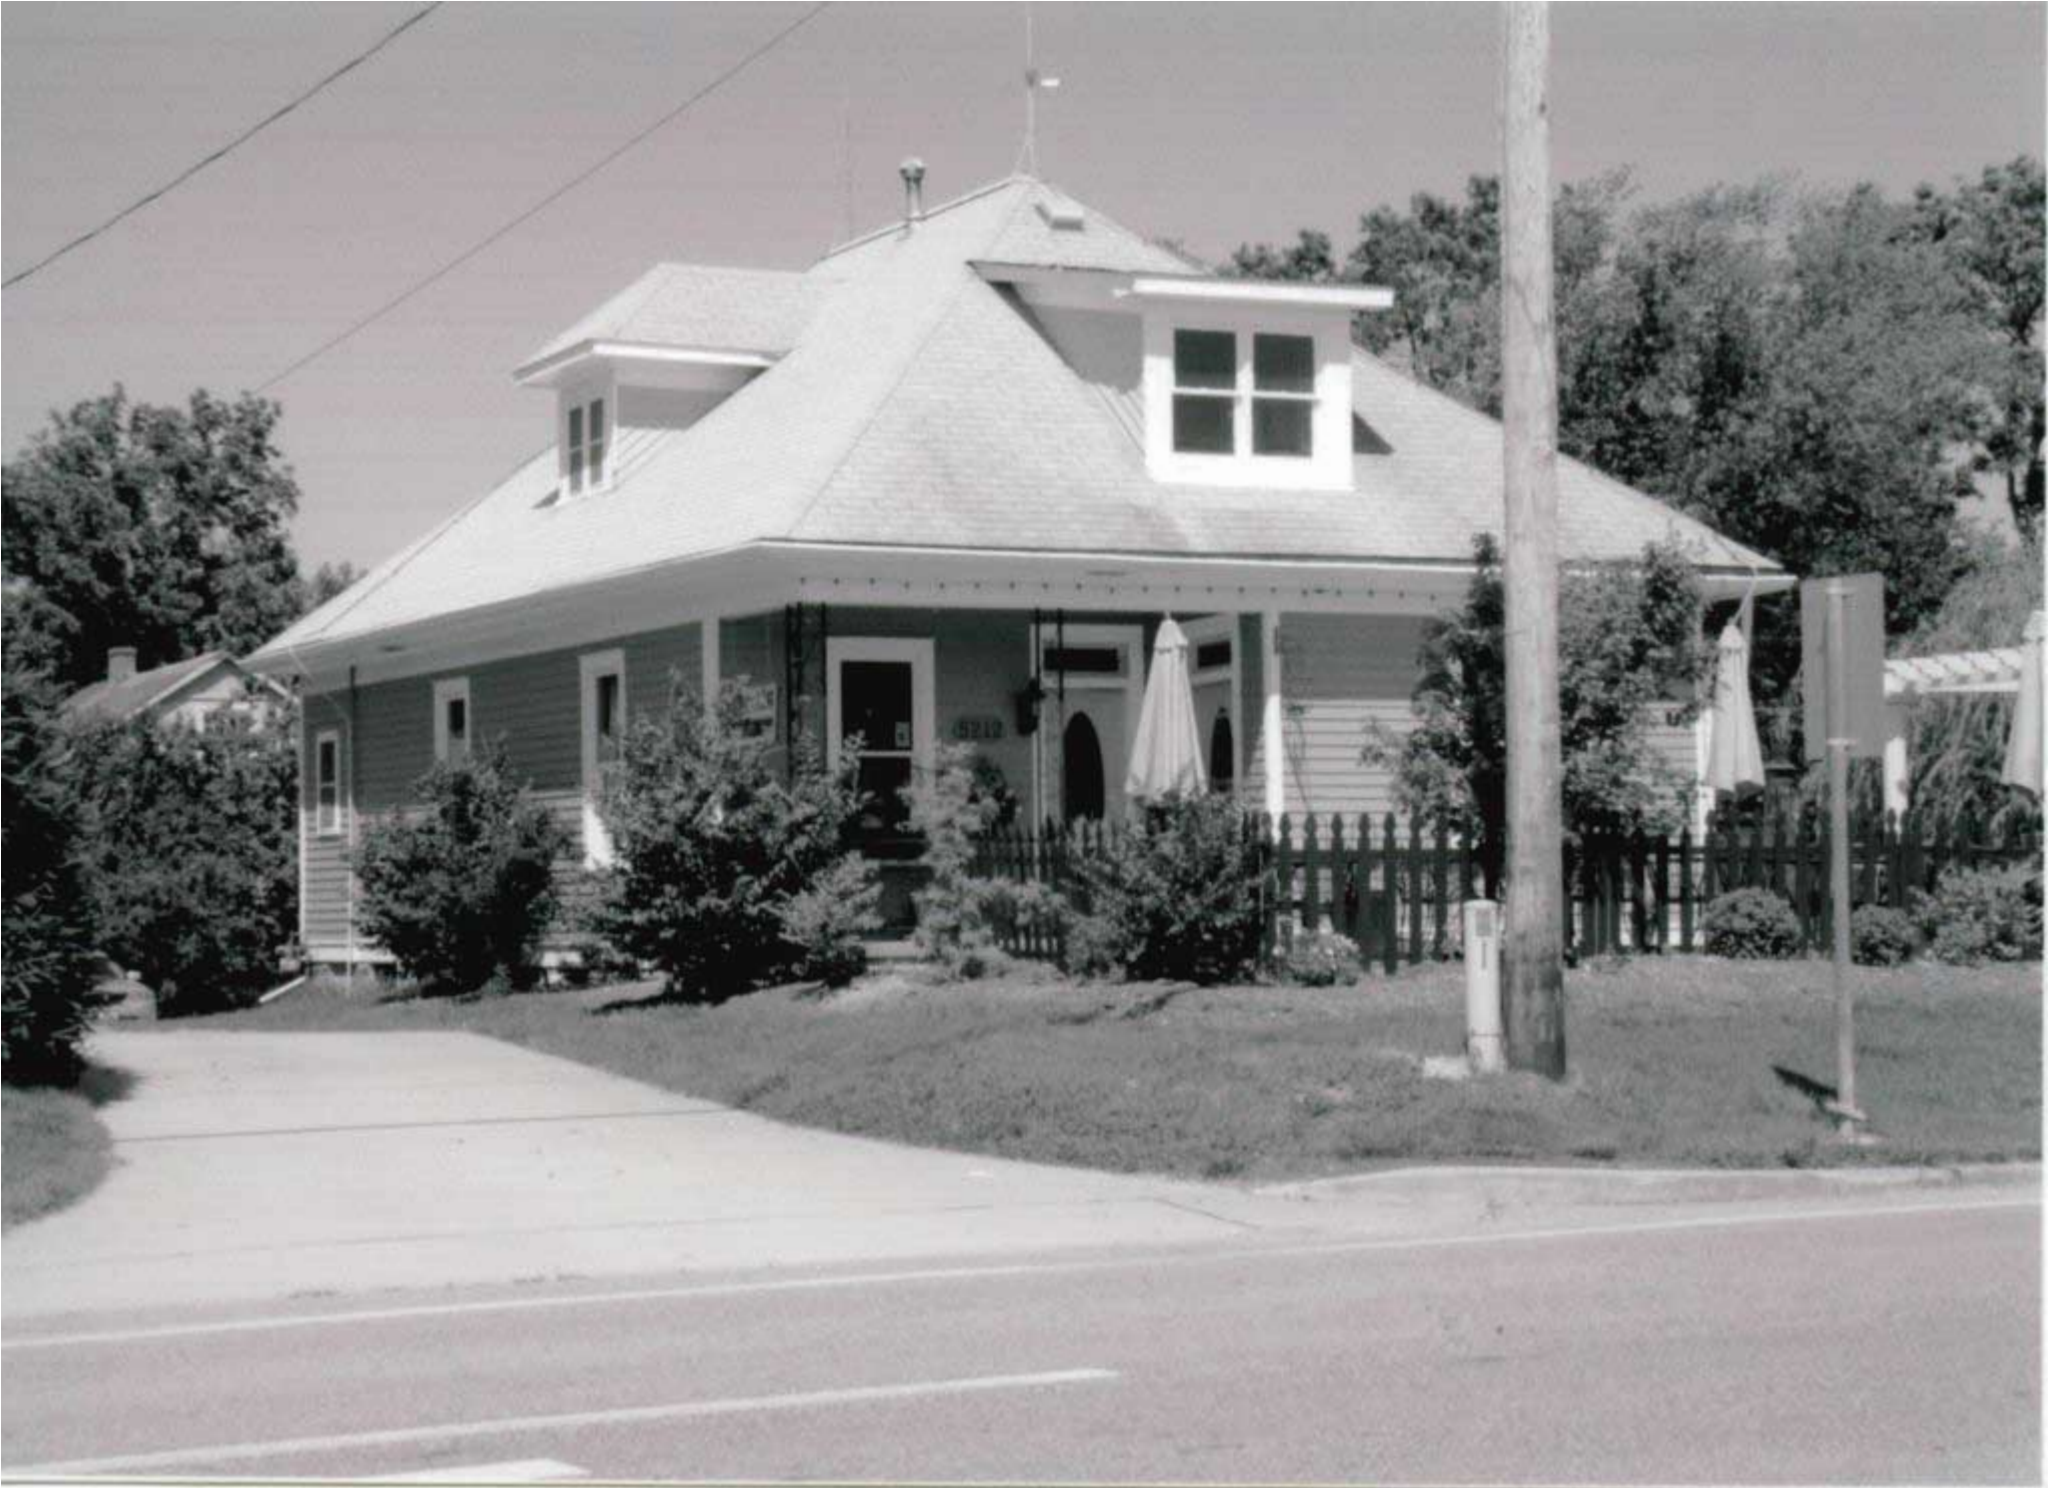
One and a half story, frame pyramidal residence clad in wood clapboard and sitting on a concrete foundation. A 1/1 sash window is found in the southern bay, and two new wood and glass doors create the cornered double entrance on the umbrage porch. A shed dormer with paired 1/1 sash windows is centered in the second story. The building's square plan and recessed porch are unique in Cottleville. The exterior of the building has undergone few changes since construction, with the exception of the porch posts and doors. The interior is relatively intact, though slightly altered for commercial use.

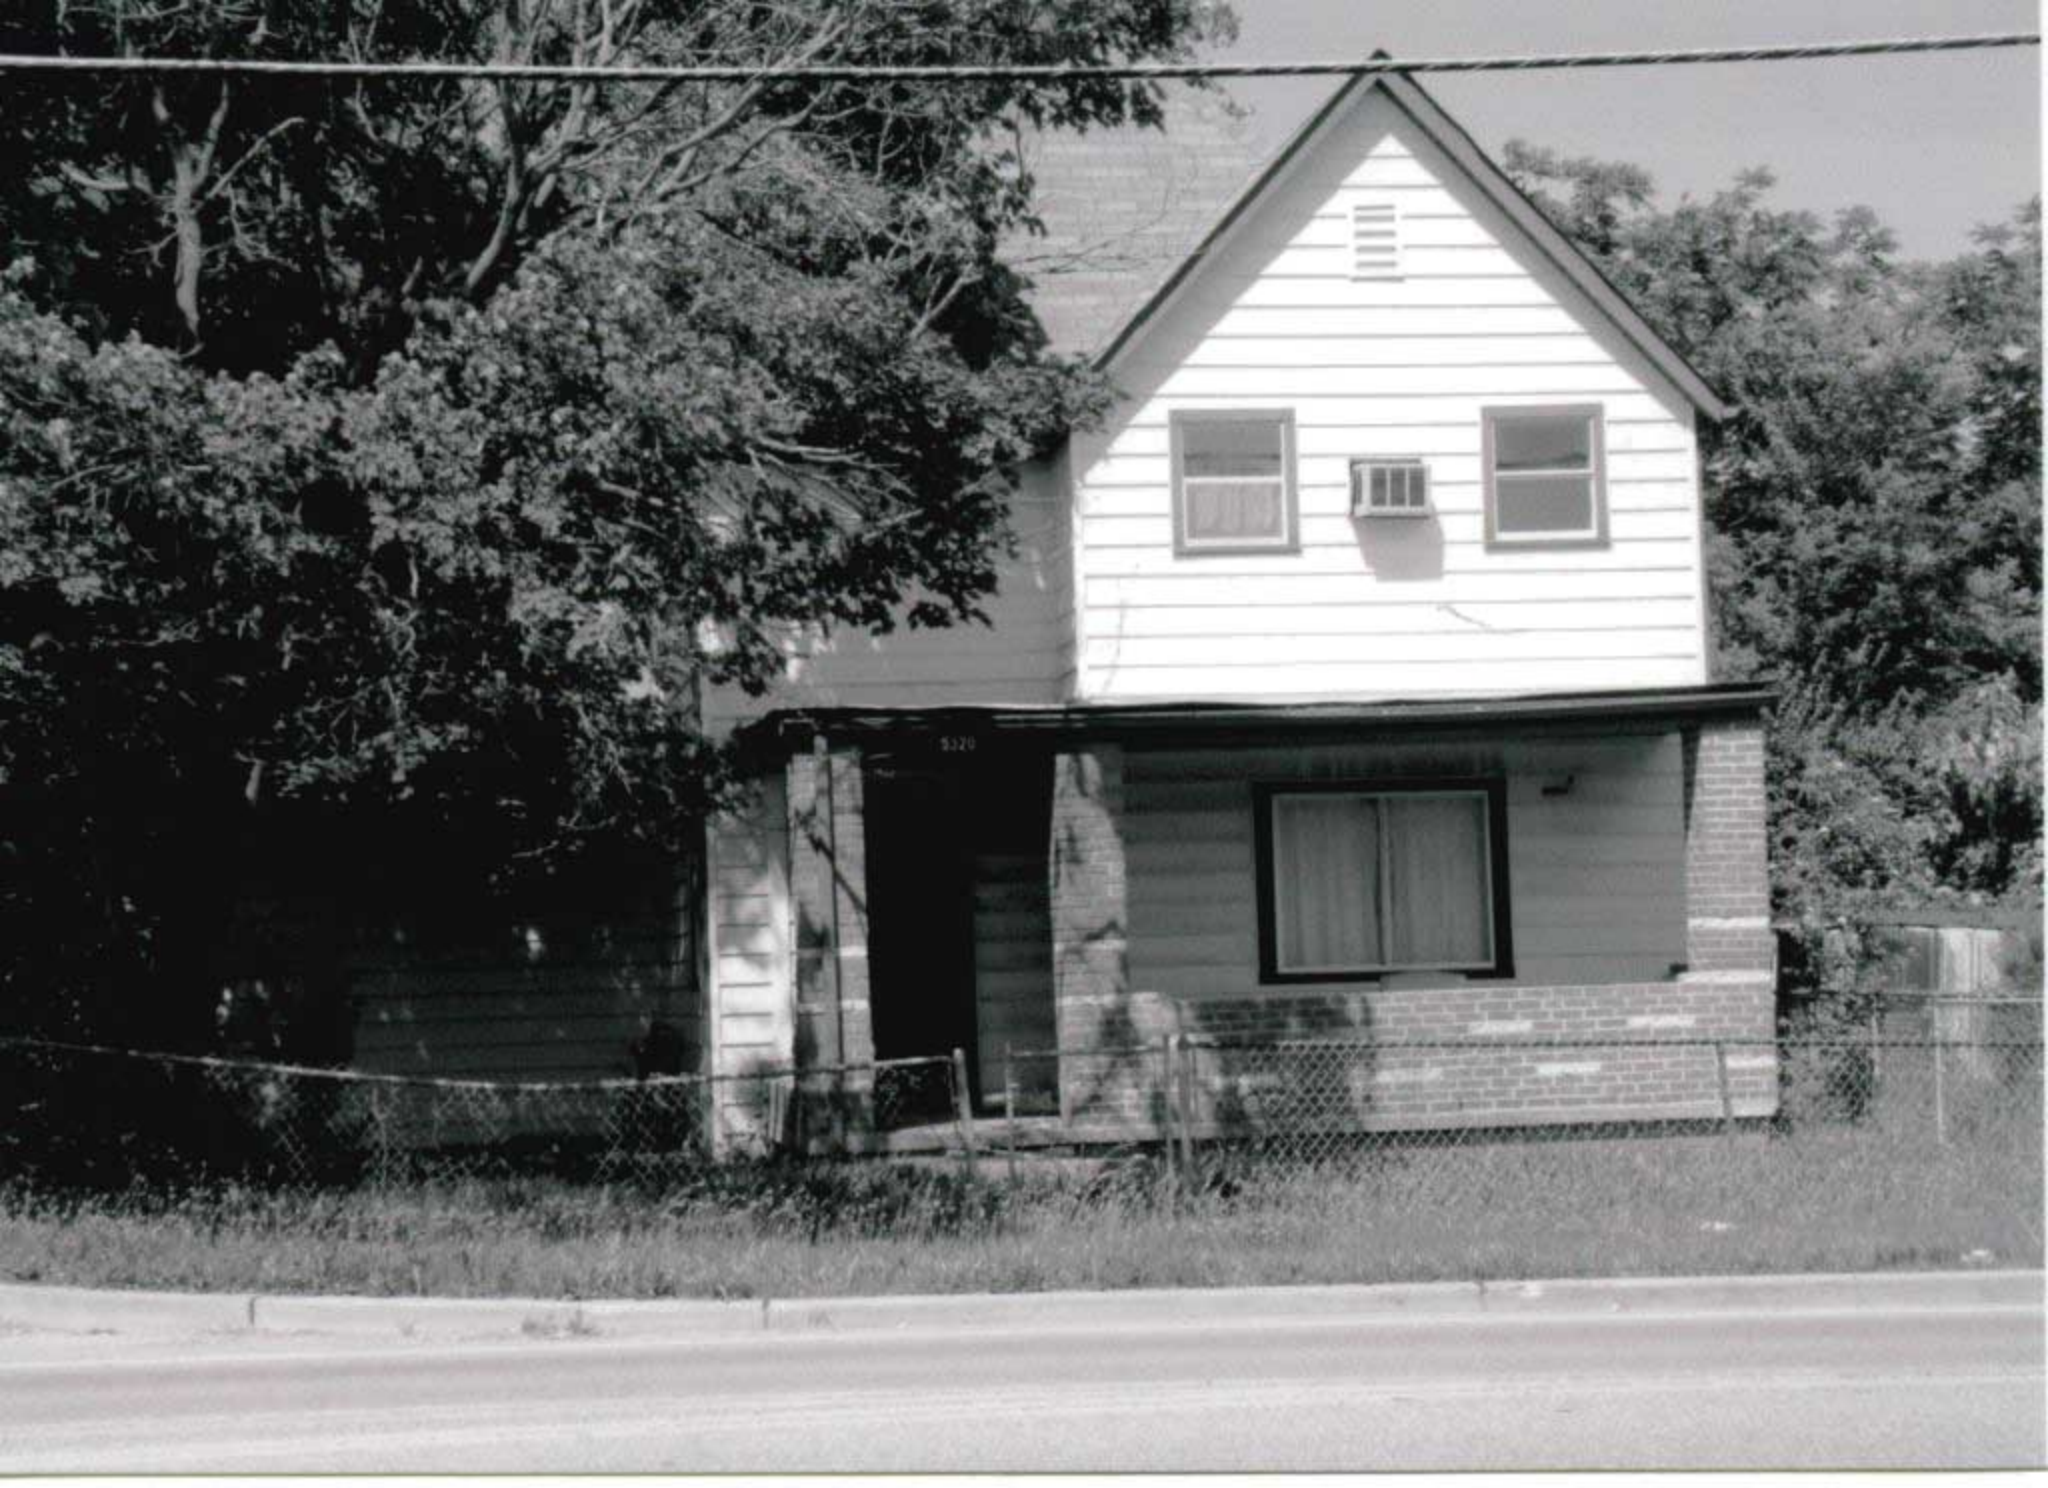
Two-story, frame, steeply pitched cross gabled residence clad in aluminum siding and sitting on a concrete foundation. A two pane sliding window is found in the northern bay, located north of the off center modern wood entrance door. A brick and concrete open porch encloses the first level. The second level features two 1/1 sash windows, with an air conditioning unit located between them in the projecting cross gable. The plan is of early 20th century design, however a number of alterations have significantly muddled the main façade.

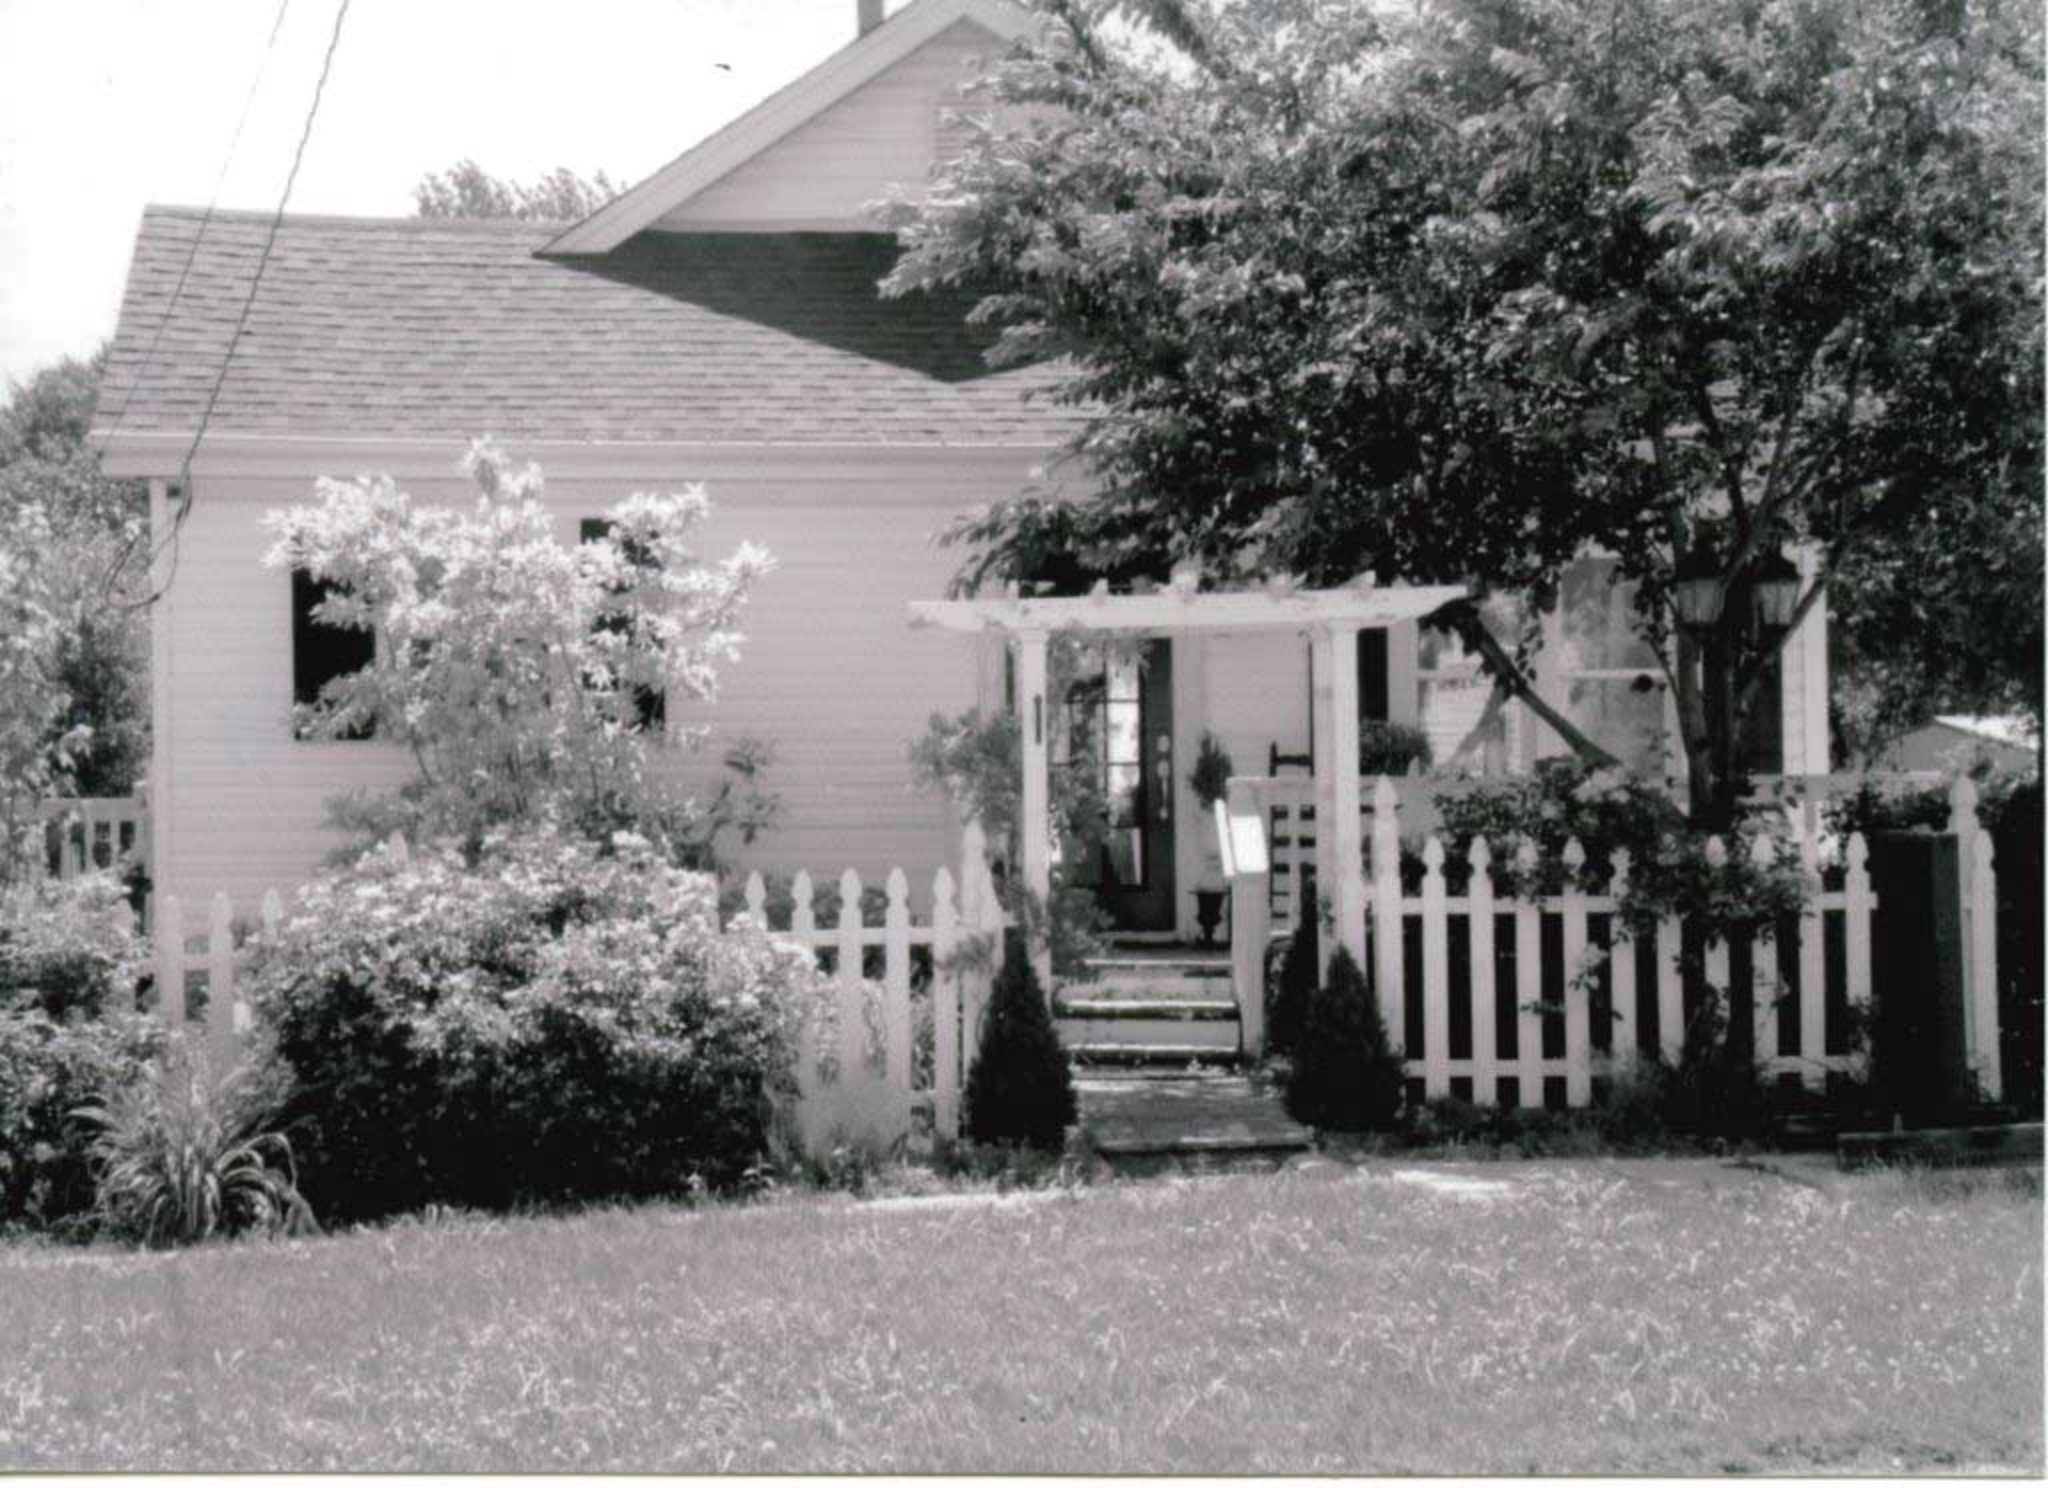
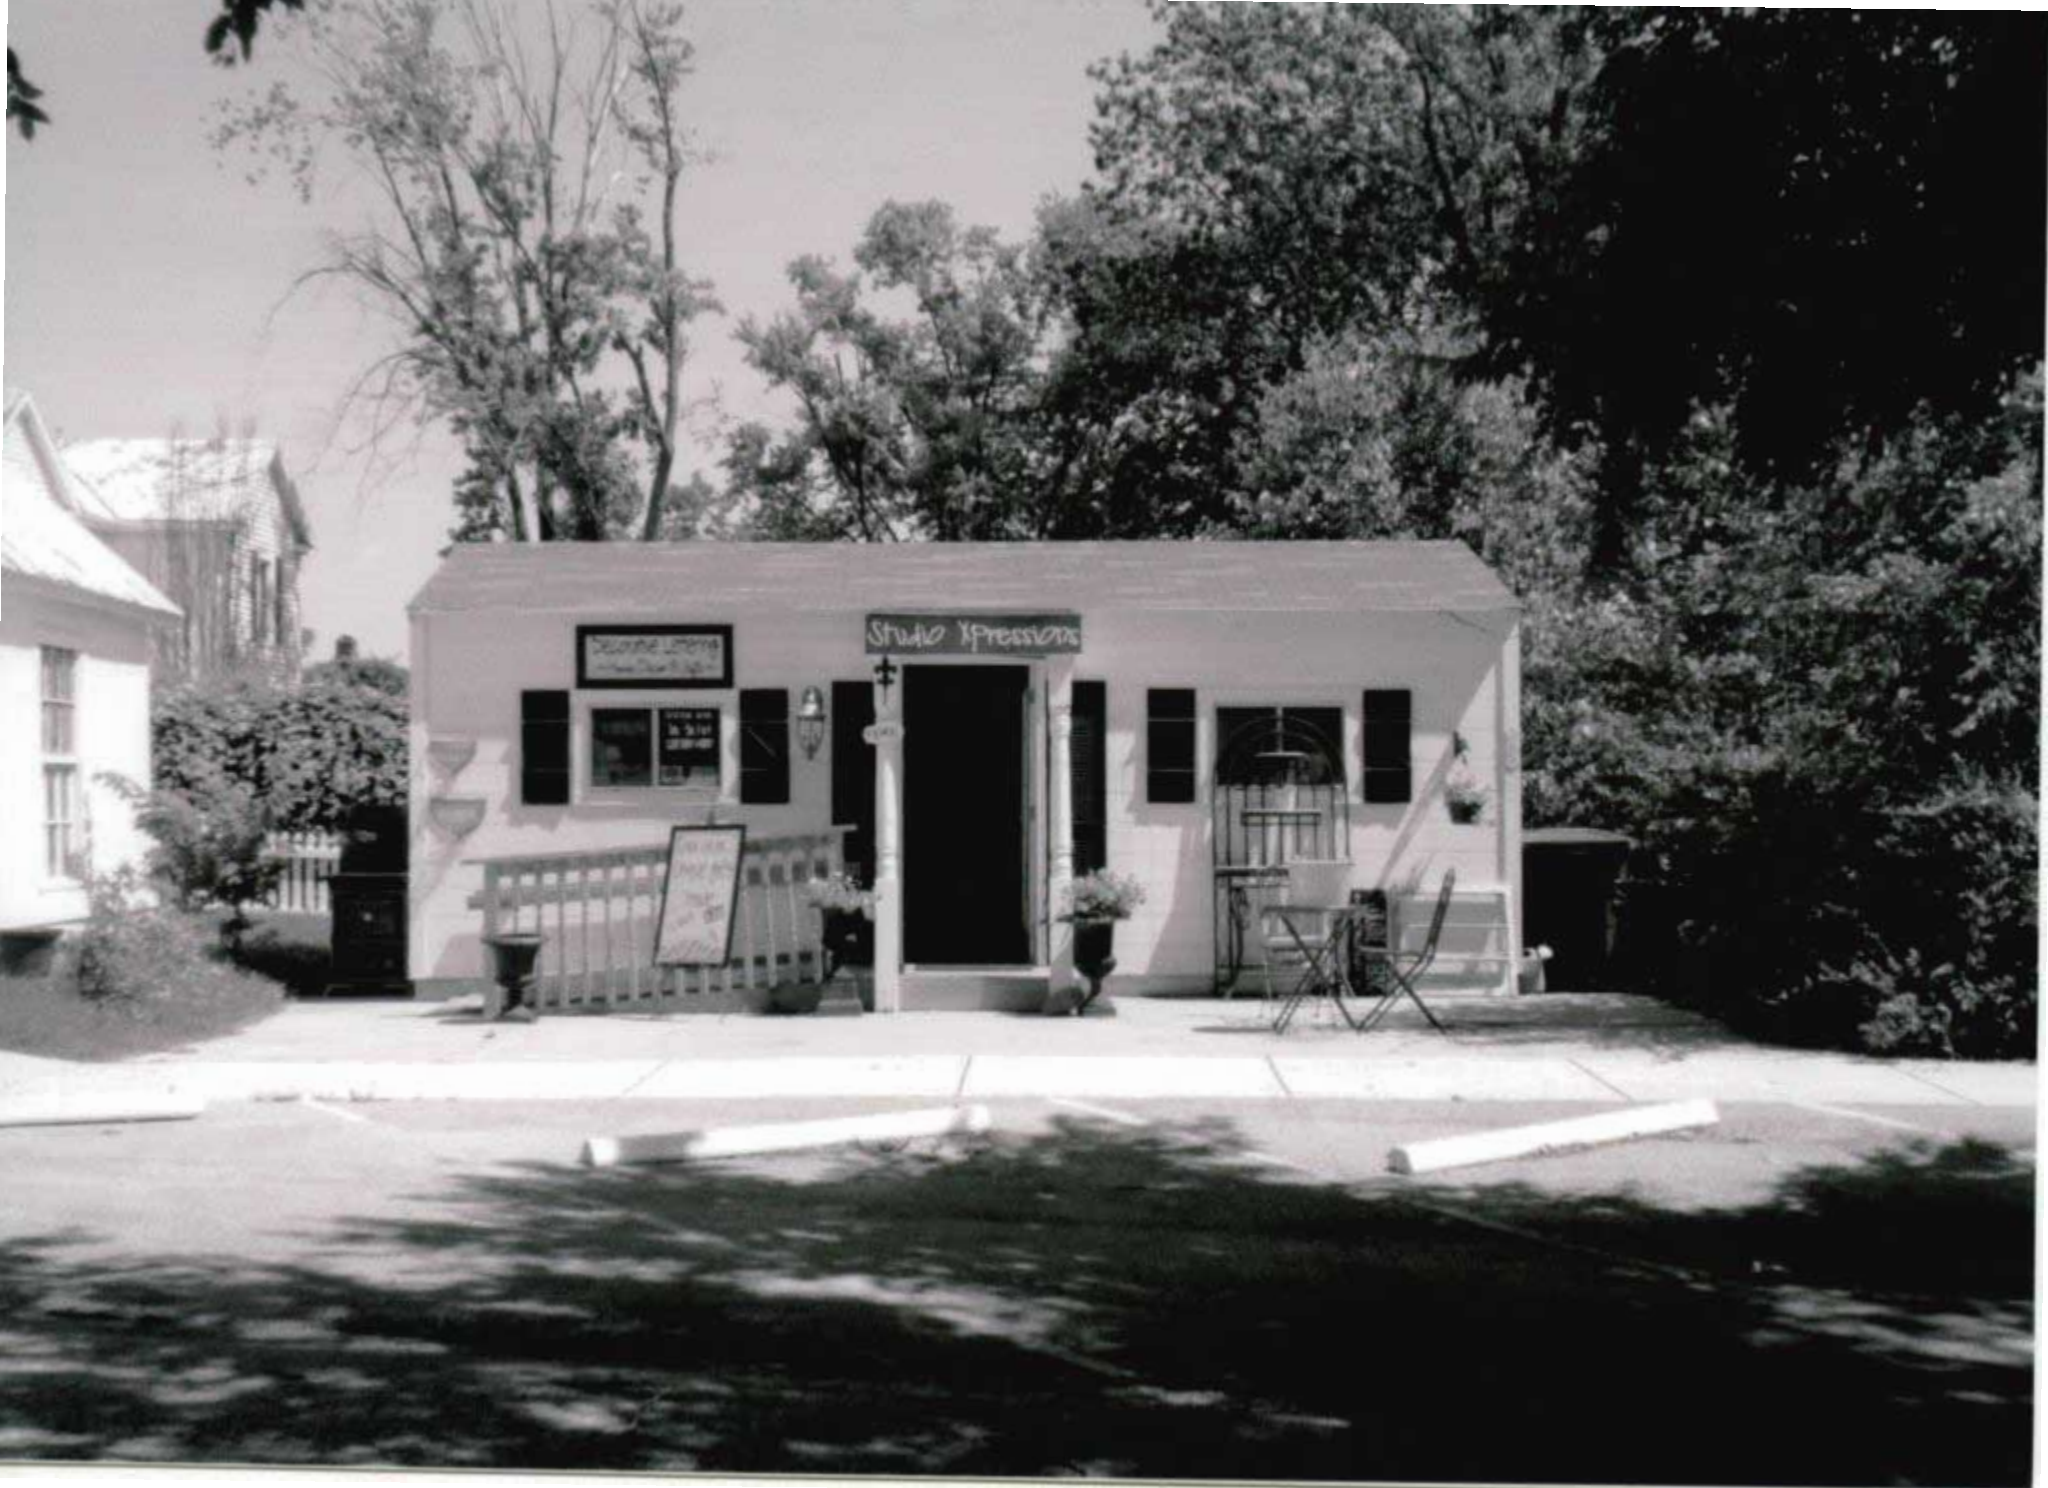
A one-story, frame, cross-gable Minimal Traditional residence clad in vinyl siding and sitting on a concrete foundation. A 1/1 sash window is located to the north of the central wood and glass door. A paired 1/1 sash window is found to the south of the entrance. A handicapped accessible ramp is located on the south elevation and leads to the wood porch on the primary entrance. Though converted to commercial use, the exterior of the building does not appear to reflect any significant alterations to its residential design.
