ARCHITECTURAL/HISTORIC INVENTORY FORM

1. Survey No. SCAS001-0014		2. Survey Name: City of Cottleville Architectural/ Historic Resource Survey	
3. County: St. Charles		4. Address: 5209 4 th Street	
5. City: Cottleville	Vicinity: <input type="checkbox"/>	6. UTM: 15 /704000/ 4290982	7. Township/Range/Section: T: 43 R: 03 S: 00
8. Historic Name (if known): Schulte Brother's Store		9. Present/Other name (if known): The Flower Stop	
10. Ownership: <input checked="" type="checkbox"/> Private <input type="checkbox"/> Public		11. Historic Use (if known): Domestic/ Commercial	11. Current Use: Commercial

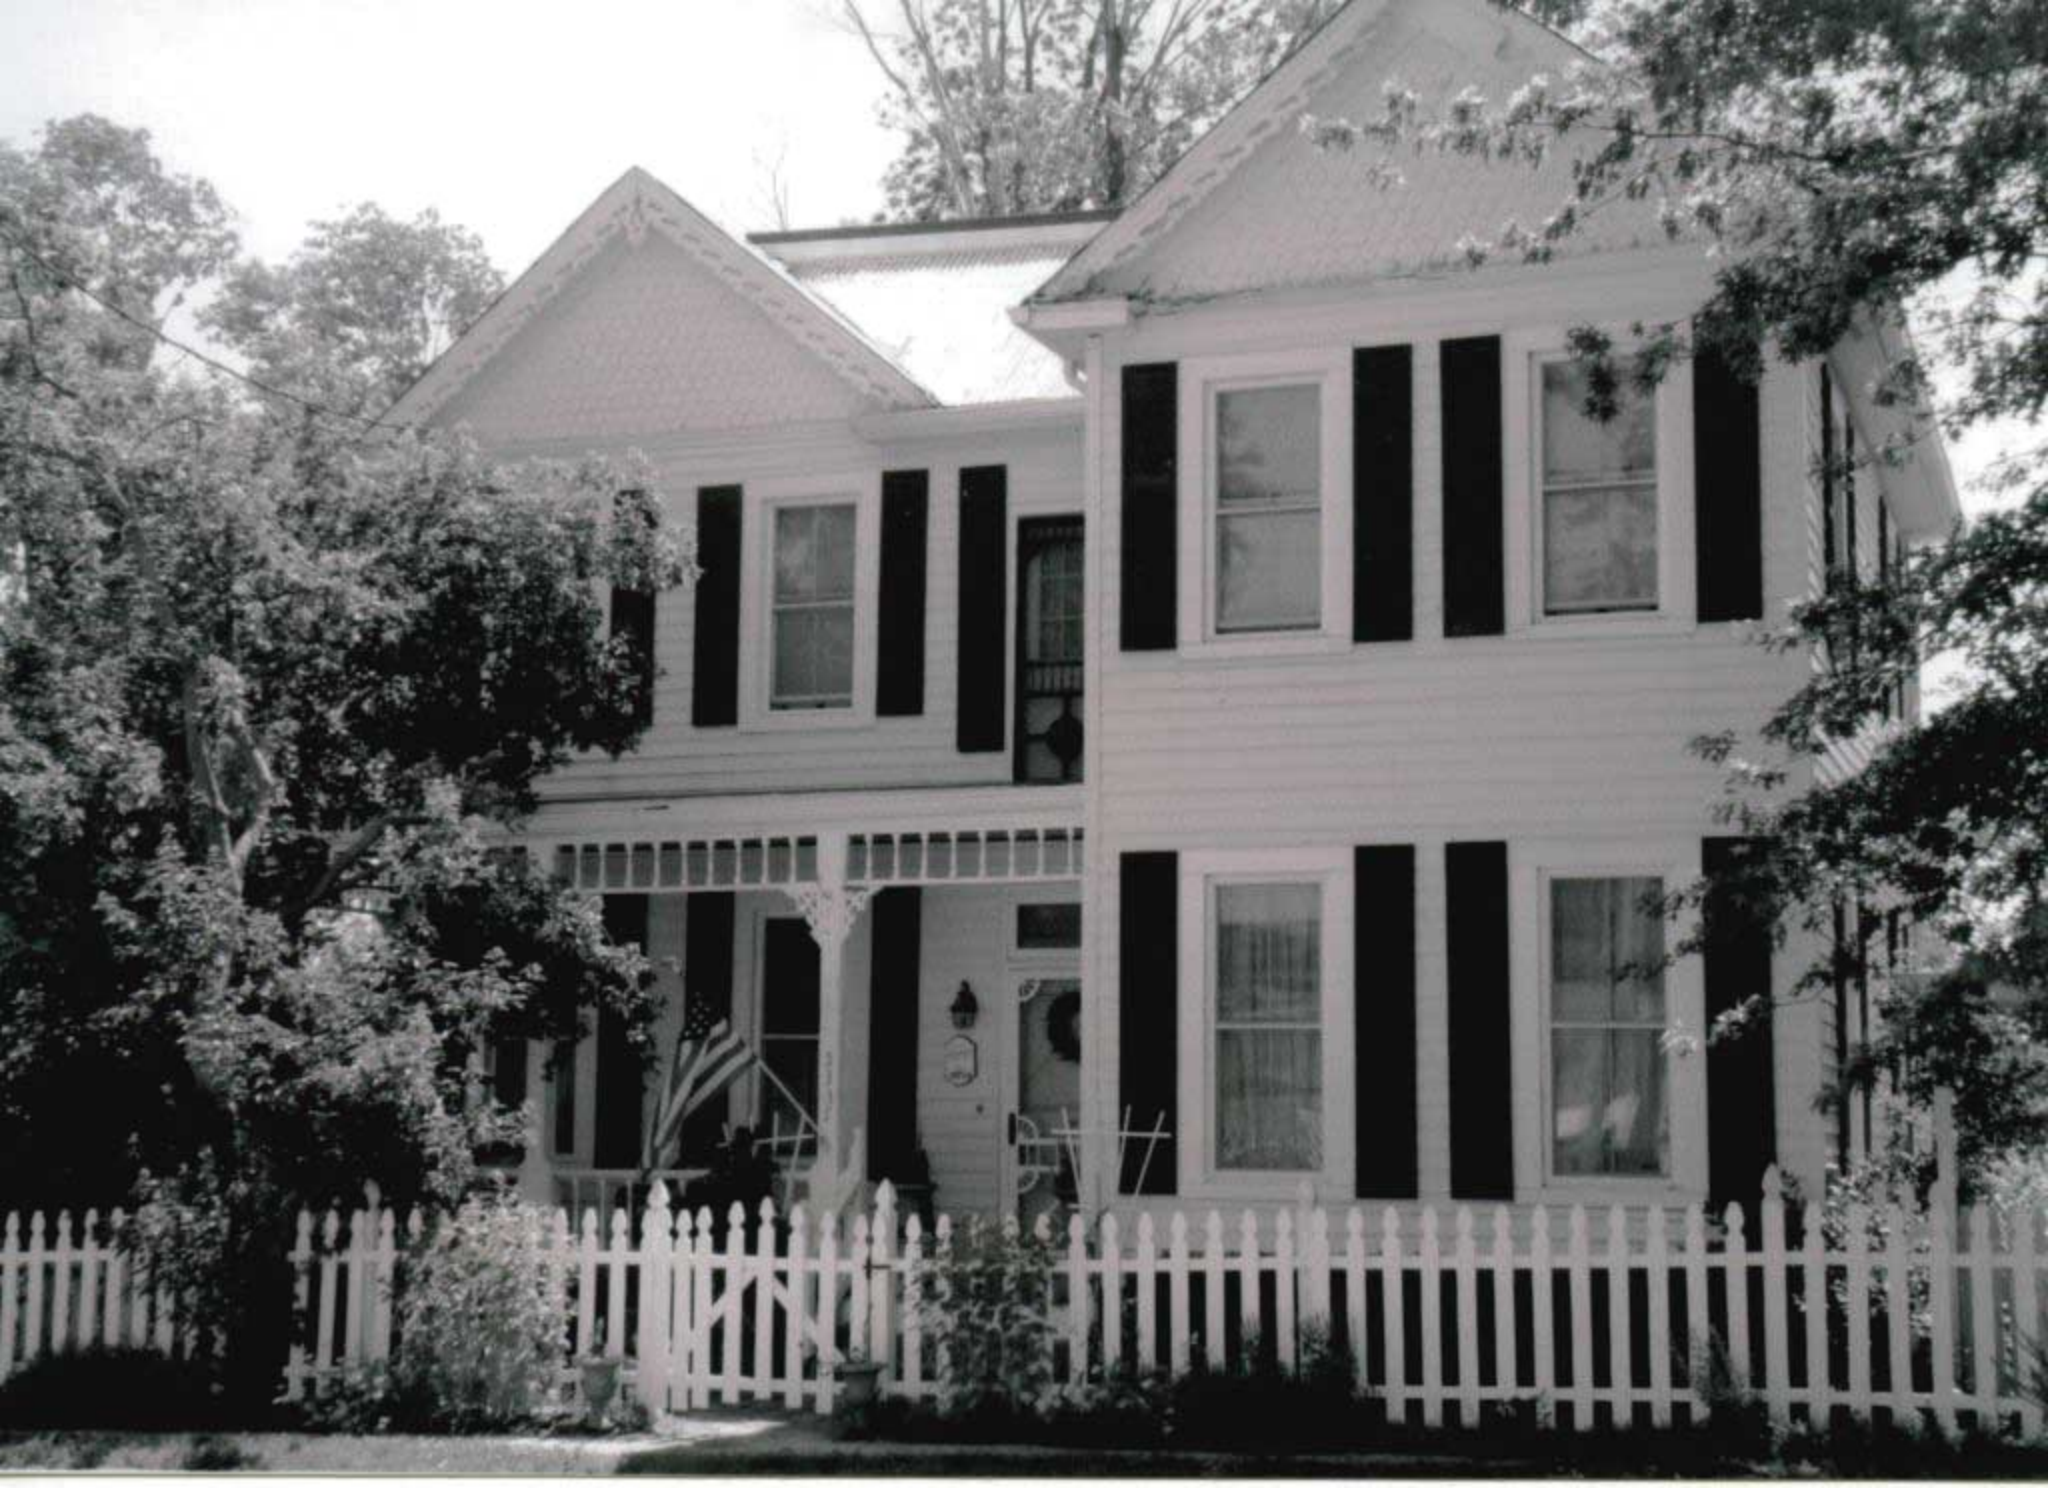
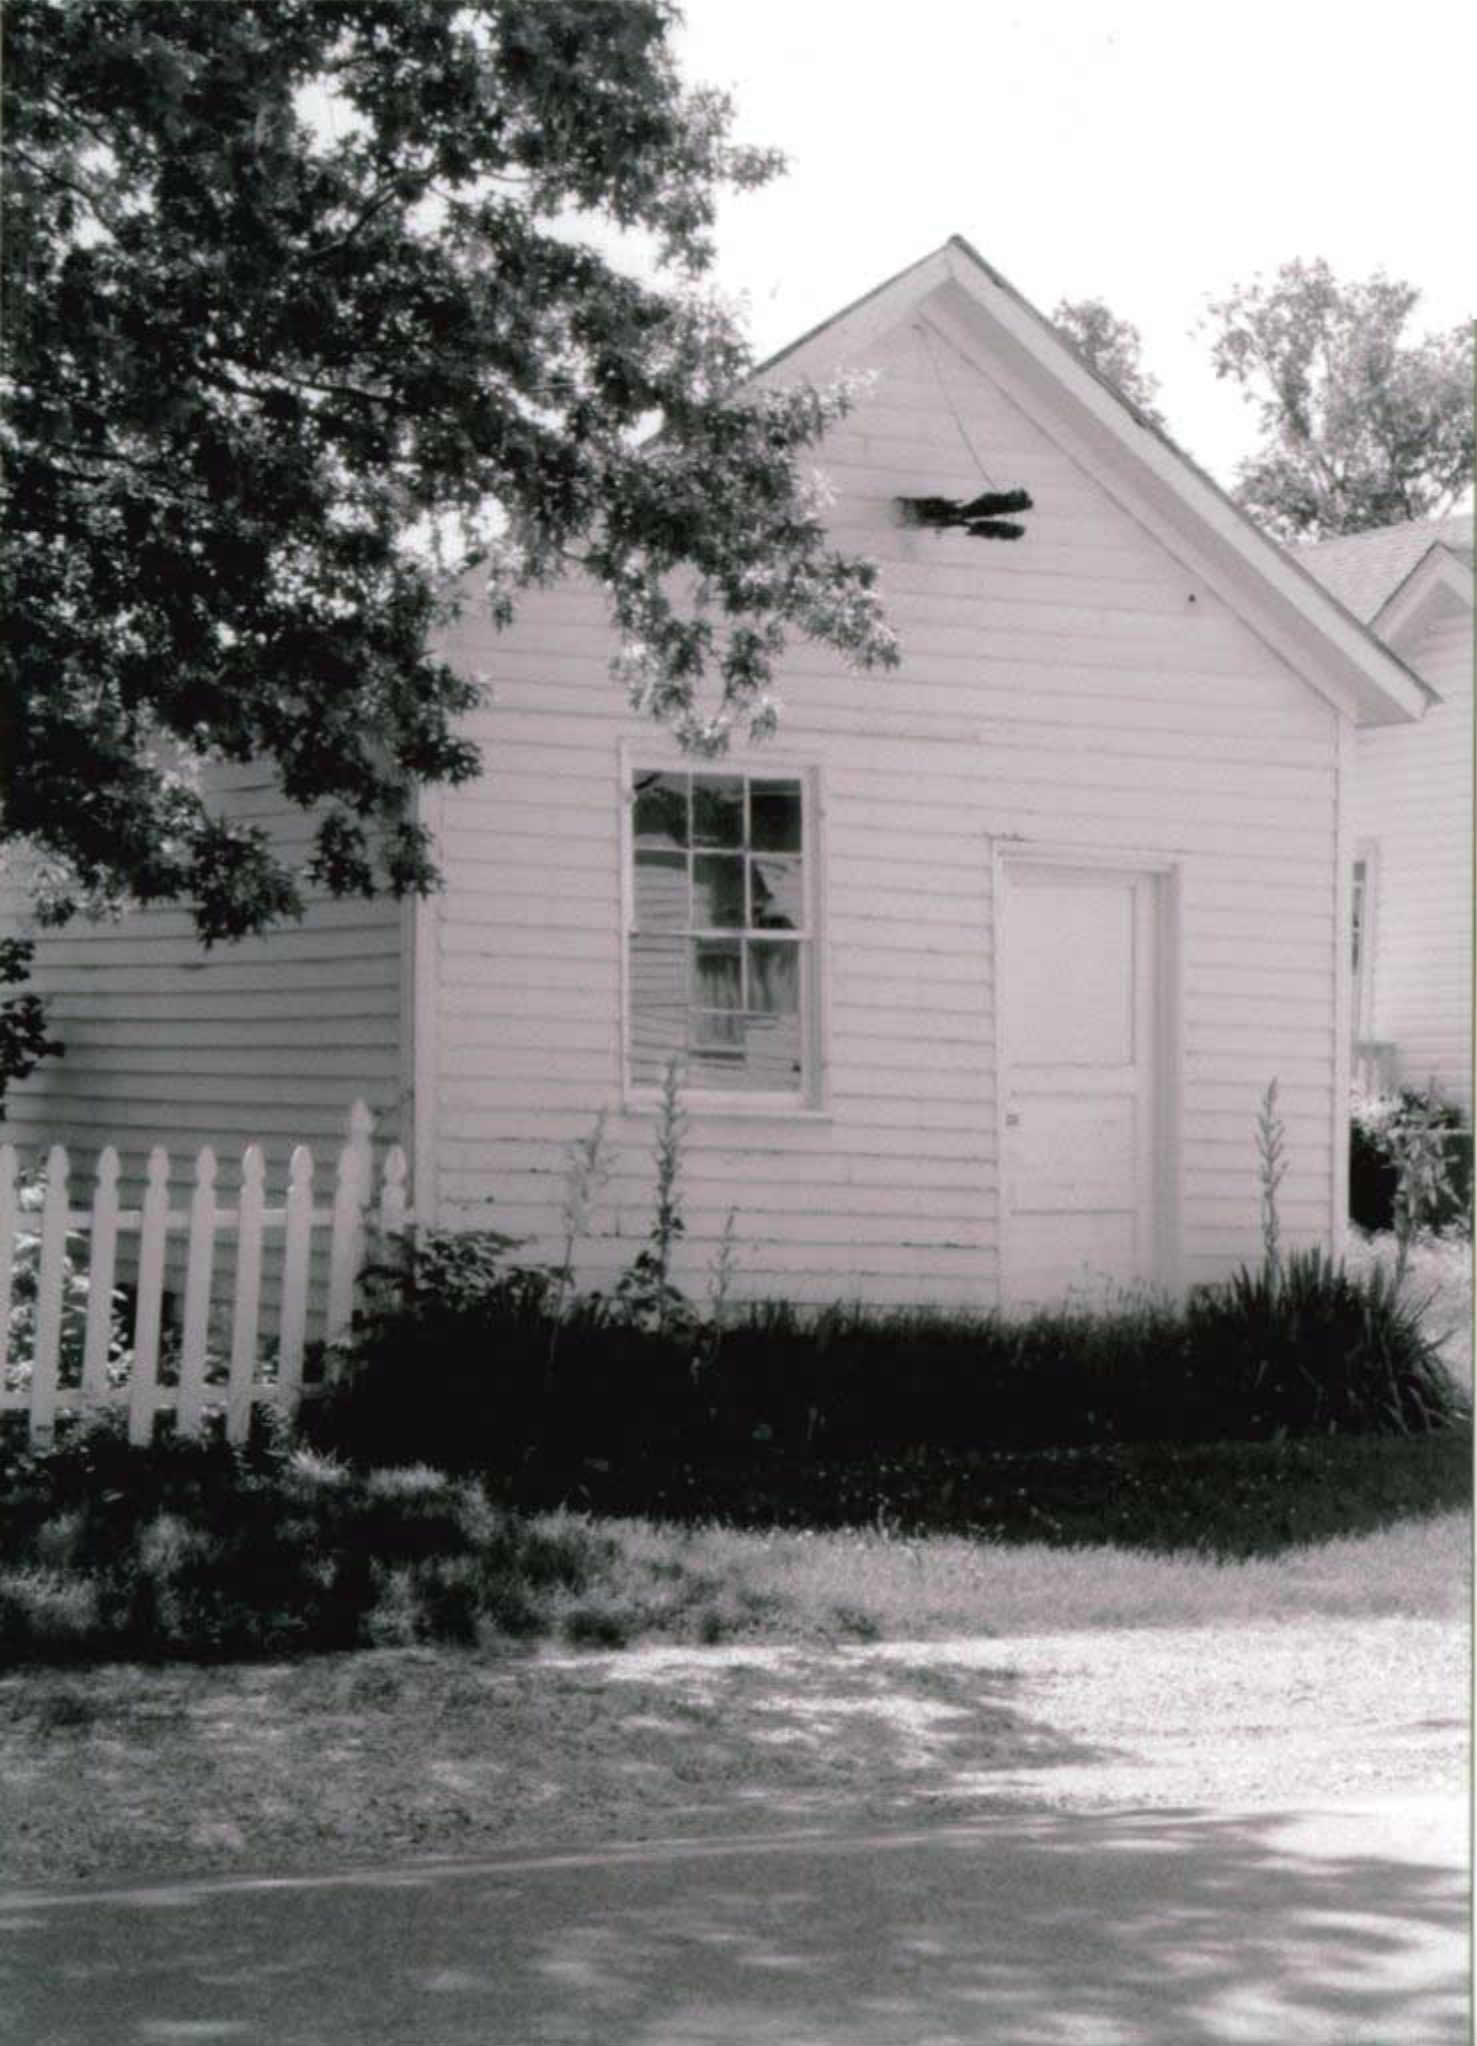
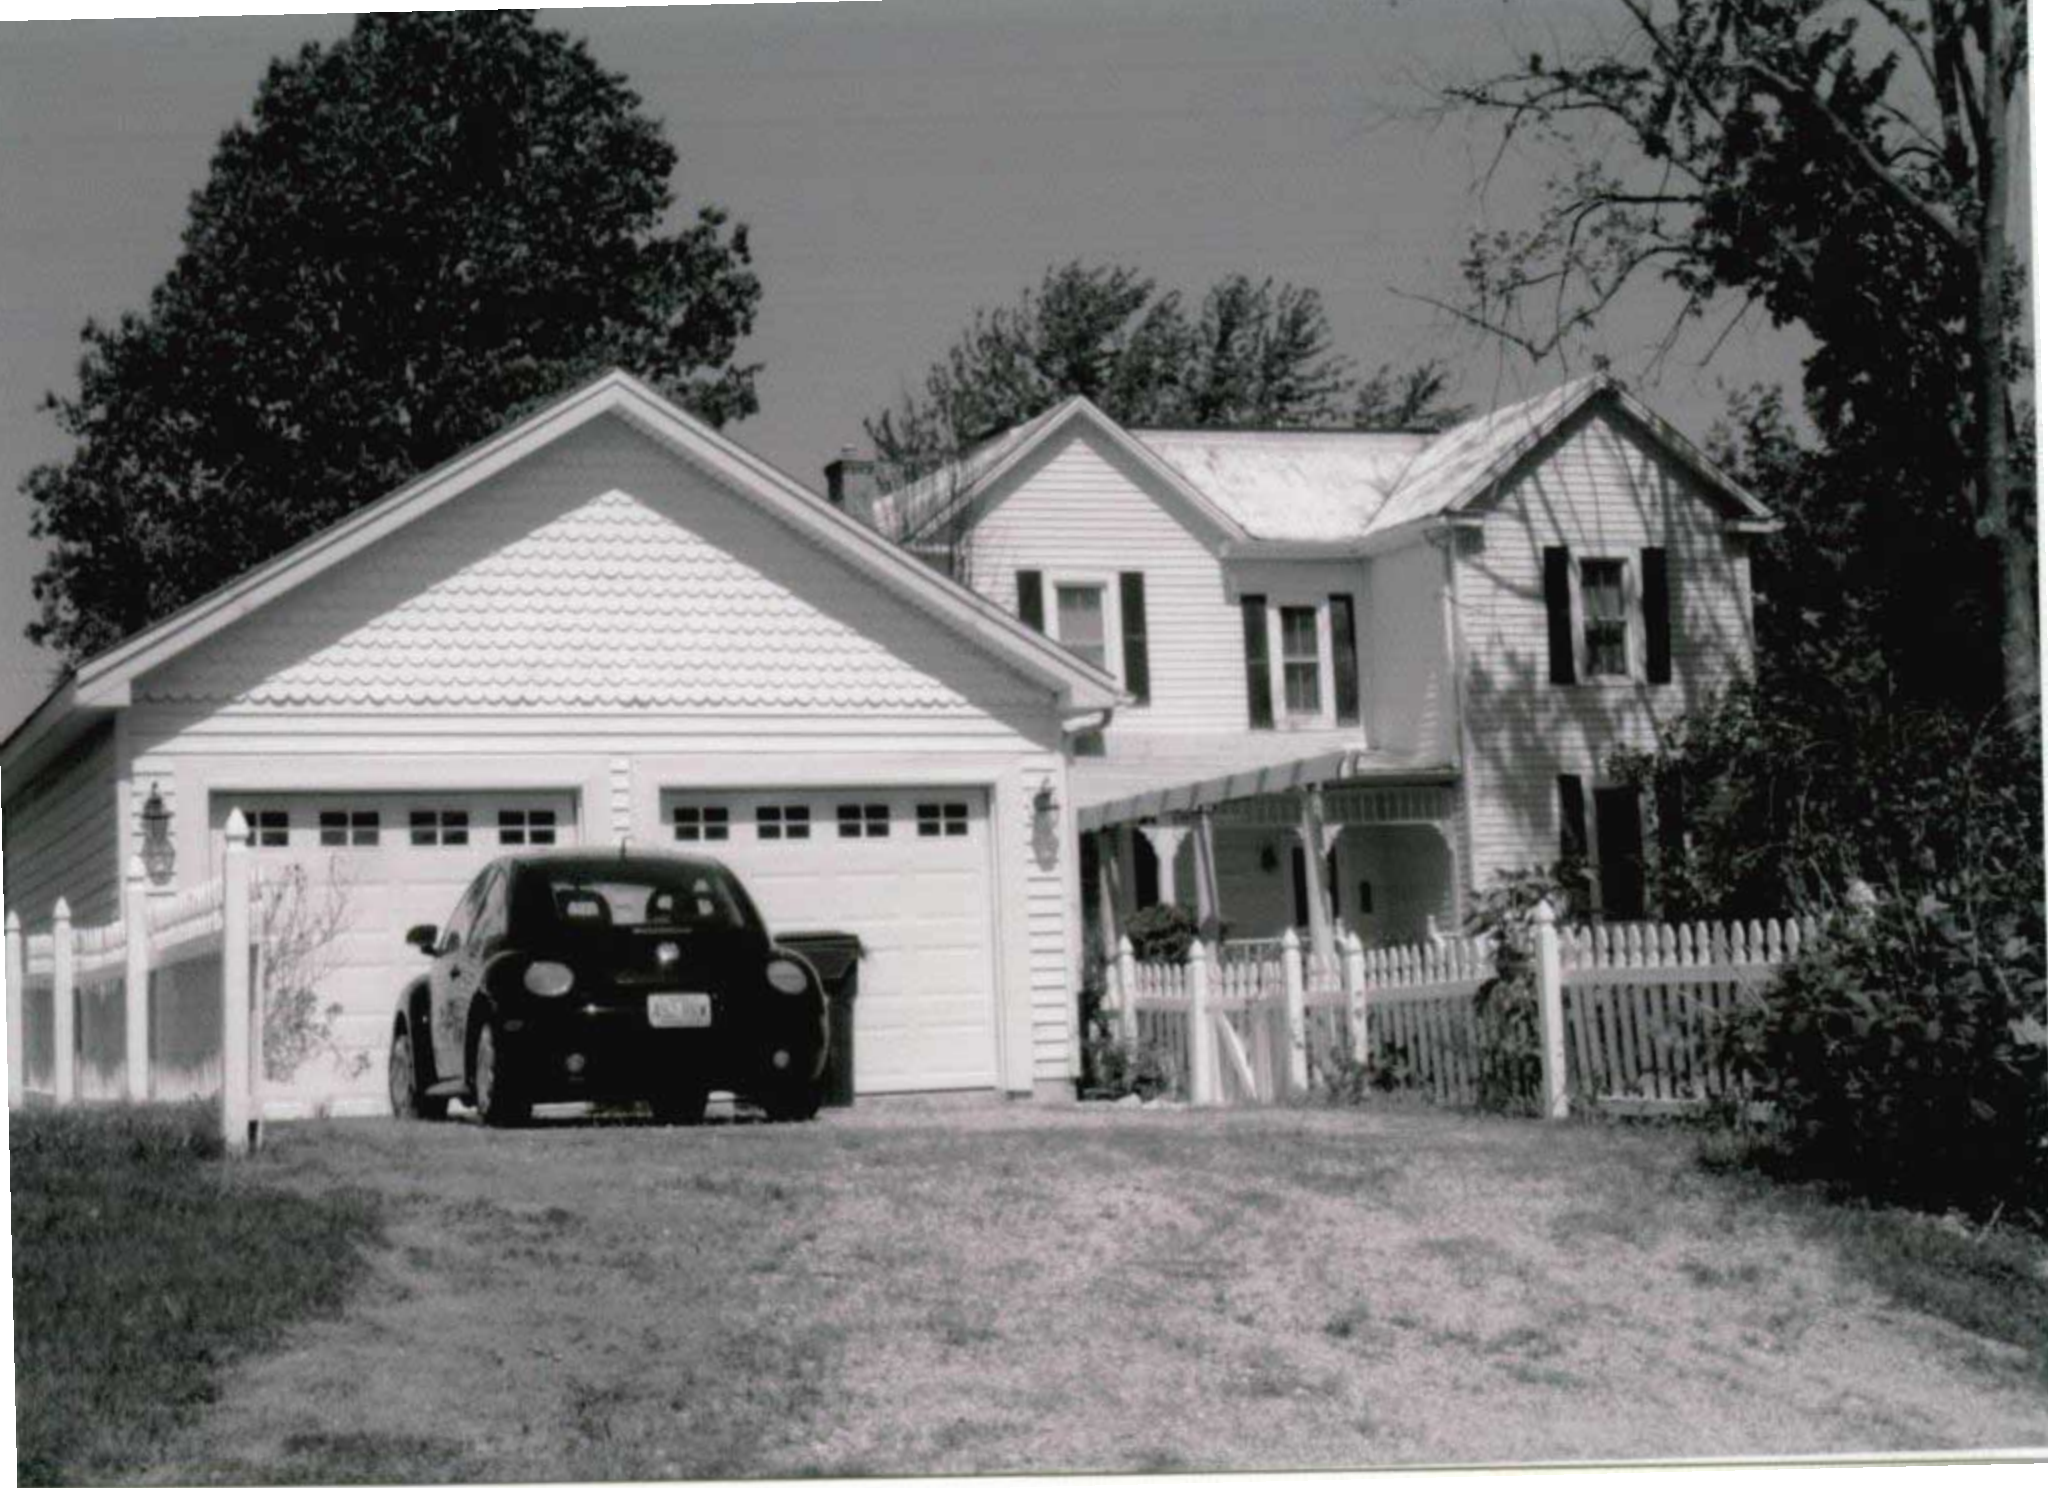
The property has a one-story, front gabled shed facing 4th Street/ Highway N south of the main building, which was originally used as a doctor's examination room. A one-story garage is found at the southeast corner of the property, and another one-story gabled shed is found at the northeast corner of the property.

A two-story frame cross gabled residence clad in vinyl siding and sitting on a stone foundation. Two 2/2 sash windows are found to the north of the central wood entrance door with glass transom. The fenestration pattern is mimiced on the second level, with a cross gable featuring fish scale shingles above the windows. A cross gabled projection is found to the south of the entrance, featuring two 2/2 sash windows on each level. The building was divided into two dwellings at one point, and the rear of the building mirrors the design of the main façade. Though covered in siding, the building was restored in 1987 to resemble a 1920s photograph. The colonial revival detailing has been well preserved.

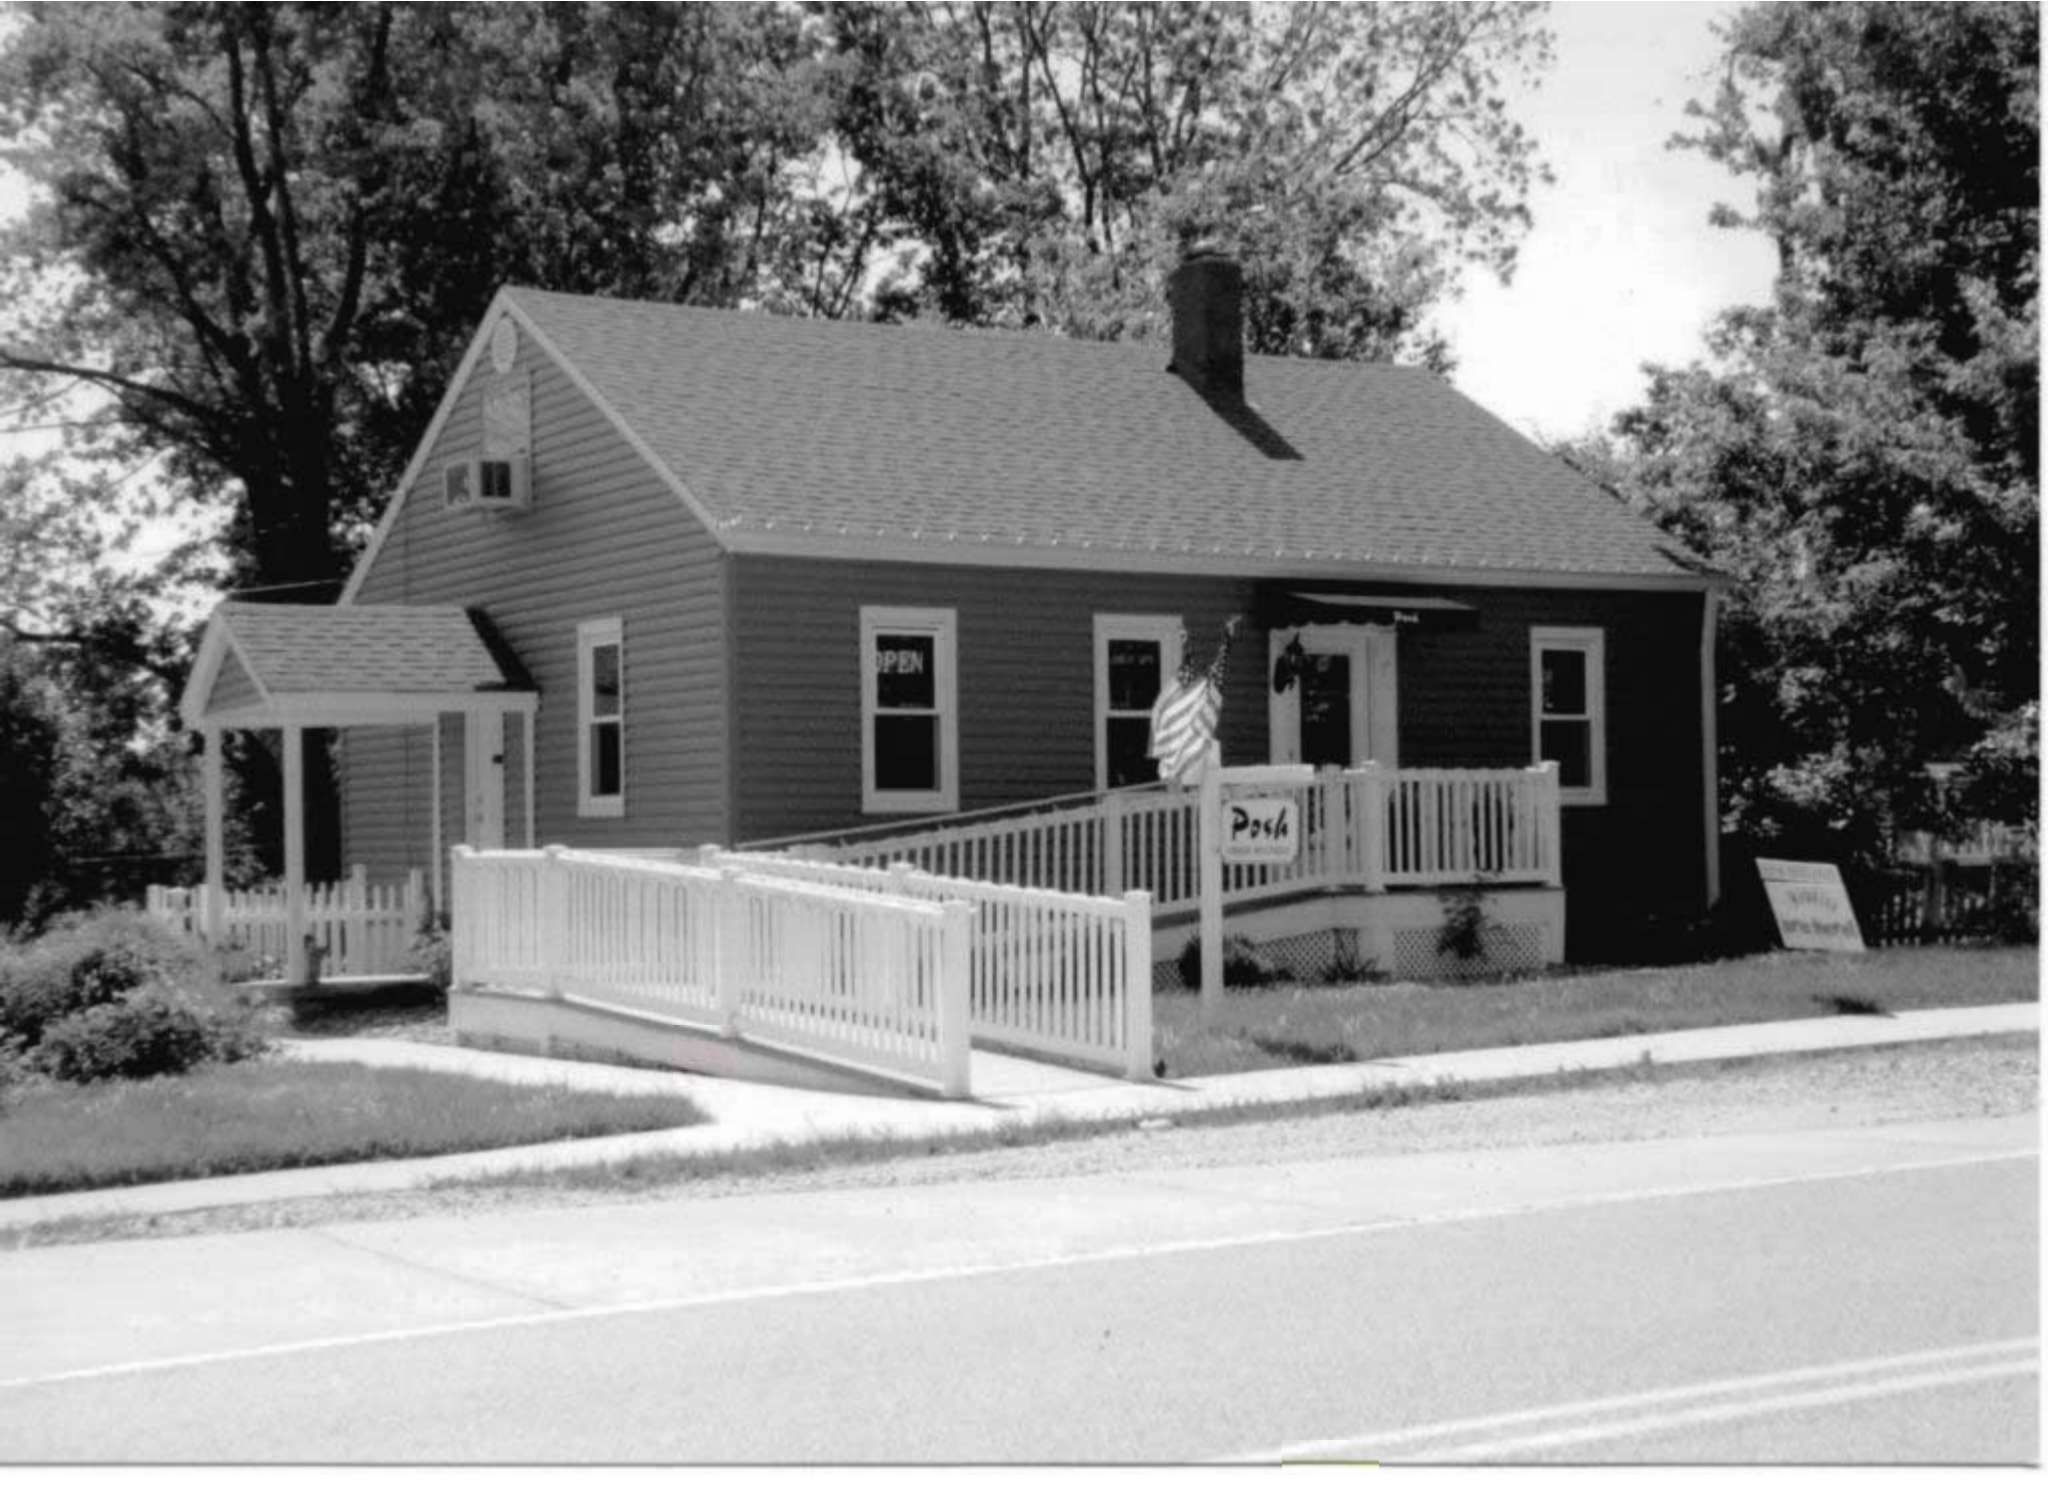
One-story, brick side-gable residence clad in vinyl siding and sitting on a concrete foundation. A modern glass and metal door entrance is located off center below a cloth awning, with 1/1 metal sash windows filling the remaining three bays. Building was originally brick and has been sided since construction. A handicap accessible ramp has been added to the façade for commercial use.

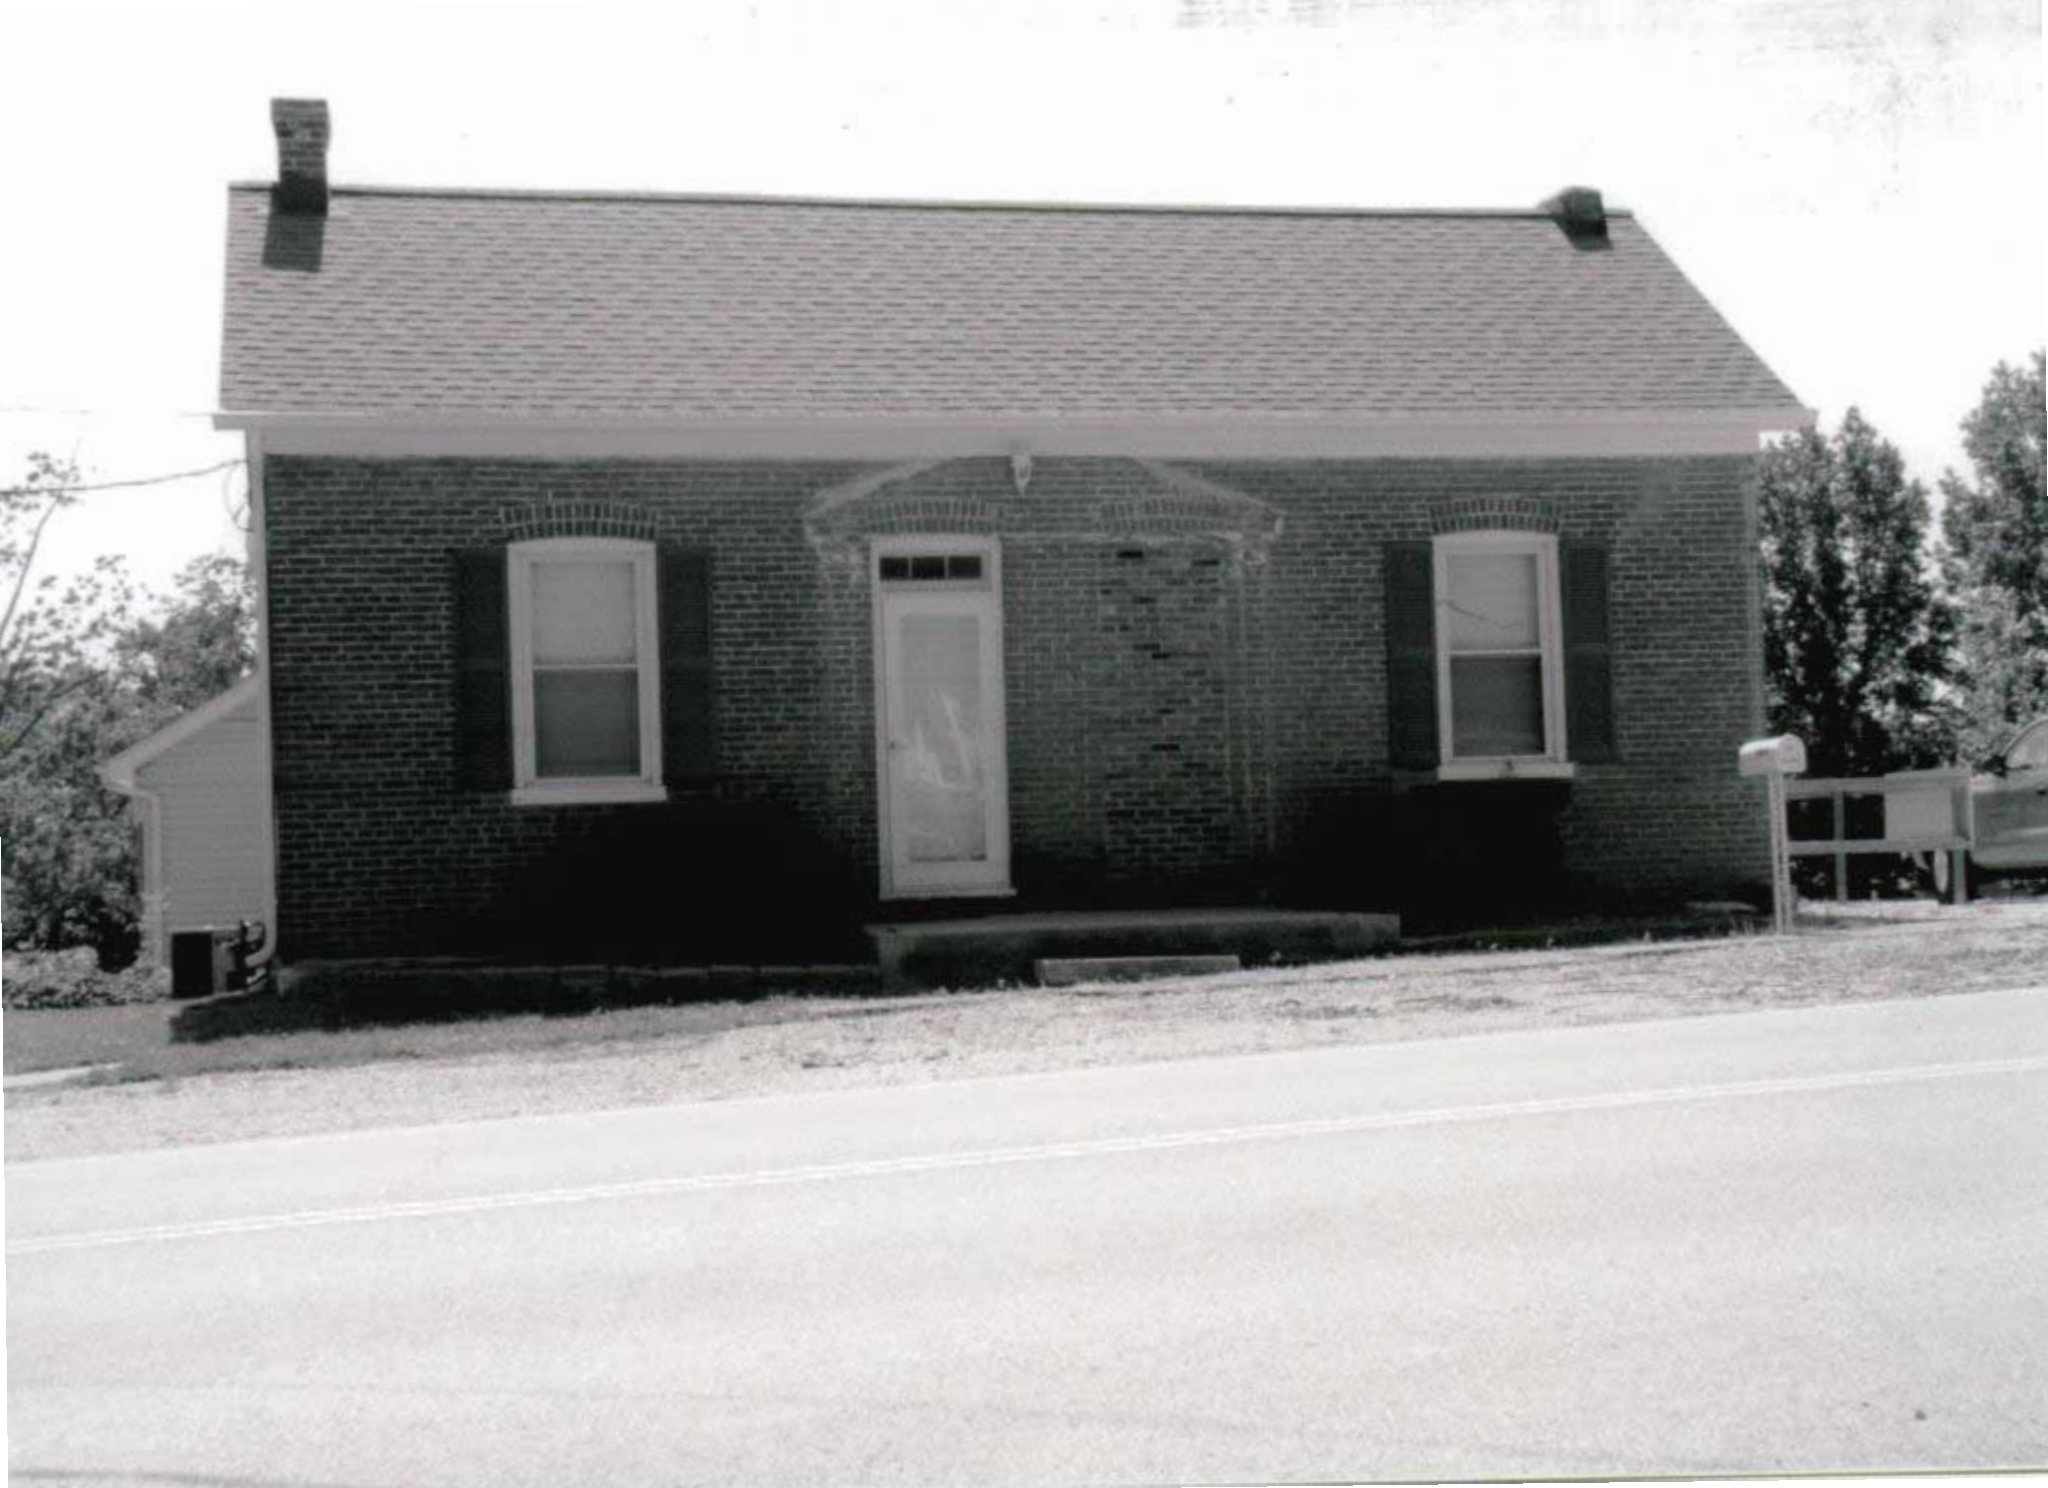
One-story, brick, side gabled, german vernacular residence sitting on a stone foundation. The façade consists of four bays, with modern 1/1 sash windows in the outer bays. The northern central bay contains a new metal door with a glass transom, and the southern central bay has been bricked in. Each bay is accented by a segmental arched brick lintel. Evidence of an open porch can be seen in the brick over the central bays, but a concrete stoop is all that remains.

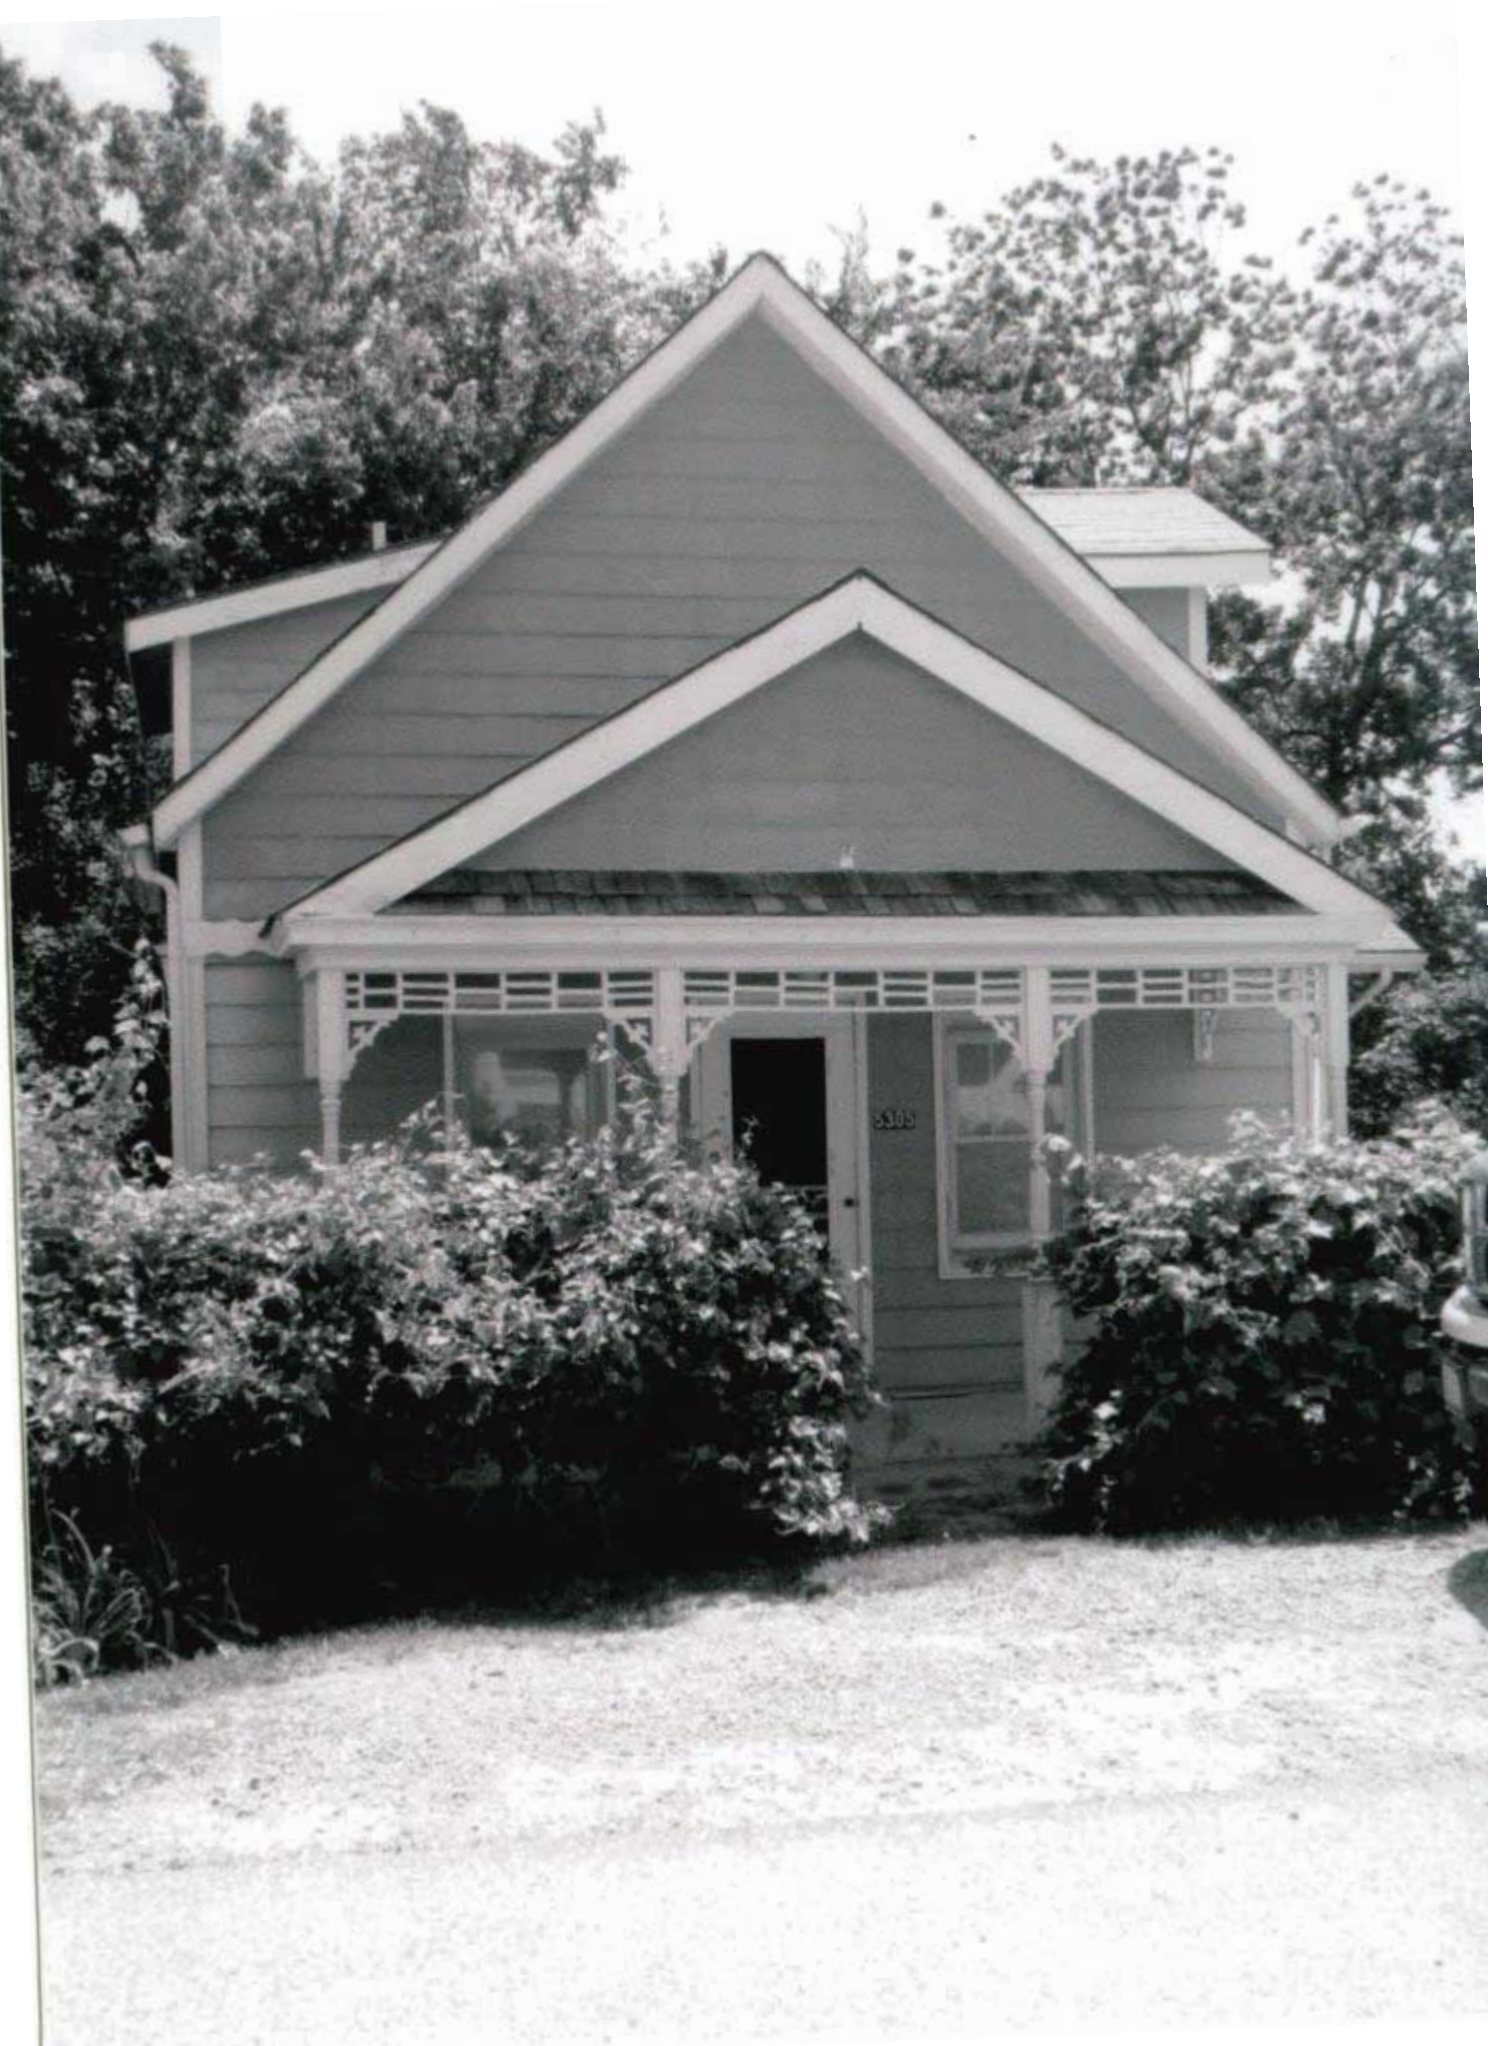
One-and-a-half-story, frame, gable front residence clad in wood siding and sitting on a concrete foundation. A 3/1 wood sash window is found on either side of the of the central entrance door. The open porch features some Victorian detailing.
