ARCHITECTURAL/HISTORIC INVENTORY FORM

1. Survey No. SCAS001-0014		2. Survey Name: City of Cottleville Architectural/ Historic Resource Survey	
3. County: St. Charles		4. Address: 5209 4 th Street	
5. City: Cottleville	Vicinity: <input type="checkbox"/>	6. UTM: 15 /704000/ 4290982	7. Township/Range/Section: T: 43 R: 03 S: 00
8. Historic Name (if known): Schulte Brother's Store		9. Present/Other name (if known): The Flower Stop	
10. Ownership: <input checked="" type="checkbox"/> Private <input type="checkbox"/> Public		11. Historic Use (if known): Domestic/ Commercial	11. Current Use: Commercial

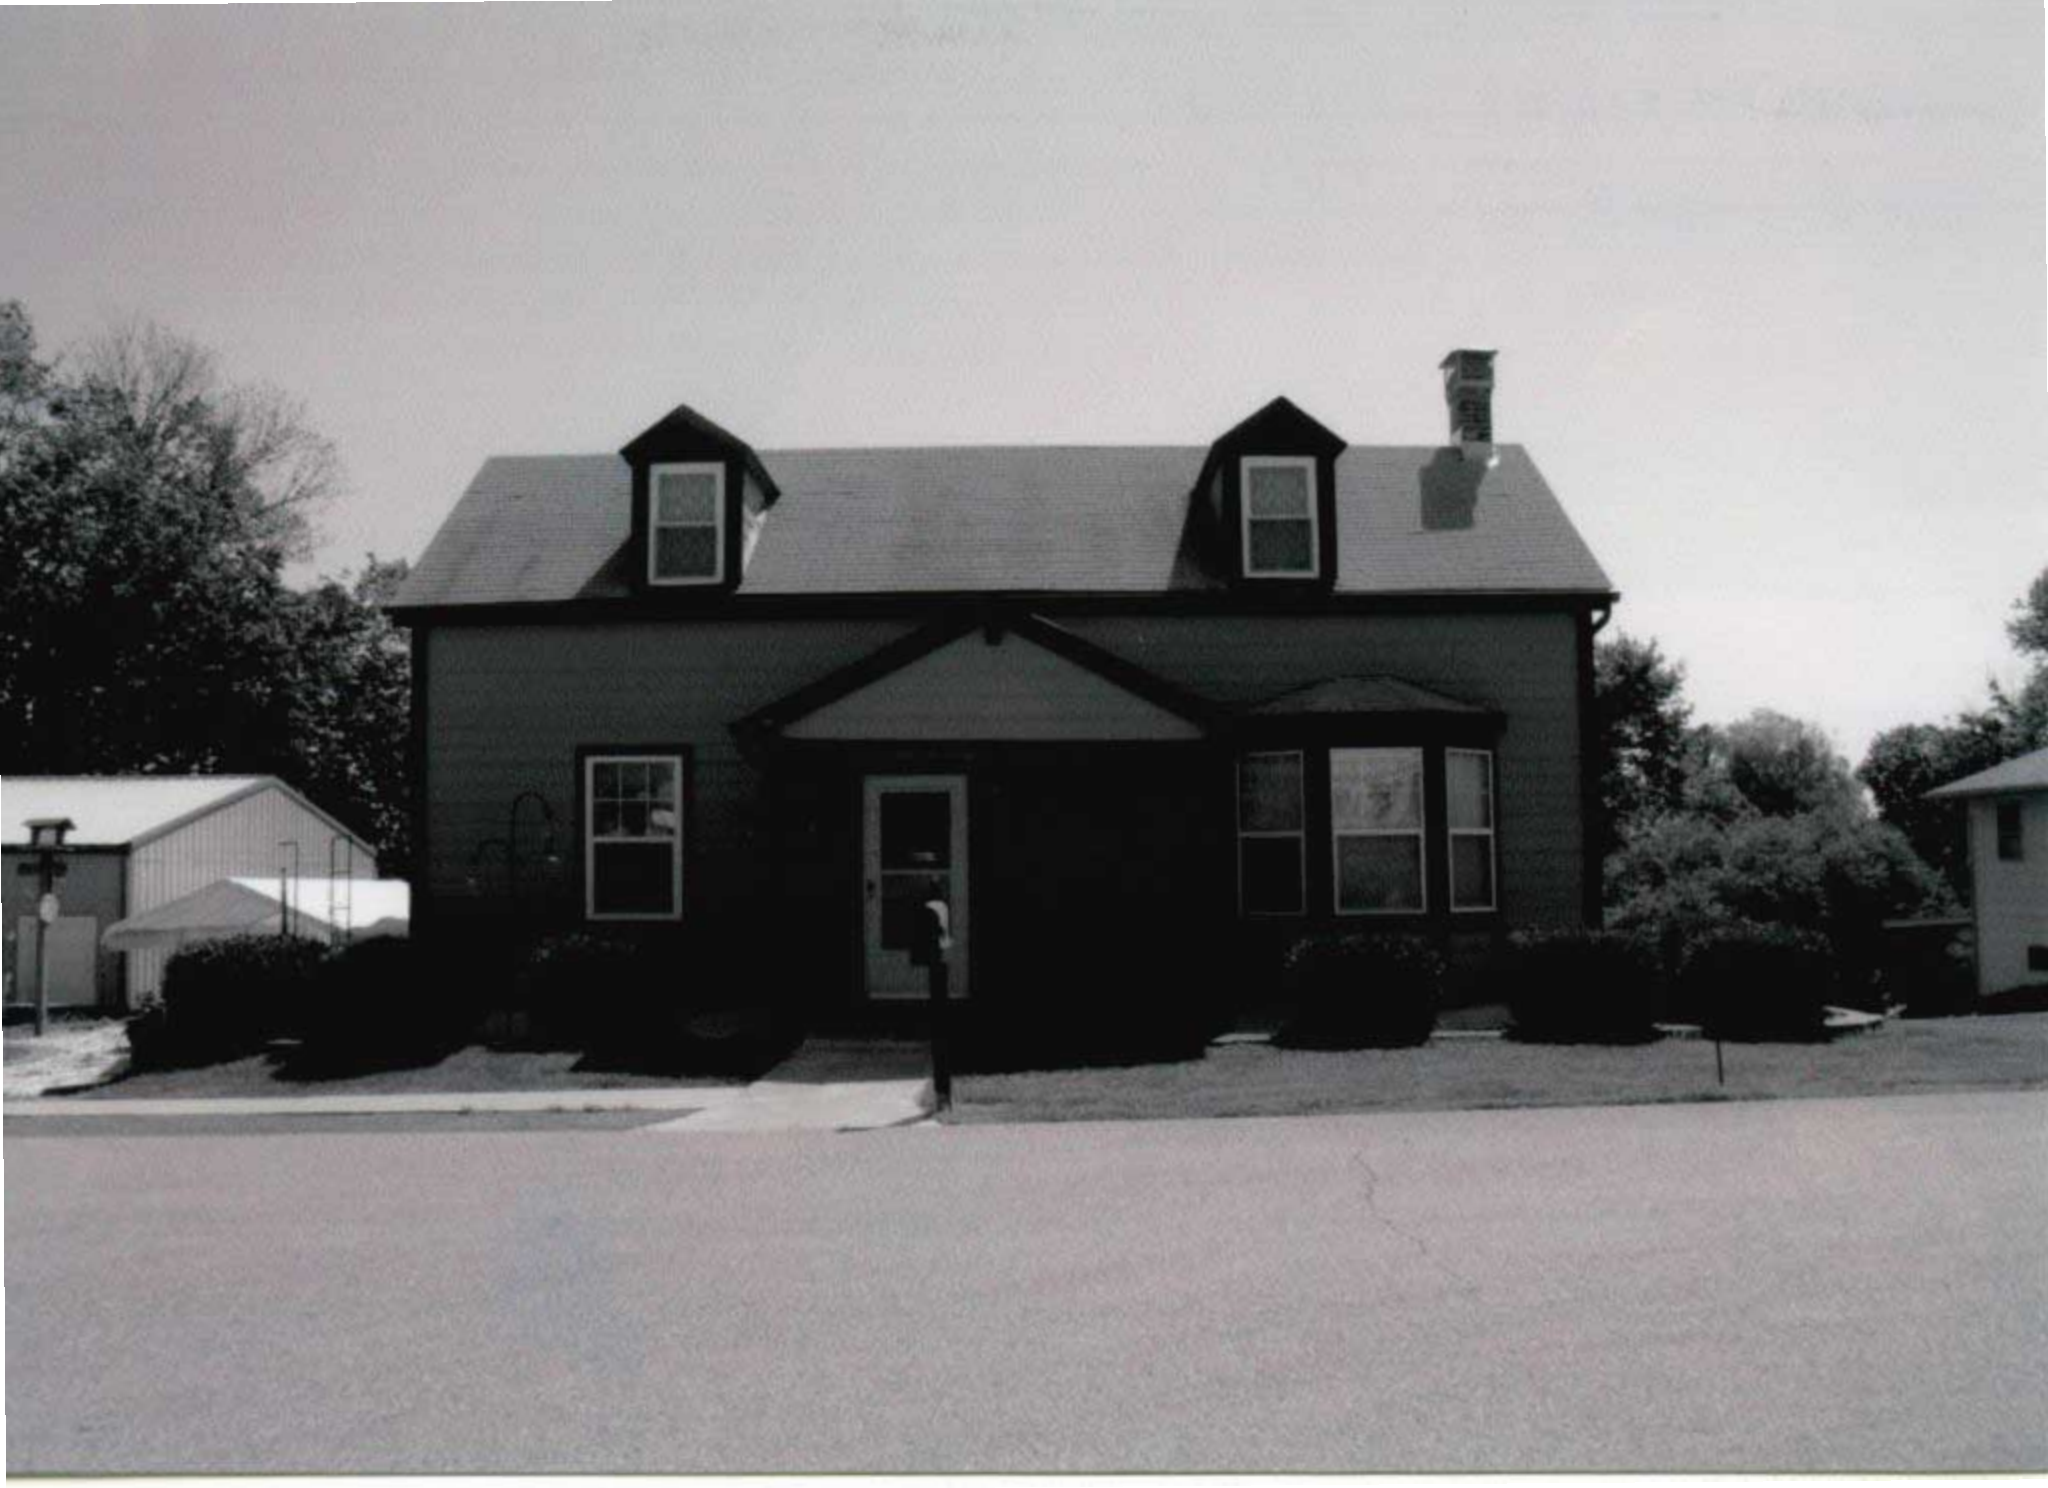
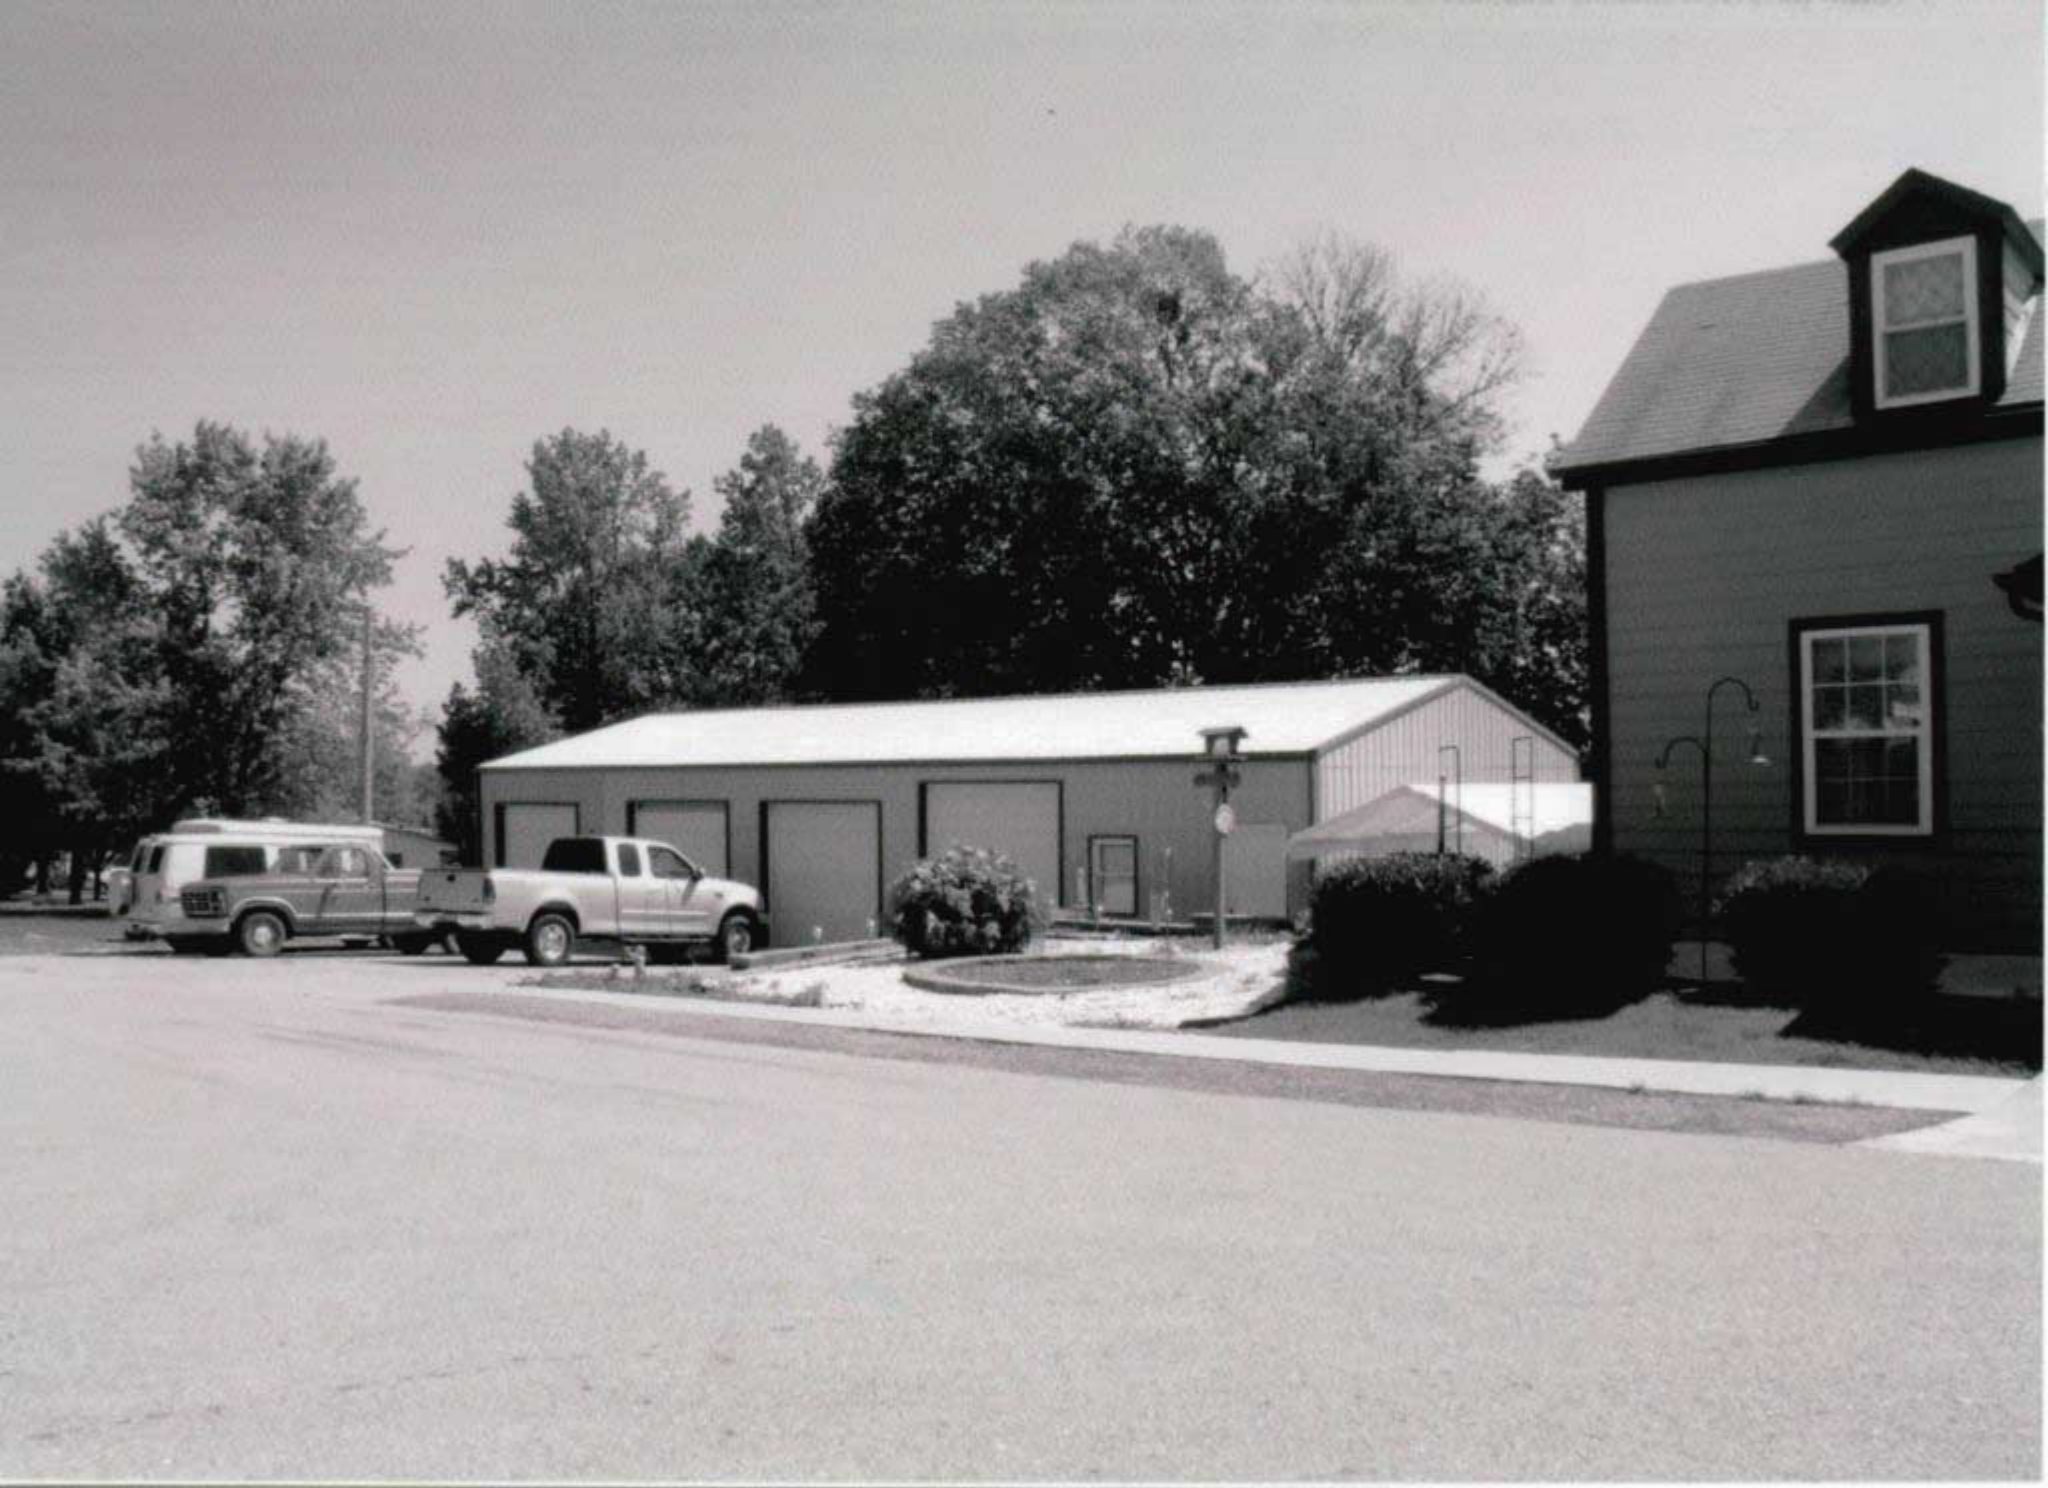
One and a half story, frame side-gable hall and parlor residence clad in vinyl siding and sitting on a stone foundation. The asymmetrical façade features an off center door below a gabled portico, with a single 6/6 sash window in the northern bay and a three part bay window in the southern bay. Two front gabled dormers with sash windows break the roofline. The façade has been covered in siding and painted and the windows have been replaced, but the fenestration pattern remains fairly intact with the exception of a three part bay window added to the main façade in the last 10 years. It is possible a second door existed under the porch.

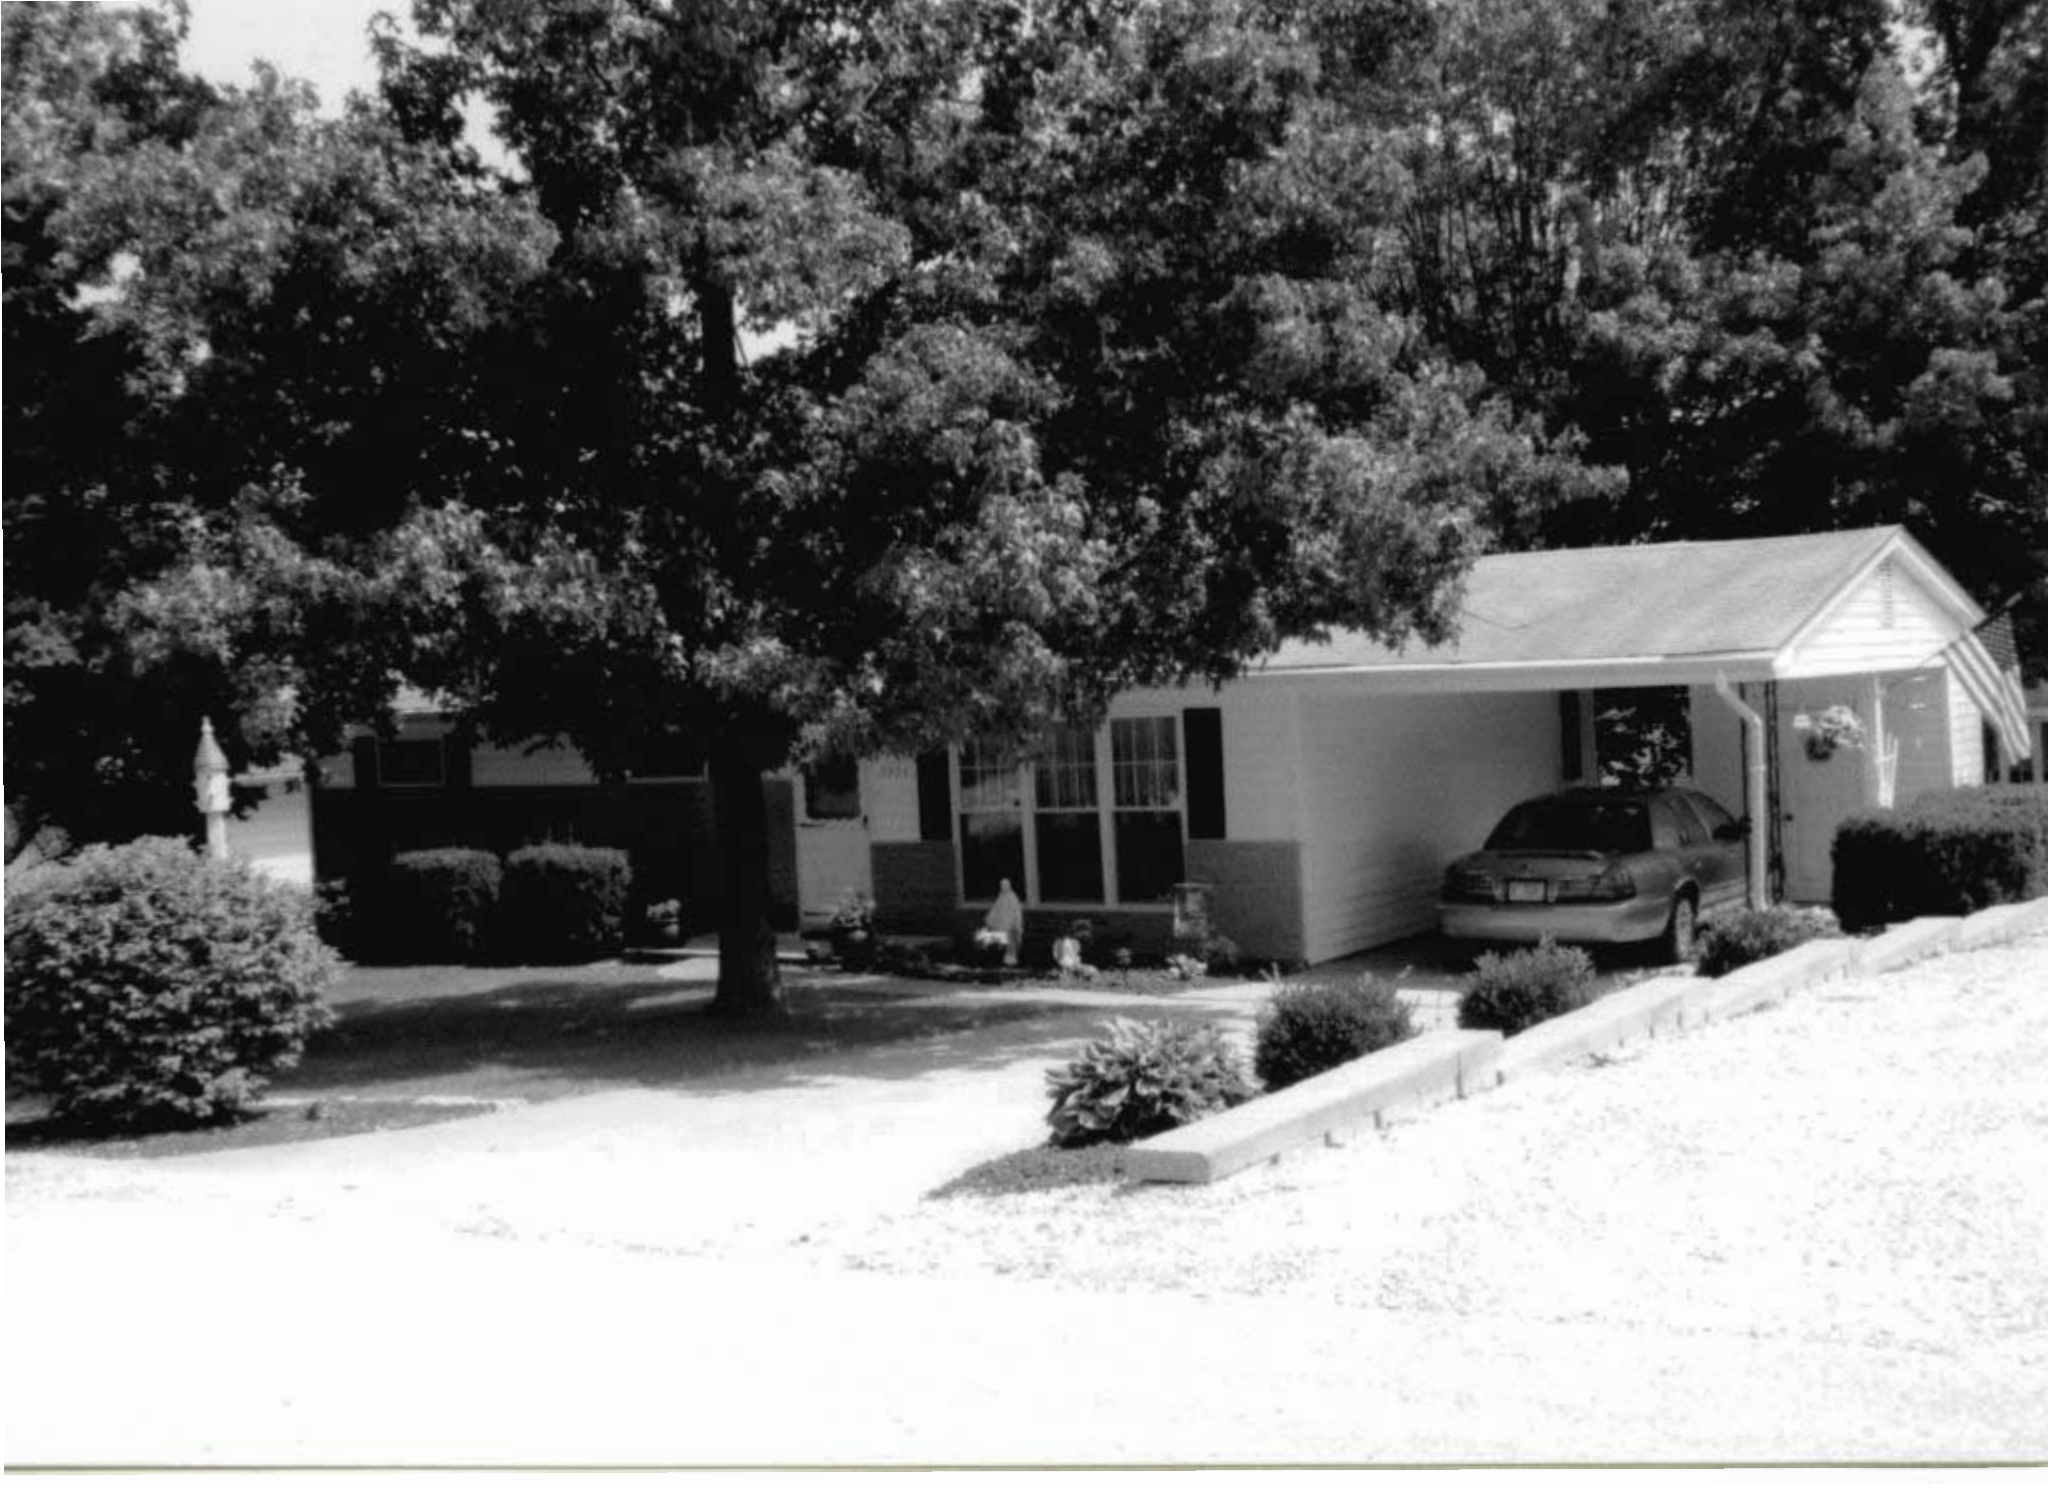
Windows in the north two bays are sliding eight pane windows that possess the typical horizontality of wide rectangular openings found on ranch style homes.

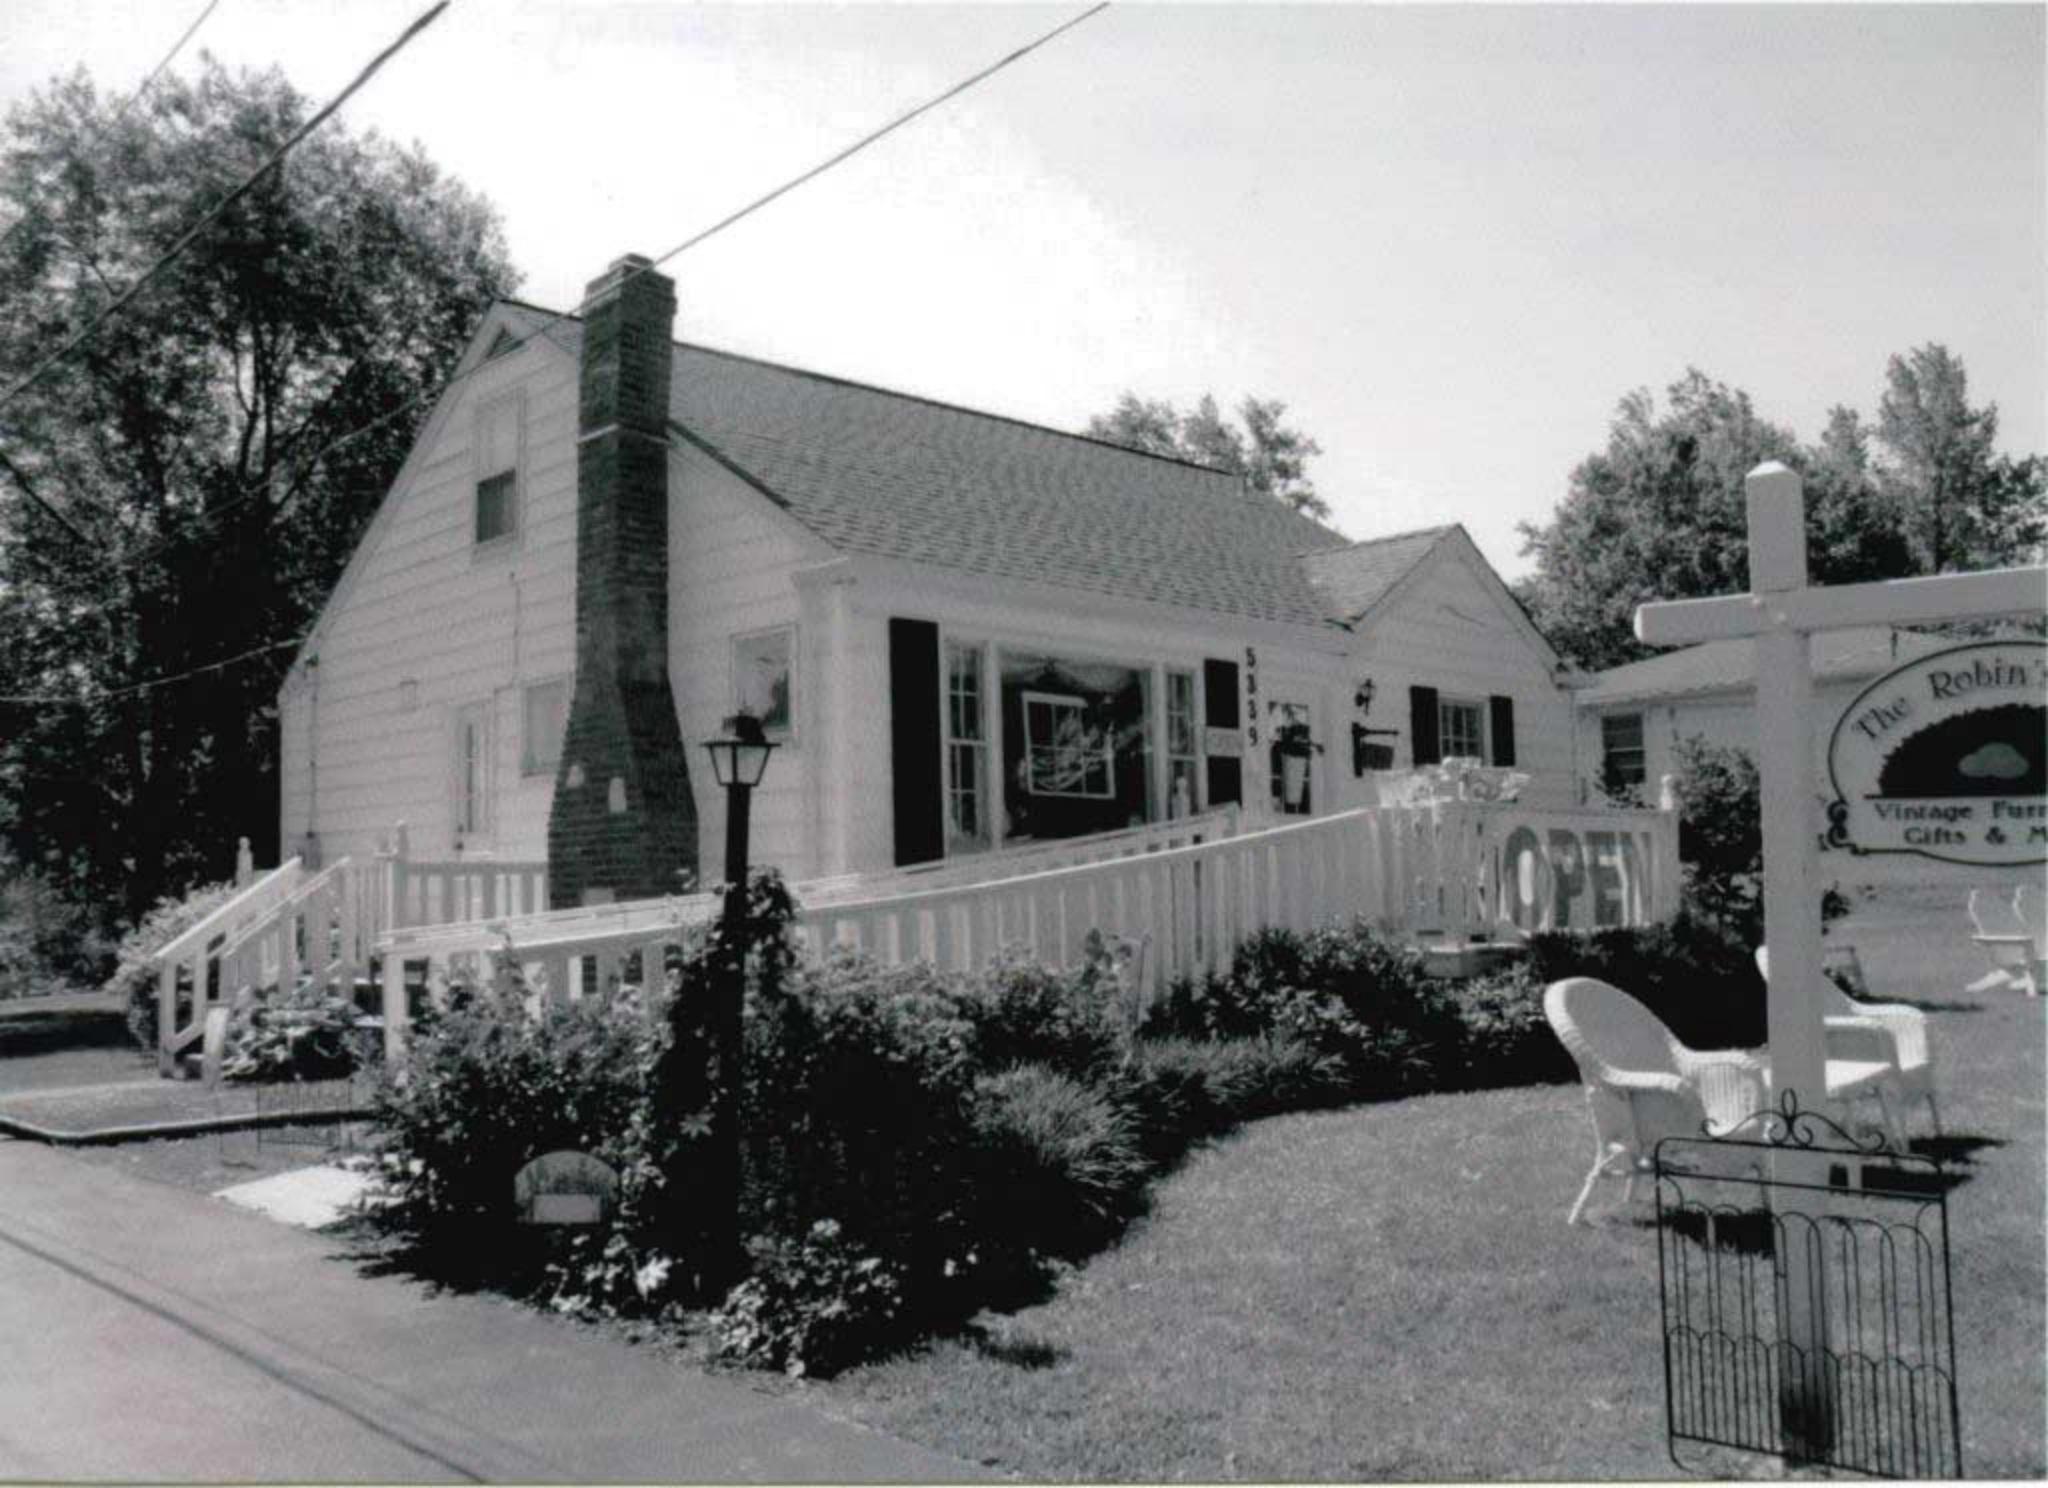
One-story, frame side gable Minimal traditional residence clad in vinyl siding sitting on a concrete foundation. A tripart picture window with fixed center pane and 4/4 double hung windows is located to the north of the off-center entrance. A 6/6 double hung window is located under a small cross gable to the south. A handicap accessible ramp and deck have been added to the front of the building for commercial access.

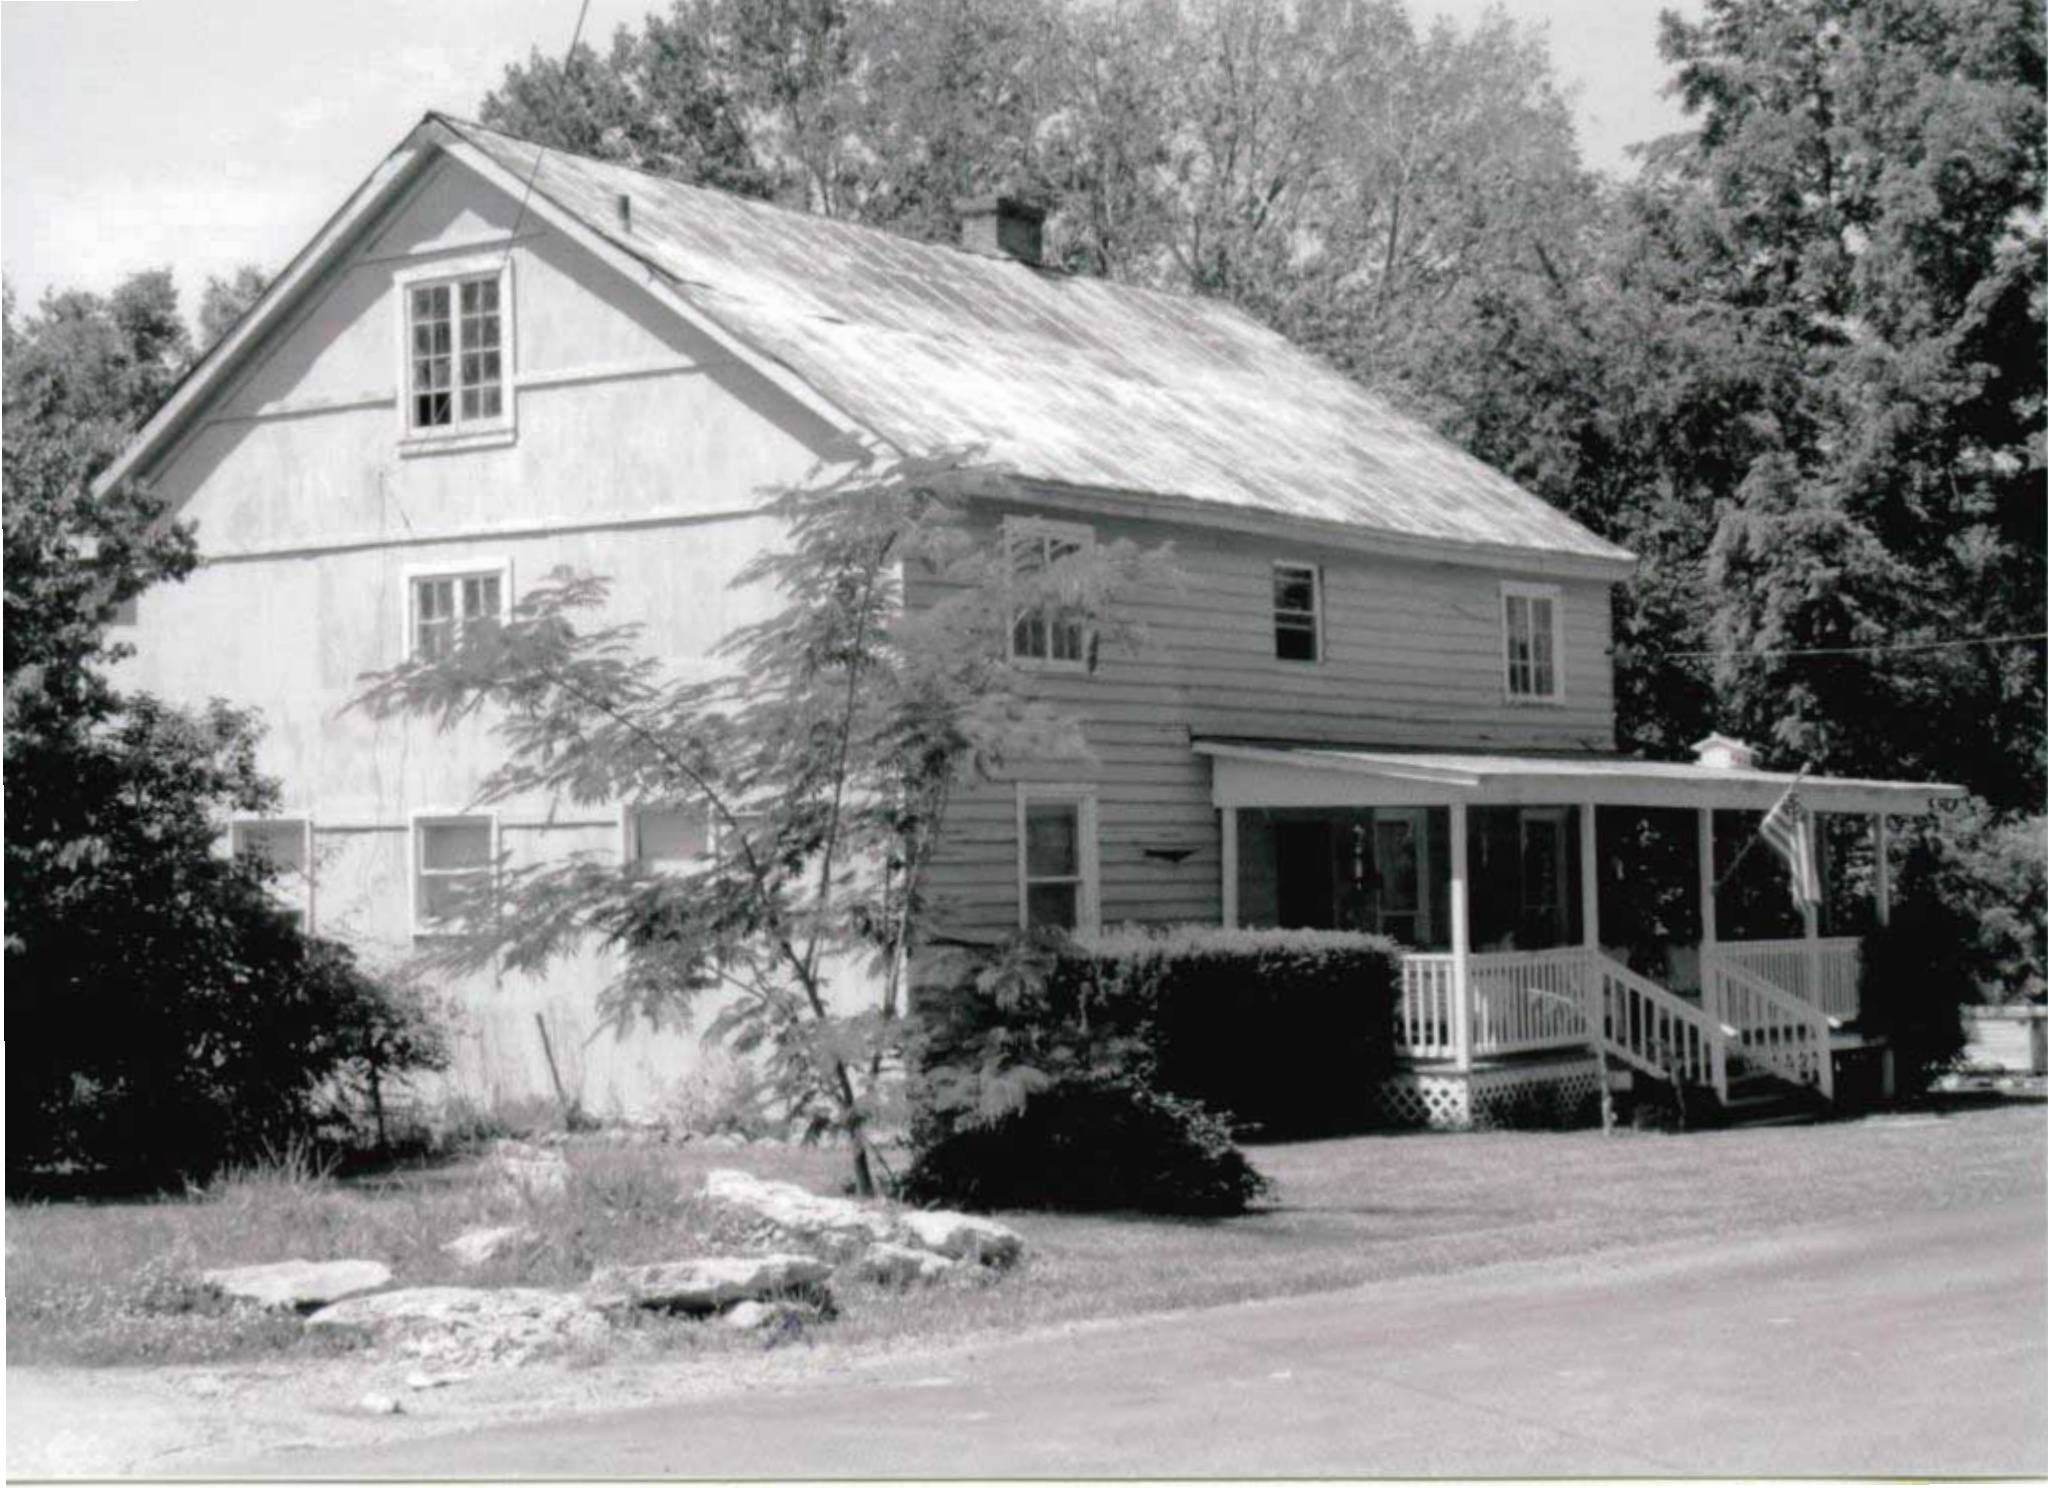
Two-and-a-half-story, frame, side gabled I-House residence clad in wood siding and sitting on a stone foundation. A modern wood door is centered below an open porch, with two 1/1 sas windows to the east and a single 1/1 sash window to the west. The second floor fenestration consists of paired eight pane casement windows, with a 1/1 sash window centered between them. The exterior of the building has received some fenestration changes and new siding material was added. The building has been converted for residential use, and therefore does not express the same interior plan it possessed at construction.
