2015 Thematic Survey of Flounder Houses in St. Louis City Survey Report

July, 2015
Cultural Resources Office
Planning and Development Agency
City of St. Louis

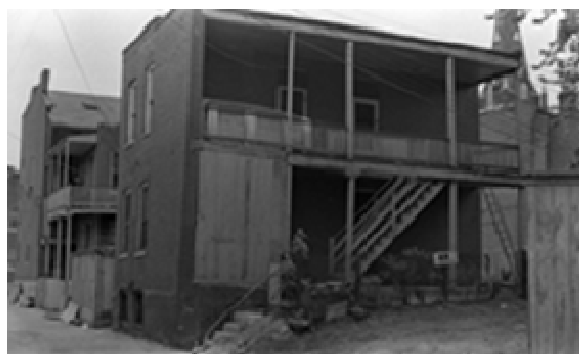
Figure 2. Gallery. This unidentified photograph taken in Soulard ca. 1870 is a Charleston House type with a side gallery (porch with internal steps) with a brick wing wall at the street end of the porch.

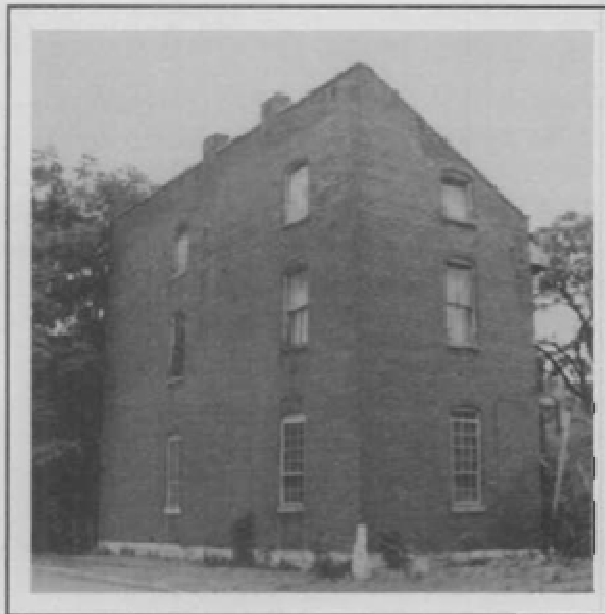
- The single-sloped roof is the main defining feature of this single-bay house.
- One room wide and one or two rooms deep are the most frequently found plans. One-and-one-half or two-and-one-half story versions are the most common height. The two-and-one-half story version will normally consist of a cellar, two full stories, and a loft.

- Flounders most often appear in urban areas, in working or middle class neighborhoods, on narrow lots with the gable end facing the street or alley. They are also found "attached" to more pretentious houses as a rear "ell" or "back house."

- The entry is most commonly found to the side along the lowest edge of the roof and is covered by a gallery porch. The porch roof is often a continuation of the building's roofline.

- Known free-standing examples of the house type are all located in St. Louis.
- The windows frequently diminish in height with each additional story.
- Although normally constructed of red brick, examples once existed in St. Louis that were constructed with stone, frame, and half-timbered bearing walls.

This two-and-one-half story flounder at 2306 Hickory St., St. Louis, is a free-standing example showing vestiges of a gallery porch.

As interest in vernacular house types increased during the late twentieth century, the St. Louis flounder received some attention. For example, the Missouri State Historic Preservation Office presented a description of the St. Louis flounder in a ca. 1993 issue of its publication, *Preservation Issues* (Fig. 3). The alley flounder at 2306 Hickory in the Lafayette Square neighborhood was included in the 2015 survey; it has been rehabilitated and is occupied.

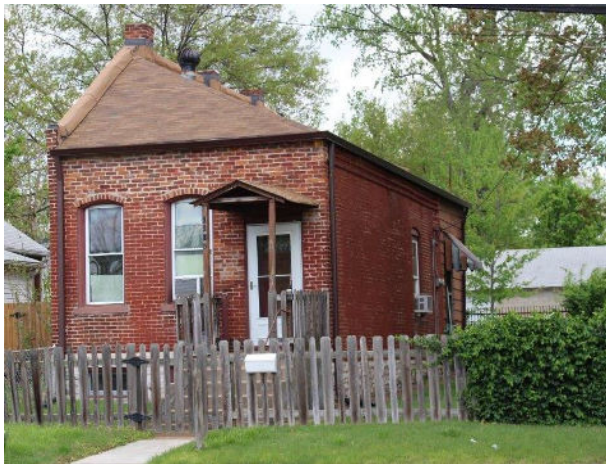
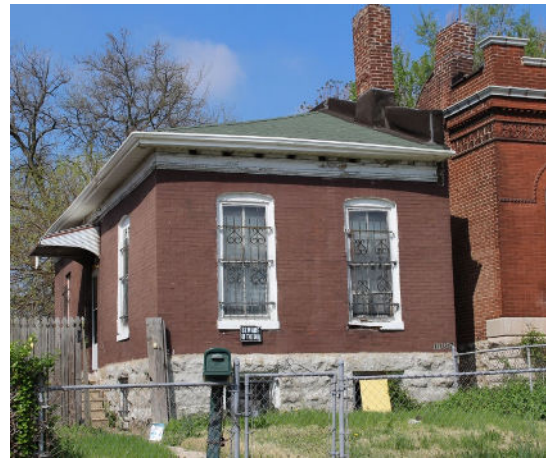
Figure 8. Two circa 1890 flounders west of Grand Avenue

Two flounders west of where most flounders were built demonstrate these trends. The circa 1888 flounder at 6857 Southwest Avenue was built as one of the first houses on “Old Manchester Road,” now Southwest Avenue, near the west boundary of the City. The 1909 Sanborn Map shows a row of five brick houses and four frame ones. As all of these buildings remain standing, the group demonstrates that one of the brick houses was a flounder, suggesting that in circa 1890 a modest flounder might still be built. The flounder, with a hipped-front roof, is quite similar to earlier one-story flounders except that it has a front entrance and has a small recessed rear corner porch rather than a full side gallery. 1127 Kentucky Avenue, built in what is now the Forest Park Southeast neighborhood (south of I-64 and east of S. Kingshighway, southeast of the city’s Forest Park), is also west of most of the flounders recorded in the city. This circa 1890 one-story flounder has a side entrance, no gallery, and a low-pitched hipped-front roof.

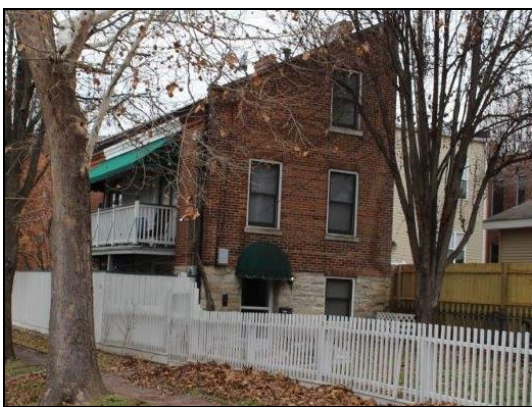
Nearly all flounders are rectangular in form with the short side facing the street – regardless of the location on the lot. A small number of flounders are positioned with their long side facing the street. These properties tend to be corner properties or lots on the short end of blocks adjacent to the alley. 2121 Crittenden is an example of this orientation.

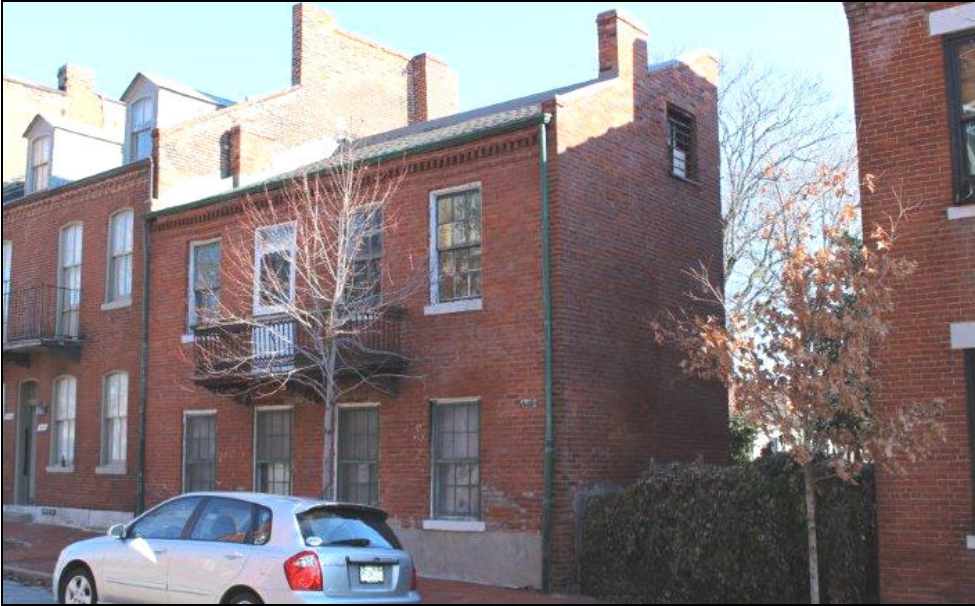
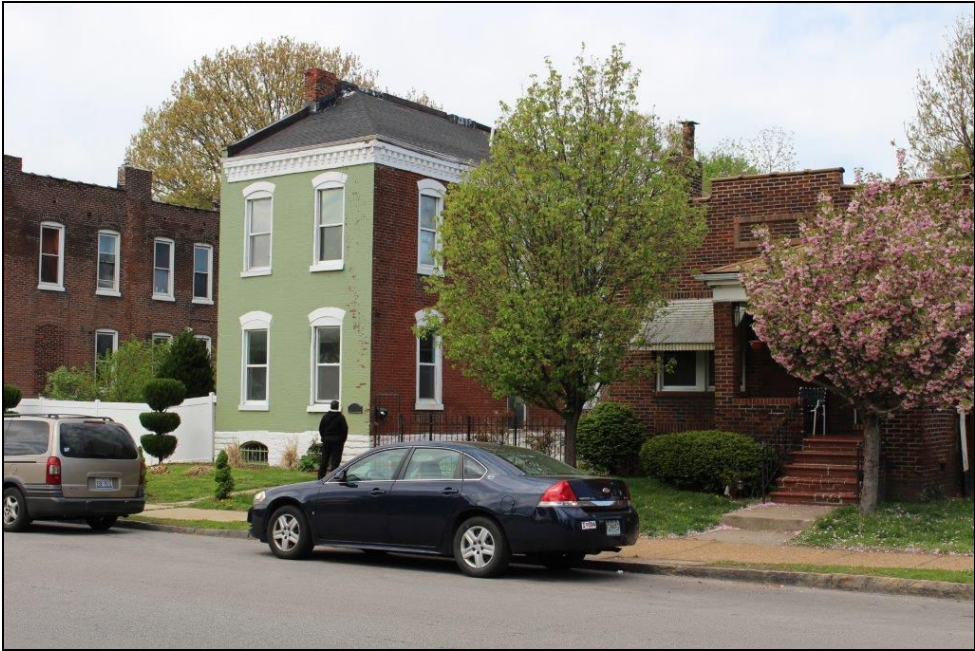
Figure 9. Two main flounder roof forms, shed roof and shed roof with hipped front

The three edges of the sloping shed roofs of flounders initially had brick coping. Parapet tiles, an improvement as they more water-resistant, appear on most flounders, as constructed or altered. These slightly projecting forms, as well as chimneys that rise where the shed roof meets the taller wall, add substance to the roofline.

Shed roof only, 1812 S. 8th Street

Shed roof with hipped front, 1935 College Street

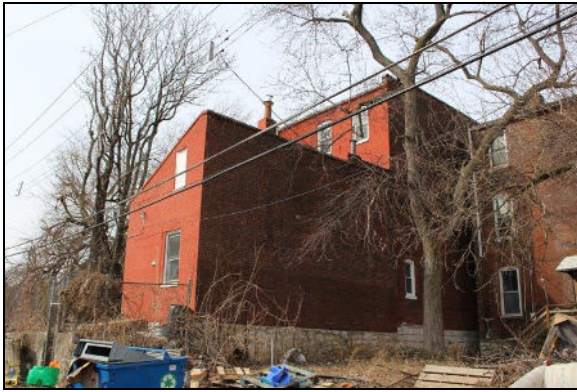
The possibility that an alley flounder was intended to be the rear wing for a larger house was not supported by the extant flounders. The survey documented a very limited sample of adding a larger front house to an alley flounder. The alley flounder at 4048 Nebraska Avenue was clearly the first of a two-stage building project. This 1½-story flounder has a side gallery with two entrances. A 2 ½-story dwelling was later constructed in front of the flounder. Foundations of different heights and appearance of the rear wing as a flounder rather than a flounder-shaped rear ell constructed at the same time as the front portion of the house, supports this progression of development that occurred before 1883. A two-stage construction project also took place at 1905 Obear Avenue.

Flounders that have been incorporated into larger buildings are not as common as expected but some can be identified. Most of the examples noted are rear wings that clearly do not have the typical form of the rear flounder ell and can be documented to have been freestanding. The rear building at 736 S. Broadway has been connected to the front building with small wings, but was initially a free-standing building. Evidence on the building indicates that the flounder at the rear of 1231 Allen Market was built first. 4048 Nebraska Avenue and 1905 Obear Avenue (pictured on page 25) are additional examples of this type.

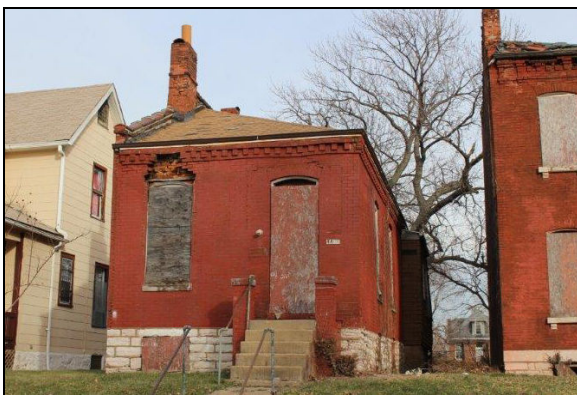
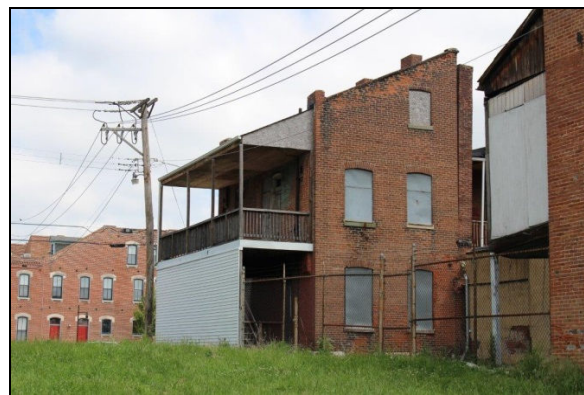
In a city where brick construction is dominant, it is not surprising that 91 percent of the extant flounders are load-bearing brick construction. The brick is usually a consistent red brick and the brick on the façade is the same as that on the side and rear walls, as opposed to being face brick. Brick flounders typically display two common methods of building in brick. Most openings have segmentally-arched heads. This form of arch is stronger than a round arch form and does not require a lintel, and thus is very common on brick buildings; it should be considered to be more of a functional than aesthetic choice. A corbelled or denticulated cornice of brick, a stepped out form and widens the brick wall to receive roof framing members, is also very common on brick buildings. 4408 Blair Avenue has a modest corbelled brick cornice with dentils; both the Blair flounder and 2511 Rear Benton Street have segmentally-arched openings.

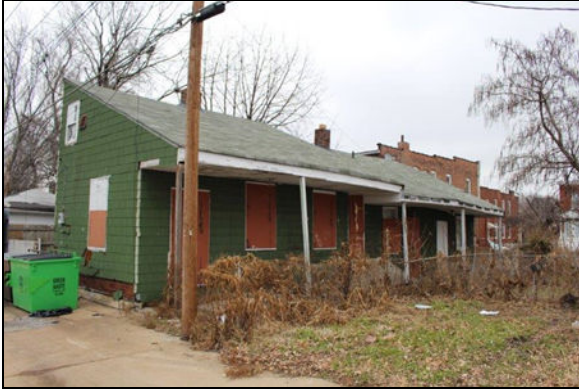
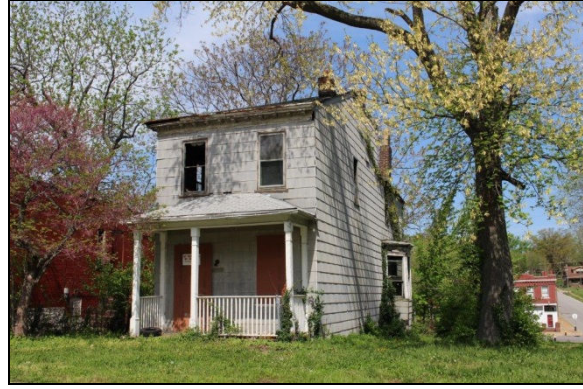
Frame construction – used for only nine percent of the recorded flounders – ranges from small 1 ½-story flounders to larger and taller residences. 3533 Missouri Avenue is an example of the former and layers of later sheathing cover its original lapped wood siding. 1507 E. Gano Avenue is a later example, built circa 1895; here the flounder form is combined with amenities provided on other houses of the time, including a full front porch and a bay window on each side. Its original siding is also concealed under later materials.

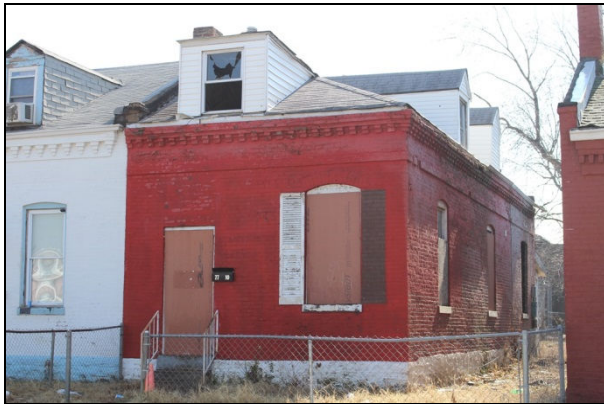
The eaves, where the wall meets the roof, of any house, is a location where common building practices meet opportunities for embellishment – even in the relatively plain flounder. Most of the brick flounders have a minimal denticulated brick cornice where the eaves are horizontal, as a means to terminate the wall and provide additional thickness to support roof framing members. Others have a more developed corbelled cornice for the same reason. A few brick flounders that have a more fully articulated aesthetic have prominent wood cornices that may include brackets and dentils.

Brick cornice
7710 Water Street

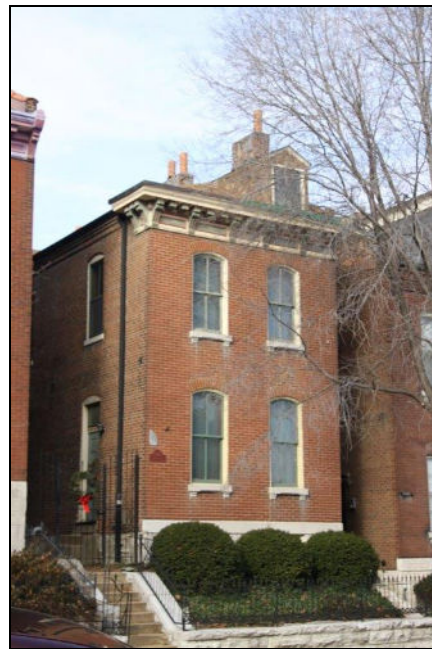
Bracketed wood cornice
2307 S. 11th Street

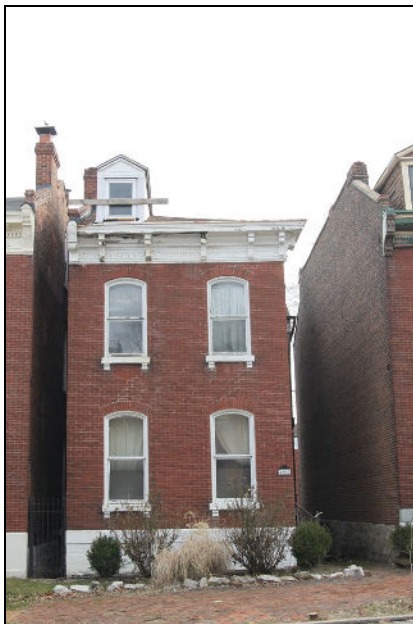
As with most brick buildings in St. Louis, extant flounders have foundations of limestone that extend above grade. The stone masonry ranges from roughly cut and coursed rubble walls to more carefully cut and coursed work. A small number of foundations have a band of smooth ashlar stone at the top edge. Another uncommon condition is a founder built with a minimal foundation of only a course or two above grade or without any stone above grade. Many of the founders have foundations tall enough to allow for some or all of the basement windows to be above grade. Exterior entrances to basements with pitched bulkhead doors above grade are not uncommon; like galleries, they position staircases on the exterior of the building. An uncommon variant is a brick building with no stone foundation above grade.

Typical foundation height
2308 S. 12th Street

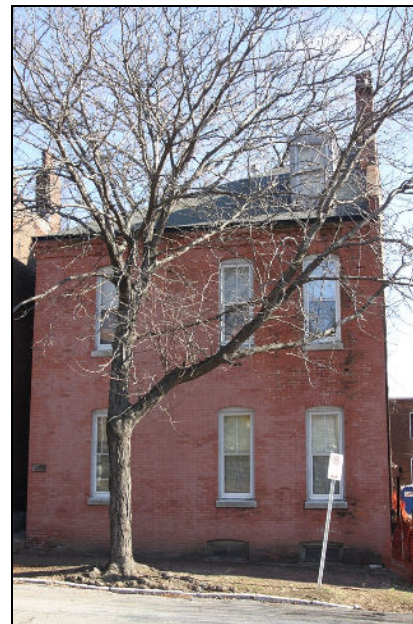
No stone foundation above grade
2110 S. 11th Street

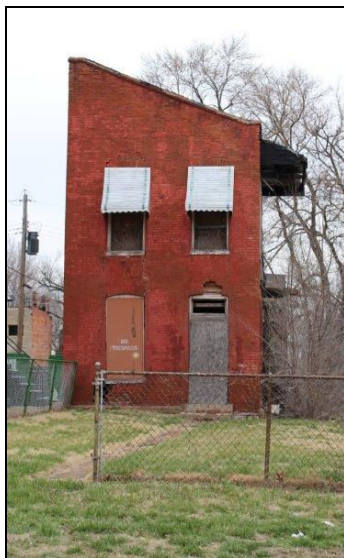
2729 Howard Street
The gallery roof remains

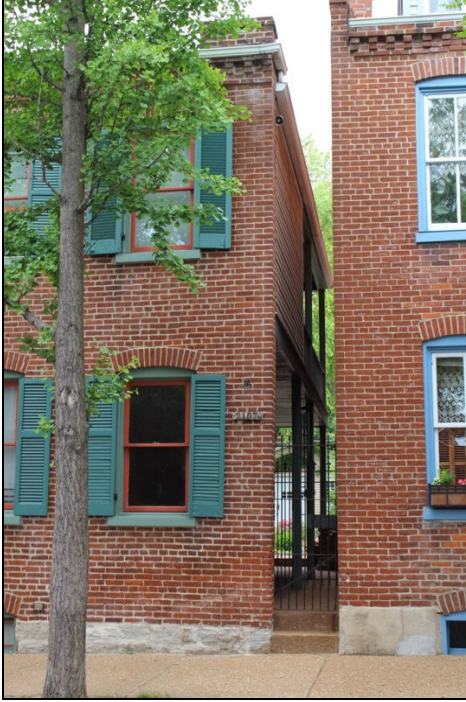
Typical brick wing wall in front of gallery,
2107 Menard Street

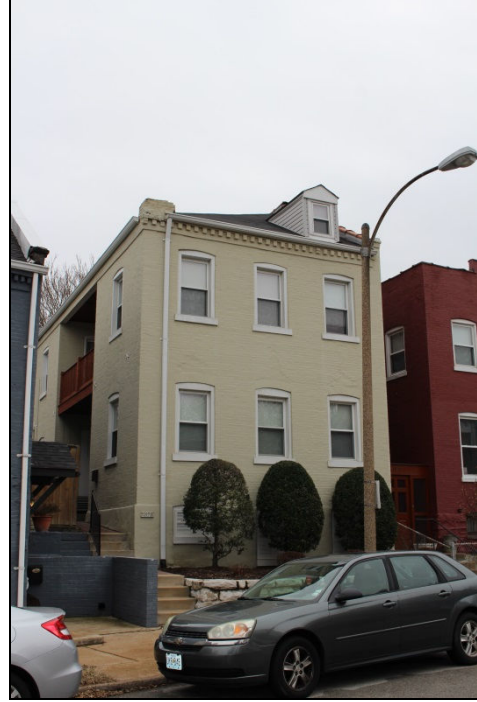
Central bay gallery variant,
2816 Indiana Avenue

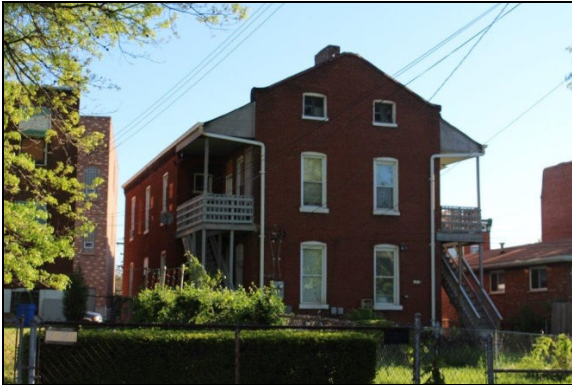
A rear gallery or porches were often amenities of a flounder when a full-length gallery was not provided. The rear gallery flanks a rear wing that is narrower than the main block of the house. The gallery often incorporated a staircase.

Rear wing galleries at 2814 and 1826 Arsenal
Street

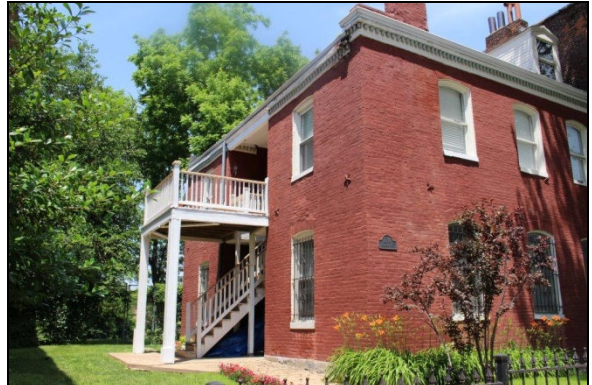
Central bay variant at 2711 Indiana Avenue

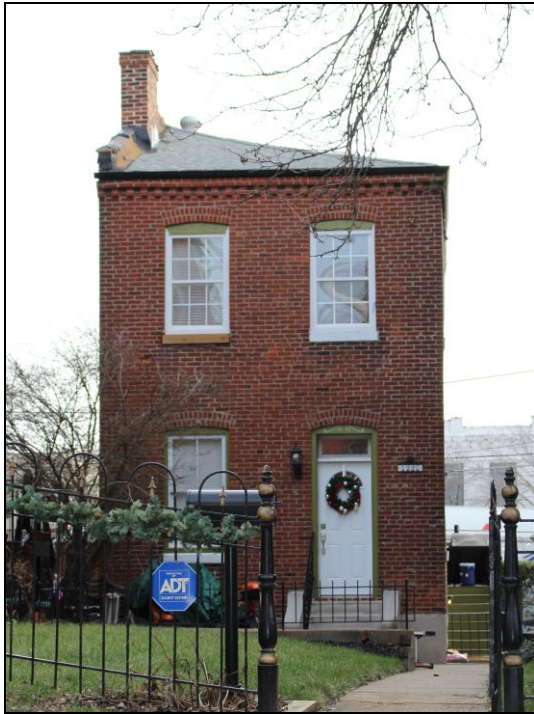
1222 S. 9th Street with front entrance

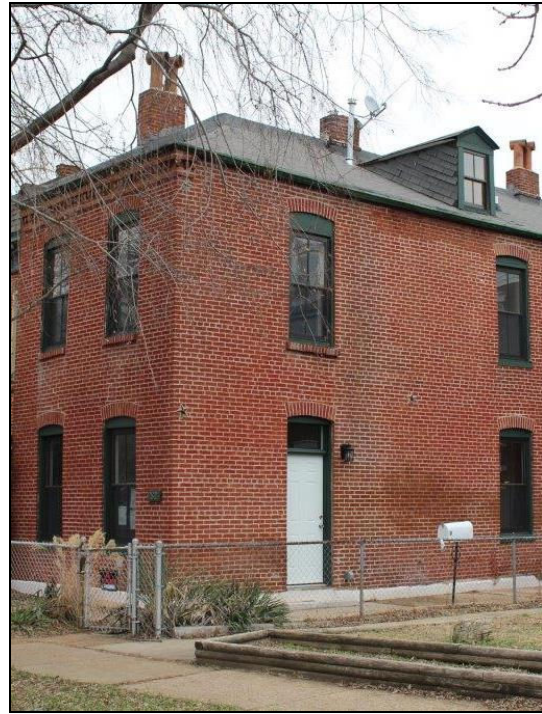
2824 Salena Street with side entrance

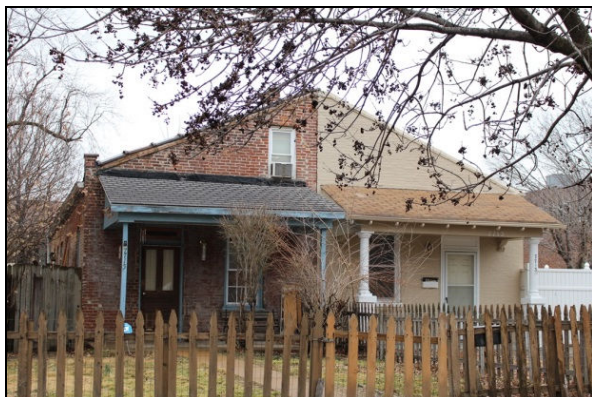
7113, 7115 Michigan Avenue with porches

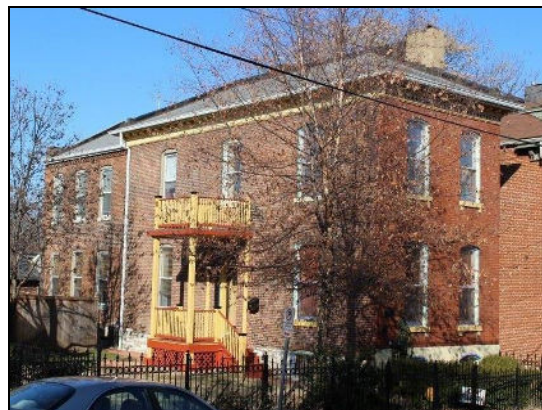
1207 Missouri Avenue with side porch

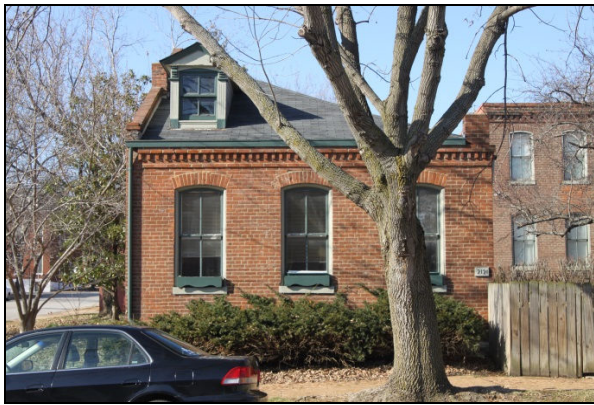
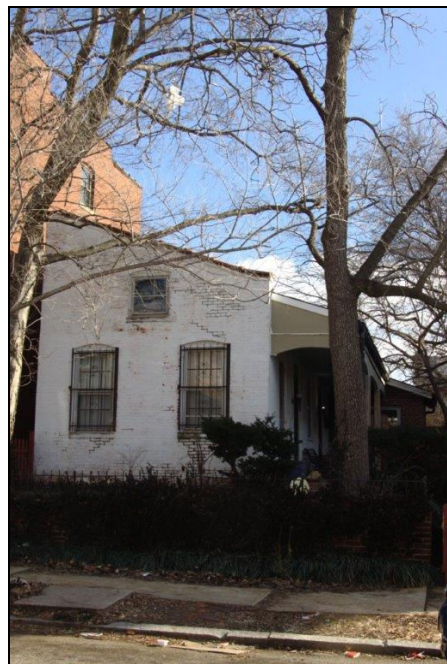
Both lofts with little headroom and taller attic spaces are provided with light and ventilation. Many flounders have windows in one or both end walls. Small gabled dormers are common on the front slopes of hip-fronted shed roofs and less common on the side slopes of shed roofs. This provision of light and ventilation suggests that these small spaces were used for storage or occupancy. As wood dormers deteriorate without maintenance and it is assumed many have been removed when roof sheathing is replaced, it is difficult to determine the number of occupiable stories of some of the flounders. 2121 Menard Street has a typical small dormer that lights and ventilates the loft. The small window in the upper wall of 3154 Pennsylvania Avenue serves the same for the attic.

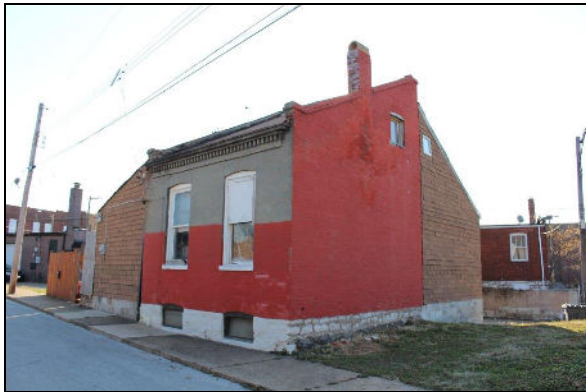
Some of the smallest flounders have received several additions, as at 2206 Gaine Street demonstrates.

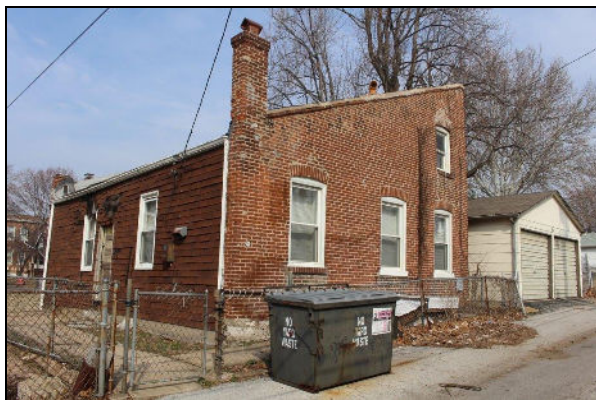
3466 Grace Avenue

Changes to common features vary in impact. Windows have replacement sash of varying degrees of historic design and materials. Galleries and porches are perhaps the most altered elements of flounders. Wood galleries have been enclosed, partially enclosed, and rebuilt. Yet most of them retain the essential form and size of the original galleries, as well as associated staircases. A few flounders with galleries have been more noticeably altered when an enclosing wall with windows and doors that has no association with the gallery form has been installed; the examples below indicate how gallery enclosures that maintain a simple entrance are less of an impact than others that incorporate modern design elements. Porches, often side ones, have also been rebuilt. Alterations to the portions of flounders most exposed are most common. Certainly, both dormers and chimneys have been removed on some flounders with neither feature.

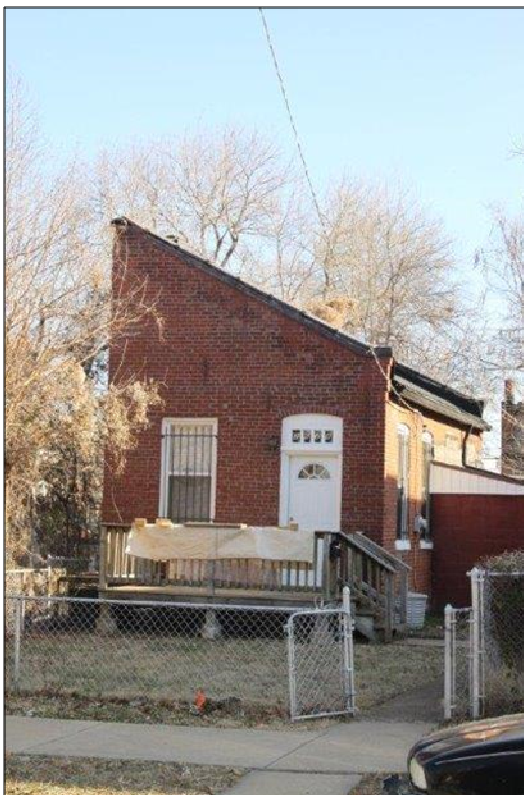
2628 Ohio Avenue

While this type of flounder has many variations, the important fact that the dwelling was initially free-standing is defining. These flounders are located at the building line, at mid-lot, and at alleys. Many of them have a hipped-front roof; many of them have a side entrance and a gallery would not be unusual. Despite the dense development in the city where most extant flounders were built, the free-standing house was clearly one of the preferred forms of housing.

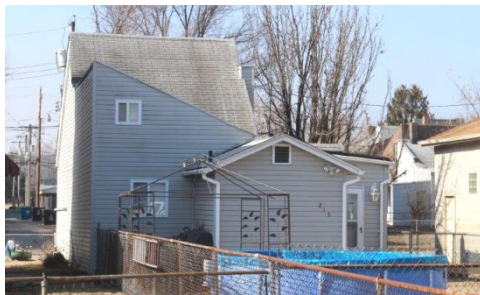
215 E. Schirmer Street (rear)

In the Patch neighborhood at the extreme south of the many of the earliest extant flounders are now incorporated into larger buildings. A discernable pattern has been identified where the first building on the property is a small flounder — usually frame — sited on the parcel in such a way as to allow future construction of a front block at the street. A few years later, a 1 or 1-1/2 story, 2-room house was attached at the front. 215 E. Schirmer Street is an example. It appears on the Hopkins 1883 Atlas without its front addition, which was constructed c. 1890.

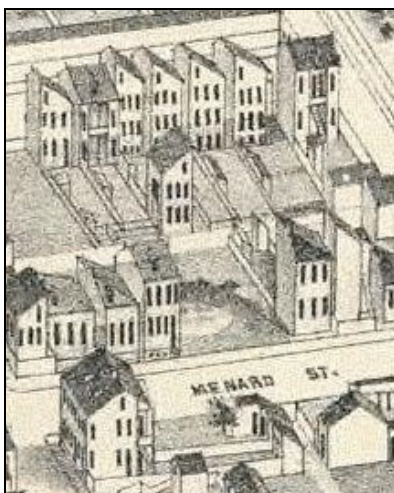
The history and use of these buildings has suggested that “townhouse” better describes their appearance than their use as dwellings, as a townhouse was typically occupied initially as a single-family dwelling. The common occurrence of this property type in the Soulard neighborhood prompted the study of one block on which several examples still stand. City directories indicate, that at least during the 1880s and later, this small sample of flounders was occupied by several individuals or families (see Appendix II). The rentals had occupants who changed locations of their residency frequently suggesting low-cost rental properties. The presence of galleries on many of these buildings, exterior stairs, and doors at both stories accessing the galleries, no doubt accommodated the occupants in access to various portions of the buildings .

Rear views of flounders on S. 11th Street
at top of view

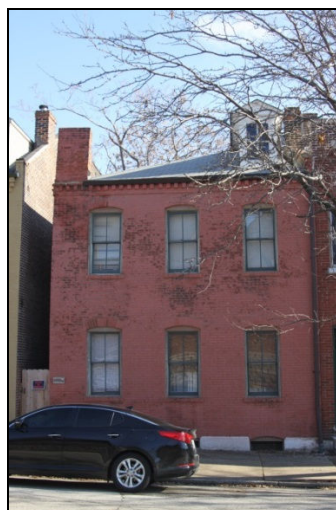
2106 S. 11th Street, one of the
flounders depicted at left

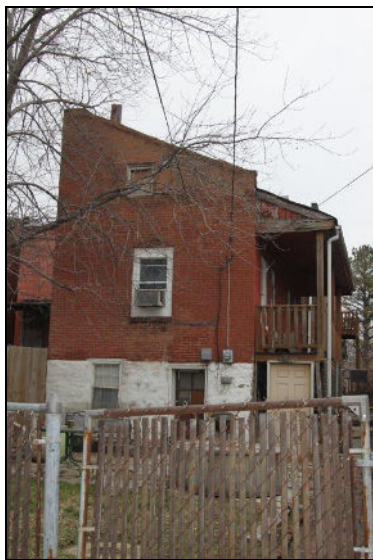
2002 Rear Withnell Avenue

A distinct type of flounder, yet one not particularly common in the extant group, is the flounder with a nearly full-height, or raised, basement. While it is common in St. Louis for the basement windows to be above grade, those windows are set high in basement walls. The raised basement flounder has a significantly taller basement above grade. Some of the raised basement flounders are quite small, suggesting that the basement needed to be more than an ancillary portion of the building. It is known that the raised basement of 2121 Crittenden Street (see above) was historically the kitchen,²¹ and that use likely occurred elsewhere as well.

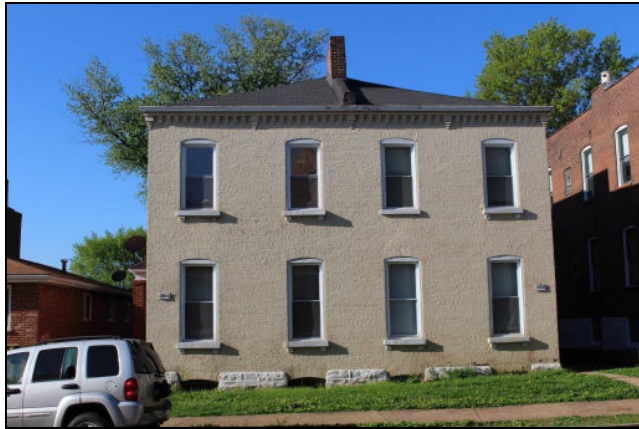
2814, 2816 Arsenal Street

There are enough extant pairs of flounders to identify the semi-detached flounder as a flounder type with two common variants that appear throughout the areas where flounders were commonly built. The pairs of attached nearly identical flounders generally have hipped fronts on shed roofs. The taller blind walls are the party walls that extend above the roofline with a curb-height fire wall. Some pairs were built at the same time, but are slightly different. Both the wood-framed pair on Gaine Street and the brick pair on Pennsylvania have the same variation in the attached flounders: one unit has a side gallery and the other does not. Other pairs do not appear to have been built at the same time but are quite similar, such as the alley houses at 915 and 917 Geyer Avenue.

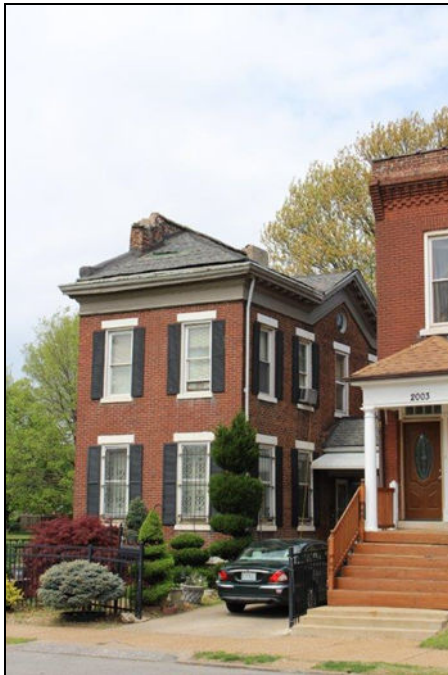
2007 E. College Street

Few of the extant flounders recorded have the architectural presence to take them out of a vernacular building type with Federal style influences. Yet when a flounder exhibits a style, it is likely to be the Federal or Italianate style. The most intact extant example of this type is 2007 E. College Street. This flounder has a fully-developed Federal style five-bay façade facing the side yard, rather than the street, in typical flounder tradition. The entrance is located in the central bay; a replacement porch reveals the ghost lines of a gabled entrance porch. The prominent wood cornice is bracketed on the side façade only; an intersecting gable in the roofline allows space for an oculus window at the center bay. Hipped ends to the shed roof continue the horizontal eaves across the front and rear walls. Window openings have prominent flat stone lintels and sills.

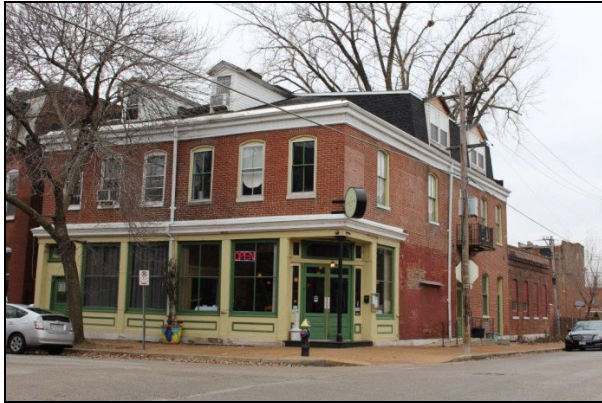
2901 Salena Street

A small number of extant flounders were built for mixed use and otherwise have the common attributes of the store and loft buildings in St. Louis. Located at corners, they provide one or more storefronts on the ground story and residential space above. The flounder version of this common building type differs mainly in roof form. Examples of such flounders include 2300 Menard Street in the Soulard neighborhood and 2901 Salena in the Benton Park neighborhood.

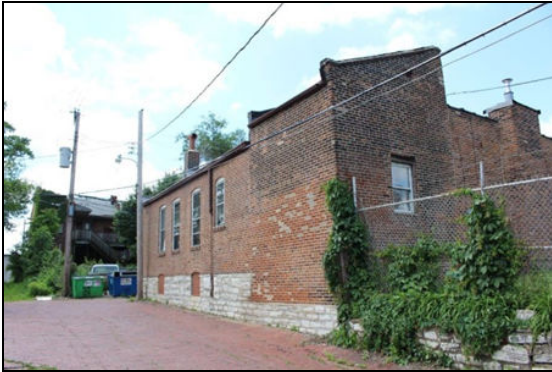
The survey documented a few flounders that due to their size and location may be non-residential in function, or outbuildings, on a lot with a main building. A small brick flounder labeled as a smoke house on a 1909 Sanborn map, stands as part of a larger alley complex of buildings at the rear of a N. Florissant Avenue property. Some of these flounders have a door and windows, suggesting use that requires light and ventilation. The 1909 Sanborn map for 2203 Rear Menard Street notes that the small flounder was used as a cigar factory.

Smokehouse at 3712 Rear N. Florissant Avenue

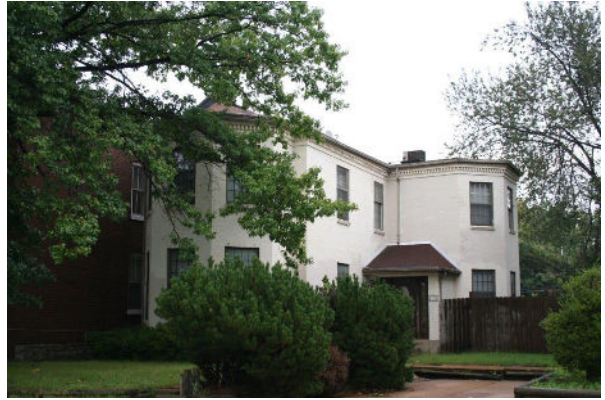
This is a less common flounder type, but one that shows the popularity and adaptability of the flounder form. The flounder at 3919 Nebraska built with a narrow two-bay façade facing the street, was enlarged with a second flounder form positioned to form an L-plan dwelling and doubling the width of the façade. Map evidence suggests that 2907 Crittenden Street was built in its current form. The bays projecting from the flounder form at 4128 Michigan Avenue form another example of unusual massing.

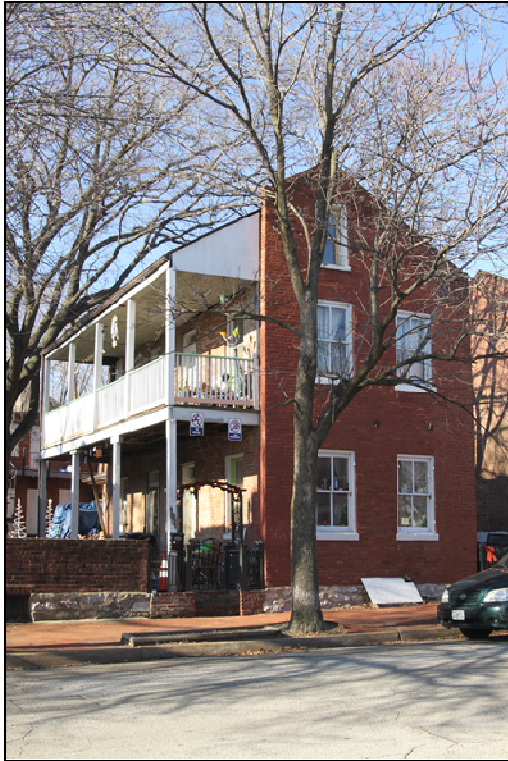
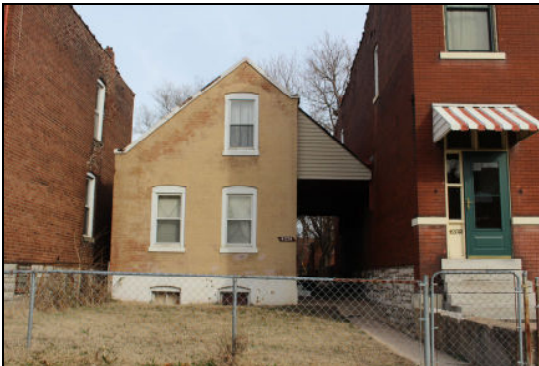
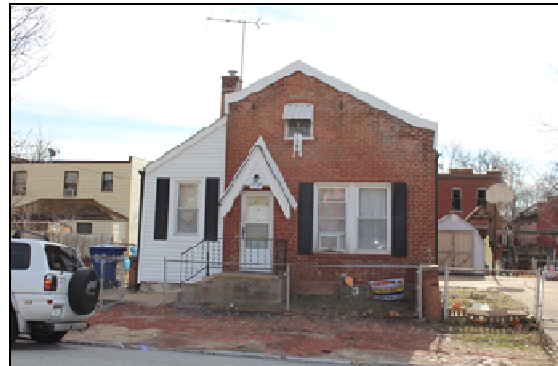
The House with “Gablet” Roof

This “gablet” roof form occurs on several houses that would otherwise have many characteristics of a flounder. The addition of an opposing slope to the roof of the main block of the house.

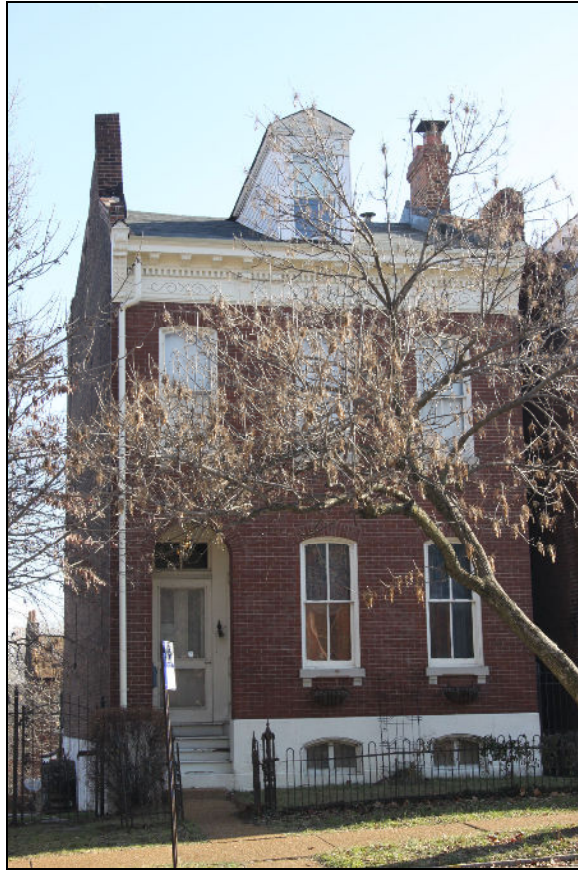
2306 S. 12th Street is an example of a house with a taller side wall on one side and from certain vantage points appears to be a flounder. The depth of the side-gabled front portion of the roof was used to exclude houses with such complex roofs from the definition of a flounder for this survey.
