1. Survey No. JO-AS-007-0122		2. Survey name: GROVER & BROAD STREETS ARCHITECTURAL/HISTORICAL SURVEY	
3. County: JOHNSON		4. Address (Street No.) 100	Street (name) S MITCHELL APARTMENTS A-D
5. City: WARRENSBURG	Vicinity: <input type="checkbox"/>	6. Geographical Reference: 38.76238 / -93.72660	7. Township/Range/Section: T: 46 R: 26 S:24
8. Historic name (if known):		9. Present/other name (if known):	
10. Ownership: <input checked="" type="checkbox"/> Private <input type="checkbox"/> Public		11a. Historic use (if known): MULTIPLE DWELLING	11b. Current use: MULTIPLE DWELLING

HISTORICAL INFORMATION

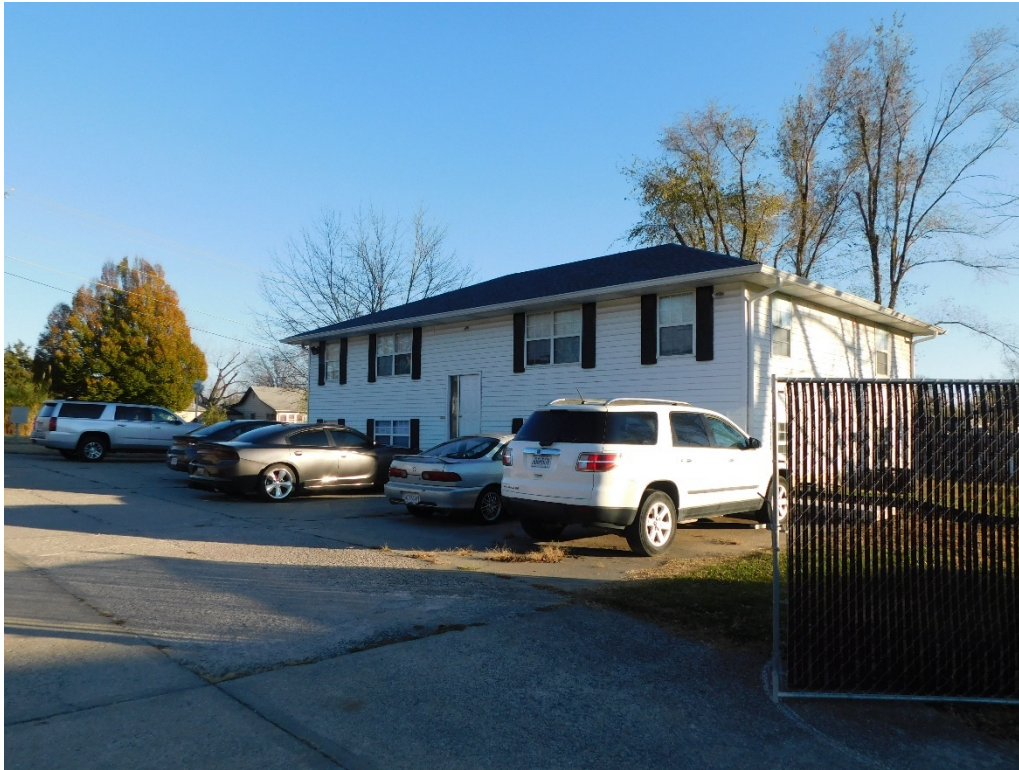
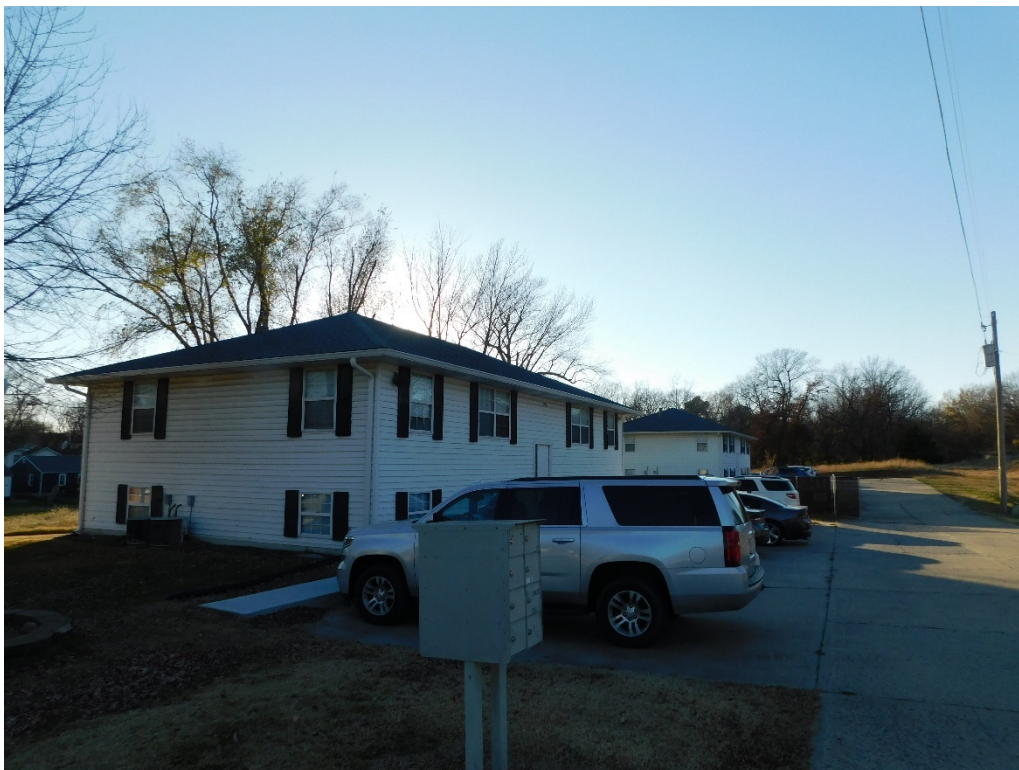
Description:
LOOKING SOUTHEAST

Description:
LOOKING SOUTHWEST

This two-story apartment building features a concrete foundation, vinyl exterior walls, and a hipped gable roof. The façade faces north towards the railroad tracks. The façade is five bays with original paired six-over-six hung vinyl windows with faux shutters in the all the bays except the third centered bay. The third bay features a wood door with one, one-light sidelight, and concrete steps. The second story windows are larger than the first story windows. There are single original six-over-six hung vinyl windows with faux shutters over the first and last bay, and there are original paired six-over-six hung vinyl windows with faux shutters over the second and third bay. The side elevations feature two original six-over-six hung vinyl windows on the first and second story. The building is not eligible since it does not meet the 50-year threshold.

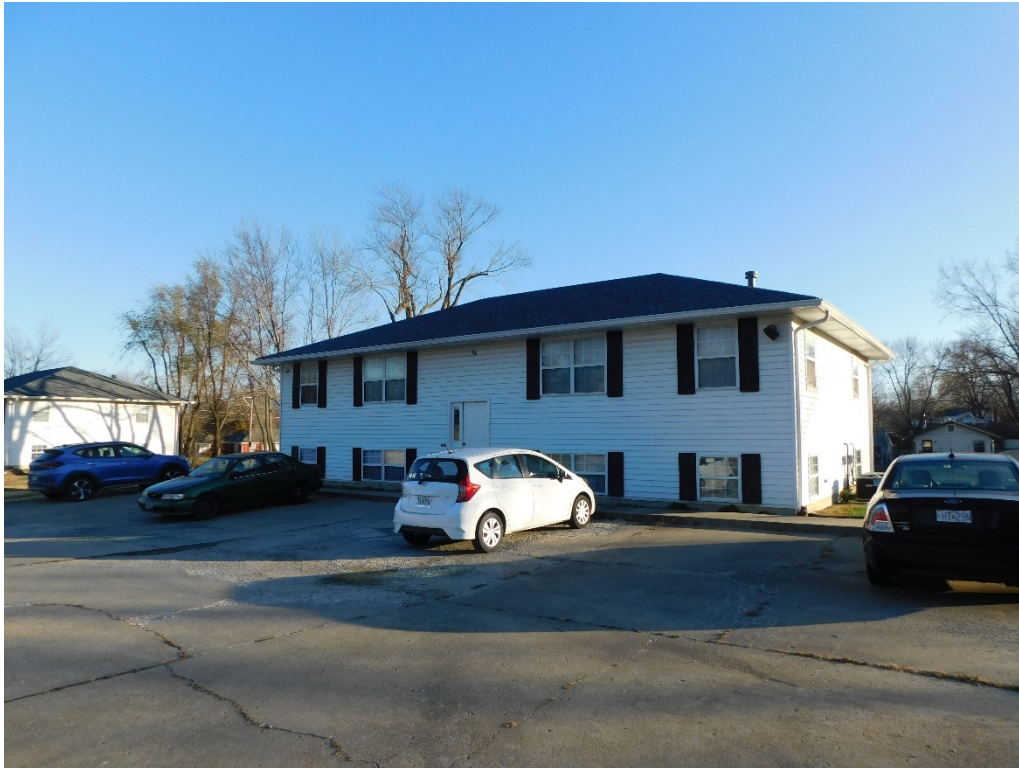
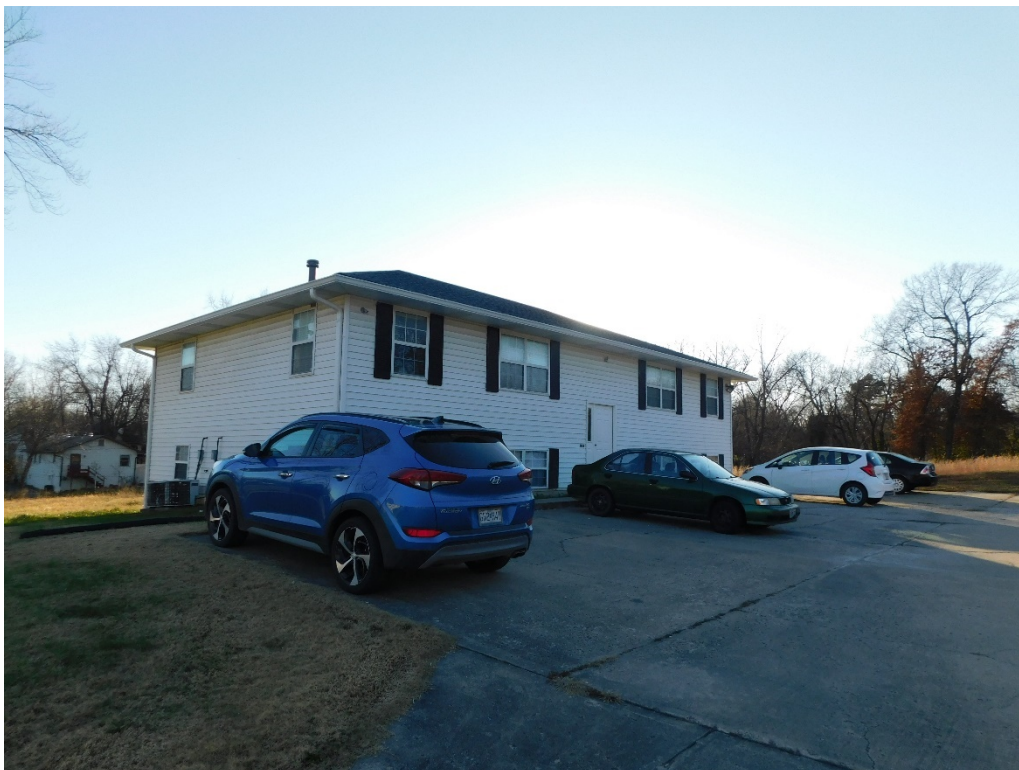
Description:
LOOKING SOUTHEAST

Description:
LOOKING SOUTHWEST

This two-story apartment building features a concrete foundation, vinyl exterior walls, and a hipped gable roof. The façade faces north towards the railroad tracks. The façade is five bays with original paired six-over-six hung vinyl windows with faux shutters in the all the bays except the third centered bay. The third bay features a wood door with one, one-light sidelight, and concrete steps. The second story windows are larger than the first story windows. There are single original six-over-six hung vinyl windows with faux shutters over the first and last bay, and there are original paired six-over-six hung vinyl windows with faux shutters over the second and third bay. The side elevations feature two original six-over-six hung vinyl windows on the first and second story. The building is not eligible since it does not meet the 50-year threshold.

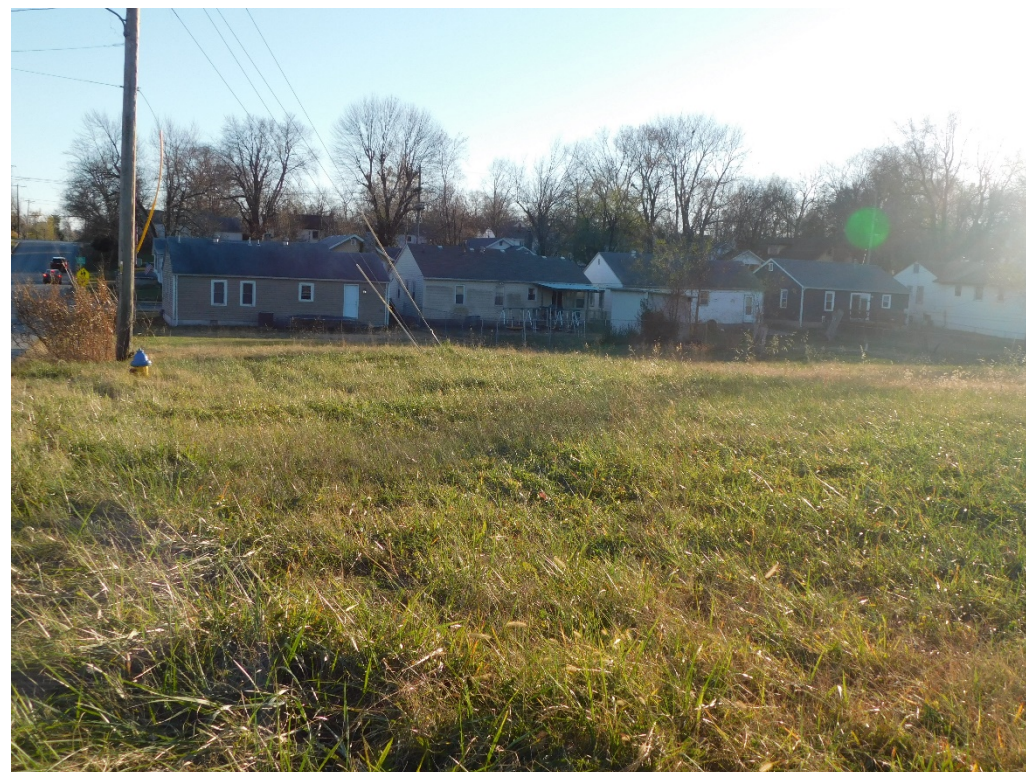
Photographer: KRISTIN DYER	Date: 11/17/2020	Description: LOOKING SOUTH (ACROSS 102-104 S MITCHELL)
-------------------------------	---------------------	---

This is an undeveloped lot. Previously, there was a c. 1900 gable-front-and-wing house at this location, which was demolished in 2015.

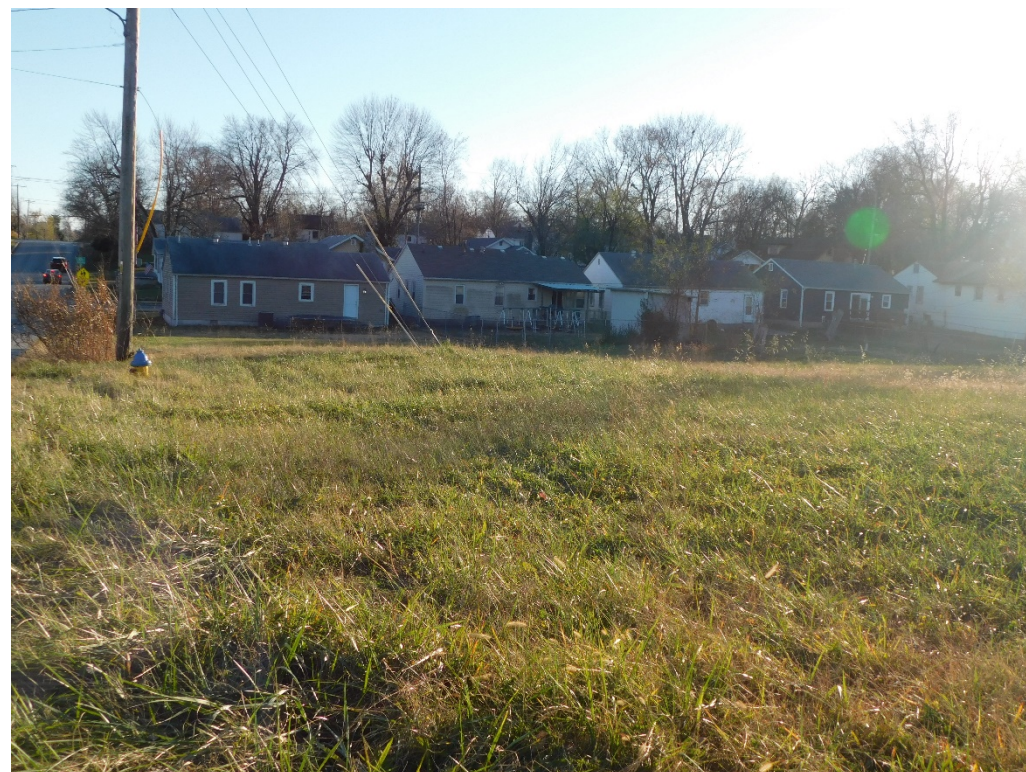
Photographer: KRISTIN DYER	Date: 11/17/2020	Description: LOOKING SOUTH (ACROSS 102-104 S MITCHELL)
-------------------------------	---------------------	---

This is an undeveloped lot, and there may be evidence of a structure based on previous plat maps.

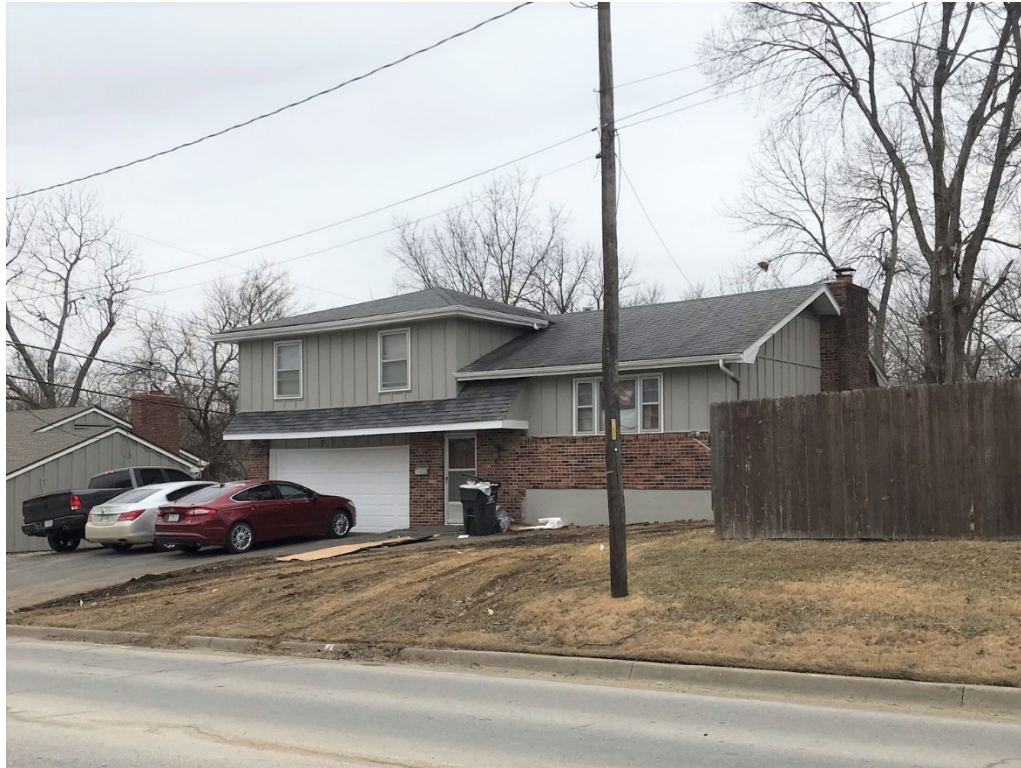
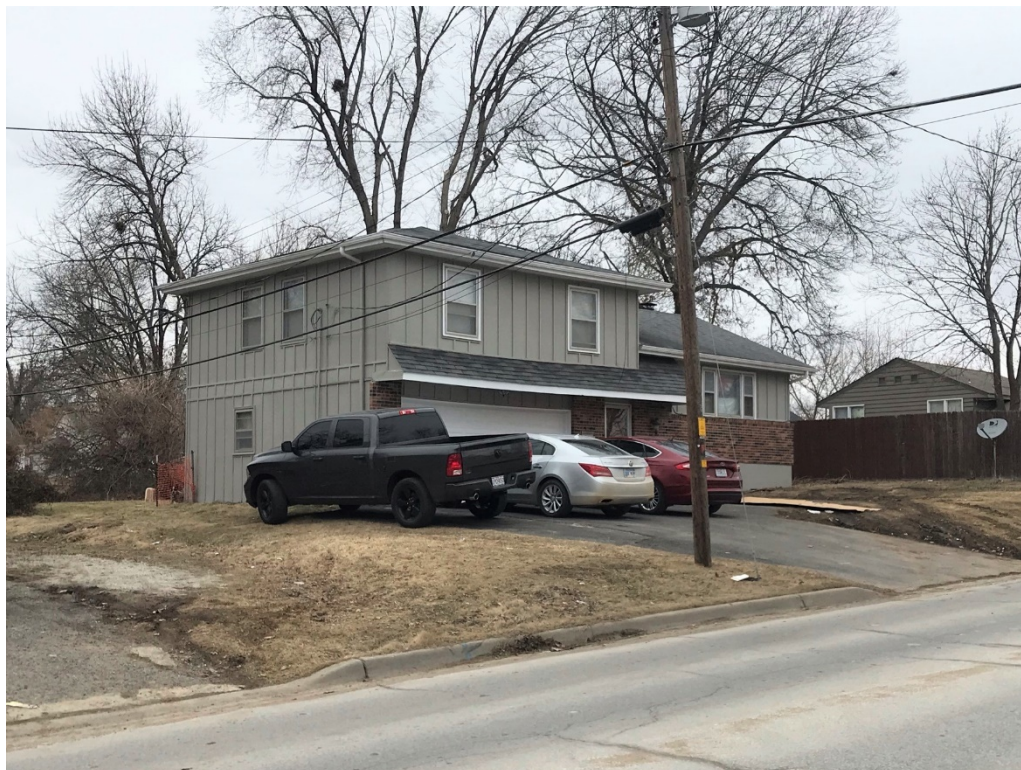
Photographer: KRISTIN DYER	Date: 02-26-2021	Description: LOOKING SOUTHWEST
-------------------------------	---------------------	-----------------------------------

Photographer: KRISTIN DYER	Date: 02-26-2021	Description: LOOKING NORTHWEST
-------------------------------	---------------------	-----------------------------------

This one-story split-level features a concrete foundation, wood and brick exterior walls, and a side gable roof with a hipped cross gable. The façade is three bays. The first bay is located in the two-story section with brick siding and a metal paneled garage door on the first story. There is a board and batten-style wood siding and original two one-over-one hung wood windows with horizontal panes on the second-story. The first bay features the hipped roof, and there is a shed eave overhang dividing the first and second stories as well as covering the second bay. The second bay features brick siding and a wood door. The third bay features board and batten-style wood siding with a brick wainscot. There is a wood picture window with original two one-over-one hung wood windows with horizontal panes. The side elevations feature board and batten-style wood siding and original one-over-one hung wood windows. There is an exterior brick chimney on the north elevation. This building remains its integrity, and it is considered non-contributing since it is less than 50 years old.

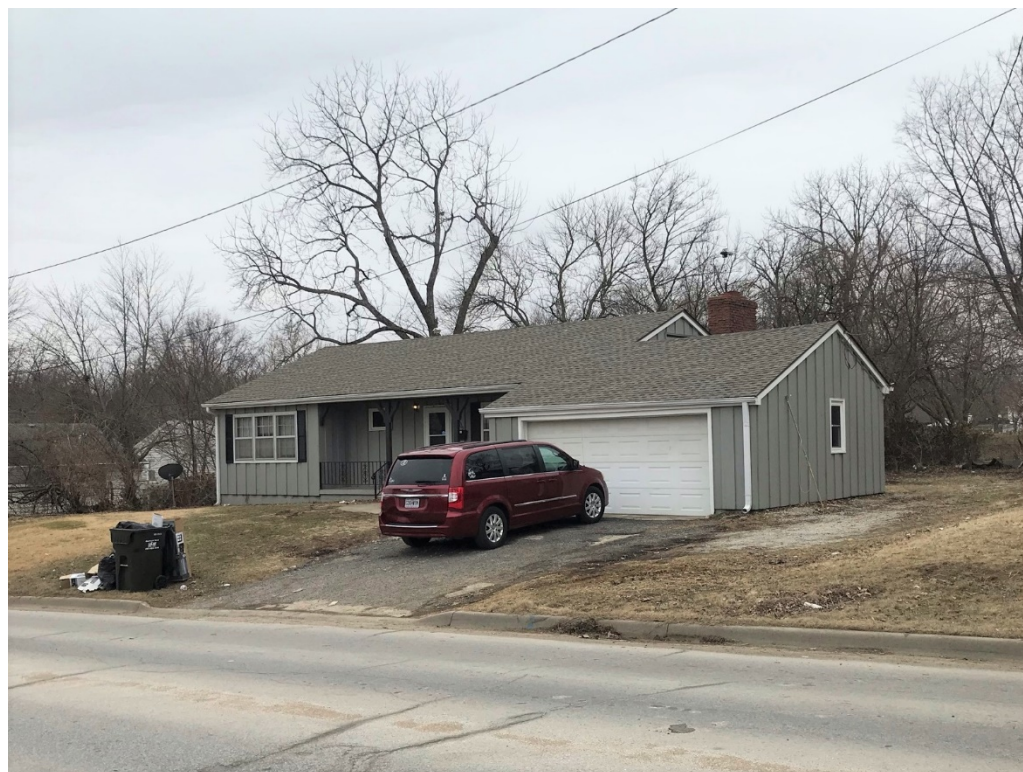
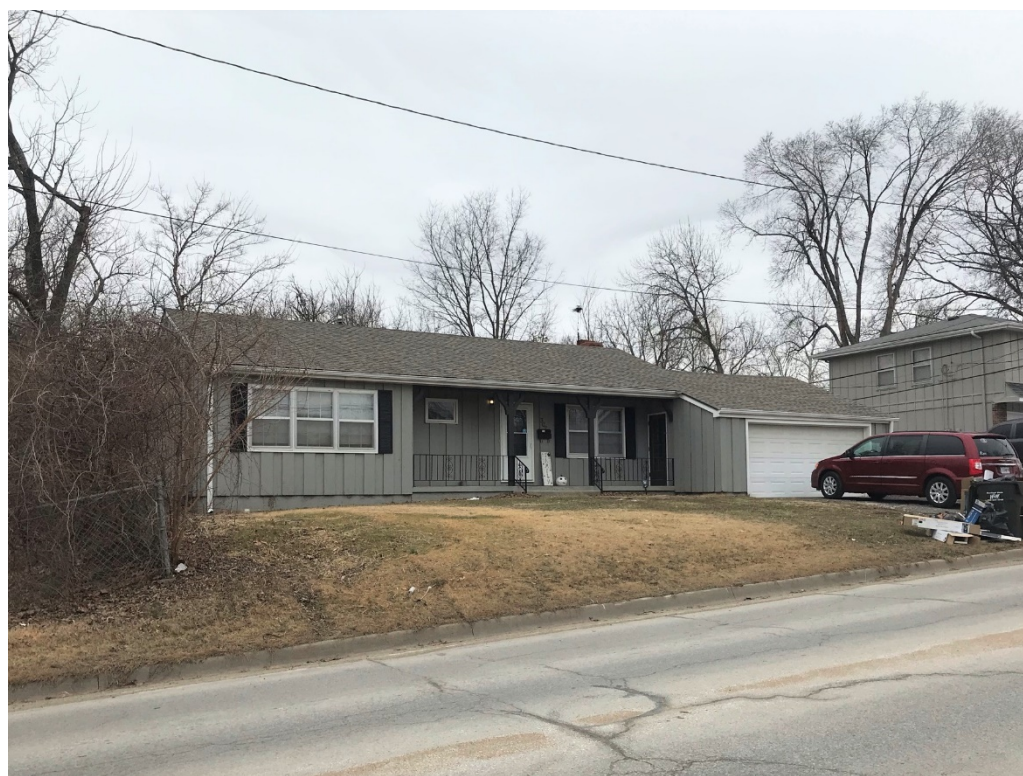
Description:
LOOKING SOUTHWEST

Description:
LOOKING NORTHWEST

This one-story ranch features a concrete foundation, vertical wood siding, and a side gable roof. The façade is five bays. The first bay features grouped original six-over-six hung wood windows. The second, third, and fourth bays are located under a recessed porch. The second bay is filled with an original one-light window. The third bay features a wood door, and the fourth bay features paired original two-over-two hung wood windows with horizontal panes. The porch features wood columns, metal railing, and a concrete foundation. There is a wood door located on the interior wall of the fifth bay. The fifth bay features a tiered roof and a metal paneled garage door. The side elevations feature vertical wood siding, and there is an exterior brick chimney on the north elevation.

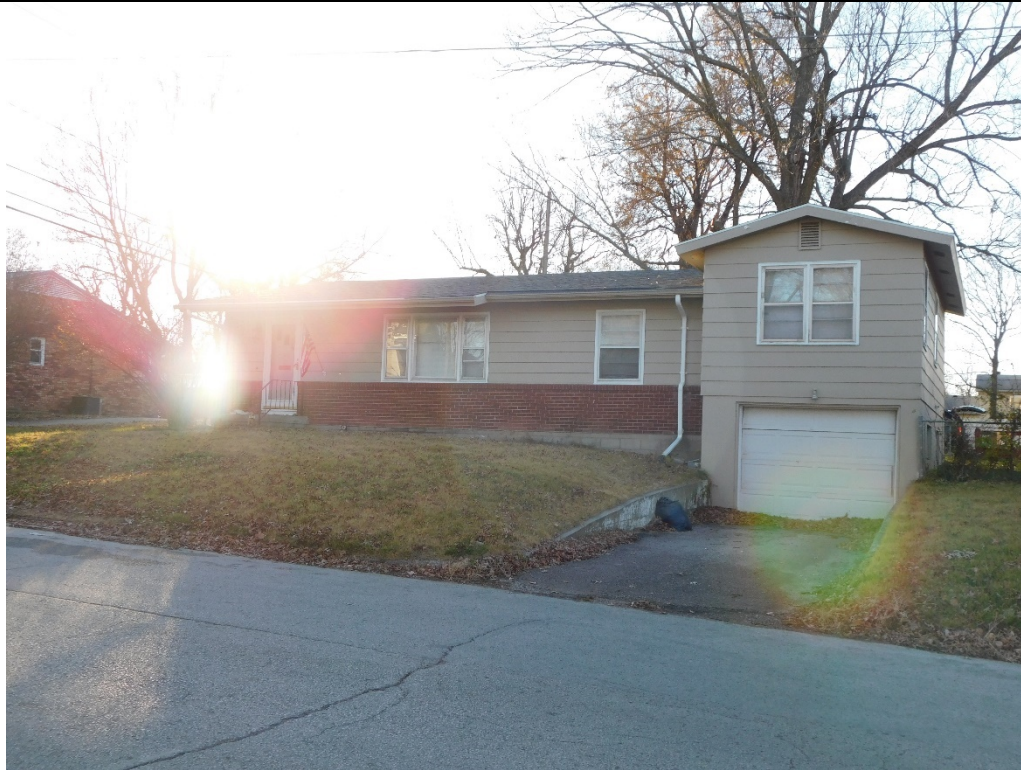
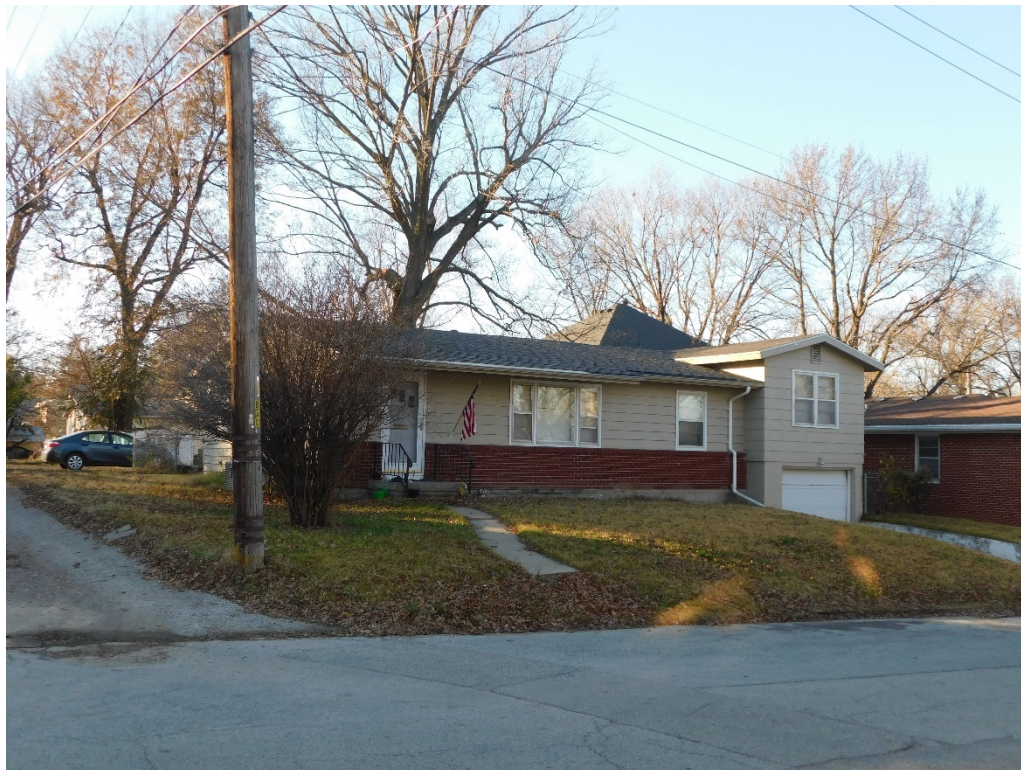
Description:
LOOKING WEST

Description:
LOOKING NORTHWEST

This one-and-a-half story split-level house features a concrete foundation, brick and weatherboard siding and a cross gable roof. The façade is four bays with weatherboard siding and a brick wainscot. The first bay features a wood door with a concrete landing and metal railing. The second bay features an original wood picture window with two-over-two hung wood windows with horizontal panes. There is an original two-over-two hung wood windows with horizontal panes in the third bay, and the fourth bay features two-stories with a metal paneled garage door in the first story with concrete walls and paired original two-over-two hung wood windows with horizontal panes in the second-story gable-end with weatherboard siding. The north and south elevations feature two original two-over-two hung wood windows with horizontal panes and weatherboard siding.

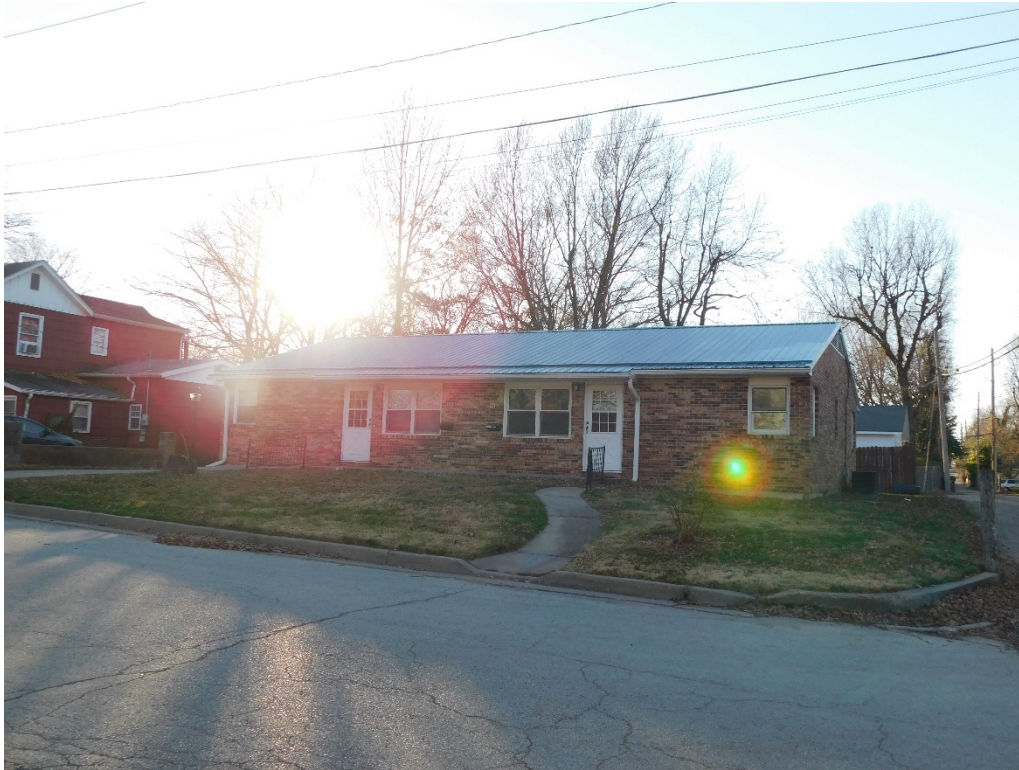
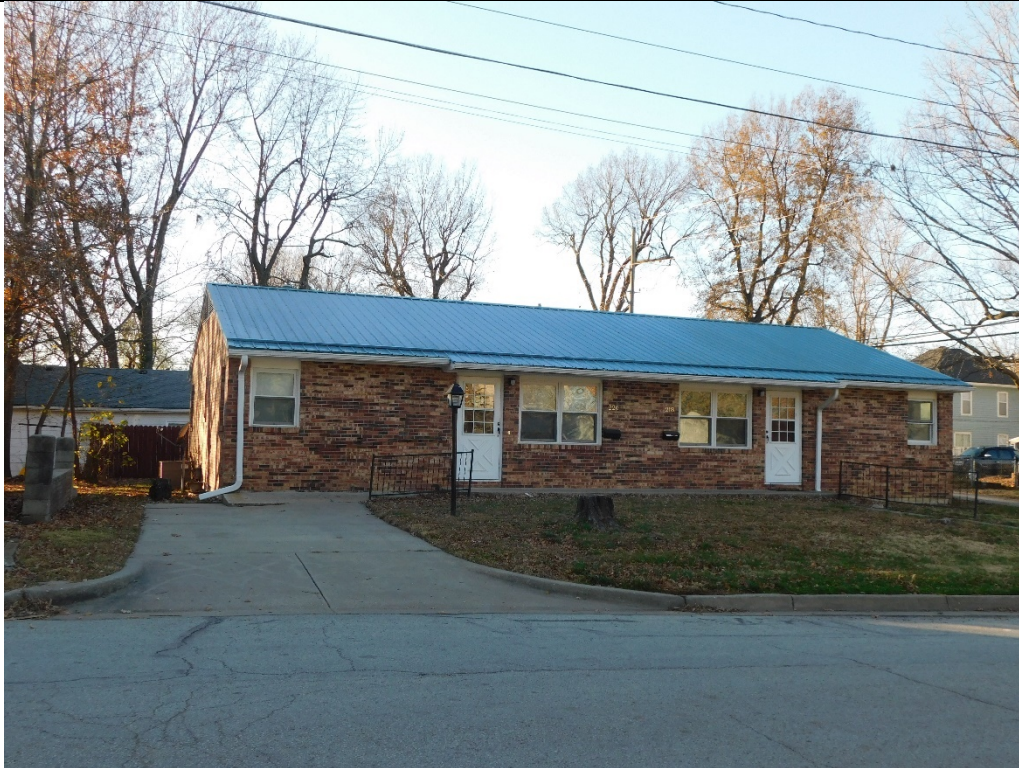
Description:
LOOKING SOUTHWEST

Description:
LOOKING NORTHWEST

This one-story duplex features a concrete foundation, brick exterior walls, and a metal side gable roof. The façade is six bays with a replacement one-over-one hung vinyl window in the first and last bay, 12-light wood door in the second and fifth bay, and paired replacement one-over-one hung vinyl windows in the third and fourth bay. There is a concrete walkway in front of the dupe with a metal railing on the sloped areas. The side elevations feature brick siding with three replacement one-over-one hung vinyl windows.

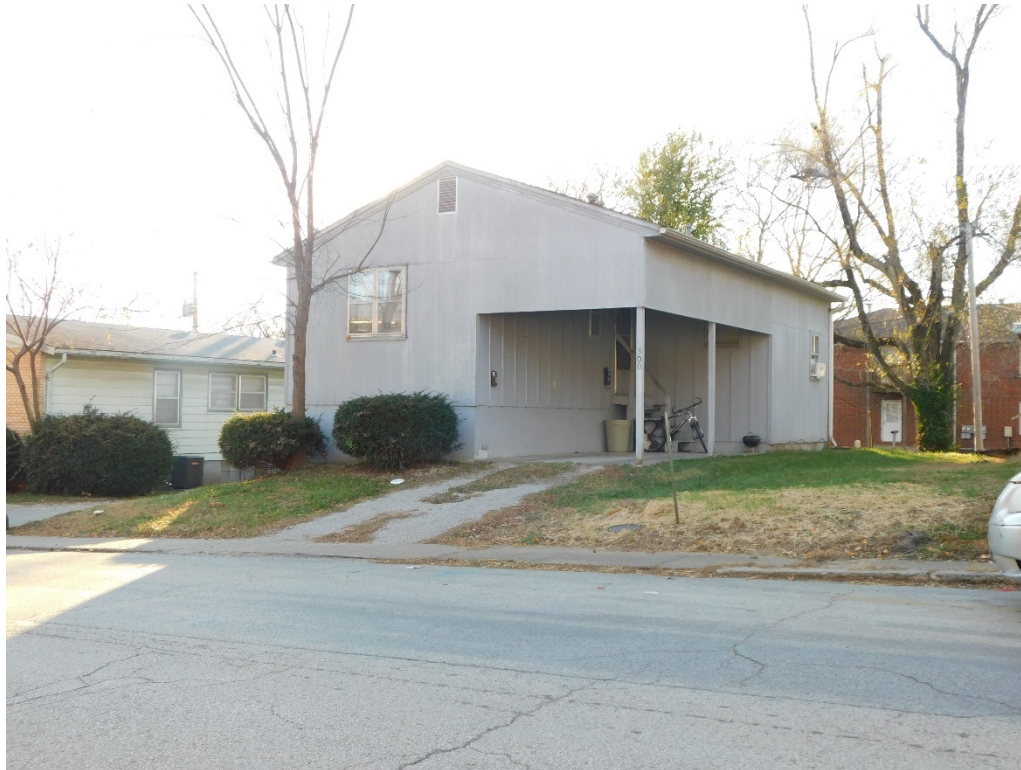
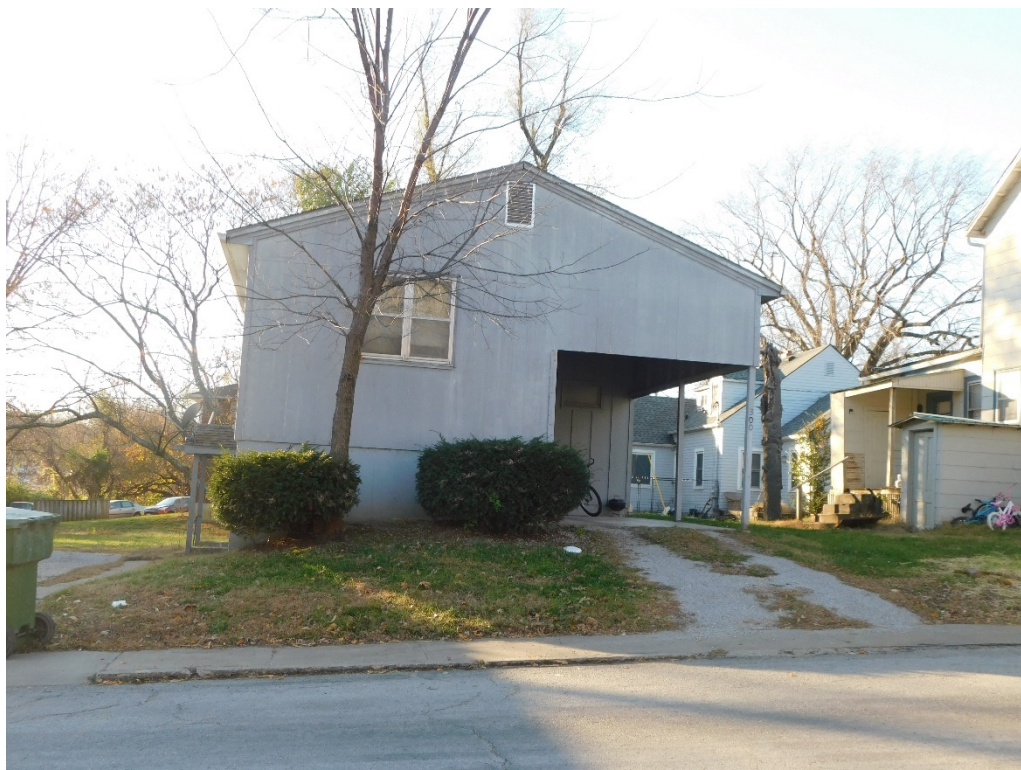
Description:
LOOKING SOUTHWEST

Description:
LOOKING WEST

This one-story split vernacular house features a concrete foundation, wood exterior walls, and a front gable roof. The façade is two bays with paired original one-over-one double-hung wood windows in the first bay. The second is located in a recessed carport with wood posts, and board-and-batten interior walls. Along the rear of the interior side wall, there is a wood door with wood stairs and railing. The remaining north elevation features an original one-over-one double-hung wood window. The south elevation features four original one-over-one double-hung wood windows. The basement level features three original one-over-one double-hung wood windows and a wood door. There is a one bay porch over the door with a gable roof, wood posts, and a concrete landing.

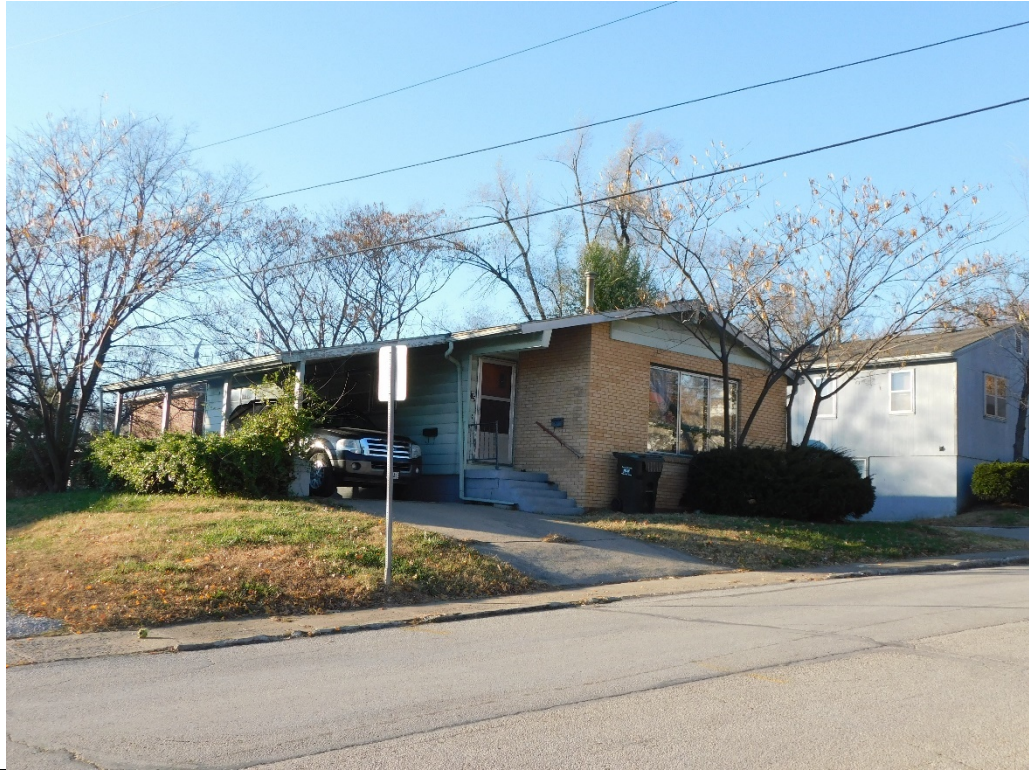
Date: 11/17/2020	Description: LOOKING SOUTHWEST	
Photographer: KRISTIN DYER	Date: 11/17/2020	Description: LOOKING NORTHWEST

<p>21. (cont.) History and significance. Expand box as necessary, or add continuation pages.</p>
<p>22. (cont.) Sources of information. Expand box as necessary, or add continuation pages. 1955, 1957, 1958, 1959 City Directory; WARRENSBURG CULTURAL RESOURCES SURVEY PHASE I AND PHASE II</p>
<p>40. (cont.) Description of environment and outbuildings. Expand box as necessary, or add continuation pages.</p> <p>There are no outbuildings at this location.</p>
<p>41. (cont.) Description of primary resource. Expand box as necessary, or add continuation pages.</p> <p>This one-story contemporary house features a T-plan with a concrete foundation, brick and vinyl exterior walls, and a low-pitch front gable roof. The façade is two bays with a recessed one-bay porch with an entry door in the first bay and grouped original wood casement windows with vinyl siding above the windows. The south elevation features an attached lean-to carport extending from the roof with wood columns and concrete piers. There is vinyl siding and original two-over-two hung woods windows with horizontal panes along the south wall. The north elevation features vinyl siding and original two-over-two hung woods windows with horizontal panes.</p>

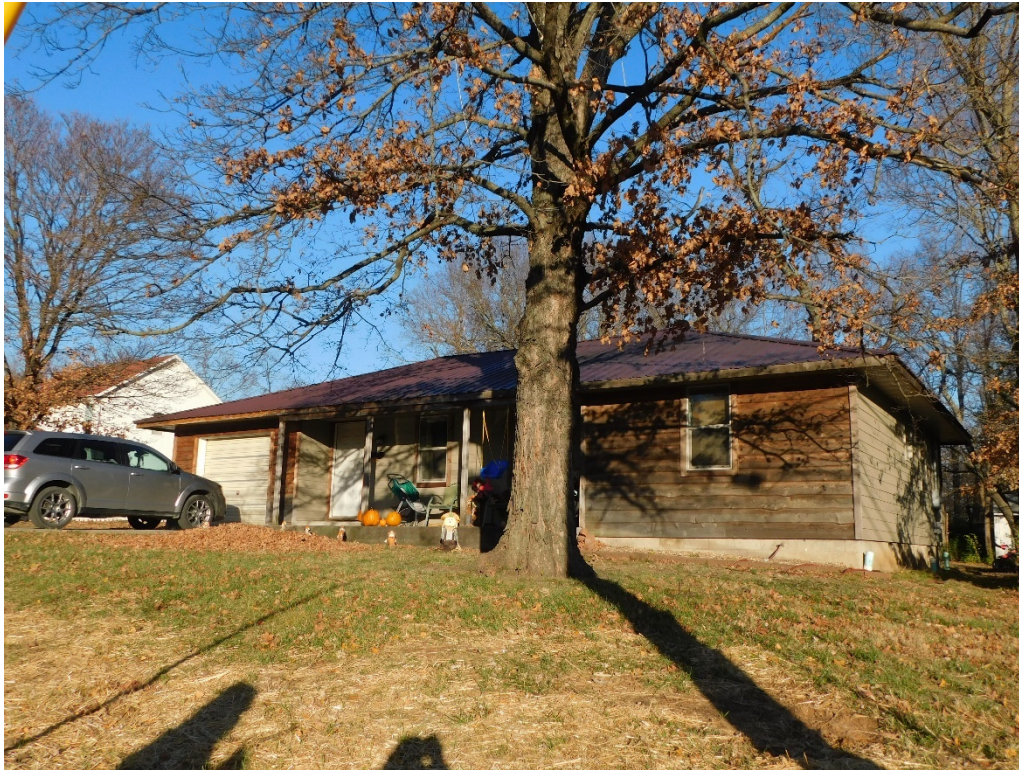
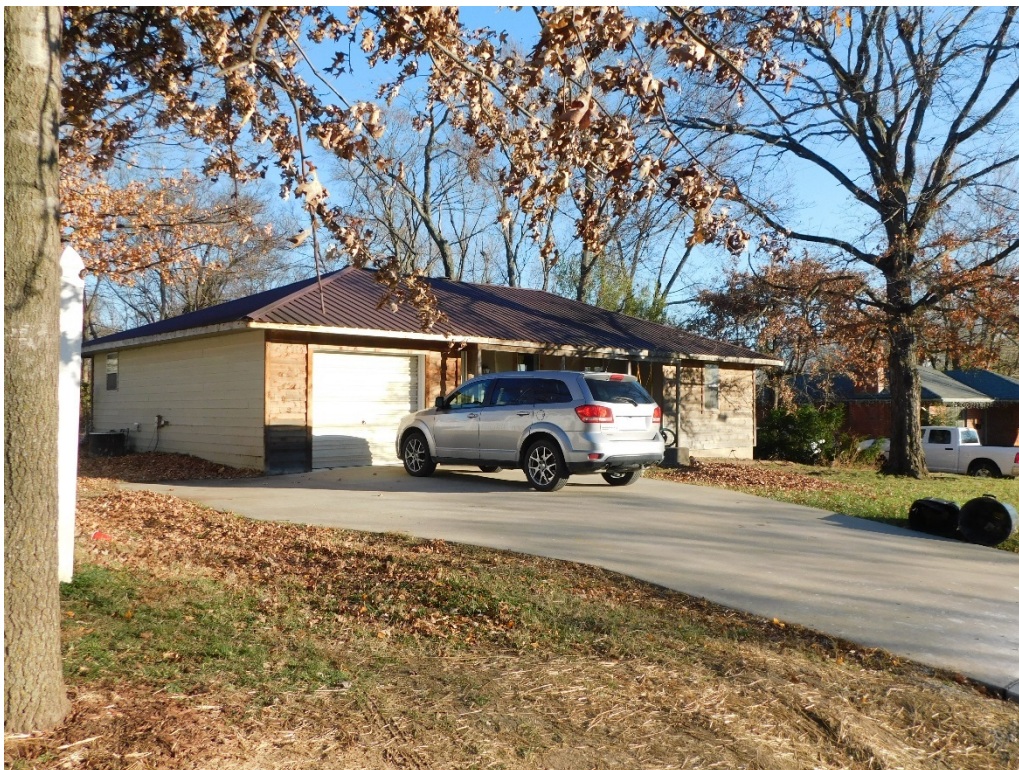
Description:
LOOKING NORTHEAST

Description:
LOOKING SOUTHEAST

This one-story ranch features a concrete foundation, wood and vinyl siding, and a hipped corrugated metal roof. The façade is five bays and features rustic wood siding. The first bay features a metal paneled garage door. The second, third, and fourth bays are located under a recessed porch with wood columns and a concrete foundation. There is a wood door in the second bay, and replacement one-over-one hung vinyl windows. The fifth bay features a replacement one-over-one hung vinyl window. The side elevations feature vinyl siding and replacement one-over-one hung vinyl windows. The house was remodeled after 2013 with new siding and alterations to the windows; therefore, this building is not eligible due to alterations to the siding and fenestration.
