SHPO Note for Marlborough Village Historic Resources Survey, Kansas City, Jackson County

Marlborough Village Historic Resources Survey

City of Kansas City, Missouri

June 2016

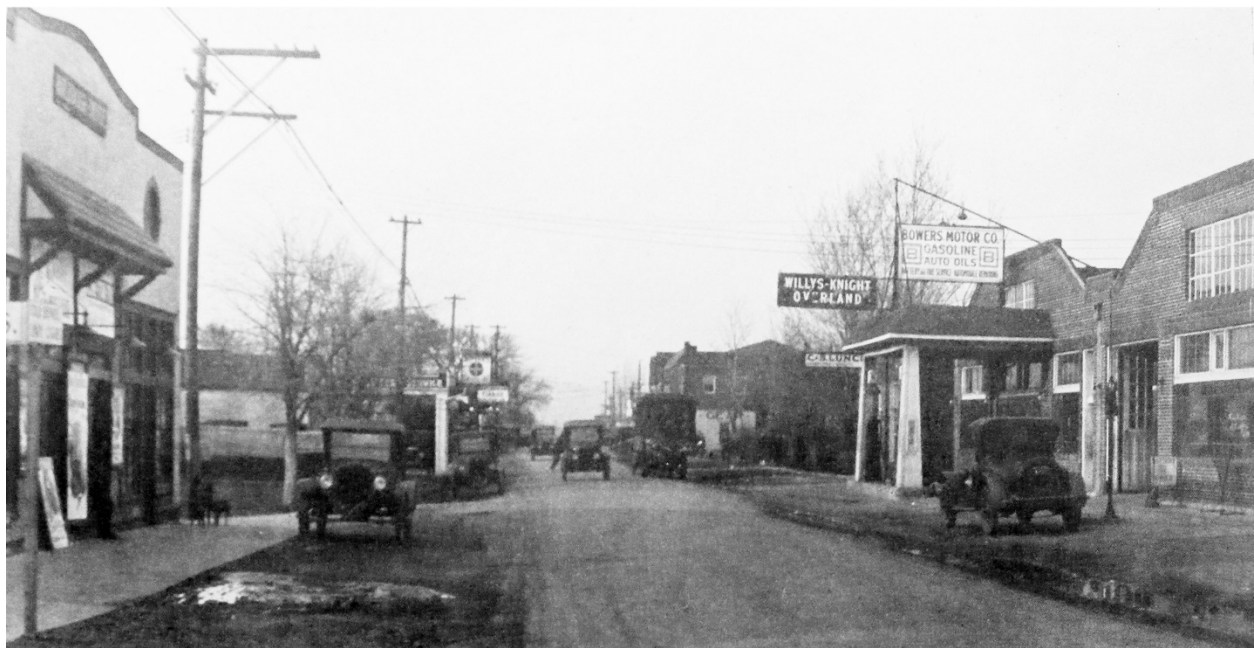
Figure 11. Marlborough Business District, looking north on Woodland Avenue between 80th and 81st Streets, 1926. The 1930 Kansas City Directory lists the Bowers Motor Co (the building on the right) at 8025 Woodland Avenue.

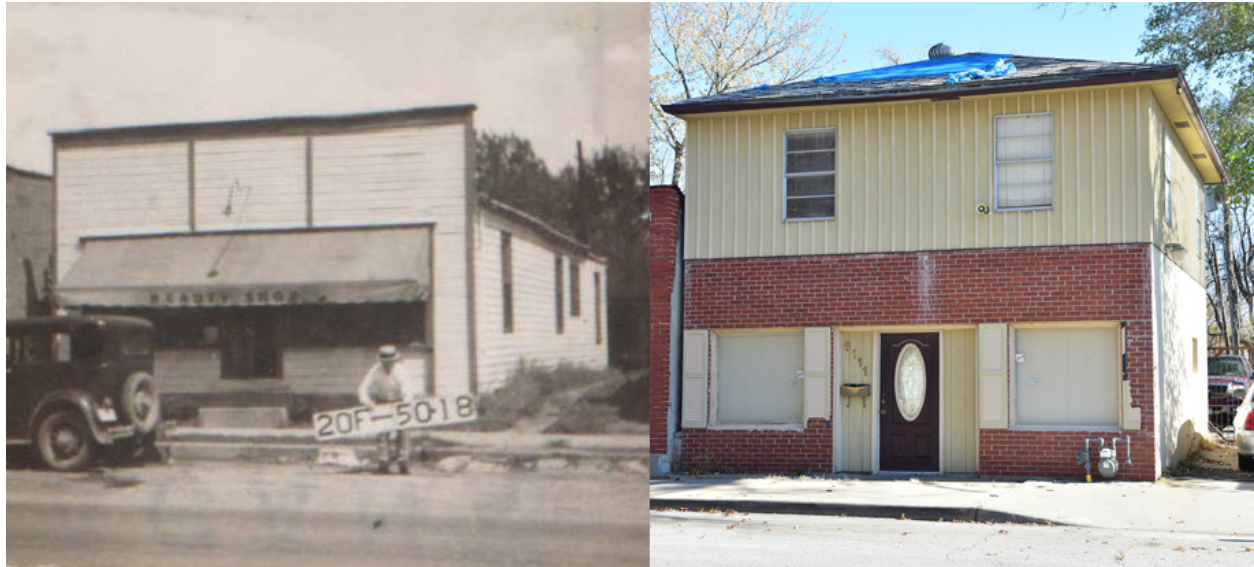
Figure 16. 8111 Woodland Avenue (The Paseo). 1940 tax assessment photograph showing wood-frame construction and present-day building, constructed in 1965 of brick and concrete block.

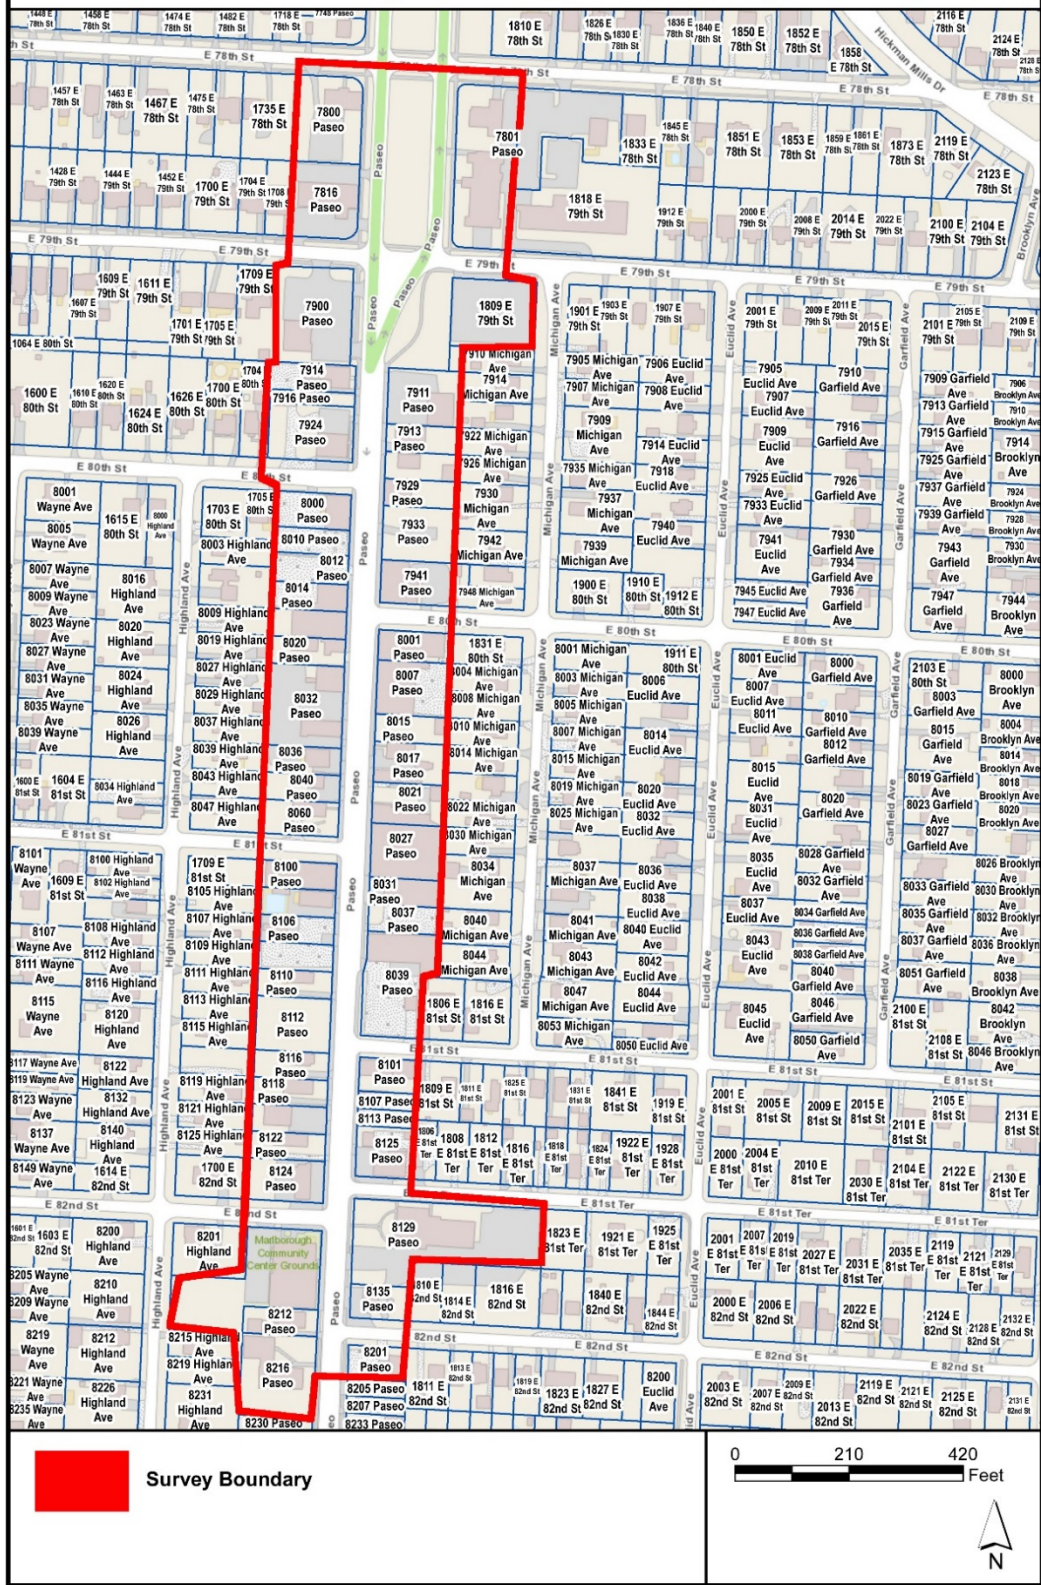
FIGURE 17. MARLBOROUGH VILLAGE HISTORIC RESOURCES SURVEY BOUNDARY MAP

Commercial buildings comprise the majority of the Survey Area. Eleven single-family residential properties constructed between the 1910s and the 1940s are scattered throughout the Survey Area. Lots are generally long and narrow with the short side fronting The Paseo. The land surrounding each building is predominantly flat. About one-third of the properties have one or more detached outbuildings. The irregularity of setbacks and the orientation of resources compounds the variability created by the range in block and lot sizes. The historic commercial buildings along The Paseo typically form a uniform streetwall abutting the sidewalk, particularly in the 8000 block. Newer commercial buildings are set back from the street, often to accommodate parking.

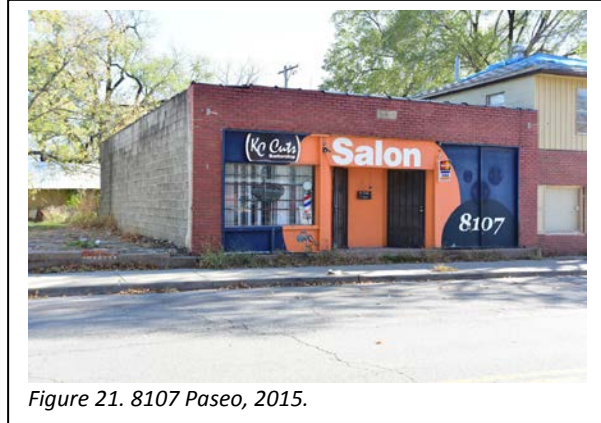
Figure 21. 8107 Paseo, 2015.

The One-Part Commercial Block building has only a single story and is a simple cube with a decorated façade. In several examples, multiple storefronts with separate entrances occupy one building and a cornice or parapet spans the width of the façade. The storefront of **8107 Paseo** was altered, but the commercial function remains clear (*Figure 21*).

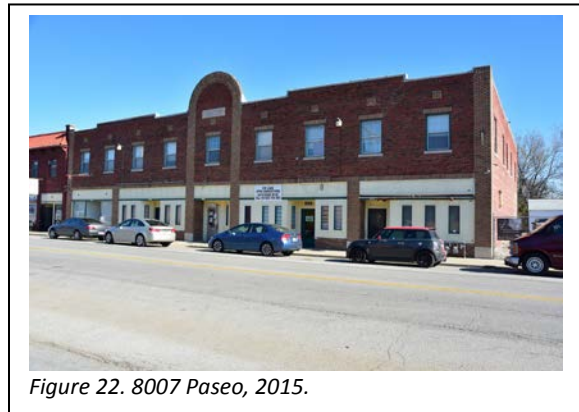
Figure 22. 8007 Paseo, 2015.

Slightly more complex than their one-story cousins, Two-Part Commercial Block buildings are typically two to four stories in height, although the Survey Area contains buildings none taller than two stories. They have a clear visual separation of use between the first-story customer service/retail space and the upper-story office, meeting room, or residential uses. Similar to One-Part Commercial Block buildings, the styling of the first story focuses on the storefront glazing and entrance(s). The design of the upper stories identifies the building's architectural influences. Good examples of Two-Part Commercial Blocks in the Survey Area include **8001 Paseo** and **8007 Paseo**. (*Figures 22 and 23*). Alterations include the infill of the storefront openings and the replacement of the second story windows. Shaped or tiled parapets, patterned brickwork, and stone lintels ornament the buildings.

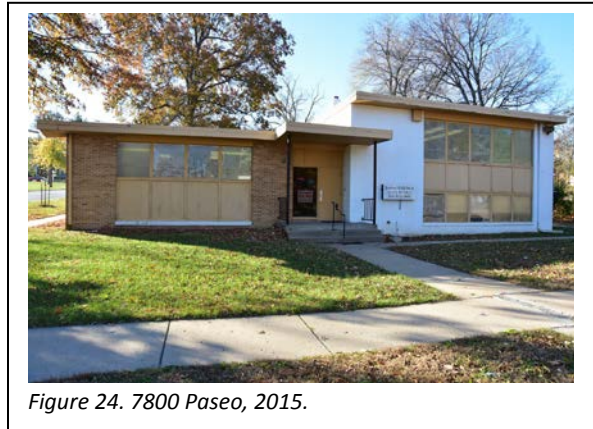
Figure 24. 7800 Paseo, 2015.

dimensional objects that defined space. Parking lots on one or all four sides of a building became dominant defining features of the commercial landscape, relegating the building to the role of back drop.³⁰ The healthcare clinic at **7800 Paseo** is an excellent example of a mid-twentieth century Free-Standing Commercial Block. (Figure 24). Brick and concrete block along with ribbon windows and an open stoop express the simple Modern Movement features.

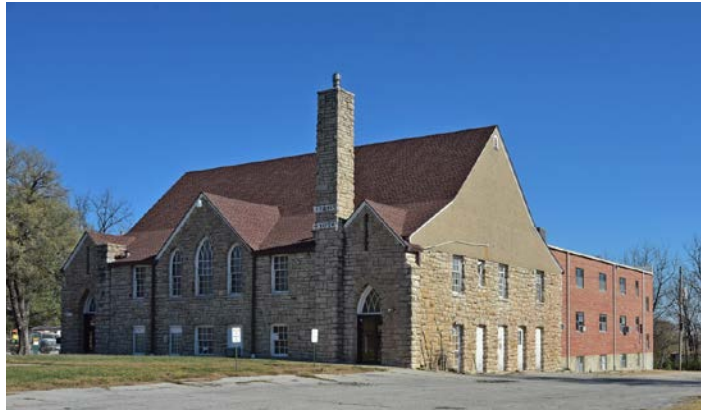
Figure 26. 8129 Paseo, 2015.

The survey included three churches. Constructed between 1927 and 1948, they represent common architectural styles and religious building forms from their period of construction. The rectangular form, stone cladding, and pointed-arch windows highlight the Gothic Revival style of the **Marlborough Baptist Church** at **8129 Paseo**. (*Figure 26*). The large stone building was constructed c. 1927. A mid-century addition compromises the integrity of the church. The building at **8216 Paseo** is an example of a small, neighborhood church that grew with an expanding neighborhood population (*Figure 27*). The three story, apsidal plan, red brick church at **7801 Paseo** exhibits restrained Mission Revival ornament (*Figure 28*).

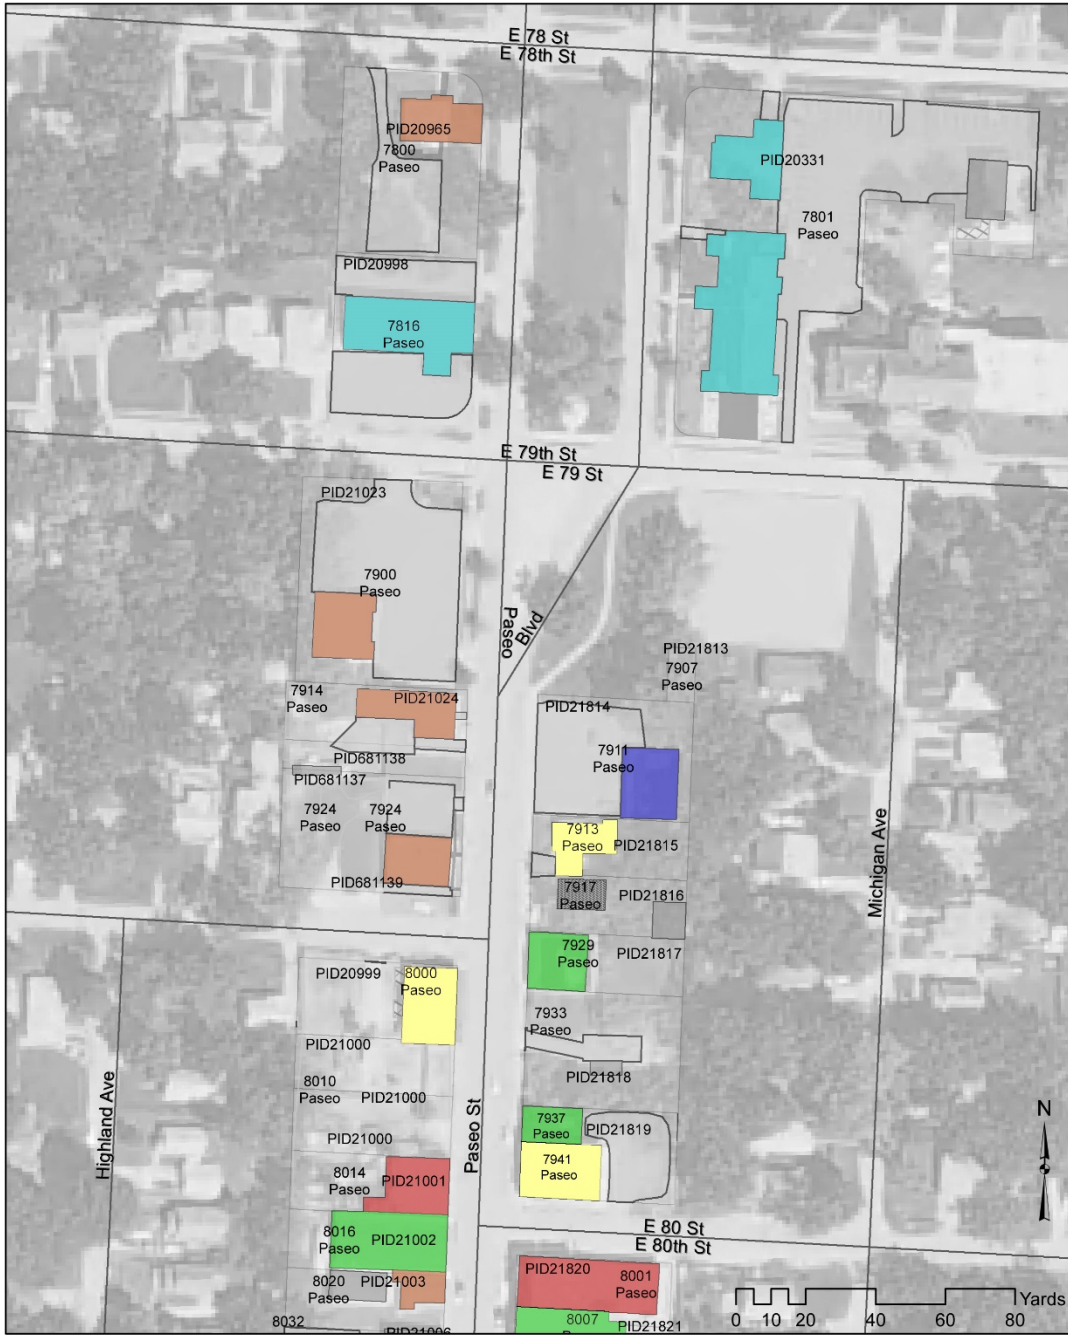
Map 1 of 3

Marlborough Village Dates of Construction

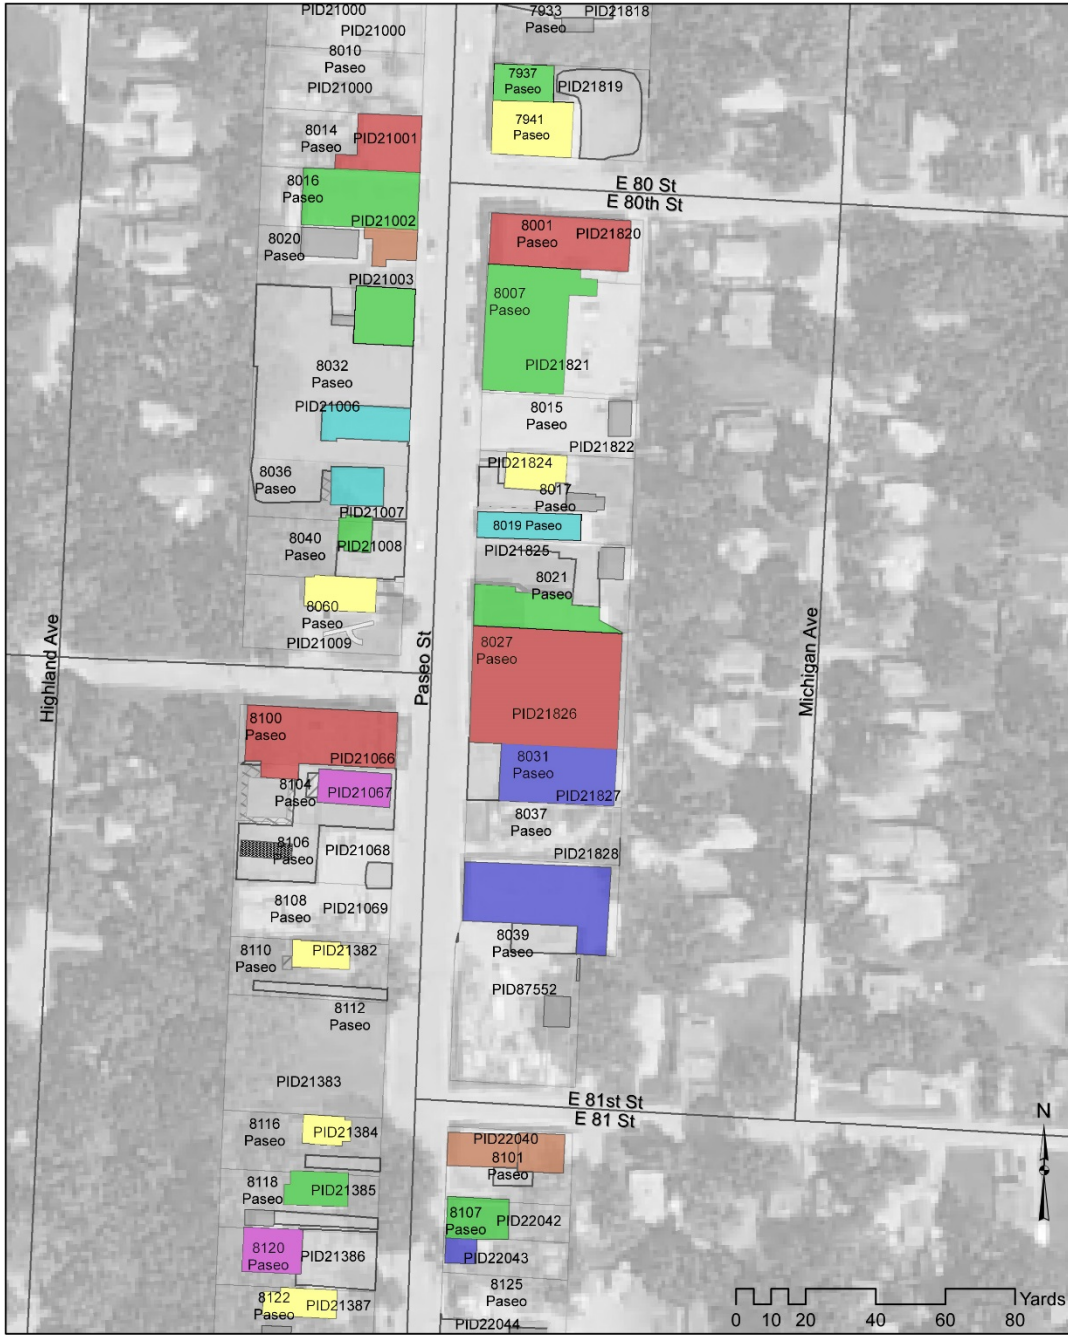
Map 2 of 3

Marlborough Village Dates of Construction

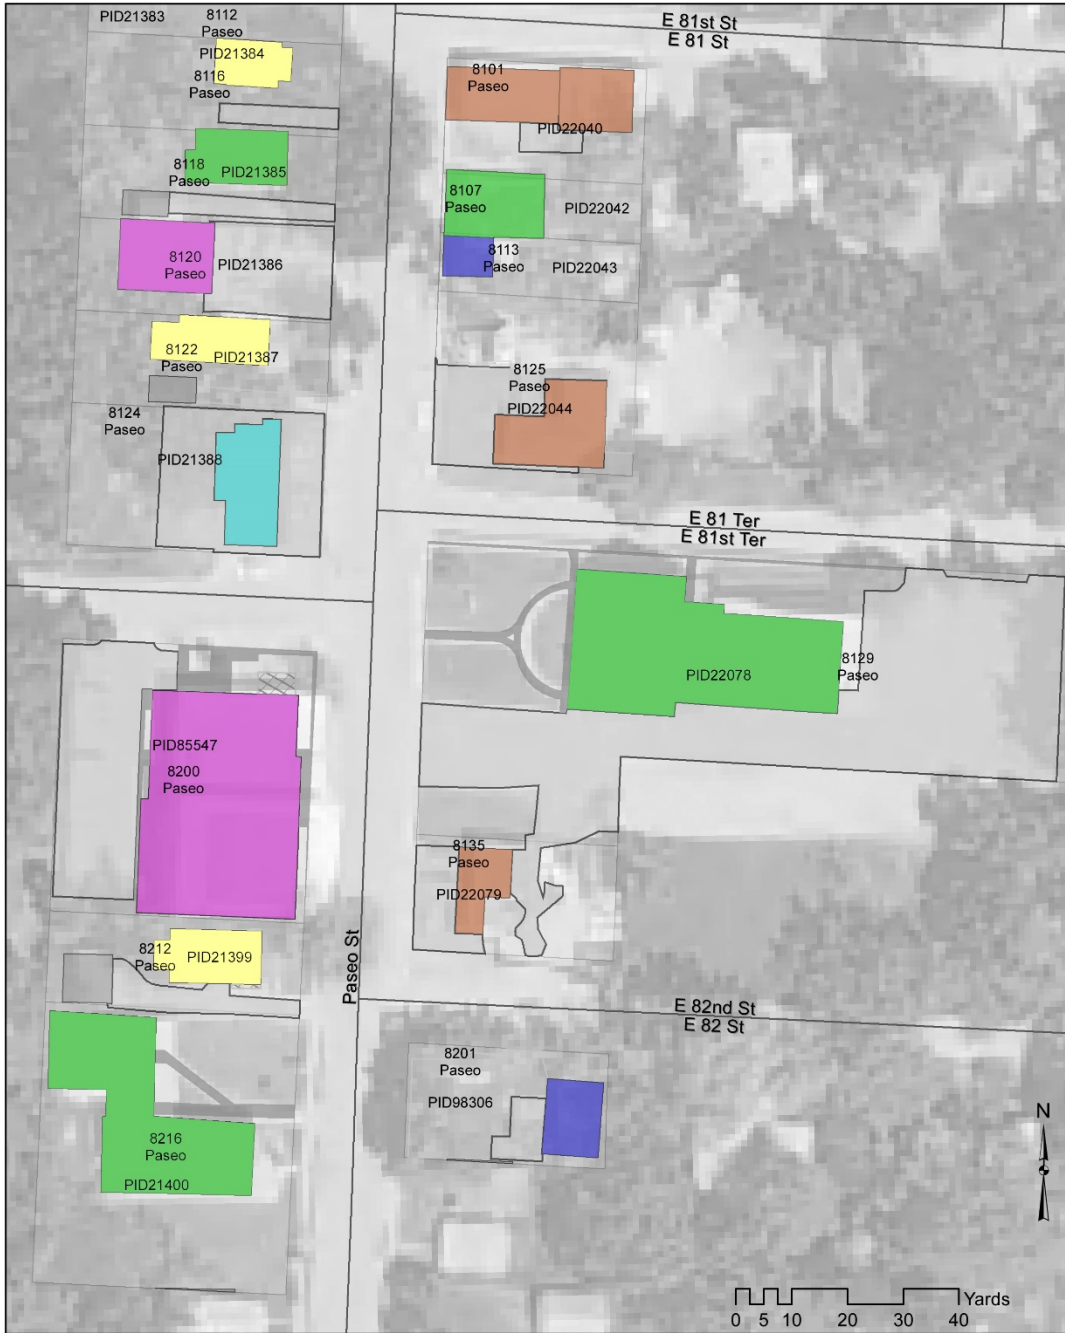
Map 3 of 3

Marlborough Village Dates of Construction

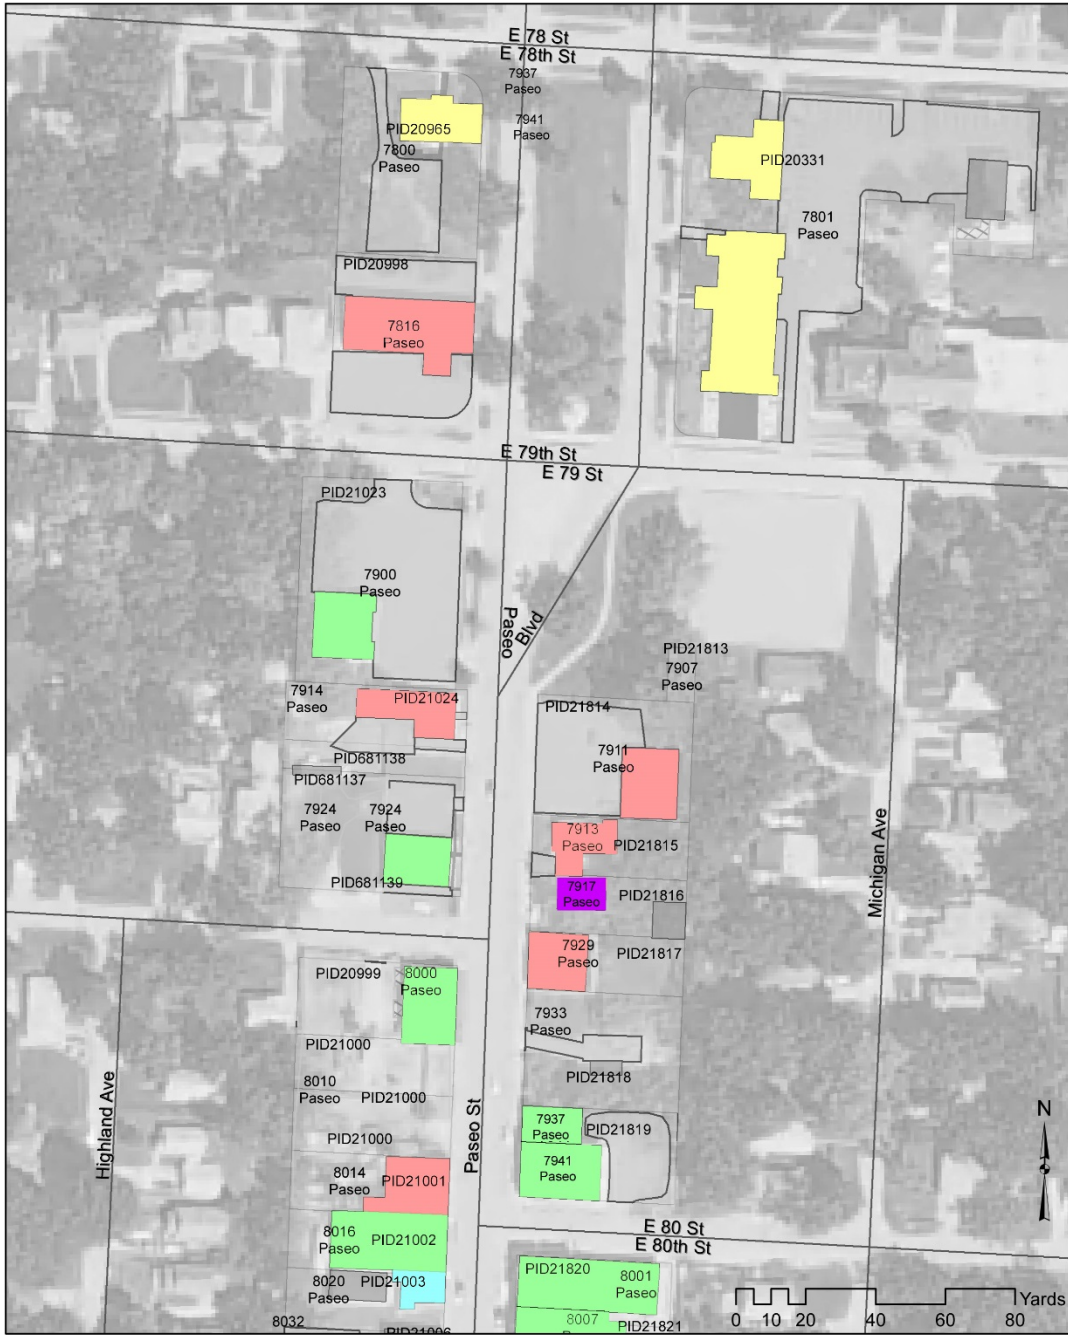
Map 1 of 3

Marlborough Village Architectural Integrity

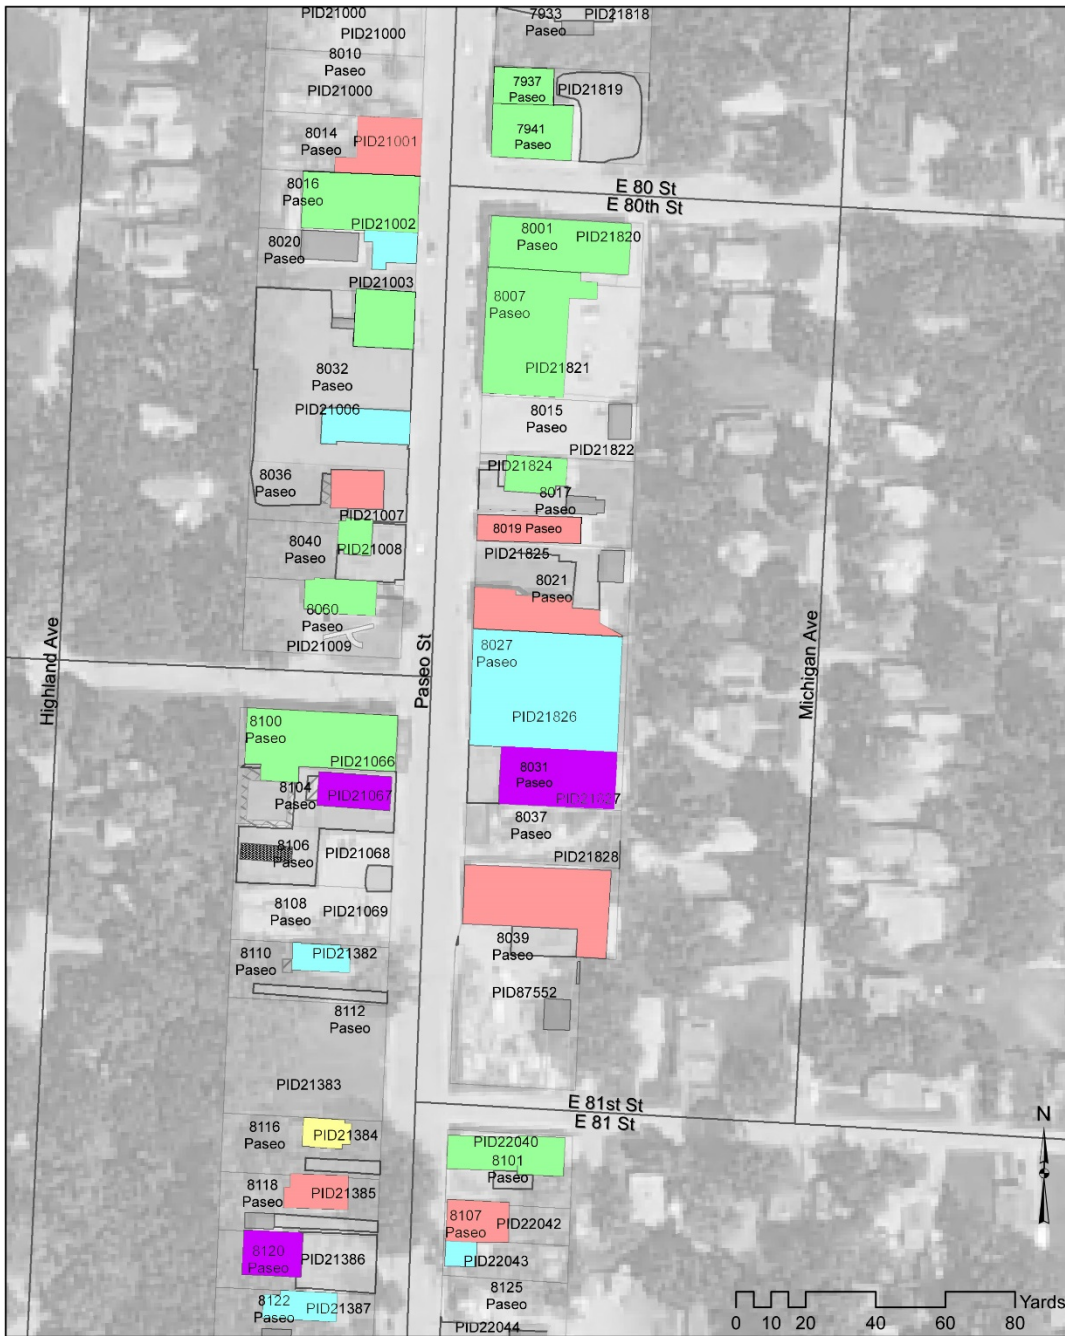
Map 2 of 3

Marlborough Village Architectural Integrity

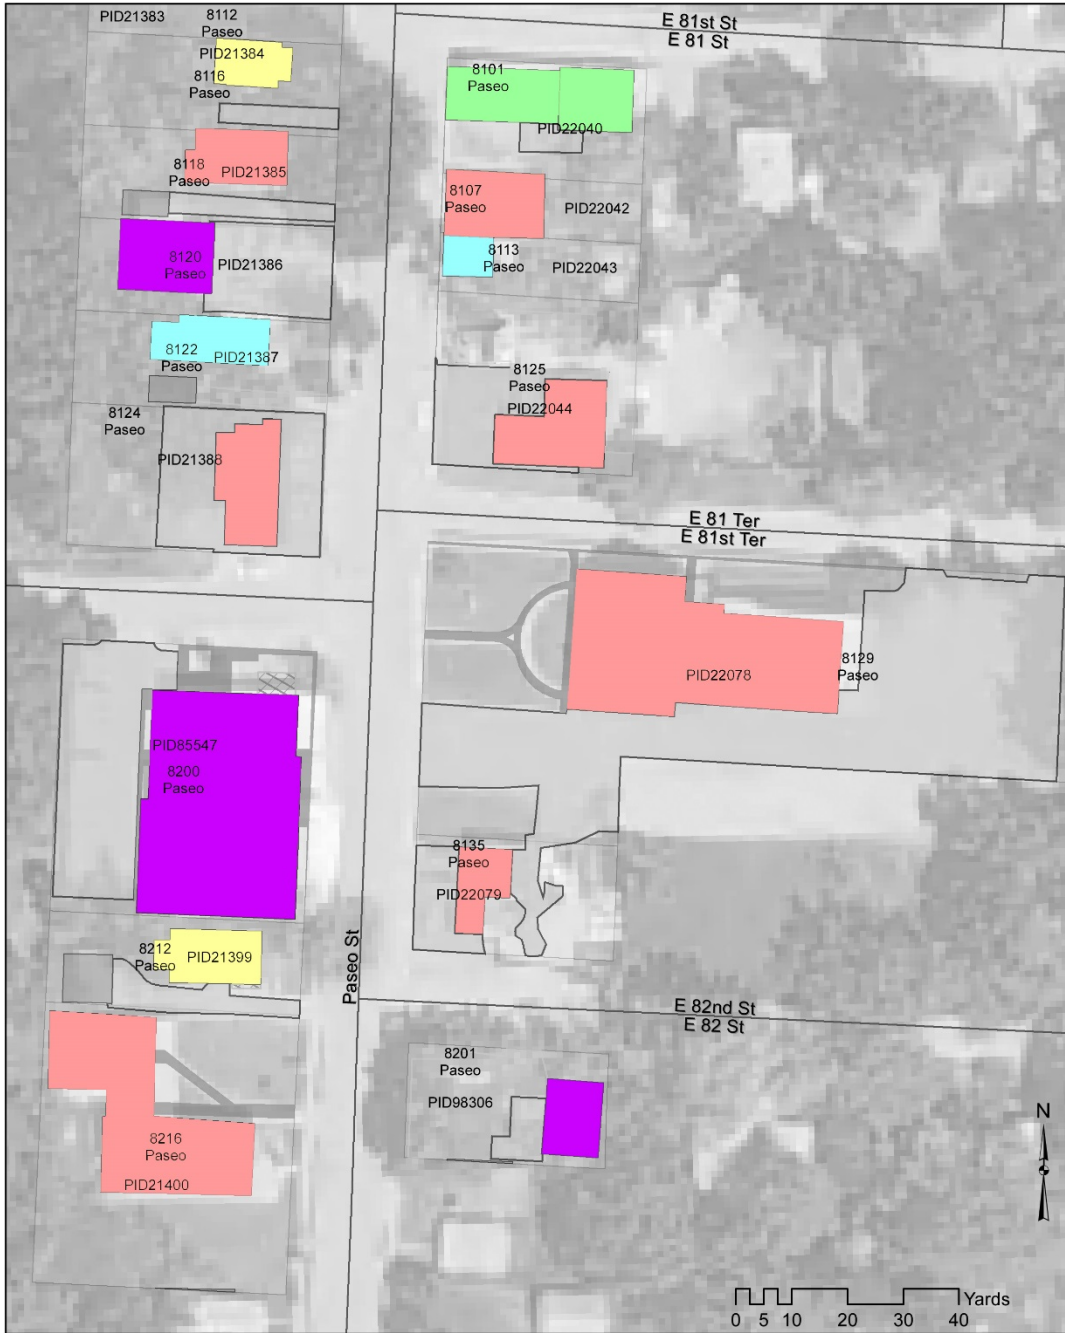
Map 3 of 3

Marlborough Village Architectural Integrity
