**PENN SURVEY PROJECT
PHASE TWO
SUMMARY REPORT**

PENN SURVEY PROJECT, PHASE TWO

SUMMARY REPORT

Prepared by
The URBANA Group
for the
St. Joseph Department of Planning and Community Development
and
St. Joseph Landmark Commission

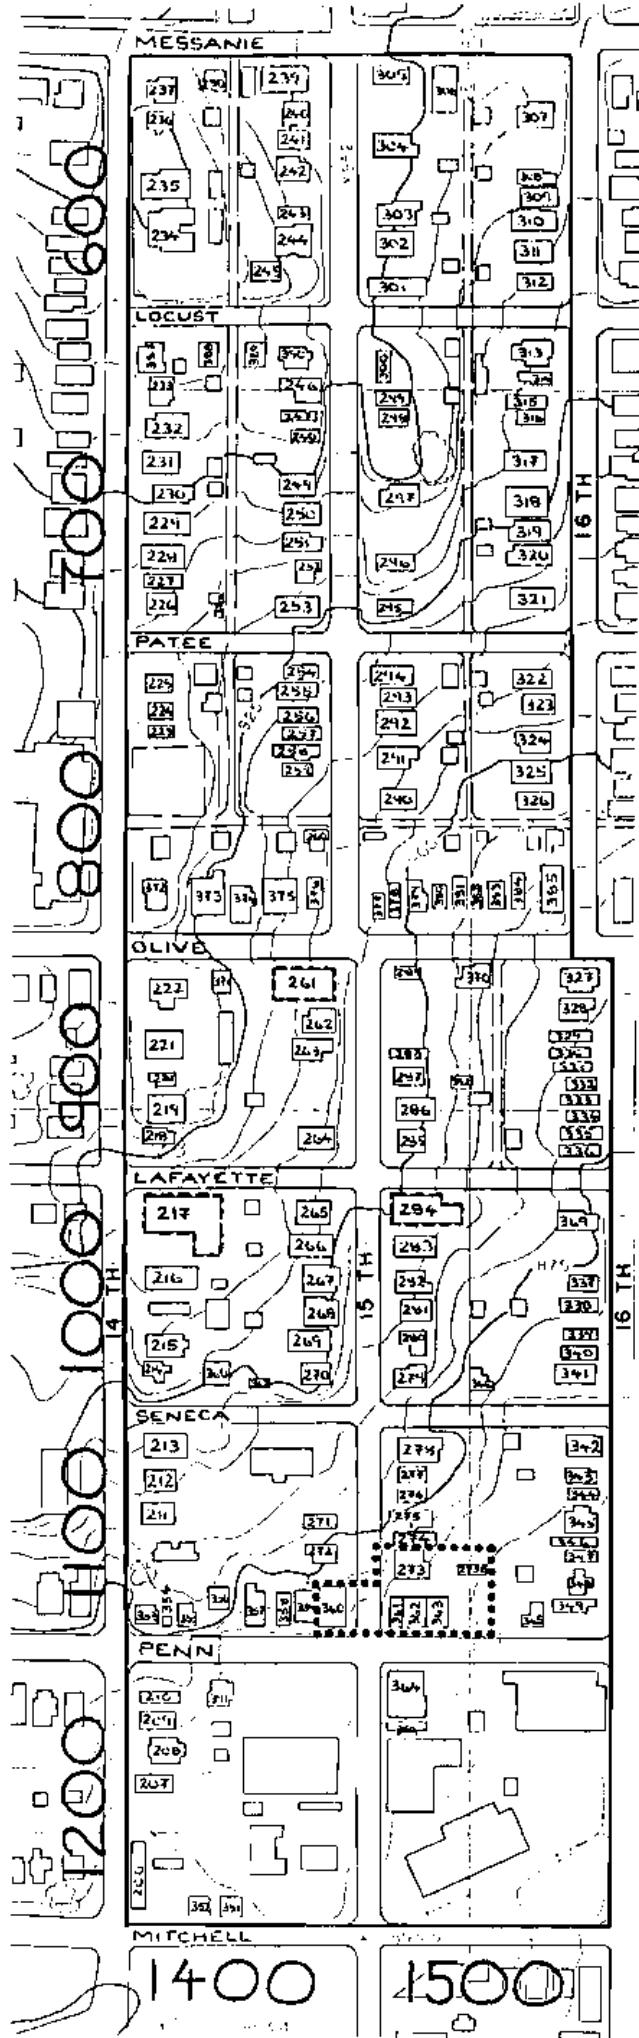
Survey Area Map
with
Inventory Reference Numbers
and Block Numbers

National Register Recommendations

- Historic District
- - - Individually Eligible
