Land-Use
and
Building
Condition
Survey
Report –
Poplar
Bluff, MO

2012-
2013

Prepared by
Terri L. Foley,
Historic
Preservation
Consultant

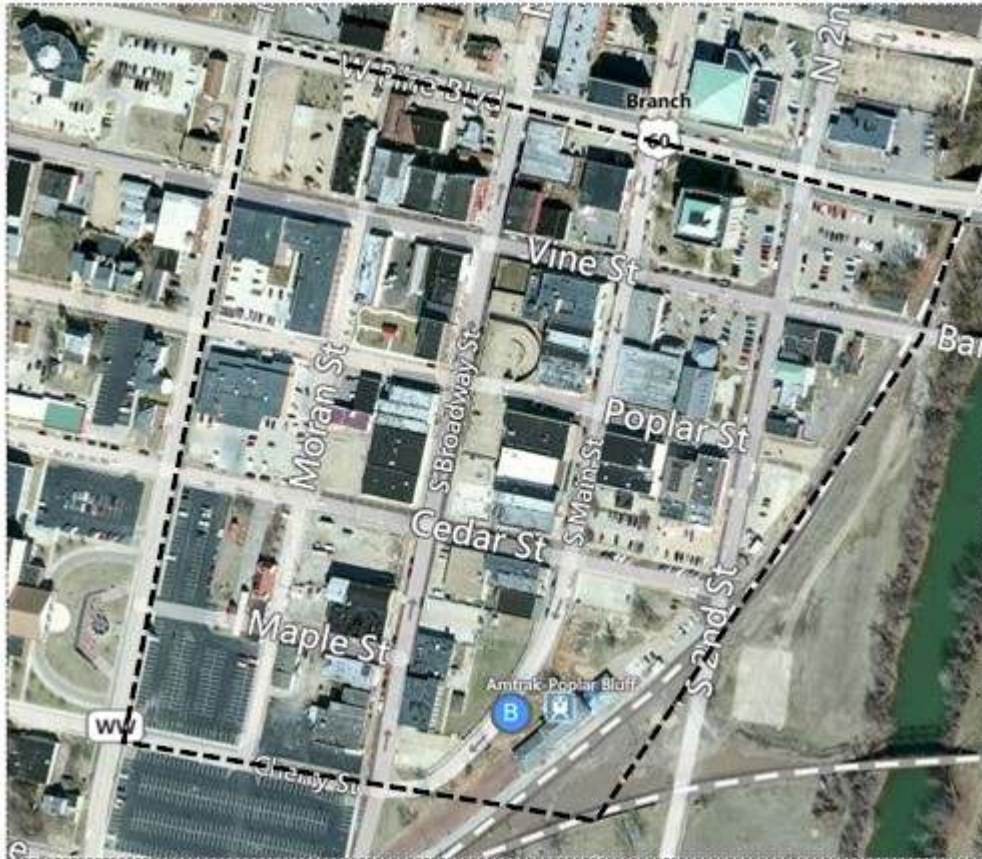
Chart 1. Study Area and CX-3, Central Commercial, Mixed-Use District Boundary Map – Boundary of area is designed by dotted lines -----

For the purposes of this analysis, the study area was defined as being all land parcels located within the boundaries of the CX-3, Central Commercial, Mixed-Use District, as defined in the Ordinance No. 7301. Please refer to the map below for an overview of the survey area's boundaries. For the purpose of this study, the charts and results by streets combine Maple and Moran Streets data together. Each street holds one building; the building located on Maple Street (420) is located near the corner of Maple and Moran Streets.

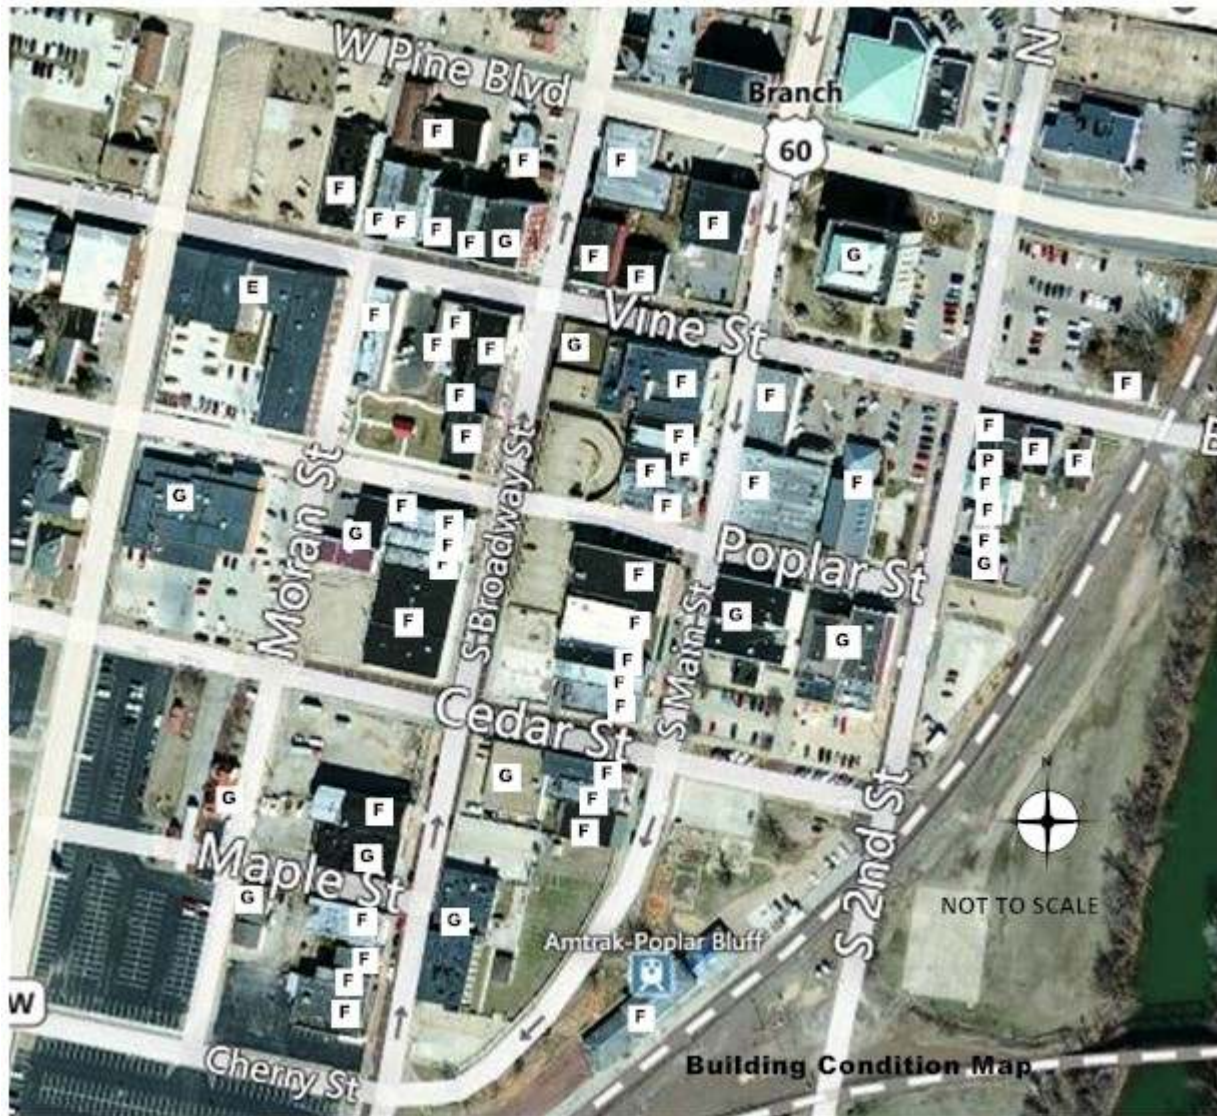
Chart 41: Building Condition Map

Overall findings of the survey revealed that approximately 17 percent of the surveyed buildings are in good condition. The average building condition score is 25 of a possible 36; therefore, the average property shows some signs of deterioration. Buildings were automatically scored a 3 in categories which were not applicable to the individual building. For instance a building was given a 3 if no trim or gutters existed on the building instead of no score. If no score was given, the rating would have been reduced unfairly. However, it is recommended to those buildings without gutters and downspouts to install these items for the overall well-being of the building. Noticeably, properties rated as excellent and good are in the minority, and the survey discovered no dilapidated properties and only one property rated in poor condition. Please see individual survey forms for total score on each building.

The following map represents the building conditions in the study area.

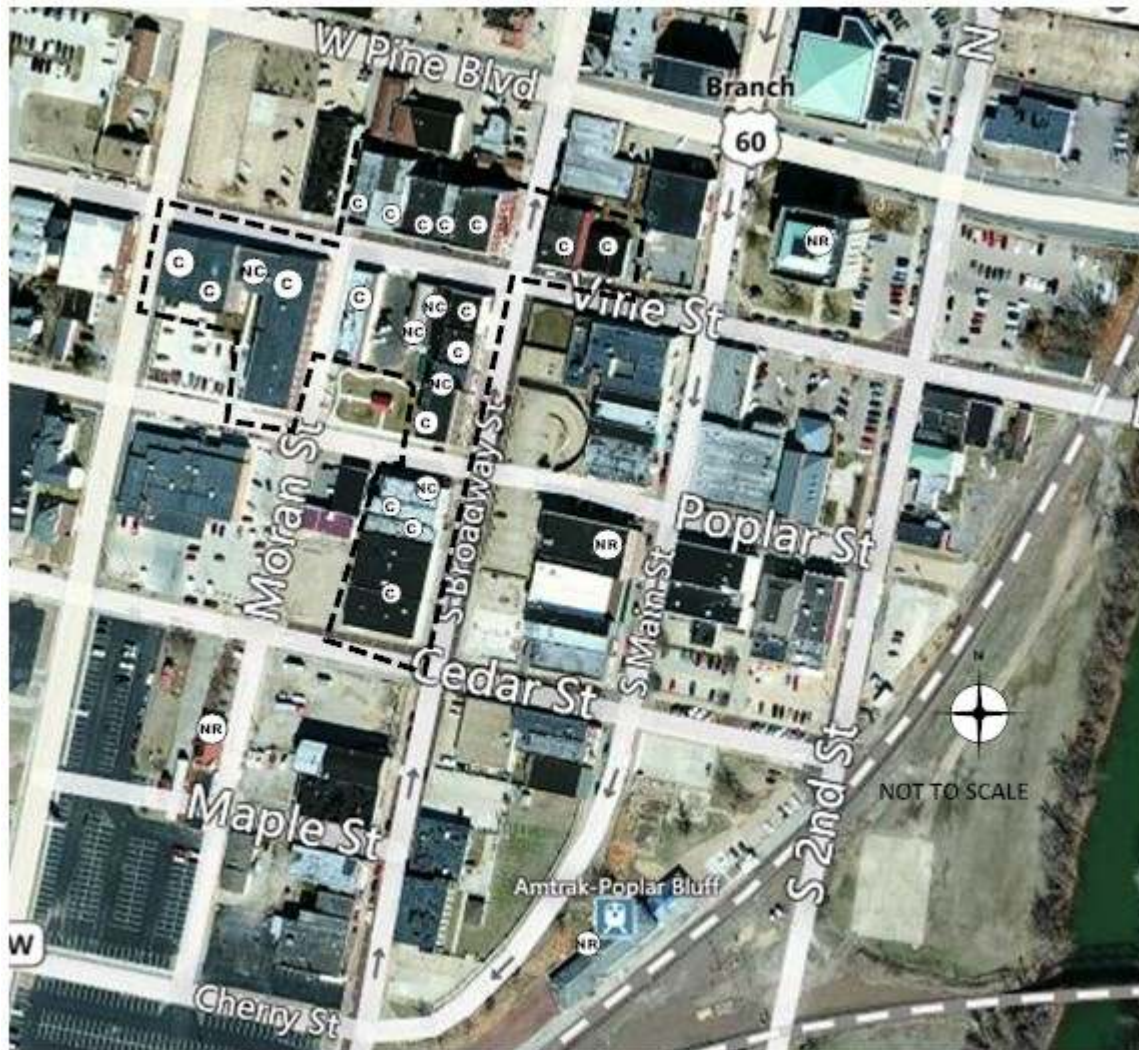
Chart 55: National Register of Historic Places Map

C - Contributing properties in Poplar Bluff Commercial Historic district (eligible for tax credits)
NC - Non-Contributing properties in Poplar Bluff Commercial Historic district (not eligible for tax credits)
***NR** - Individual buildings listed in the National Register of Historic Places
*These properties are all owned by entities which make the buildings not eligible for tax credits
Poplar Bluff Commercial Historic District Boundaries are highlight by - - - - -

It is recommended that two buildings within the study area be evaluated for National Register of Historic Places eligibility. Those two buildings are 206 Poplar Street and 200 S. Main Street. Also recommended for evaluation is the 100, 200, 300 blocks of S. Main Street as a potential National Register District. These properties should be evaluated to determine if the buildings are considered eligible for listing in the National Register of Historic Places and if the properties
