PRESERVING

HISTORIC

SEDALIA

A STUDY OF SEDALIA'S ARCHITECTURAL AND HISTORICAL HERITAGE

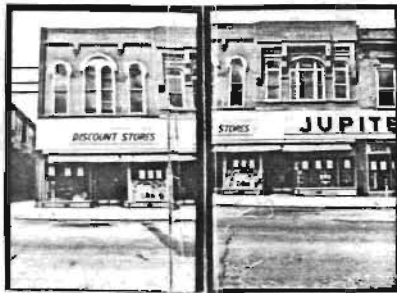
Danny's Zip Drugstore - 302 South Ohio

4. For many years the Sedalia National Bank was at this address. The decorative carvings on the east facade are exceptional, consisting of an eagle and a shock of wheat. This building still has a "bank look" and is unique enough to merit a priority rating. Parking is fairly close by and ample.

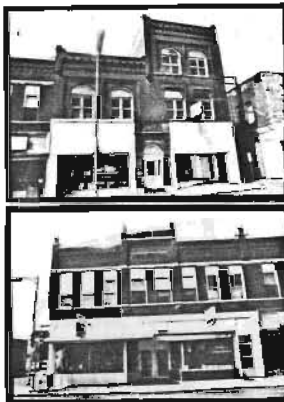
Avco, NuWay, B & J Design Shop, Frank's Shoe

10. This group of buildings contains some of the best pressed brickwork in Sedalia. The architects made good use of curved bricks, terra cotta and decorative trim in a very impressive manner. The planning employed gives these buildings a uniqueness and individuality that is unsurpassed. The lower stories have been altered, but the upper stories retain their originality. In this half of the block since 1915, Demand Shoes is a familiar name to Sedalia. Hill Business College and the YMCA also were early occupants of these buildings.
