# **“TOWN OF GRANDVIEW”** **HISTORIC RESOURCES RE-SURVEY**

PREPARED FOR:  
The City of Grandview, MO

PREPARED BY:  
Rosin Preservation, LLC

August 2018

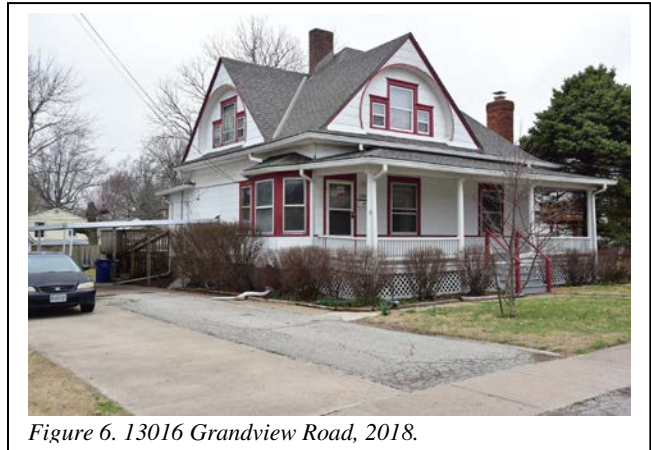
*Figure 6. 13016 Grandview Road, 2018.*

Anne residence's most-character-defining feature is its overall form. The massing of Queen Anne homes features protruding cross-gables and turrets that contribute to an asymmetrical form. Additional exterior decoration was achieved through wall overhangs, voids, extensions and the application of a variety of materials. The Free Classic Queen Anne incorporates classical design elements such as the Palladian window, dentils, and classical columns. Two resources in the Survey Areas exhibit the Queen Anne style. A ca. 1910 example is located at 13016 Grandview Road (*Figure 6*).

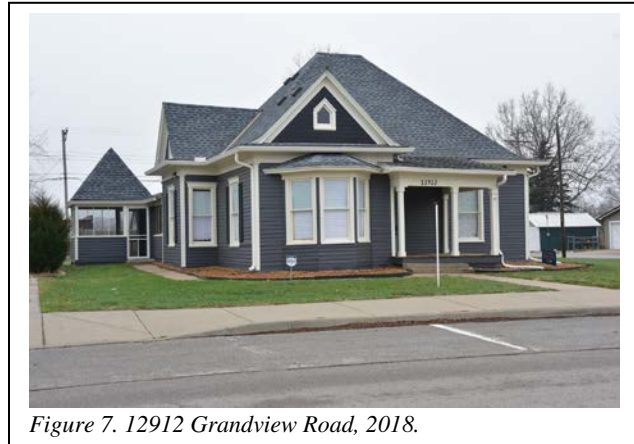
Figure 7. 12912 Grandview Road, 2018.

As the Queen Anne style evolved, the emphasis on patterned wood walls became more pronounced. The one-story partial, full, or wrap-around porches that extended across the façades of these houses typically feature turned or jigsawed ornamental trim. Extensive one-story porches are common and accentuate the asymmetry of the façade. They always address the front entrance area and cover part or all of the front façade. It is not uncommon for these porches to extend along one or both sides of the houses. The most common configuration is the one- to one-and-one-half-story hipped roof with lower cross gables. One example of this roof type in the Survey Area includes **12912 Grandview Road**. (Figure 7). While larger examples of this shape subtype commonly incorporate towers or turrets in their compact footprints, this example of the hipped-roof-with-lower-cross-gable dwelling in the Survey Area has a more rambling, linear footprint.

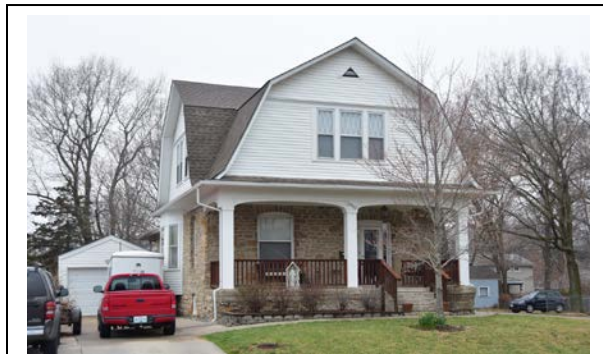
*Figure 9 12902 Grandview Road, 2018.*

The term “Colonial Revival” refers to the rebirth of interest in the styles of early English and Dutch houses on the Atlantic Seaboard. The Georgian and Adams styles, often combined, form the backbone of the revival styles. Those built in the late nineteenth century were interpretations of the earlier colonial style, while those built from about 1915 to 1930 were more exact copies of the earlier adaptations. As their use continued into the mid-twentieth century, the style became more simplified.<sup>25</sup> Fifteen total resources express the Colonial Revival style in some way, though form or ornament may vary. The two-story dwelling constructed for Dr. Robert and Maude Haire ca. 1928 at **13008 10<sup>th</sup> Street** is an excellent example of the Colonial Revival style (*Figure 8*). One resource, **12902 Grandview Road**, expresses the Dutch Colonial subtype of the Colonial Revival Style (*Figure 9*). Character-defining features include the gambrel roof and symmetrical façade.

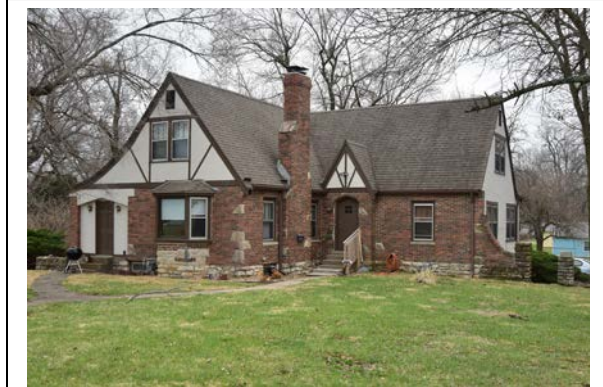
*Figure 10. 1101 Highgrove Road, 2018.*

Six residences in the Survey Area exhibit the Tudor Revival style. The Tudor Revival became immensely popular after World War I when new technologies made it easier to apply a brick or stone veneer to frame construction and returning veterans sought to recreate the architecture they had seen overseas. A steeply pitched roof defines Tudor revival. Cross-gables, decorative half-timbering, arched doors and openings, and prominent chimneys are also common. The residence at **1101 Highgrove Road**, built ca. 1925 is an excellent example of a small Tudor Revival style residence. (*Figure 10*).

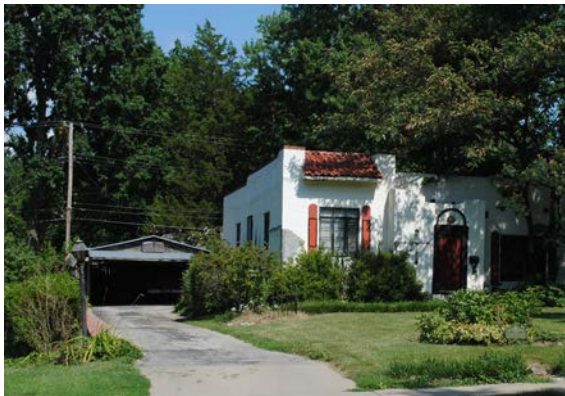
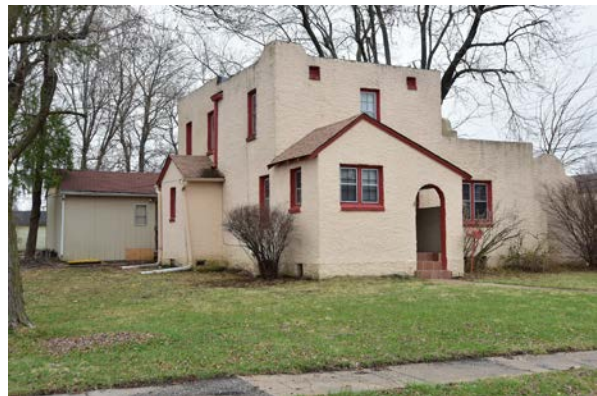
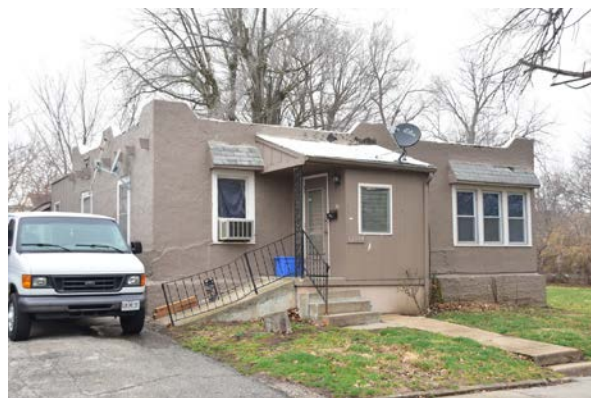
The Spanish Revival dwelling is most common in the southwest, however vernacular examples of the style are found throughout the United States in suburban developments. Spanish Revival dwellings are typically one-to-two stories with low-pitched or flat roofs and an asymmetrical façade. Additional characteristic features include stucco walls, red tile roofs, and arched doorways. The 1915 Panama-California Exposition popularized the syle, which experienced its peak constuction period from 1920 through 1930. The three examples were identified in the Survey Area date to the end of this period (*Figures 11 through 13*).

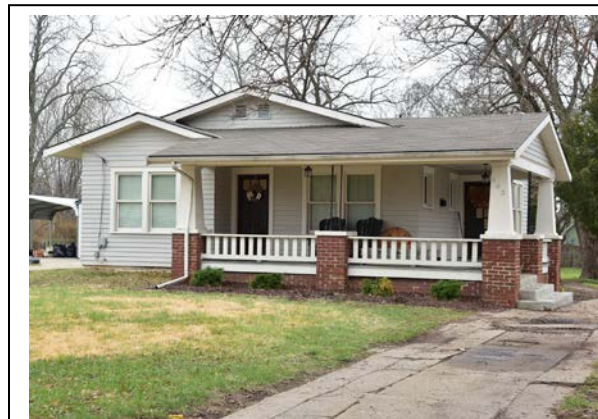
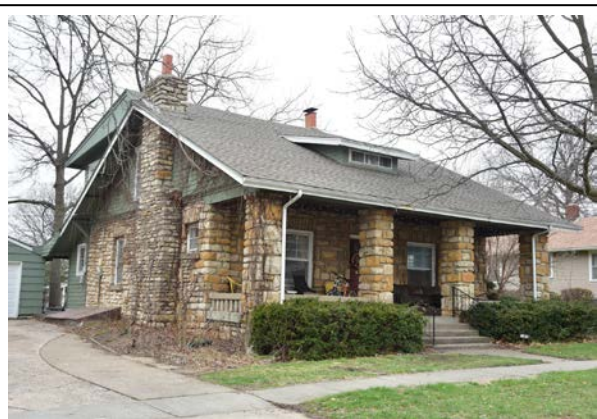
Craftsman houses date from circa 1905 through 1930. Most evolved from the early designs of Charles Sumner Greene and Henry Mather Greene who practiced architecture in California from 1893 to 1914. The Greene's designed both elaborate and simple bungalow houses that incorporated designs inspired from the English Arts and Crafts movement and from Asian architecture. Popularized by architectural magazines and builder pattern books, the one-story Craftsman house became popular nationwide during the early decades of the twentieth century as the most fashionable style for a smaller house. Identifying features include low-pitched roofs; wide eave overhangs, often with exposed roof rafters; decorative beams or braces under gables; and full- or partial-width porches supported by square piers.<sup>26</sup> Nineteen resources in the Survey Area are Craftsman dwellings. The low-pitched roof tapered square columns with piers and three-over-one double-hung windows with vertical muntins on the house at **903 Highgrove Road** clearly exemplify Craftsman design. (*Figure 14*). The house at **13014 10<sup>th</sup> Street** is an excellent example of a home that references the Craftsman style through its open eaves and overall massing (*Figure 15*).

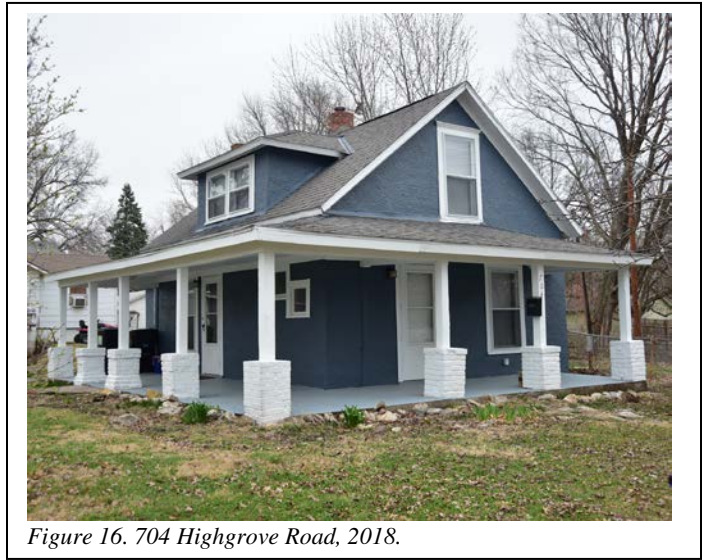
*Figure 16. 704 Highgrove Road, 2018.*

were one- to one-and-one-half-stories with shallow-pitched roofs, wide eaves and a wide front porch, as illustrated by the residence at **704 Highgrove Road** (*Figure 16*).

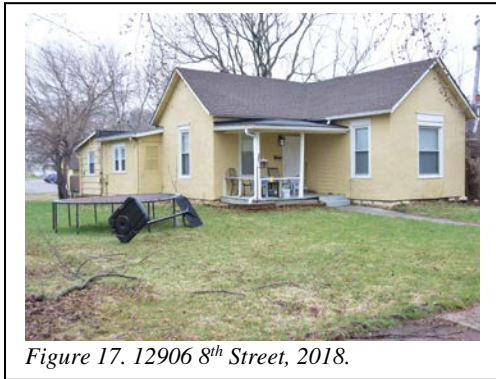
*Figure 17. 12906 8<sup>th</sup> Street, 2018.*

front gives the house its distinctive L-shaped massing. Architectural ornament is minimal. Both the one-story and two-story forms became common in the Midwest in the late nineteenth century. The residence at **12906 8<sup>th</sup> Street** is a good example of one of the nine Gable Front and Wing houses identified in the survey, with its steep cross-gable roof, narrow windows, and minimal ornament. (*Figure 17*).

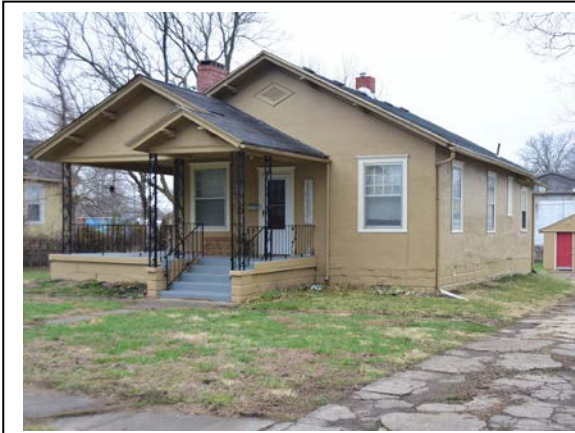
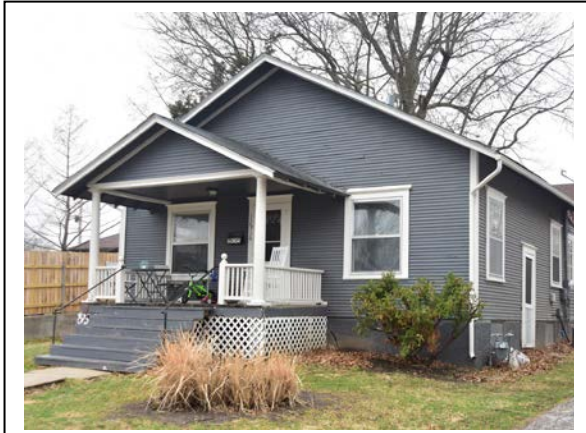
The Bungaloid dwelling shares many features with the Craftsman Bungalow, however it lacks the formal characteristics associated with the style. They possess side-gable, cross-gable, or front-gable roofs and one to one-and-one half stories in height. Architectural ornament is minimal, however modestly references Craftsman elements. Bungaloid dwellings are common in the Survey Area and account for eighteen percent of the residential resources. The residences at **12904 8<sup>th</sup> Street** and **12916 10<sup>th</sup> Street** are good examples of the forty bungaloid houses identified in the survey, with their front-gable roofs, open eaves and porches, and minimal ornament (*Figures 18 and 19*).

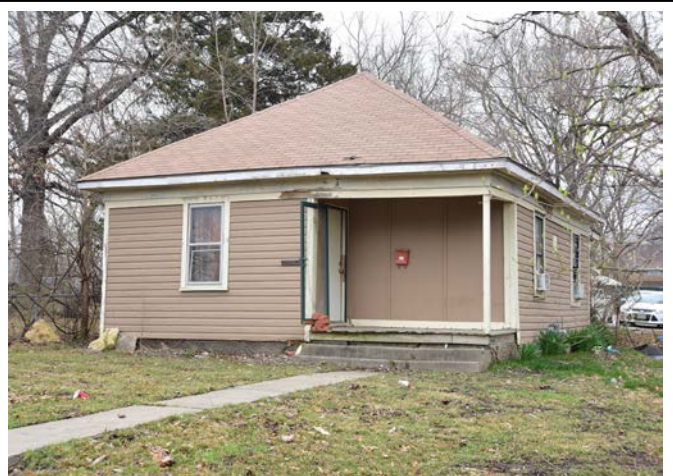
Figure 20. 13124 4<sup>th</sup> Street, 2018.

The Pyramid Square house at **13124 4<sup>th</sup> Street** is a compact one-story dwelling with low pitched roof and recessed partial-width porch and is representative of the one-story pyramidal roof houses within the Survey Area (*Figure 20*).

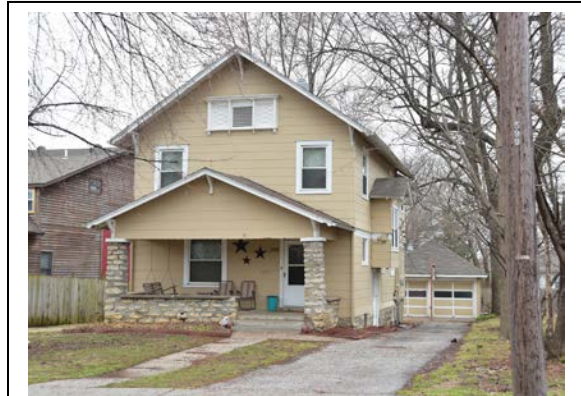
*Figure 21. 13008 Grandview Road, 2018.*

Seven Pyramidal/Hipped Roof resources in the Survey Area have the form and massing commonly referred to as the American Foursquare. Such resources are square in plan and have full-width porches with gabled roofs with eave returns or shallow hipped roofs with center dormers (*Figure 21, 13008 Grandview Road*). The square plan, massing, shallow hip roof with dormer, and overhanging eaves identify the dwelling at **13012 Grandview Road** as an American Foursquare house. (*Figure 22*).

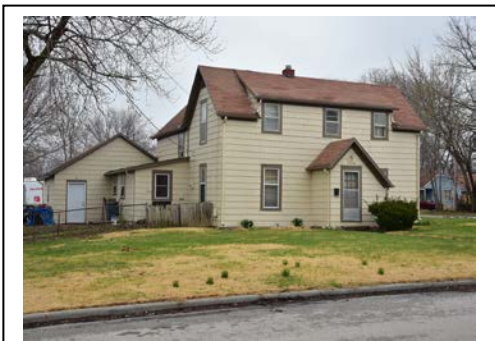
*Figure 23. 506 Pinkston Avenue, 2018.*

height of the house. The railroad increased the accessibility of the primary components of the balloon frame, primarily longer pieces of lumber and mass-produced metal nails. Alterations and additions were often constructed on the rear elevation. The Survey identified one example of the I-house form and seven examples of the Hall & Parlor family. The dwelling at **506 Pinkston Avenue** is a simple example of the I-house form, with its narrow, rectangular plan and center entrance. (*Figure 23*).

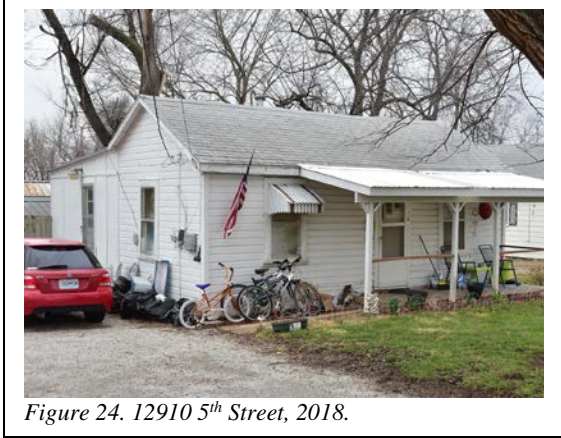
Figure 24. 12910 5<sup>th</sup> Street, 2018.

The residence at **12910 5<sup>th</sup> Street** is an example of the Hall & Parlor form (*Figure 24*). Although alterations to the porch compromises its integrity, the dwelling otherwise retains good integrity.

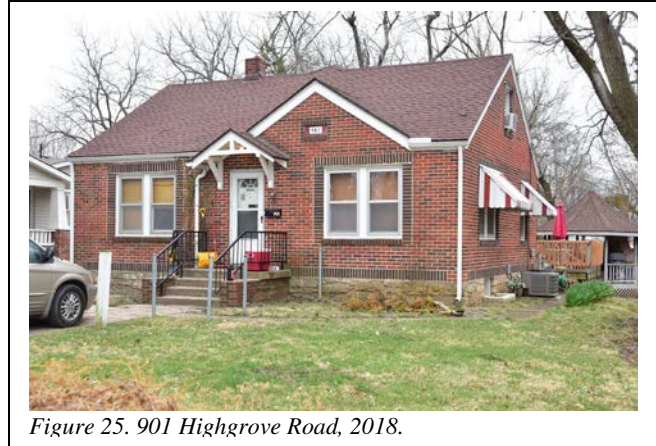
Figure 25. 901 Highgrove Road, 2018.

Minimal Traditional dwellings evolved in the 1940s from the Tudor Revival and Colonial Revival styles of the 1920s and 30s. The simplified version that evolved after the Depression typically retained the dominant side gable form and the dormered roof while compacting the massing, tightening the eaves, and removing most of the decorative ornament. The resources have symmetrical façades with small side additions, as can be seen at **901 Highgrove Road**. (Figure 25).

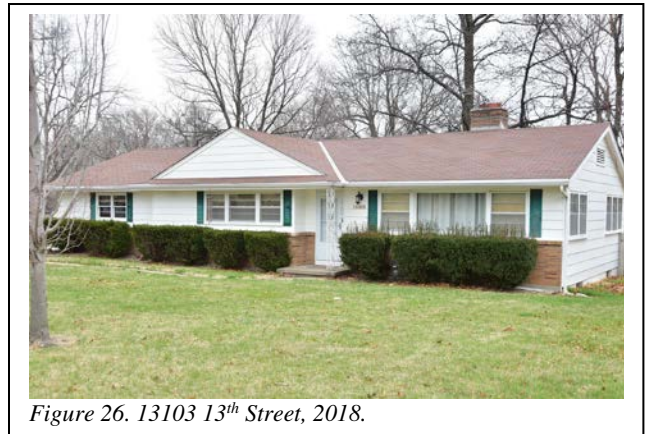
Figure 26. 13103 13<sup>th</sup> Street, 2018.

The basic Ranch House is a low, wide one-story building with moderate to wide eaves. The low-pitched roof may be gabled or hipped; the façade may be symmetrical or asymmetrical, with the latter being far more common; and the plan may or may not include an integrated garage. The survey identified thirty-one examples of the Ranch form including one split-level Ranch. As illustrated by **13103 13th Street**, these simple dwellings have shallow roofs, asymmetrical facades; aluminum, vinyl, or asbestos shingle siding with brick or stone veneer, a variety of window types and sizes, and an attached garage. (Figure 26).

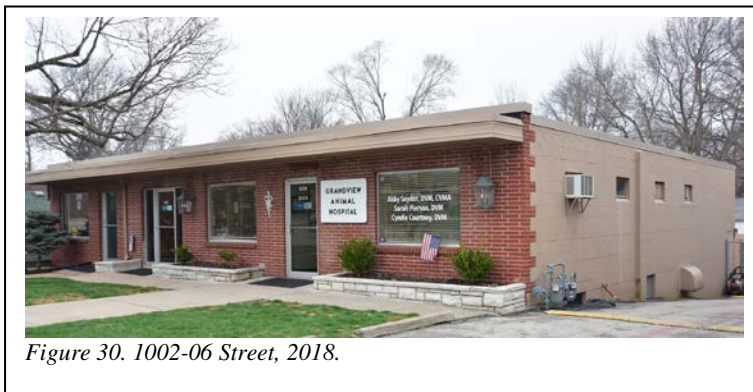
Figure 30. 1002-06 Street, 2018.

**1002-06 Main Street** is an excellent example of a mid-twentieth century Free-Standing Commercial Block. (Figure 30).

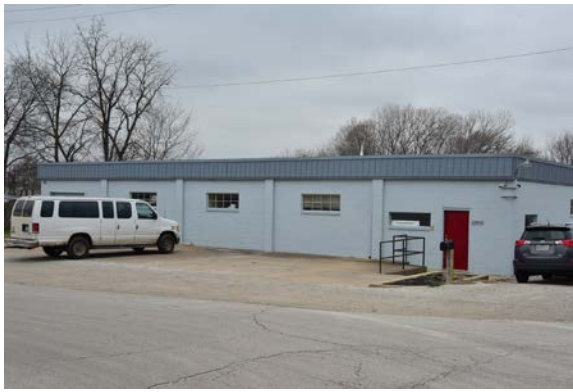
Figure 31. 12800 5<sup>th</sup> Street, 2018.

Four resources relating to industry or processing were recorded. These resources are located near the railroad tracks in the west end of the Survey Area and were designed to serve specific functions. Except for a ca. 1970 steel radio antenna tower at the west end of Main Street, they are one-story concrete block buildings with rectangular plans. The fenestration, door openings, and loading areas of each resource reflect the original use. Two resources, **12800 5<sup>th</sup> Street** and **12921 5<sup>th</sup> Street** retain good integrity (Figures 31 and 32).

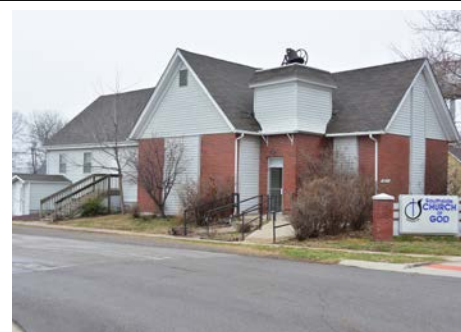
Figure 33. 12908 8<sup>th</sup> Street, 2018.

The survey included two churches. Constructed in 1908, the steepled-ell church at **12908 8<sup>th</sup> Street** has been significantly altered (*Figure 33*). Alterations include a modern rear addition with a gabled roof, application of non-historic cladding, and the removal or covering of the original block's fenestration. A ca. 1970 two-story Modern Movement church with a rectangular plan is located at **13011 Grandview Road**. The windows have been replaced and a full-height aluminum-framed system of colored glass and a pair of doors at the church's north entrance has been removed. This ca. 1970 resource is nearly fifty years of age (*Figure 34*).

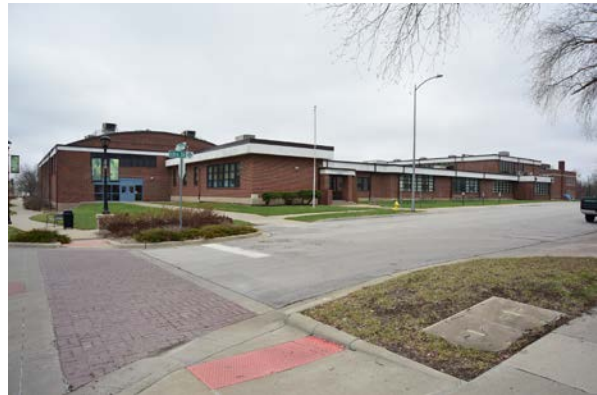
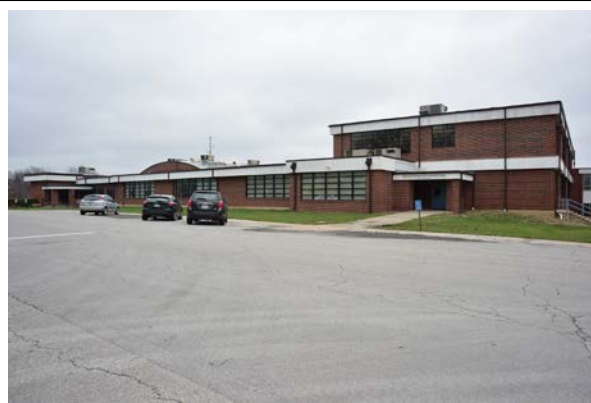
One school complex was identified in this survey. It occupies a large parcel near the eastern boundary of the Survey Area. The lot is bound by Main Street to the north, 12<sup>th</sup> Street to the west, Highgrove Road to the south, and 10<sup>th</sup> Street to the east. The complex includes a ca. 1922 two-story original block with brick walls, rectangular footprint, and stone beltcourses and sills (*Figure 35*). The school was expanded in 1949 and again in 1952. Both additional blocks feature brick walls and bands of metal windows characteristic of their mid-twentieth century construction (*Figures 36 and 37*).

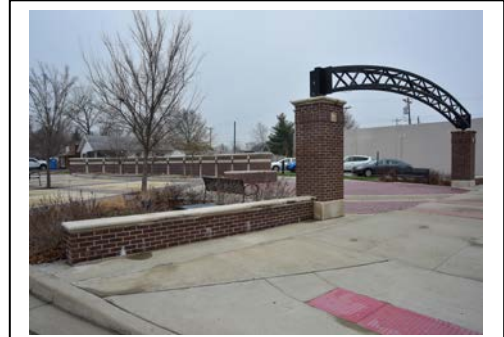
*Figure 38. 12908 8th Street, 2018.*

One public plaza was identified. This space is located at the northeast corner of Main and 8<sup>th</sup> Street (*Figure 38*). A water feature is surrounded by red and buff pavers. Landscaping beds and public benches are positioned throughout the plaza. Constructed in 2013, this resource has not yet attained fifty years of age.

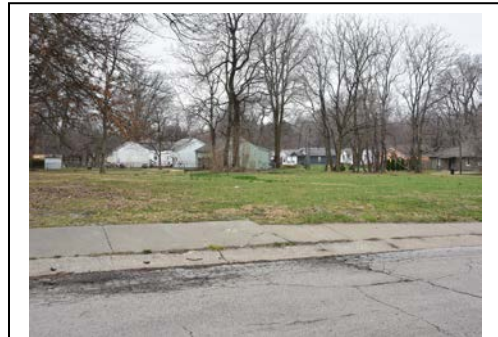
*Figure 40. 803 Highgrove Road, 2018.*

A total of nineteen vacant lots was identified. These lots are primarily located between the two sets of Kansas City Southern Railroad tracks at the west end of the Survey Area. These lots are characterized by open grassy areas. Three lots have become vacant since the 2003 survey. These lots are located at 13002 5<sup>th</sup> Street, 13019 5<sup>th</sup> Street, and 803 Highgrove Road (*Figure 40*)

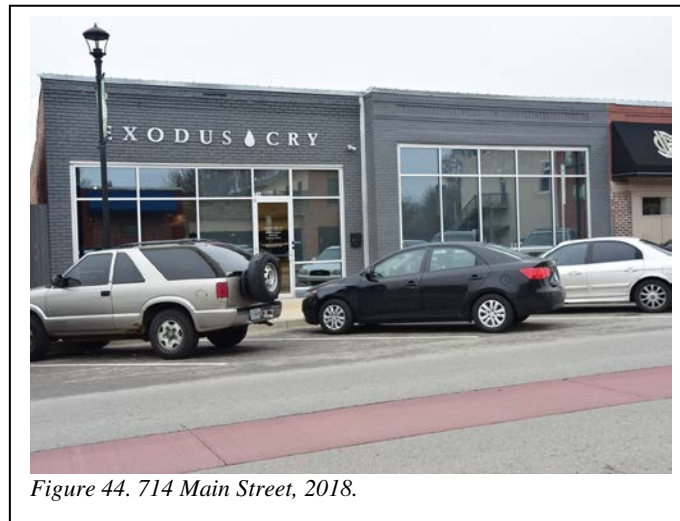
*Figure 44. 714 Main Street, 2018.*

Comparisons between the 2003 and recent survey data revealed much of the Survey Area has not experienced a significant change in integrity since the previous survey. Approximately fifty-eight percent of primary resources experienced no change in integrity. Roughly forty percent of primary resources exhibit a reduction in integrity between survey periods. The replacement of windows and cladding were widespread and the most commonly observed alterations which contributed to these changes in integrity. One resource exhibited improved integrity. Alterations to the storefront of 714 Main removed previous non-historic alterations, restoring the historic storefront openings (*Figure 44*). Five resources within the Survey Area were constructed after the 2003 survey period.
