**ARCHITECTURAL/HISTORIC INVENTORY FORM**

1. Survey No. SC-AS-012-0052		2. Survey Name: Reconnaissance Level Survey of Historic Downtown Wentzville	
3. County: St. Charles		4. Address (Street No.) 105	Street (name) South Linn Ave
5. City: Wentzville	Vicinity: <input type="checkbox"/>	6. UTM:	
8. Historic name (if known):		9. Present/other name (if known): Land Fair Corp.	
10. Ownership: <input type="checkbox"/> Private <input type="checkbox"/> Public		11a. Historic use (if known): COMMERCE/TRADE	11b. Current use: COMMERCE/TRADE/professional
5. City: Wentzville		7. Township/Range/Section:

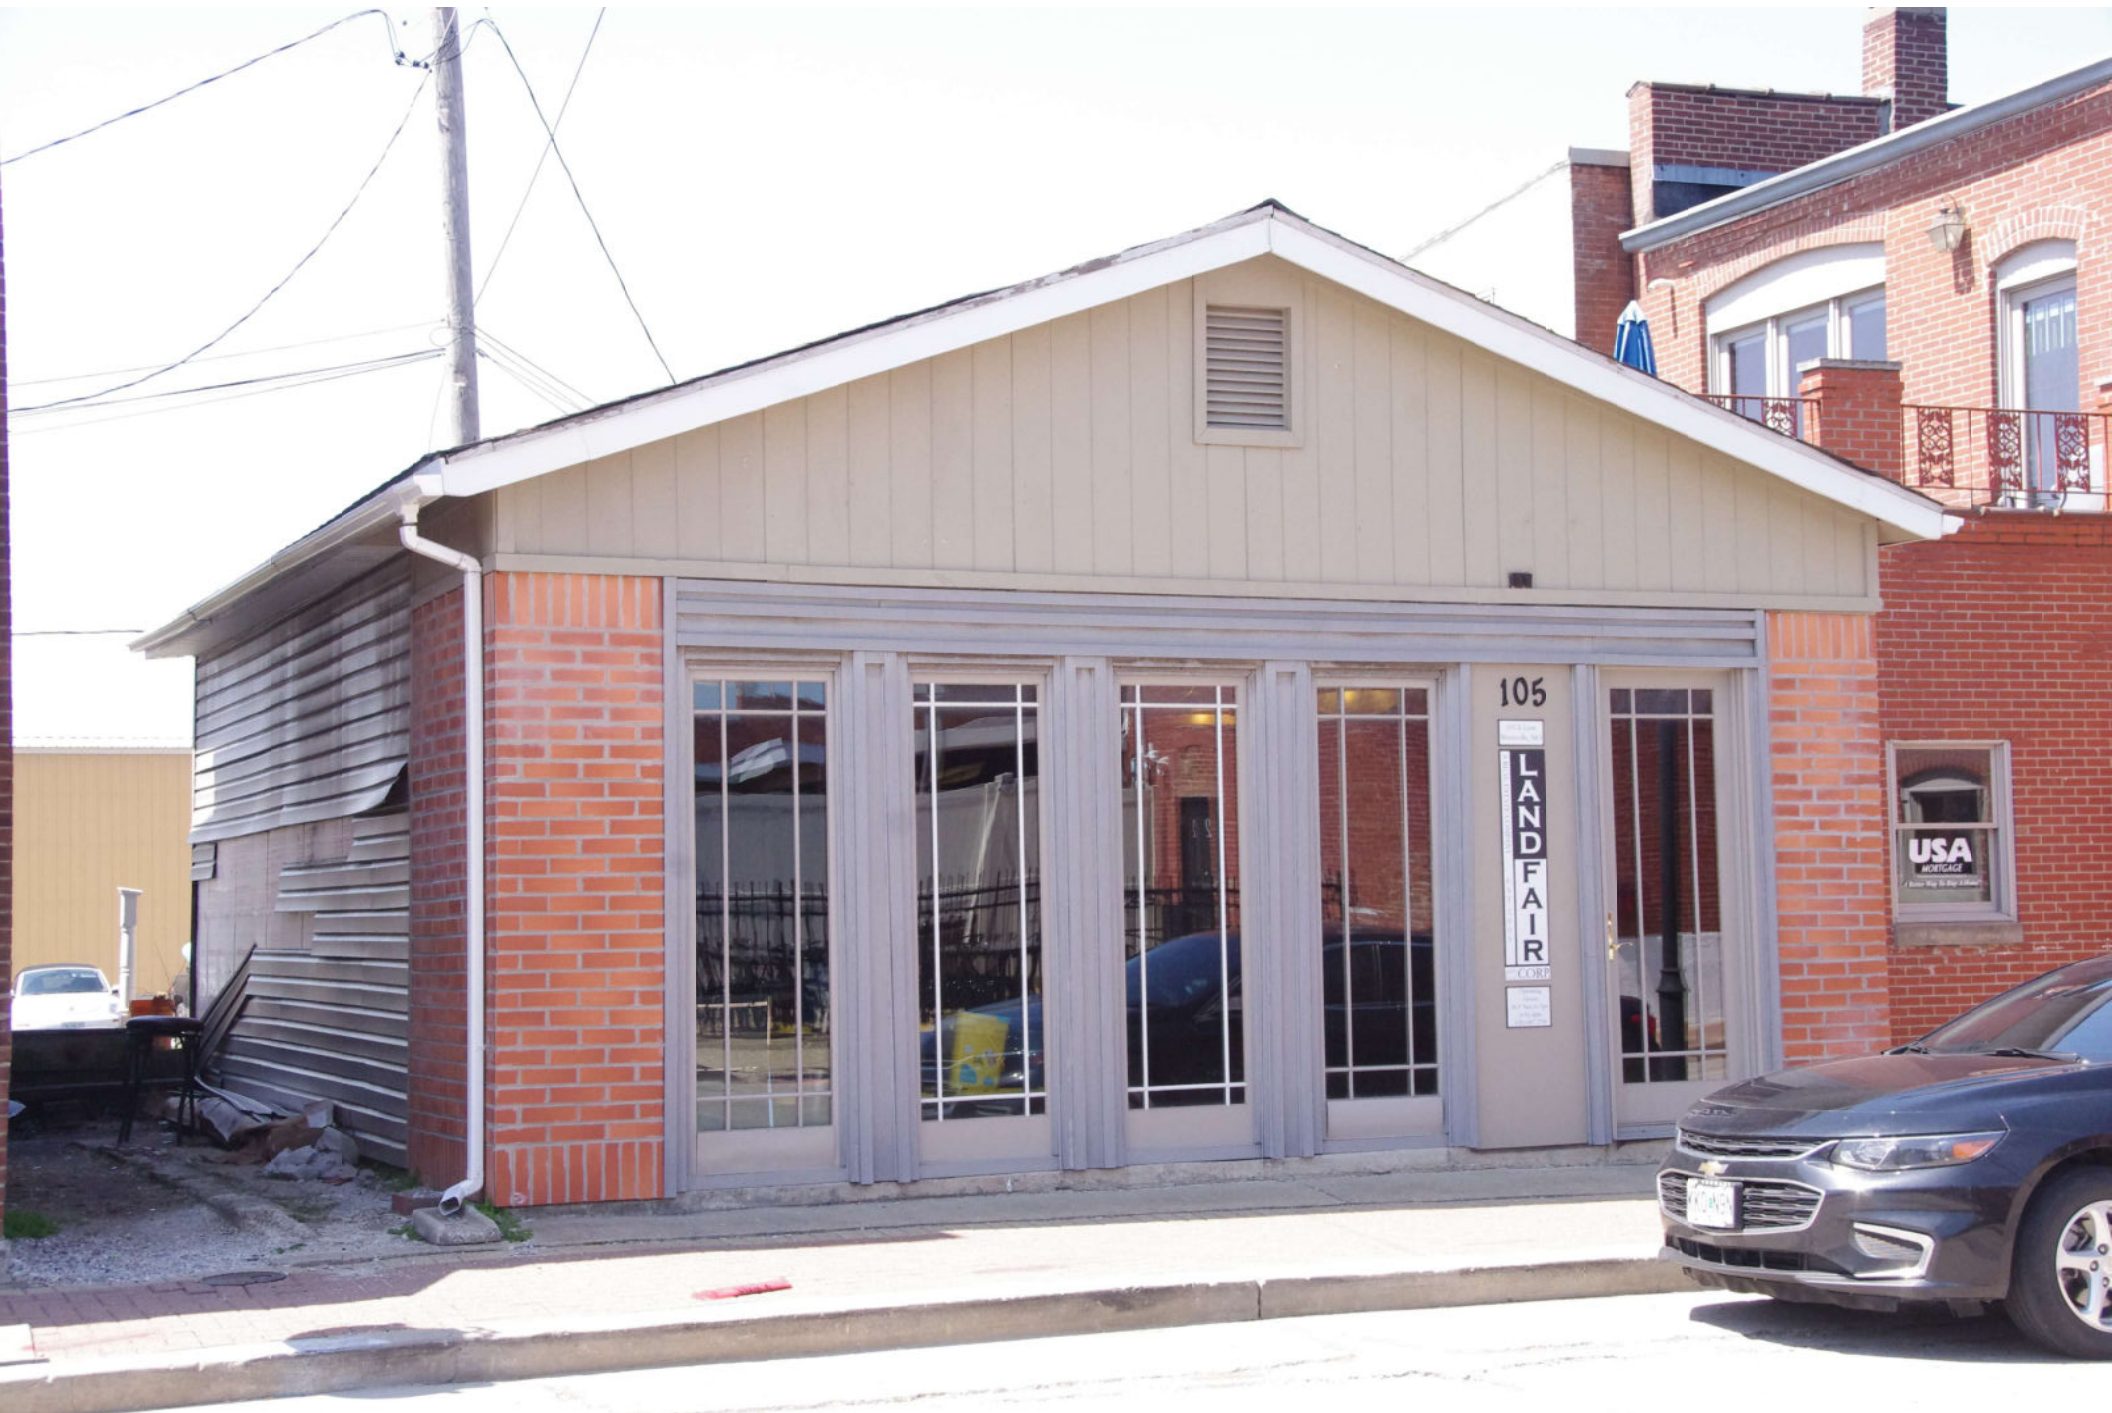
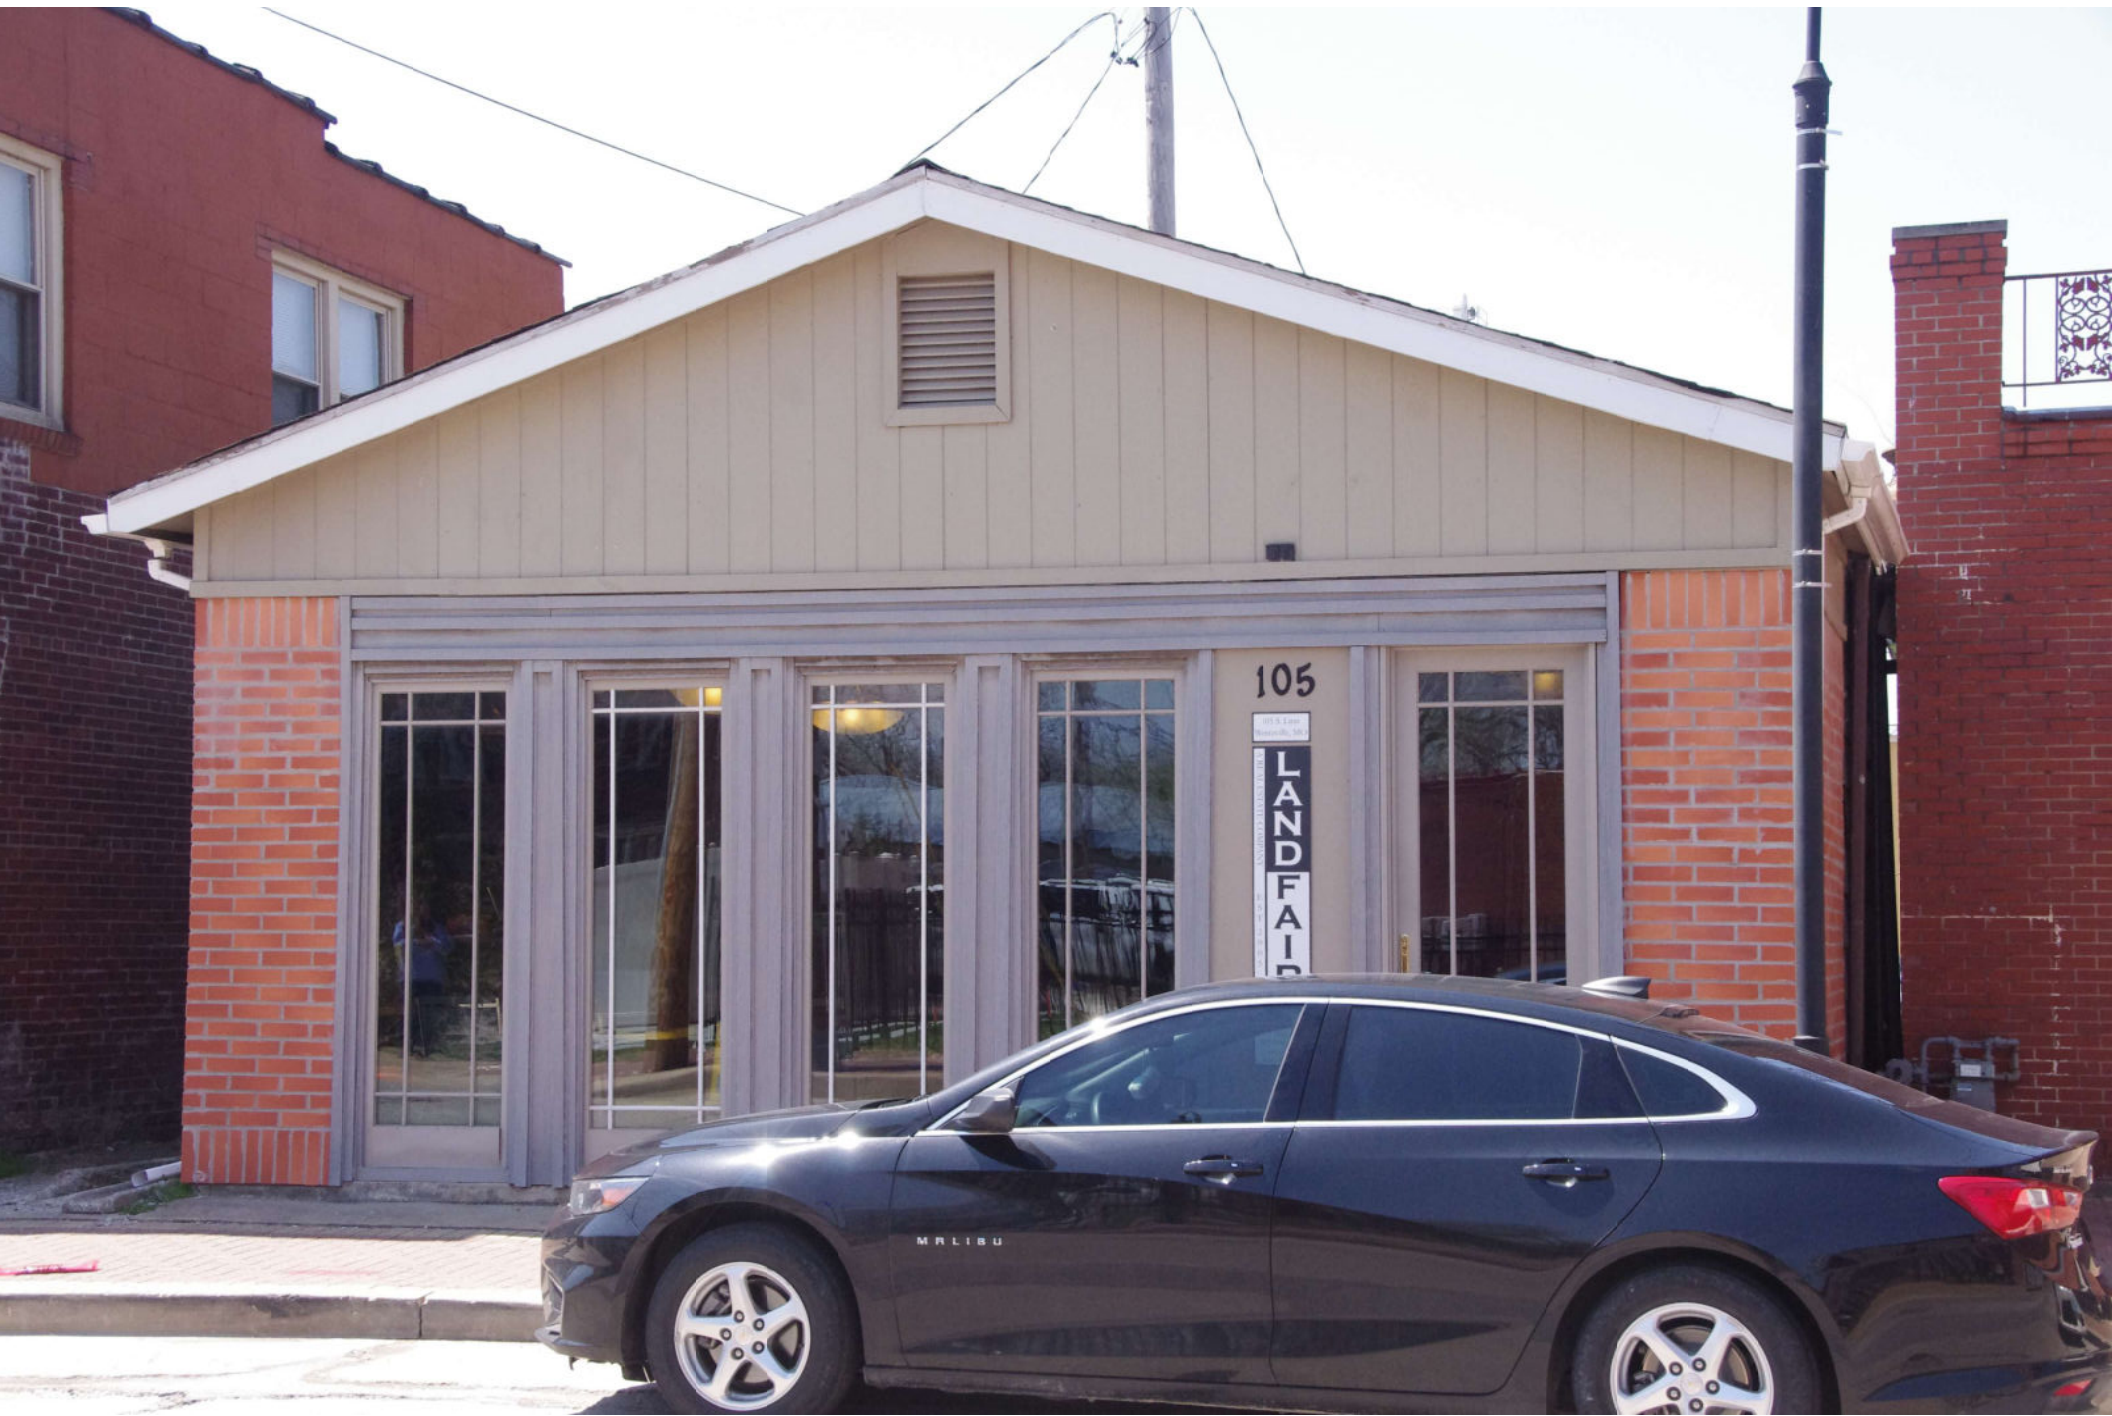
105

This is a one-story gabled brick and vinyl building that faces South Linn. The entrance includes a wood and glass door in the northern bay, and four full length vertical windows fill the remainder of the facade. The gable is filled with wood paneling. Since this was shown as a frame building on the 1927 fire insurance map, the current building on this property may be the same structure, with the brick veneer added at a later date and the type of brickwork (with soldier courses top and bottom of the brick corner piers) does seem to indicate it was laid more recently, possibly in 2005 when it appears renovations were done for the current occupant when it opened for business. While the south wall had been clad with vinyl siding, some sort of damage had removed some of the siding, exposing the wall beneath, which appears to be poured concrete. Because of the extensive alterations, with a new display windows and even the finishes on the gable end, it is not possible to identify the historic elements or integrity of this building or whether this truly is the historic building from the 1905-1927 time period.

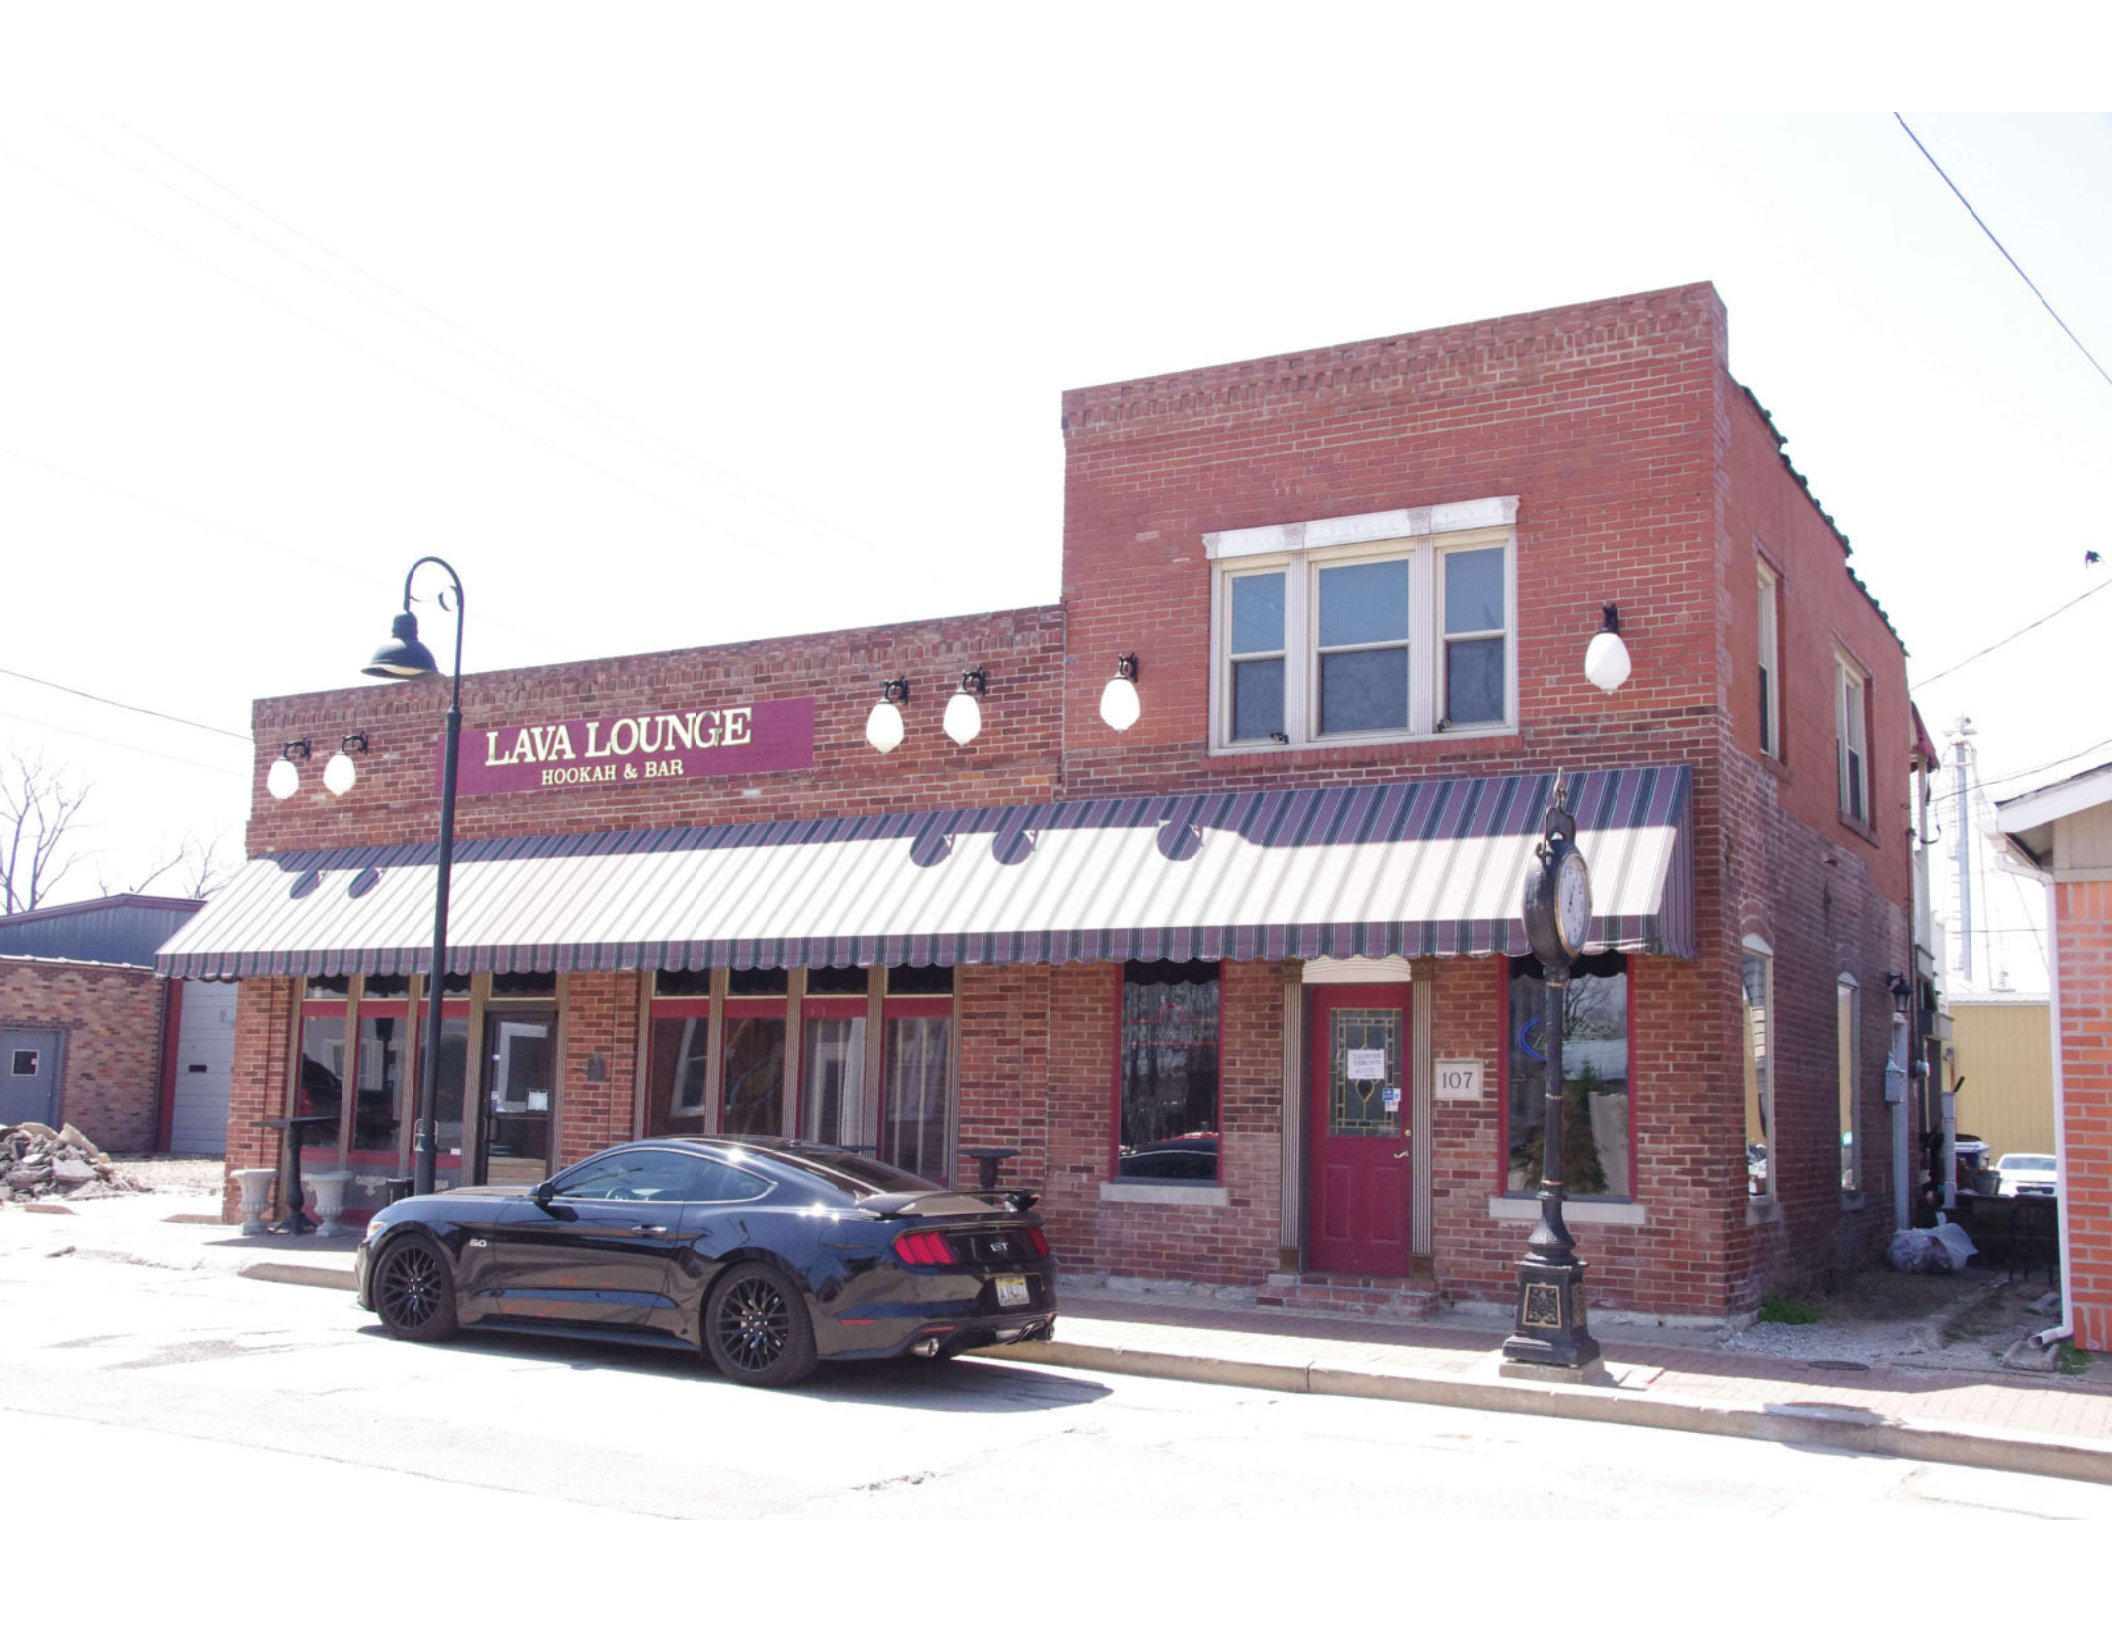
This building was originally two separate buildings, but it is connected internally now as a single business (bar). The two-story brick commercial building has a stone foundation and a flat roof and a simple brick dentil course at the top of the parapet. The leaded glass, half light wood door is a recent replacement; it is centered on the two story façade with cast iron pilaster strips added within the masonry opening (these do not appear to be original to the building since they are resting on brick steps). To either side are metal display windows with cast stone sills filling the outer two bays. On the north elevation there are two additional first floor window openings, with segmental arched lintels and single light, fixed windows. All of these windows are proportioned such that they probably originally had sashed windows. Replacement, one-over-one sash windows brick sills are found in triplicate in the upper bay of the façade. The upper level of the north elevation has a painted concrete block wall, and the upper façade has a different color brick than the lower façade and side walls, indicating the second floor was added at some point, probably in the 1940s. The other two storefront bays are still the original one-story storefronts connected with a single, simple brick parapet with a dentil course at the top and a projecting brick stringcourse at the base of the parapet. An additional turn-of-the-century brick commercial one-story building is now connected to the northern building. The façade includes two bays. The façade is occupied by two display window openings that have a series of vertical light display windows with transoms and wood panel kick plates, separated by what appears to be cast iron pilasters but these do not appear to be historic. These are found in quadruplet in the northern bay, and triplicate to the south of the metal and glass entry in the southern bay. A canvas awning runs the length of the building. On the south side, there are four segmental arched openings, three with replacement fixed single light windows and one with a commercial aluminum framed glass door and transom.

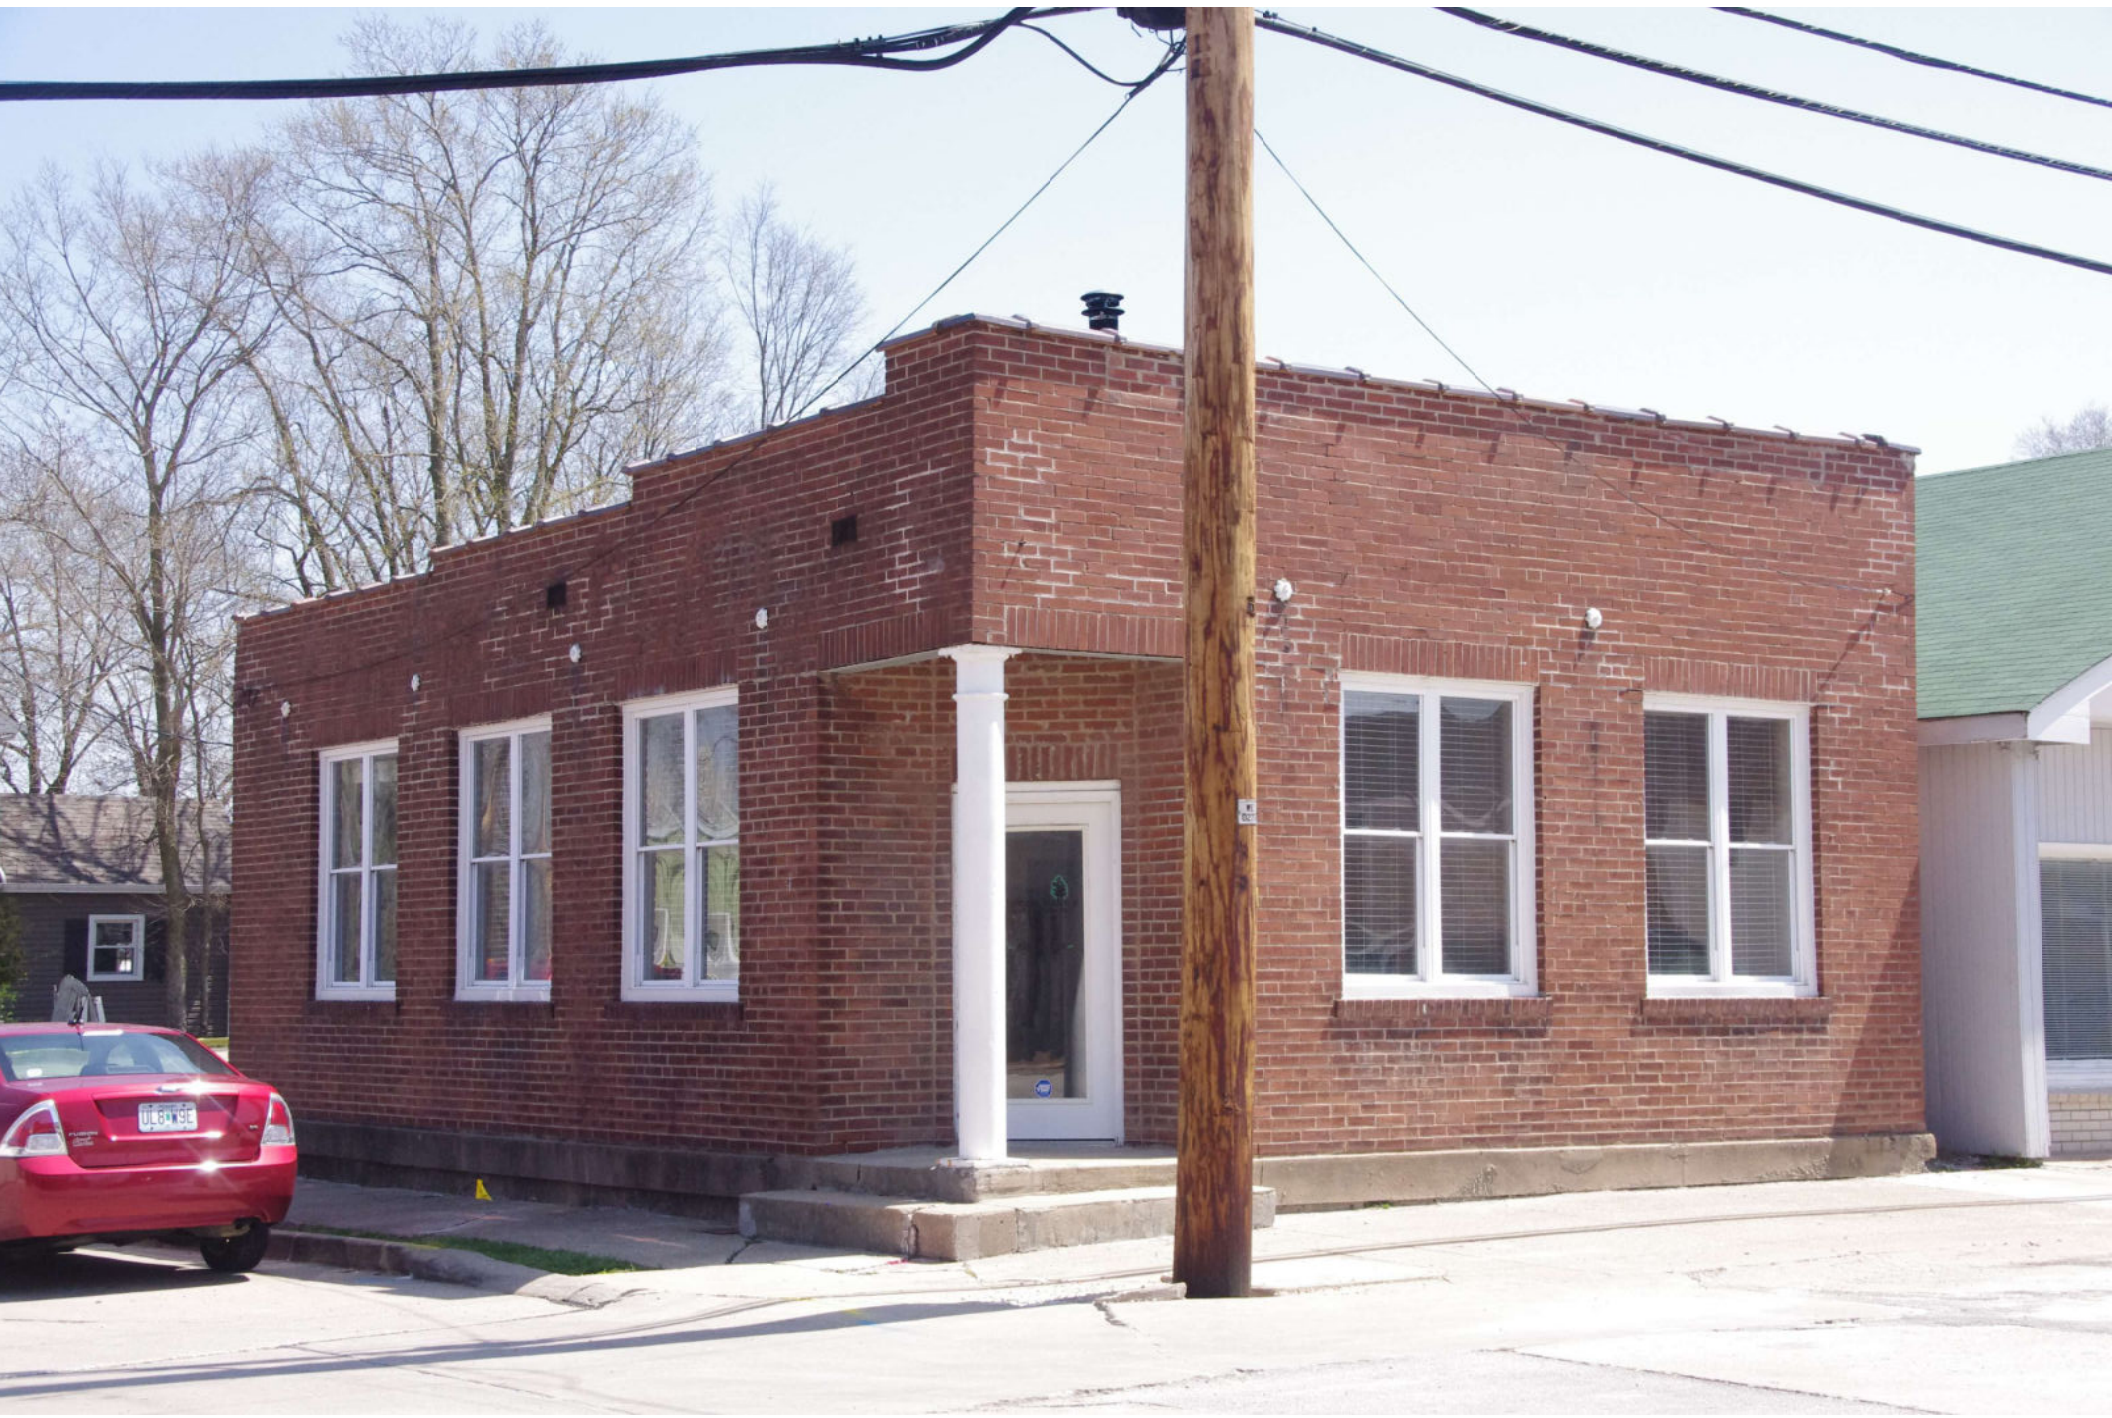
This one story, red brick, flat roofed commercial building has a clipped corner entry recessed under the squared off parapet that is supported by a Doric style cast iron column at the corner. The column rests on the corner of the thick poured concrete foundation that extends as a watertable on both street elevations, projecting slightly from the brick walls. There is an additional concrete step surrounding the corner entry opening down to the public sidewalk. The door is a replacement full light door. Both street elevations have replacement, paired, 1/1 sashed windows, 2 sets on the Linn elevation and 3 sets on the Pitman elevation, each with soldier course brick lintels, like the head of the corner entry opening. The parapet on the Linn façade was modified in 2017 (Google street views from June 2013 and August 2017), between the corner extensions; originally it had a stepped parapet on the middle of this façade that extended slightly higher than the corners, but it was originally capped with the same clay coping tiles and the stair stepped parapet on the Pitman elevation remains intact.

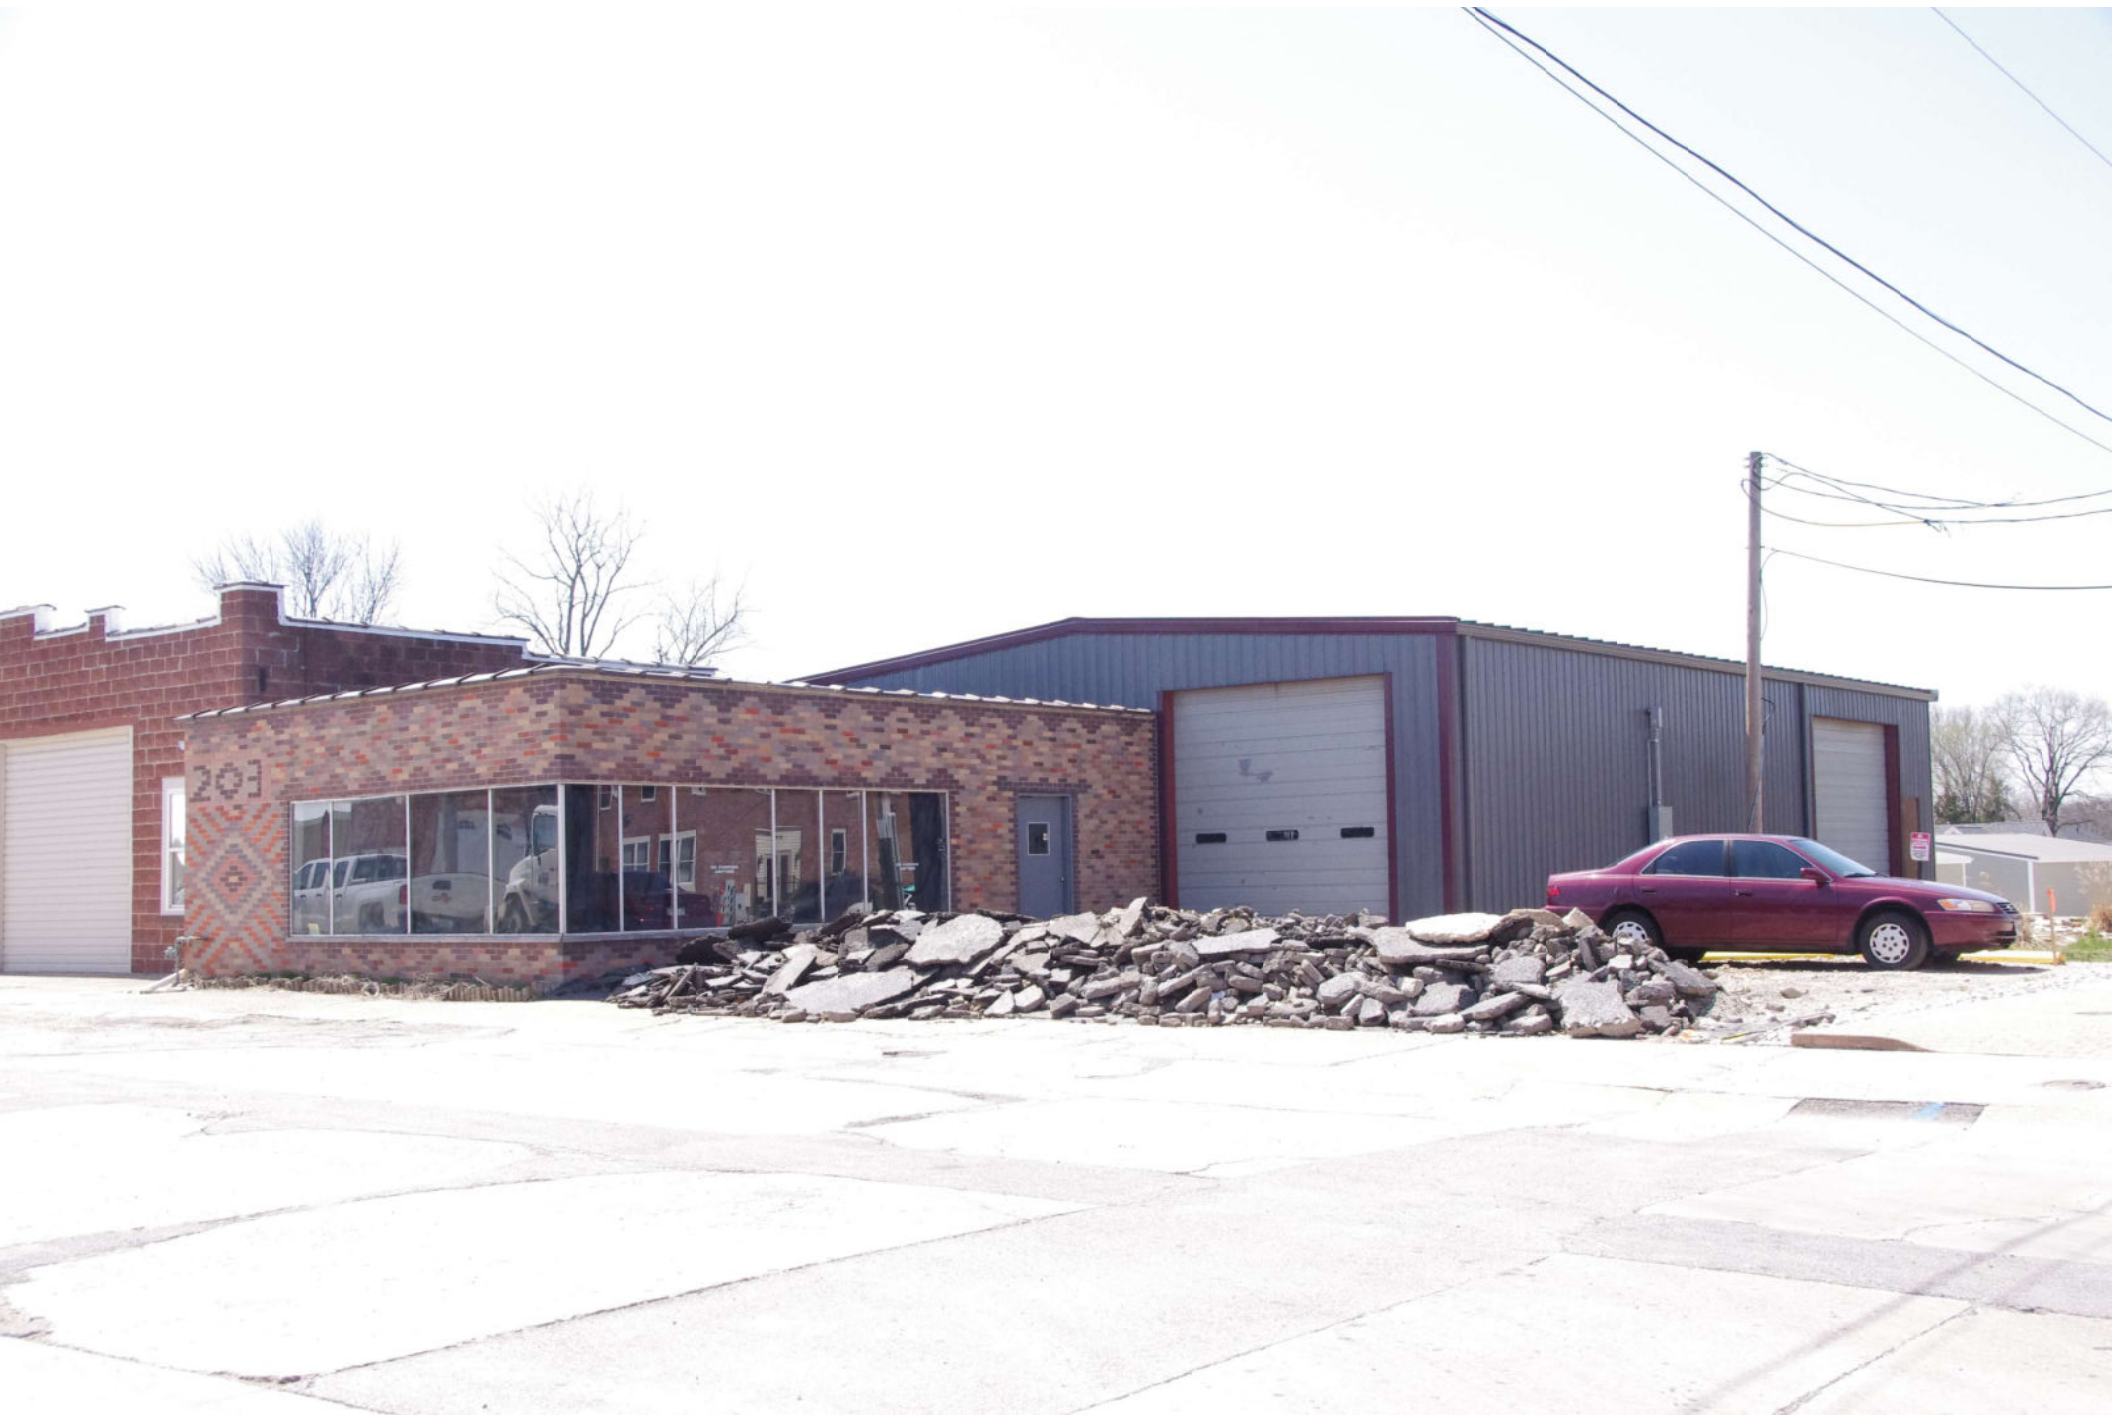
203

This resource is a one-story brick commercial building with a flat roof. The façade has been painted in a multicolored brick pattern and clay coping tiles now top of the parapet across the façade and north side (originally it had a simple concrete cap and was originally a buff colored brick, that was commonly used on clean lines of the Mid-Century Modern commercial buildings, as is the use of the corner display window--extending the band from the façade around to the north elevation and framing it with aluminum frames. The building retains the original window openings and the original frames, but the glass has been replaced with with a tinted glass. The entry door, located on the north elevation appears to be the original door opening but it has a replacement steel door with a small rectangular light. The alterations are simply cosmetic (paint on the brick and tint on the glass) and as such the building would still contribute to a proposed historic district.

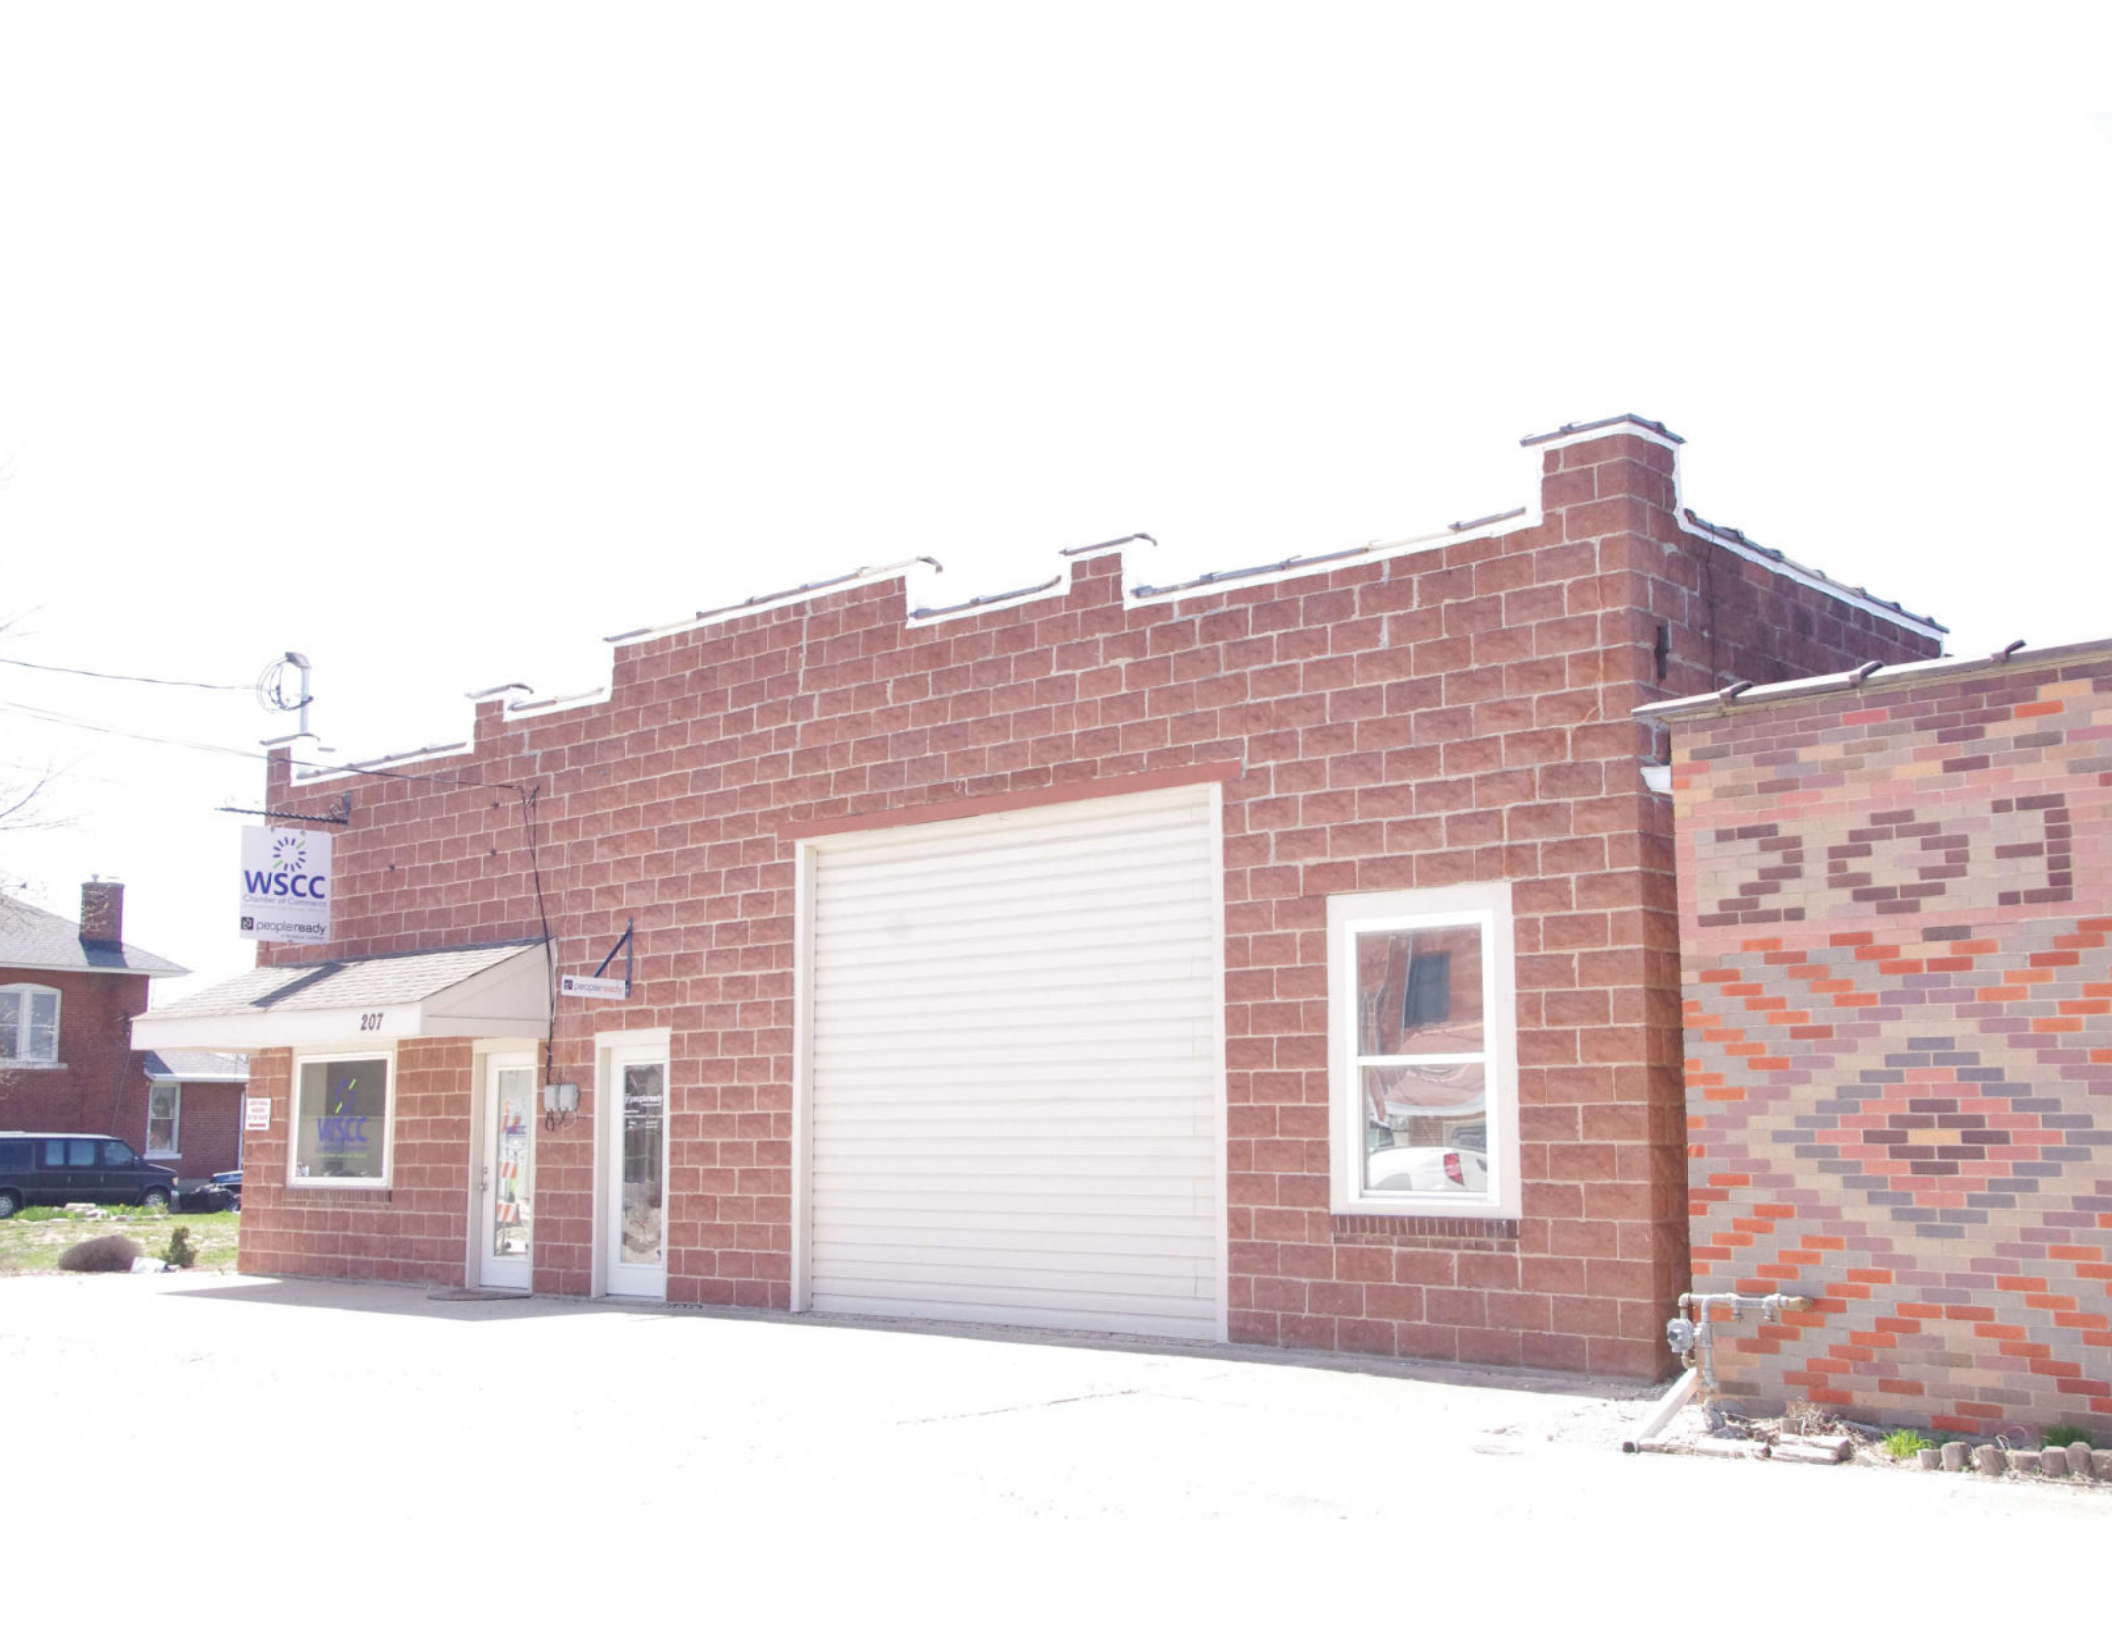
This resource is a one-story, cast rock faced block service garage building with a a clay coping tile stepped parapet roofline. The northern bay includes a replacement one-over-one sash window. Beside it is an steel coil overhead garage door within the original garage door opening. Located just south of center is a full light wood commercial door. A shingled awning covers the southern bays, which include a full light wood door and a square display window. While the windows and doors are replacements, they retain the original openings on the building. Unfortunately, the new EPDM roofing was wrapped under the clay coping tiles but anchored to the face of the parapet, creating a white outline at the stepped parapet.
