**ARCHITECTURAL/HISTORIC INVENTORY FORM**

1. Survey No. SC-AS-012-0052		2. Survey Name: Reconnaissance Level Survey of Historic Downtown Wentzville	
3. County: St. Charles		4. Address (Street No.) 105	Street (name) South Linn Ave
5. City: Wentzville	Vicinity: <input type="checkbox"/>	6. UTM:	
8. Historic name (if known):		9. Present/other name (if known): Land Fair Corp.	
10. Ownership: <input type="checkbox"/> Private <input type="checkbox"/> Public		11a. Historic use (if known): COMMERCE/TRADE	11b. Current use: COMMERCE/TRADE/professional
5. City: Wentzville		7. Township/Range/Section:

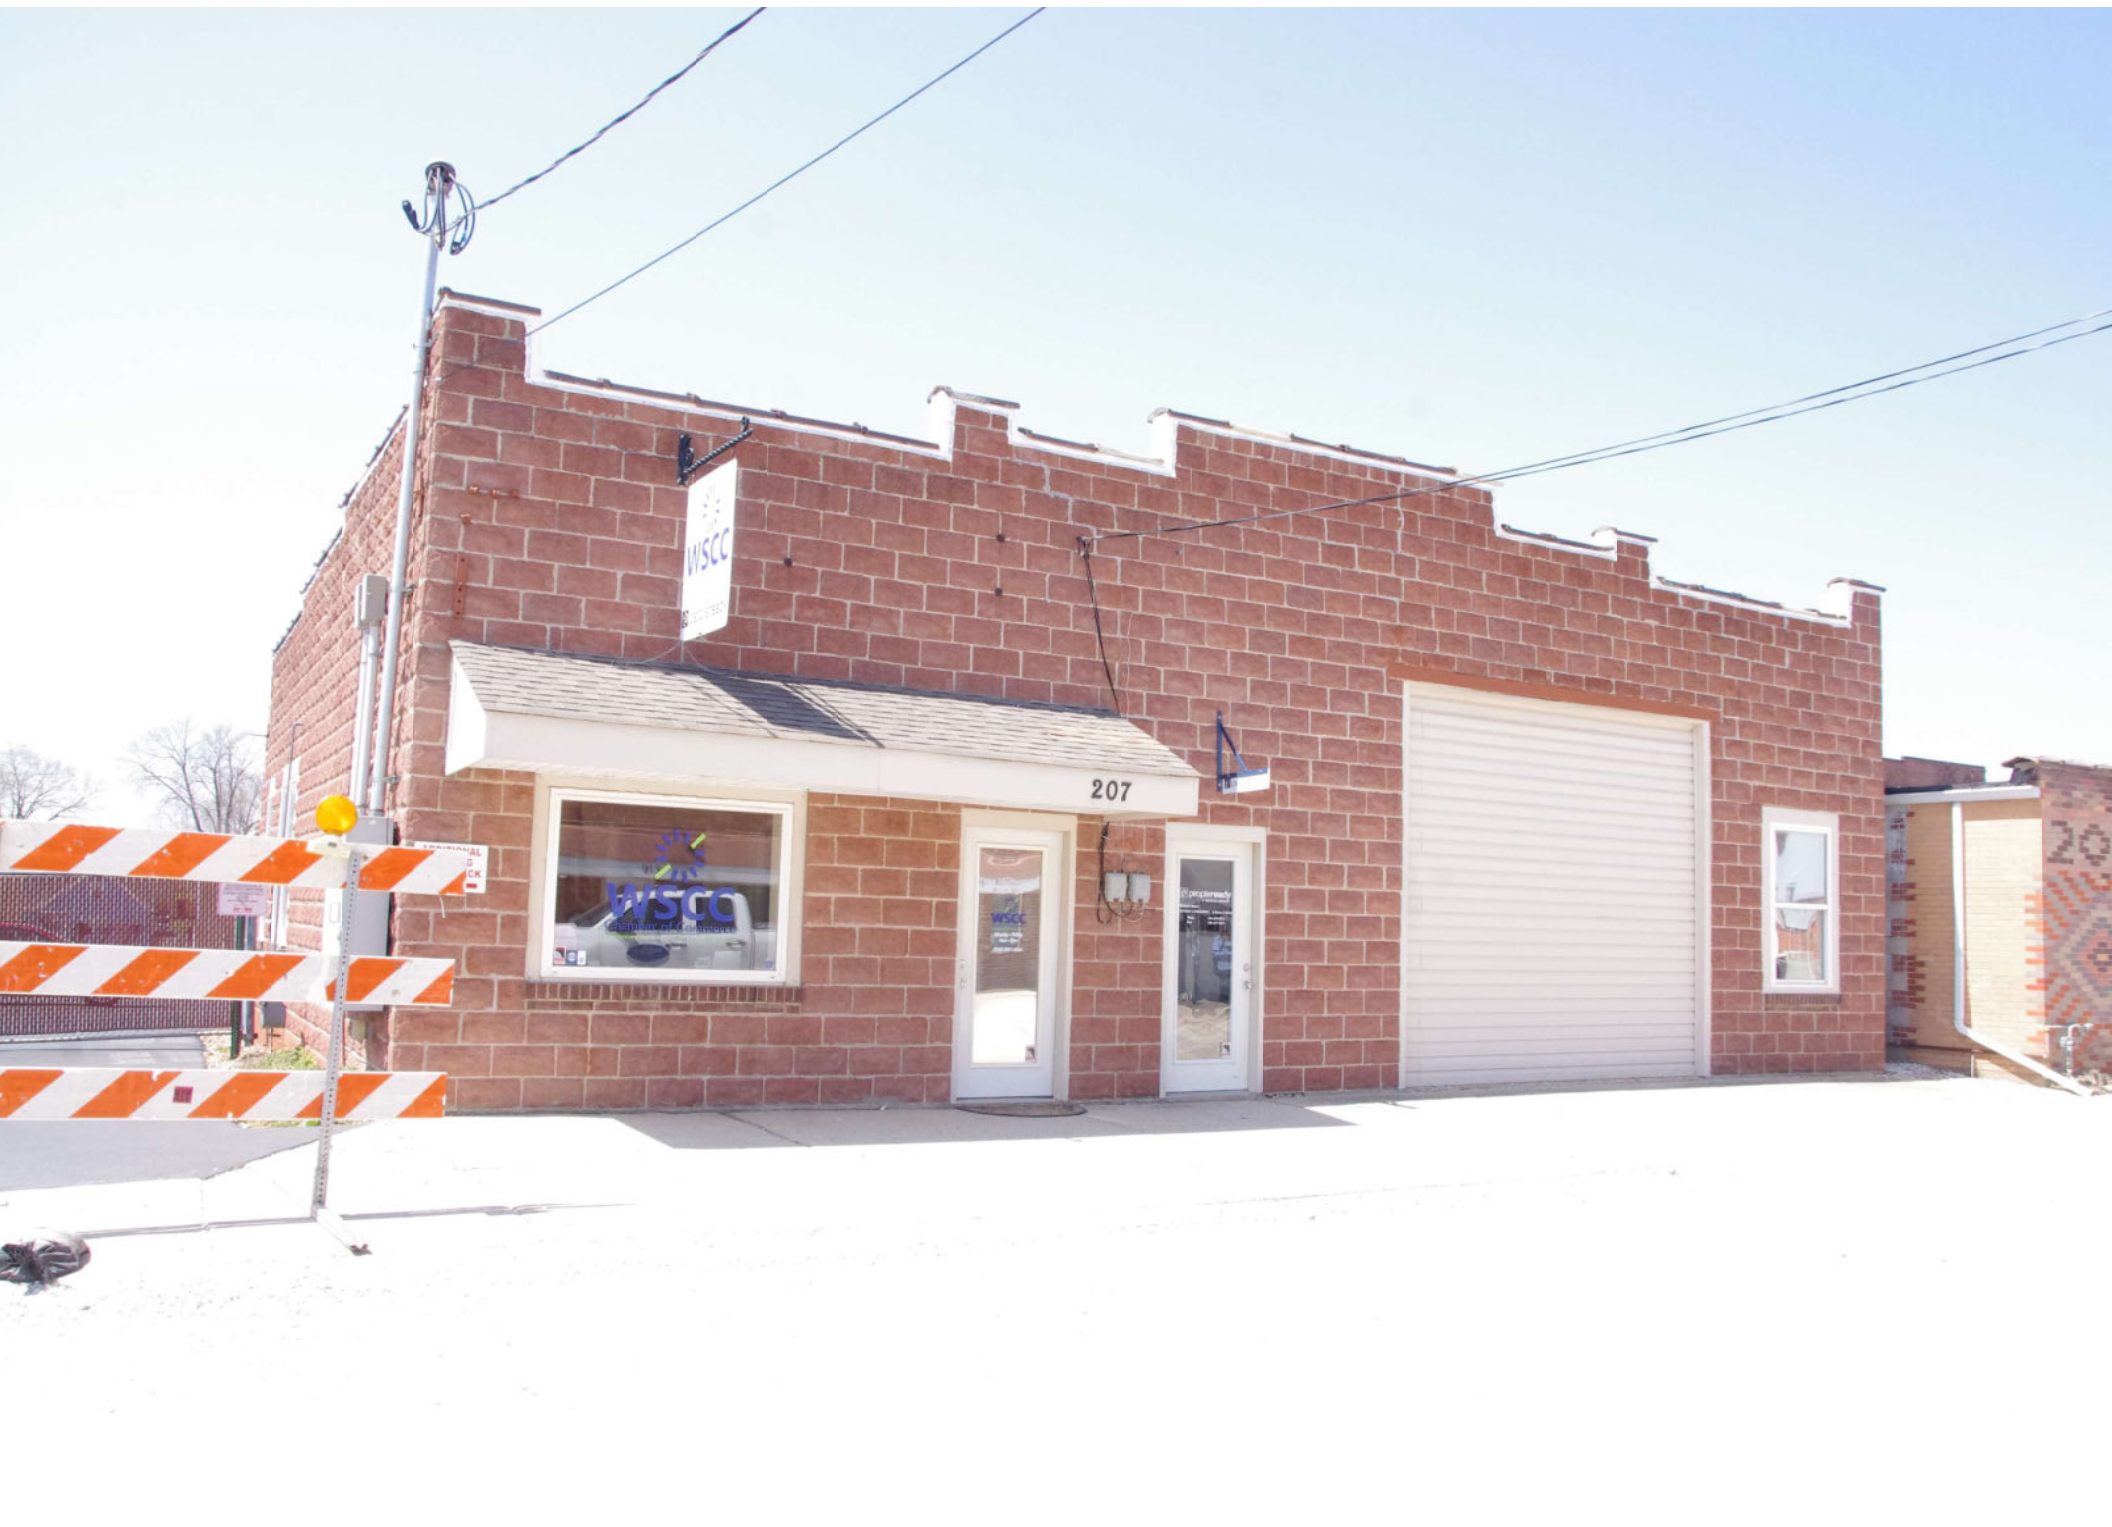
207

This resource is a one-story, cast rock faced block service garage building with a a clay coping tile stepped parapet roofline. The northern bay includes a replacement one-over-one sash window. Beside it is an steel coil overhead garage door within the original garage door opening. Located just south of center is a full light wood commercial door. A shingled awning covers the southern bays, which include a full light wood door and a square display window. While the windows and doors are replacements, they retain the original openings on the building. Unfortunately, the new EPDM roofing was wrapped under the clay coping tiles but anchored to the face of the parapet, creating a white outline at the stepped parapet.

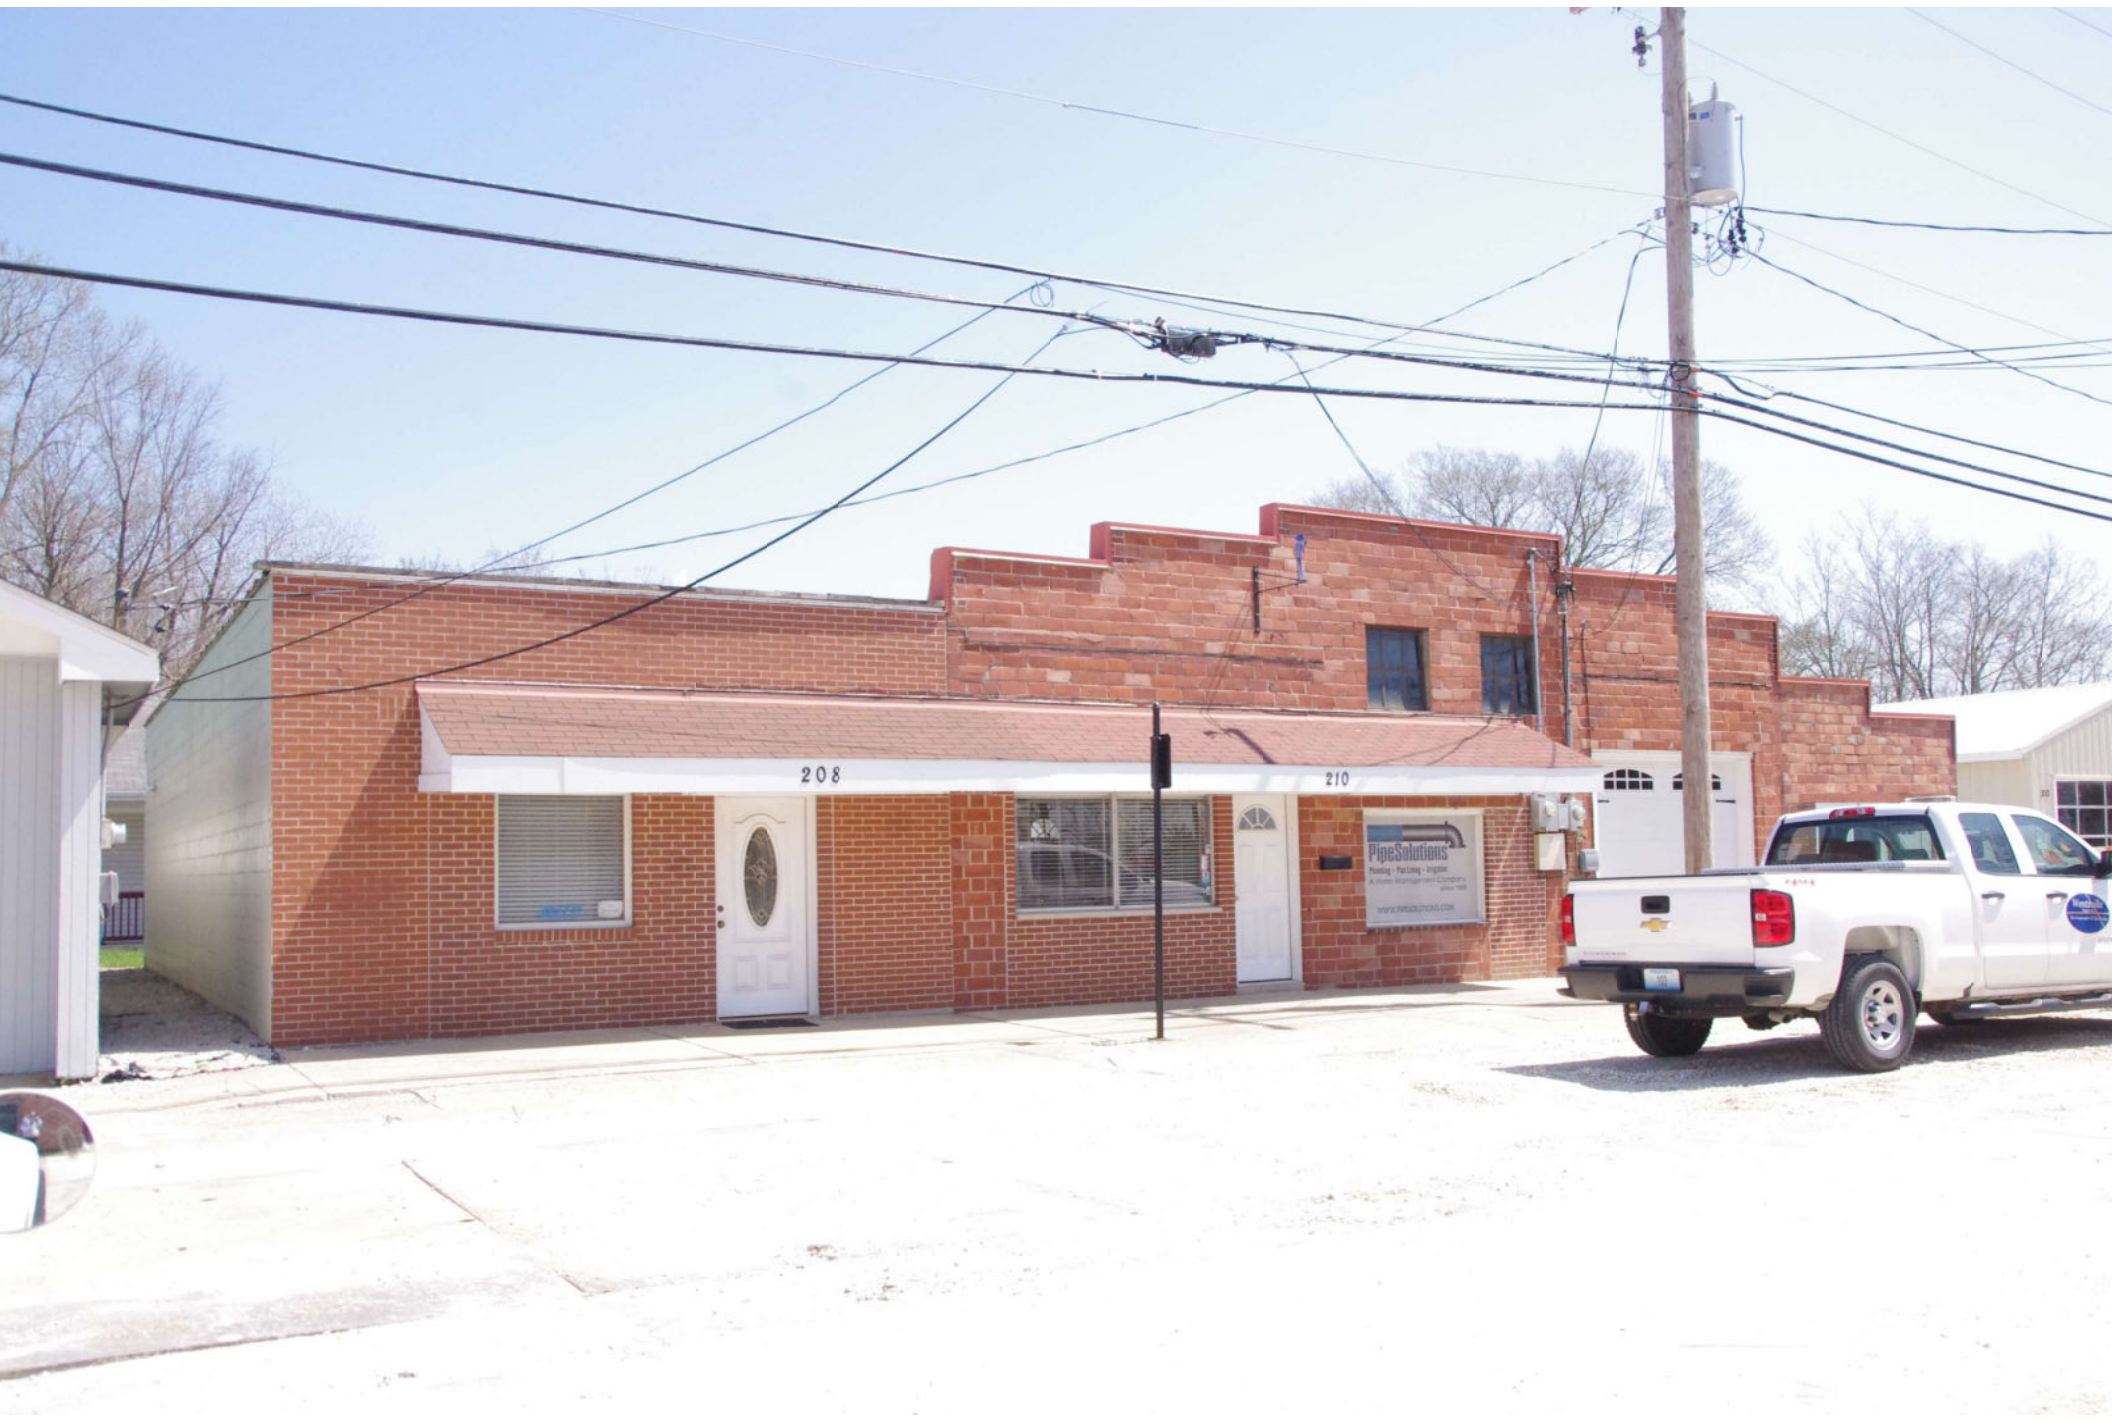
This resource is a one-story brick commercial structure with a concrete foundation and a corrugated metal shed roof, sloping to the north with a shallow parapet on the facade. It originally had a garage door opening on the façade, but that has been infilled with brick and a oval light paneled door and small metal framed display window.

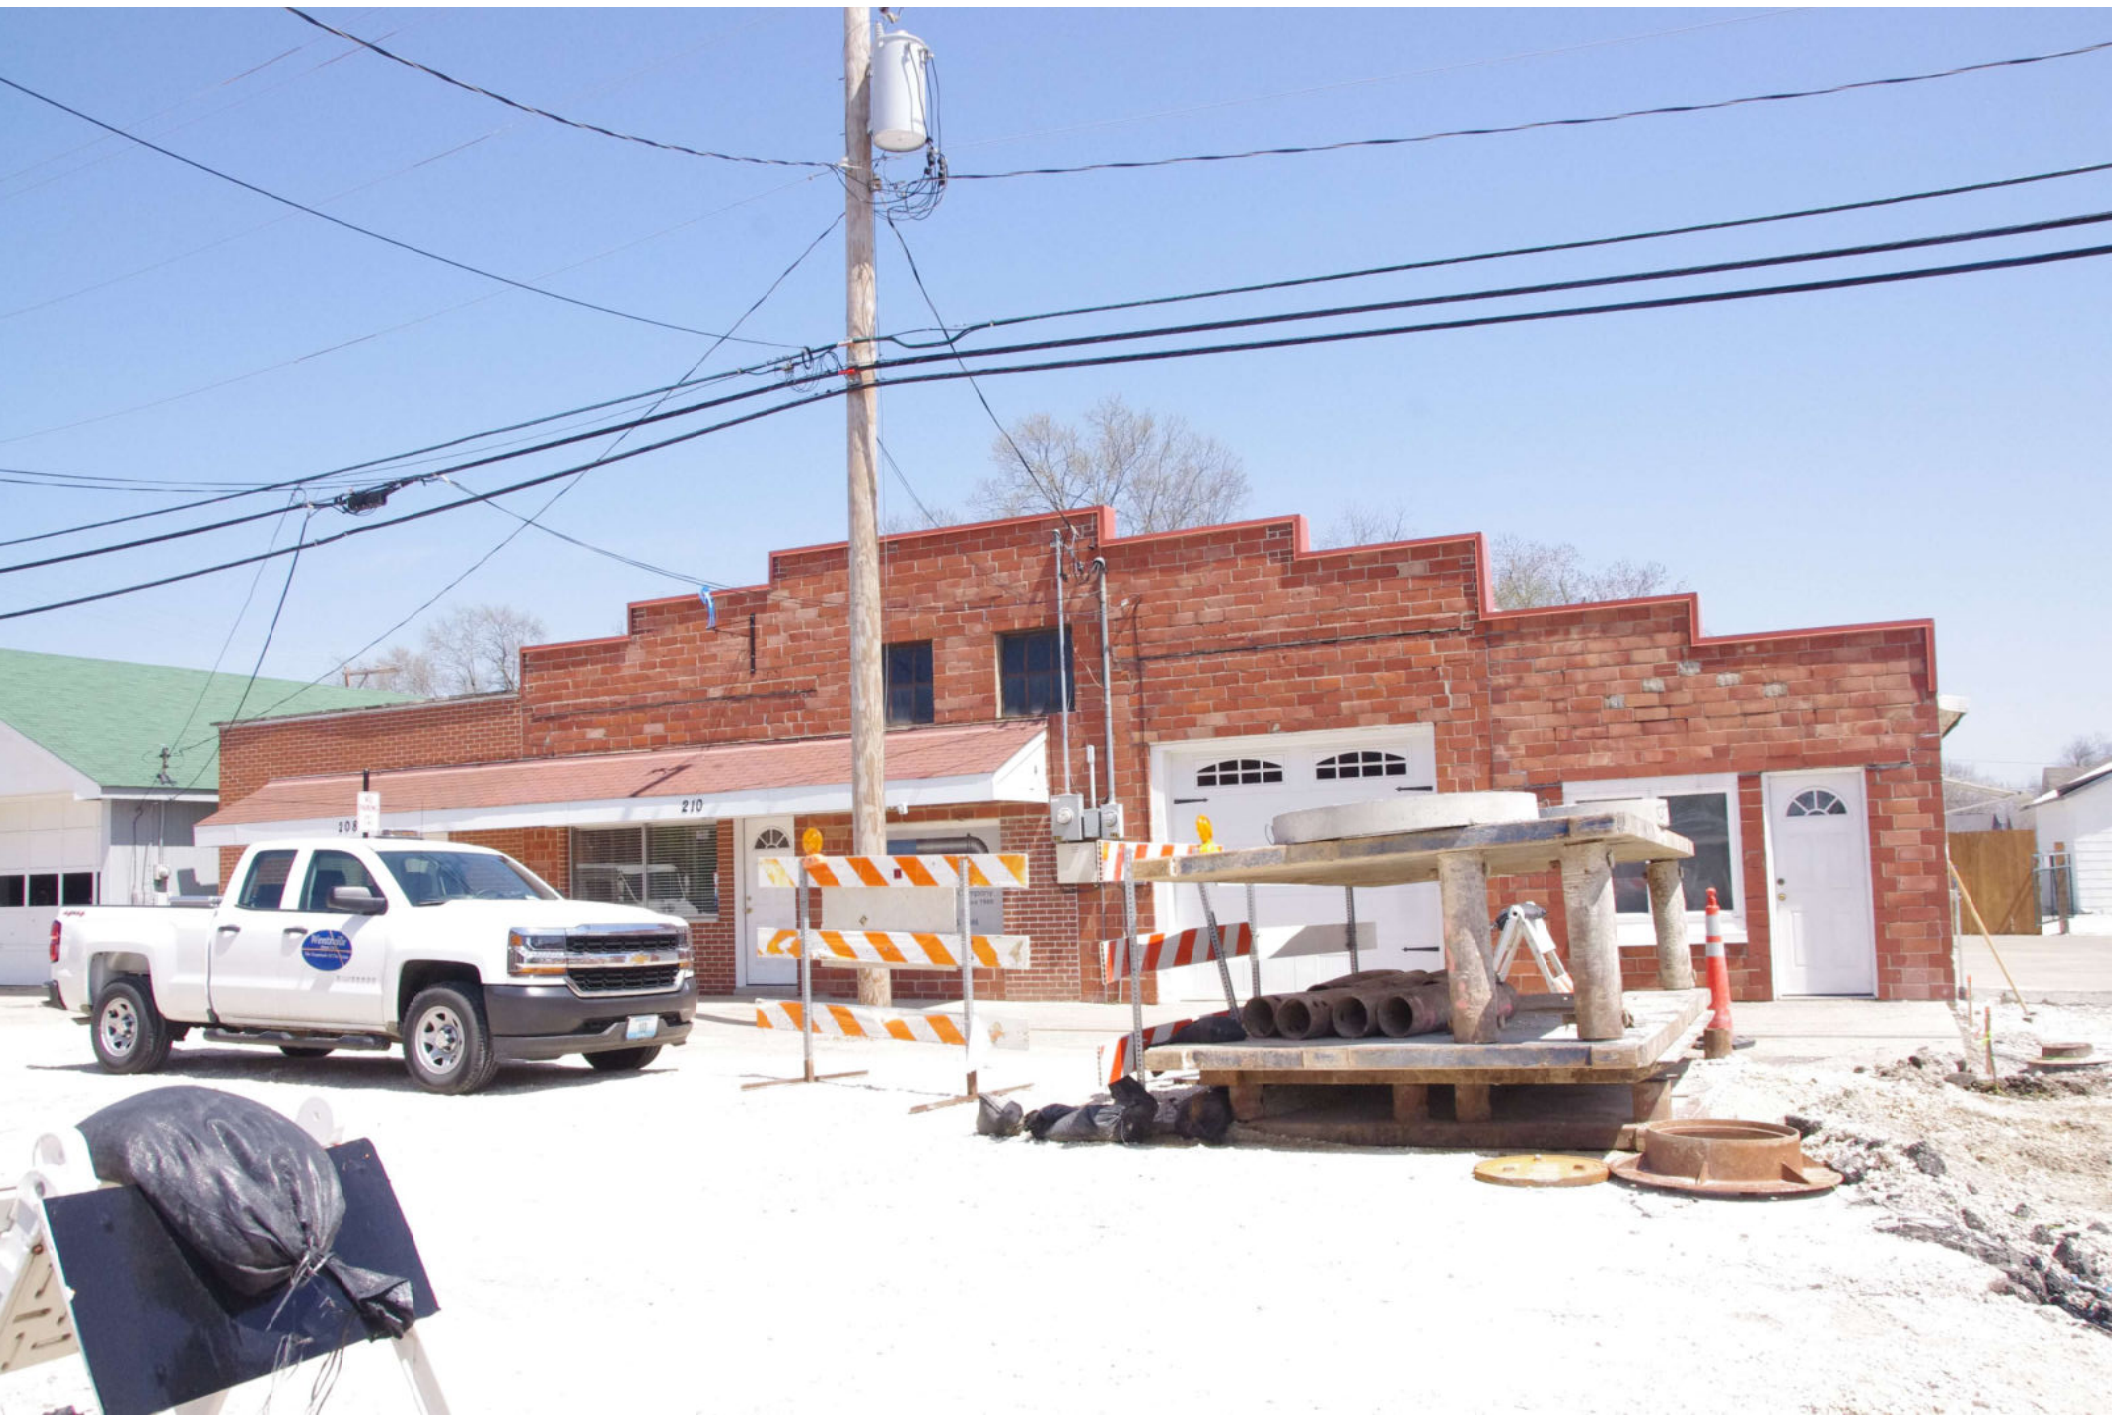
This resource is a one-story, large orange brick commercial garage with a concrete foundation and a barrel shaped roof with a stepped parapet on the façade. The southern bay includes a wood door with fanlight beside paired fixed pane windows. An overhead metal garage door with eight pane arched windows fills the next bay. A wood framed display window (covered on the interior with the business sign) is located just north of center and to its right is an brick infilled man door opening. Another wood door with fanlight stand on the opposite side of the display window with an aluminum framed, two light display window opening to its north; this door and window are within what was originally a tall garage door opening (see historic photo, Bowman, p. 55) and the garage door near the south end is also positioned within what was a matching tall garage door opening. These openings were altered early in the history of the building since the lintel line of brick is still visible above, but the infill brick is the same uncommon large sized brick as the original façade, indicating it was probably changed at some point by the 1960s and that is probably when the display windows were added as well. The south bay was also an addition to the original building, because of the cold seam joint and the slightly different color on the brick, but it is shown in the same historic photo that appears to have been taken in the 1940s given the age of the trucks in front of the building. Nine pane industrial metal windows are centered in the stepped parapet wall.

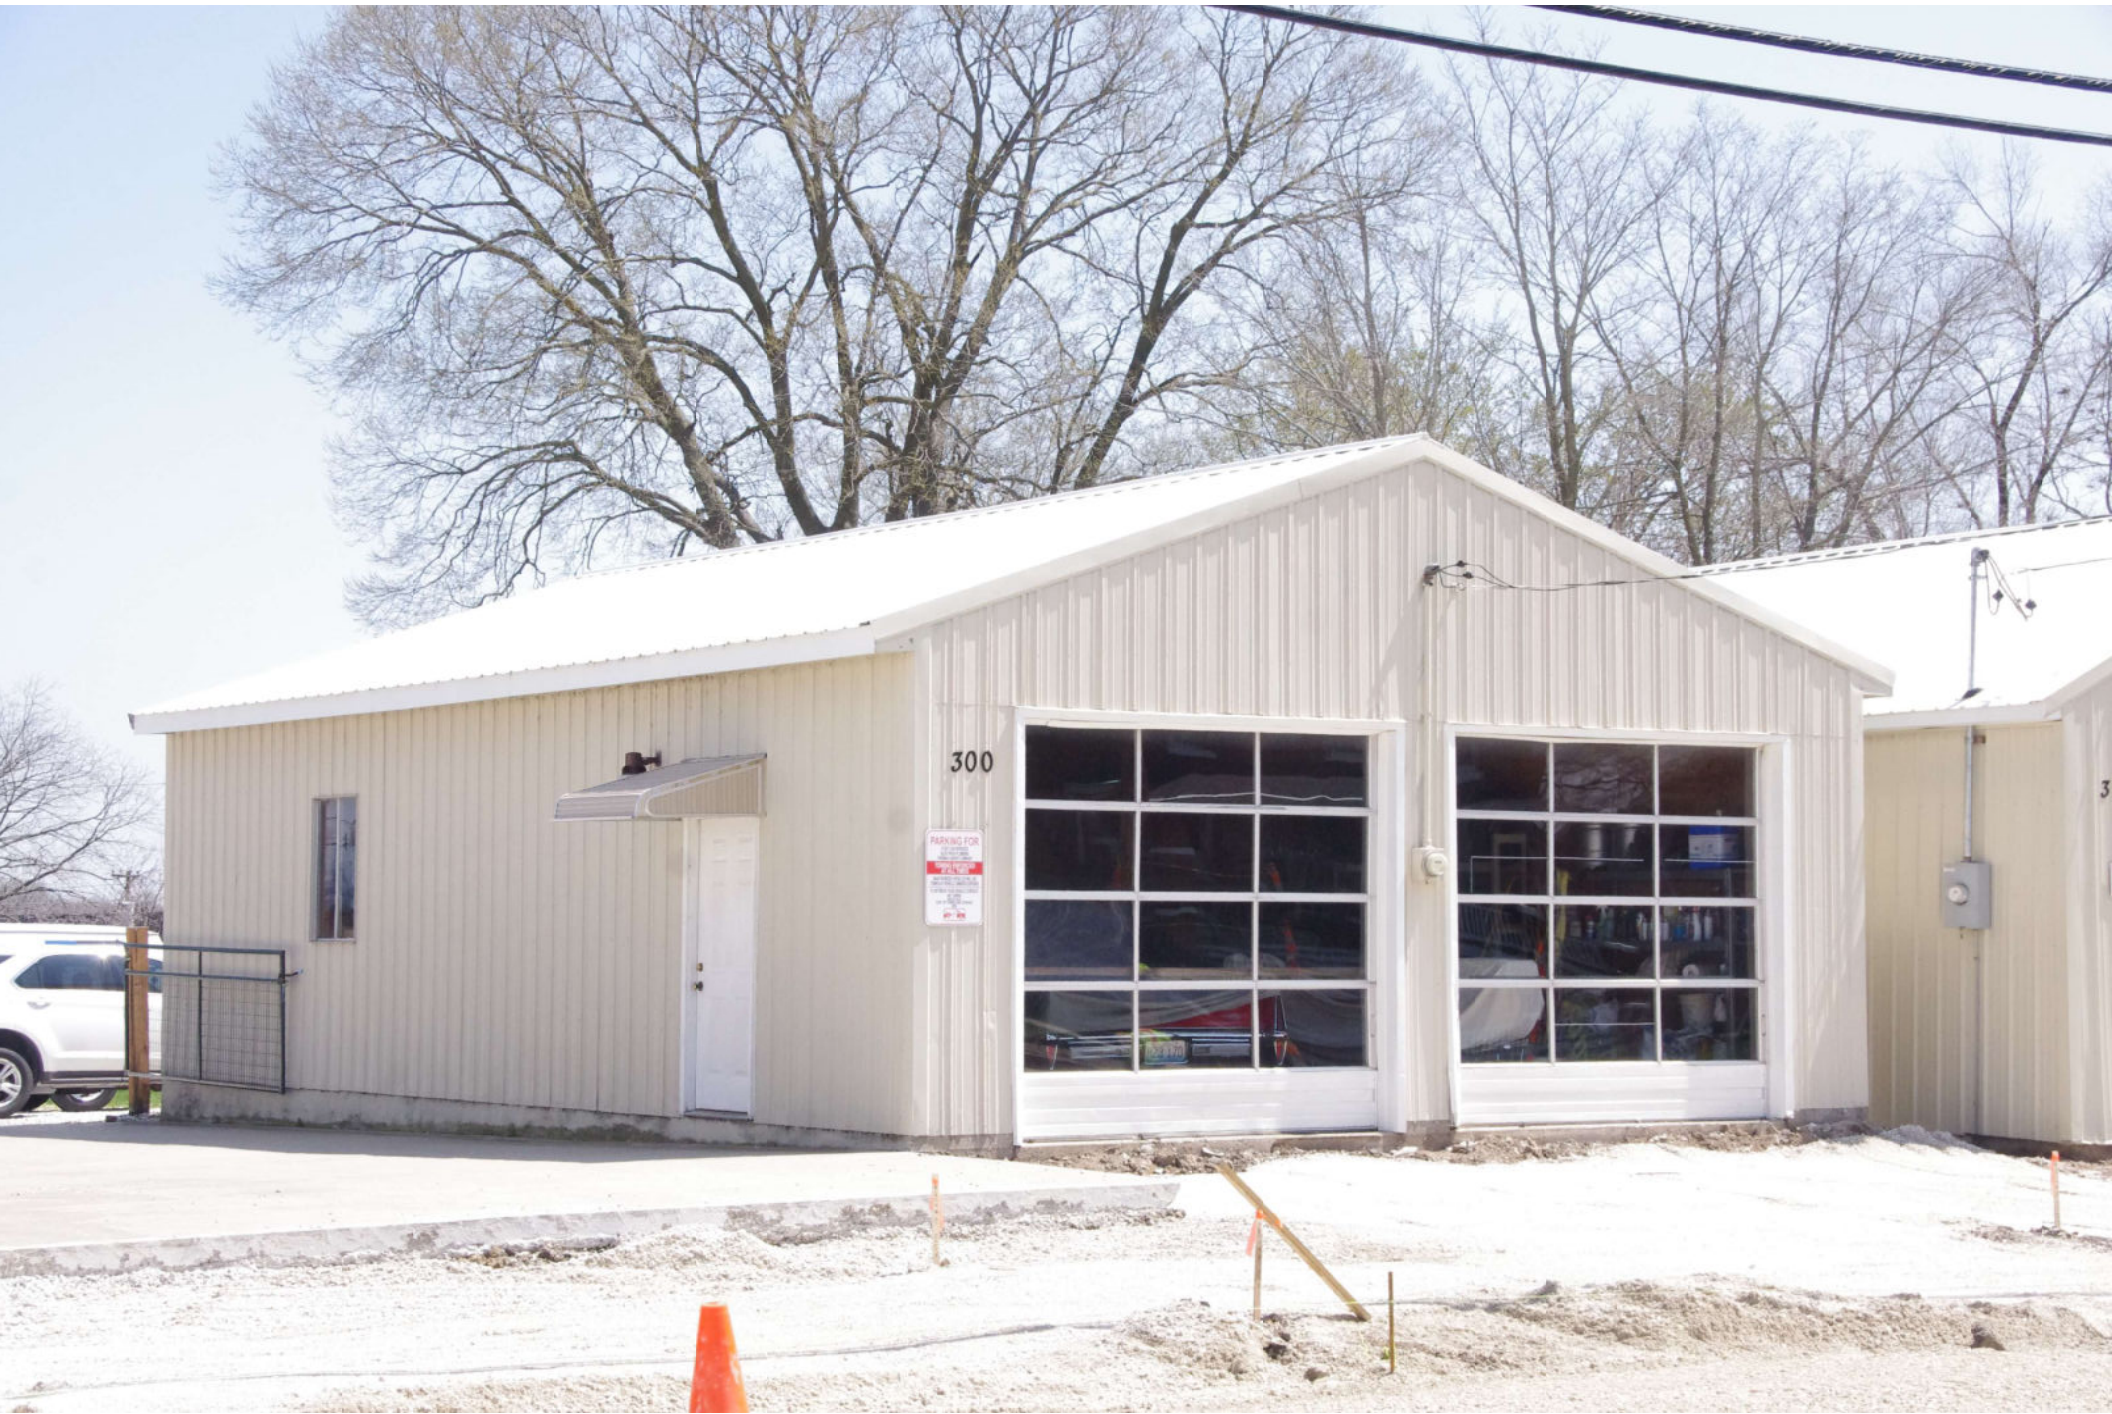
The building is labeled "300" and features a gabled metal two-bay garage with metal and glass overhead garage doors facing Linn.

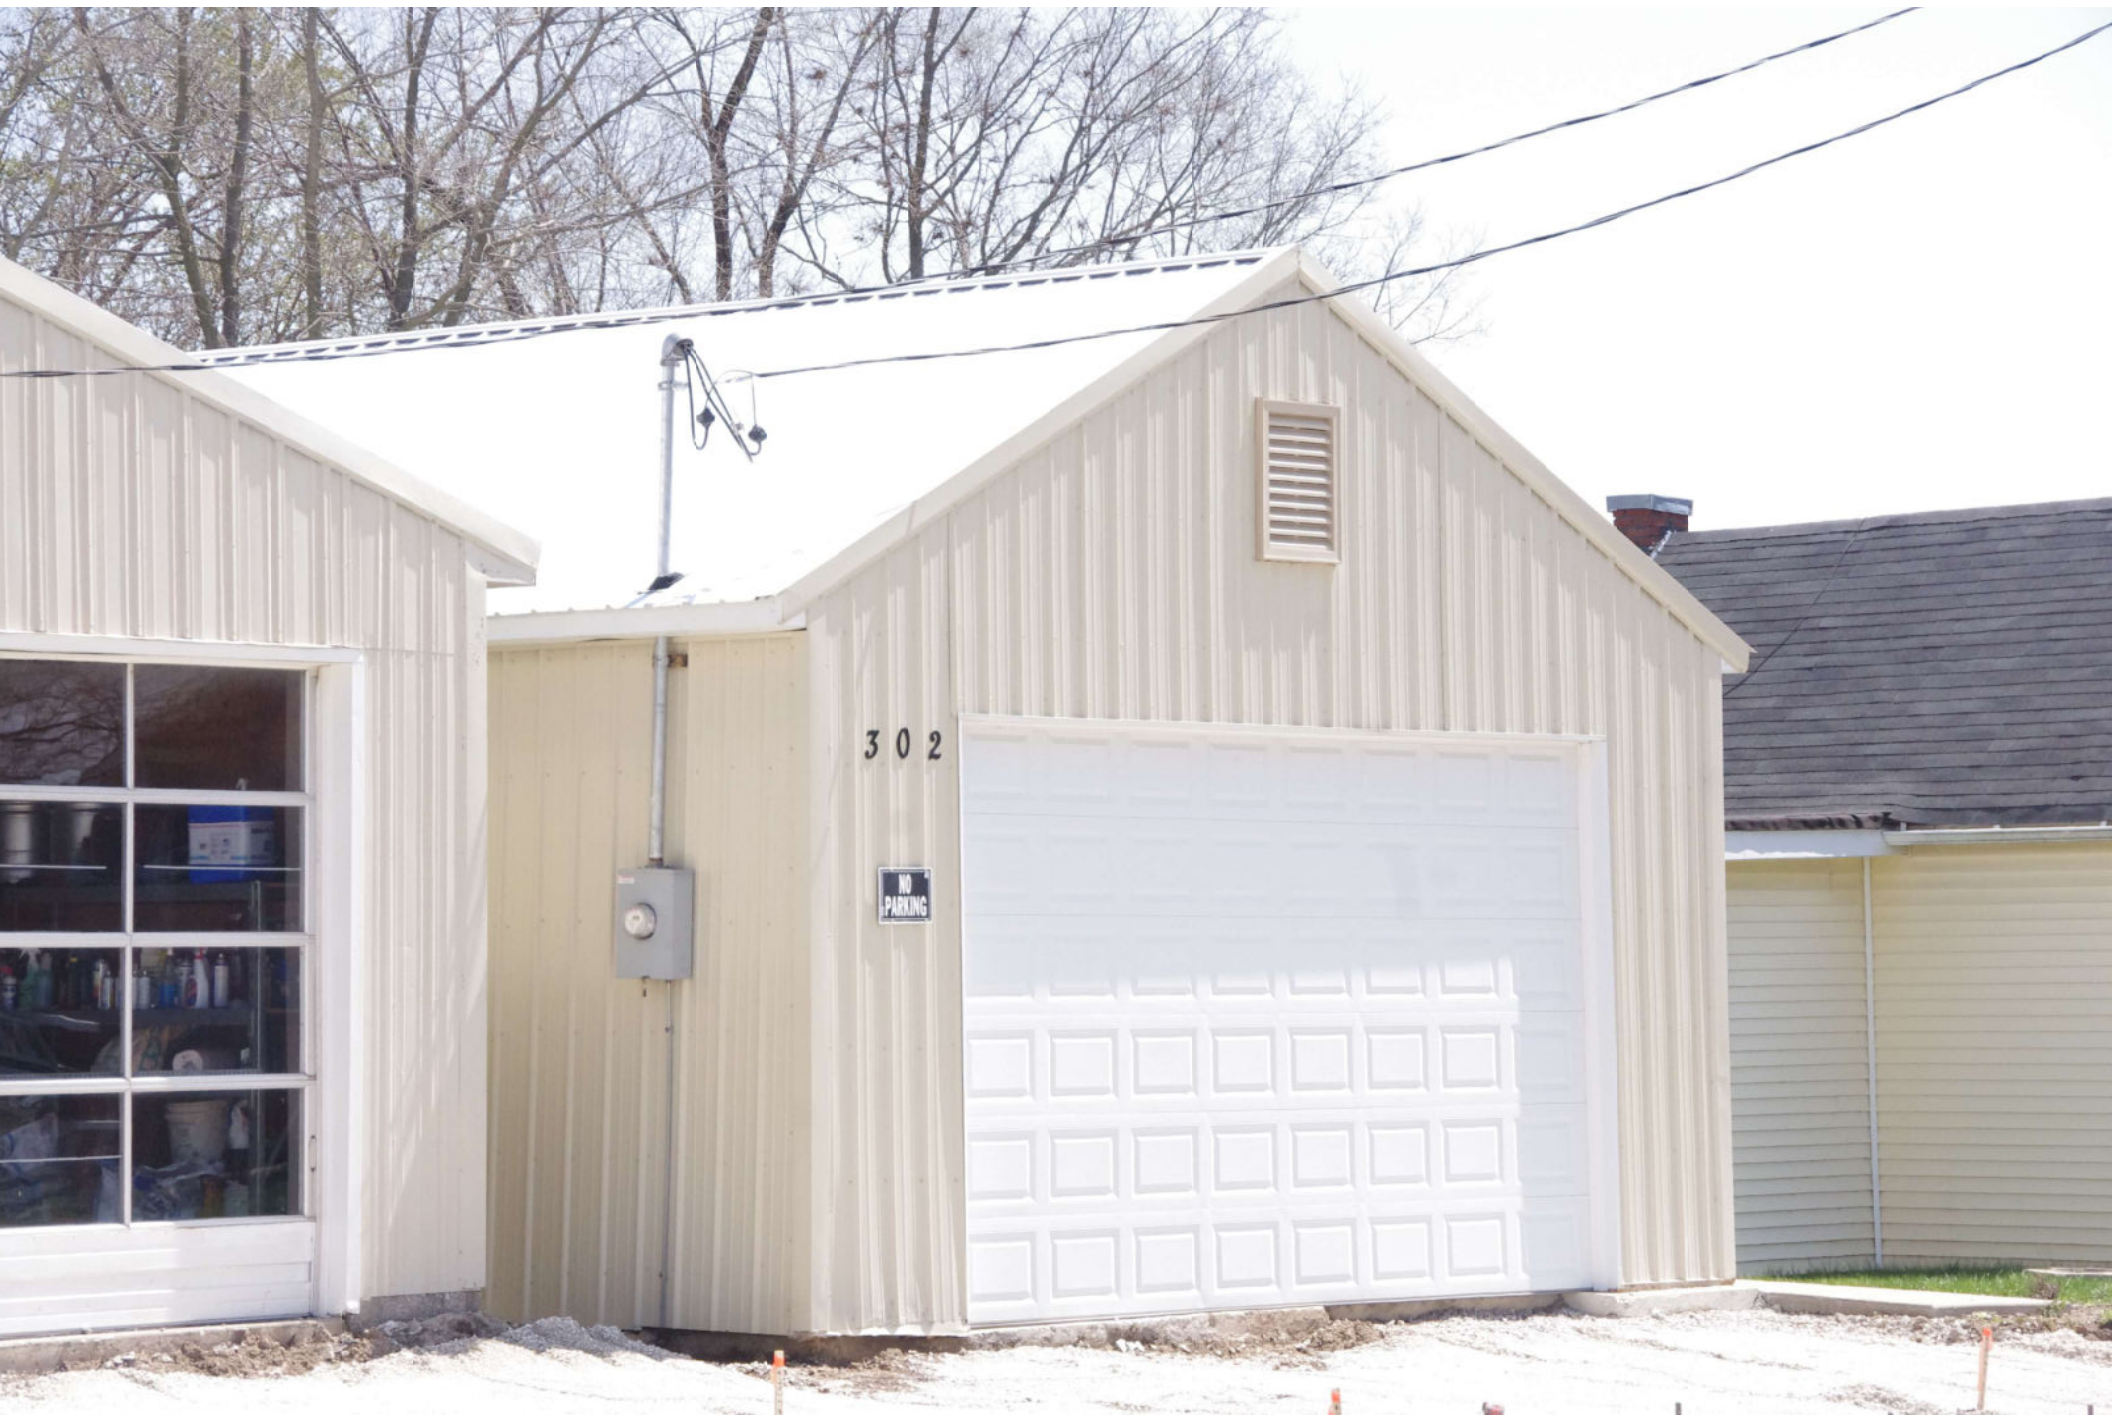
302

The building is located at the south end of the property, and labeled "302." This structure is a gabled one-bay metal garage with an overhead, oversized metal garage door facing Linn.
