**ARCHITECTURAL/HISTORIC INVENTORY FORM**

1. Survey No. SC-AS-012-0052		2. Survey Name: Reconnaissance Level Survey of Historic Downtown Wentzville	
3. County: St. Charles		4. Address (Street No.) 105	Street (name) South Linn Ave
5. City: Wentzville	Vicinity: <input type="checkbox"/>	6. UTM:	
8. Historic name (if known):		9. Present/other name (if known): Land Fair Corp.	
10. Ownership: <input type="checkbox"/> Private <input type="checkbox"/> Public		11a. Historic use (if known): COMMERCE/TRADE	11b. Current use: COMMERCE/TRADE/professional
5. City: Wentzville		7. Township/Range/Section:

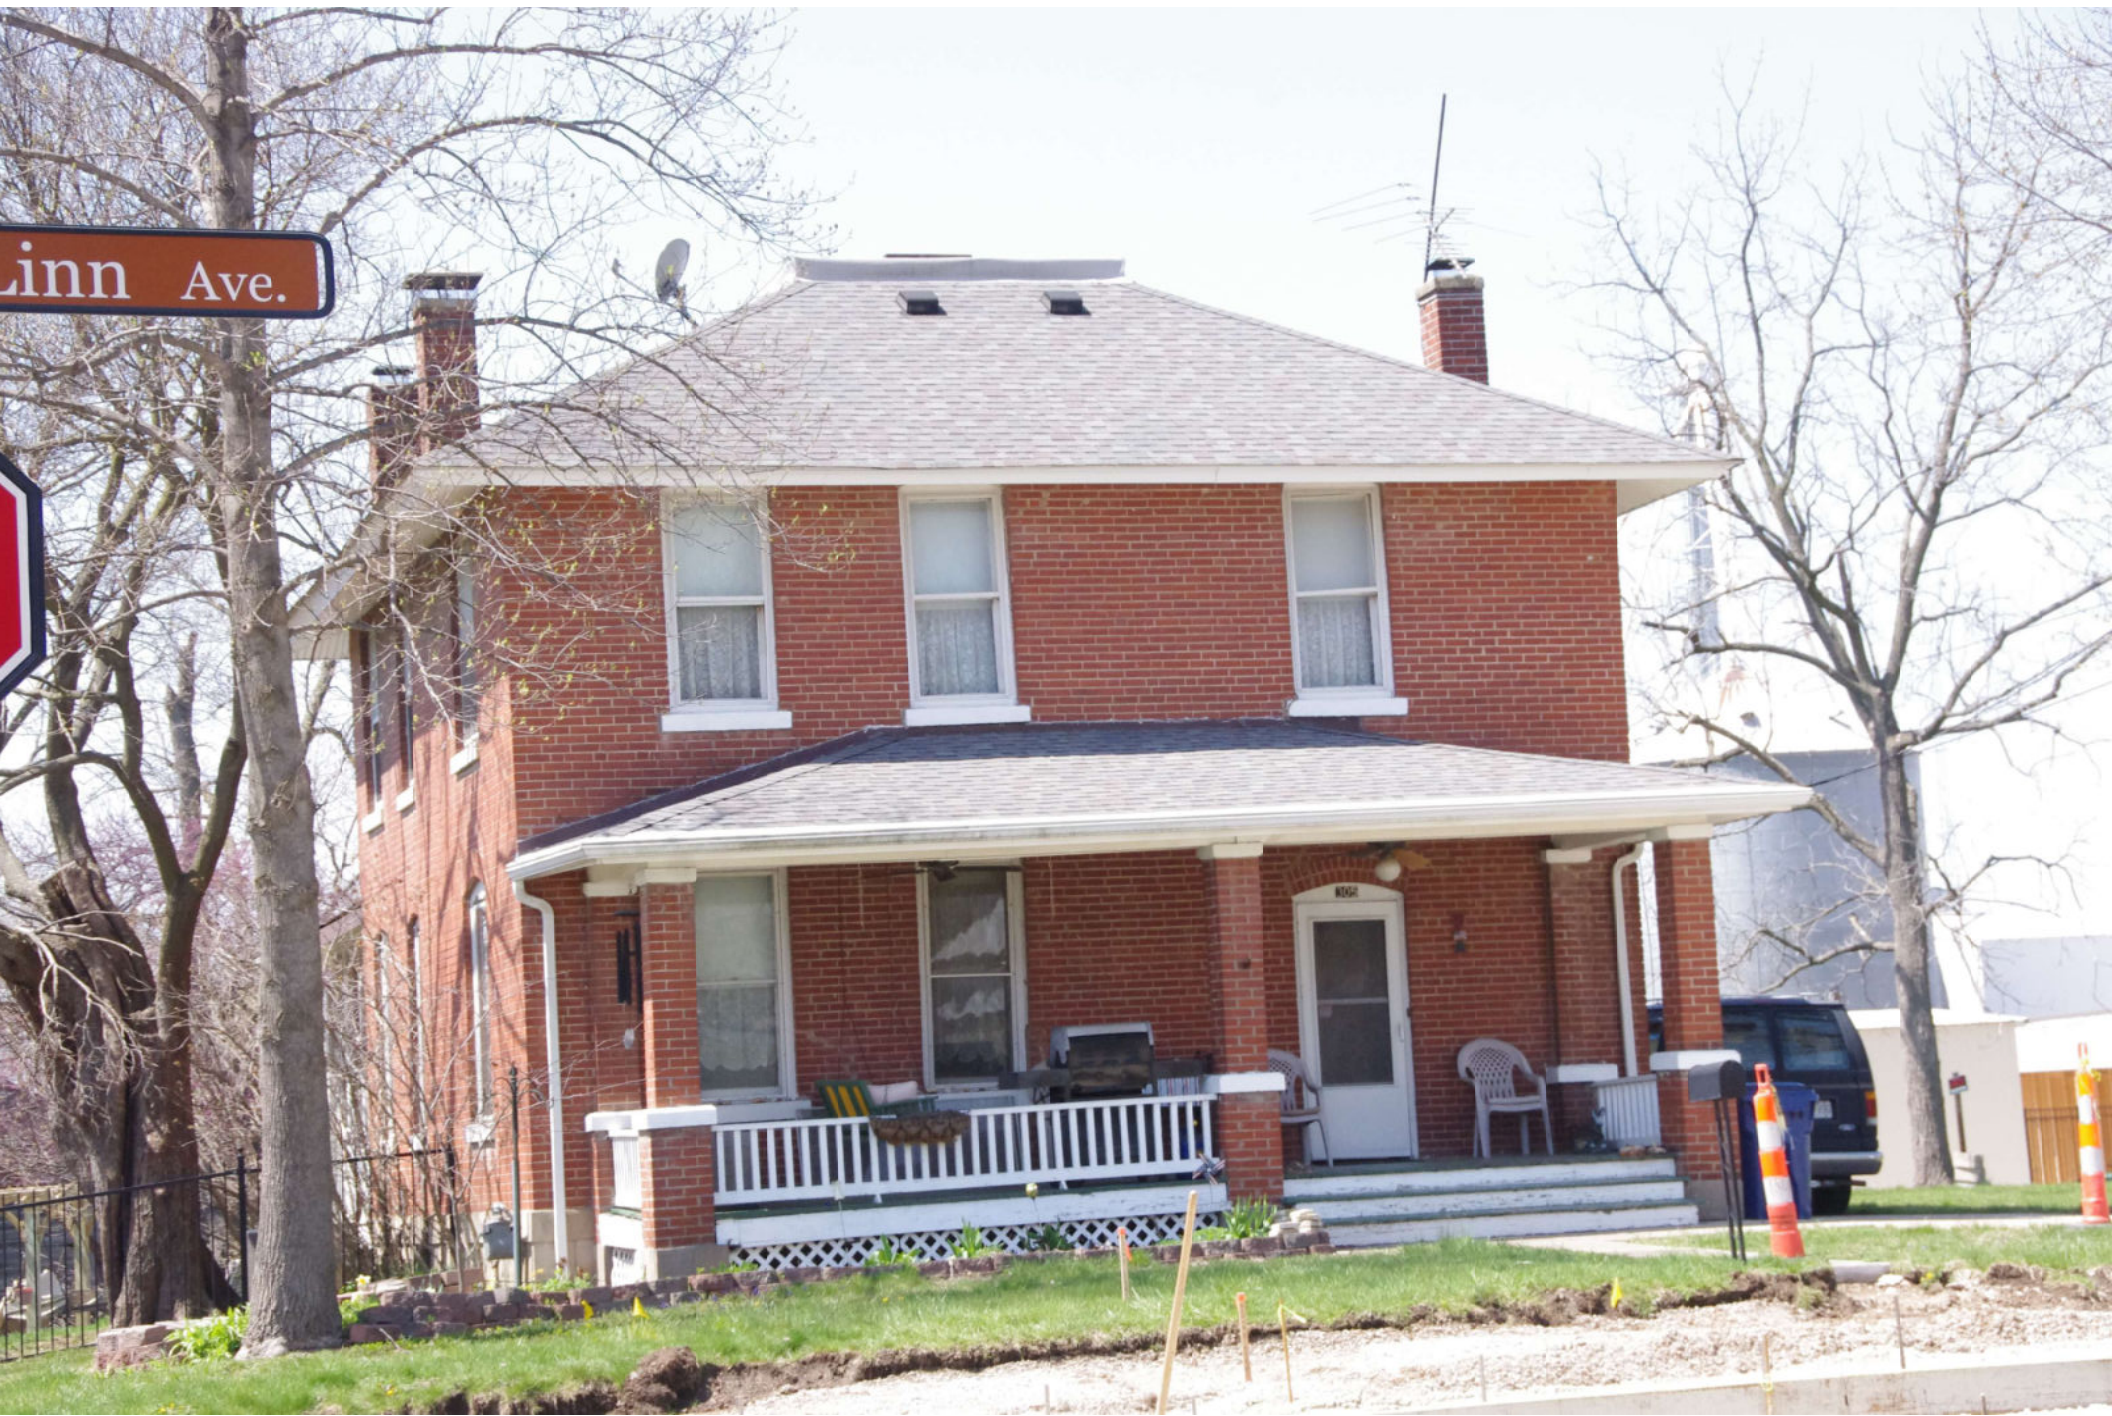
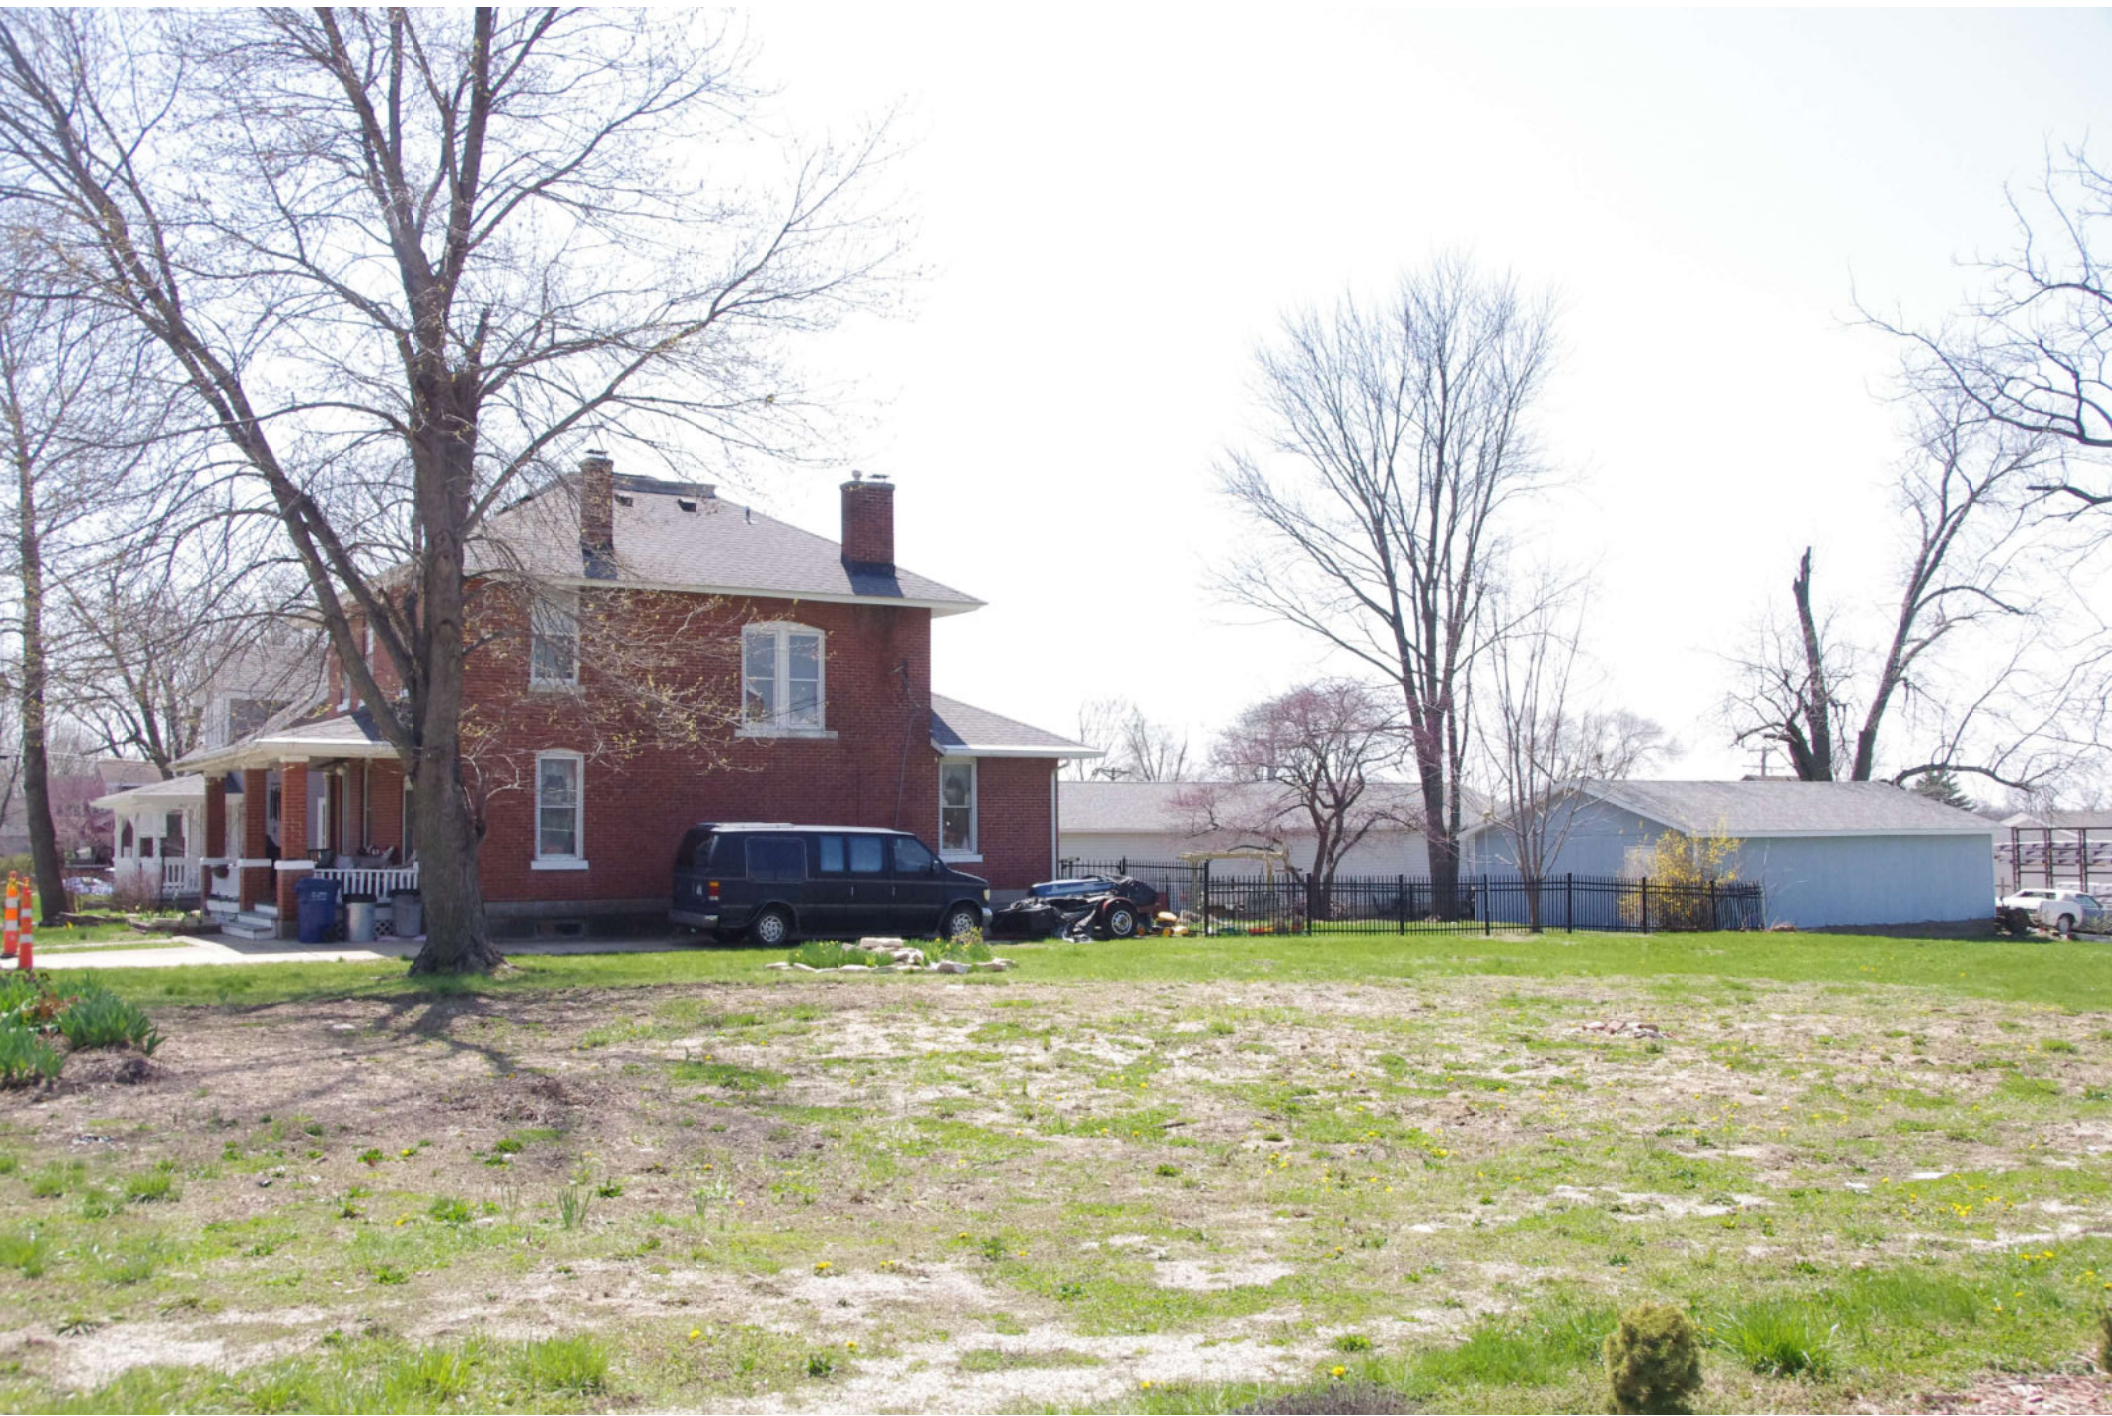
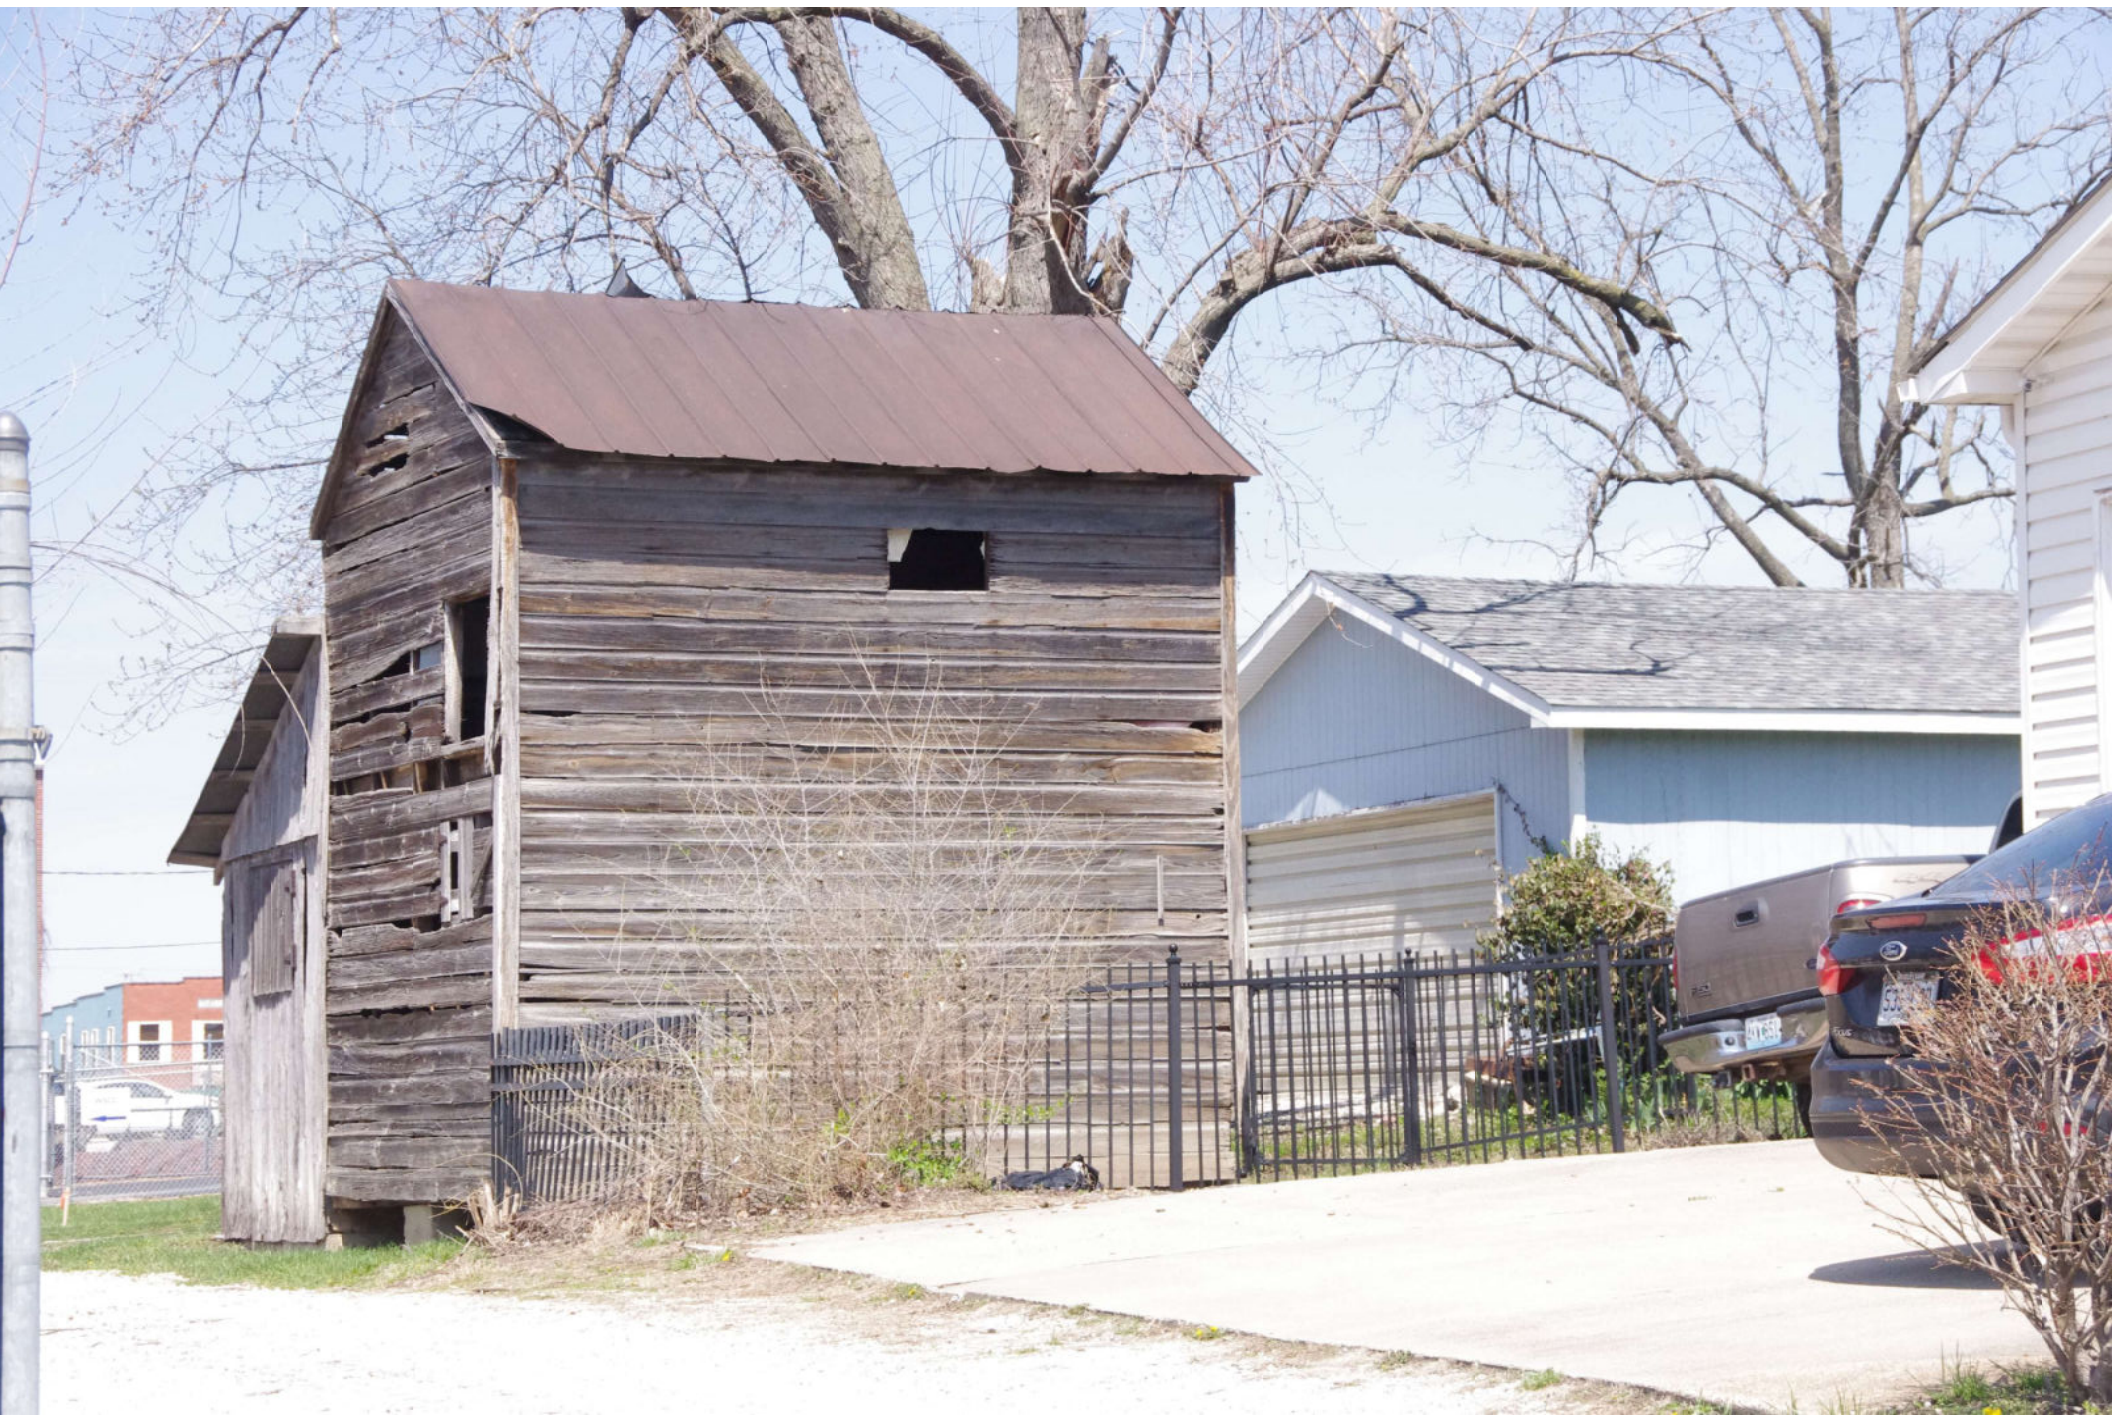
This resource is a two-story brick Four Square house with a hipped roof. The hipped roof, full width open porch has a wood floor and brick pillars on brick plinths between which spans the original wood railings. The entrance is located in the northern bay featuring a wood door with an aluminum storm door and a segmental arched brick lintel. The remaining two bays on the first floor and three bays on the second floor contain one-over-one sash windows with concrete sills and segmental arched lintels. There is a one story, hipped roof wing across the back of the house.

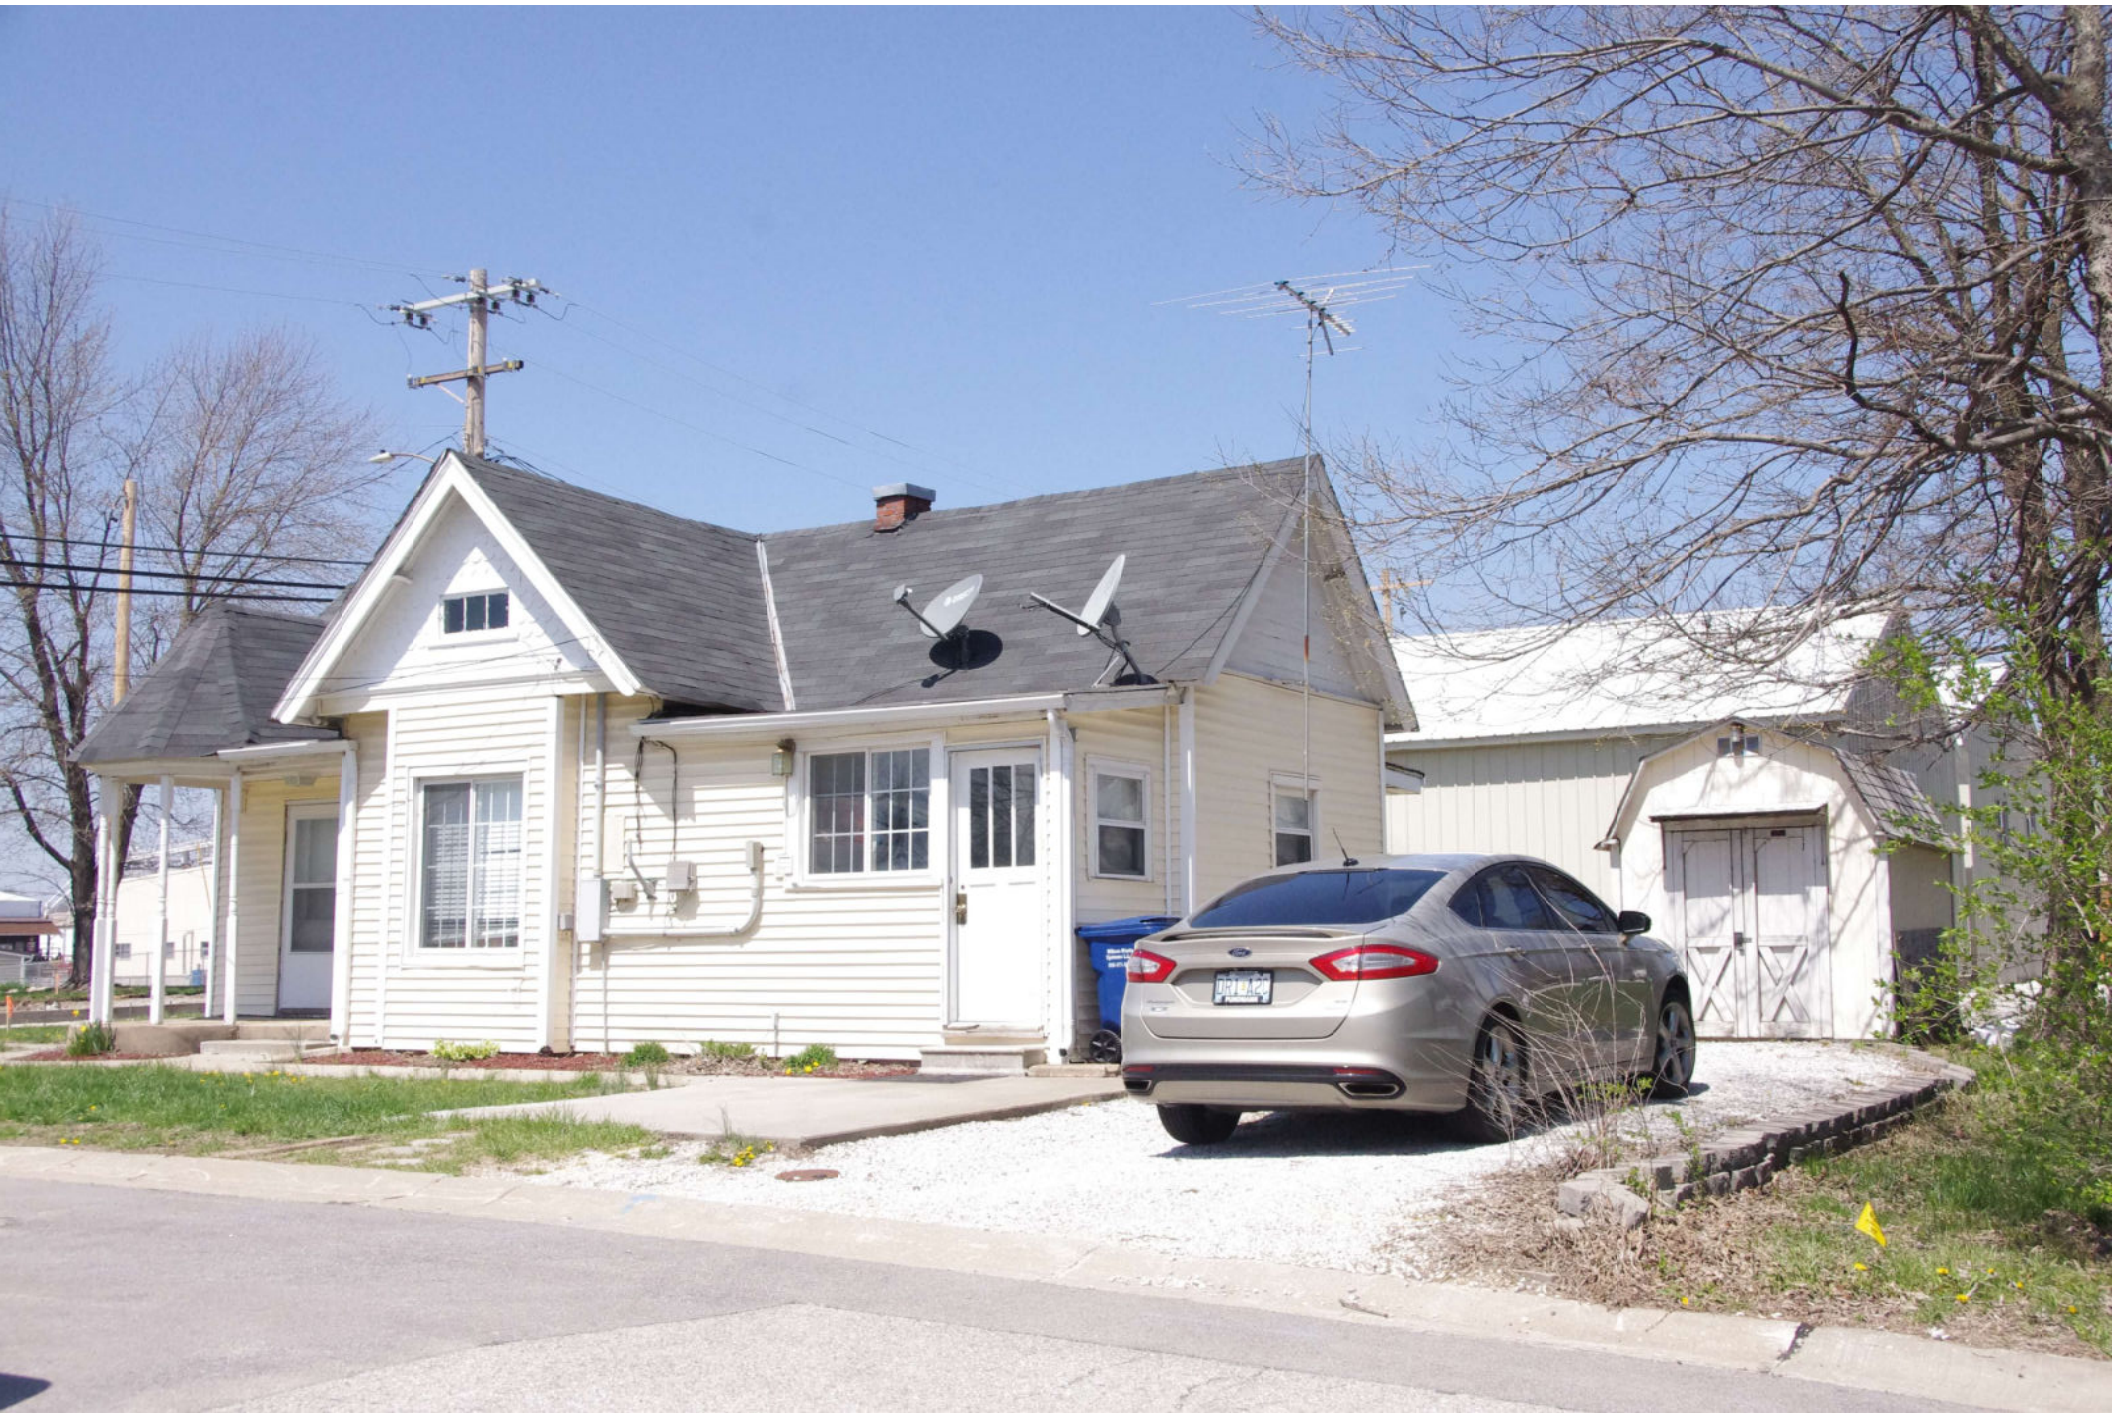
A one-story vinyl sided Folk Victorian house has a cross gable. The entrance is located in the western bay, accessed by a conical roofed open porch with wood turned spindle posts that rest on a replacement poured concrete porch floor, so the posts may be replacements as well. The front door is a half light wood door behind the aluminum storm door. The central bay is slightly projected, with paired six-over-six replacement windows below vinyl fish scale shingles in the cross gable. The eastern bay contains of two nine-pane replacement windows and a 3-vertical light with 2 vertical panel wood door. This eastern bay was enclosed at a later date; it was originally an open porch and retains its shed roof. The style of the door indicates this change was probably made in the 1930s.

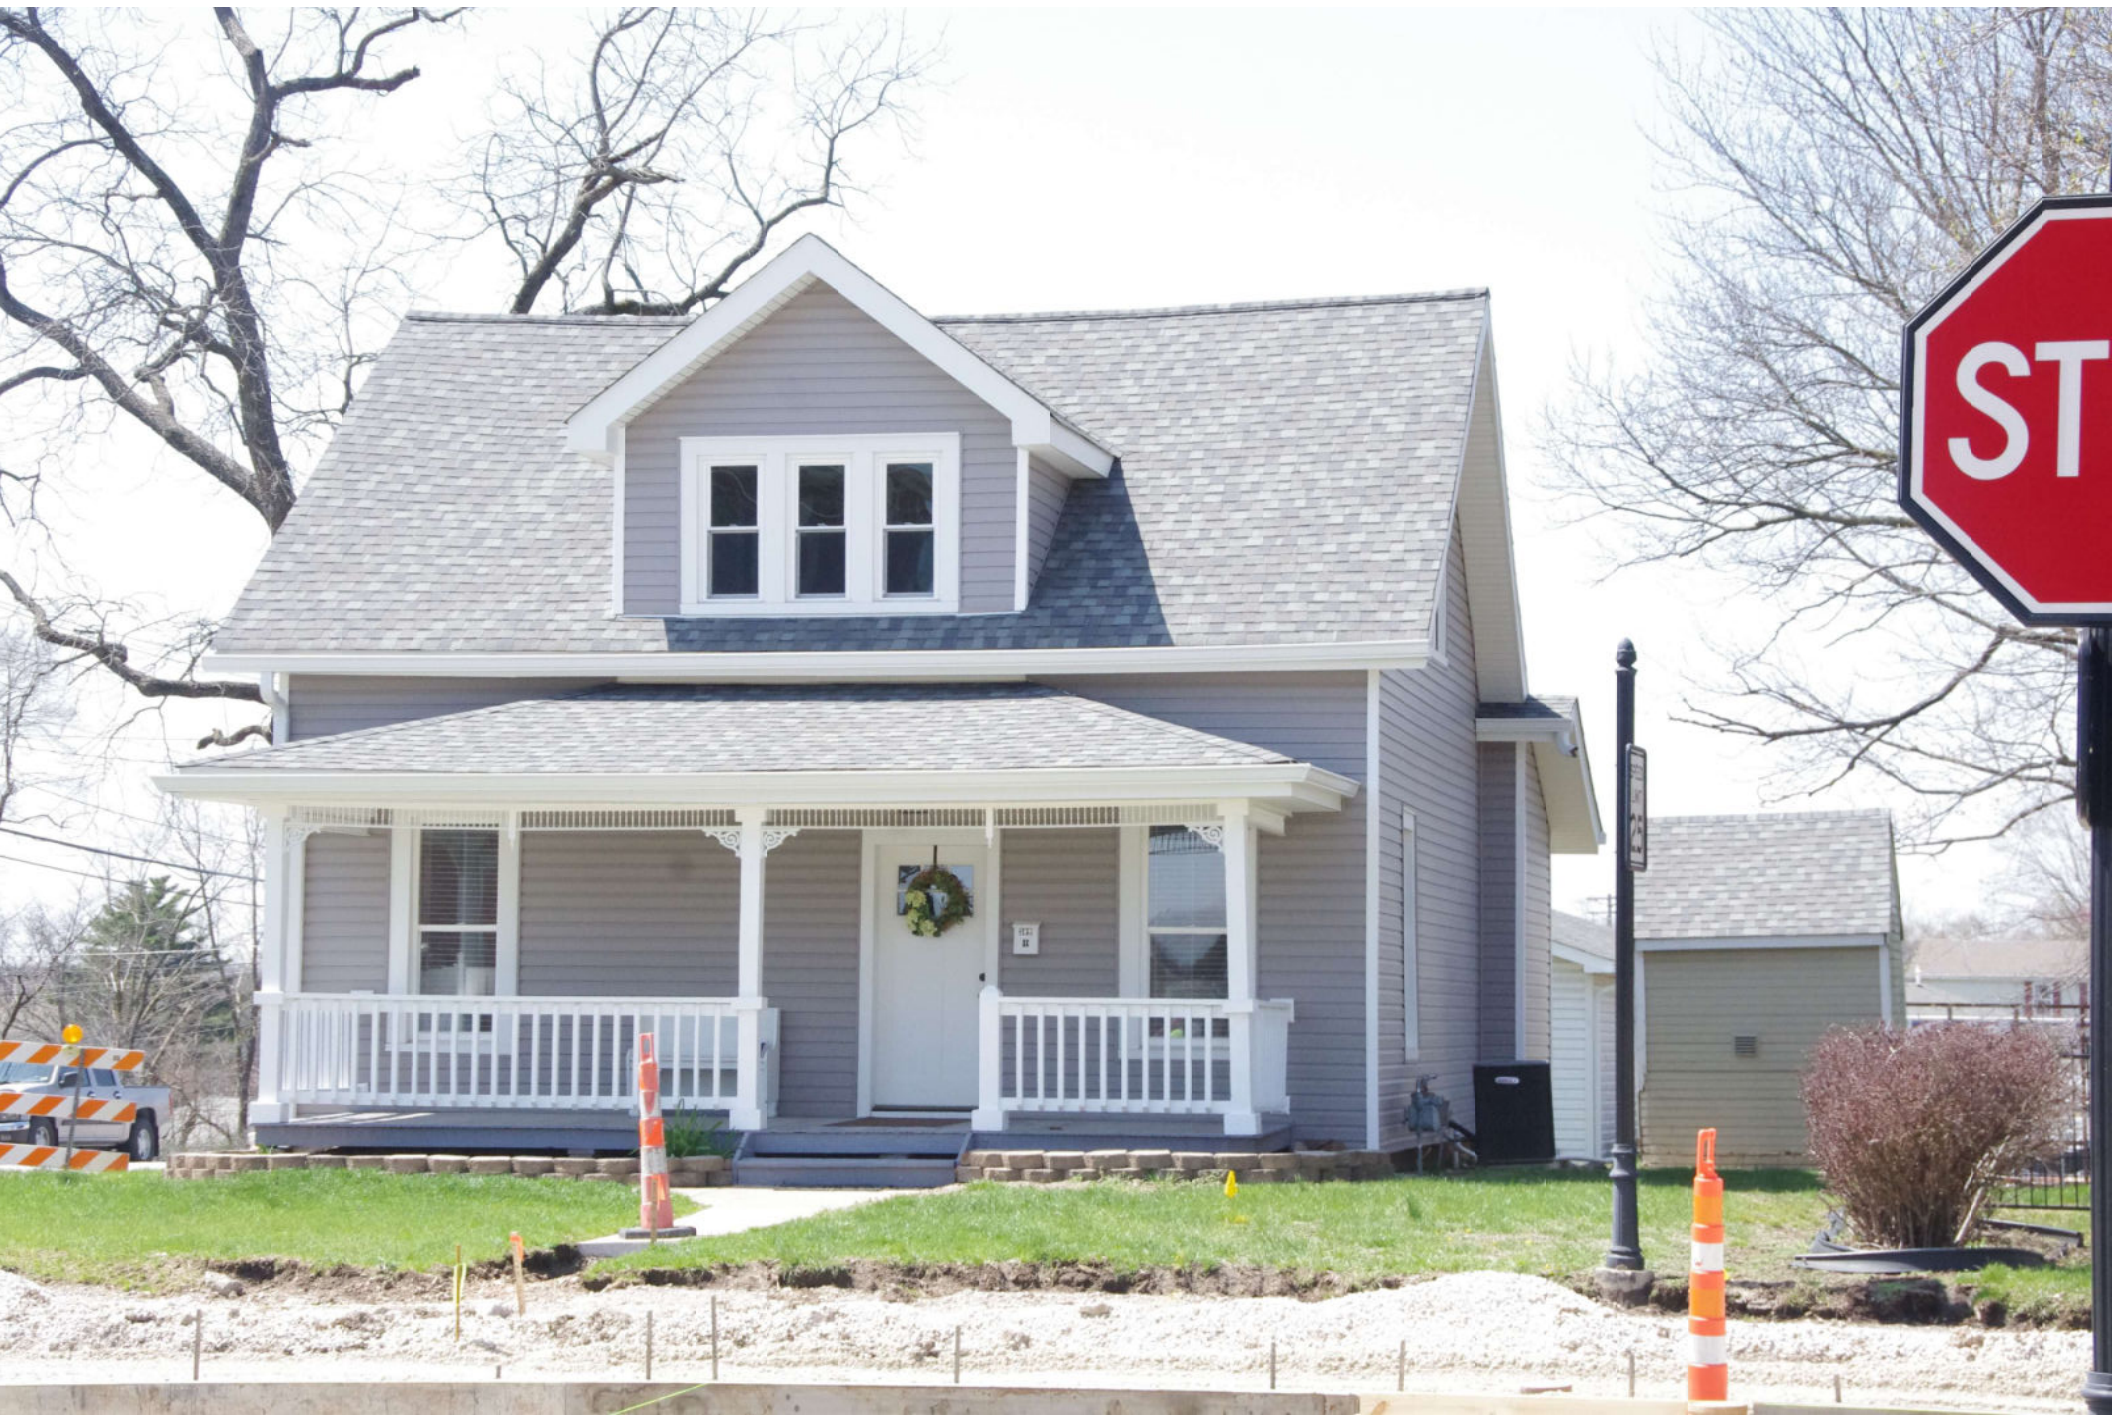
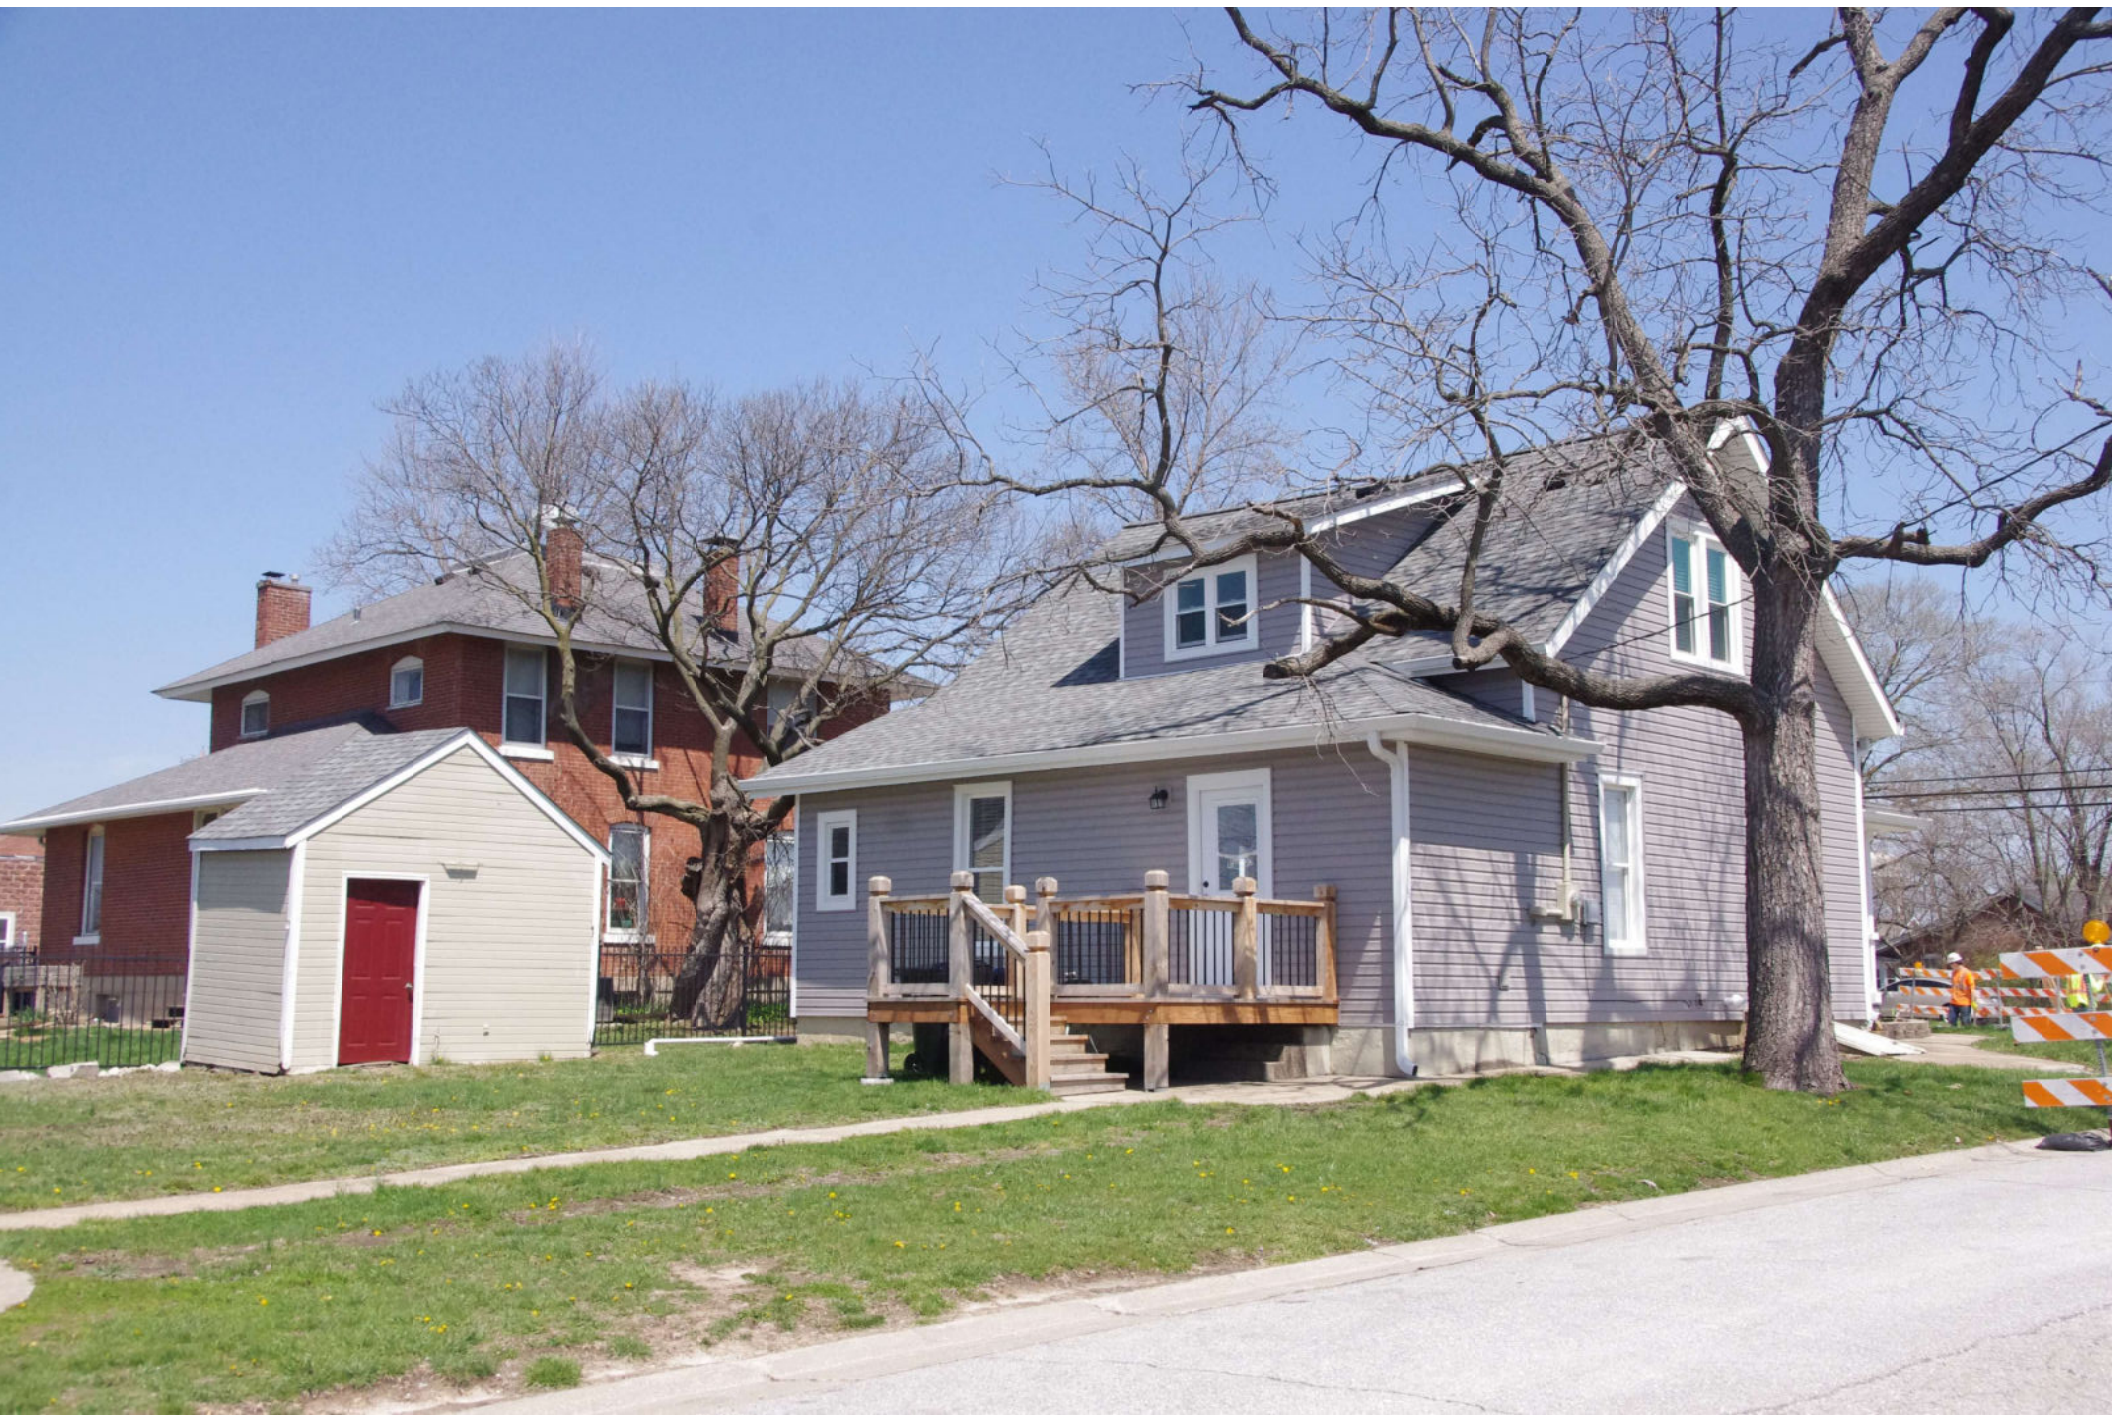
Although the assessor's website dates this building to 2003, physical evidence of the stucco coating crumbling off to expose an old foundation and an old rear concrete step under the new deck, seem to indicate that this is the same building that was shown on both the 1905 plat map and the 1927 fire insurance map.

This side gabled house is one-and-a-half stories and has been totally reclad in vinyl siding and trim. The hipped roof open porch spans the façade and has a new wood porch railing (components structured like a modern deck railing) between square replacement posts and the spindlework fretwork and scrollwork brackets appear to be vinyl products, not original to the building so it is difficult to tell whether the original detailing was Folk Victorian or not. The small rectangular light (6 panes) over two long vertical panels on the door is more of a Craftsman style. The entrance is located just north of center, flanked in the outer bays by one-over-one replacement windows. The central gabled dormer features similar windows found in triplicate. There is a one-story, hipped roof wing across the back of the house with a shed roof dormer above.
