**ARCHITECTURAL/HISTORIC INVENTORY FORM**

1. Survey No. SC-AS-012-0052		2. Survey Name: Reconnaissance Level Survey of Historic Downtown Wentzville	
3. County: St. Charles		4. Address (Street No.) 105	Street (name) South Linn Ave
5. City: Wentzville	Vicinity: <input type="checkbox"/>	6. UTM:	
8. Historic name (if known):		9. Present/other name (if known): Land Fair Corp.	
10. Ownership: <input type="checkbox"/> Private <input type="checkbox"/> Public		11a. Historic use (if known): COMMERCE/TRADE	11b. Current use: COMMERCE/TRADE/professional
5. City: Wentzville		7. Township/Range/Section:

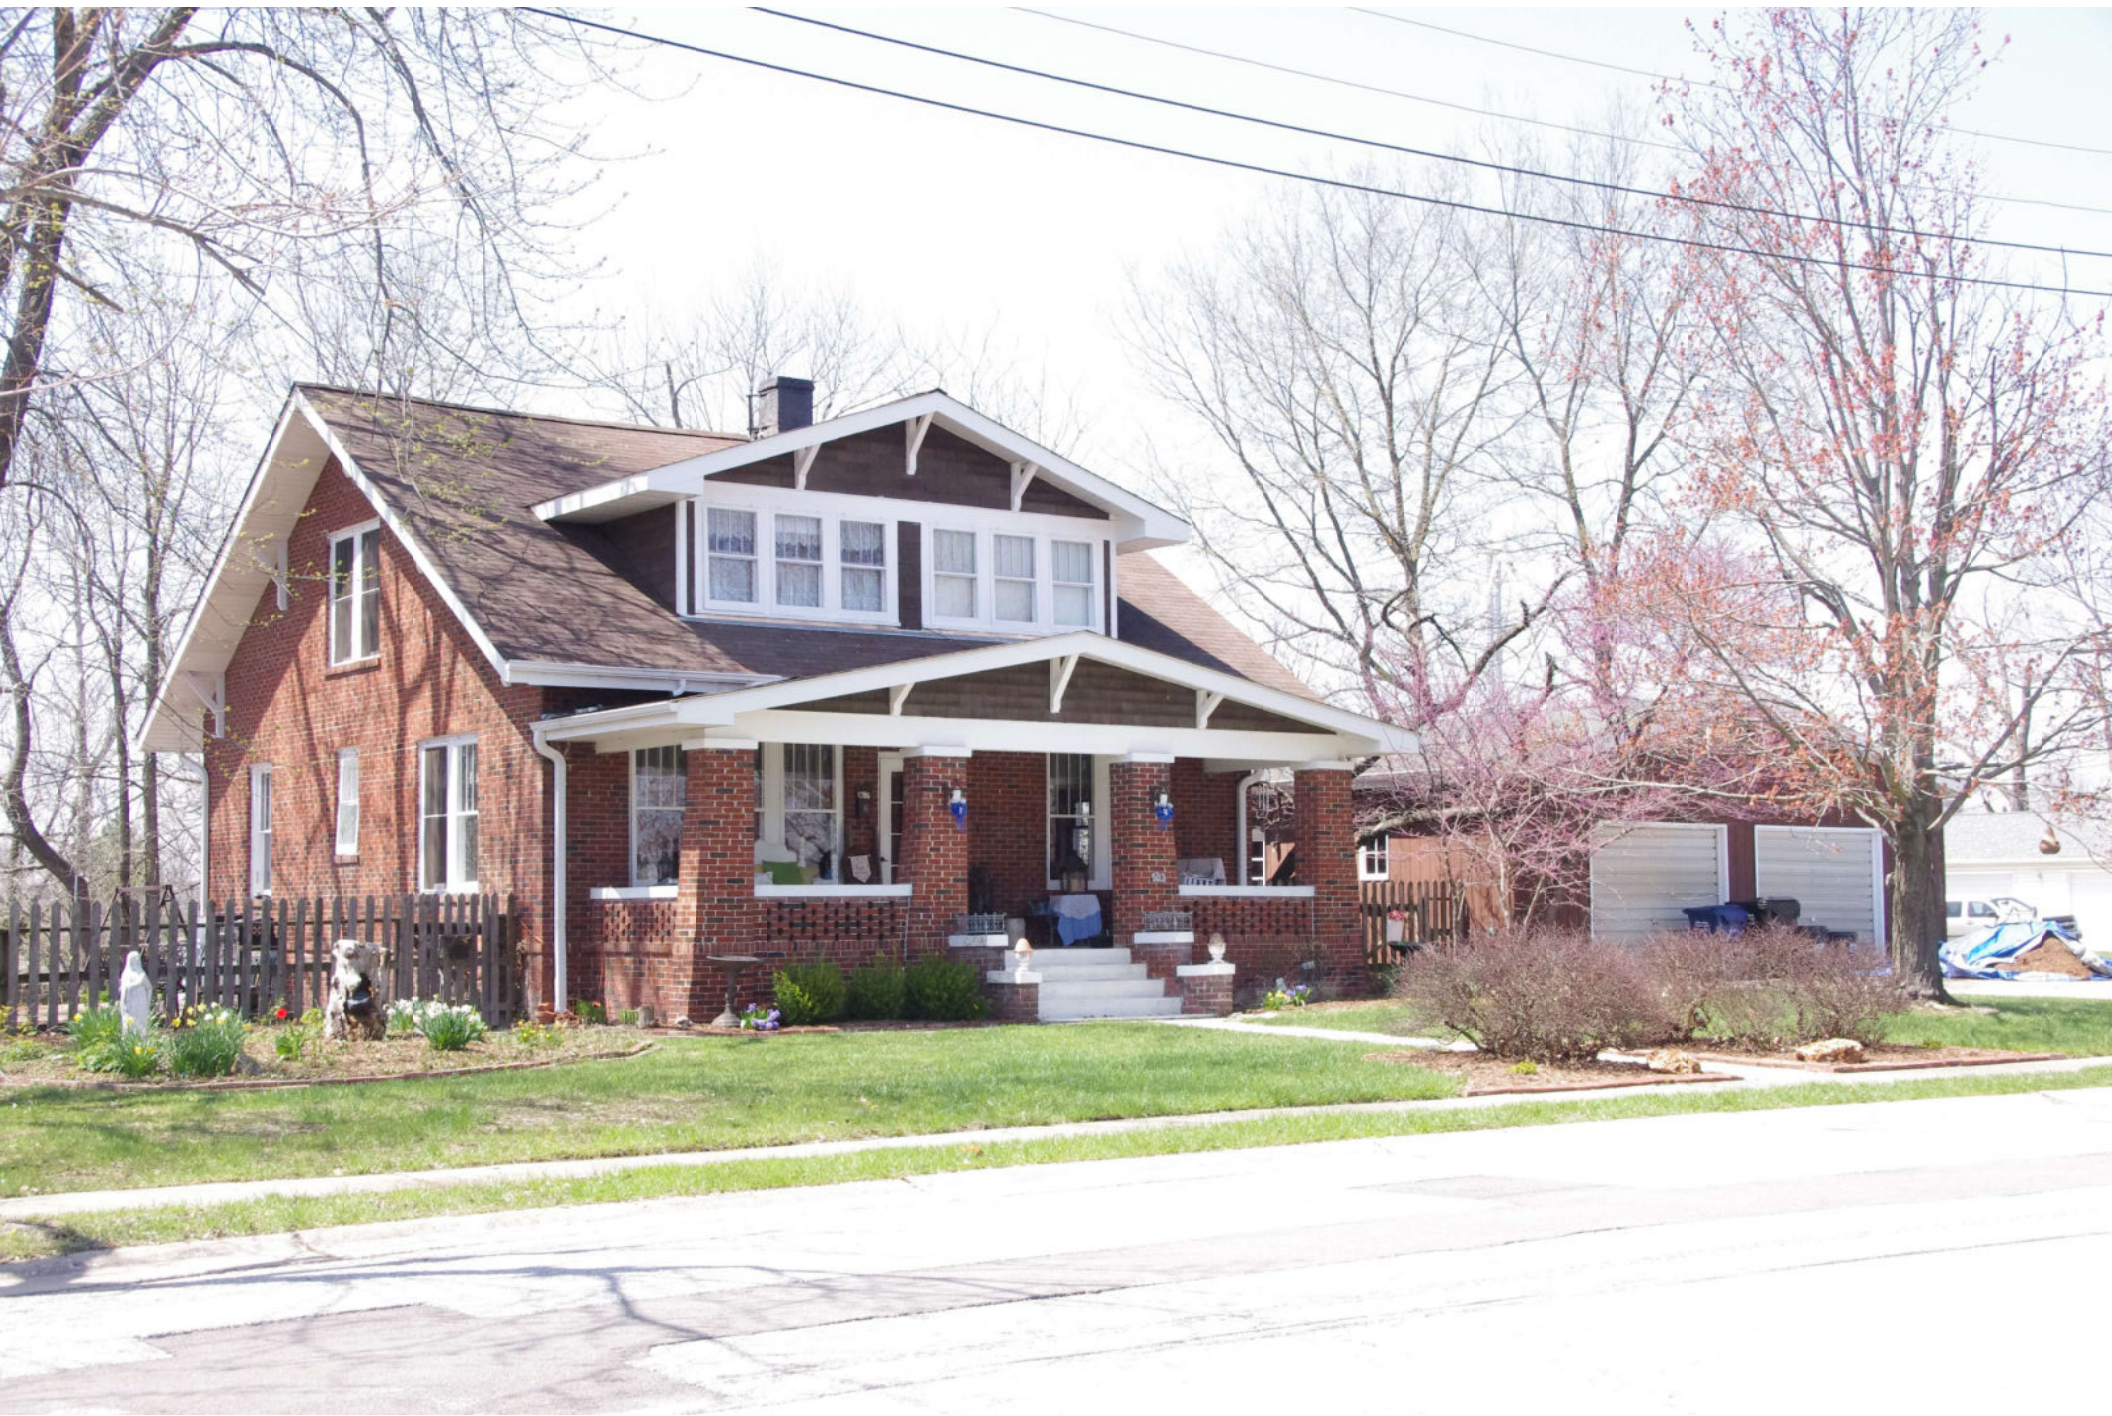
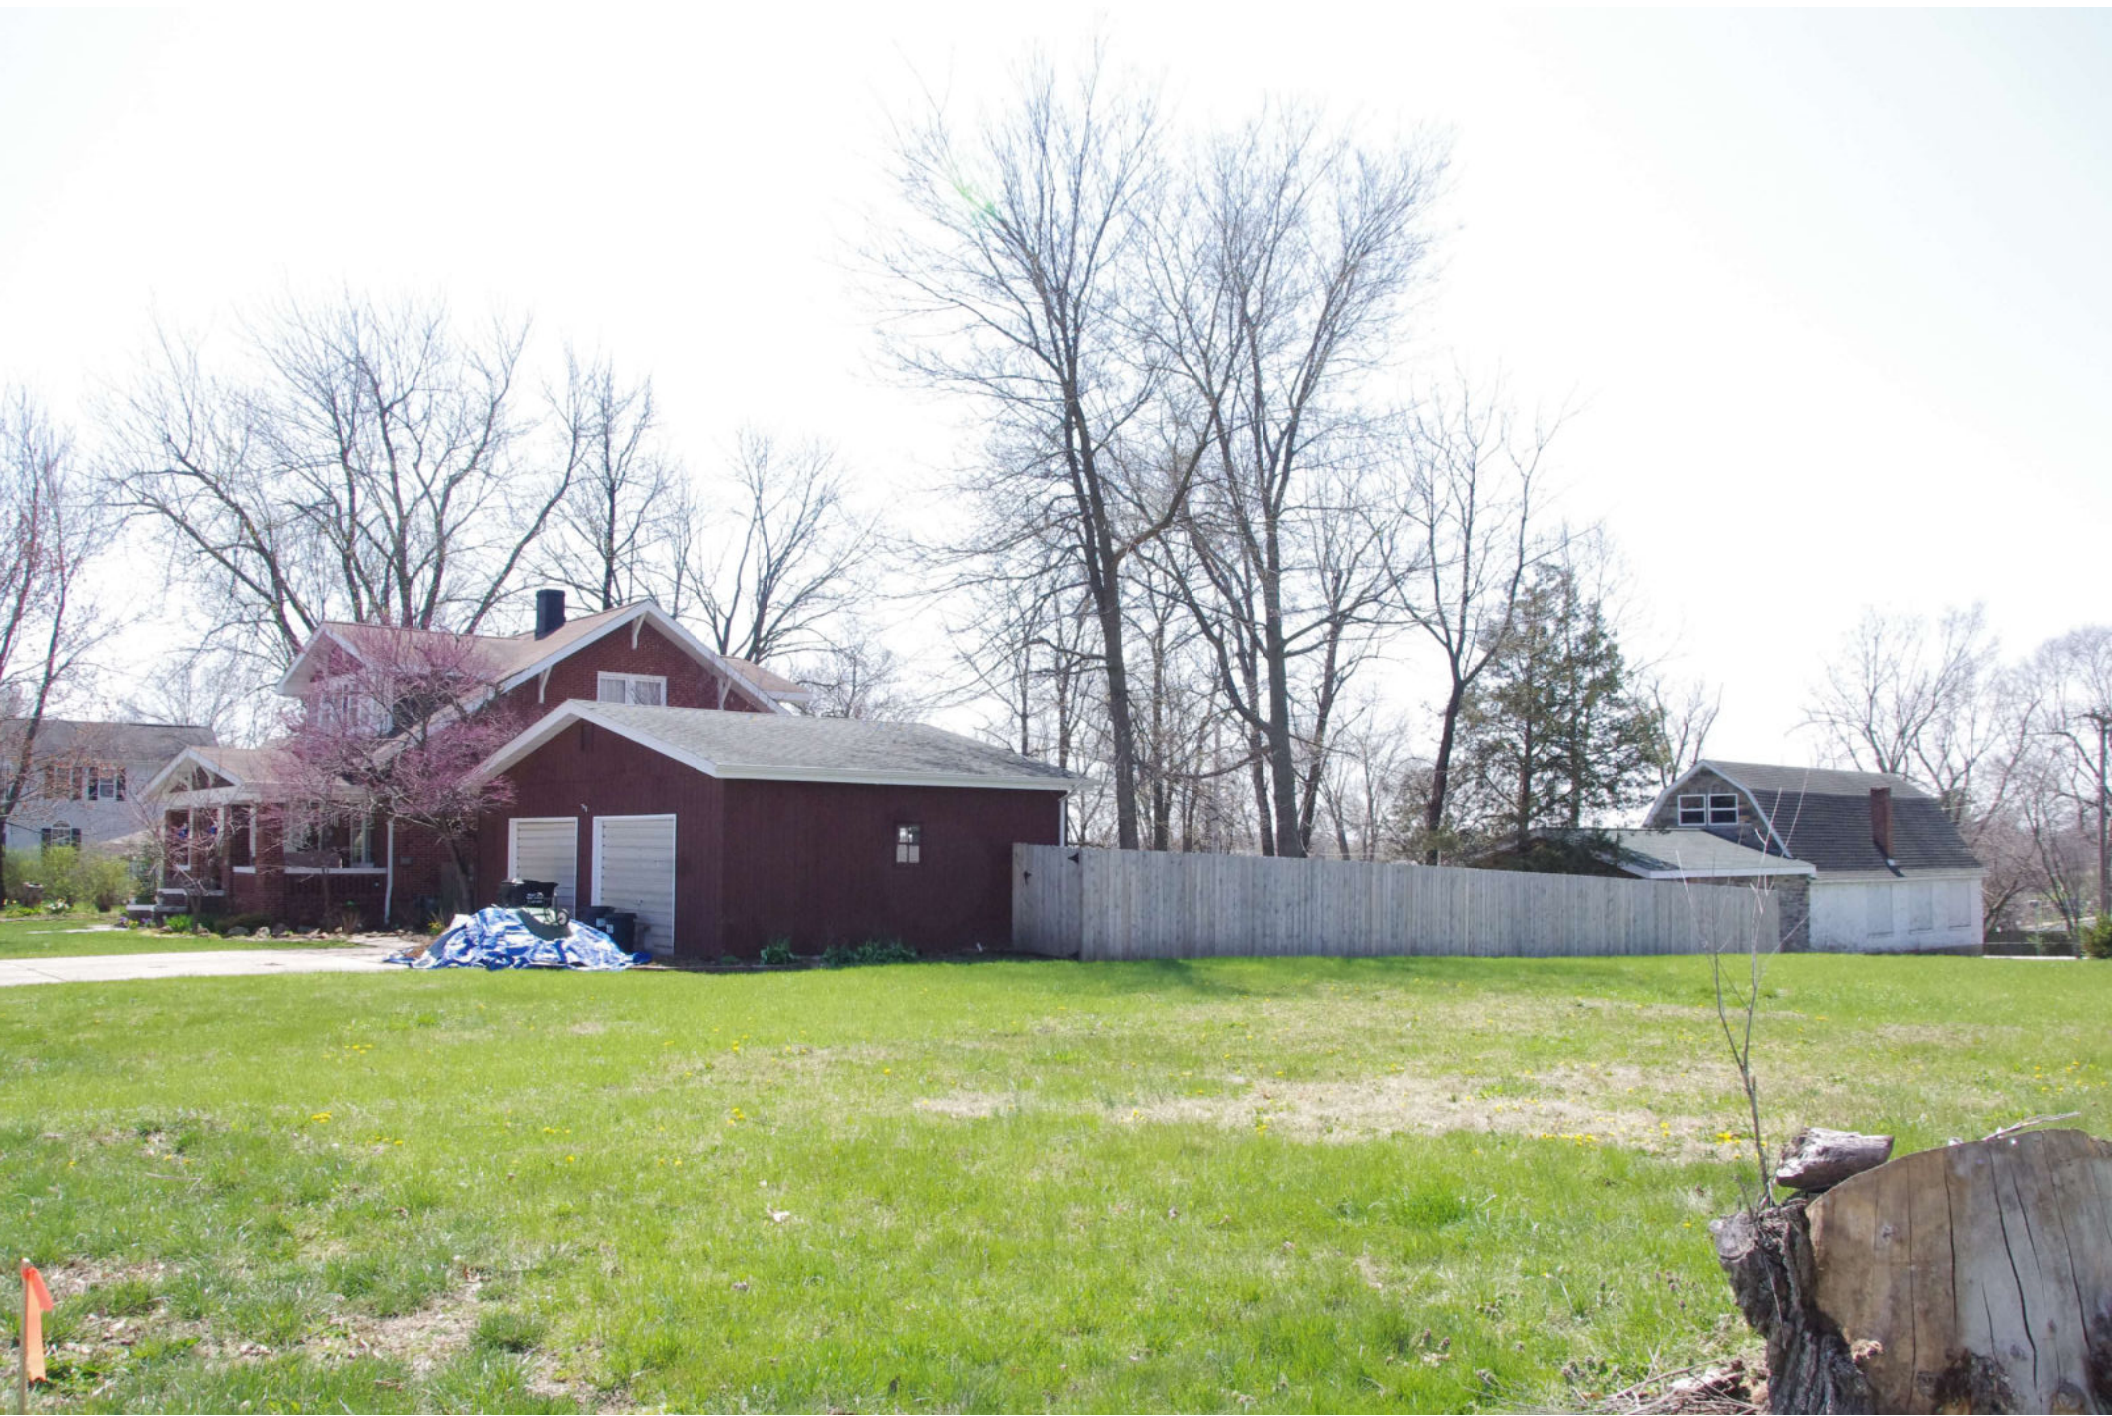
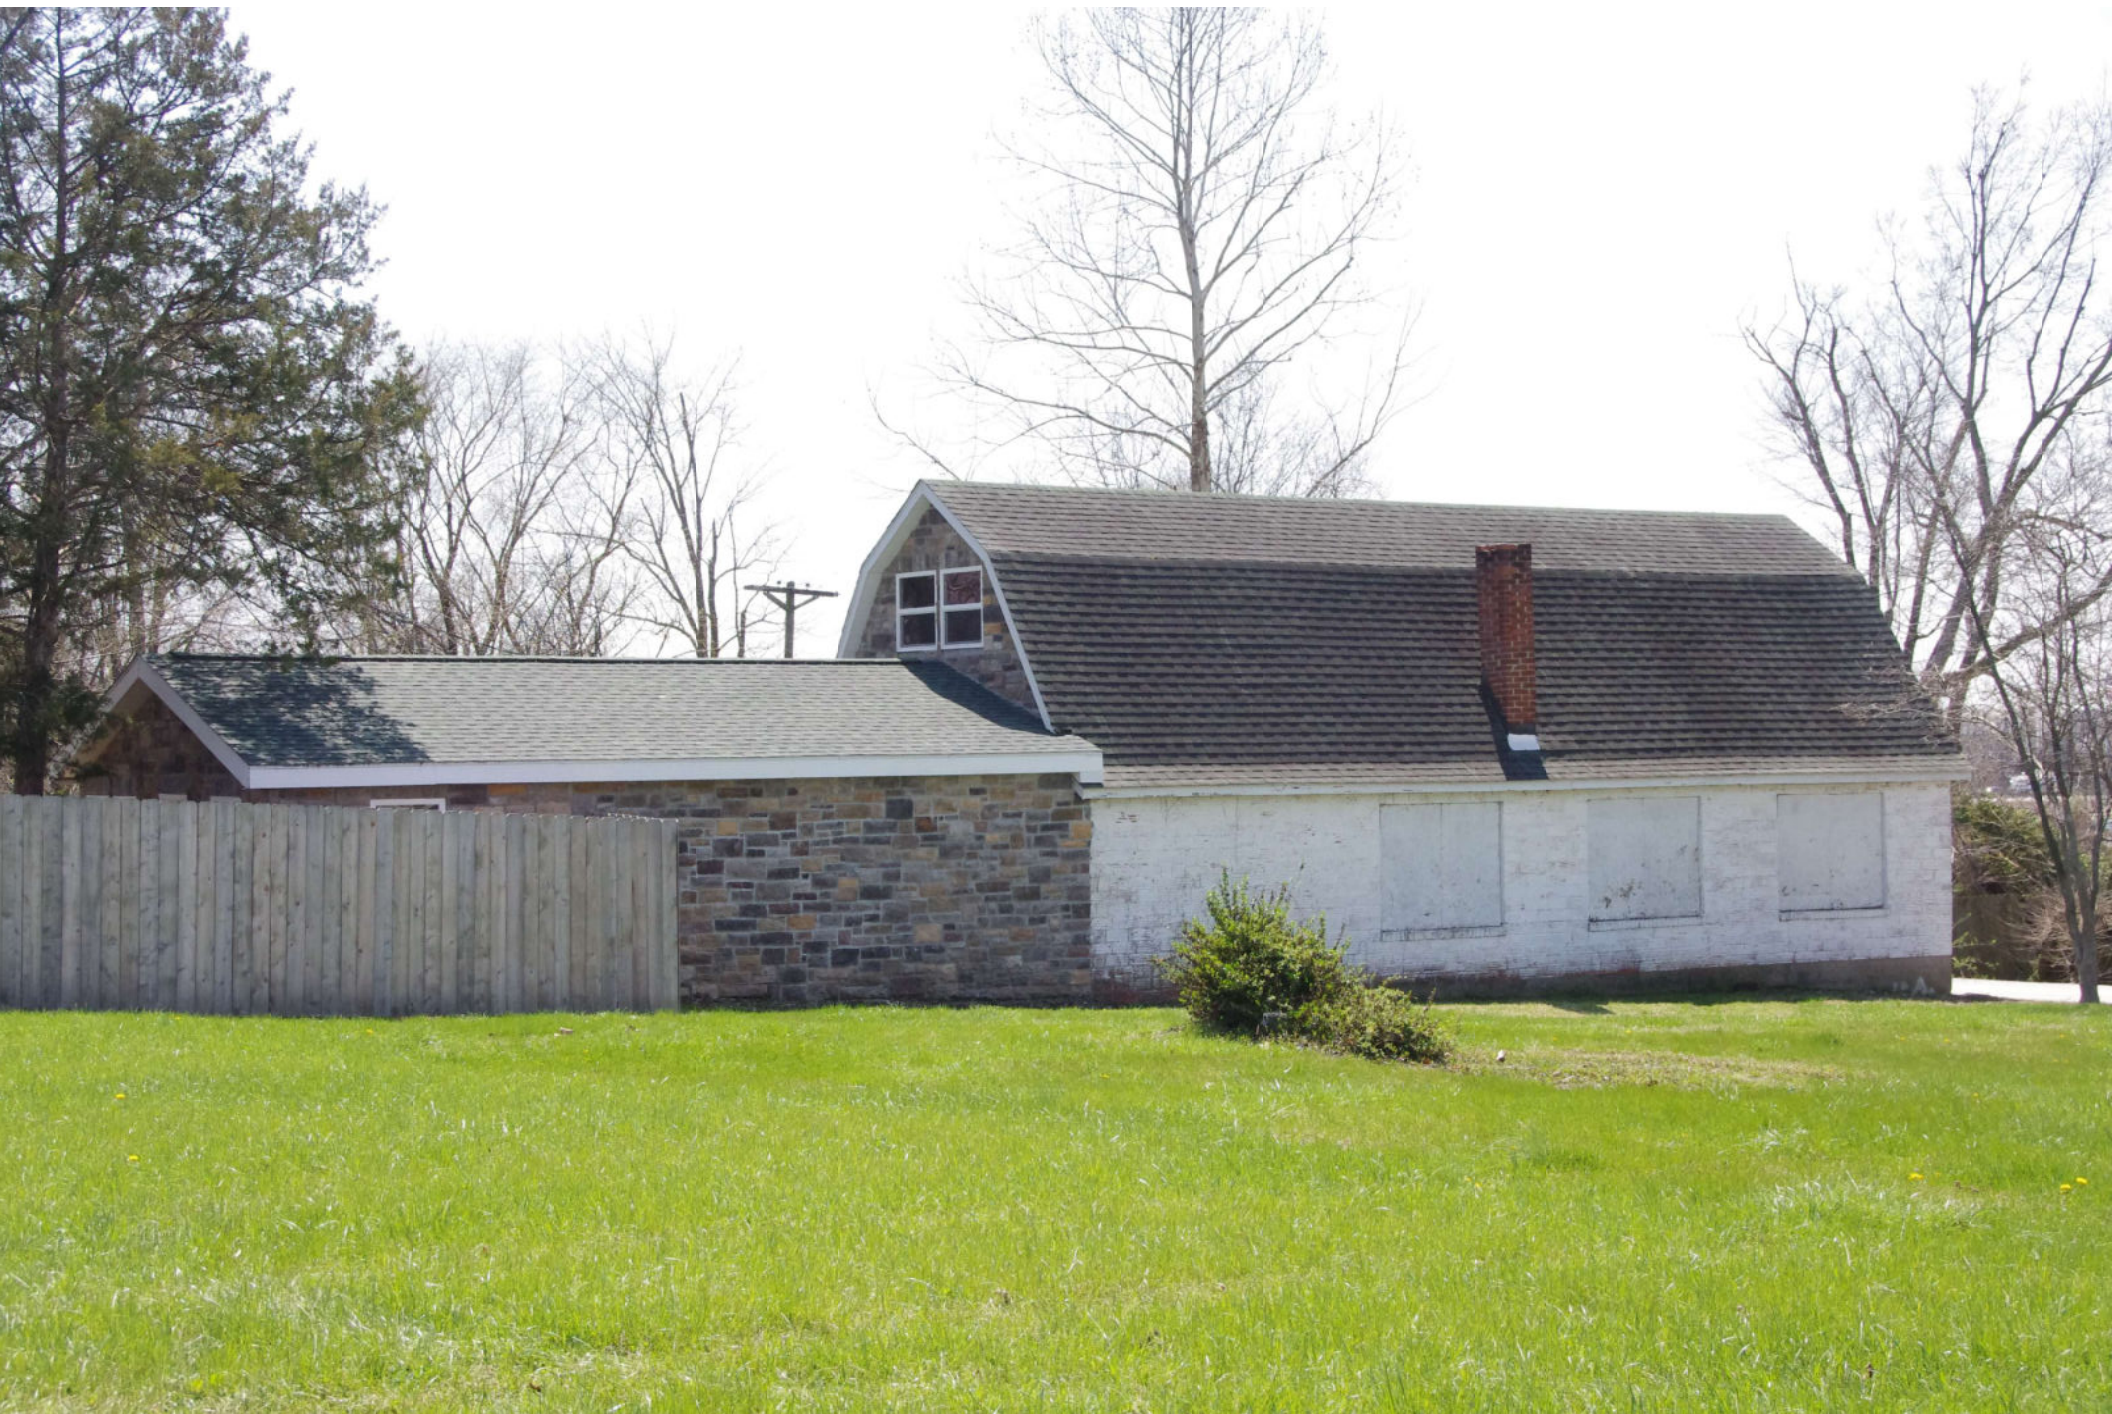
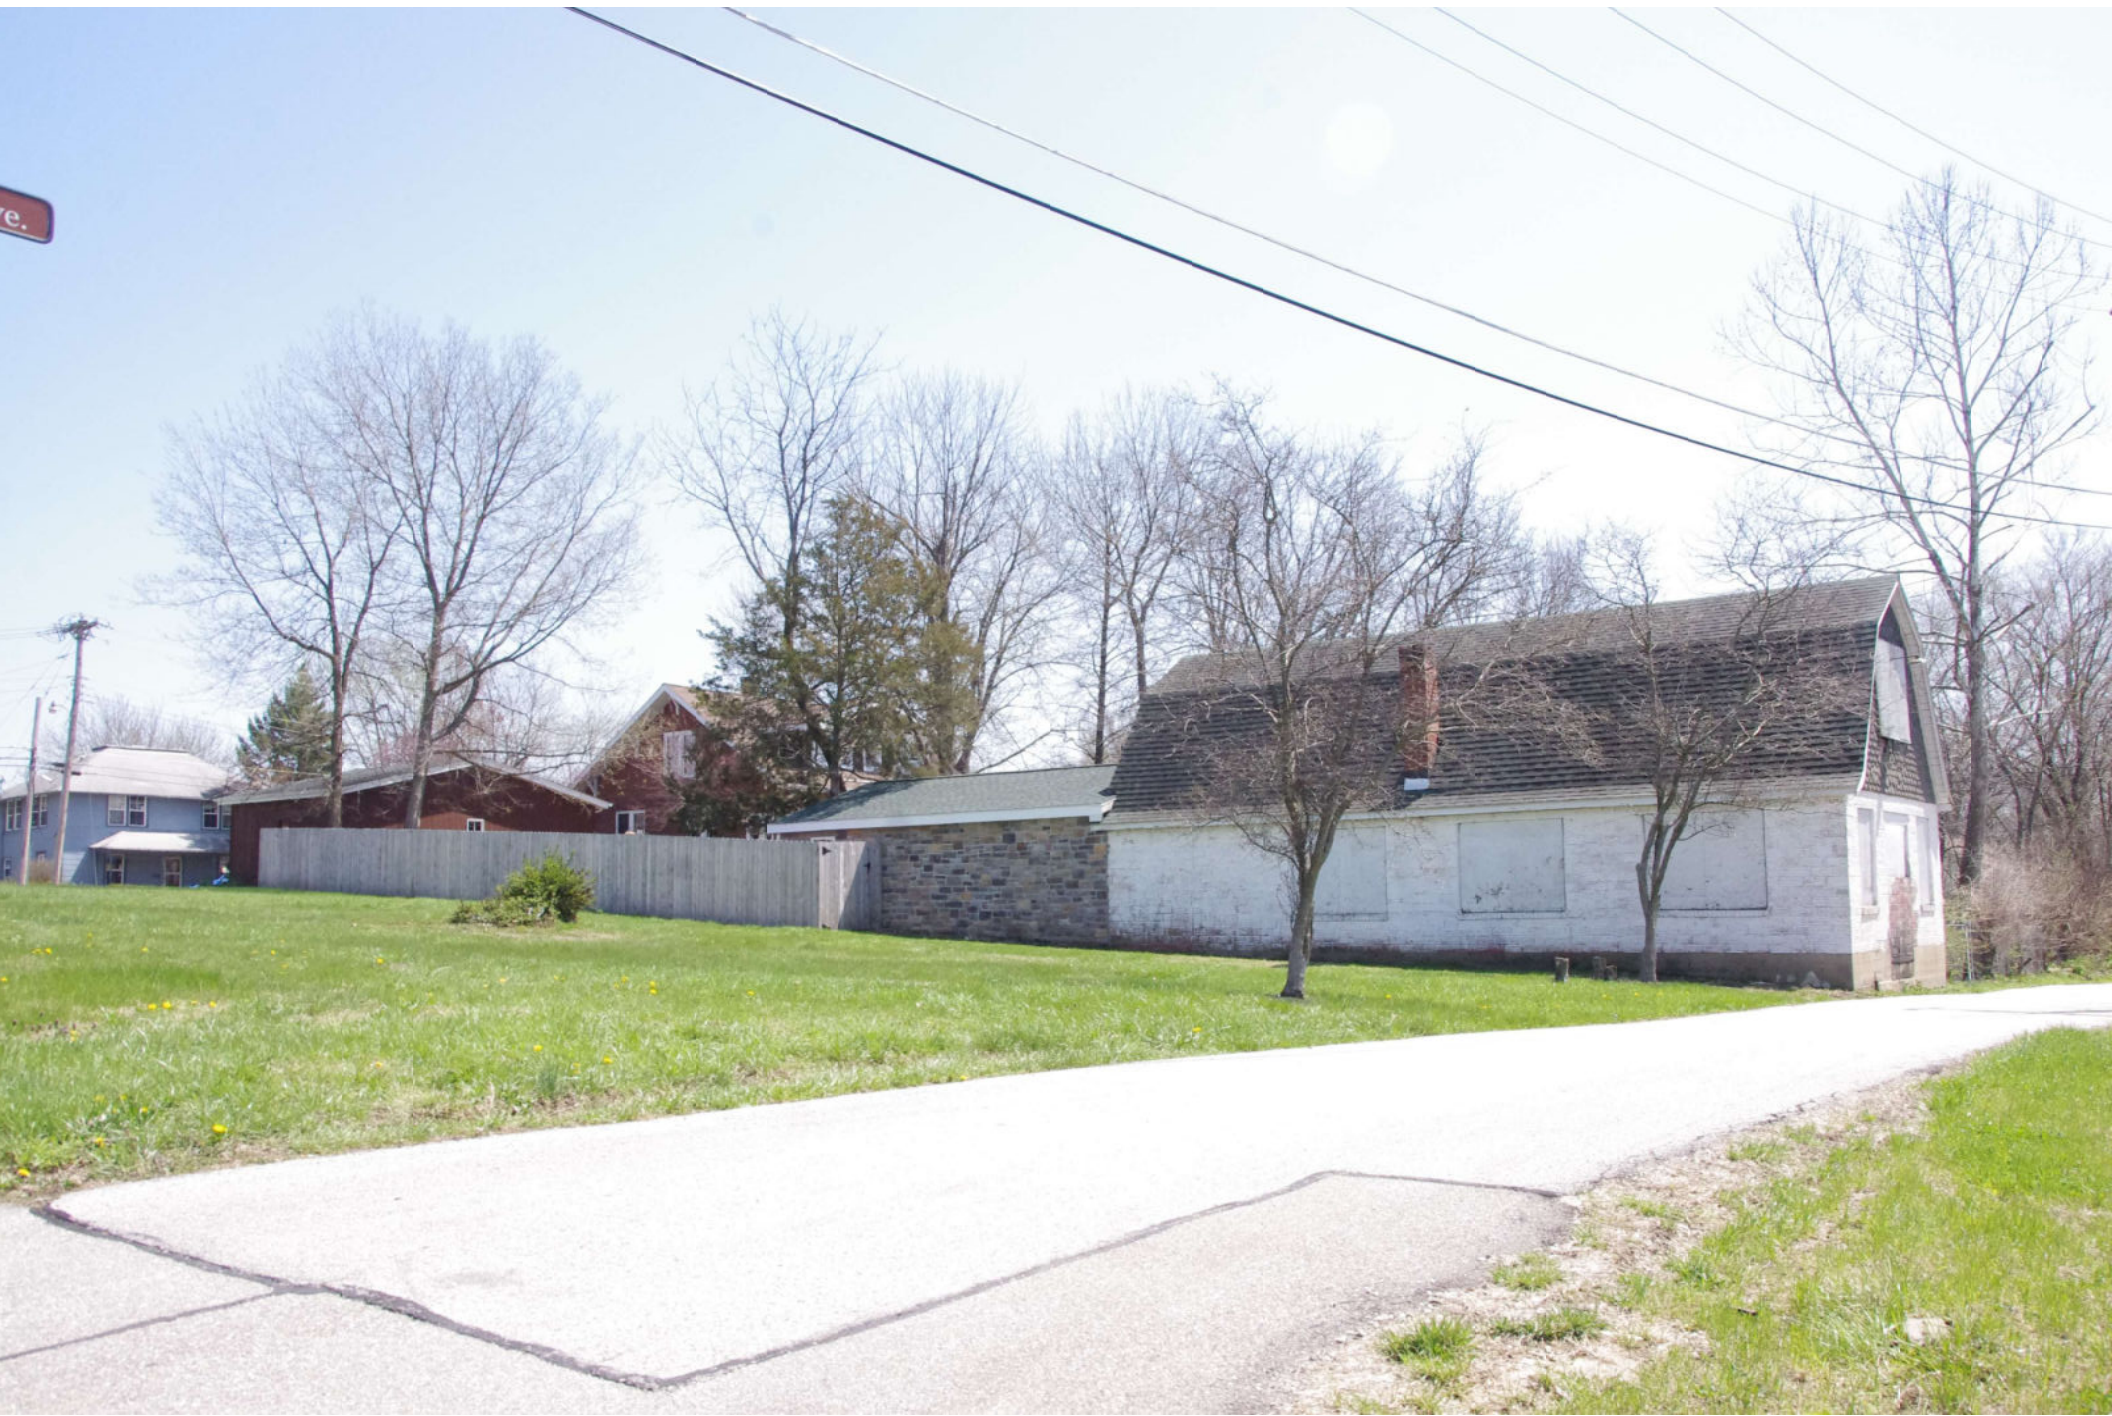
This resource is a two-story red multihued brick bungalow with a side gable roof. The house has wide eaves on the main roof, the full width gabled roof porch and the equally broad gabled dormer on the façade, all of which have knee brace supports. The porch has tapered brick piers with concrete caps and pierced brick railings as well as brick side walls to the concrete steps. The central wood entrance is flanked by paired four-over-one wood windows on the north and triple four-over-one windows to the south side. Three of these windows are clustered into two sets in the gabled dormer on the second level. There is a similar gabled dormer on the rear.

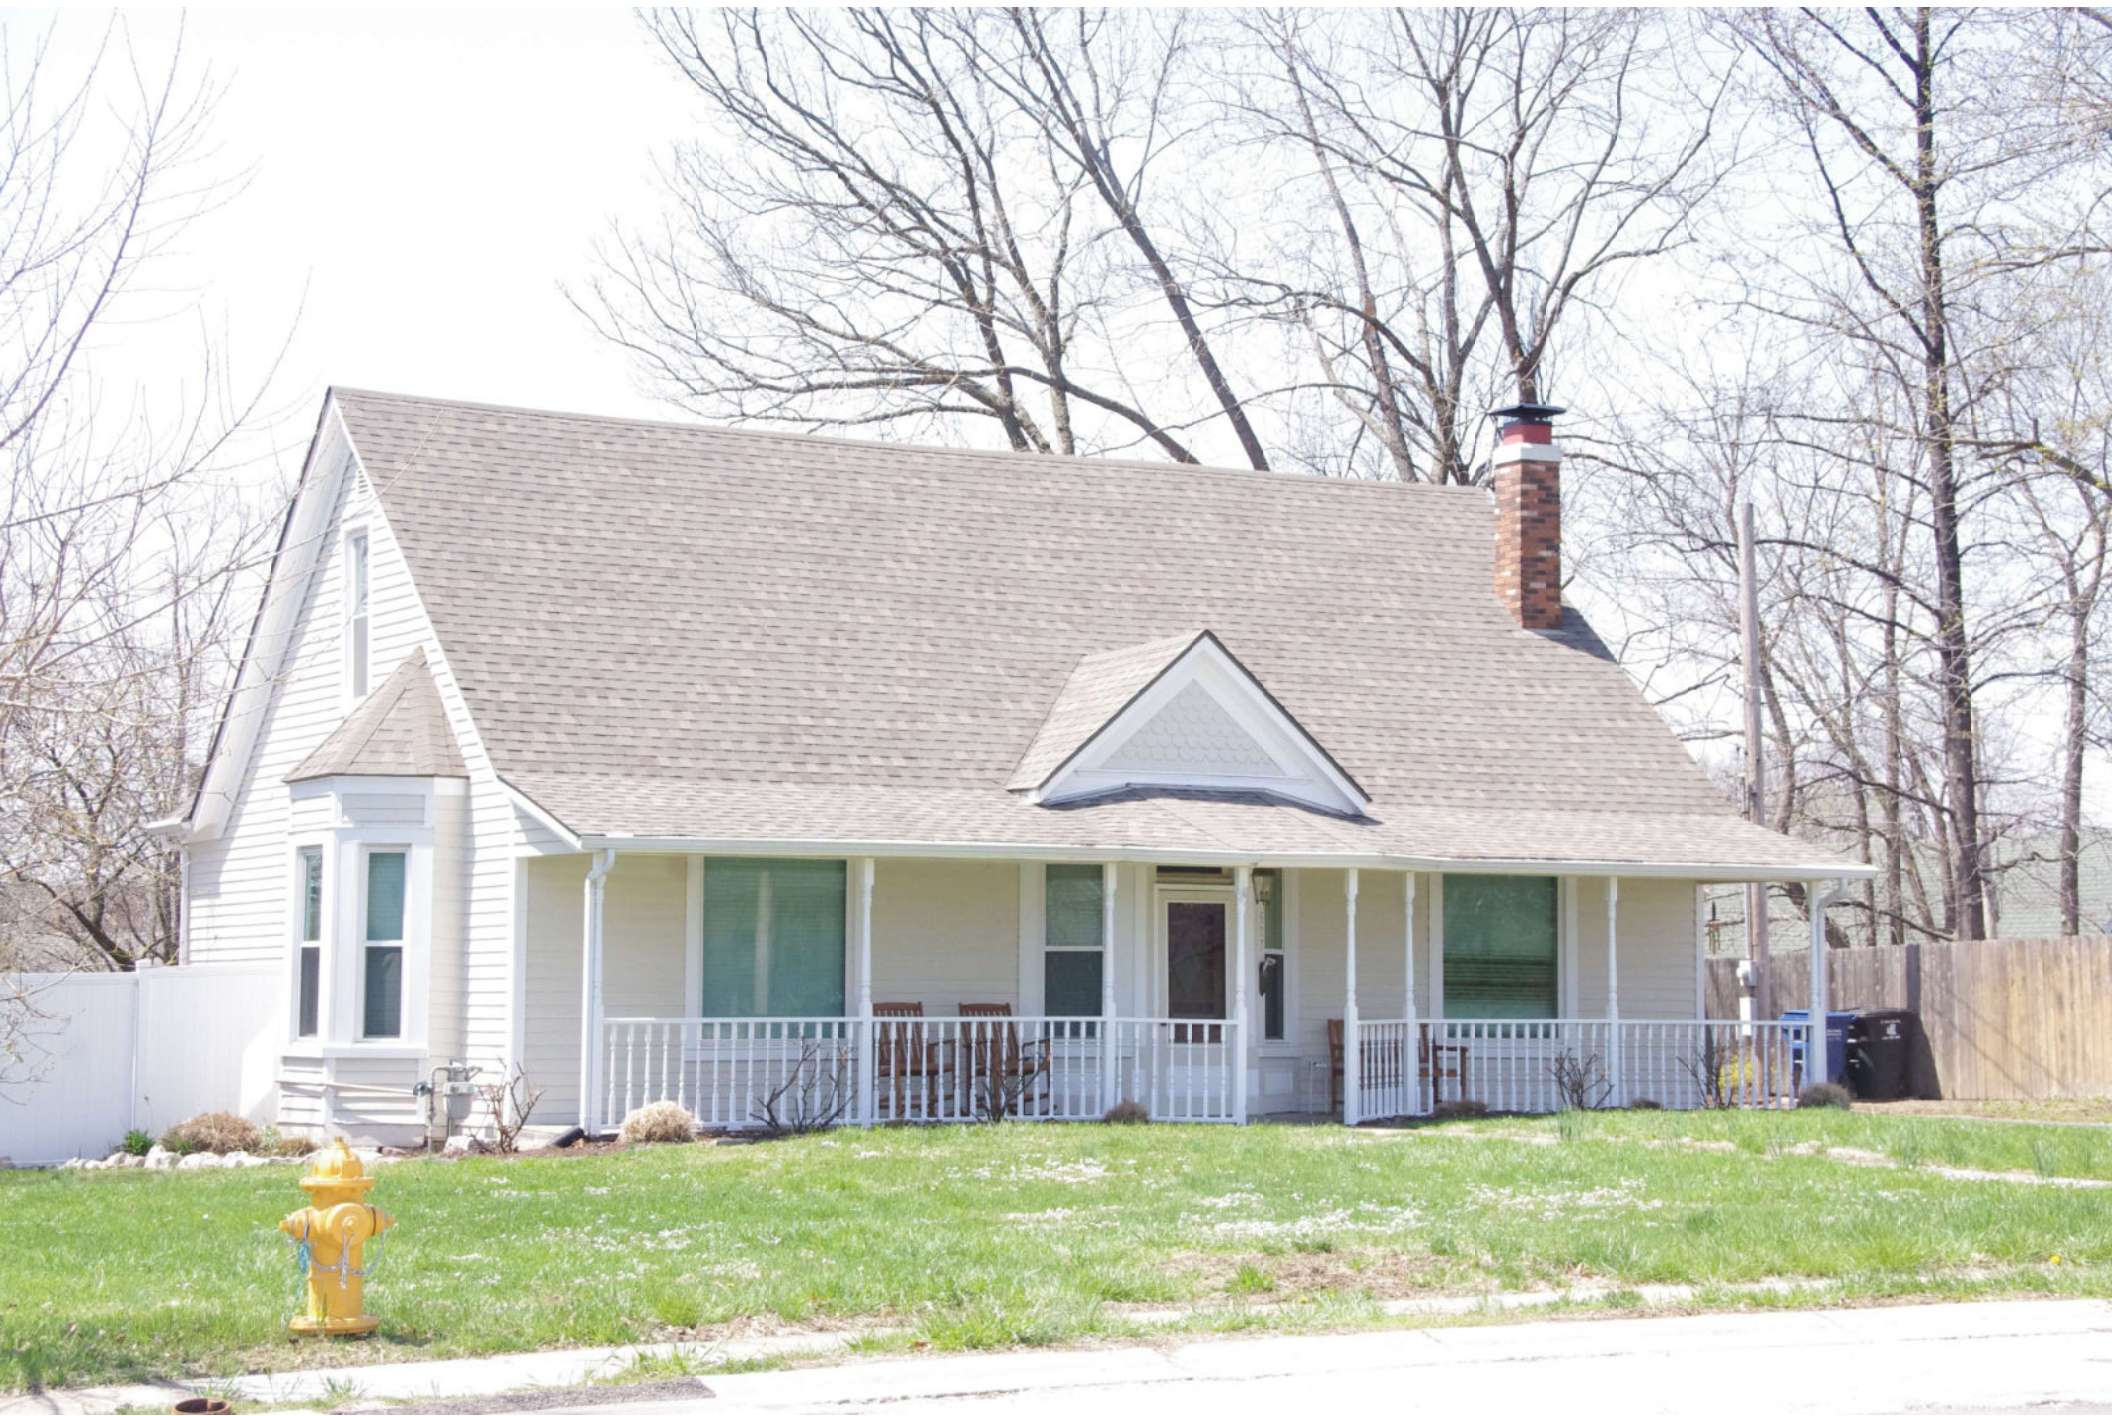
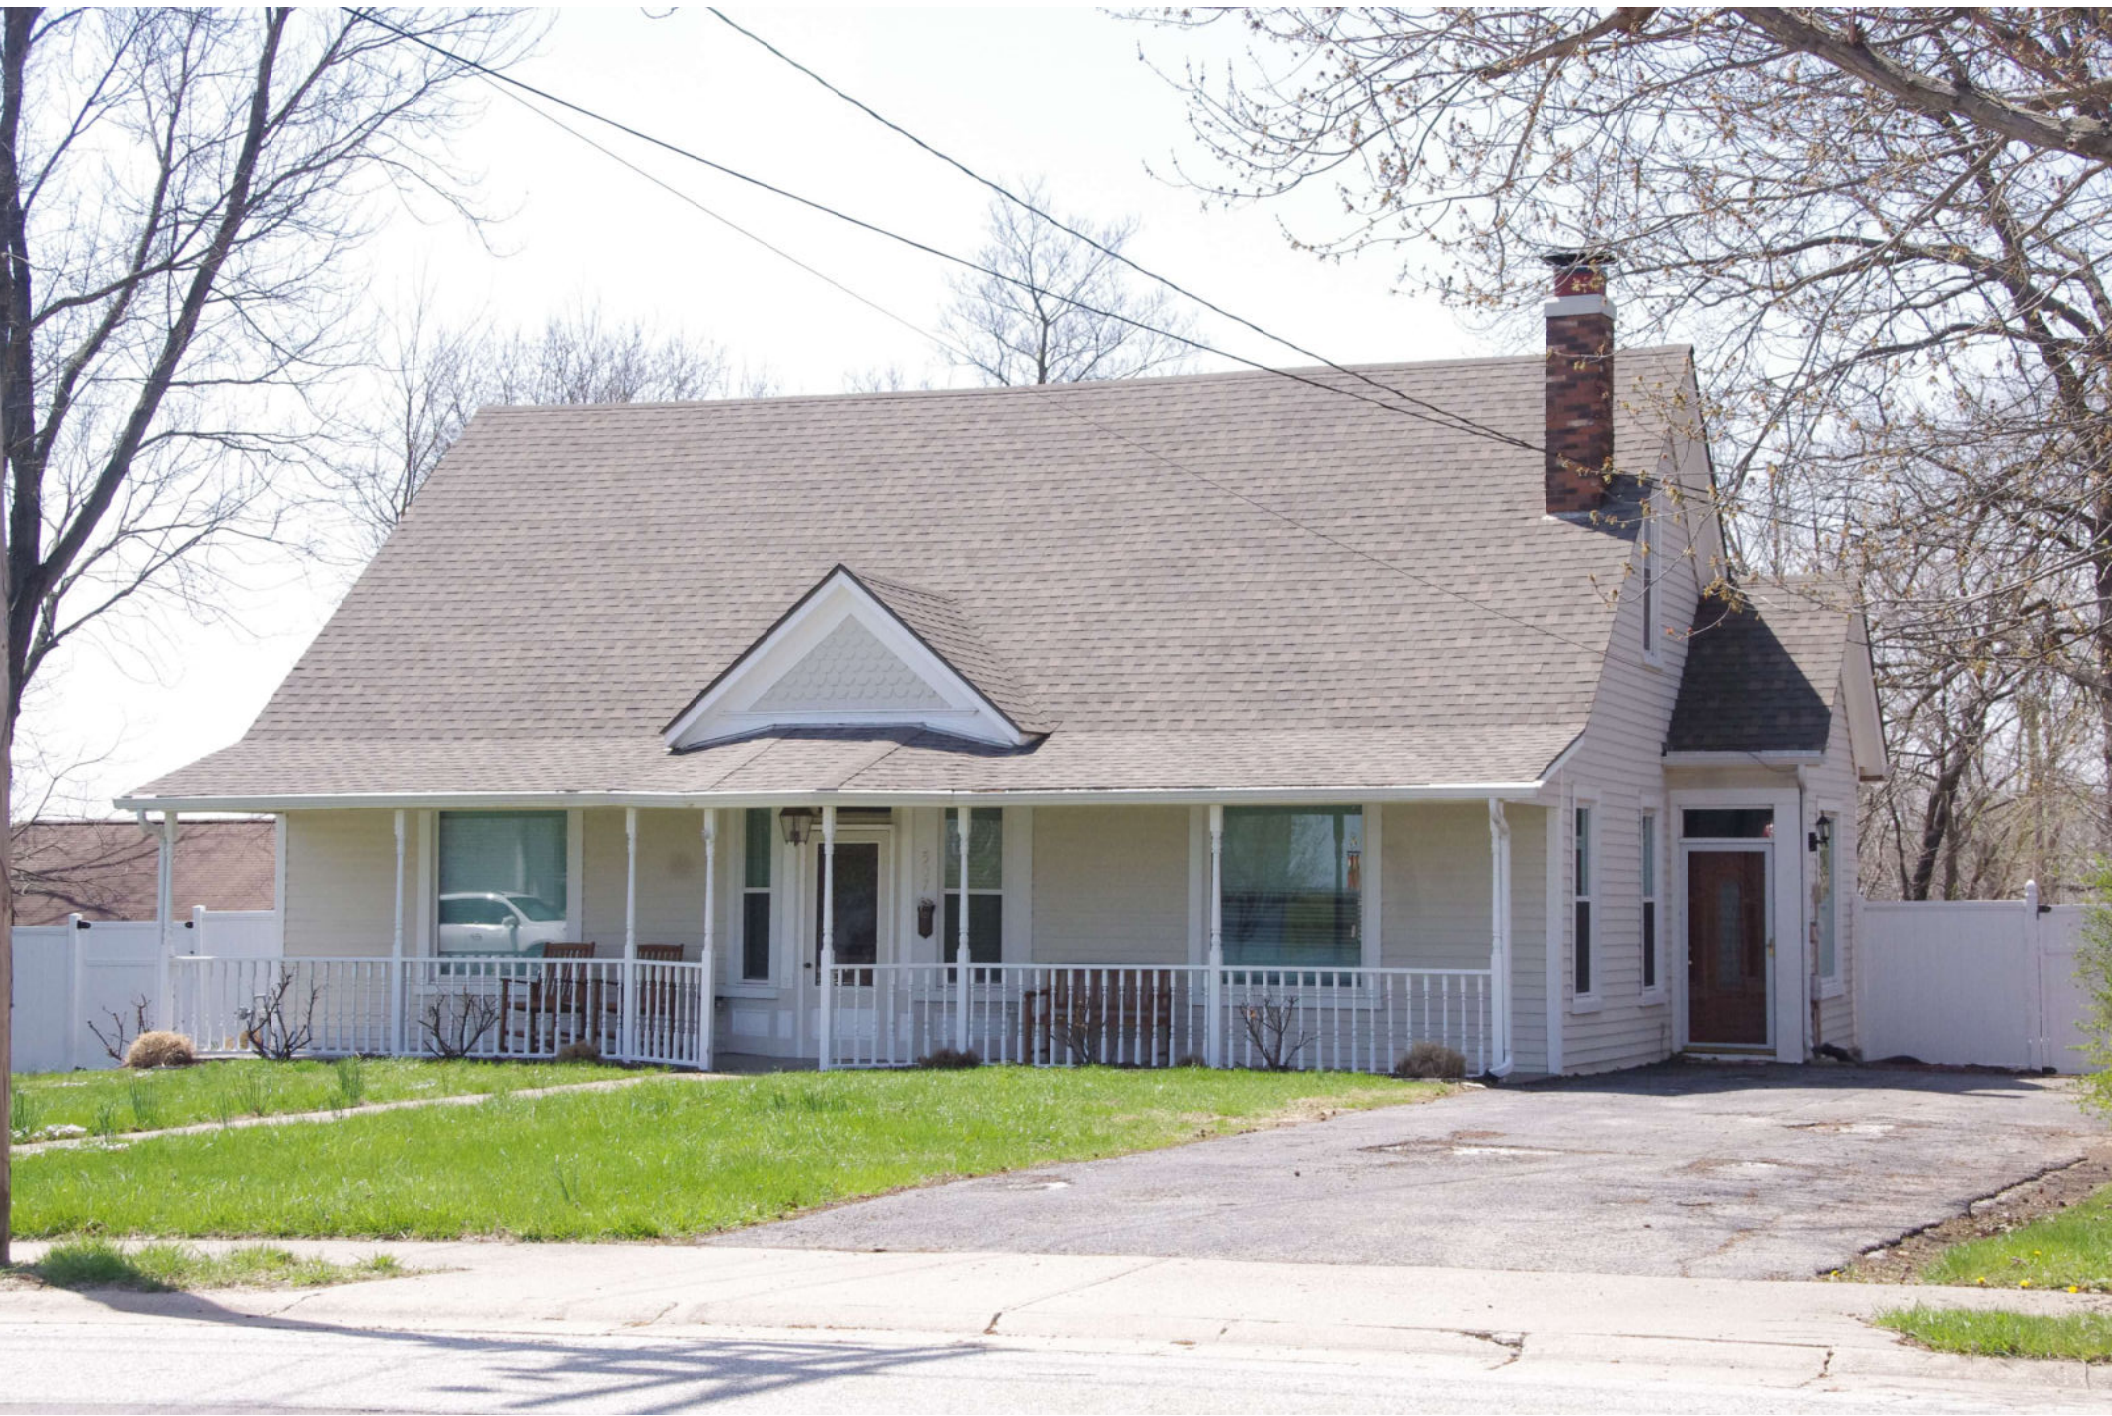
This one-story side gabled Folk Victorian house appears to be one of the rare examples in Wentzville retaining its original wood siding, although closer inspection might reveal it is Hardy cement board siding (because it is in such good condition). The full width porch has turned wood spindle supports and a spindlework railings, but the height of the railing indicates that the railings, and possibly the posts are replacements. The entrance is in a projecting canted bay under the porch roof (which also angles at the entry), with a half light wood door with a transom flanked by one-over-one replacement windows with wood panels below the windows. To either side of the entry bay, the two outer bays have replacement single light windows within the large window openings. Above the porch roof, centered on the façade is a small triangular dormer with fishscale shingles in the gable end. On the south side of the house is a canted bay window. On the north side, near the rear is a small enclosed entry vestibule with a transomed wood door.

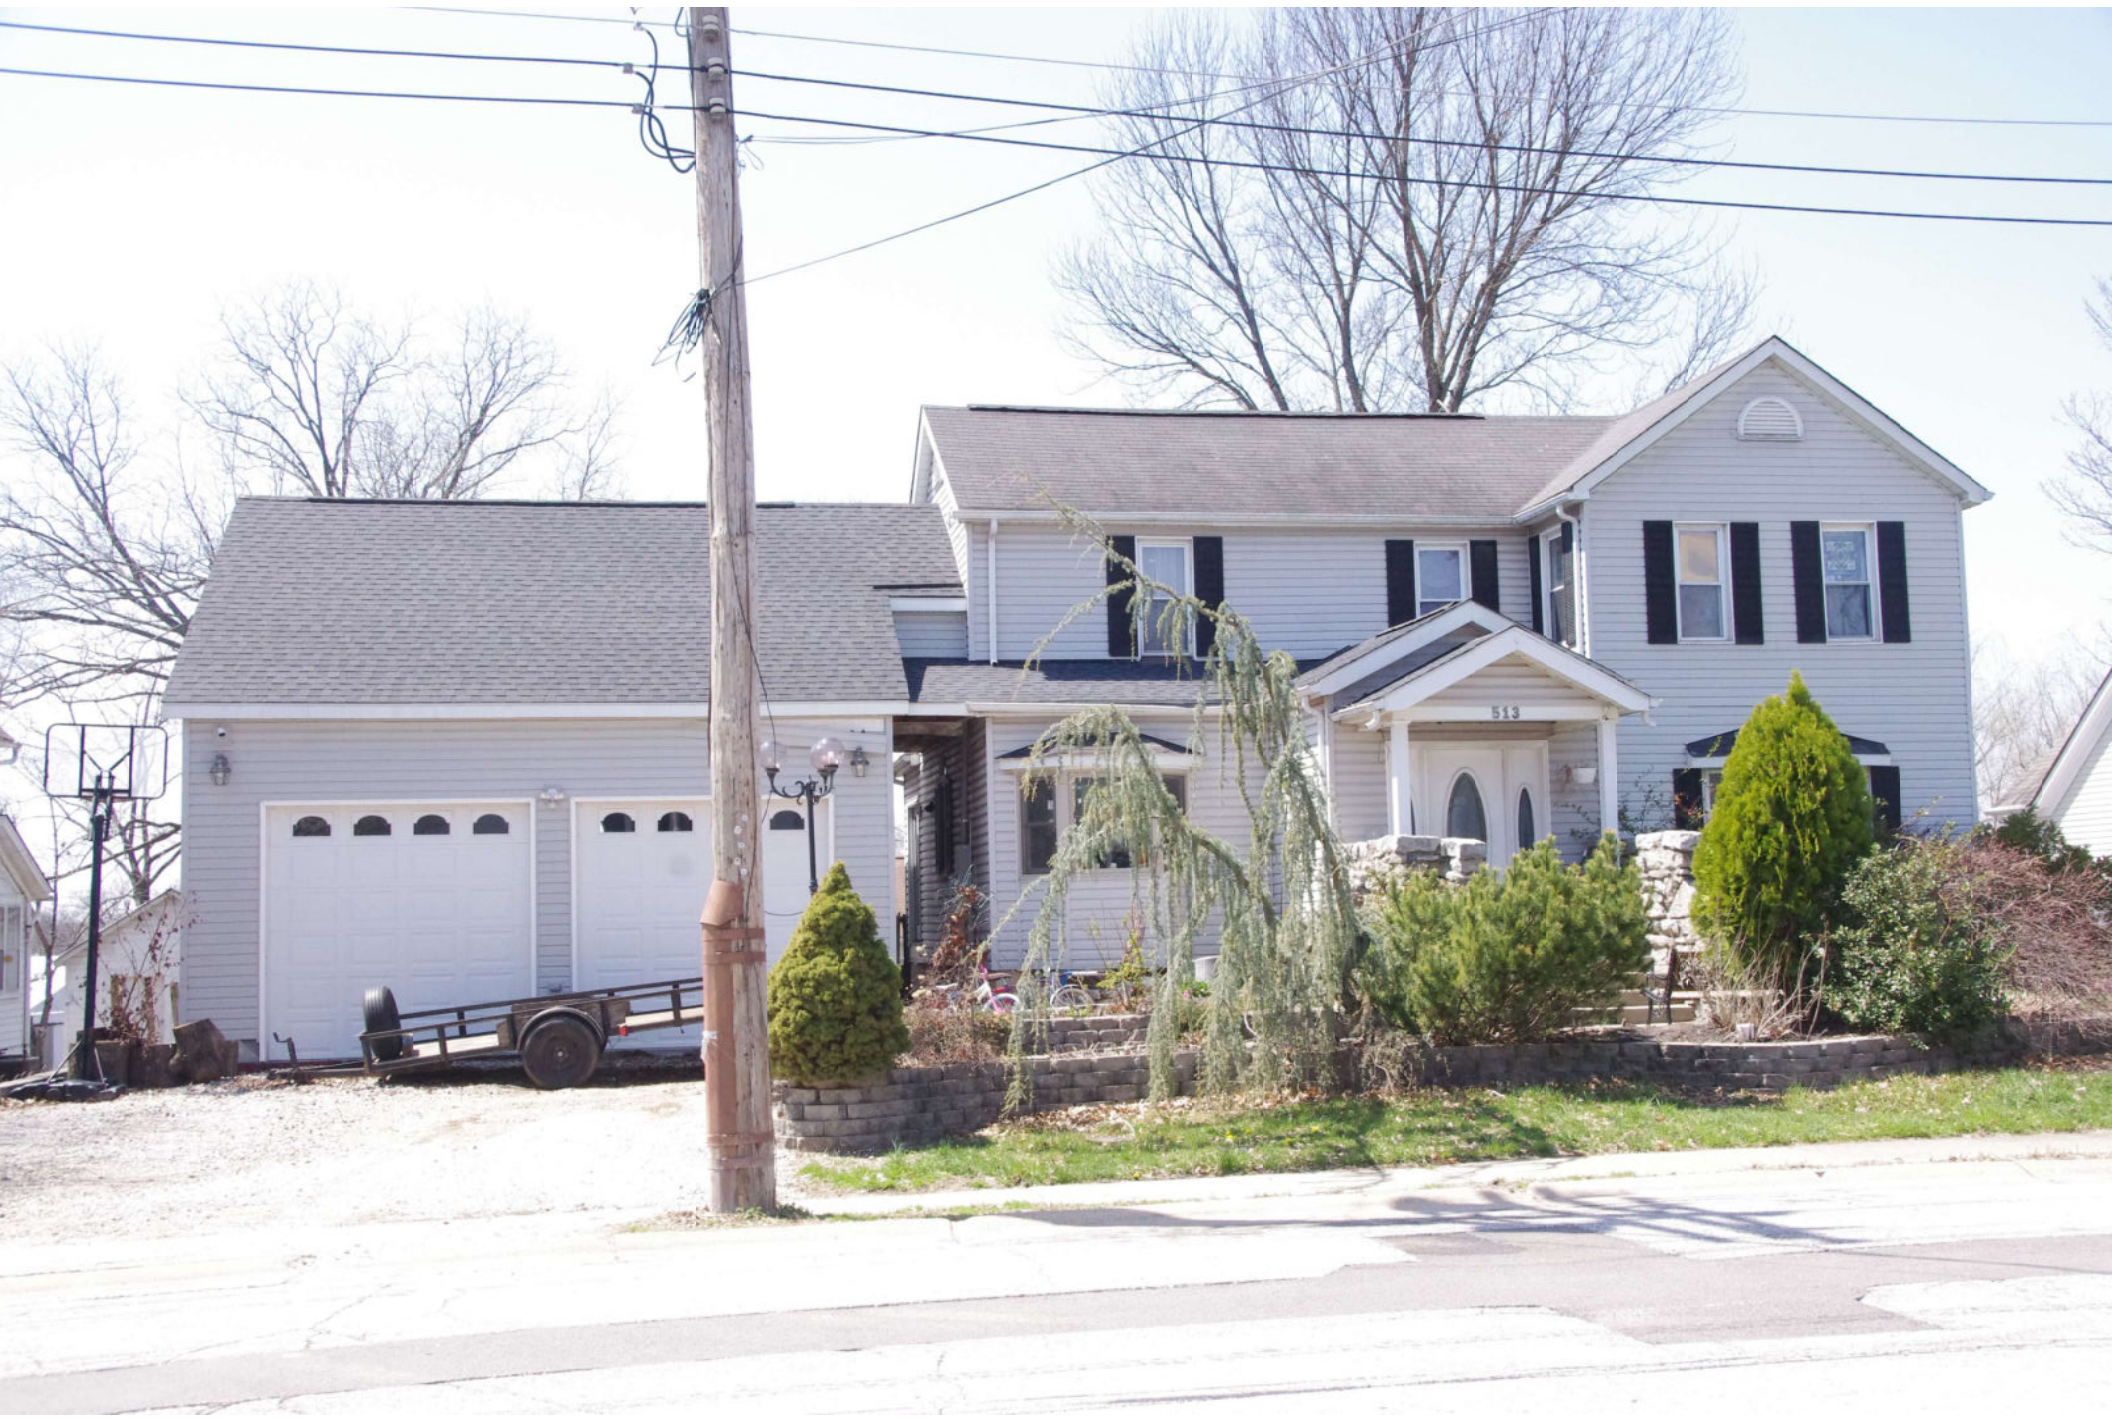
This resource is a two-story gable and wing house with a central gabled open porch in front of an gabled, enclosed vestibule addition with a shed roofed addition to its south. The wood entrance door has an oval light and a wood and oval window sidelight, all recent additions. Four single pane rectangular lights fill a canted bay window to the north of the entrance and there is another small canted bay to the south of the entry. Replacement one-over-one windows are located in the southern bay, and in the five bays of the second level. The two-bay side gabled garage with two overhead doors was added to the southern side of the house. Faux shutters have been added to the façade windows.
