**ARCHITECTURAL/HISTORIC INVENTORY FORM**

1. Survey No. SC-AS-012-0052		2. Survey Name: Reconnaissance Level Survey of Historic Downtown Wentzville	
3. County: St. Charles		4. Address (Street No.) 105	Street (name) South Linn Ave
5. City: Wentzville	Vicinity: <input type="checkbox"/>	6. UTM:	
8. Historic name (if known):		9. Present/other name (if known): Land Fair Corp.	
10. Ownership: <input type="checkbox"/> Private <input type="checkbox"/> Public		11a. Historic use (if known): COMMERCE/TRADE	11b. Current use: COMMERCE/TRADE/professional
5. City: Wentzville		7. Township/Range/Section:

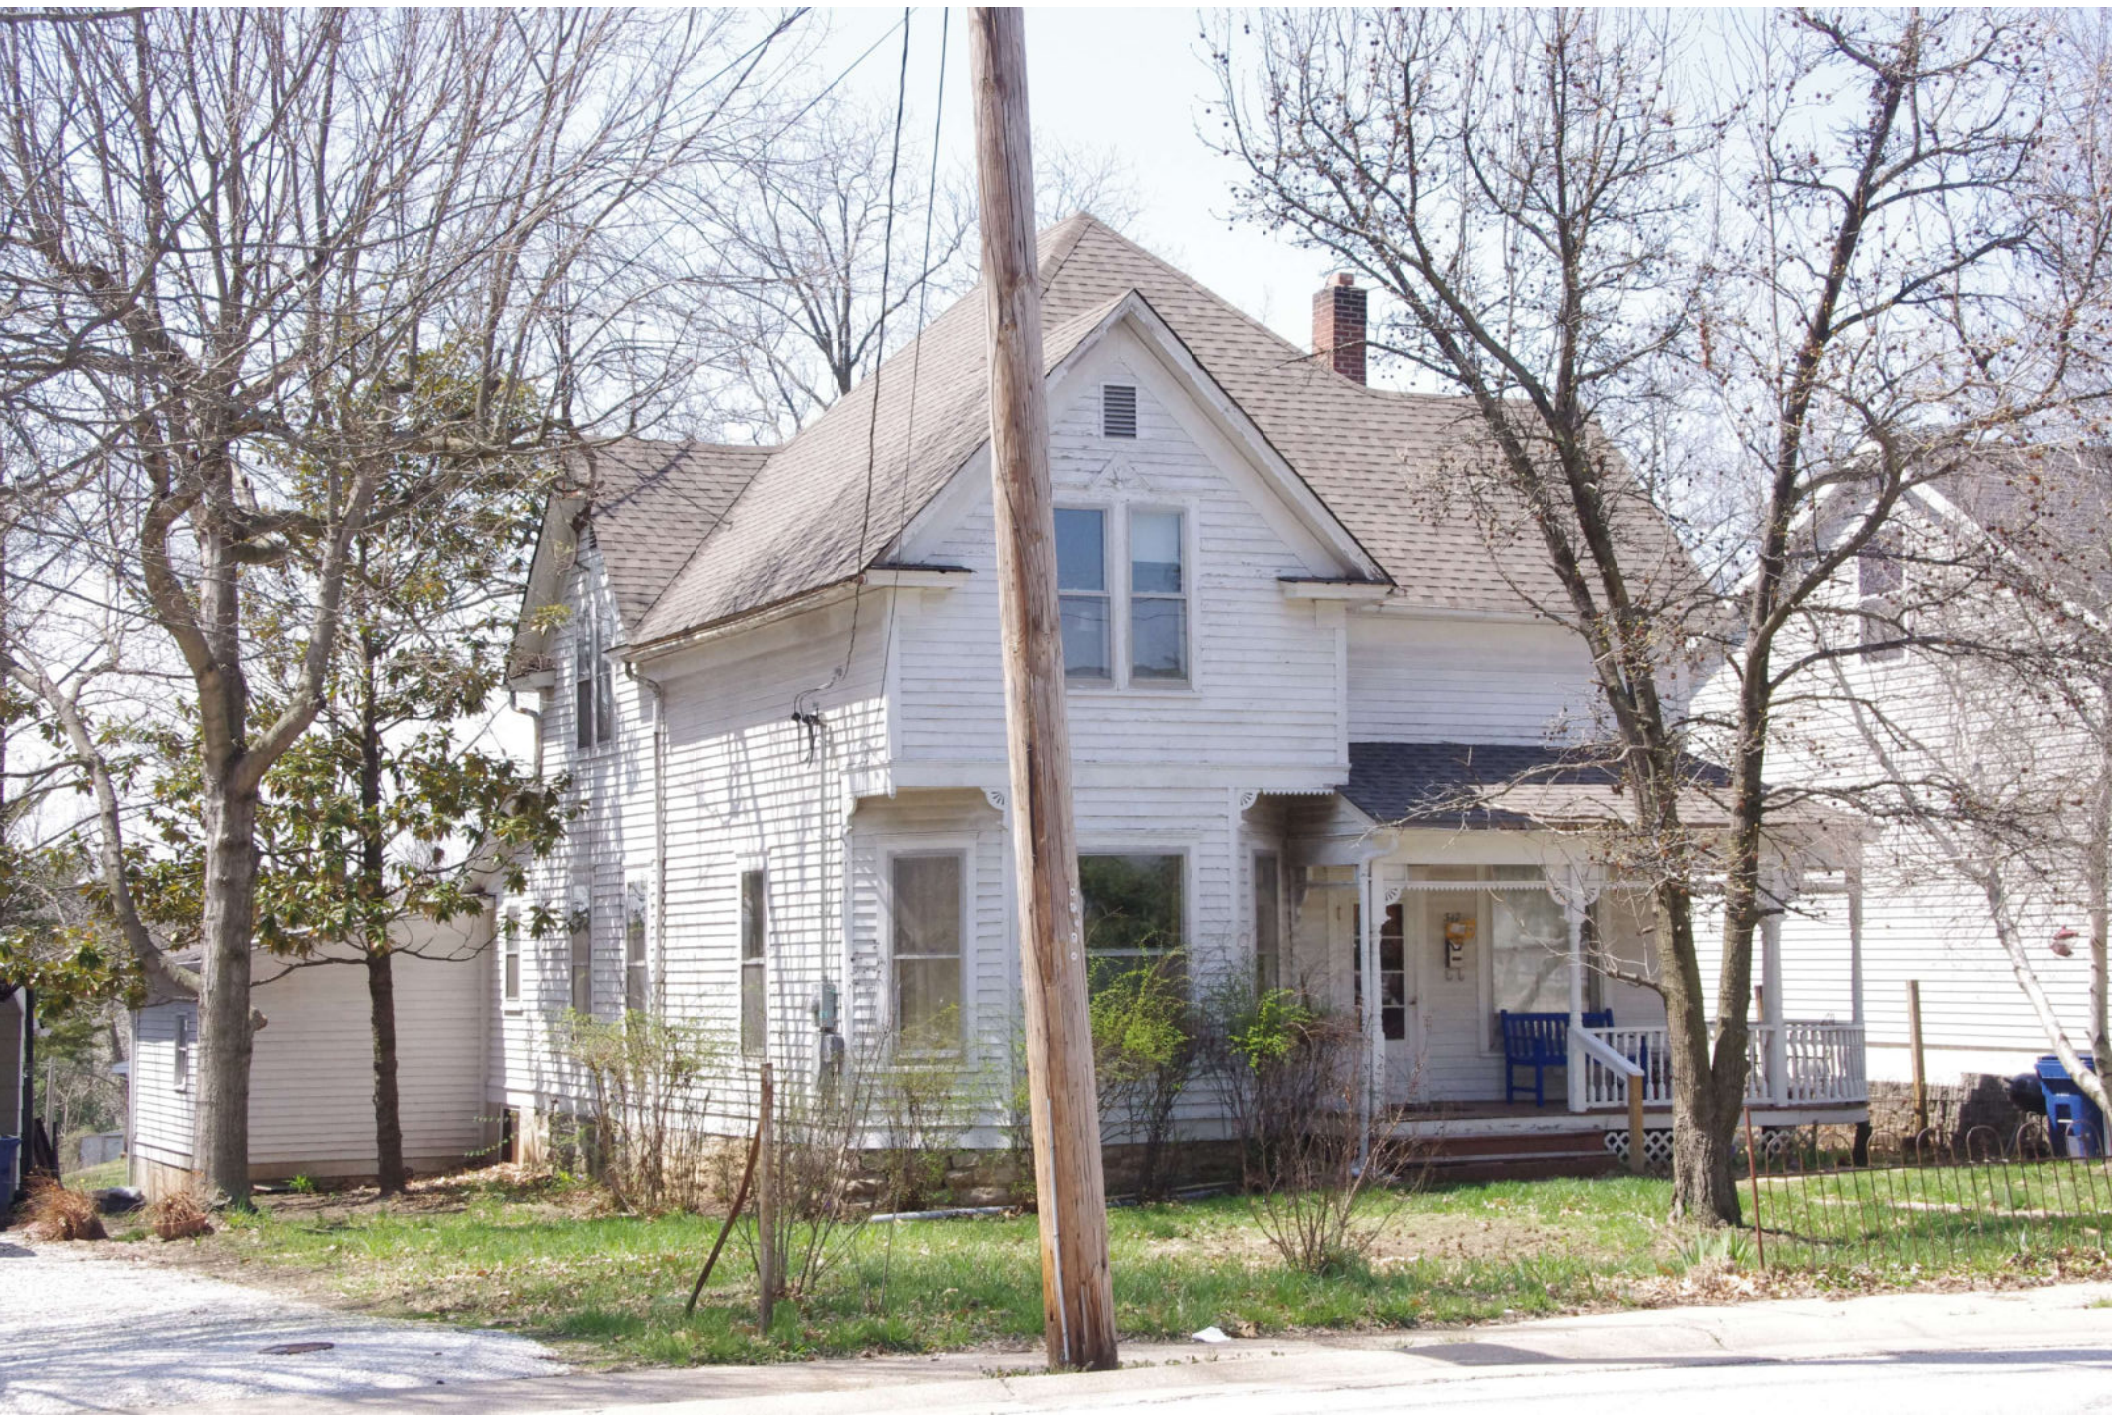
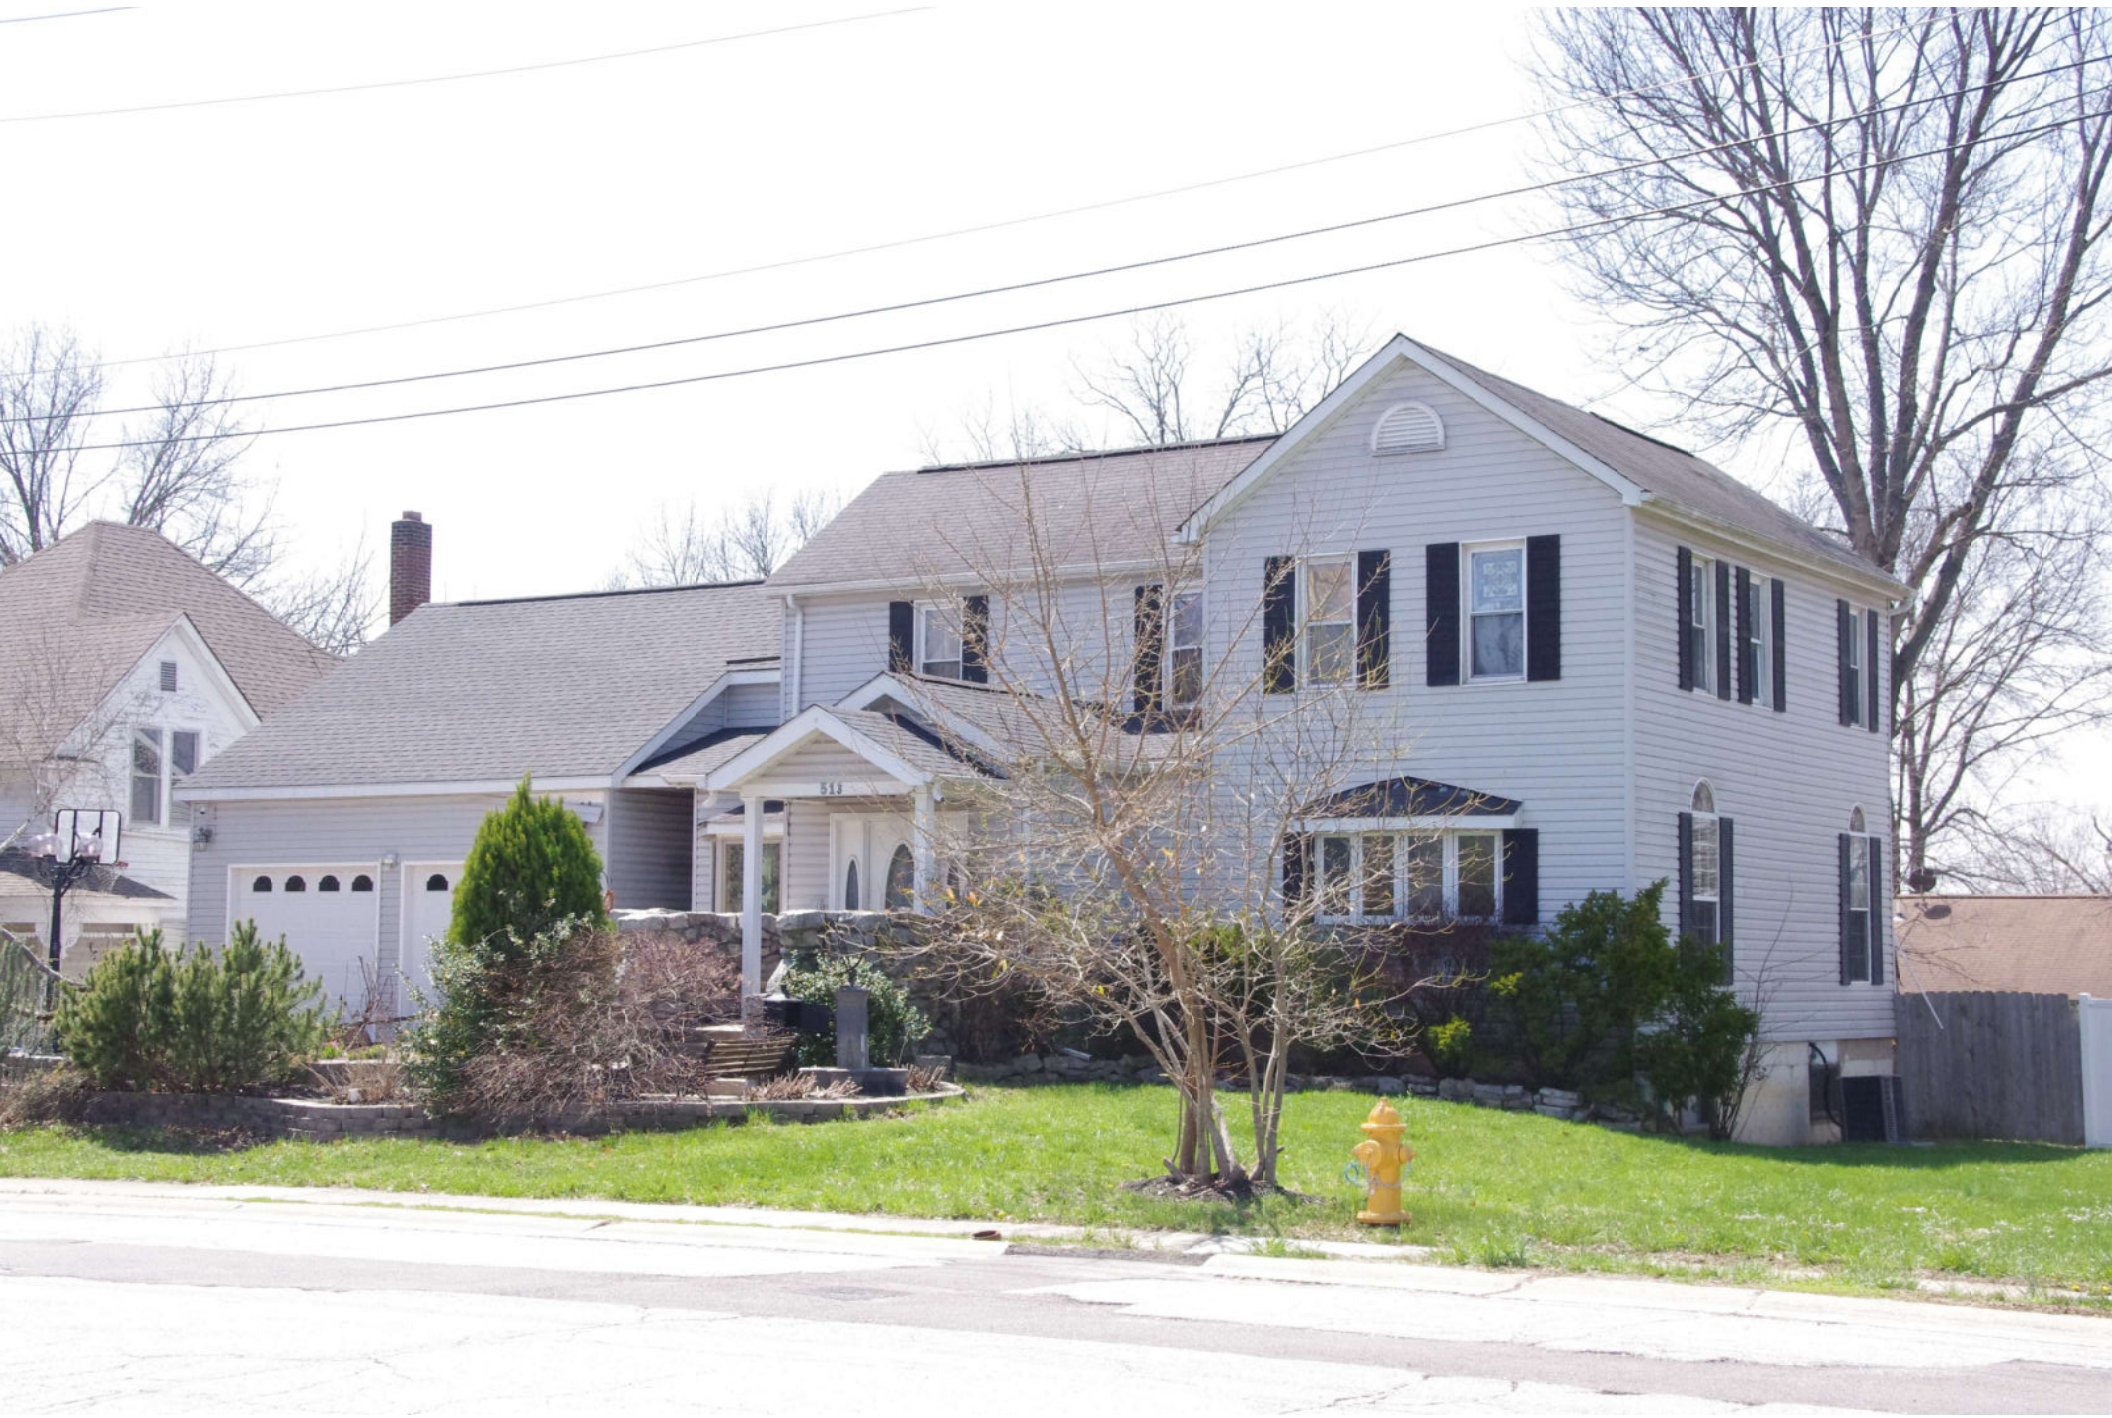
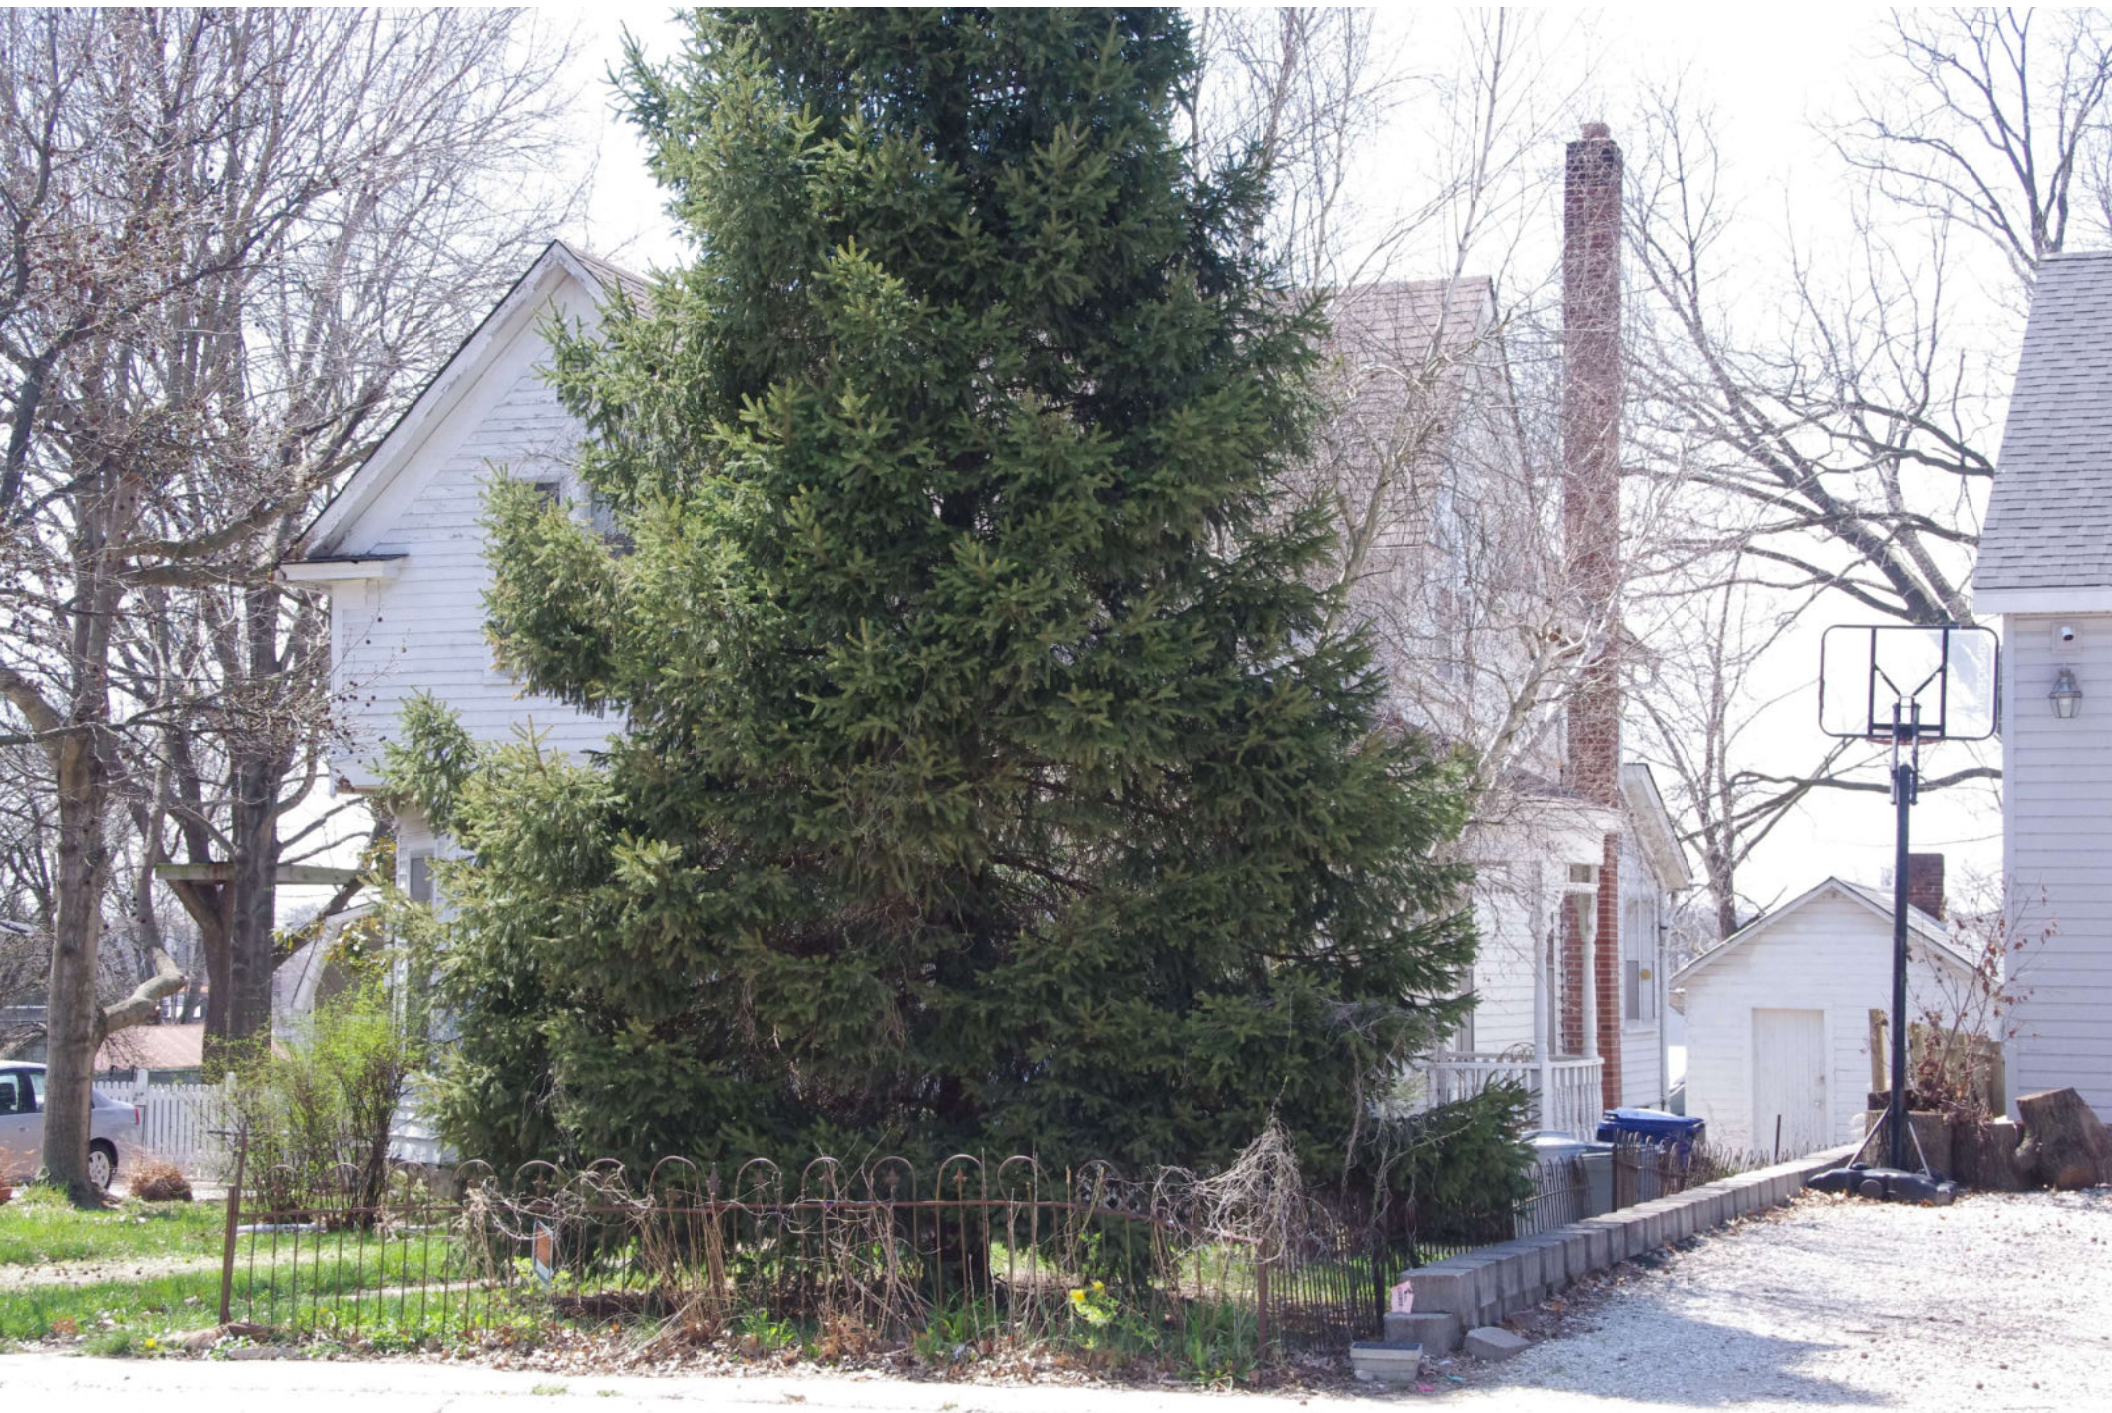
This resource is a wood framed, Queen Anne house with a two-story hipped roof with cross gables. It has an open porch that wraps the north half of the façade and around the north corner, with a half conical roof on that end of the porch. The shed roofed porch features turned spindle railing and turned wood posts with decorative fretwork and brackets. The half light wood door is covered by a wood storm door and located beyond the porch. North of the door is a large, 1/1 wood sashed window. The gable end on the façade contains a canted bay window on the first floor with 1/1 wood sashed windows and the upper level has paired one-over-one sash windows with wood molding. Facing south is another cross gable with paired sashed windows on the second floor and the first floor has three 1/1 sashed windows on the south façade. A ca. 1950 one-story, wood sided gable, two bay garage is attached on the rear of the house.

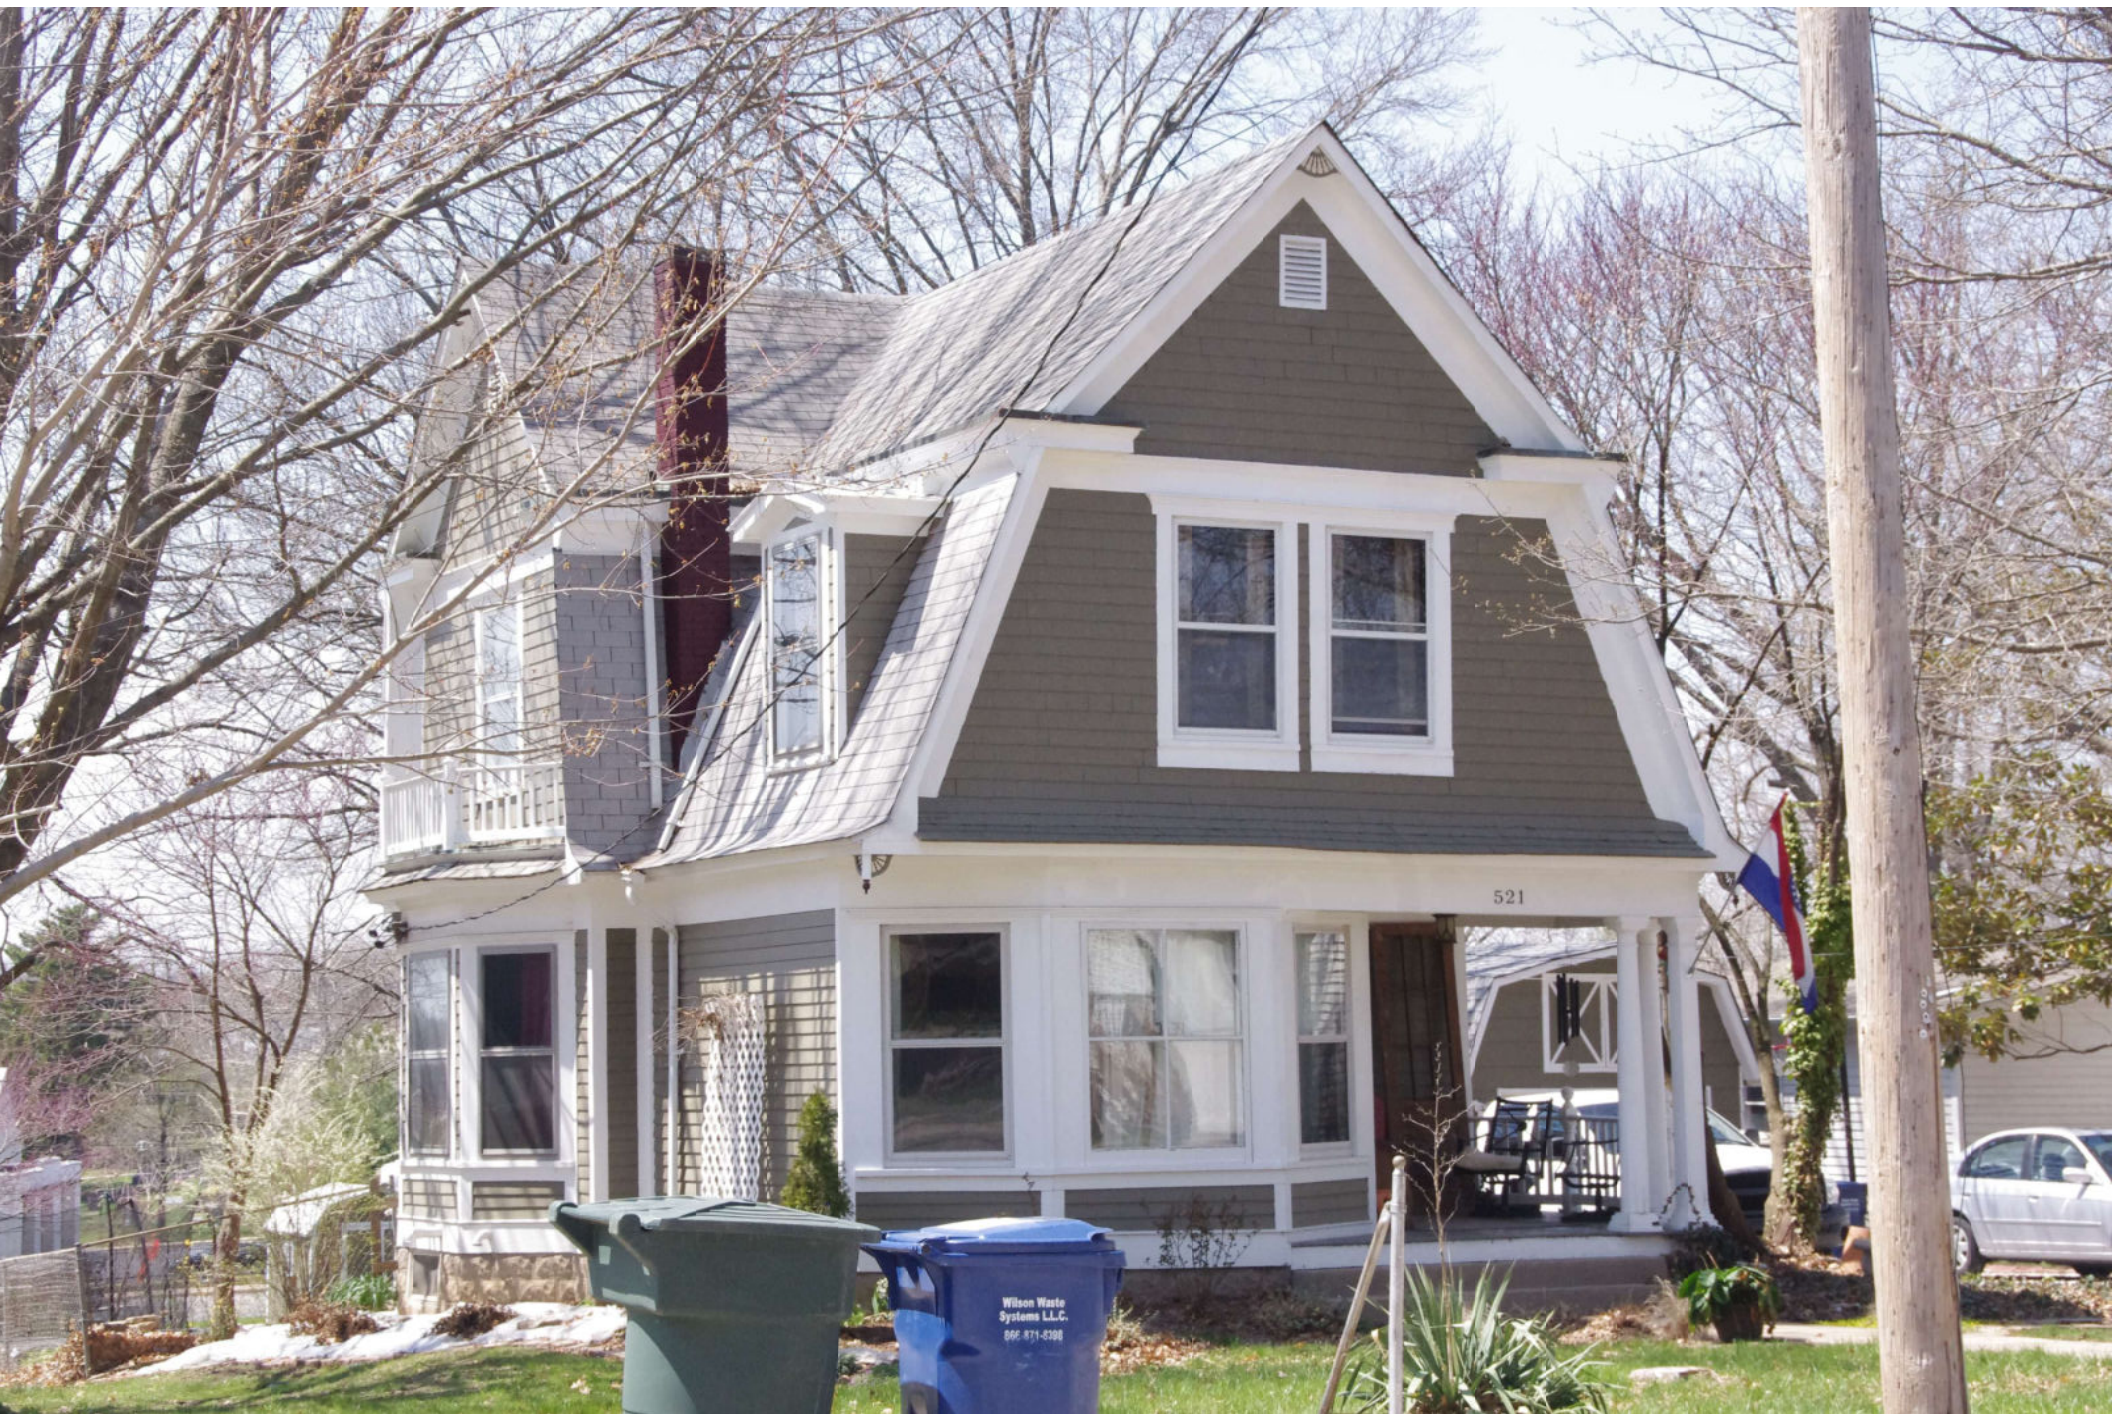
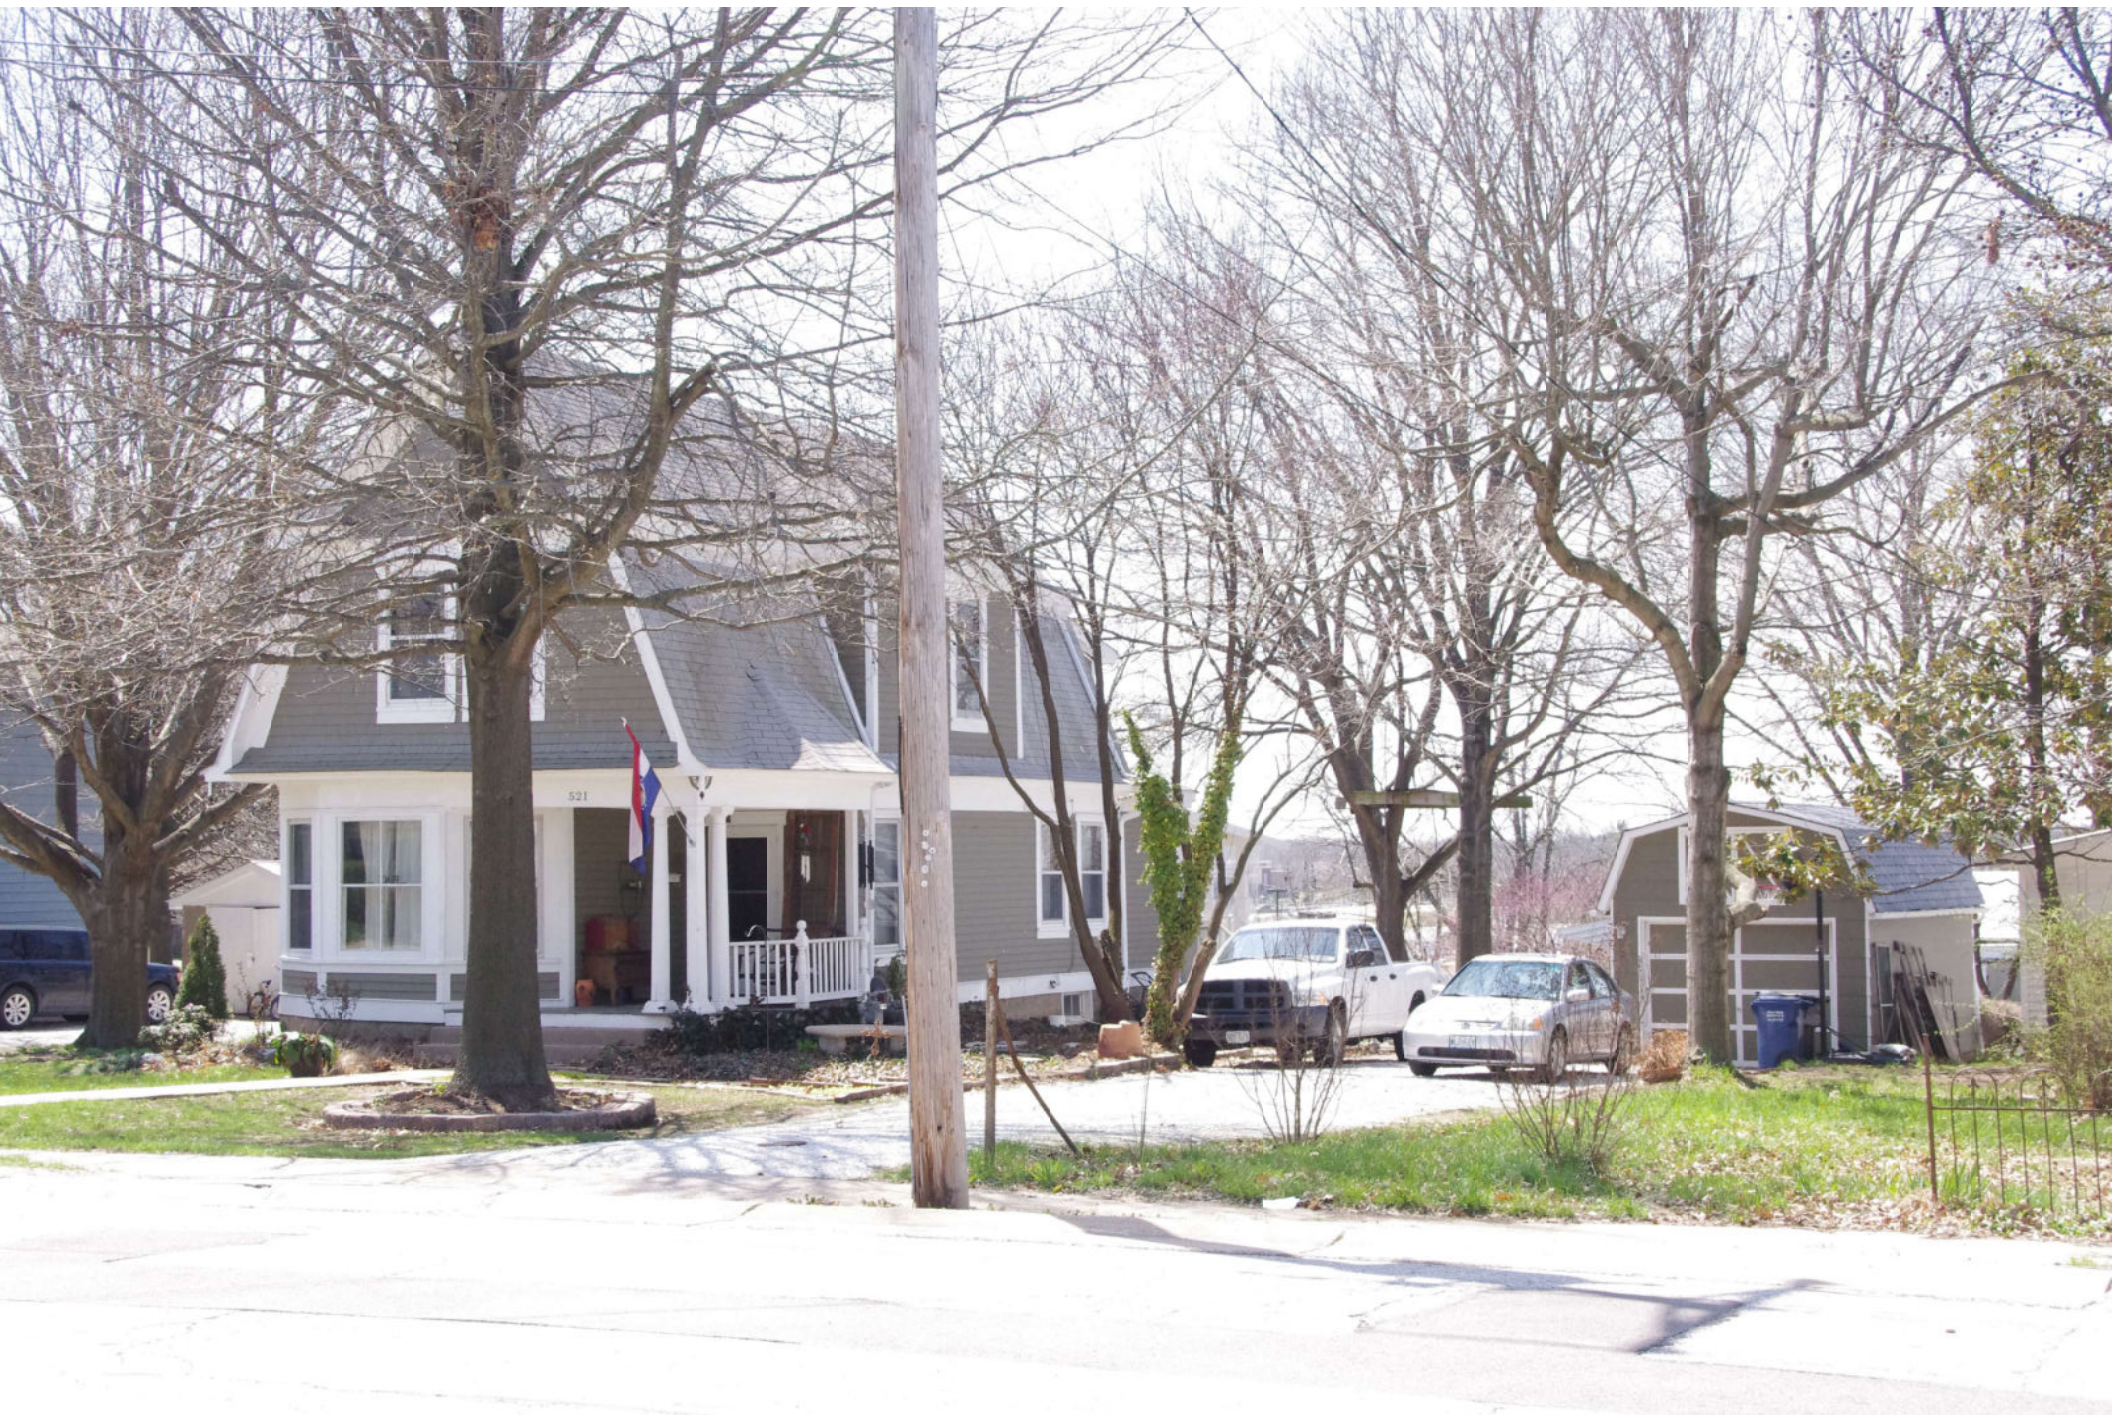
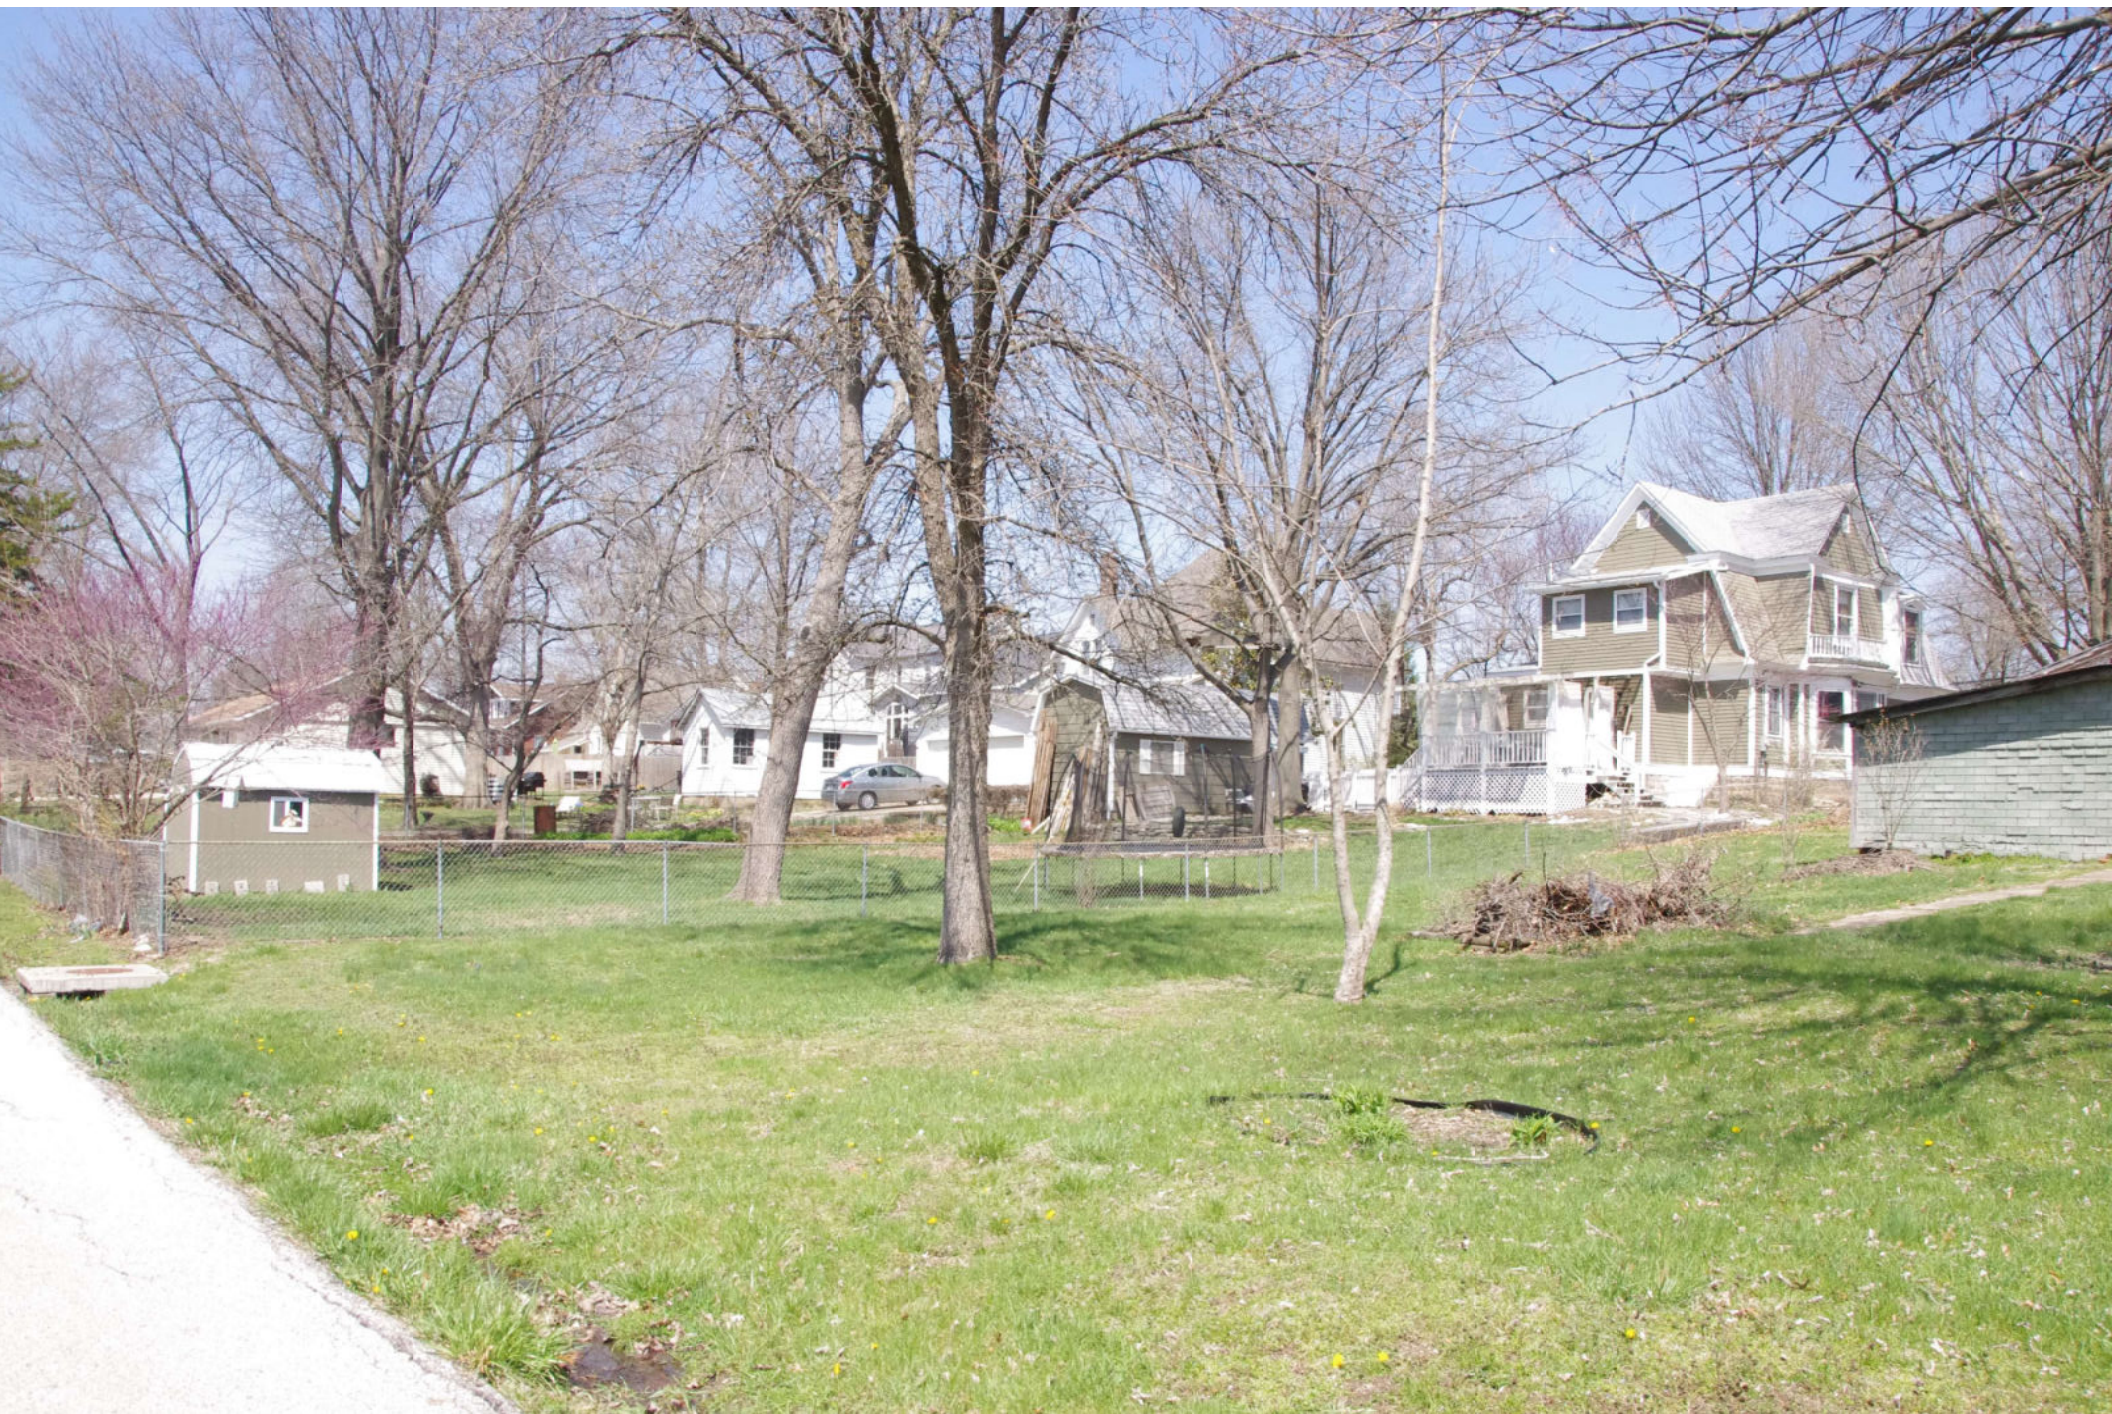
This Dutch Colonial Revival, two-story house has a gambrel roof, wood lap siding on the first floor and wood shingle siding on the upper levels. The façade is divided into two bays on the first floor beneath the large gambrel roof end which has paired 1/1 wood sashed windows on the second floor. Below, the wood door is recessed in the northern bay beyond a recessed wood porch with 3 wood Tuscan columns pillars clustered at the outer corner. The south bay on the façade is a canted bay window with a one-over-one wood sashed windows and a central four pane fixed window (or wood storm) is located to the south. There are dormers on both sides of the house as well as another canted bay on the south side with a balustrade on top around the second floor window in the cross-gabled dormer.
