**ARCHITECTURAL/HISTORIC INVENTORY FORM**

1. Survey No. SC-AS-012-0052		2. Survey Name: Reconnaissance Level Survey of Historic Downtown Wentzville	
3. County: St. Charles		4. Address (Street No.) 105	Street (name) South Linn Ave
5. City: Wentzville	Vicinity: <input type="checkbox"/>	6. UTM:	
8. Historic name (if known):		9. Present/other name (if known): Land Fair Corp.	
10. Ownership: <input type="checkbox"/> Private <input type="checkbox"/> Public		11a. Historic use (if known): COMMERCE/TRADE	11b. Current use: COMMERCE/TRADE/professional
5. City: Wentzville		7. Township/Range/Section:

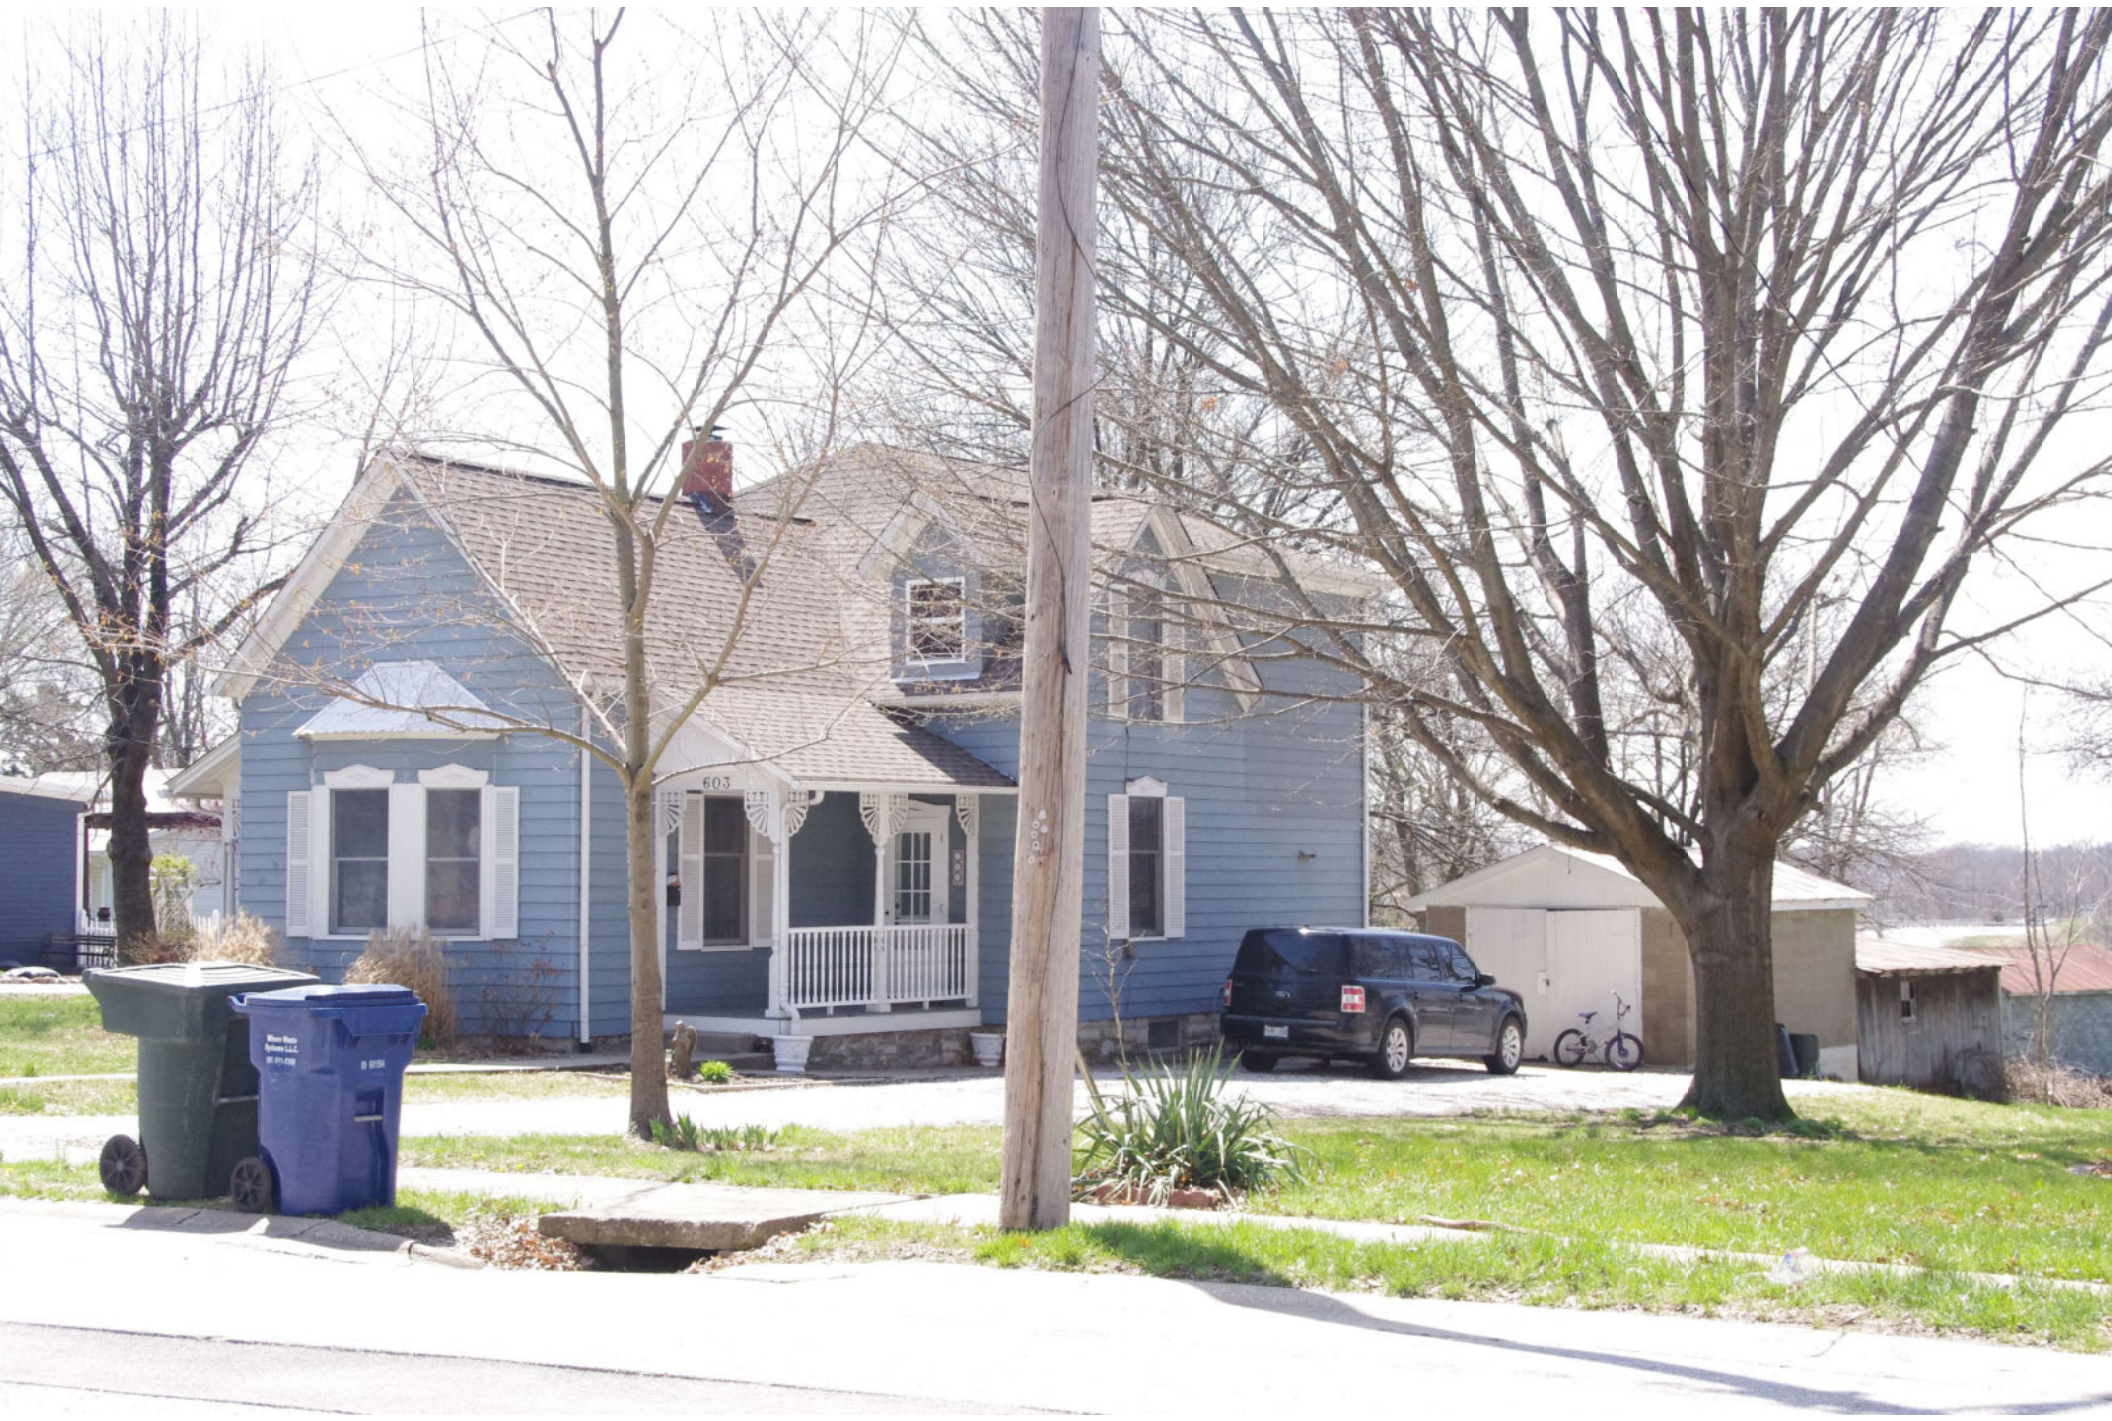
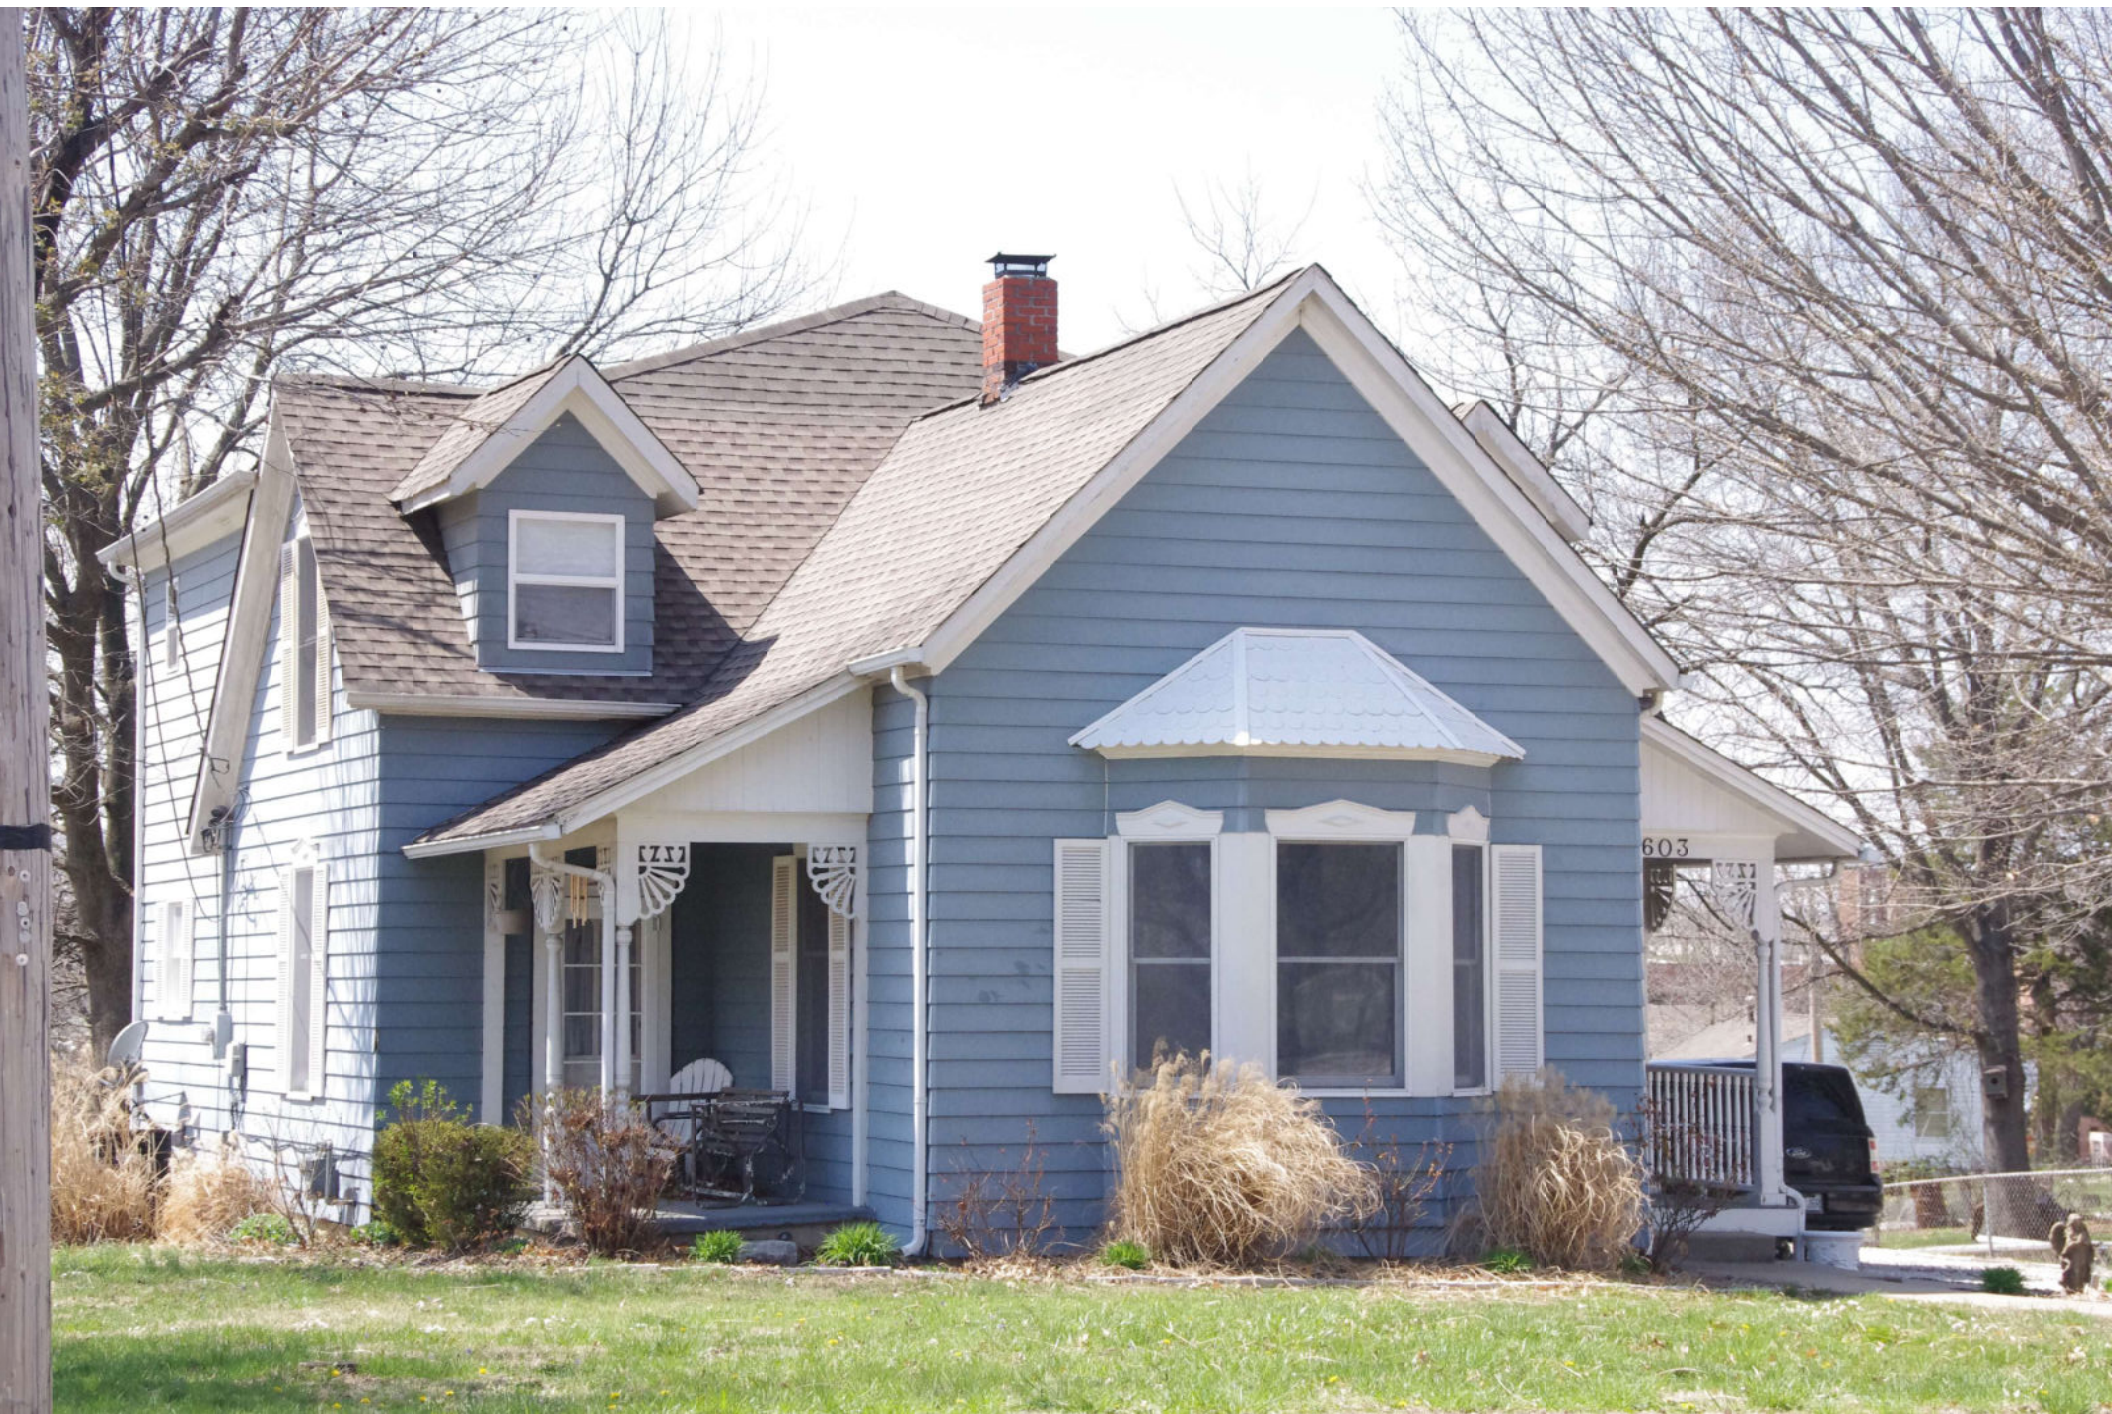
This resource is a one-and-a-half story Folk Victorian house has a symmetrical, cross gabled façade with the central gable having a canted bay window with 1/1 wood sashed windows. On either side, facing to the side, is a shed roofed porch with a wood door facing east (with a wood, eight pane storm door) and turned posts, wood porch floor and scrollwork brackets. The railing is a replacement, taller than the historic railing would have been but it does have turned spindles. A gabled dormer with one-over-one window is located above each of the entrance porches facing the façade and positioned in the cross gables. The house appears to have originally be a T-shaped plan but has had large additions built onto the back of the house, the latest looking like it dates from the 1960s with a poured concrete foundation and low pitched gable roof.

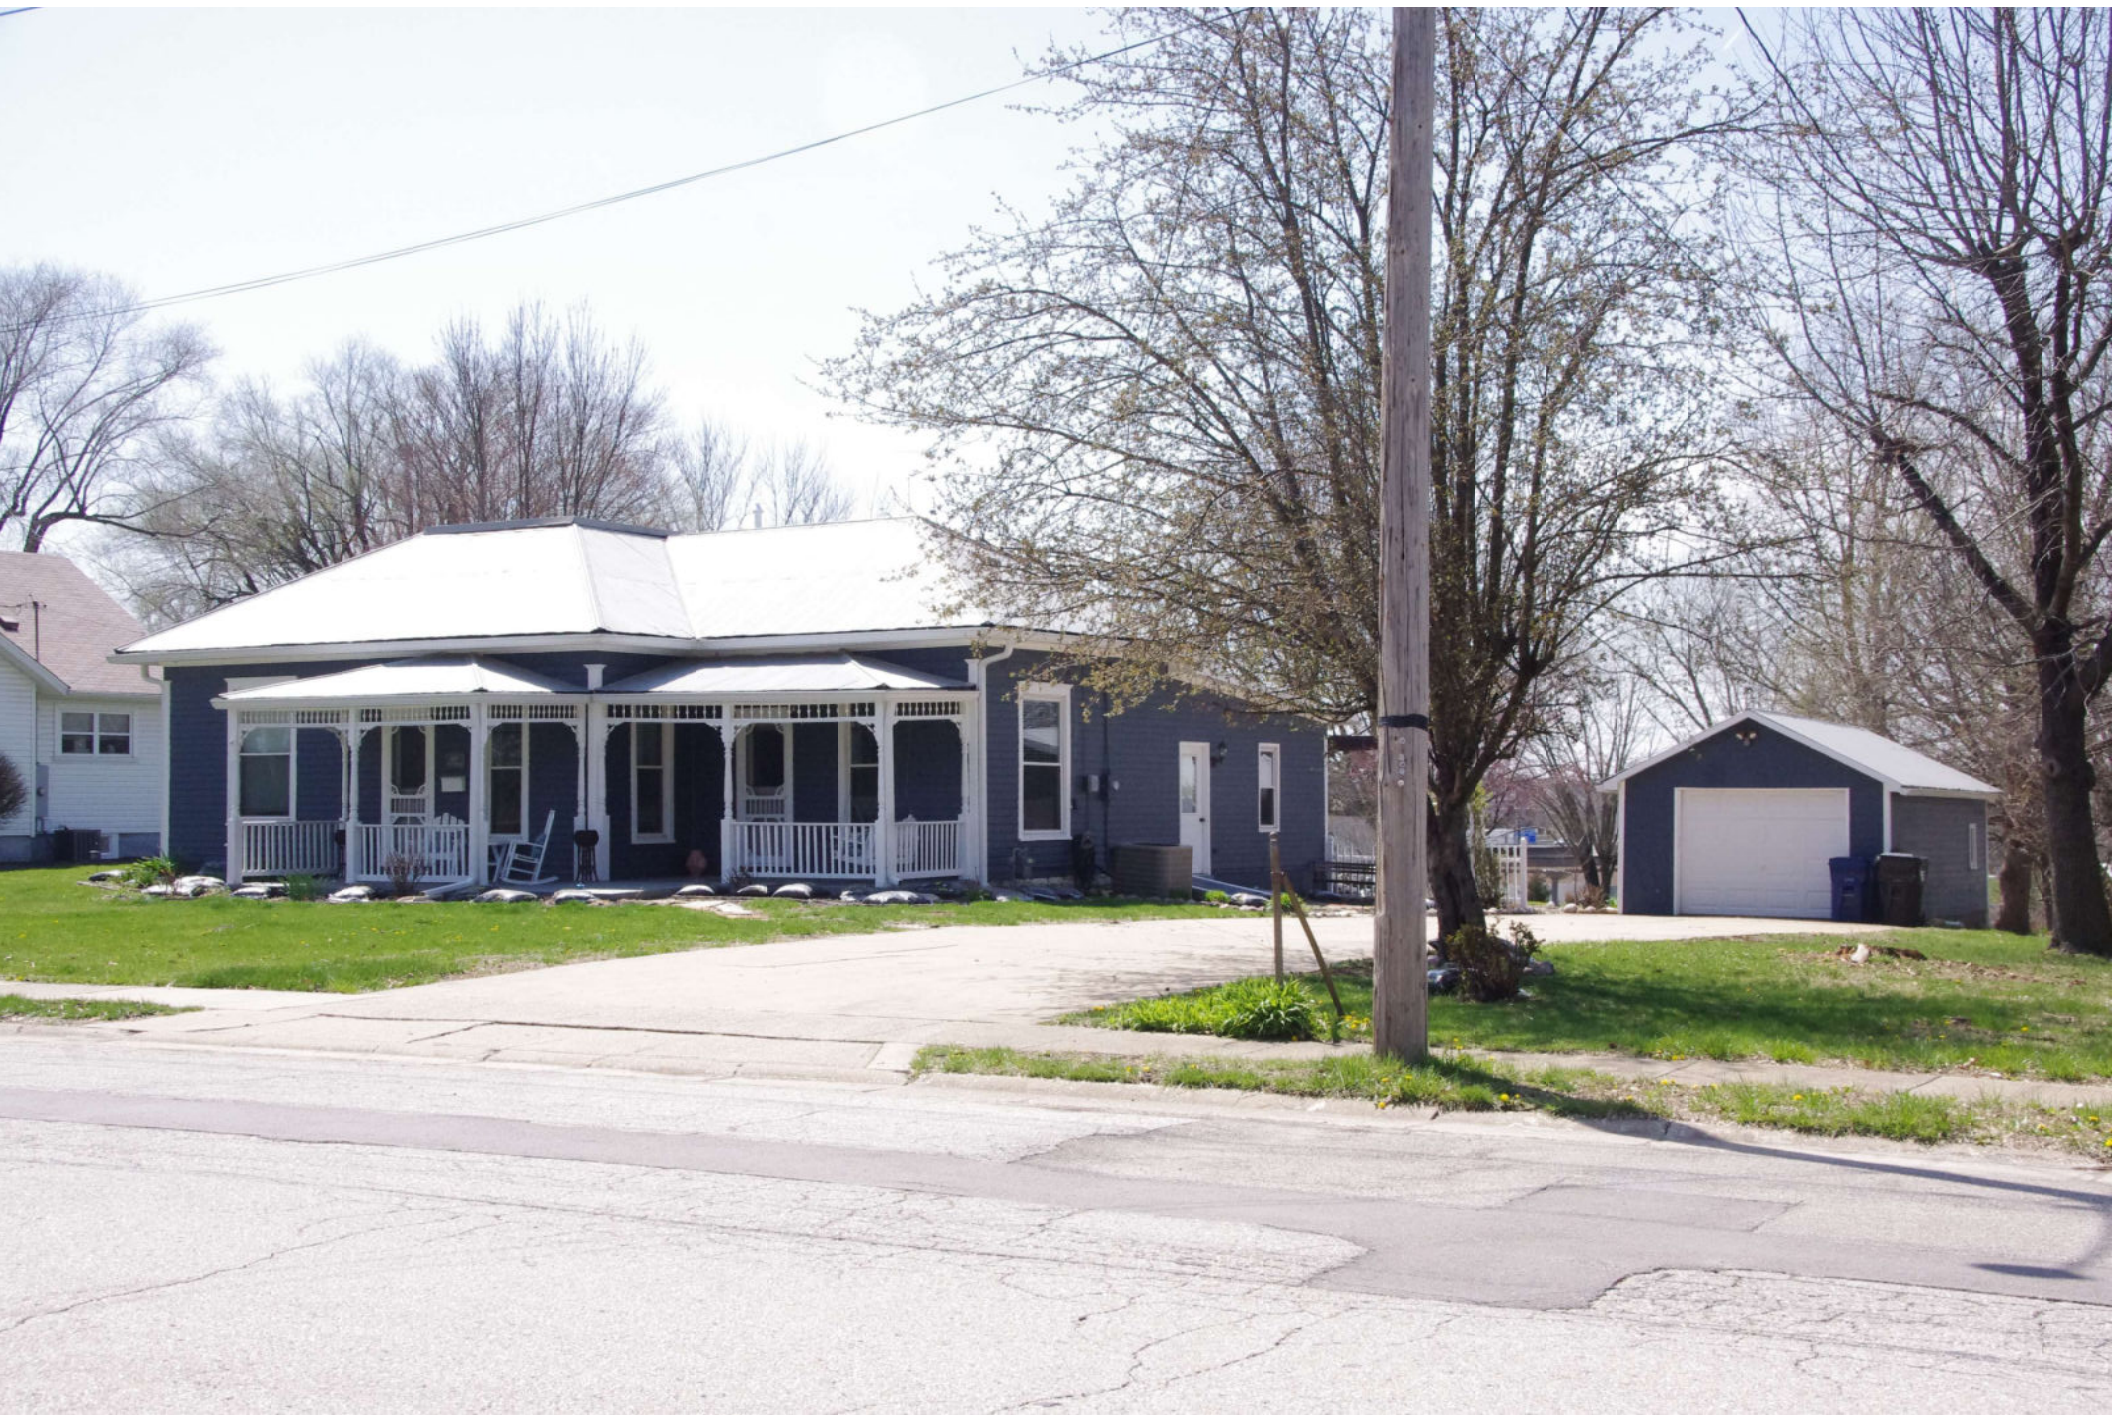
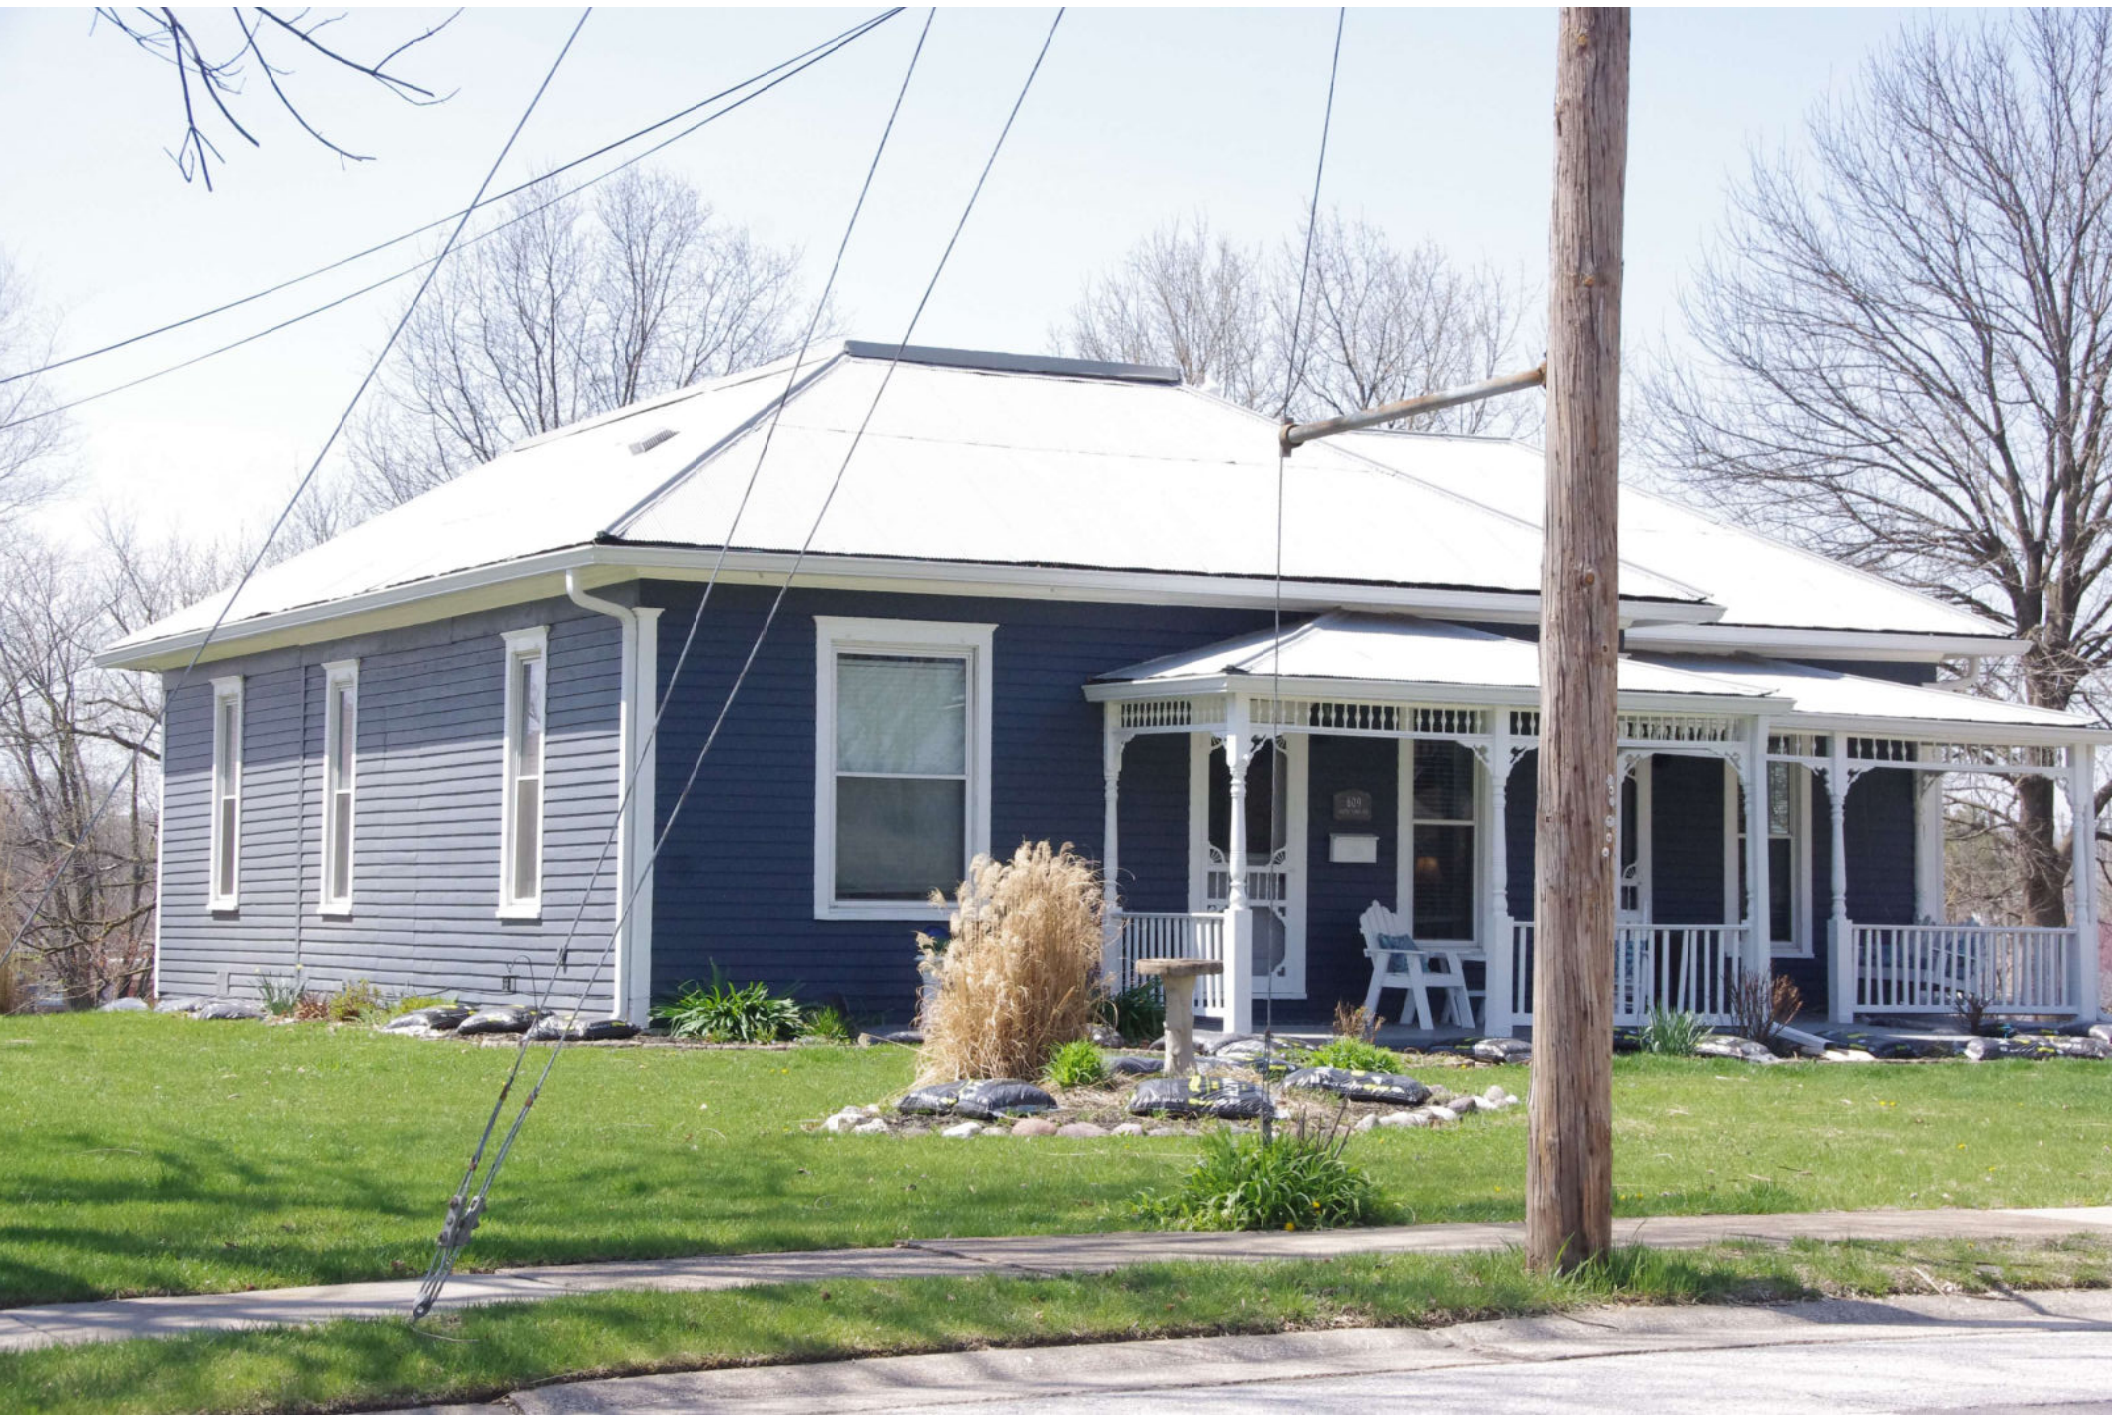
This resource is a one-story truncated hipped roof house with Folk Victorian stylistic details which appear to be original, not recent reconstructions like so many other houses in Wentzville. The house has 2 entries on the façade, both with half-light wood paneled doors behind Victorian spindlework details on the screen door. A door and one-over-one wood sashed window are located on one of the two front hipped roof porches, with turned spindle posts with spindlework fretwork and brackets, although the railing appear to be replacements and the base of the posts seem to have been modified as simple square posts. One of the porches is in the main hip and the other is on the façade side of the hipped roof wing, creating a staggered façade. A one-over-one square pane window is located south of each porch. On the rear, there appears to be a ca. 1950 shed roofed addition.

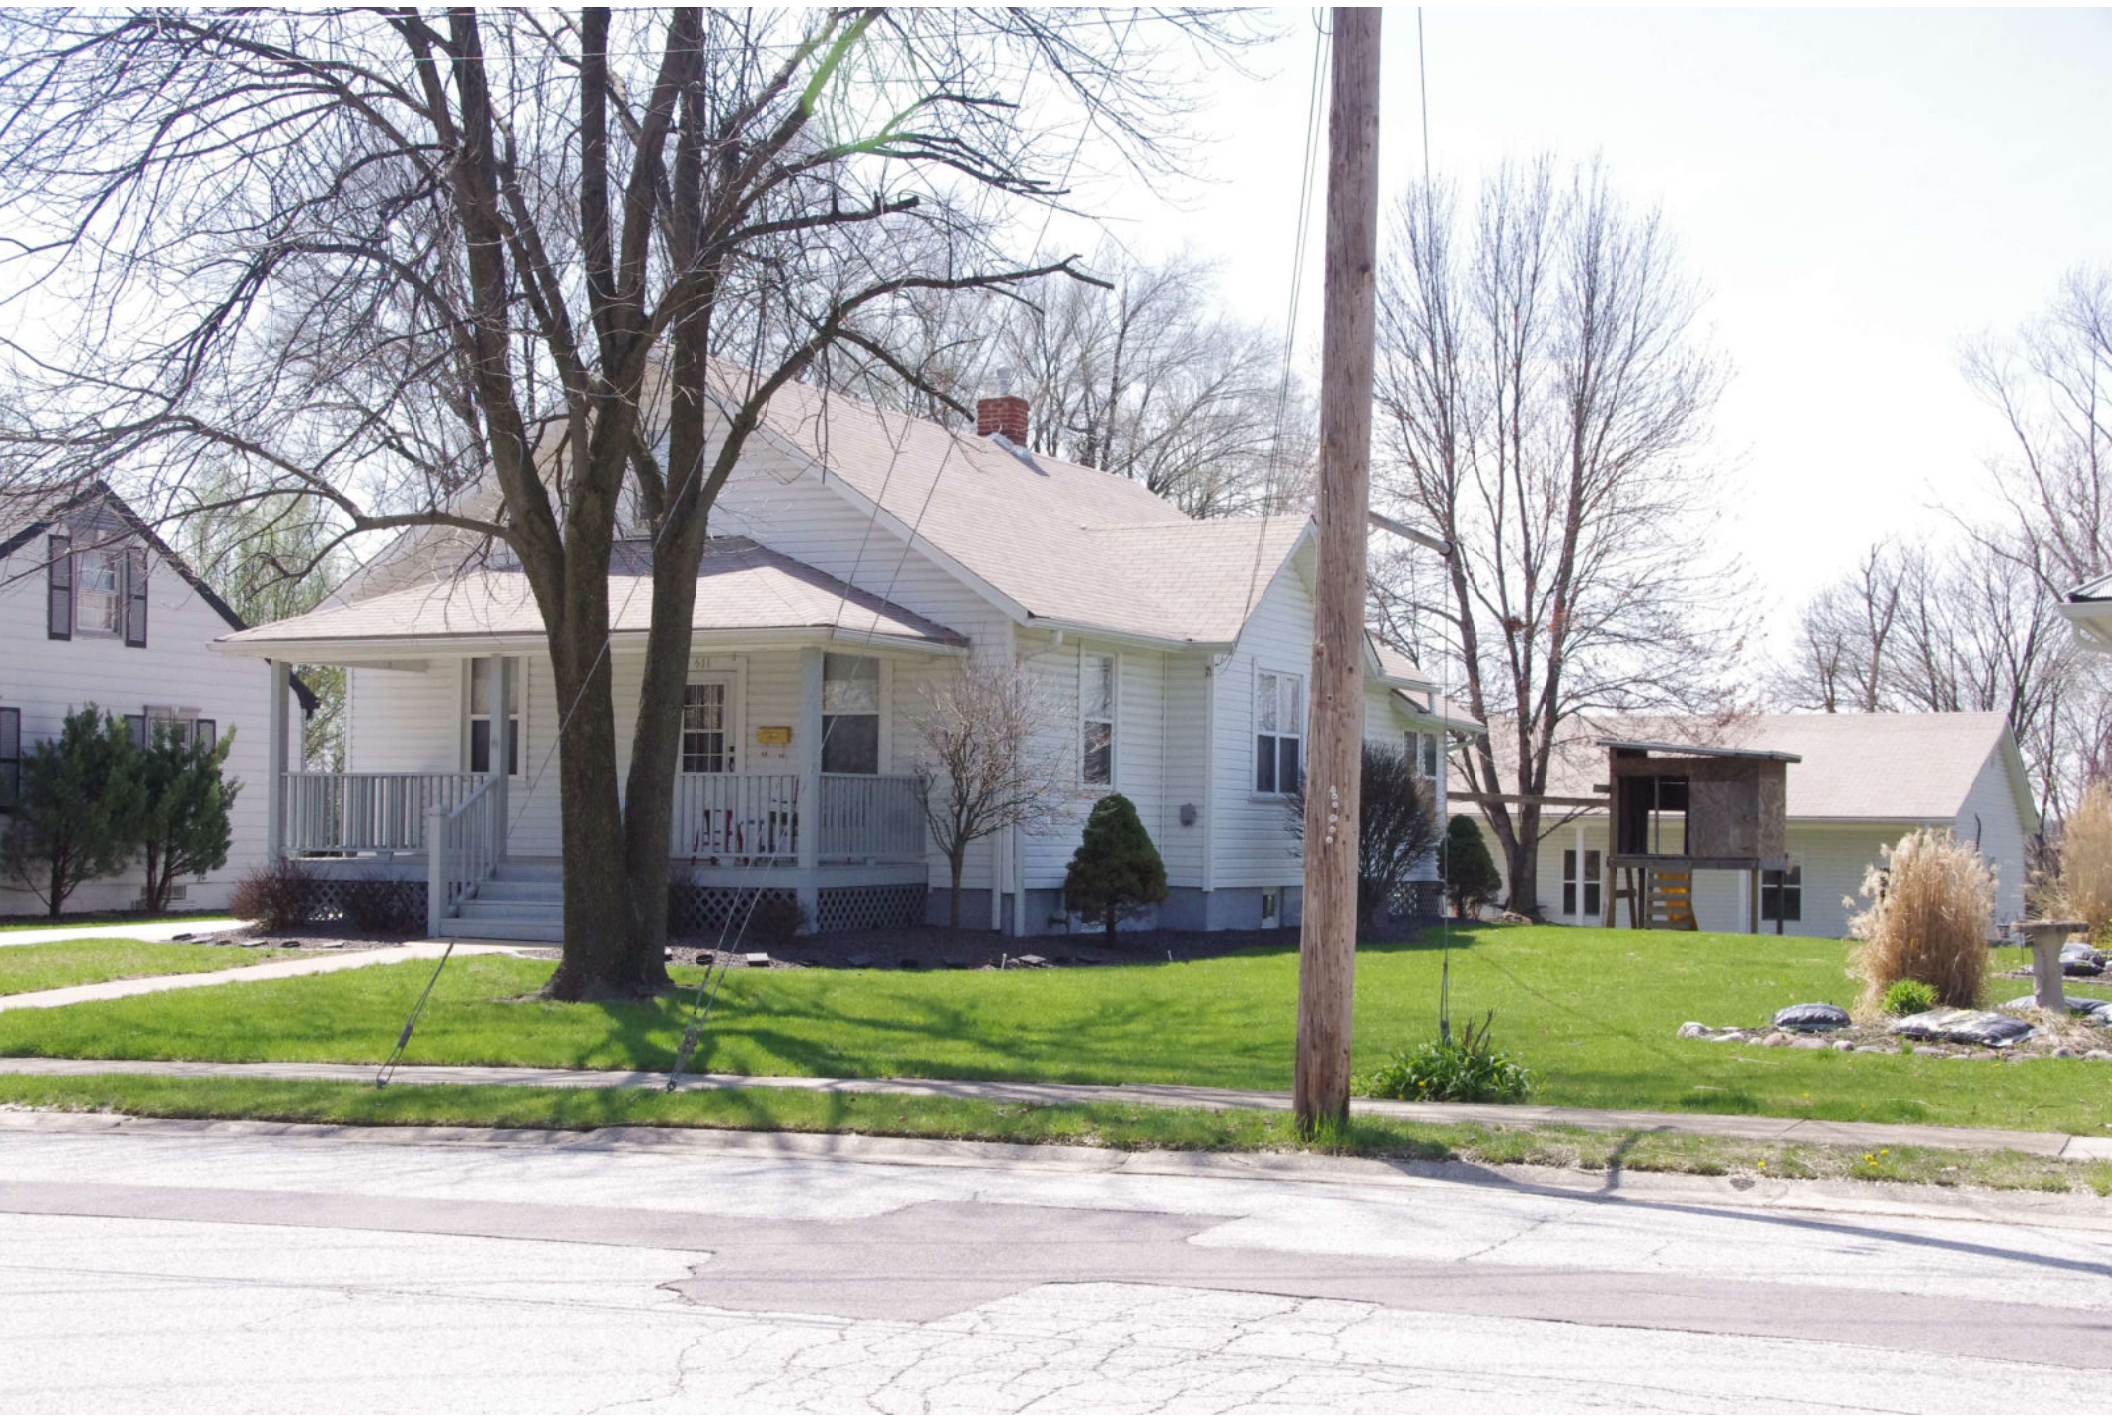
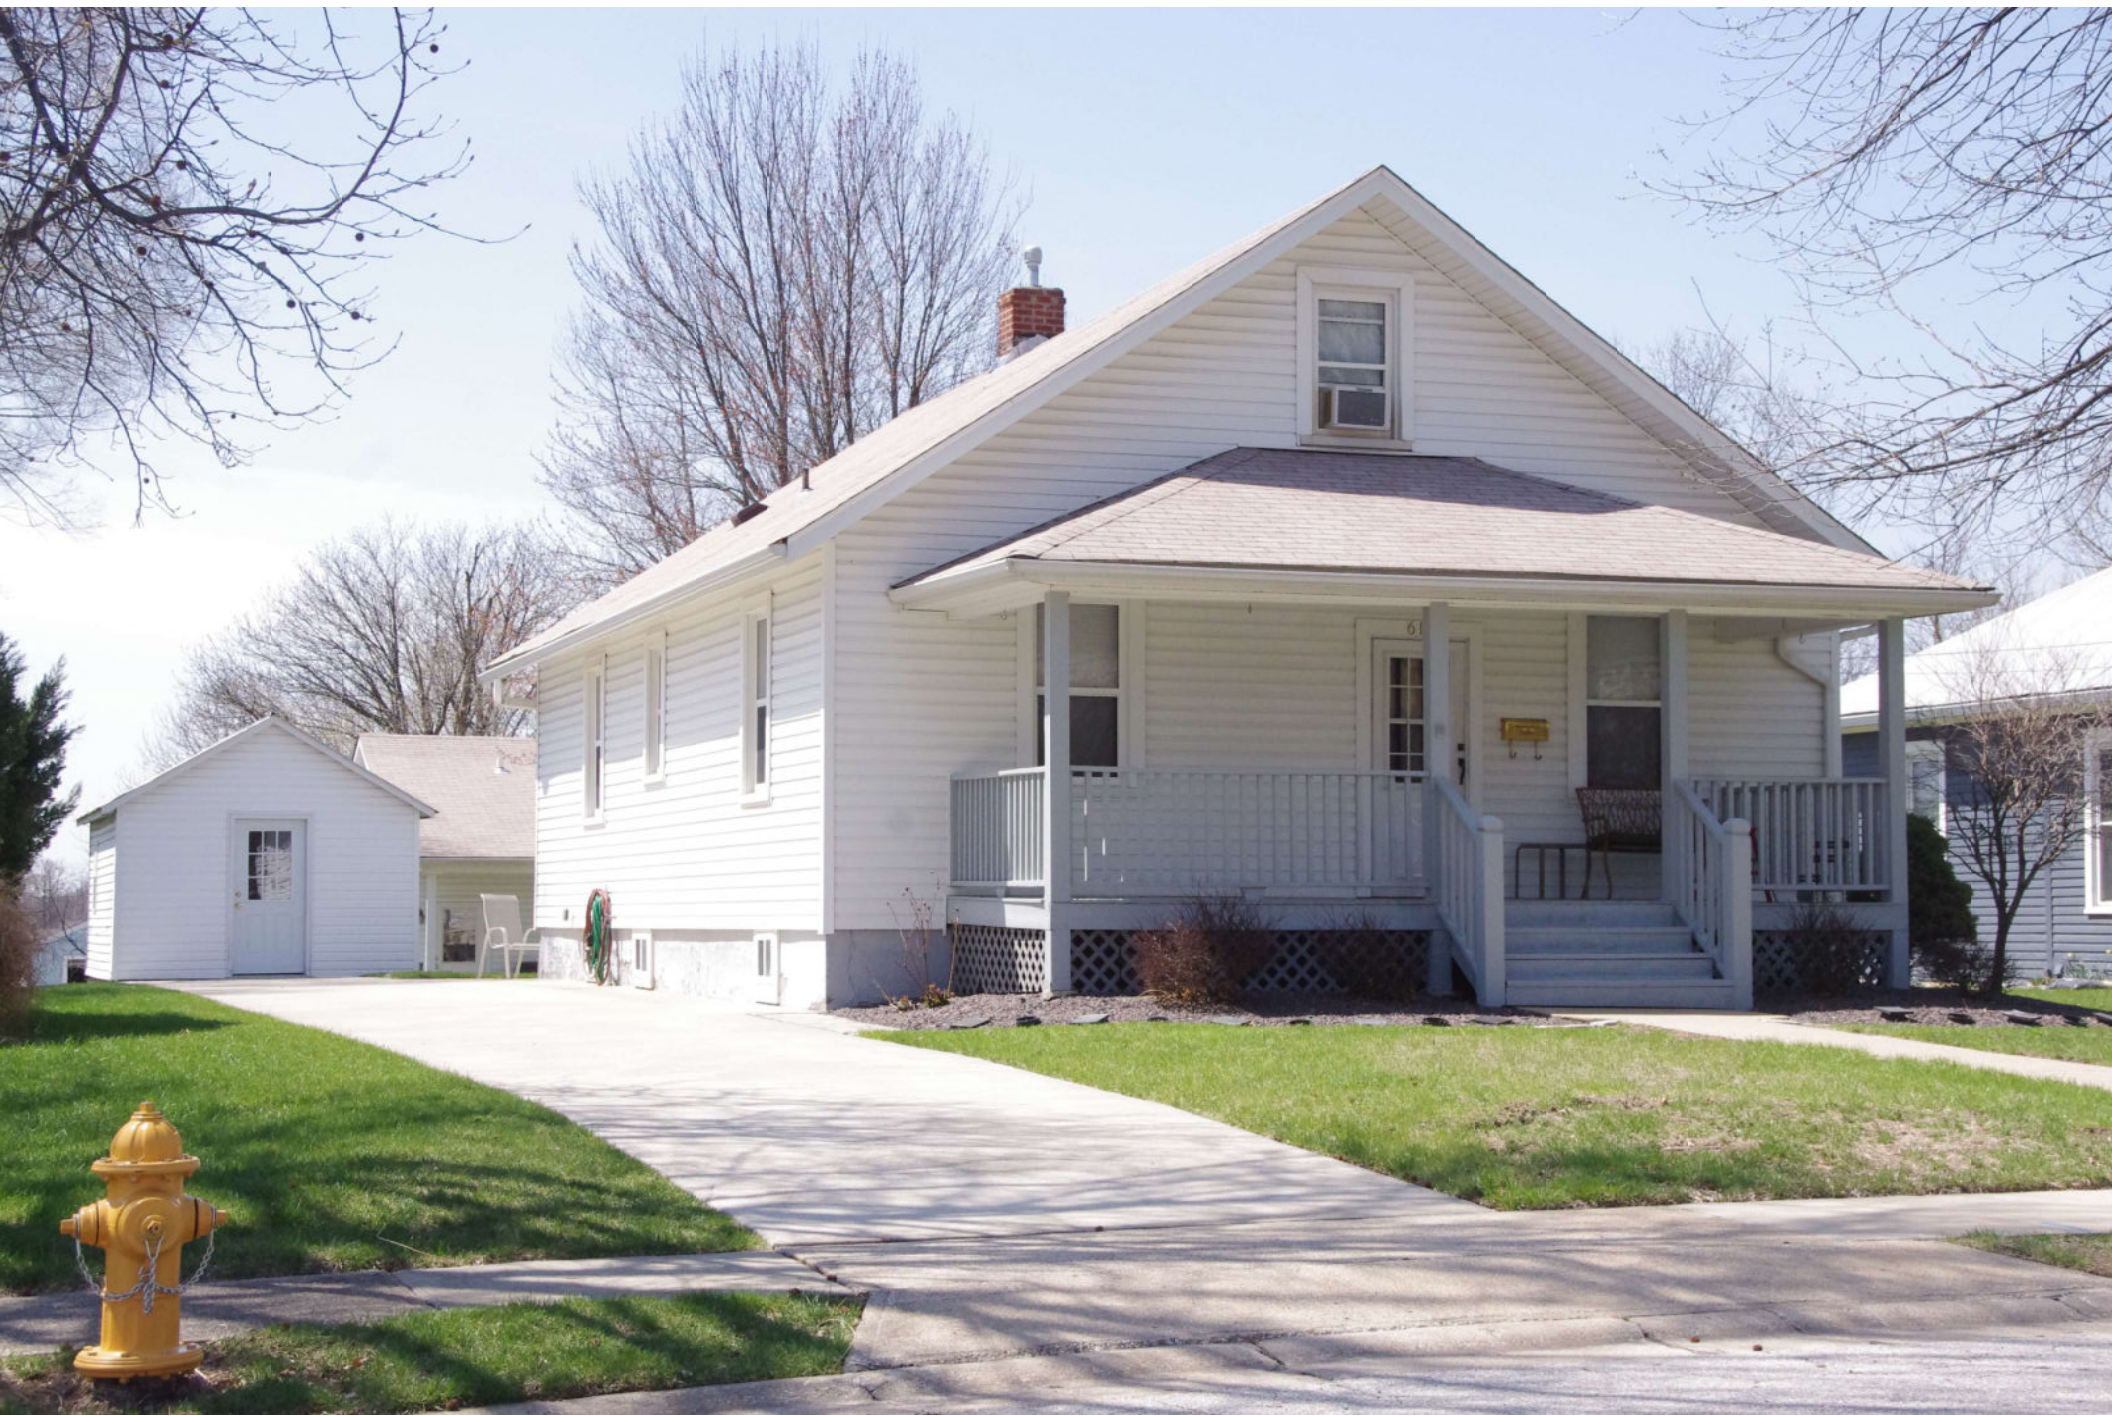
This is a modest, one-story house with an end gable roof and full width hipped roof porch supported by square posts resting on the wood porch floor with broad, wood steps just off center. The railings are recent replacements. The central door is covered by a twelve pane half light storm door and flanked by one-over-one replacement sash windows. A similar window is found in the gable end above. The house has recently been re-sided with vinyl siding, vinyl trim boards around the windows and doors, and new vinyl windows, making it difficult to determine how much this has changed from the historic details.
