**ARCHITECTURAL/HISTORIC INVENTORY FORM**

1. Survey No. SC-AS-012-0052		2. Survey Name: Reconnaissance Level Survey of Historic Downtown Wentzville	
3. County: St. Charles		4. Address (Street No.) 105	Street (name) South Linn Ave
5. City: Wentzville	Vicinity: <input type="checkbox"/>	6. UTM:	
8. Historic name (if known):		9. Present/other name (if known): Land Fair Corp.	
10. Ownership: <input type="checkbox"/> Private <input type="checkbox"/> Public		11a. Historic use (if known): COMMERCE/TRADE	11b. Current use: COMMERCE/TRADE/professional
5. City: Wentzville		7. Township/Range/Section:

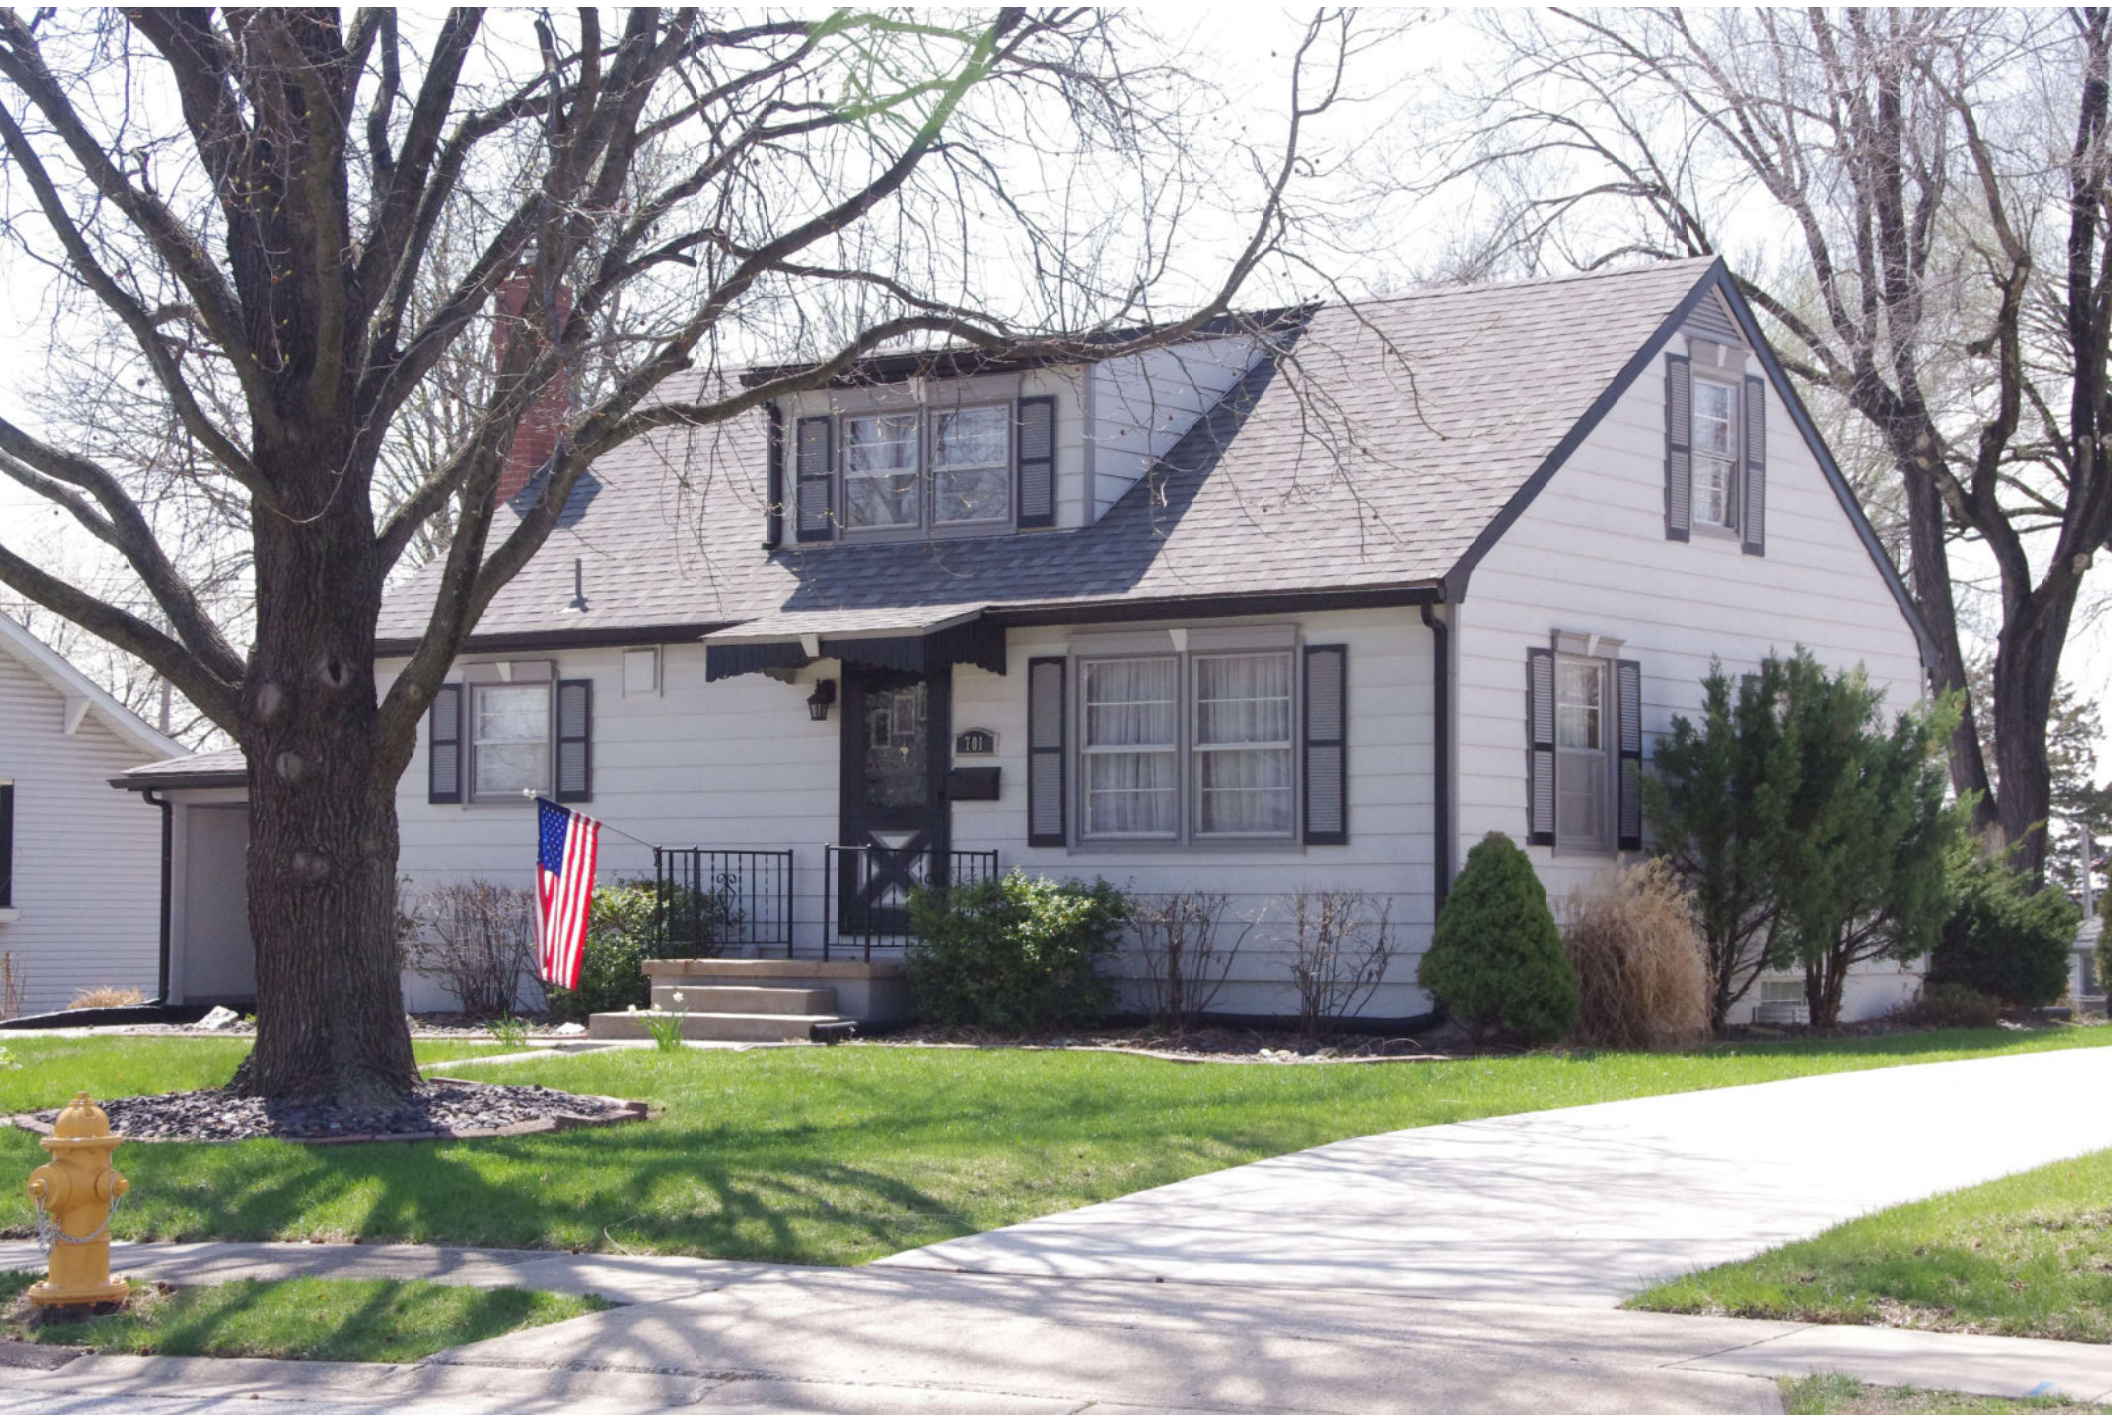
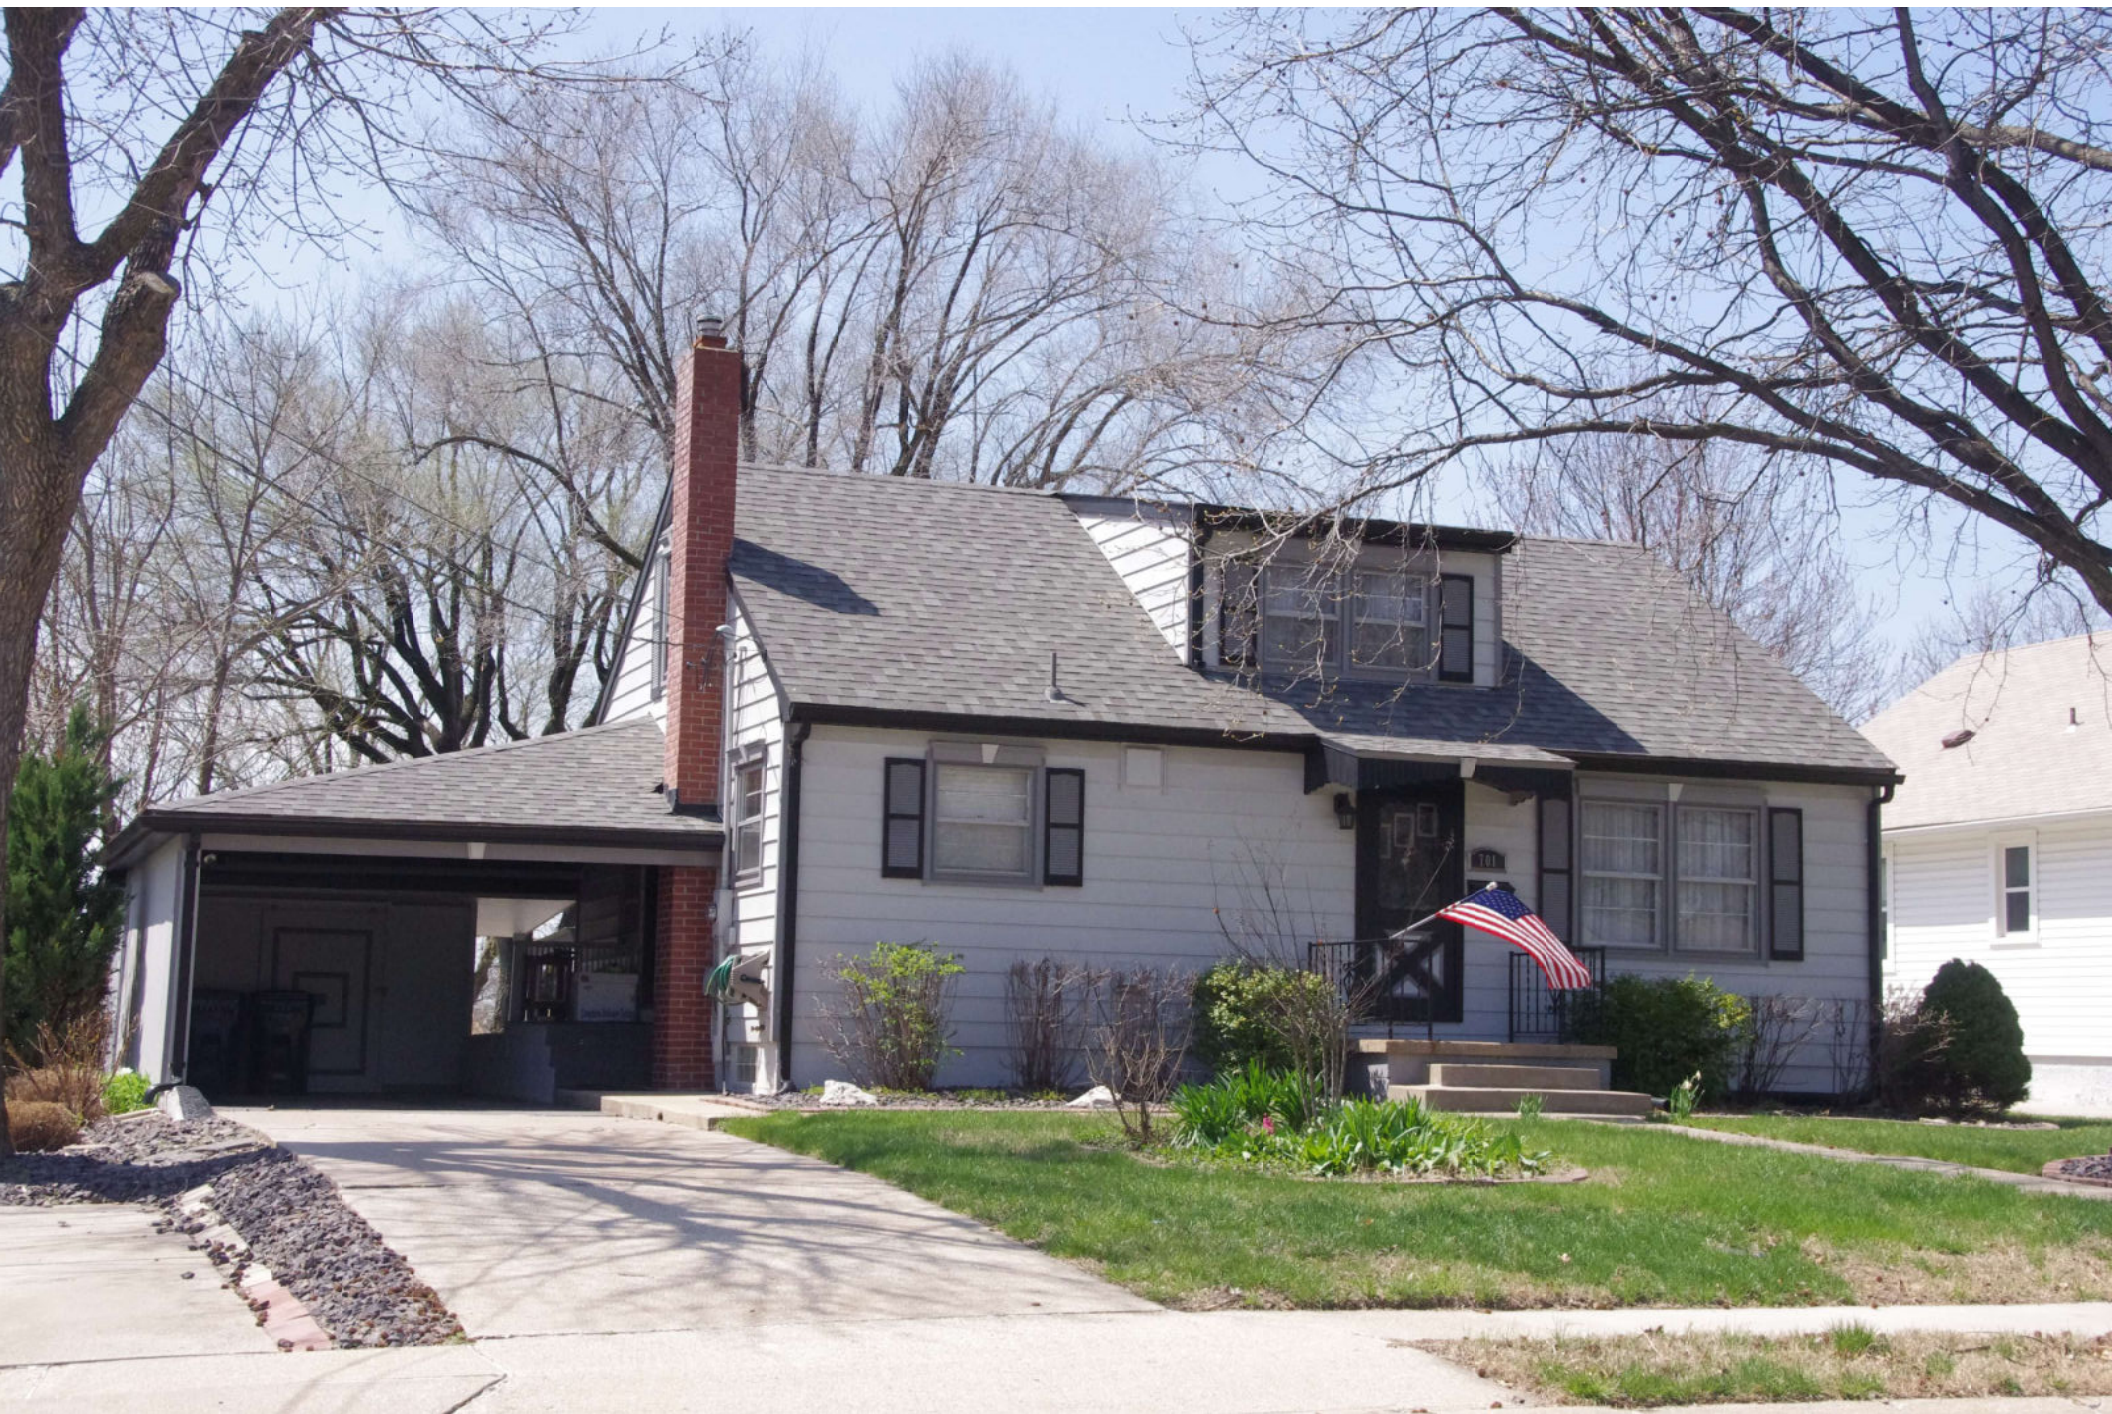
This resource is a one-and-a-half story, Cape Cod style cottage with a side gable roof. The façade is divided into three bays with the wood door with straggered small rectangular lights and metal storm door centered on the house, accessed by a concrete stoop with metal railings. There is a shed roof over the stoop. Paired 2/2 horizontal light wood sashed windows are located in the northern bay, and a smaller 2/2 sash window is located in the southern bay. Paired 2/2 windows are located in the shed roof dormer. A hipped roof, one bay, enclosed carport is located on the south side of the façade. Given the date of construction, 1951, the metal siding may be original to the building, but the fake shutters are a later addition as are the applied keystone lintels.

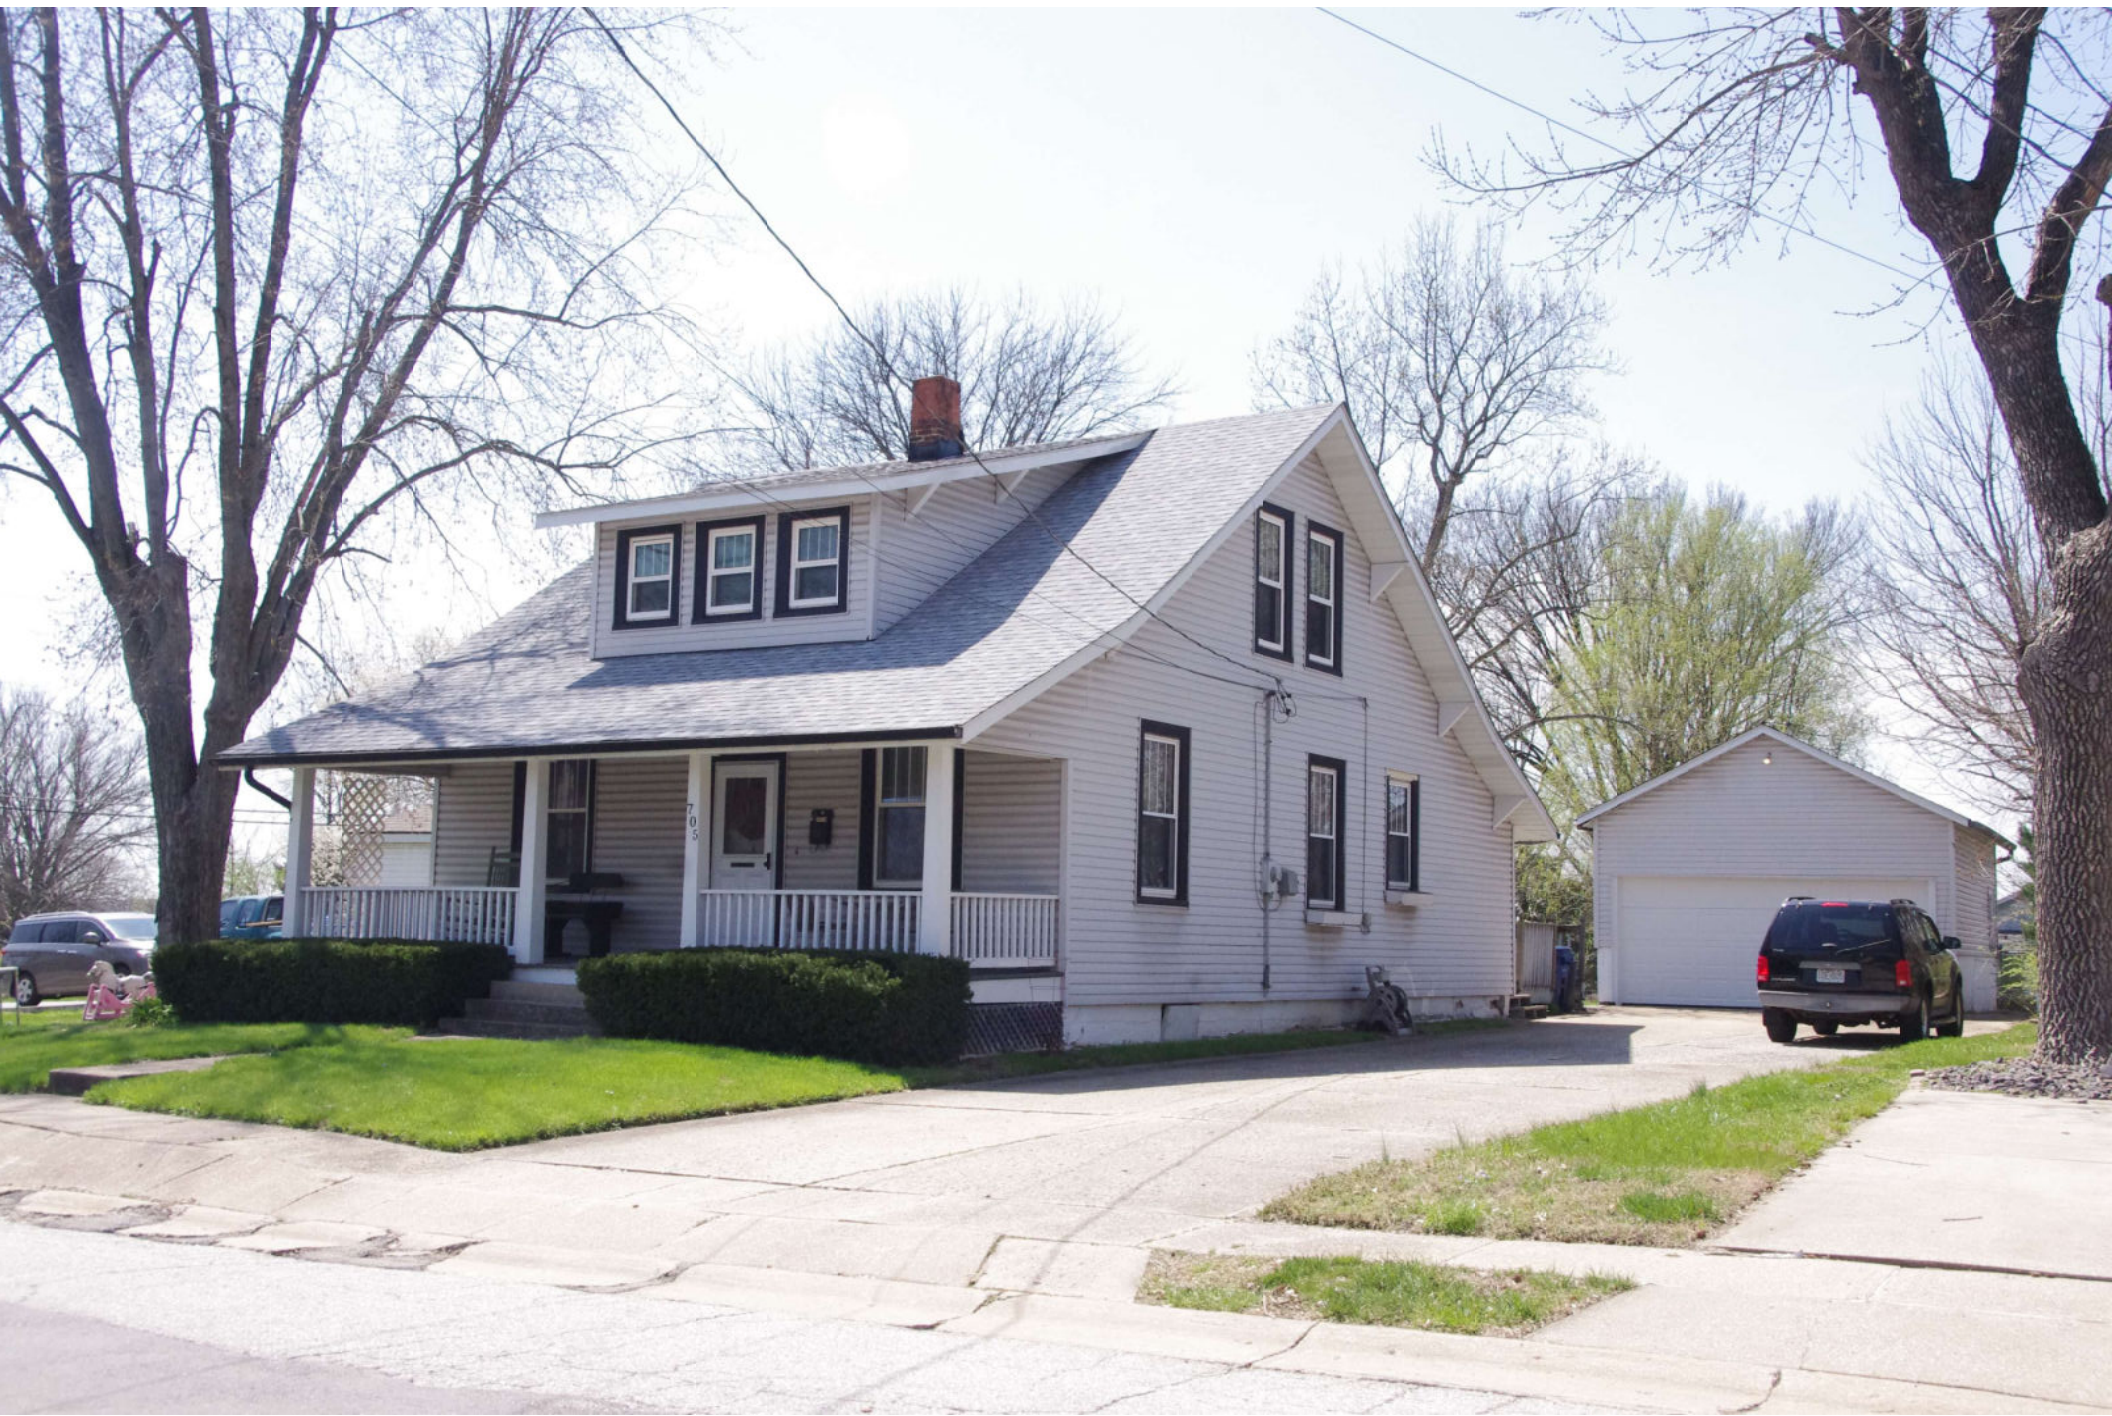
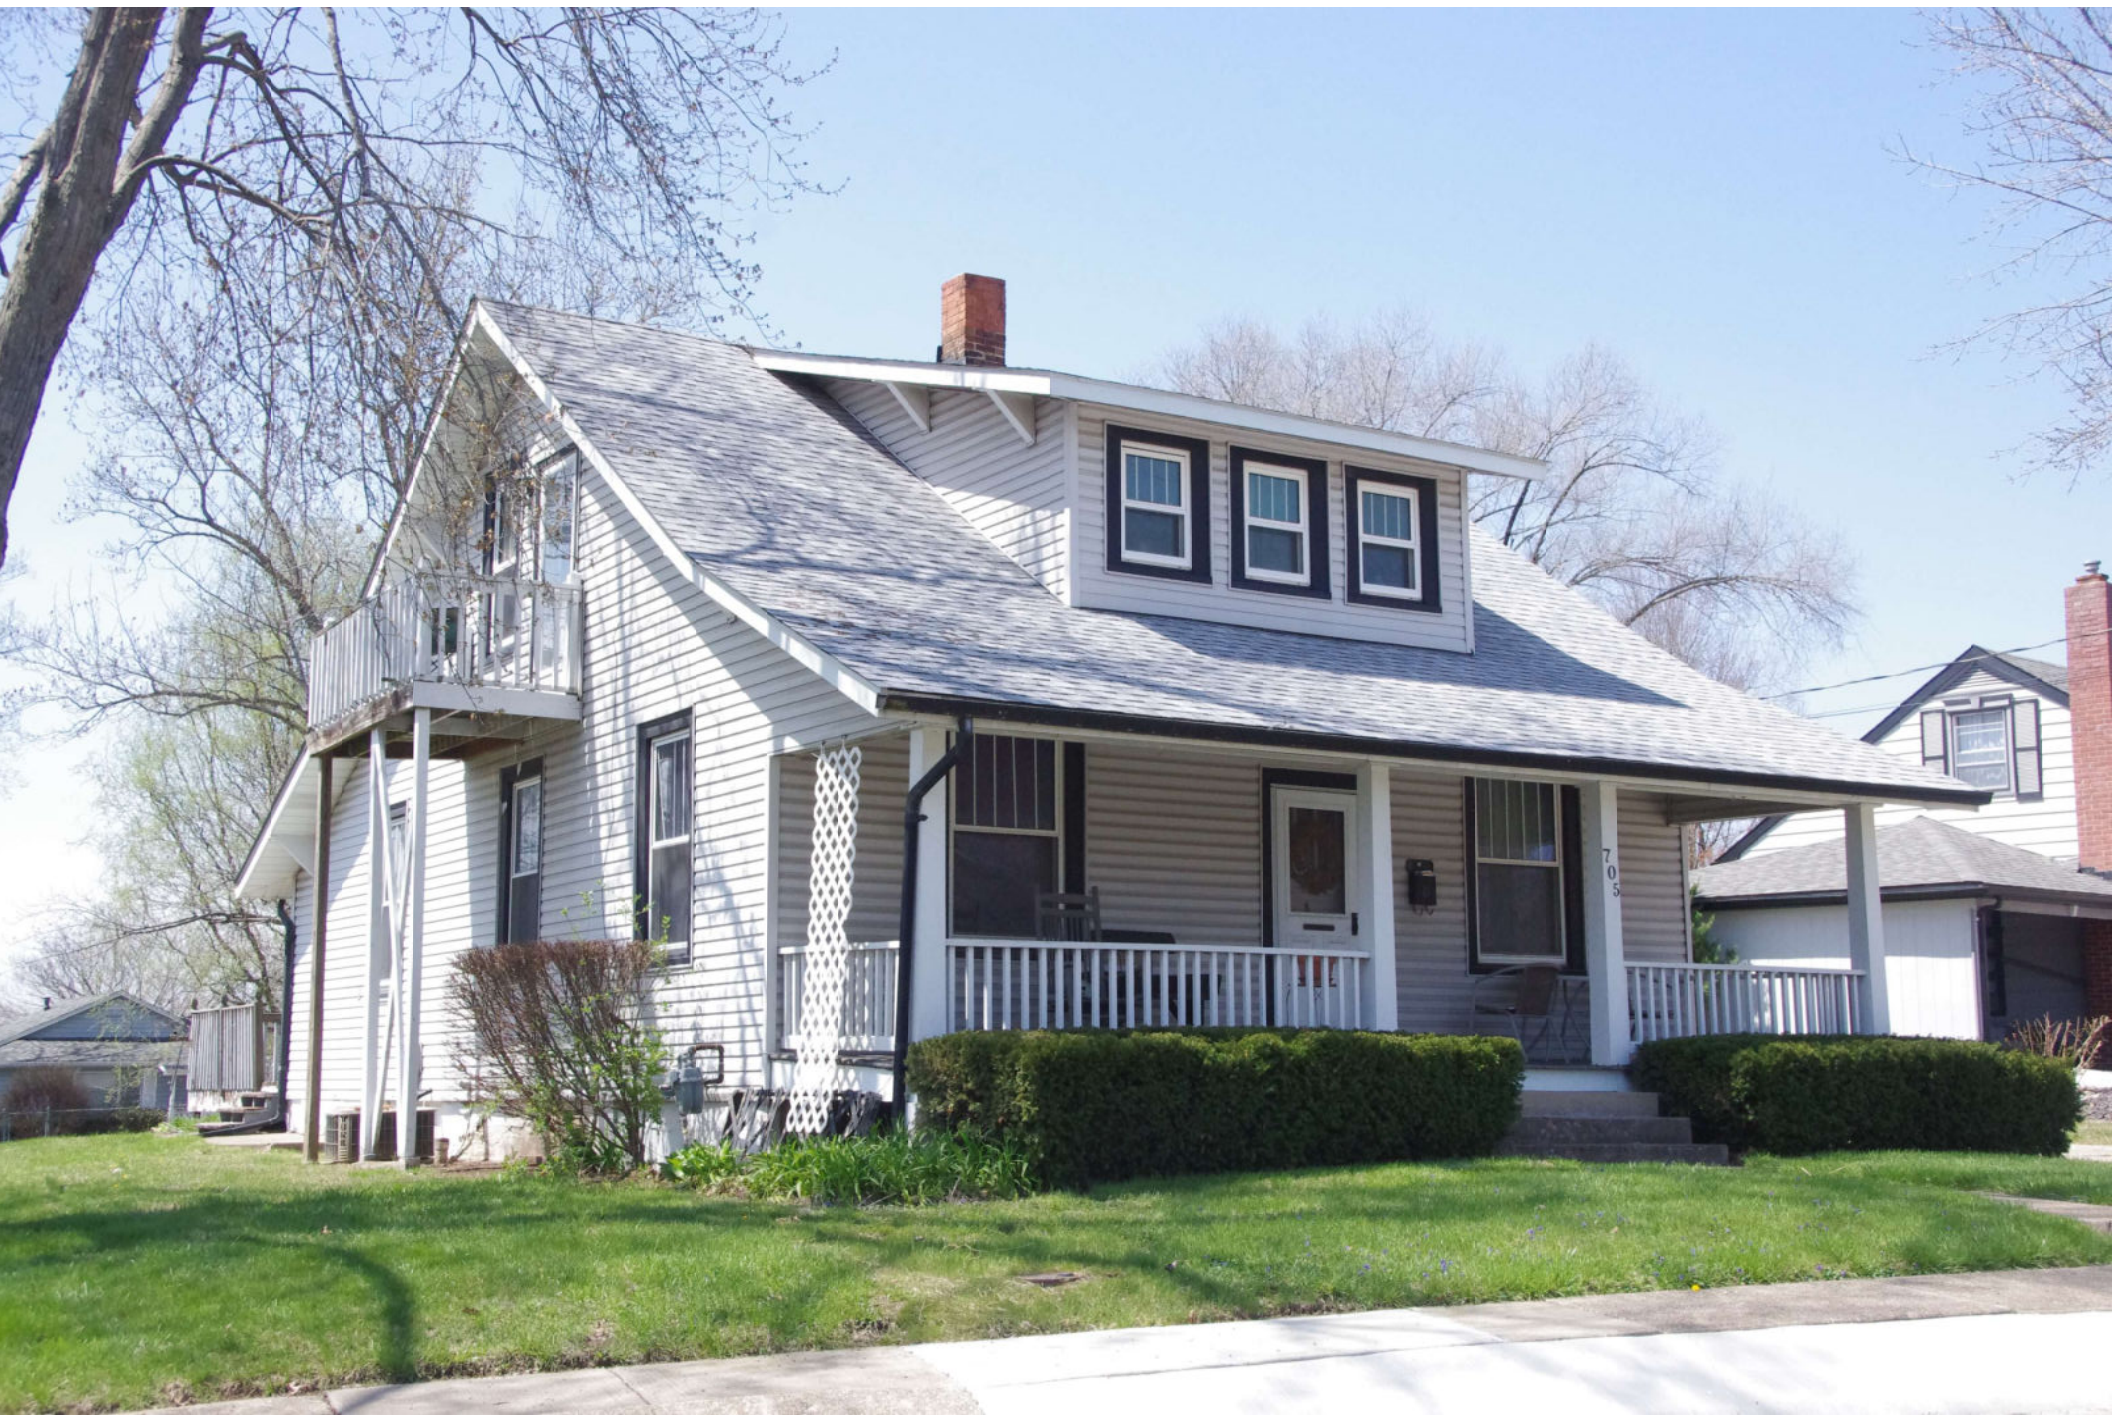
This one-and-a-half story Craftsman bungalow has a side gabled roof with the full width porch under the main roof supported by tapered square columns with simple wood balustrade railings. Centered on the façade is a wood door obscured by the metal storm door flanked by five-over-one (vertical light) sash windows in the outer bays. Three four-over-one sash windows are located in the shed dormer centered on the façade. The windows appear to replacement vinyl windows emulating the original Craftsman style windows. The house has wide eaves supported by knee braces that have been encased with vinyl siding. The walls have been clad with vinyl siding that covers over the original face trim of the windows. A nonhistoric door opening has been added on the south side, with a wood porch structure on the second floor added that appears to have previously had a set of steps as a fire exit.

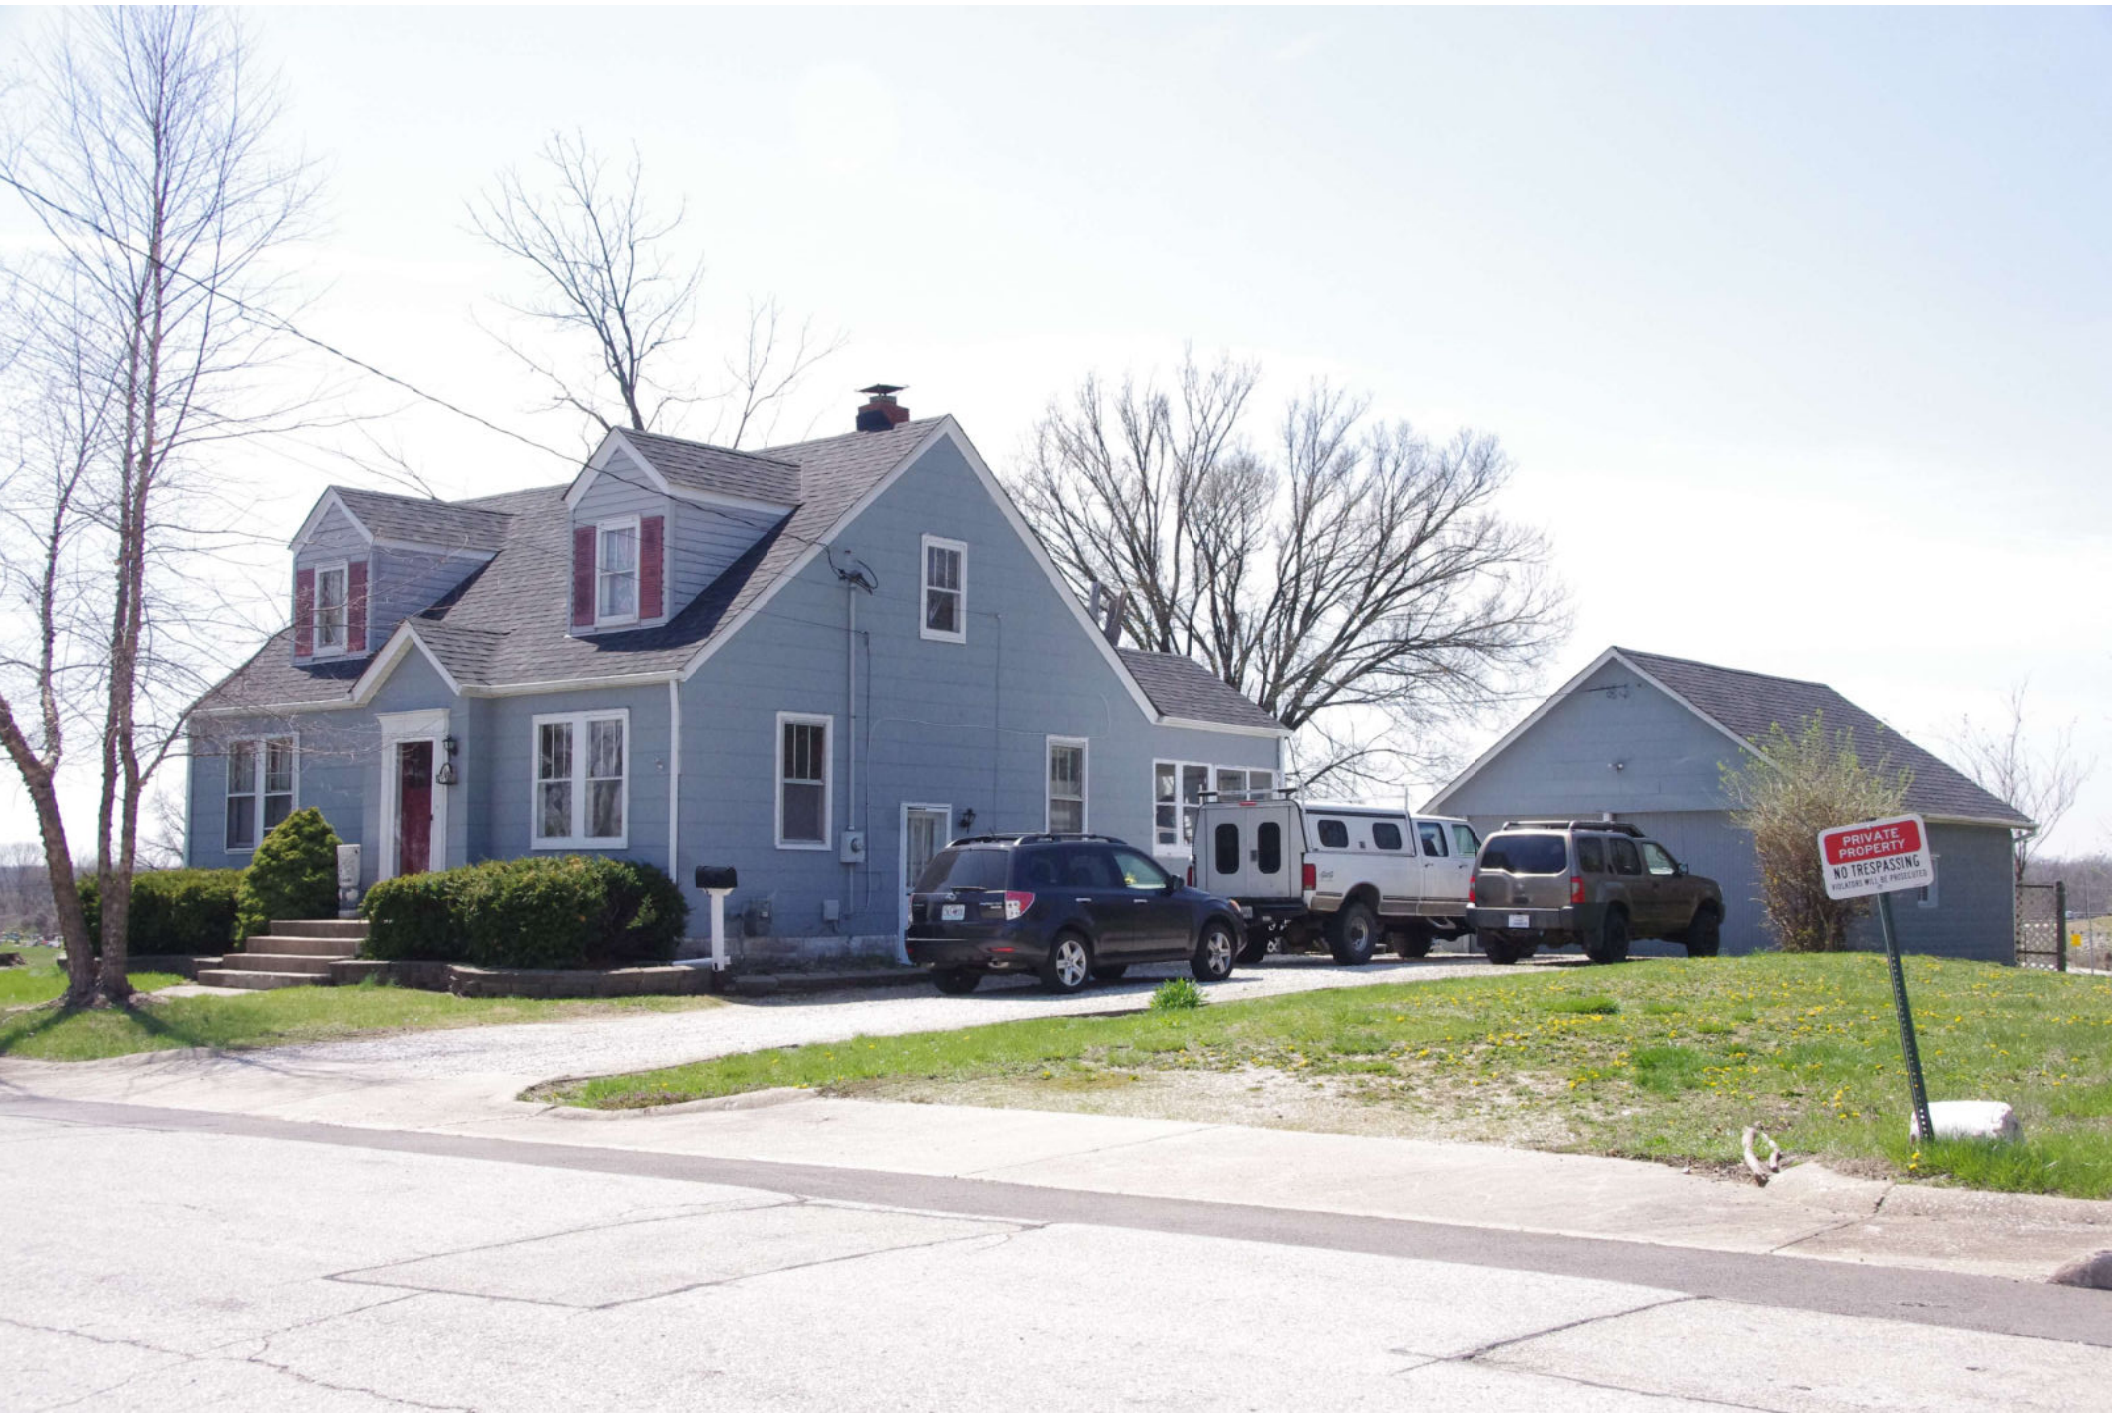
This Cape Cod cottage is one-and-a-half stories with a side gabled roof, two gabled dormers on the façade and a gabled one story slightly projecting entry vestibule with pilasters and an entablature around the wood paneled door accessed by a concrete stoop. Paired, three vertical-over-one light wood windows are located in the bays on either side of the entry. Similar sash windows are located in gabled dormers over the outer bays. On the north side, there is a three vertical light/half light wood door at the driveway flanked by three-over-one sashed windows. The house has been sided with steel siding, probably a replacement siding given the age of the house. The house retains some of the original wood storm windows but others are aluminum storms. On the rear is a gabled, one story, porch wing.

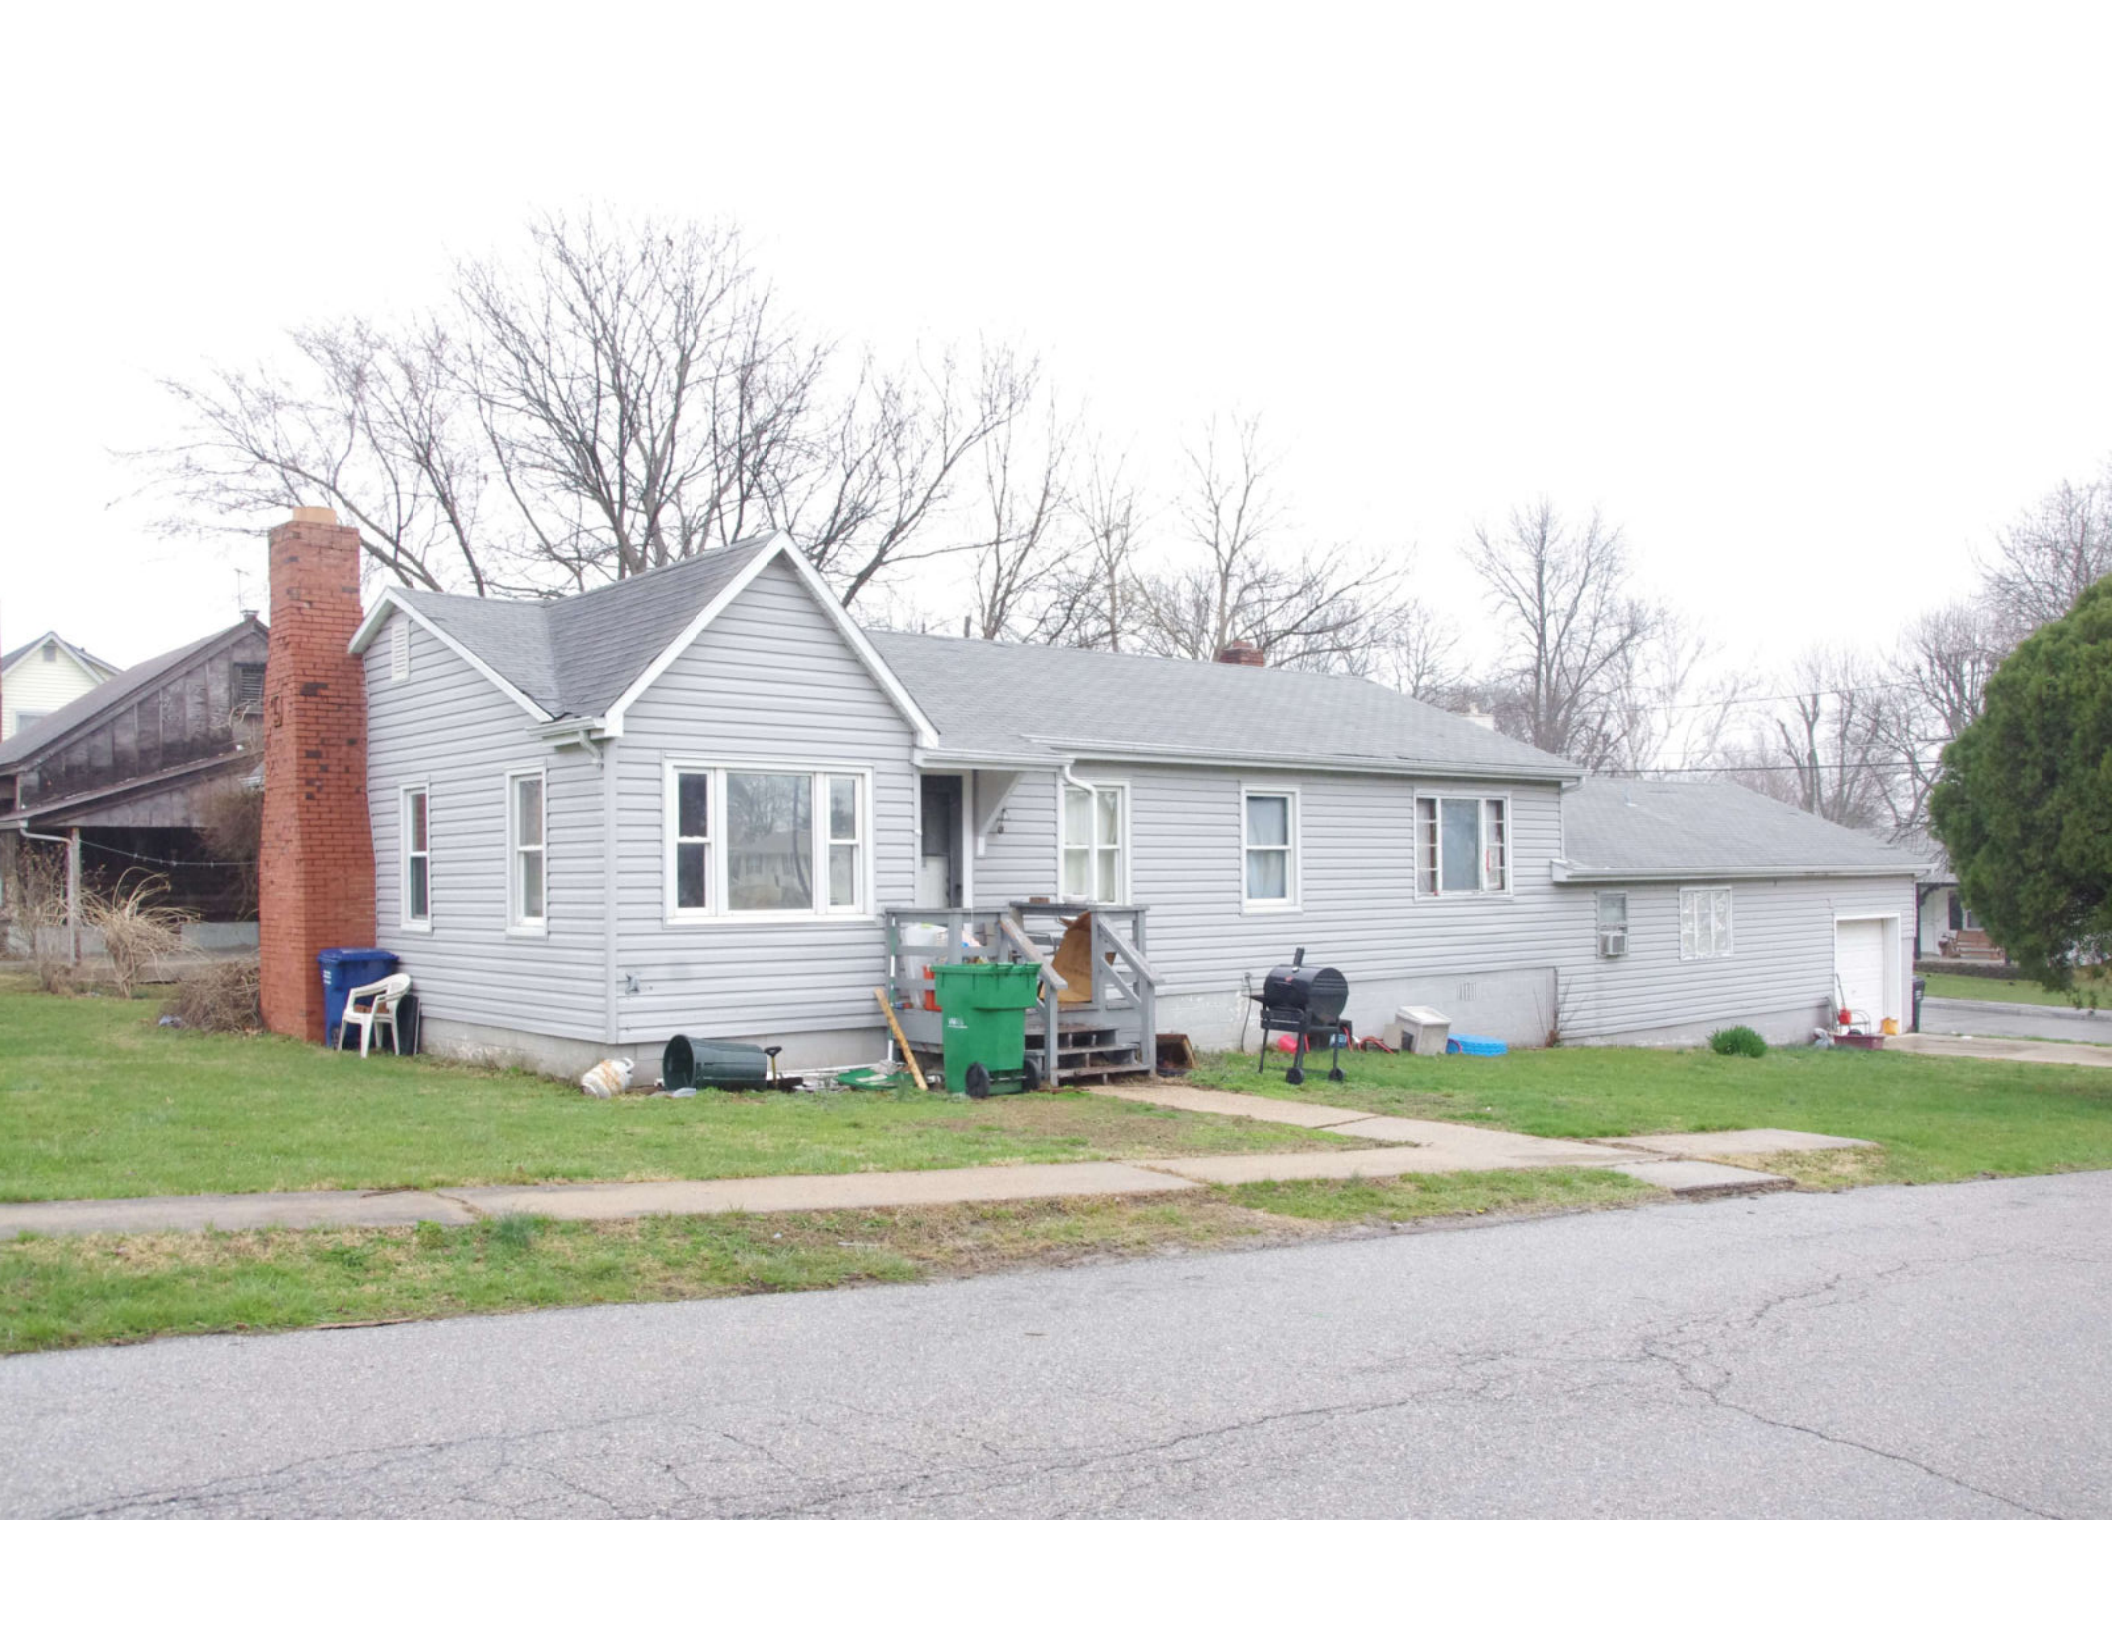
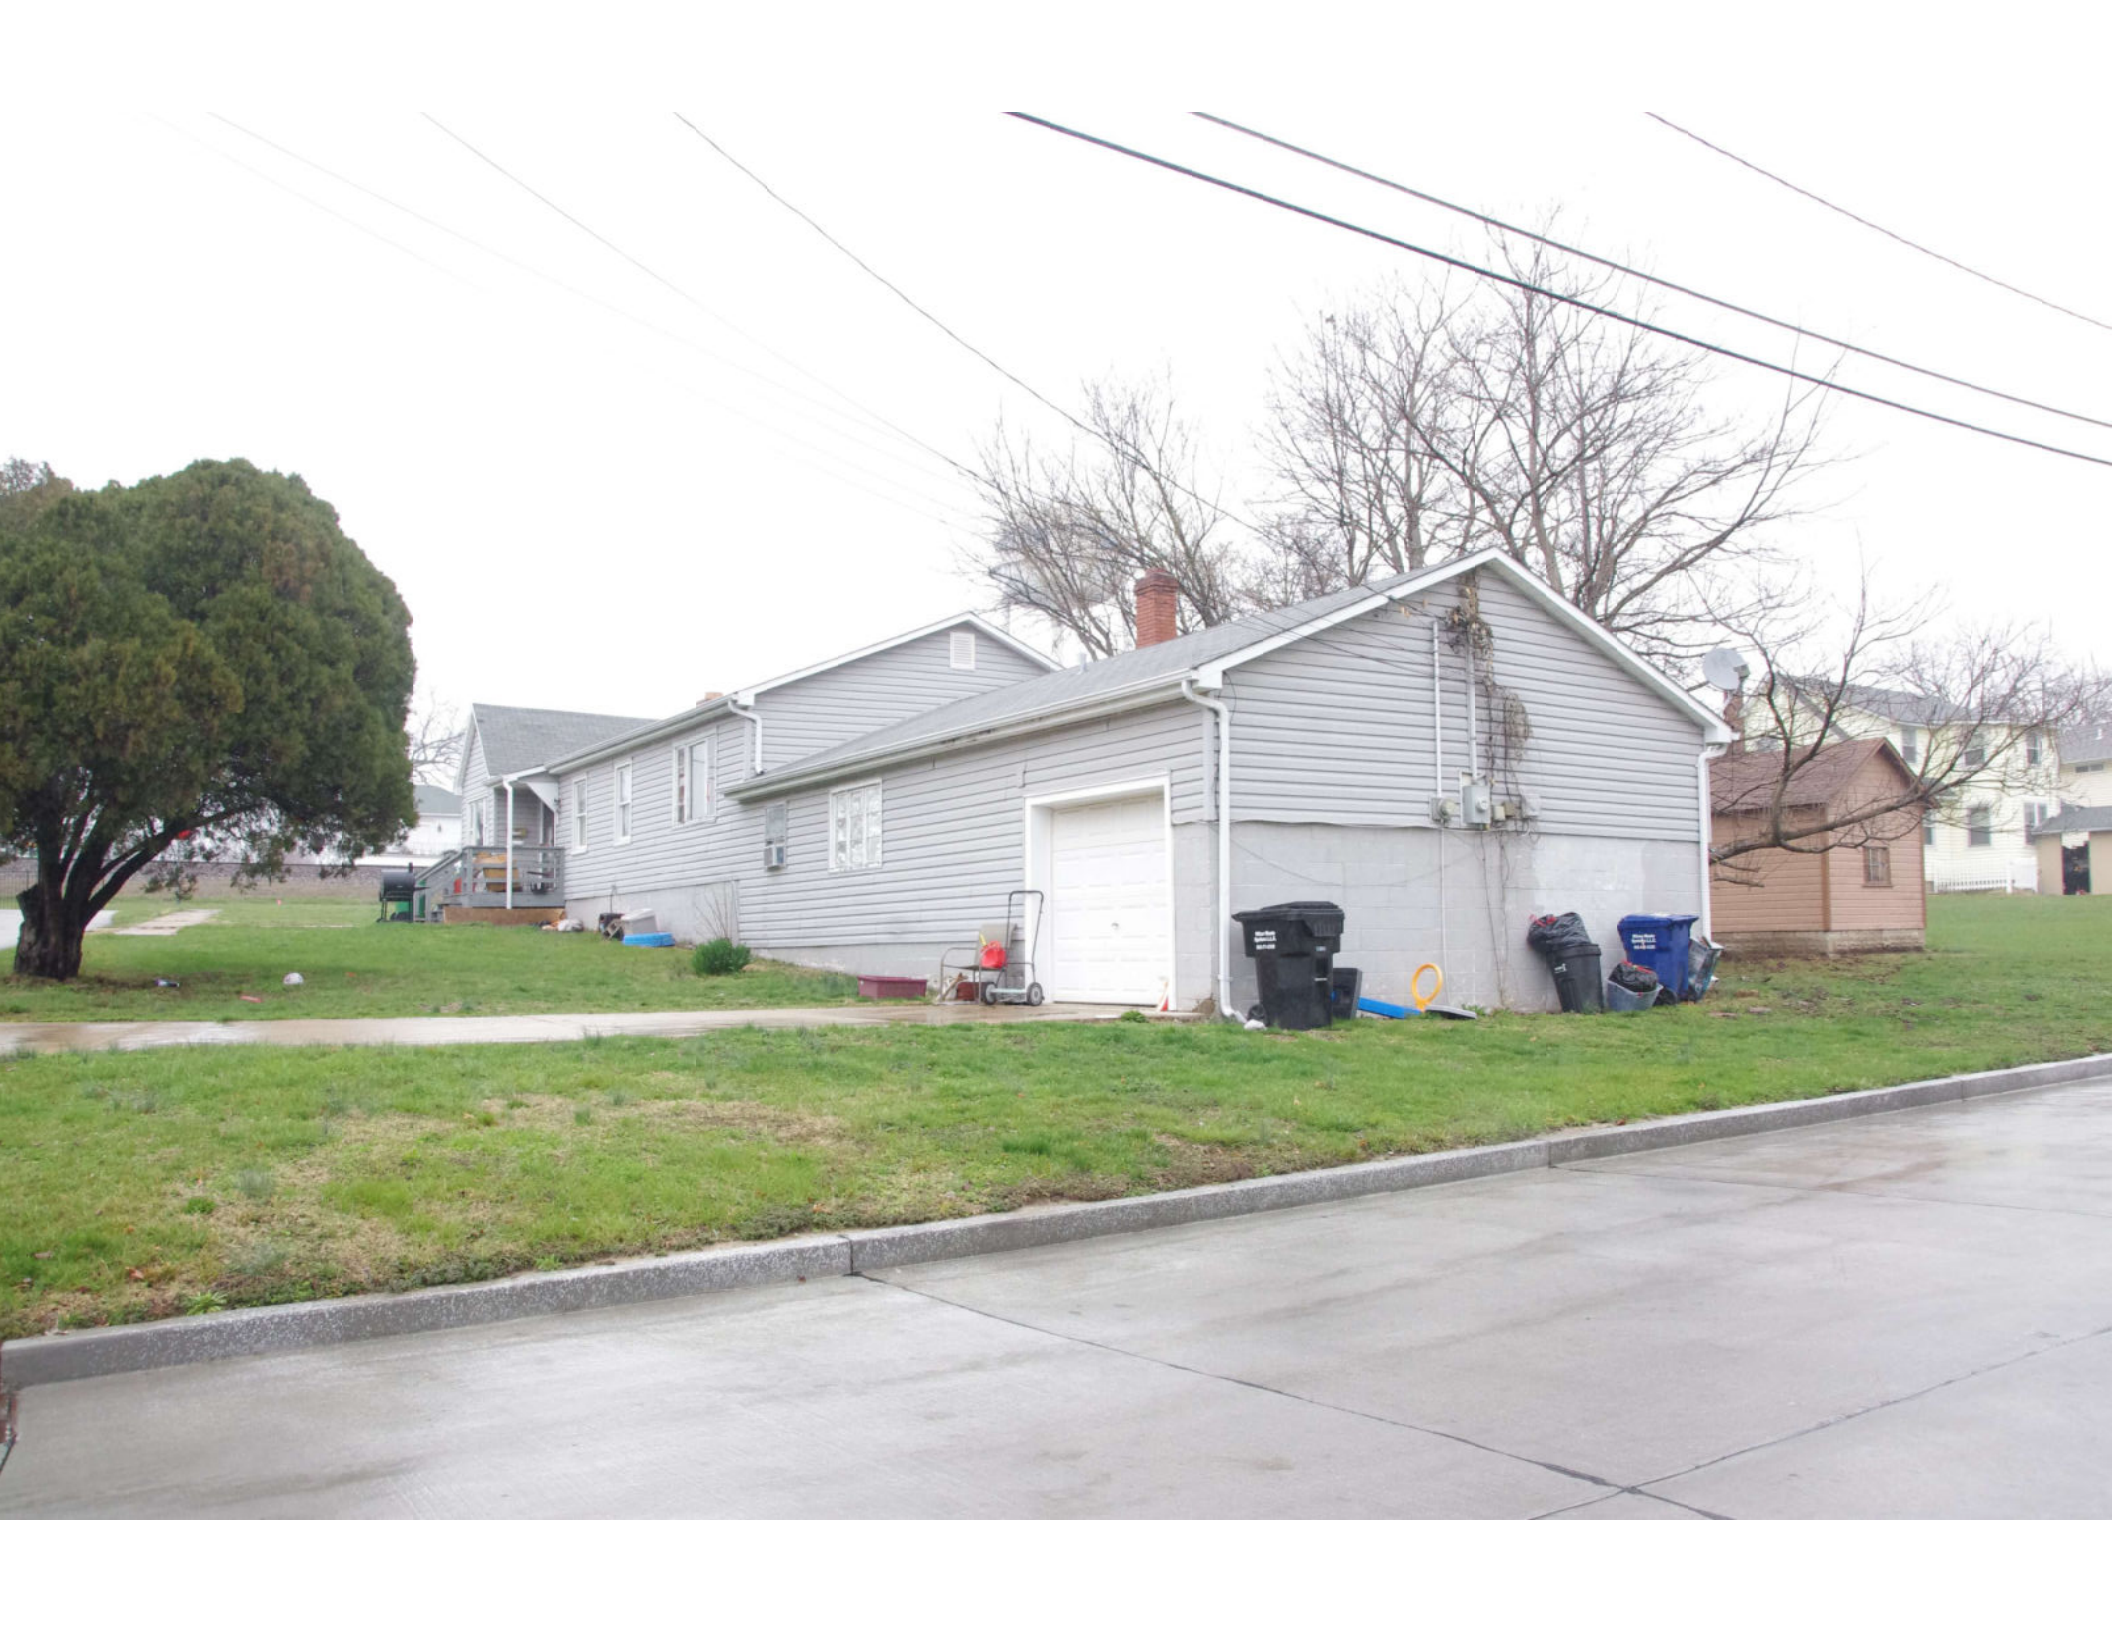
This resource is a one-story Ranch house with a cross gable at the north end of the façade. It has been re clad with vinyl siding and has replacement 1/1 vinyl windows, but it still retains the wide eaves, picture windows, at least one of which is original, with its horizontally lighted sidelights. The main house is divided into five bays on the façade with the attached garage addition located on the southern end of the building, featuring a small sashed window opening, a nine pane fixed window, a one-bay overhead garage door and a chimney between the main house and garage. There is an exterior end wall chimney on the north side of the house. The cross gable bay at the north end has a replacement picture window with one-over-one sashed sidelights. The paneled door is a replacement, located in the adjacent bay, with a shed roof extension supported by a knee brace that has been wrapped with vinyl and below is a replacement for the original stoop, a wood deck. The central two bays feature one-over-one sash windows, and the southern bay includes an original picture window with four pane sidelights.
