**ARCHITECTURAL/HISTORIC INVENTORY FORM**

1. Survey No. SC-AS-012-0052		2. Survey Name: Reconnaissance Level Survey of Historic Downtown Wentzville	
3. County: St. Charles		4. Address (Street No.) 105	Street (name) South Linn Ave
5. City: Wentzville	Vicinity: <input type="checkbox"/>	6. UTM:	
8. Historic name (if known):		9. Present/other name (if known): Land Fair Corp.	
10. Ownership: <input type="checkbox"/> Private <input type="checkbox"/> Public		11a. Historic use (if known): COMMERCE/TRADE	11b. Current use: COMMERCE/TRADE/professional
5. City: Wentzville		7. Township/Range/Section:

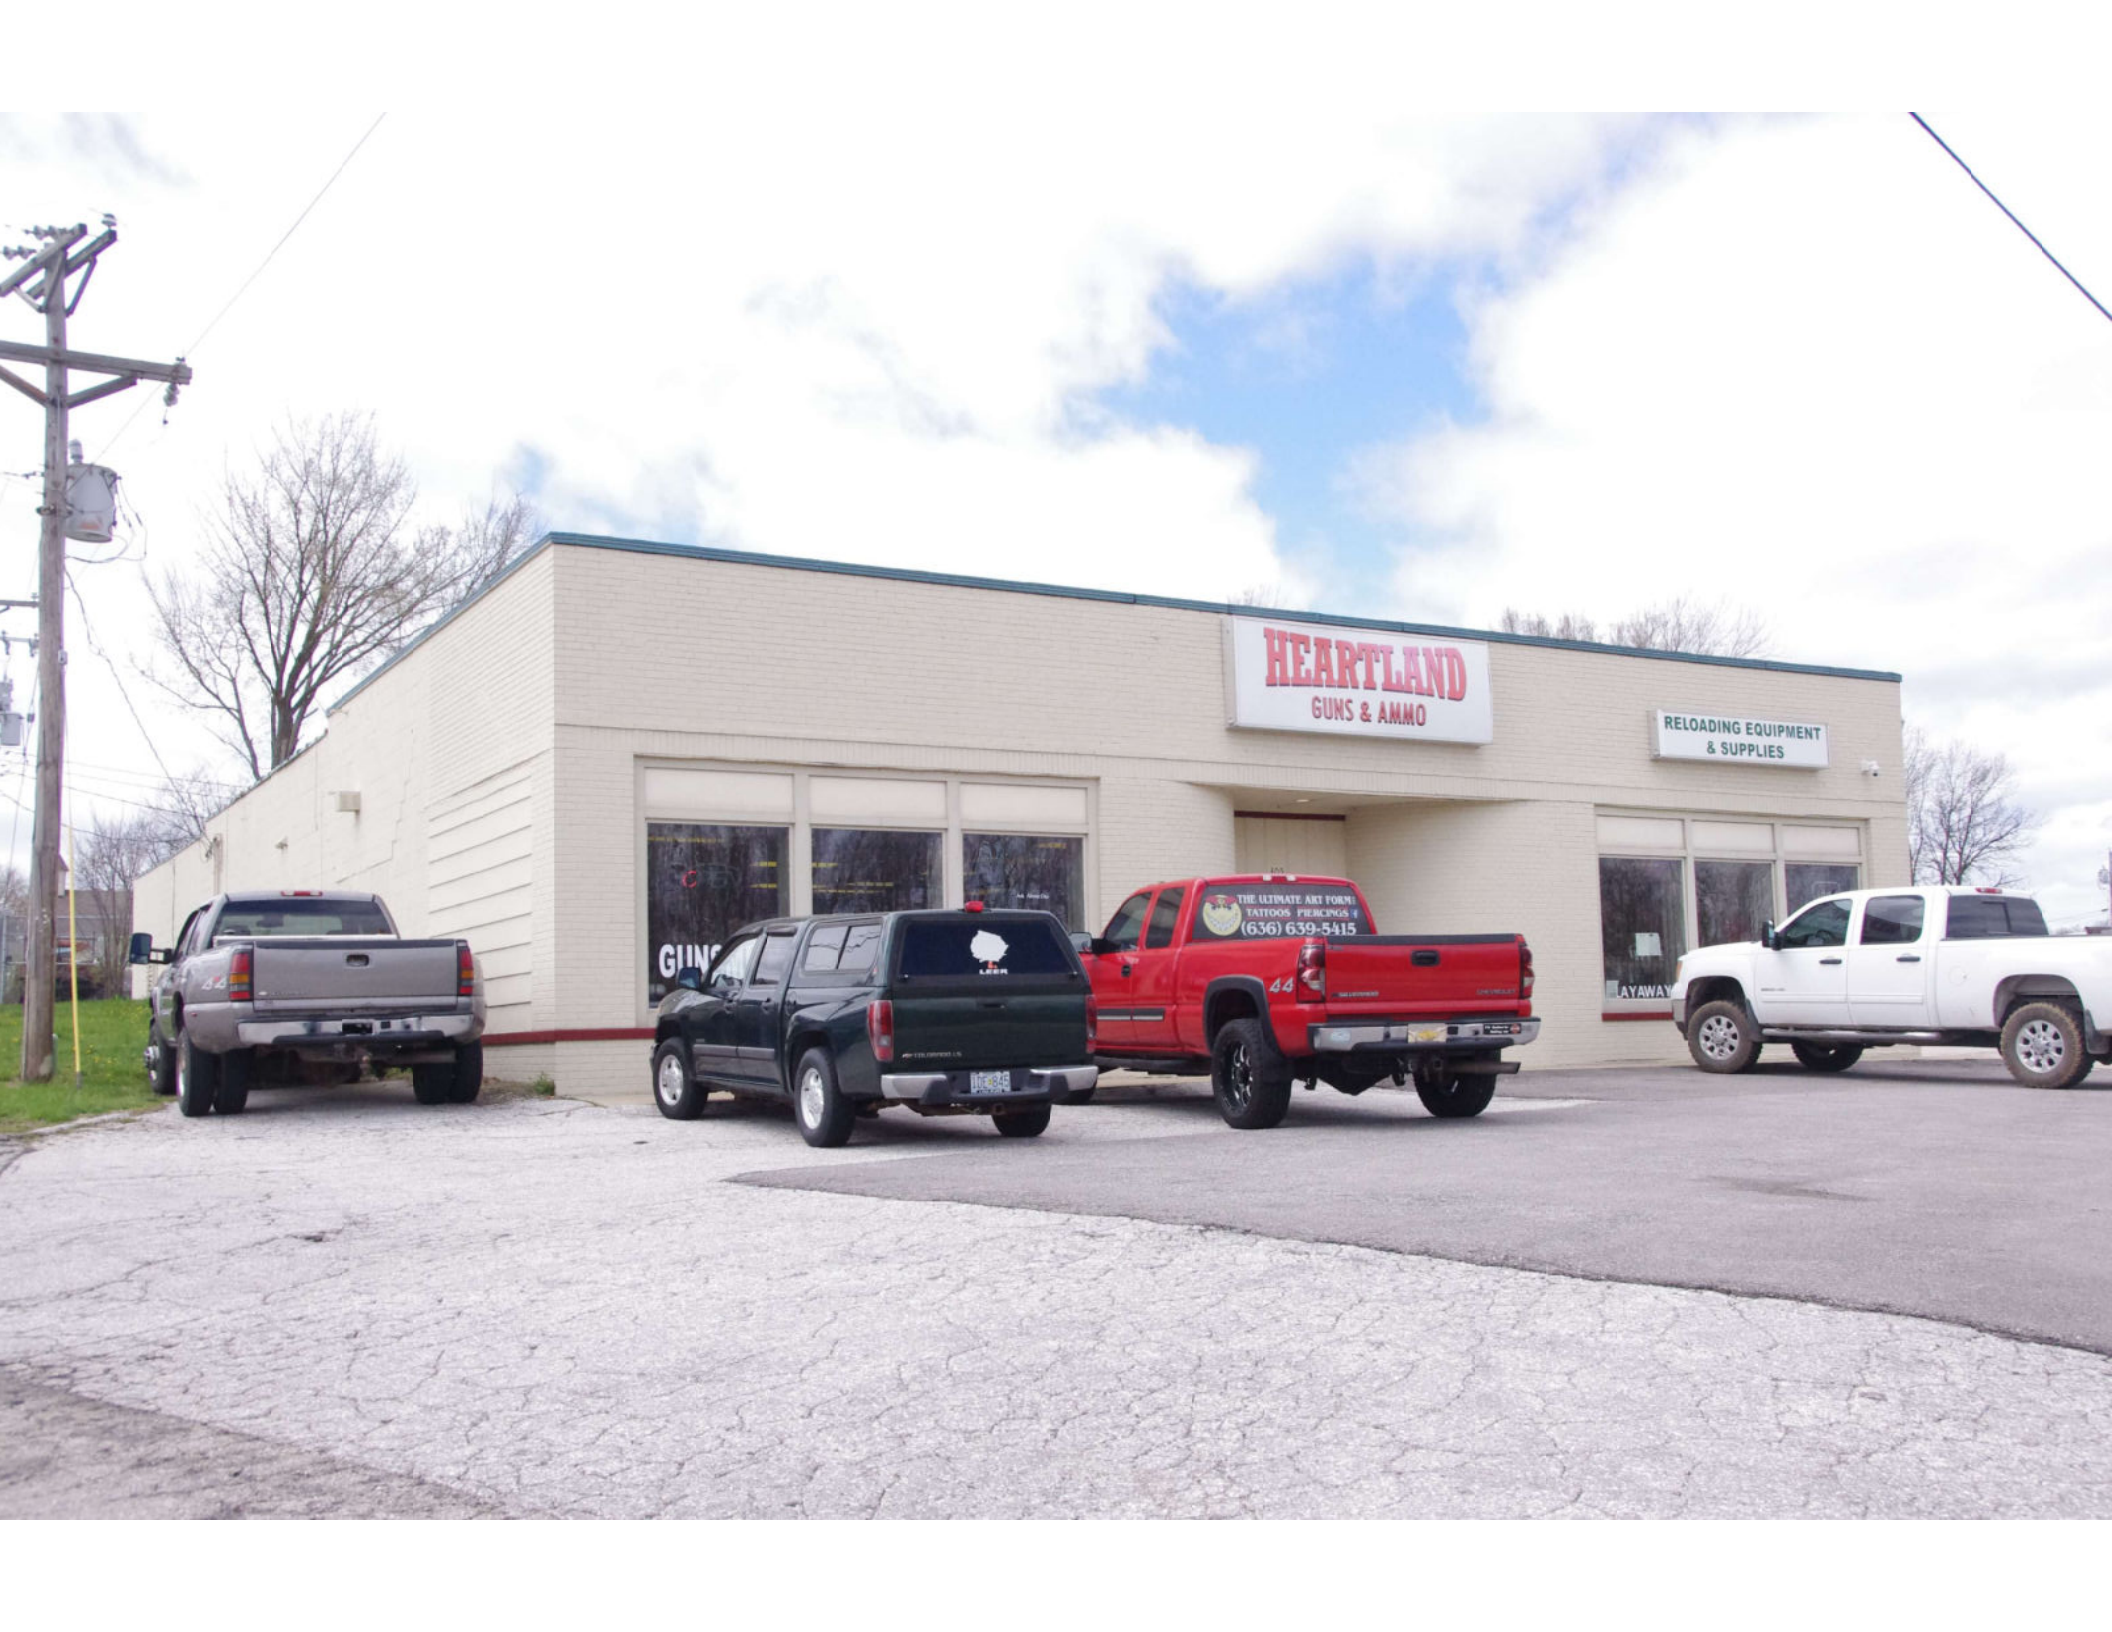
This resource is a one-story brick commercial building with a flat roof that has some indications of a Streamline Modern design but the brick has been painted obscuring the details although the paired metal framed glass doors are recessed in the center bay with curved brick walls on either side. These doors have either been painted or boarded in the sidelights and transom over the door, although the aluminum framing appears to be intact. The outer bays feature three large replacement display windows with concrete sills and wood panels just below the lintels. There is a brick soldier course that serves as a lintel across the façade. The side elevations have brick walls around the front bay, which have an infilled display window on each side, and then the remaining elevation walls are concrete block with evidence of additional window openings that have been blocked in. On the north side, two garage door openings are located near the rear. The adjoining lot at 307 Luetkenhaus is part of this same legal parcel and previously included an outbuilding (gas pump canopy) which was demolished prior to this survey.

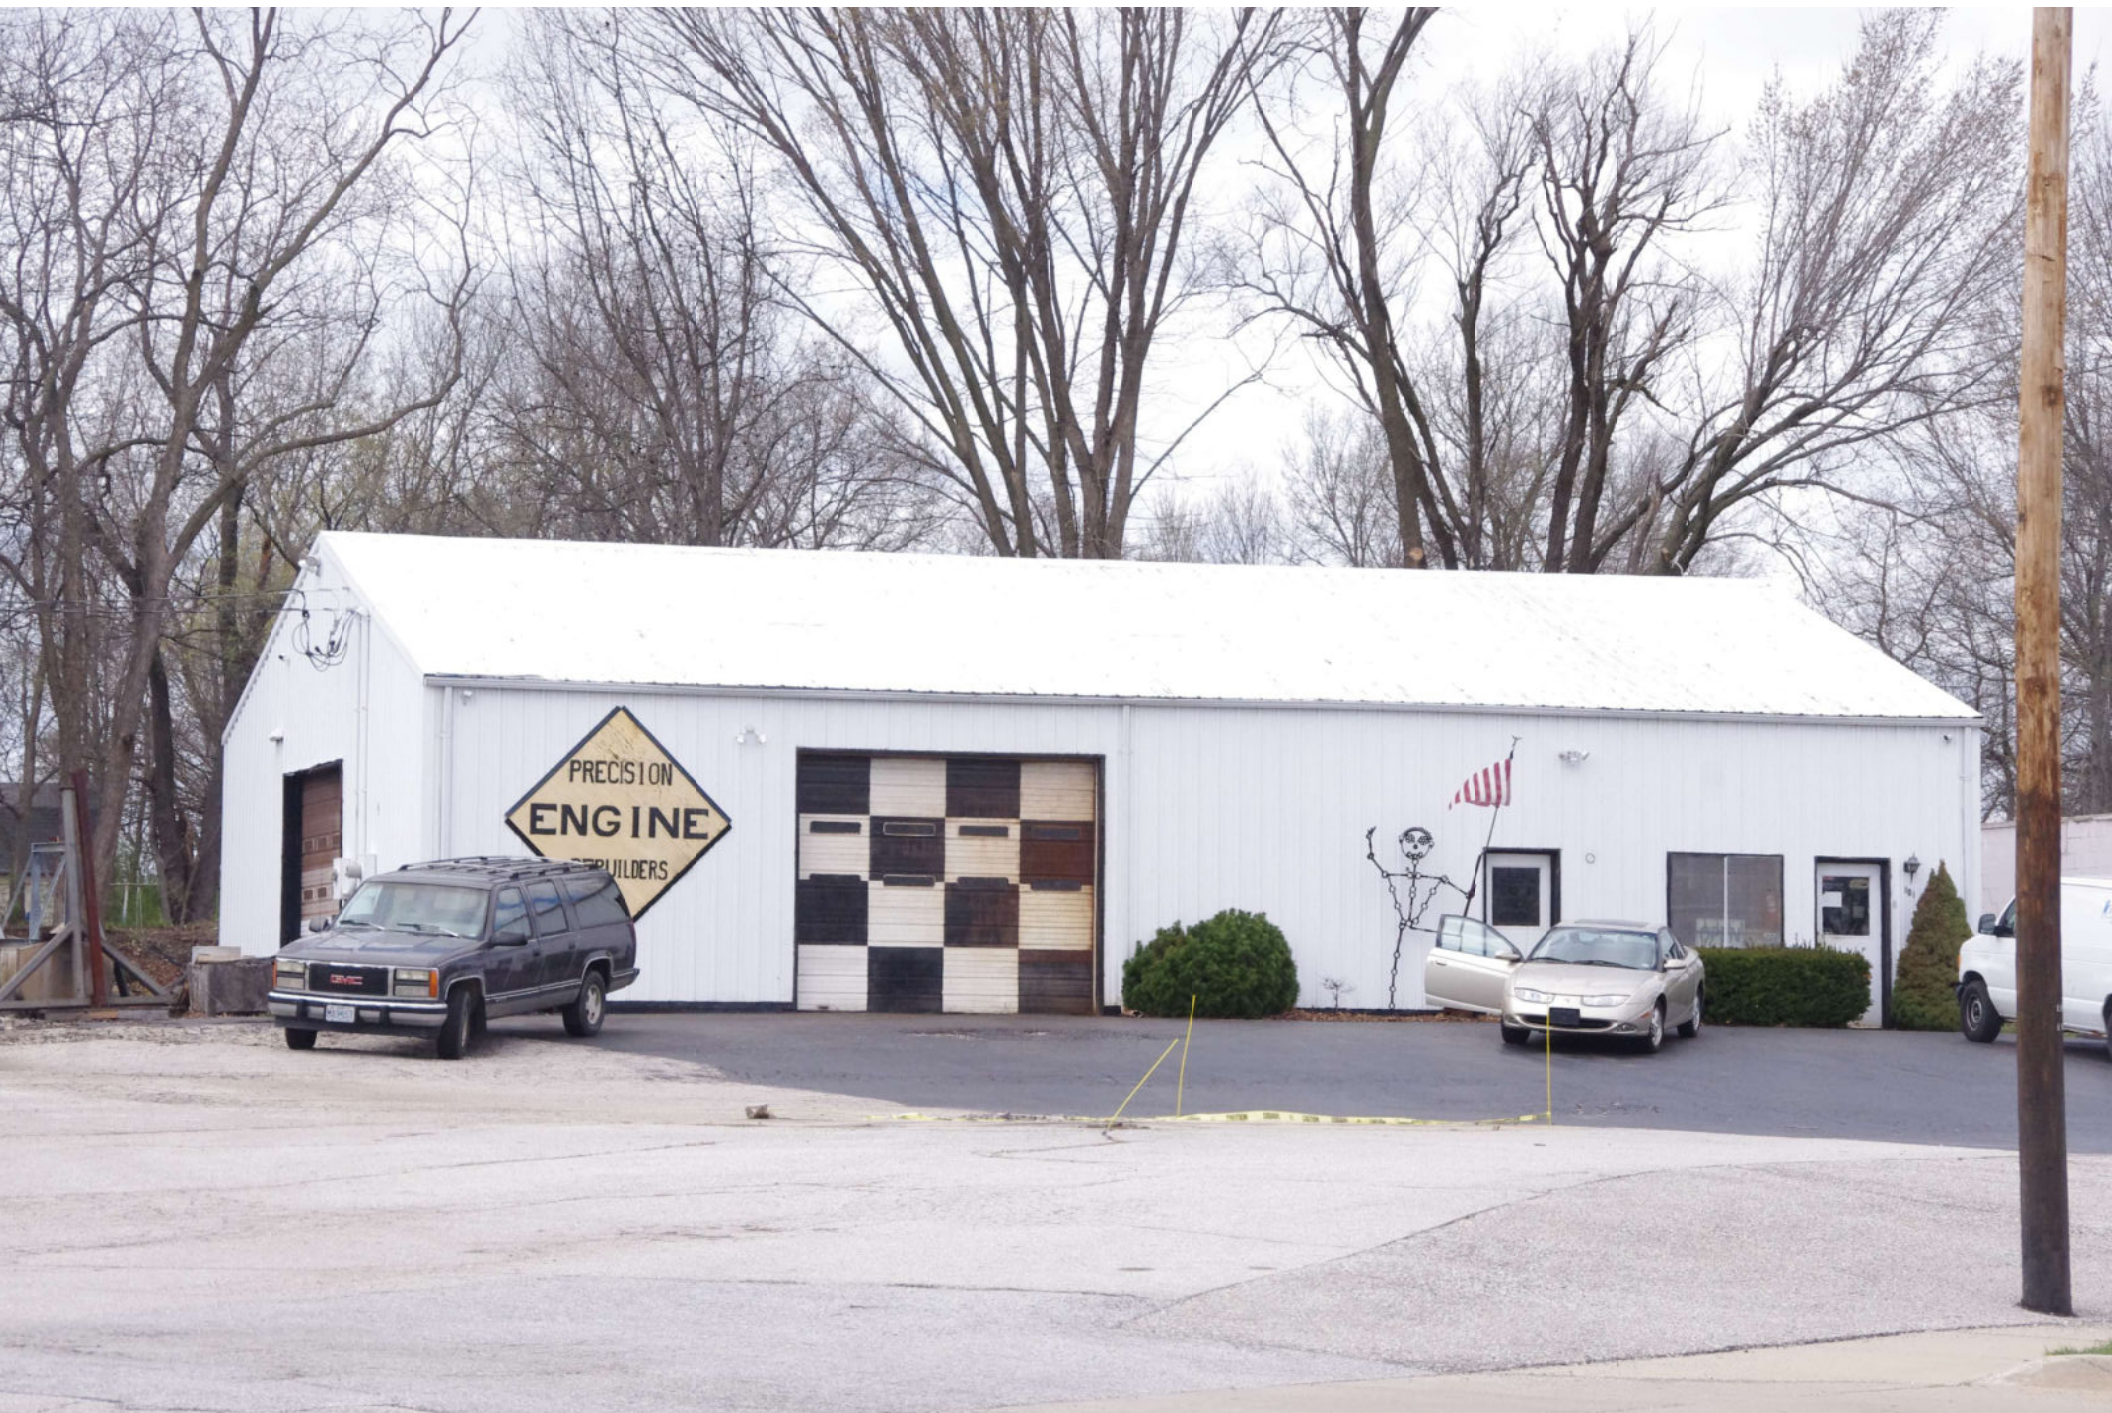
This resource is a one-story metal sided commercial building with a side gabled metal roof. An overhead garage door is located in the southern bay and there is another overhead garage door on the south elevation, both being coil doors. The northern bay features half light metal doors on either side of a large display window covered by a metal security grate.

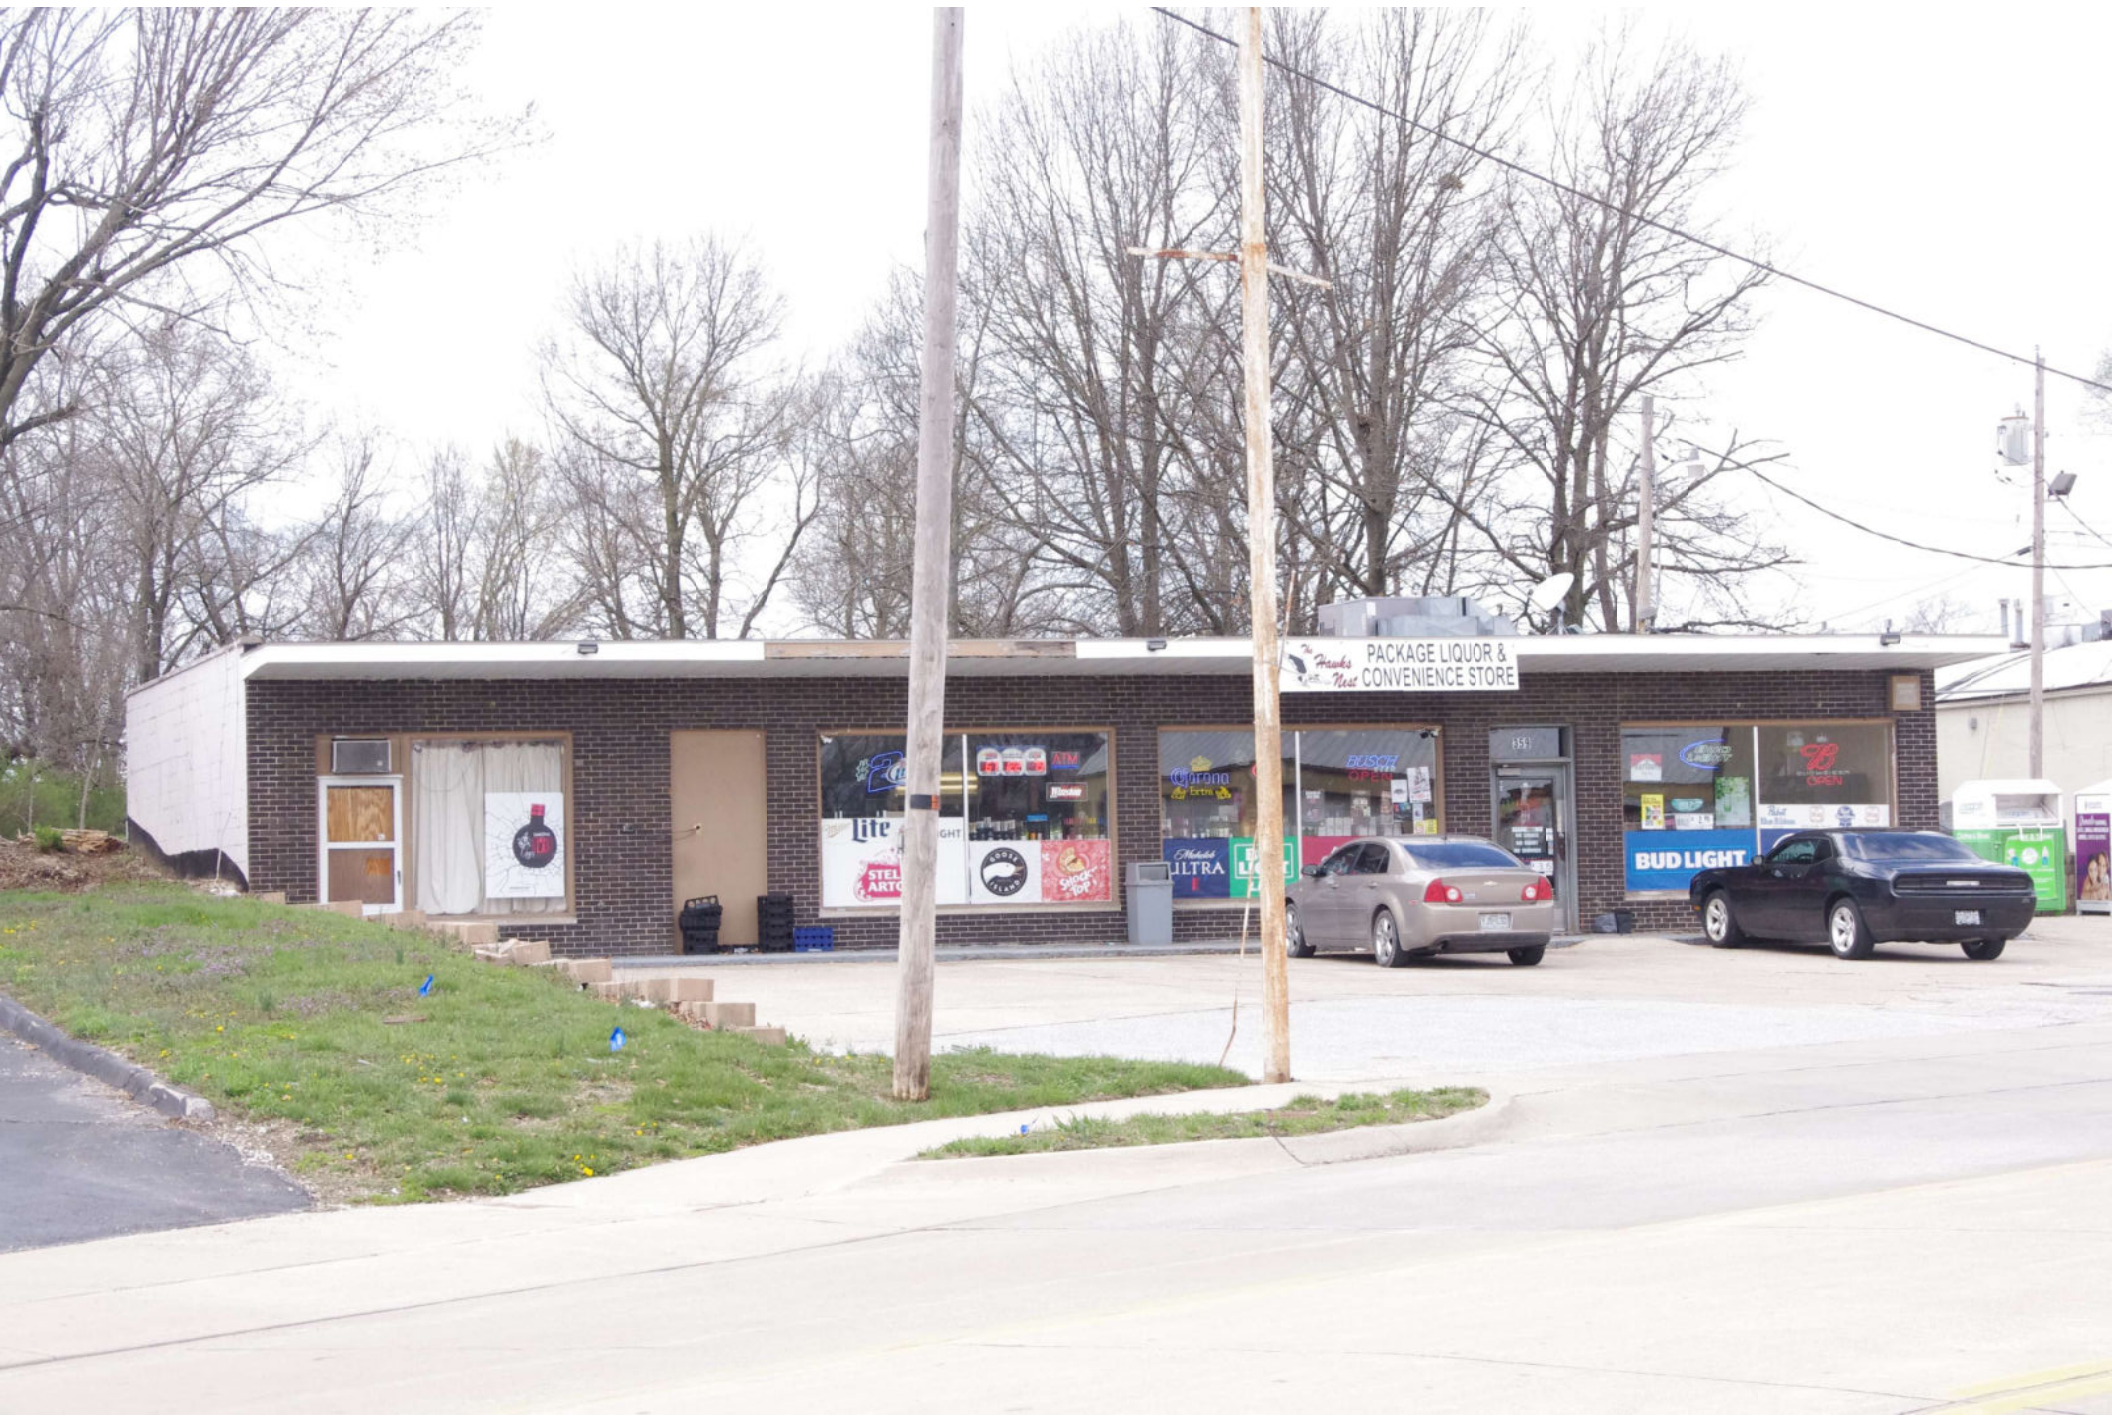
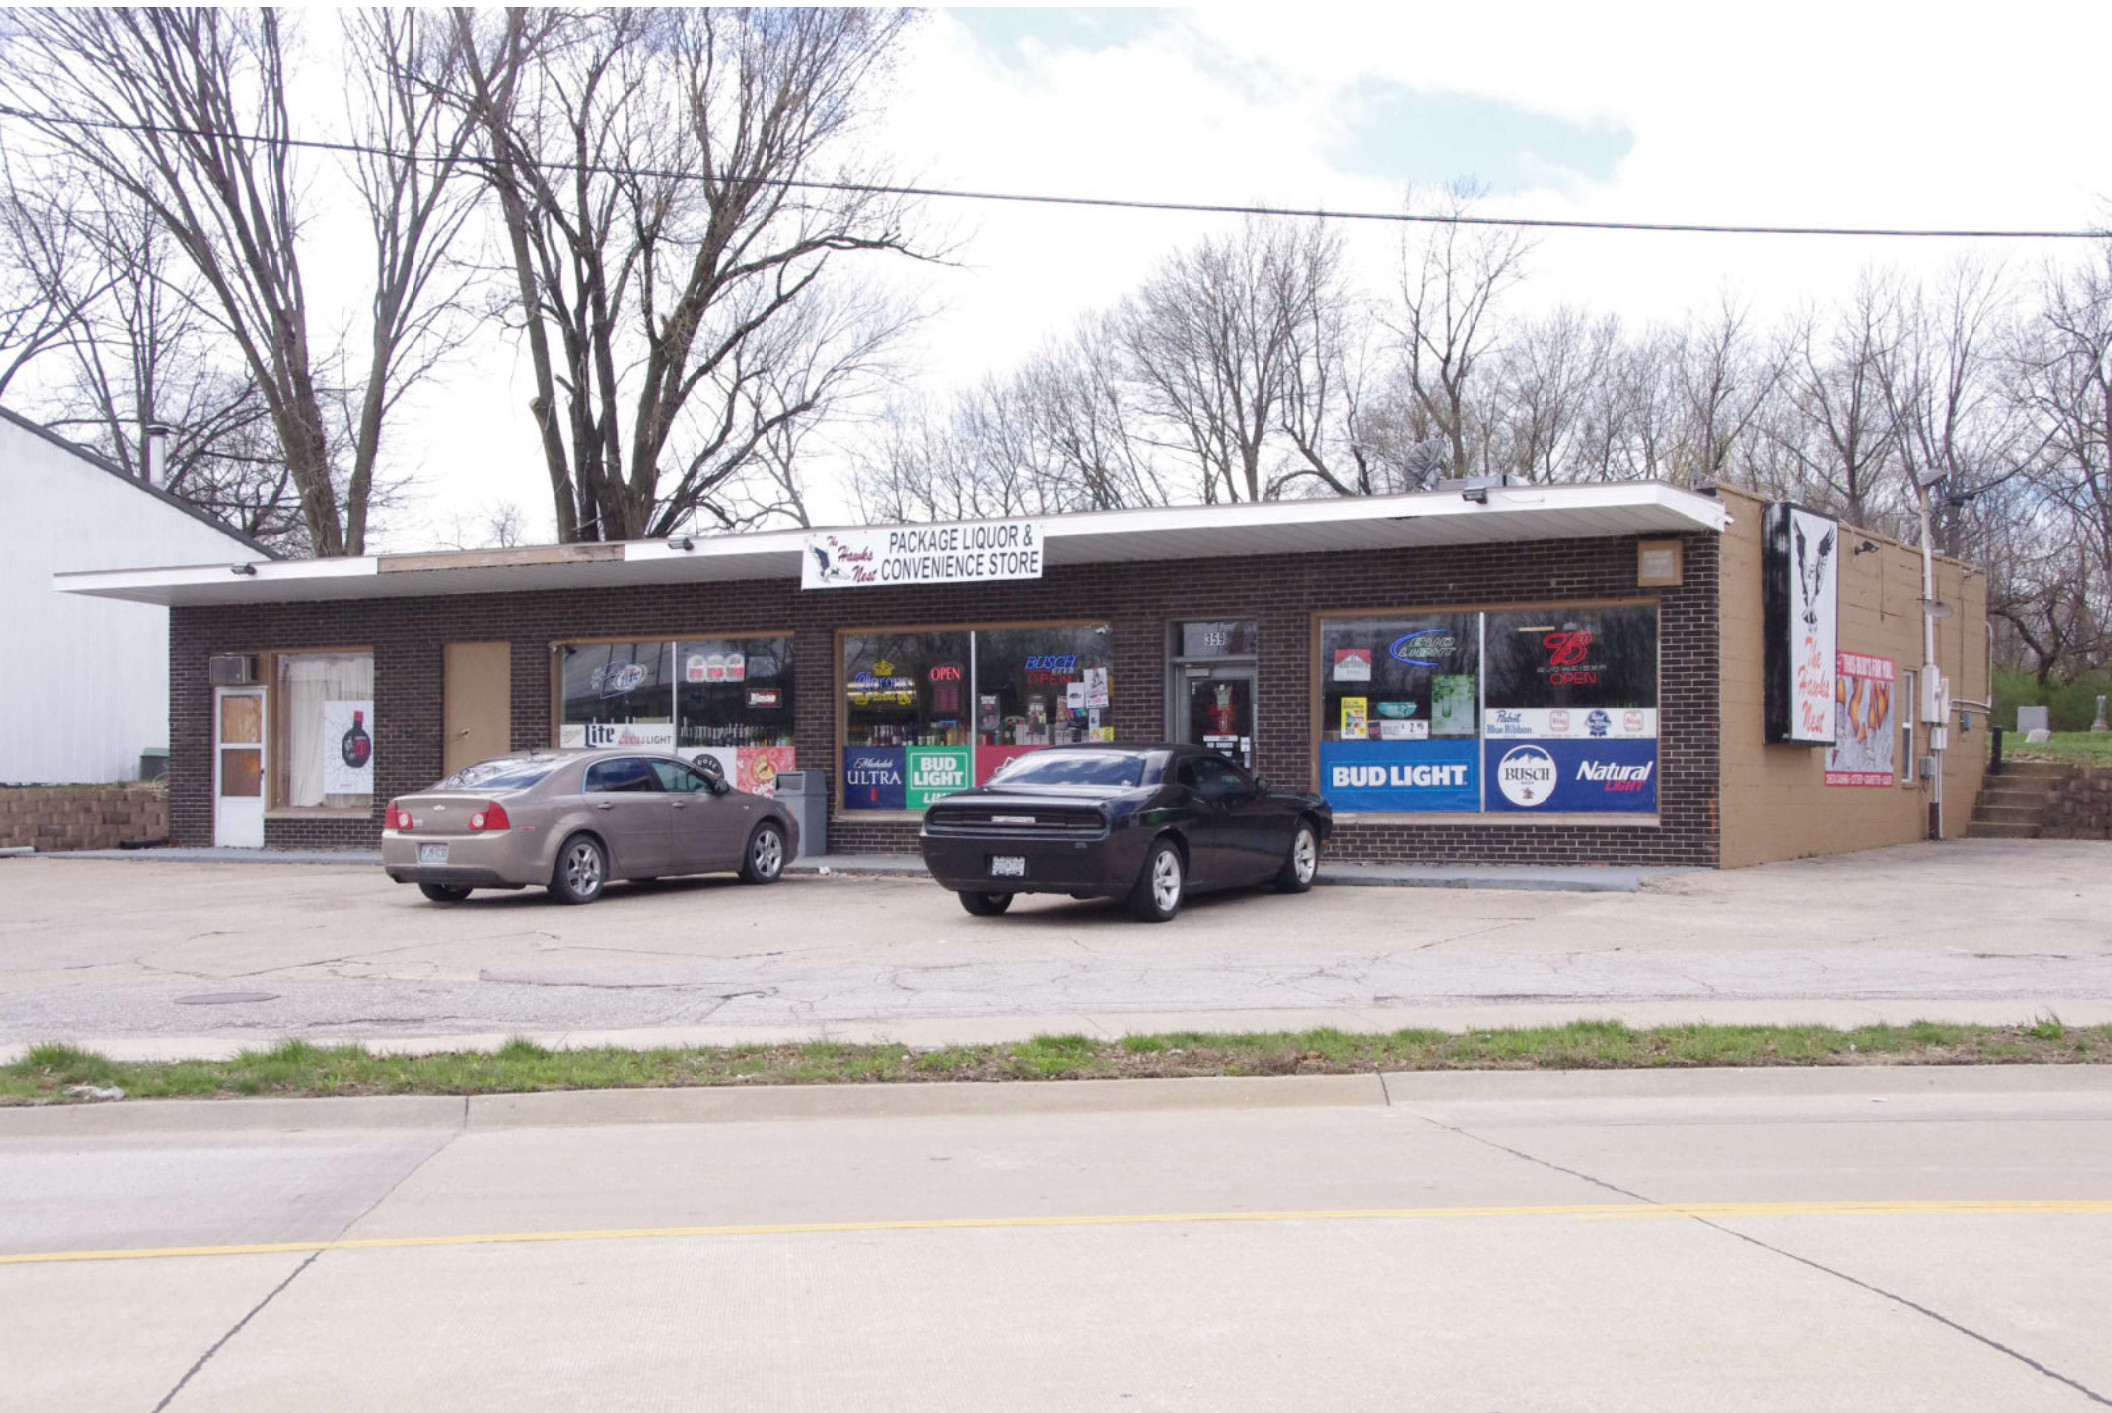
This resource is a one-story brick faced, concrete block commercial building with a flat roof and a projecting flat canopy that extends the length of the facade. There are four display windows which retain their original metal frame around the perimeter but they have had additional metal mullions added to divide the display window into two lights. The south bay window has a connected aluminum framed glass door with transom. Between the southern two and the northern two bays is a door opening, but the southern doorway is boarded in. The northern doorway retains the original full light door with transom.

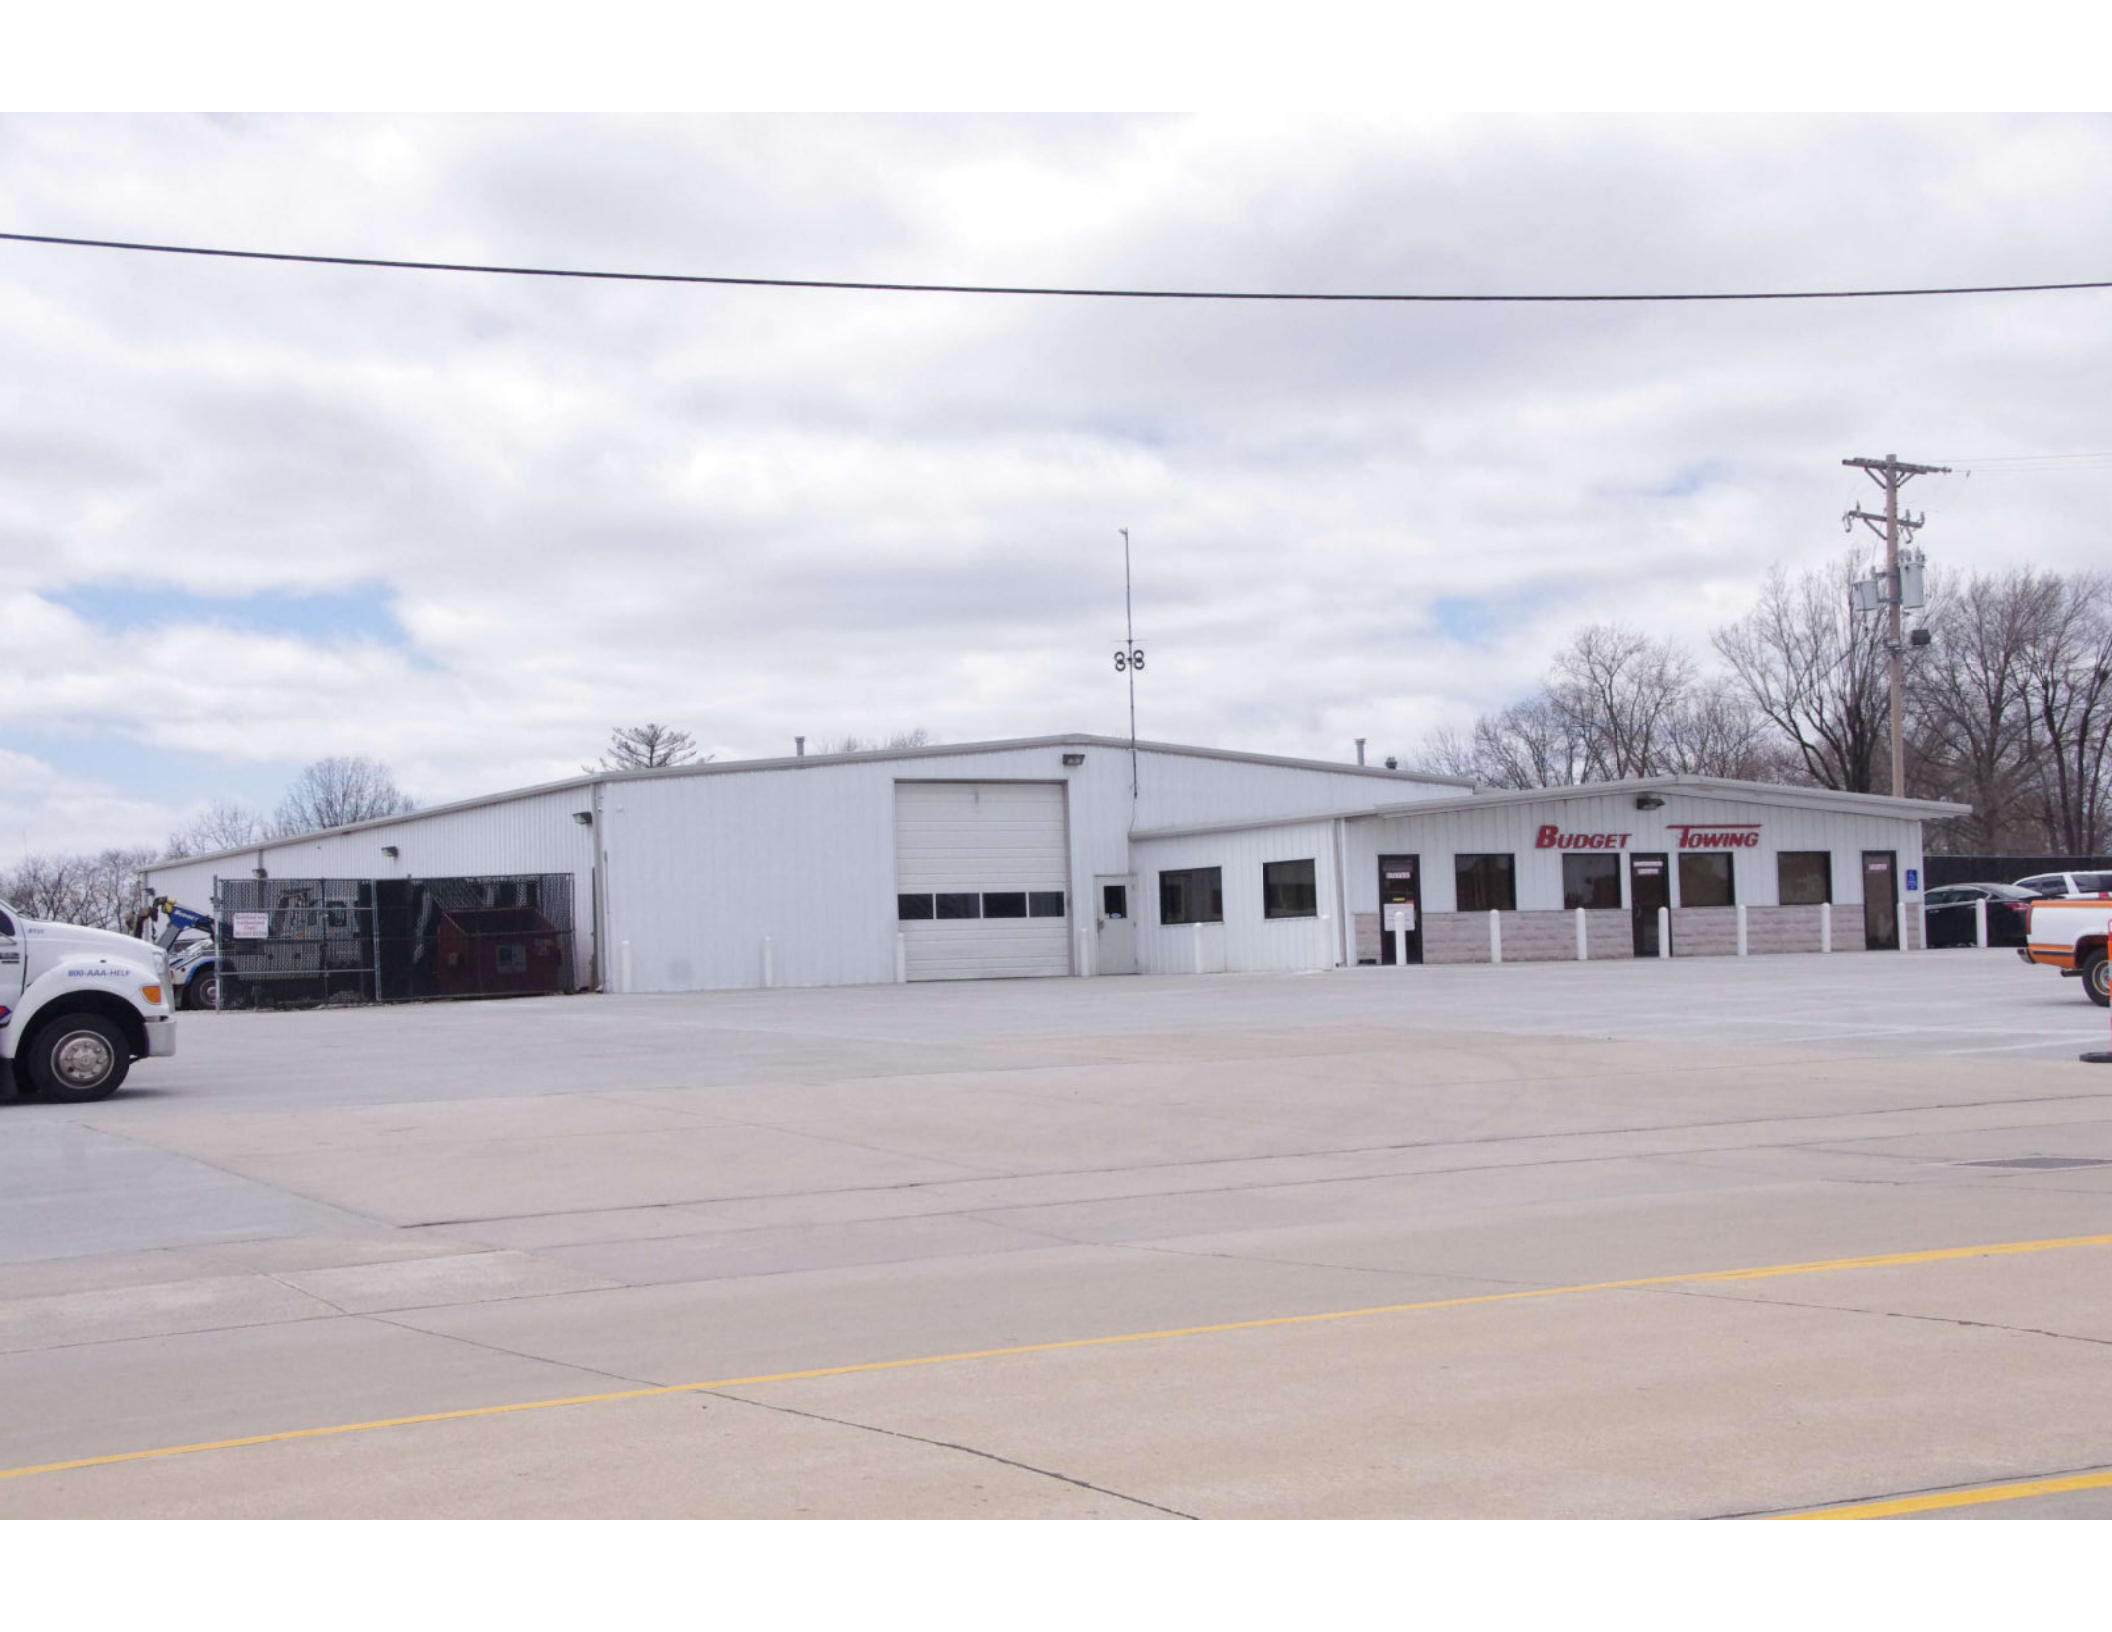
This resource is a one-story metal commercial building with a broad, shallow gabled metal roof that has a 2 story metal storage building that is attached to the rear and extends further toward the south, creating the middle bay of the façade with tall overhead coil door. The façade of the office building includes a faux stone half wall with a central glass door flanked by two smoked glass, metal framed display windows on either side and additional glass doors at each end of its façade. The doors are metal framed with smoked glass. There are two additional display windows on the south elevation and one on the north elevation of this office wing.

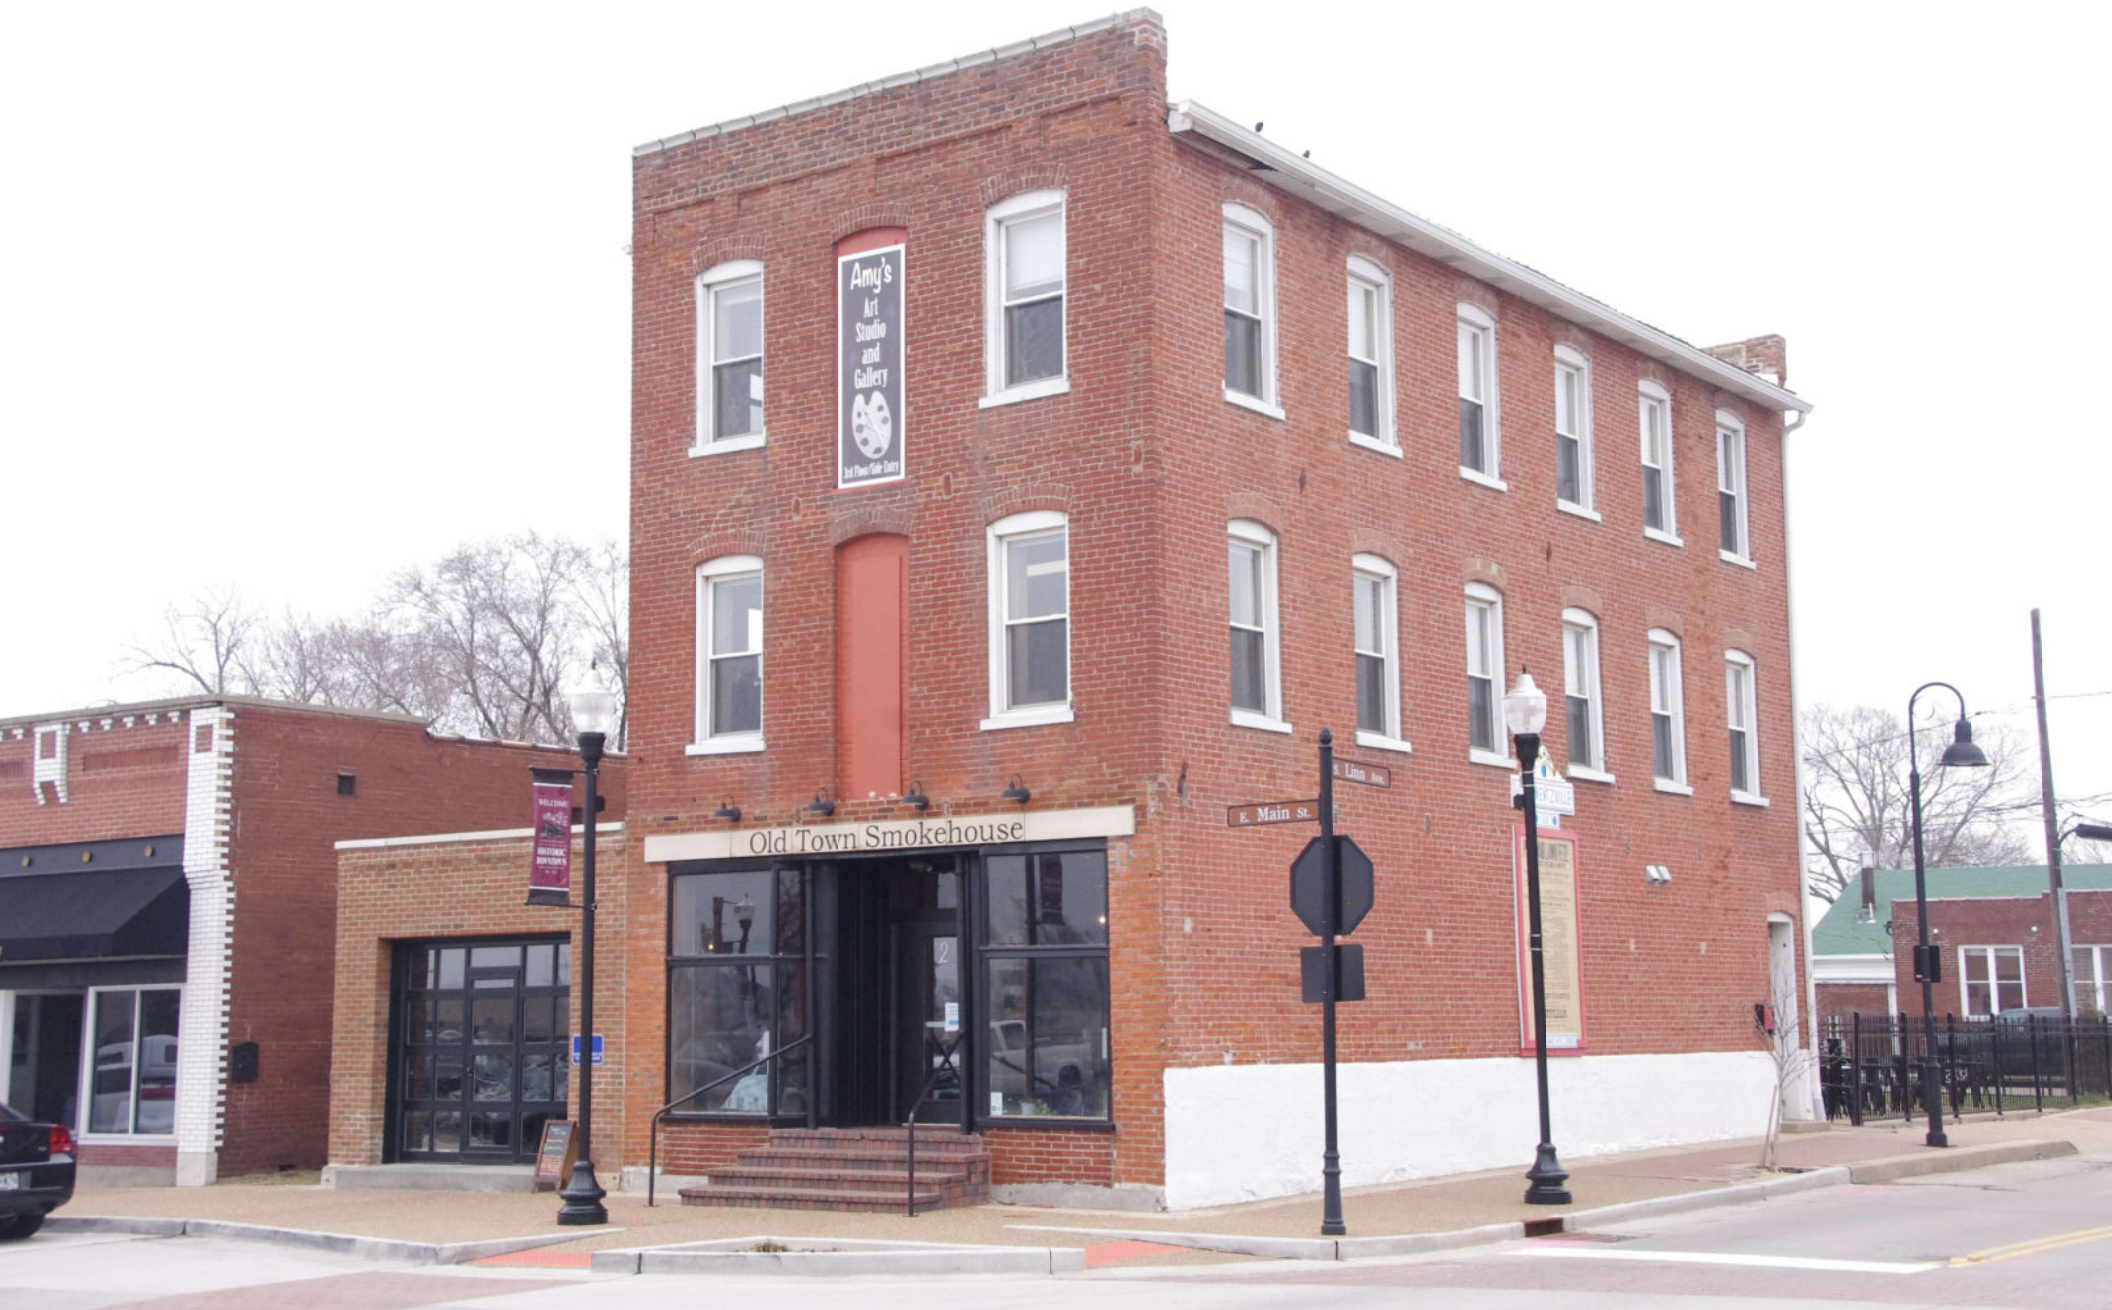
A three-story brick commercial building has a flat roof with stone coping on the parapet. In the early historic photos it appears that the parapet originally sported a projecting cornice, but that has been removed and the base of the parapet has a row of recessed brick friezes, which may be original to the building design, but the rows of brick above appear to have been relaid. The central recessed wood framed storefront with the large plate glass on either side of the central recessed entry seems to date from the 1920s, given historic photos, while the earlier storefront had display windows divided into 4 lights on either side of the recessed doorway. The full light glass door appears newer, but the transomed opening seems to date to the 1920s storefront. One-over-one sash windows with stone sills and arched brick lintels fill the outer bays of the second and third floors, while the central bays are boarded in door openings (the third floor door is not visible in the 1908 photo (Bowman, p. 122), apparently added later, but both doors opened onto the two-story gallery porch that originally spanned the façade (still intact in the 1908 photo). The second and third floor of the side elevations have one-over-one sashed windows as well. In the early historic photos these windows were two-over-two, but the current windows are more recent replacements with panning around the brickmold. There are replacement brick steps up to the entry door. A one-story brick addition is located on the eastern side of the building. It may be a rebuilt façade of a much older 1-story wing that is shown on the 1927 fire insurance map as open to the interior of the 3-story building. Square pane metal windows and door imitate the design of an overhead garage door in the single bay façade.
