**ARCHITECTURAL/HISTORIC INVENTORY FORM**

1. Survey No. SC-AS-012-0052		2. Survey Name: Reconnaissance Level Survey of Historic Downtown Wentzville	
3. County: St. Charles		4. Address (Street No.) 105	Street (name) South Linn Ave
5. City: Wentzville	Vicinity: <input type="checkbox"/>	6. UTM:	
8. Historic name (if known):		9. Present/other name (if known): Land Fair Corp.	
10. Ownership: <input type="checkbox"/> Private <input type="checkbox"/> Public		11a. Historic use (if known): COMMERCE/TRADE	11b. Current use: COMMERCE/TRADE/professional
5. City: Wentzville		7. Township/Range/Section:

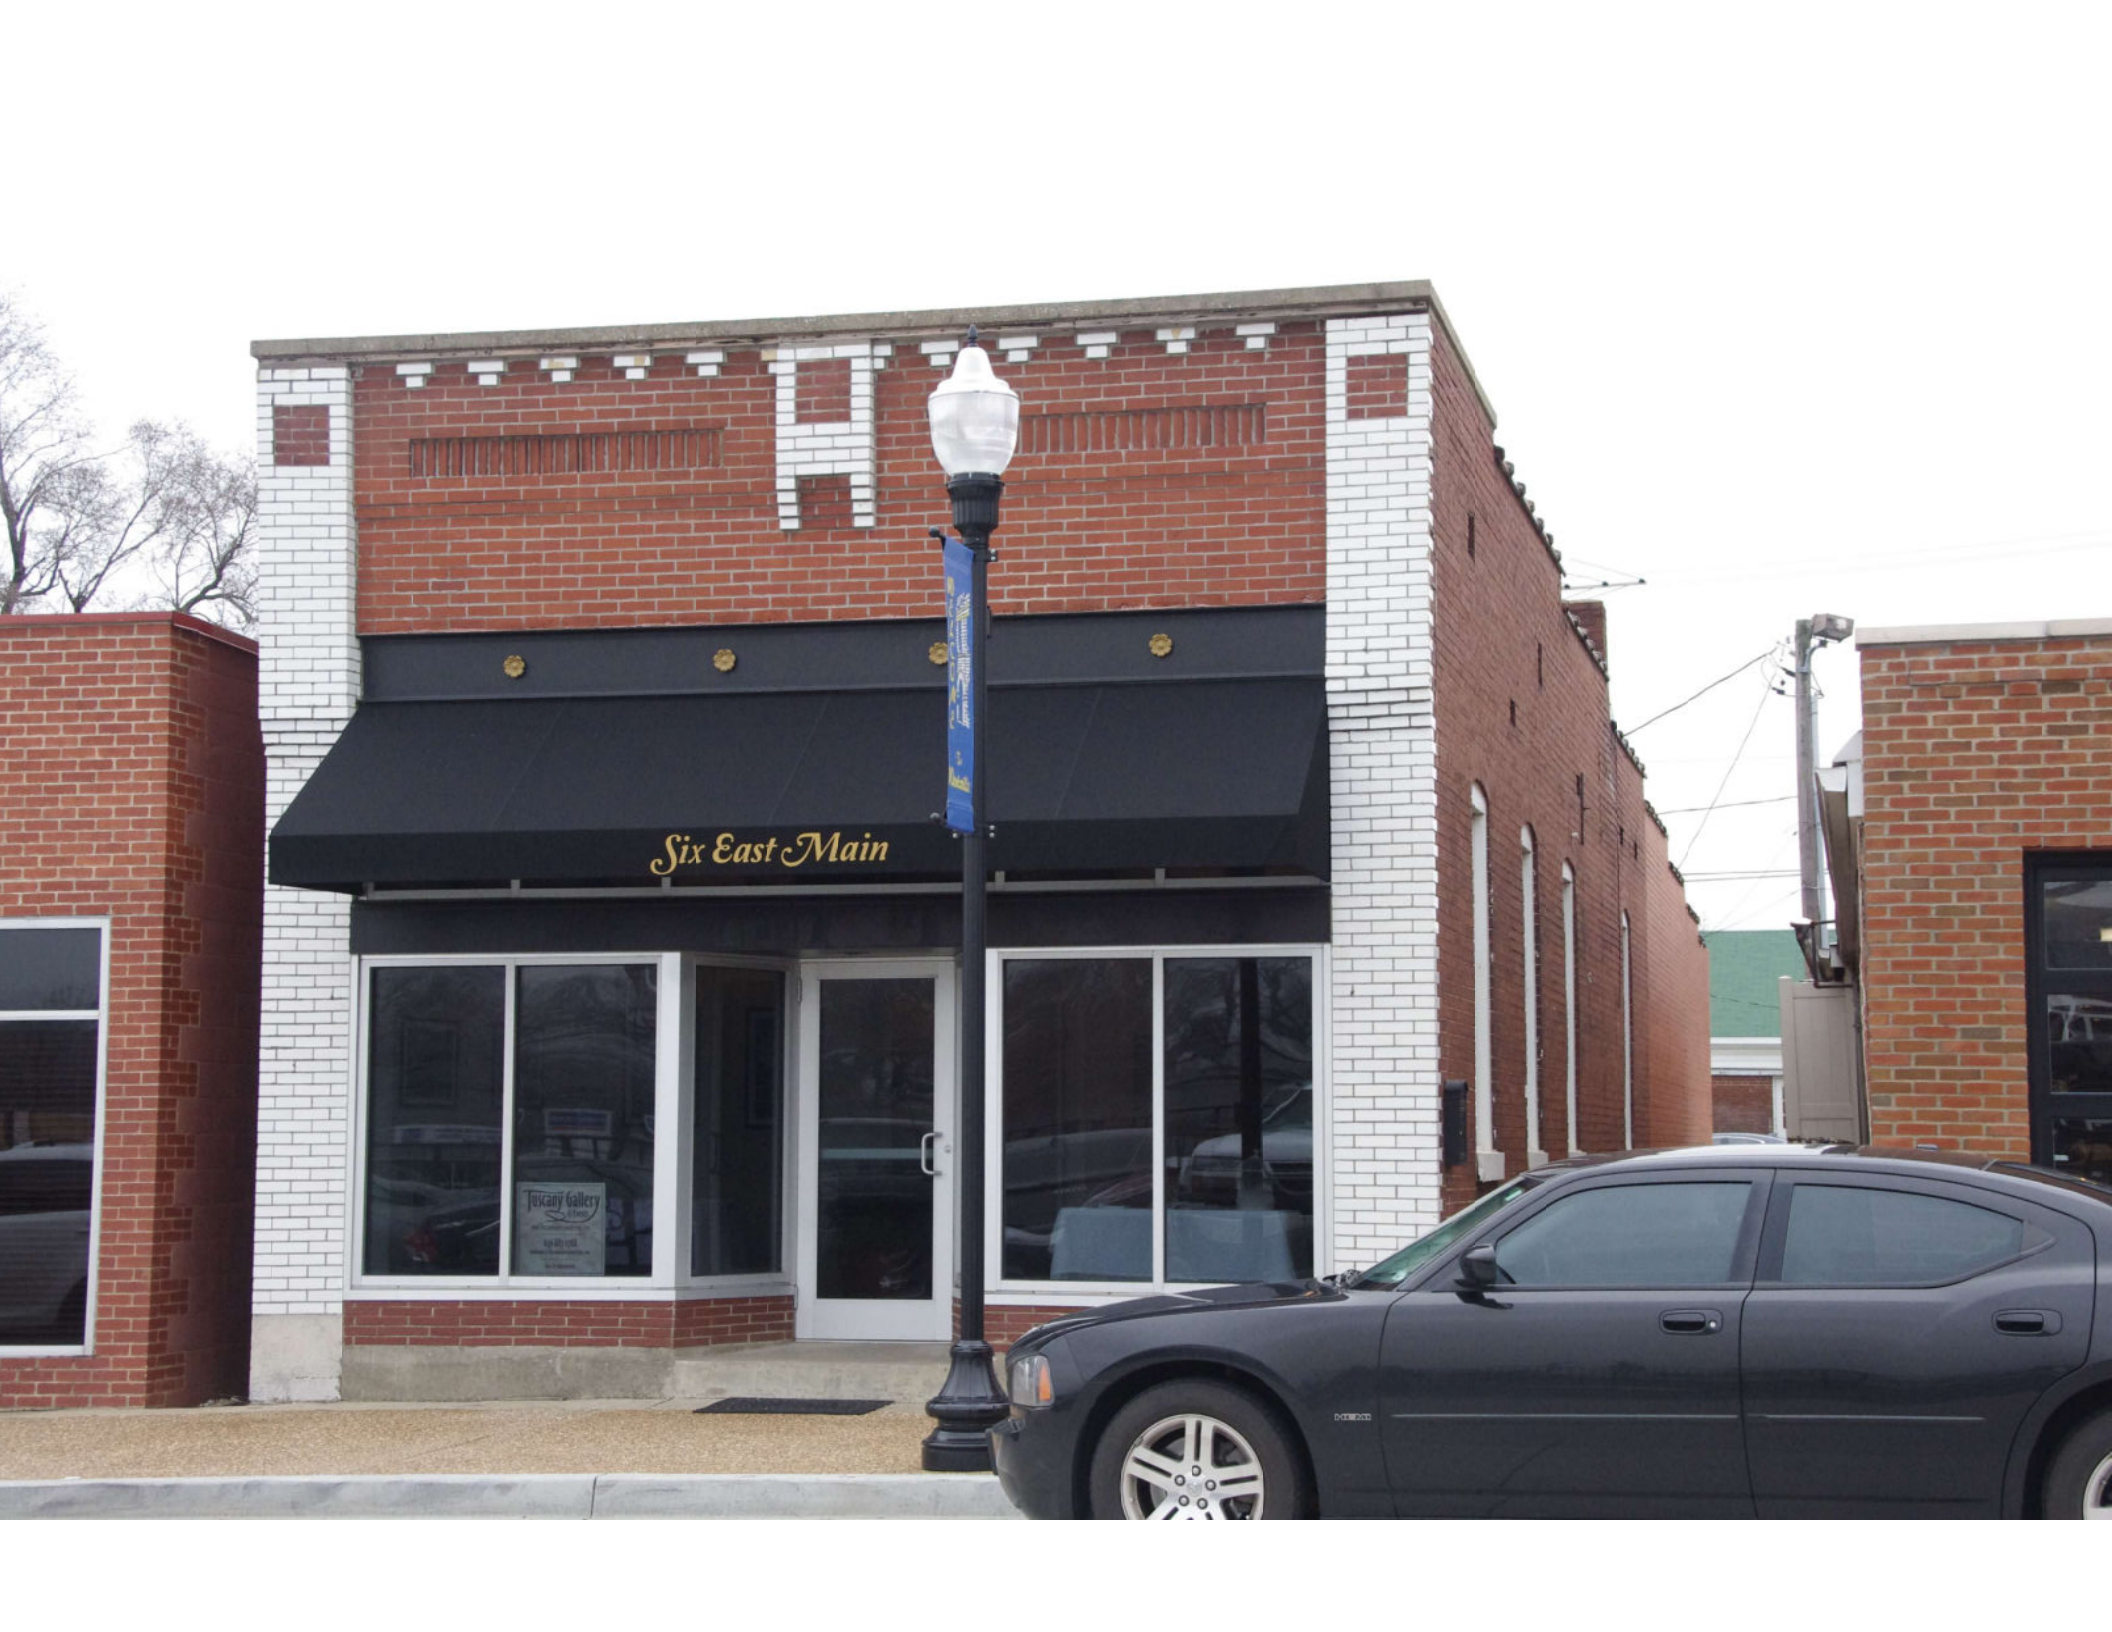
This one-story brick commercial building has a flat roof with glazed white bricks used to form a dentil pattern at the top of the parapet and as the piers on either end of the facade. There are recessed brick friezes on either side of another glazed white brick motif centered on the façade. The top of the parapet now has a replacement concrete cap, but originally it had several rows of glazed white brick with the corner piers as well as the central motif extending above the top of the parapet. The building seems to have always had a central recessed entry, with the 5 light transom across the façade, but the display windows have been reframed and divided into two panes of glass on each side of the entry. And the full light metal door is a recent replacement.

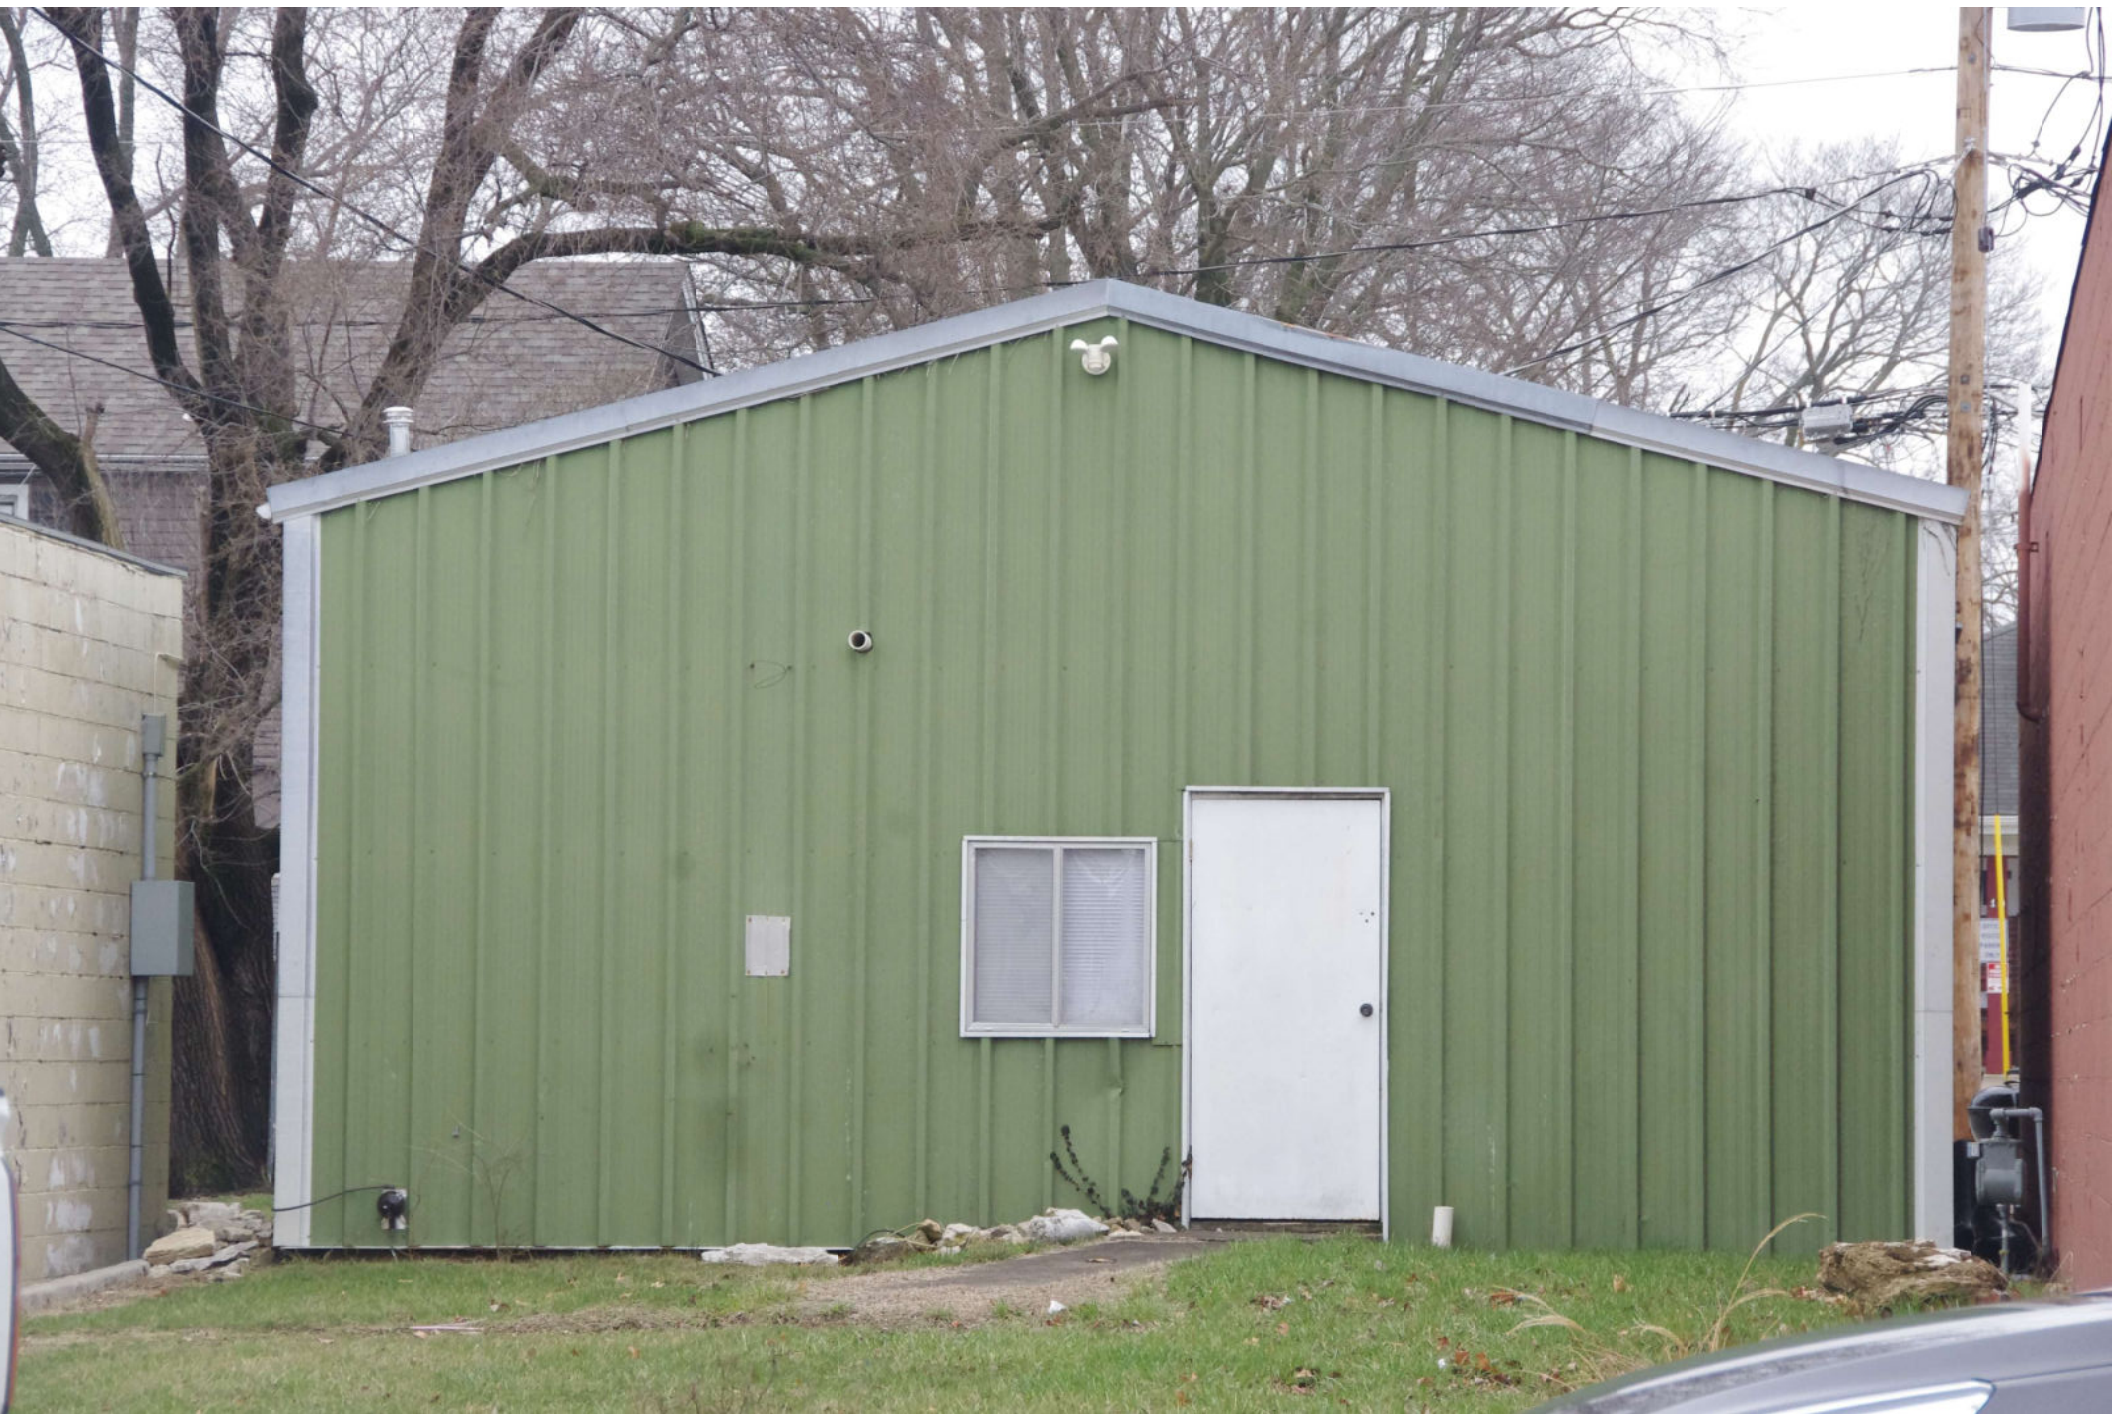
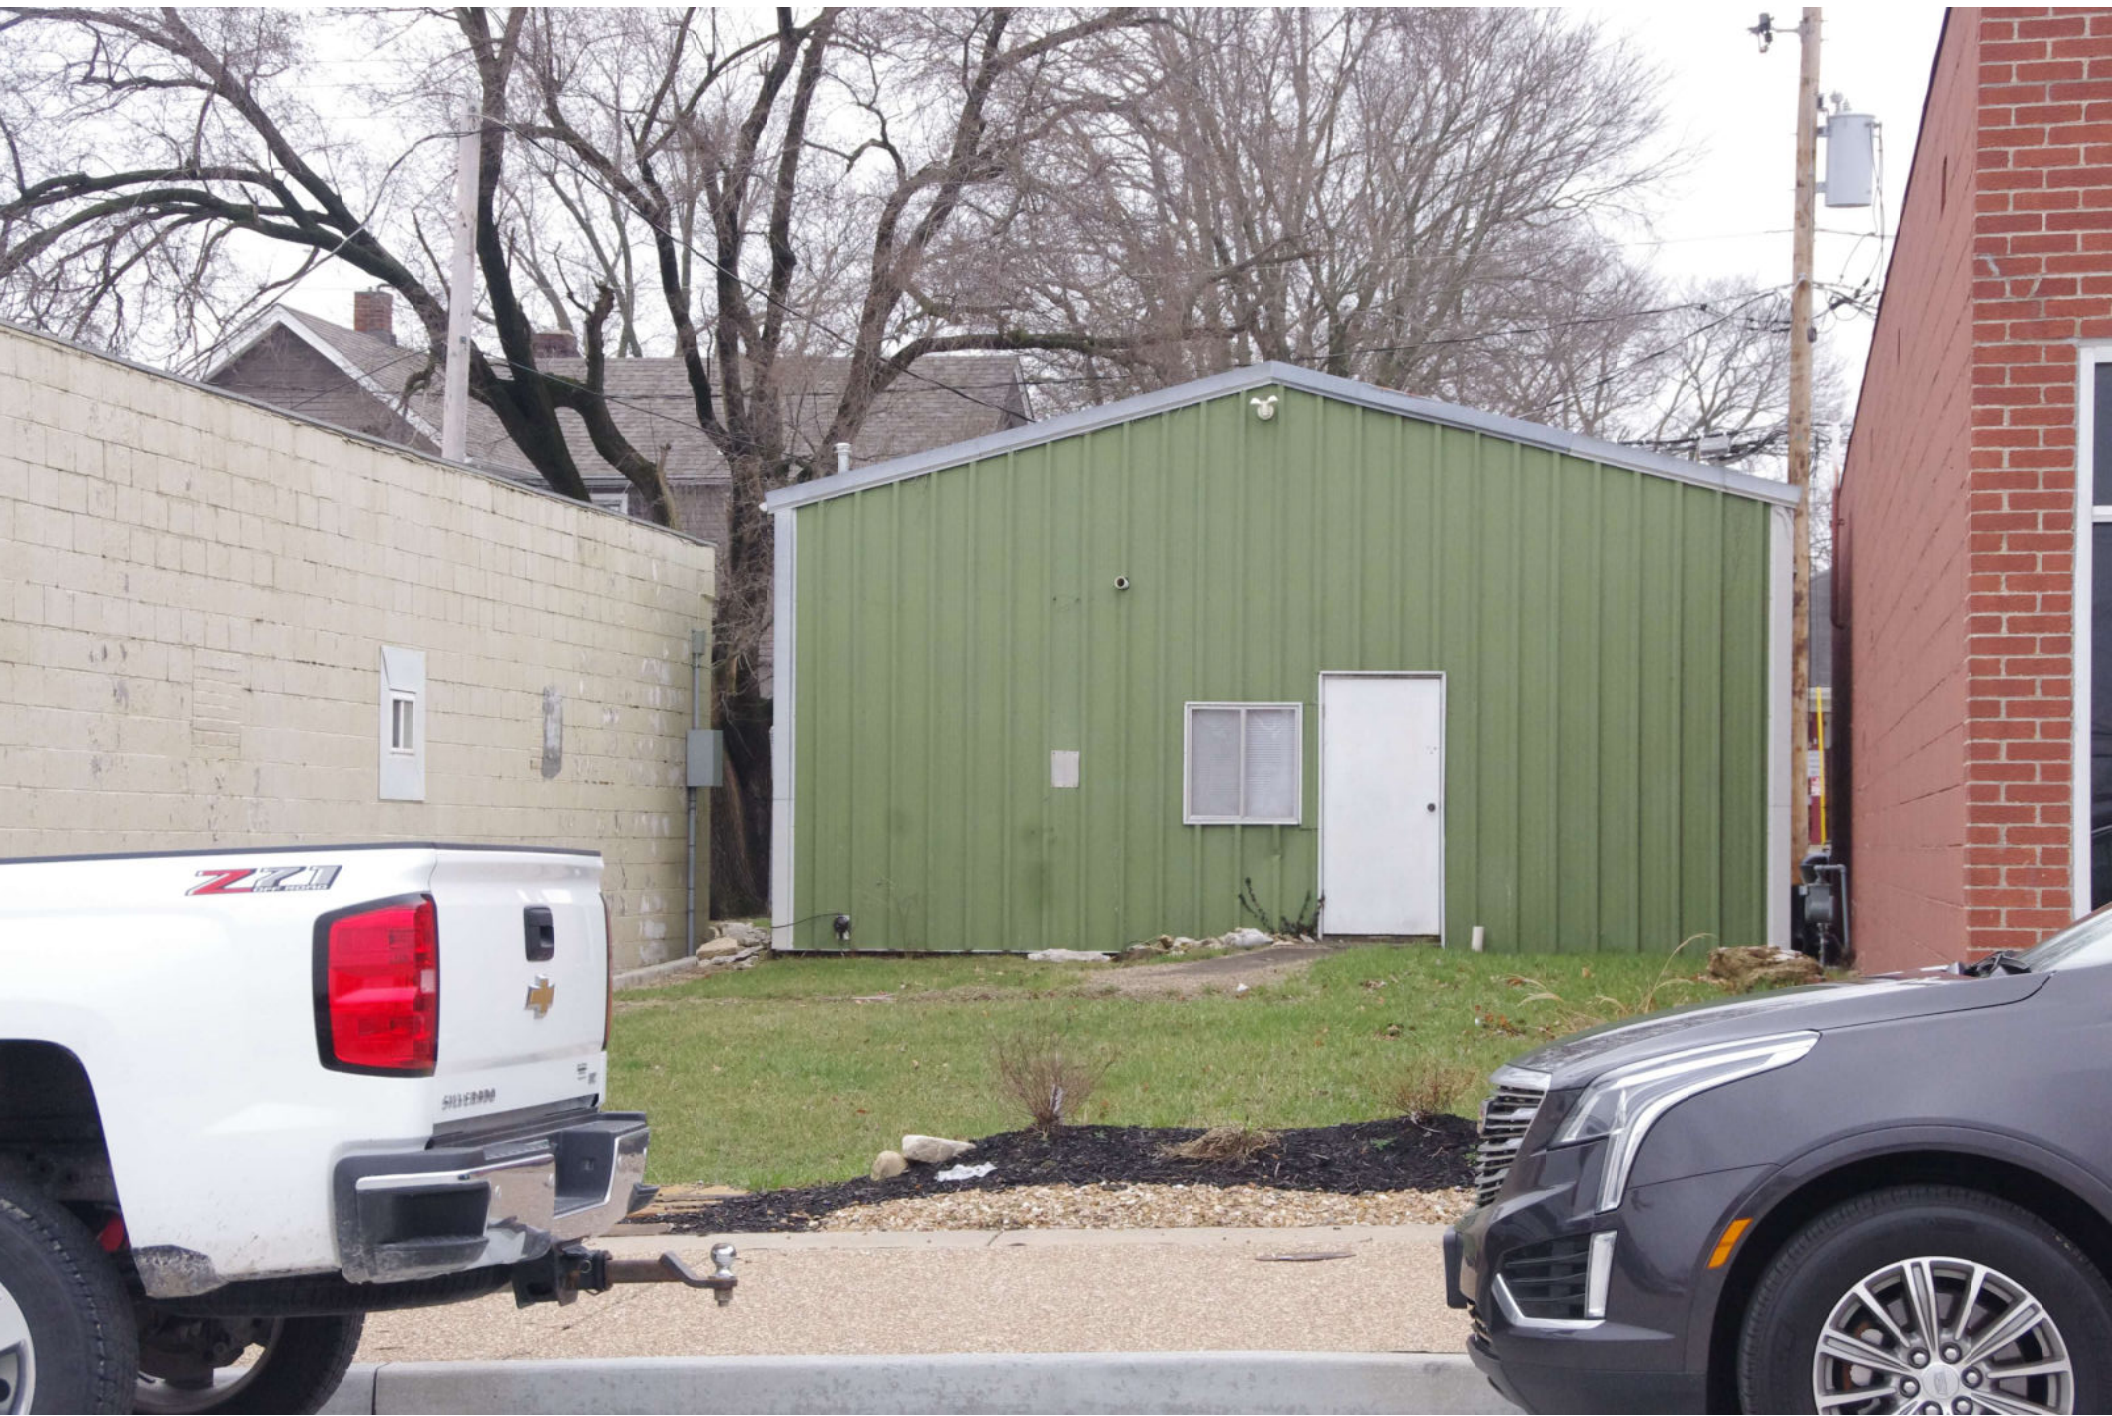
This resource is a one-story prefab metal building with a gabled metal roof. The building is set far back from the street, with a metal door at center and a horizontal sliding one-by-one window to the east.

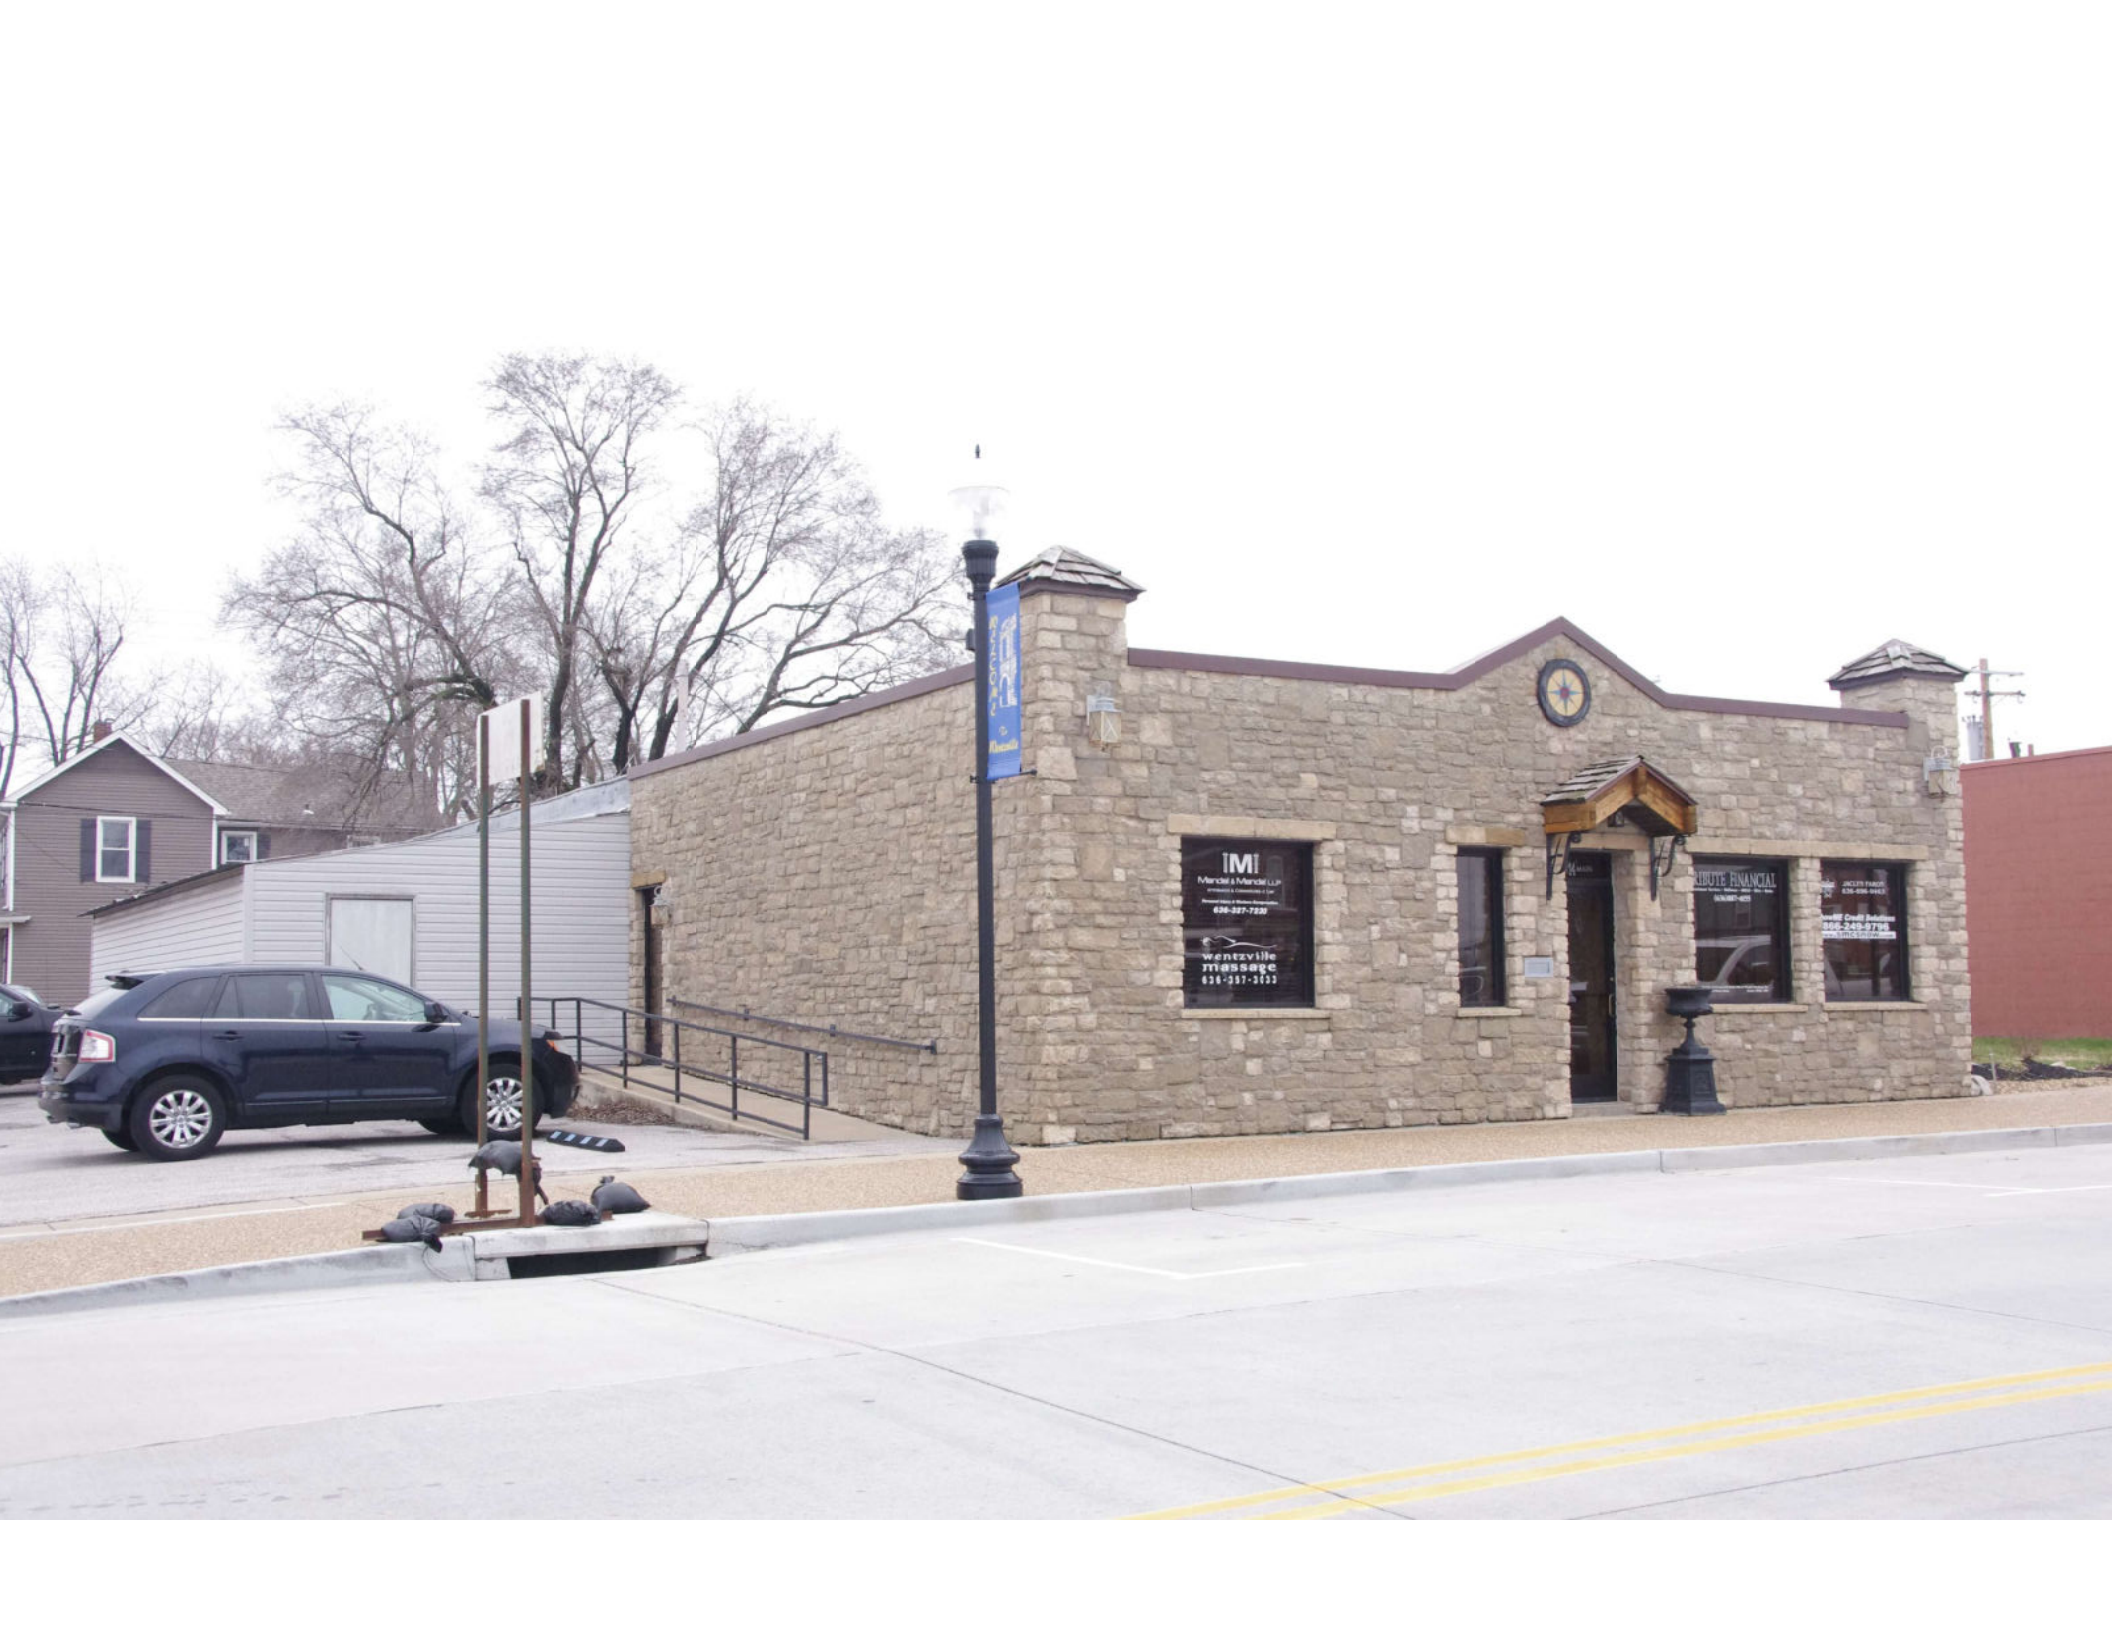
This resource is a one-story commercial building with a triangular central parapet and corner piers capped with wood shingles. It is not clear whether the triangular parapet or corner piers are historic or not since the entire façade and east elevation have recently been re-clad with a stone veneer. The central entrance is a full frame glass door, covered by a nonhistoric gabled carved wood awning. To the east in the same bay is a narrow, single pane rectangular window. Square single pane replacement windows fill the remaining bays, with one to the east and two to the west of the entrance. All of the glass is a black reflective glass. On the west side of the building the original concrete block walls are still visible. On the east side, at the rear, there is a vinyl sided, shed roofed addition and a concrete ramp into the main building.
