**ARCHITECTURAL/HISTORIC INVENTORY FORM**

1. Survey No. SC-AS-012-0052		2. Survey Name: Reconnaissance Level Survey of Historic Downtown Wentzville	
3. County: St. Charles		4. Address (Street No.) 105	Street (name) South Linn Ave
5. City: Wentzville	Vicinity: <input type="checkbox"/>	6. UTM:	
8. Historic name (if known):		9. Present/other name (if known): Land Fair Corp.	
10. Ownership: <input type="checkbox"/> Private <input type="checkbox"/> Public		11a. Historic use (if known): COMMERCE/TRADE	11b. Current use: COMMERCE/TRADE/professional
5. City: Wentzville		7. Township/Range/Section:

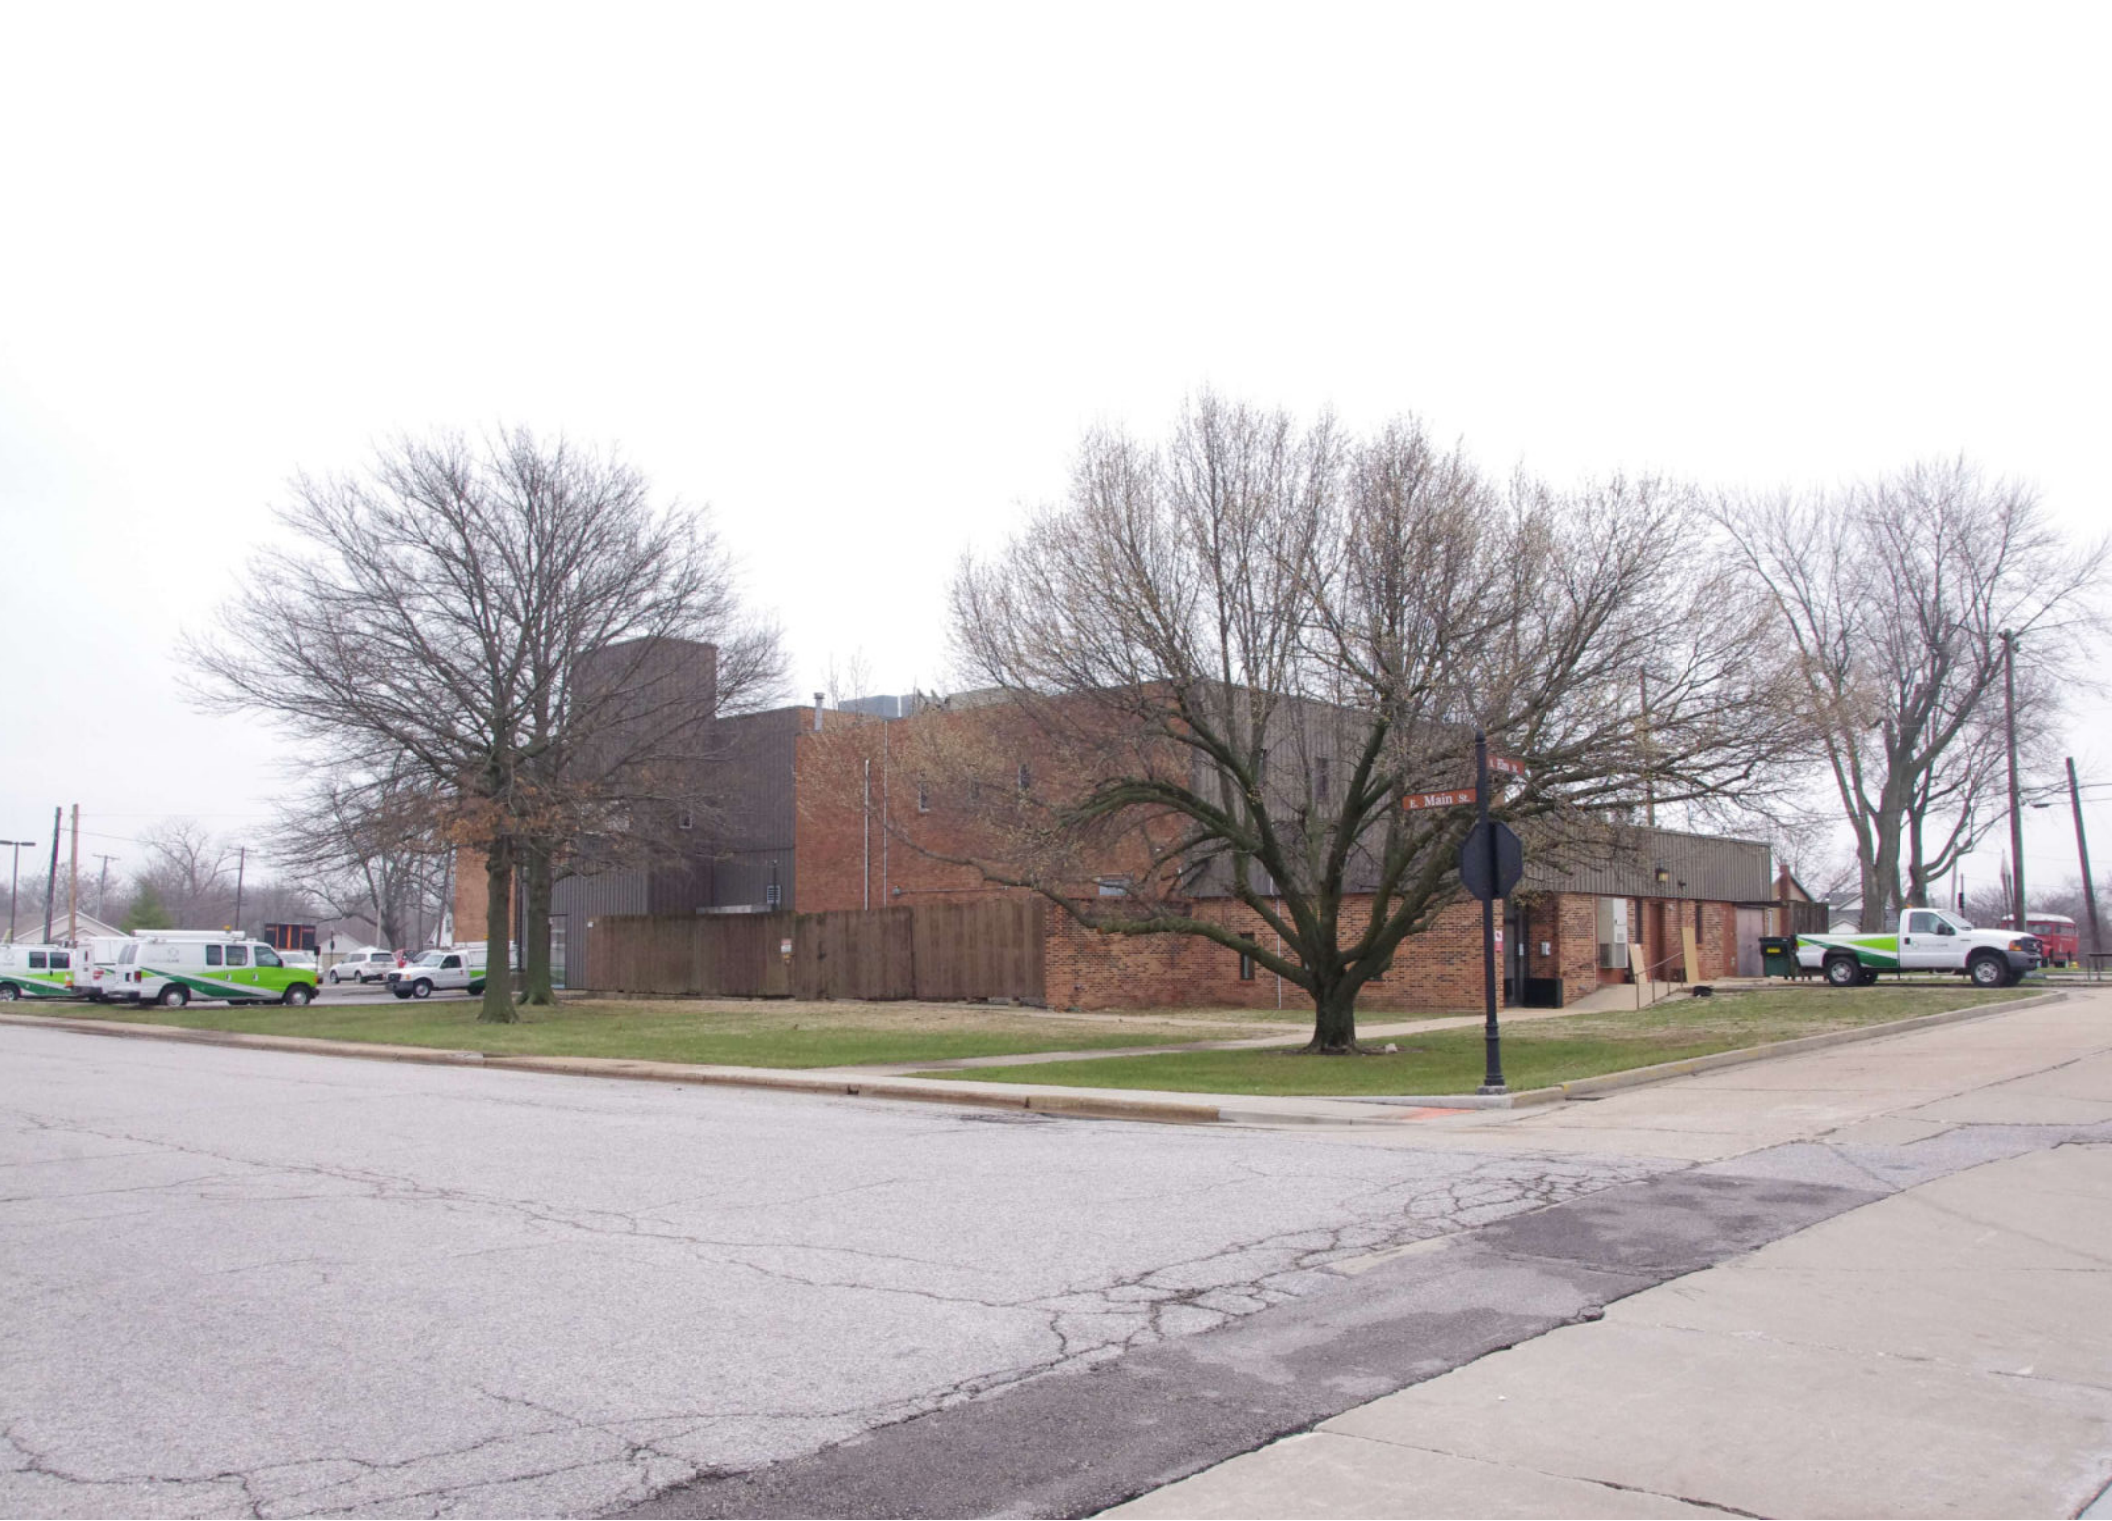
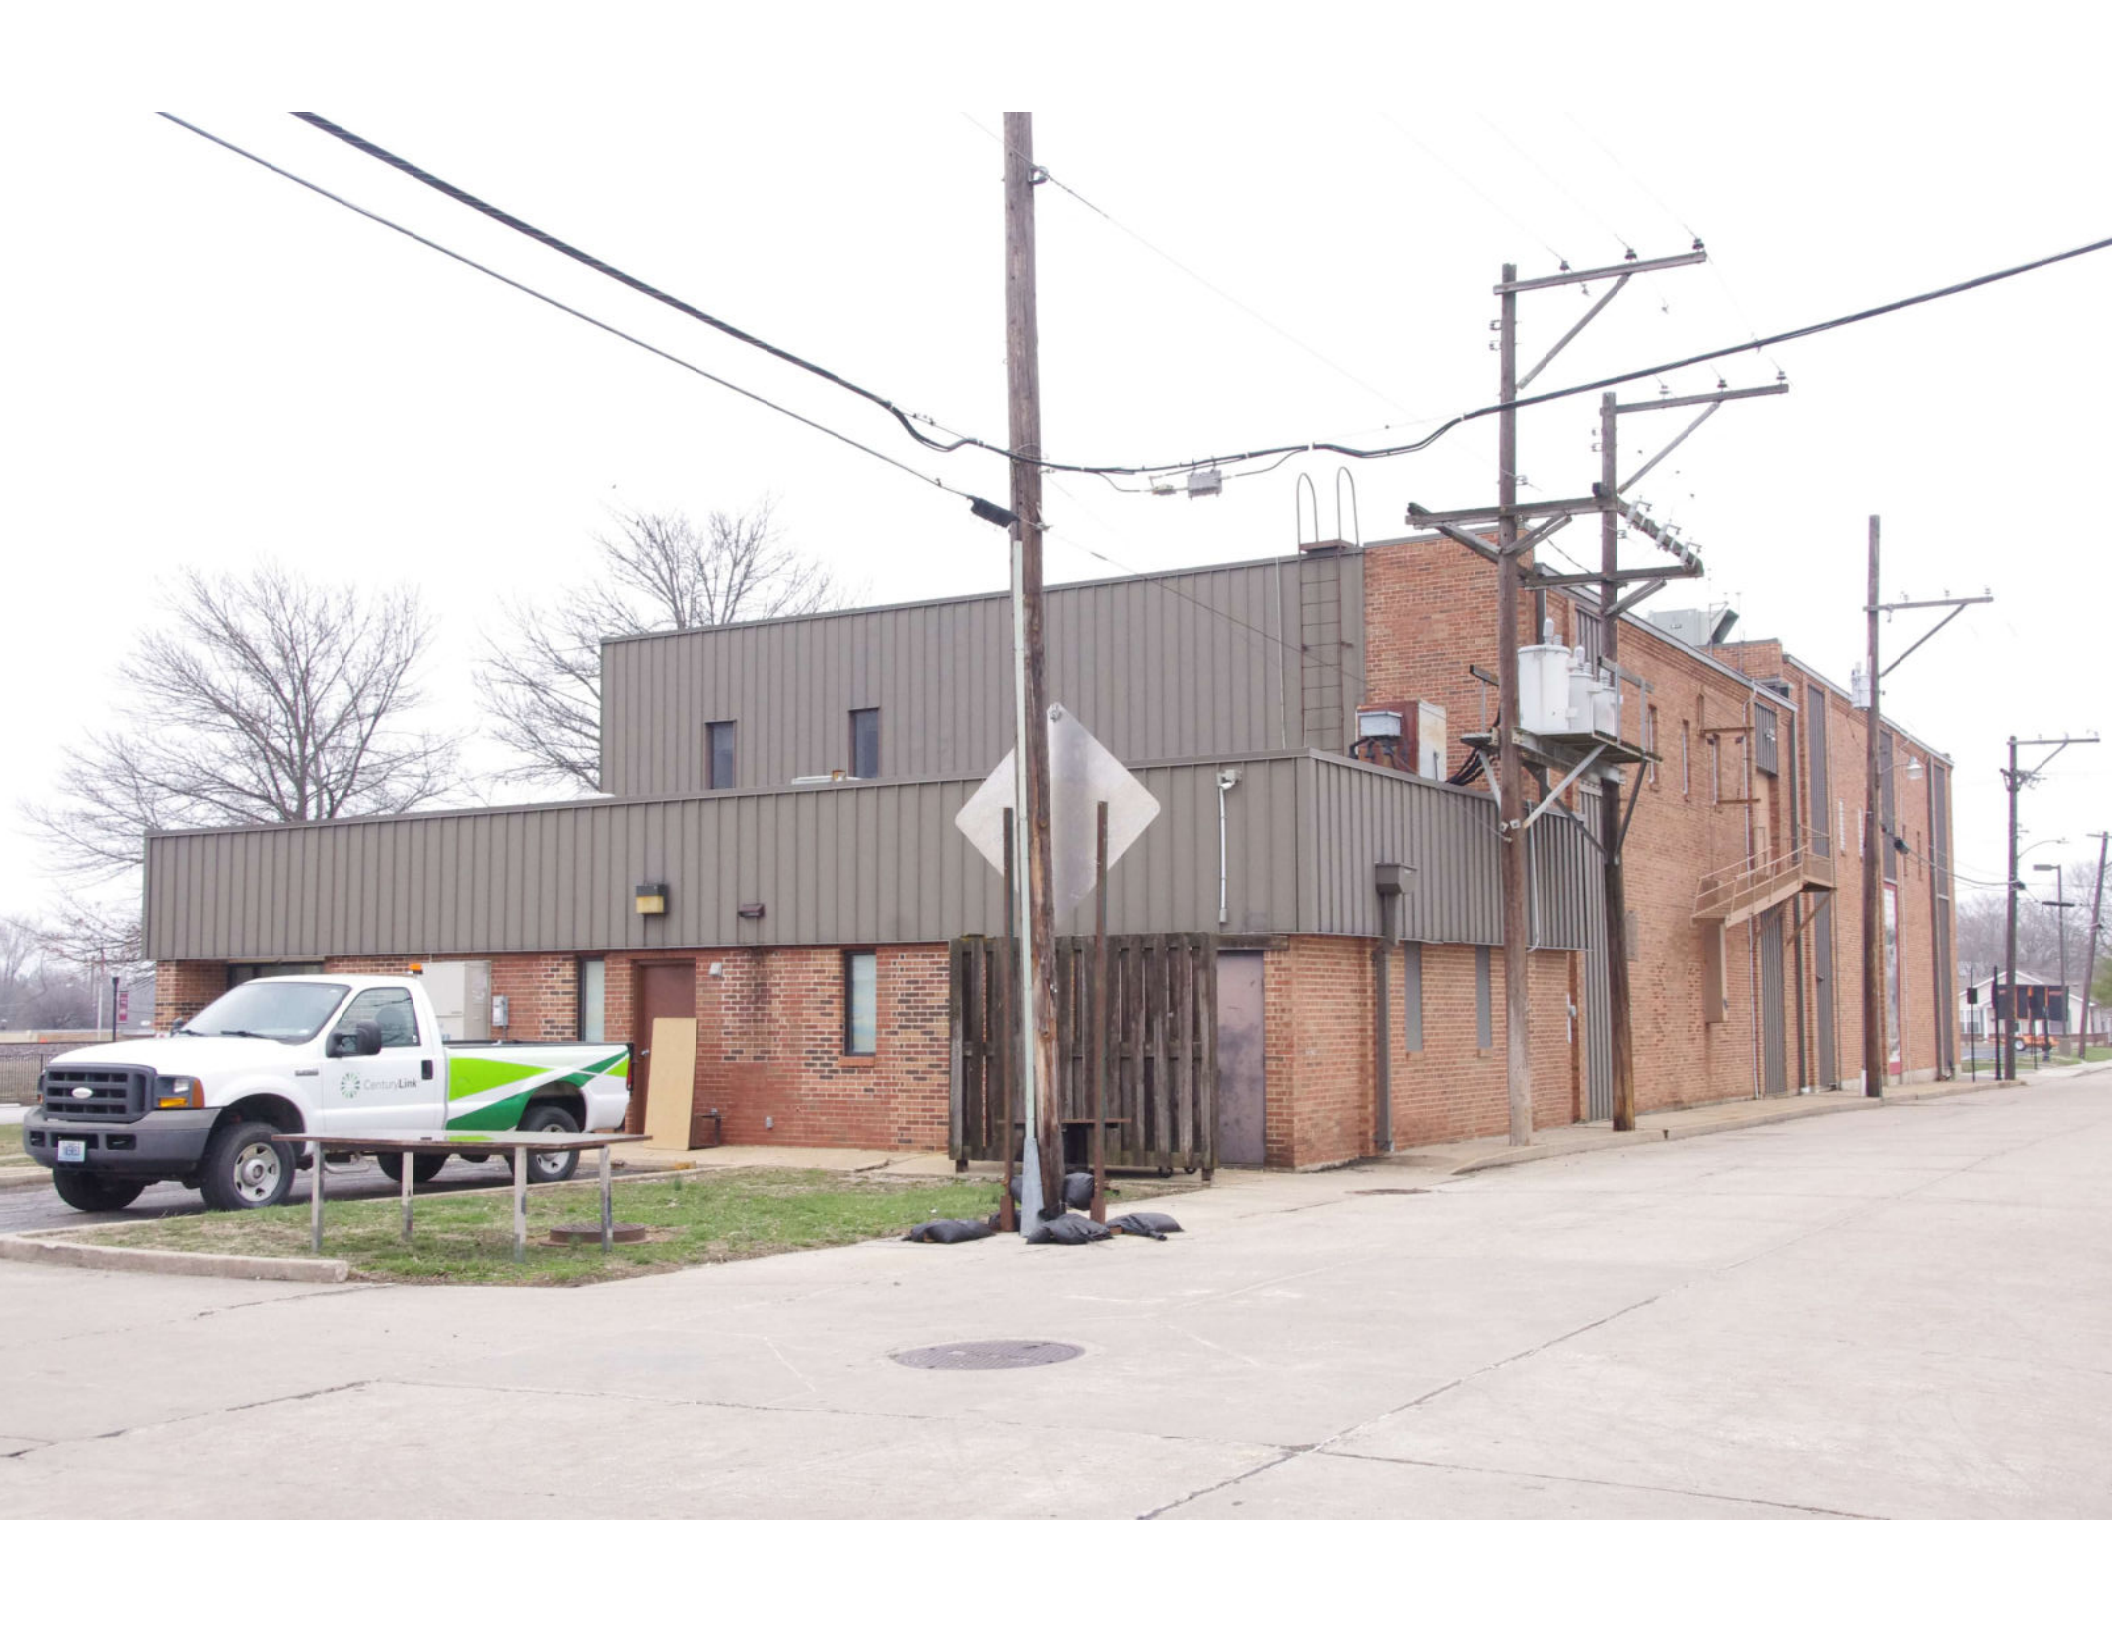
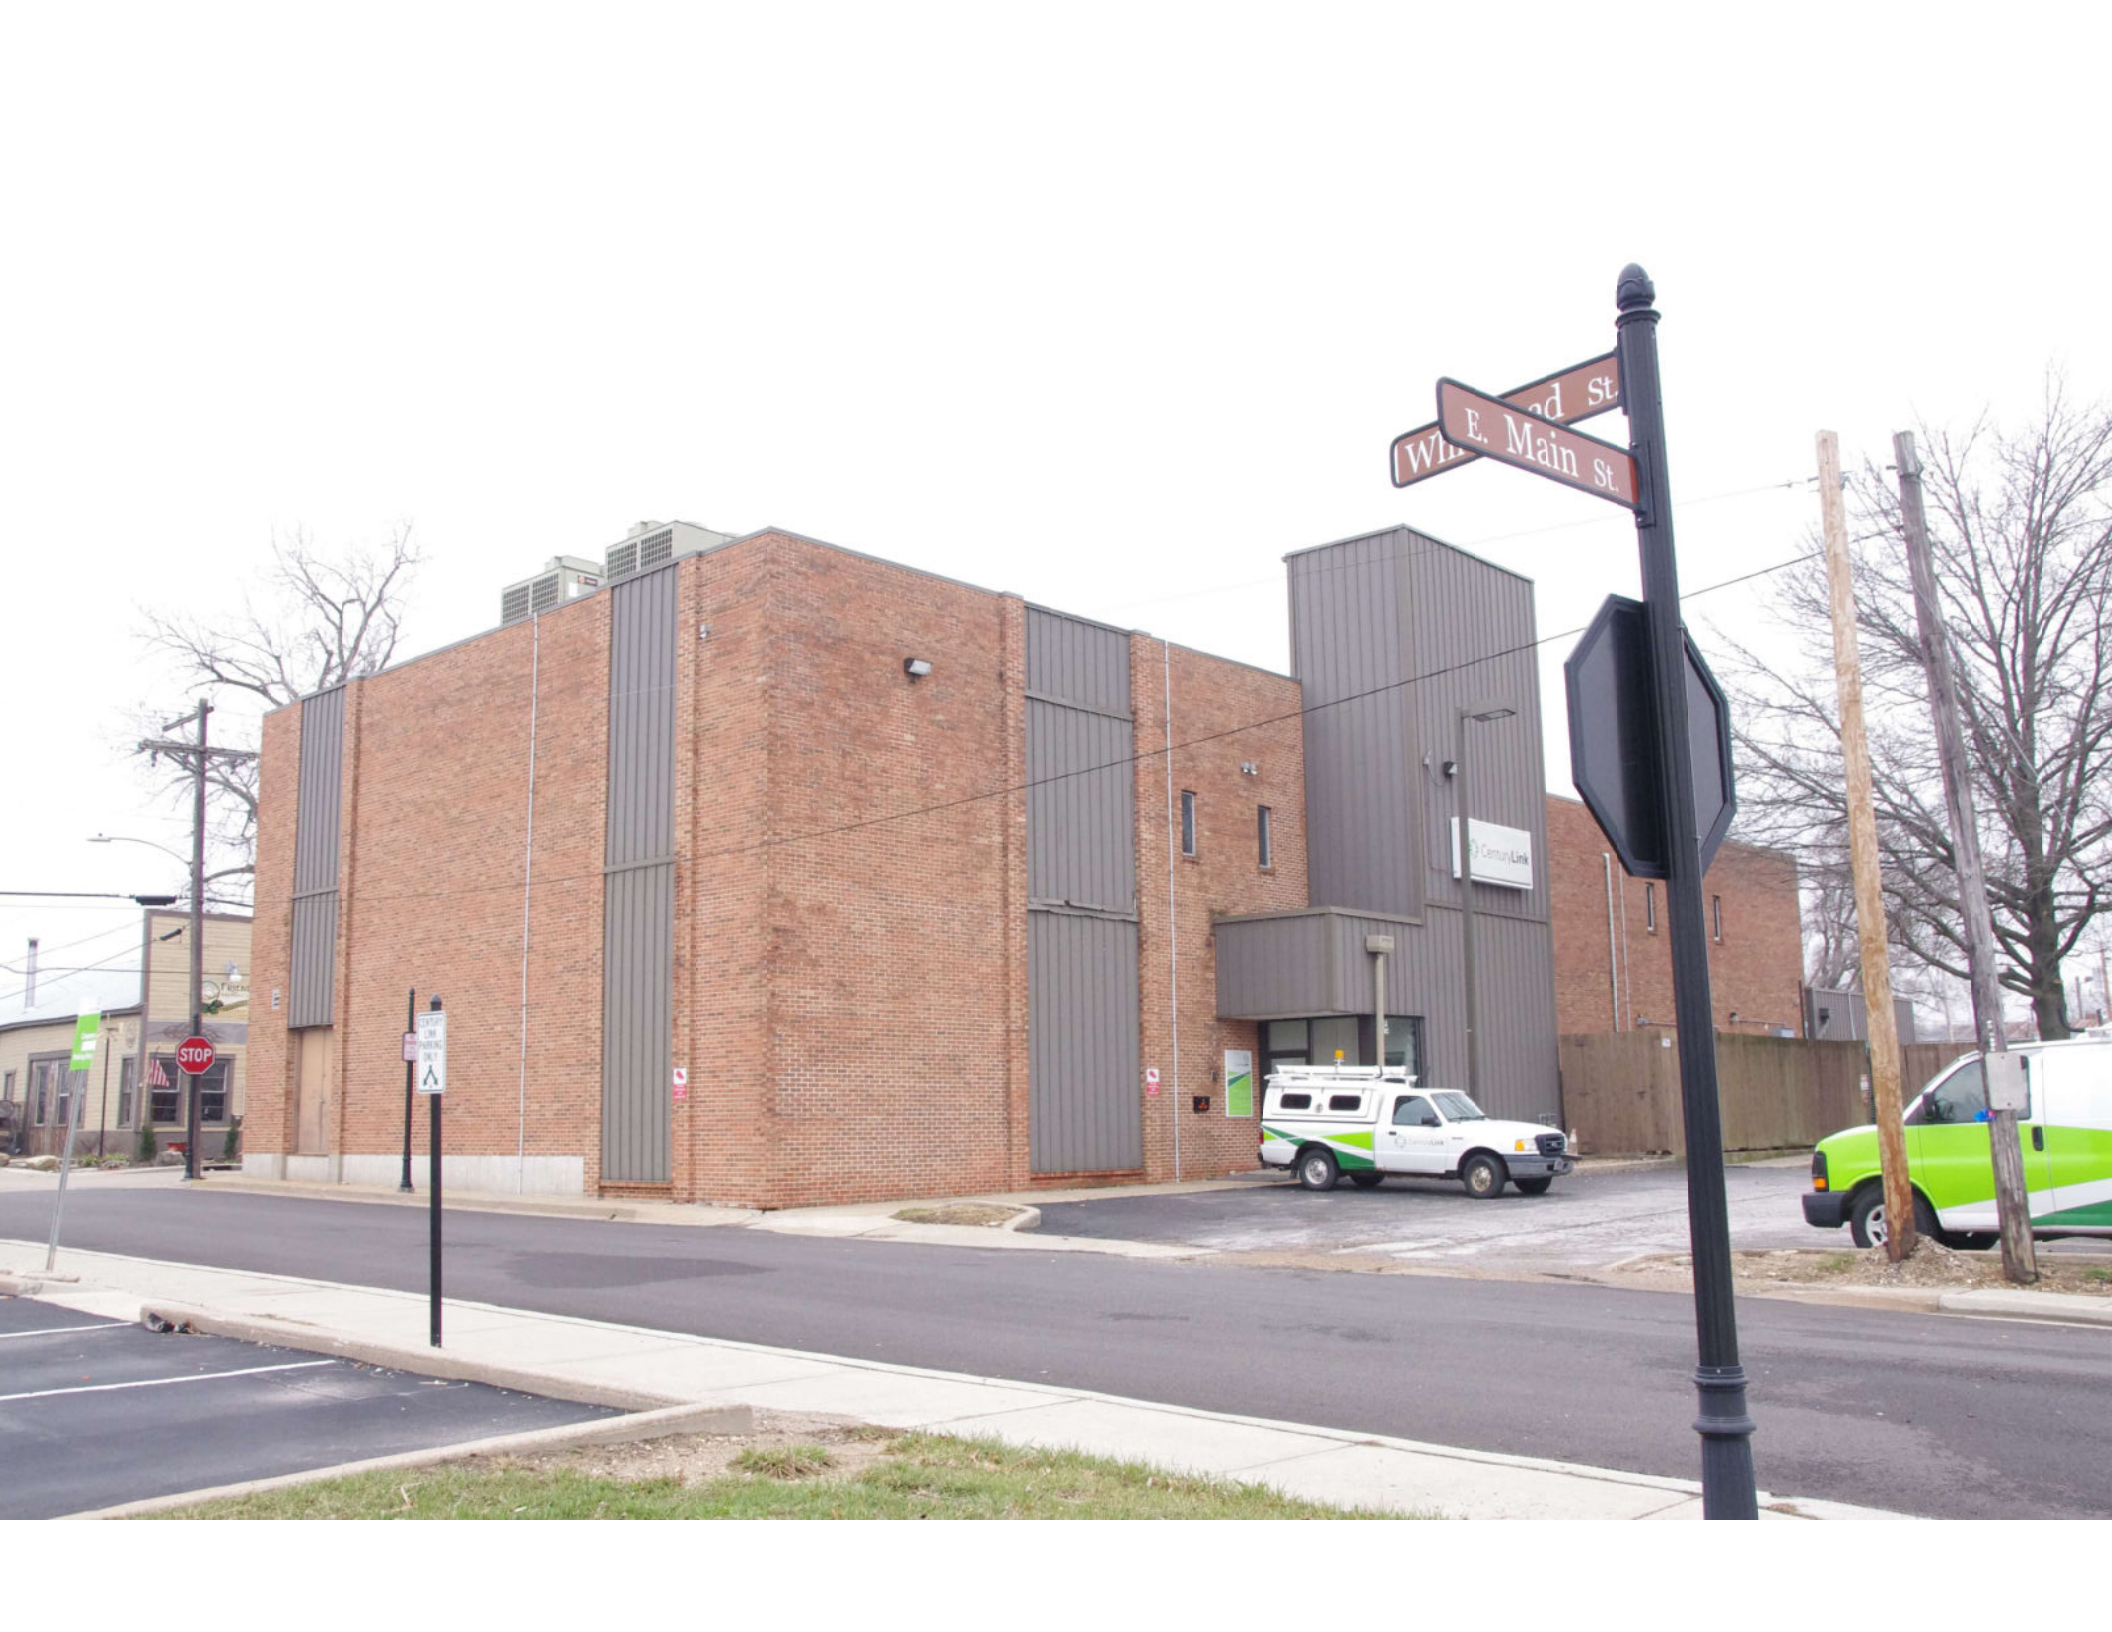
This resource is a two-story brick industrial building with a flat roof. The façade is located on the north side of the building, where there is what appears to be a elevator shaft clad in standing seam metal panels applied to the face of the brick building. At the base of this shaft is a aluminum framed glass door with sidelight and transom window recessed iat the northwest corner. What appears to have originally been vertical shafts of windows on the north, south and east elevations have been covered with the same metal panels, from ground level to top of the parapets between brick pilasters. These seem to be elements of design often associated with Modern Movement buildings, but the replacement metal panels may camouflage other stylistic details. The west end of the building is only one-story high and has metal paneling lining the upper parapet to the roof . What appear to be replacement, single pane windows are found in the west elevation first floor and above, on the upper level of the three-story west wall, with a roof access ladder near the southern corner. A large addition is located on the rear of the building, with an entrance facing East Main.

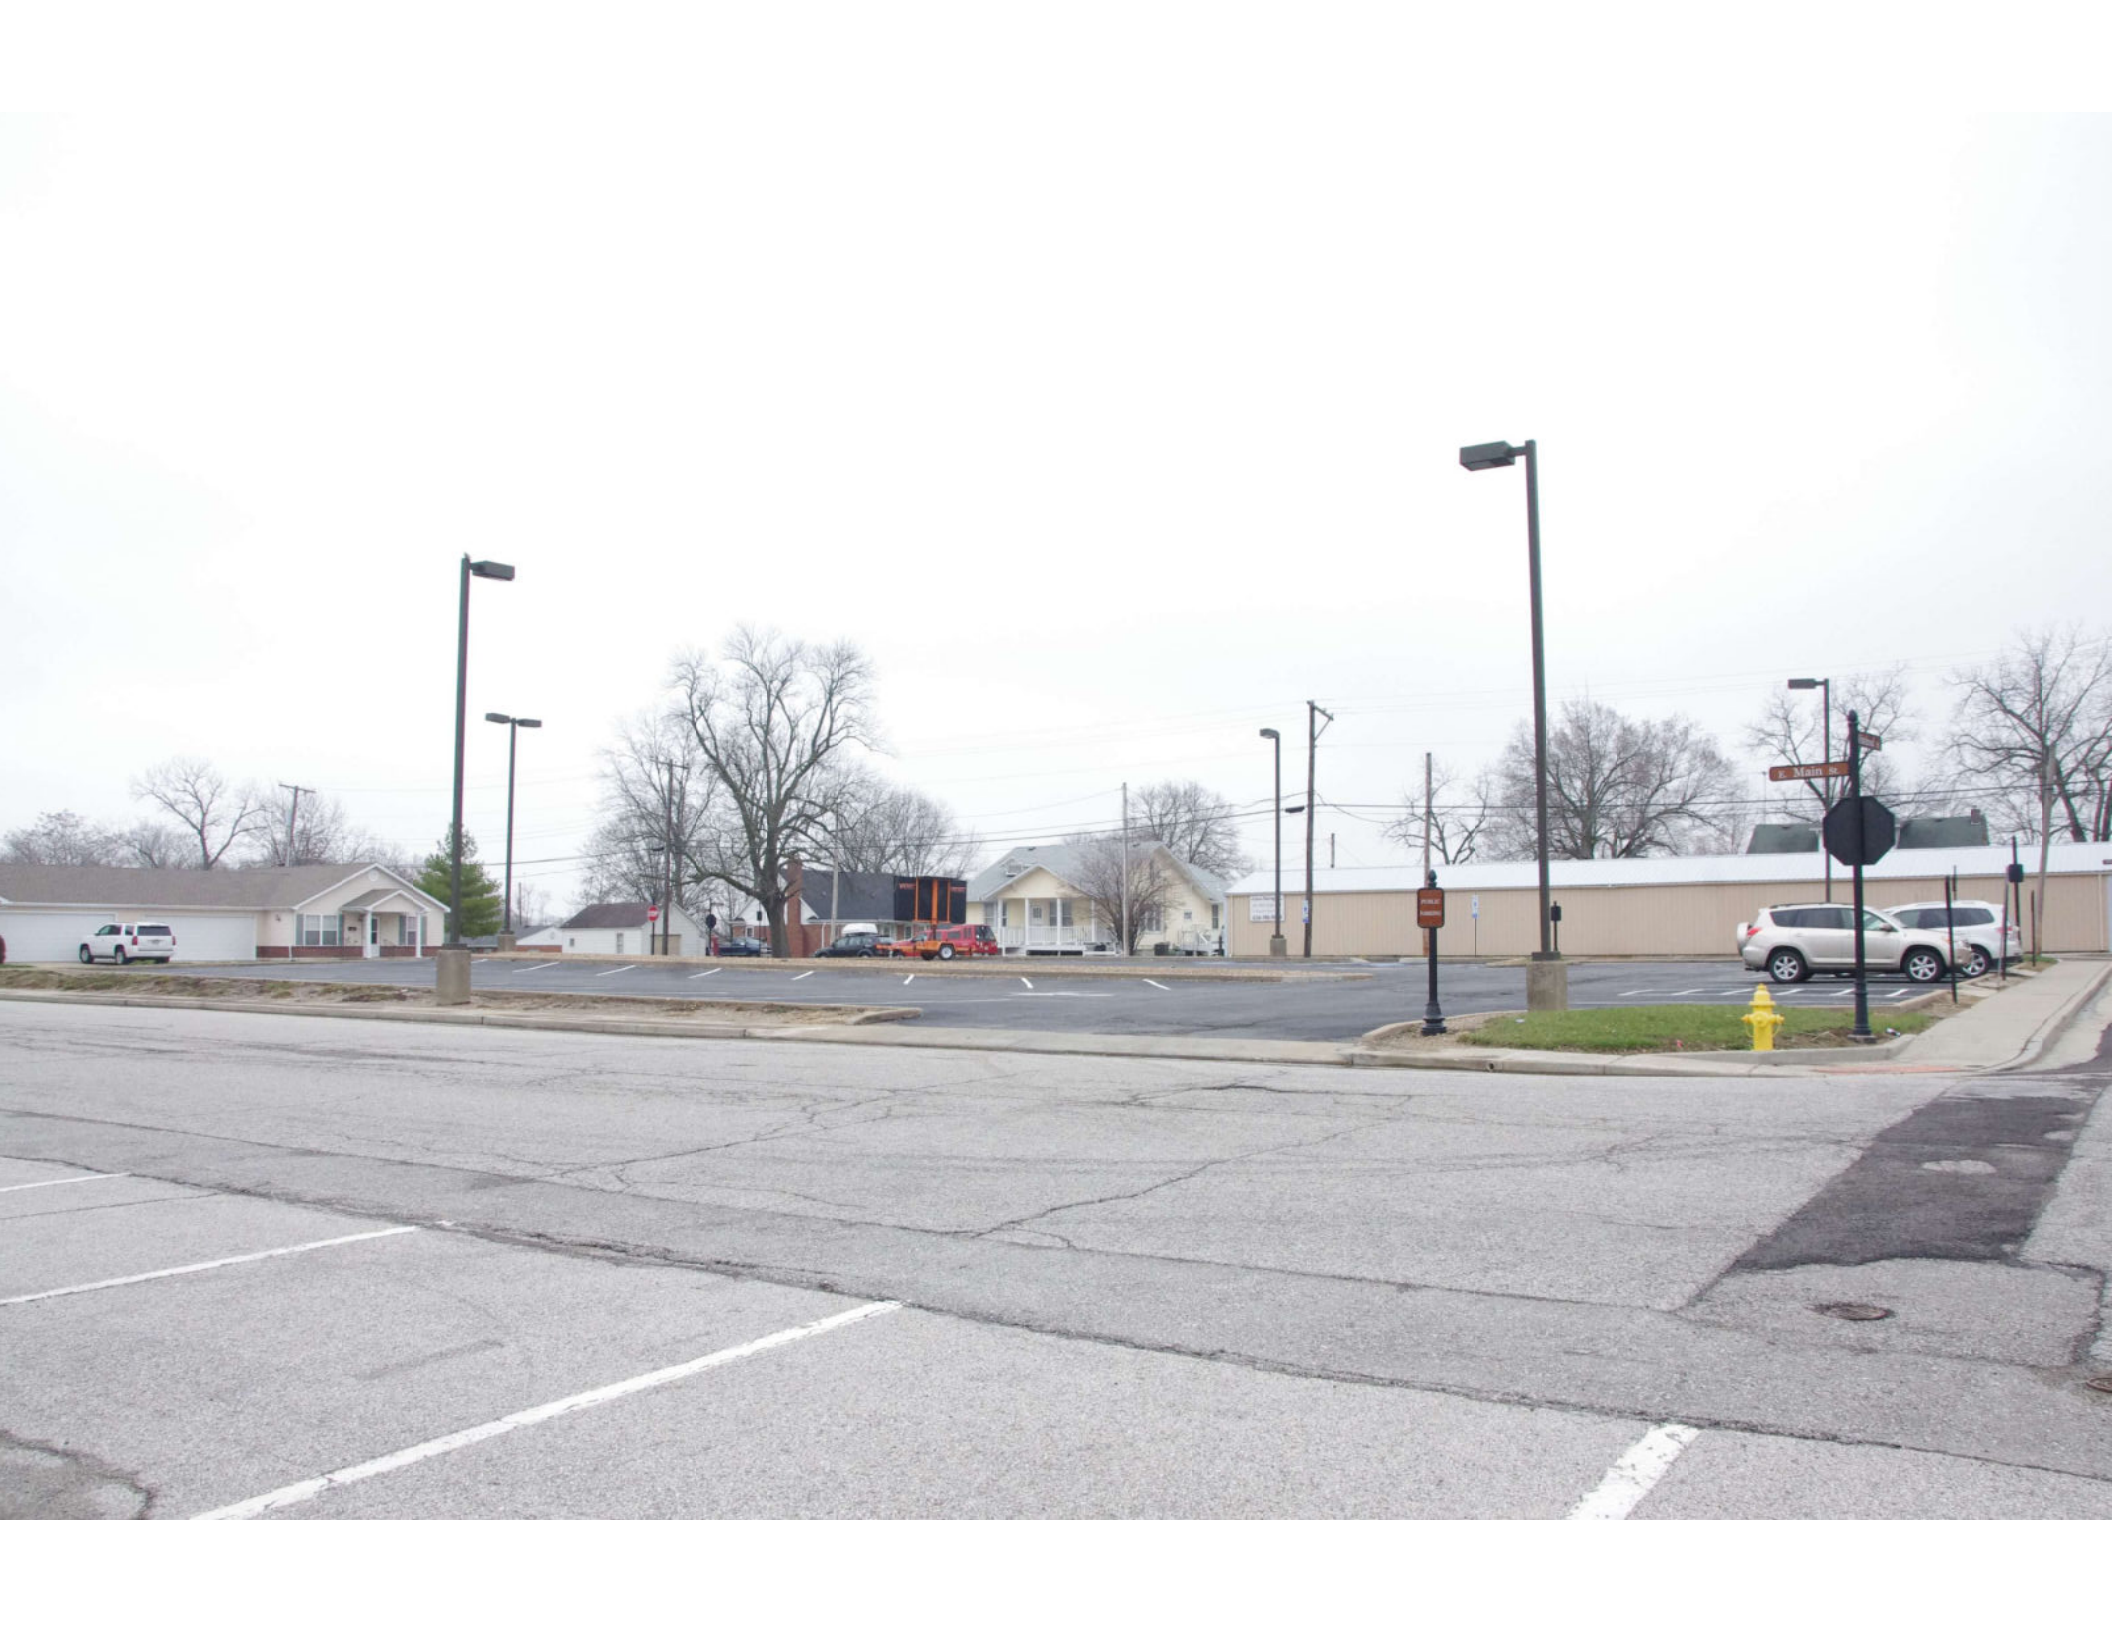
This resource is a 198 x 120 foot parking lot. It is not known if there were buildings on the property previously.

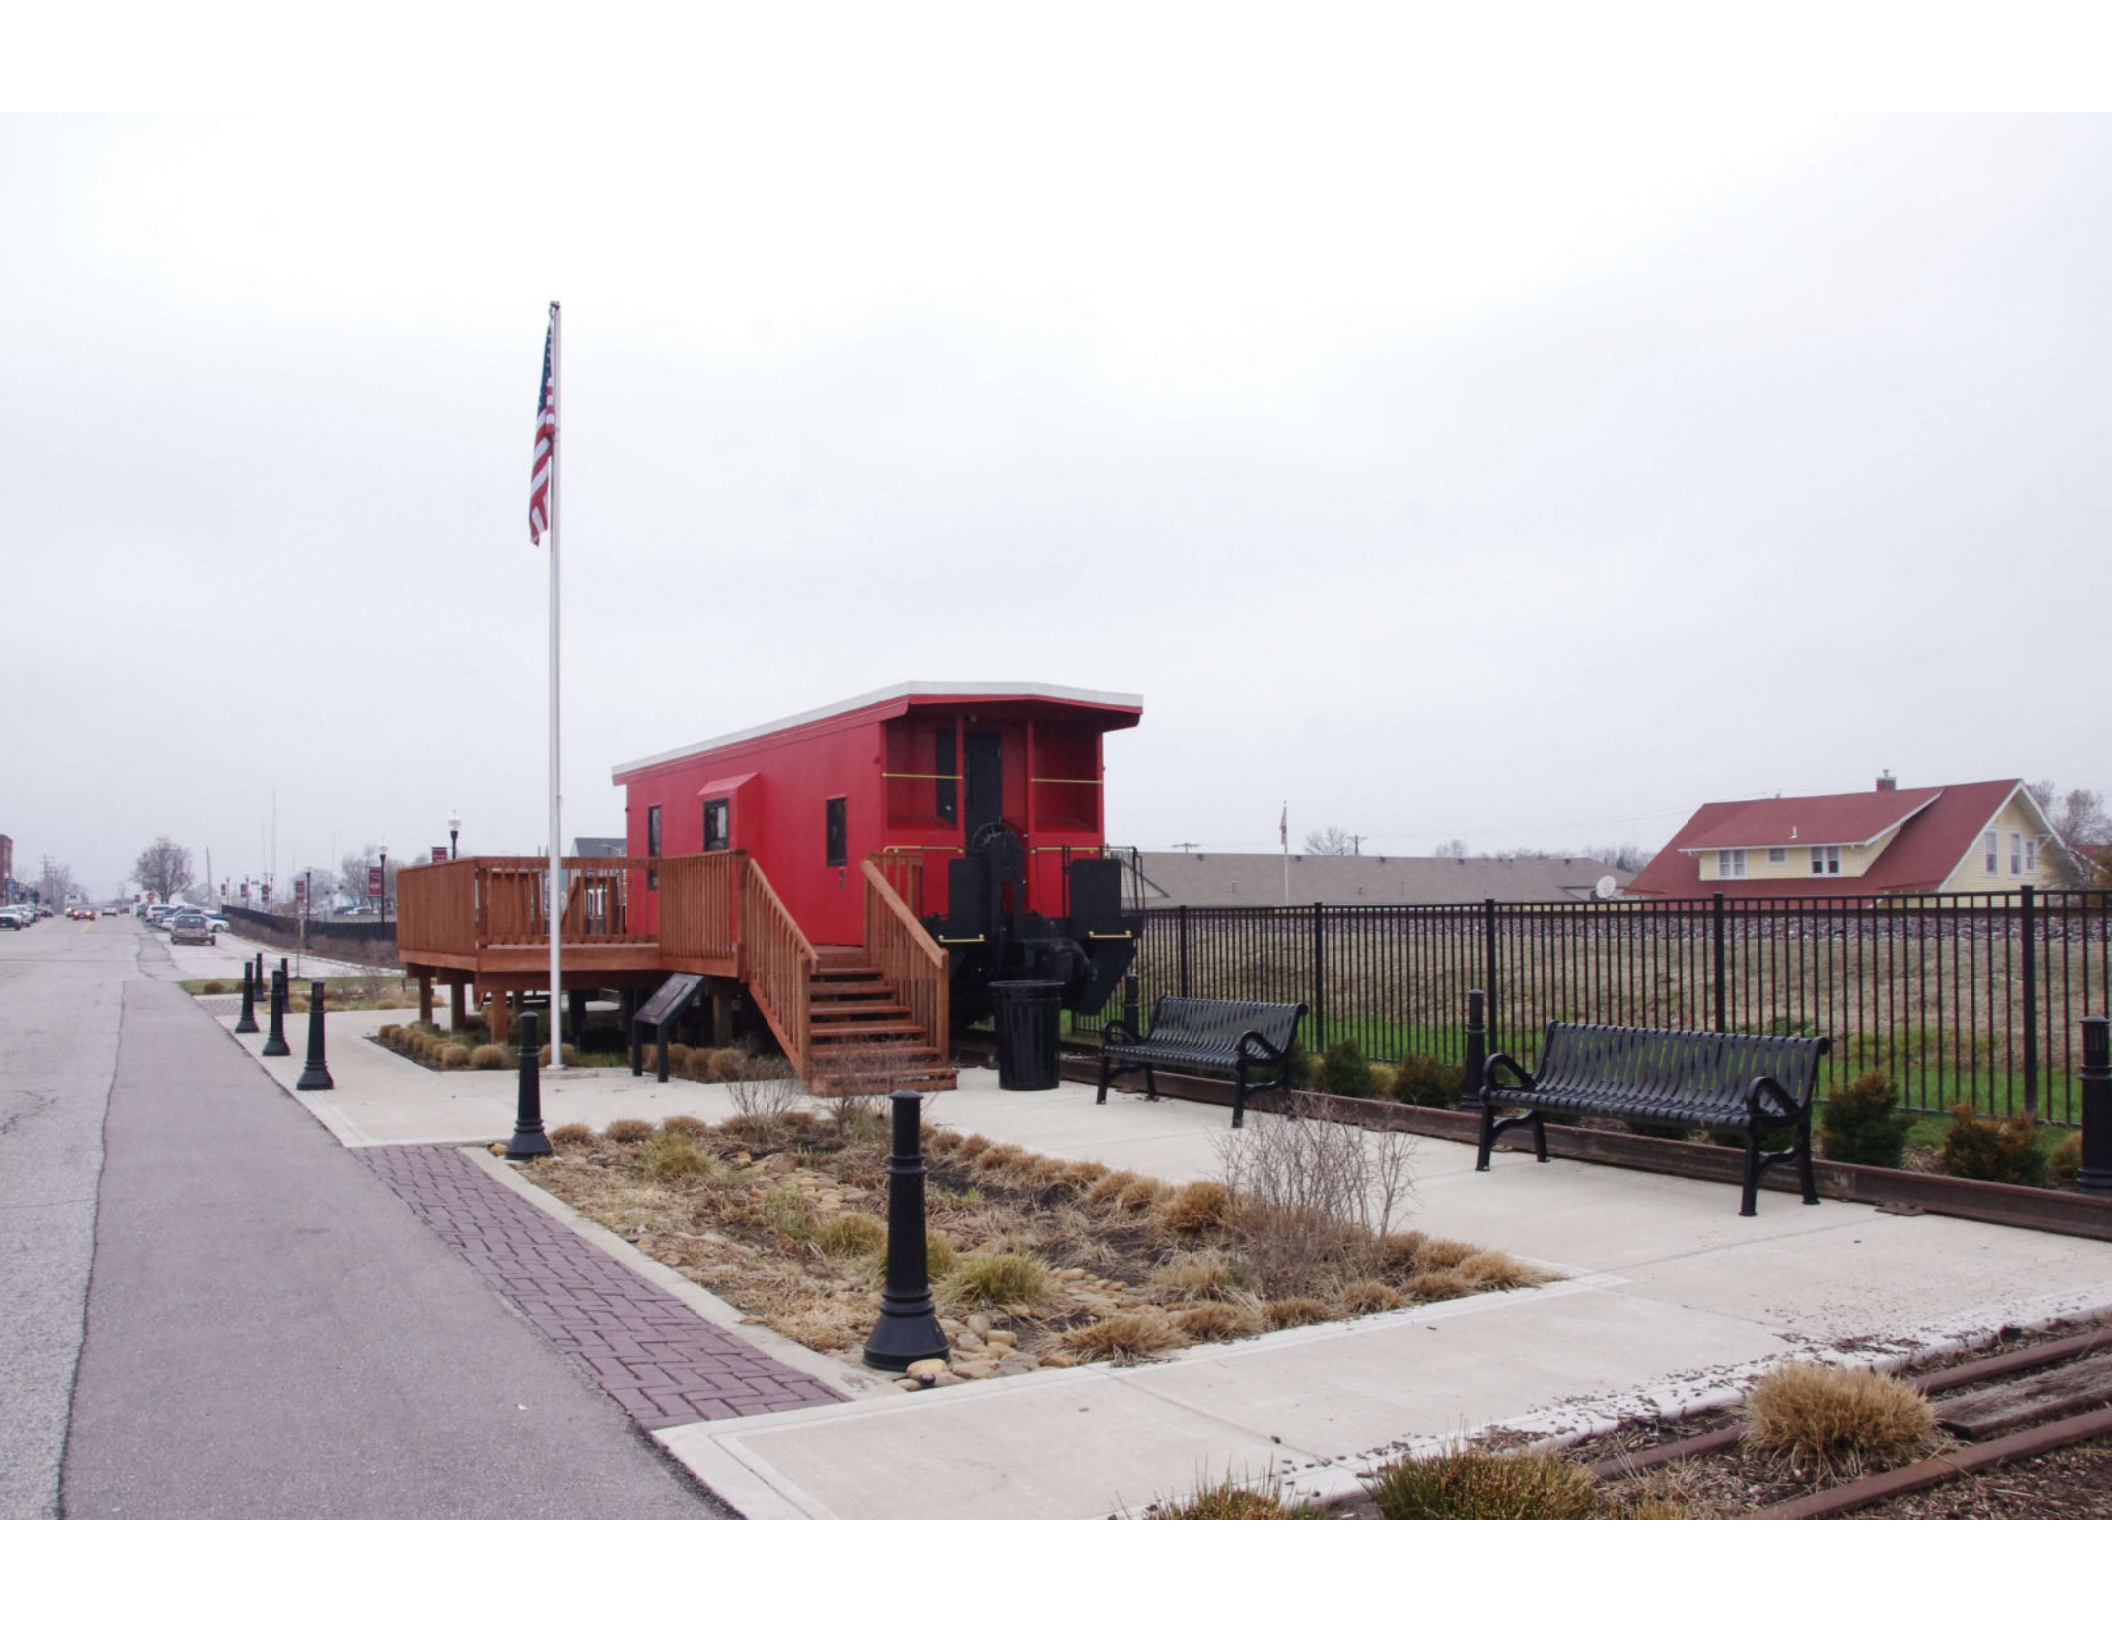
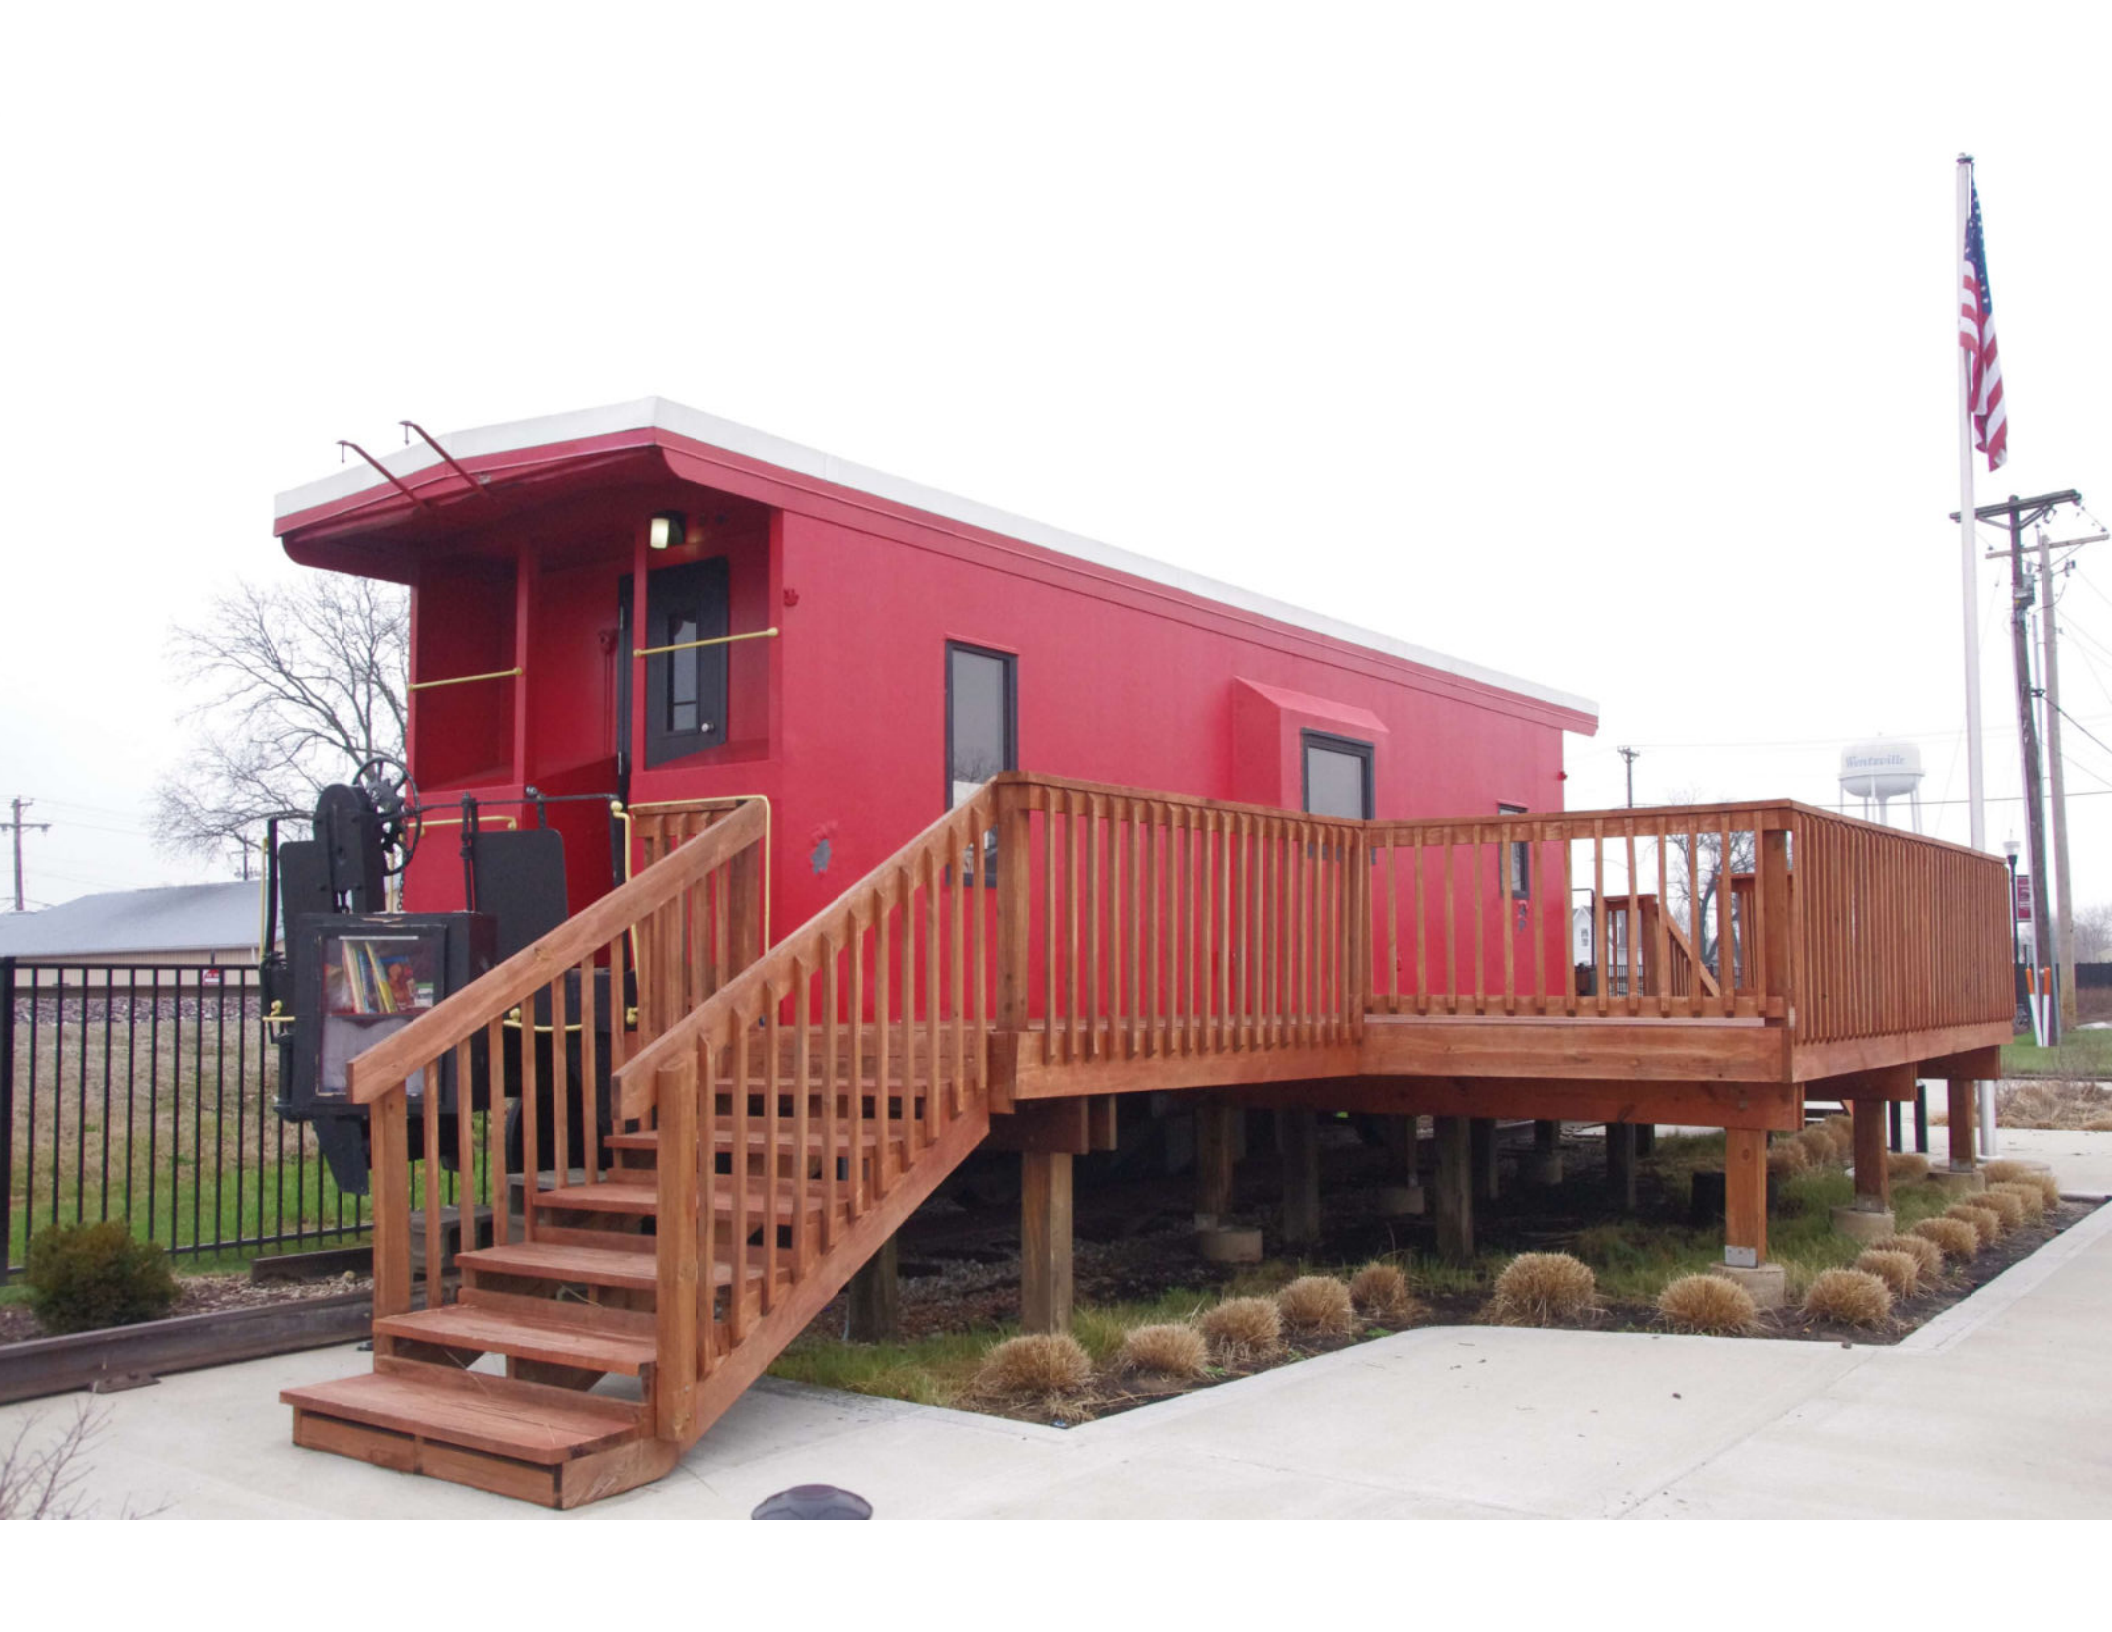
This resource is a refurbished train caboose with a wood deck stretching across the south side, full length from east to west. The structure was recently used as an office for the Wentzville Historical Society.
