**ARCHITECTURAL/HISTORIC INVENTORY FORM**

1. Survey No. SC-AS-012-0052		2. Survey Name: Reconnaissance Level Survey of Historic Downtown Wentzville	
3. County: St. Charles		4. Address (Street No.) 105	Street (name) South Linn Ave
5. City: Wentzville	Vicinity: <input type="checkbox"/>	6. UTM:	
8. Historic name (if known):		9. Present/other name (if known): Land Fair Corp.	
10. Ownership: <input type="checkbox"/> Private <input type="checkbox"/> Public		11a. Historic use (if known): COMMERCE/TRADE	11b. Current use: COMMERCE/TRADE/professional
5. City: Wentzville		7. Township/Range/Section:

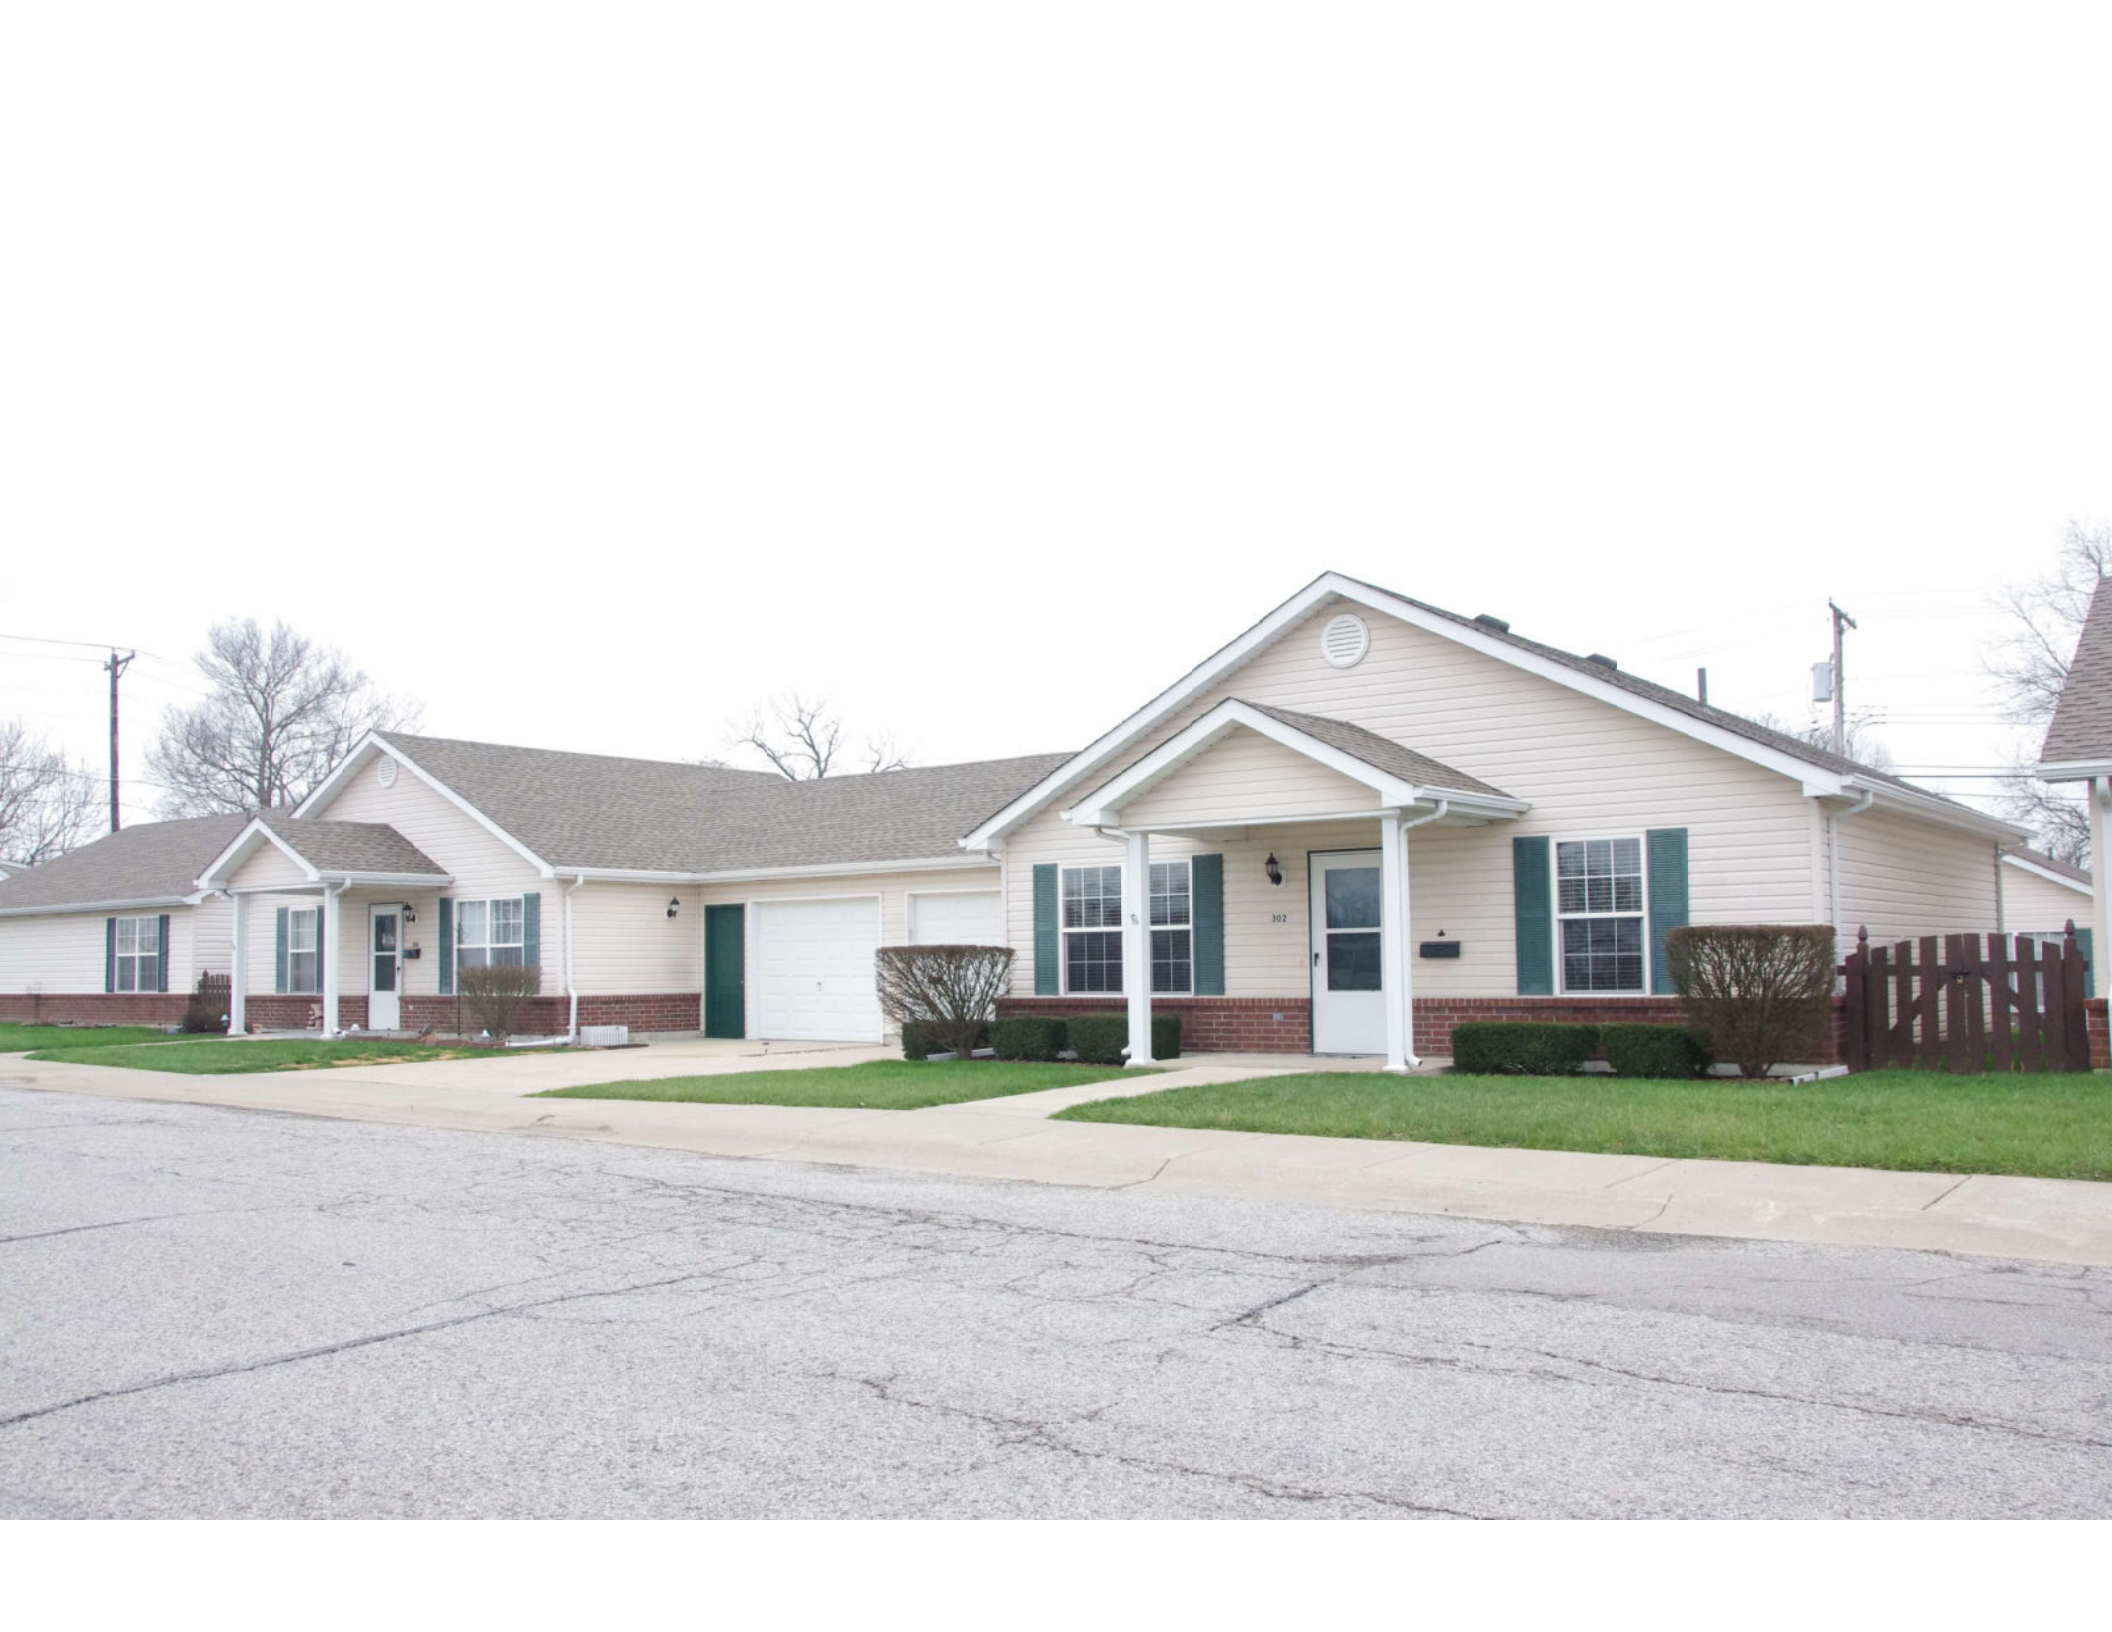
This town home is one-story vinyl sided, with brick walls below the window sills. The L-shaped town home has an end gabled roof and side gable 2-car garage wing that connects to the adjacent town home's garage which is a mirror image of this resource. There is a centered, open porch with a gabled roof supported square corner posts resting on concrete base. The paneled entry door is covered by a aluminum storm door. Toward the outer corner is a six-over-six sash window and the opposite side from the porch has paired six-over-six sash windows.

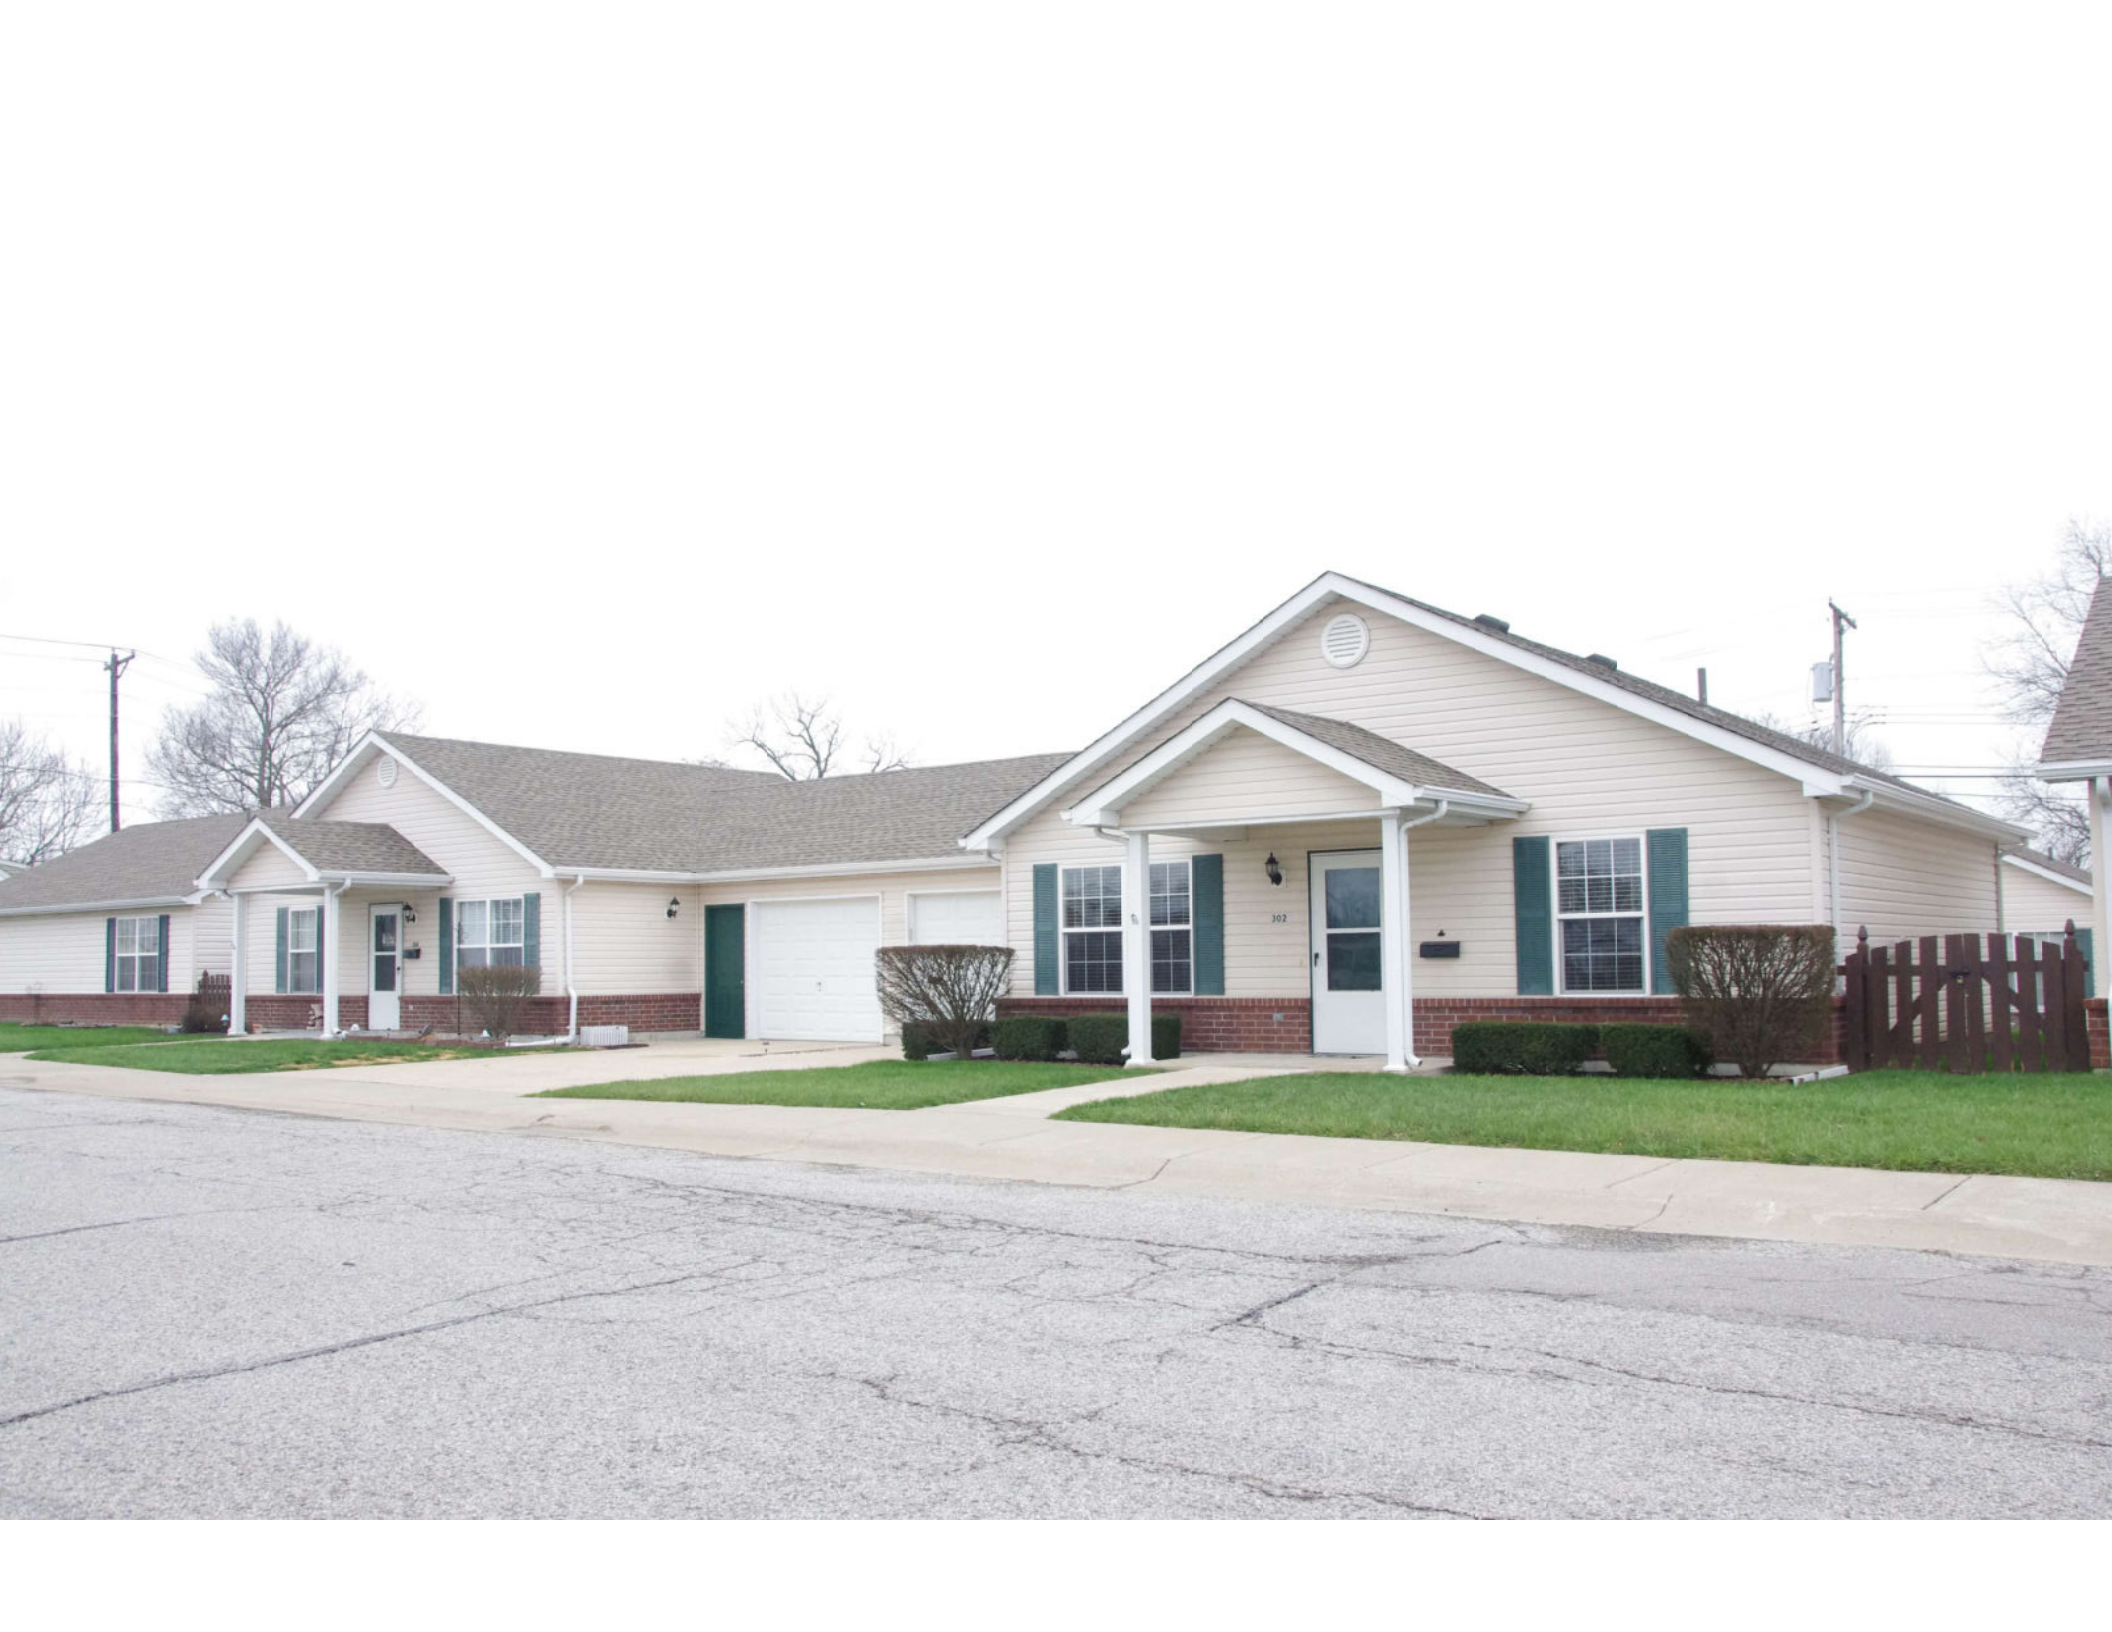
This town home is one-story, vinyl sided, with brick walls below the window sills. The L-shaped town home has an end gabled roof and side gable 2-car garage wing that connects to the adjacent town home's garage which is a mirror image of this resource. There is centered, open porch with a gabled roof supported square corner posts resting on concrete base. The paneled entry door is covered by a aluminum storm door. Toward the outer corner is a six-over-six sash window and the opposite side from the porch has paired six-over-six sash windows.

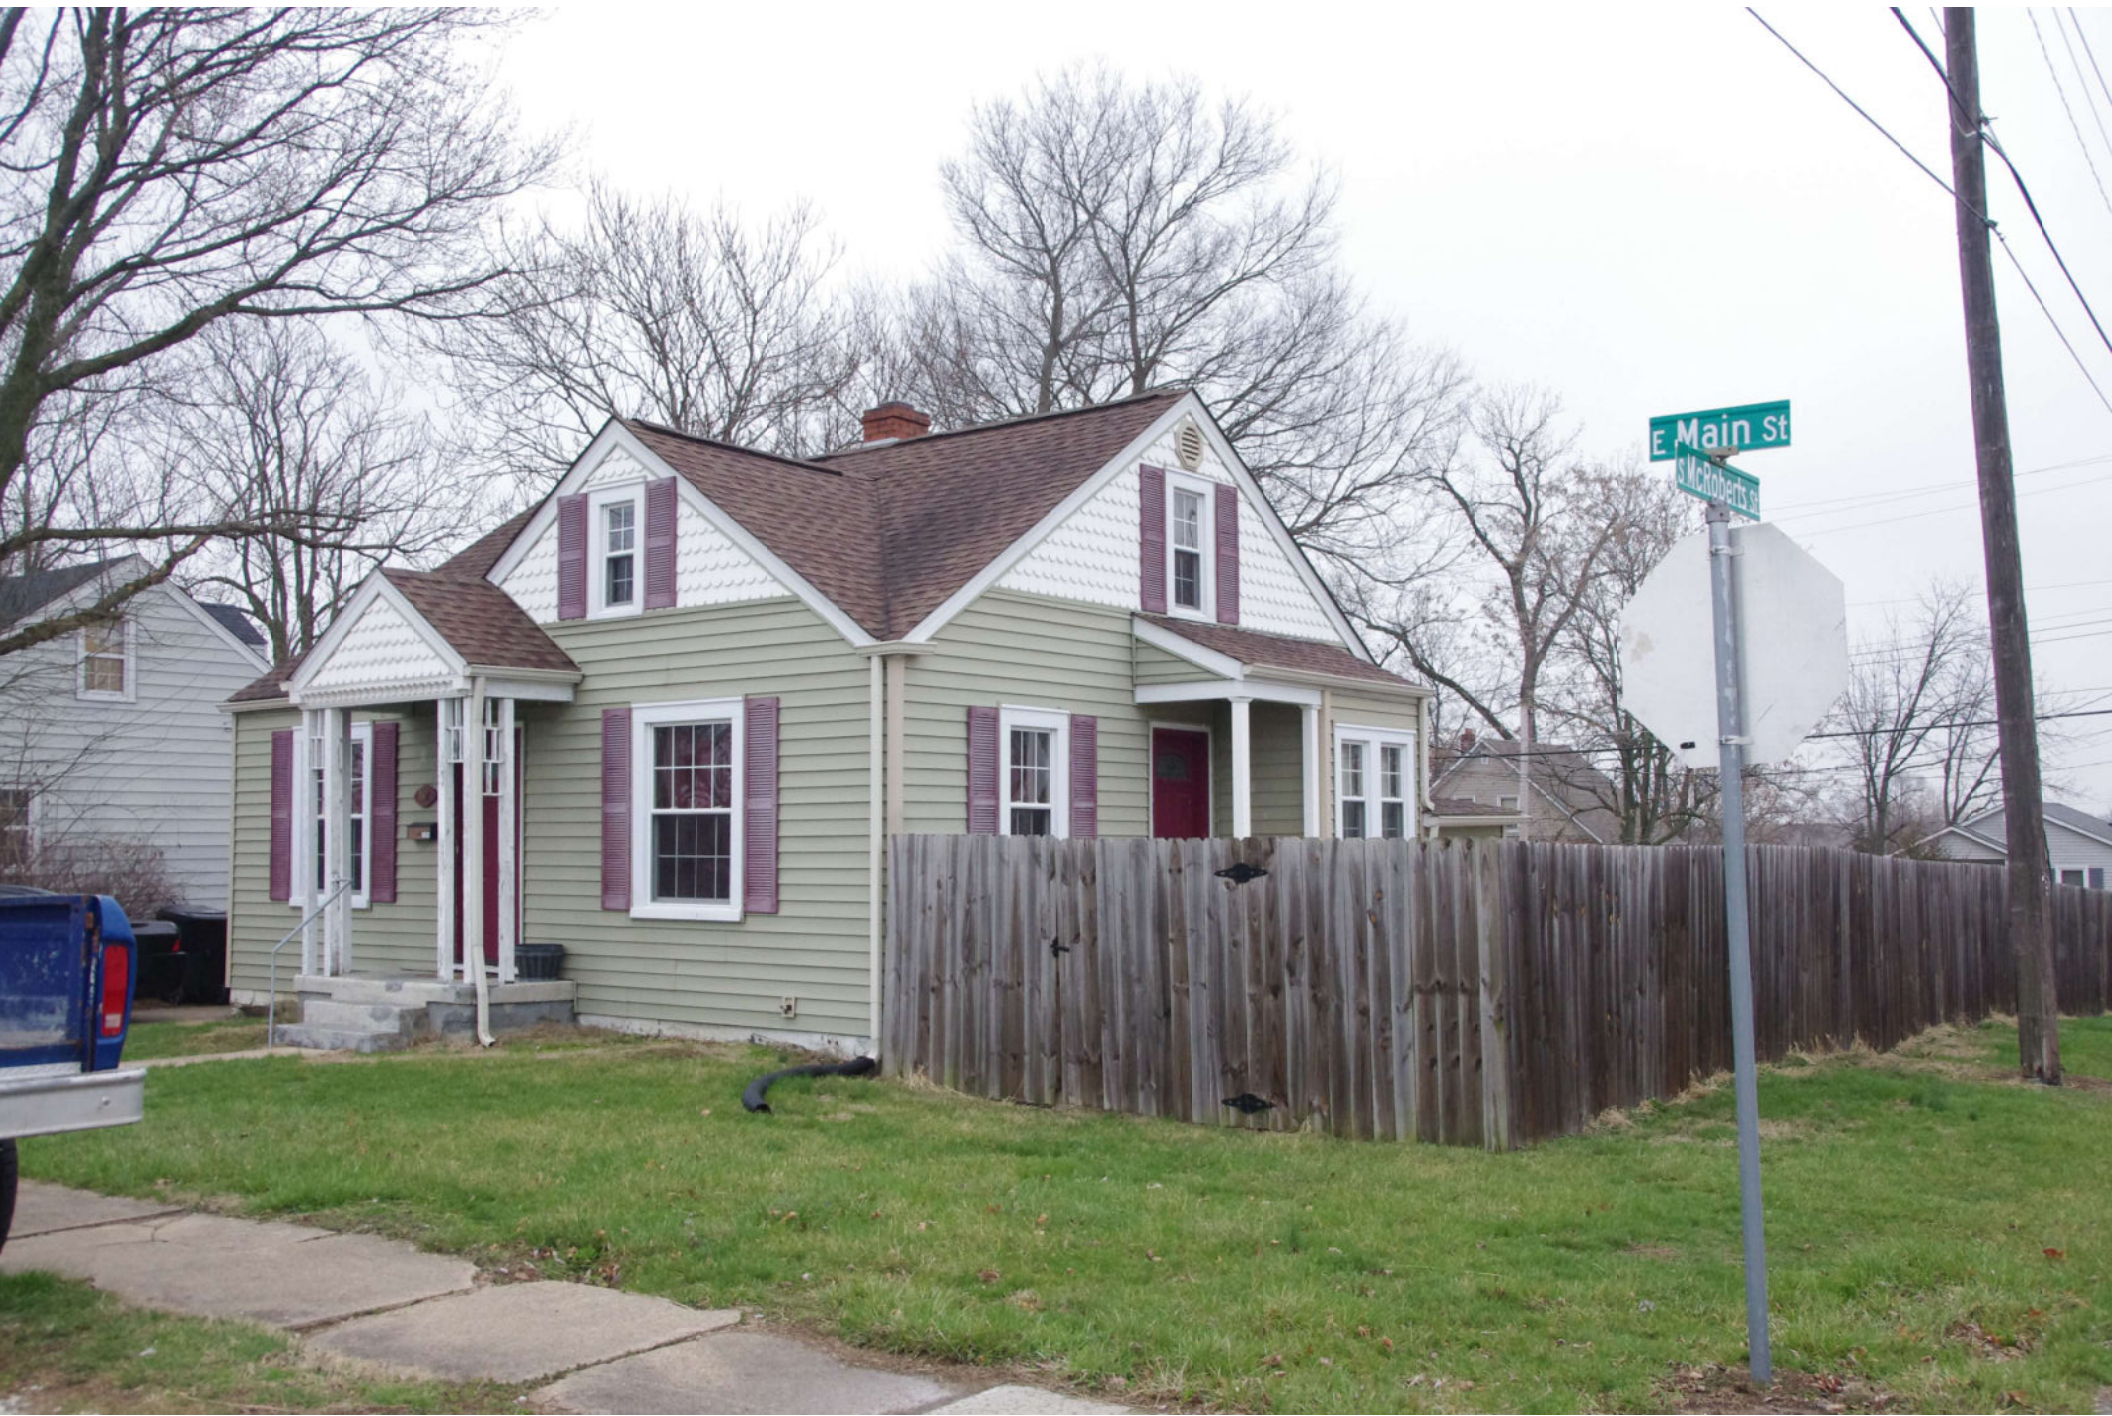
This is a modest Minimal Traditional style house, one-and-a-half stories with a side gable roof and. A cross gable is located on the west half of the façade, overlapped by the small gable of the front entry porch, with the clustered wood posts with the geometric connection on each corner. The porch floor is concrete and the paneled door has a fanlight. These are all characteristic of Minimal Traditional style houses, but the vinyl fishscale shingles in the gable ends and the vinyl siding on the walls are recent alterations. The outer bays are filled with replacement 8/8 sash windows with faux shutters. There is a 4/4 sash window with shutters on the second floor in the gable end. A side gabled, one bay garage is attached, recessed on the east side of the building.

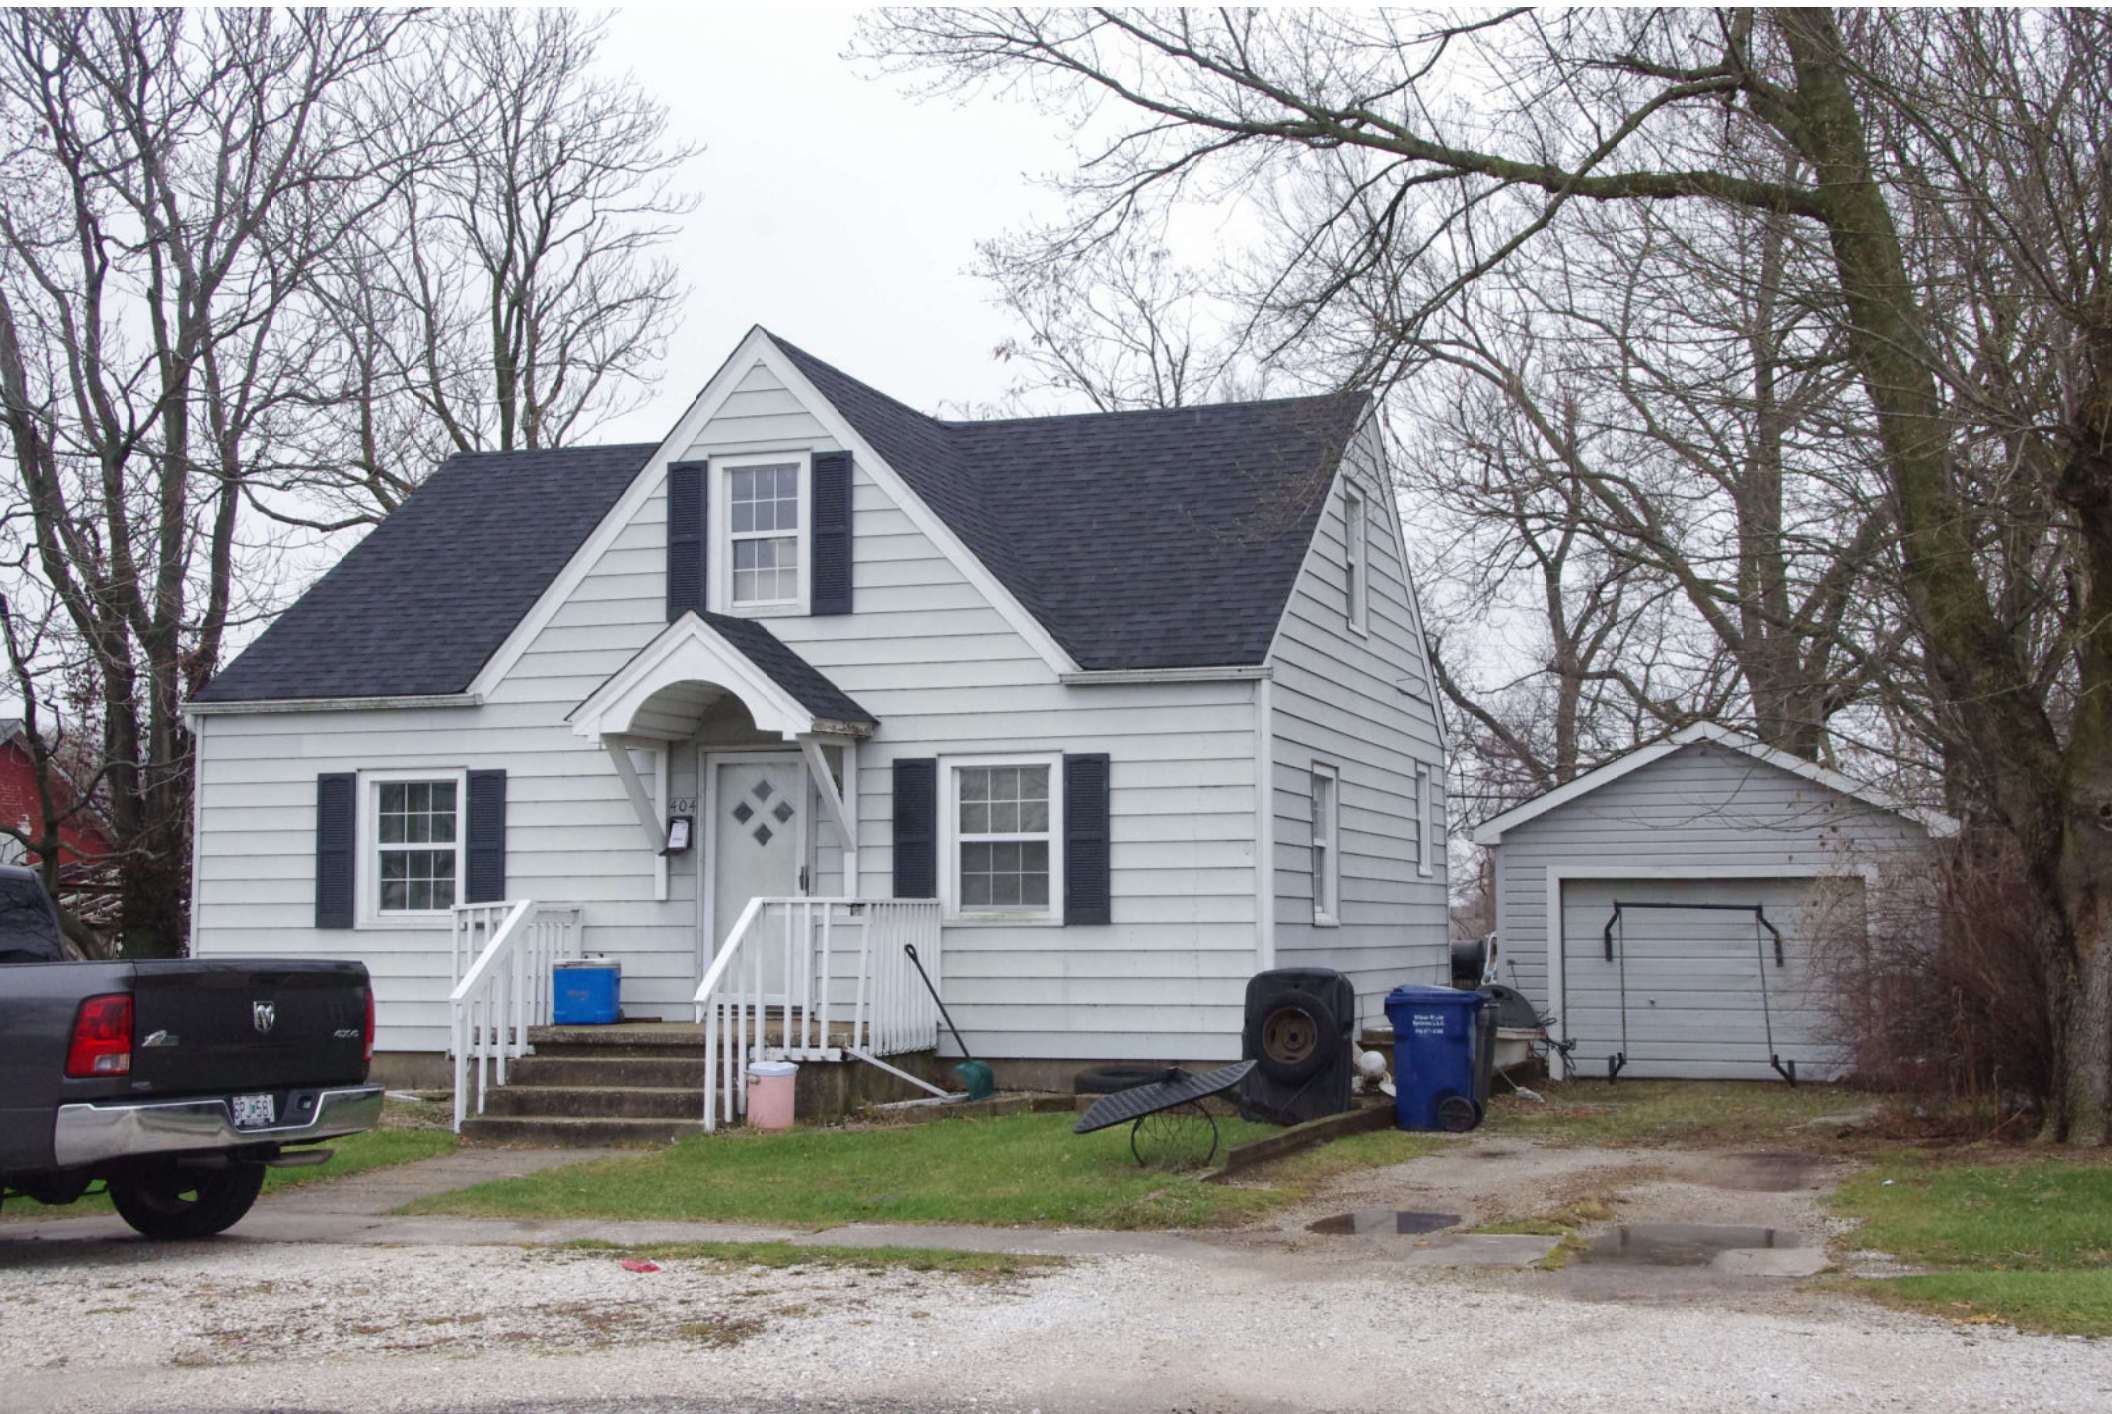
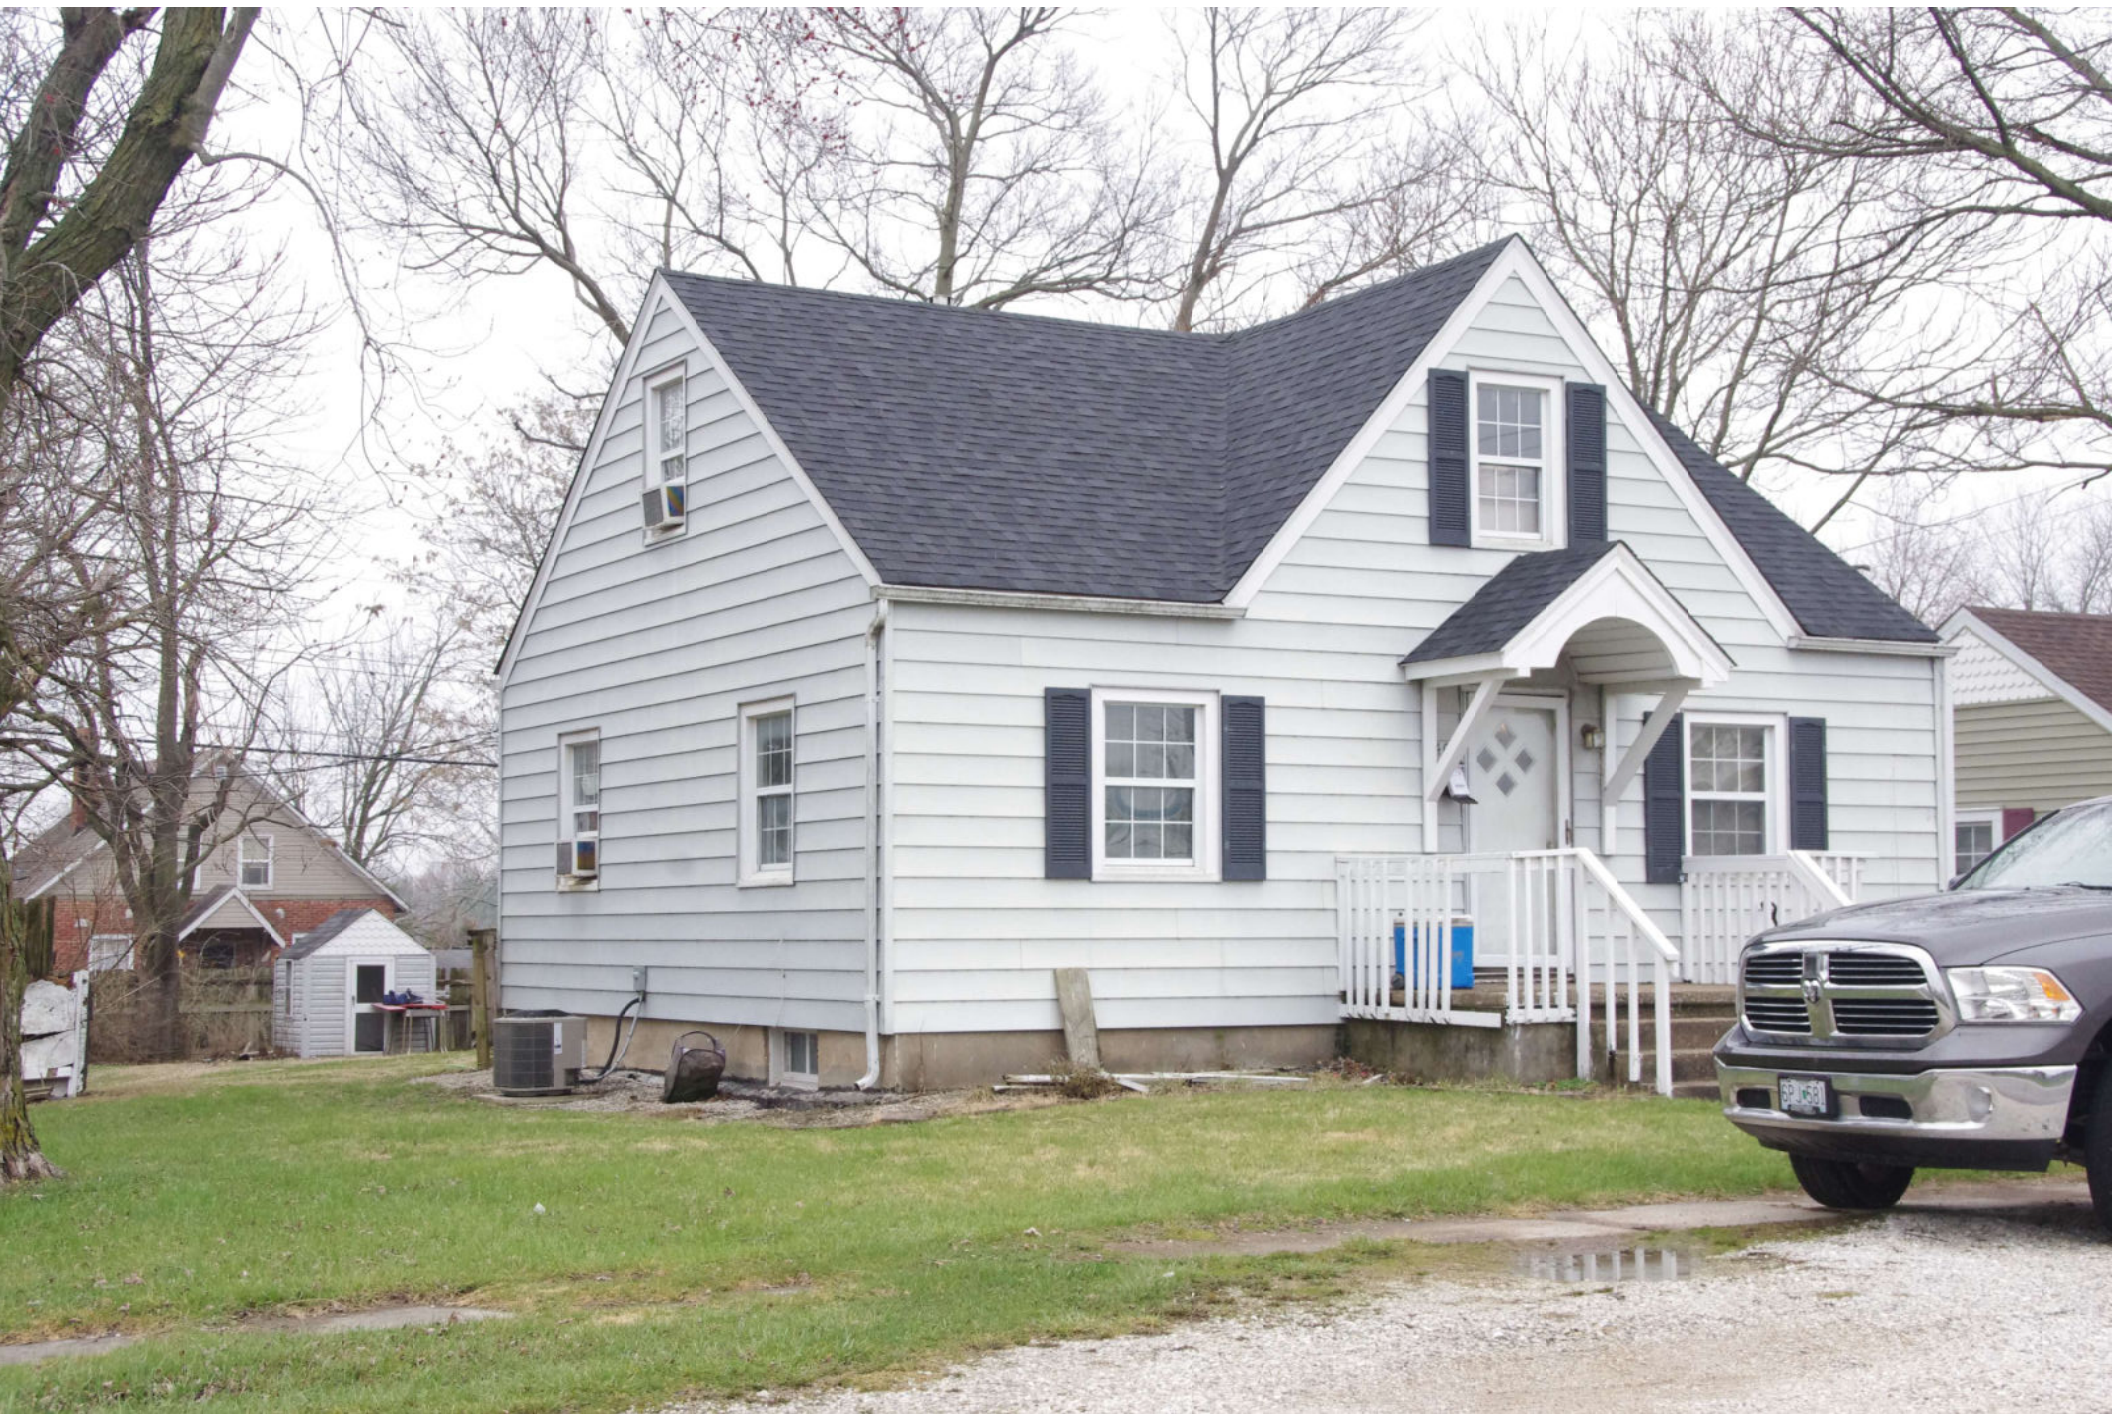
This one-and-a-half story side gabled house has a central cross gable roof with the entry door centered on the building, accessed by a concrete stoop and covered by a gabled roof with an round arched ceiling supported by knee braces. A wood railing has been added recently to the concrete stoop. The door appears to be the original, an unusual wood door with a diamond pattern of four diamond lights at the top of the door. Replacement six-over-six sash windows with faux shutters are positioned in the outer bays on the first level and centered above the entry is another six-over-six window.

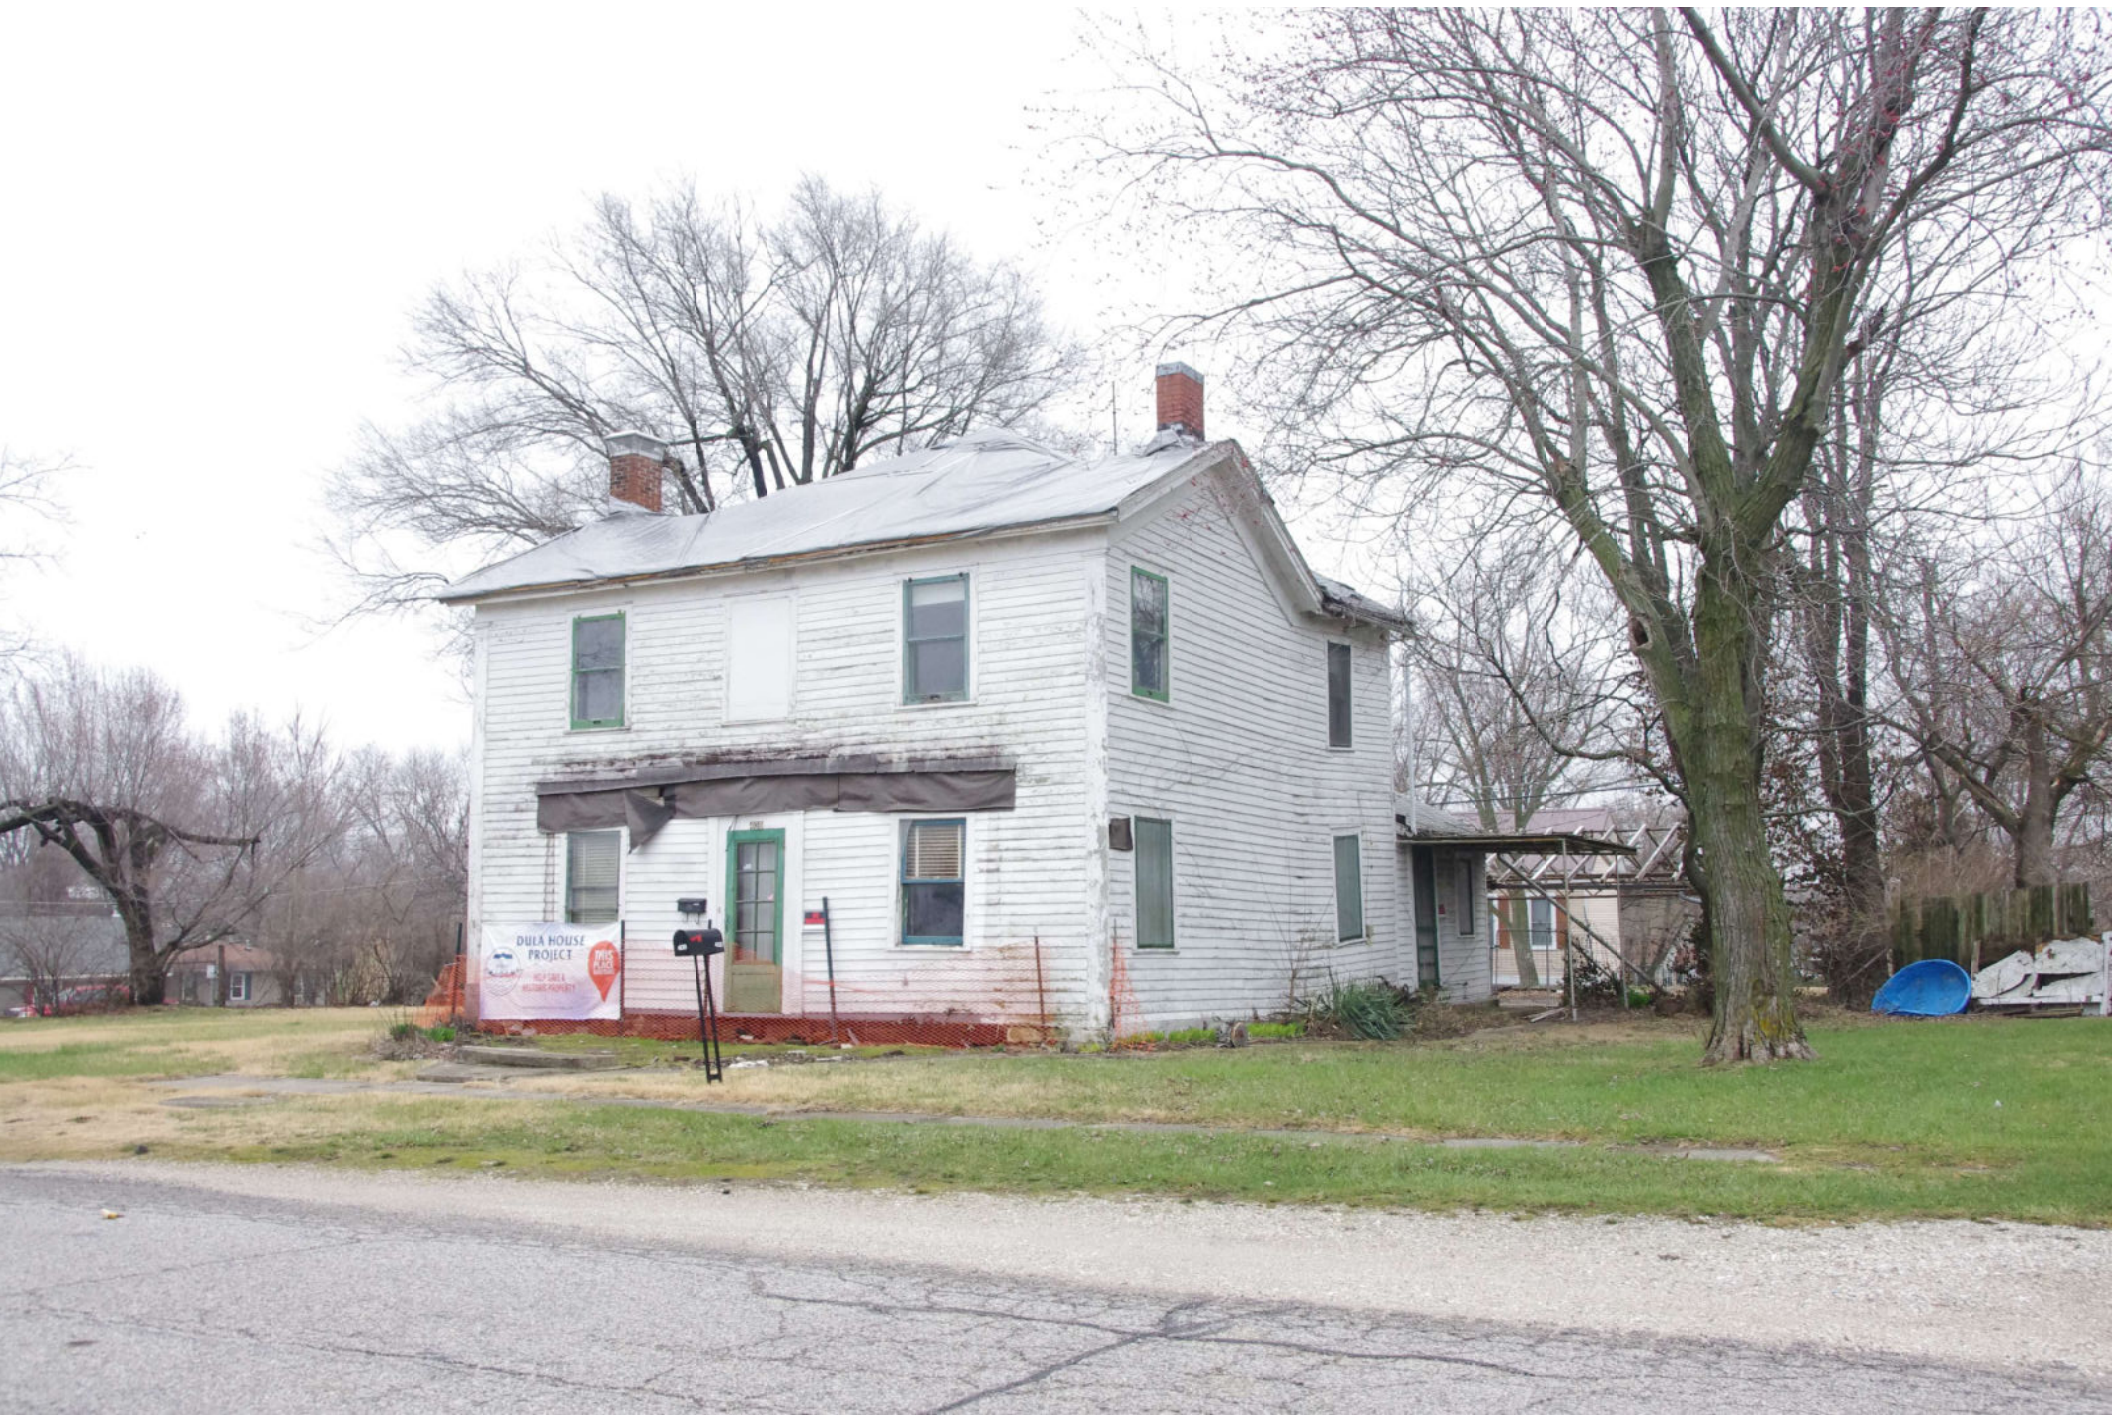
The Dula House is a two-story, wood sided house with a stone foundation and a hip-on gable roof. The 8-light wood storm door is centered on the façade and flanked by one-over-one wood sash windows that were under the half-round front porch. Above, on the second floor, there are three one-over-one wood sash windows although the middle window has been boarded over. The porch was carefully removed in 2018 as part of the preservation efforts for the building since the roof was failing. The pieces have been stored for safekeeping. The porch and columns are visible in historic photos as well as the 2013 Google Street View. The columns are tapered Doric columns that rest on raised wood paneled plinths that rest on the low wood porch floor. The historic photo (Bowman pg 125) shows the original wood turned spindle railing that spanned between the plinths and as well as the rooftop balustrade. On the rear, there is a cross gable, making the sides appear to have a end gable with a shed roof behind, with a one-over-one wood sashed window vertically aligned in both the gabled and shed roofed section of each side of the house. Rear window openings are not symmetrically placed and currently have no windows. There are brick, interior, end wall chimneys on each end of the façade, at the gable ridge, and there is another brick chimney in the rear east room. A gabled porch has been added to the rear of the building.
