**ARCHITECTURAL/HISTORIC INVENTORY FORM**

1. Survey No. SC-AS-012-0052		2. Survey Name: Reconnaissance Level Survey of Historic Downtown Wentzville	
3. County: St. Charles		4. Address (Street No.) 105	Street (name) South Linn Ave
5. City: Wentzville	Vicinity: <input type="checkbox"/>	6. UTM:	
8. Historic name (if known):		9. Present/other name (if known): Land Fair Corp.	
10. Ownership: <input type="checkbox"/> Private <input type="checkbox"/> Public		11a. Historic use (if known): COMMERCE/TRADE	11b. Current use: COMMERCE/TRADE/professional
5. City: Wentzville		7. Township/Range/Section:

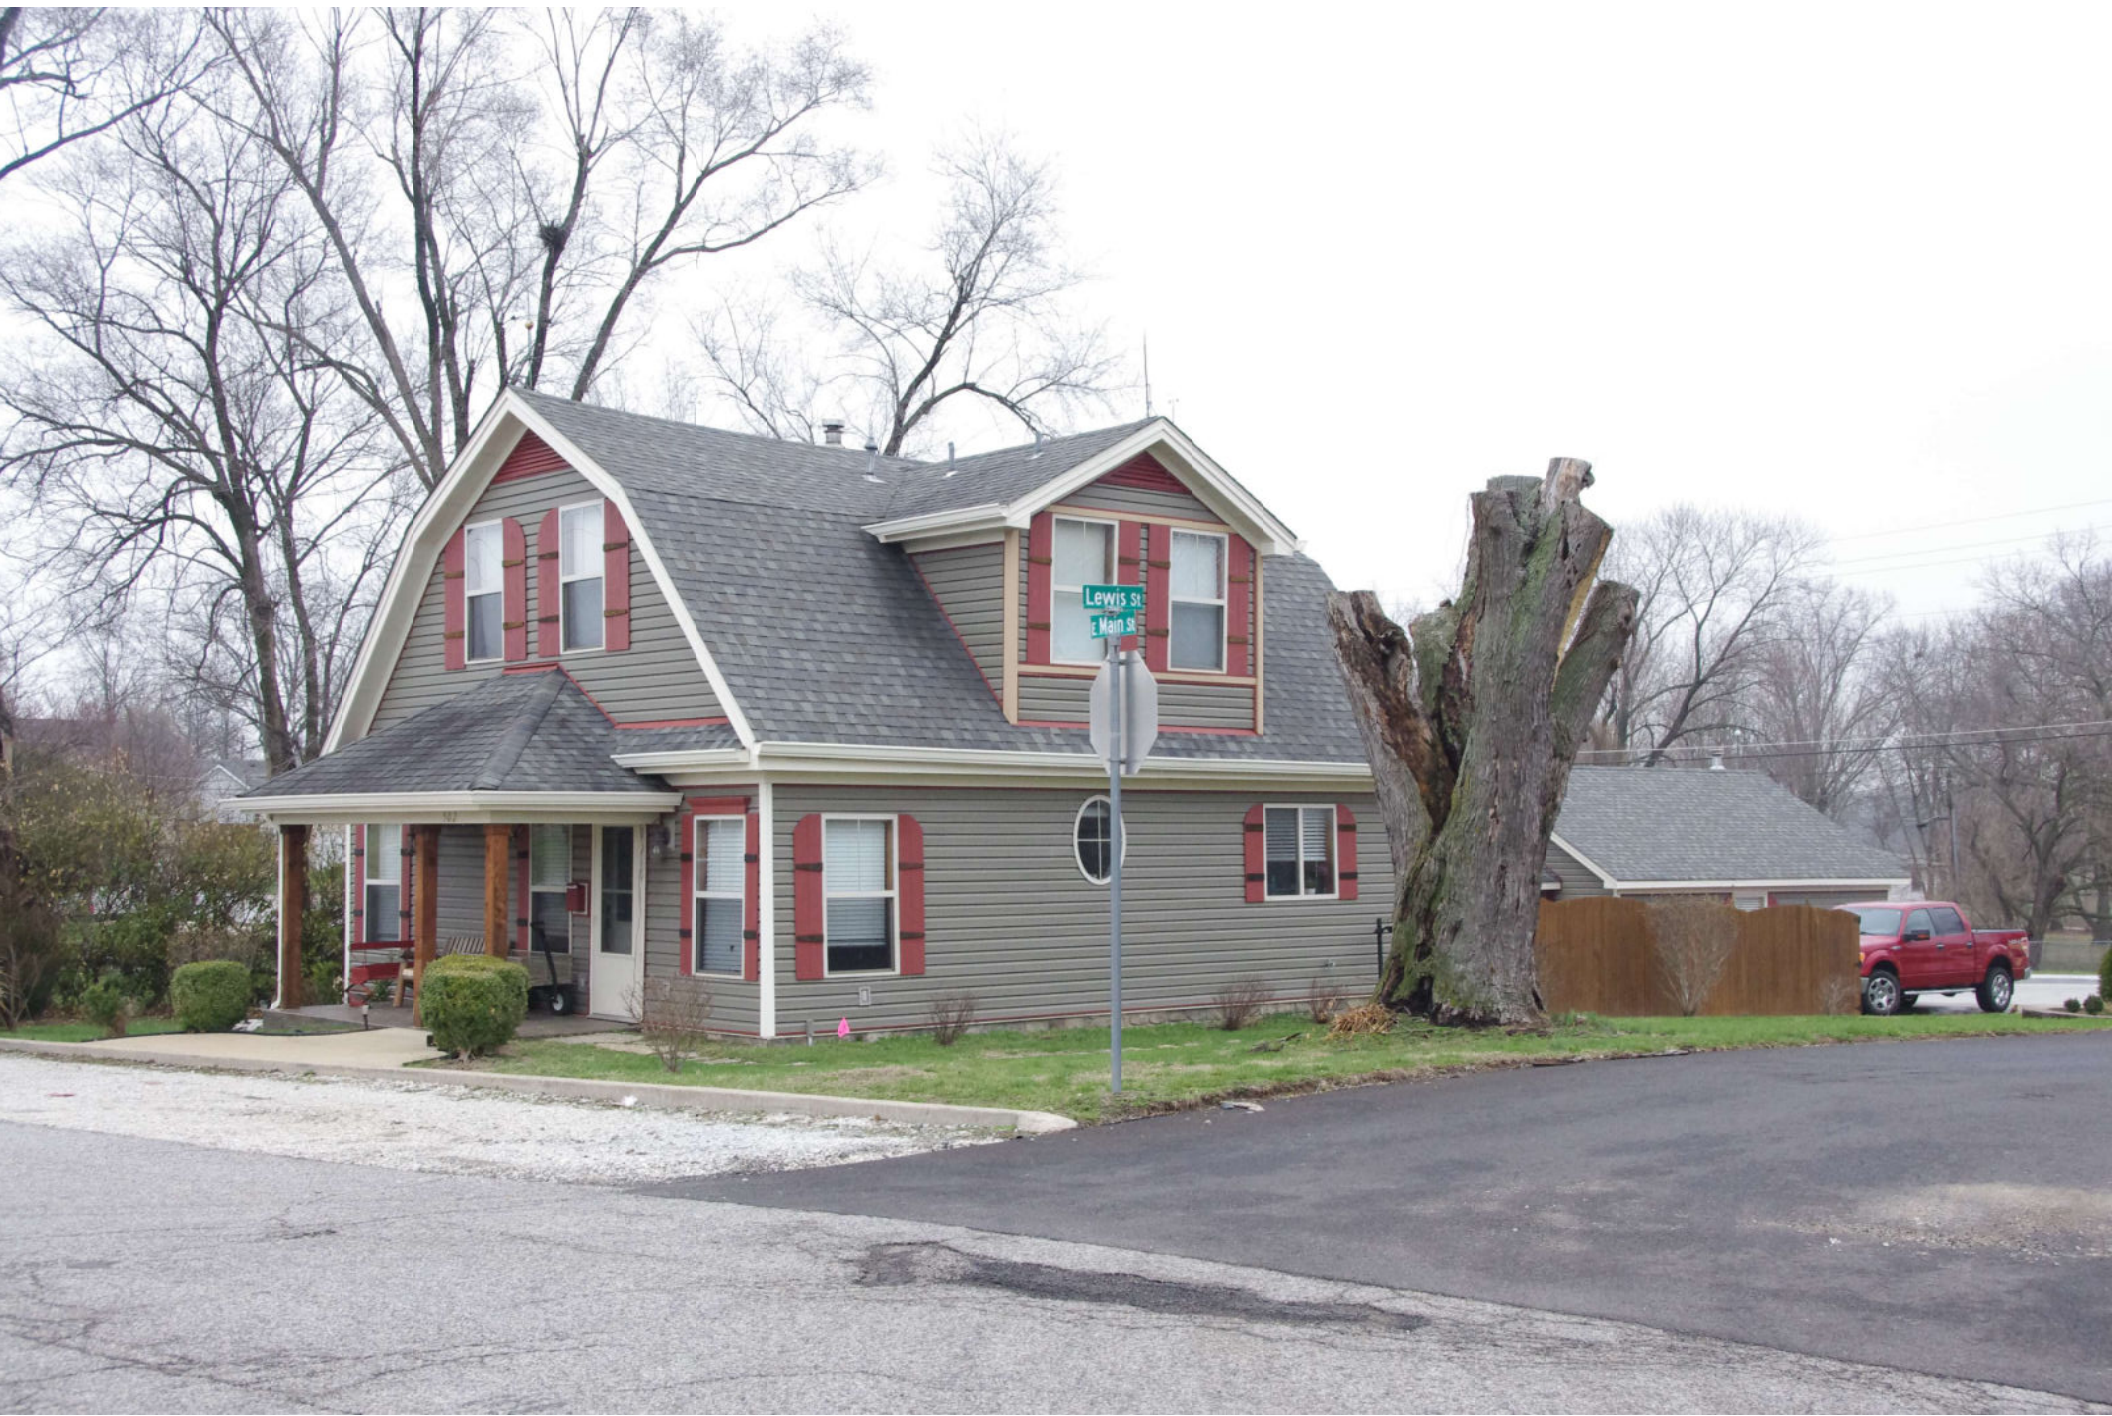
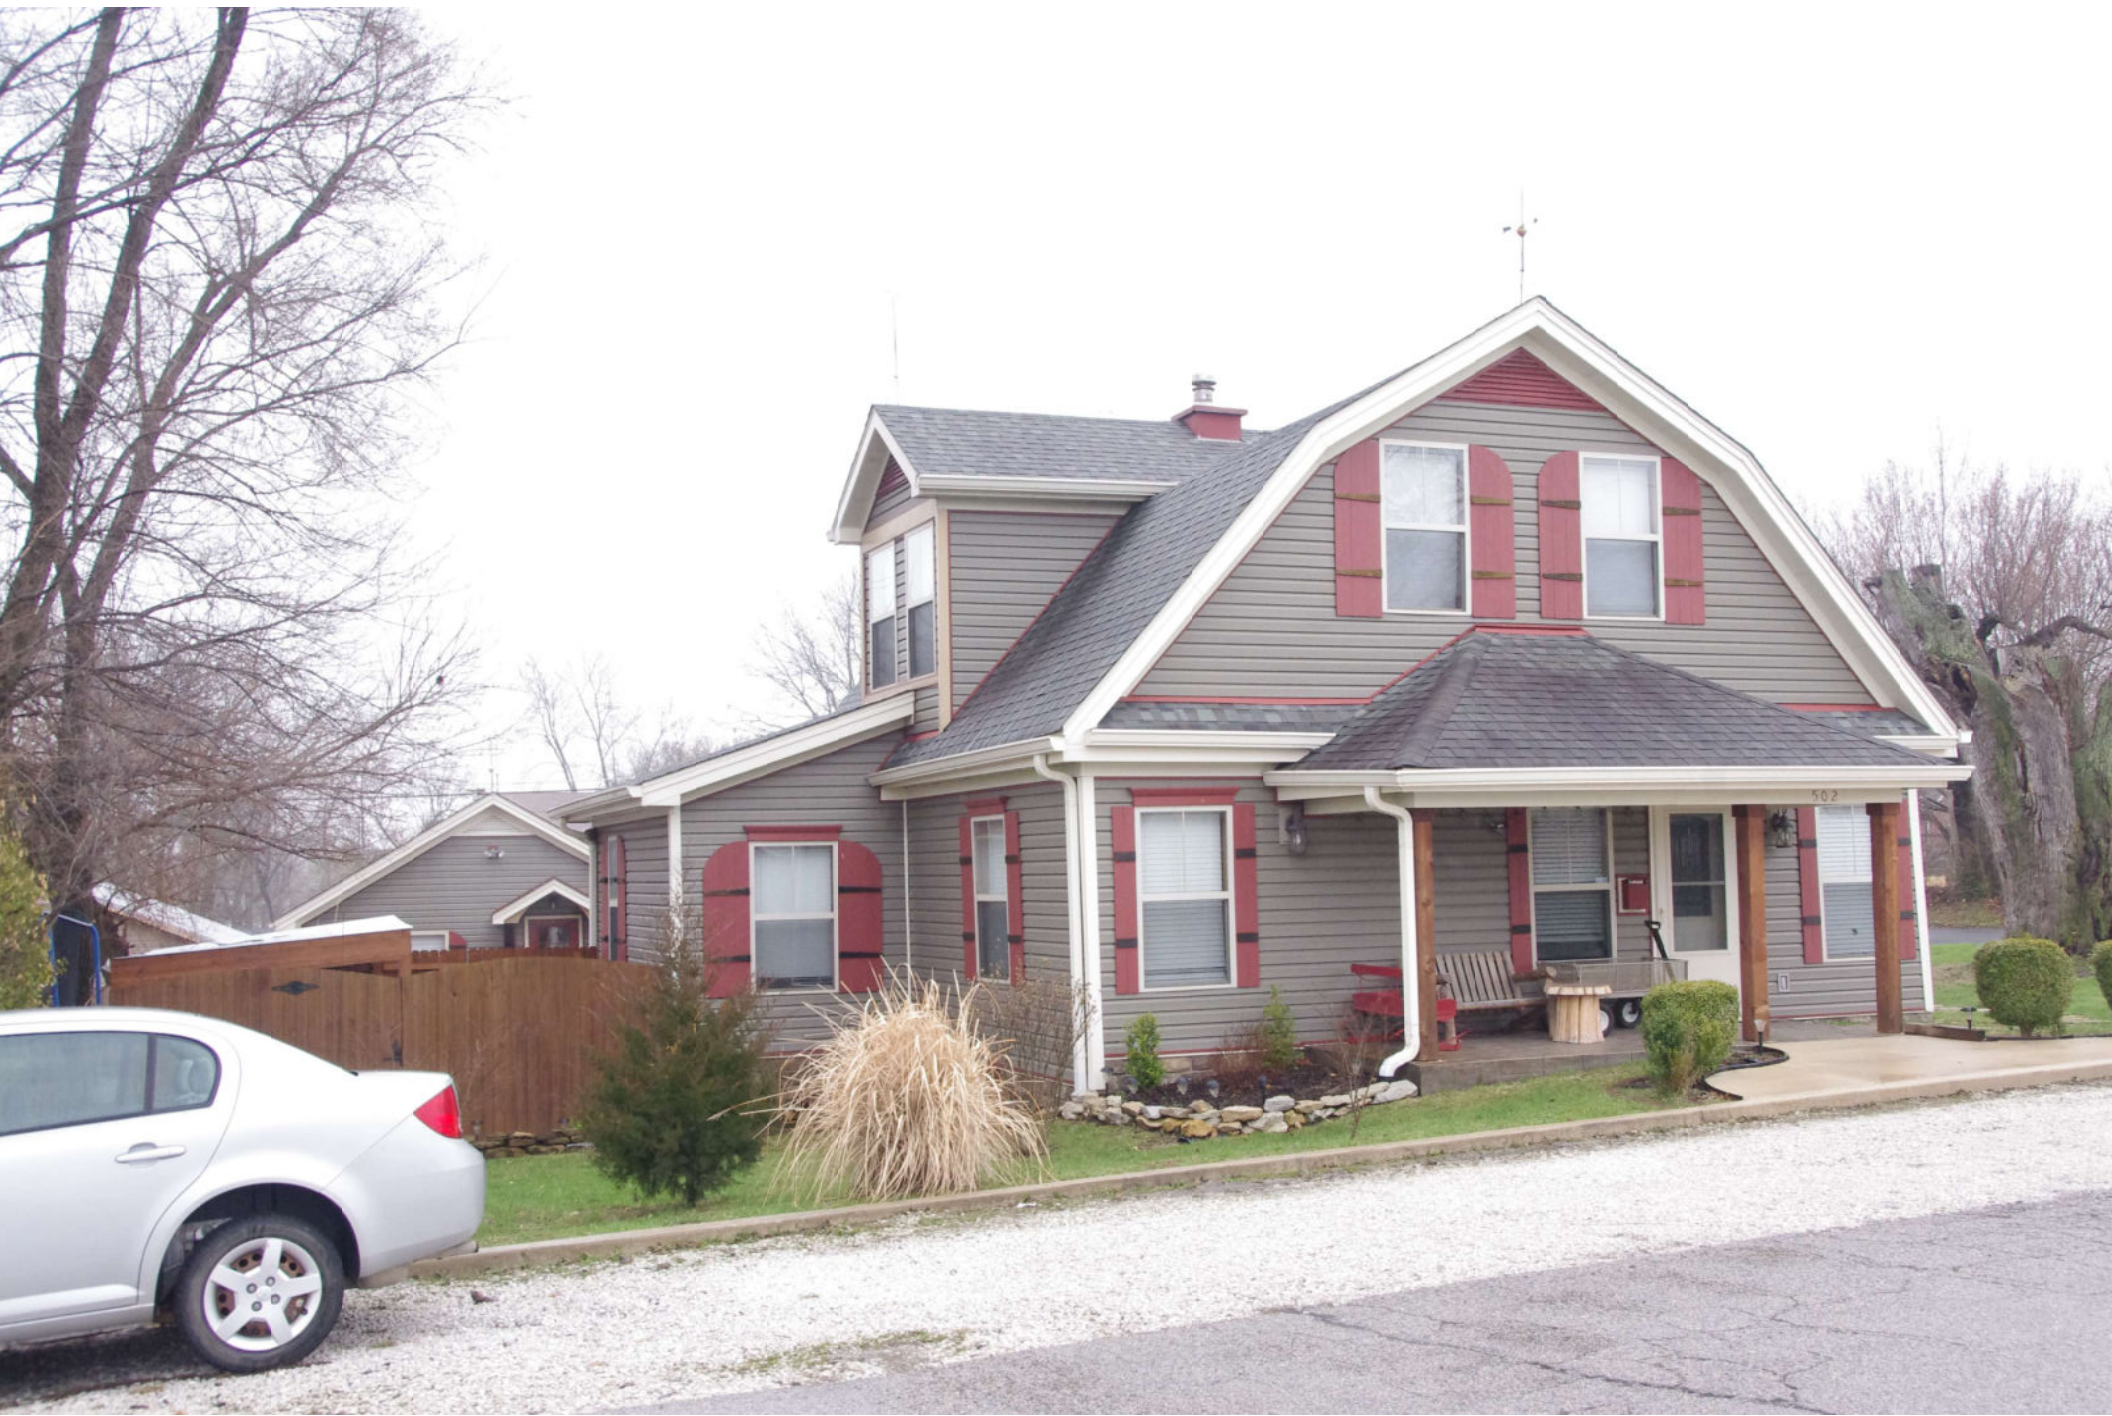
This Dutch Colonial Revival house is 1.5 stories with an asphalt shingle gambrel roof. It has a hipped roof, open porch with replacement wood posts and a concrete porch floor at grade. The entry door is a half light wood door, with an adjacent 2/1 window under the porch roof. On either side of the porch, there is another 2/1 window and there are two 2/1 windows on the second floor above the porch. The house has been re-clad in vinyl siding and the windows replaced with 2/1 windows with arched, faux shutters on all windows. On each side, there is a large, gabled dormer with paired windows. On the west elevation, below the dormer is an oval window. On the east elevation there is a shed roofed, enclosed wing.

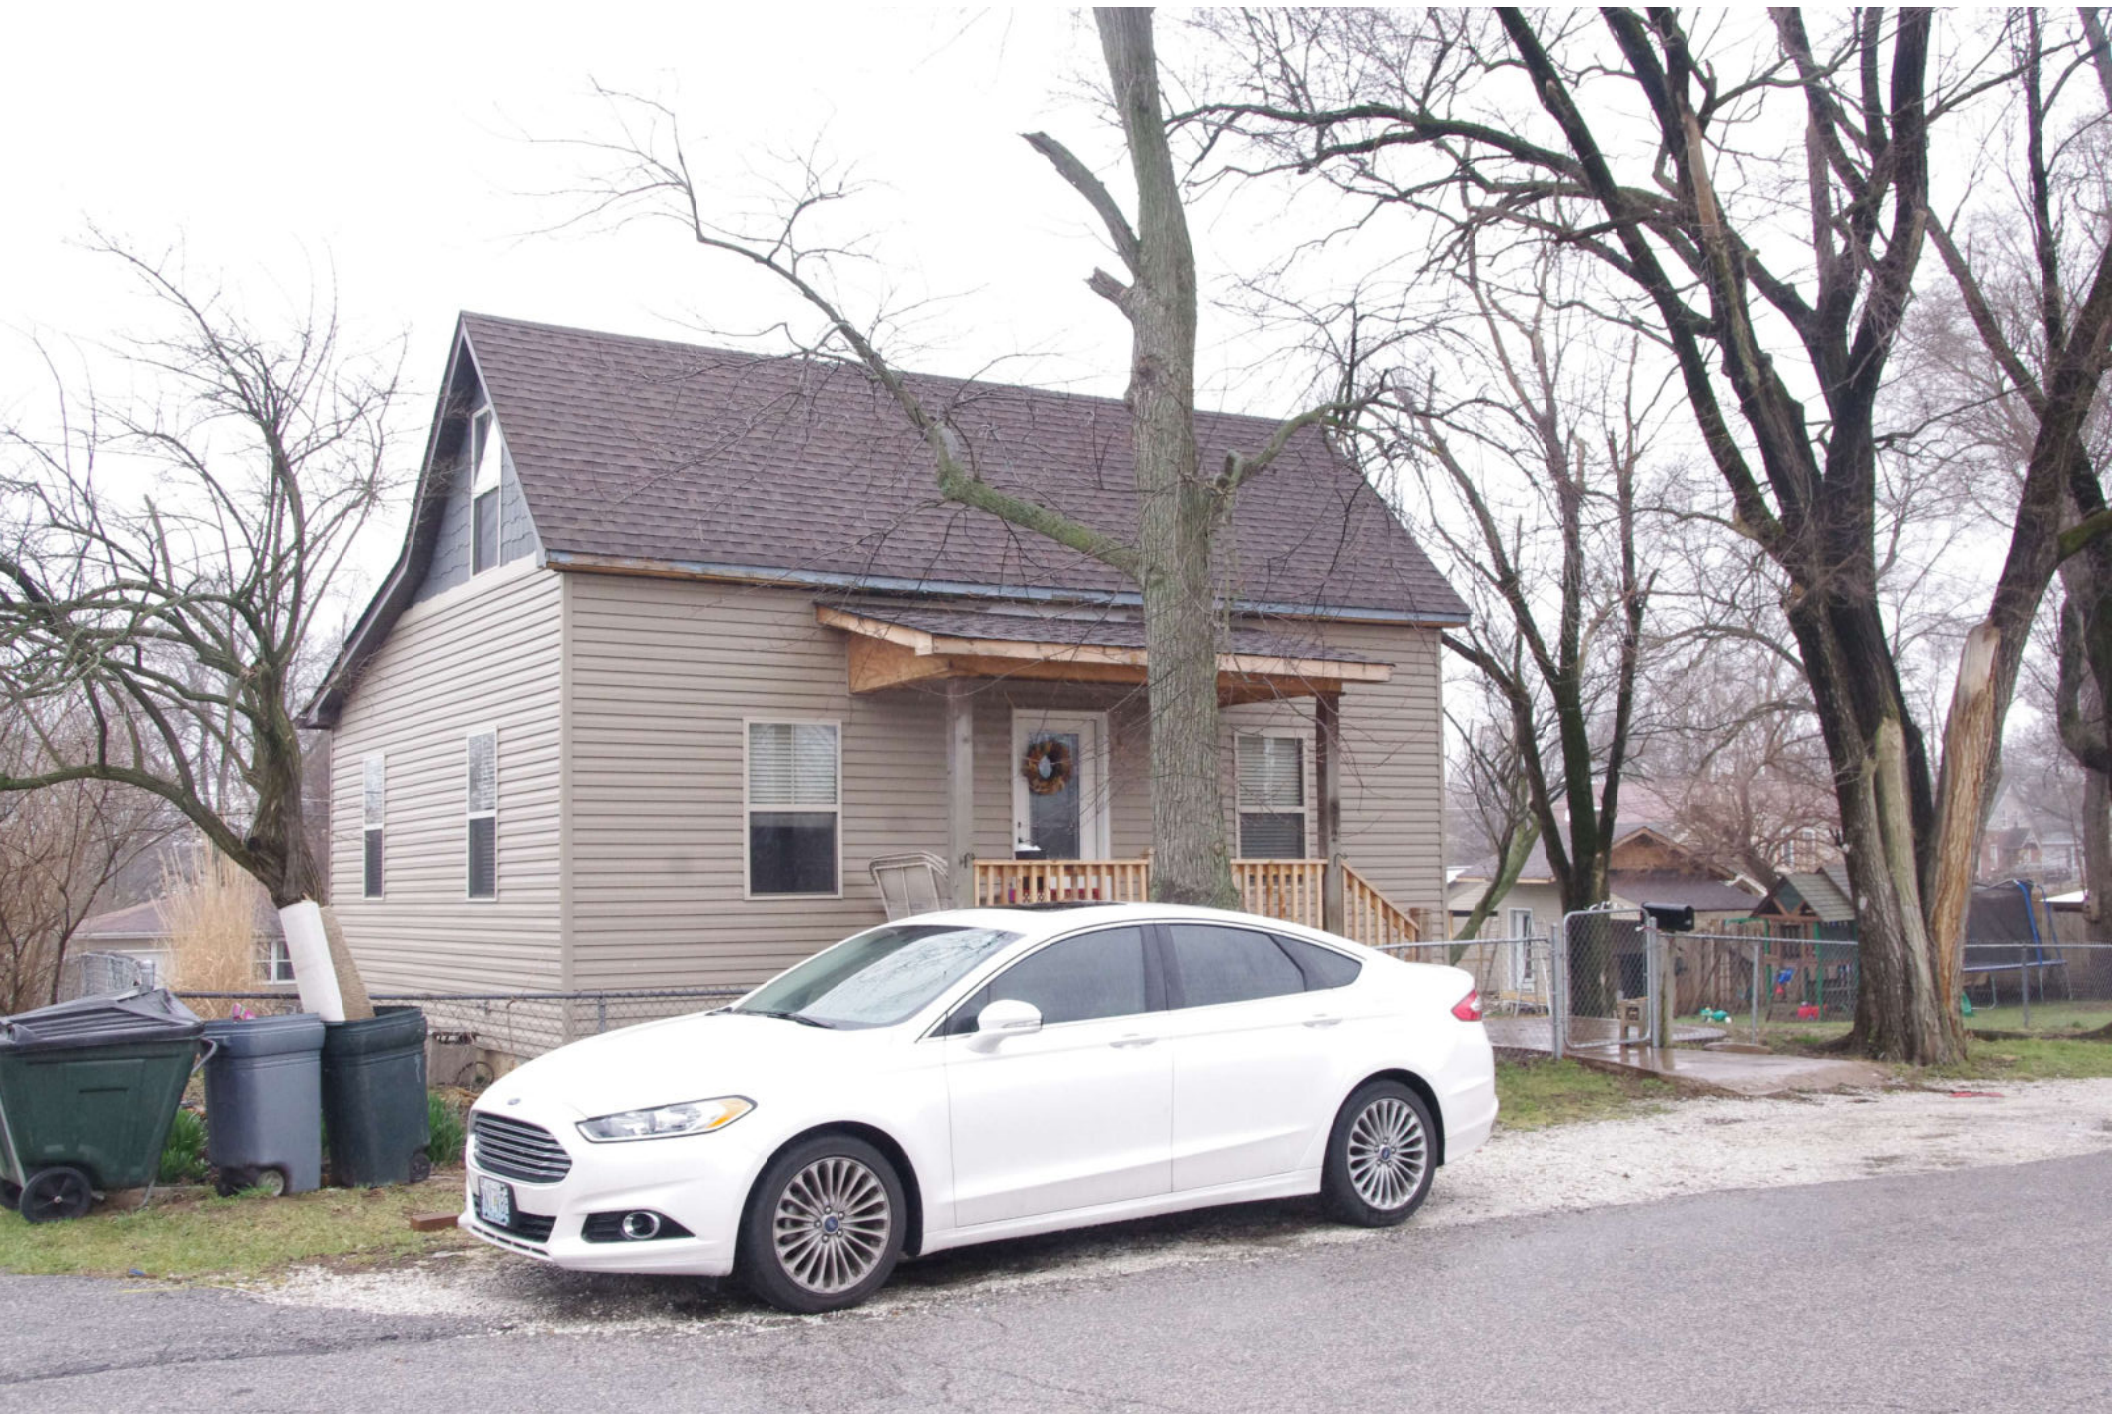
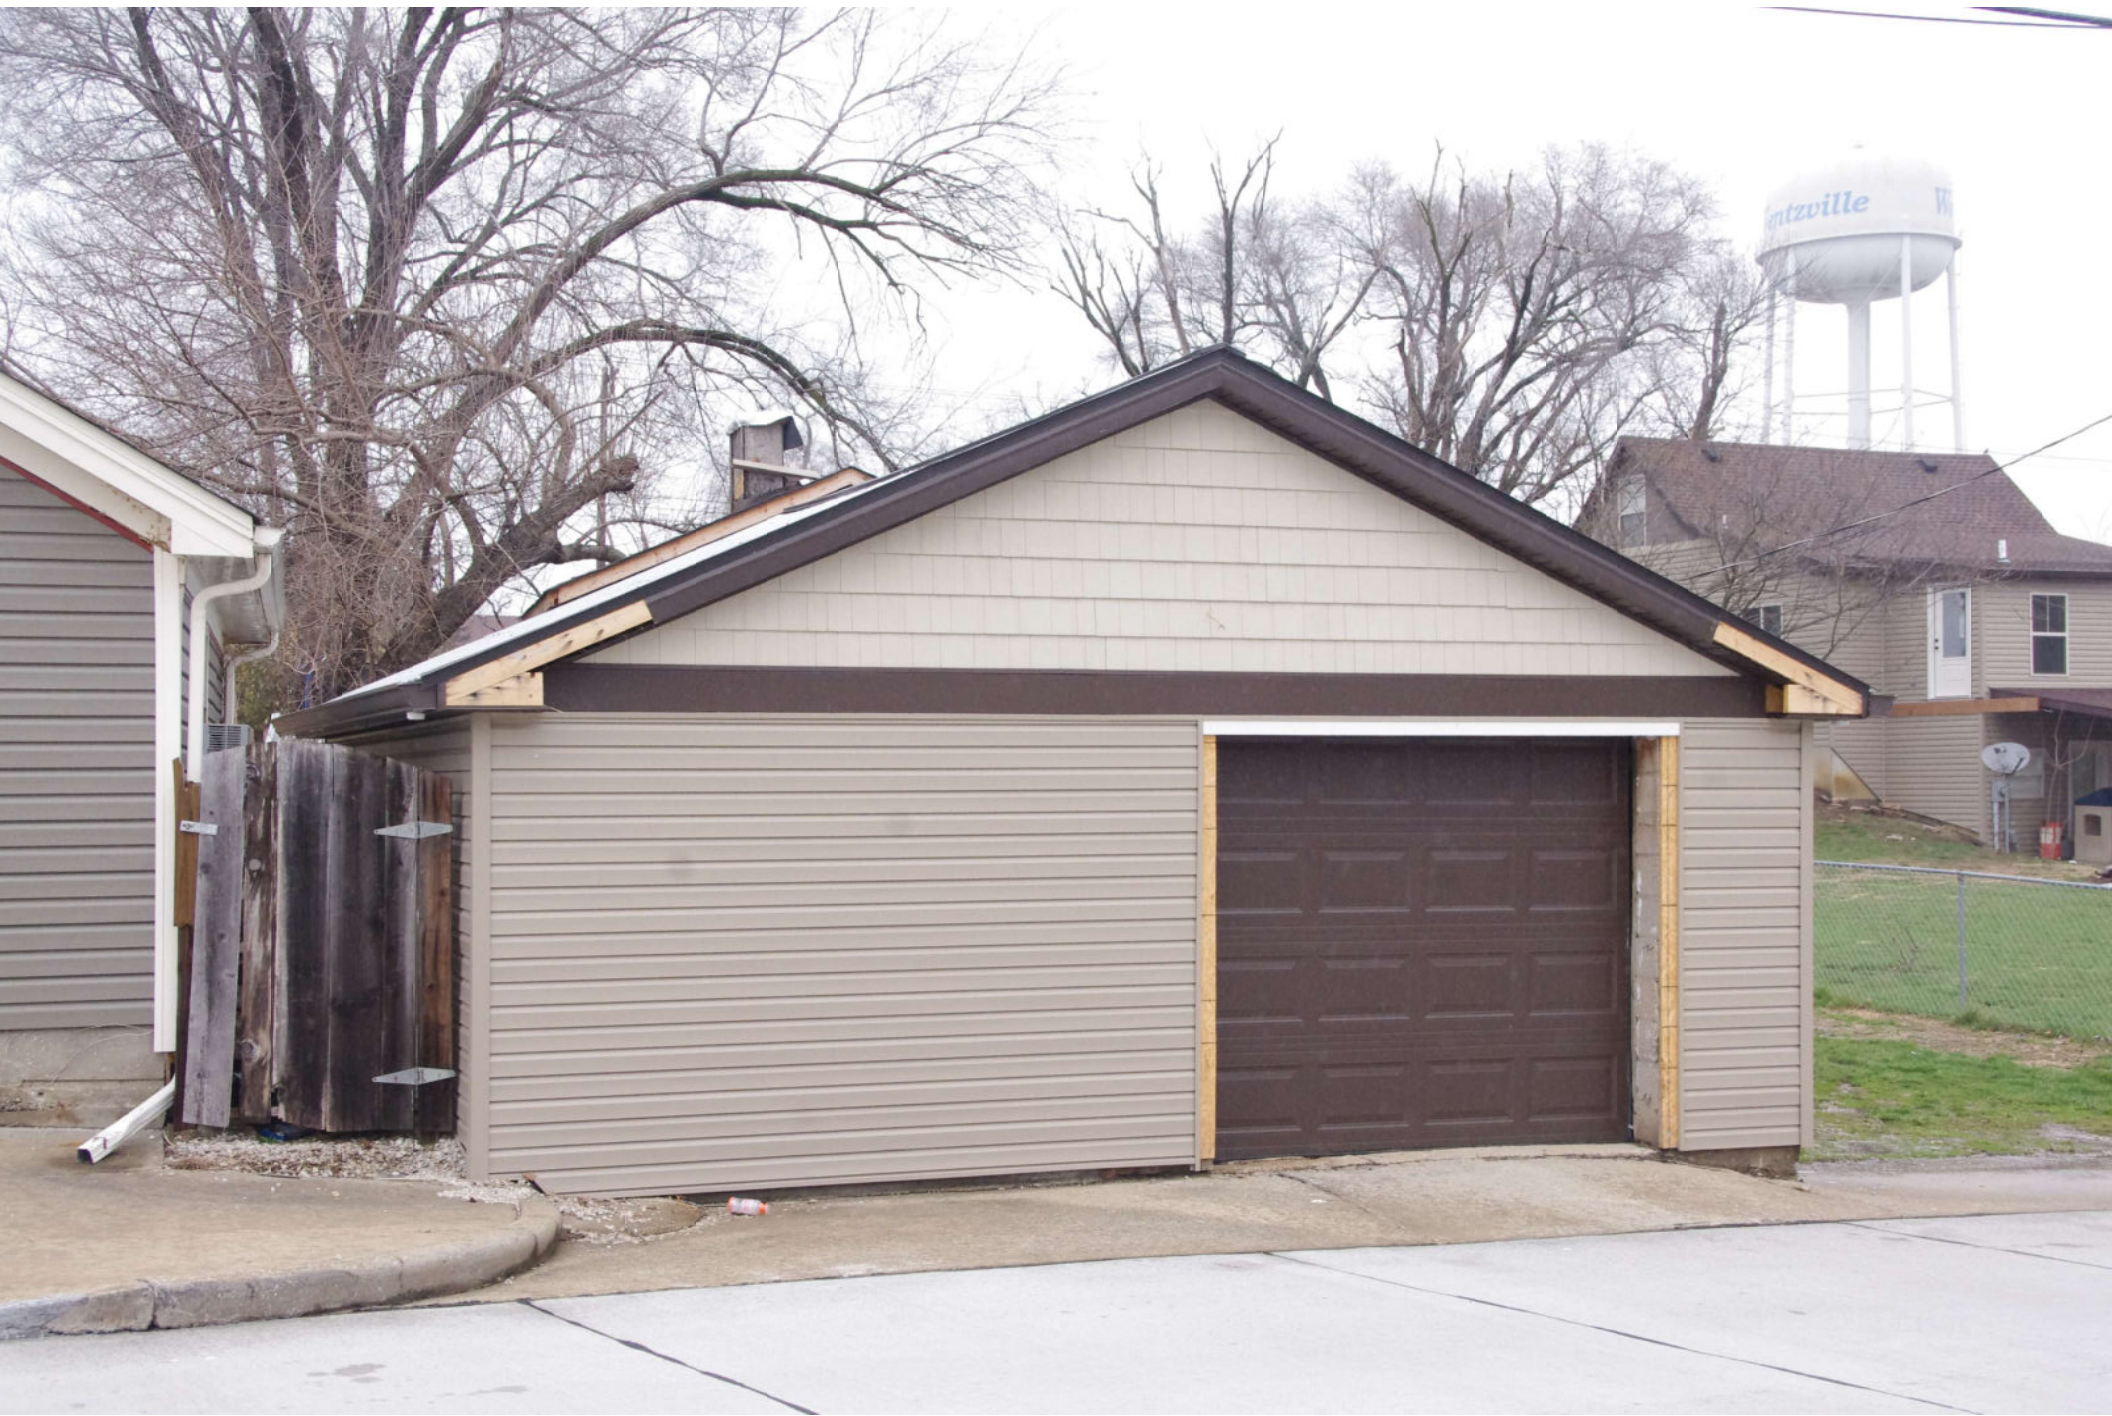
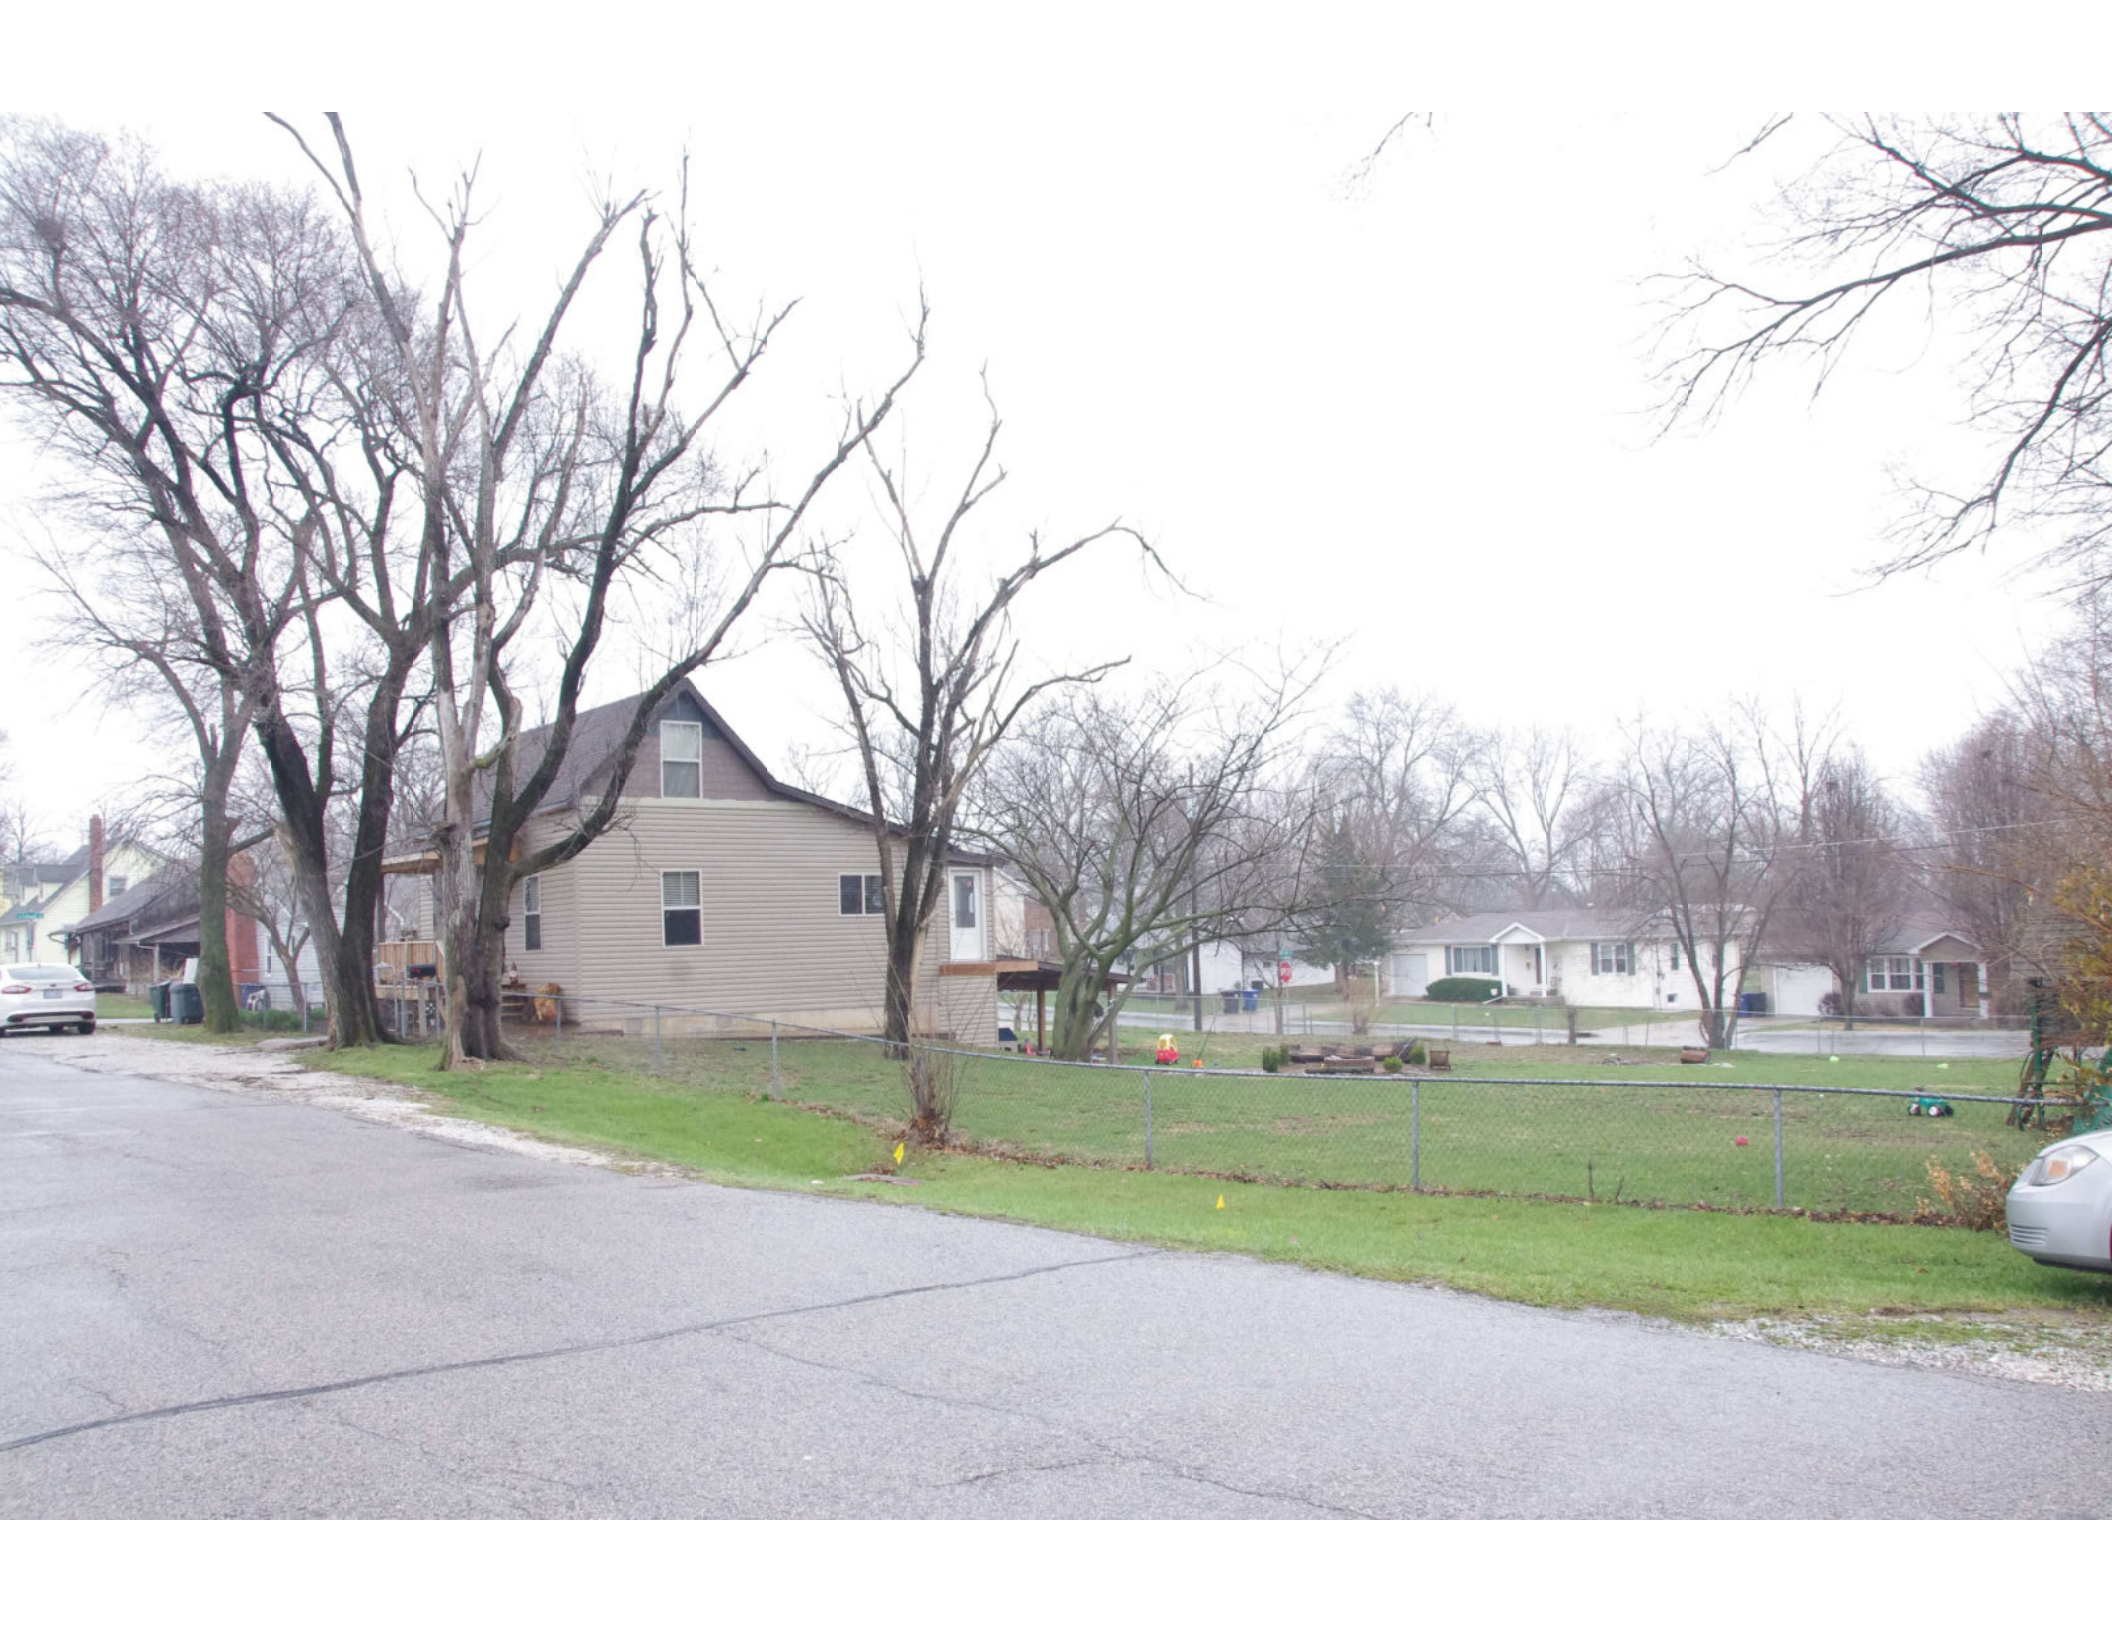
This resource is a 1.5-story side gabled house with vinyl siding and a central shed roofed front porch with replacement wood posts and replacement wood railing. Centered under the shed roof is the entry door, covered with a half light metal storm door. On either side are 2/1 replacement windows. On the rear is a shed roofed addition, two-stories in height since it extends to a walk-out basement level with french doors.

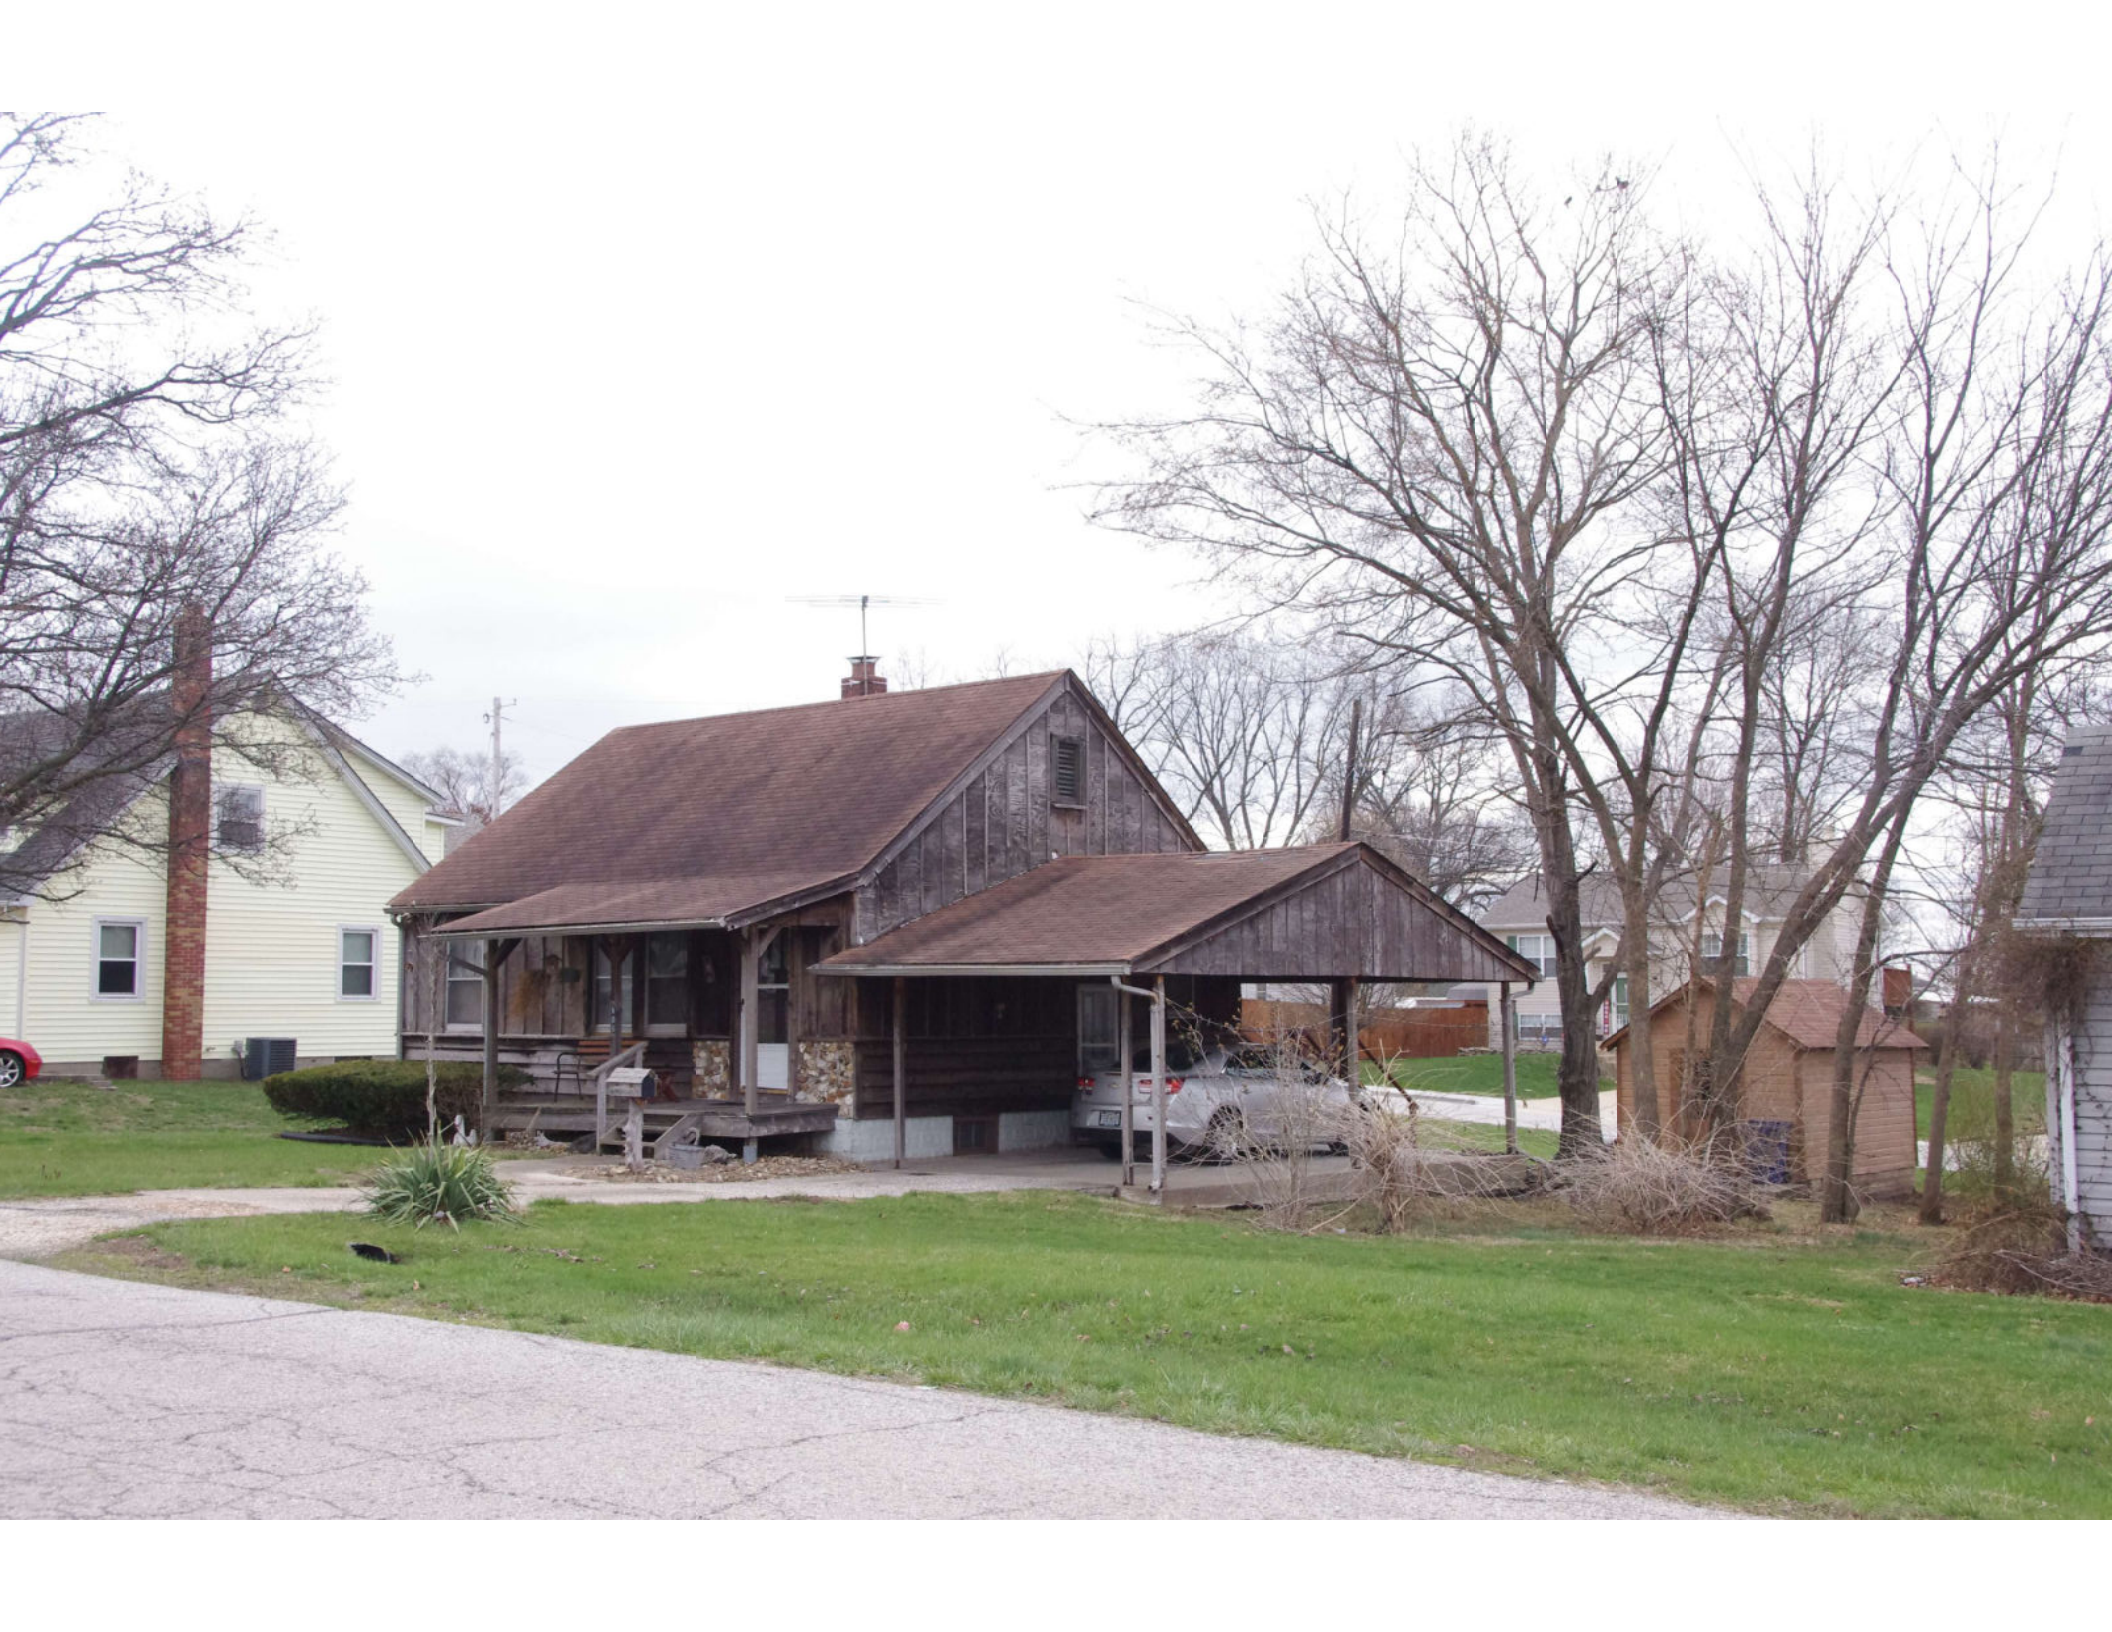
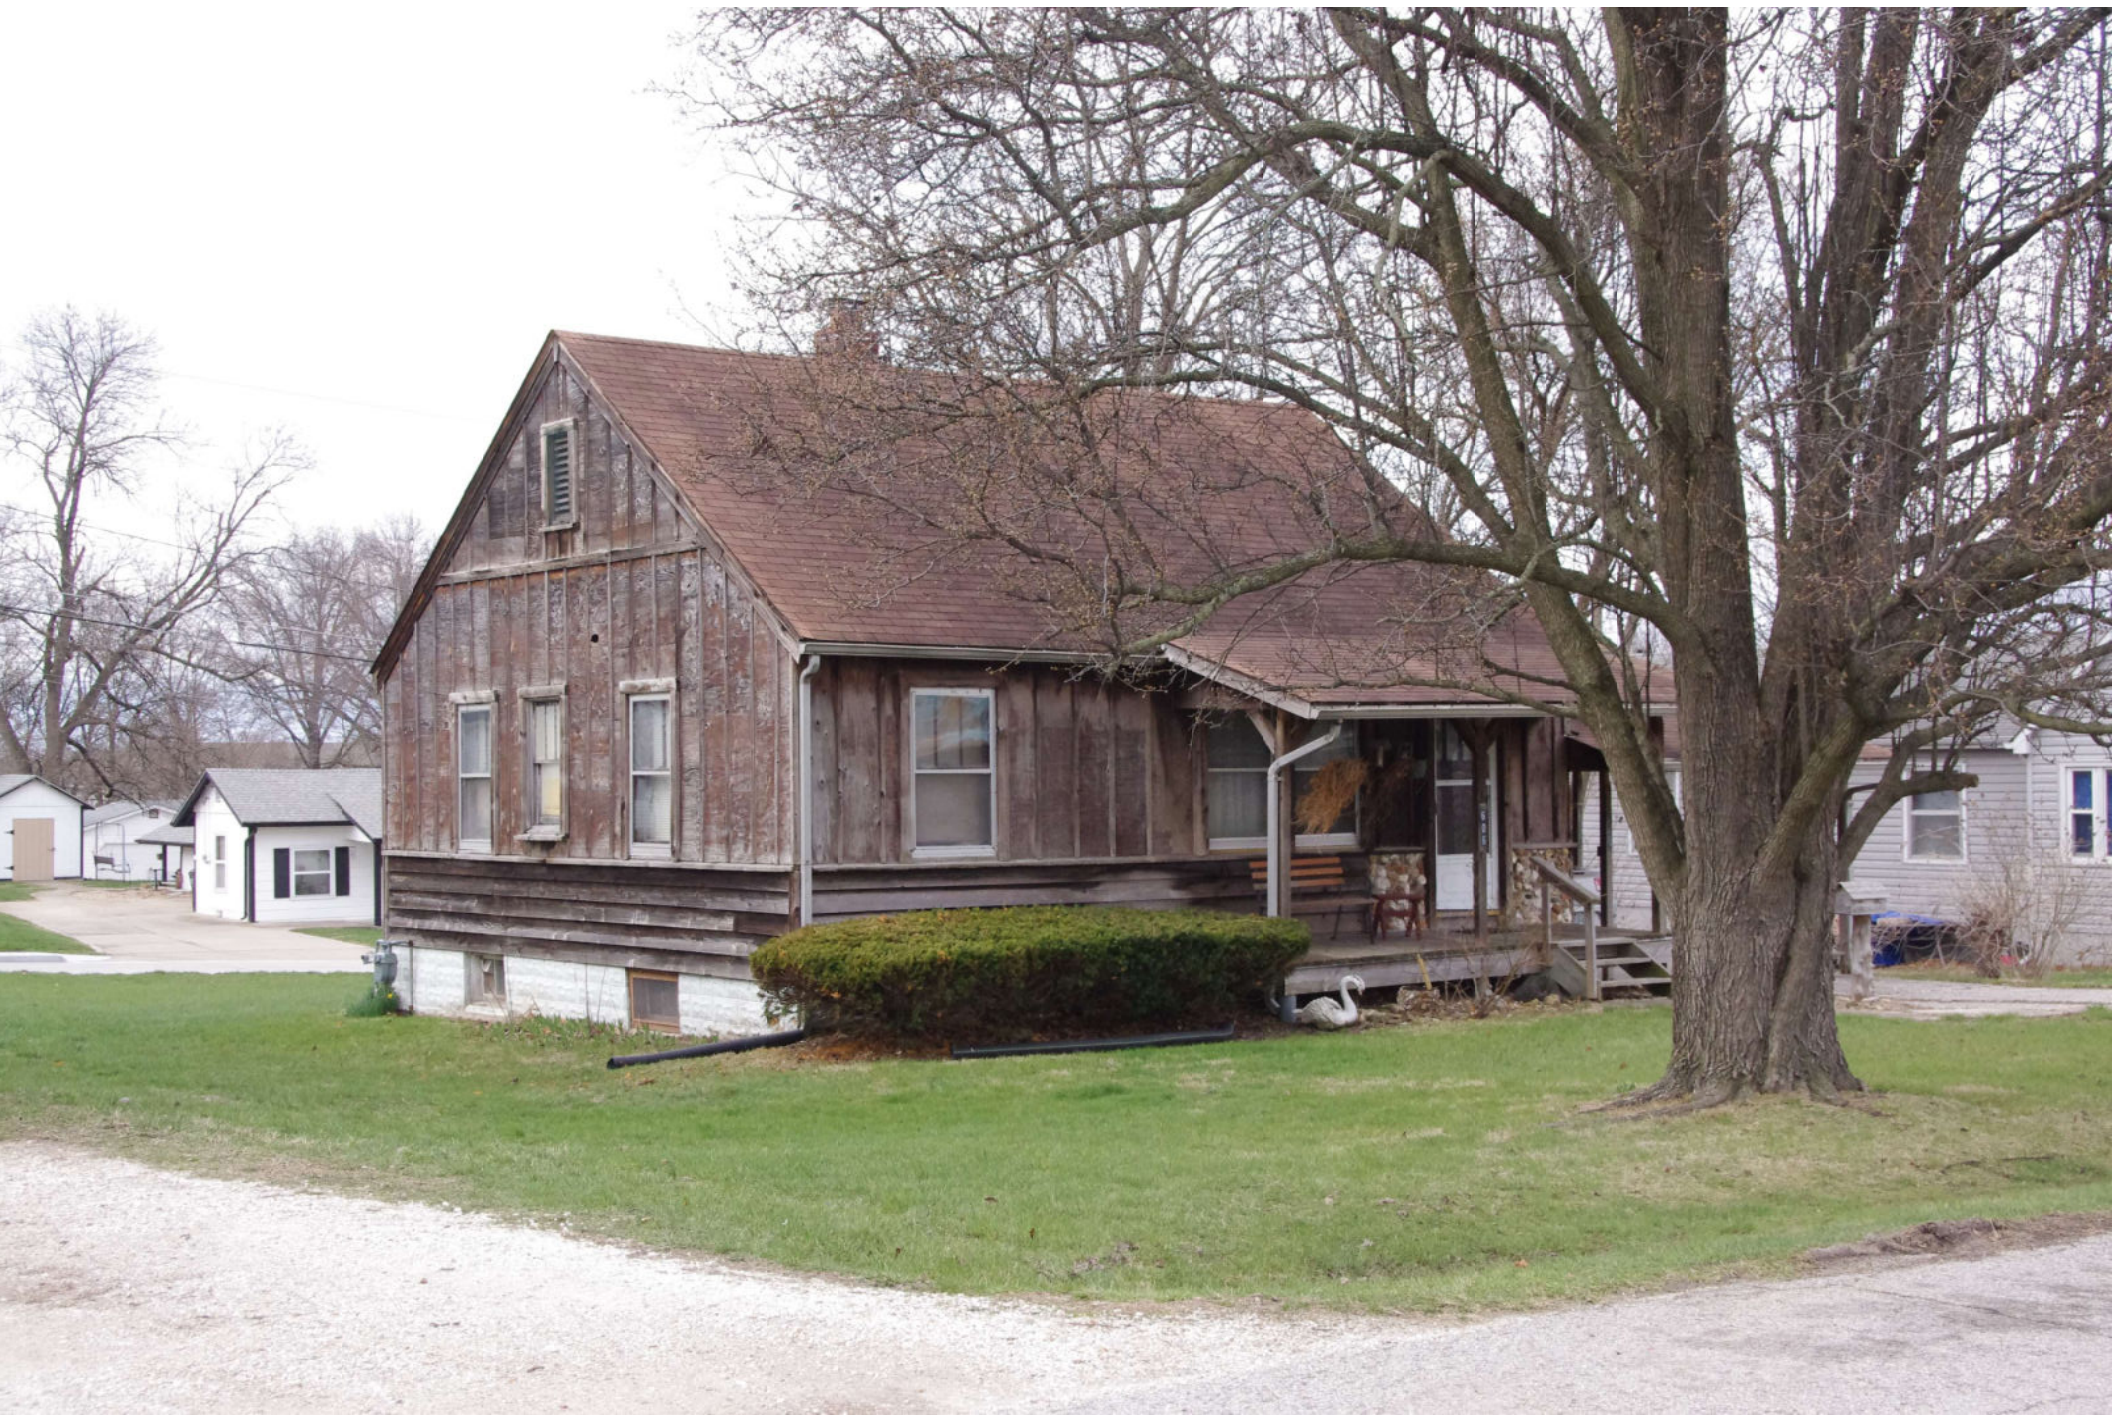
This one story, side gabled house has replacement siding made of plywood with battens added above wood lap siding that extends to the window sills, but none of the wood has been treated or painted, and is deteriorating. The shed roof porch covers the western and central bays. Its roof is supported by simple wood posts resting on the wood porch floor. Panels of rock have been added below the sill height on either side of the entry door. The wood door is covered by a metal storm door and is positioned in the west bay. Paired one-over-one sash are adjacent in the central bay. A three-over-one wood sash window is in the east bay on the façade. A side-gabled carport with wood posts is attached to the west side of the building. The only remaining original detail that is visible are the 3/1 wood sashed windows in most window openings. The faux stone foundation and the central brick chimney. The gable ends have louvered attic vents.
