**ARCHITECTURAL/HISTORIC INVENTORY FORM**

1. Survey No. SC-AS-012-0052		2. Survey Name: Reconnaissance Level Survey of Historic Downtown Wentzville	
3. County: St. Charles		4. Address (Street No.) 105	Street (name) South Linn Ave
5. City: Wentzville	Vicinity: <input type="checkbox"/>	6. UTM:	
8. Historic name (if known):		9. Present/other name (if known): Land Fair Corp.	
10. Ownership: <input type="checkbox"/> Private <input type="checkbox"/> Public		11a. Historic use (if known): COMMERCE/TRADE	11b. Current use: COMMERCE/TRADE/professional
5. City: Wentzville		7. Township/Range/Section:

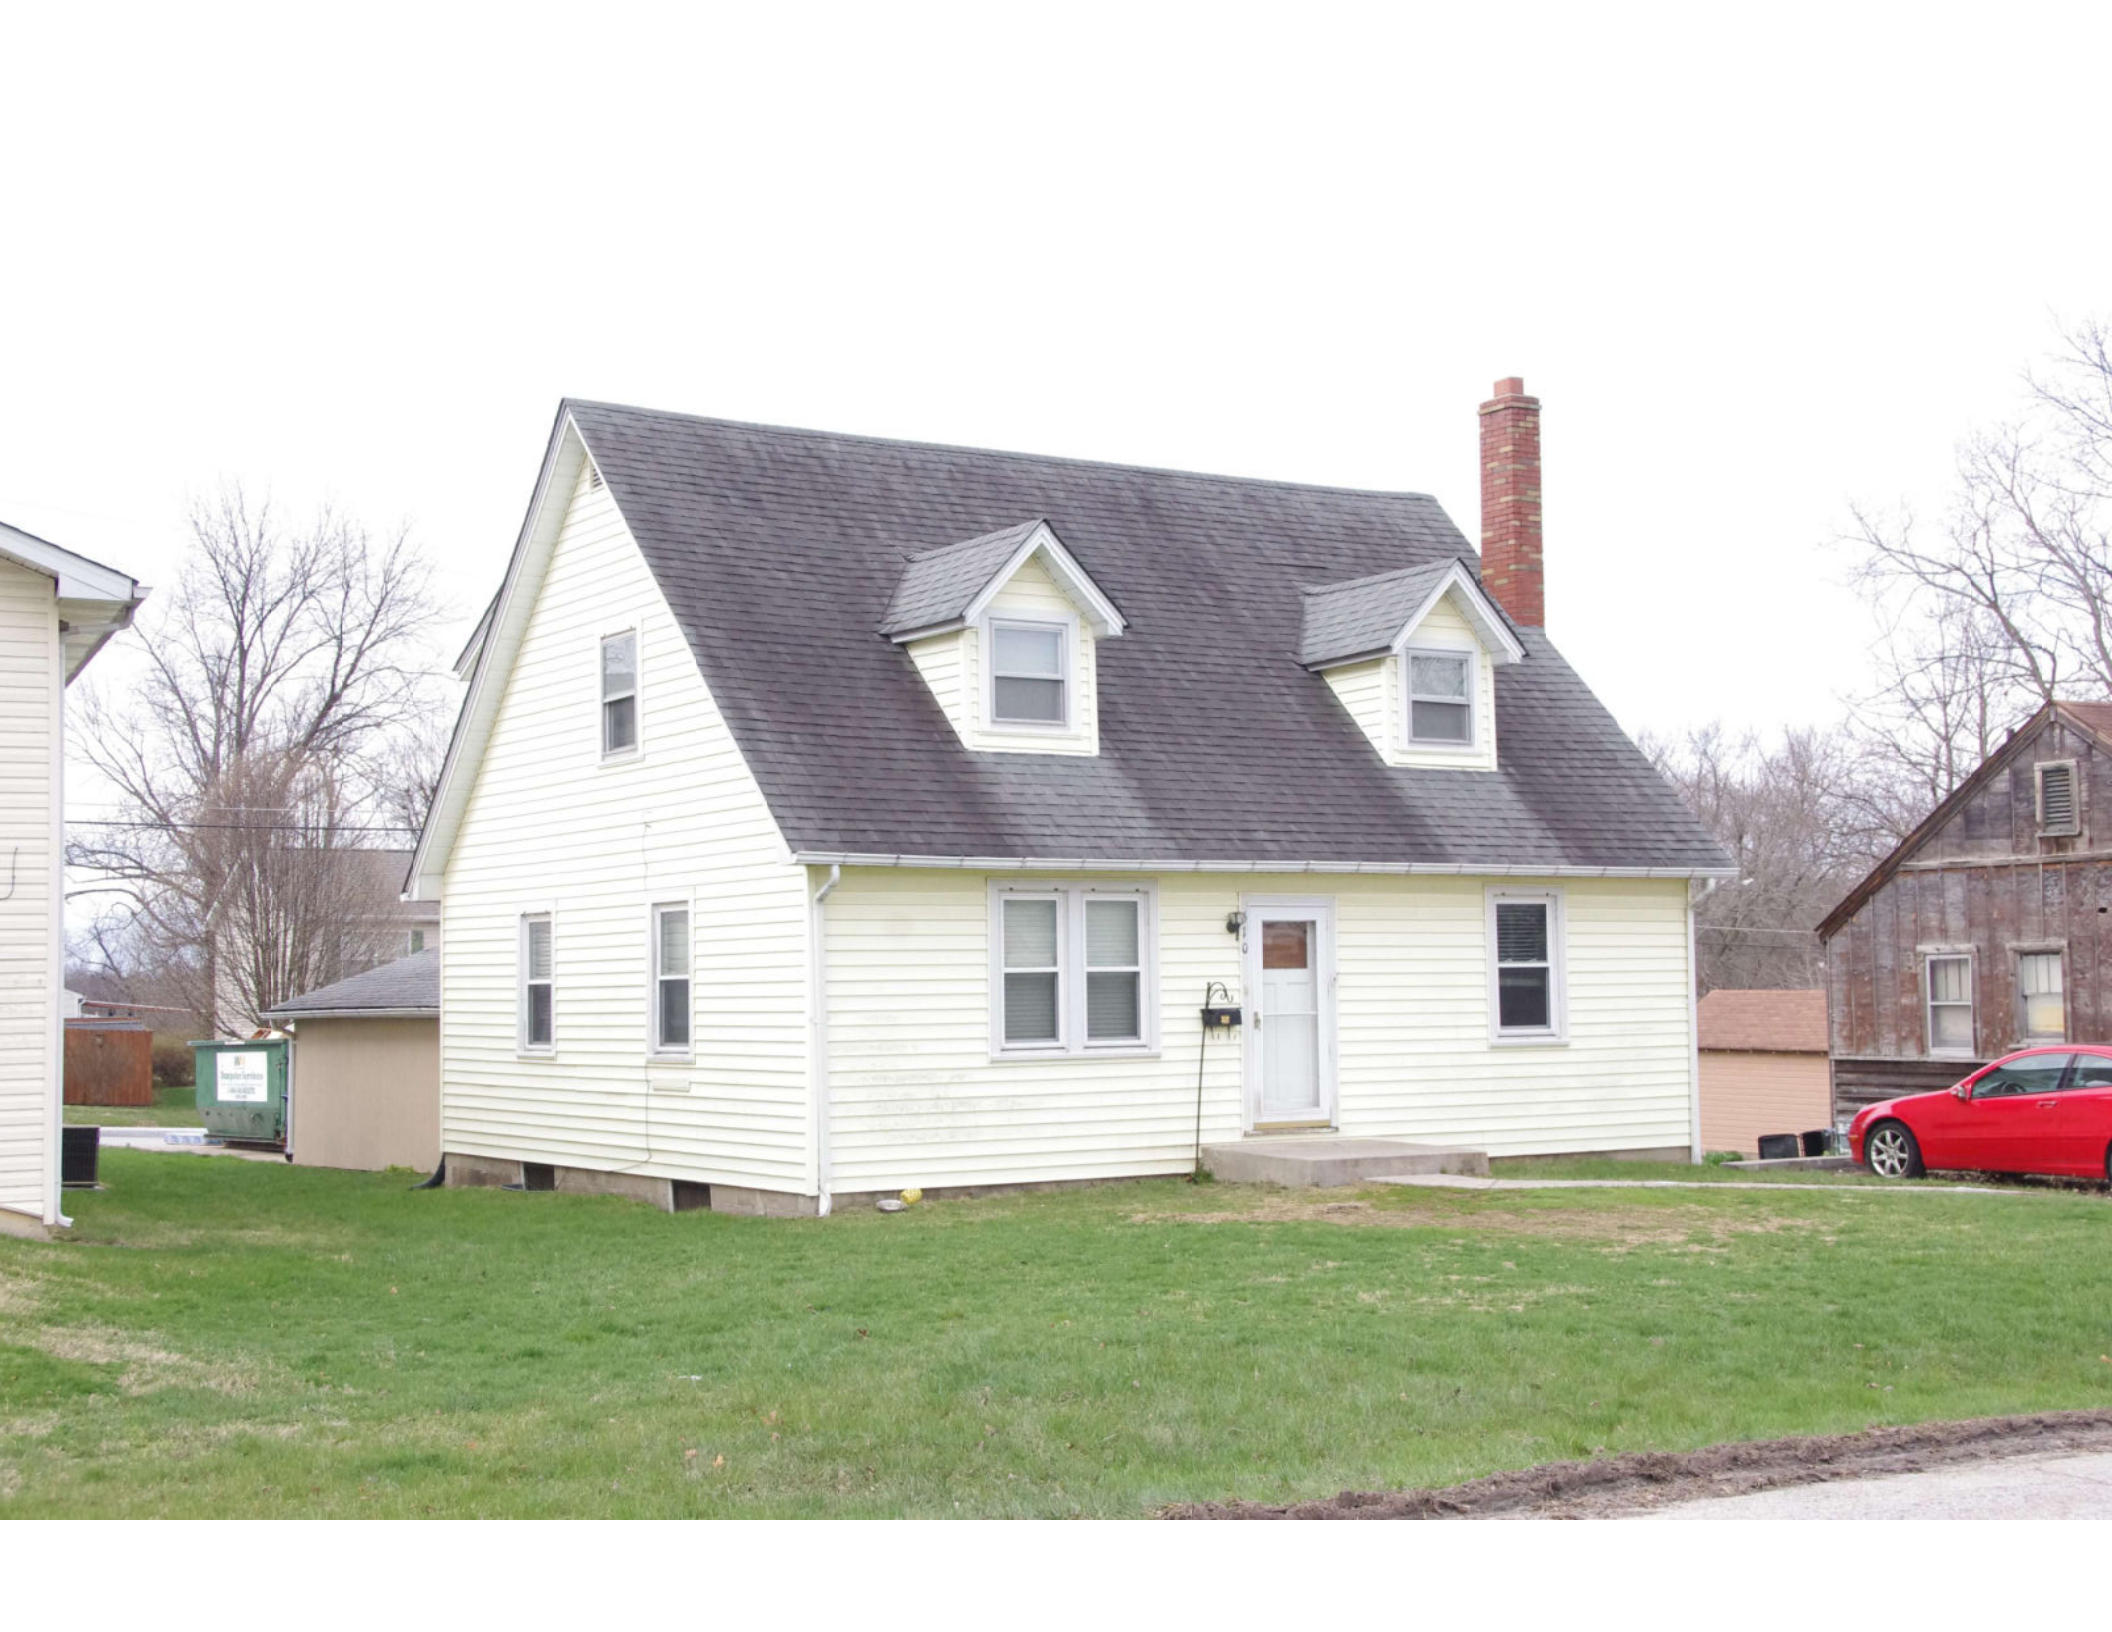
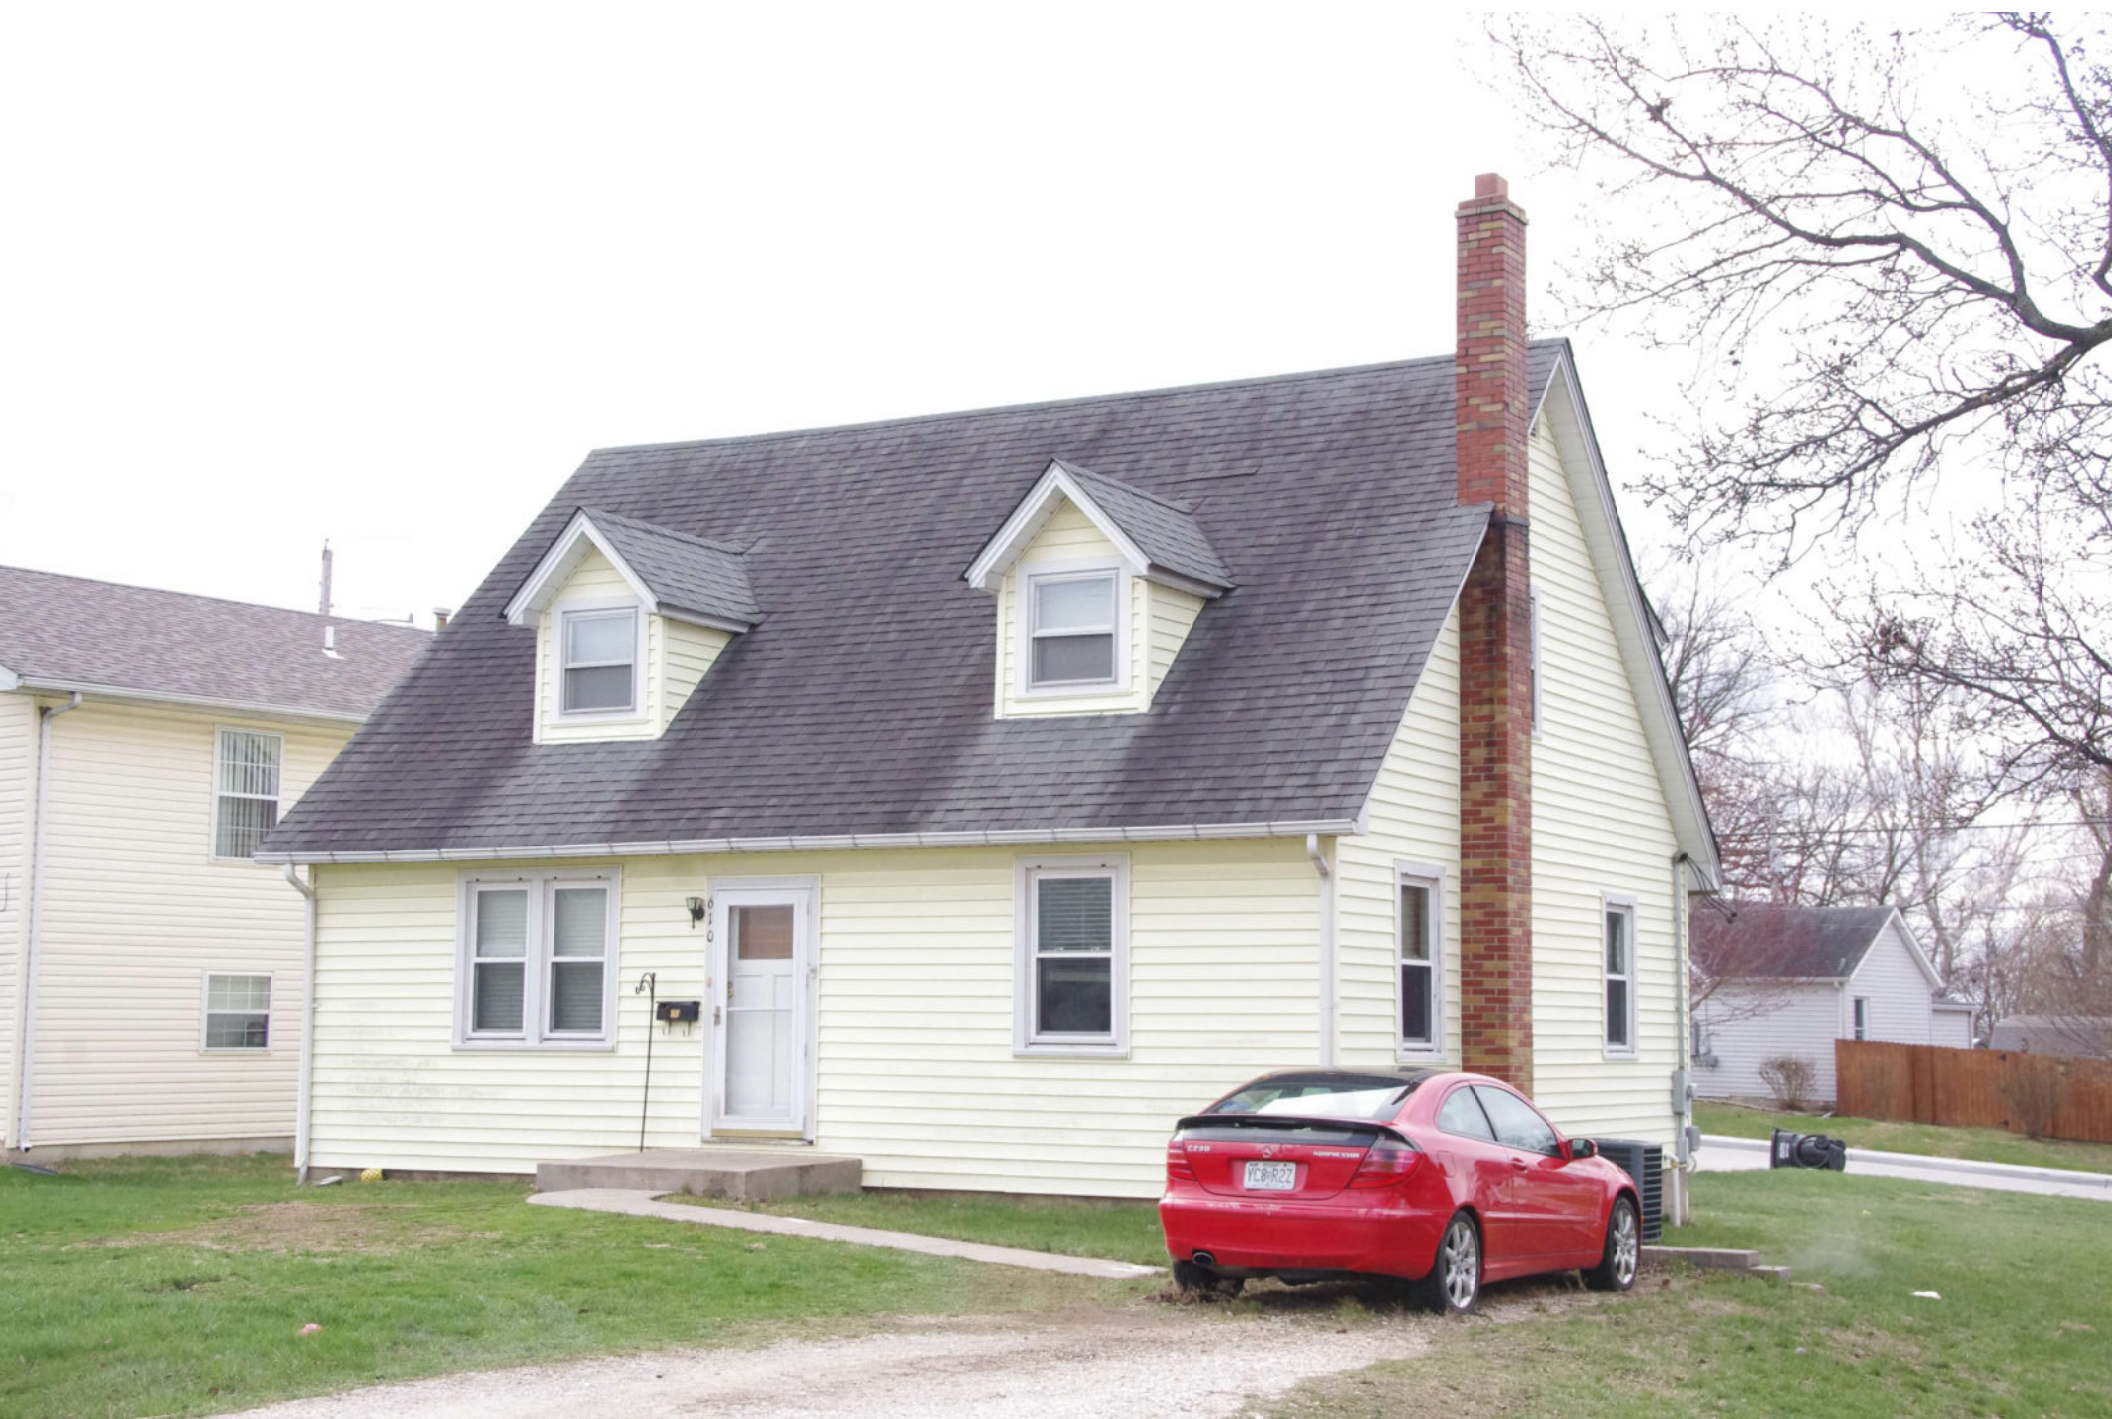
This 1.5 story, steeply pitched side gable, Cape Cod house has two gabled dormers on the façade with the one-quarter light, two tall vertical panel wood door and simple, low concrete stoop centered on the façade. To the east are paired, 1/1 sashed windows and to the west is a single 1/1 sashed window. There is a red brick chimney on the west side, piercing through the wide eaves. The rear of the house faces Pitman and has an original broad shed roofed dormer and shed roofed porch, but a central two story addition has been added in the center of the rear façade with a shed roof. Attached behind is a one car, end gabled garage that was being added at the time of the survey, attached to the rear of this two story addition and the rear porch.

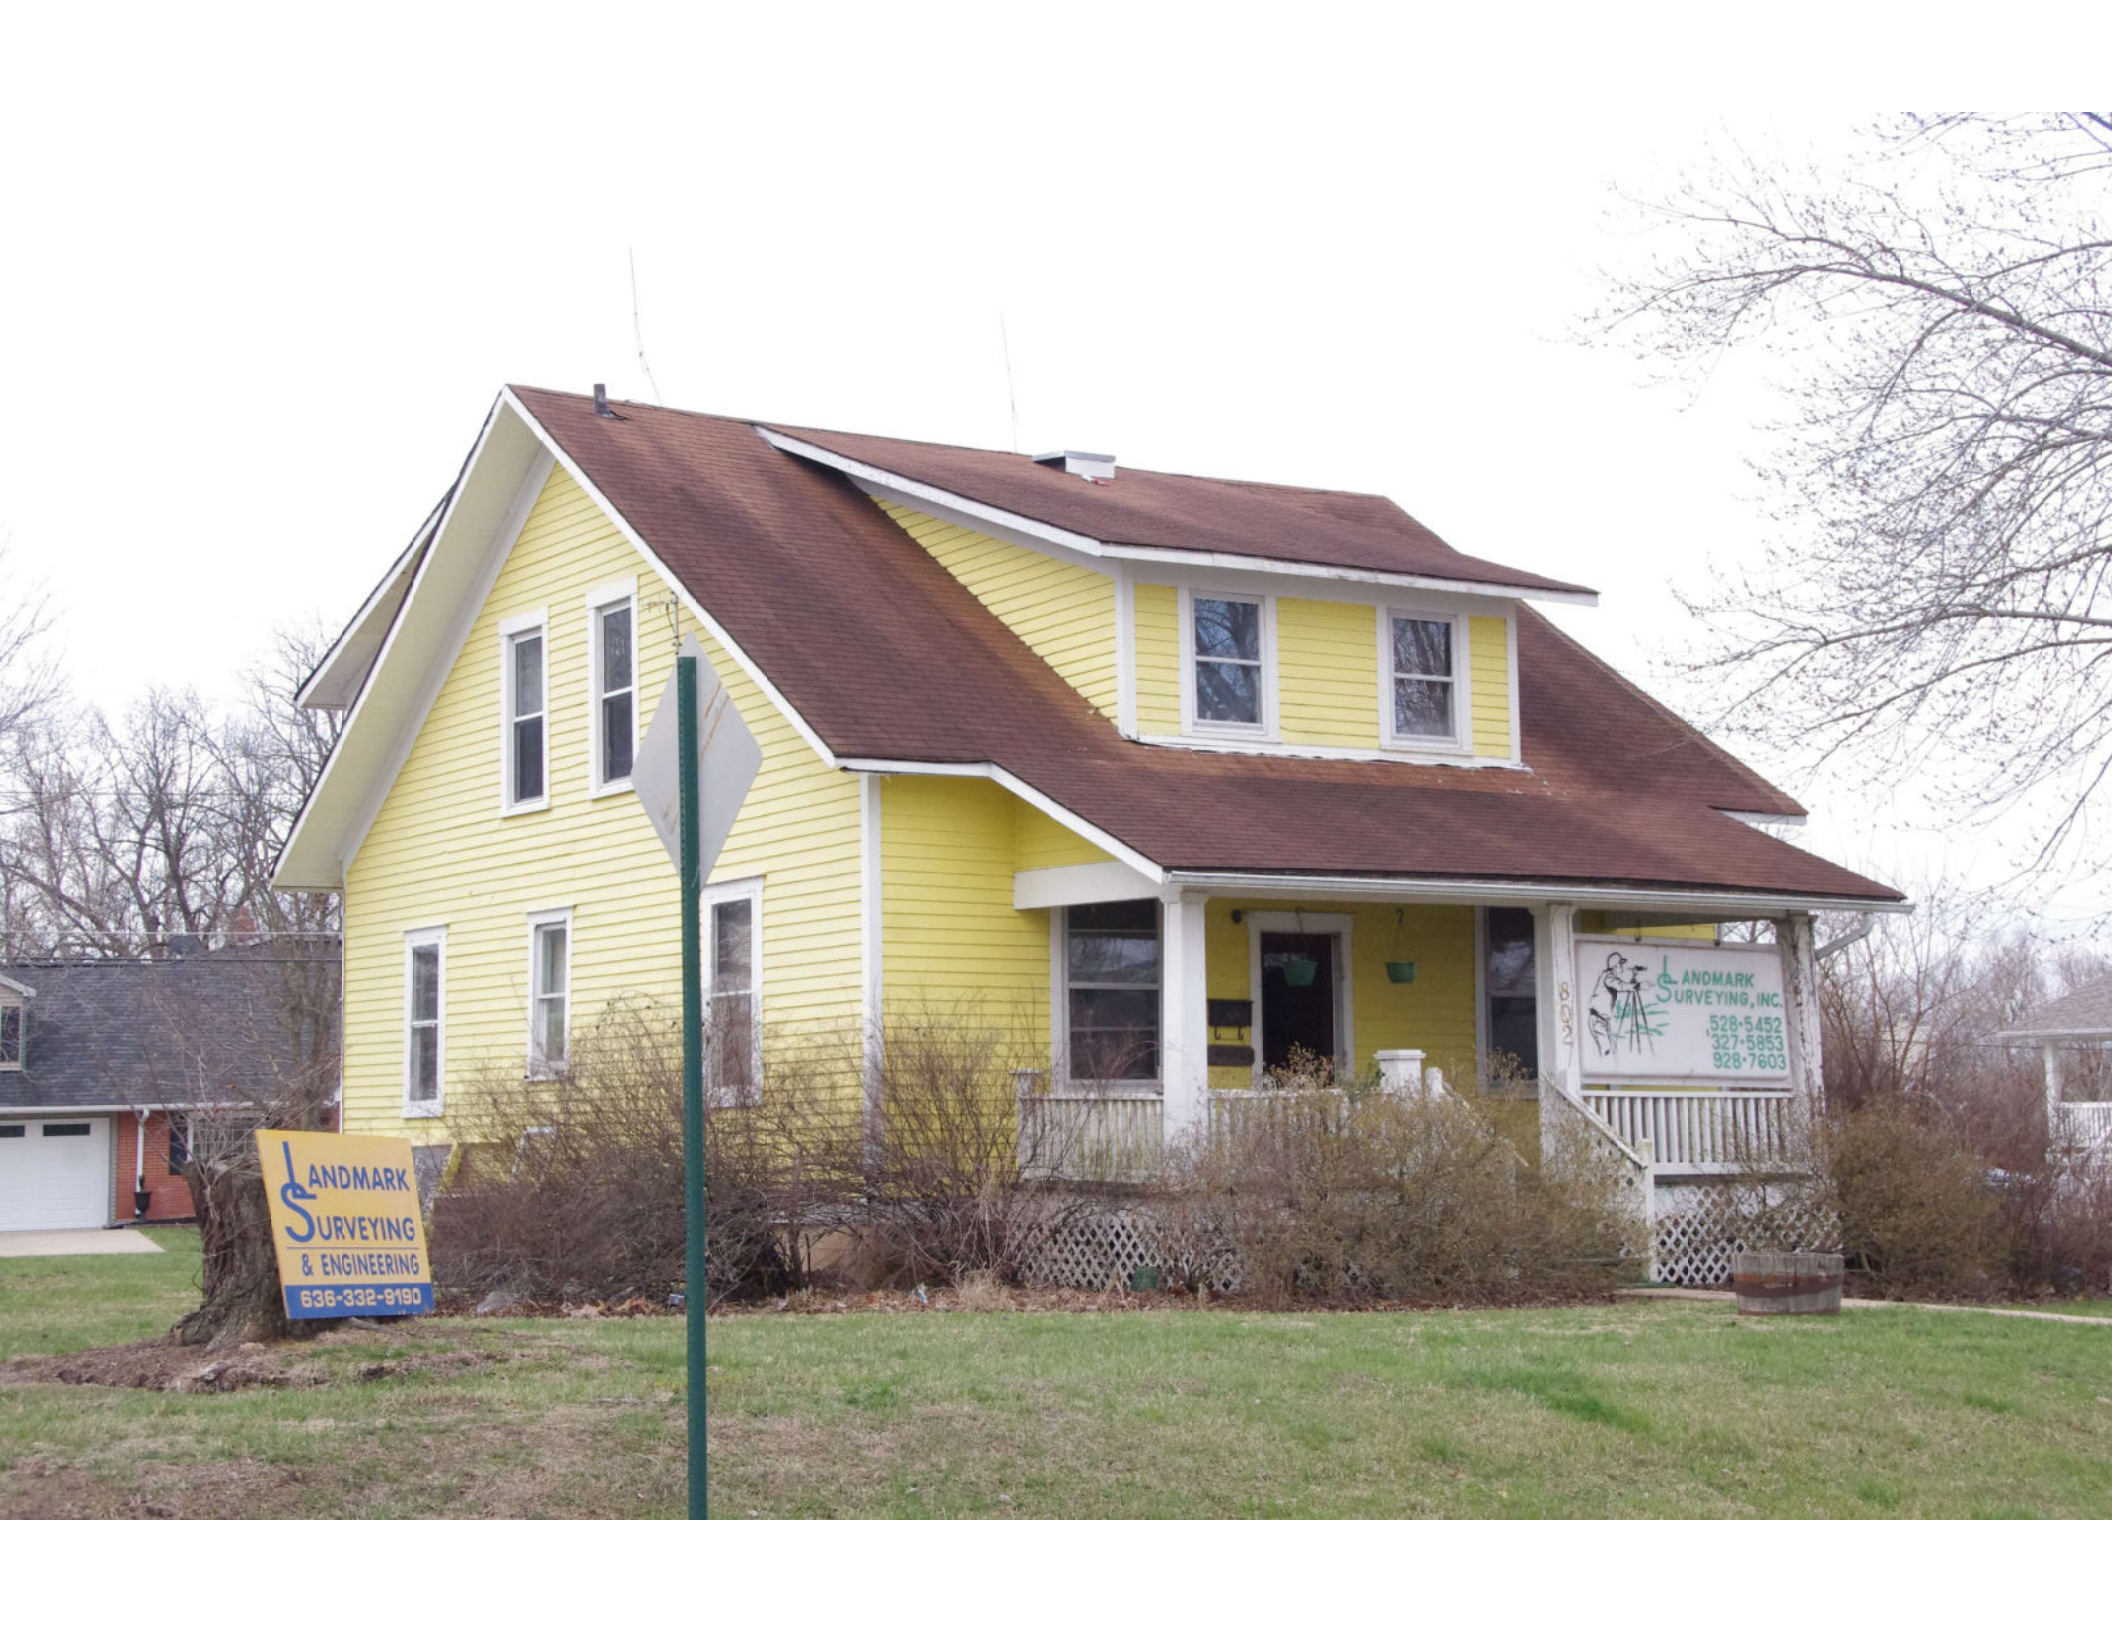
This one-and-a-half story, Craftsman bungalow has a a steeply pitched side gabled roof that extends into the shed roofed, nearly full width front porch. The porch retains its original, large square wood paneled columns, square baluster railings, wood porch floor and wide eaved roof. The main house roof has wide eaves as does the shed roofed dormer with bead board on the underside of he eaves. The entry door is flanked on both sides by broad historic one-over-one sash windows. There are two one-over-one sash windows in the shed dormer above. There is another shed roofed dormer on the rear, off-center toward the east with a corner sunroom on the southwest corner of the house with the rear entry stairs.

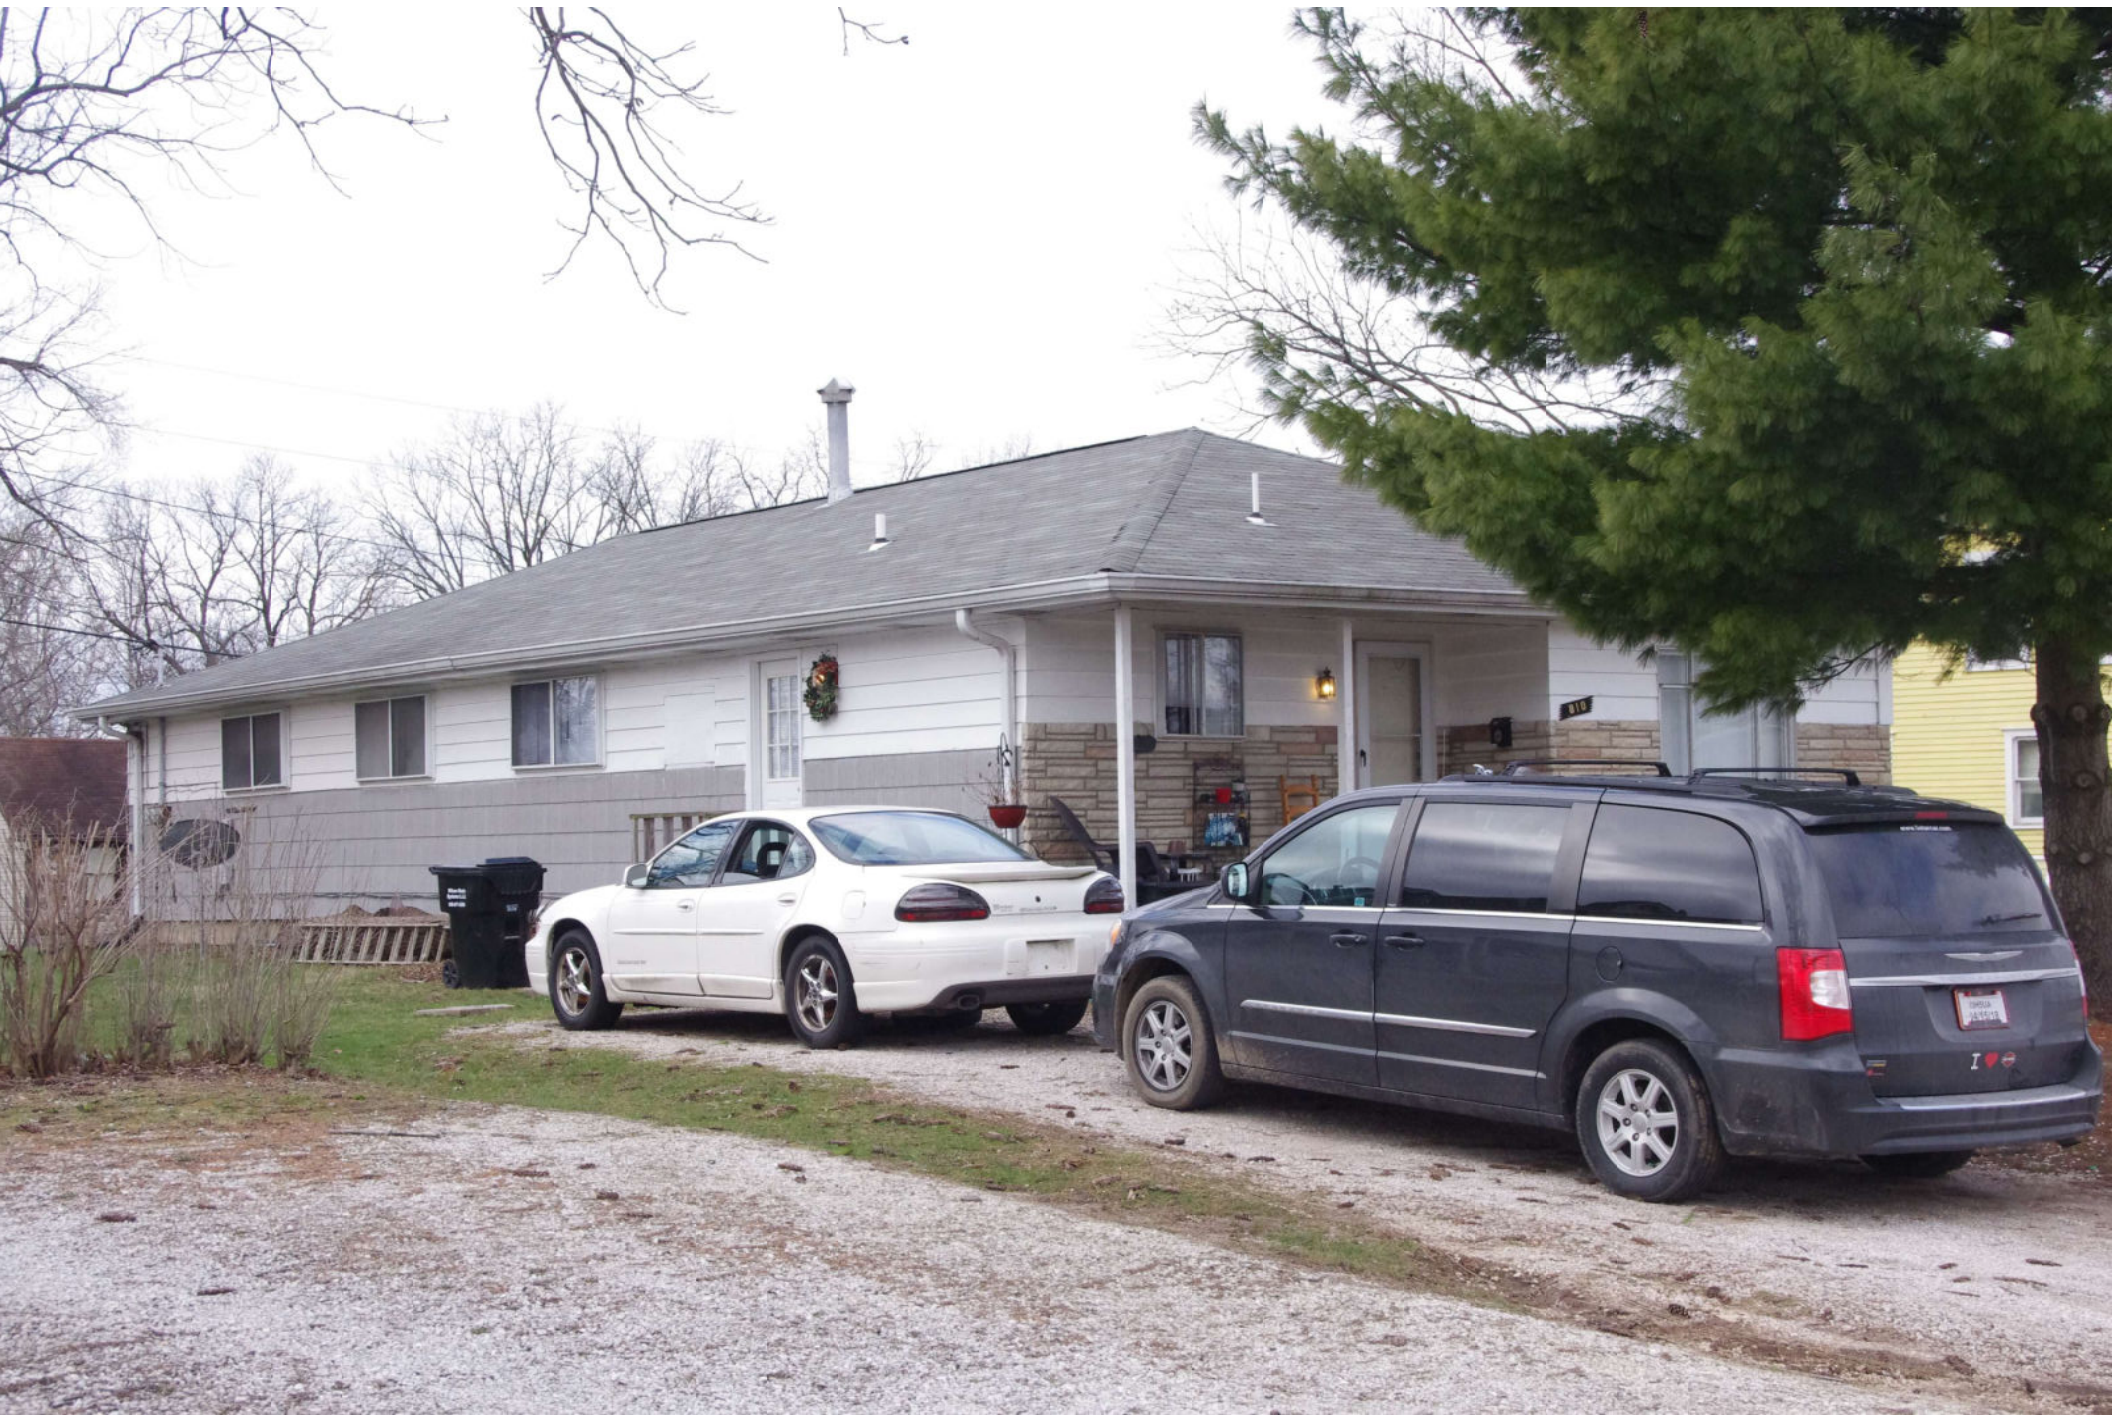
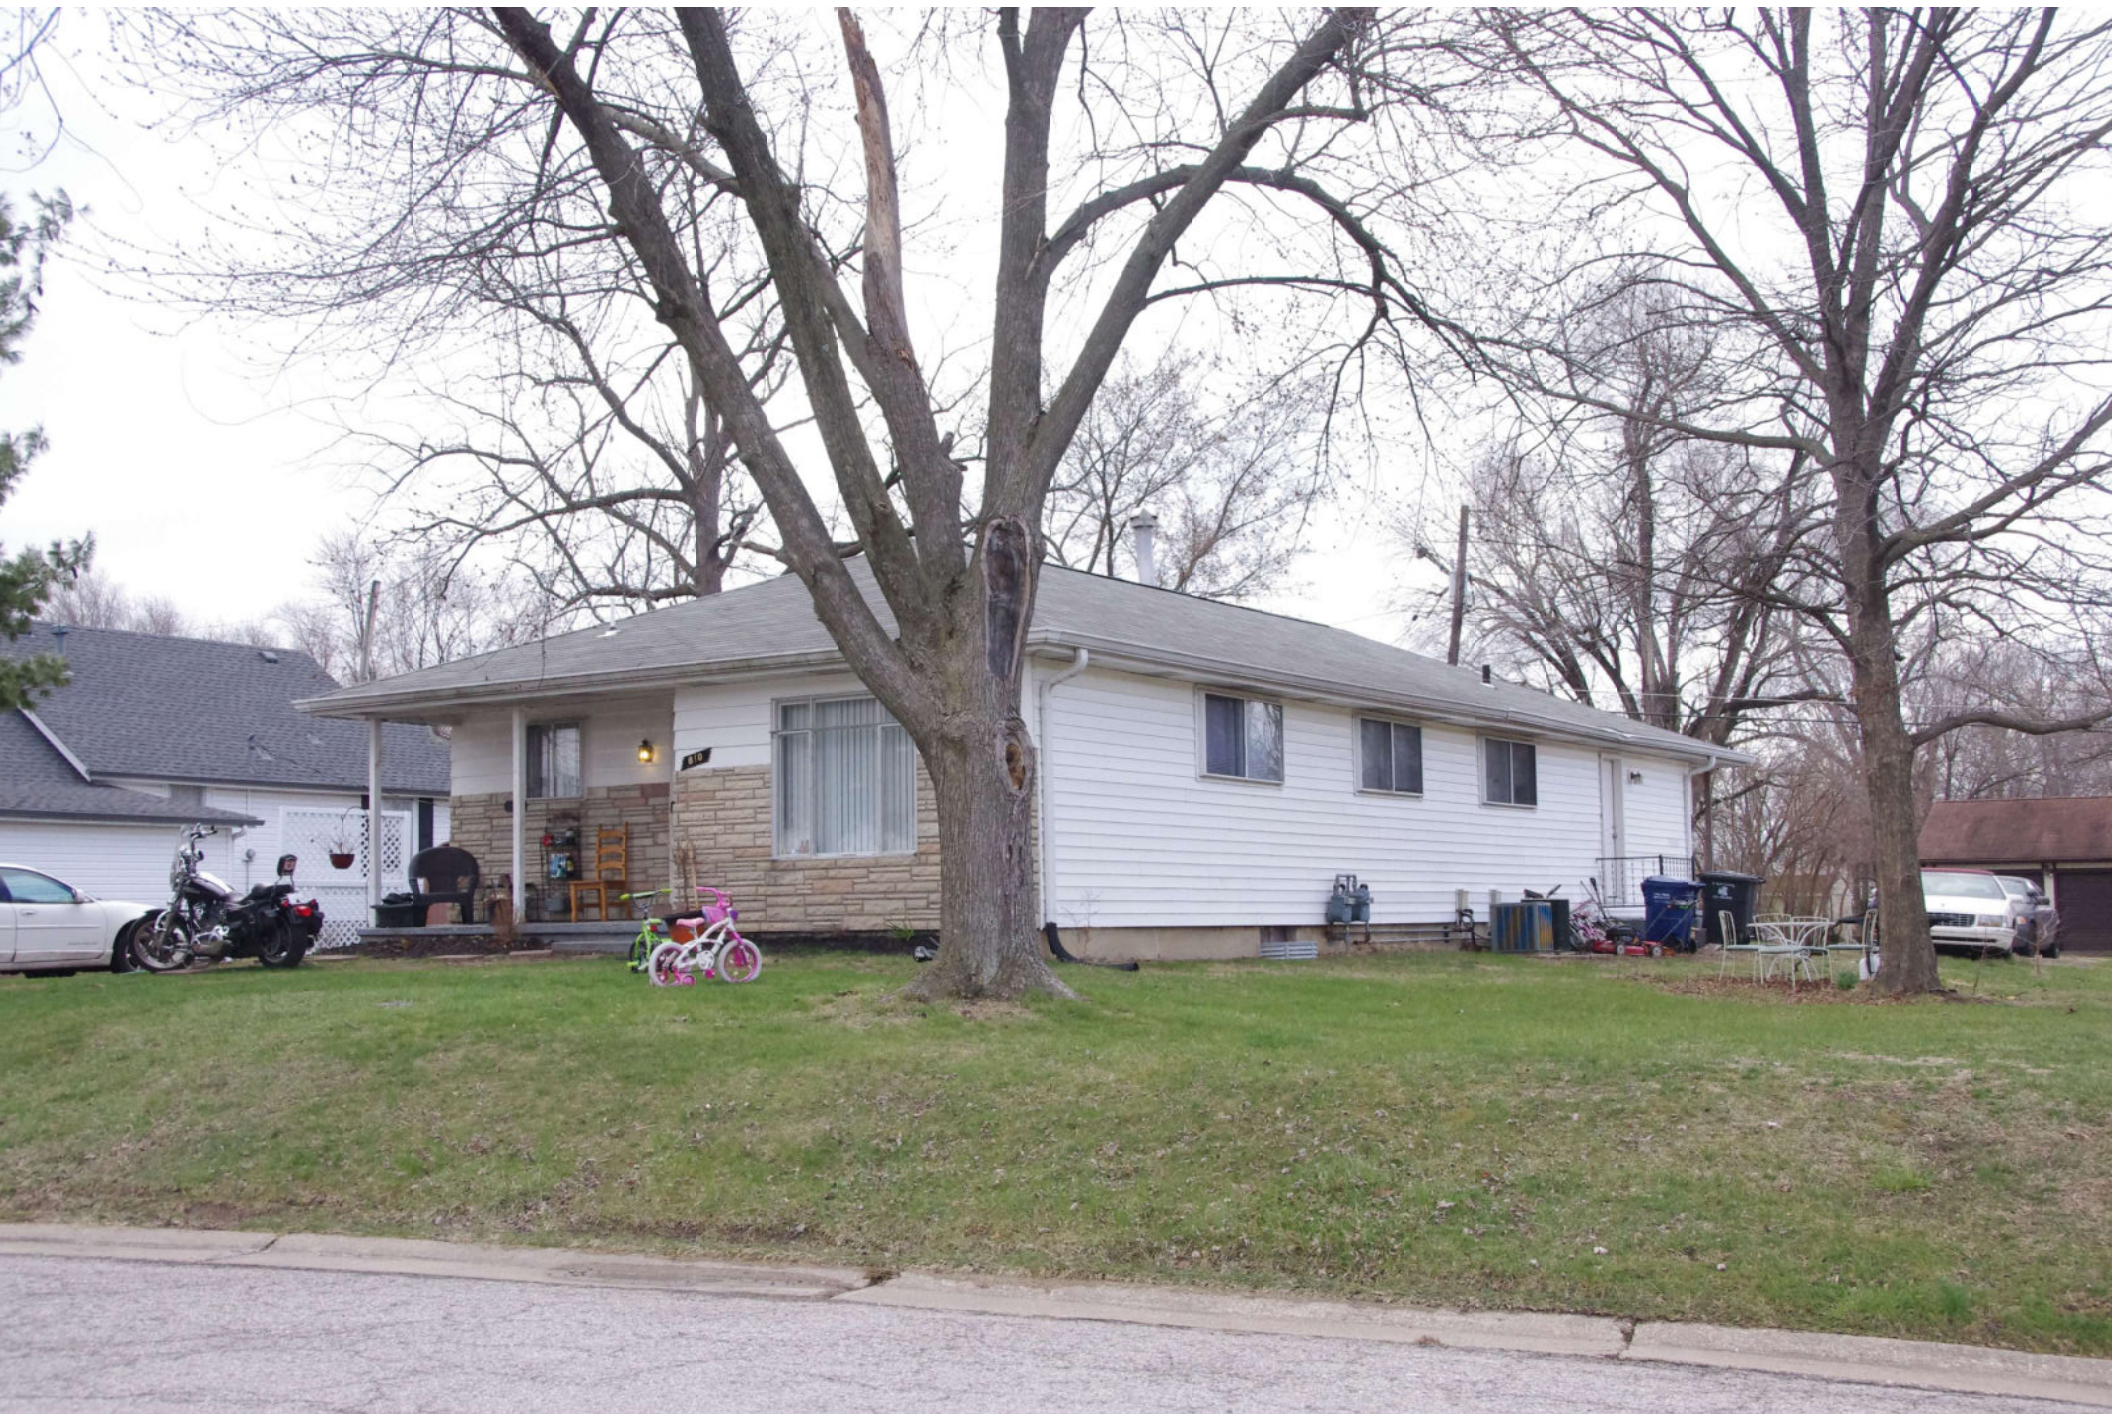
This unusual double house has two identical facades, back to back. It has a hipped roof with wide enclosed eaves and aluminum siding which may be original given the date of construction. An ashlar stone veneer covers the bottom two-thirds of the façade, with aluminum siding above. Recessed on the left half of the façade is an open porch supported by simple square posts resting on the low concrete porch floor. The door is nestled next to the interior corner of the porch with a raised window next to the door (on 810 East Main it is one of the 2 light aluminum slider windows found on most of the building; on 811 East Pitman has been replaced with a 1/1 sashed window). The other half of the façade has a picture window divided by slender mullions to create the appearance of sidelights and transoms. The central wood door is recessed below and open porch. Horizontal sliding single pane windows fill the western bay. The side elevations have aluminum siding on the upper portion but asbestos shingle siding on the lower two-thirds, from the base of the slider windows.

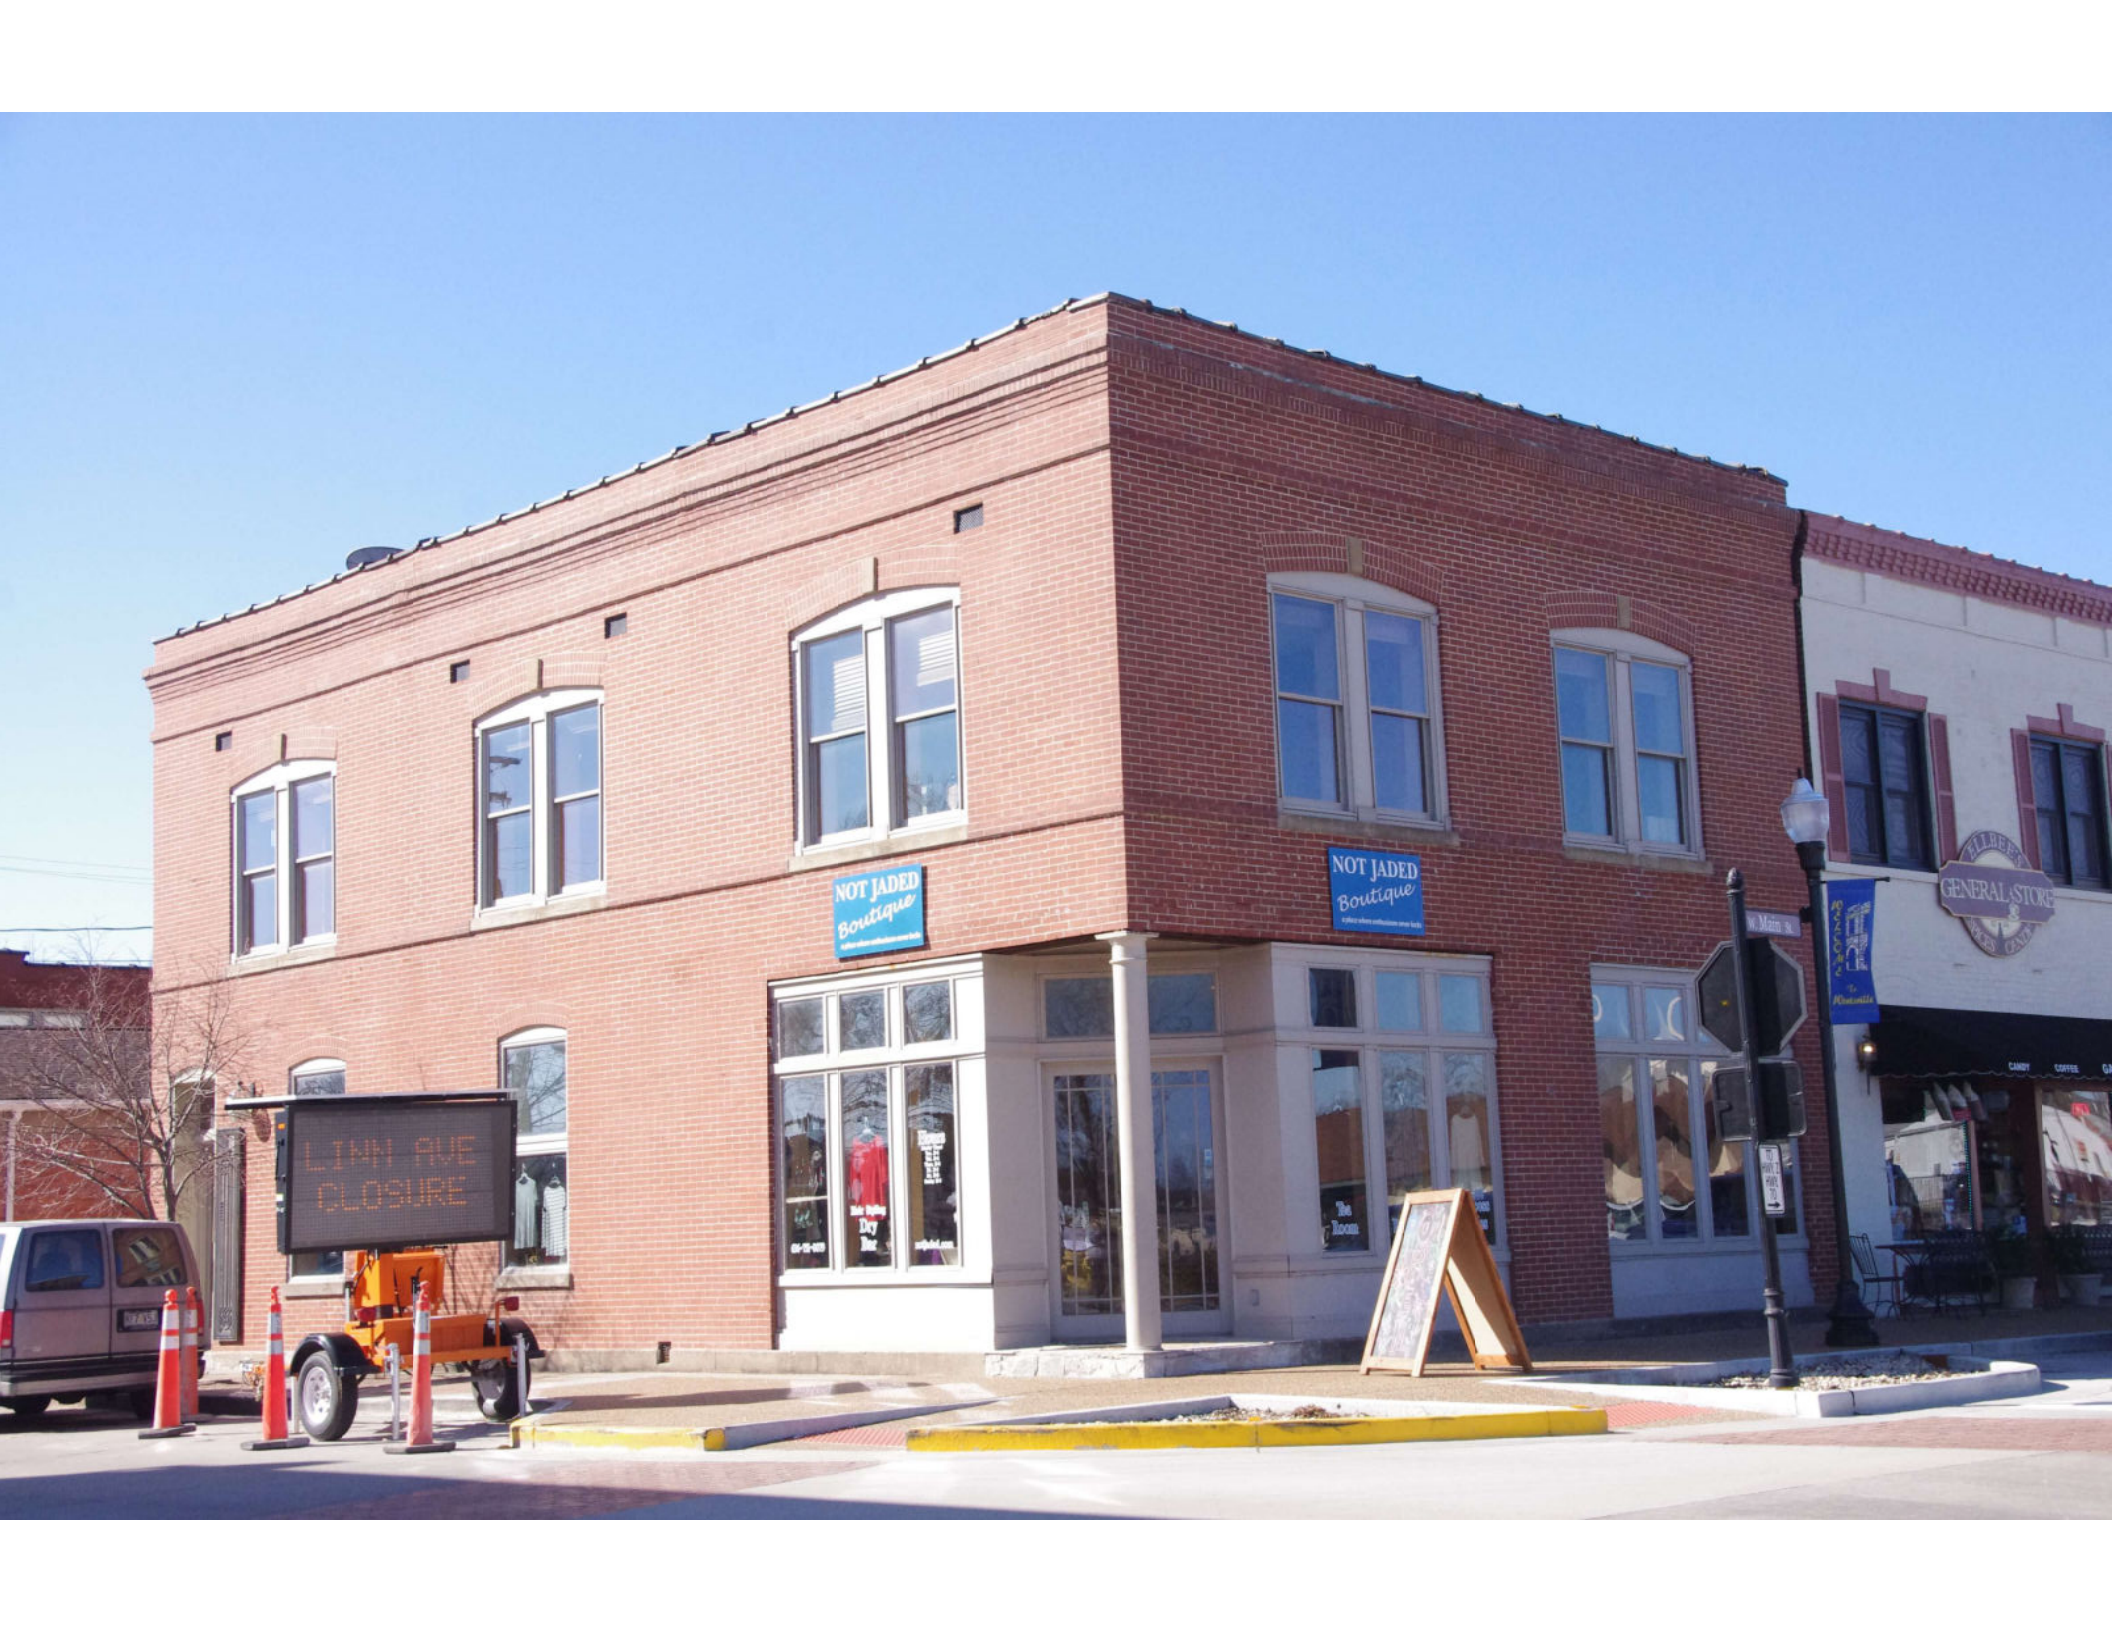
Secondary address: : 100 S. Linn Ave.. 1927 fire insurance map addresses this property as 566 Main Street and 678-679 Linn Ave. This 2-story, flat roofed, red brick commercial building has a Doric style cast iron column where the two street elevations meet. The clipped corner entry behind the column as well as the first floor display windows have been rebuilt in recent years to approximate the original entry and display windows within the original masonry openings (see p. 63 of Wentzville) but had been covered and encased in brick by the 1940s (see. P. 76 of Wentzville). There are two display windows facing Main and one on Linn, with 2 sashed window openings as well as a transomed doorway on the first floor of Linn. The two-part commercial block has a projecting 2-course brick continuous sill course (with concrete window sills) that separates the first and second floor. The second floor has paired sashed windows within brick segmental arched openings (with concrete keystones)—two on the Main façade and 3 along the Linn elevation. Both street elevations are capped with a corbelled brick that forms a cornice below the clay tile parapet cap. On the south (rear) elevation there has been a one story brick addition with 3 brick chimney-like extensions and wrought iron railings for the rooftop deck. The first floor of this addition is recessed back from the street with a single door and window—flat headed openings (while the main historic building has segmental arched openings). The addition was added at some point after the 1927 fire insurance map was compiled. Given the alterations to the display windows and entry, as well as the second floor window replacement, which seems to have also changed the mullion between the paired window units, the building is not considered individually eligible for listing in the National Register, even though it is an important building in historic downtown.
