**ARCHITECTURAL/HISTORIC INVENTORY FORM**

1. Survey No. SC-AS-012-0052		2. Survey Name: Reconnaissance Level Survey of Historic Downtown Wentzville	
3. County: St. Charles		4. Address (Street No.) 105	Street (name) South Linn Ave
5. City: Wentzville	Vicinity: <input type="checkbox"/>	6. UTM:	
8. Historic name (if known):		9. Present/other name (if known): Land Fair Corp.	
10. Ownership: <input type="checkbox"/> Private <input type="checkbox"/> Public		11a. Historic use (if known): COMMERCE/TRADE	11b. Current use: COMMERCE/TRADE/professional
5. City: Wentzville		7. Township/Range/Section:

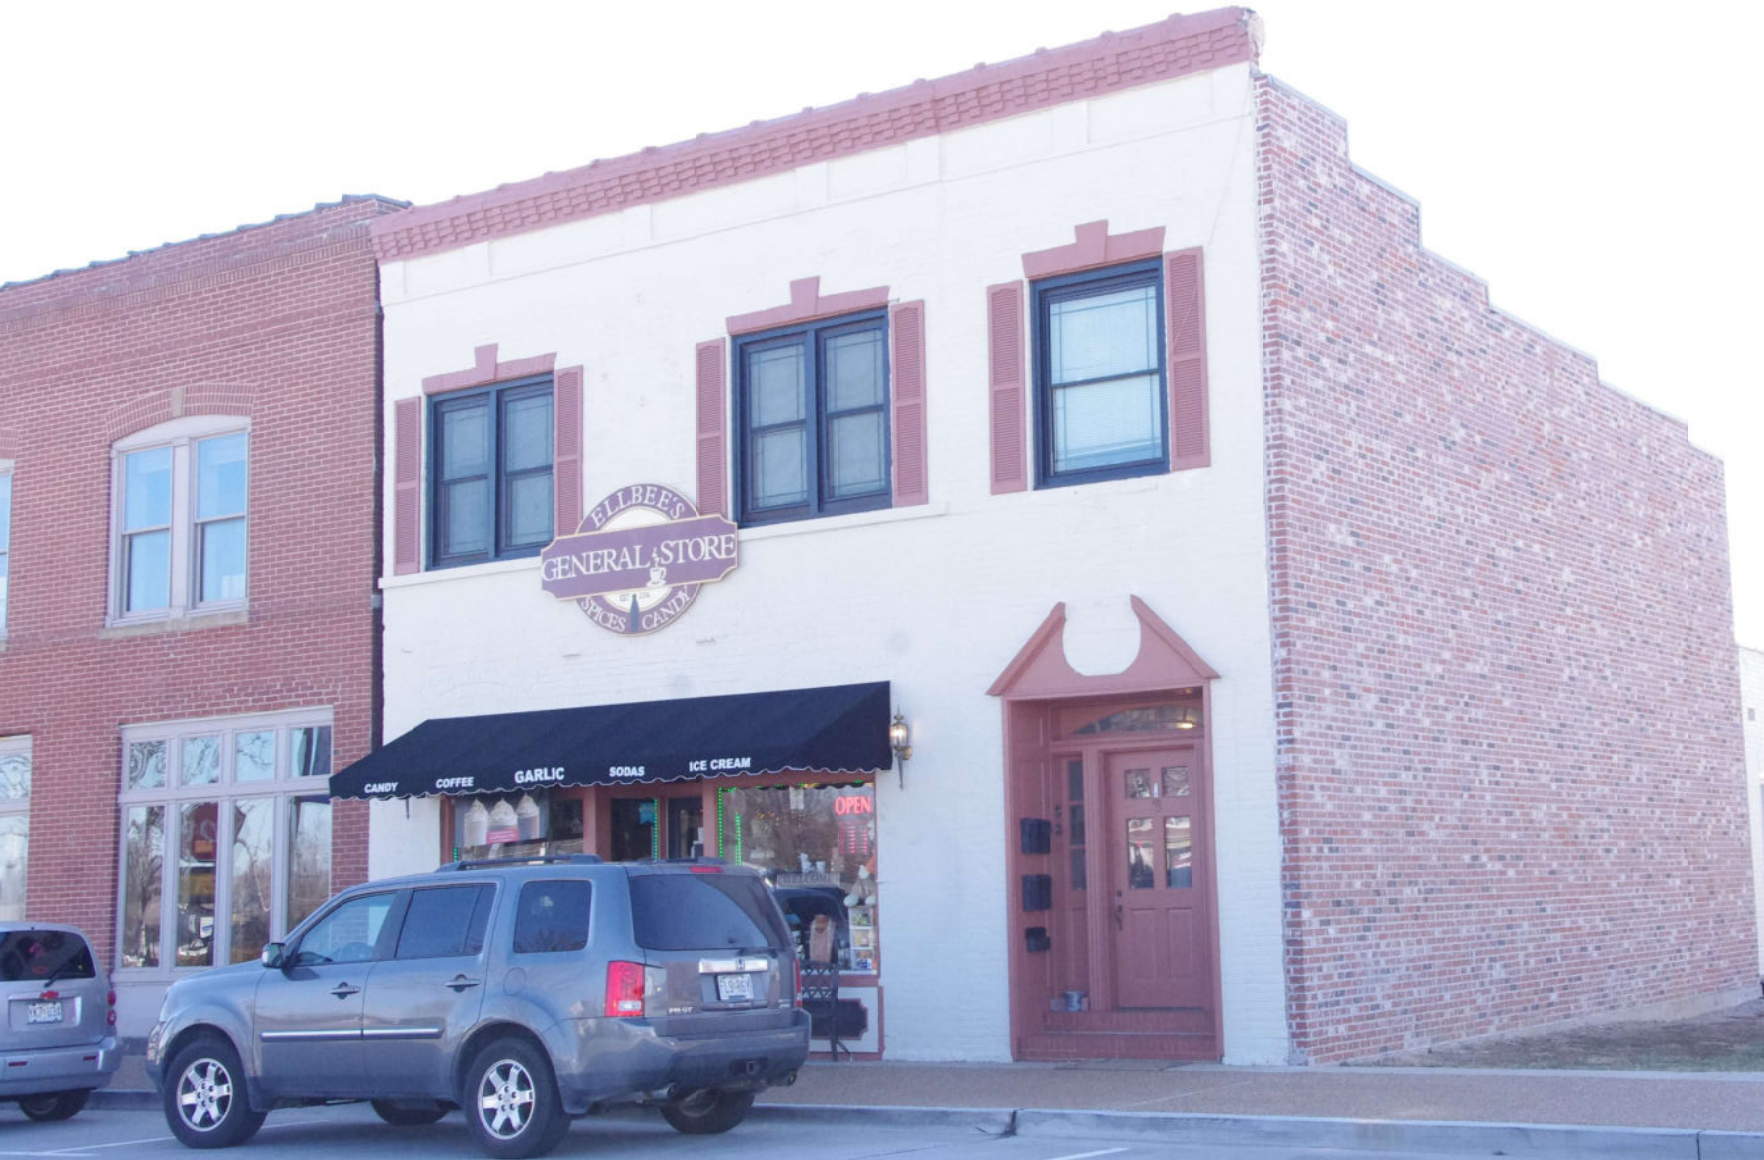
This two-story, red brick, flat roofed commercial building has a painted façade. The second floor has three window openings, each with a soldier course brick lintel with a keystone; the east and middle window openings have paired sashed windows while the west window is a single, sashed window. On the first floor, the central recessed entry is positioned below the two eastern window openings, it is a wood framed storefront with a 2/3 light wood door and transoms. The entry to the western portion of the building is slightly recessed, with a brick step up to the 6-panel (top four lighted) door with a sidelight and wood paneled walls in the alcove. Fluted pilaster strips separate the door and sidelight and support the horizontal mull separating the door from the shallow arched, multipaned transom. Over the recessed entry is a wooden broken pediment that dates to the 1935-1940s alterations. The second floor windows have been replaced with what appear to be vinyl windows and the bulkheads below the display windows have been covered with a wood panel that appears to be a more recent vintage. There is a one story flat roofed painted brick wing on the rear with a covered porch at grade; like the west side wall of the building, it has a tiered parapet, and it has a segmental arched window. This rear wing extends only behind the western portion of the building, the section that was identified as the dwelling on the 1927 fire insurance map and this one story rear wing is shown on that 1927 map, but its construction makes it appear to be an early addition. The entire façade was rebuilt between 1935 and the early 1940s and it appears the display windows and apartment entry date from that era, as do the second floor window openings and lintels, but the shutters are a recent addition. The corbelled brick parapet and the brick frieze panels date from the early façade since it is the same as is clearly visible in earlier photos. There is evidence of the earlier façade in the painted brick façade wall—segmental arched openings peak above the awning for the original first floor openings and the separation between the dwelling on the west end of the façade and the storefront section is still visible as a seam in the brick wall as well as in the slightly smaller frieze panels where its parapet was extended up to match the storefront section; in the 1940s photo these façade changes are more evident because the brick had yet to be painted and you can clearly see the second floor level masonry changes, especially the bricked in doorway.

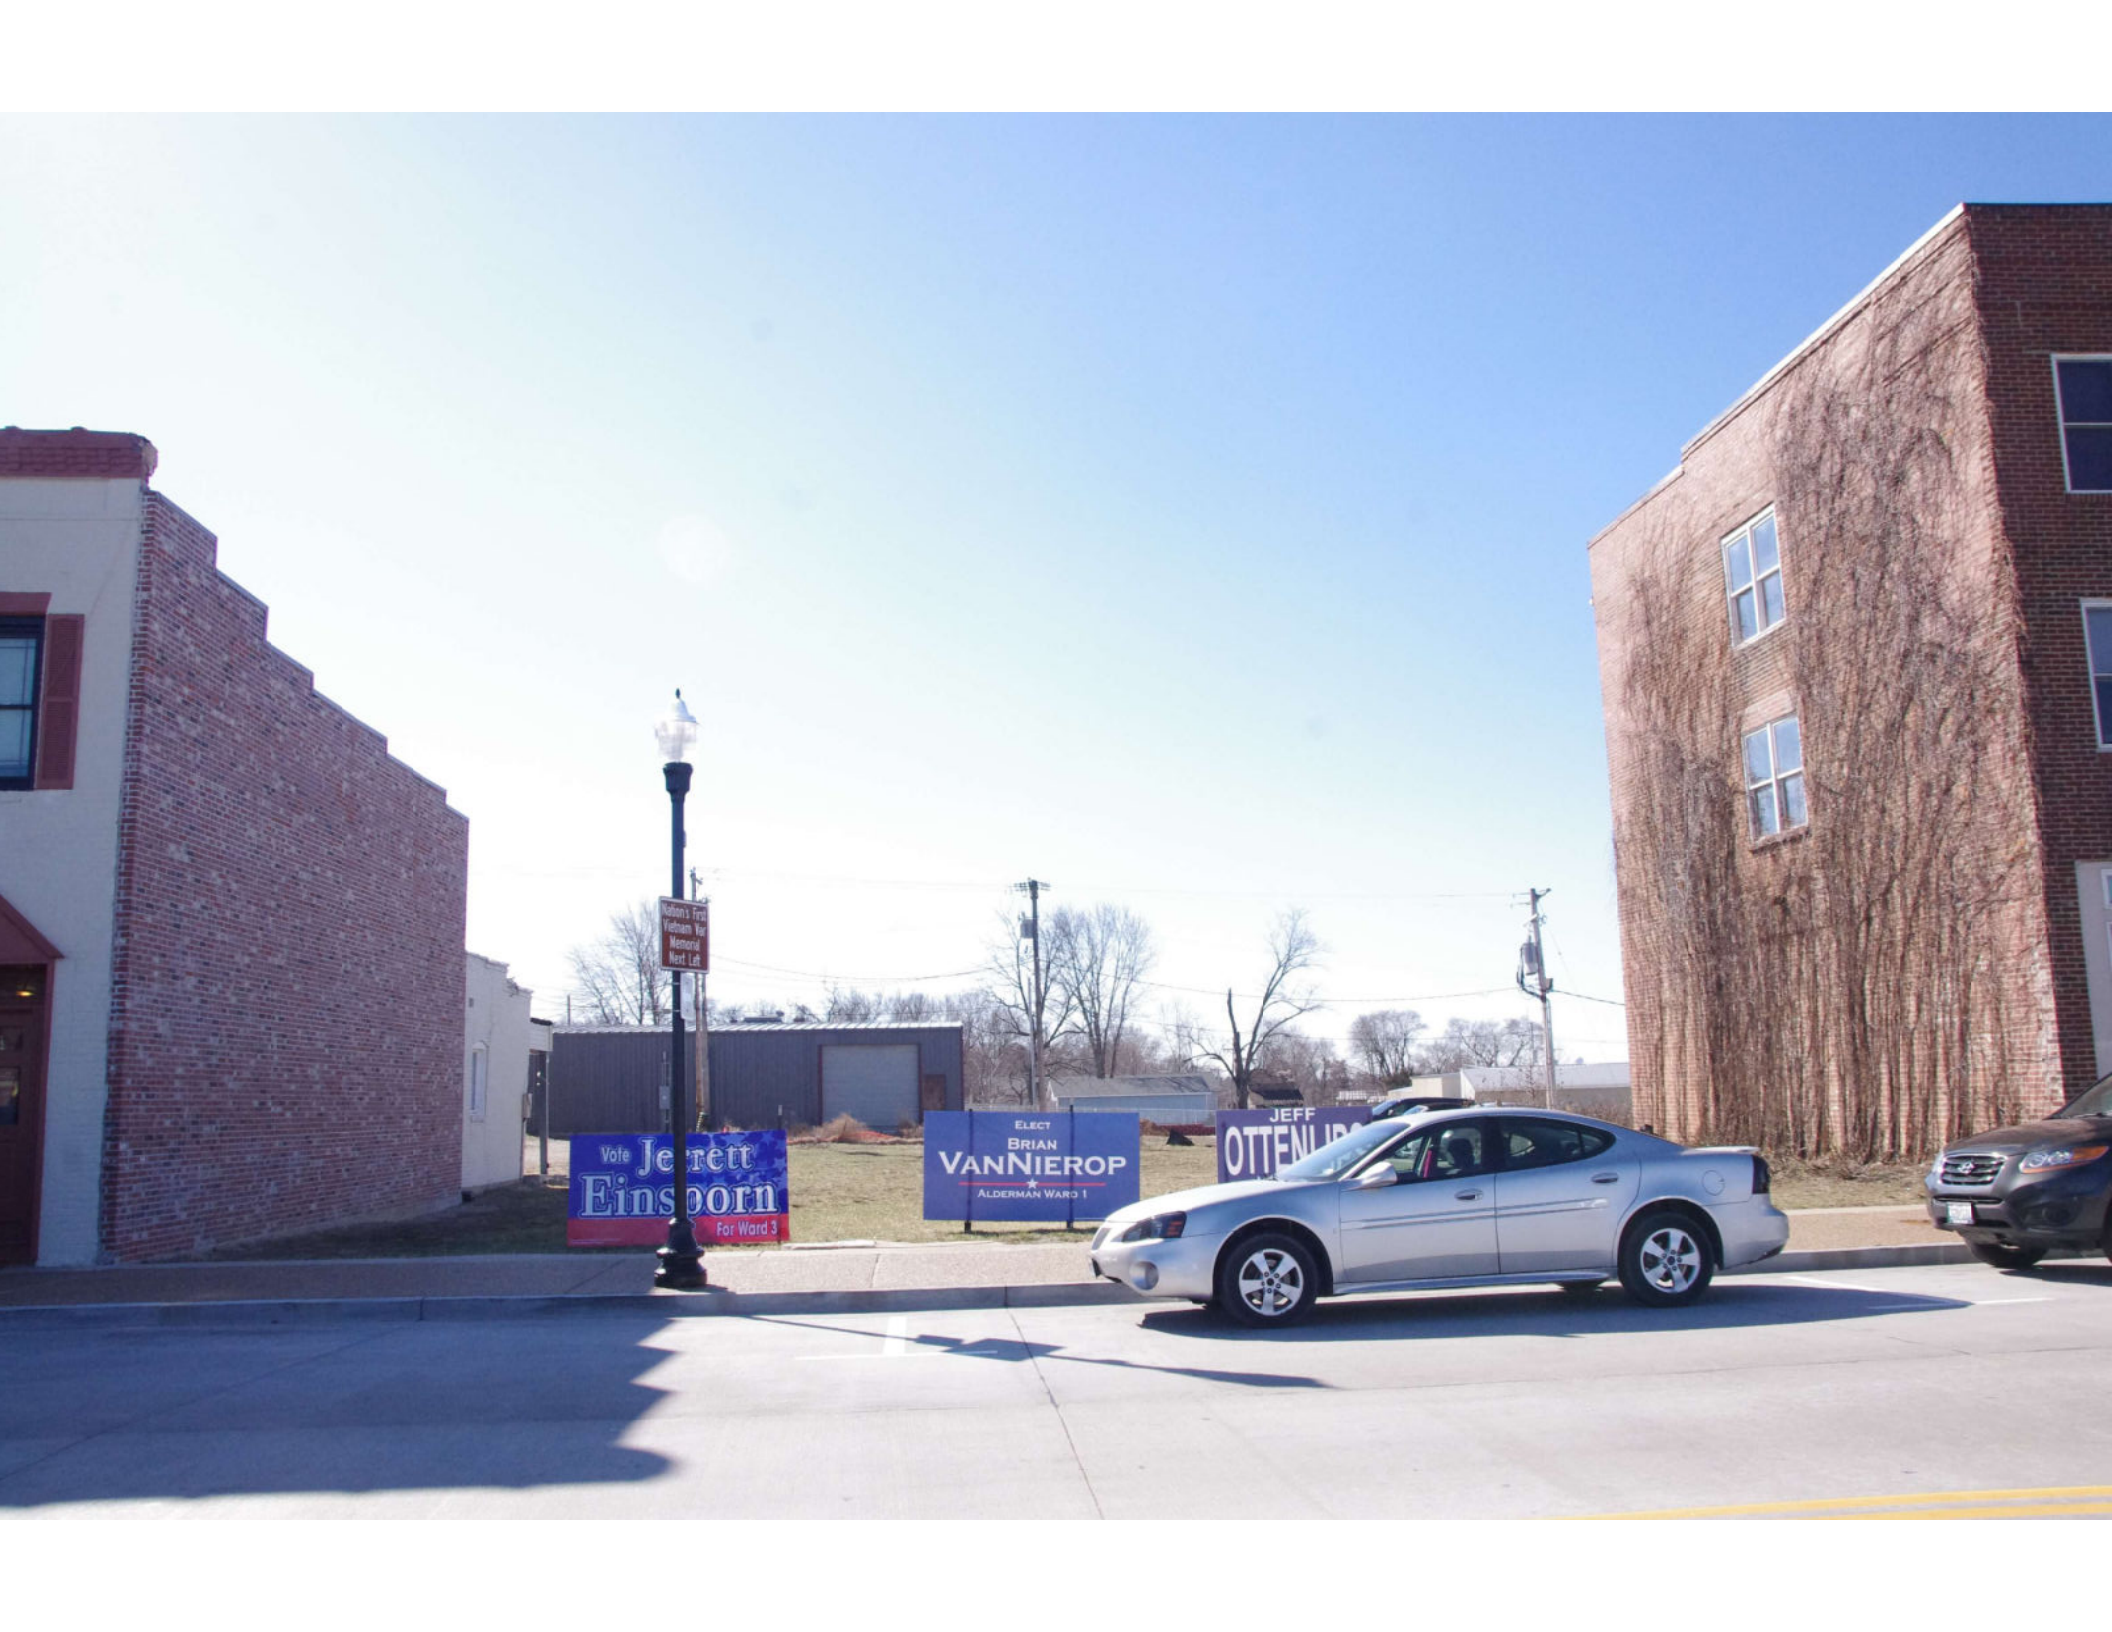
The property is a grass lot that extends to the public sidewalk on the north side. It is approximately 65-70 feet wide, having originally comprised 3 storefronts of about 22 feet wide each with a narrow side lot to the west.

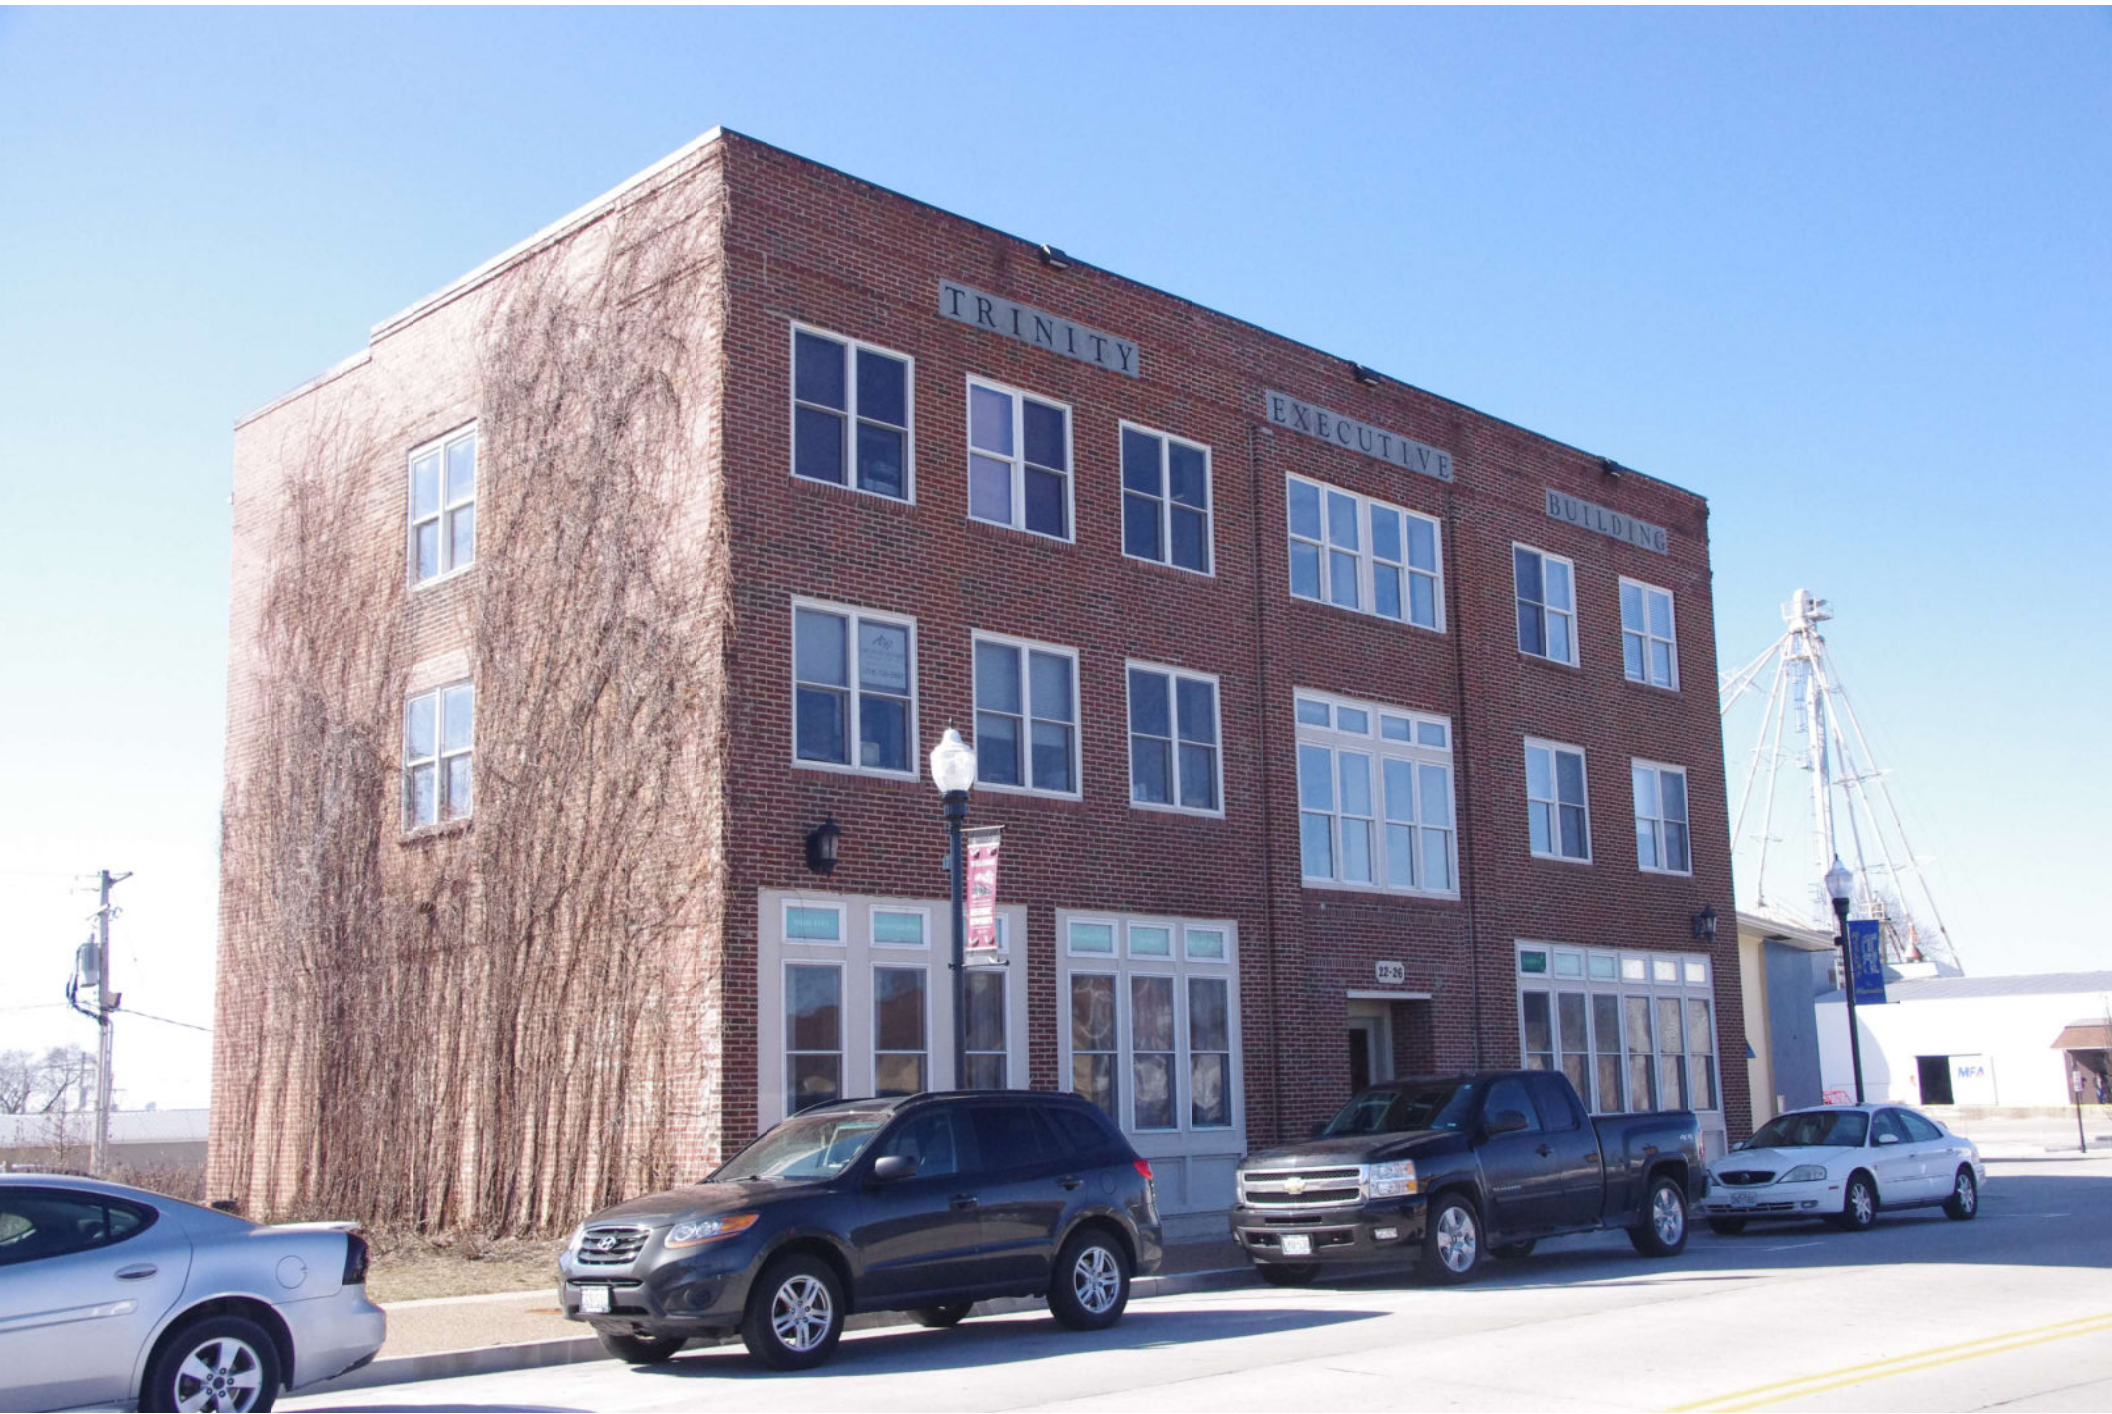
This three story, red brick, flat roofed commercial building is divided into three sections by brick pilaster strips that extend up to the projecting brick stringcourse that forms the bottom of a double frieze panel that wraps the entire west elevation and the front edge of the east elevation as well as the façade; the frieze panel has another projecting brick stringcourse in the middle and another at the top of the parapet. The central bay has a recessed entry with paired full light doors. There is a soldier course brick frieze panel above the entry opening. The upper floors of this bay are spanned by a large window opening with 4 doublehung sashed windows in each opening; the second floor windows have transoms. The eastern bay is wider, having 3 paired windows on the second and third floors while the western bay has 2 paired windows on each upper level. The first floor of the eastern bay has two openings with 3 doublehung sashed windows with transoms in each opening. The first floor of the western bay has one large opening with 6 doublehung sashed windows with transoms. It appears that the windows on all three levels are wood sashed windows, indicating they might be original to the building, but the windows in the outer bays are all covered with what appear to be painted aluminum storm windows. The two-tone paint scheme on the windows and trim may highlight more recent trim pieces added to the windows and transoms. It appears that the recessed panels below the first floor windows may be a recent application since the frames extend beyond the face of the masonry and the concrete panels that spell out Trinity Executive Building have been added more recently, positioned within the original brick frieze at the parapet.

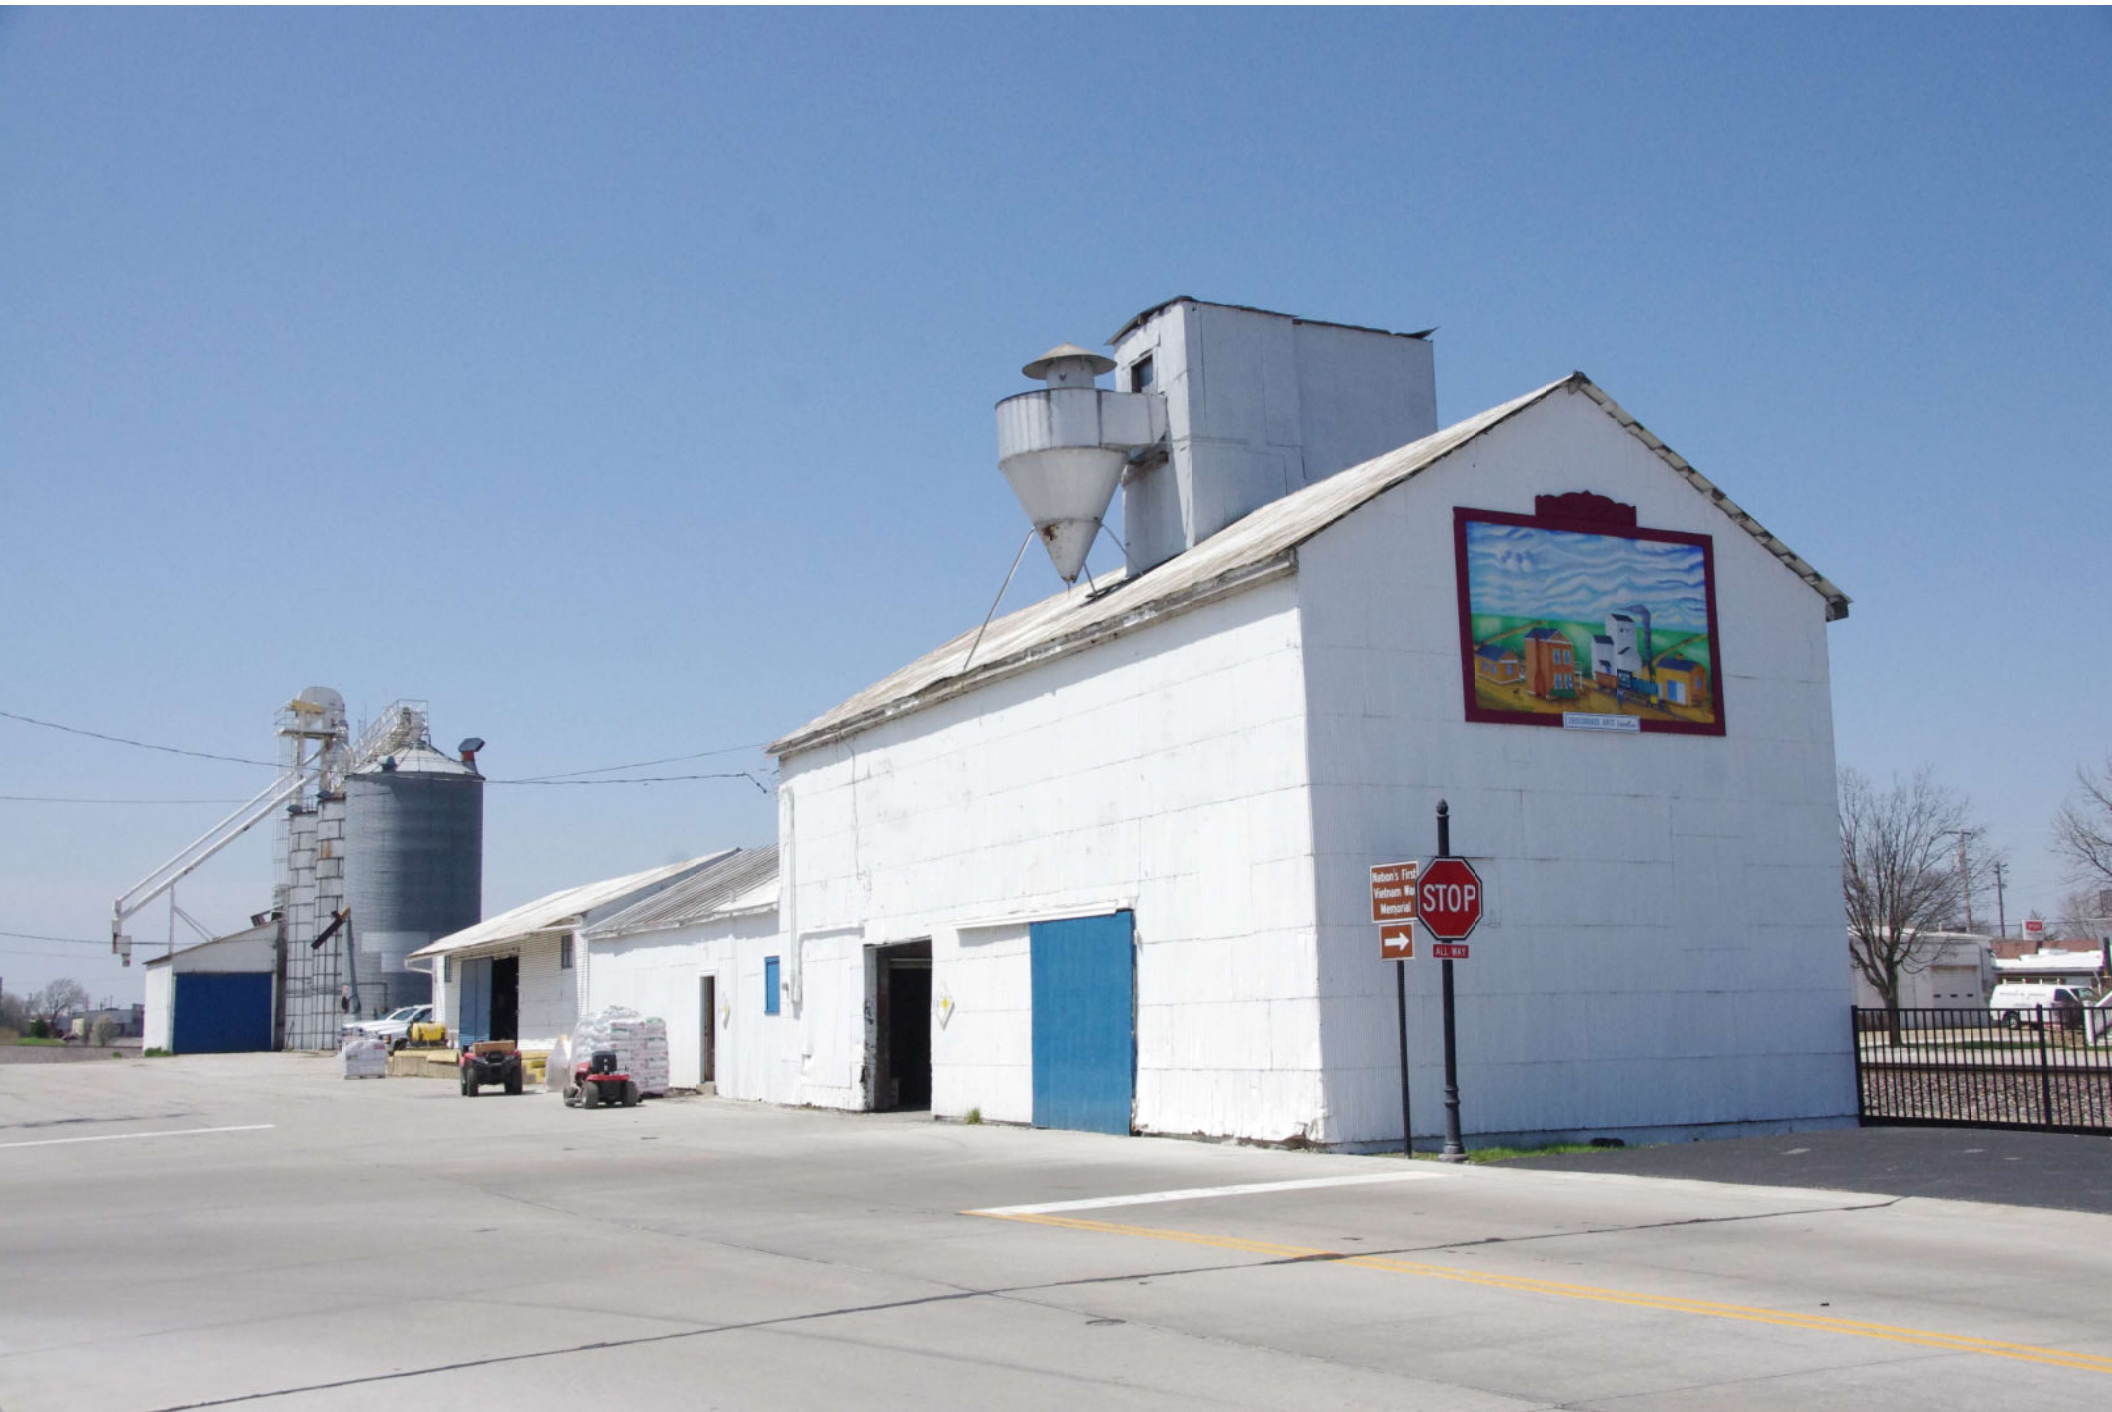
The eastern most building in the complex is actually two connected buildings. The eastern portion is two stories in height with a corrugated metal, side gabled roof and walls facing south onto the intersection of Main and Church Streets. It has a corrugated metal clad, very shallow pitched end gable penthouse structure centered on the roof and there are two large, metal sliding doors on the south façade. The western section is only one story high and is connected to the two story high building at the east end of the complex. This one story high wing also has a corrugated metal walls, with a simple man door east of center on the façade and small wood framed rectangular window at the east end of this bay facing Main Street, but its roof is a standing seam metal roof, the eastern portion of which has been overlaid with corrugated metal roofing. Both sections of the building appear to be built at grade with a concrete foundation and wood framing. At least the eastern, two-story section of this building is shown on the 1927 fire insurance map so the western portion may be a slightly later addition (probably in the 1940s) but the 1940s photo looking west on Main Street shows this complex prominently at the end of the Main Street business district (Bowman, p. 76).

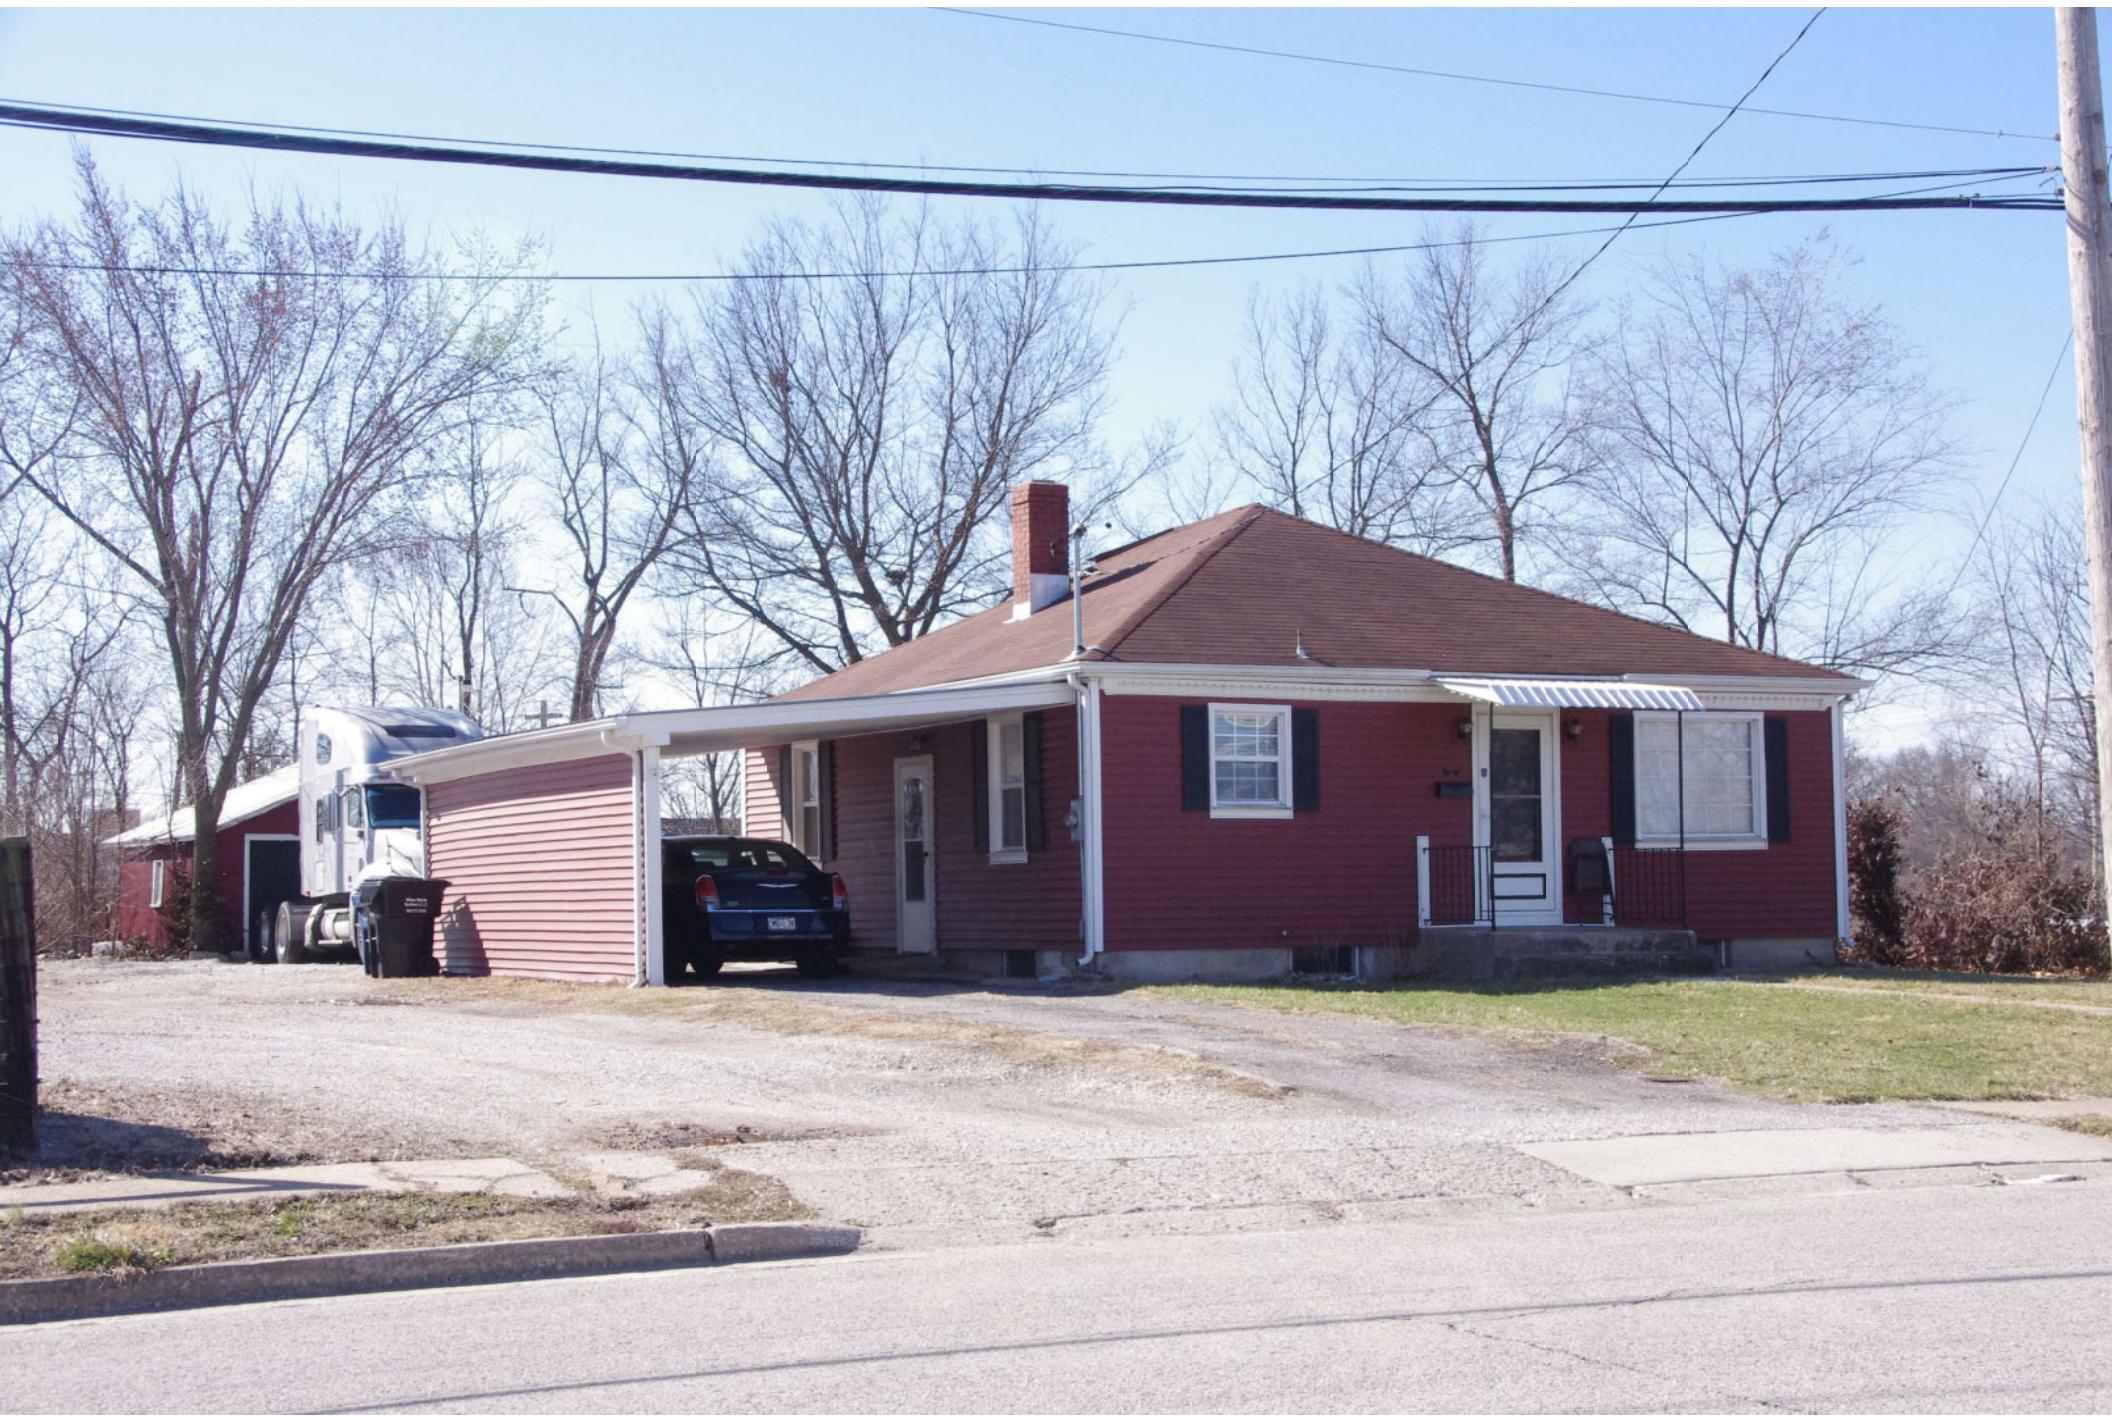
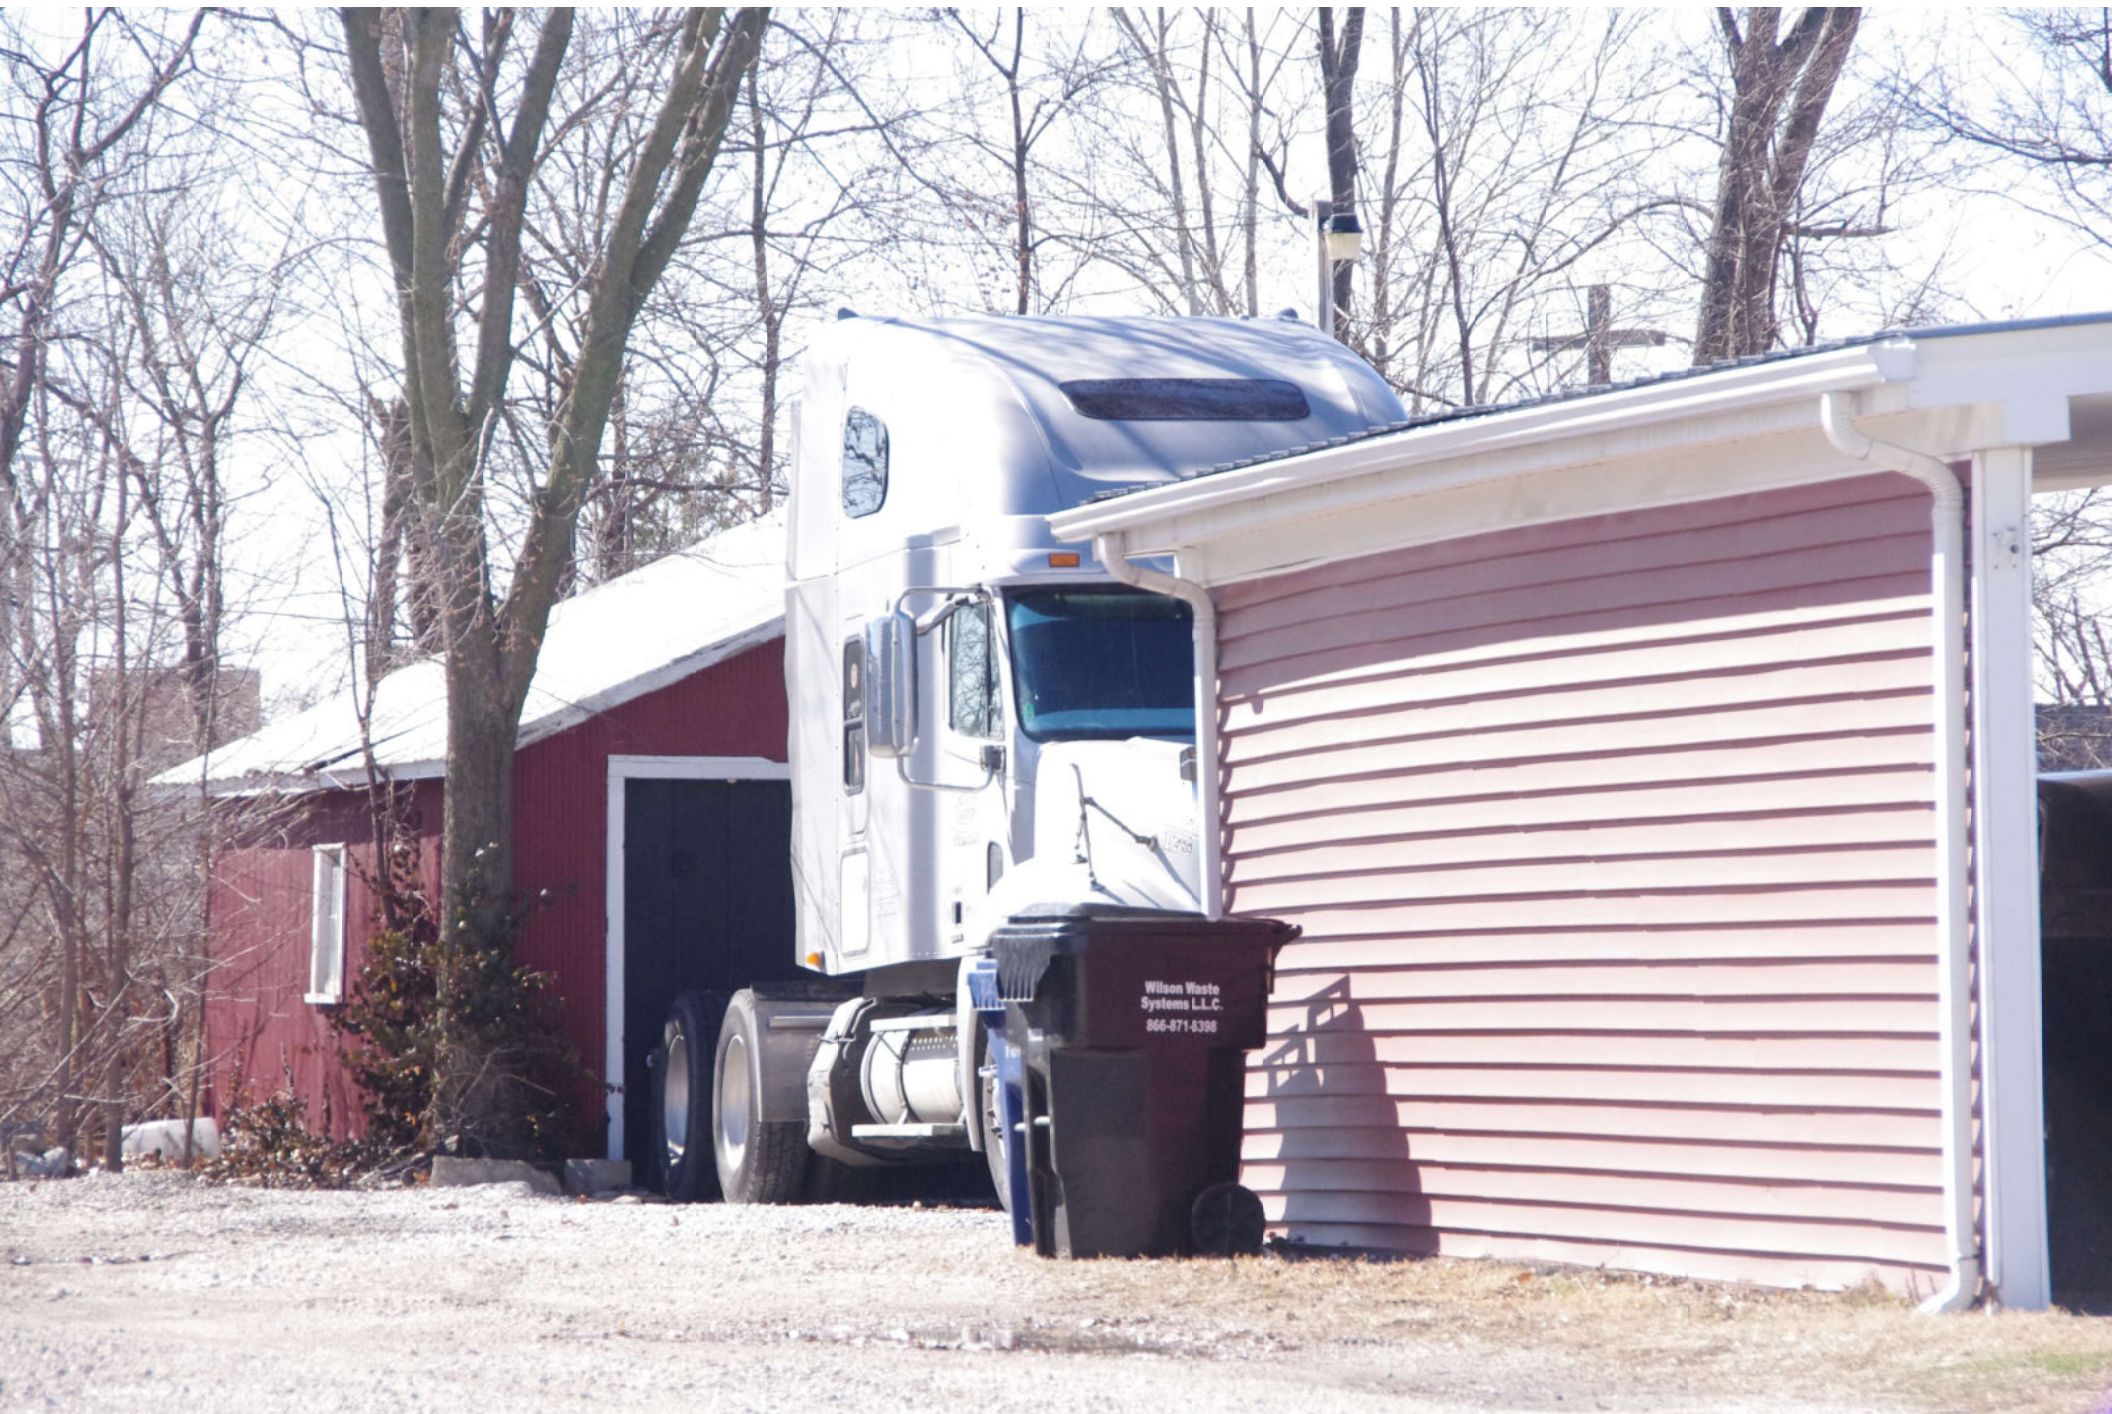
This pyramidal roofed, one story house has an asphalt shingle roof and replacement vinyl siding as well as added vinyl dentil detailing at the soffit on the façade since there is no eave overhang. There is an aluminum shed roof awning over the central entry with its concrete stoop. To the west of the entry door (which is covered by an aluminum storm door), is a replacement 20-light picture window and to the east is a replacement 6/6 sashed window, both with faux shutters. On the east elevation there are two, 1/1 sashed windows flanking the side entry door. An interior brick chimney is positioned on the east slope of the roof midbuilding. A shed roofed, open carport with a vinyl sided wall on the east side is connected to the east elevation of the house.
