**ARCHITECTURAL/HISTORIC INVENTORY FORM**

1. Survey No. SC-AS-012-0052		2. Survey Name: Reconnaissance Level Survey of Historic Downtown Wentzville	
3. County: St. Charles		4. Address (Street No.) 105	Street (name) South Linn Ave
5. City: Wentzville	Vicinity: <input type="checkbox"/>	6. UTM:	
8. Historic name (if known):		9. Present/other name (if known): Land Fair Corp.	
10. Ownership: <input type="checkbox"/> Private <input type="checkbox"/> Public		11a. Historic use (if known): COMMERCE/TRADE	11b. Current use: COMMERCE/TRADE/professional
5. City: Wentzville		7. Township/Range/Section:

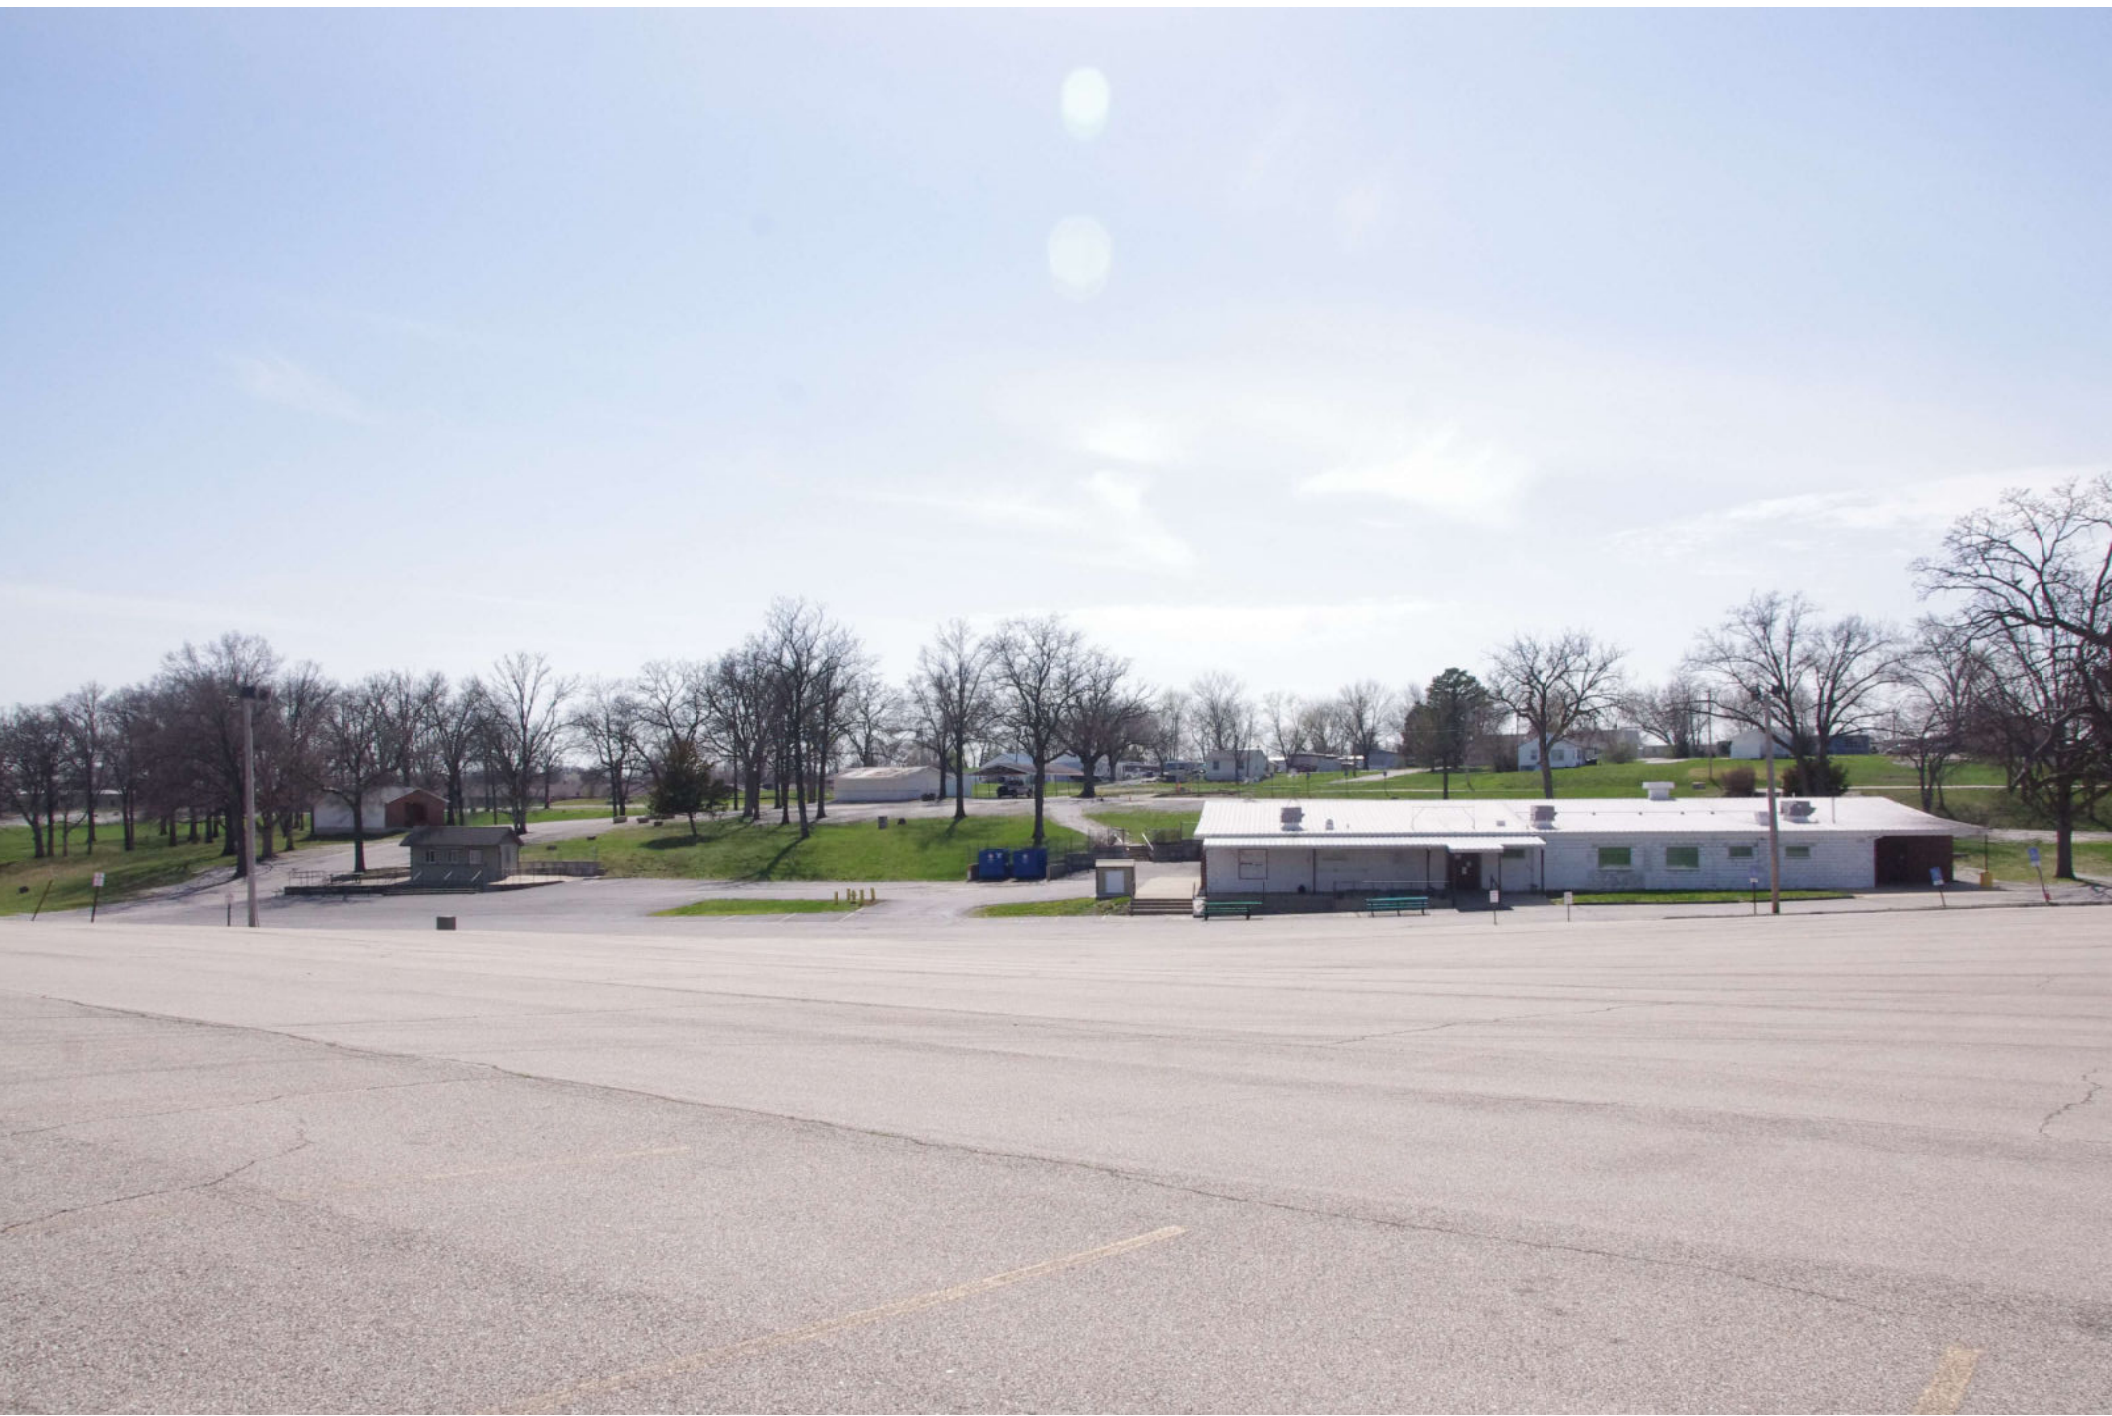
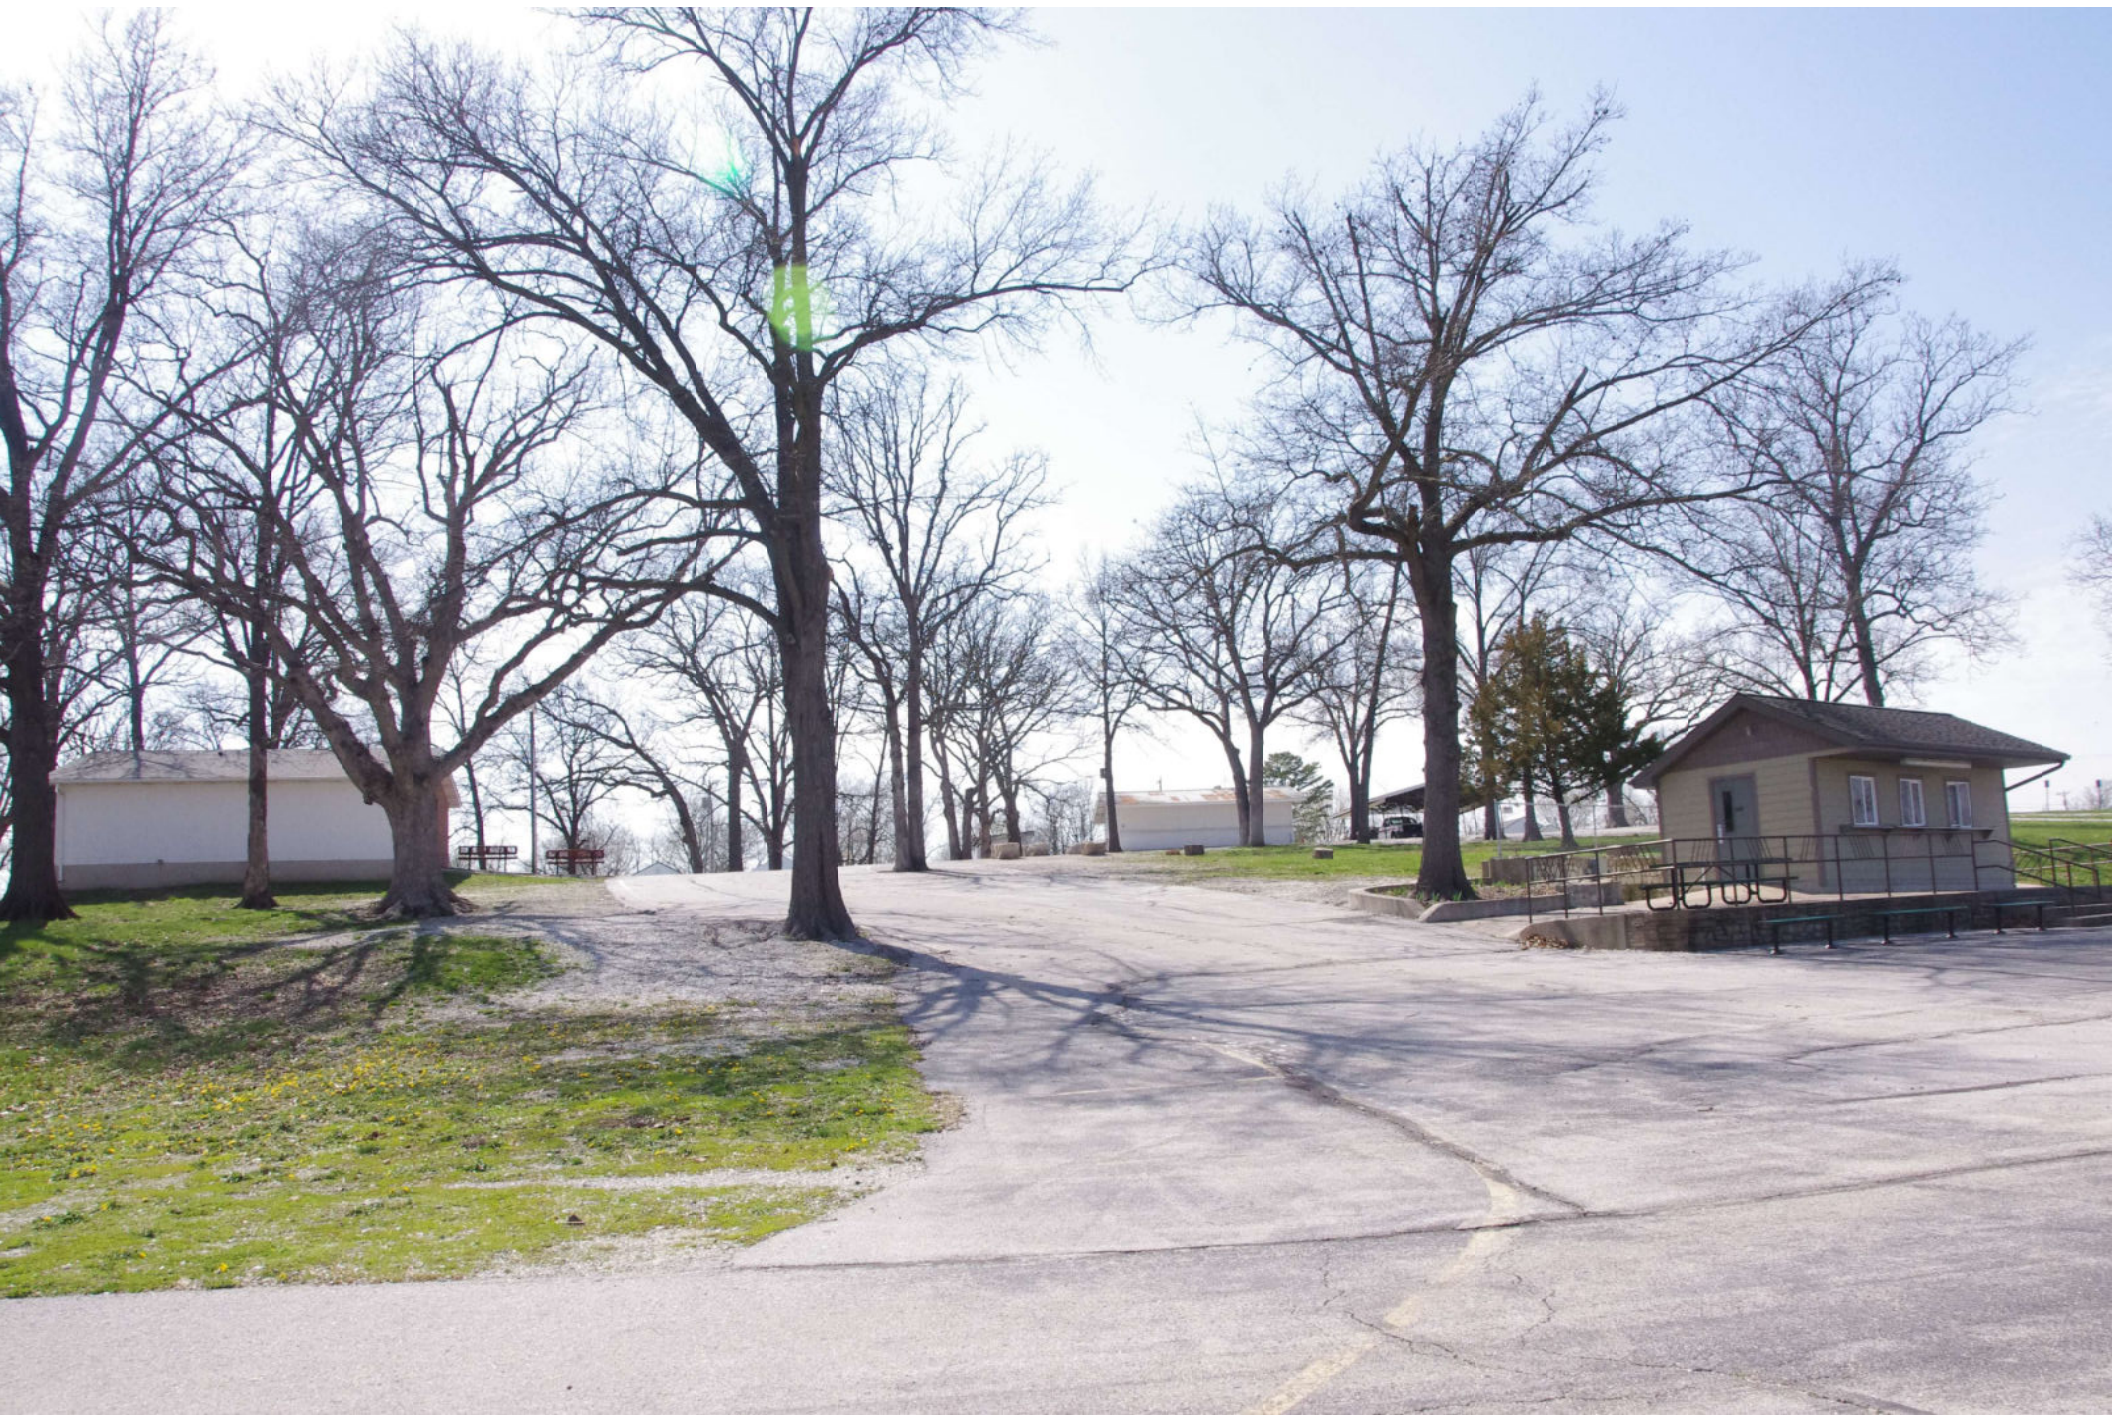
The 1962 roller rink/community club building is a one-story painted concrete block commercial building with a very shallow pitched gable roof and flat roof bay along the east side, which faces the driveway into the property. This is clearly identifiable as the same building shown in the historic photo (Bowman, p. 96) and retains most of that original fenestration pattern along the east elevation as well as the brick pilasters that are attached to the concrete block east elevation wall, dividing it into six bays. Most of these windows are single light, wood frame windows with replacement tinted glass, two are larger display size windows (in the fourth and fifth bays from the south end) and some are high horizontal, single light openings. There has been an addition on the north end of the building that spans the entire width of the building, adding an additional bay to the east elevation; it extends the same roof pitches from the original building, creating a recessed entry with a simple metal pole supporting the roof at the open northeast corner. The north wall is now brick as are the walls under the recessed entry. There is a three-bay shed roof pavilion supported by metal poles extending along the southern end of this side of the building that has been added more recently with two wooden doors from the building accessed under the porch. The remaining bays have been boarded over.
