1. Survey number: JP-AS-006-184		2. Survey Name: East Town (Original Joplin) Historic Survey Phase 1	
3. County: JASPER		4. Address 1401	Street (name): E. Hill Street
5. City: Joplin	Vicinity <input type="checkbox"/>	7. Township/Range/Section: T: R: S:	
8. Historic name (if known):		9. Present/other name (if known):	
10. Ownership: <input checked="" type="checkbox"/> Private <input type="checkbox"/> Public		11a. Historic use (if known): Domestic/Single Dwelling	11b. Current use: Domestic/Single Dwelling

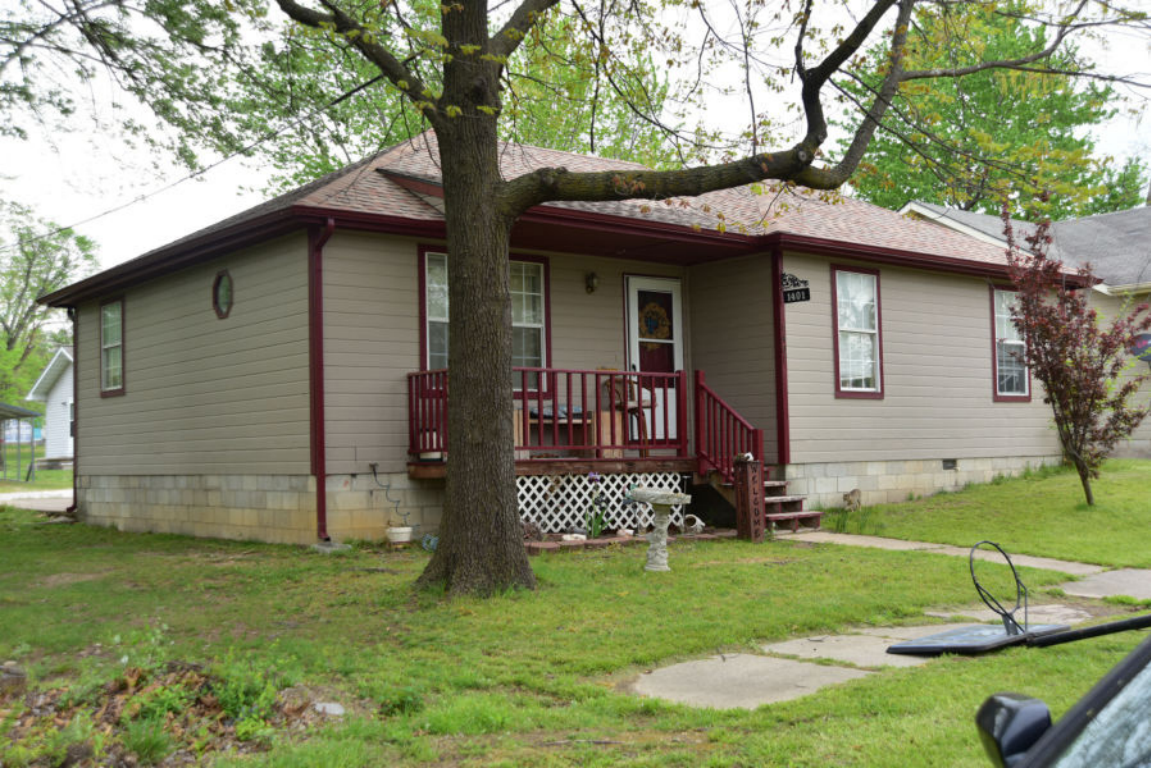
1401

This Minimal Traditional dwelling faces south and has an L-shaped footprint. It has a concrete masonry unit foundation and wood cladding. The hipped roof with cross-gables has asphalt shingles. The dwelling is four bays wide and two asymmetrical bays deep. The west two bays are recessed, creating a partial-width open porch. The porch elements are non-historic. A Non-historic wood door occupies the second-from-west bay while six-over-six vinyl windows occupy the remaining bays.

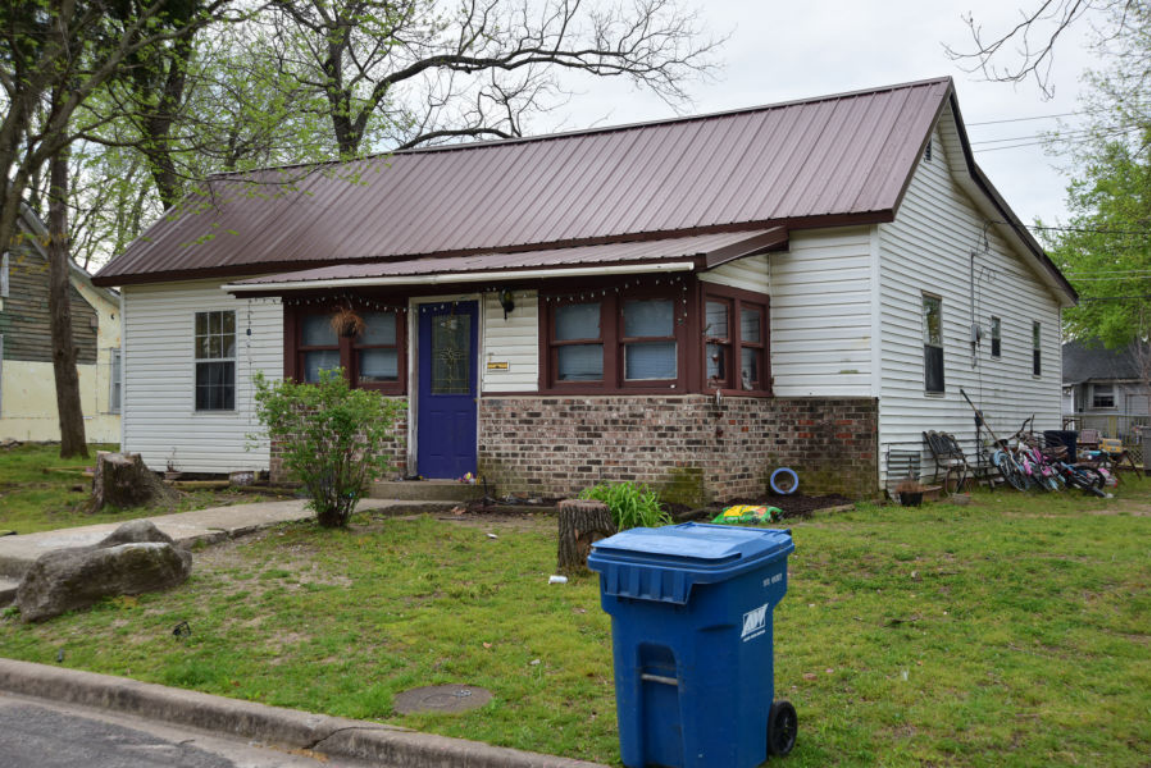
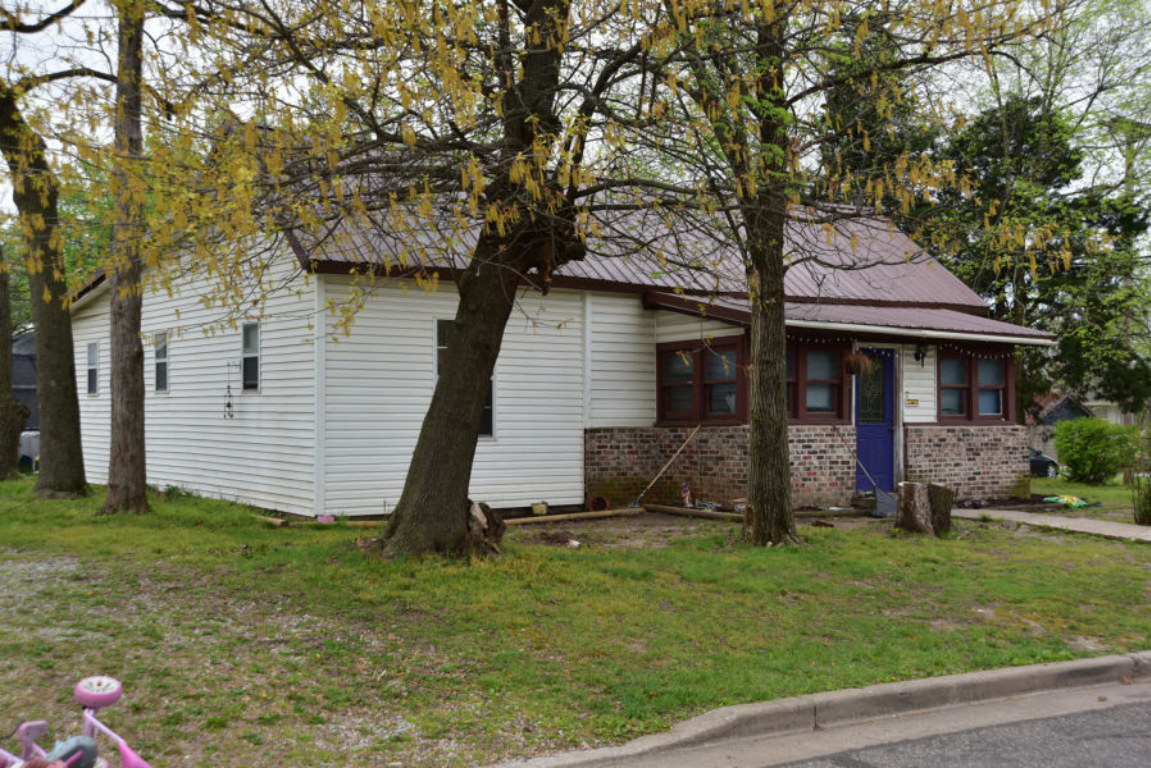
This National Folk House dwelling faces north and has a square footprint. It has a concrete foundation and corrugated metal roof. Brick veneer clads the lower third of the enclosed porch at the primary elevation. The remainder of the dwelling has vinyl siding. The dwelling is four asymmetrical bays wide and three bays deep. A three-quarter width enclosed porch with a shed roof contains the three west bays. The porch enclosure is an alteration. One-over-one wood windows occupy the first and third bays of the dwelling while a six-over-six vinyl window occupies the fourth bay. A non-historic wood door with glazing defines the second bay.

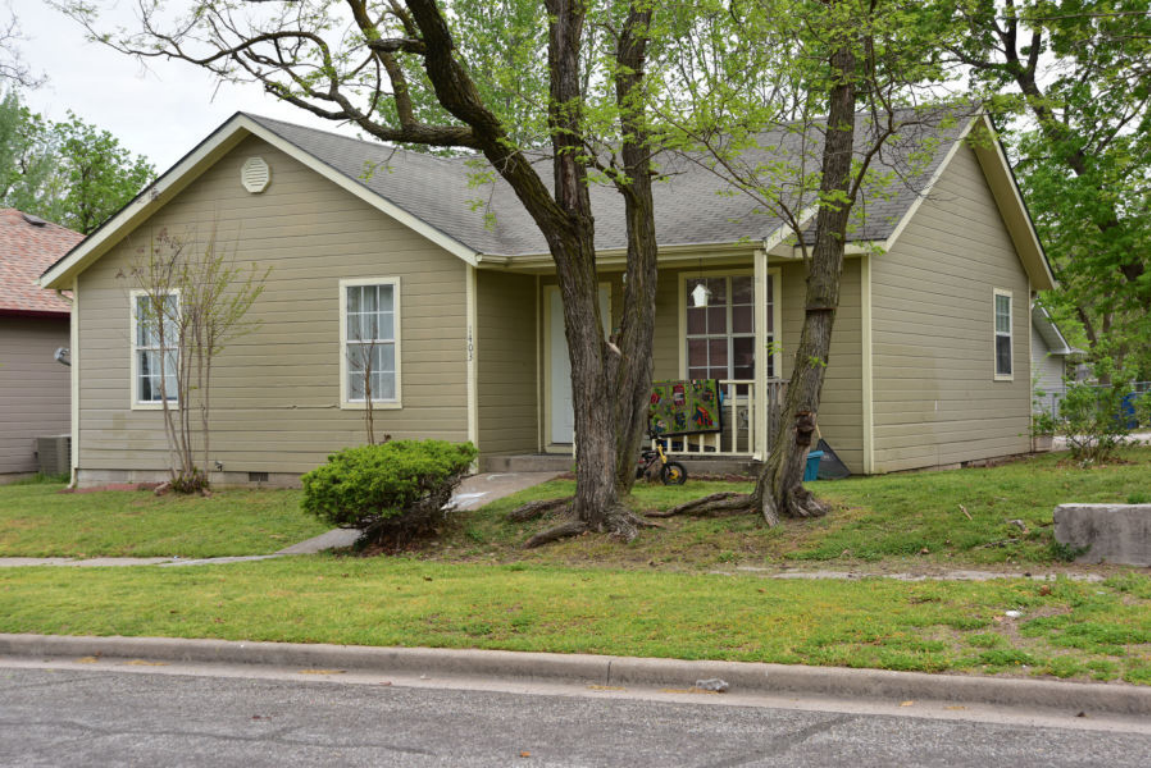
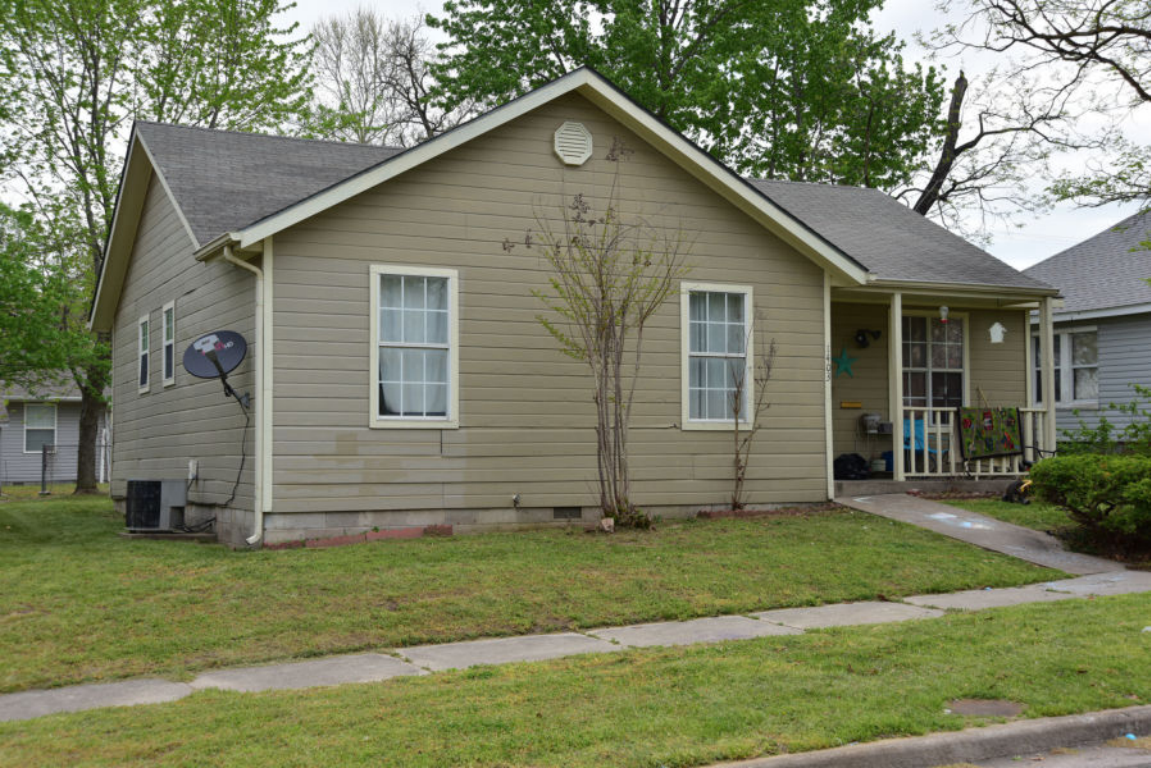
This Minimal Traditional dwelling faces south and has an L-shaped footprint. It has a concrete masonry unit foundation and wood cladding. The intersecting gable roof has asphalt shingles. The dwelling is four bays wide and two asymmetrical bays deep. The east two bays recede, creating a partial-width open porch. The porch has a shed roof, concrete foundation, and matchstick balustrade. A wood door with glazing occupies the second-from-east bay while six-over-six vinyl windows occupy the remaining bays.

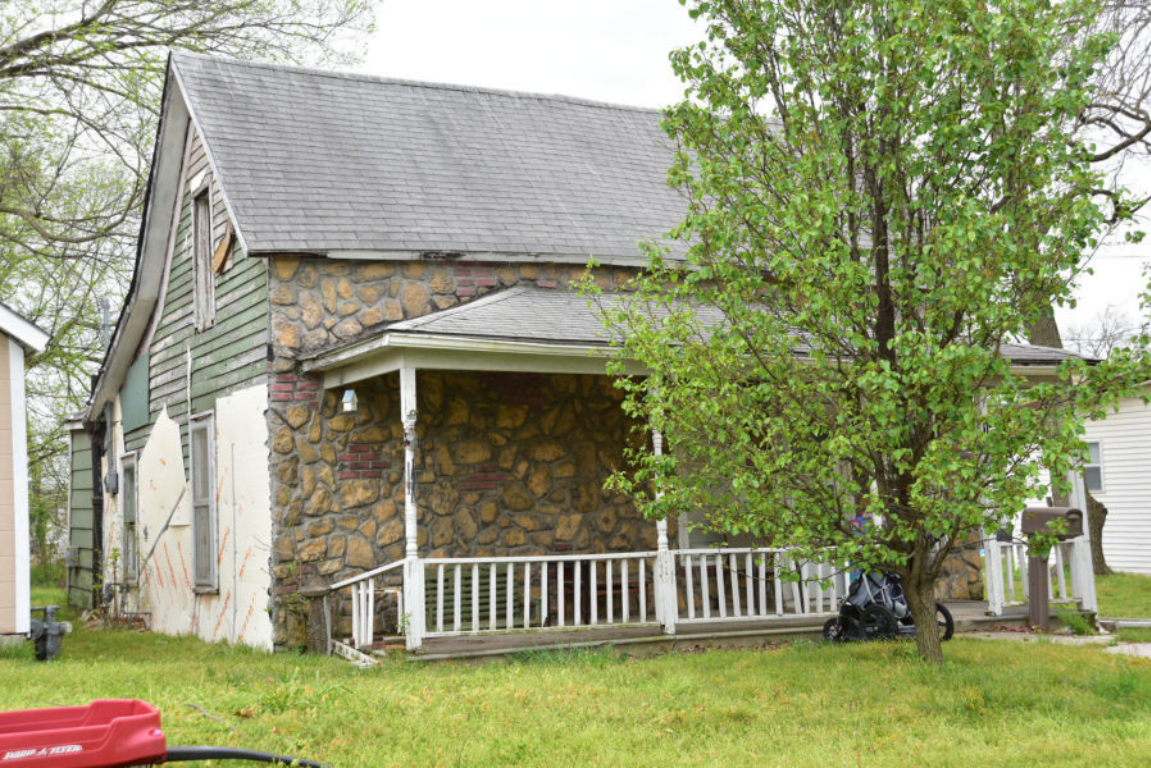
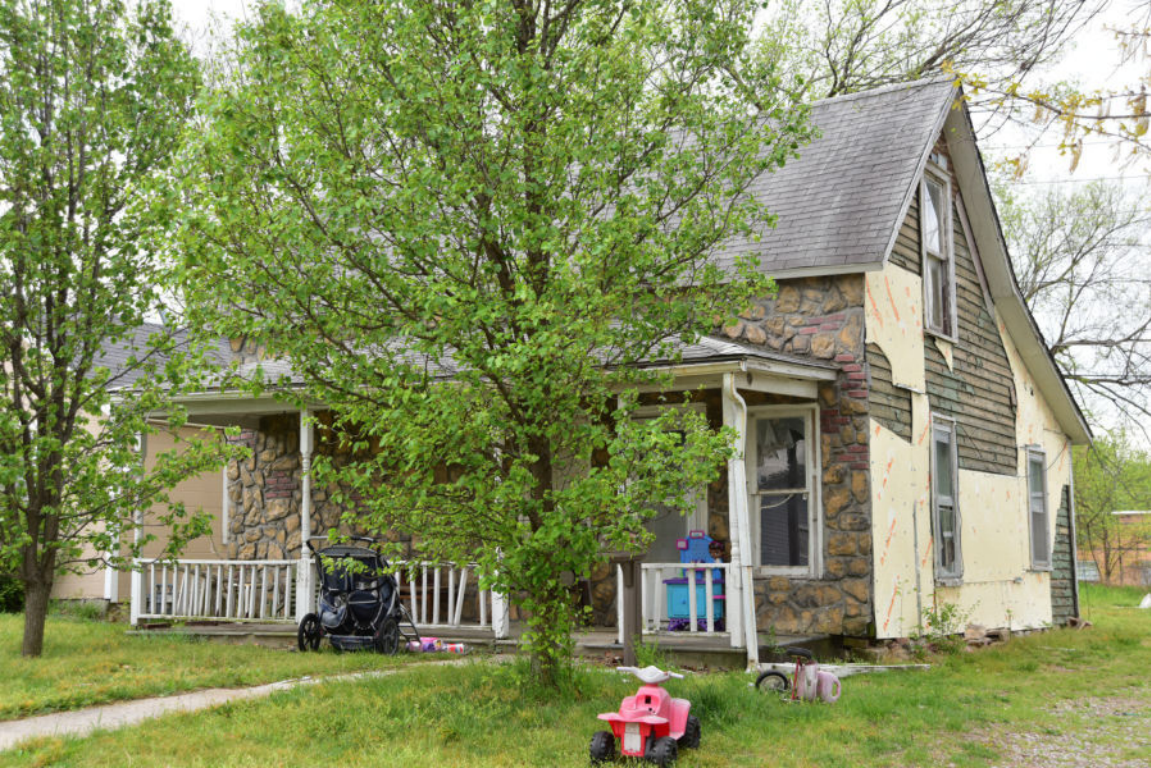
This National Folk House dwelling faces north and has a rectangular footprint. It has a stone foundation and asphalt shingle roof. Stone and brick veneer clads the primary elevation while wood clapboards clad the secondary elevations. The dwelling is three asymmetrical bays wide and two bays deep. A historic wood door occupies the center bay while historic one-over-one wood windows fill the remaining bays. A non-historic porch with a hipped roof, turned wood support posts, and concrete foundation spans the primary elevation. An enclosed porch projects from the south elevation.

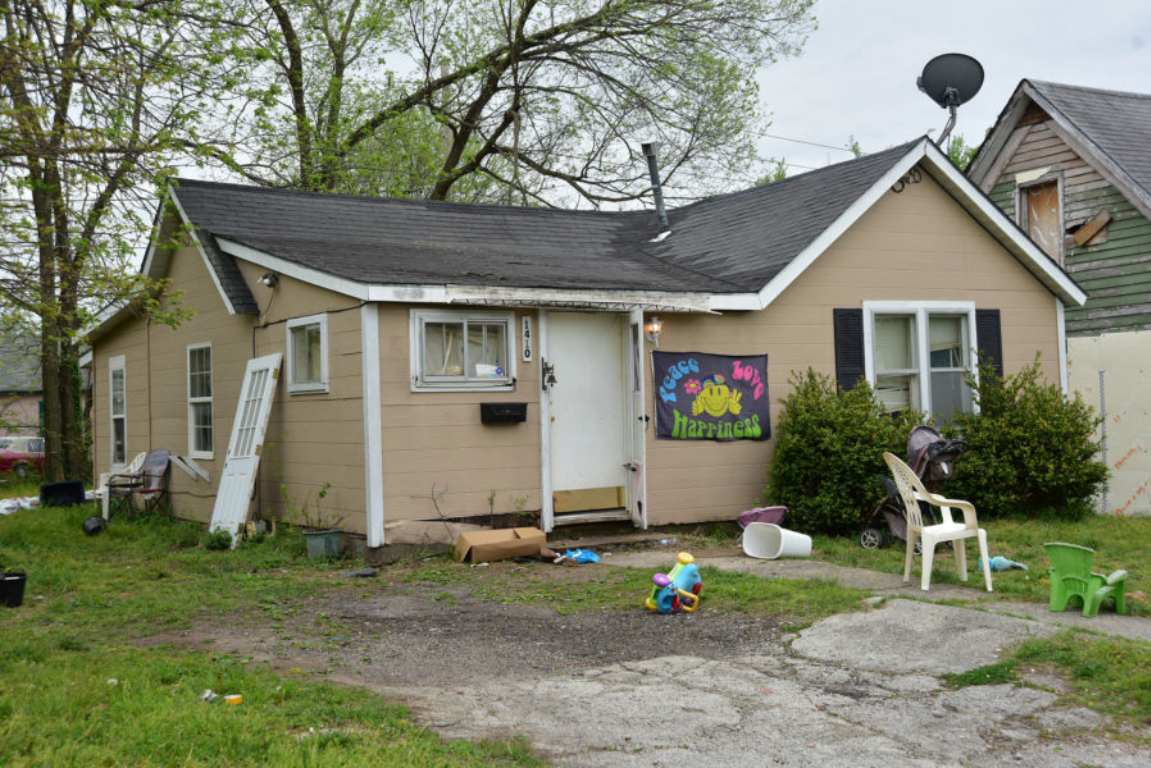
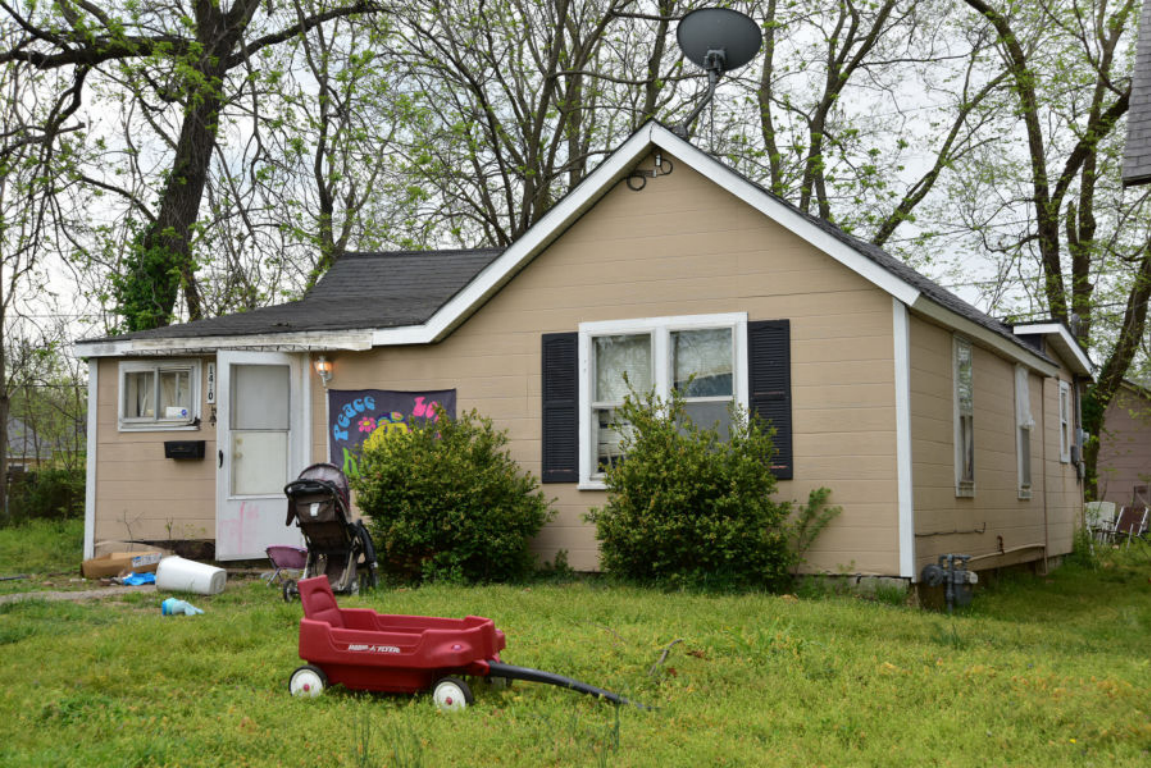
This Gabled-Ell dwelling faces north and has a rectangular footprint. It has a concrete foundation and non-historic wood cladding. The roof has asphalt shingles. The dwelling is three bays wide and three bays deep. An enclosed porch with a shed roof contains the east two bays. The enclosure is an alteration. A non-historic wood door occupies the center bay while a one-by-one metal window occupies the west bay. A pair of one-over-one metal windows with false shutters occupies the west bay. An enclosed shed-roof porch projects from the south elevation.

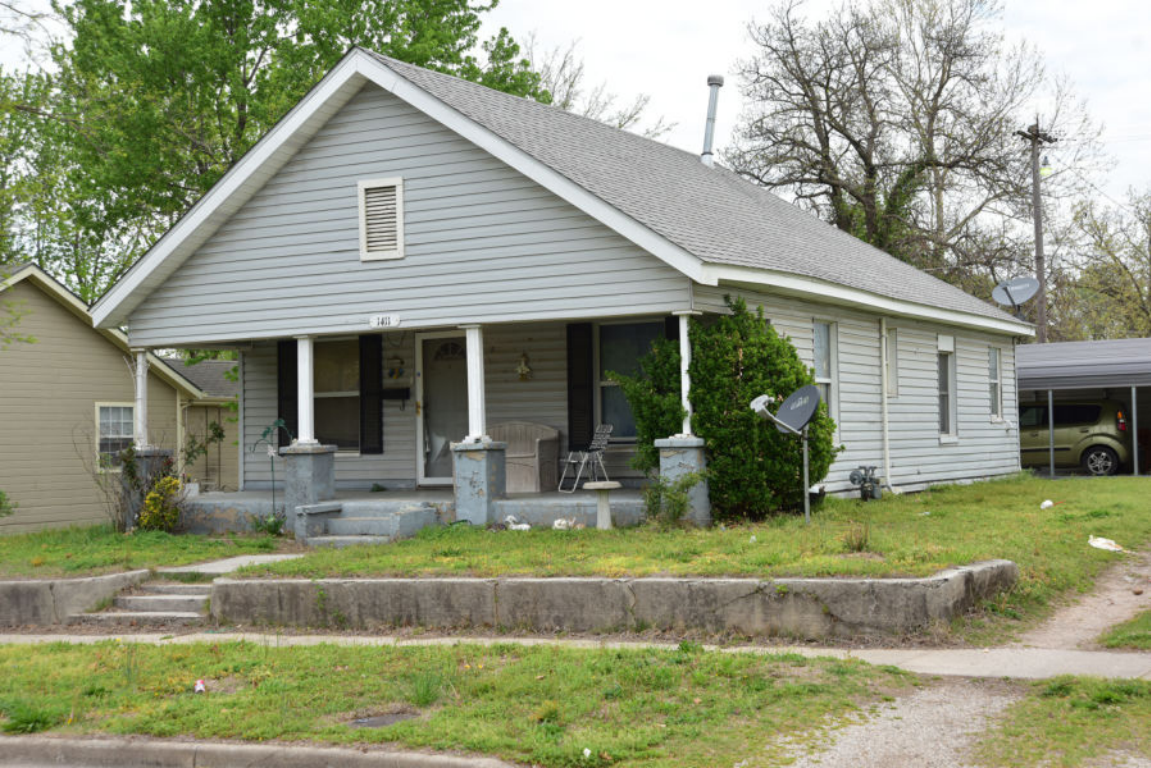
This bungalow dwelling faces south and has an irregular footprint. It has vinyl cladding and an asphalt shingle roof. The foundation is not visible. The dwelling is three bays wide and four bays deep. An open porch with a concrete foundation spans the primary elevation. Squared wood columns on concrete piers support the porch roof. A non-historic fiberglass door occupies the center bay of the primary foundation while one-over-one vinyl windows with false shutters occupy the adjacent bays.

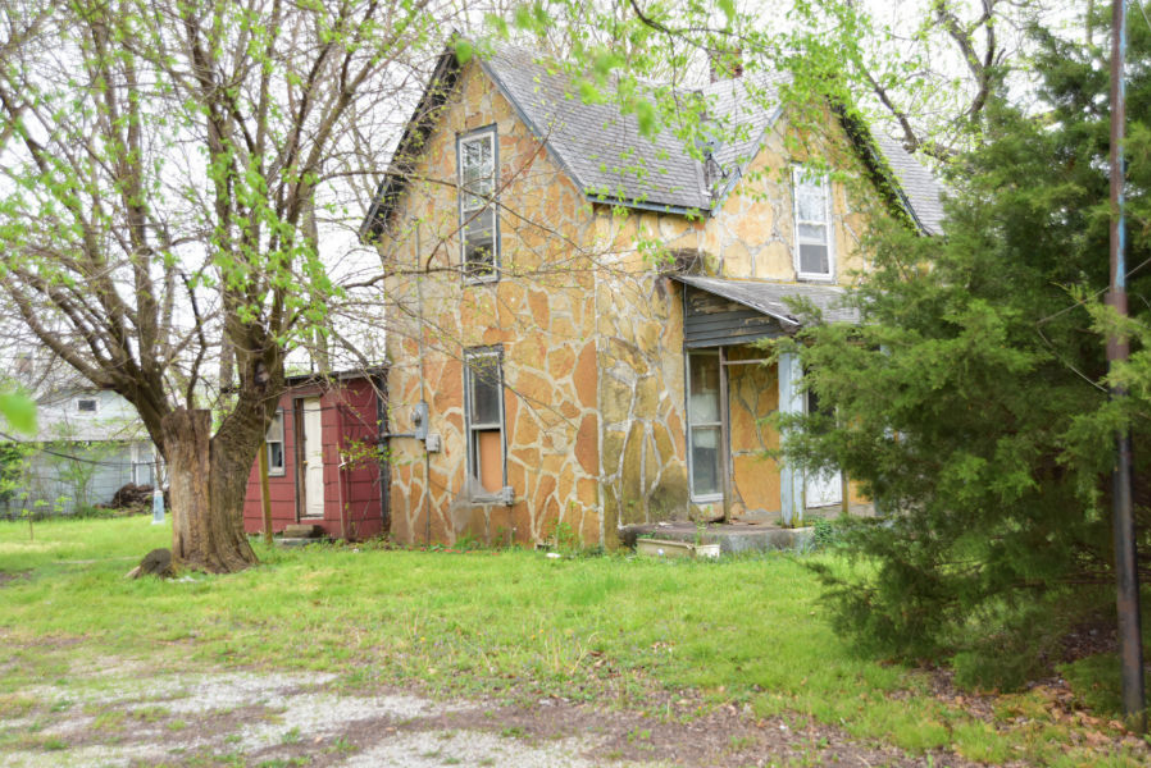
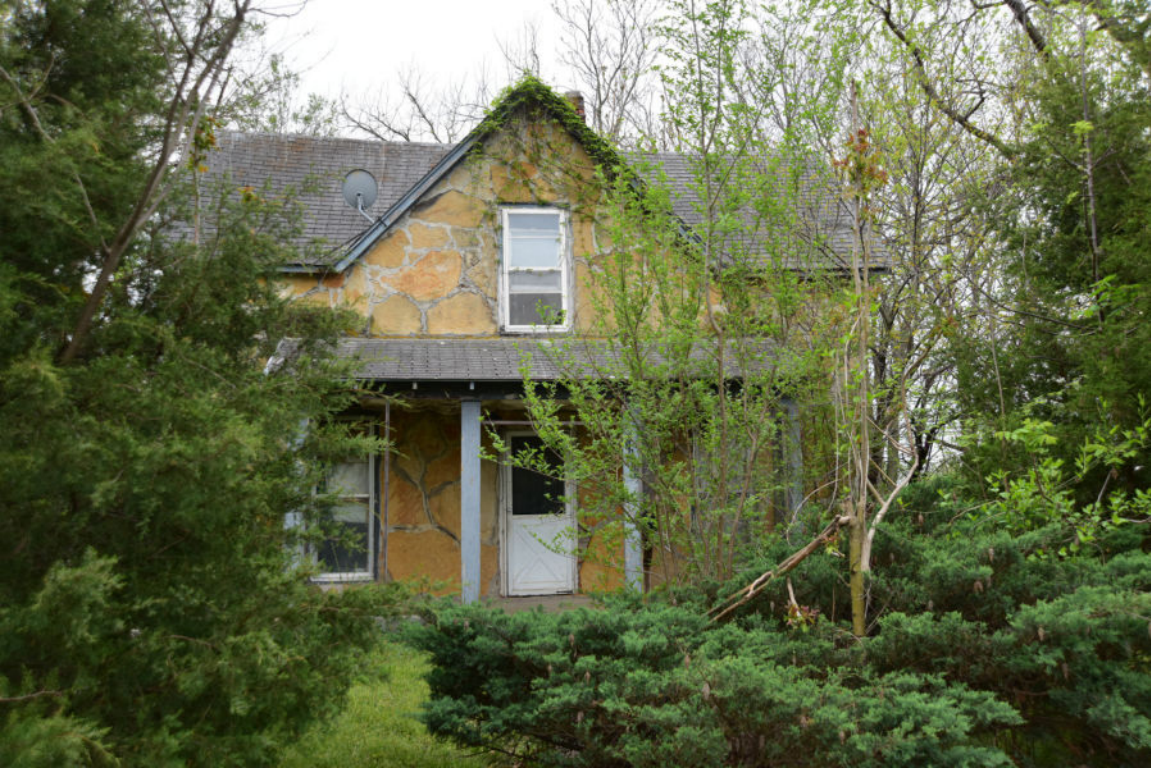
This two-story Gothic Revival dwelling faces north and has a rectangular footprint. It has a field stone foundation and split-slab field stone cladding. The roof has asphalt shingles and a brick chimney pierces the ridge. The dwelling is three bays wide and one bay deep. An open, three-quarter width historic porch shelters the primary elevation bays. A non-historic wood door occupies the center bay while narrow historic one-over-one wood windows occupy the remaining bays. A historic one-over-one wood window occupies the center gable.

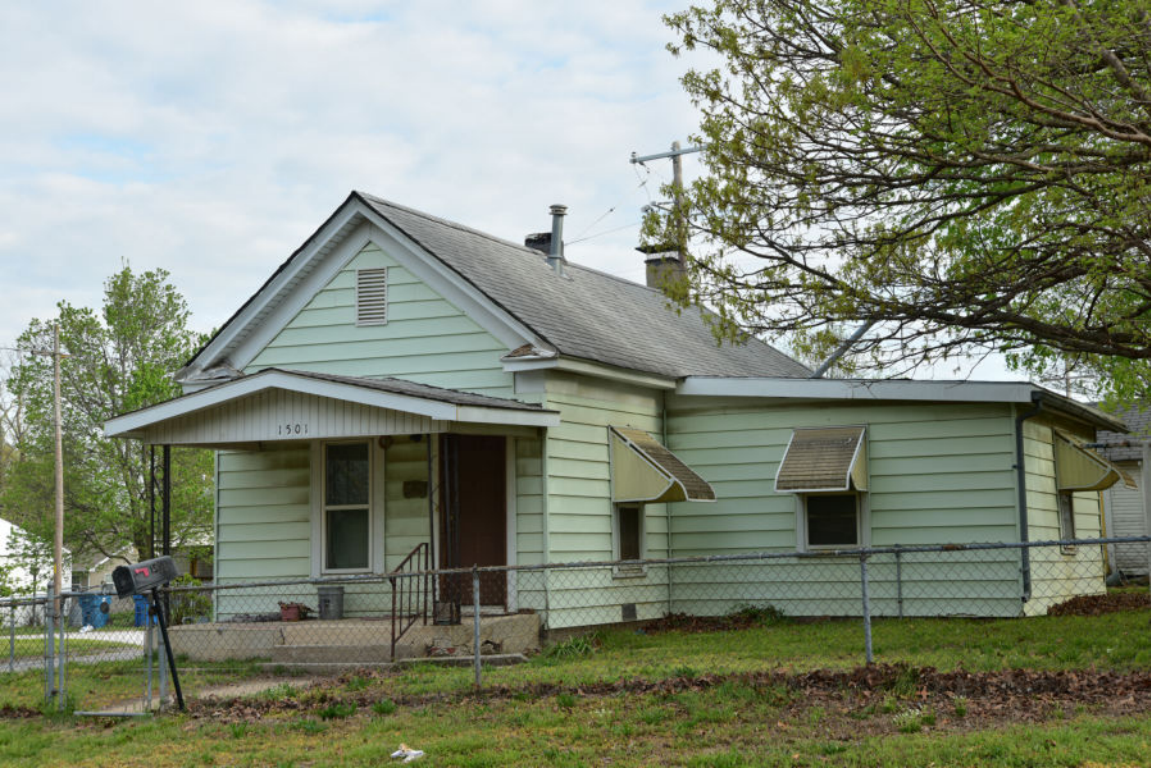
1501

This Shotgun dwelling faces south and has an irregular footprint. It has a concrete foundation, vinyl cladding, and asphalt shingle roof. A shed-roof addition projects from the east elevation. A non-historic porch with front-gable roof and metal support posts shelters the primary elevation bays. A non-historic wood door occupies the east bay while a one-over-one vinyl window occupies the west bay. Windows at secondary elevations have non-historic awnings. The east addition is not present on the 1950 Sanborn Map, but is present in the 1961 aerial photograph.

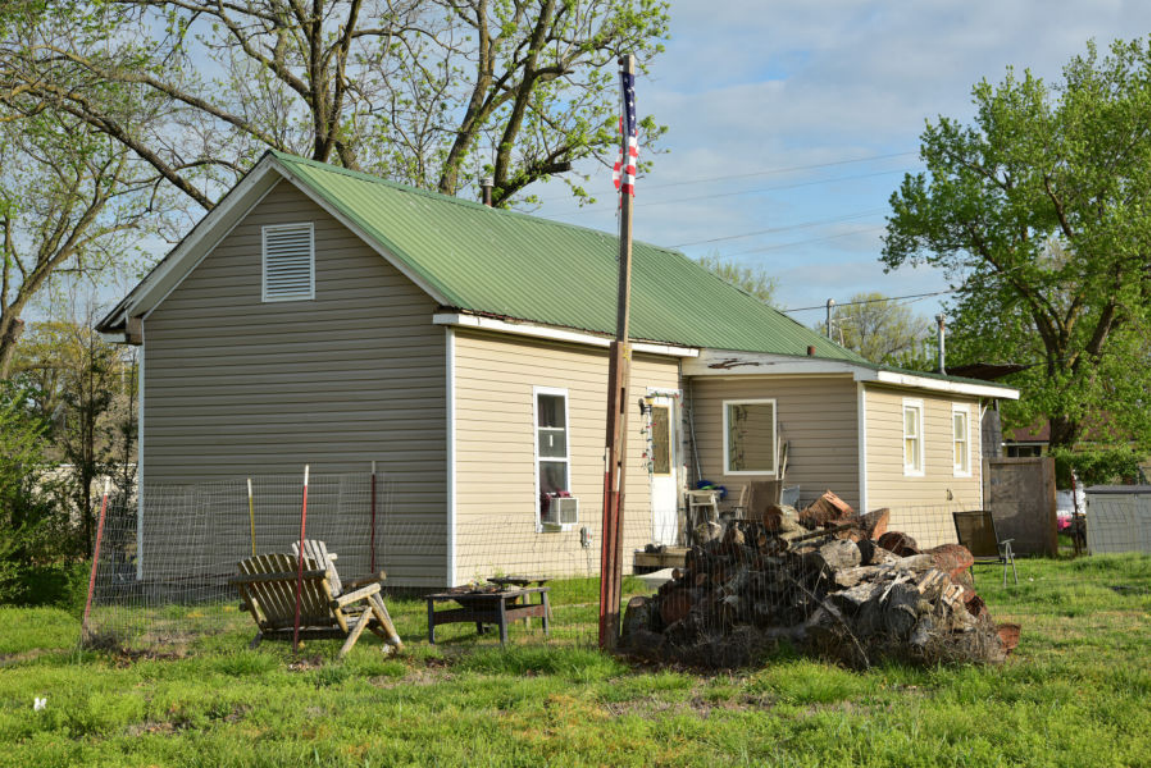
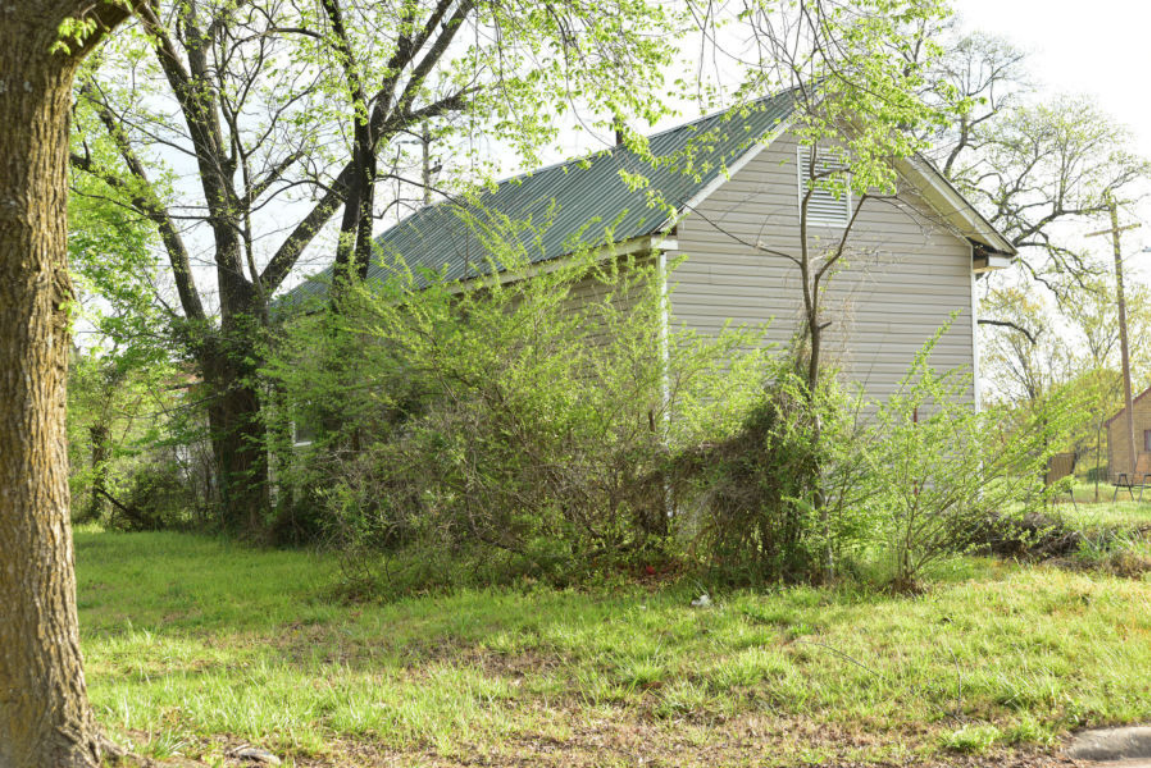
This resource has poor integrity. Non-historic alterations, including the application of non-historic siding that covers the entire south façade obscuring the historic entrance and any indication that there was once a porch there, as well as the replacement of windows and roof compromise the ability of this resource to convey its historic function and date of construction. This resource would be non-contributing to the East Joplin Residential Historic District, significant for its associations with the early residential development of Joplin, specifically the African American community. Areas of significance are Community Planning & Development, and Ethnic History/Black.

This dwelling faces south and has an L-shaped footprint. An enclosed porch contains the north two bays of the east elevation. The dwelling has a concrete foundation, vinyl cladding, and a seamed metal gabled roof. It is four bays wide. A non-historic wood door with glazing occupies the second bay while one-over-one vinyl windows occupy the remaining bays. The 2013 Google Street View shows that the northeast porch was already enclosed with historic wood siding and the south elevation had a single door and a window, both of which have been infilled. The south porch had been removed prior to 2007.

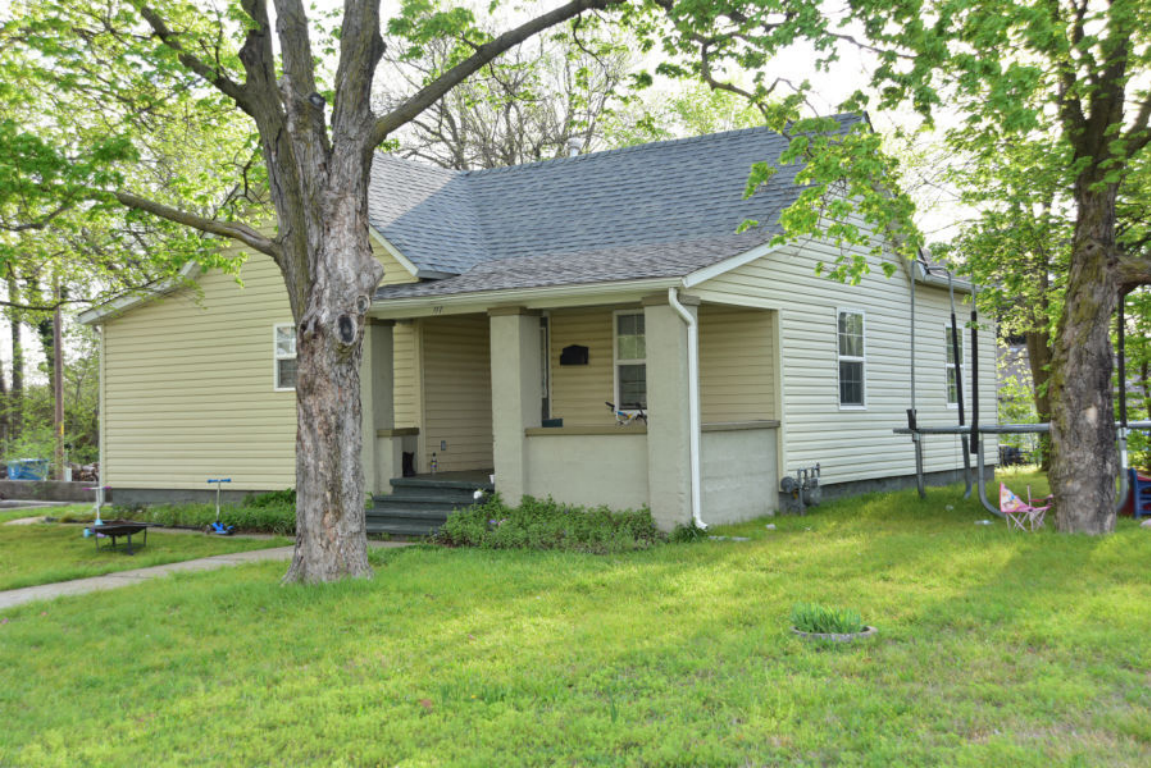
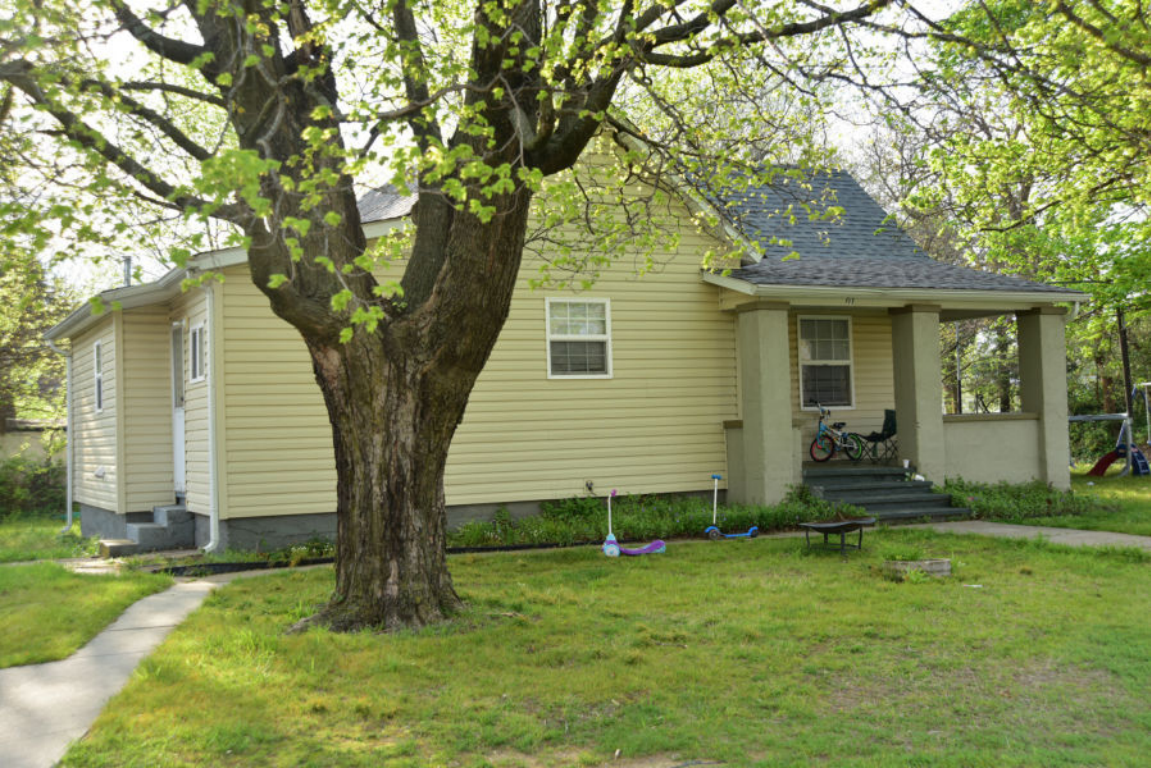
This Gabled-ElI dwelling faces south and has an L-shaped footprint. It has a parged foundation and vinyl cladding. The roof has asphalt shingles. The dwelling is three bays wide and two bays deep. The east two bays recede, creating a partial-width open porch. The porch has a shed roof and concrete foundation. The masonry walls and piers are parged. A non-historic wood door with non-light glazing occupies the center bay at the primary elevation while a six-over-six vinyl window occupies the west bay and a six-over-six wood window occupies the east bay.

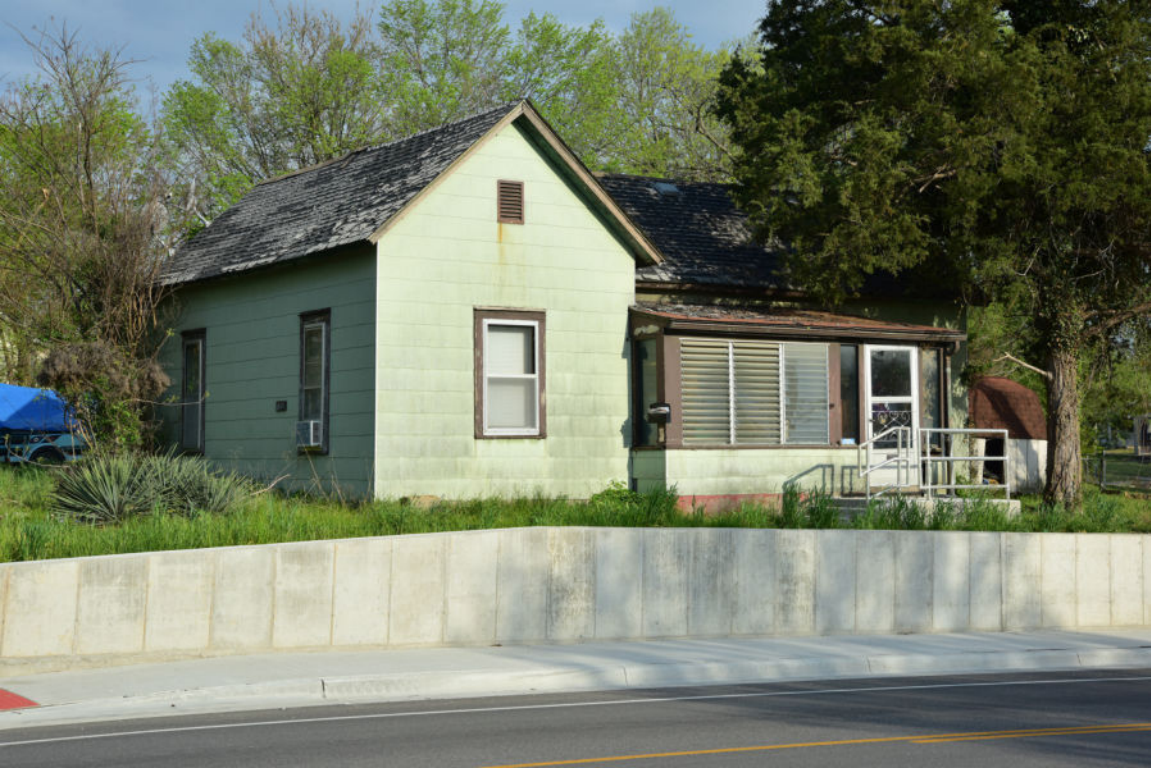
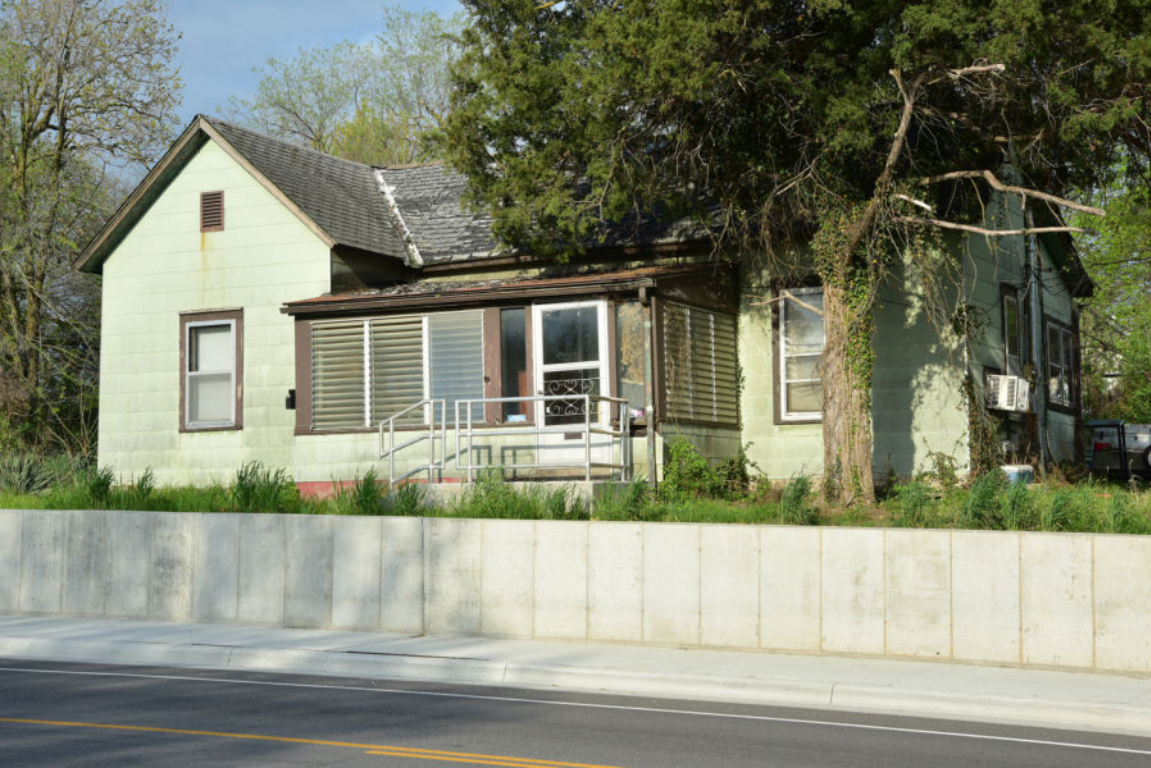
This Gabled-Ell dwelling faces east and has a T-shaped footprint. It has a concrete foundation, asbestos shingle cladding, and asphalt shingle roof. The dwelling is three bays wide and two bays deep. A historic enclosed shed-roof porch with jalousie windows defines the center bay. One-over-one metal windows with flat board trim define the remaining bays. The primary entrance door is not visible.

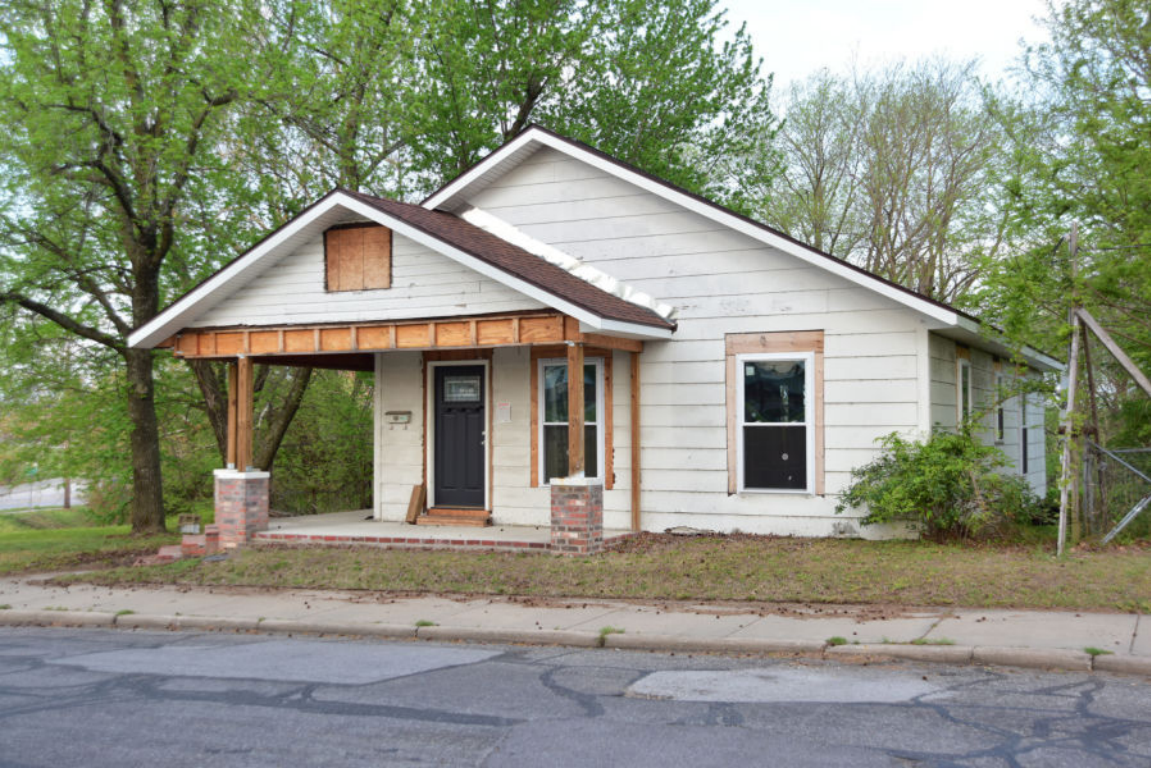
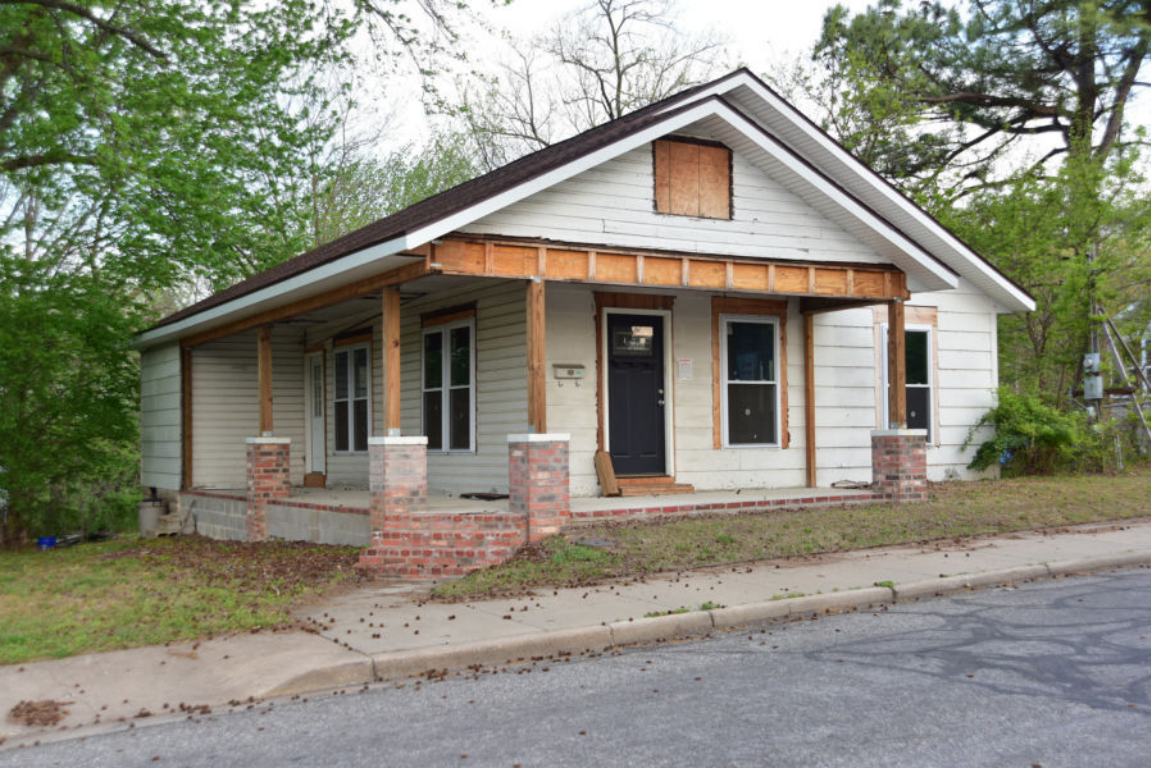
This Open Gable dwelling faces east and has a rectangular footprint. It has a concrete foundation and pressboard cladding. The front-gable roof has asphalt shingles. The dwelling is three bays wide and three bays deep. A front-gable roof shelters the south two bays of the primary elevation. The porch wraps around the south elevation has a concrete foundation and brick piers. Brick steps are located at the southeast corner. Non-historic wood posts support the roof. A non-historic wood door with glazing occupies the south bay while one-over-one vinyl windows fill the remaining bays. The new windows are smaller than the original openings and thus have wood infill. It is unknown what the new siding material will be.

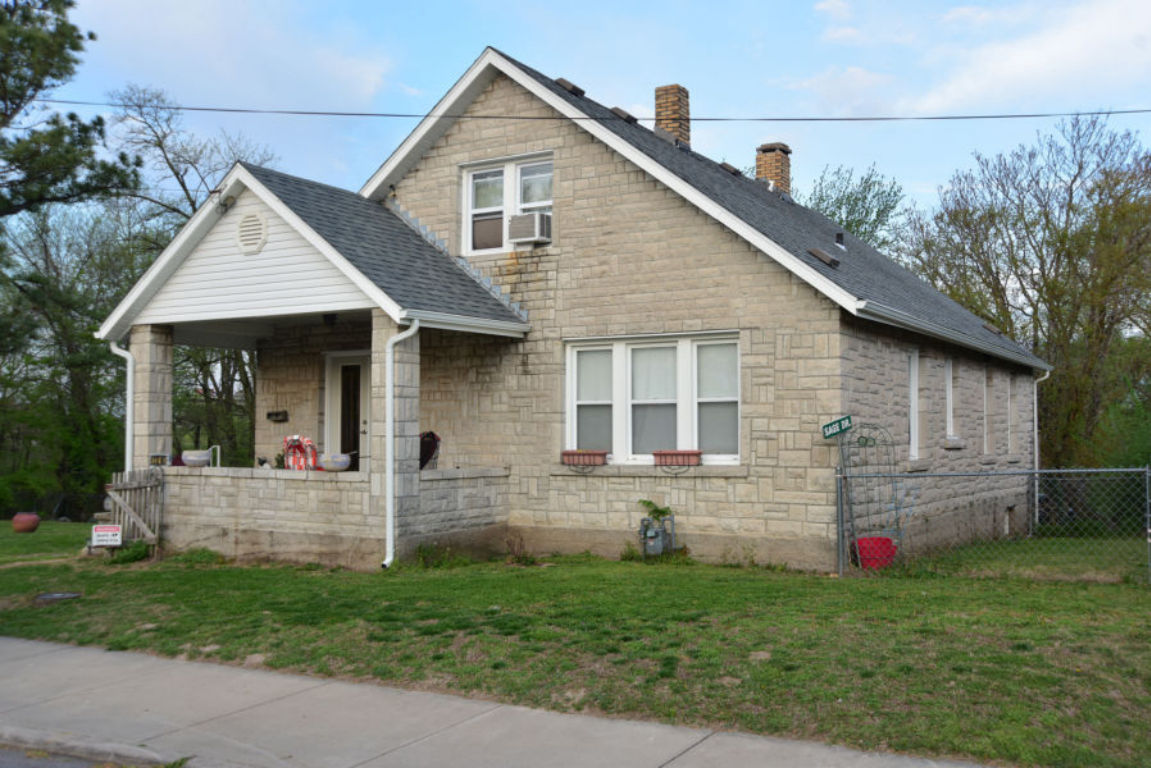
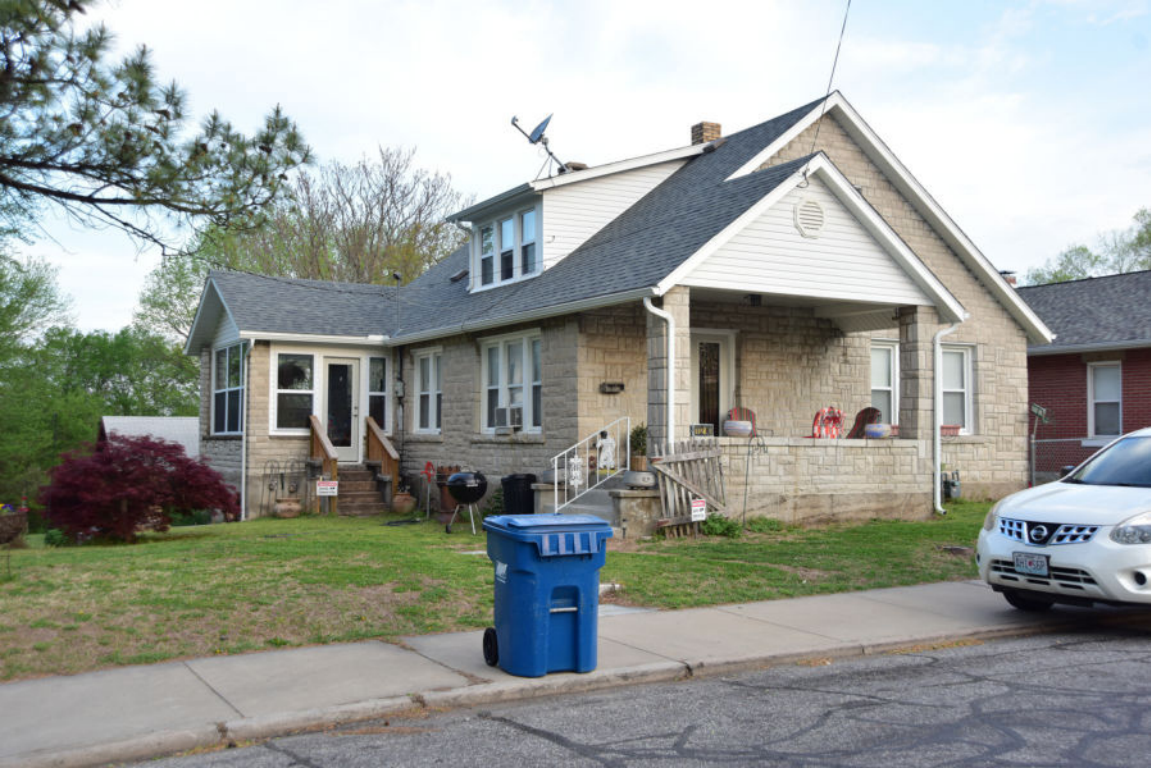
This bungalow dwelling faces east and has a L-shaped footprint. It has a concrete foundation and cut stone cladding. The front-gable roof features asphalt shingles and two straddle-ridge brick chimneys. A shed roof dormer is located on the south slope. An enclosed porch with a gabled roof projects from the south elevation. The dwelling is two bays wide and four bays deep. A front-gable porch with concrete foundation shelters the south primary elevation bay. The porch features cut stone walls and piers. A non-historic door occupies the south bay while a set of three one-over-one vinyl windows occupies the north bay. The dwelling windows have stone sills.
