1. Survey number: JP-AS-006-184		2. Survey Name: East Town (Original Joplin) Historic Survey Phase 1	
3. County: JASPER		4. Address 1401	Street (name): E. Hill Street
5. City: Joplin	Vicinity <input type="checkbox"/>	7. Township/Range/Section: T: R: S:	
8. Historic name (if known):		9. Present/other name (if known):	
10. Ownership: <input checked="" type="checkbox"/> Private <input type="checkbox"/> Public		11a. Historic use (if known): Domestic/Single Dwelling	11b. Current use: Domestic/Single Dwelling

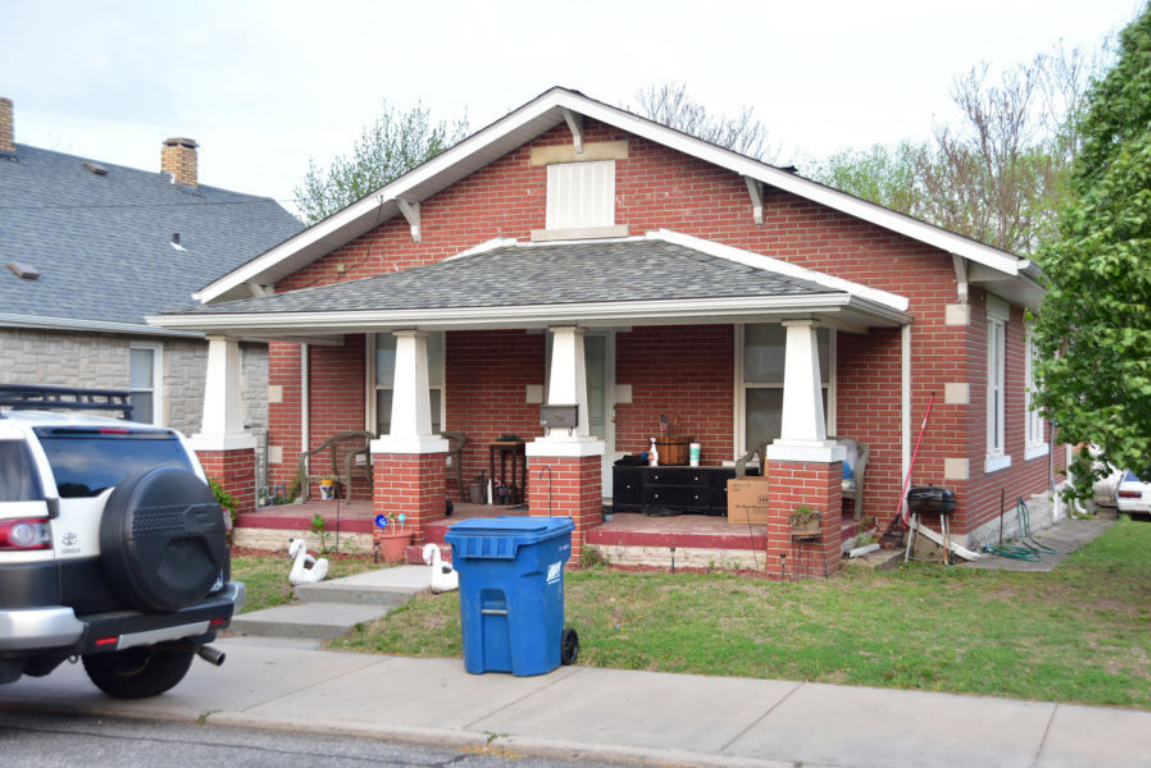
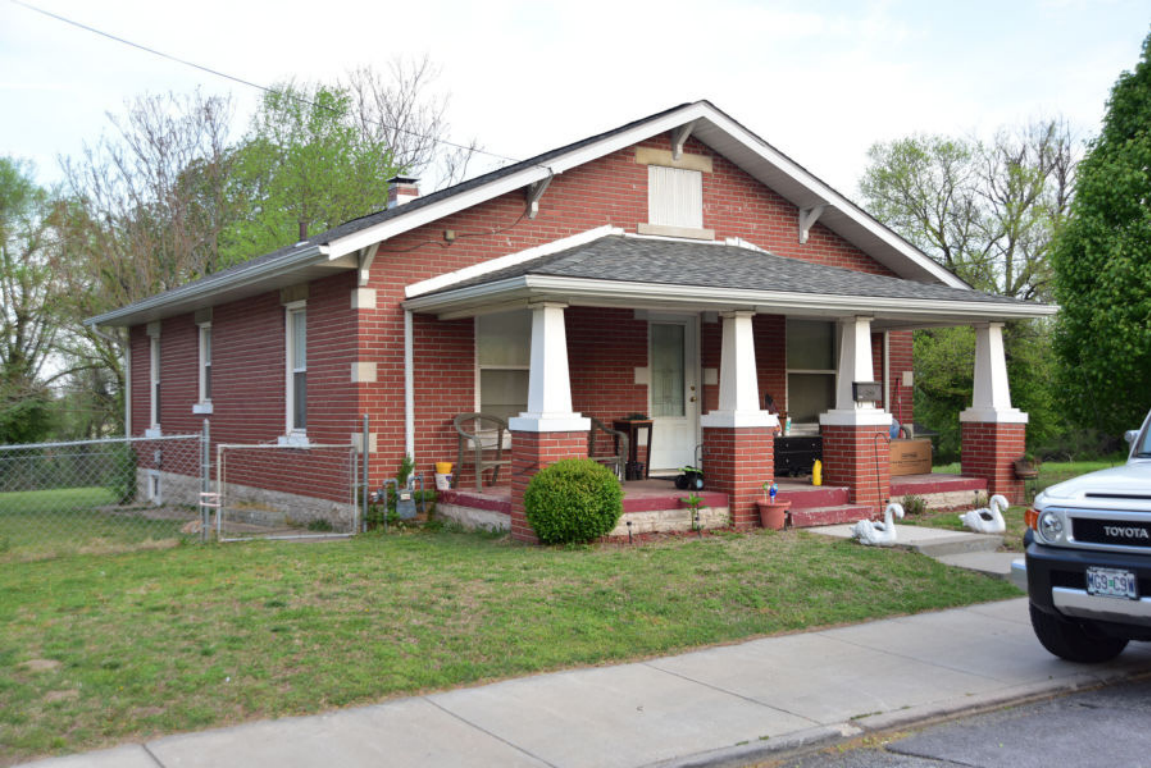
This bungalow dwelling faces east and has a rectangular footprint. It has a concrete block foundation and brick cladding with stone quoins. The front-gable roof features brackets at the gable end and asphalt shingles. A square window opening with a stone sill and lintel occupies the gable peak. The dwelling is three bays wide three bays deep. An open, three-quarter width porch shelters the primary elevation bays. It has a concrete block foundation and shallow hipped roof. Tapered wood columns on brick piers support the roof. A non-historic wood door with glazing occupies the center bay while one-over-one vinyl windows fill the remaining bays. The windows have stone sills. One-over-one vinyl windows with stone sills and lintels are present at the secondary elevations.

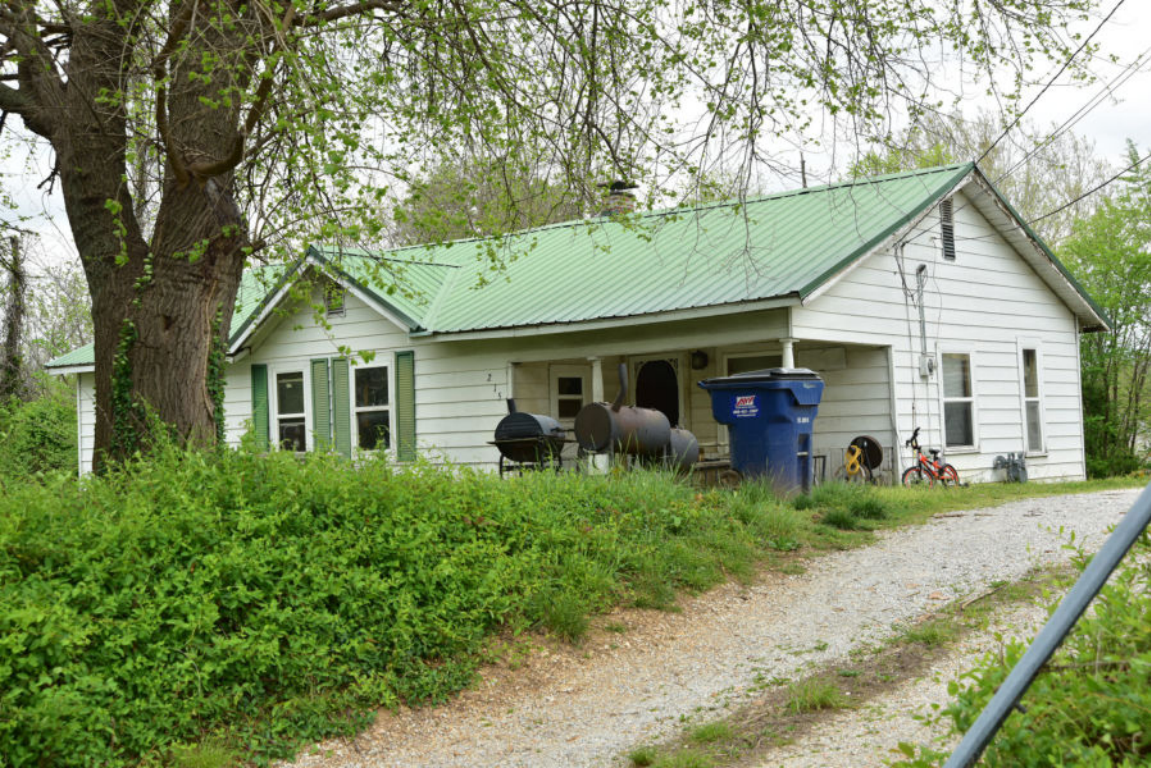
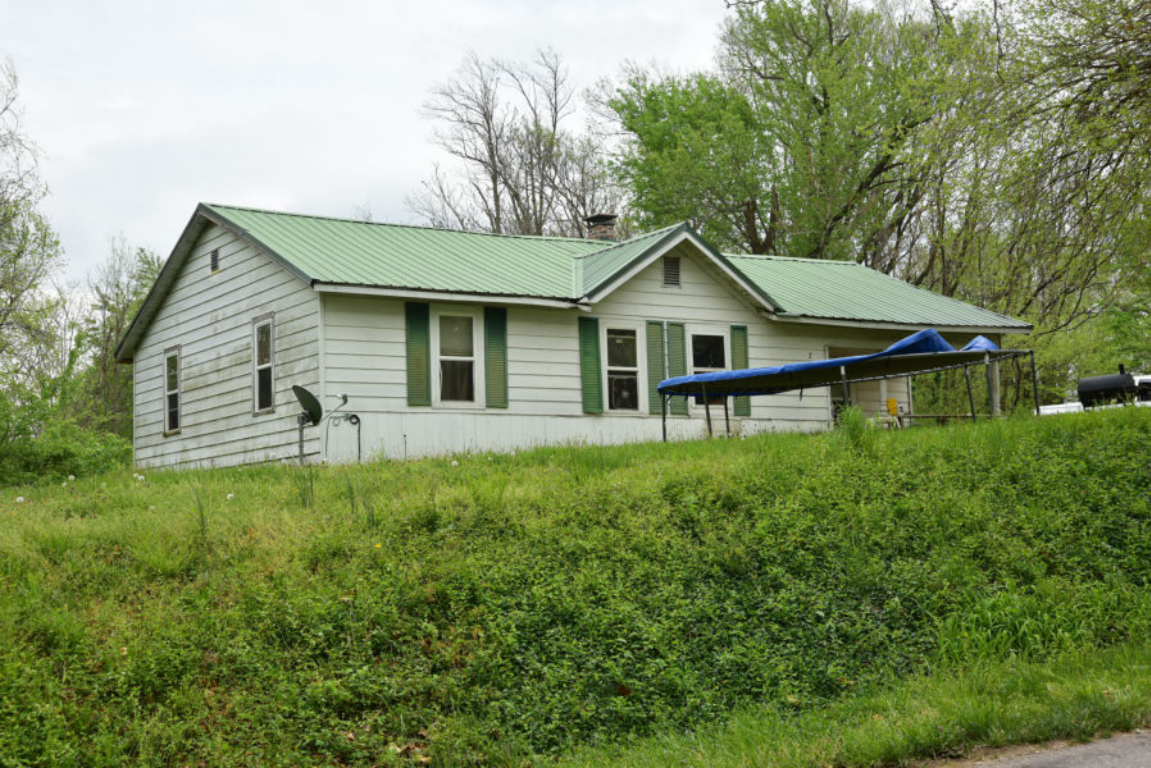
This Ranch dwelling faces west and has a rectangular footprint. It has metal cladding and a seamed metal roof with a center gable. The foundation is not visible. The dwelling is four bays wide and two bays deep. One-over-one wood windows with false shutters occupy the north two bays. A wood door forms the third bay and a one-over-one wood window occupies the south bay. The south two bays recede, creating a partial-width open porch. Wood columns support the porch roof.

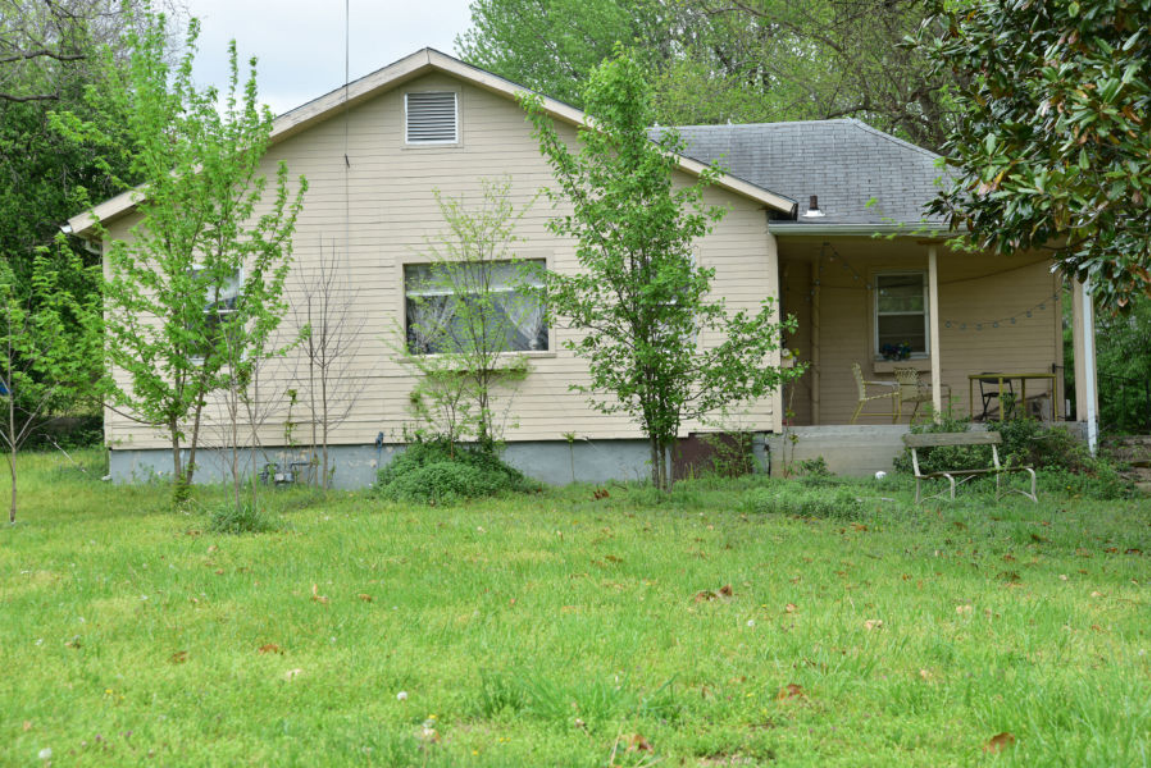
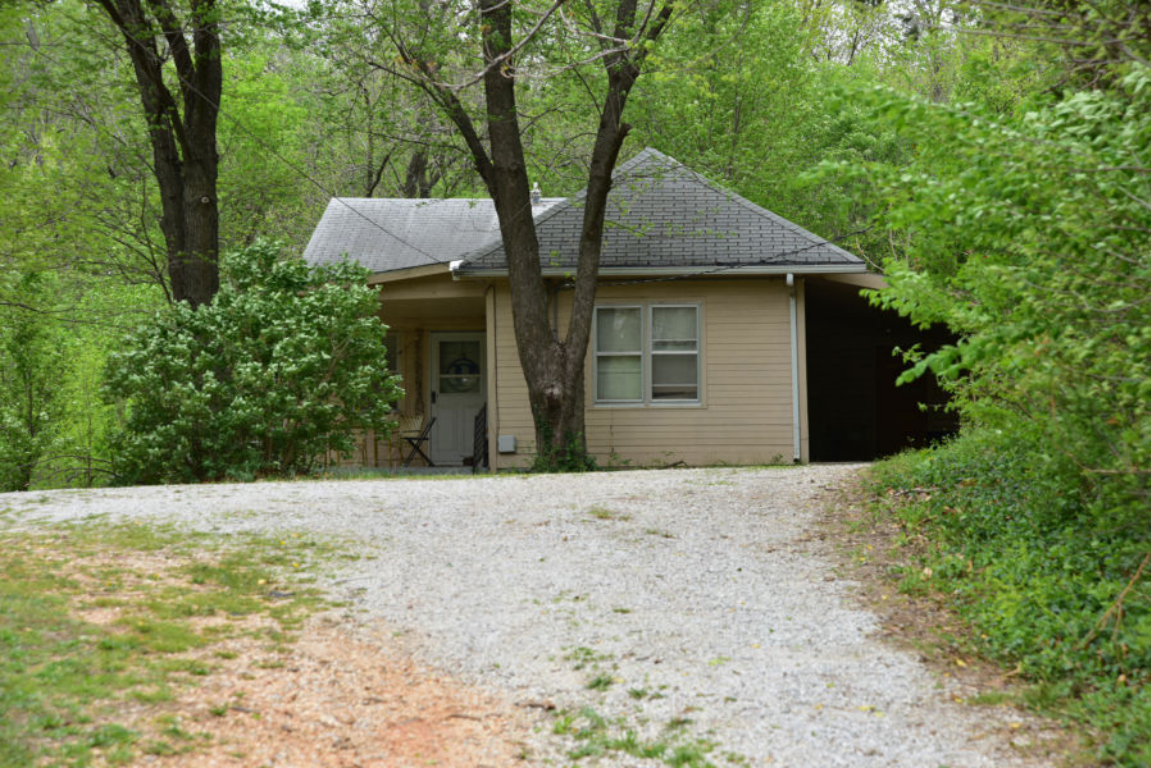
This dwelling faces south and has a square footprint. It has wood clapboard cladding and an asphalt shingle roof. The foundation is not visible. The dwelling is three bays wide. The west two bays recede, creating a partial-width open porch with a shed roof. Non-historic wood posts support the porch roof. One-over-one metal windows occupy the first and third bays. The primary entrance occupies the center bay; however, the door is not visible. A shed-roof carport projects from the east elevation.

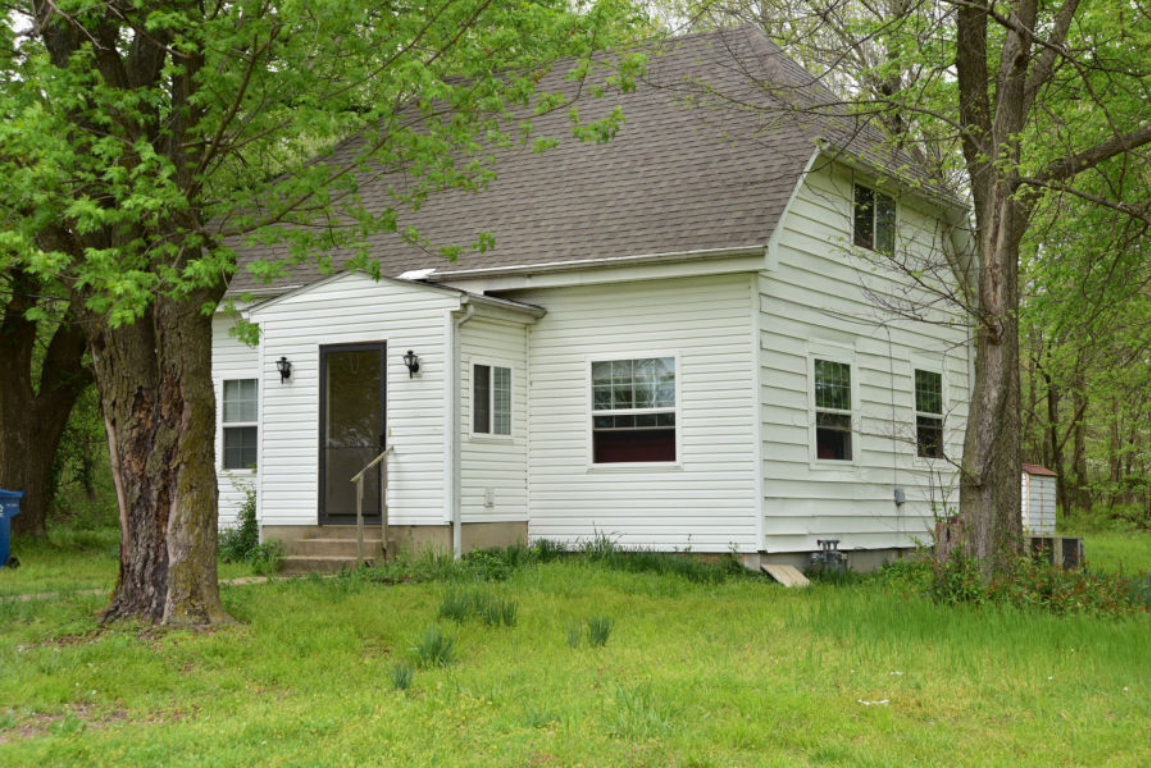
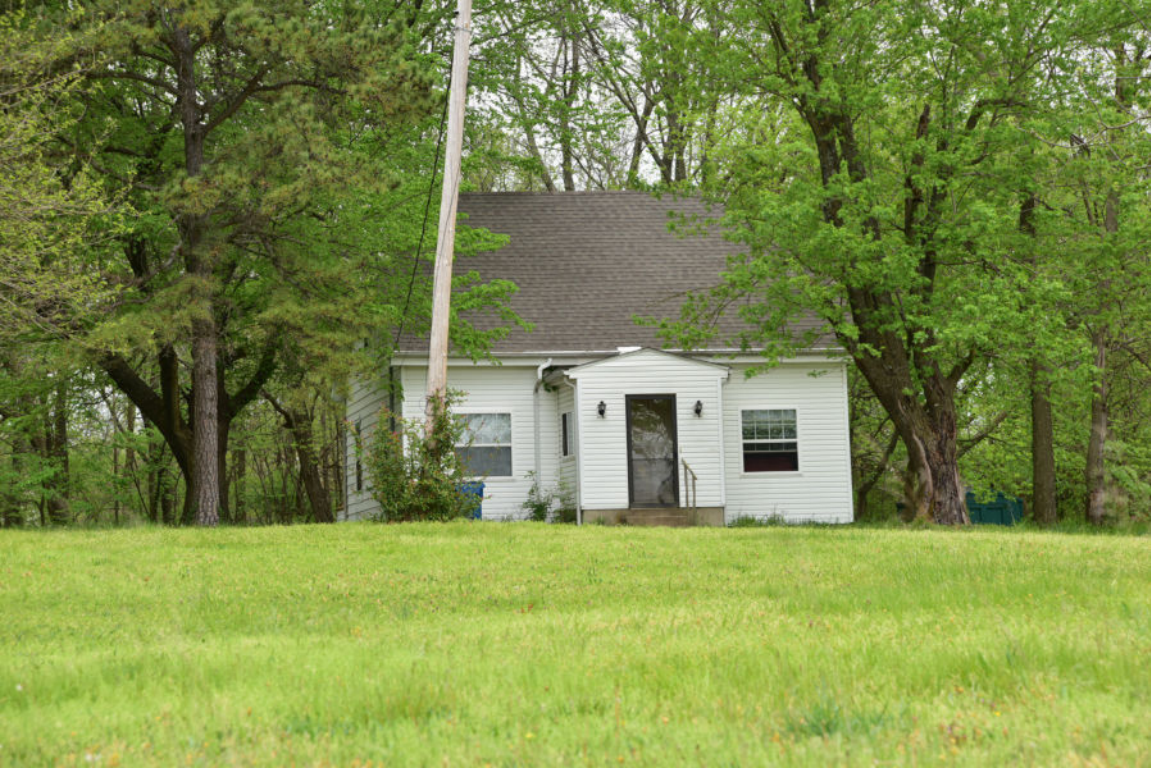
This dwelling faces west and has a rectangular footprint. It has a concrete foundation and hipped-gable roof with asphalt shingles. The primary elevation is vinyl-clad while the secondary elevations have metal siding. The dwelling is three bays wide and two bays deep. A non-historic enclosed stoop with a front-gable roof, concrete foundation, and vinyl cladding obscures the center bay of the primary elevation. It features a non-historic metal door with glazing and obscures the non-historic wood primary entrance door. Eight-over-eight vinyl windows occupy the north and south bays of the primary elevation. Eight-over-eight vinyl windows occupy the first-story bays of the secondary elevations while one-by-one windows are present in the gable ends.

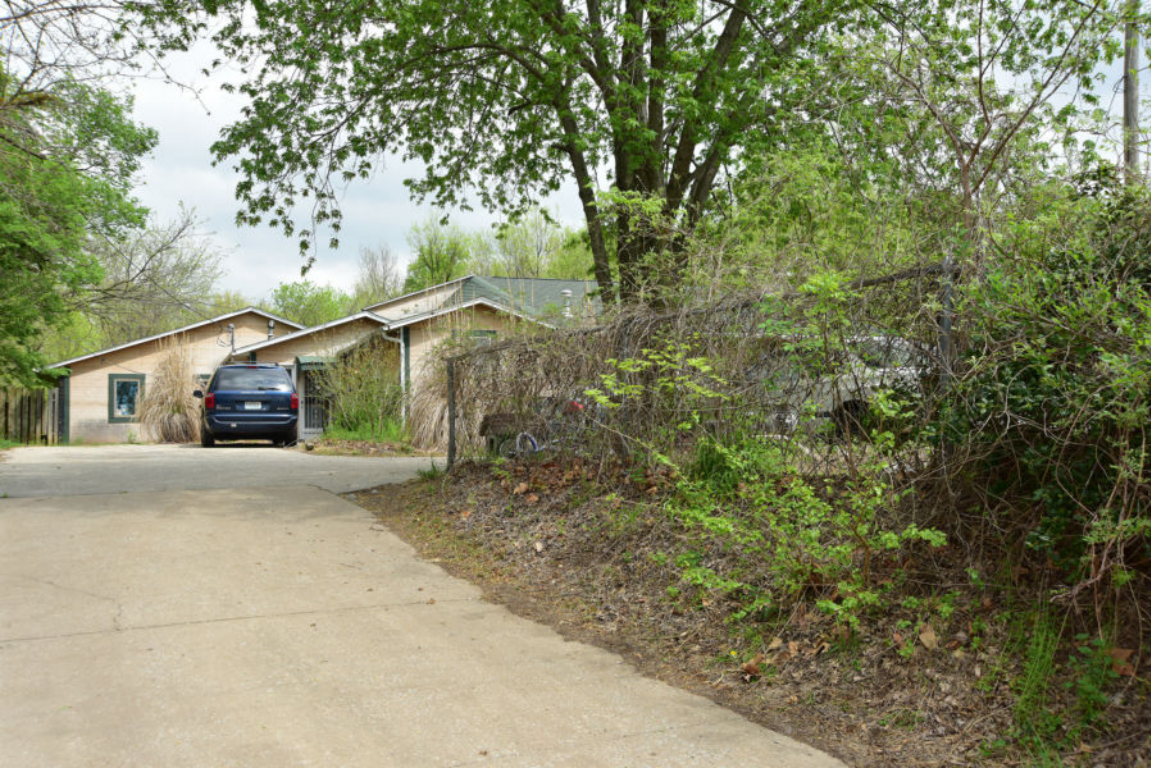
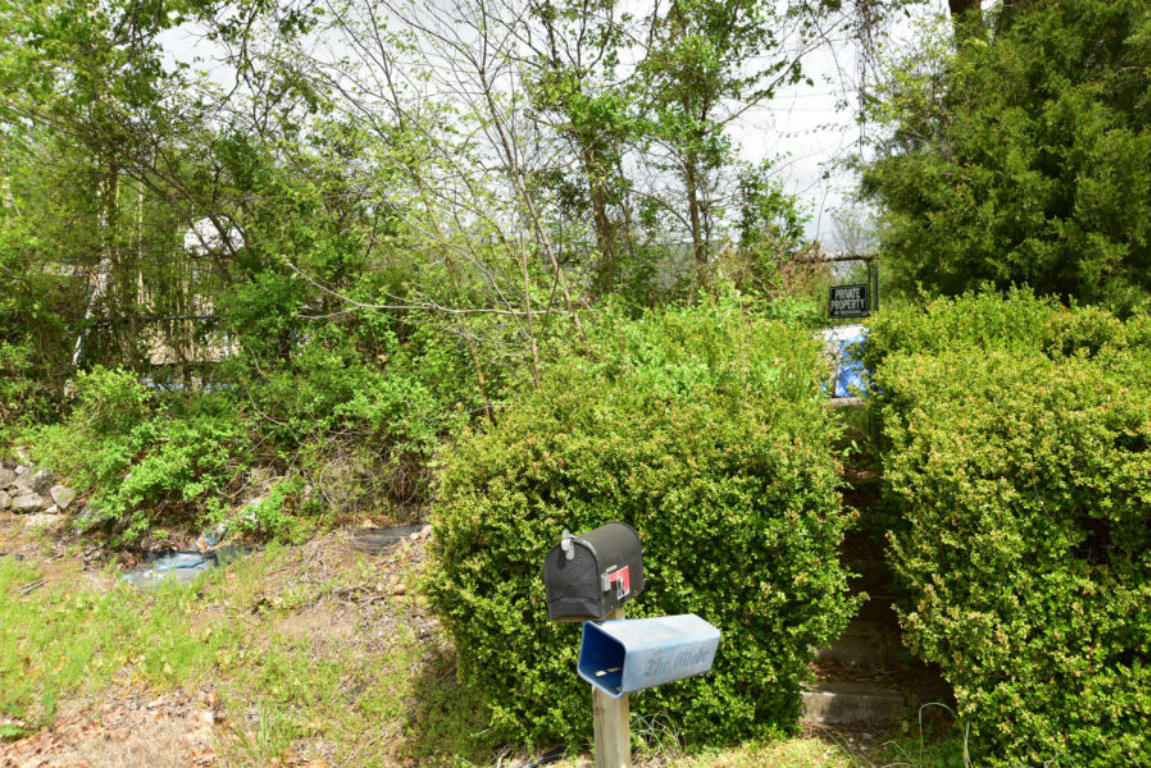
This dwelling faces west and has an irregular footprint. It is heavily obscured by fencing and brush, making it difficult to photograph from the public right-of-way. The complex roof has asphalt shingles and the foundation is not visible. It has stone veneer panel cladding.

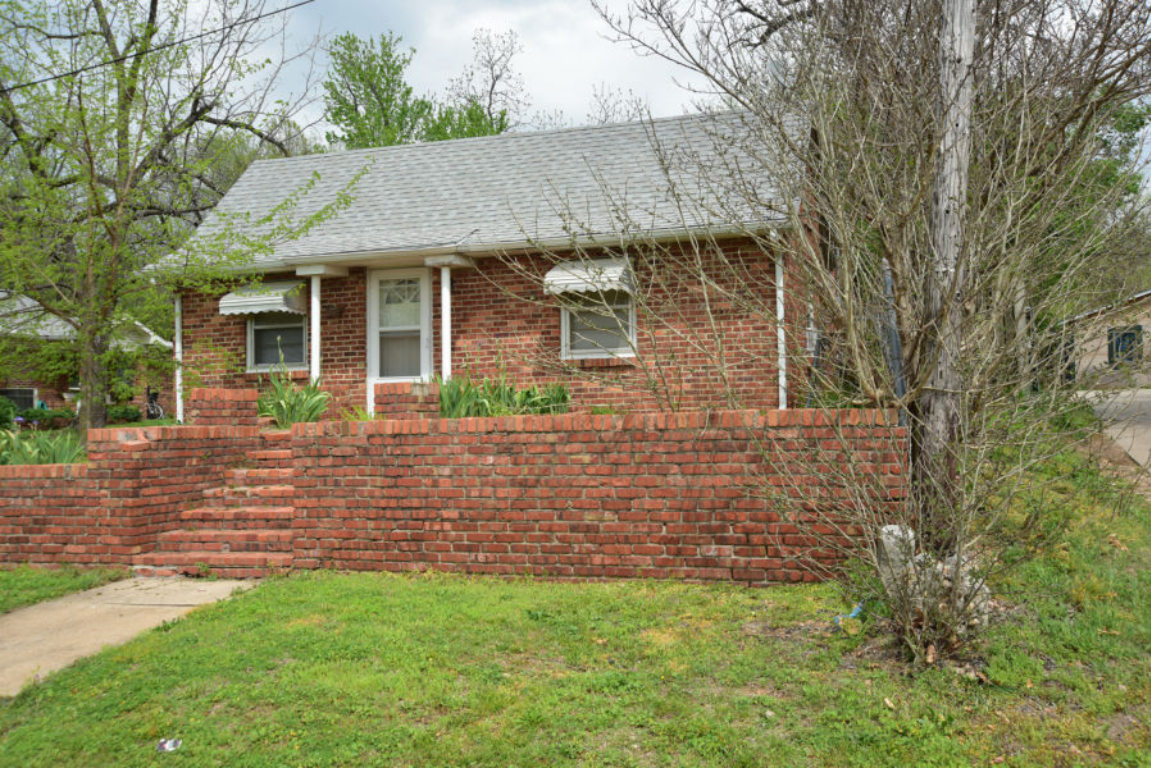
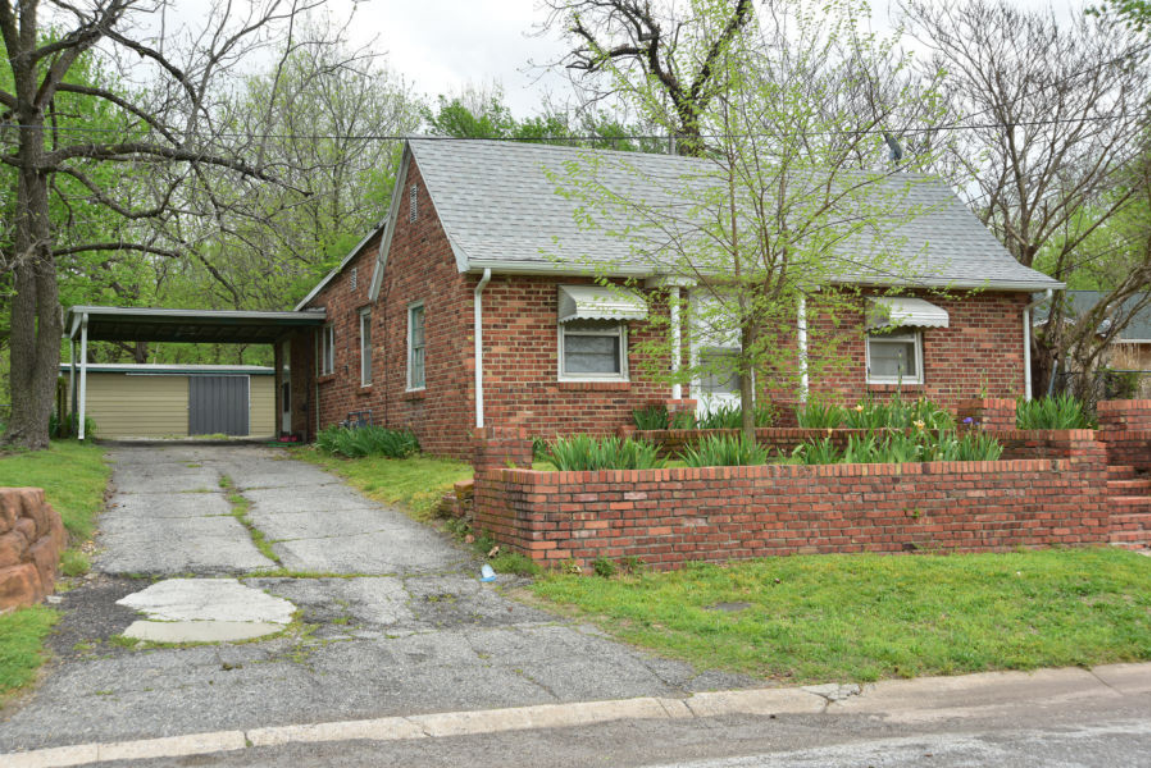
This dwelling faces west and has an L-shaped footprint. It has brick cladding and an asphalt shingle roof. The foundation is not visible. The dwelling is three bays wide and four bays deep. A non-historic fiberglass door occupies the center bay of the primary elevation while historic two-over-two wood windows with header brick sills occupy the remaining bays. A frame carport projects from the north elevation and shelters a secondary entrance.

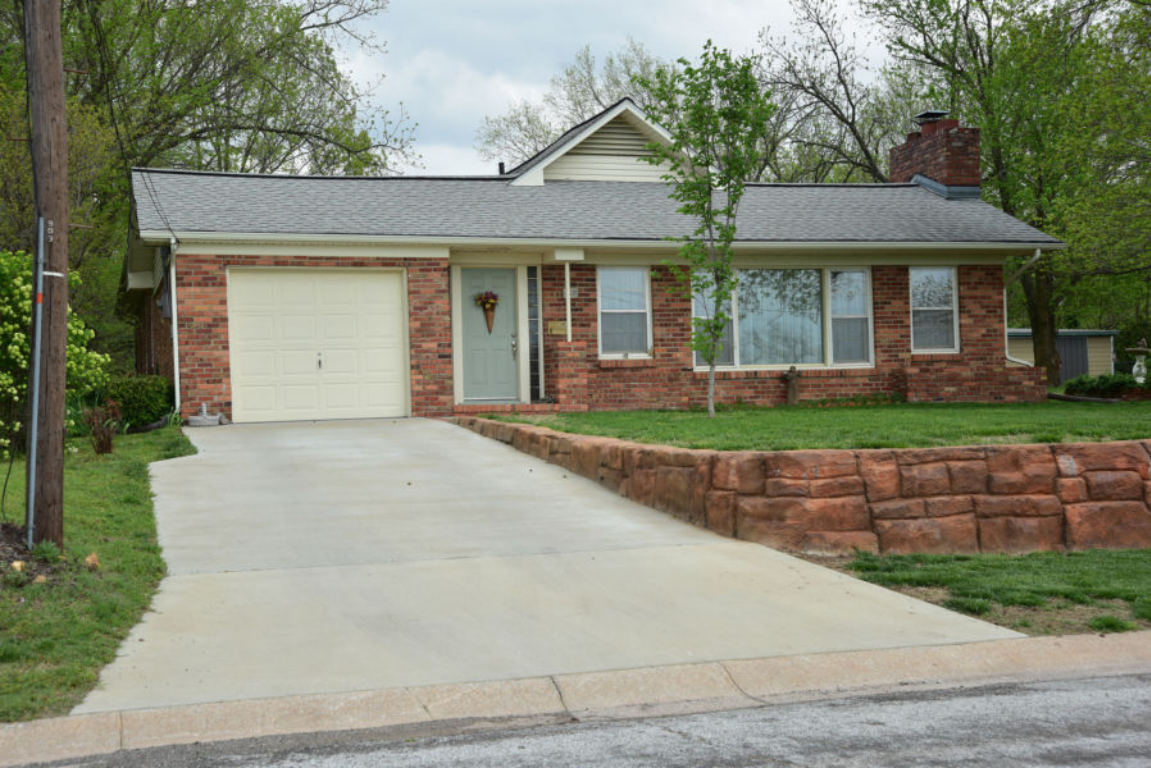
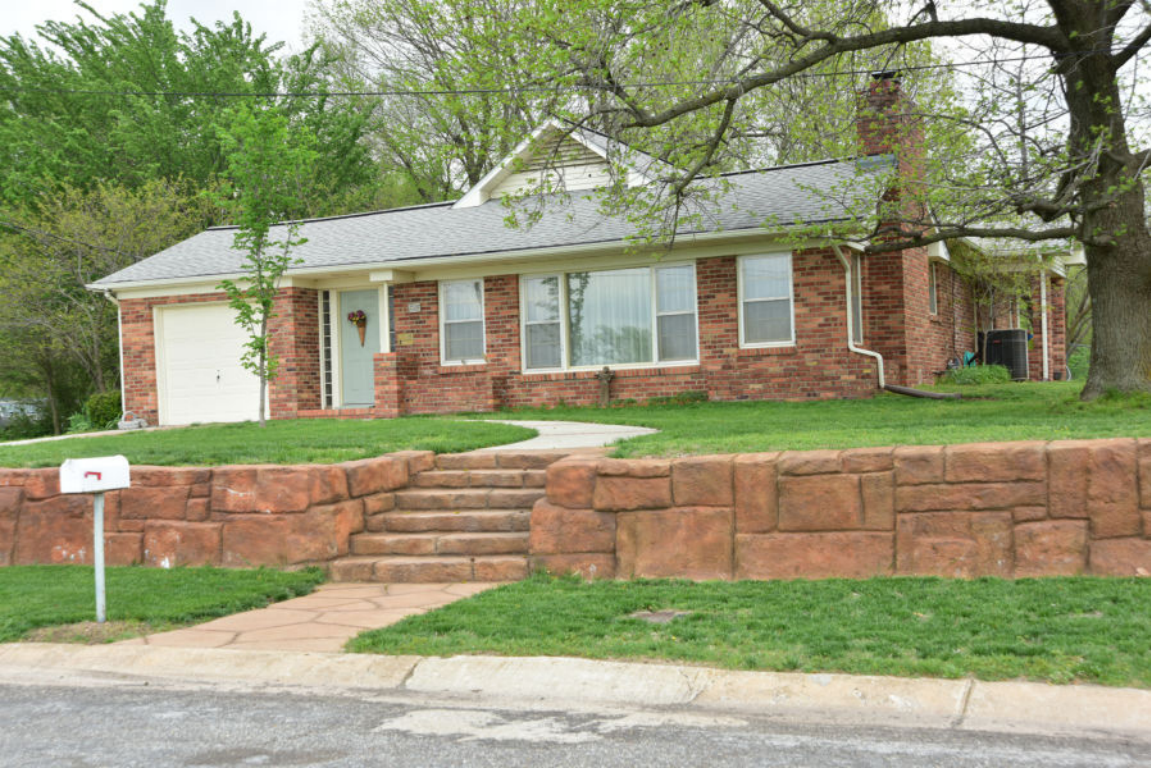
This dwelling faces west and has a rectangular footprint. It has brick cladding and an asphalt shingle roof. The foundation is not visible. The dwelling is five bays wide. A non-historic overhead garage door occupies the north bay while a wood door with sidelights fills the adjacent bay. The second bay is slightly recessed, creating a recessed stoop. Two-over-two wood windows occupy the third and fifth bays while a tripartite picture window fills the fourth bay. The picture window features a single-light wood window flanked by two-over-two wood windows. A front-gable porch with brick support pillars projects from the south elevation. An exterior brick chimney is located at the southwest corner of the dwelling.

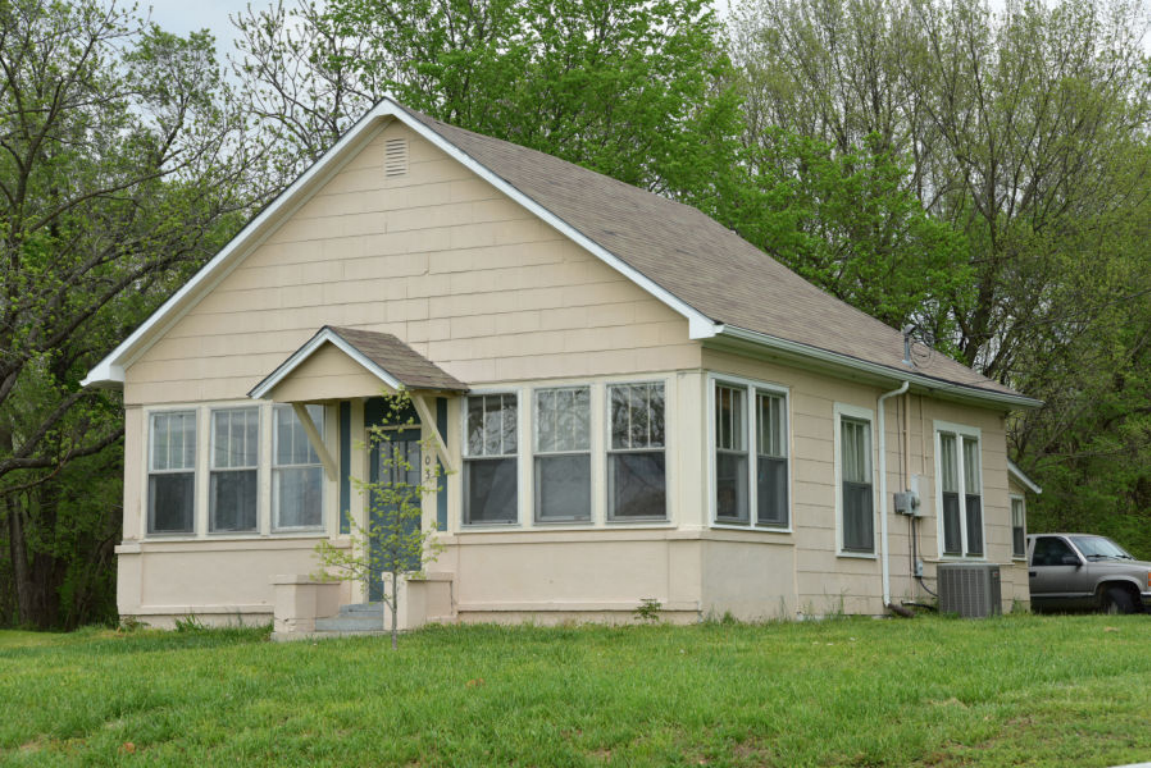
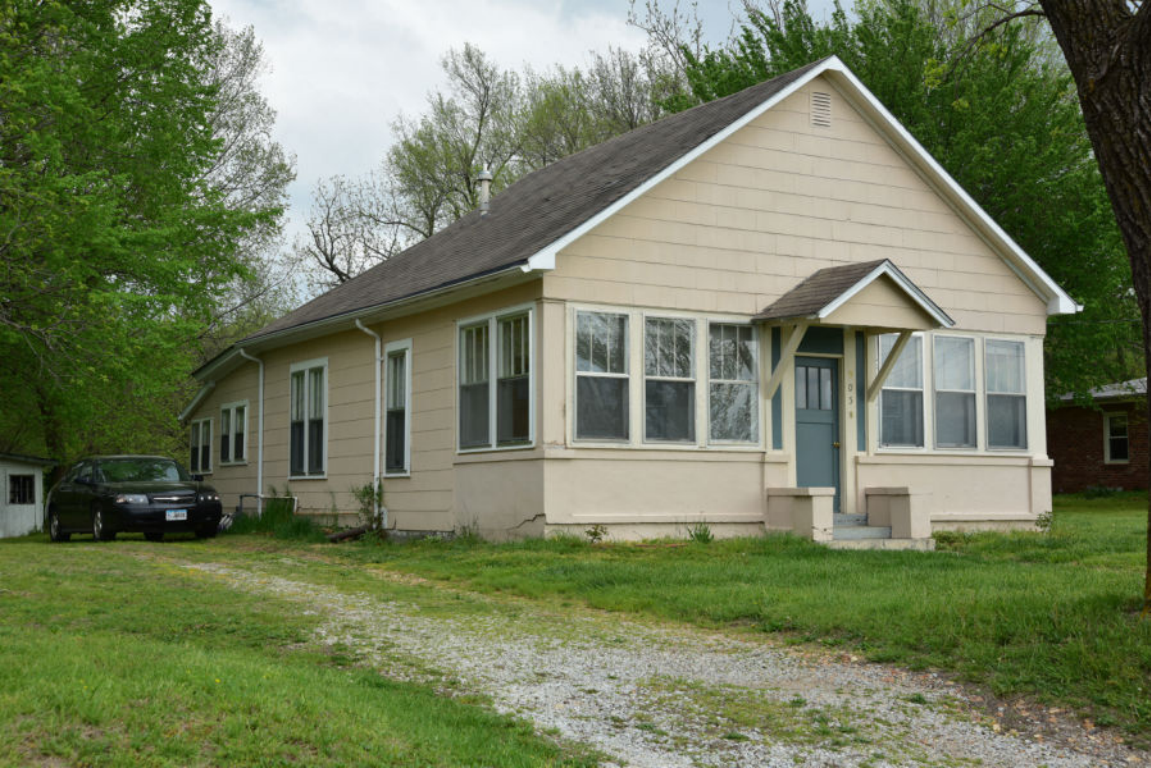
This bungalow dwelling faces west and has a rectangular footprint. It has a concrete foundation and asbestos shingle cladding. The front-gable roof has asphalt shingles. The dwelling is three bays wide and five bays deep. An enclosed porch spans the primary elevation. A historic wood door with three-light glazing occupies the center bay of the primary elevation. Sets of three historic three-over-one wood windows occupies the north and south bays. The entrance features a concrete stoop with a front gable roof. The stoop roof features exposed rafter tails and knee brackets.

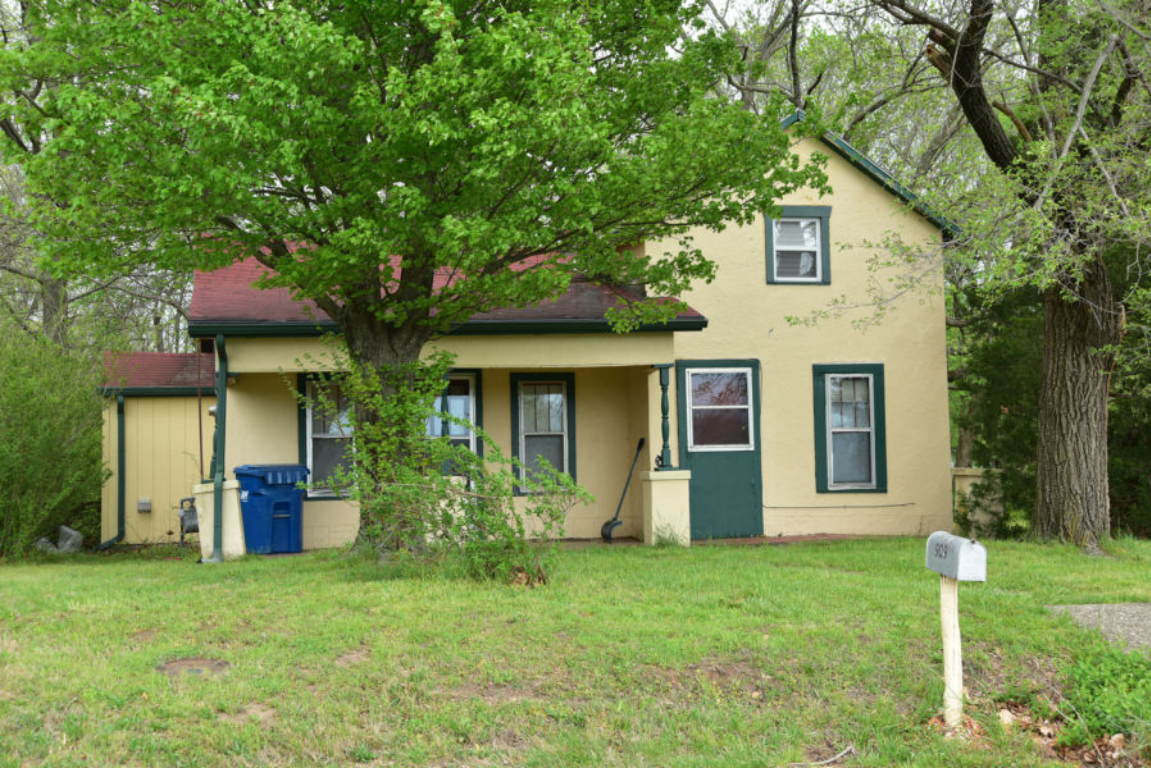
This Gabled-Ell dwelling faces west and has an L-shaped footprint. It has stucco cladding and an asphalt shingle roof. The foundation is not visible. The dwelling is five bays wide. Historic three-over-one wood windows occupy the first, third, and fifth bays while a historic wood door with three-light glazing occupies the second bay. A one-over-one aluminum window and wood infill occupies a former entrance opening in the fourth bay and a one-over-one vinyl window is located in the gable peak. The north three bays are recessed, creating an open, partial-width porch. The porch has a shed roof and concrete foundation. Non-historic turned wood posts on parged piers support the roof.

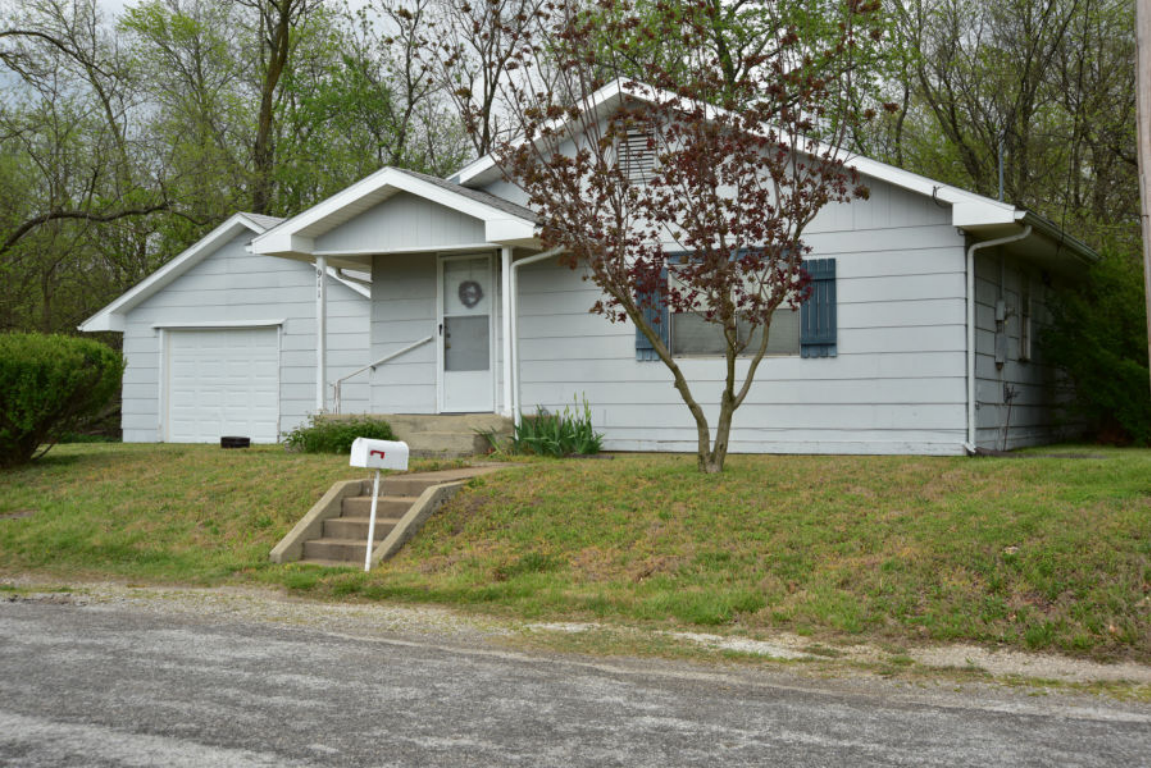
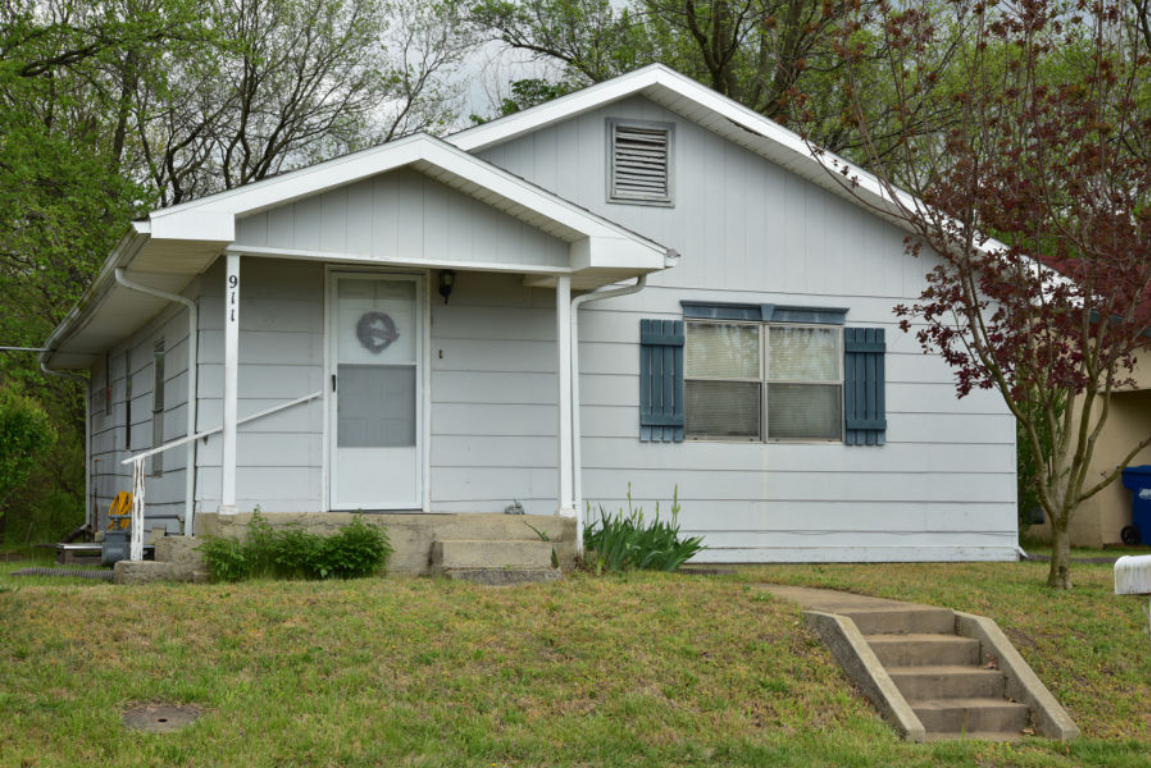
This bungalow dwelling faces west and has a rectangular footprint. It has asbestos shingle cladding, concrete foundation, and a front-gable roof with asphalt shingles. The dwelling is two bays wide and three bays deep. A non-historic wood door occupies the north bay of the primary elevation while a pair of one-over-one wood windows occupies the south bay. The windows feature non-historic false shutters and a non-historic wood lintel with keystone detail. A front-gable porch shelters the entrance. It has a concrete foundation and non-historic wood support posts.

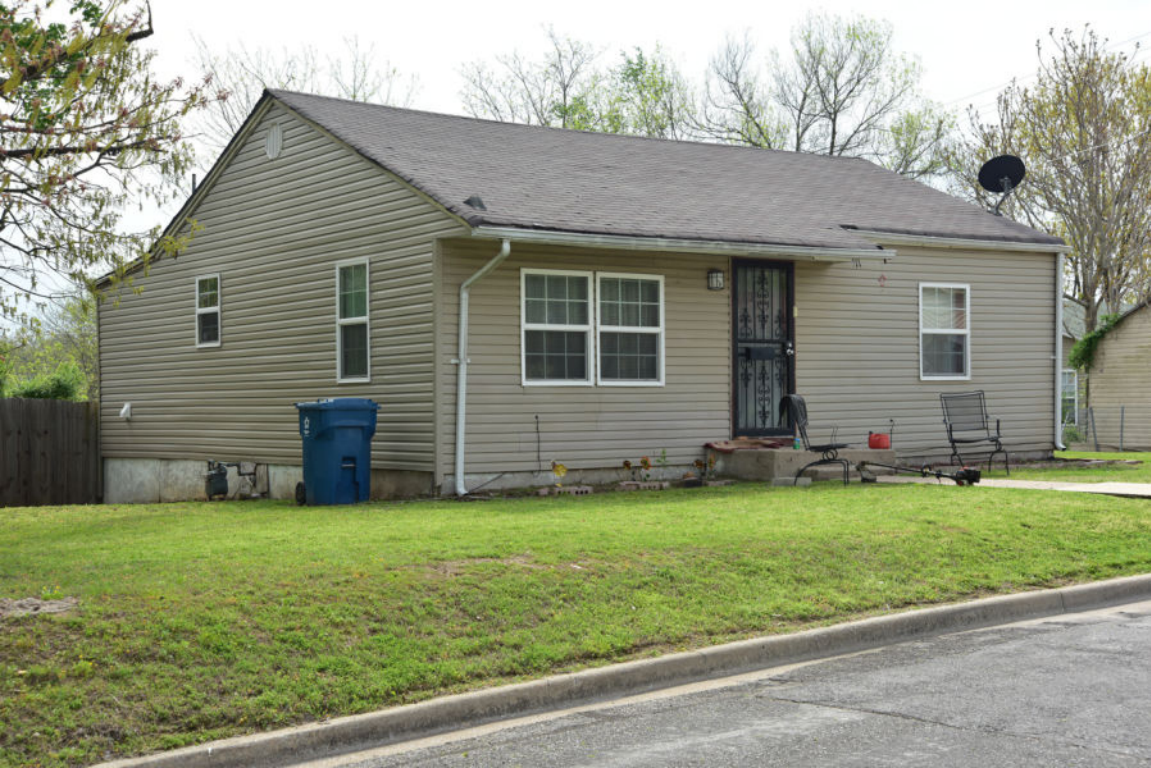
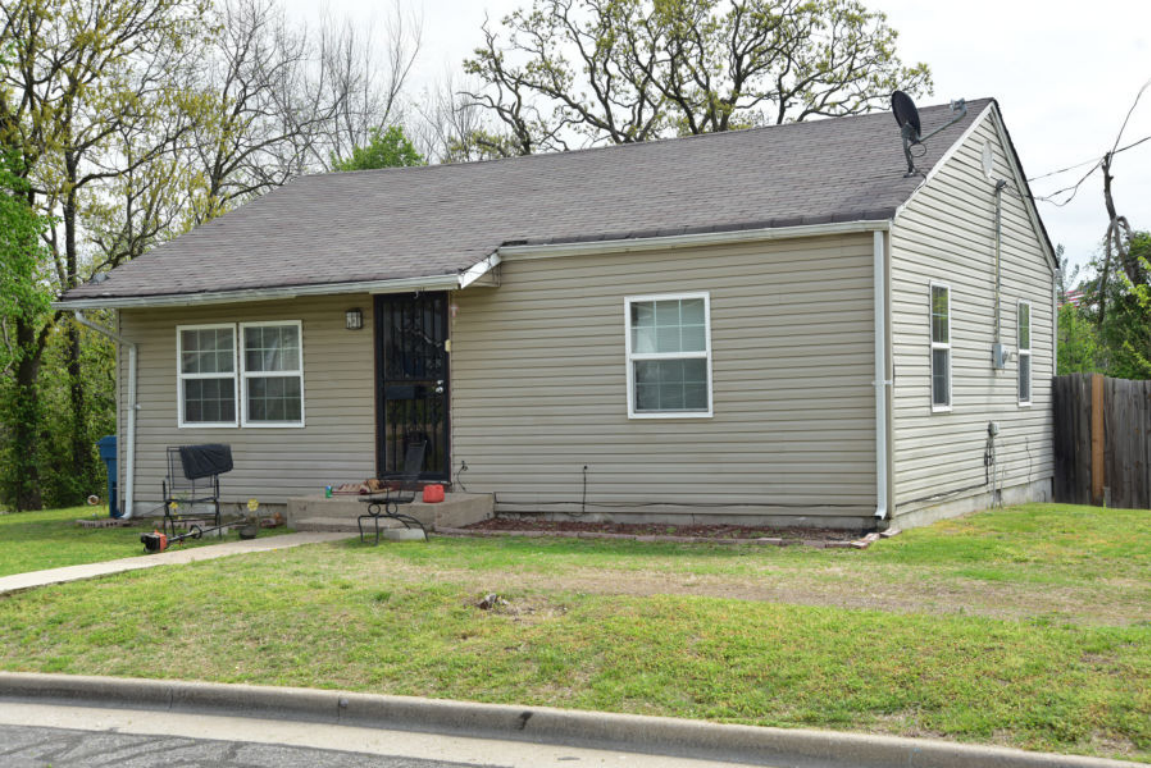
This dwelling faces west and has an L-shaped footprint. It has a parged stone foundation and vinyl cladding. The side-gable roof has asphalt shingles. The dwelling is three bays wide and two bays deep. Singles and pairs of six-over-six vinyl windows occupy the north and south bays of the primary elevation while a non-historic wood door occupies the center bay. The roof slightly overhangs and shelters the north two bays and a concrete stoop.

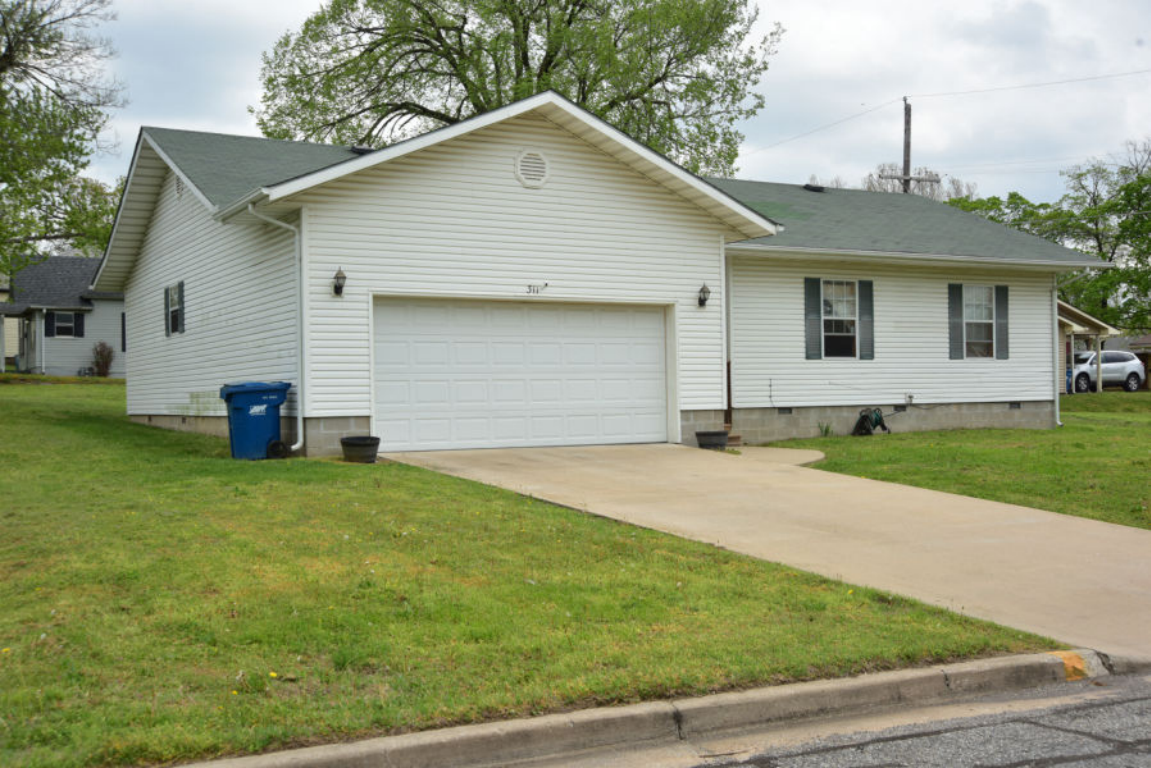
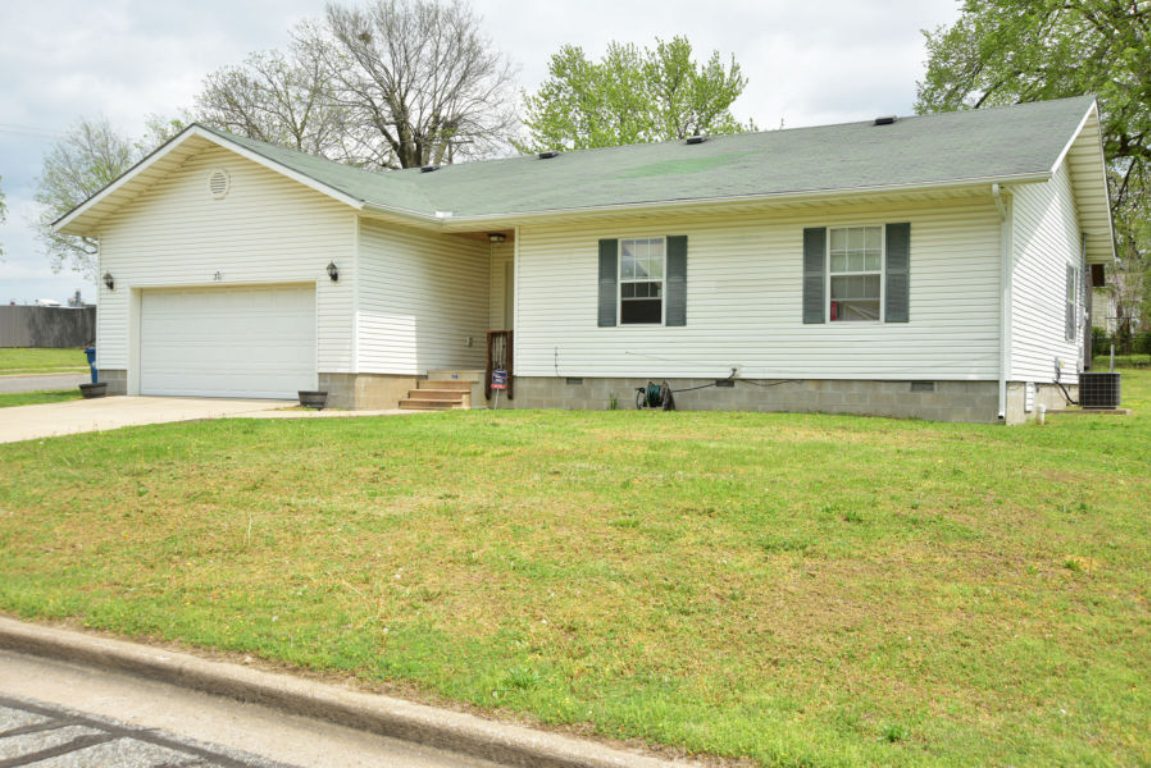
This Ranch dwelling faces west and has an L-shaped footprint. It has a concrete masonry unit foundation, vinyl cladding, and a side-gable roof with asphalt shingles. A cross-gable is located at the north end of the dwelling and houses an attached garage. The dwelling is four bays wide and one bay deep. The garage forms the first bay while six-over-six vinyl windows with false shutters occupy the third and fourth bays. The second bay is recessed and contains the primary entrance.
