1. Survey number: JP-AS-006-184		2. Survey Name: East Town (Original Joplin) Historic Survey Phase 1	
3. County: JASPER		4. Address 1401	Street (name): E. Hill Street
5. City: Joplin	Vicinity <input type="checkbox"/>	7. Township/Range/Section: T: R: S:	
8. Historic name (if known):		9. Present/other name (if known):	
10. Ownership: <input checked="" type="checkbox"/> Private <input type="checkbox"/> Public		11a. Historic use (if known): Domestic/Single Dwelling	11b. Current use: Domestic/Single Dwelling

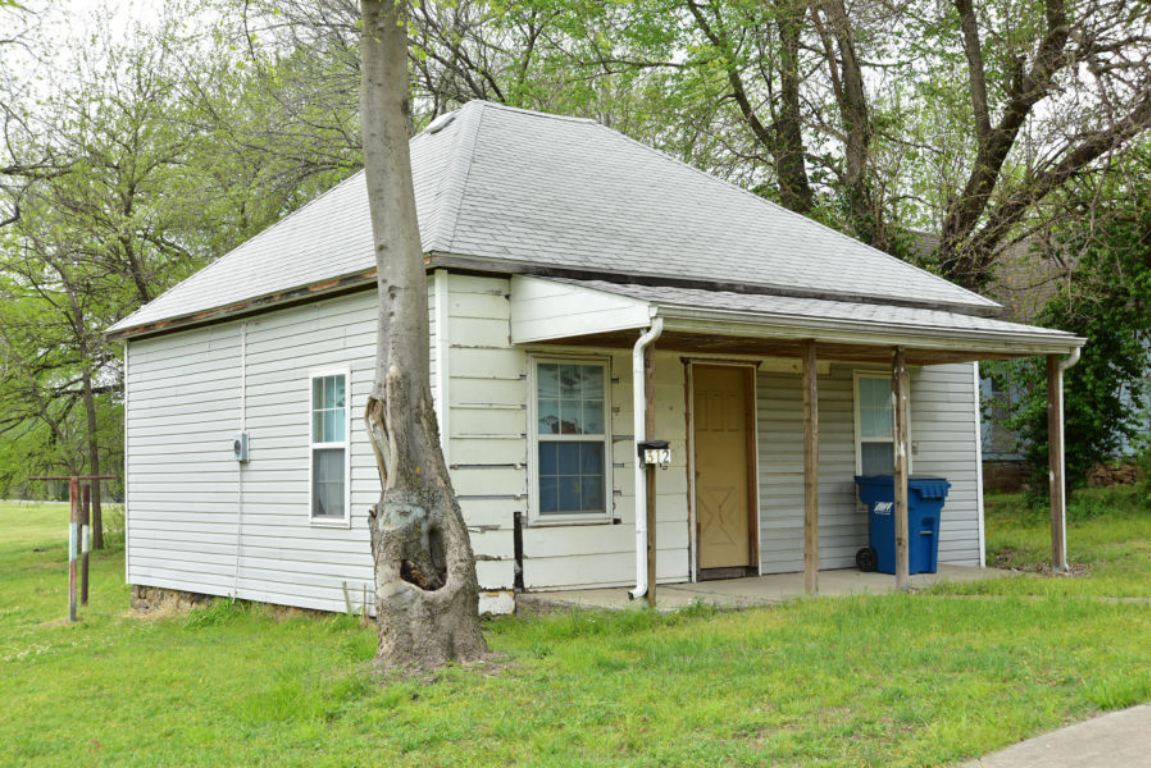
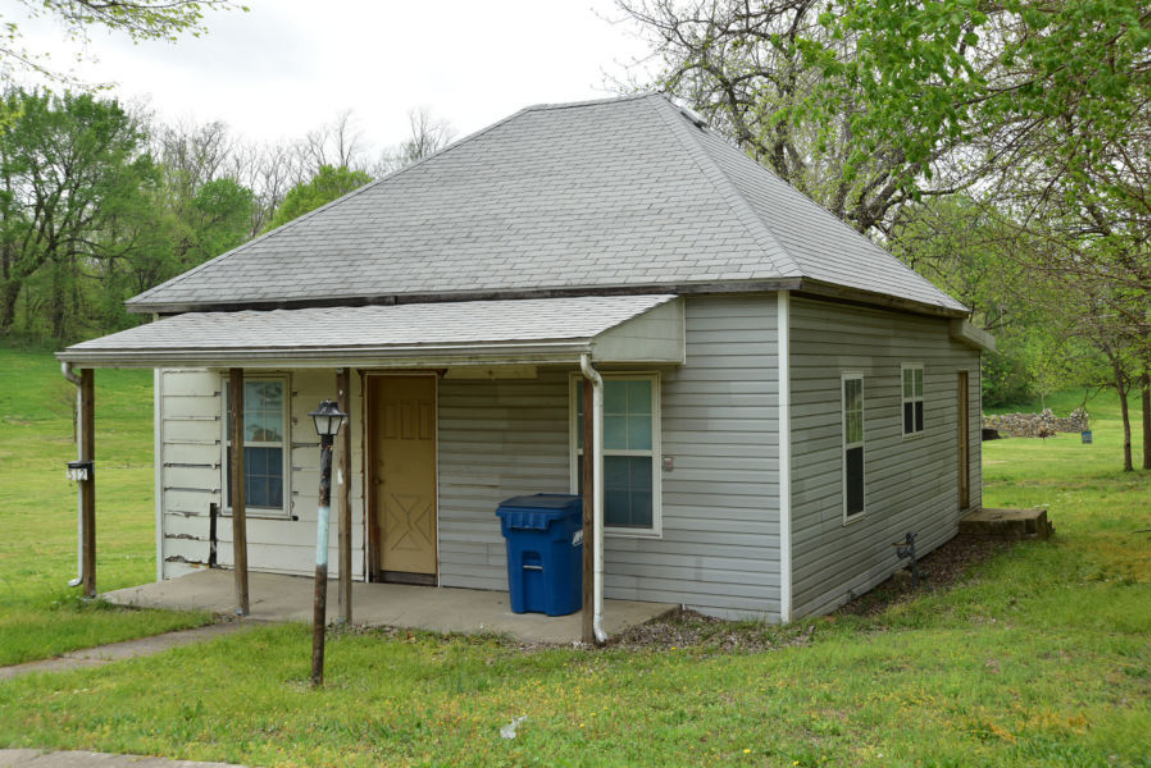
This Pyramid Square Folk House faces east and has a T-shaped footprint. It has a stone foundation, asphalt shingle roof, and pressboard and vinyl cladding. The dwelling is three bays wide and three bays deep. A non-historic wood door occupies the center bay of the primary elevation while six-over-six vinyl windows occupy the remaining bays. A non-historic, three-quarter width open porch shelters the bays. It has a shed roof supported by wood posts and a concrete slab foundation.

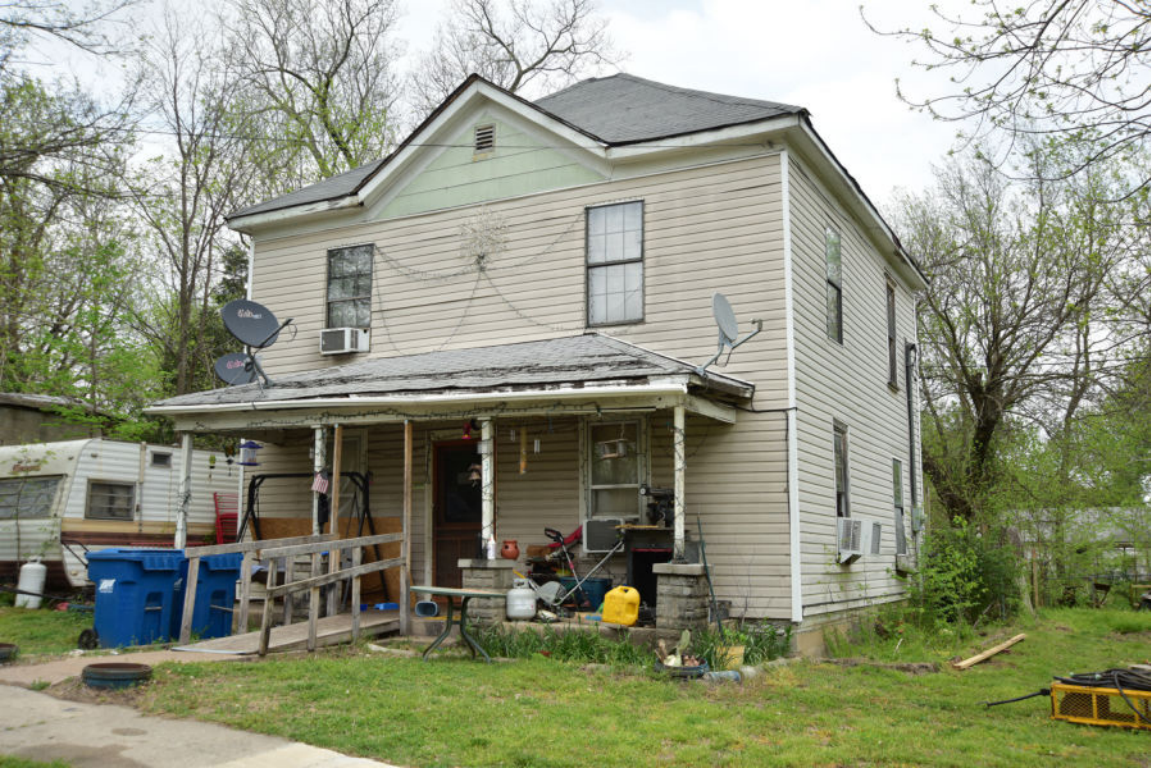
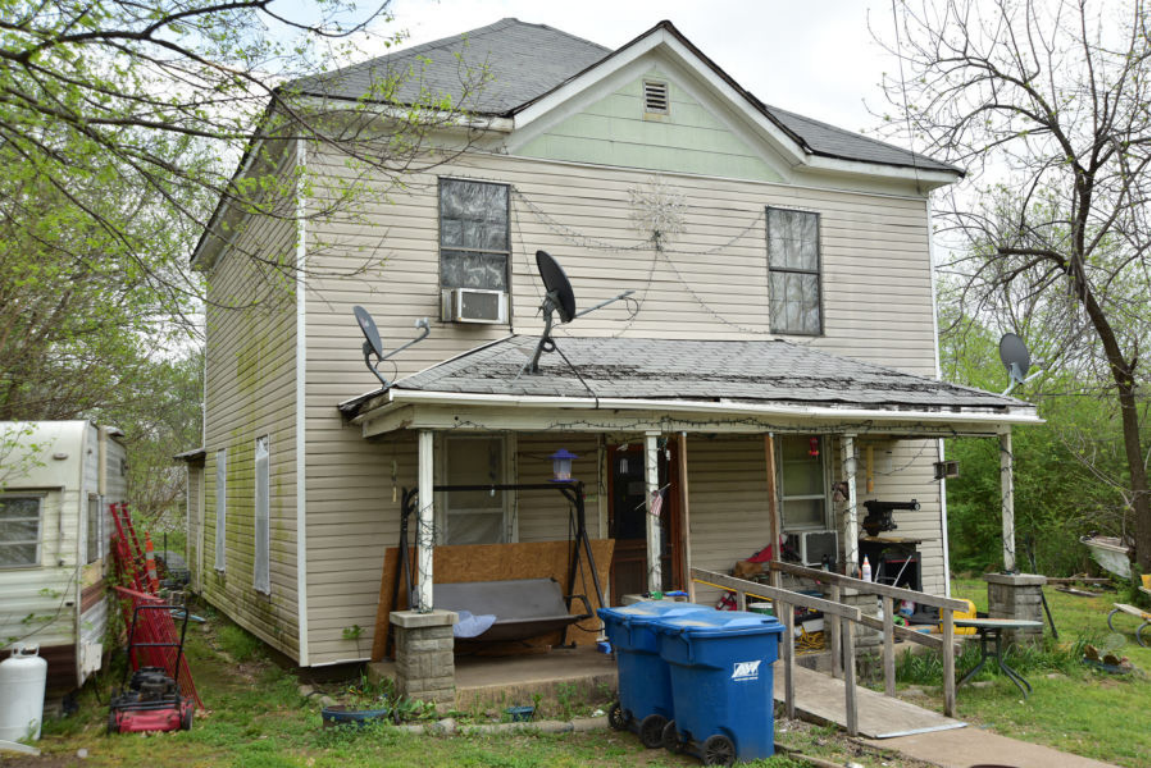
This two-story dwelling faces west and has a rectangular footprint. The dwelling has a concrete masonry unit foundation, vinyl cladding, and a hipped roof with asphalt shingles and a center gable at the primary elevation. The dwelling is three bays wide and three bays deep. A one-story hipped roof addition projects from the rear elevation and forms the third bay. One-over-one vinyl windows occupy the north and south first-story bays of the primary elevation and an entrance forms the center bay. The door was not visible at the time of survey. Six-over-six windows occupy both second-story bays at the primary elevation. A three-quarter width open porch shelters the primary elevation bays. It has a concrete foundation and hipped roof with asphalt shingles. Squared wood posts on concrete block piers support the porch roof.

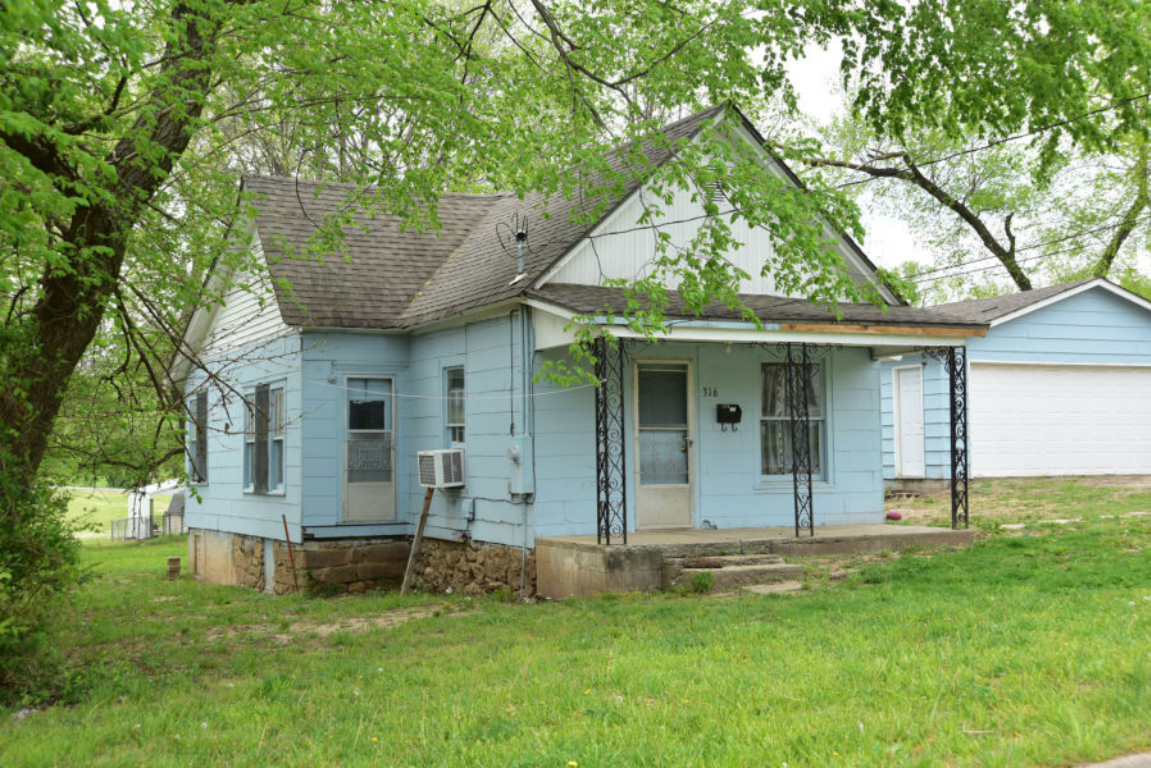
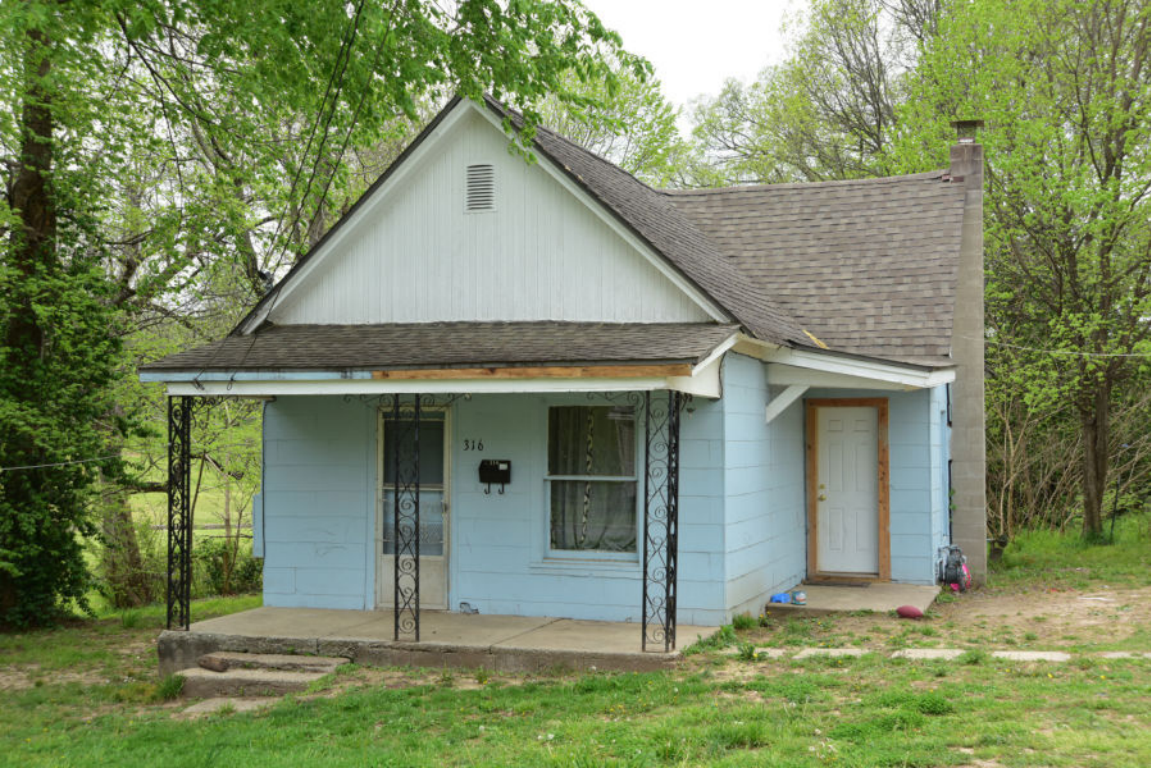
This National Folk House dwelling faces east and has a rectangular footprint. It has a stone foundation and cross-gabled roof with asphalt shingles and wood cladding in the gable peaks. The dwelling has asbestos shingle cladding. It is two bays wide and three asymmetrical bays deep. A non-historic wood door occupies the south bay of the primary elevation while a historic one-over-one wood window occupies the north bay. A shed-roof porch with a concrete foundation and non-historic decorative metal support posts spans the width of the primary elevation. Secondary entrances are located at the west elevations of the cross-gabled projections. The south secondary entrance contains a historic wood door with historic trim while the north secondary entrance contains a non-historic wood door with non-historic flat trim. A concrete masonry unit exterior chimney is located at the north elevation.

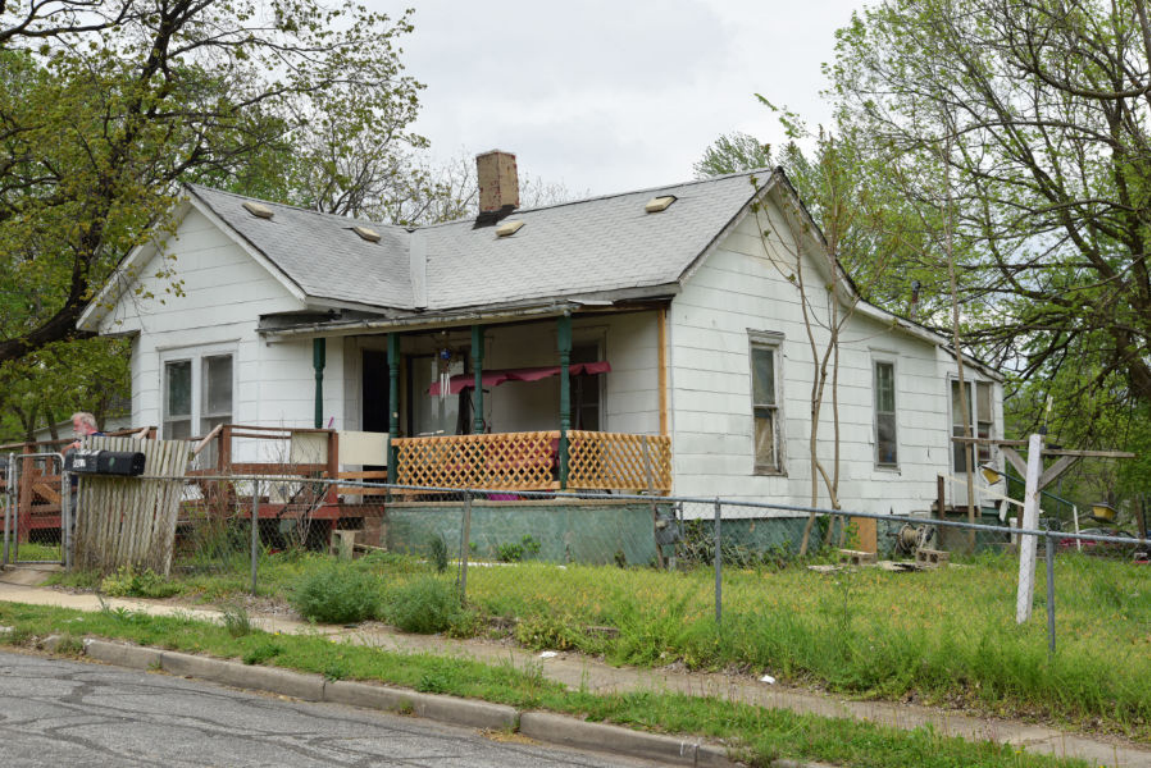
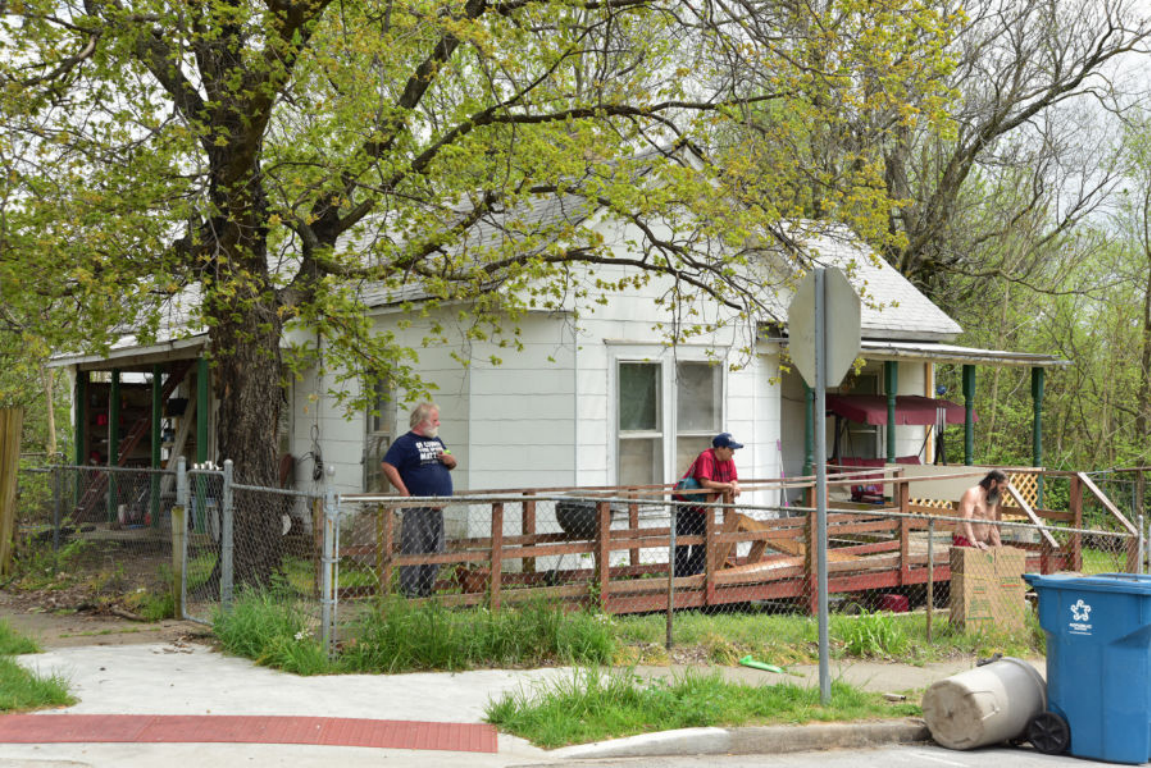
This Gabled-Ell dwelling faces west and has a square footprint. It has stone foundation, asphalt roof, and asbestos shingle cladding. A brick straddle-ridge chimney pierces the roof. The dwelling is three bays wide and three bays deep. An enclosed shed-roof porch forms the fourth bay. A pair of historic one-over-one wood windows occupies the north bay of the primary elevation while single historic one-over-one wood windows occupy the remaining bays. The south two bays recede, creating a partial-width open porch. The porch has a shed roof, parged foundation, and turned wood support posts. An entrance is located in the north wall of the projecting ell at the west elevation. The dwelling's windows feature historic wood trim and modest crown molding.

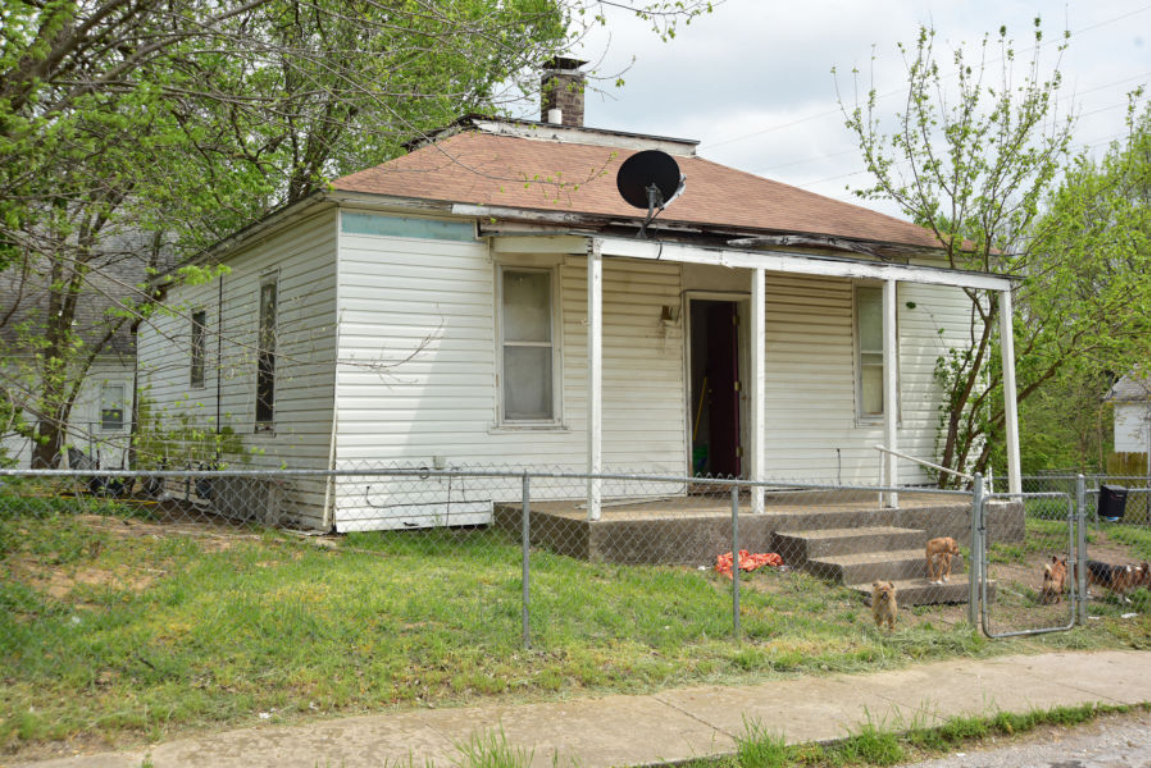
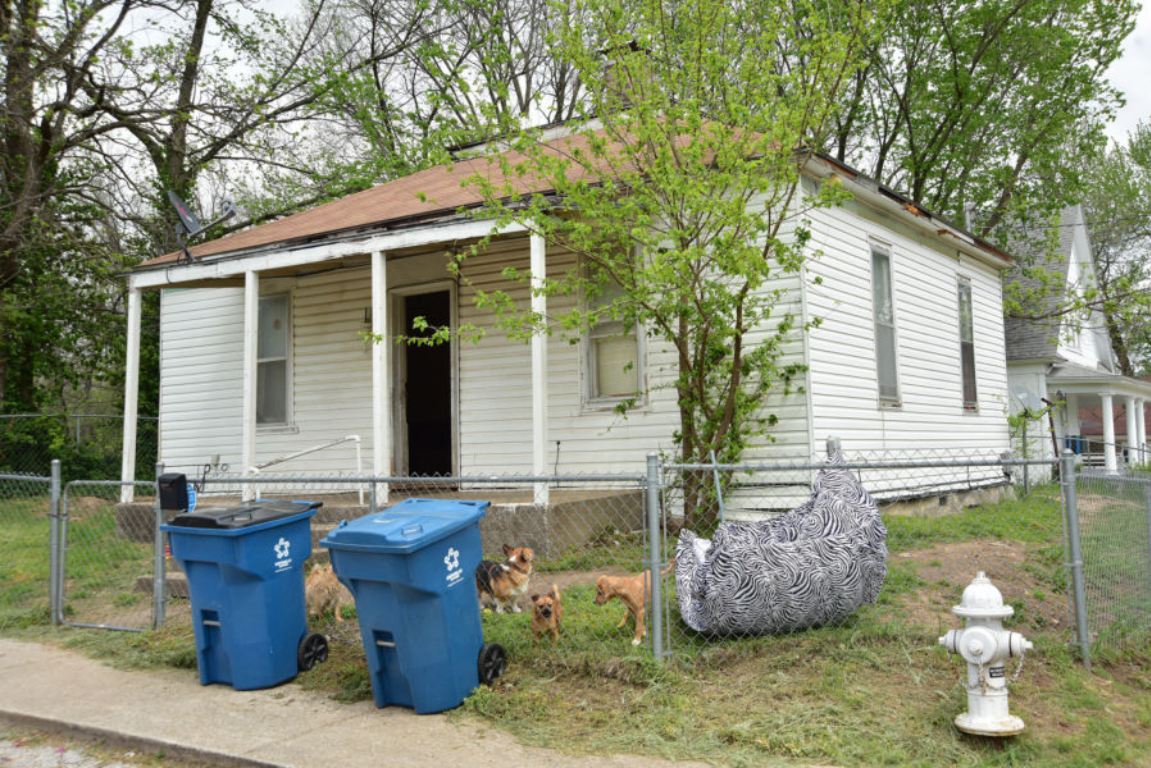
This Pyramid Square Folk House faces west and has a square footprint. It has a parged foundation, asphalt shingle roof, and vinyl cladding. It is three bays wide and two bays deep. A brick chimney pierces the chimney peak. A wood door occupies the center bay of the primary elevation while narrow one-over-one wood windows fill the remaining bays. An open, three-quarter width porch shelters the bays. It has a shed roof, concrete foundation, and squared wood support posts.

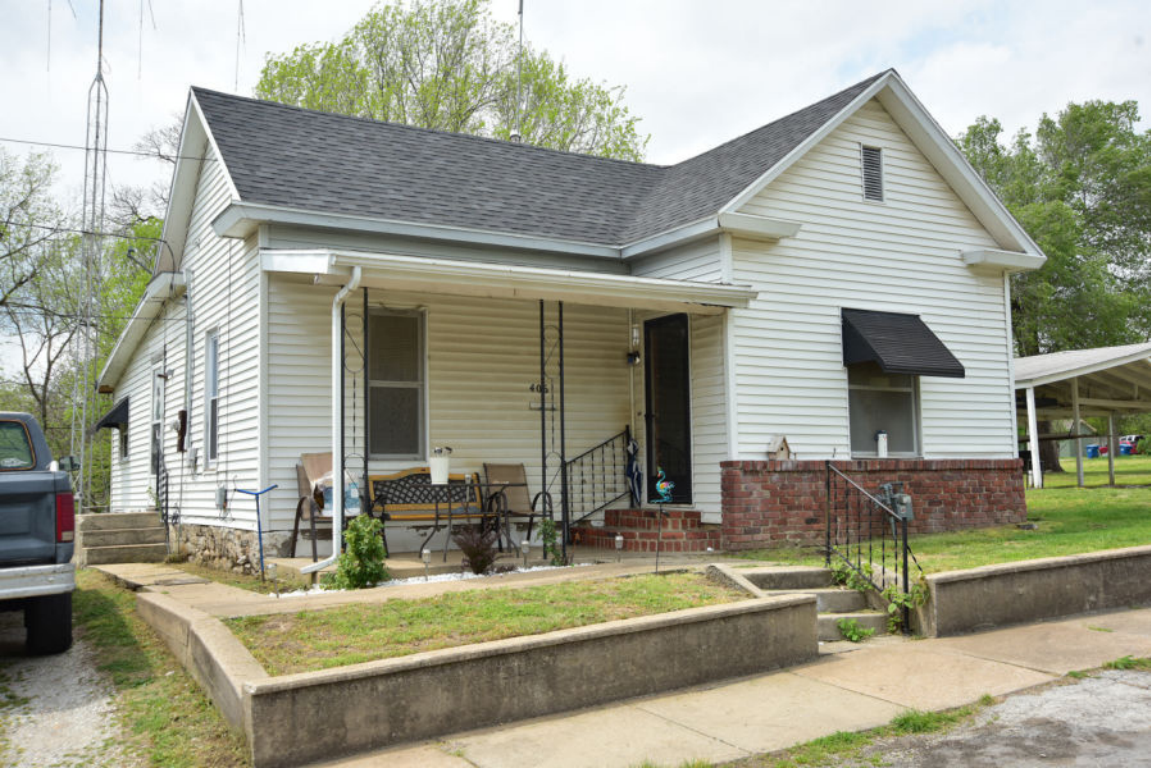
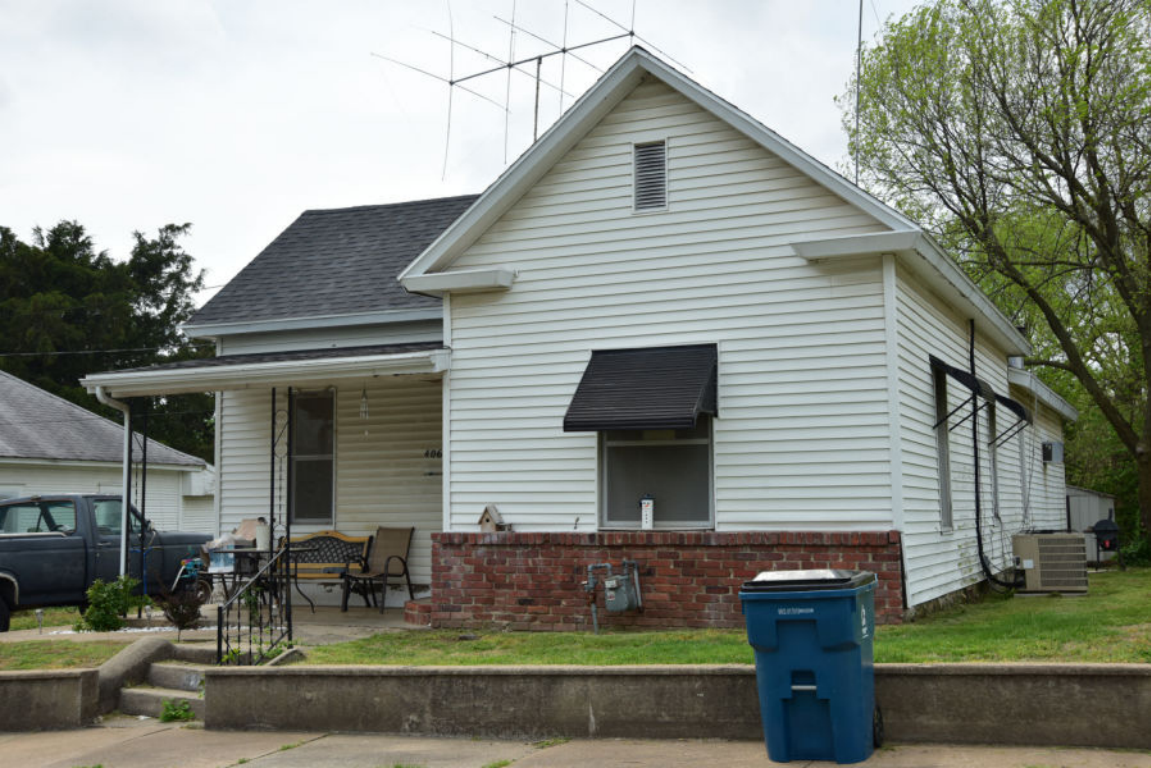
This Gabled-Ell dwelling faces east and has a rectangular footprint. It has a stone foundation and complex asphalt shingle roof. Brick veneer clads the lower quarter of the primary elevation gabled-ell while vinyl clads the remainder of the dwelling. The dwelling is two asymmetrical bays wide and four bays deep. An enclosed shed-roof porch forms the fourth bay. One-over-one wood windows occupy the primary elevation bays. The primary entrance features a non-historic wood door and curved brick steps and is located in the south wall of the gabled-ell. A non-historic shed-roof porch shelters the entrance and south bay. It has a concrete slab foundation and decorative metal support posts. A secondary entrance with a concrete stoop is located at south elevation.

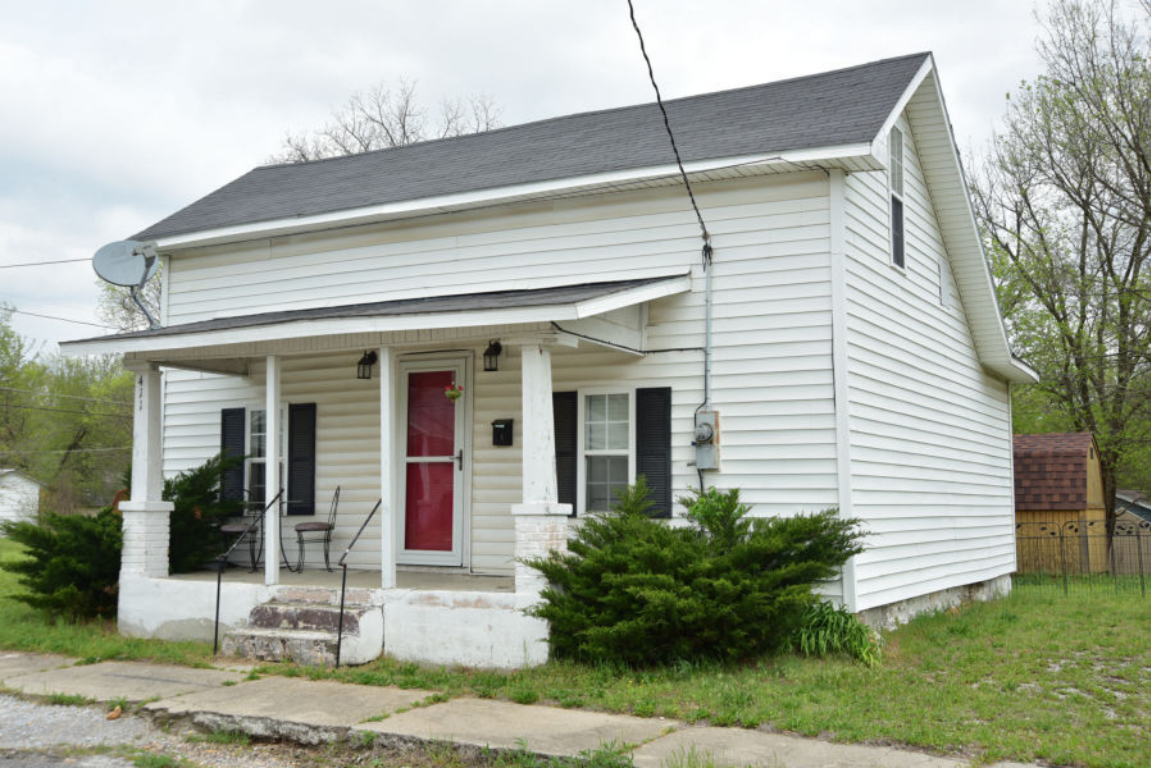
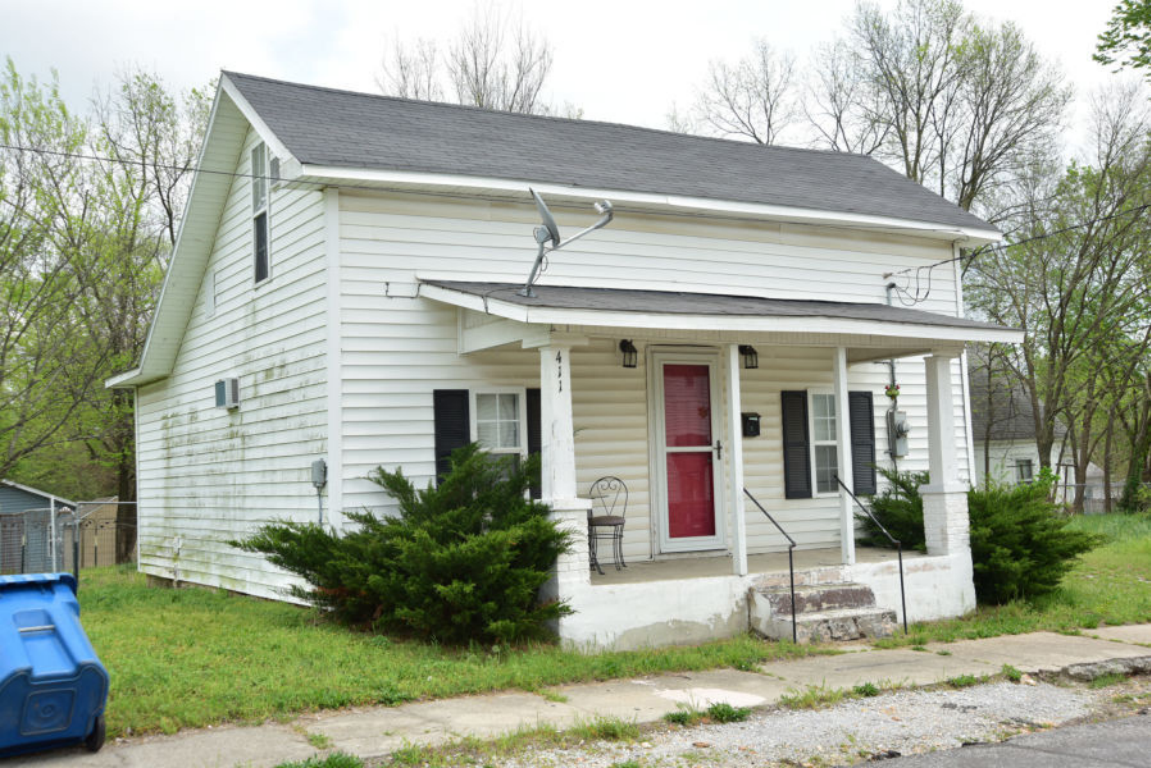
This dwelling faces west and has a rectangular footprint. It has a stone foundation, metal cladding, and asphalt shingle roof. It is three bays wide. A non-historic wood door occupies the center bay while four-over-four vinyl windows occupy the remaining bays. Four-over-four vinyl windows are located in the gable peaks and are the only windows at the north and south elevations. An open, three-quarter width porch shelters the primary elevation bays. It has a shed roof and concrete foundation. Wood columns on brick piers support the porch roof.

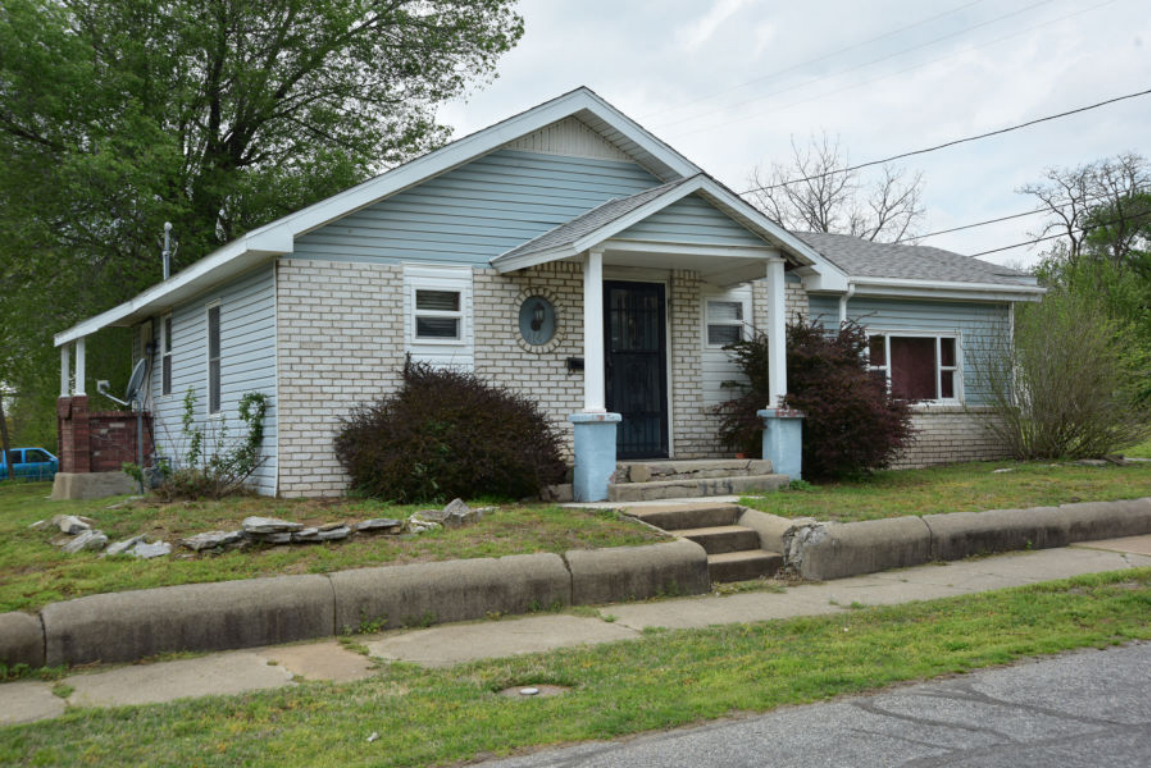
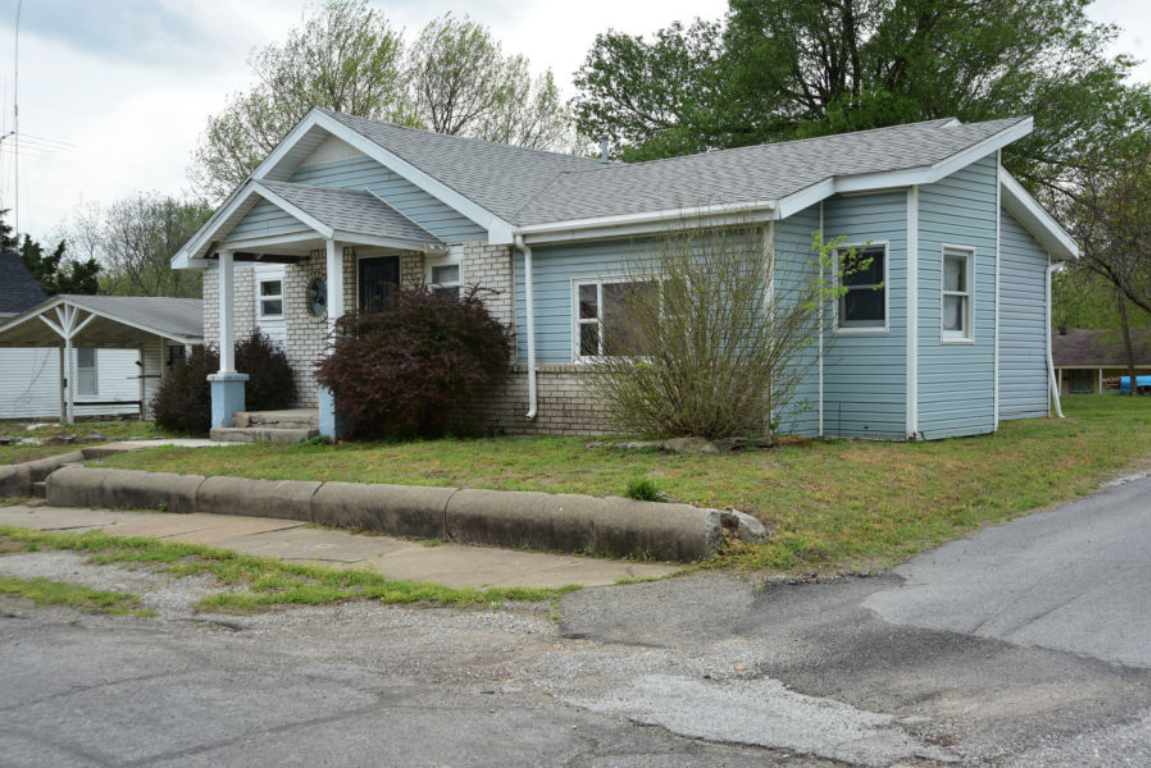
This Minimal Traditional dwelling faces east and has an irregular footprint. It has a concrete foundation and asphalt shingle roof. The primary elevation has a combination of brick and vinyl cladding. The secondary elevations have vinyl cladding. The dwelling is four bays wide and three bays deep. One-over-one vinyl windows occupy the first and third bays while a vinyl tripartite picture fills the fourth bay. A wood panel door defines the second bay. A front-gable porch shelters the entrance. It has a concrete foundation and steps. Squared wood columns on concrete piers support the porch roof. A secondary entrance is located at the south elevation. A shed-roof porch with brick walls shelters this entrance. The roof above the south wing has been raised above its original height.

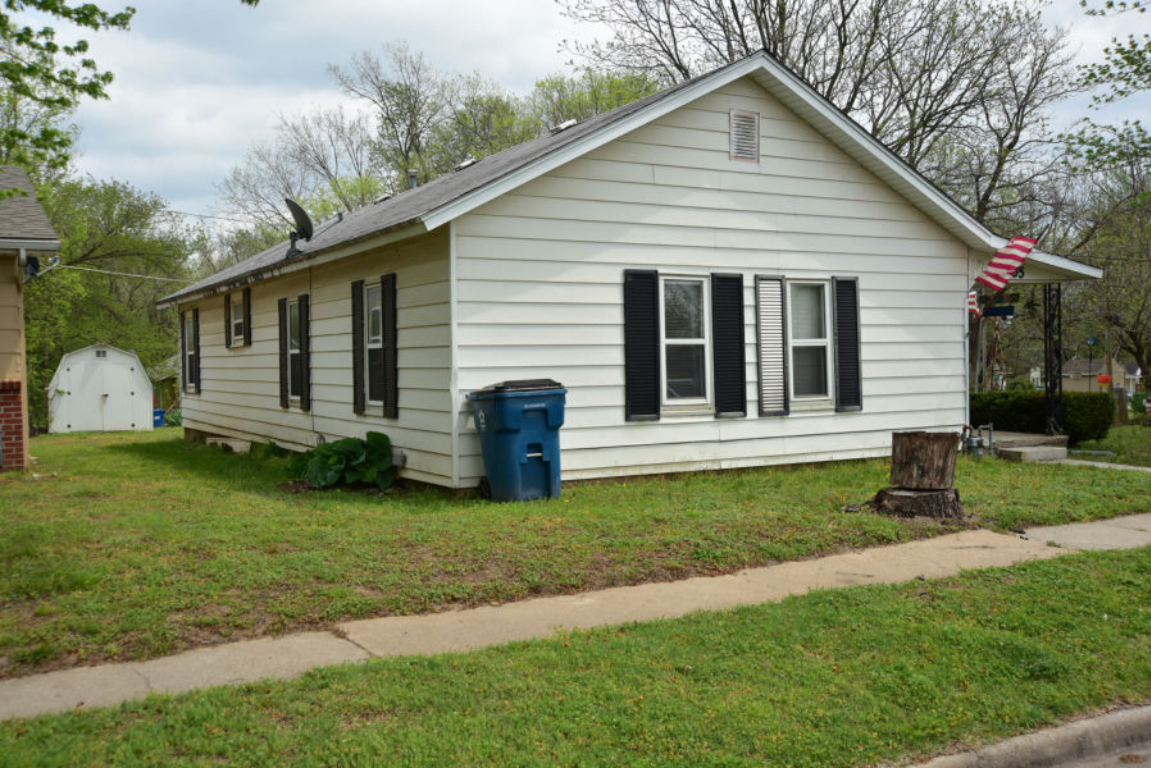
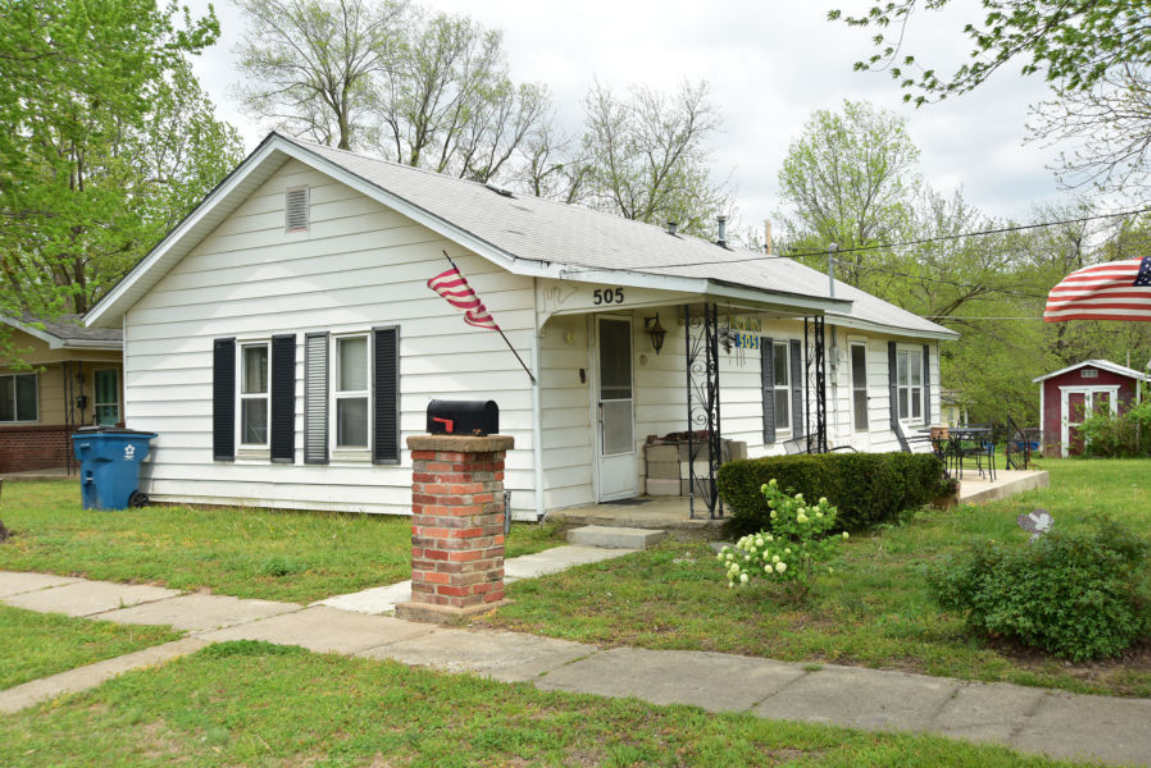
This Ranch dwelling faces south and has a rectangular footprint. It has a concrete foundation and metal siding. The front-gable roof has asphalt shingles. The dwelling is four bays wide and one bay deep. A non-historic wood door occupies the first bay. Single one-over-one window vinyl windows occupy the second and third bay while a pair of one-over-one vinyl windows defines the fourth bay. A shed-roof porch shelters the entrance and features a concrete foundation and non-historic decorative metal support posts. A non-historic concrete slab porch spans the rest of the primary elevation.

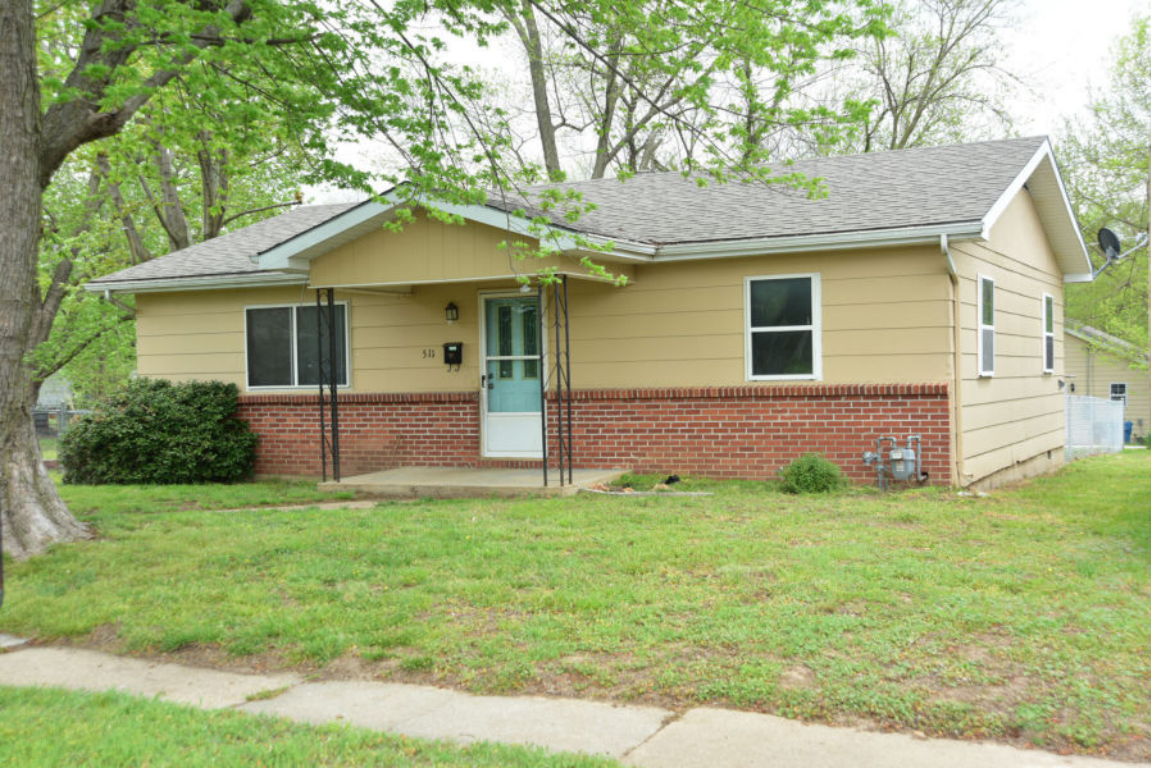
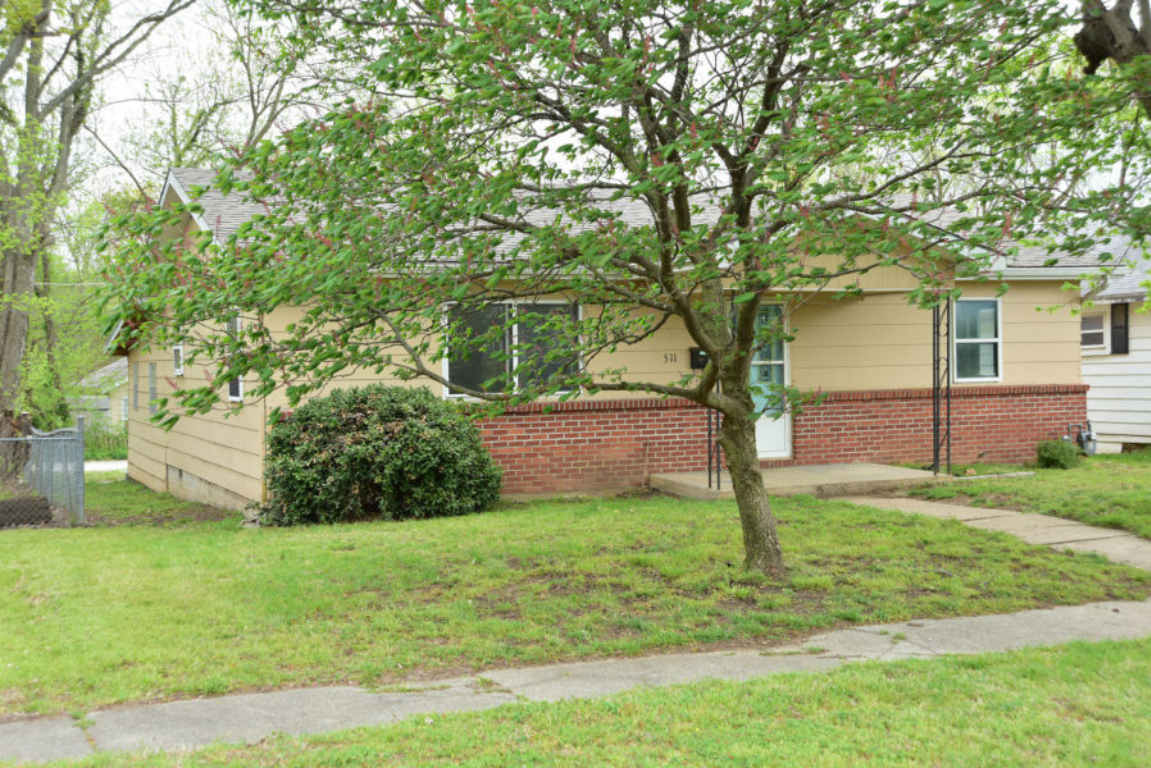
This Ranch dwelling faces west and has an L-shaped footprint. It has a concrete masonry unit foundation and an asphalt shingle roof. Brick veneer clads the lower third of the primary elevation and the remaining of the cladding is pressboard. The dwelling is three bays wide and four bays deep. A non-historic wood door with glazing occupies the center bay while a one-over-one vinyl windows occupies the south bay. The north bay contains a one-by-one wood window. A non-historic porch with a concrete foundation, front-gable roof, and decorative metal support posts shelters the entrance bay.

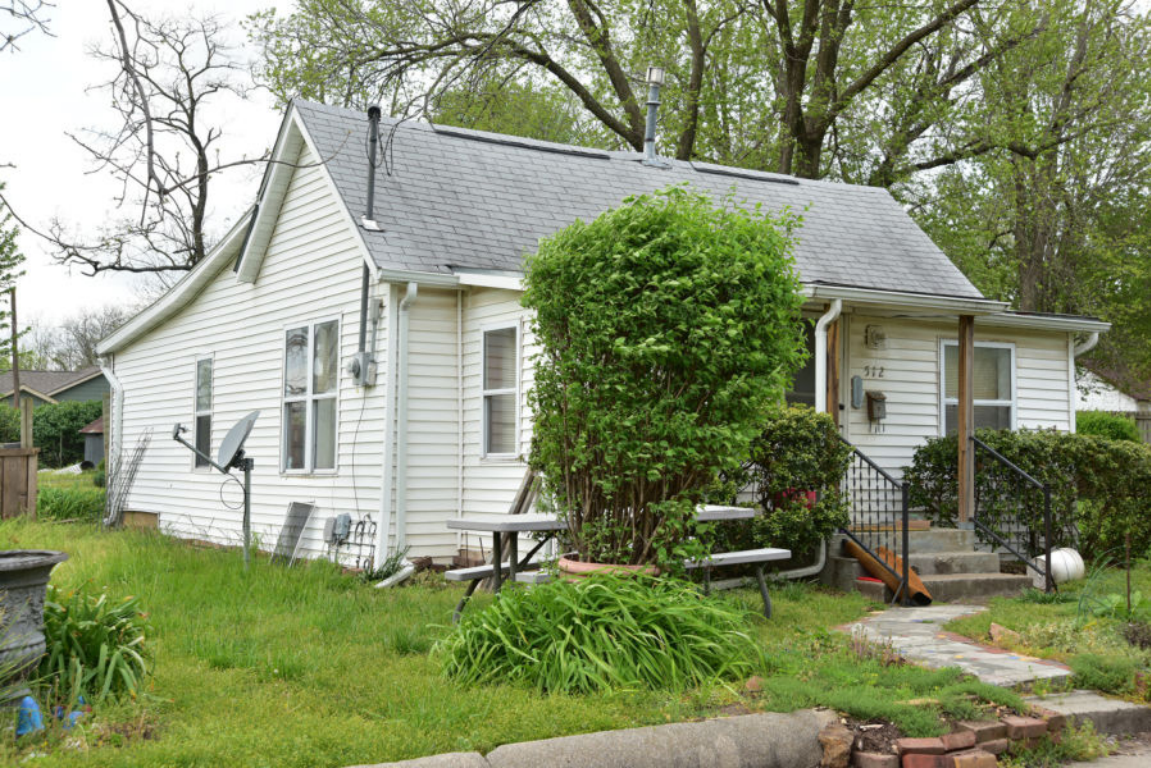
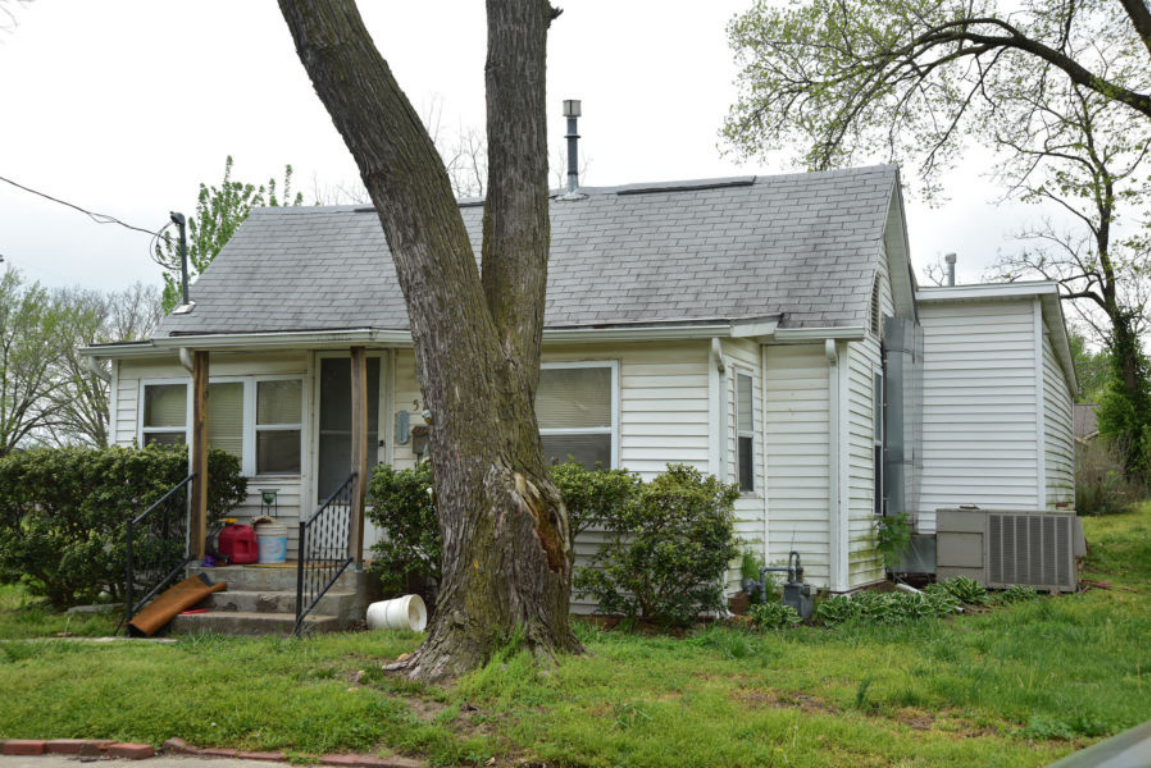
This National Folk House dwelling faces east and has a rectangular footprint. It has an asphalt roof and metal cladding. The foundation is not visible. The dwelling is three bays wide and three bays deep. An enclosed shed-roof porch at the west elevation forms the third bay. An enclosed shed-roof porch contains the primary elevation bays. The porch enclosure is an alteration. A non-historic wood door occupies the center bay while a one-over-one vinyl window occupies the north bay. A vinyl tripartite picture window defines the south bay. A non-historic flat-roof porch with a concrete foundation, wood support posts, and a metal railing shelters the entrance
