OFF SYSTEM BRIDGE INSPECTION REPORT Educational

COUNTY City of St. Louis BRIDGE NO. 600.02 ROUTE Washington Dr.

6 Features Intersected River Des Peres Lagoon

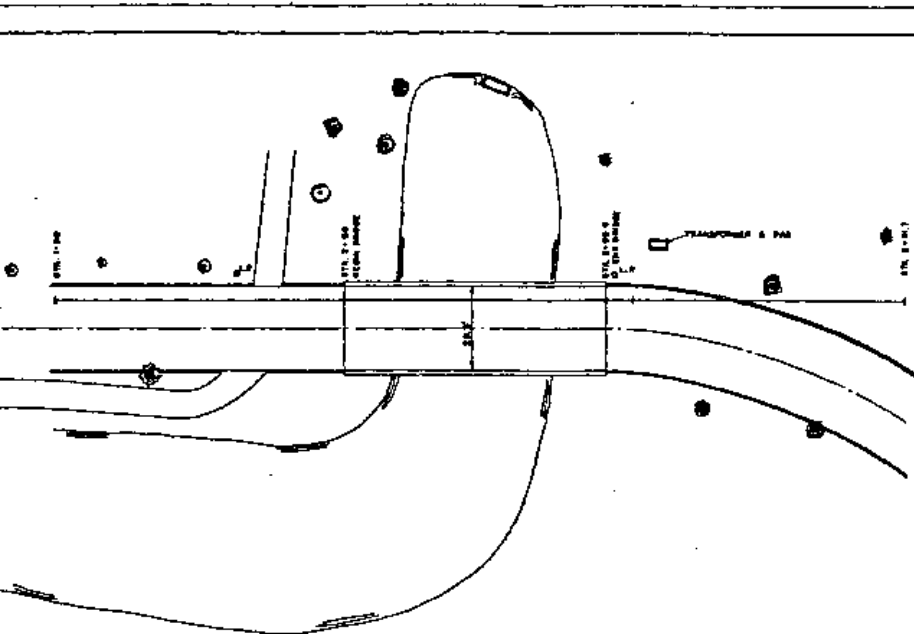
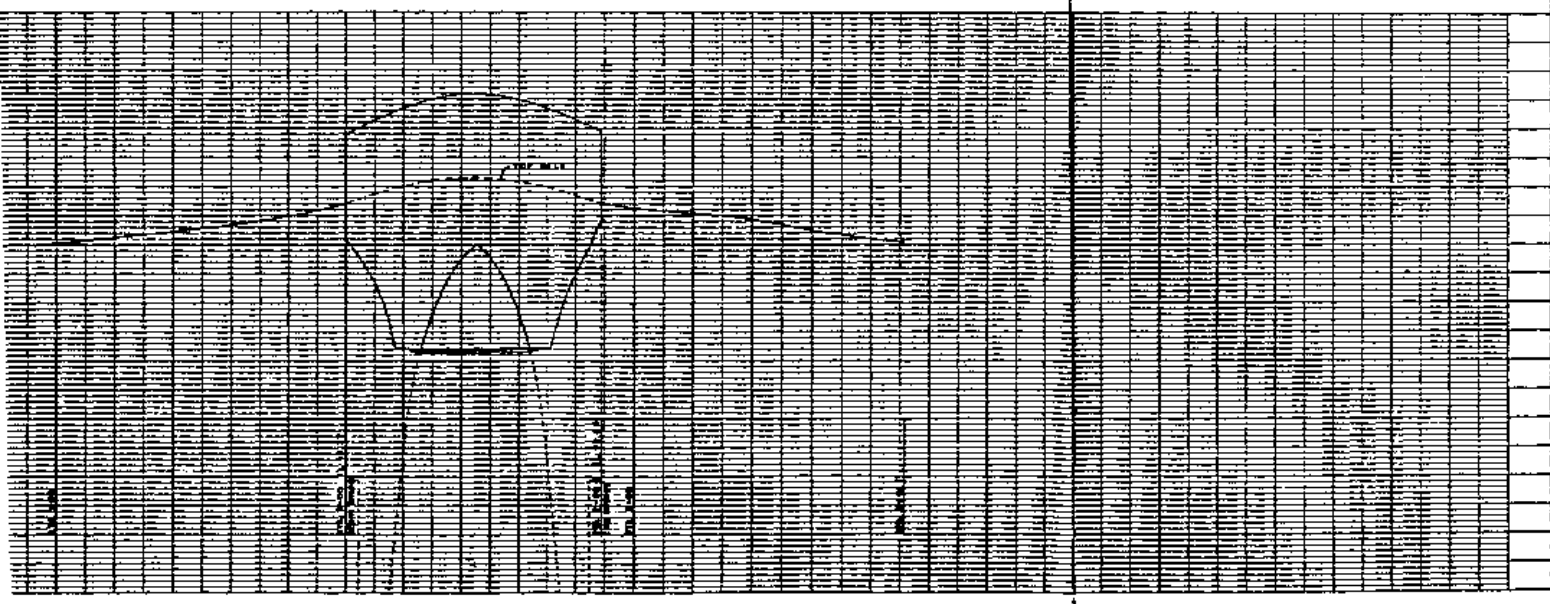
PROFILE 1 PLAN, PROFILE 2 & 3 SEE SHEETS 1 & 2

Note: 11.00 EL. 4824 N.E. CORNER OF TRANSFORMER PAD  
 11.00 EL. 4824 S.E. CORNER OF BRIDGE

Surveys were conducted to determine the bridge location, roadway profile and alignment, and the topographic features of the area. A preliminary drawing has been prepared and is presented herein.

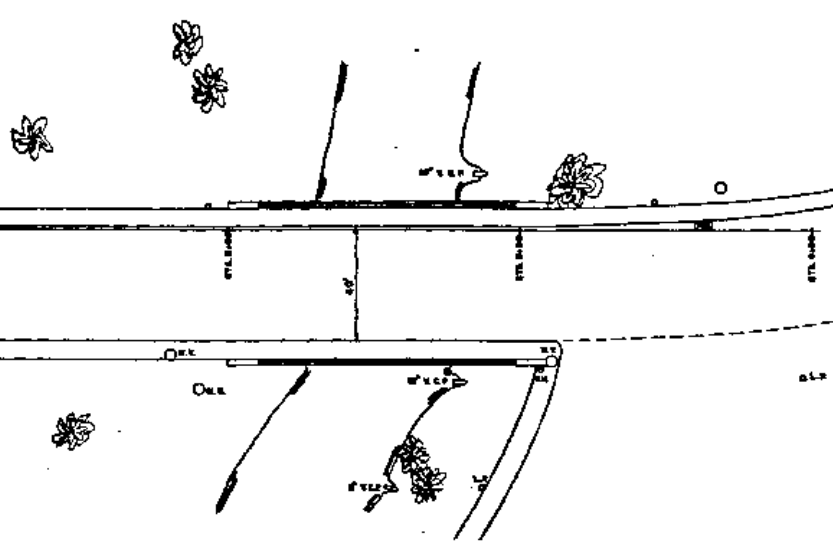
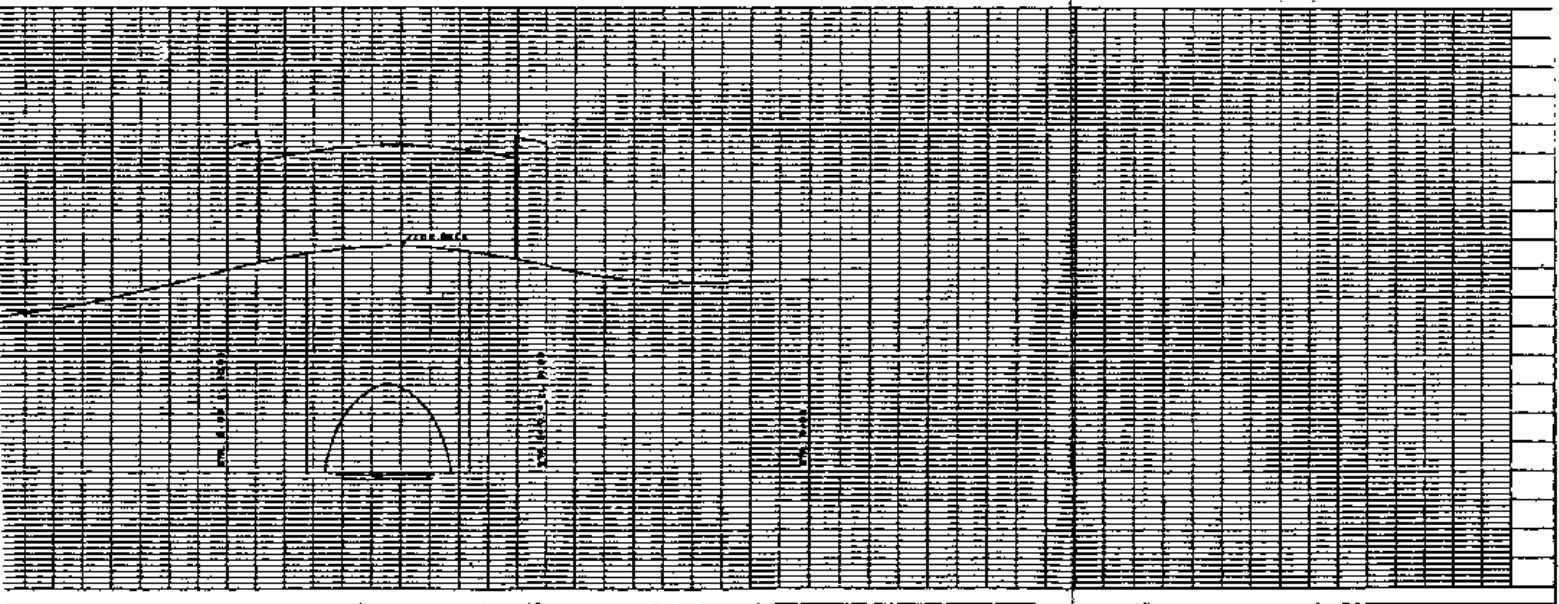
PLATE 1 PLAN & PROFILE OF OLD STABLE BRIDGE

SEE 58 1/2 IN OPEN ON FIRE HYDRANT  
SOUTH EAST CORNER OF BRIDGE

Surveys were conducted to determine the bridge location, roadway profile and alignment, and the topographic features of the area. A preliminary drawing has been prepared and is presented herein.

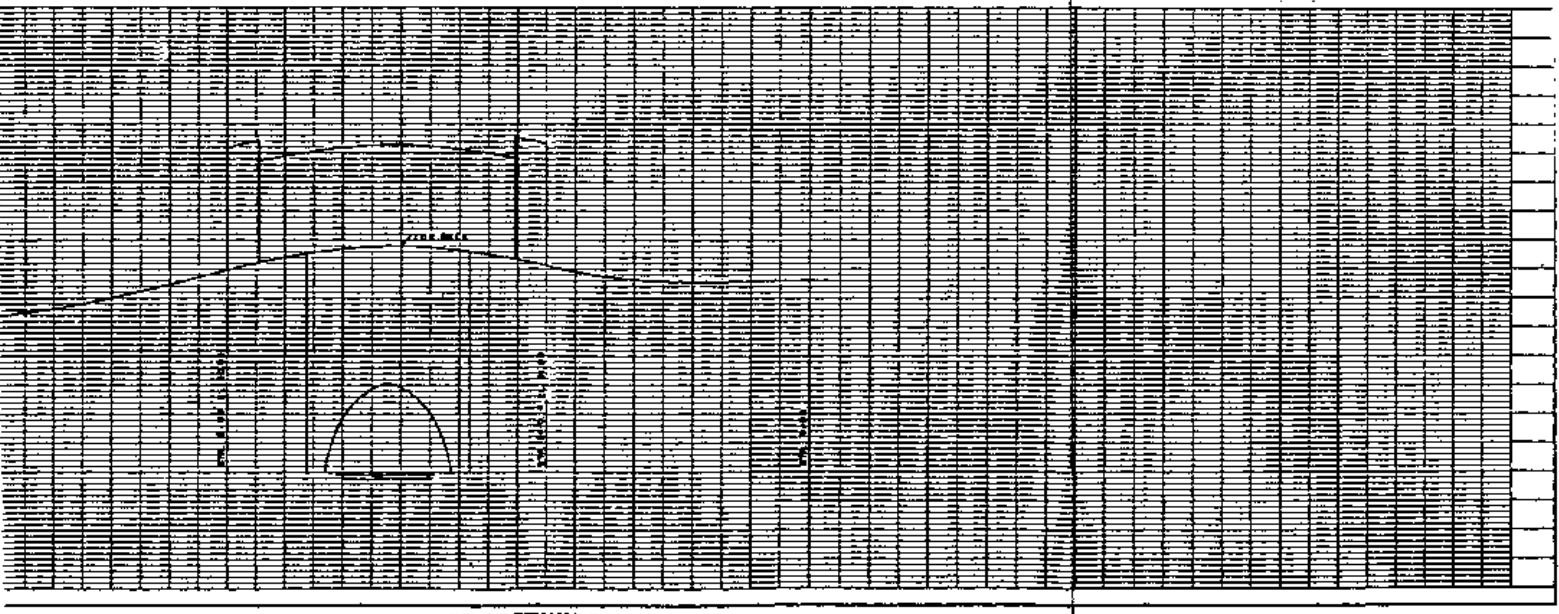
PLATE 1 PLAN & PROFILE OF OLD STABLE BRIDGE

SEE 58 " IN OPEN ON FIRE HYDRANT  
SOUTH EAST CORNER OF BRIDGE
