HARRISONVILLE HISTORIC RESOURCES

Resource No. 109

1. Property name, present 102-Sharp Bonding Co.
100-Edward D. Jones & Co.; 104- Worthley's
Fashions; 106- AA Building
Property name, historic
Evan's Building
2. Address/location
100-106 N. Independence
4. Owner's name and address
100/102-Pearson Investment Co.
P. O. Box 343 Harrisonville, MO 64701
104/106- Robert C. Worthley
703 Green St. Harrisonville, MO 64701
5. Building Structure
 Site Object
6. Use, present commercial
Use, original commercial *OSE*

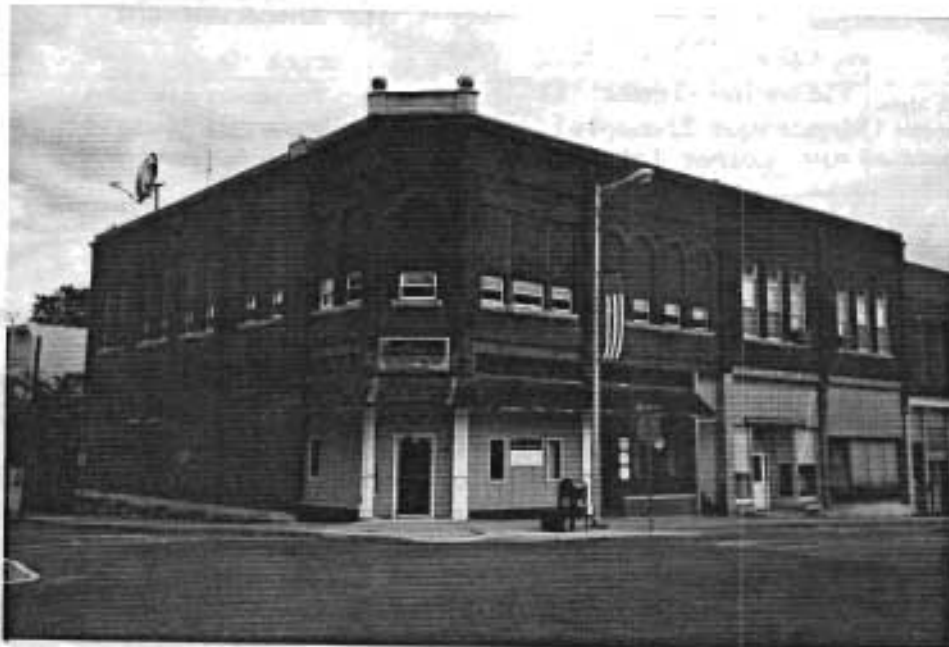
This two story building houses four businesses. 100 has a angled corner entry of a new aluminum frame glass door. Small vertical rectangular windows have replaced original window openings and a brick bulkhead is below. Metal siding covers the rest of this shopfront area. 102 has a recessed entry to the left side and is a wood panel door. Two small vertical fixed pane windows are to the right and have a brick bulkhead. Metal siding also covers the transom area. An upstairs entry is to the right and is a wood door with top diamond shape pane. A wood shingle covered awning wraps around the building. The entry to 104 is centered and recessed. A new nine light and wood paneled door has sidelights and metal surrounds the plate glass windows on each side. Vertical aluminum siding covers the shopfront transom area. The entry to 106 is recessed, to one side, and is a wood panel and glass door. Sectioned plate glass windows are to the right and a metal bulkhead is below. Vertical metal siding covers the transom. An iron lintel with fleuron motif is visible above 104 and 106. Pressed design cast iron pilasters, inscribed with "Keystone Iron Works Co., Kansas City, Mo.", are still visible and separate the different (con't.)

Located on the northwest corner of the town square, this structure has a two story brick building on its north and a small vacant area on its west, followed by a two story stucco and iron building.

20. (con't.) shopfront areas (between 102 and 104, the pilasters are covered over with metal siding. The second story windows are grouped into threes and fours. From north to south, facing S. Independence St. they are as follows: A set of three with semi-circular brick arches, half-round transoms and 1/1; a group of three 1/1 with rectangular transoms set within rectangular frames; a group of four with semi-circular arches and top sash and transoms covered; a group of three with top sash and transoms covered set within rectangular frames. All window groupings have running stone sills. Brick piers visually separate the groupings. The cornice area is corbeled with a brick stringcourse below. At the corner of the building the parapet is topped with a stone inscription plate reading, "Evans Block". Two large stone balls cap the edges of the stone. The facade facing Pearl Street is similar at the second story level except that the windows are paired.

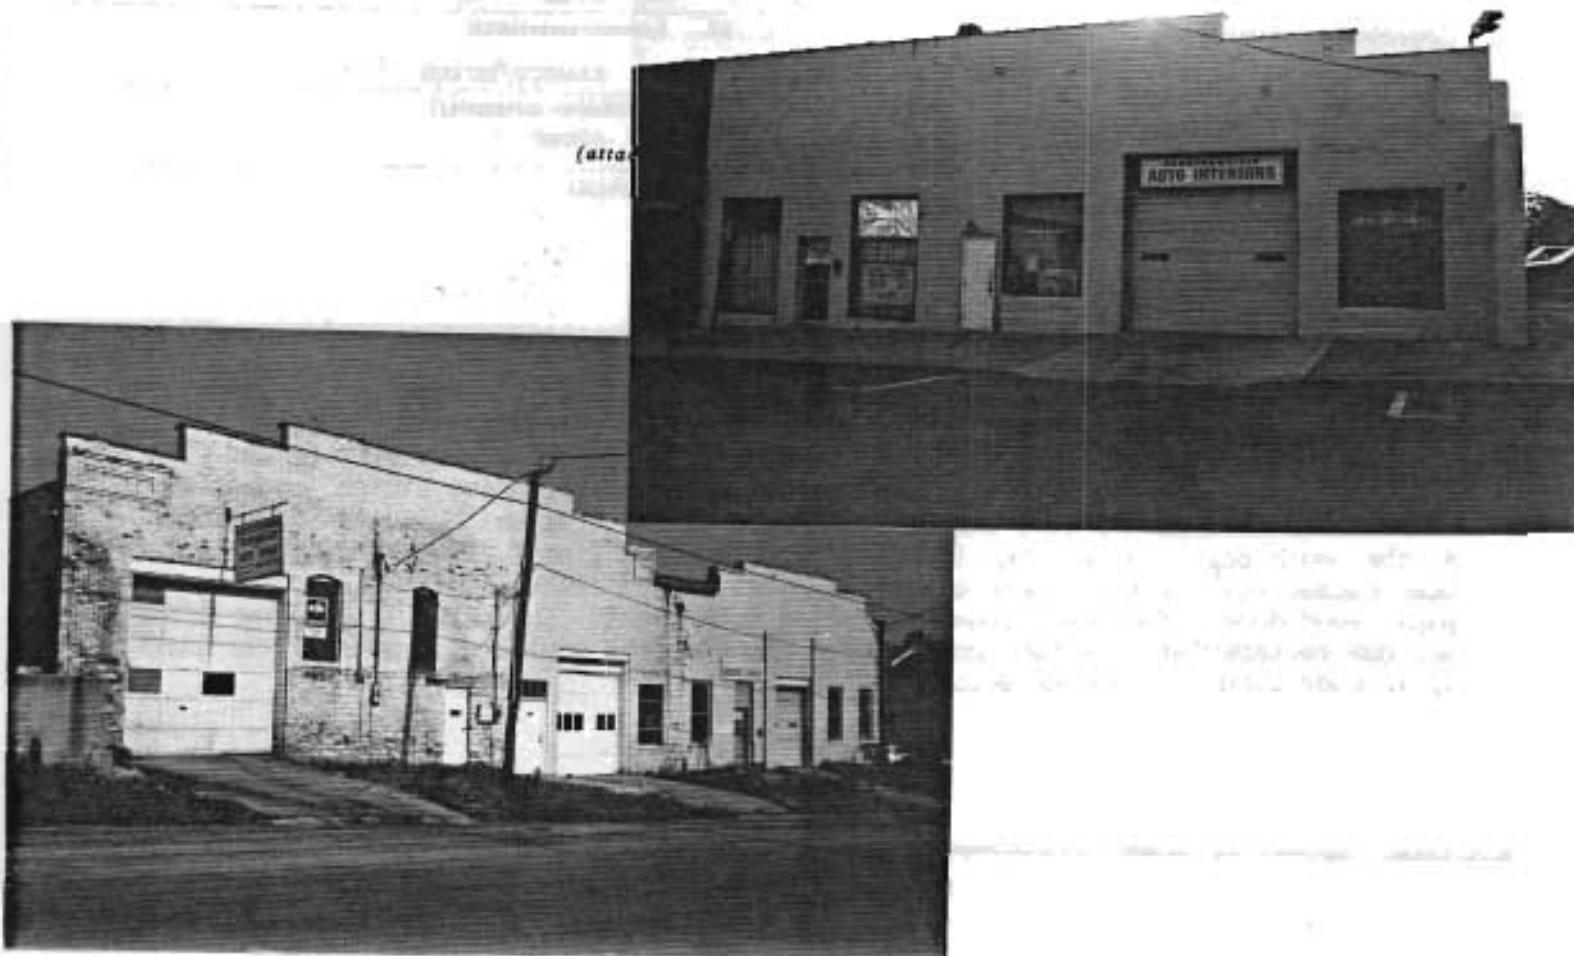
This building is visually adjoined to the two buildings to the north by a common, new parapet facade. This section has a wood door entry at the north edge and two 1/1 windows separated by a garage door. This facade has smooth stucco over brick. The brick is exposed on the south elevation and the southeast corner shows a high, stone foundation. The Lexington Street facade shows more of the original building and openings. At the south edge a garage bay is topped with an iron lintel. Two windows, that have been closed still retain their brick segmental arched lintels. Another entrance is a plain wood door. The high stone foundation is present. The parapet roofline is stepped and has rectangular recessed panels. The stone at the southeast corner of the structure is in poor condition and crumbling.

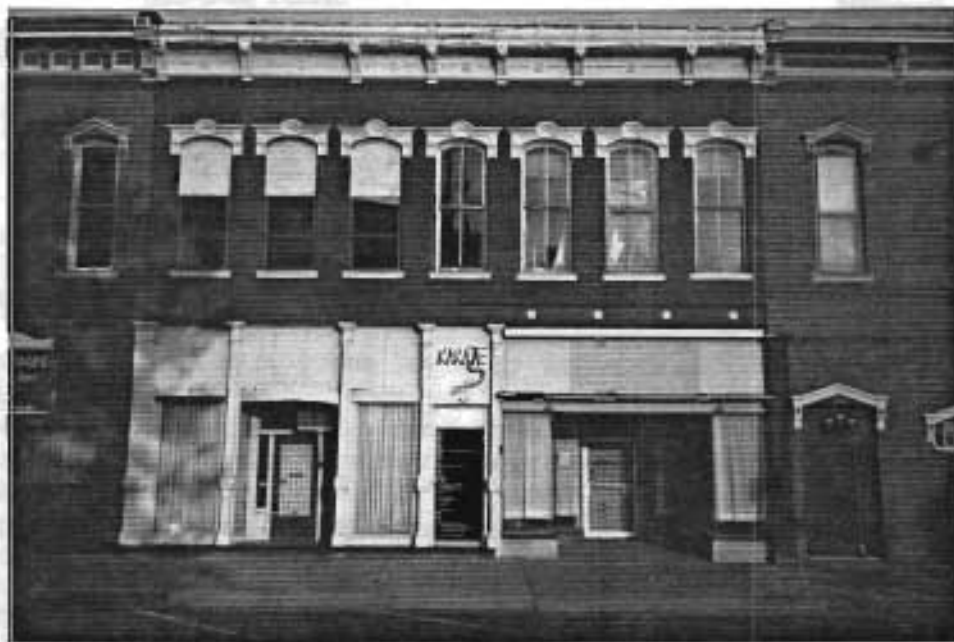
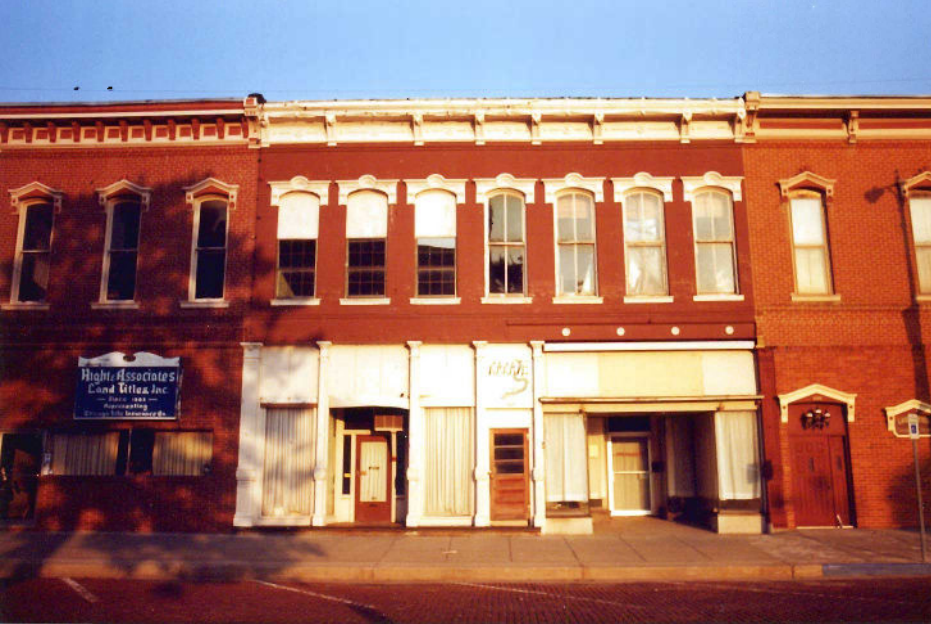
20. Additional physical description
 Both shopfront areas have been altered. The store on the right has a new brick facade with a modern aluminum frame glass door, off-center, and a two-sectioned horizontal plate glass window to the right. The three second story windows are 1/1 wood frame with decorative projecting pedimented wood lintels. The cornice is supported by decorative brackets with brick stringcourses below. The shopfront area of the left business (now vacant) has also been bricked in with modern plate glass windows on either side of the center entry. Large wooden, rustic pilasters and lintel frame the entrance. An upstairs entrance of a wood door with covered transom, is located at the south end of the building and a decorative cast iron column is to its side. The second story windows and cornice are identical to the other side of the structure.

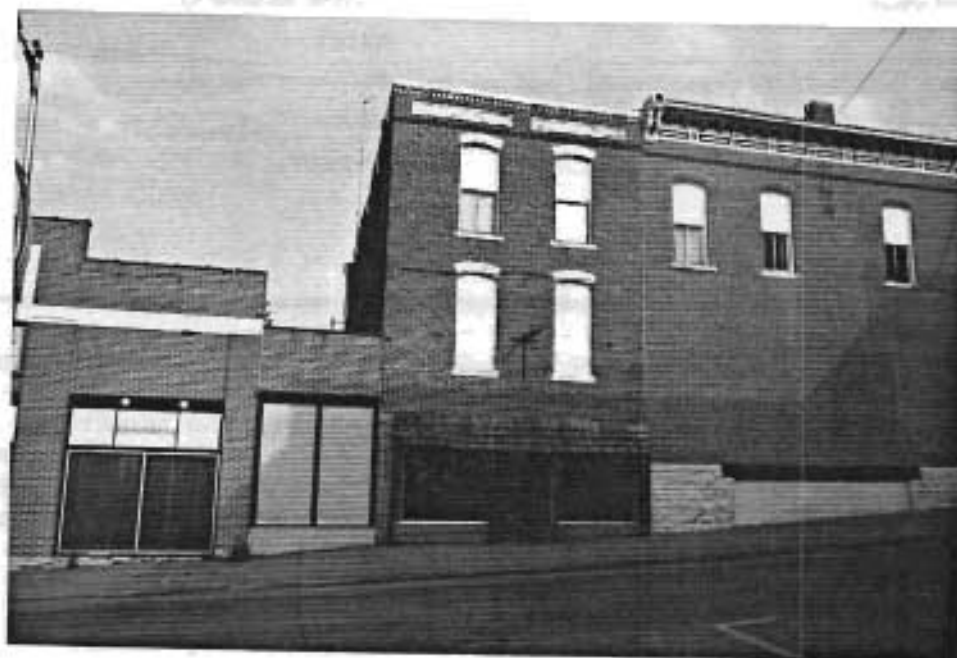
13. Plan Shape rectangular RC	19. Porch(es) 21
20. Additional physical description The shopfront area of this building has been altered and has a center recessed entry of a wood frame and glass door. Rustic wood posts with curved brackets frame the plate glass windows on each side. A wood shingle shed roof covers the shopfront. The two second story windows are set in rectangular frames with segmental arches. They have been covered with wood. The two third story windows with identical surrounds have the upper sash covered with wood and the lower sash reveals two lights. Recessed rectangles of painted brick are at the cornice. Dentil trim caps the cornice.

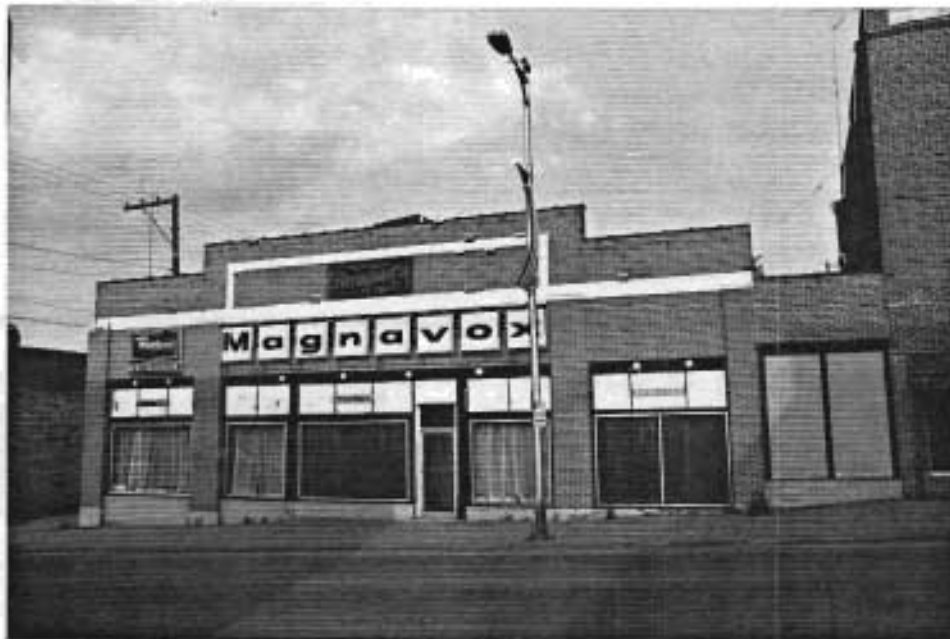
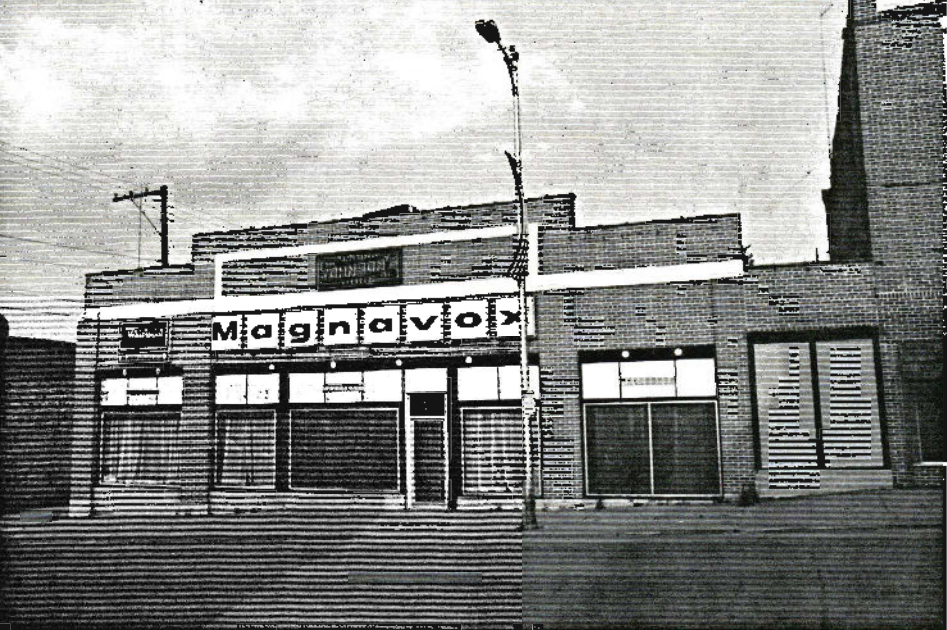
20. Additional physical description
The entrance to this building is slightly off-center in the facade and is a modern aluminum frame glass door with transom. Plate glass windows, which are newer, smaller replacements, are on each side and separated by engaged brick piers. Transom areas above remain and cast iron pilasters are still visible. A cast iron lintel with a fleuron motif runs above the shopfront area. The parapet is trimmed with a white brick rectangular design and tile coping caps the rooftop.

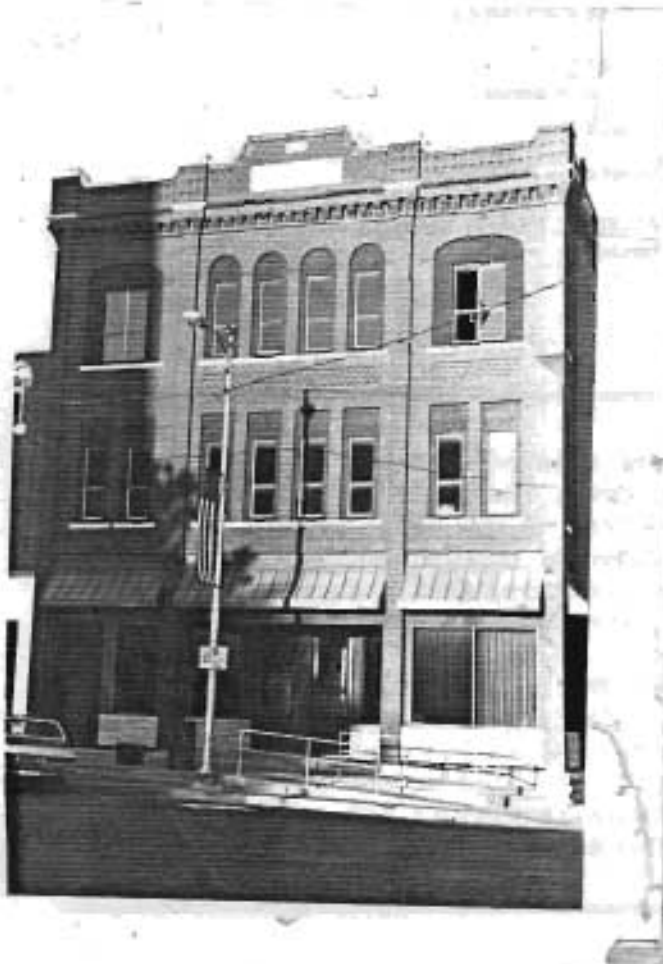
The shopfront area of this three story brick has been altered with the addition of stone veneer to the bulkhead and new plate glass windows. The centered, step-up recessed entry displays double, ornate wood frame doors. A new metal awning runs the length of the shopfront. The upper stories are divided by engaged brick piers into three bays. All windows are new aluminum frame replacements, thus reducing the opening size. The third story has four central 1/1 windows within arched openings. 2/2 windows, on either side, also have arched openings. The second story windows differ in that the original openings are rectangular and the side bays each contain two windows. All windows have cut stone sills and radiating brick voussoirs. The cornice features a sculpted parapet with stone cap and an inscription stone with "Deacon" and "1892" above. A checkerboard pattern created of brick and a corbel table decorate the cornice area. Brick fretwork is visible between the second and third stories and a cast iron lintel with fleuron motif runs directly above the signboard area.

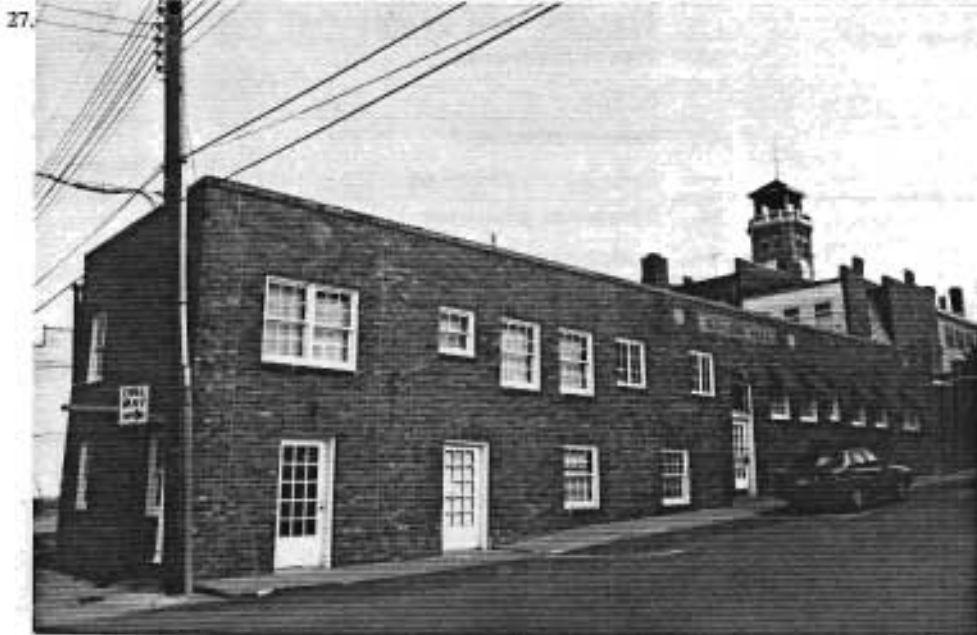
The main entrance to this building is on the northern most end and is angled to the street. Brick, circular steps lead to the wood frame glass door with transom. A metal edged stucco covered flat, circular roof covers the entry. The varigated brick above is capped with a stone parapet. Two frosted glass fixtures hang on each side of the entry. Two other entrances face Lexington, one in the middle of the facade. It is a multi-light wood frame door with a transom covered by a geometric design iron grille. The entrance on the southern edge of the building is a wood paneled door. Thirteen windows of varying size line the facade. Two are casement type, the others are wood frame double hung, most being multi-light. Centered in the cornice area is a stone name plate reading "D. S. LONG." Stone octagonal forms are on each side. At each end of the building are stone cruciform designs, flush with the facade. Brick coursing that visually divides the facade is formed using the end of the varigated brick. This coursing runs at top and bottom and at each end. A cut stone cap tops the roofline.

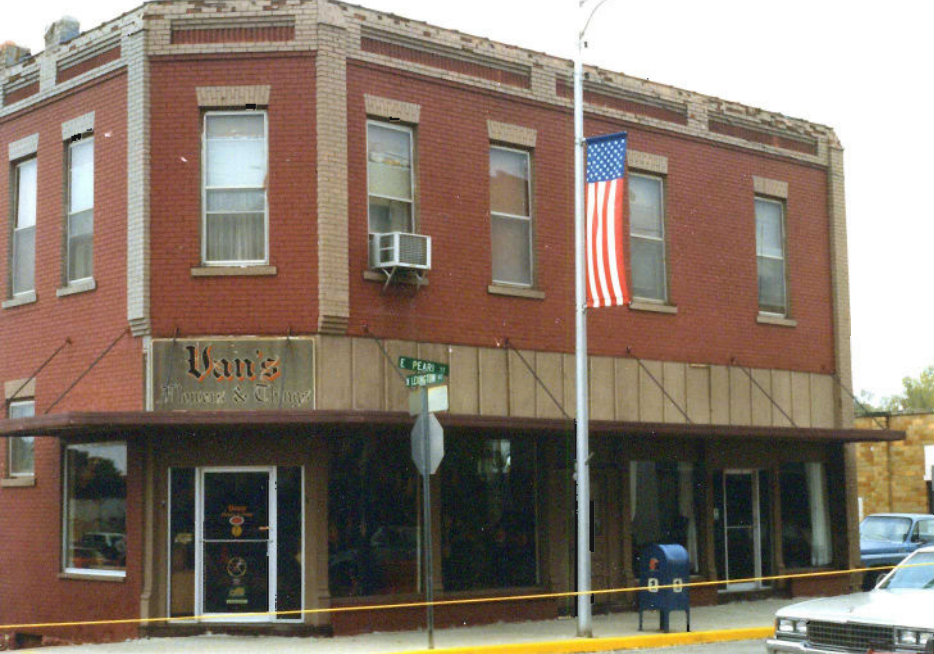
20. Additional physical description
 This structure houses two businesses, each with separate entries. The entrance to 200 is angled to the corner and is a new aluminum frame glass door with sidelights, framed by iron pilasters. The entrance to 202 faces Pearl Street and is a step-up entry of a aluminum frame glass door with sidelights. Plate glass windows with a brick bulkhead are on each side. Iron pilasters inscribed with "Harrisonville Foundry" frame the shopfront sections. The first story level facing Lexington Street has five smaller fixed pane windows and one larger plate glass window. A flat metal awning wraps around the building and wood panels cover the shopfront transom area. An upstairs entrance faces Pearl Street and is a wood paneled and three light door with a two-sectioned transom. The second story windows are 1/1 wood frame with painted vertical brick lintels in a radiating design. The plain sills are iron. The cornice is decorated with recessed panels of angled, vertical brick with the addition of brick stringcoursing below. The coursed rubble stone foundation and basement windows are visible on the west facade.

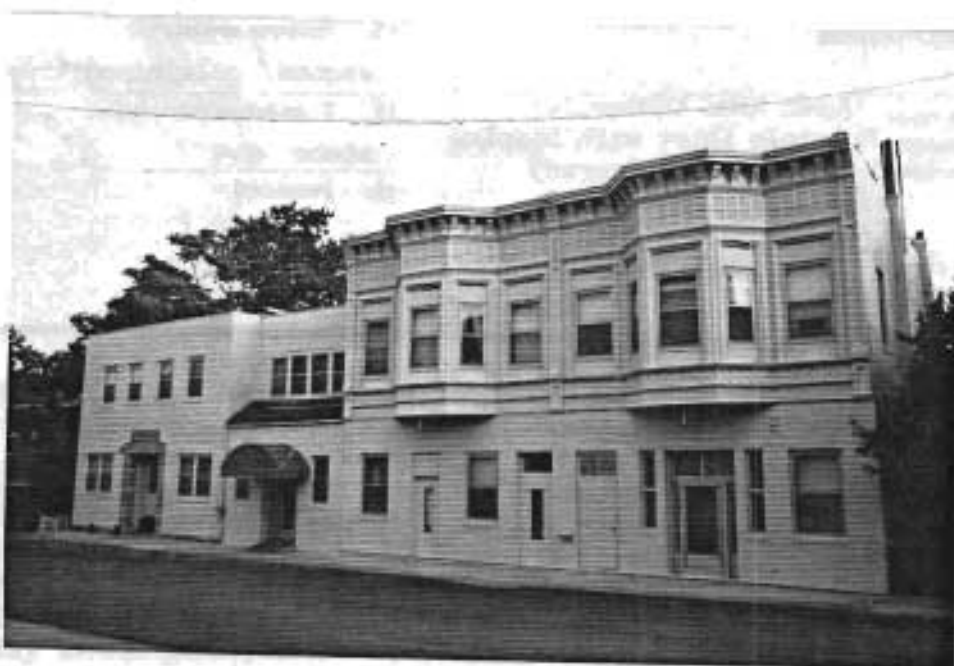
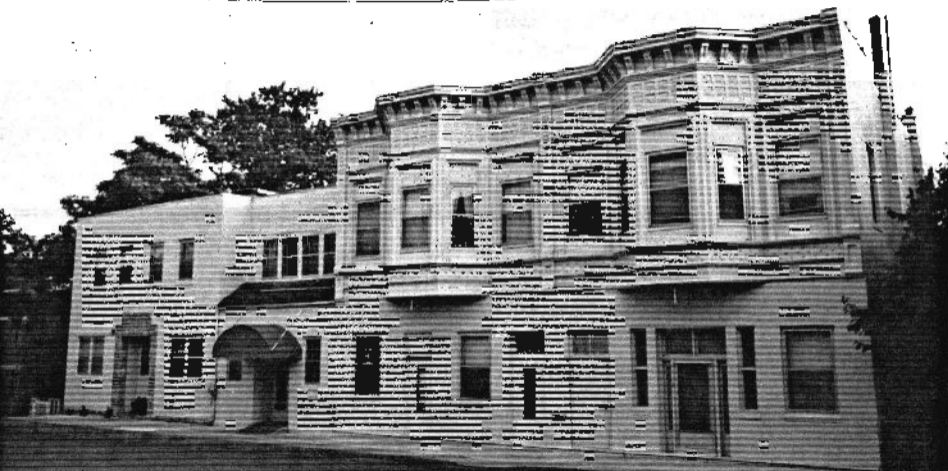
104 W. Pearl

recessed, one framed by stone veneer, the other with a shed roof. Recessed from the top of the roof is the second floor. Stone coping runs along the roof line of the newer section.

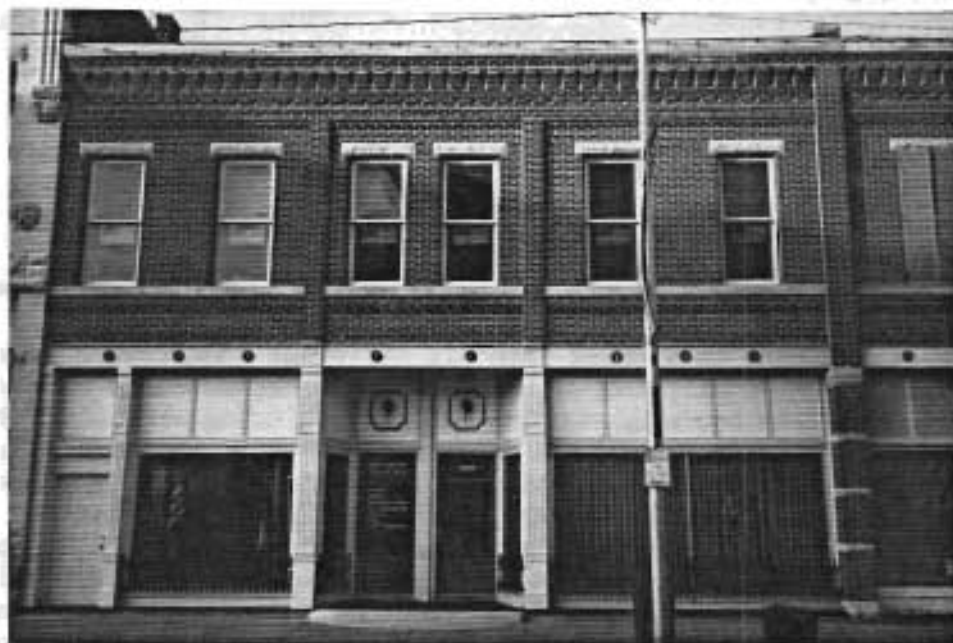
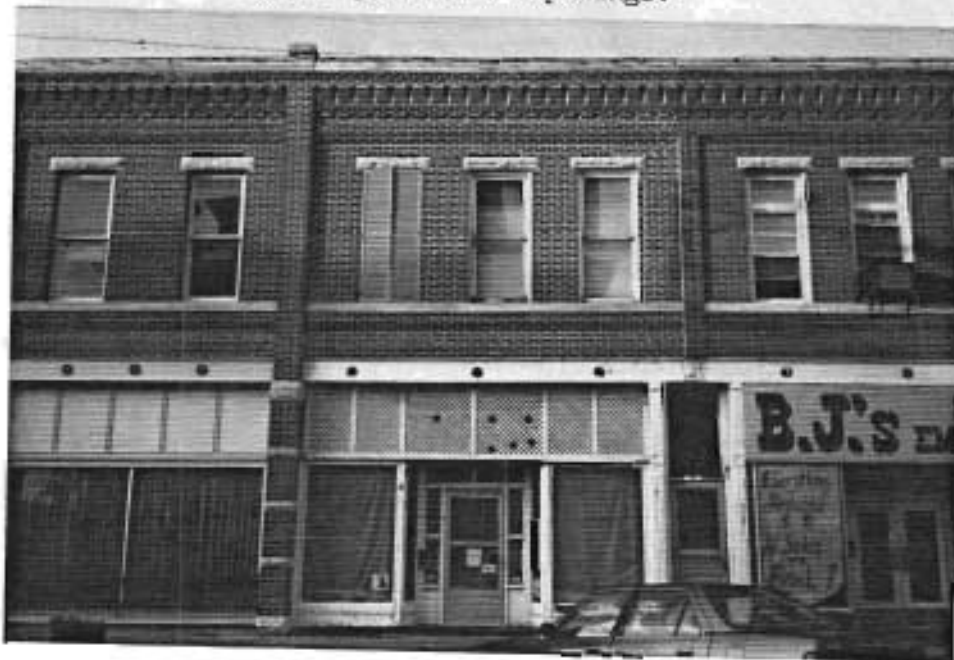
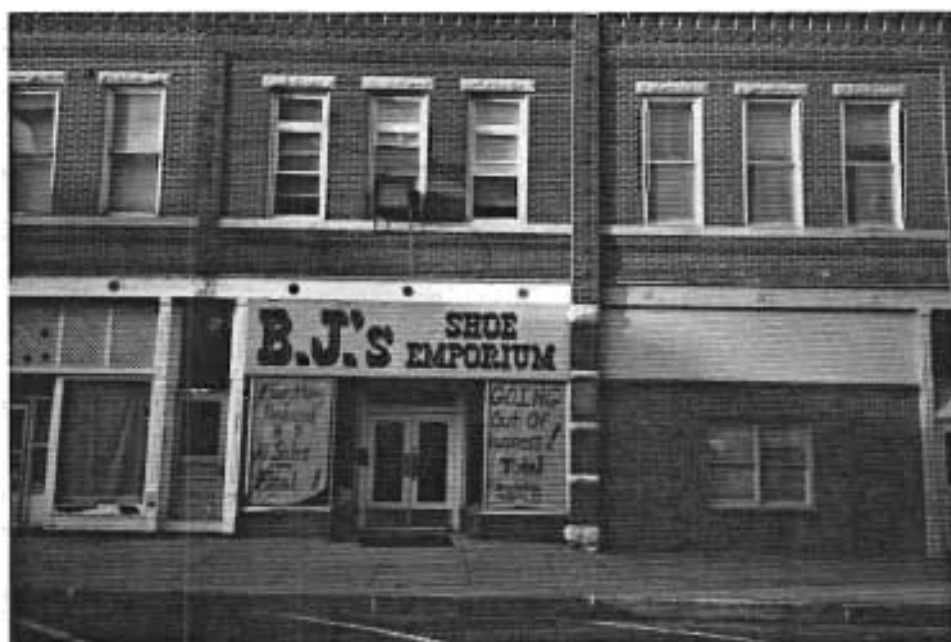
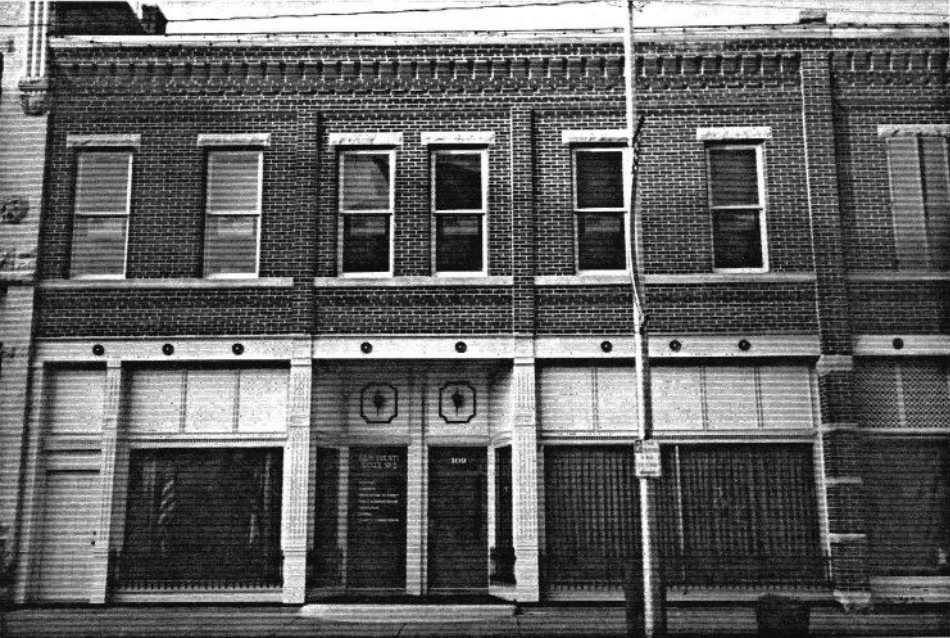
101 - 111 E. Wall

1. (con't.) 107 - vacant/ 109-111 Cass County Annex #2
20. (con't.)with a two-sectioned transom. Lattice covers the signboard area. A centered, recessed entry at 109-111 is a double door, wood paneled with top glass and the sectioned transoms are covered. Dentil wood trim is above the plate glass windows and decorative iron fencing is at the window bottoms.
22. (con't.) retain their original pattern of openings.

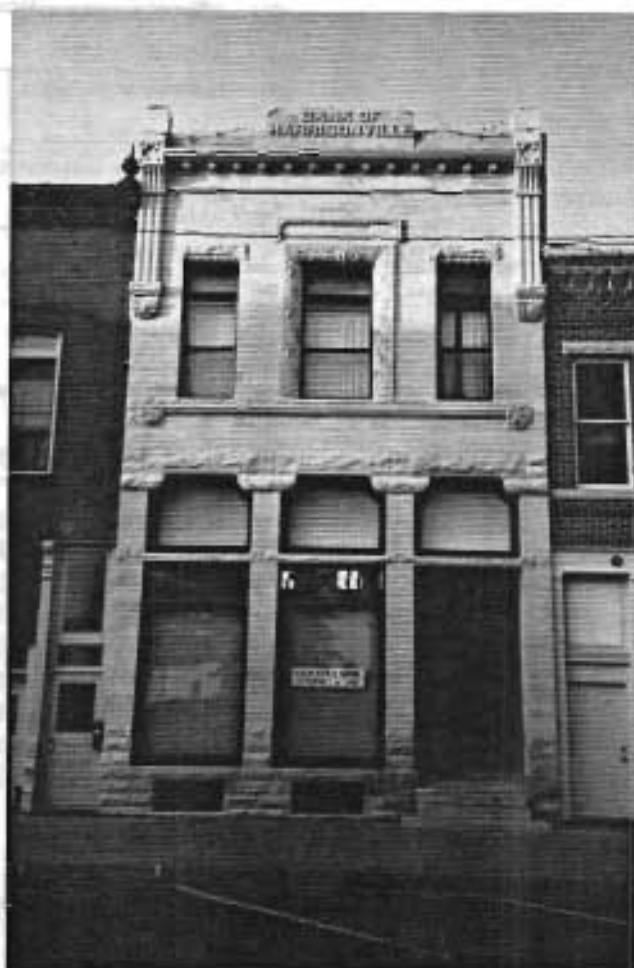
20. Additional physical description
 The shopfront area has an entry to the side approached by stone steps. The door is a single light door with fixed transom. Large, recessed display windows with three flush, fixed transom lights, painted white, are to the side. Directly above are large fixed transoms that have been covered. Cut stone piers with rusticated stone capitals frame the windows and recessed entry. The bulkhead also displays the rusticated art stone. The three second story windows are 1/1, double hung with fixed single light transom. The middle window features a cut stone leaf design surround and above a stone drip mold. The side windows have rusticated lintels and cut stone egg and dart design. Stone coursing below begins and ends in a leaf design medallion. A stone dentil cornice supports the stone parapet with an inscription plate reading "Bank of Harrisonville". Below are triple engaged columns on a leaf design base and a curved stone stringcourse.

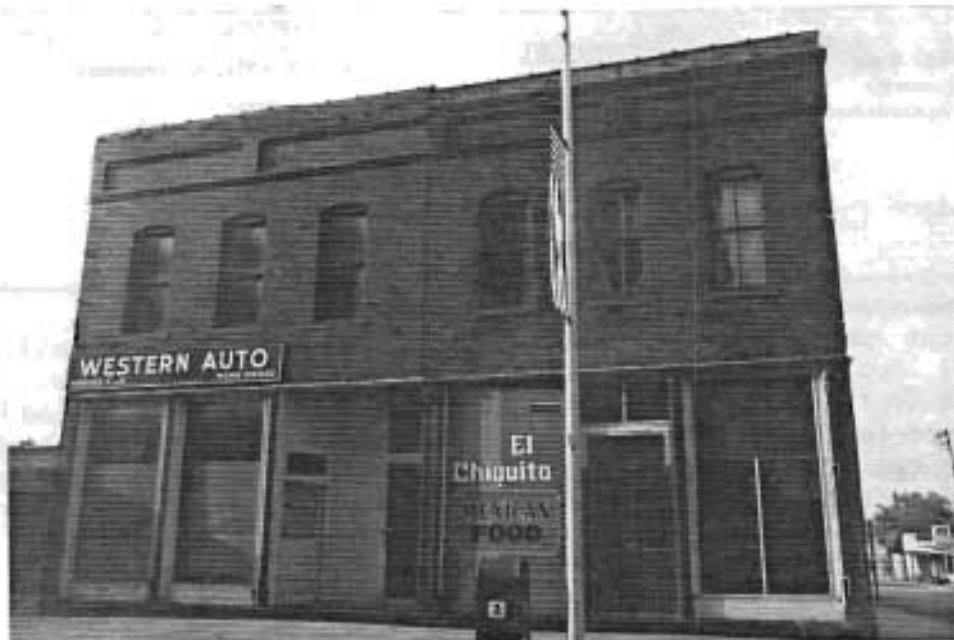
The shopfront area of this two story brick has large display windows (left one is covered) framed by cast iron pilasters. The transom area has been boarded over. A four panel wood double door with paired transoms and framed by cast iron engaged columns is placed in the middle of the facade. The second story windows are 2/2 double hung framed in segmental arches with radiating brick voussoirs. The metal cornice has a pressed design with brick rectangular patterns below. Rubble stone foundation is visible on the west side and a concrete block garage has been attached to the rear of the building.

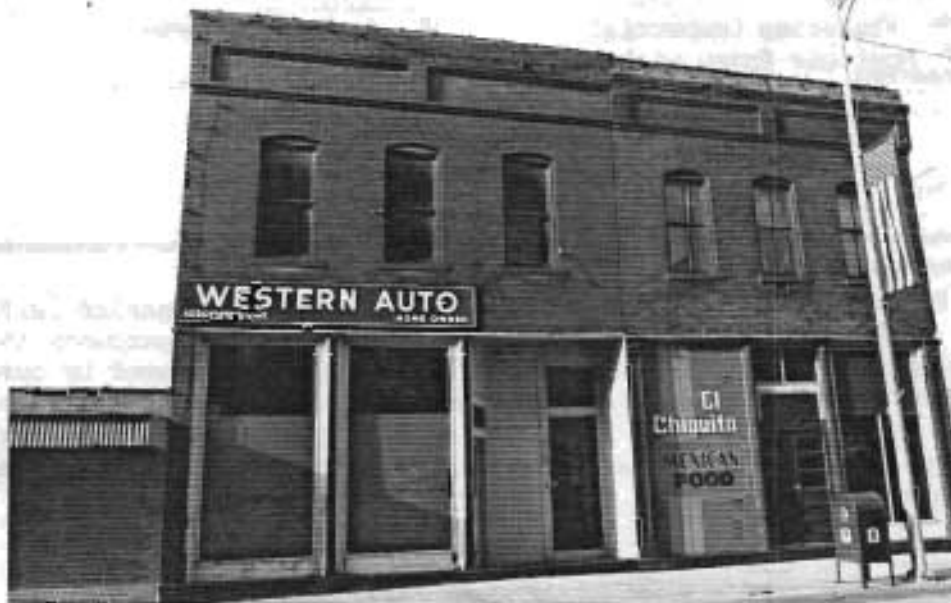
This building has an angled recessed, step-up entry of a wood paneled (with top glass missing) door, with transom above. Tongue-in-groove paneling surrounds the entry. Two large wood frame plate glass windows are to the left and are framed by cast iron pilasters. The second floor features three 1/1 windows under segmental brick arched lintels. The plain sills are iron. The cornice is decorated with two recessed rectangular brick panels and tile coping edges the roofline. An upstairs entry is at the right edge of the building and is a multi-light wood frame door with transom.

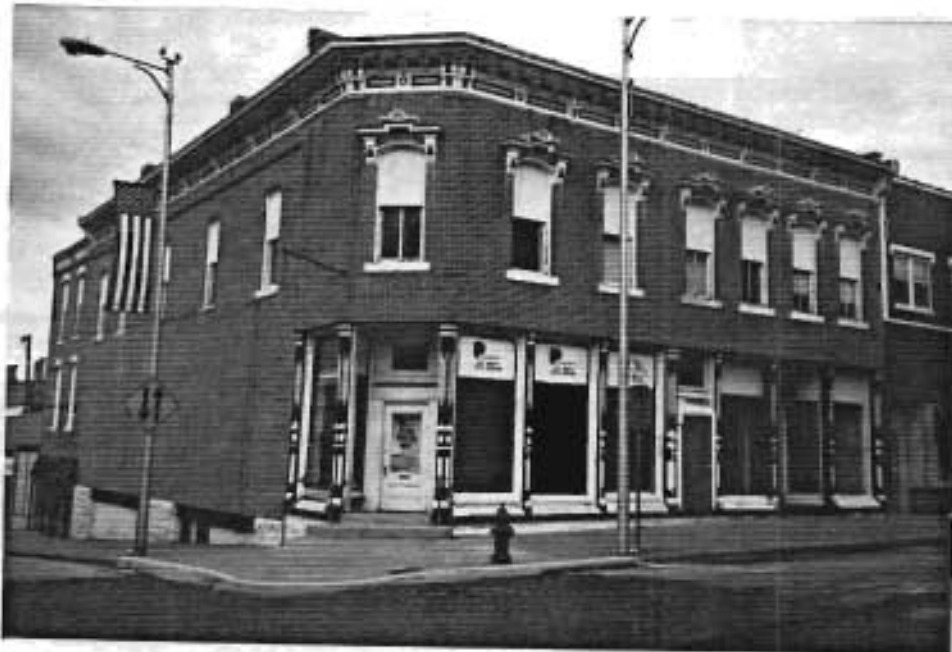
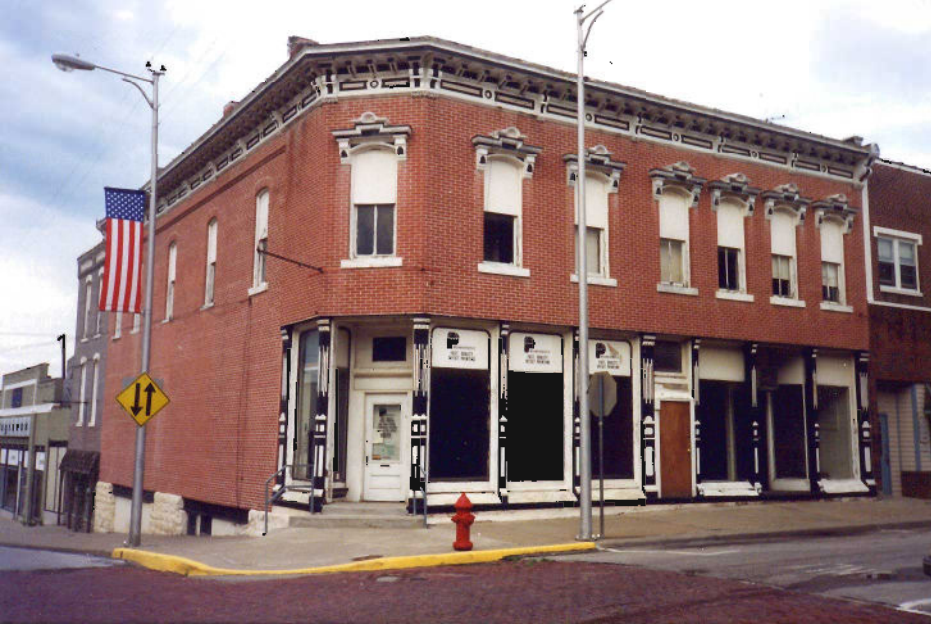
101 - 103 W. Wall

22. (con't.) its period and style. In spite of apparent sandblasting and closed-in second story windows, it would be a significant contributing building to a potential historic district.

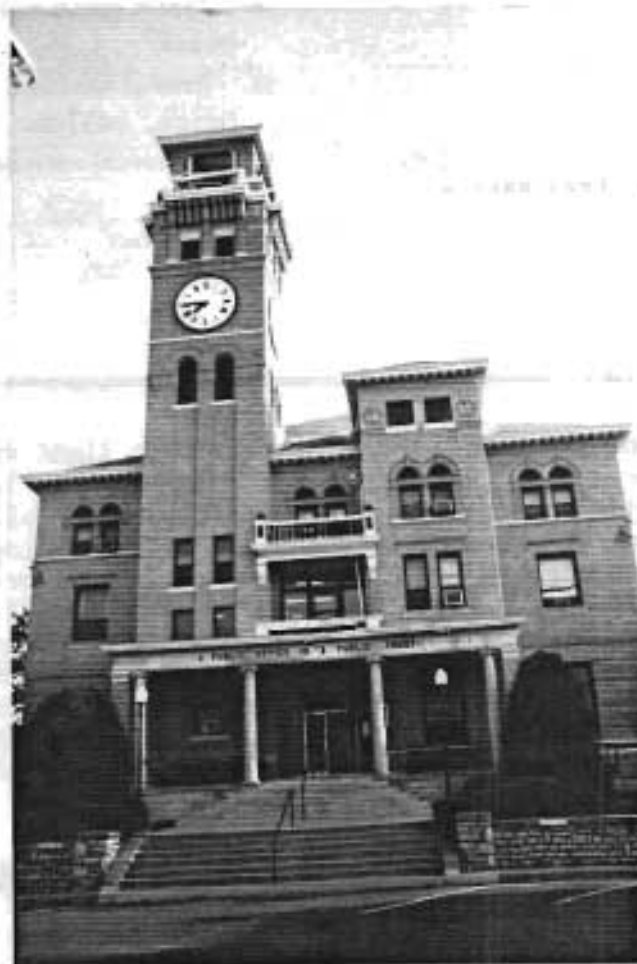
104 W. Wall

The cut stone foundation contains recessed rectangular, two light windows. A wide stone belt course marks the first floor level. Recessed brick areas on this level create a rusticated effect and horizontal coursing creates visual floor divisions on all four facades. Cartouches are located on each corner of the structure, below the sill coursing on the third floor. Heavily decorated brackets support the shingle hipped roof. Two brick chimneys, trimmed with cut stone, are at the north facade. The window fenestration on all sides of the structure is 1/1, double hung, in rectangular frames. The first floor windows have radiating voussoirs with flat arch lintels and stone sills coursing below. The second floor windows are more decorative using stone drip molds above with stone sills below. Paired windows framed by ionic pilasters are on the third floor and ionic columns separate the window bays. Arched, covered transoms are above, stone sills below. Above the transoms, radiating brick voussoirs are accented with keystones.

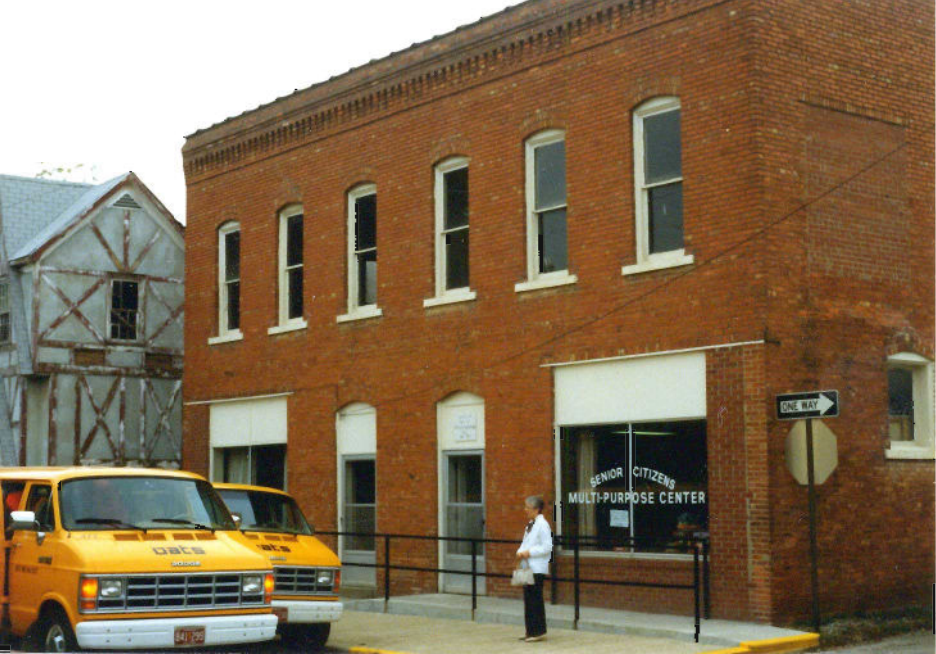
SENIOR CITIZENS
MULTI-PURPOSE CENTER

Two entrances are about centered in the facade. Each is a single wood door with covered transoms above and set within a segmented arch of radiating brick voussoirs. Modern plate glass windows replace original windows on the first story. The second story windows are 1/1 double hung with arched brick lintels. The brick corbeled cornice is set above brick stringcoursing. Tile coping caps the roofline.

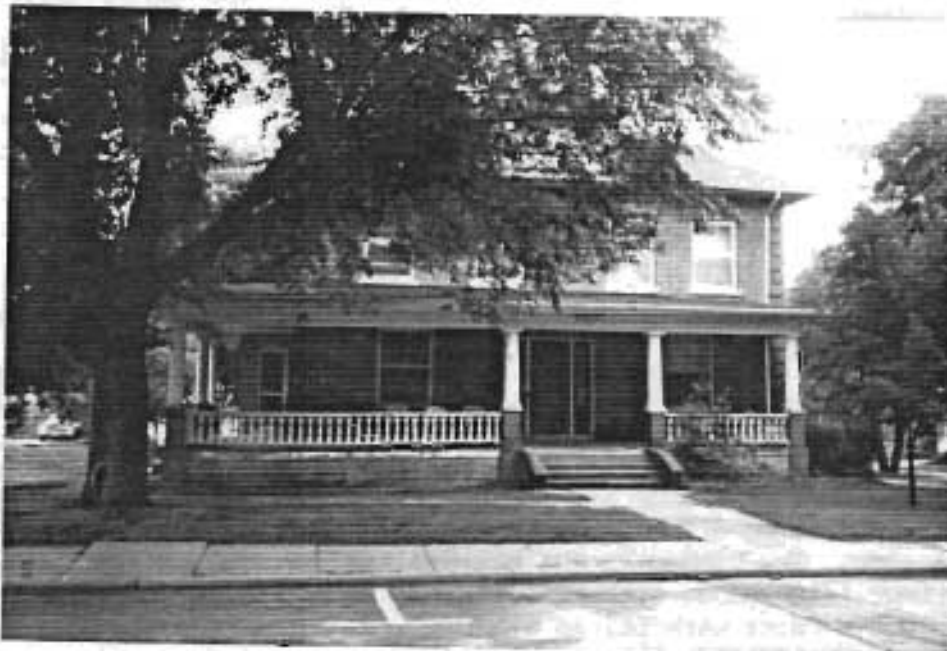
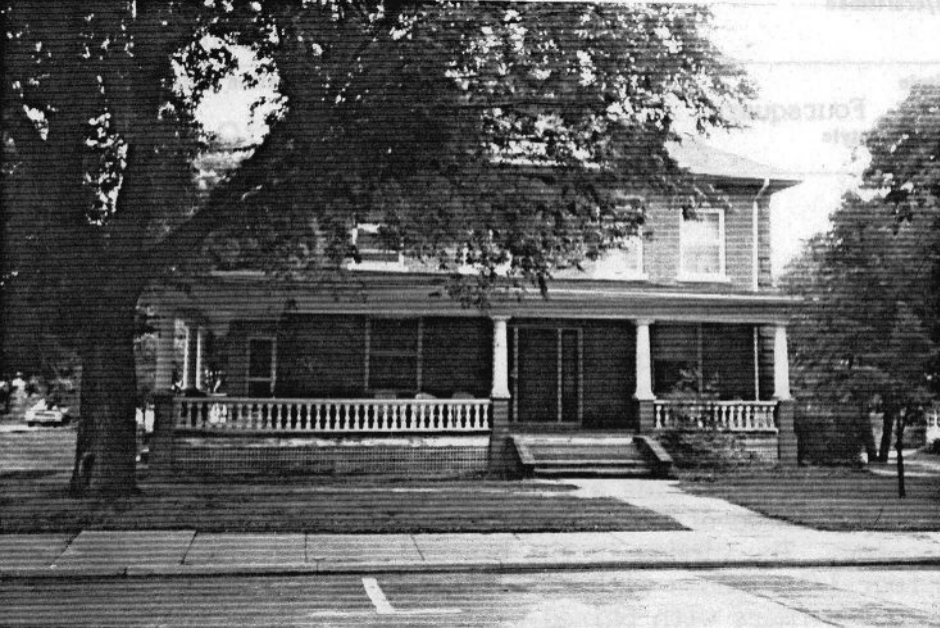
The hipped roof of this wrap-around porch is supported by wood tapered columns set on brick piers. Turned wood spindles compose the balustrade and lattice covers the open area below. Concrete steps lead up to the wood floor porch. The main entry door is wood frame and glass with sidelights, one being leaded glass. A plain stone lintel is above. Two windows on either side are large, 1/1, also with plain stone lintels. Another entrance is located off of the porch on the east side of the house and leads into a bay extension. The window in the bay has stained glass sidelights. The second story features four 1/1 windows with radiating stone voussoirs and stone sills. Wood shingled gable roof dormers with paired windows are on the front facade, the east, and west. A box bay on the second story, west side, has two windows and is wood paneled. A brick chimney is on the east slope. Raised yellow brick quoining accents the structure's edges. A back patio area leads to a rear entrance.

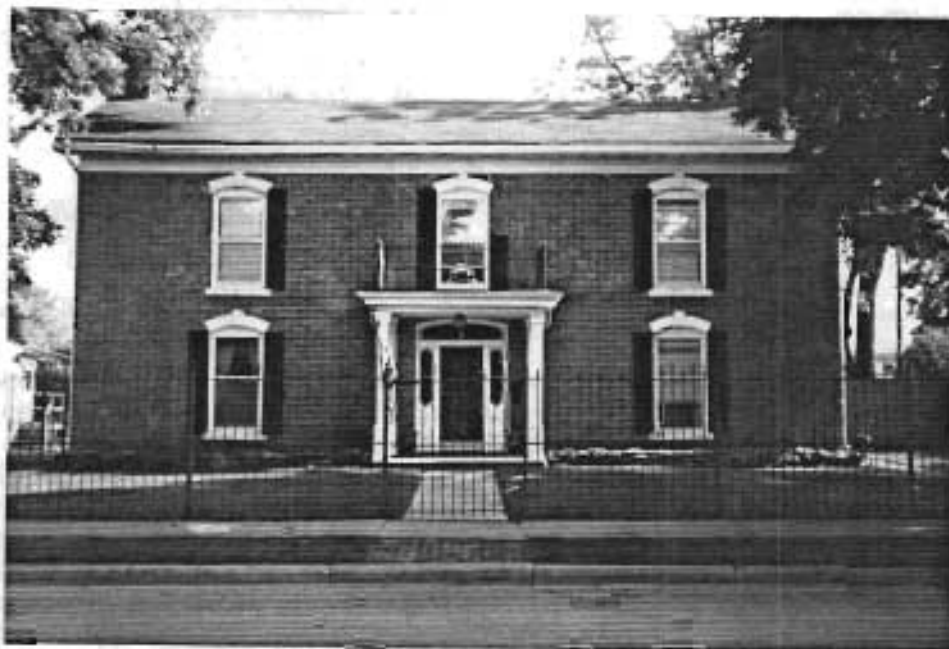
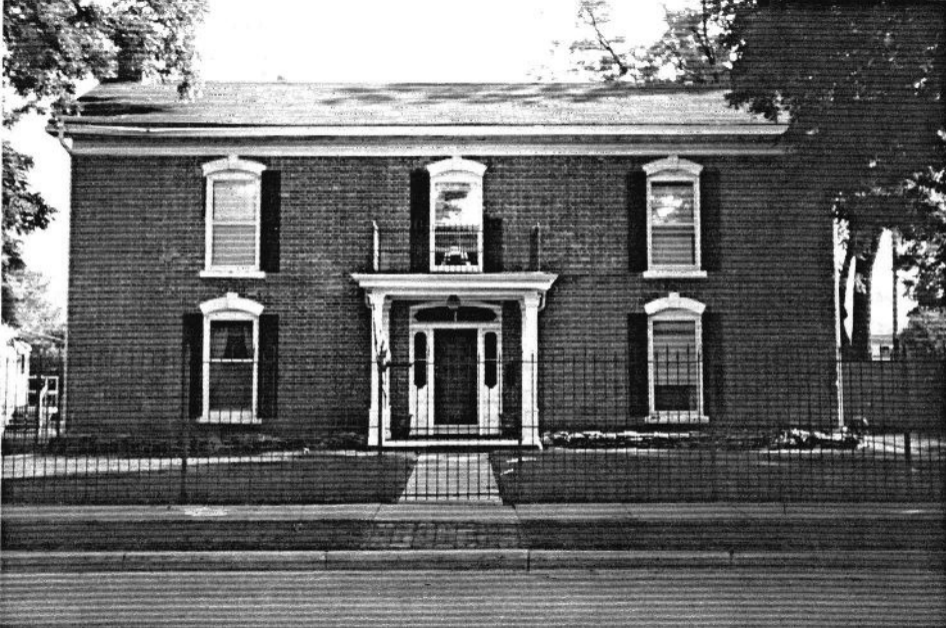
This house has a centered, entry porch with flat roof supported by two square, wood columns. A new paneled wood door has an arched stained glass transom and stained glass sidelights. The porch floor is wood and the porch roof has an ornamental iron balustrade. Two 1/1 windows are on each side of the entrance. The second story has three 1/1 windows on the symmetrical facade. All have wood shutters, stone sills and arched, vertical brick painted lintels with a center keystone accent. Two brick chimneys are at each end of the roof. A gable roof, with shed roof portion, addition is at the back of the house. This has a composition shingle roof, aluminum siding and 12 light windows with shutters. This portion also has a stone foundation and a small brick chimney.

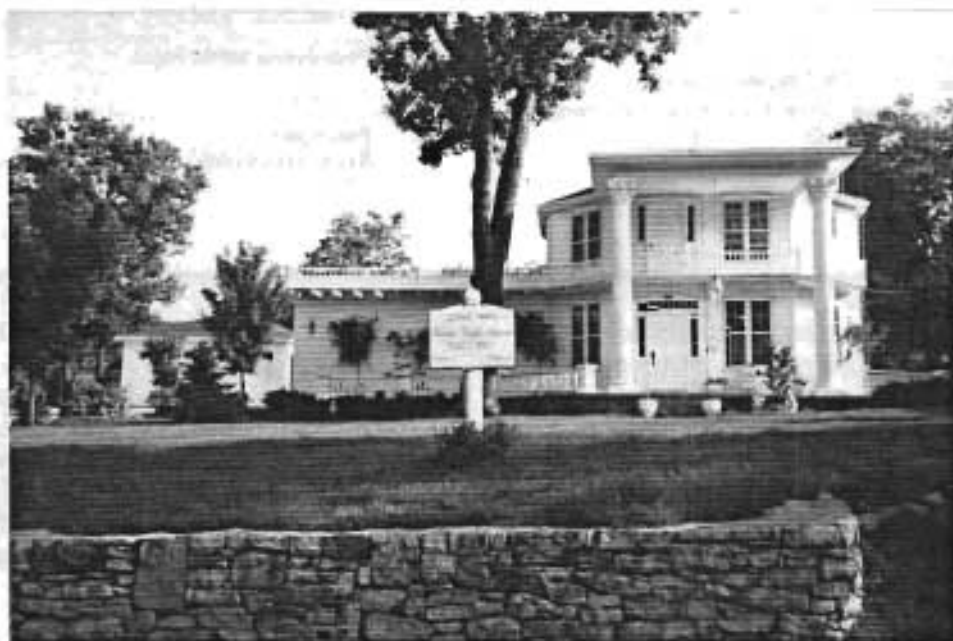
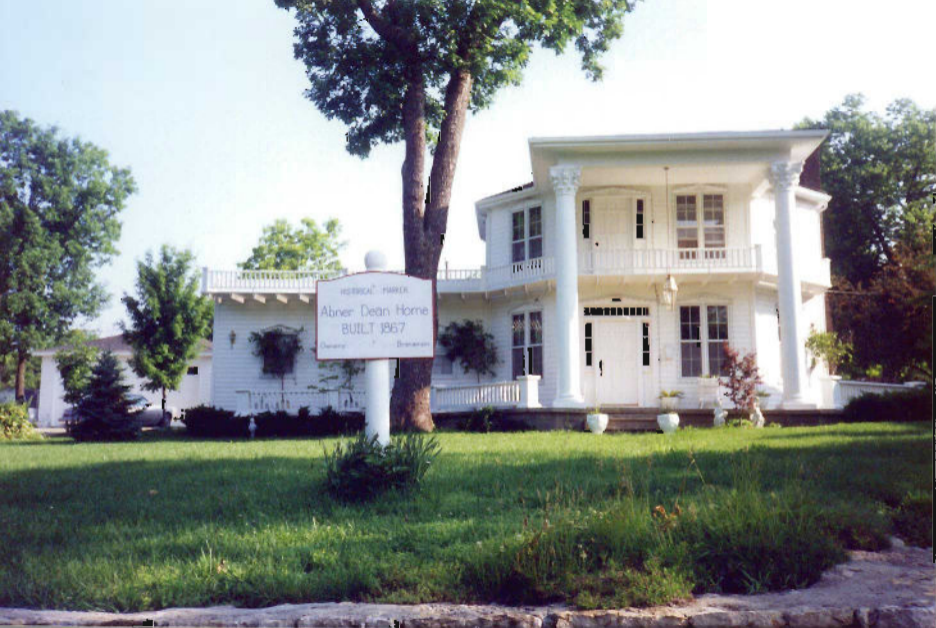
The two story, neoclassical porch was added later to this octagon shaped house. Two classical columns support the flat porch roof with wide, overhanging eaves. The columns are set upon wood paneled box piers. A wood balustrade forms the balcony and rail on the first story. The entrance is a nine panel wood door with three light sidelights. The door and all windows have a broken pediment lintel. A ten light transom is above the door. All windows on the original portion of the house are paired, eight lights each. An added wing on the west is one story with a flat roof, with the balustrade continuing. Two twelve light windows face the street from this section. A two story exposed brick chimney is on the east side of the main house.
