National Register of Historic Places
Registration Form

historic name Lilly, Edward S. and Mary Annatolie Albert, House

street & town 129 S. Lorimier N/A not for publication

city or town Cape Girardeau N/A vicinity

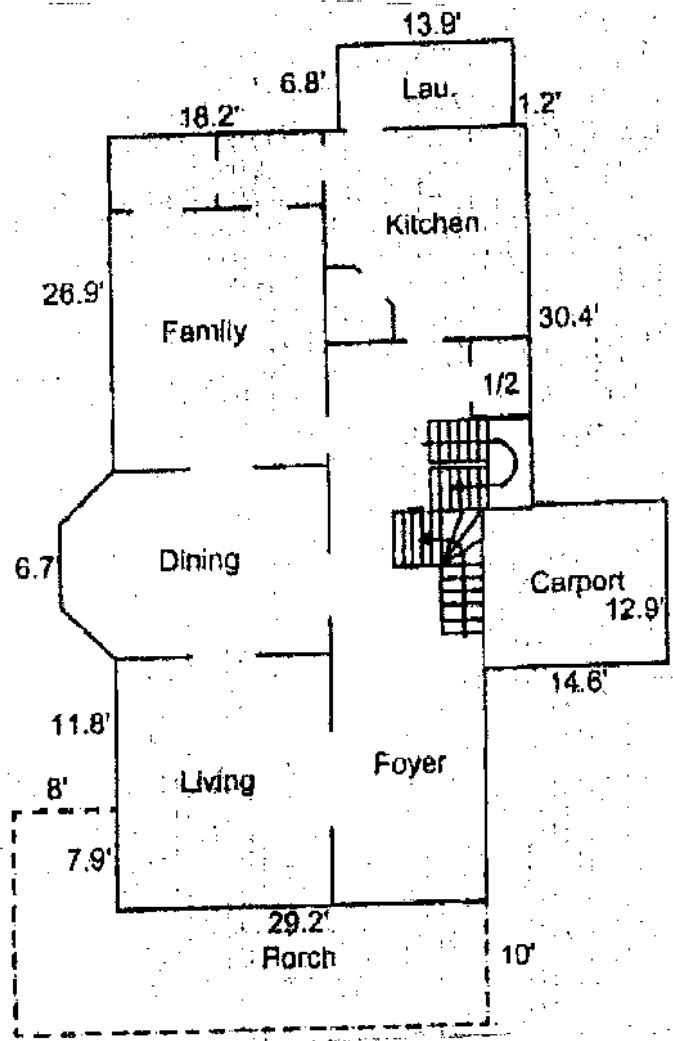
First Floor

The front door opens on a large foyer with a fireplace on the north wall and an open hallway with an elaborate staircase leading to the second level directly to the west. The ornate mantle supported by scroll brackets or ancones has a mirror above and is flanked by fluted Ionic columns resting on bases. Carved in the columns is a *fleur-de-is* symbol. Located on either side of the fireplace are two wooden built-in benches that open for storage. Above each bench is a stained glass window. To the west of the innermost bench is the ornate staircase with delicately turned balusters and a level handrail. The classically detailed opening between the foyer and the open hallway consists of two freestanding Ionic columns resting on a paneled base. The columns support a decorative entablature which extends along the ceiling visually dividing the foyer from the staircase hallway beyond. The free standing columns are each flanked by engaged Doric columns. The paneled base extends from the north wall to support a decorative squared newel post which features a symbol that resembles a three-sided clover with what appears to be a letter "M" underneath in the upper portion. On the lower section of the square newel post are two inset panels. The upper panel has a carved sun in the upper corner. The lower panel has carved suns in opposite upper and

lower corners. Half-way up the staircase is a sitting area to the north with a built-in bench and a stained glass window located above the porte cochere.

The doorway on the west wall of the hallway is elaborately decorated with Colonial Revival era detailing, including a transom balustrade supported by scroll brackets or ancones. To the south in the foyer is a pocket door that leads into the parlor or living room which contains an original fireplace with glazed tile surround with grate and hearth. Colonial Revival-era molded wood details distinguish the mantel. The walls are plaster, and wood baseboards are evident throughout the room. A pocket door on the west wall leads into the adjoining room behind it. This second room on the south side of house features a pocket door that leads to the adjoining room to the west, also with an original fireplace with glazed tile surround and hearth. The original door and window trim exists around almost all the doors and windows throughout the house, and a distinctive pattern comprised of bullseye molding topped by decorative crowning is evident in most of the rooms. (See attached floor plans for the layout of the first floor, page 7).

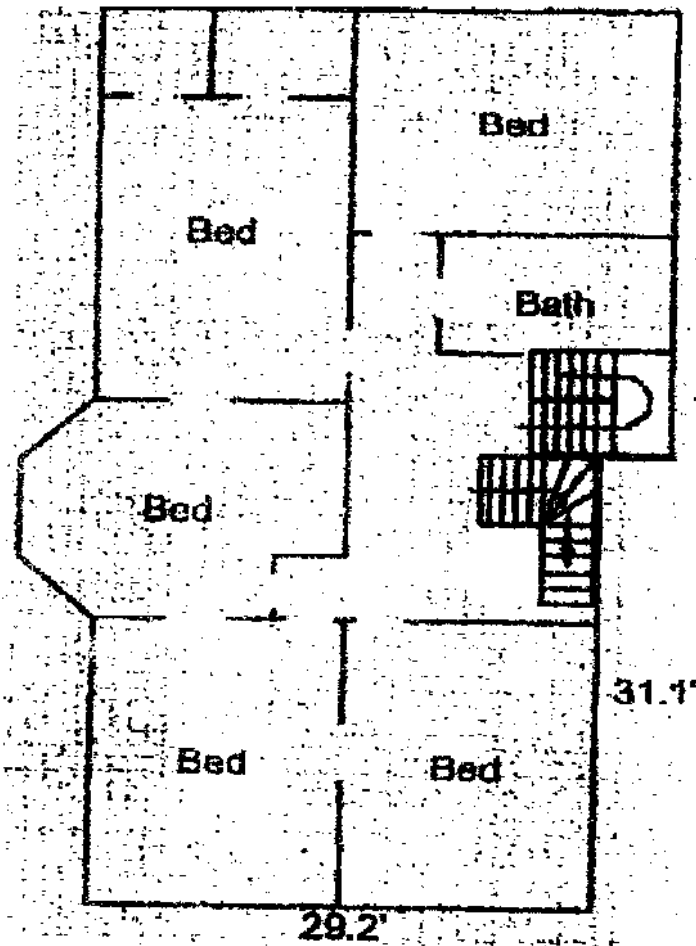
Second Floor

The second story has a similar plan to the first. There are five rooms and one bathroom. Two of the three rooms on the south side of the building have original fireplaces with pocket doors joining the three rooms. The northeast corner bedroom is the only room that is missing its original fireplace. To the west of the staircase is the back staircase that leads to the third floor. Original door and window trim are evident throughout. (See attached floor plan for the layout of the second floor, page 8).

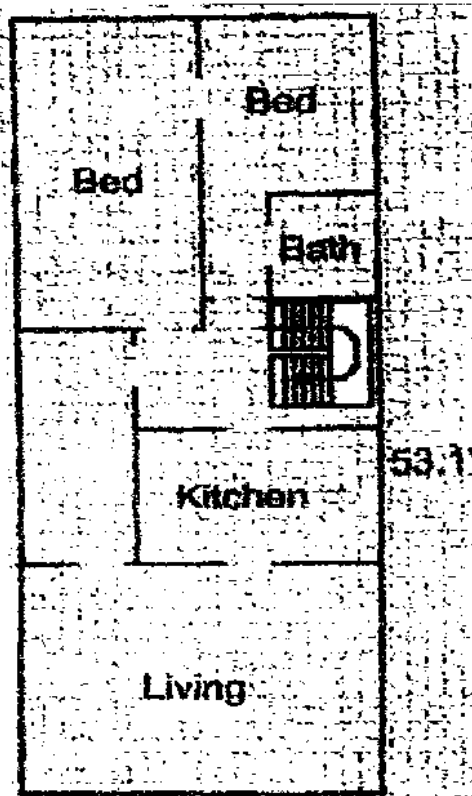
20.6'
Third Floor

The third floor is approximately nine feet shorter in width and four feet shorter in length than the first and second floors with a ceiling height of approximately eleven feet. Access to the third floor is by way of a rear staircase located on the second floor, directly west of the main staircase. (See attached floor plan for the layout of the third floor, page 8).
