NATIONAL REGISTER OF HISTORIC PLACES
REGISTRATION FORM

historic name Poplar Bluff Commercial Historic District

street & number Along sections of S. Broadway and Vine Street not for publication N/A

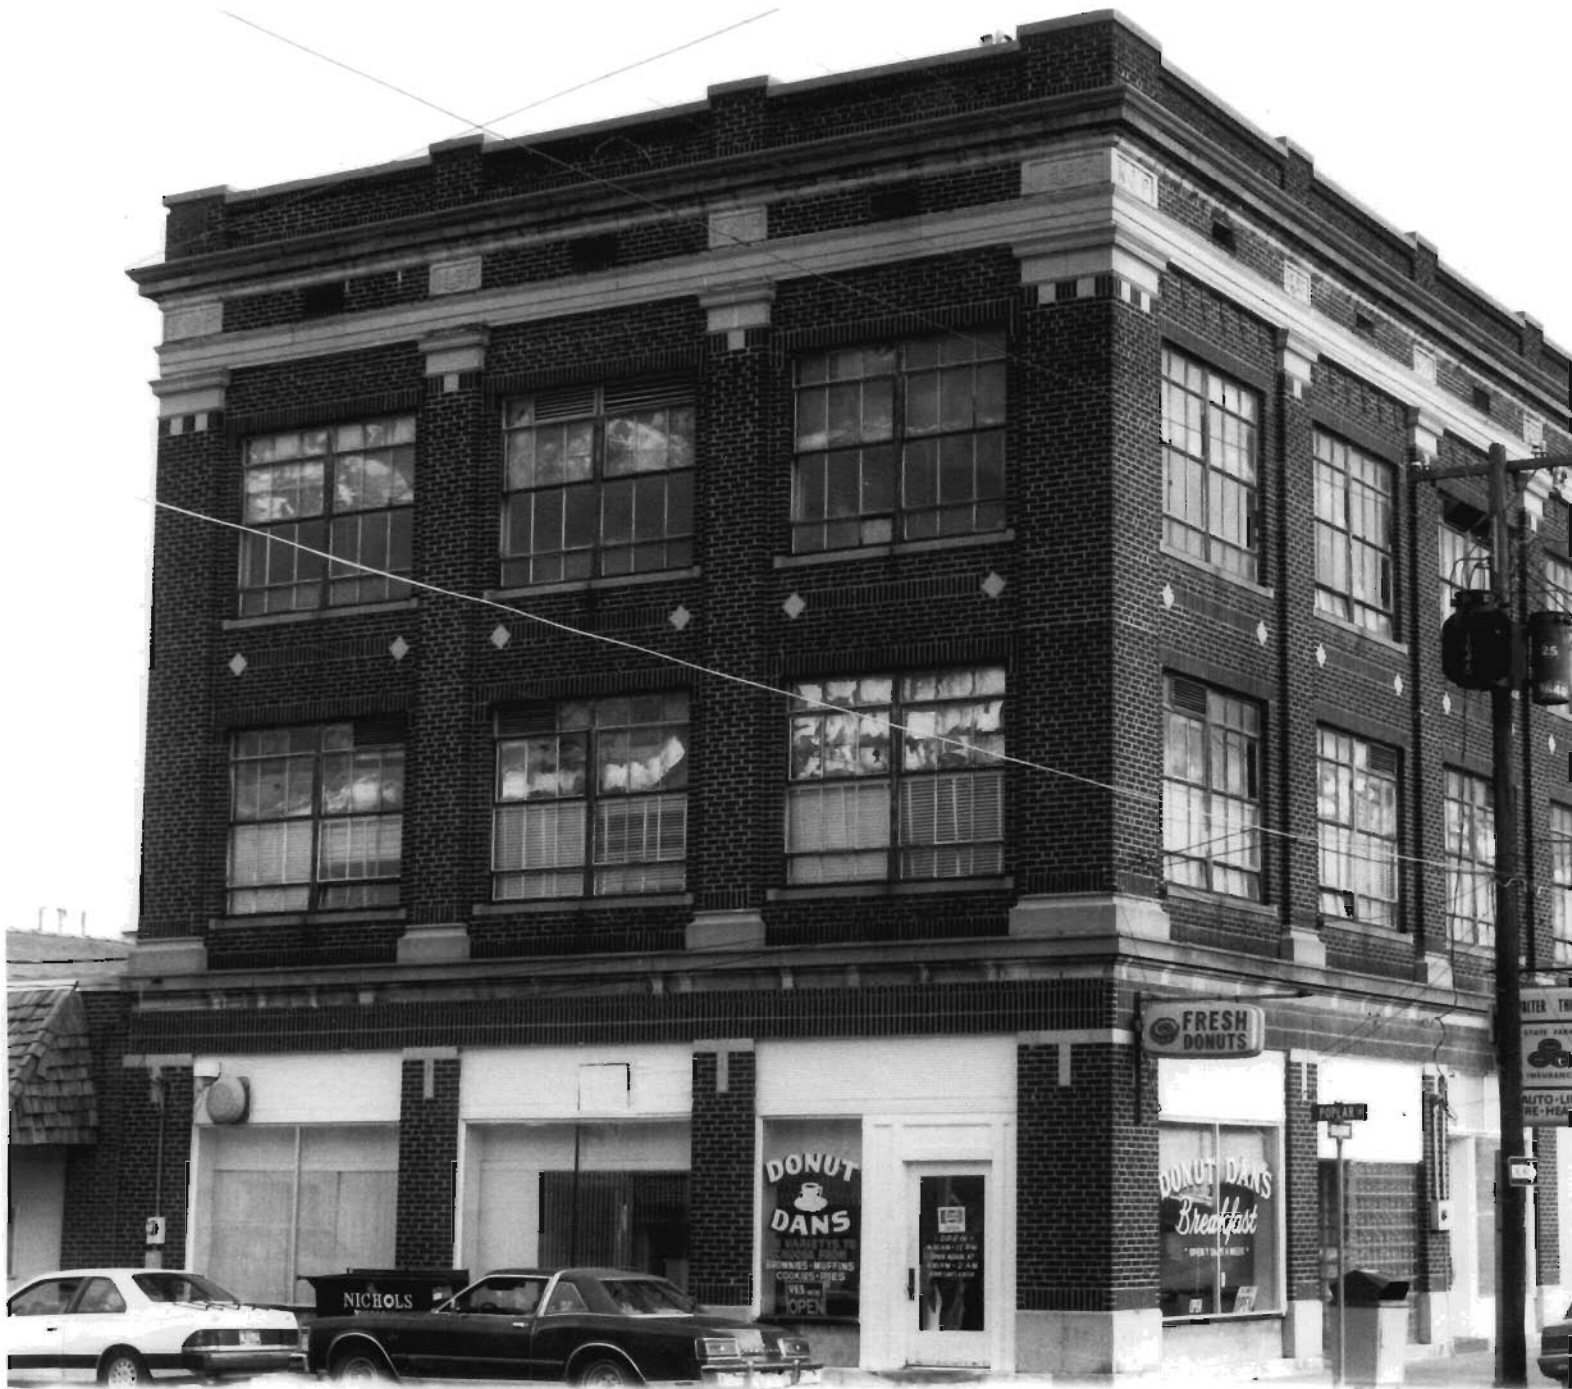
Photo #4 of 12 - Poplar Bluff Commercial Historic District, Poplar Bluff, MO - 1

Photo No. 4: Fraternal Building at 117-119 S. Broadway, view towards northwest.

3. 117-119 South Broadway - Fraternal Building: This is a three-story brick commercial building constructed in a rectangular plan ca. 1928. The building faces both Poplar and S. Broadway Streets with storefronts on both facades. All of the storefronts have been altered although several retain original single light glass and wood doors. Most storefronts have added metal panels and display windows and enclosed transoms. The north storefront bay on the S. Broadway Street facade is the most original and has original brick bulkheads, a single light glass and wood door, and a large single light display window. Dividing each storefront are brick piers with concrete bases. Dividing the first and second floors is a large cast concrete cornice and rows of soldier course brick. The upper two floors contain five bays of windows on the S. Broadway Street facade and three bays of windows on the Poplar Street facade. Each window bay is divided by a full height brick pilaster with concrete Doric capitals. The window openings have original concrete sills and soldier course lintels. The windows are 12-light casement windows of metal. Between the windows are rectangular panels of decorative brick and concrete laid in diamond patterns. Above the third story windows are two concrete cornices and concrete panels inscribed "IOOF" and "KP." At the roofline is a stepped parapet with concrete coping. (C)

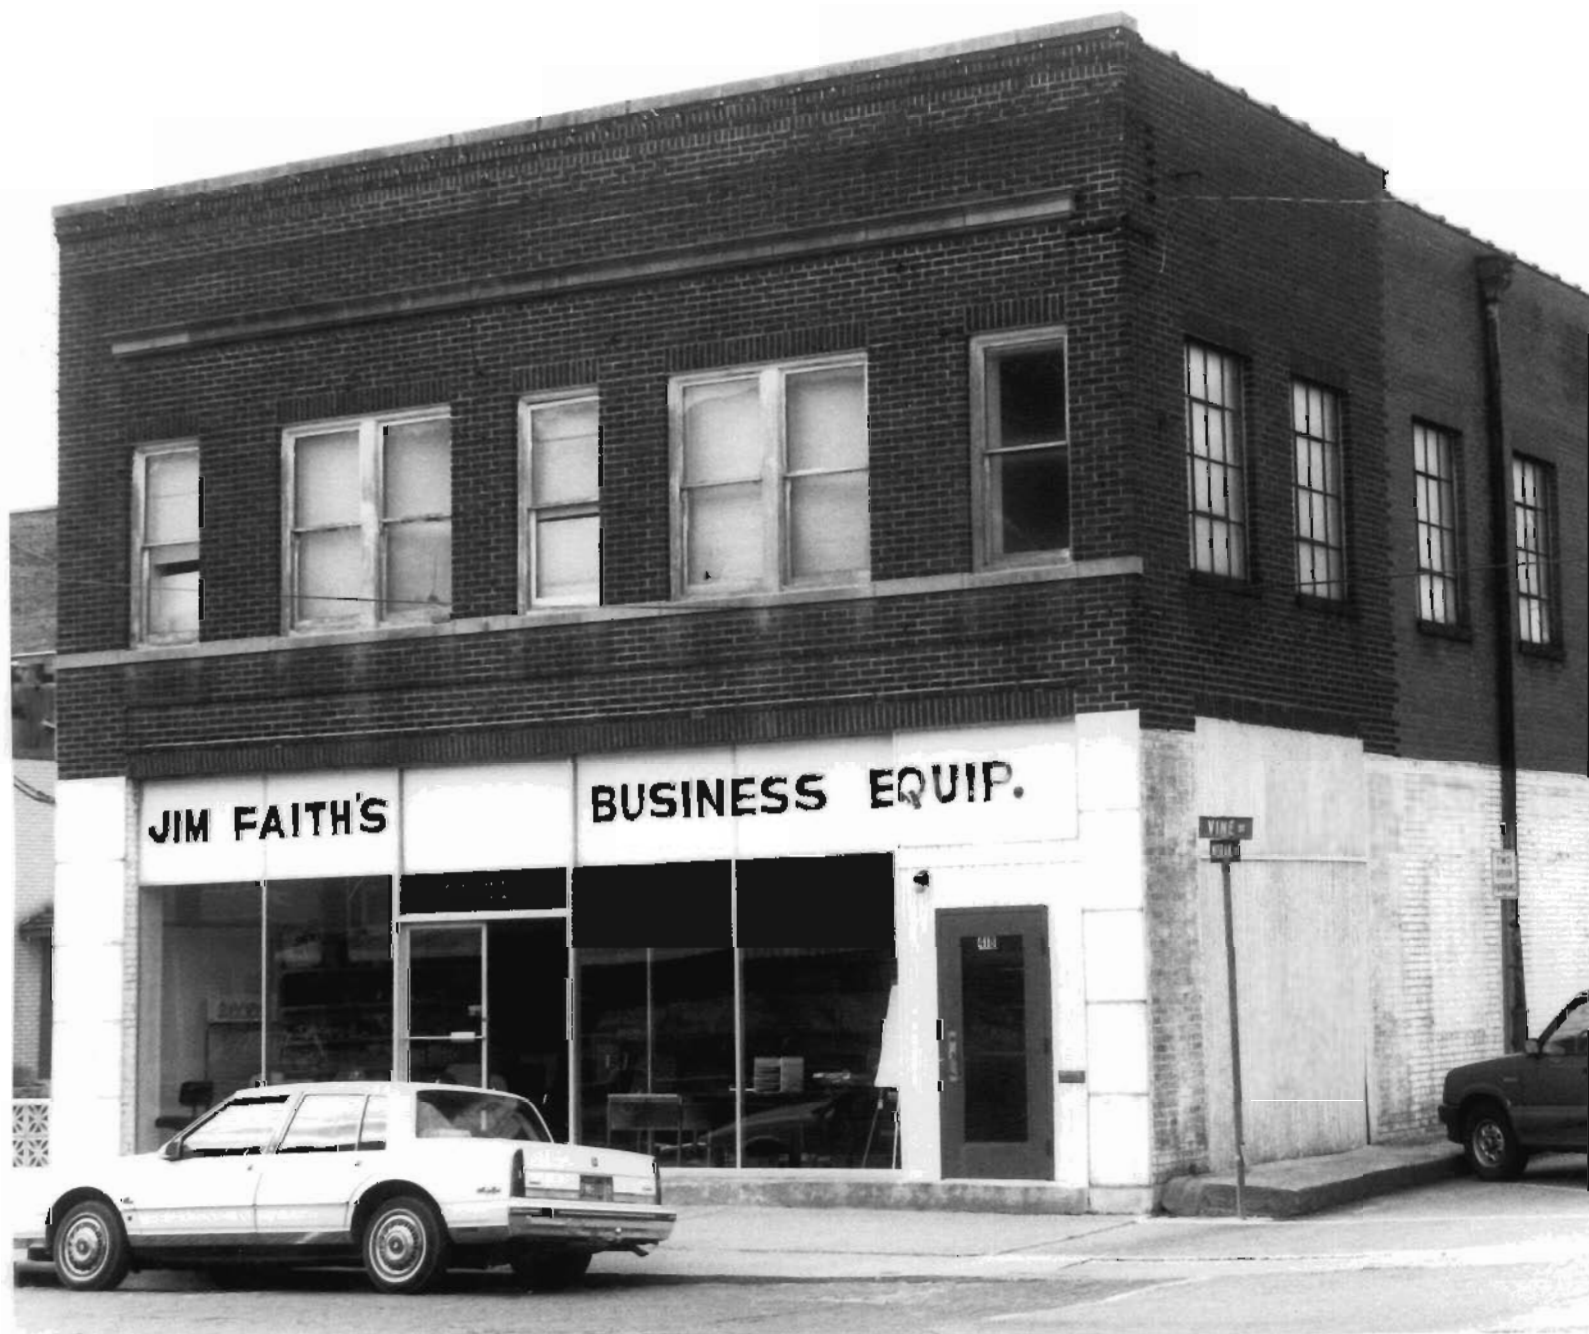
Photo # 7 of 12 - Poplar Bluff Commercial Historic District, Poplar Bluff, MO

Photo No. 7: 416 Vine Street, view towards southeast.

16. 416 Vine Street: This is a two-story brick, rectangular plan commercial building constructed ca. 1900 and the main facade was largely rebuilt ca. 1928 following the tornado. The building is of Tapestry Brick style and has been altered on the storefront. The storefront has ca. 1970 metal and glass doors, display windows and transoms. In the west bay of the storefront is an original glass and wood door which leads to a second story staircase. On the second floor are five bays of one-over-one rectangular wood sash windows. Two window openings contain paired one-over-one sash windows. The windows share a concrete sill and above the windows are soldier course lintels. Above the windows is a concrete sill and at the roofline is a flat parapet with concrete coping. (C)
