National Register of Historic Places
Registration Form

historic name St. John's Evangelical Lutheran Church and Parochial School

street & town 112 Walters Street not for publication: N/A

city or town Corning vicinity: N/A

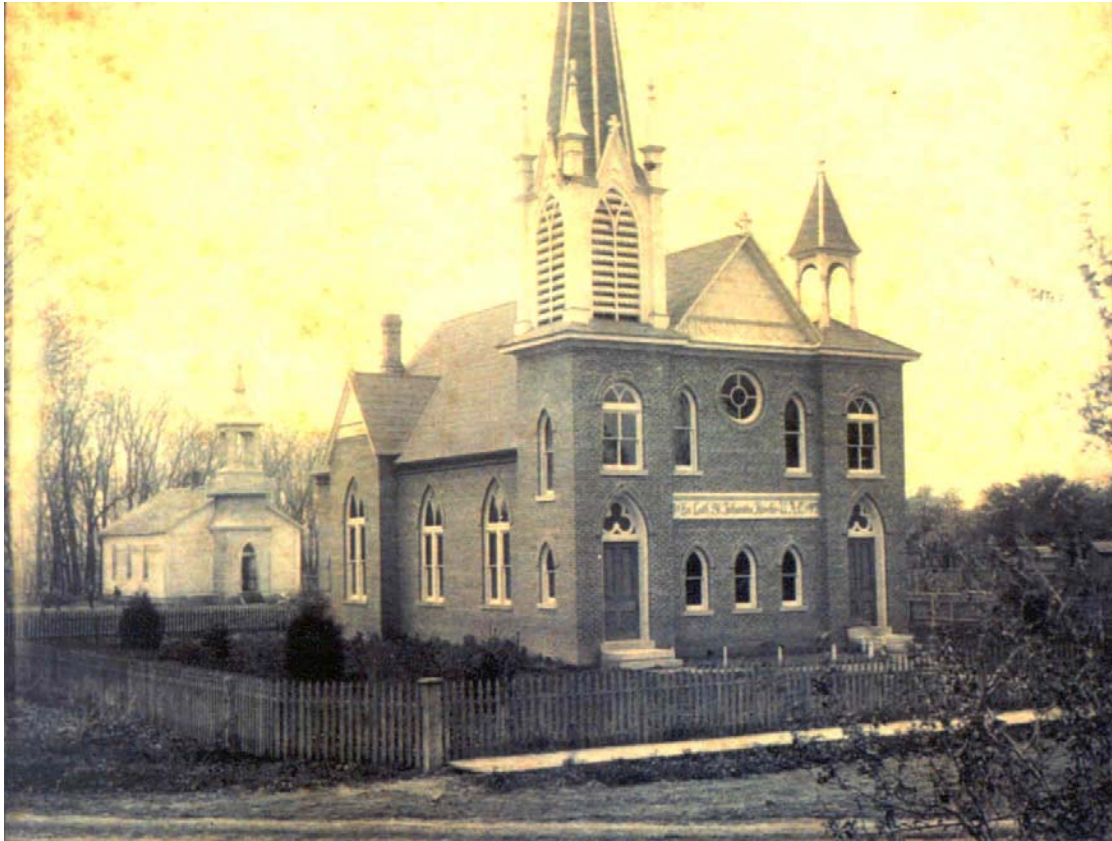
Figure 1: Historic photograph (taken around 1894), shortly after St. John's Evangelical Lutheran Church was constructed, showing the relocated "Church in the Timber" behind it.

The two steeples of different heights on the eastern façade were designed to hold significance for the entrances they stand above. The taller of the two steeples, which houses the church's original bell, is topped by a red eight-sided spire surrounded by four smaller spires and is crowned with a wooden, four-sided cross. This, the highest point of the building, rises above the south or "male" entrance," originally intended to be used only by the men of the congregation. The significantly smaller steeple, which resembles a red, spire-topped pyramid supported by four smaller columns, rises above the north or "female" entrance, originally intended for use by the women and children of the congregation who sat on this side of the church. In this way, Proft intended for the architectural design of the building to reflect the congregation's belief that men, as heads of their respective households, were responsible for the spiritual upbringing of their families and required a separate place from which they could better focus on the message of the worship service. This practice of male-female separation during the church service continued among some members even into the early to mid-20th century.

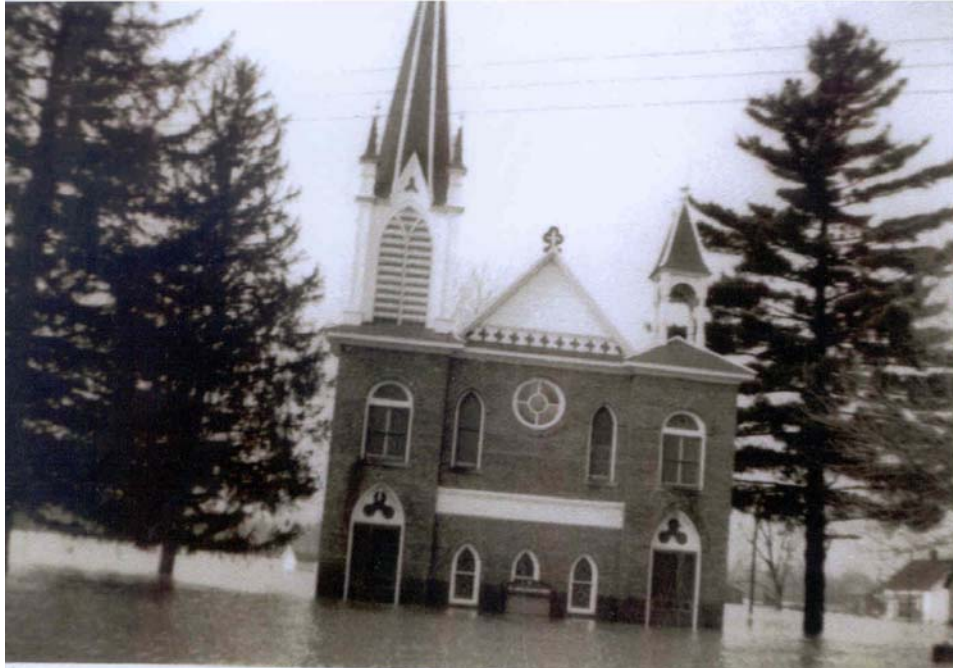
Figure 3: Historic photograph taken in April, 1952 during the Flood of 1952

In 1952, St. John's Lutheran Church faced a catastrophe that could have destroyed the congregation permanently. That year, a major flood damaged the building. However, not only did the congregation completely repair and restore the sanctuary, but it also added a Parish Hall the next year. This addition signified a major investment in the future of the church and exemplified the dedication of the St. John's congregation to the preservation of the faith of their German forefathers and the building they left behind. An even more catastrophic flood hit the church in 1993, and yet again the congregation banded together to repair and restore the facility to its former condition. Currently, projects have been initiated to restore and preserve the church's deteriorating steeple and schoolhouse. As descendants of the hardworking immigrants who found prosperity in America and built a community once known as "Little Germany," the current congregation understands the importance of both the church and the schoolhouse. Hemme's Landing, the Church in the Timber, and the businesses and once-grand houses of Corning are all gone, while these two buildings stand as the *only* remaining monuments to a nearly-forgotten era and its unique culture.

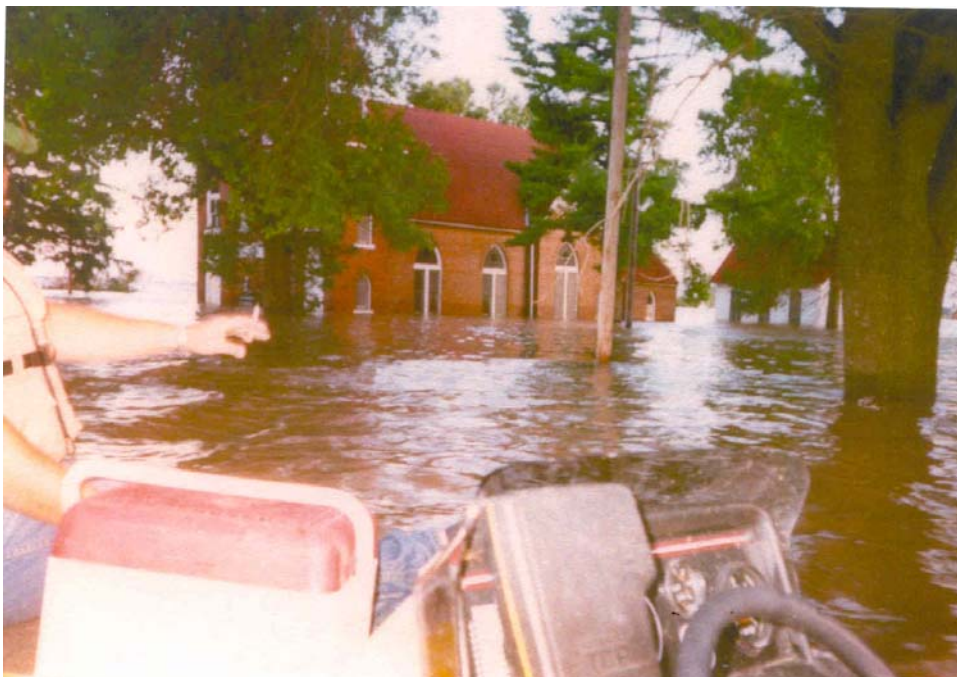
Figure 4: Historic photograph taken July 25, during the Flood of 1993
