# PHOTO IDs FOR COLUMBUS TOWNSHIP AGRICULTURAL SURVEY

All photos of Columbus Township agricultural properties were taken during December 1993 by R. Maserang. Negatives are at Show-Me Regional Planning Commission, 122 Hout St., P.O. Box 348, Warrensburg, MO 64093.

Photos are arranged according to building types. Numbers show their approximate locations on an accompanying map (Map A).

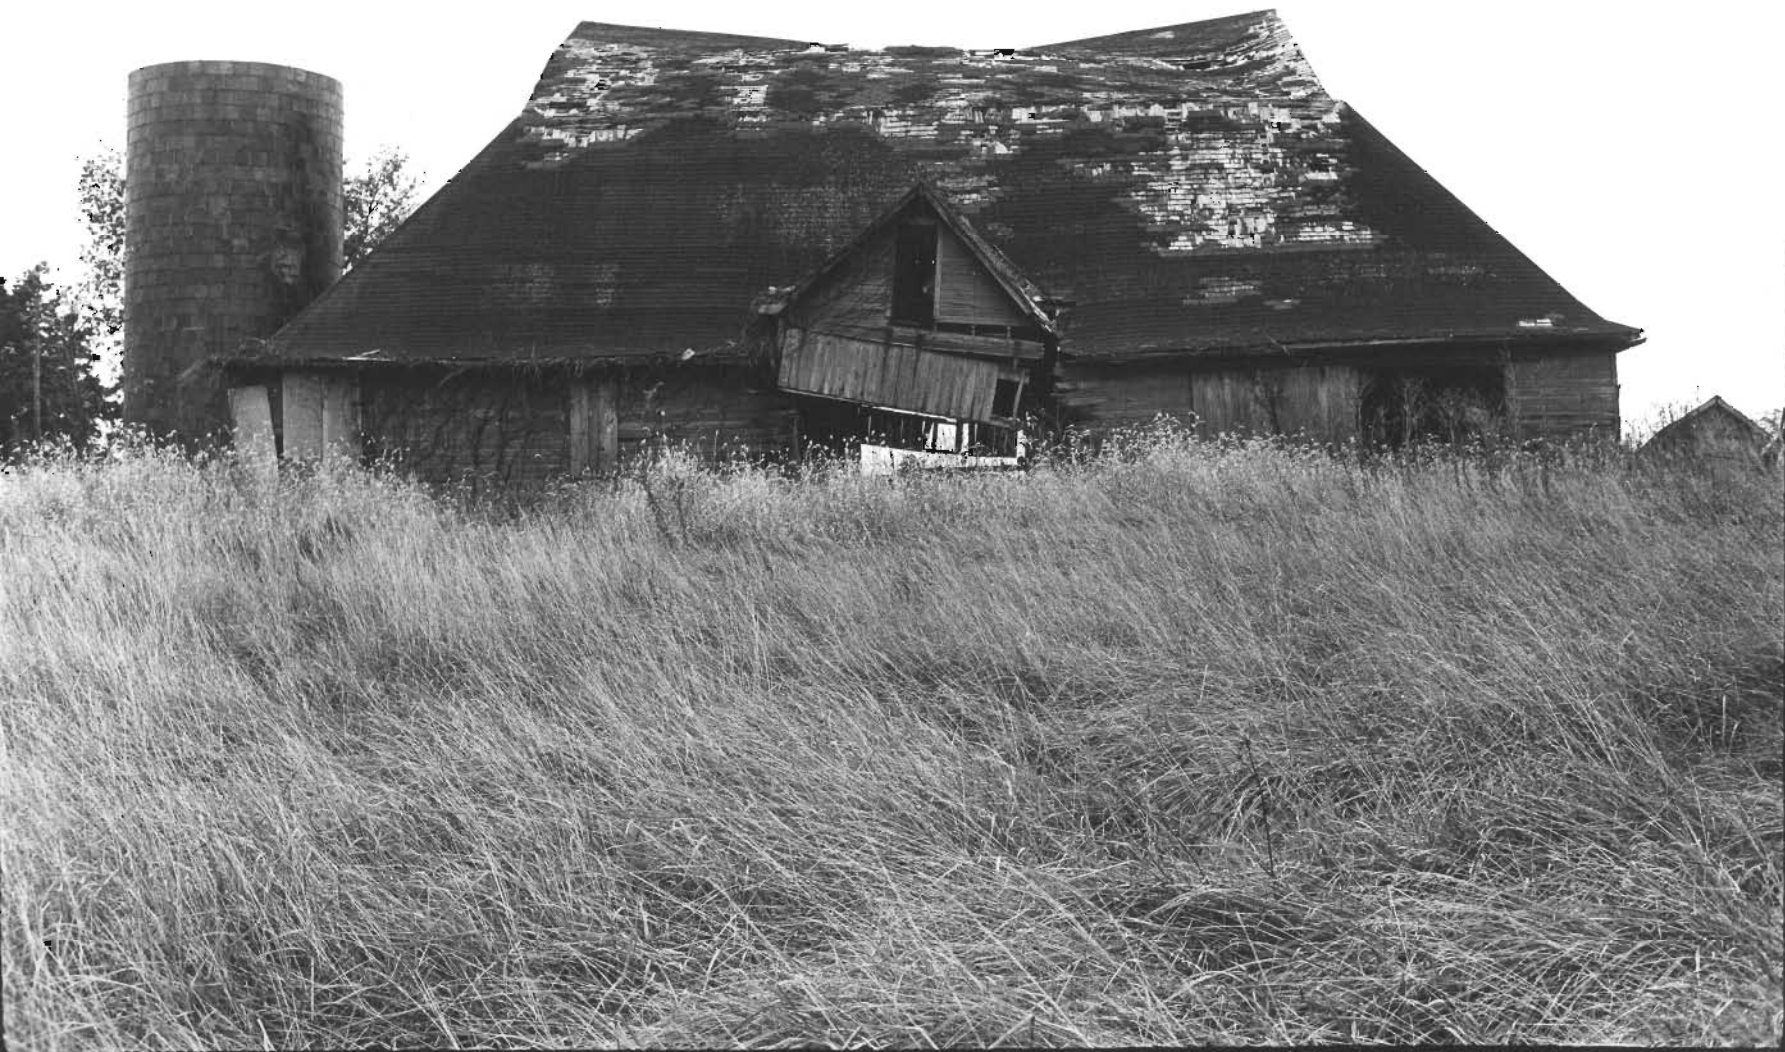
HAROLD BURGARD'S BARN, possibly an uncommon four-crib barn, was inventoried in 1985 in the Johnson County West survey. The building was sagging precariously then, and has since been razed. The barn was in Centerview Township. Although barns did not have high priority in the Johnson County West survey, the Burgard barn was sufficiently unique to attract the attention of the survey team of Tom Christopher and Roger Maserang. (See Survey Form No. 117, 11/1/85, Johnson County West Survey.)
