**Architectural/Historic Inventory Form**

*Cuba, Crawford County, Architectural/Historic Survey*

January 2007

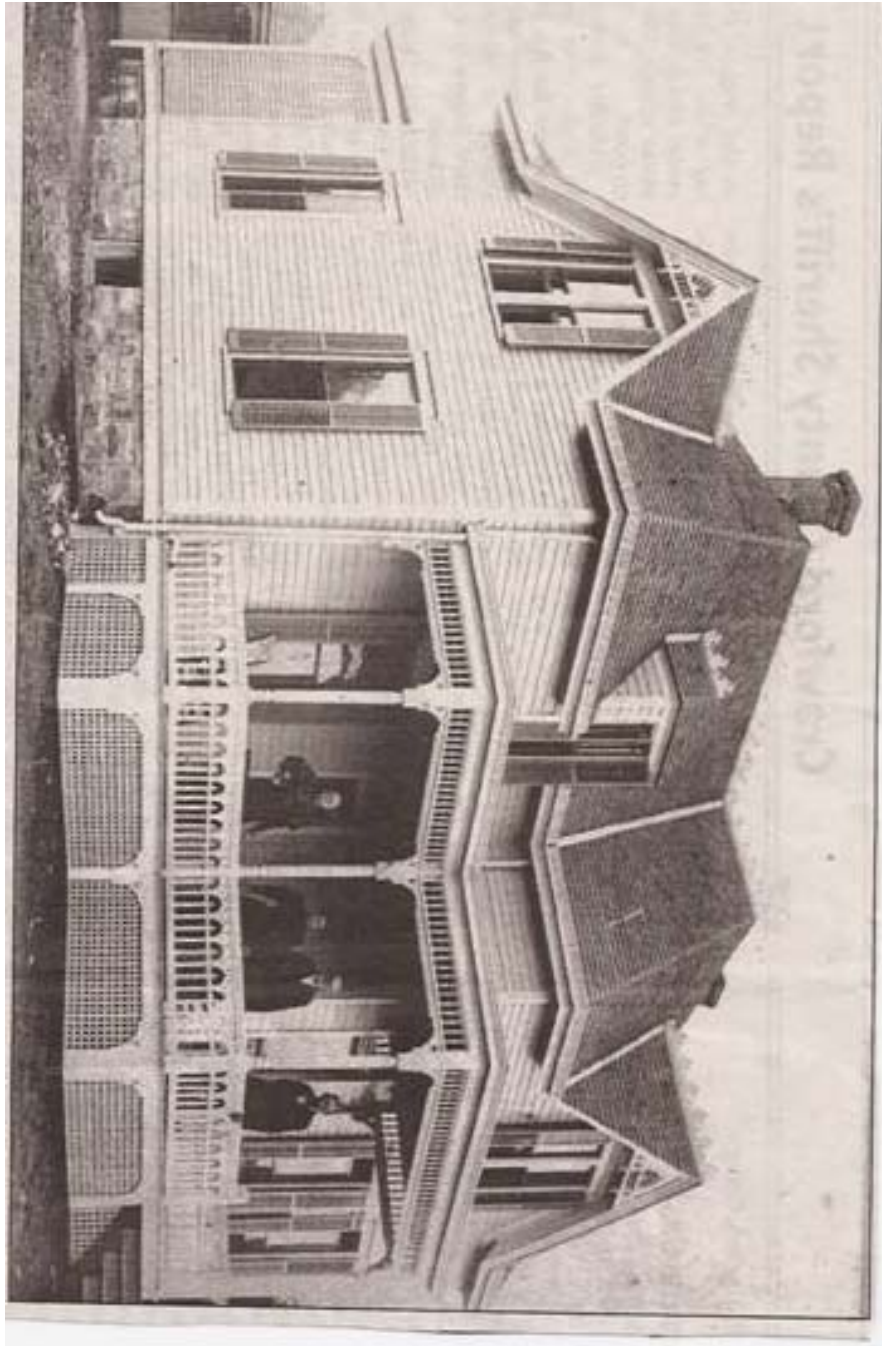
Inventory Form No. CRAS002-001

42. Further Description of Important Features The front has a full length porch with a balastrade and supported by turned posts. The entry is centered and has a window on each side. Above the porch is a gable wall dormer with a pair of 2/2 double hung windows and a vent above them. A wall dormer is also on the north elevation. The house is covered with aluminum siding. The left side of the house, beyond the porch, is an addition. See Continuation Sheet <input type="checkbox"/> 43. History and Significance See Continuation Sheet <input checked="" type="checkbox"/>
