National Register of Historic Places Registration Form

Historic name Downtown Smithville Historic District
 Other names/site number N/A
 Name of related Multiple Property Listing N/A

Street & number	<u>Roughly bounded by Bridge Street, Church Street, Commercial Street and Meadow Street</u>	<u>N/A</u>	<u>not for publication</u>
City or town	<u>Smithville</u>	<u>N/A</u>	<u>vicinity</u>
State	<u>Missouri</u>	Code	<u>MO</u>
County	<u>Clay</u>	Code	<u>047</u>
Zip code	<u>64089</u>

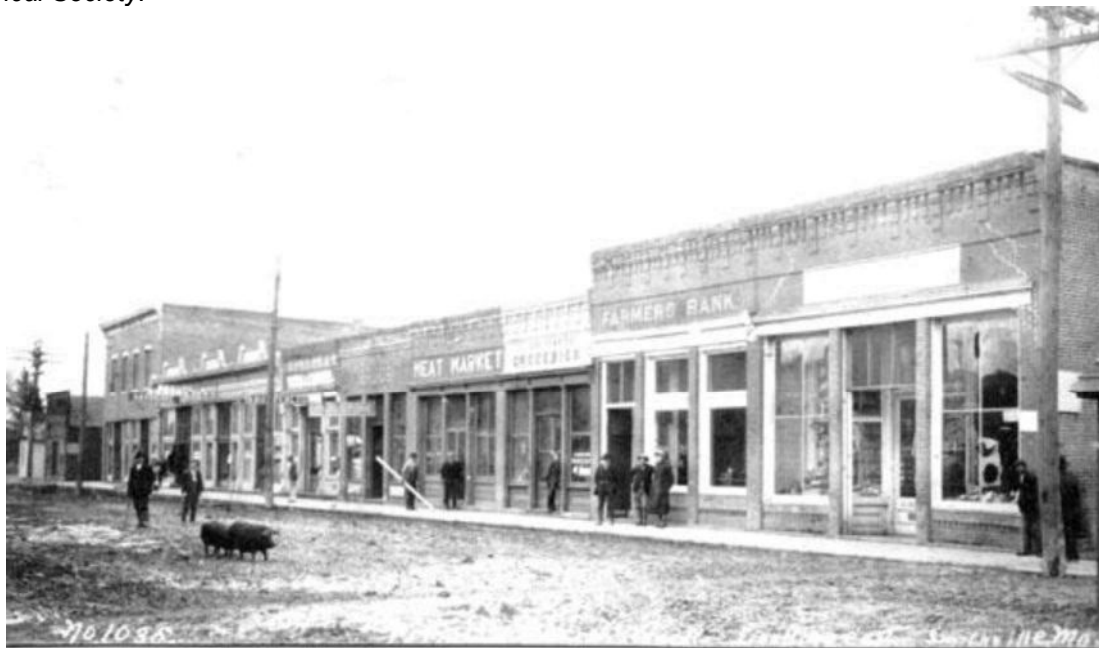
Figure 7: South side of the 100 block of East Main Street, n.d. View southeast. *Source: Smithville Historical Society.*

The disastrous flooding that had plagued the city from its earliest days continued well into the twentieth century. Damaging floods were recorded in 1915, 1947, and 1950, impacting the businesses in the commercial district (Figure 7), but the worst flood on record struck Smithville in 1965. In the commercial district, water rose as high as twelve feet, causing \$30 million in damages.³⁰ Numerous businesses closed after the flood, including three grocery stores, a feed store, a general store, a hardware store, a candy store, a chicken hatchery, the Ford dealership, and a gas station.³¹ Some of these businesses relocated to the commercial district developing at a higher elevation along Highway 169, where they could not only avoid future flooding but also take advantage of increased automobile traffic.³²

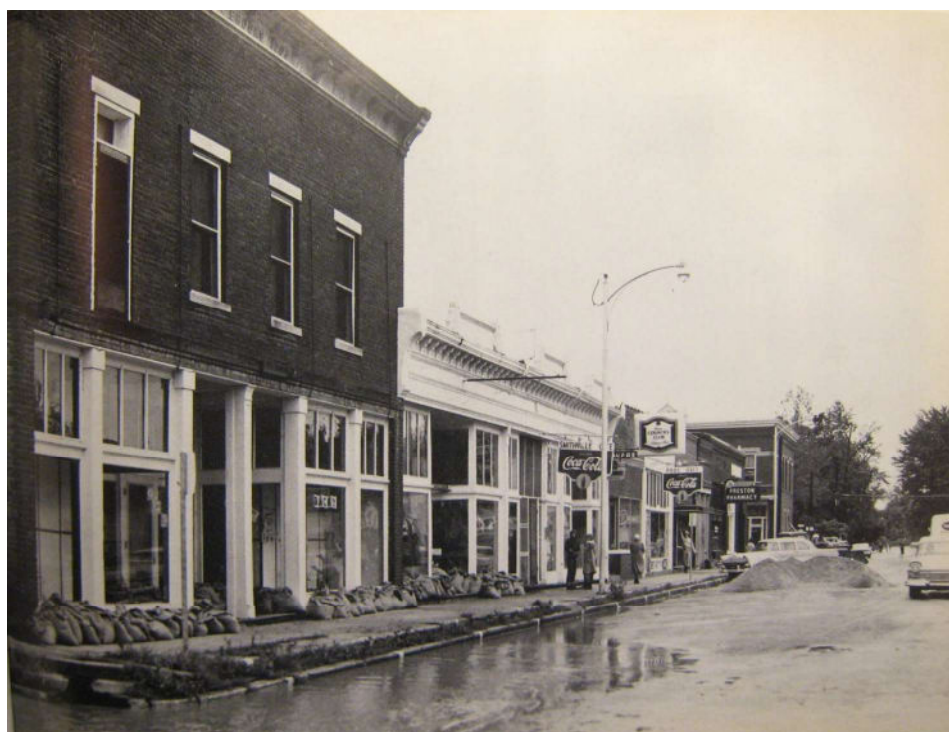
Figure 8: South side of the 100 block of East Main Street after a flood, c. 1950. View southwest. *Source: A Pictorial History of Smithville.*

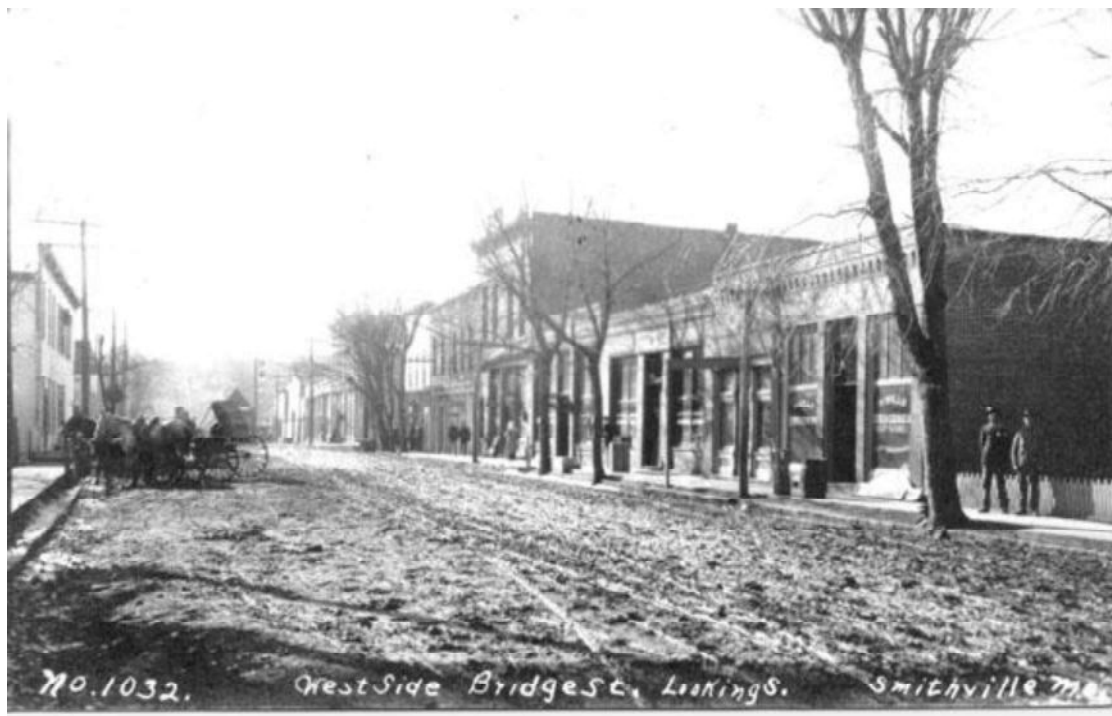
Figure 9: West side of the 100 block of North Bridge Street, n.d. Source: *Smithville Historical Society*.

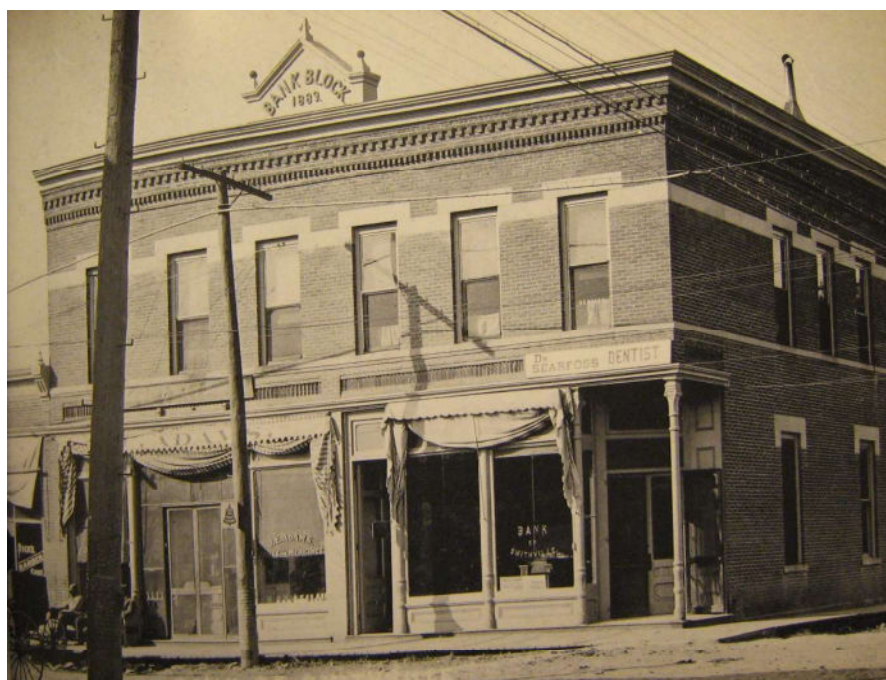
Figure 10: 104 South Bridge Street (Bank Block building), n.d. Source: *A Pictorial History of Smithville*.
