MISSOURI HISTORIC PROPERTY INVENTORY FORM

REFERENCE NUMBER		A. HISTORIC NAME Alfred Haseltine House							
B. COUNTY [077]		C. OTHER NAME(S)							
D. ADDRESS Haseltine Rd.				E. CITY Springfield			F. VICINITY G. RESTRICTED <input checked="" type="checkbox"/>	H. ACREAGE

The Alfred Haseltine house is the third of three houses along the east side of Haseltine Road at Haseltine Station, proceeding south from the railroad tracks. This first was the home of Spurgheim Ira Haseltine (not extant; see site map and old photo). The second was the home of Edwin Ira Haseltine, first son of Spurzheim (not extant; see site map and old photo). Alfred was Spurgheim's second son, and his house was the third in the row.

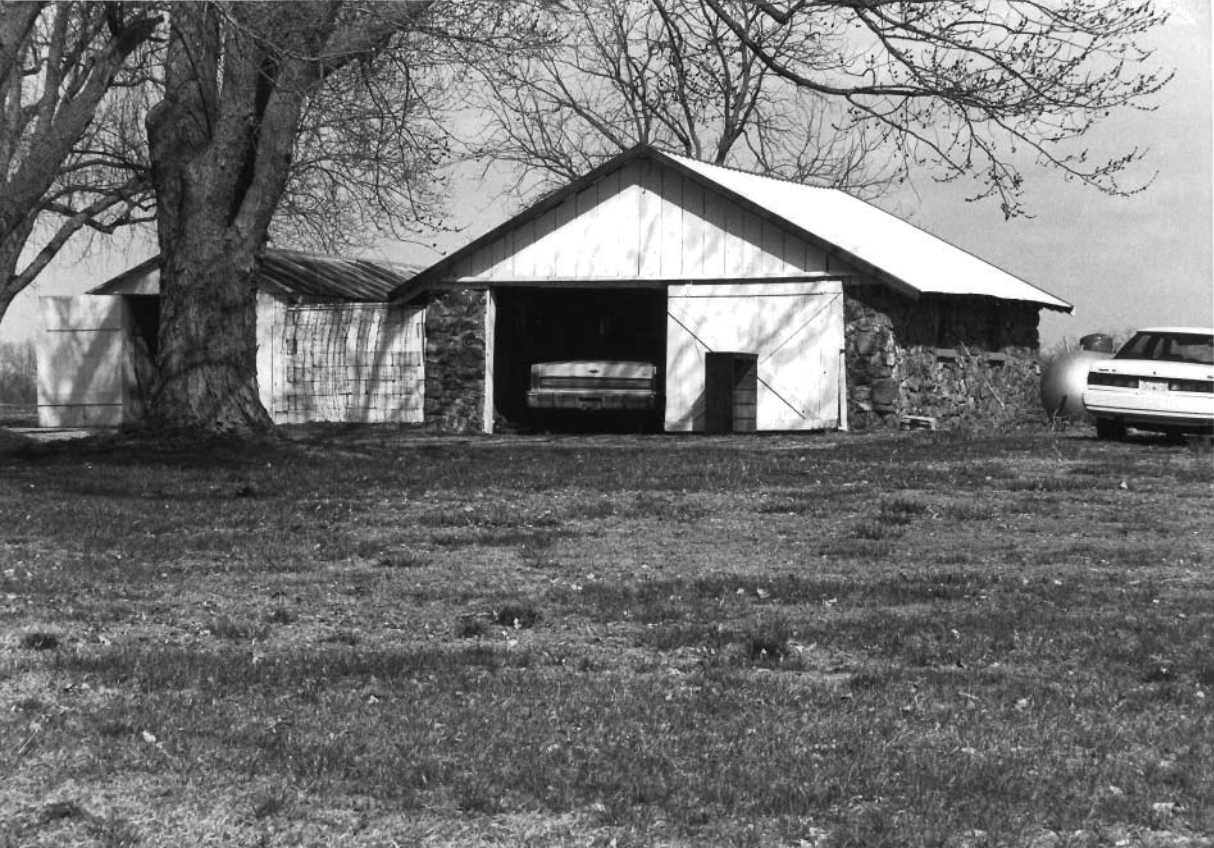
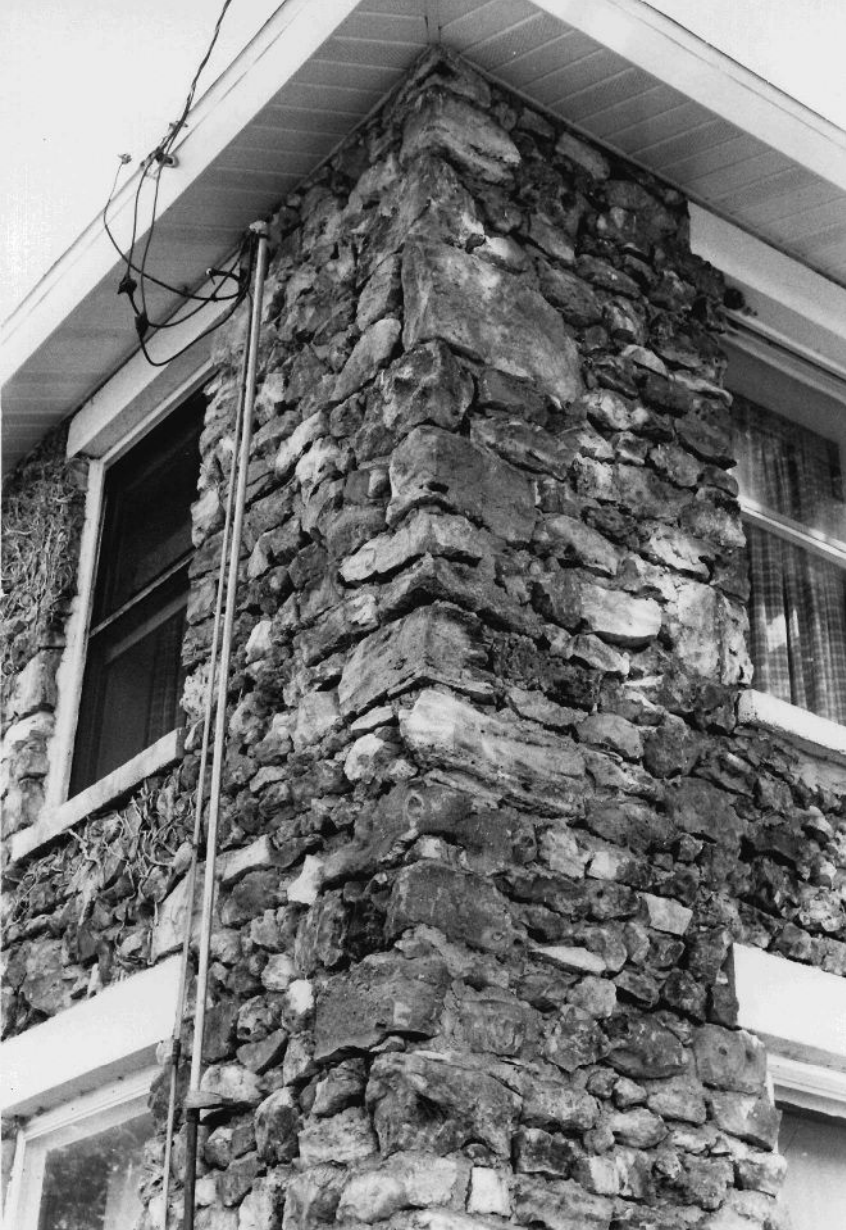
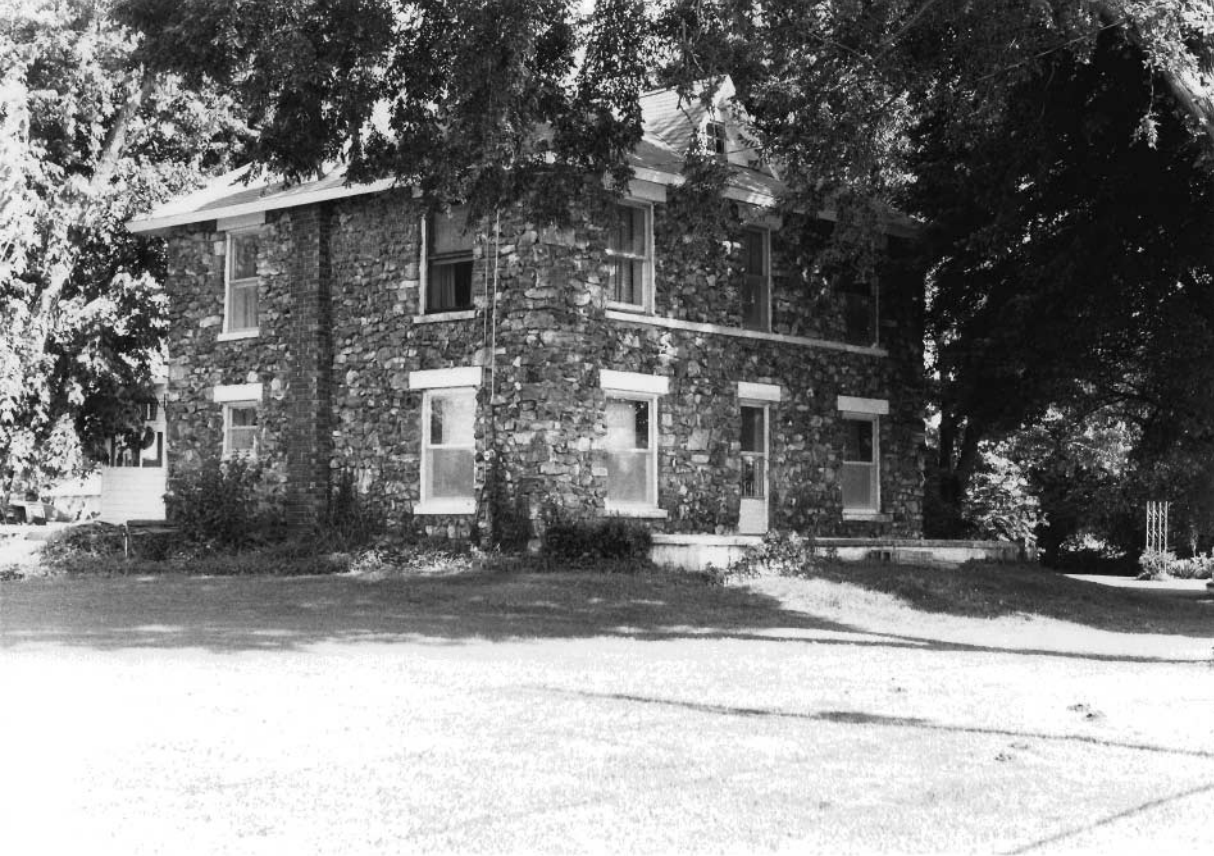
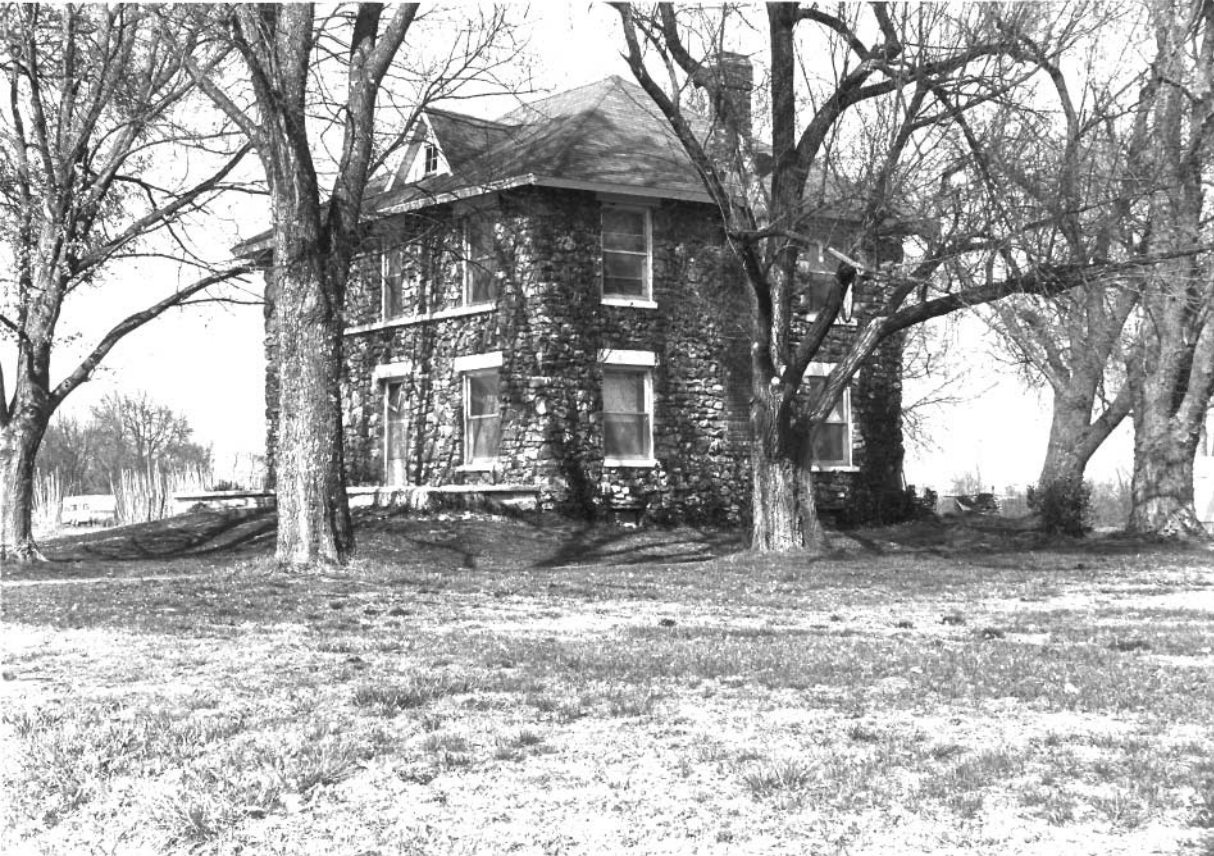
The Alfred Haseltine house is of rubblestone laid in forms, possessing an intentional rusticated appearance quite unlike those of his elder brother and father to the north of him. Though dates of none of the three are ascertained, Alfred's style suggests a generational shift in taste toward the twentieth century and away from the old-fashioned vernacular classicism of the earlier two.

Ancillary structures: These include a stone pump house and well house. While both are rubblestone, the mortaring is different from the house and suggests much later construction.

Integrity: All structures are pristine.

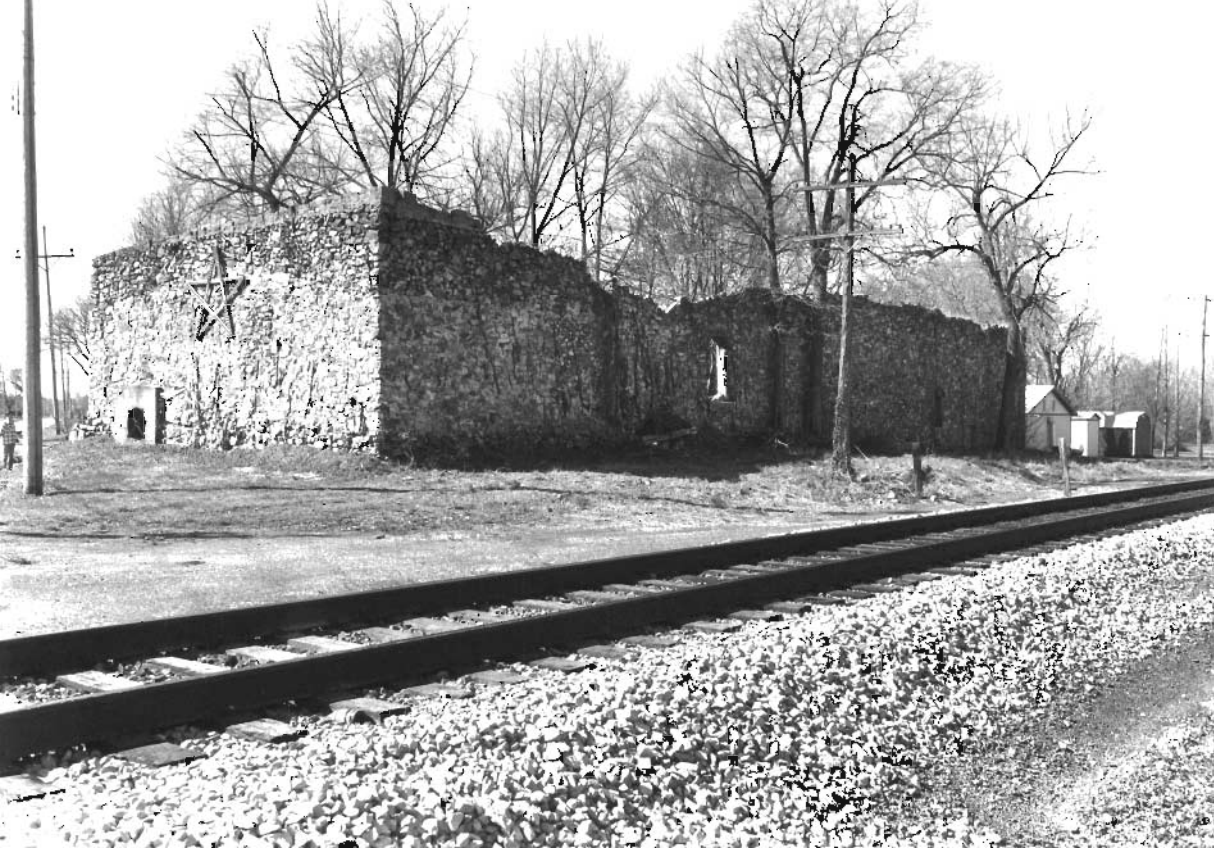
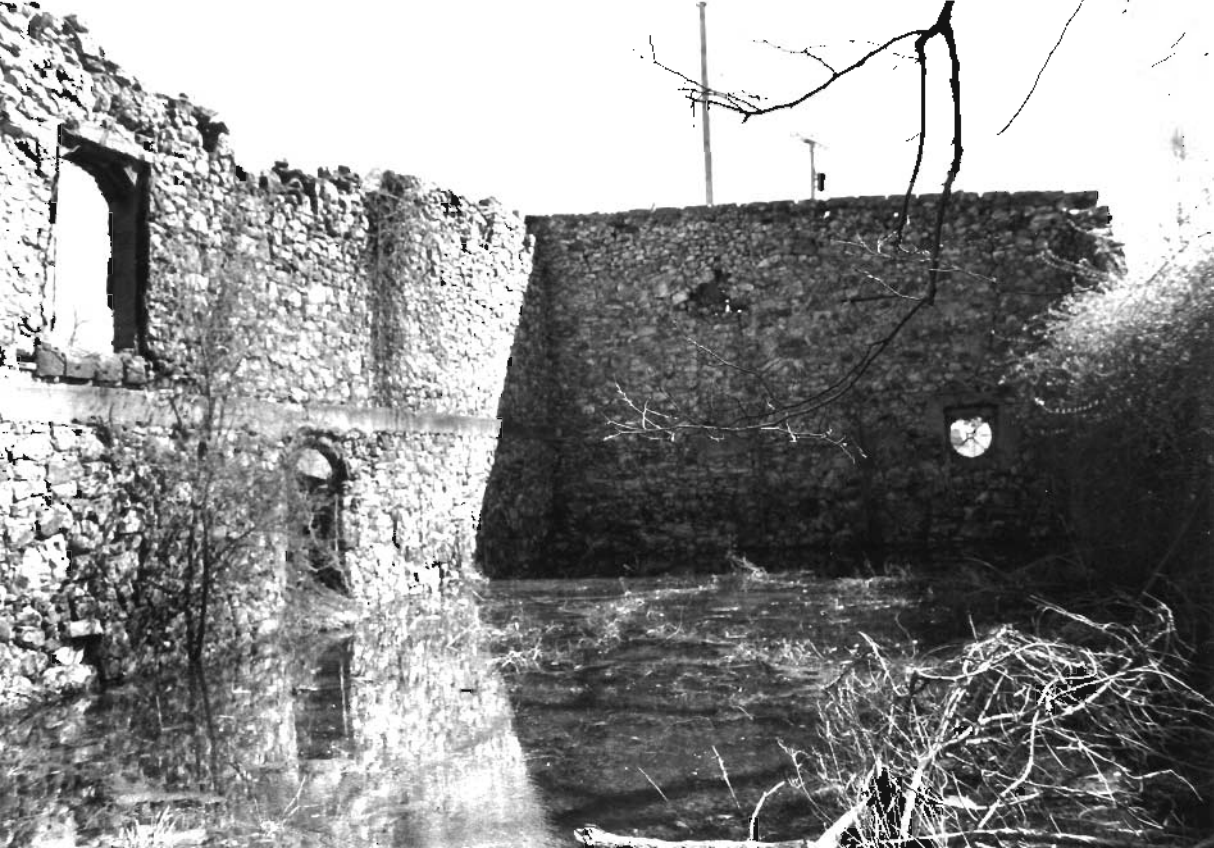
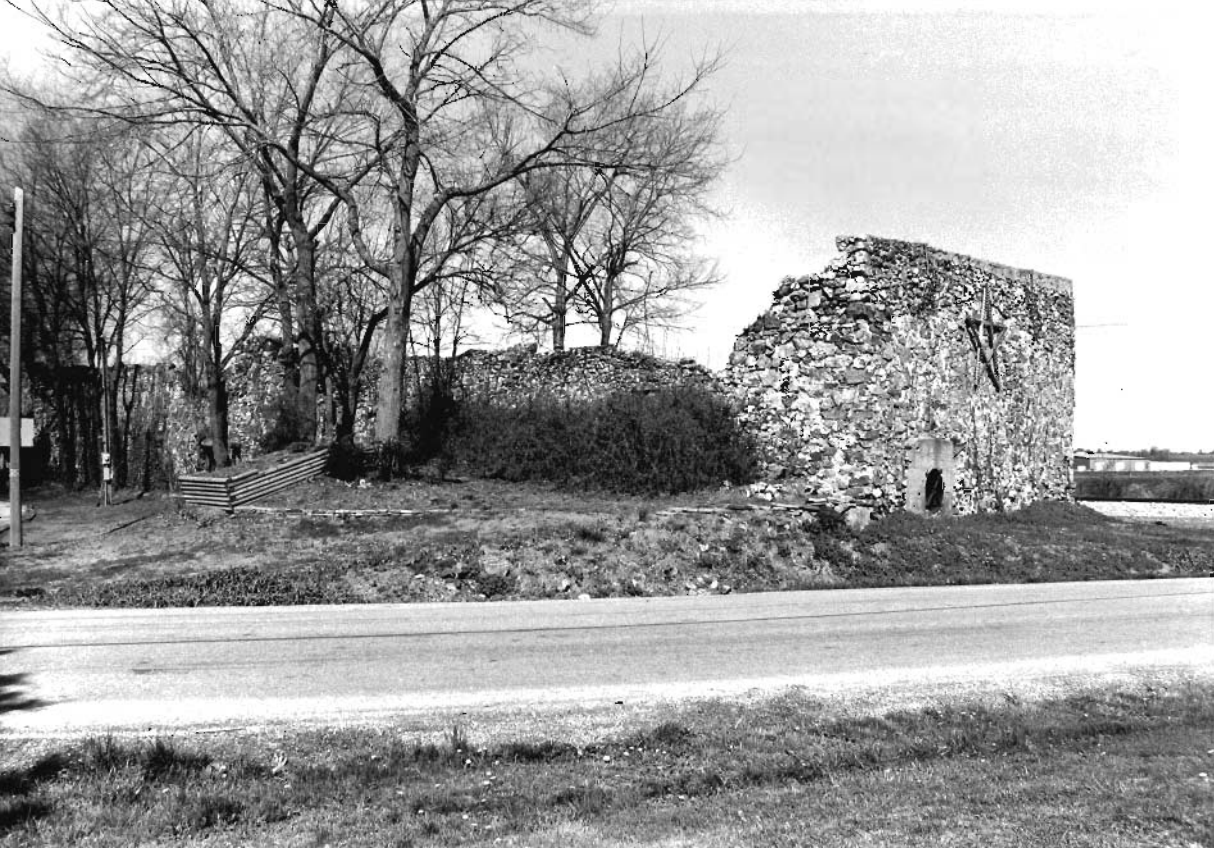
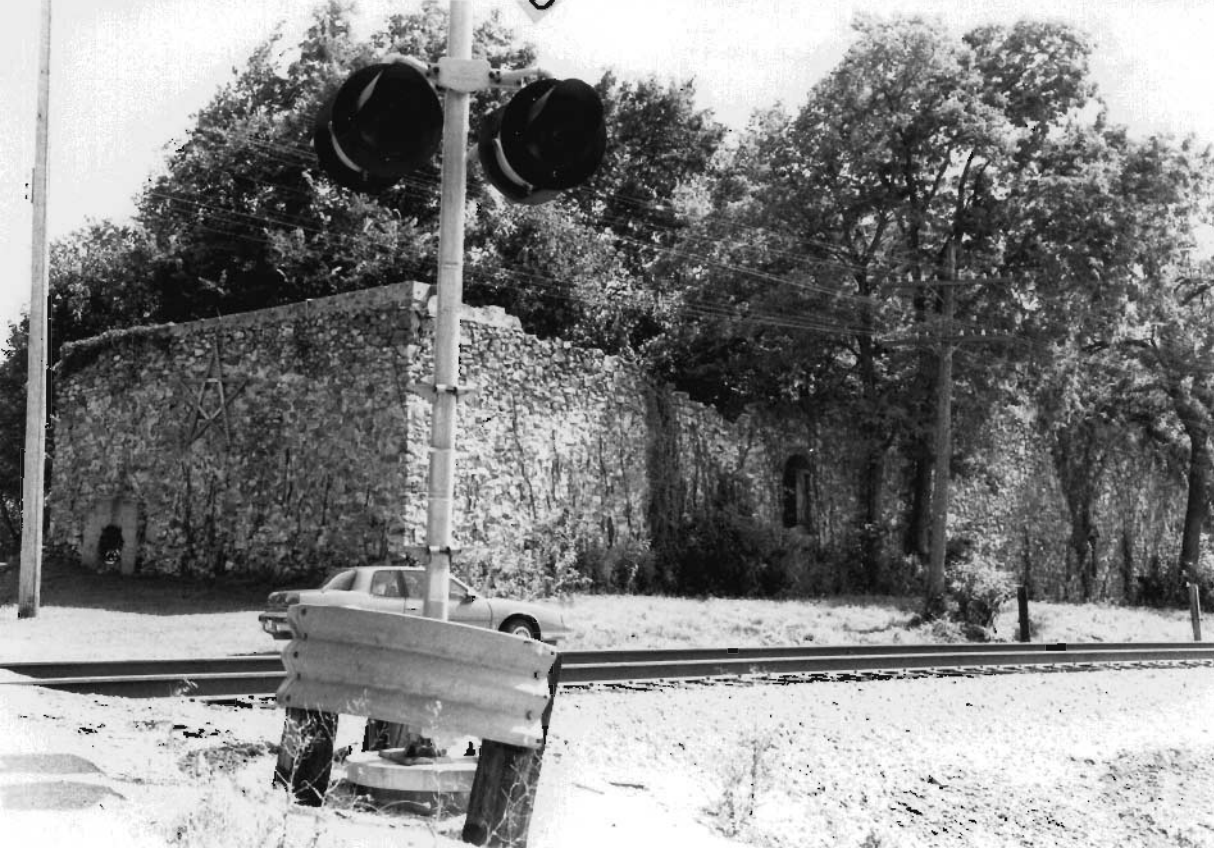
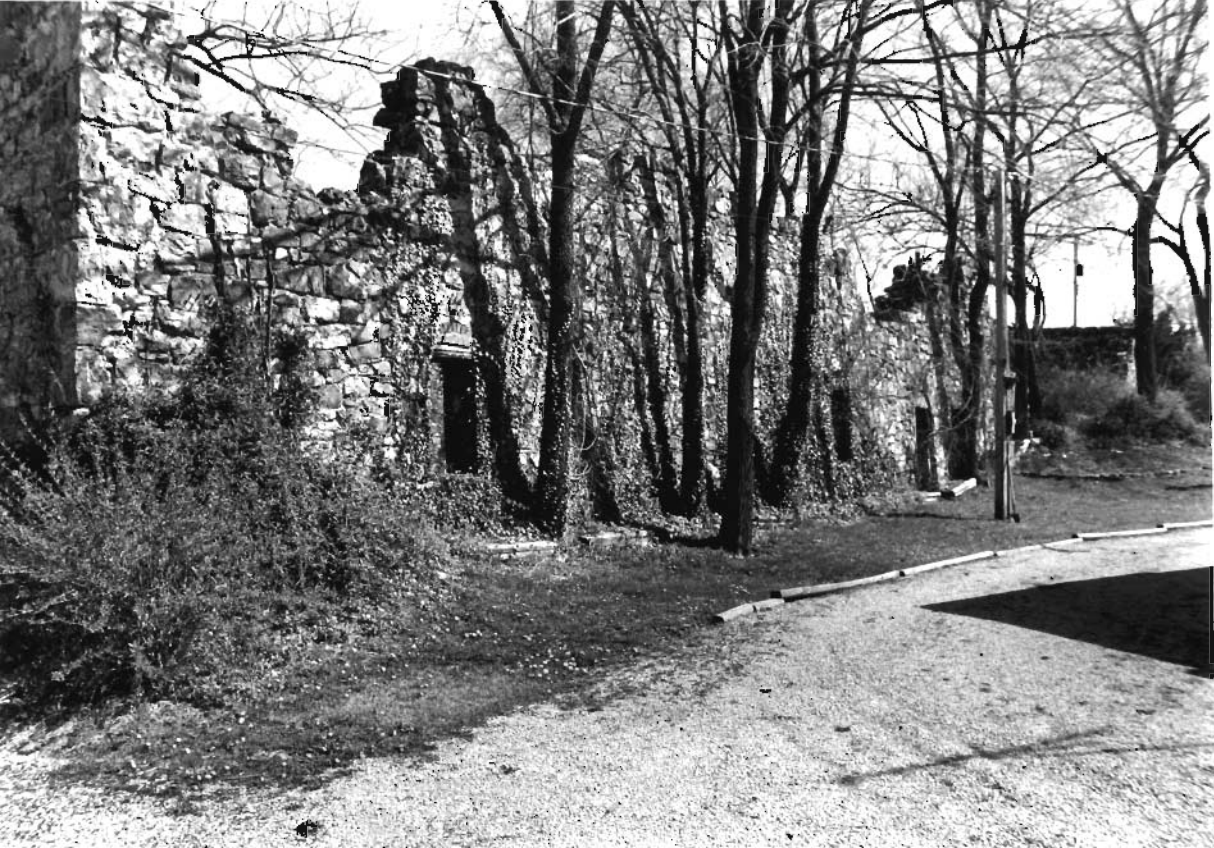
2.X. The Shipping Shed burned at a time as yet not ascertained. Only the walls remain; and they are somewhat deteriorated.

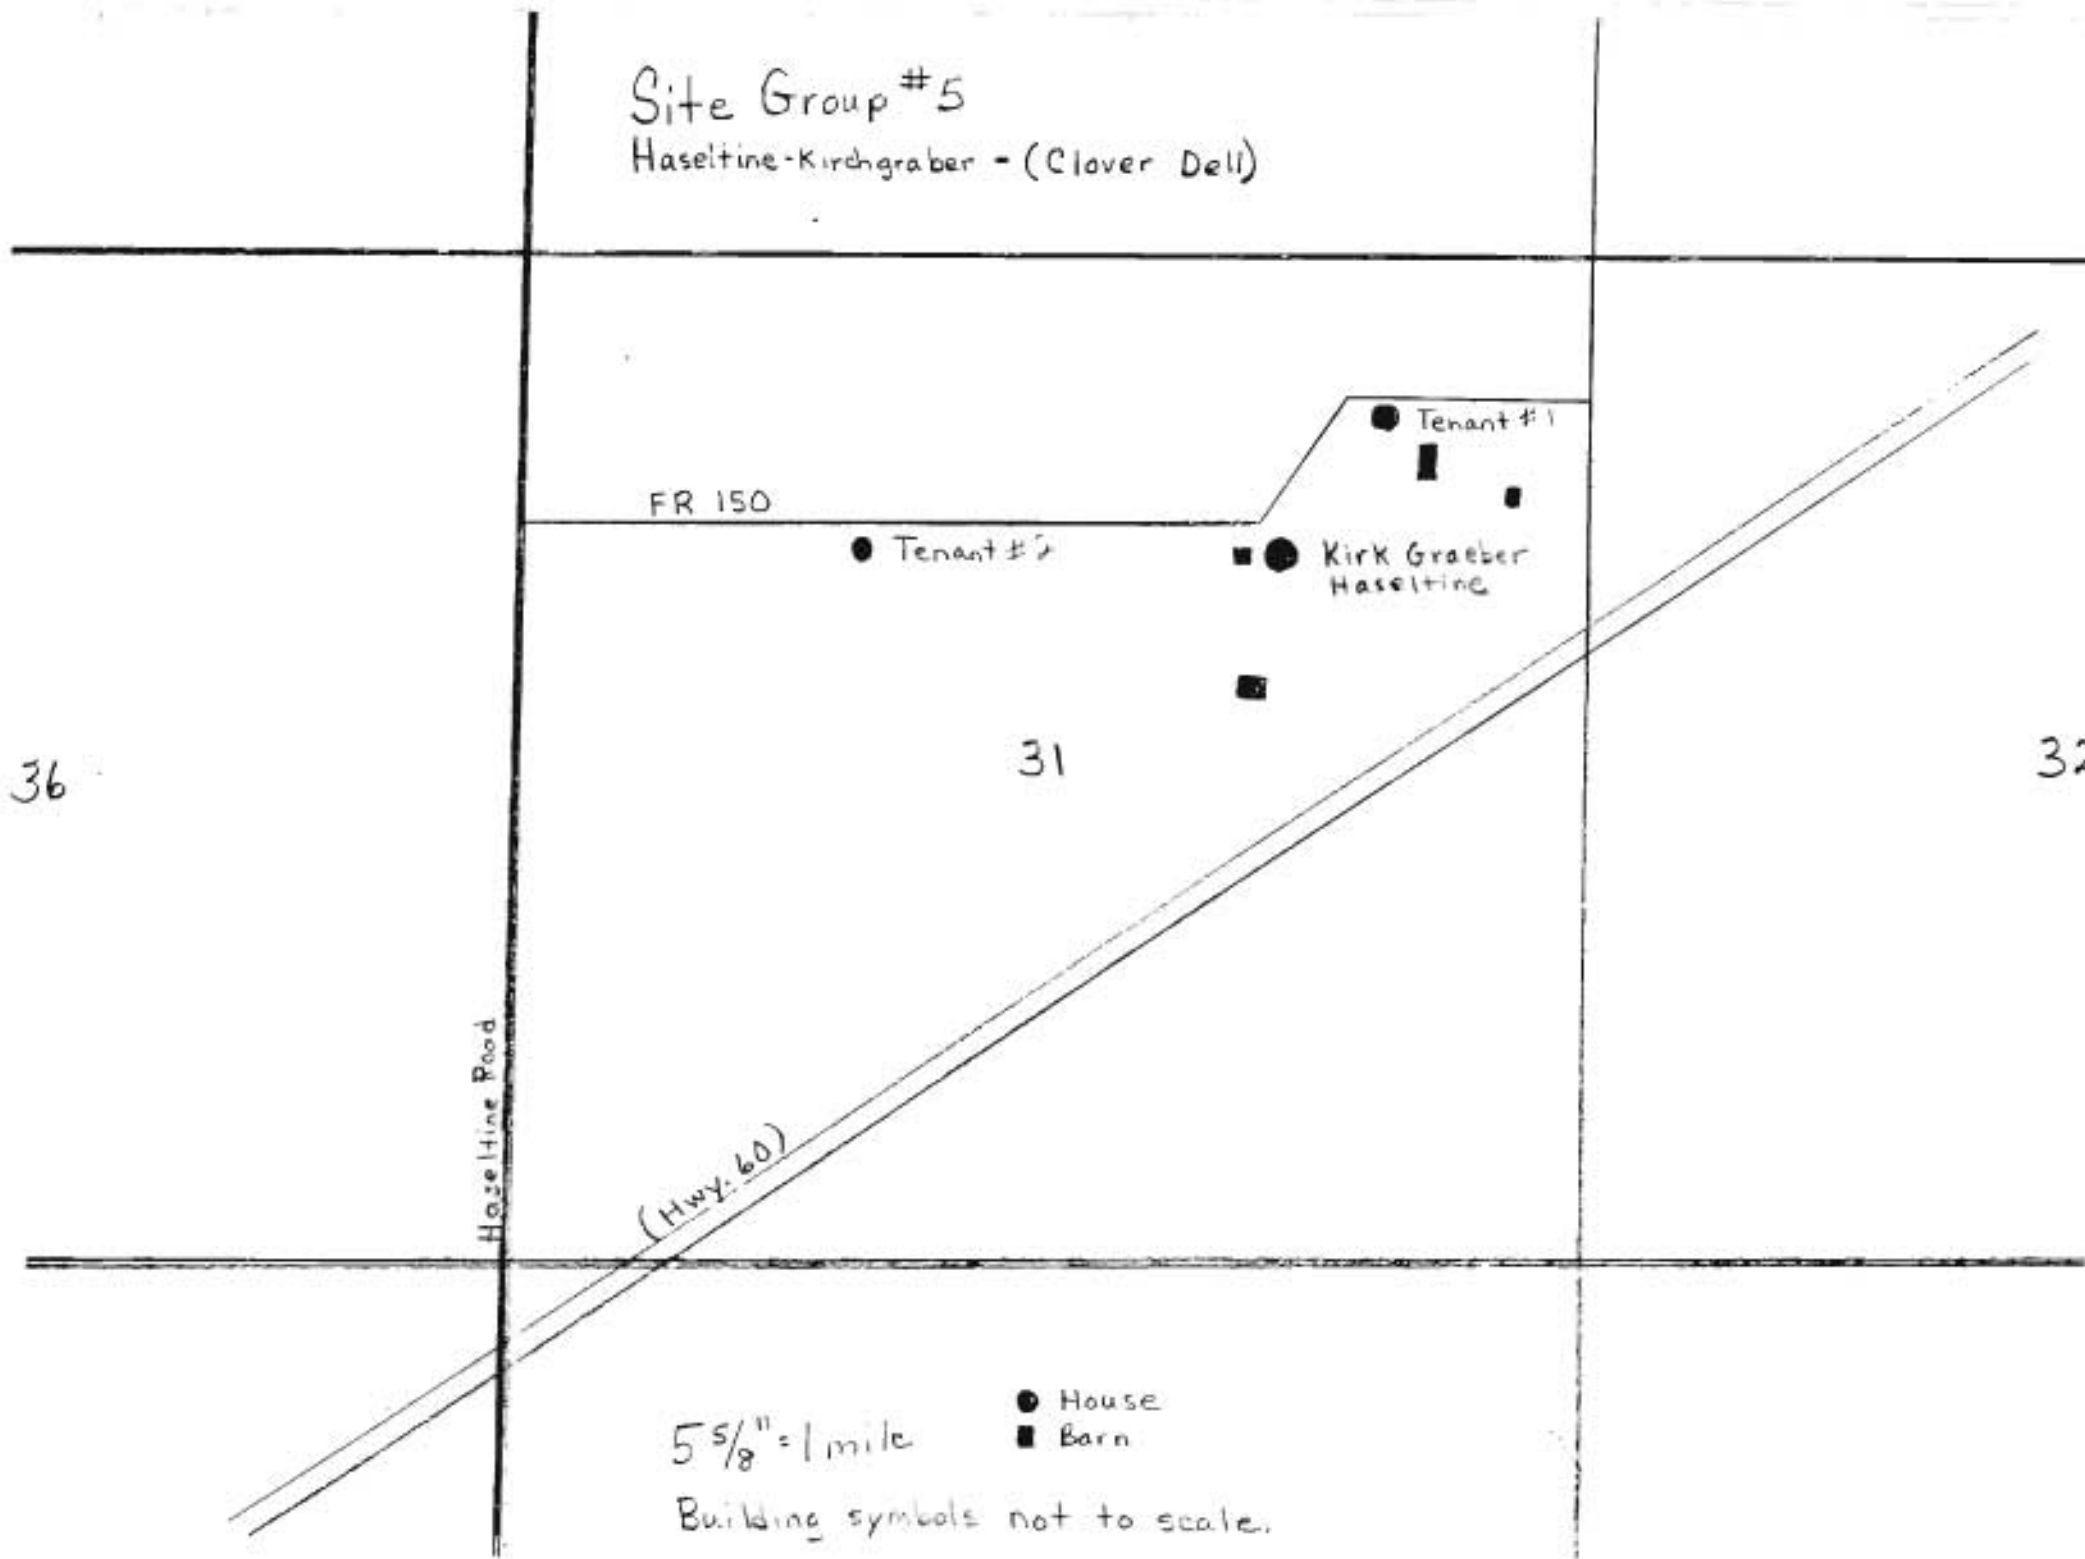
Site Group #5
Haseltine-Kirchgraber - (Clover Dell)

2.Y. The house fronts on a lane, now closed, which provided access. It was surrounded by lawns and gardens, a pride of Mrs. K.G. Haseltine. Ancillary structures are a garage of matching stone construction, and a gardening shed. Outside the grounds, the house was surrounded on all sides by orchards. The brush and orchard fire of 1953 spared the house, both because the grounds provided a buffer, and because fire fighters arrived in time to give further protection.

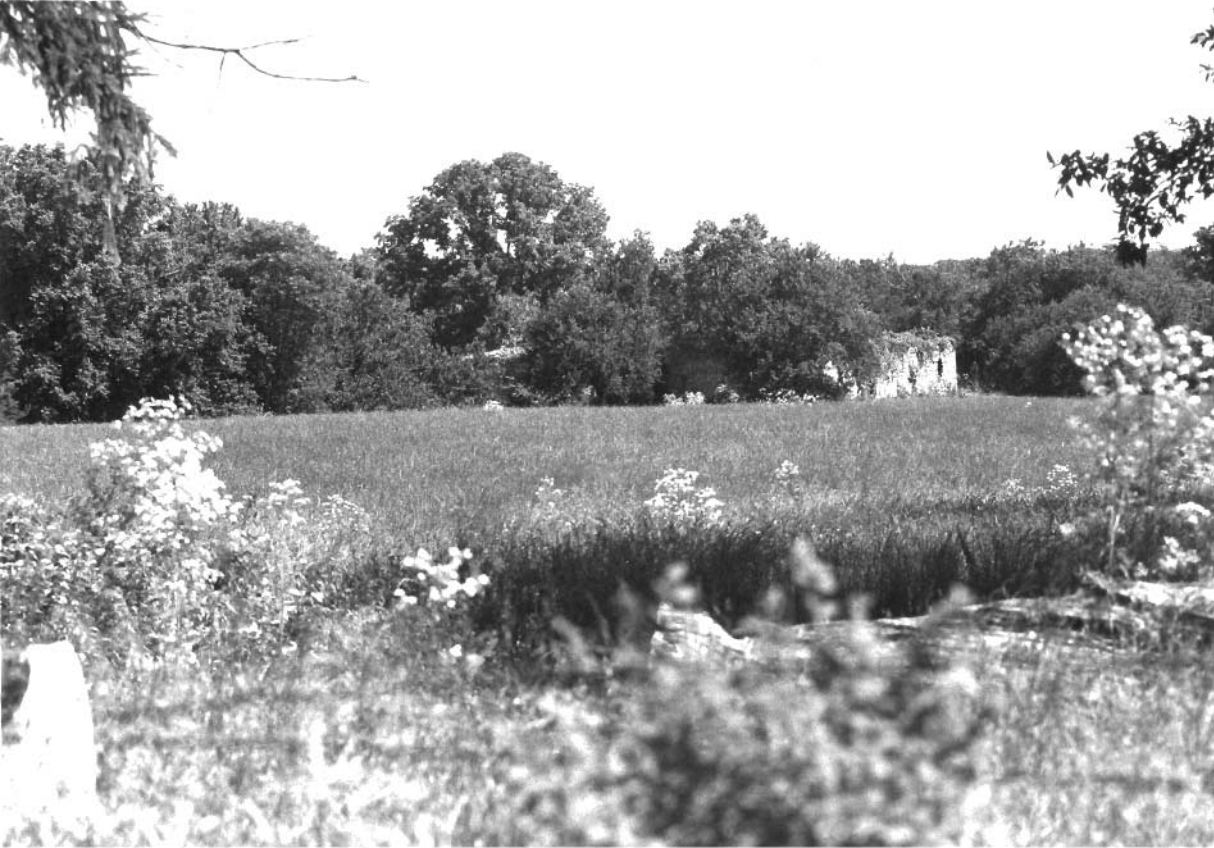
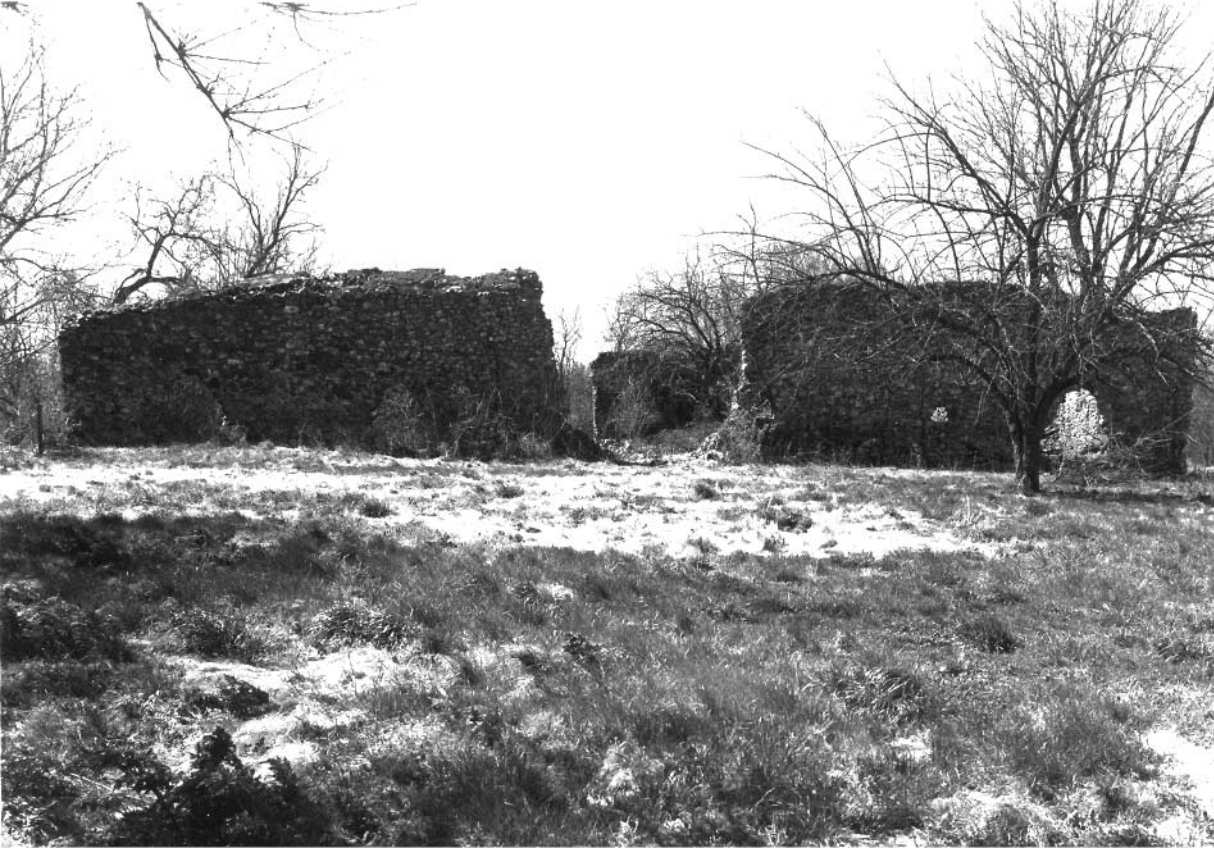
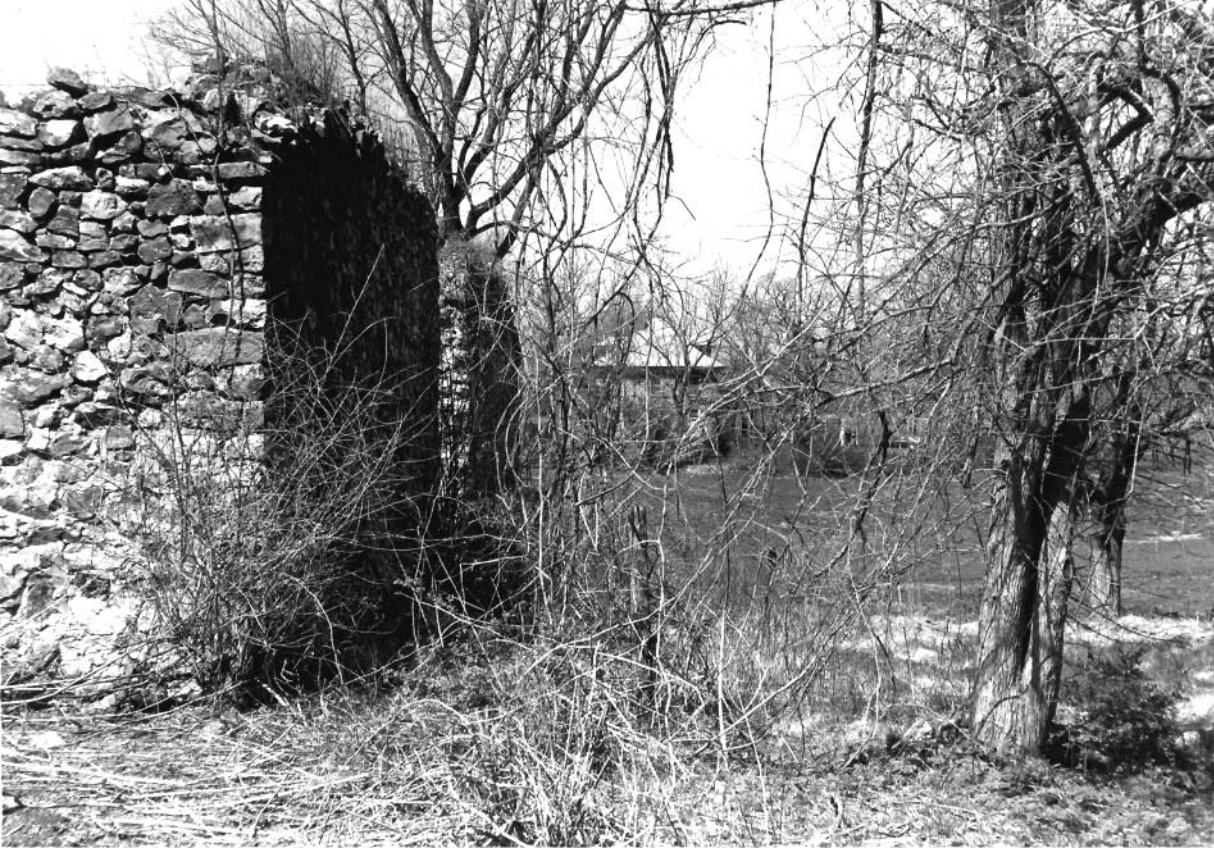
This barn, located east of the house some two hundred yards, is the largest of the Haseltine apple barns, being 75' x 75'. It is also the most deteriorated. It seems to have been the earliest to burn, based on the advanced wall decay. Located as it is away from the section line roads, it must be presumed to have been located convenient to the apple trees whose fruit it was to store.

2.X. The barn had a ground floor and two wooden floors above, like the Spurzheim barn. The walls are full double construction with ca. six inch air space between. They are rubblestones laid up in forms, giving the very rough walls an entirely smooth plane at their outer surface, and square, straight corners.

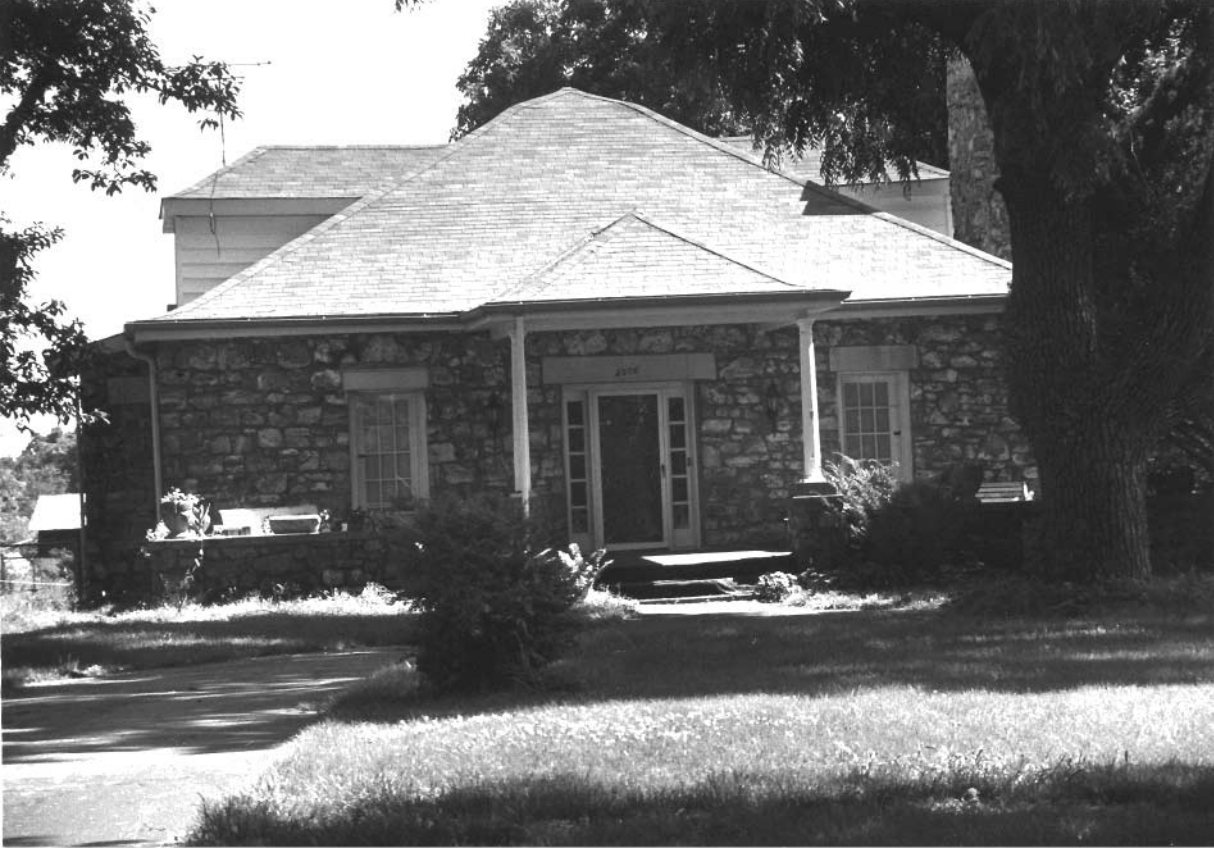
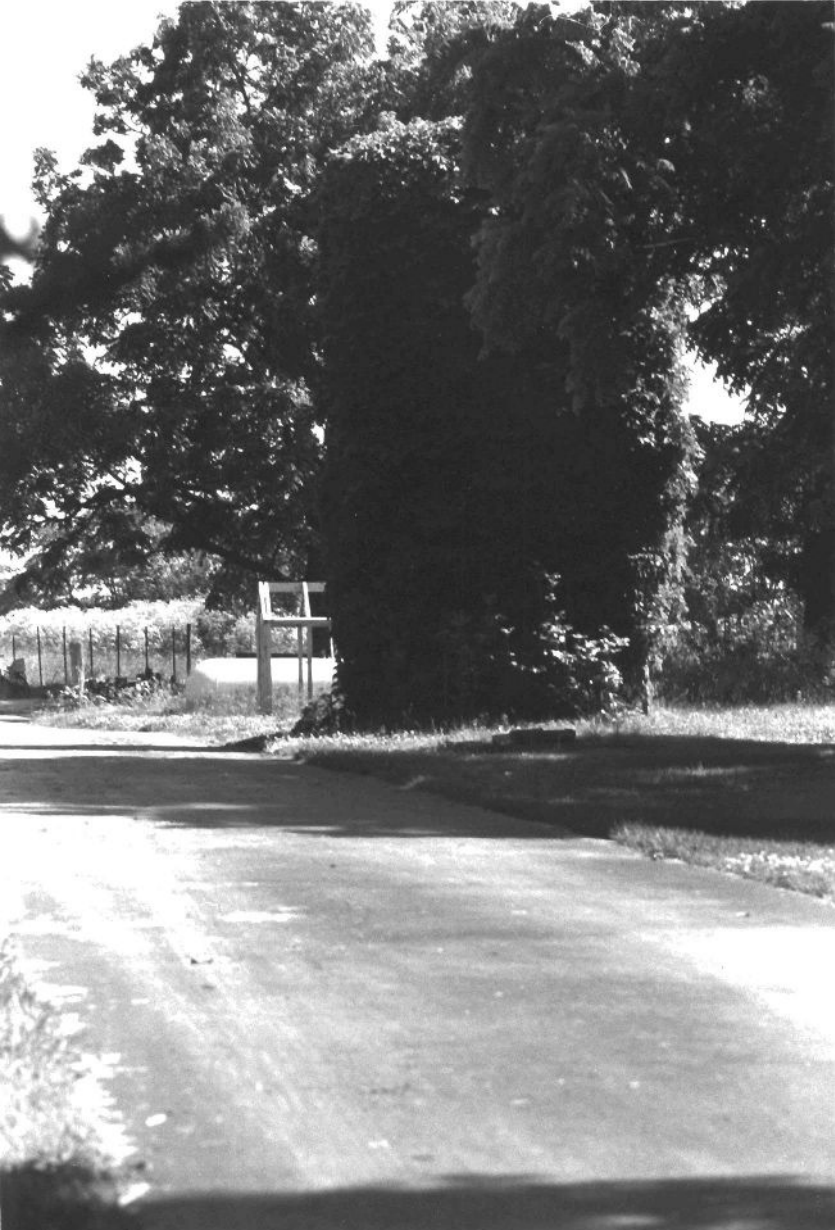
The house is rusticated limestone laid in ashlar. Its formal central bay porch and side-lighted front door have a 1910's to 1920's look about them. Compared to Uncle Alfred's house at Haseltine Station, it is the same three-bay configuration but with refinements that might be expected in the third generation of such a family as the Haseltines.

The original second story of this house burned at a date not yet ascertained. The remodeling yielded the house seen in the present photos.

Ancillary structure: Across the driveway to the west is a rusticated stone water tower. It is one of four such water towers associated with historic Haseltine dwellings.

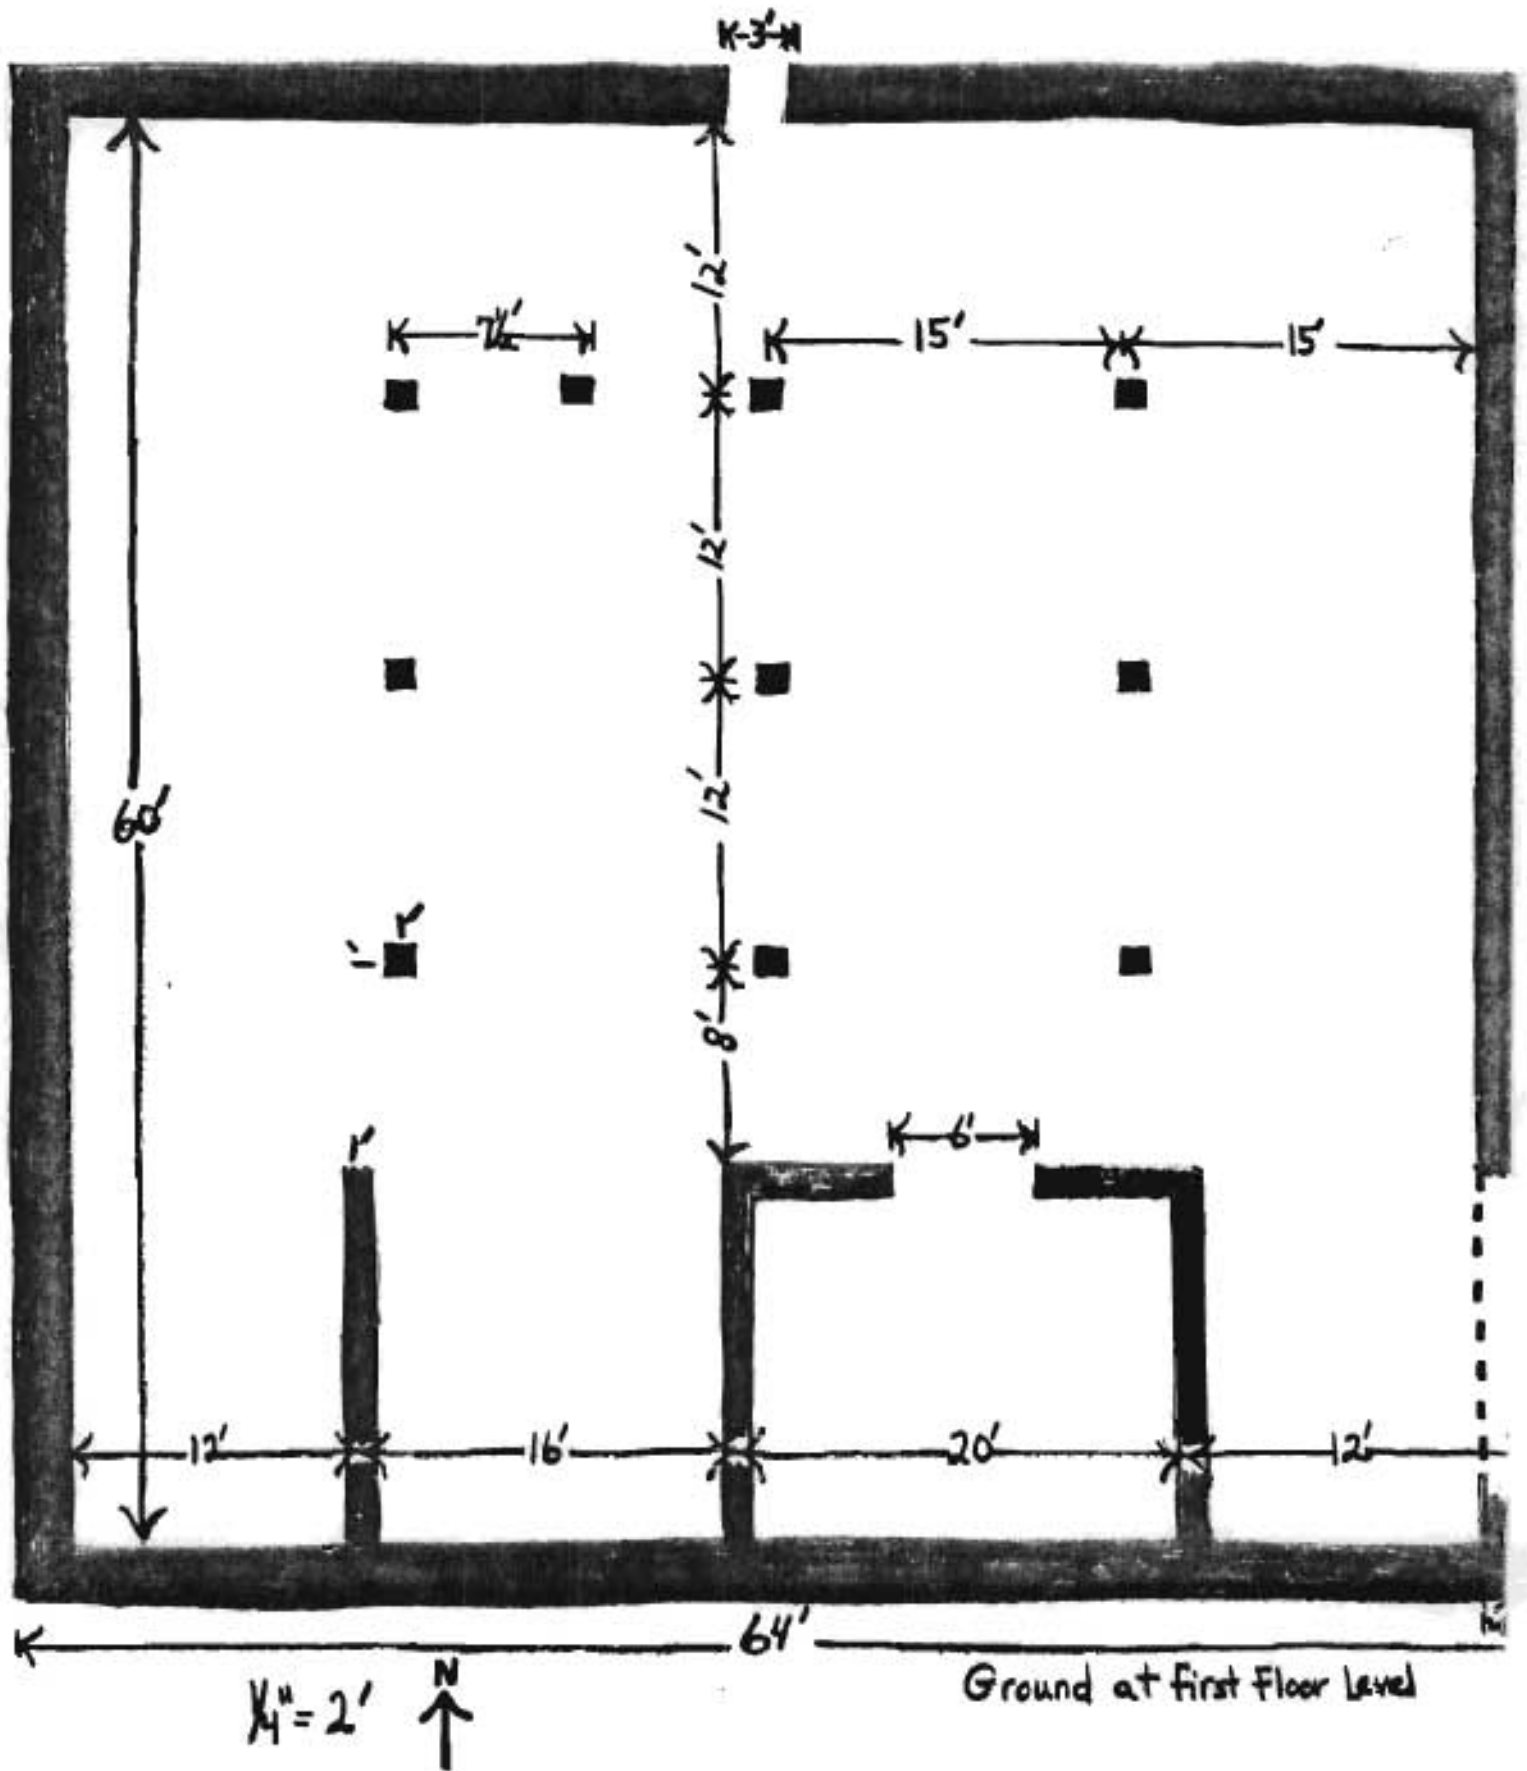
1 Spurgheim Haseltine Orchard
 Ground Level Floor Plan-Spurgheim's Orchard Barn

The unreinforced, cement-and-stone aggregate walls are in an advanced state of decay, though they still support a roof which itself is in an advanced state of deterioration.

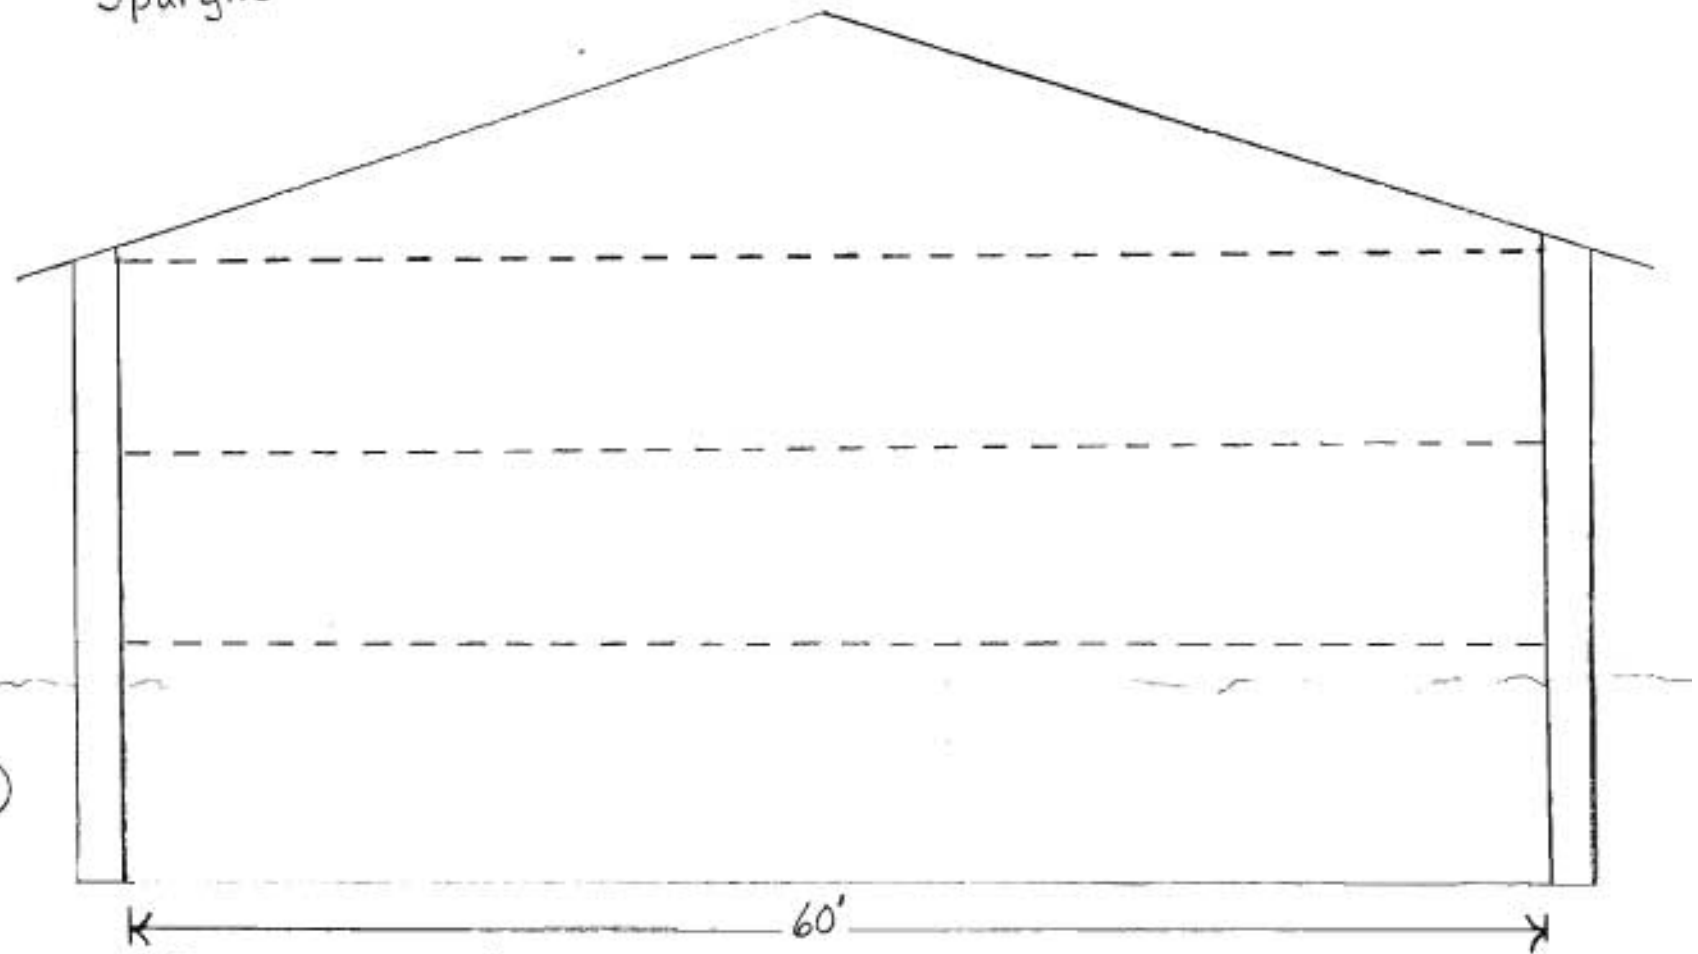
Spurgheim's Orchard Barn, north facade elevation.
