MISSOURI HISTORIC PROPERTY INVENTORY FORM

REFERENCE NUMBER		A. HISTORIC NAME Alfred Haseltine House							
B. COUNTY [077]		C. OTHER NAME(S)							
D. ADDRESS Haseltine Rd.				E. CITY Springfield			F. VICINITY G. RESTRICTED <input checked="" type="checkbox"/>	H. ACREAGE

The Alfred Haseltine house is the third of three houses along the east side of Haseltine Road at Haseltine Station, proceeding south from the railroad tracks. This first was the home of Spurgheim Ira Haseltine (not extant; see site map and old photo). The second was the home of Edwin Ira Haseltine, first son of Spurzheim (not extant; see site map and old photo). Alfred was Spurgheim's second son, and his house was the third in the row.

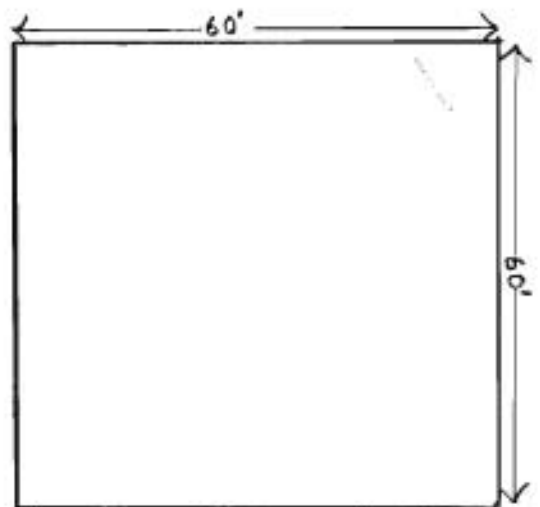
4-story Apple Storage Shed

The Spurgheim Haseltine barn is the only one of the five barns which has not burned. Its interior is significant therefore as a guide to the probable interior arrangements of the other barns, especially the two whose walls suggests a strong design similarity to this one. Unlike the others, its walls are formed concrete. However, the quantity of stone aggregate is so great in relation to the cement, and the size of many pieces so large, as to give at first an impression of the wall being stone laid in mortar. No reinforcing was used, making the tall, heavy slabs unstable when bereft of their interior timber bracing as they are now coming to be. They are, and were, especially vulnerable to water damage.

The unreinforced, cement-and-stone aggregate walls are in an advanced state of decay, though they still support a roof which itself is in an advanced state of deterioration.

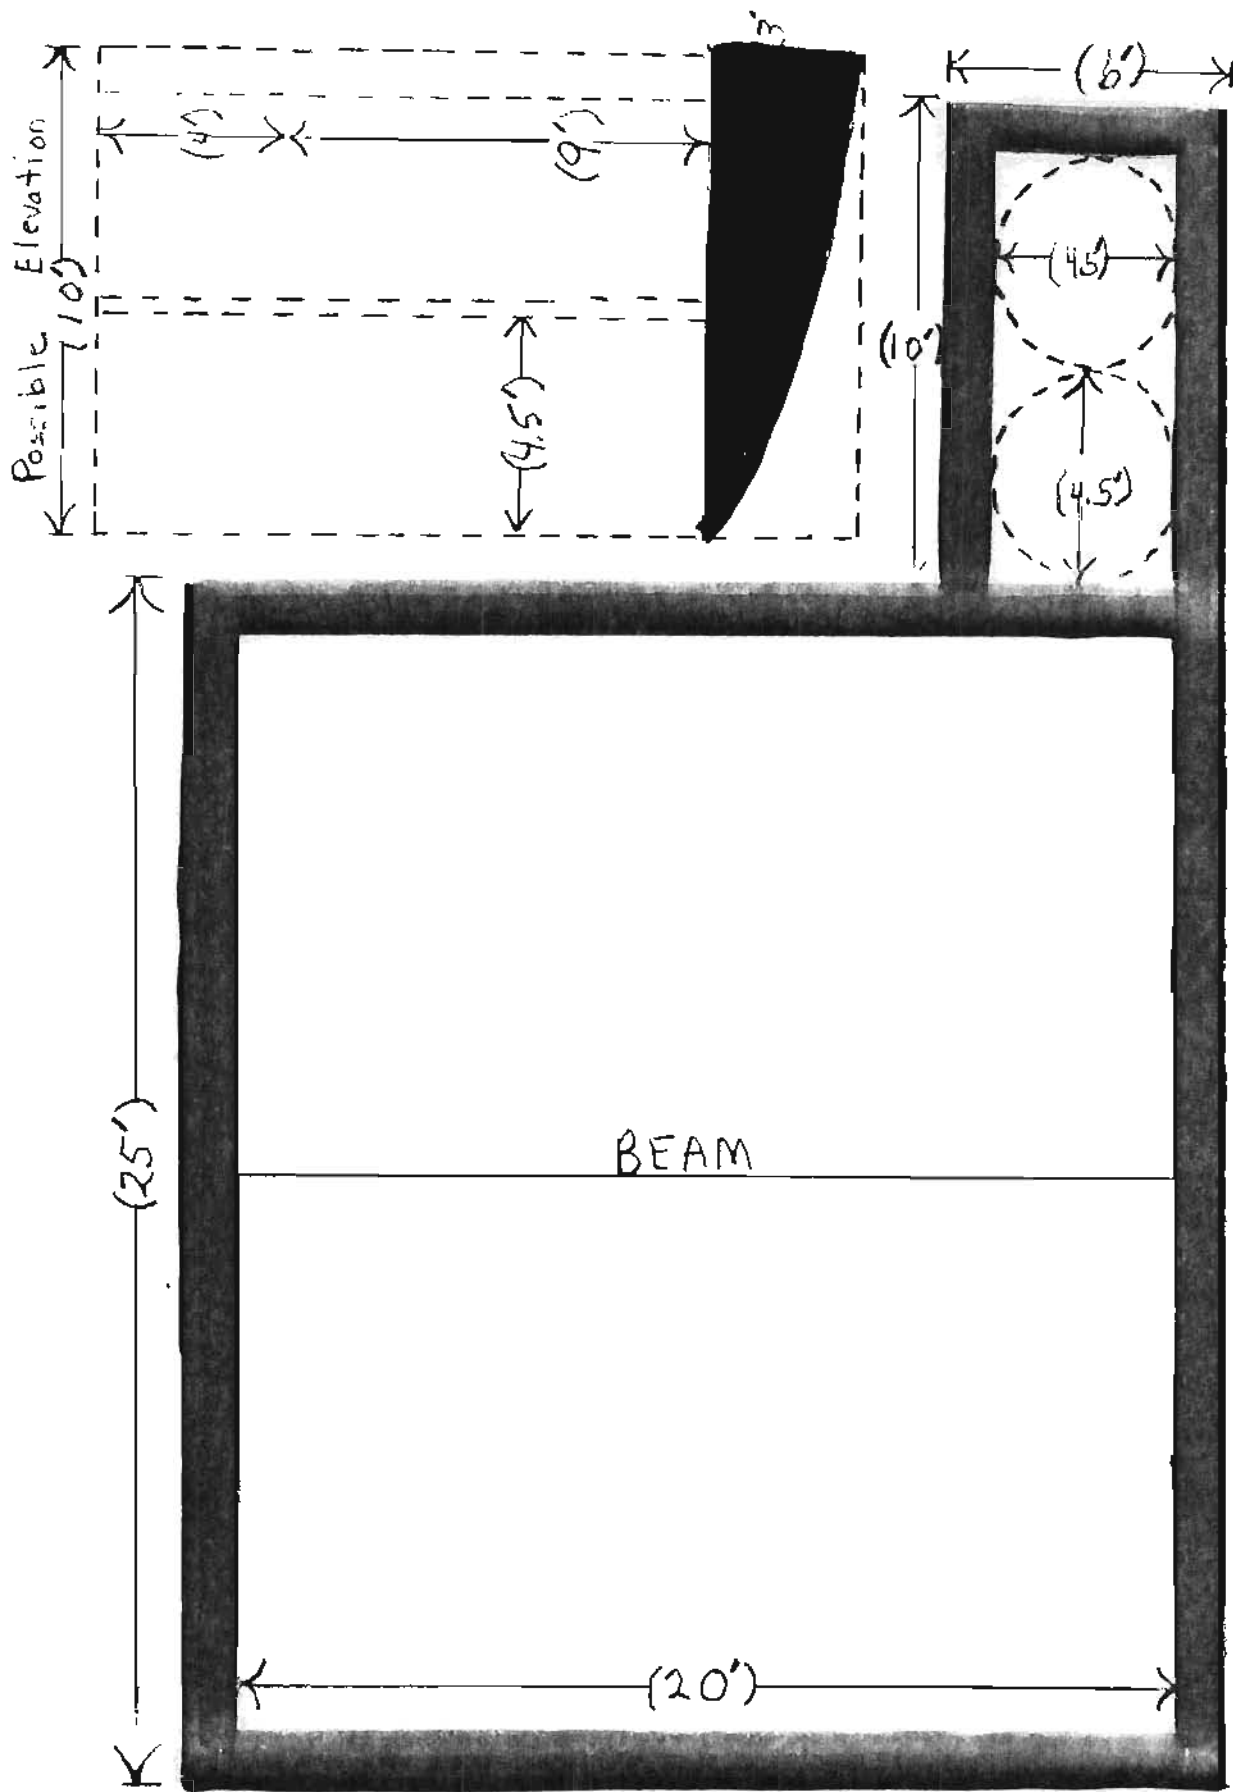
#1 Spurgheim Ira Haseltine Orchard
Cider Shed

REFERENCE NUMBER	A. HISTORIC NAME	B. COUNTY	C. ADDRESS
	Spurgheim Haseltine Cider Shed	Greene	Springfield, MO
<p>2.X. The structural condition of this building is similar to that of the barn. However, being much smaller, and the walls being thus less heavy, their structural integrity is better. The impression of impending total collapse is not so great as that of the barn.</p>

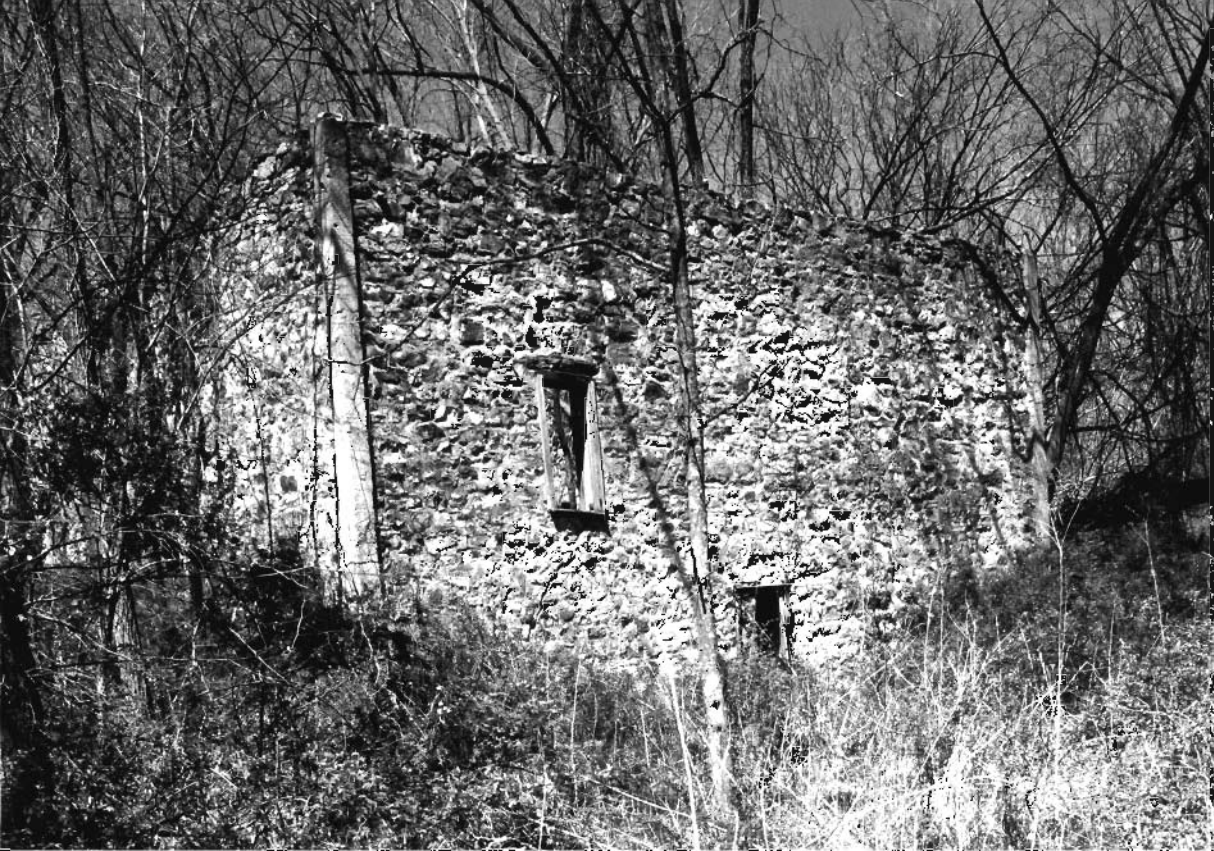
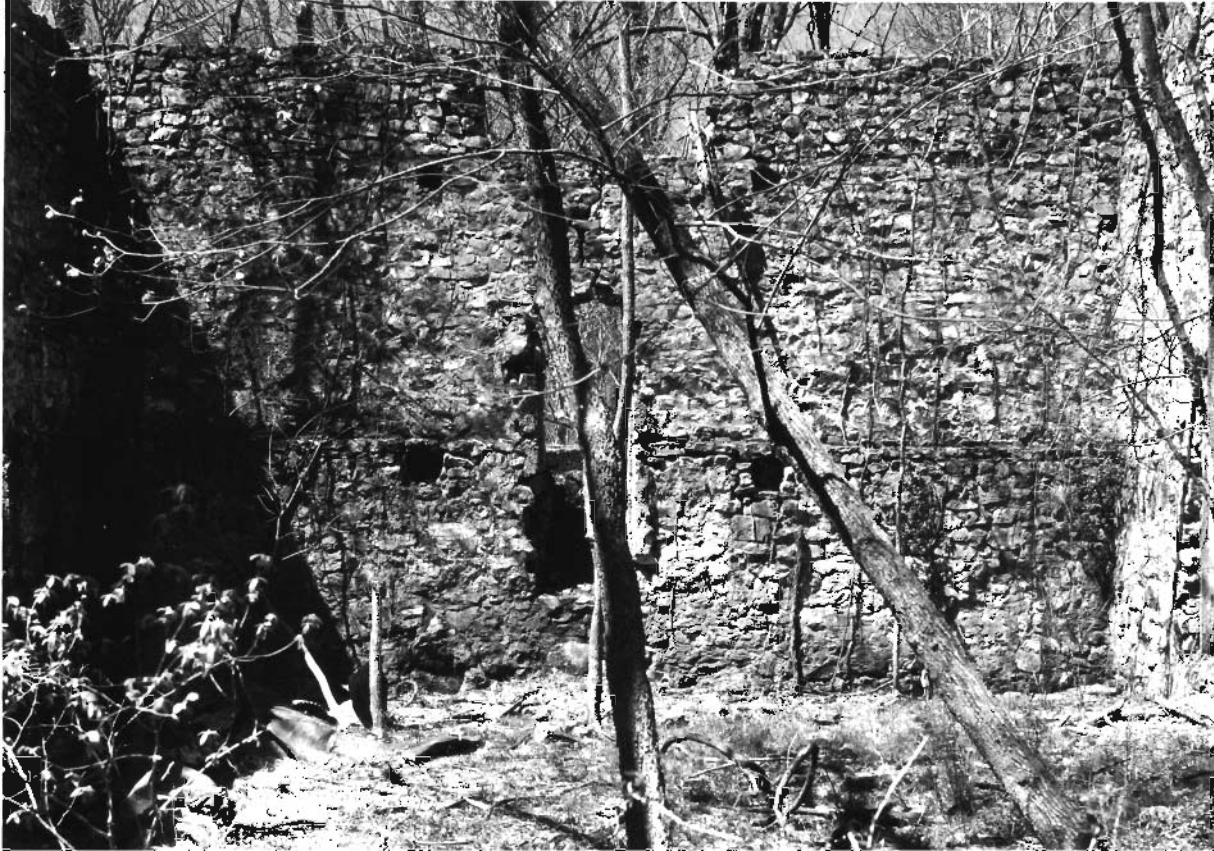
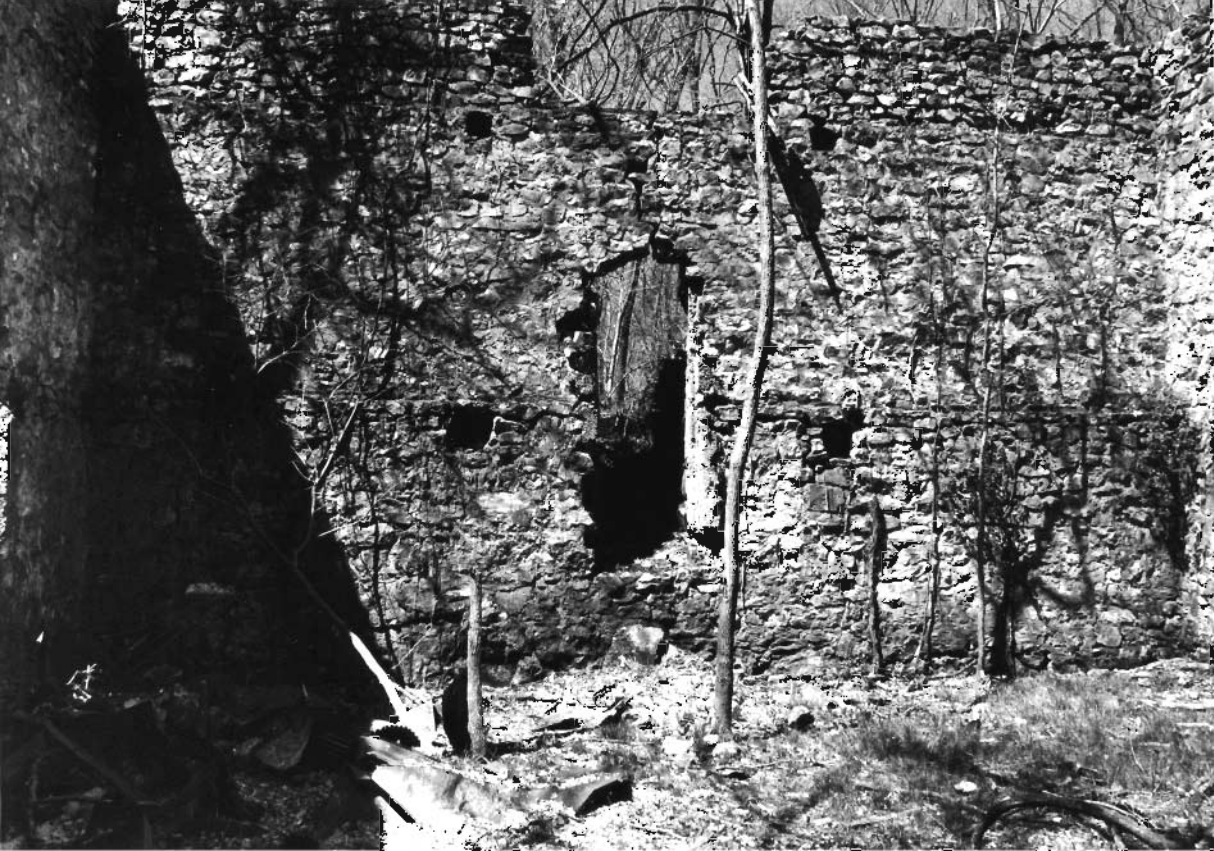
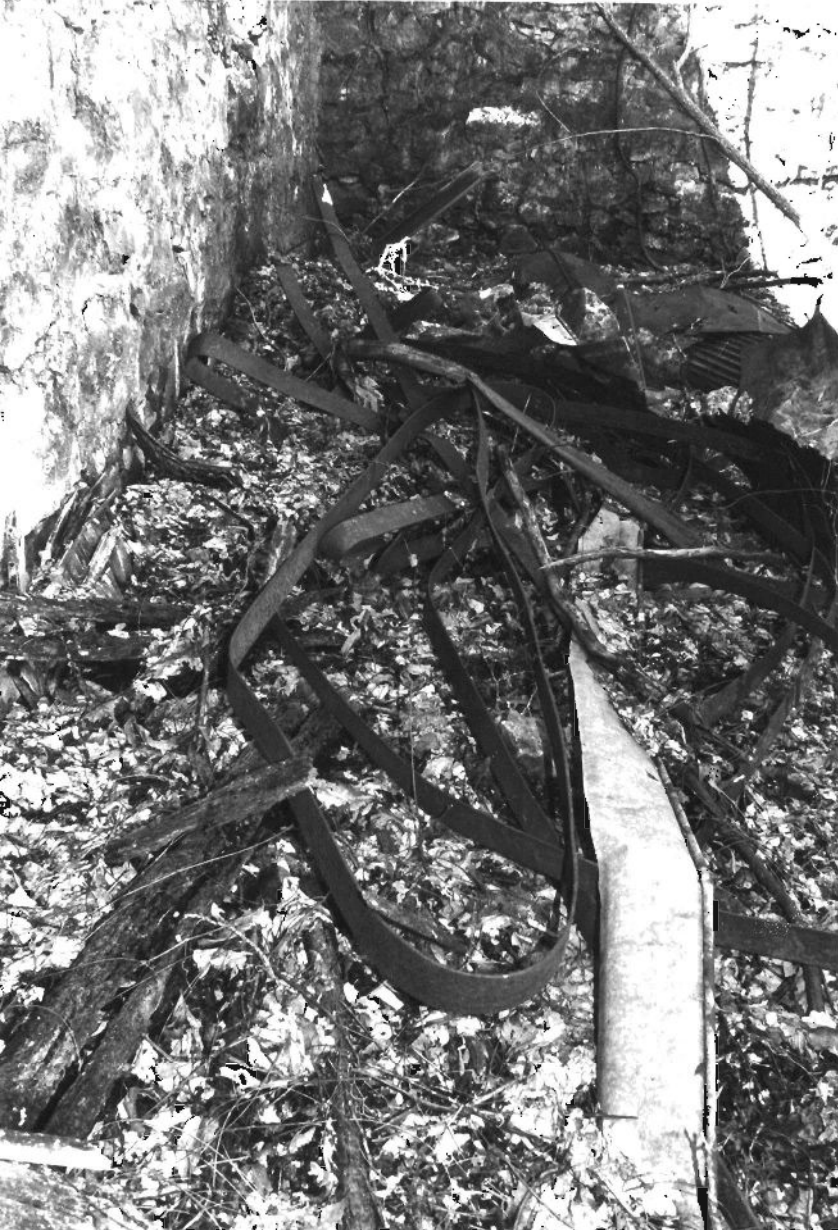
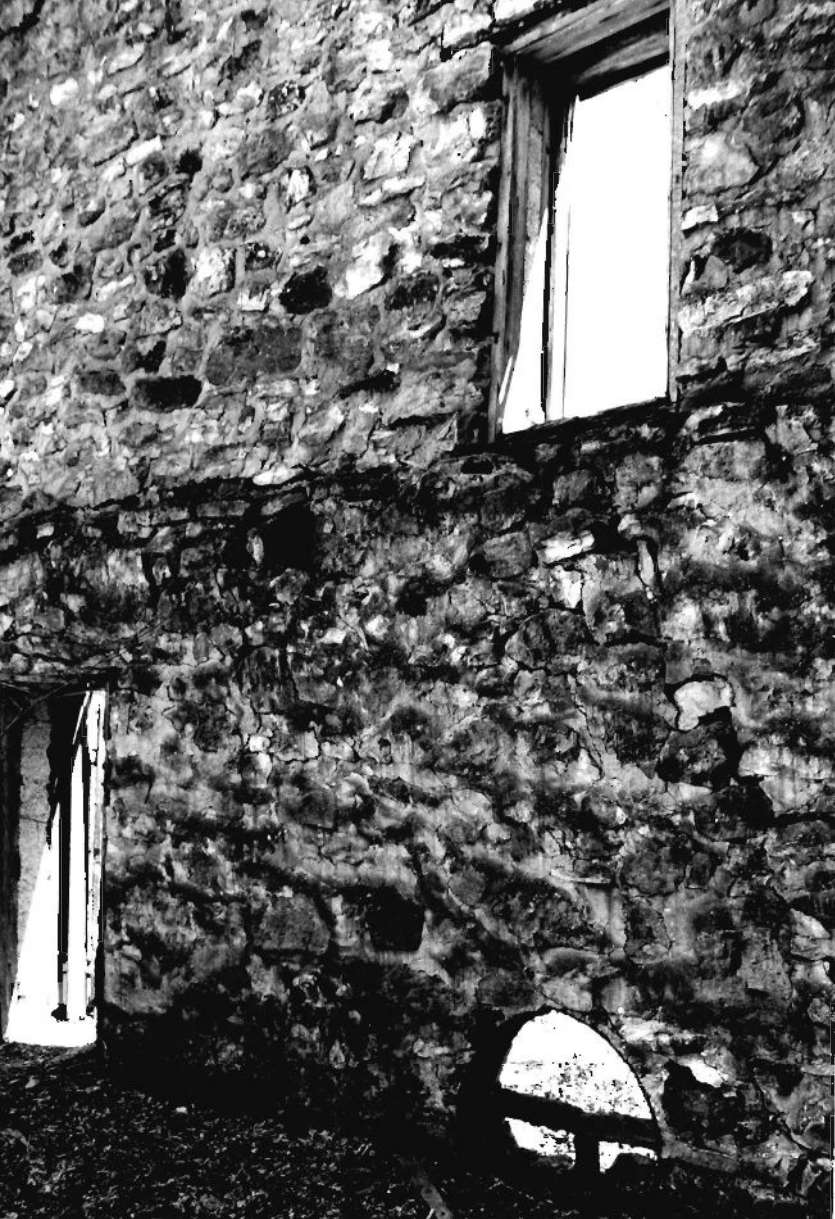
REFERENCE NUMBER		A. HISTORIC NAME Sumner Charles Haseltine Apple barn #1							
B. COUNTY [0][7][7]				C. OTHER NAME(S)					
D. ADDRESS				E. CITY Springfield		F. VICINITY <input checked="" type="checkbox"/>	G. RESTRICTED	H. ACREAGE

1. Haseltine, Sumner C.				<p>At ca 40' x 40', this is the smallest of the four stone walled Haseltine apple barns. (wall construction is rubblestone laid in forms.) The barn burned in the orchard-brush fire that consumed the Clover Dell Farm in 1953. It is sited on a steep east-facing slope that descends to Wilson's Creek. Unique to this barn are slender vertical concrete bracing posts at the corners.</p> <p>This structure is significant in the context of the Haseltine family commercial apple business in approximately the last thirty years of the nineteenth century and the first thirty years of the twentieth century. It is one of six known Haseltine stone apple barns, the remains of five of which are extant.</p>

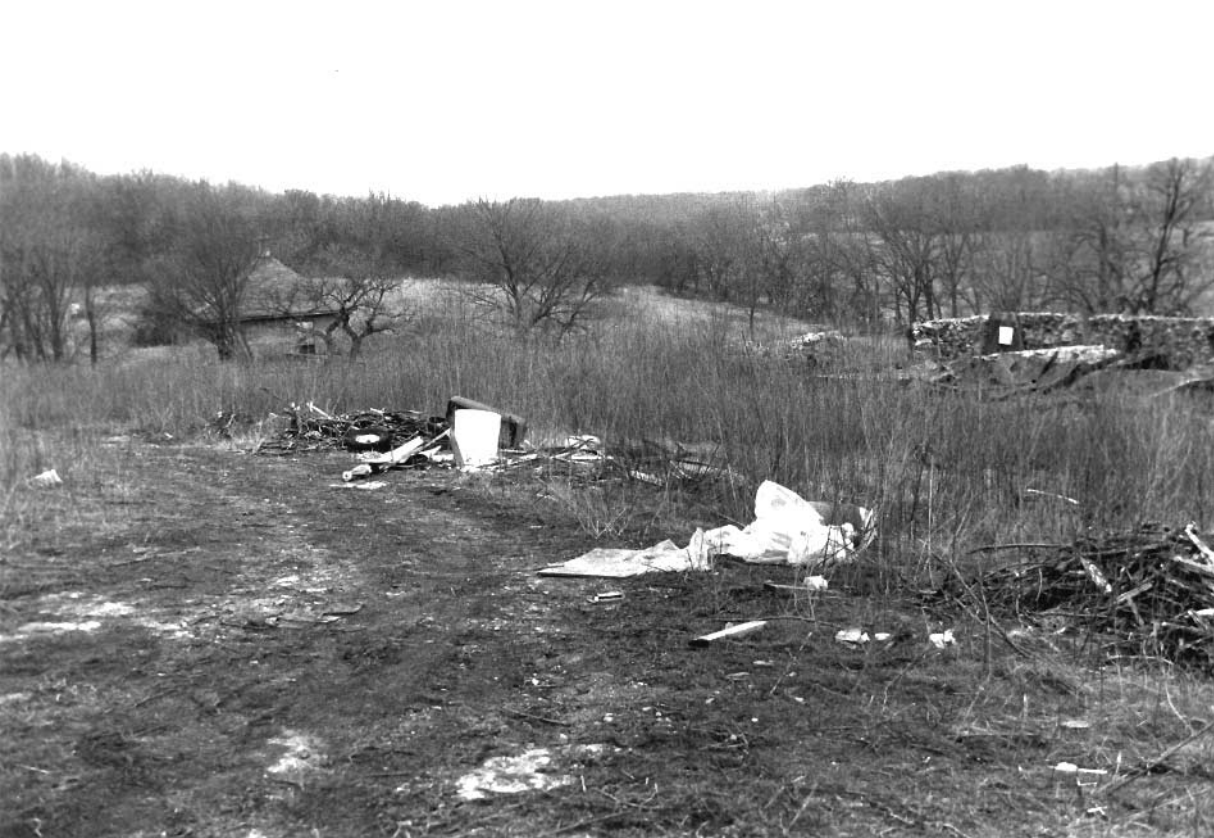
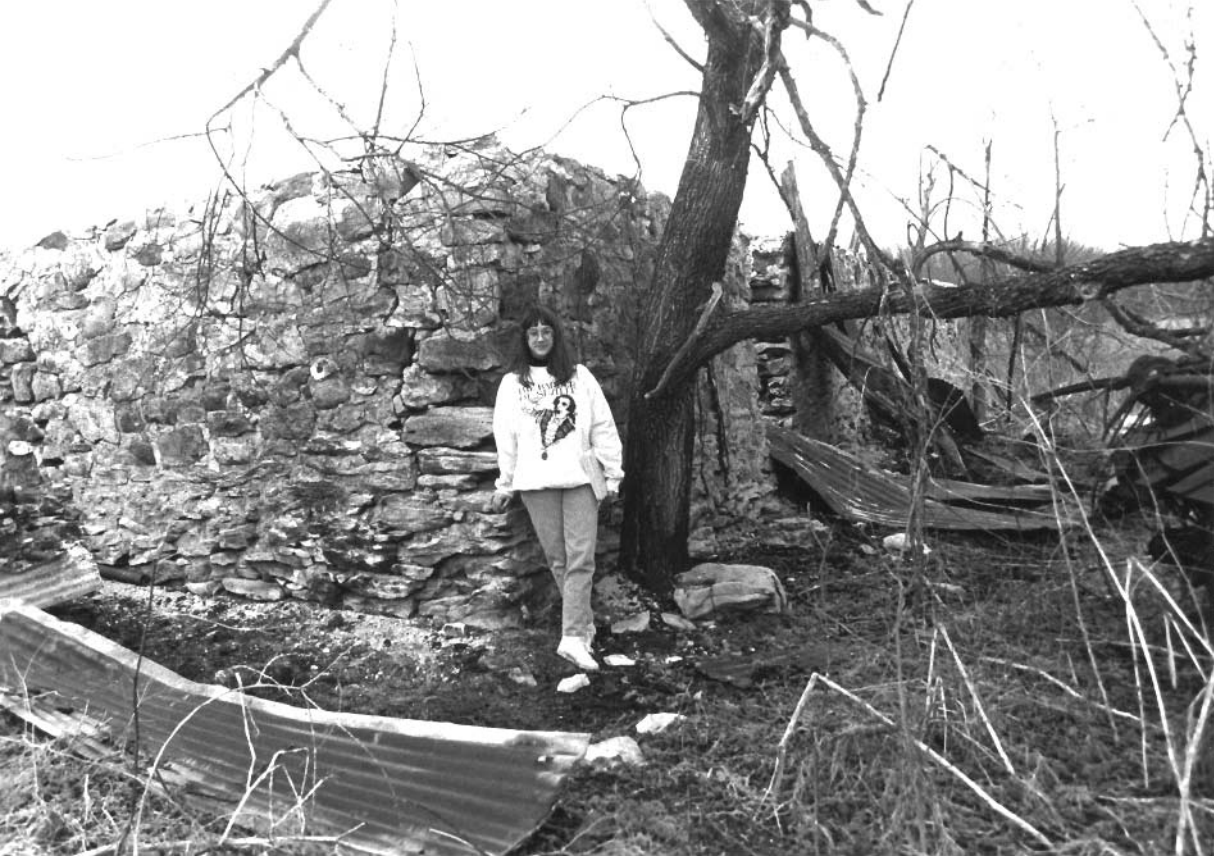
3.									3. [] [] [] []	
4.									4. [] [] [] []	
R. SIGNIFICANT PERSON(S) 1. Haseltine, Sumner C. 2. Haseltine, Kirk G. 3.				T. SIGNIFICANCE This barn was unlike the other Haseltine apple storage barns. It was rectangular rather than square, and apparently had a wooden superstructure. It burned in the fire of 1953; but a general purpose barn to the east (barn #3) which survived the fire, is illustrative of the type. Barn #2 is some hundred yards up the slope south of tenant house #1. This structure is significant in the context of the Haseltine family commercial apple business in approximately the last thirty years of the nineteenth century and the first thirty years of the twentieth century. It is one of six known Haseltine stone apple barns, the remains of five of which are extant.

REFERENCE NUMBER	A. HISTORIC NAME	B. COUNTY	C. ADDRESS
	Sumner Charles Haseltine Apple barn #2	Greene	Springfield, MO
<p>2.Y. Nearby is a small rectangular building of formed concrete, which survived the 1953 fire. It's use is not ascertained. When surveyed in 1992, the floor was covered with scattered papers including newspapers in German, and schoolbooks of German language instruction.</p>
