National Register of Historic Places Registration Form

Historic name The Home of the Friendless
Other names/site number Charless Home
Name of related Multiple Property Listing N/A

Street & number 4431 South Broadway

City or town St. Louis

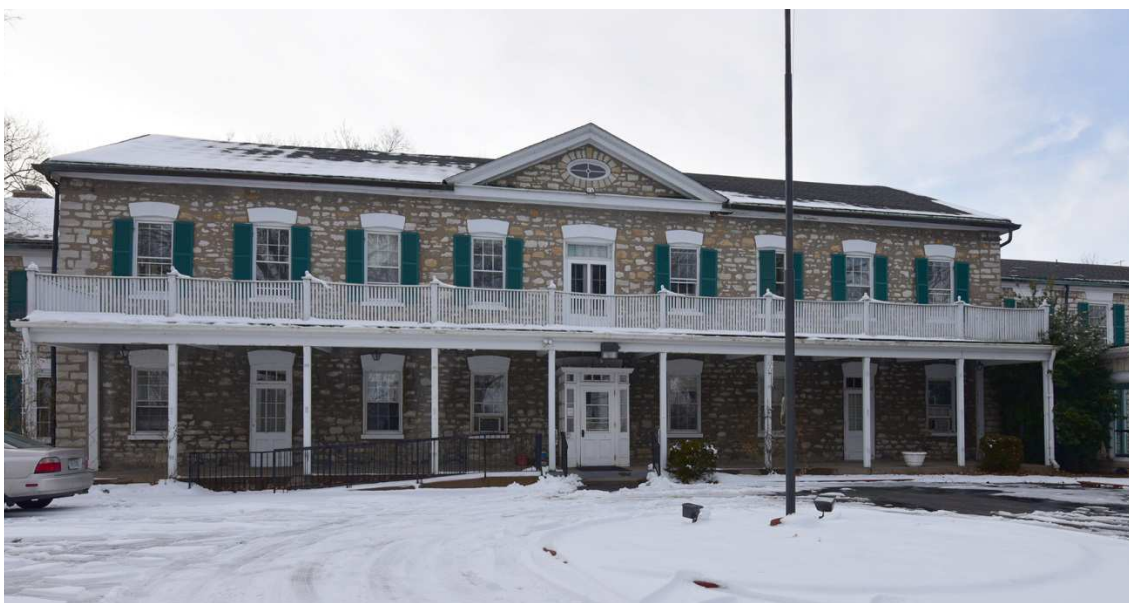
Figure 7: Resource 1, Block A, east elevation. Source: Brad Finch, F-Stop Photography, March 2015.

Nine regular bays organize the east elevation (*Figure 7*). On the first story, a small non-historic vestibule projects from Bay 5. The vestibule has glazed wood walls, narrow sidelights, and a transom. A glazed wood panel door with a multi-light transom accesses the building within the vestibule. Glazed wood panel doors with transoms fill Bays 2 and 7 on the first story. A pair of glazed wood panel doors with a transom accesses the second floor balcony. Historic six-over-six double-hung wood windows with limestone sills fill the remaining bays on each story. All openings have painted segmental arch brick headers. Wood shutters flank the openings on the second story of the primary east facade.

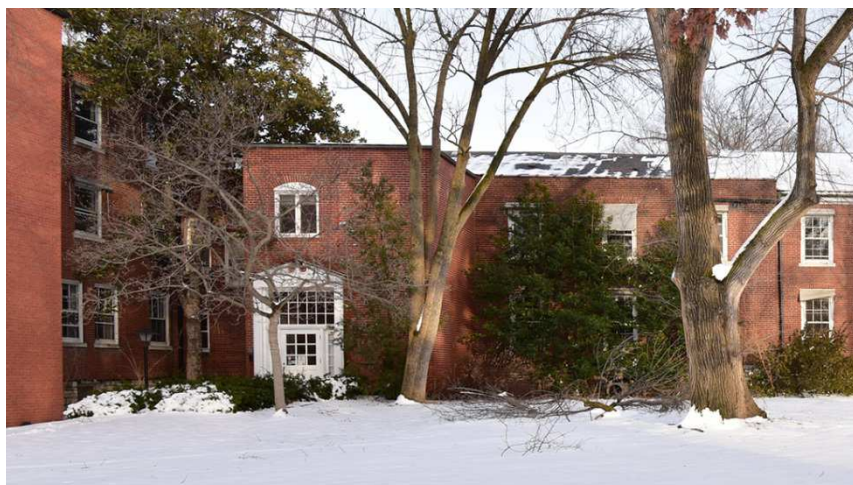
Figure 8: Resource 1, Block A, west elevation. Source: Brad Finch, F-Stop Photography, March 2015.

Seven bays organize the west elevation, south of Block C (*Figure 8*). Single openings in Bays 1-3 descend from left to right, aligned with an interior staircase. Bay 4 projects westward from the façade. An entrance with an elaborate wood surround with fluted pilasters and a broken pediment fills this bay at ground level. The glazed wood-paneled door has sidelights and a large twenty-one-light transom. A pair of non-historic casement windows pierces this bay on the second story. Historic six-over-six double-hung wood windows fill Bays 5-7.

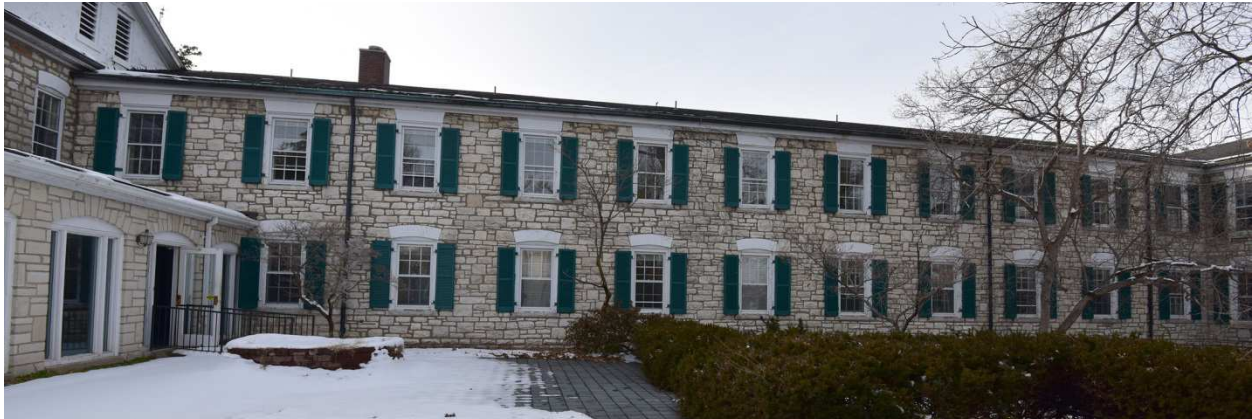
Figure 9: Resource 1, Block B, east elevation. Source: Brad Finch, F-Stop Photography, March 2015.

Eleven regularly spaced bays organize the east elevation (*Figure 9*). First story openings have segmental arch brick lintels; second story openings have flat arch brick lintels. A corridor connecting to Block G fills Bay 1 on the first story. Historic six-over-six double-hung wood windows with limestone sills and painted wood shutters fill the remaining bays.

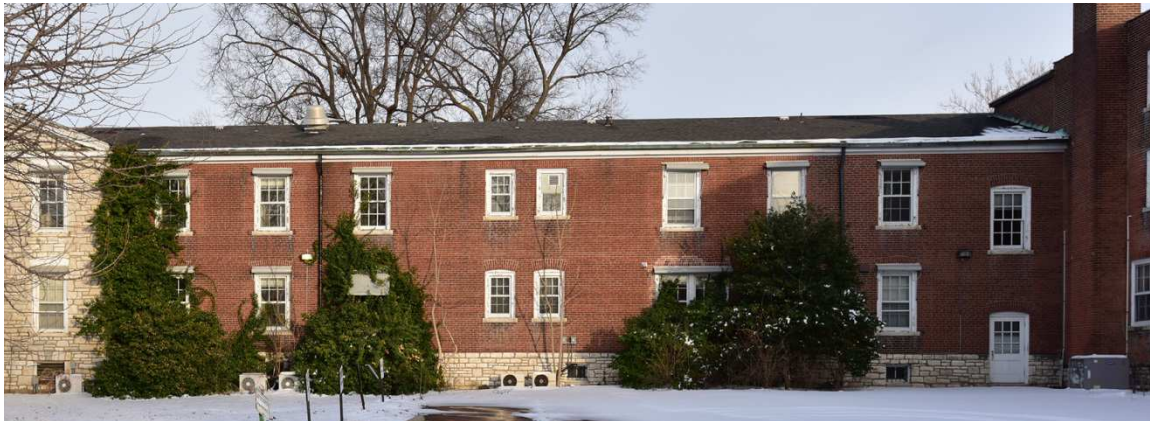
Figure 10: Resource 1, Block B, west elevation. Source: Brad Finch, F-Stop Photography, March 2015.

Nine bays organize the west elevation (*Photo 7, Figure 10*). Unless otherwise specified, first story openings have segmental arch brick lintels; second story openings have flat arch brick lintels. All have limestone sills. Historic six-over-six double-hung wood windows fill Bays 1-8. A pair of historic six-over-six wood windows with a rowlock brick lintel fills the first story of Bay 6. A wide wood panel door with glazing fills Bay 9 at the ground level. A historic six-over-six double-hung wood window with a segmental arch brick lintel pierces the second story.

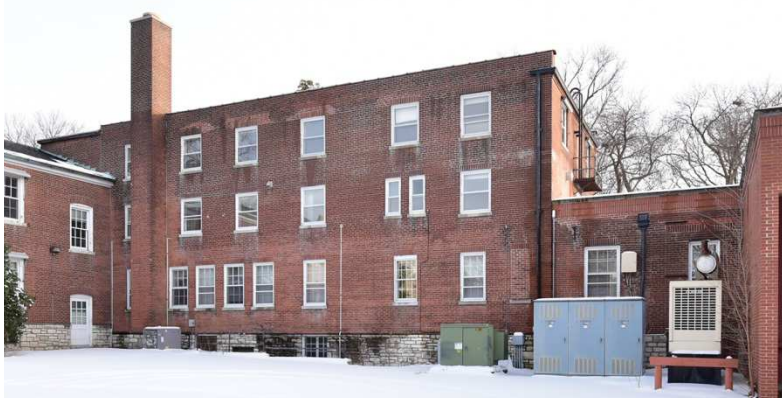
Figure 11: Resource 1, Block C, north elevation. Source: Brad Finch, F-Stop Photography, March 2015.

Six bays organize the north elevation (*Figure 11*). All have with limestone sills and flat arch brick lintels. On the first story, Bays 2 and 3 have two single openings. Historic six-over-six double-hung wood windows fill each opening in Bays 1-4. Non-historic double-hung wood windows with simulated multi-light sashes fill Bays 5 and 6. On the second story, Bay 5 has two openings. Historic one-over-one double-hung wood windows fill each opening on the second and third stories.

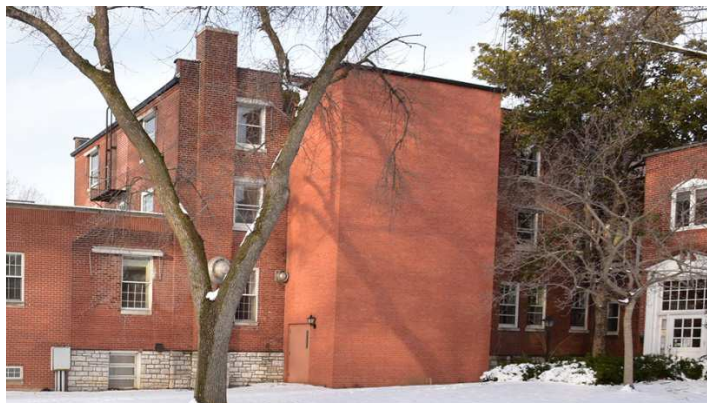
Figure 12: Resource 1, Block C, south elevation. Source: Brad Finch, F-Stop Photography, March 2015.

Five bays organize the first story of the south elevation (*Figure 12*). All have limestone sills and flat arch brick lintels. Bays 3 and 4 have two single openings. Non-historic double-hung wood windows with simulated multi-light sashes fill Bays 1 and 2. Historic six-over-six double-hung wood windows fill each opening in Bays 3-5. Historic one-over-one double-hung wood windows fill four bays on the second and third stories.

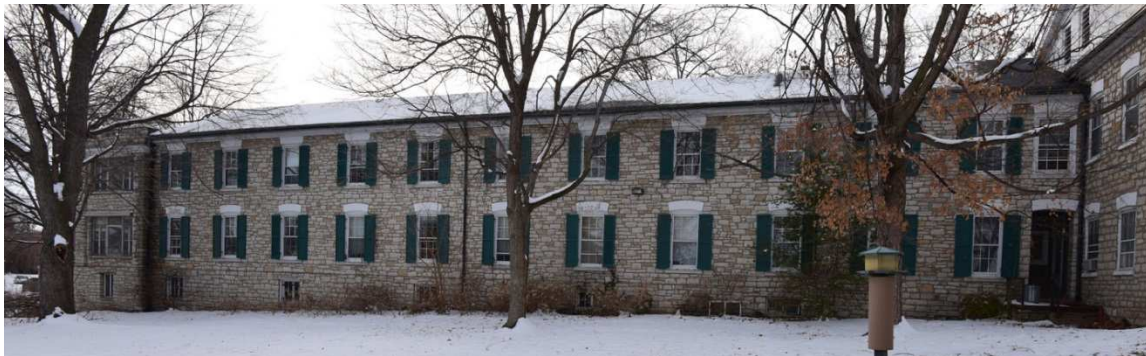
Figure 13: Resource 1, Block D, east elevation. Source: Brad Finch, F-Stop Photography, March 2015.

Thirteen regularly spaced bays with limestone sills organize the east elevation (*Photo 1, Figure 13*). Bay 1, the flat-roofed south wing identified as the sunroom, has a band of three multi-light metal windows on each story. A recessed entrance fills the first story of Bay 13. In the remaining bays, first story openings have segmental arch brick lintels; second story openings have flat arch brick lintels. Single historic six-over-six double-hung wood windows with painted shutters fill each bay. Basement openings with historic steel casement or historic wood windows pierce the basement level in Bays 1, 2, 4, 6, 8, and 10.

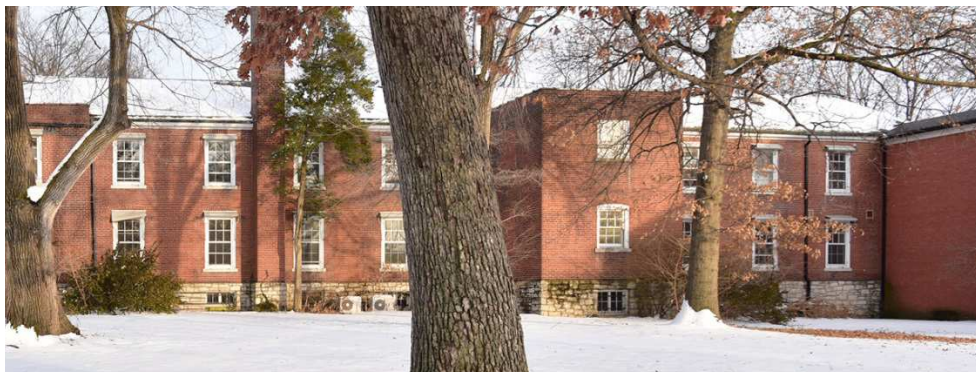
Figure 14: Resource 1, Block D, west elevation. Source: Brad Finch, F-Stop Photography, March 2015.

Ten bays with historic six-over-six double-hung wood windows organize the west elevation (*Photo 9, Figure 14*). First story openings have brick segmental arch lintels; second story openings have brick flat arch lintels. Block K projects from the south end of the west elevation.

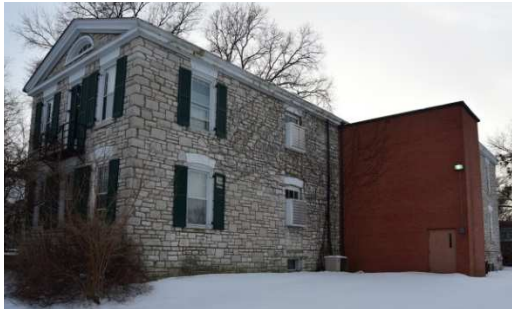
Figure 15: Resource 1, Block E, northeast corner. Source: Brad Finch, F-Stop Photography, March 2015.

Seven bays with limestone sills organize the north elevation (*Photo 4, Figures 15, 16*). First story openings have segmental arch brick lintels; second story openings have flat arch brick openings. Block F connects to Bay 7 on the first story. Historic six-over-six double-hung wood windows fill the remaining bays. Shutters flank each window in Bay 1. Air conditioning units partially obscure each window Bay 2.

Three bays with historic six-over-six double-hung wood windows, limestone sills and louvered wood shutters organize the east elevation (*Figure 15*). A window replaces a former door on the second story of Bay 2; a historic metal balconette is extant. A historic wood fanlight pierces the gable end.

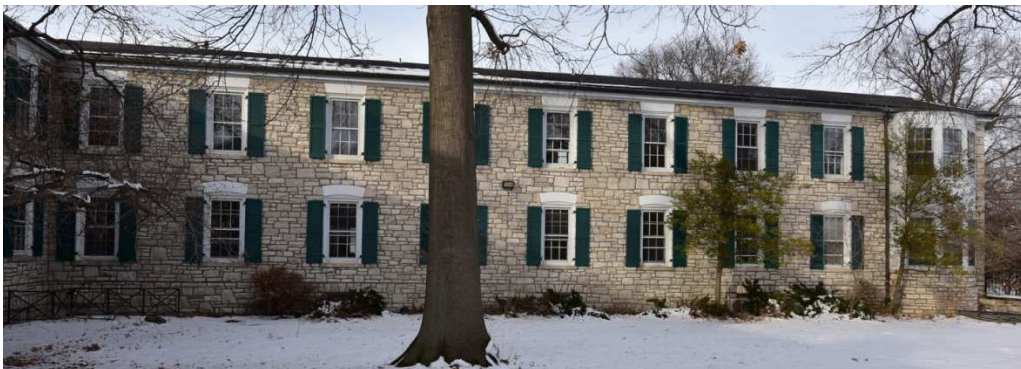
Figure 17: Resource 1, Block E, south elevation. Source: Brad Finch, F-Stop Photography, March 2015.

Nine bays with limestone sills organize the south elevation (*Photo 2, Figure 17*). First story openings have segmental arch brick lintels; second story openings have flat arch brick openings. Historic six-over-six double-hung wood windows with limestone sills and louvered wood shutters fill Bays 1-8. A two-story curved bay window with three historic six-over-six double-hung wood windows fills Bay 9.

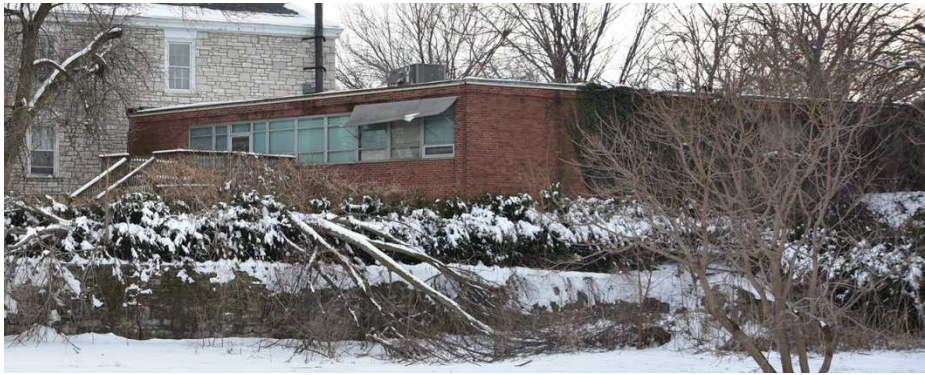
Figure 18: Resource 1, Block F, east elevation. Source: Brad Finch, *F-Stop Photography*, March 2015.

A band of nine three-part aluminum windows pierces the center of the angled east elevation (*Figure 18*). All three lights of the window are fixed except in a few select locations where the bottom light is a hopper sash. A glazed aluminum frame door pierces the south end of the band.

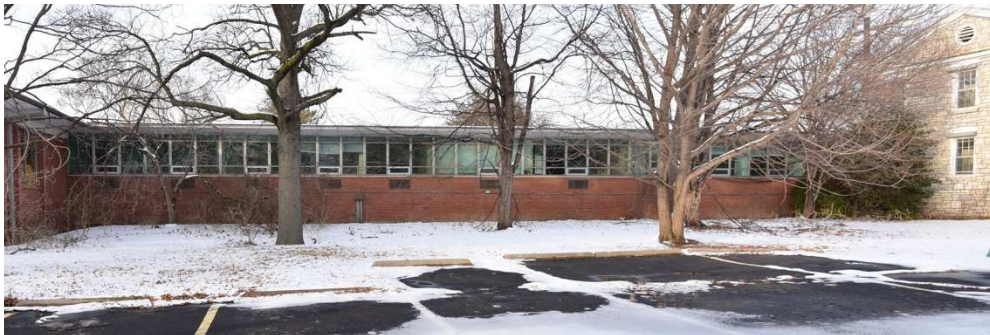
Figure 19: Resource 1, Block F, south elevation. Source: Brad Finch, *F-Stop Photography*, March 2015.

A similar band of thirty-three three-part aluminum windows pierces the south elevation (*Photo 6, Figure 19*).

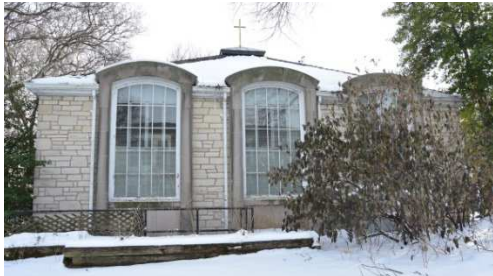
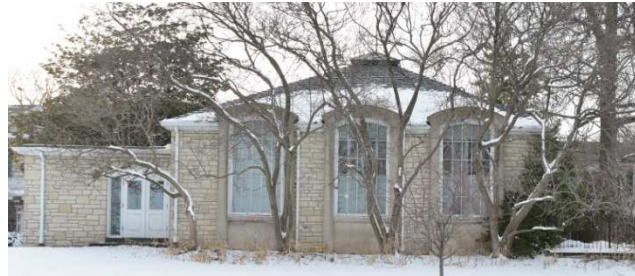
Three large segmental arched openings pierce the north, east and west elevations (*Photo 2, Figures 20, 21*). Dressed limestone surrounds each opening and extends from the foundation to slightly above the wall plane. Fixed, twenty-five-light fixed wood windows fill each opening.

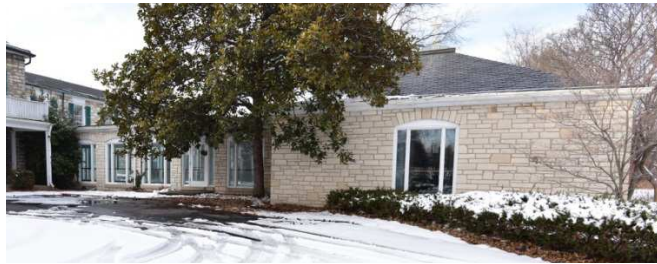
Figure 22: Resource 1, Block G, south elevation. Source: Brad Finch, F-Stop Photography, March 2015.

A single segmental arched opening with a three-part fixed wood window pierces the south elevation (*Figure 22*).

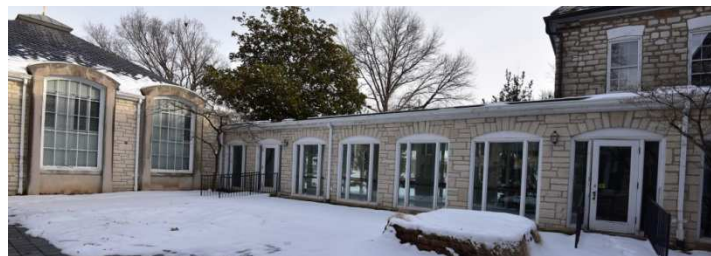
Figure 23: Resource 1, Block G, north and west elevations. Source: Brad Finch, F-Stop Photography, March 2015.

A segmental arched arcade with a flat roof forms the connecting corridor (*Figure 23*). Non-historic three-part fixed wood windows with insulated glazing line the corridor. Glazed wood doors replace two windows on the north elevation of the corridor. A pair of historic glazed wood panel doors with sidelights accesses the east elevation of the corridor.

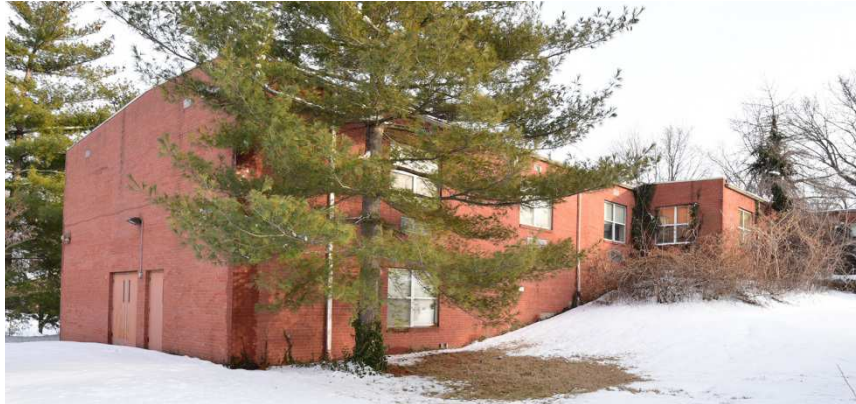
Figure 26: Resource 1, Block I, northwest corner. Source: Brad Finch, F-Stop Photography, March 2015.

Three tall fixed aluminum windows pierce the west elevation (*Photo 5, Figure 26*). A glazed aluminum door accesses the ground level on the south end of this elevation. A concrete ramp leads to a replacement door on the first story of the north elevation. A single aluminum-frame window pierces this elevation west of the door.

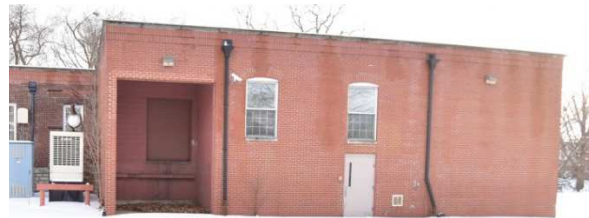
Figure 27: Resource 1, Block J, north elevation. Source: Brad Finch, F-Stop Photography, March 2015.

A recessed loading dock with a large elevated overhead door is located at the east end of the north elevation (*Photo 8, Figure 27*). A metal pedestrian door pierces this elevation at ground level; single one-over-twelve double-hung wood windows pierce the first floor.

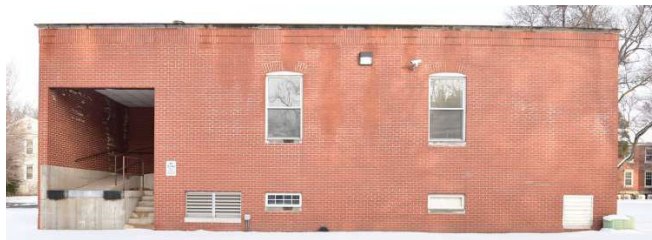
Figure 28: Resource 1, Block J, west elevation. Source: Brad Finch, F-Stop Photography, March 2015.

A recessed loading dock with a concrete ramp and stairs is located on the north side of the west elevation (*Figure 28*). Single openings with one-over-one double-hung wood windows pierce the south side of this elevation. Two louvered vents and two windows pierce the basement level.

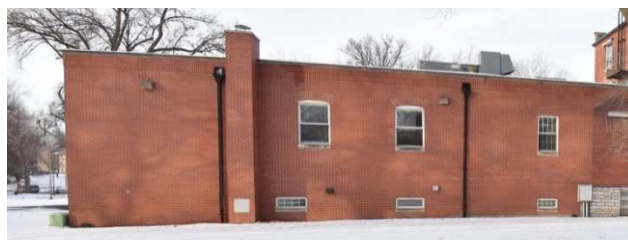
Figure 29: Resource 1, Block J, south elevation. Source: Brad Finch, F-Stop Photography, March 2015.

Three bays organize the south elevation on the first floor and basement (*Figure 29*). One-over-one double-hung wood windows fill Bays 1 and 2; an eight-over-eight double-hung wood window fills Bay 3. Fixed wood windows fill basement openings.

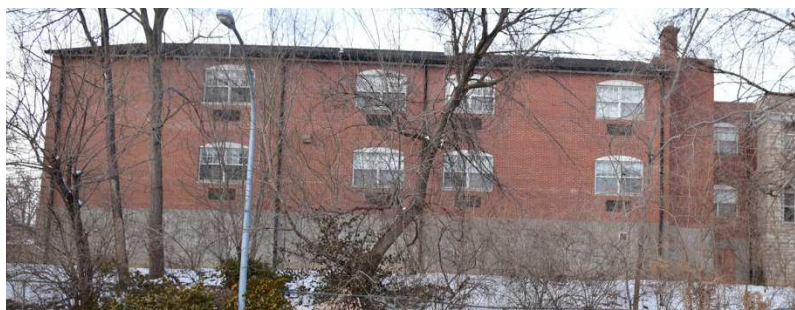
Figure 31: Resource 1, Block K, south elevation. Source: Brad Finch, F-Stop Photography, March 2015.

A two-story angled bay window with six six-over-six double-hung wood windows projects from the west elevation (*Figure 31*). A metal pedestrian door pierces this elevation at the basement level.

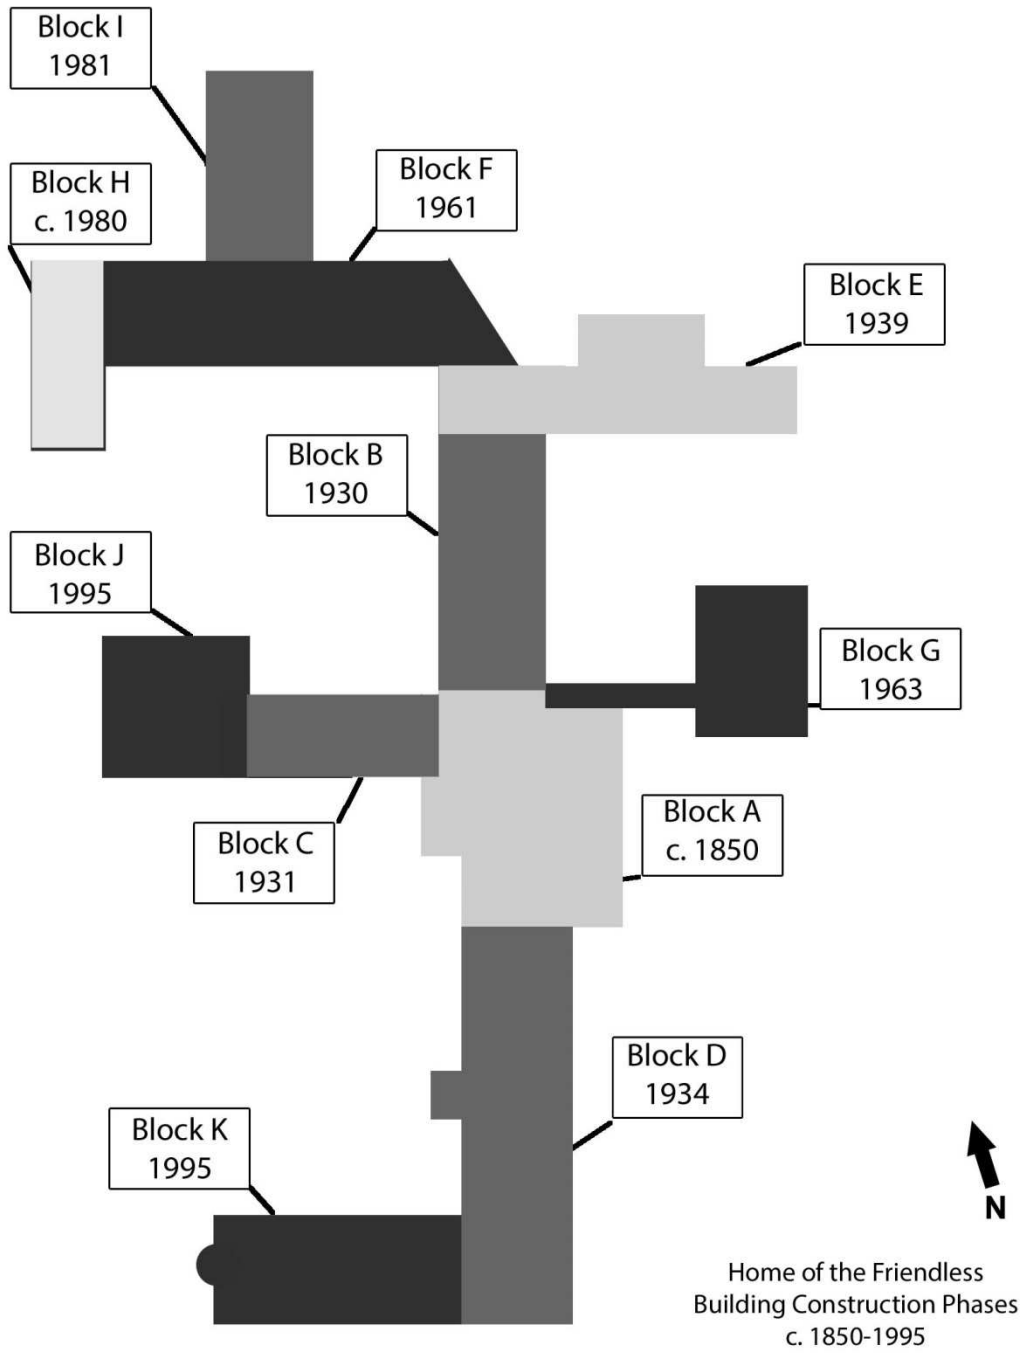
Figure 6: Construction sequence map.

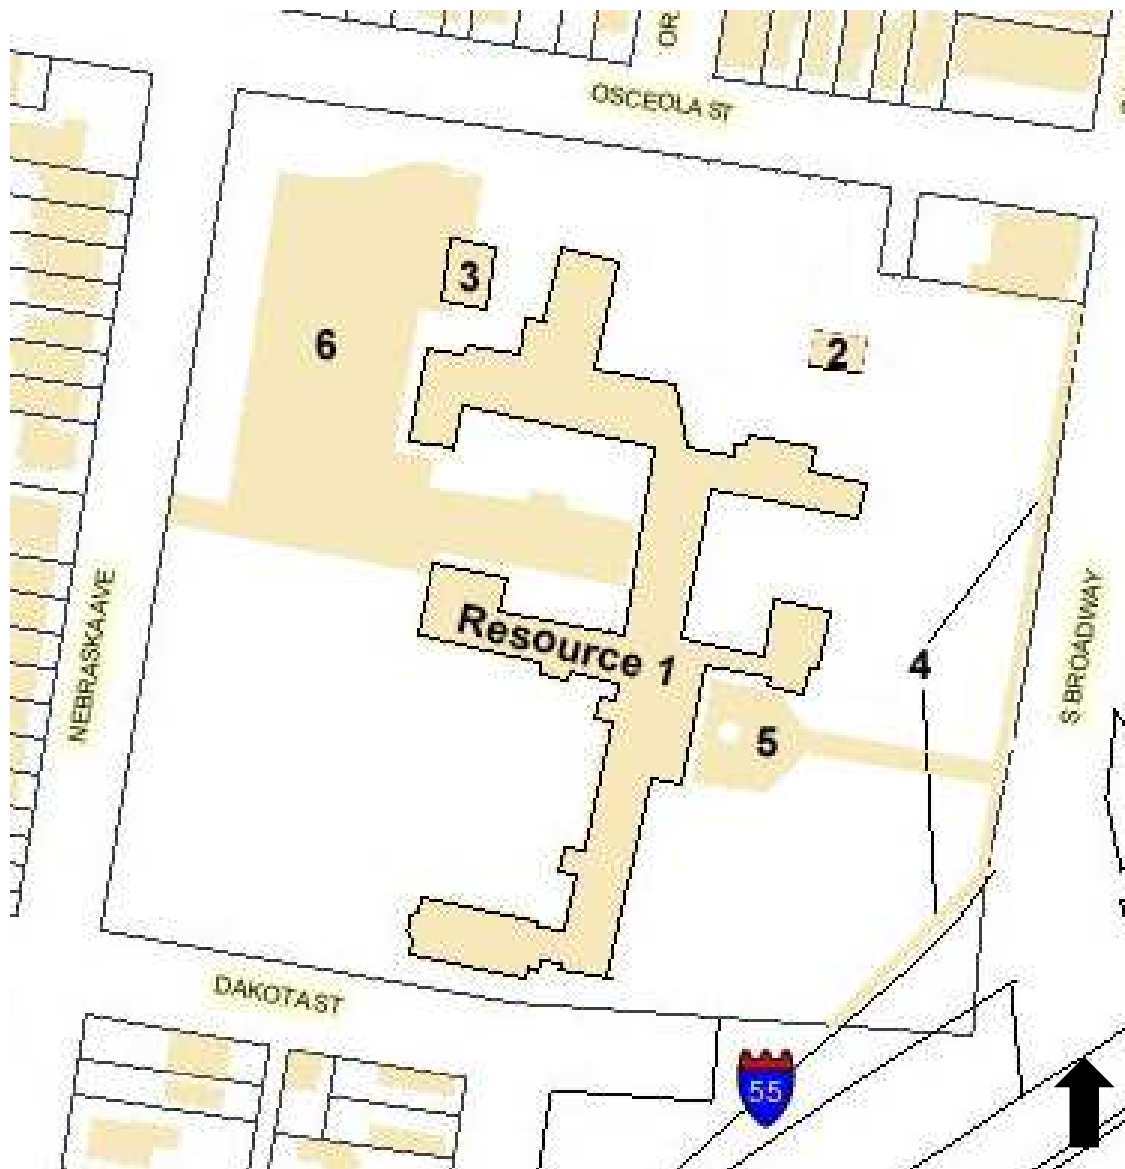
Figure 32: Site map identifying resources.

1. Resource 1: Primary Building, contributing building.
2. Resource 2: 1915 Garage, contributing building.
3. Resource 3: 1965 Garage, contributing building.
4. Resource 4: Rock wall, contributing structure.
5. Resource 5: Parking lot, non-contributing site.
6. Resource 6: Parking lot, non-contributing site.

A garage, constructed c. 1915, stands north of the main building (*Photo 4, Figure 32*). The one-story two-car garage has a concrete foundation, brick walls, and an asphalt shingle front-gable roof. A non-historic metal overhead door pierces the east elevation; a historic glazed wood-panel pedestrian door and six-over-six double-hung wood window pierce the north elevation. The garage retains integrity and was constructed during the period of significance, rendering it contributing to the nomination.

A garage, constructed c. 1965, abuts the east side of the parking lot (*Photo 5, Figure 32*). The one-story three-car garage has a concrete foundation, brick walls and an asphalt shingle hip roof. A historic two-car overhead wood panel door and a one-car overhead wood panel door pierce the west elevation. A non-historic pedestrian door pierces the south elevation. The garage retains integrity and was constructed during the period of significance, rendering it contributing to the nomination.

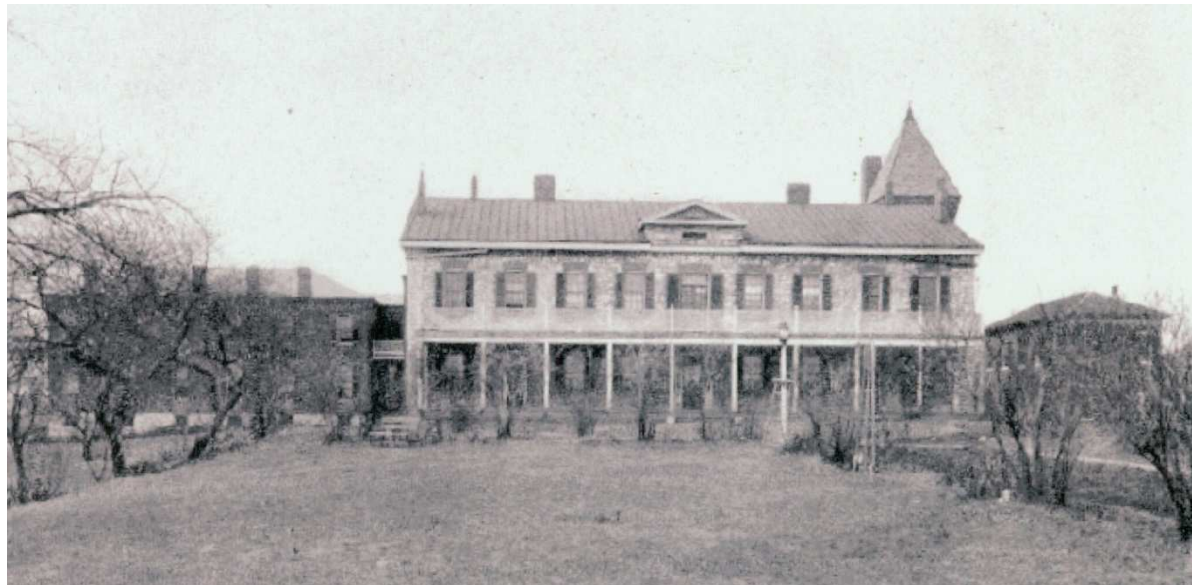
Figure 33: Home of the Friendless, earliest known photograph, n.d. The adjacent wings were demolished in the late-1800s. *Source: Missouri History Museum, St. Louis, Missouri.*

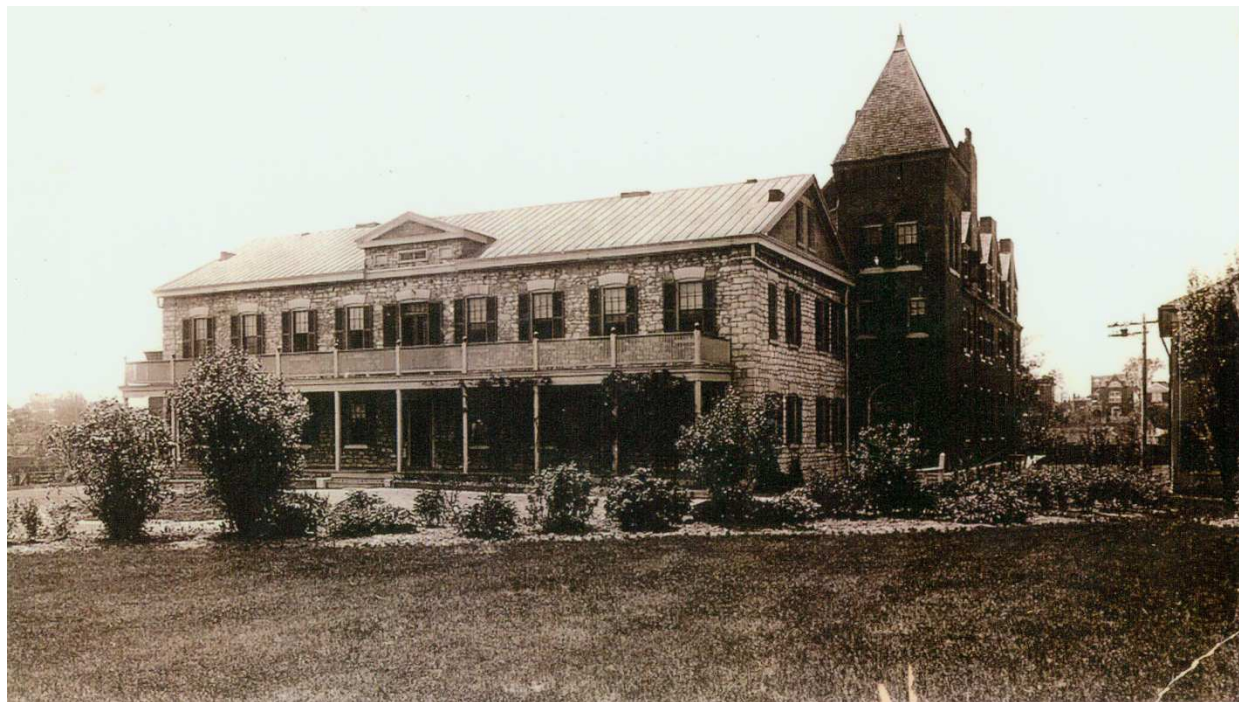
Figure 34: Home of the Friendless, n.d. The brick wing was demolished in the late-1800s. *Source: Missouri History Museum, St. Louis, Missouri.*
