National Register of Historic Places Registration Form

Historic name McGee Street Automotive Historic District

City or town	Kansas City	N/A	vicinity
--------------	-------------	-----	----------

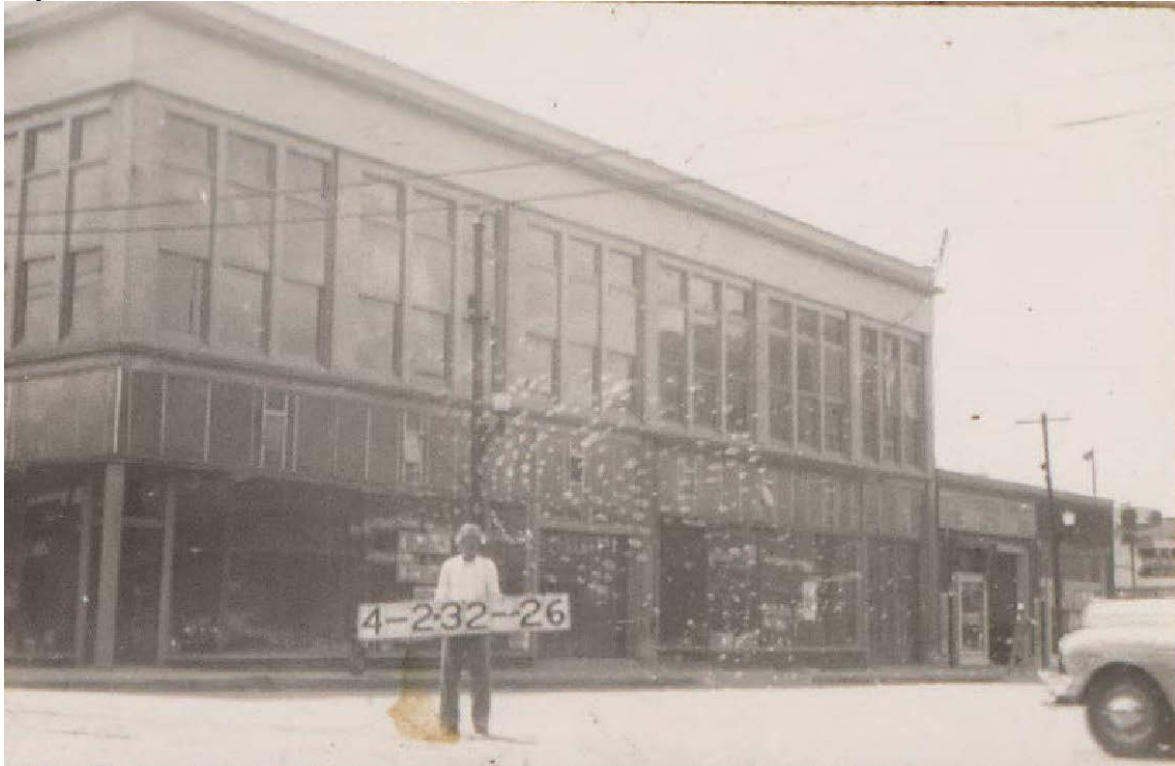
Figure 7. 1901 McGee Street with large storefront windows on the ground. *Source: Kansas City 1940 Tax Assessment Photograph, Missouri Valley Special Collections, Kansas City Public Library, Kansas City, Missouri.*

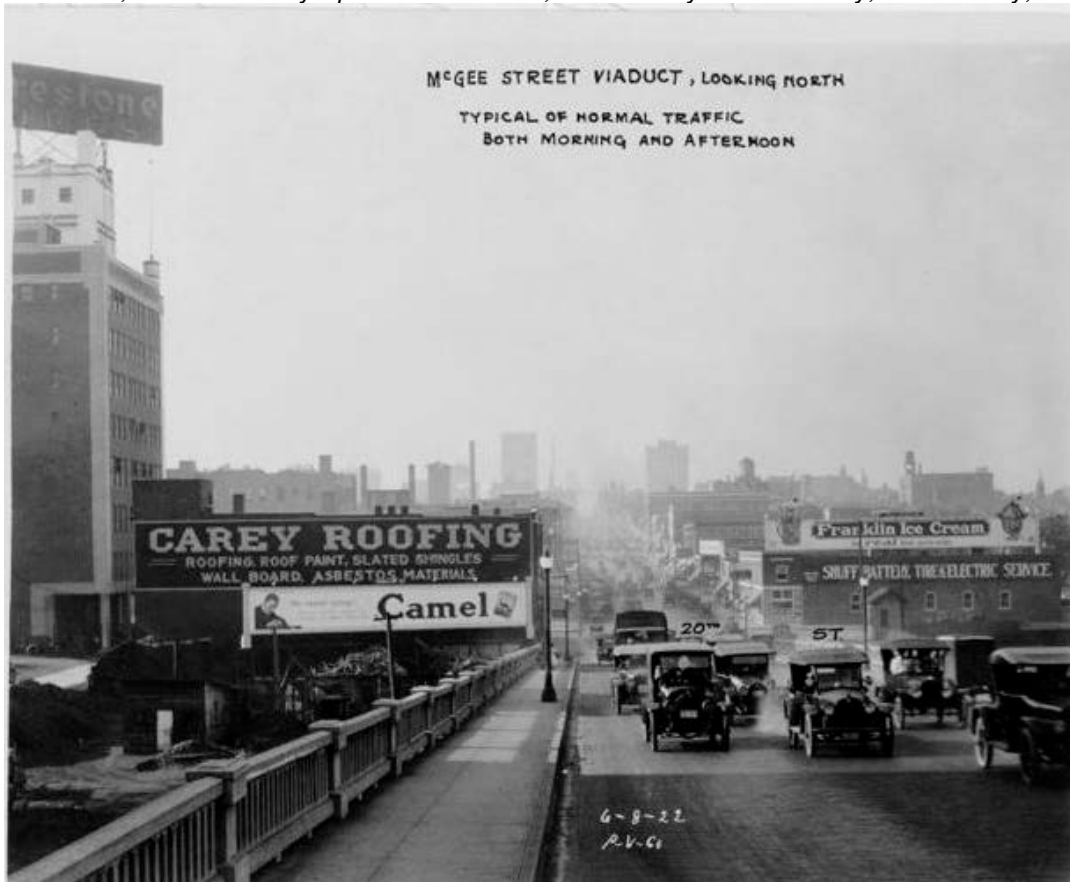
Figure 8. McGee Street in 1922 view is looking north from the viaduct immediately south of the intersection of McGee Street and East 20th Street. *Source: Judge Elmo M. Hargrave Photographic Collection, Missouri Valley Special Collections, Kansas City Public Library, Kansas City, Missouri.*

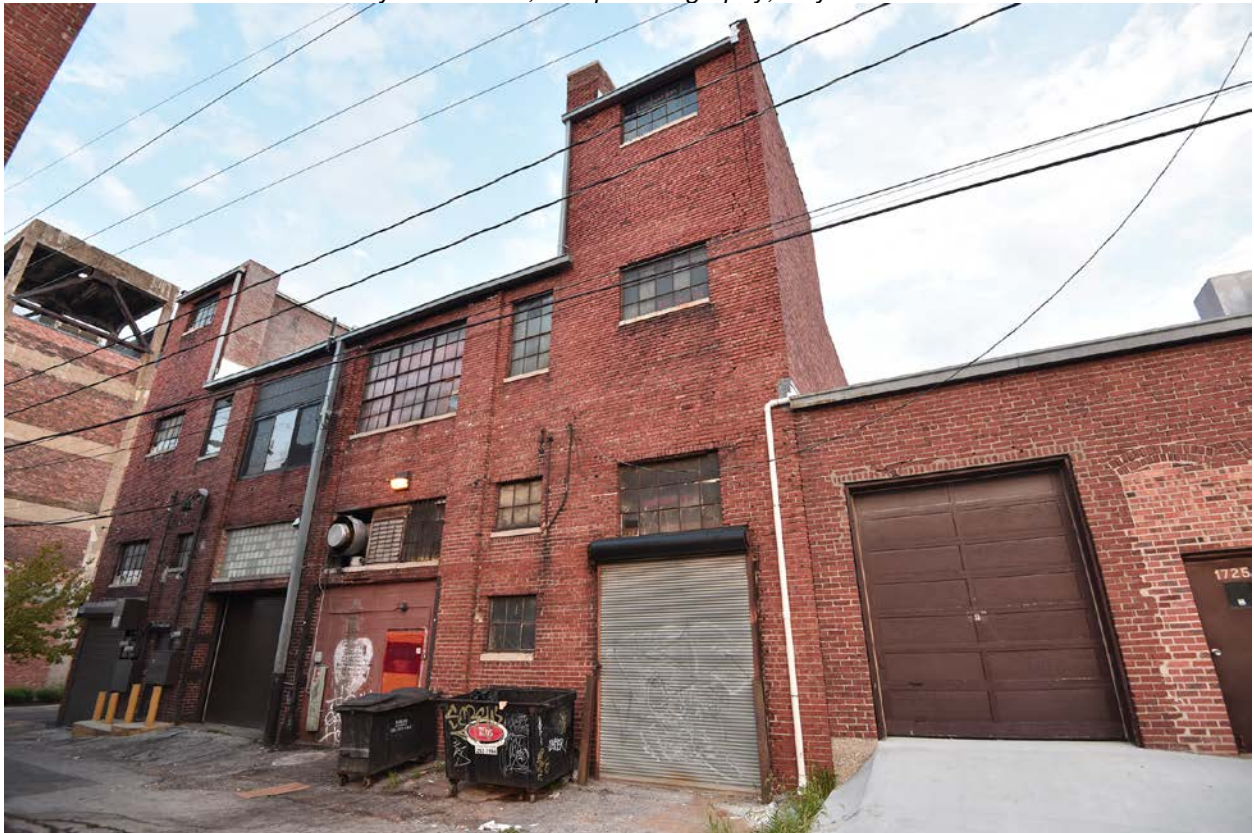
Figure 9. Elevator shaft and vehicular entrances on the rear elevation of 1727 and 1729 McGee Street. View southwest. *Photo by Brad Finch, f-stop Photography, July 2017.*

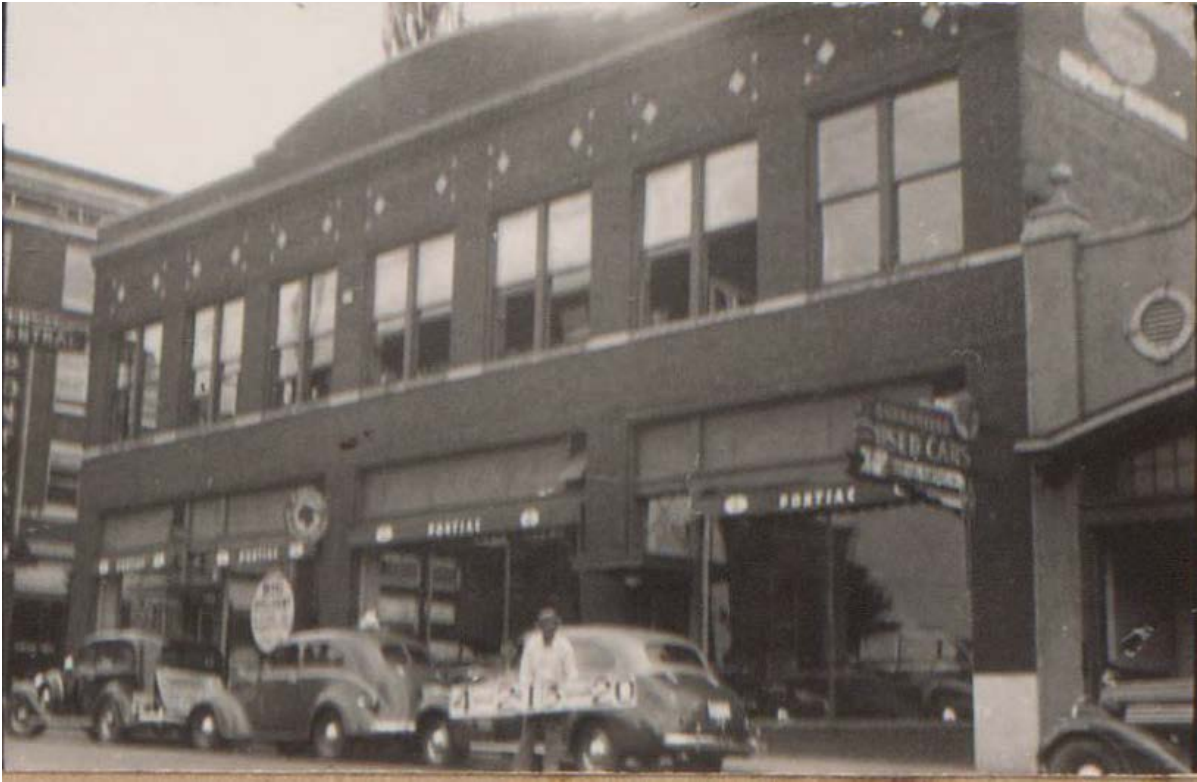
Figure 10. 1801 McGee Street had large storefront glazing on the ground floor showroom space. *Source: Kansas City 1940 Tax Assessment Photograph, Missouri Valley Special Collections, Kansas City Public Library, Kansas City, Missouri.*

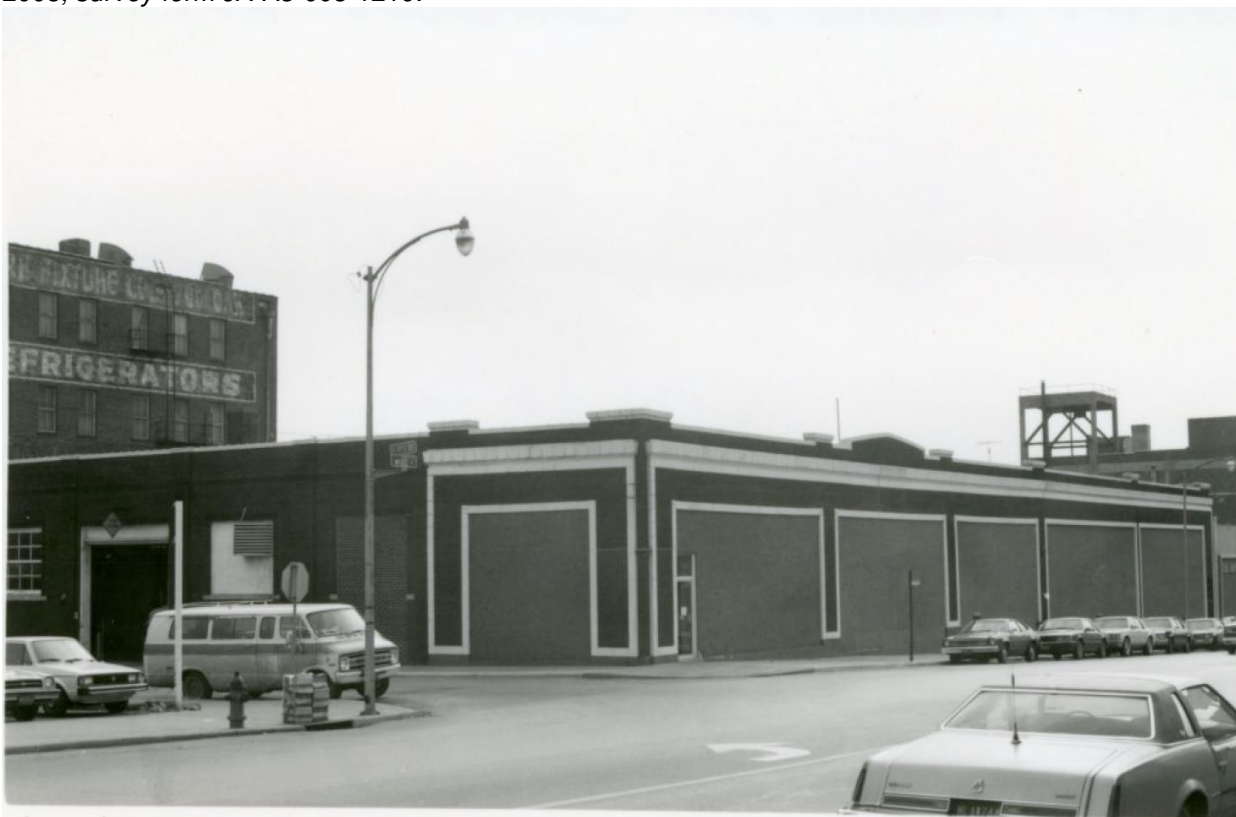
Figure 12. A 1982 photo shows 1701 McGee Street with storefront infill after the Kansas City Star newspaper purchased the building in 1968. *Source: Midtown Survey Final Report Kansas City, Jackson County, Missouri, 1981-85. Kansas City Landmarks Commission, Kansas City, Missouri, 2008, survey form JA-A3-008-1219.*

Mann Automatic Transmission Company, an auto repair business operated at 1900 McGee Street (no longer extant) in 1967. That building was vacant in 1968. Jones Auction Company moved out of 1827 McGee Street in 1968 and the building remained vacant through the 1960s. Beach-Wittman used the building at 1820 McGee Street as an automobile part warehouse space until 1967. The building was vacant in 1968. Puritan Compressed Gas Company operated their equipment division in 1701 McGee Street until 1967. The building sat vacant until the Kansas City Star purchased it in 1968 and altered the façade by infilling the storefront (*Figure 13*).

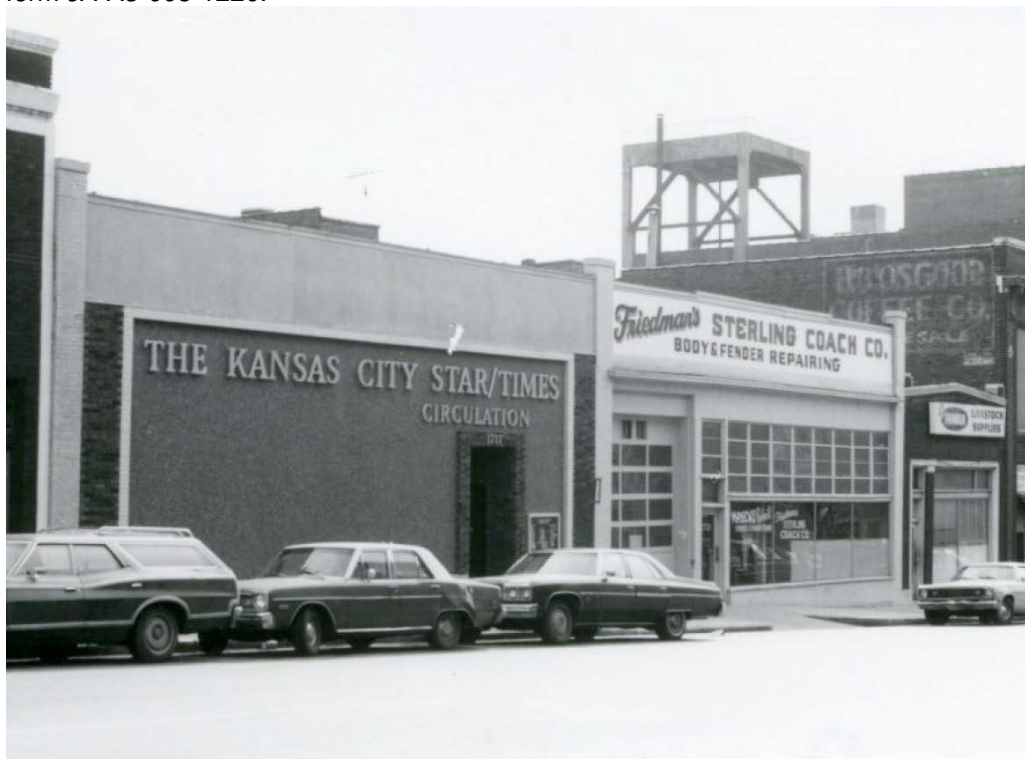
Figure 13. A 1982 photo shows 1717, 1721, and 1725 McGee Street. The Kansas City Star altered the storefront of 1717 McGee Street. 1721 is still an auto-related business and a livestock supply company occupies 1725 McGee Street. *Source: Midtown Survey Final Report Kansas City, Jackson County, Missouri, 1981-85. Kansas City Landmarks Commission, Kansas City, Missouri, 2008, survey form JA-A3-008-1220.*

and parapet by adding the wood storefront frame and vertical wood paneling. Alterations to the parapet and storefront of 1717 McGee compromise its ability to convey its significance as an early twentieth century automobile-related commercial building. The resource is recommended as non-contributing to the potential historic district.
