National Register of Historic Places Registration Form

Historic name Miller, Henry, House

Street & number 106 Cape Road

The Henry Miller House, circa 1843, is a two story, side gabled, wood frame I house with a one-story ell creating an “L” shaped footprint. Located at 106 Cape Road, Bloomfield, Missouri, the house has a medium pitch asphalt shingle roof with an exterior chimney on the east elevation and five evenly spaced windows on the second level of the façade (north elevation). The first level of the façade has seven openings; five windows located directly below the windows on the second level, and a door located between the first two windows on both the east and west ends of the façade. The original wood windows and doors on both levels of the north elevation are intact behind the plywood coverings. The house was used as a residence continually from the time it was constructed until approximately 1979 and has been vacant ever since. An addition extending the original one-story ell portion of the home was constructed in approximately 1910. The house was wired for electricity during this time and the current wood clapboard siding was added as well. Originally, the house sat

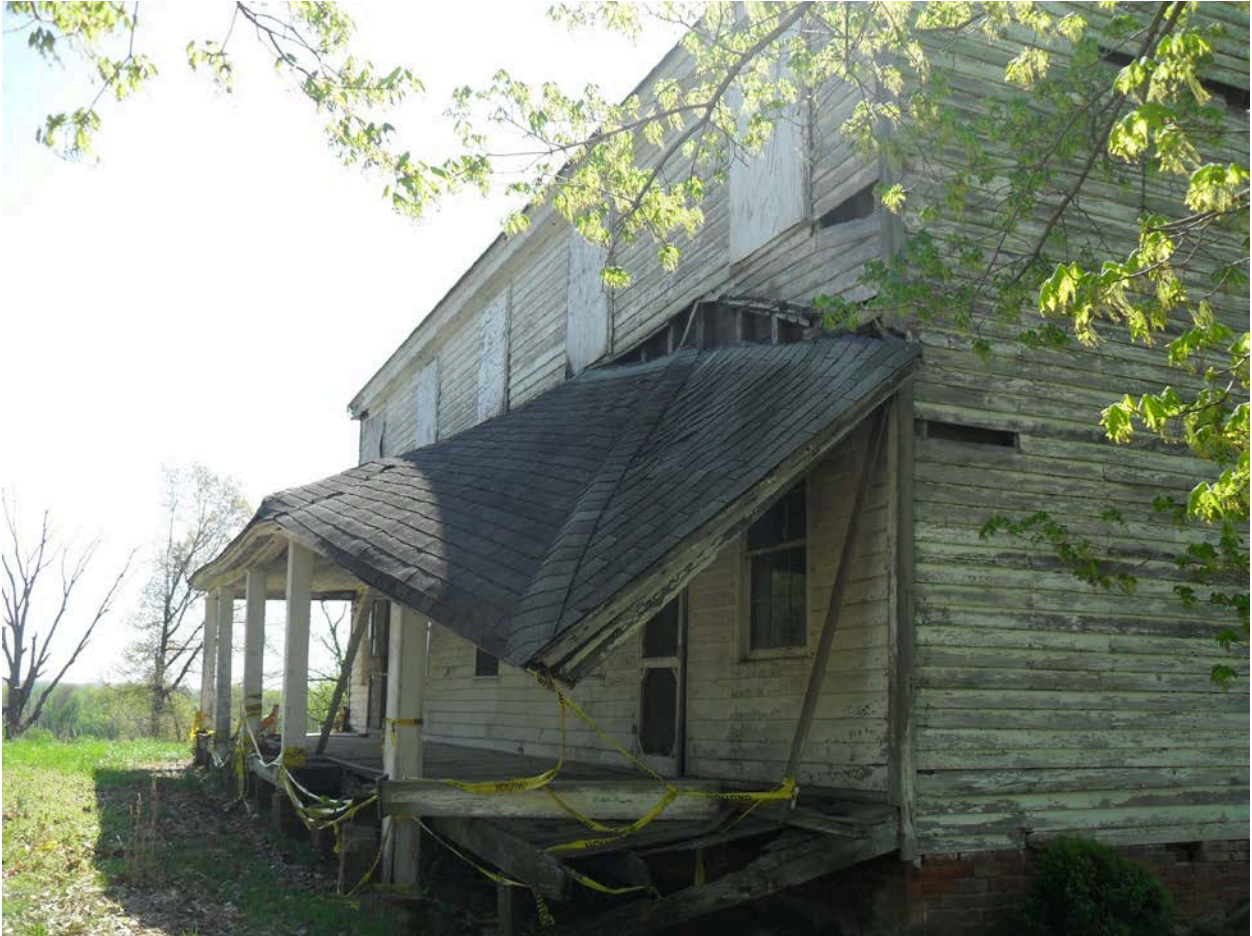
Figure 3

Henry Miller House, with front porch partially collapsed, April 2011

There are seven openings across the first level of the north façade (see photo 1). Five of the openings are six-over-six original wood sash windows and two original wood doors, one located at the eastern end and one located on the western end. On the second level of the façade, there are five window openings, containing original six-over-six wood sash windows. Currently, all façade openings are covered with plywood (see photo 8). Originally, a porch ran across the length of the north façade of the house with a small set of stairs at the eastern end. The porch rested on masonry piers constructed of modern brick with Portland cement mortar, likely added during changes to the foundation which occurred in the 1950s. The remainder of the porch was wood with a hipped roof supported by simple square pillars. The porch was removed in 2012 after the western end collapsed due to significant moisture damage (see Figures 3 and 4).²

foundation has eroded in some locations and there are missing bricks. The front porch was removed in 2012 after the western end collapsed, threatening the house's façade. The back porch remains intact, however, the brick masonry piers and the wood pillars are in significant disrepair (see photo 6).

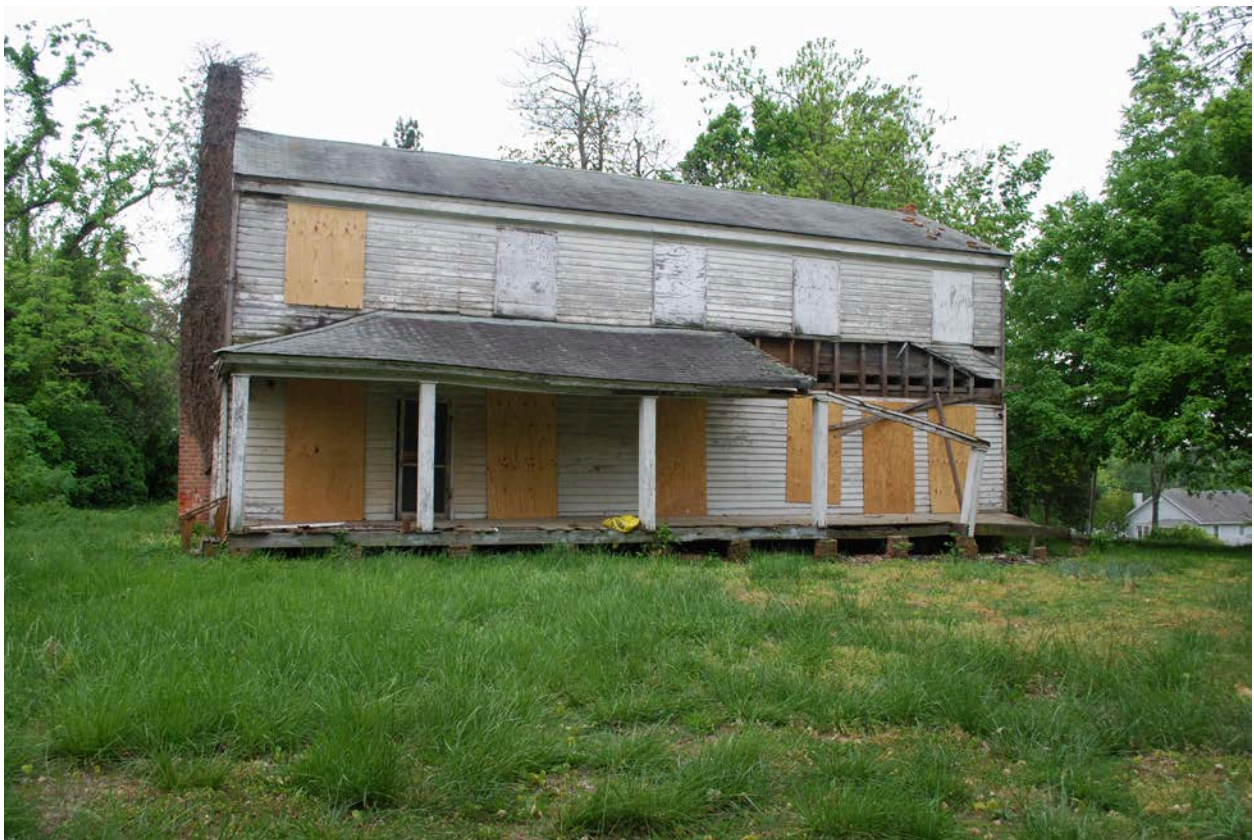
Figure 4

Henry Miller House, with front porch partially intact, April 2012

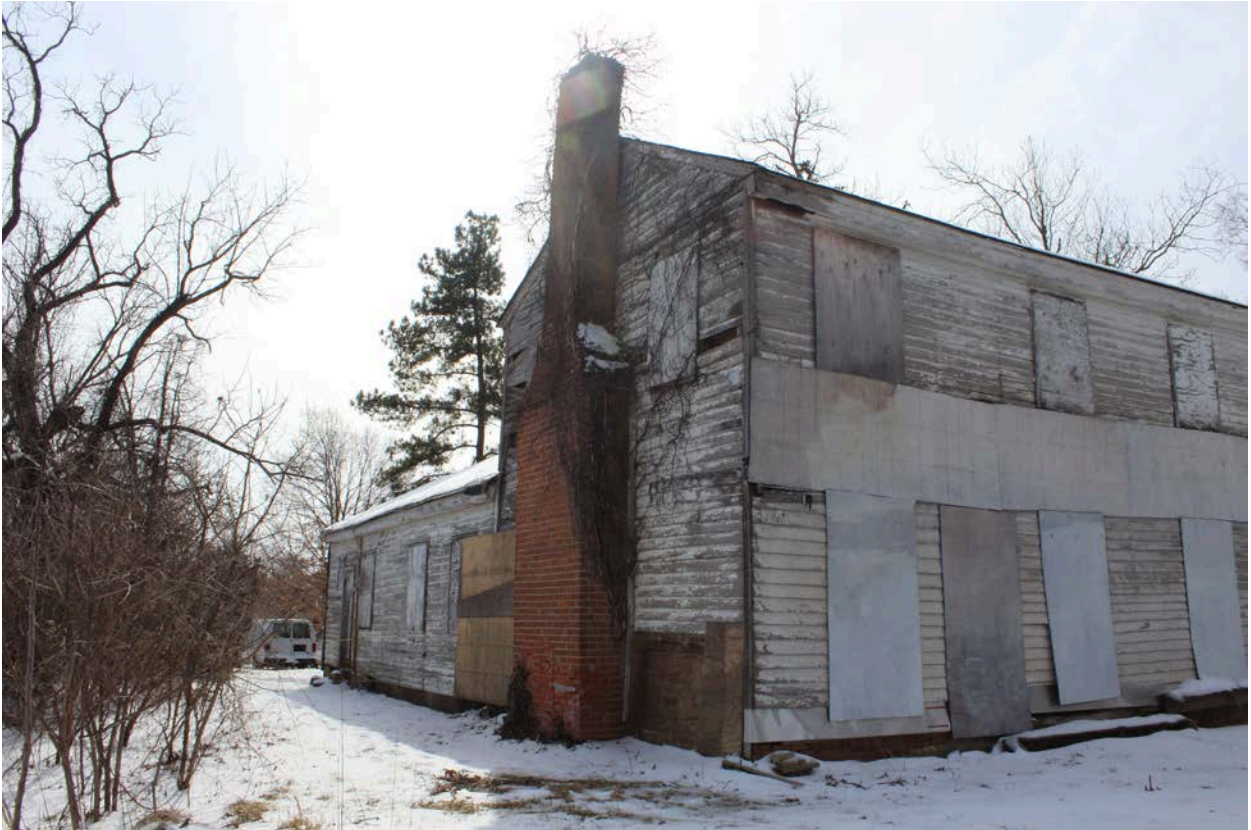
Figure 5

Henry Miller House, eastern elevation, February 2014

Photo by Chris Kinder, February 12, 2014. Note: No changes to the house have occurred since 2014, with the exception of the landscaping becoming overgrown and obscuring the view (see Photo 1).

An external chimney is located on the eastern elevation of the main house (see photo 1 and Figure 5). There are three openings on the eastern elevation of the main house. One is located on the first floor on the south side of the chimney, and two are located on the second floor on either side of the chimney. Plywood currently covers the openings, but the original six-over-six wood sash window frames remain underneath. The eastern elevation of the ell is flush with the east elevation of the front portion of the home. The eastern elevation of the ell portion of the house contains four openings including three historic wood six-over-six sash windows, covered with plywood, on the north end of the elevation and a historic wood door on the south end.

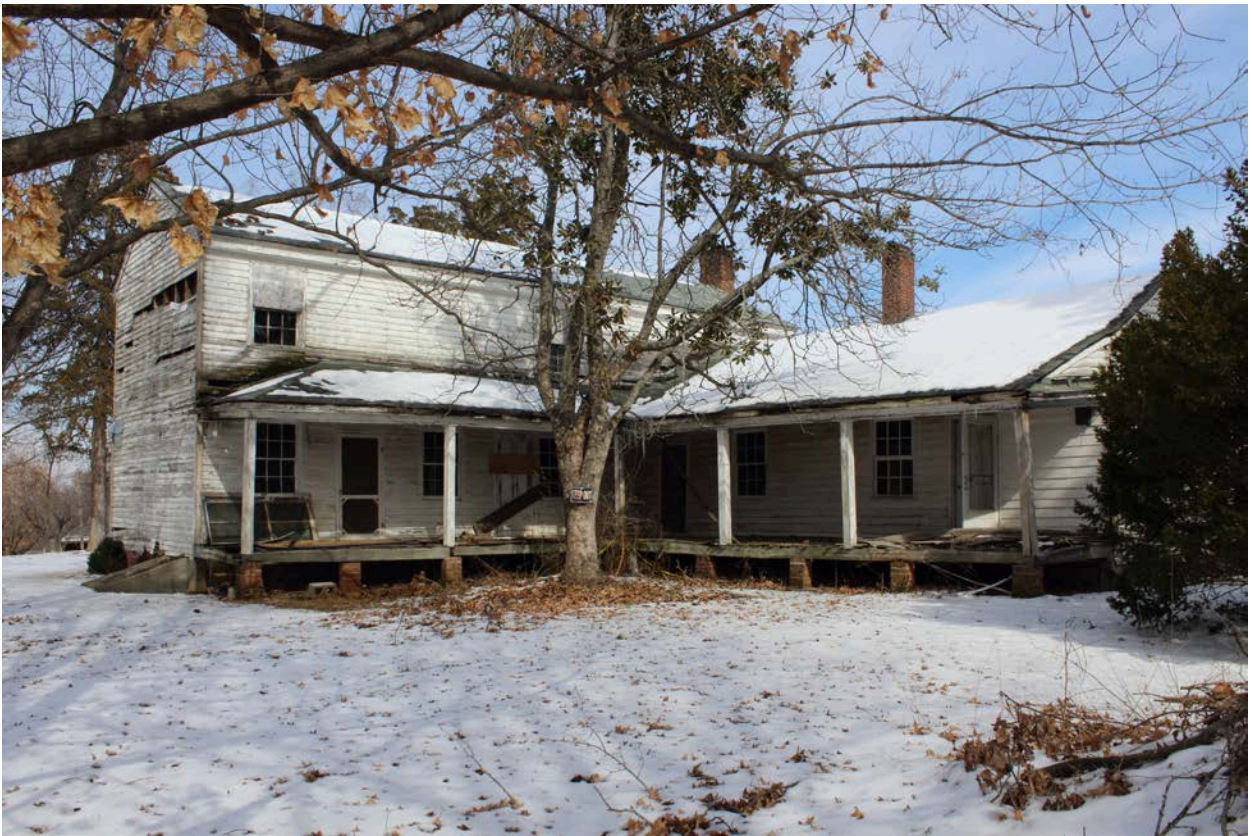
Figure 6

Henry Miller House, west and south elevations, February 2014

Photo by Chris Kinder, February 12, 2014. Note: No changes to the house have occurred since 2014, with the exception of the landscaping becoming overgrown and obscuring the view (see Photo 2).

The western elevation of the main portion of the house contains no openings (see photo 2 and Figure 6). Evidence on the interior wall suggests an exterior chimney was likely located on this elevation as well, but it was removed at an unknown date (see photo 3). The 1910s remodeling is a likely alteration date because the exterior wood clapboard siding installed at that time is continuous across the western elevation³. Also located on the western elevation is a modern 1950s era Portland concrete entrance to a historic brick cellar (see photos 2 and 12).

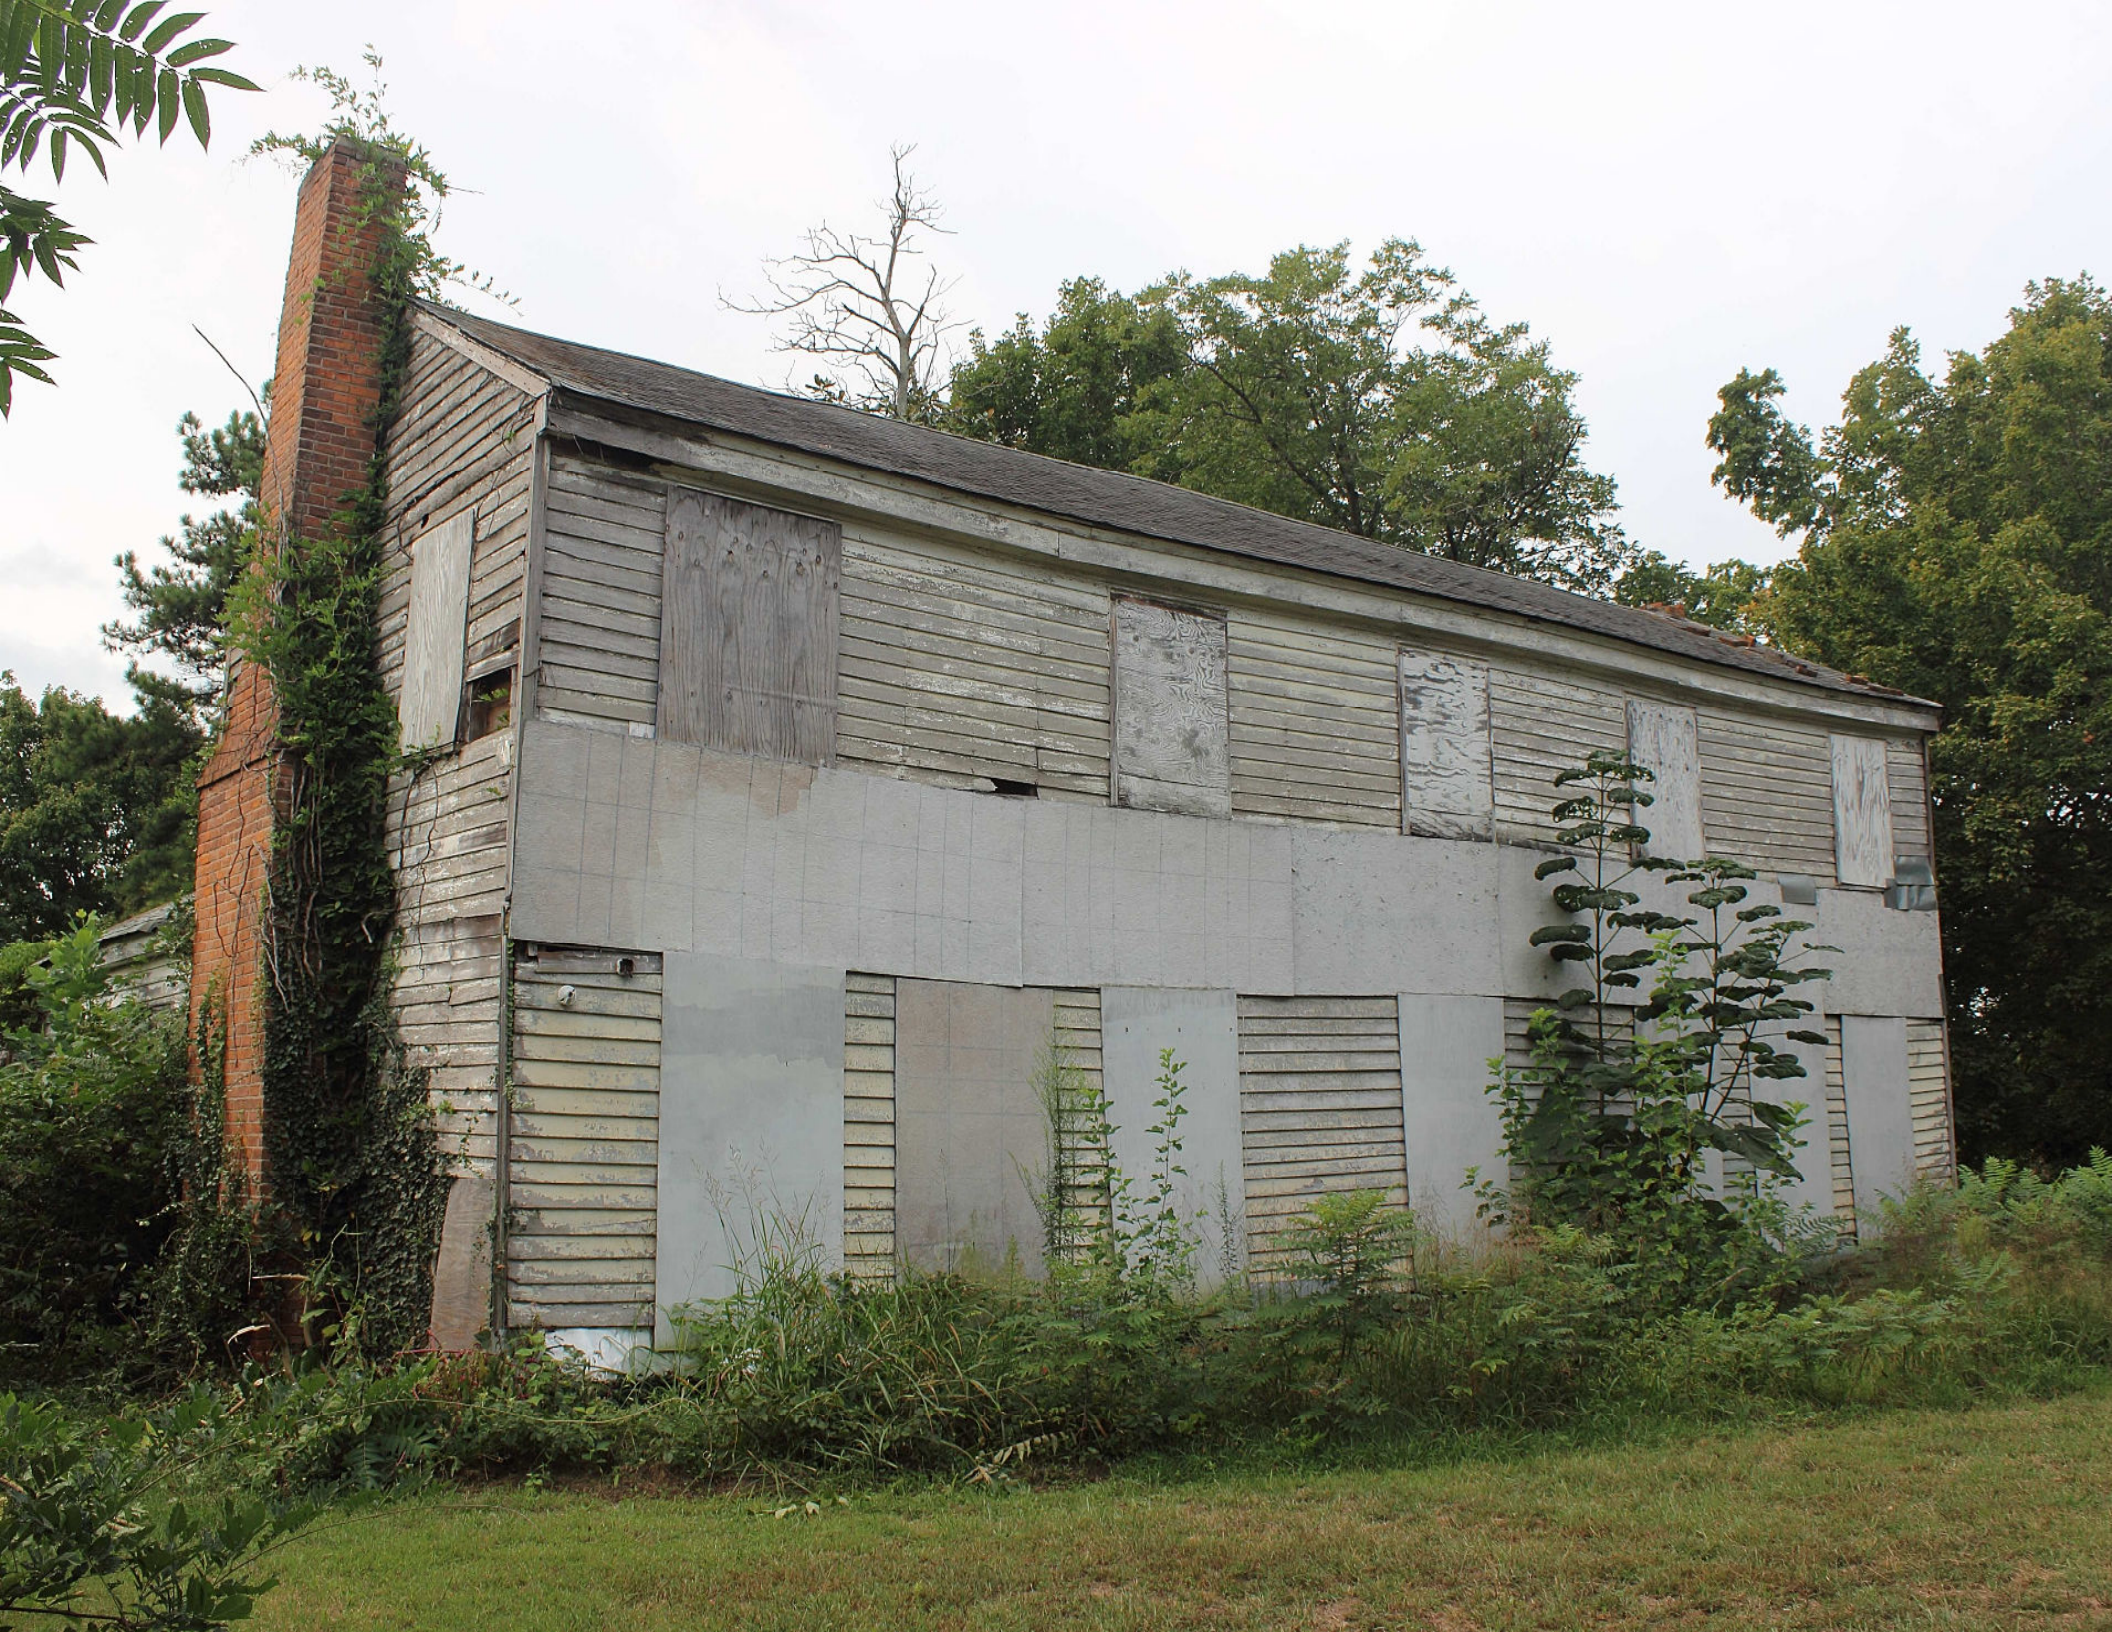
1 of 12: North façade and east elevation, facing south-west

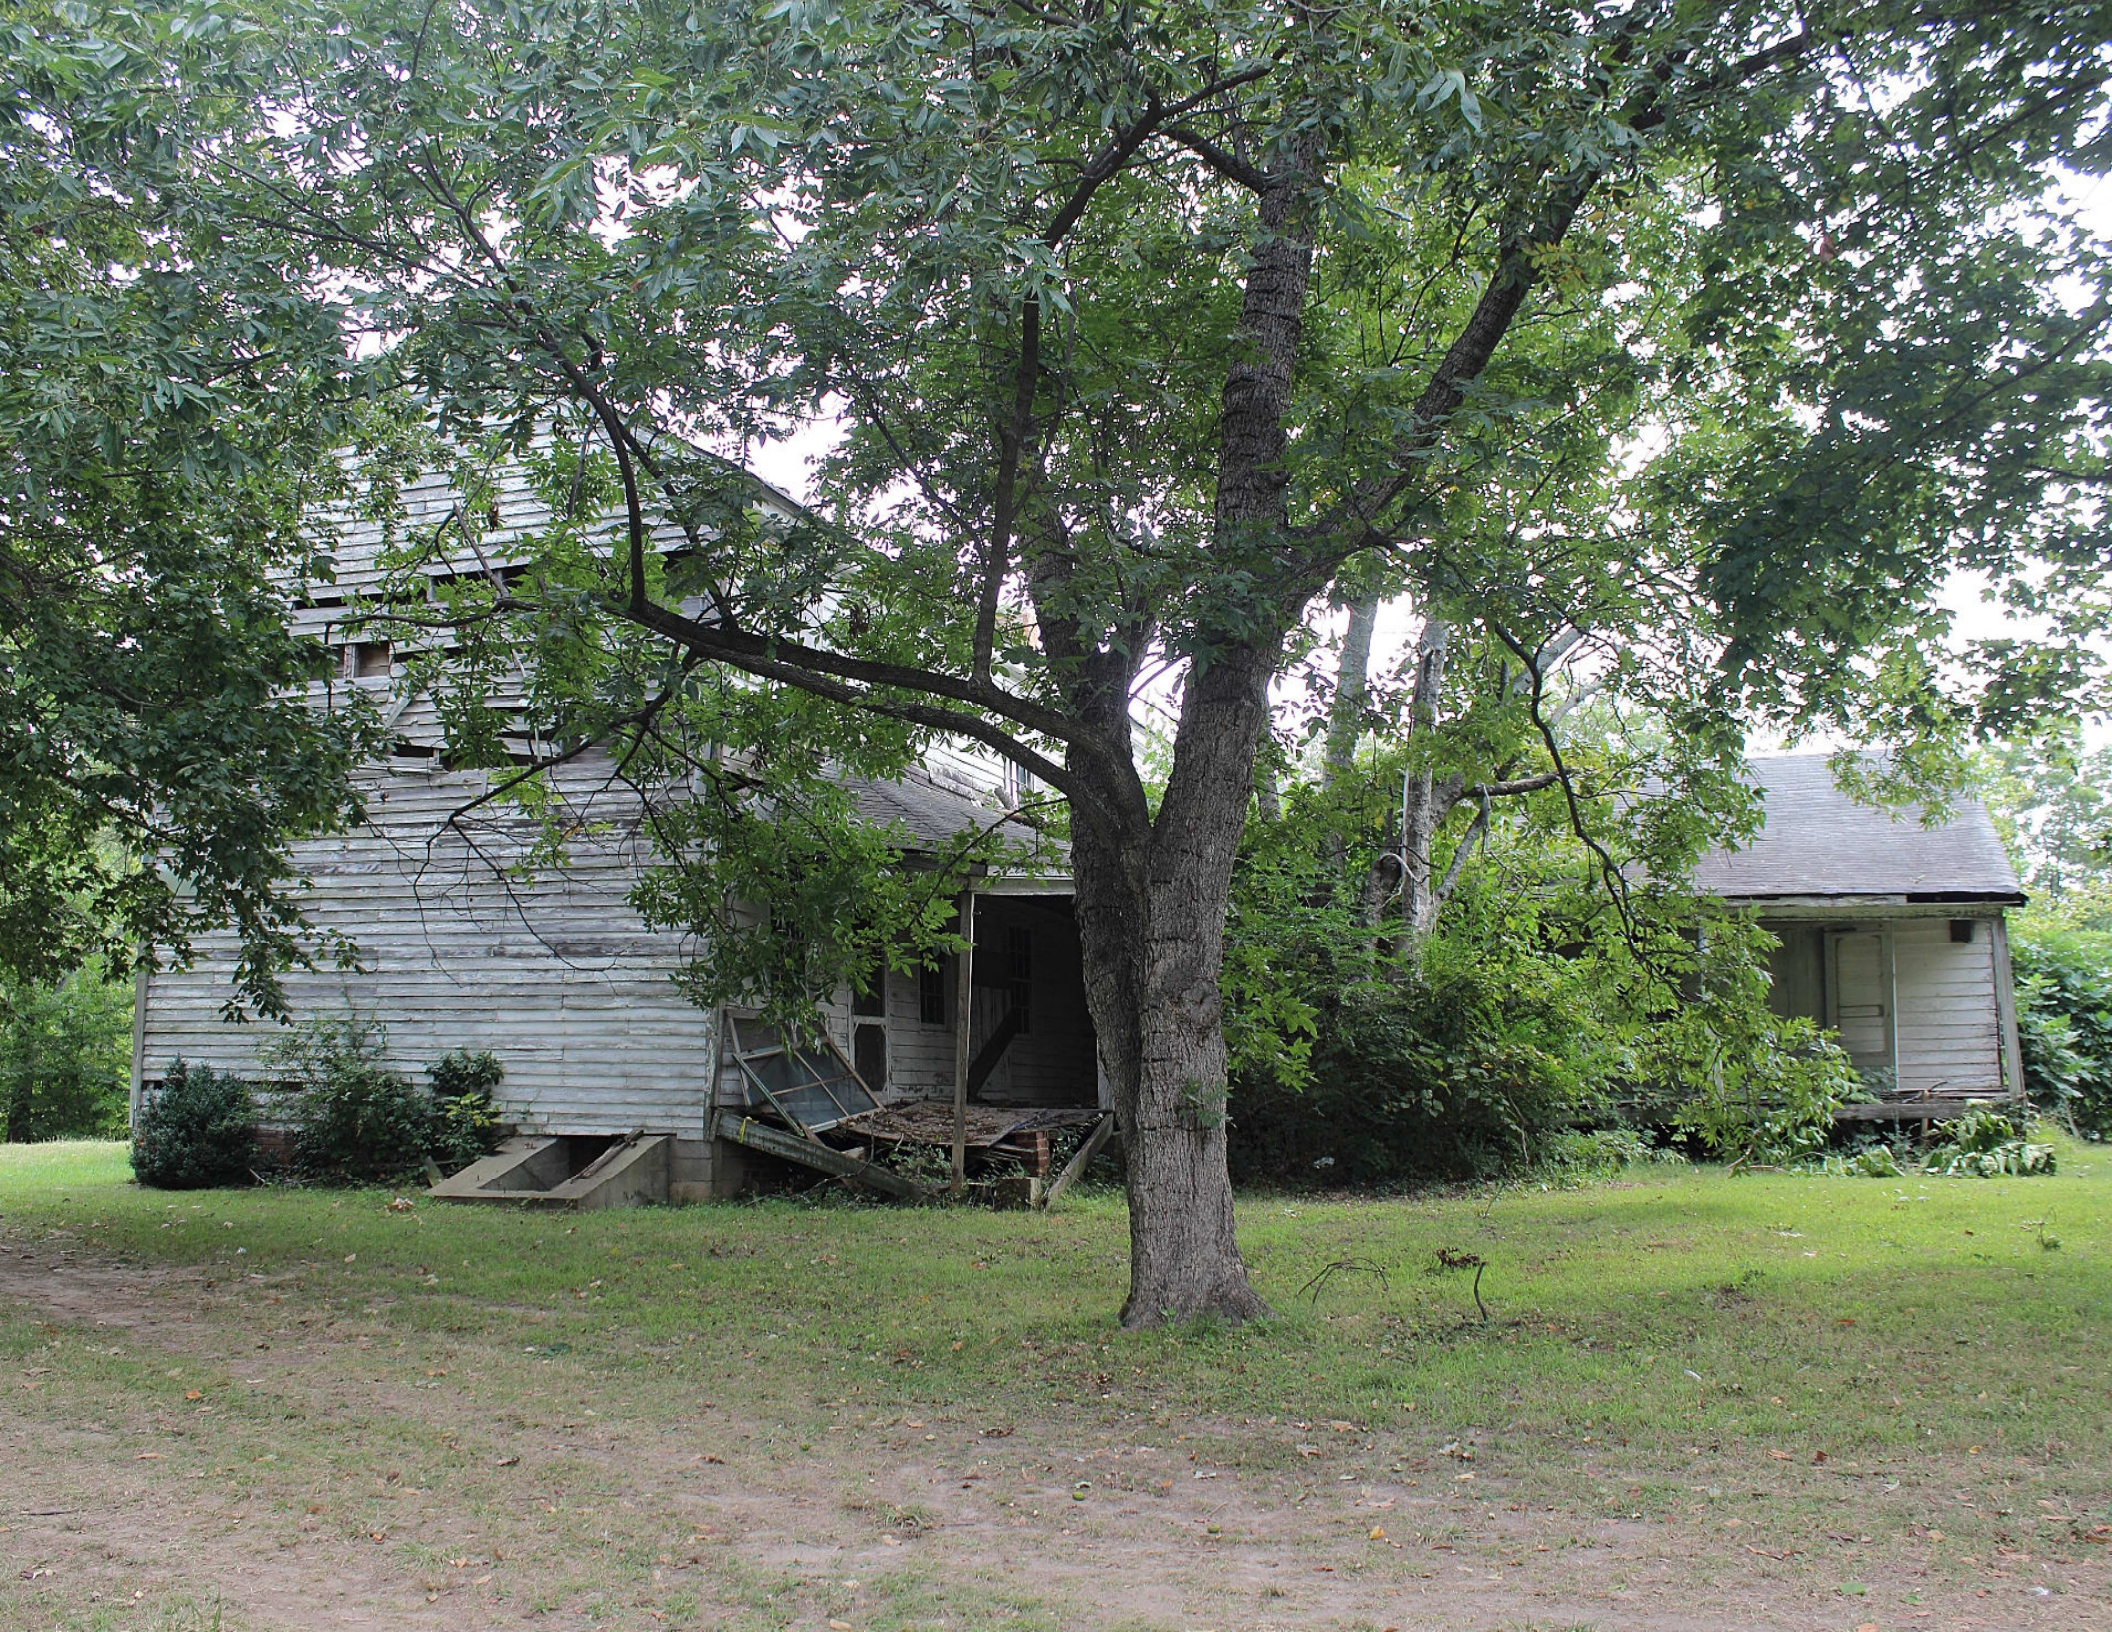
2 of 12: West elevation and south elevation), facing north-east

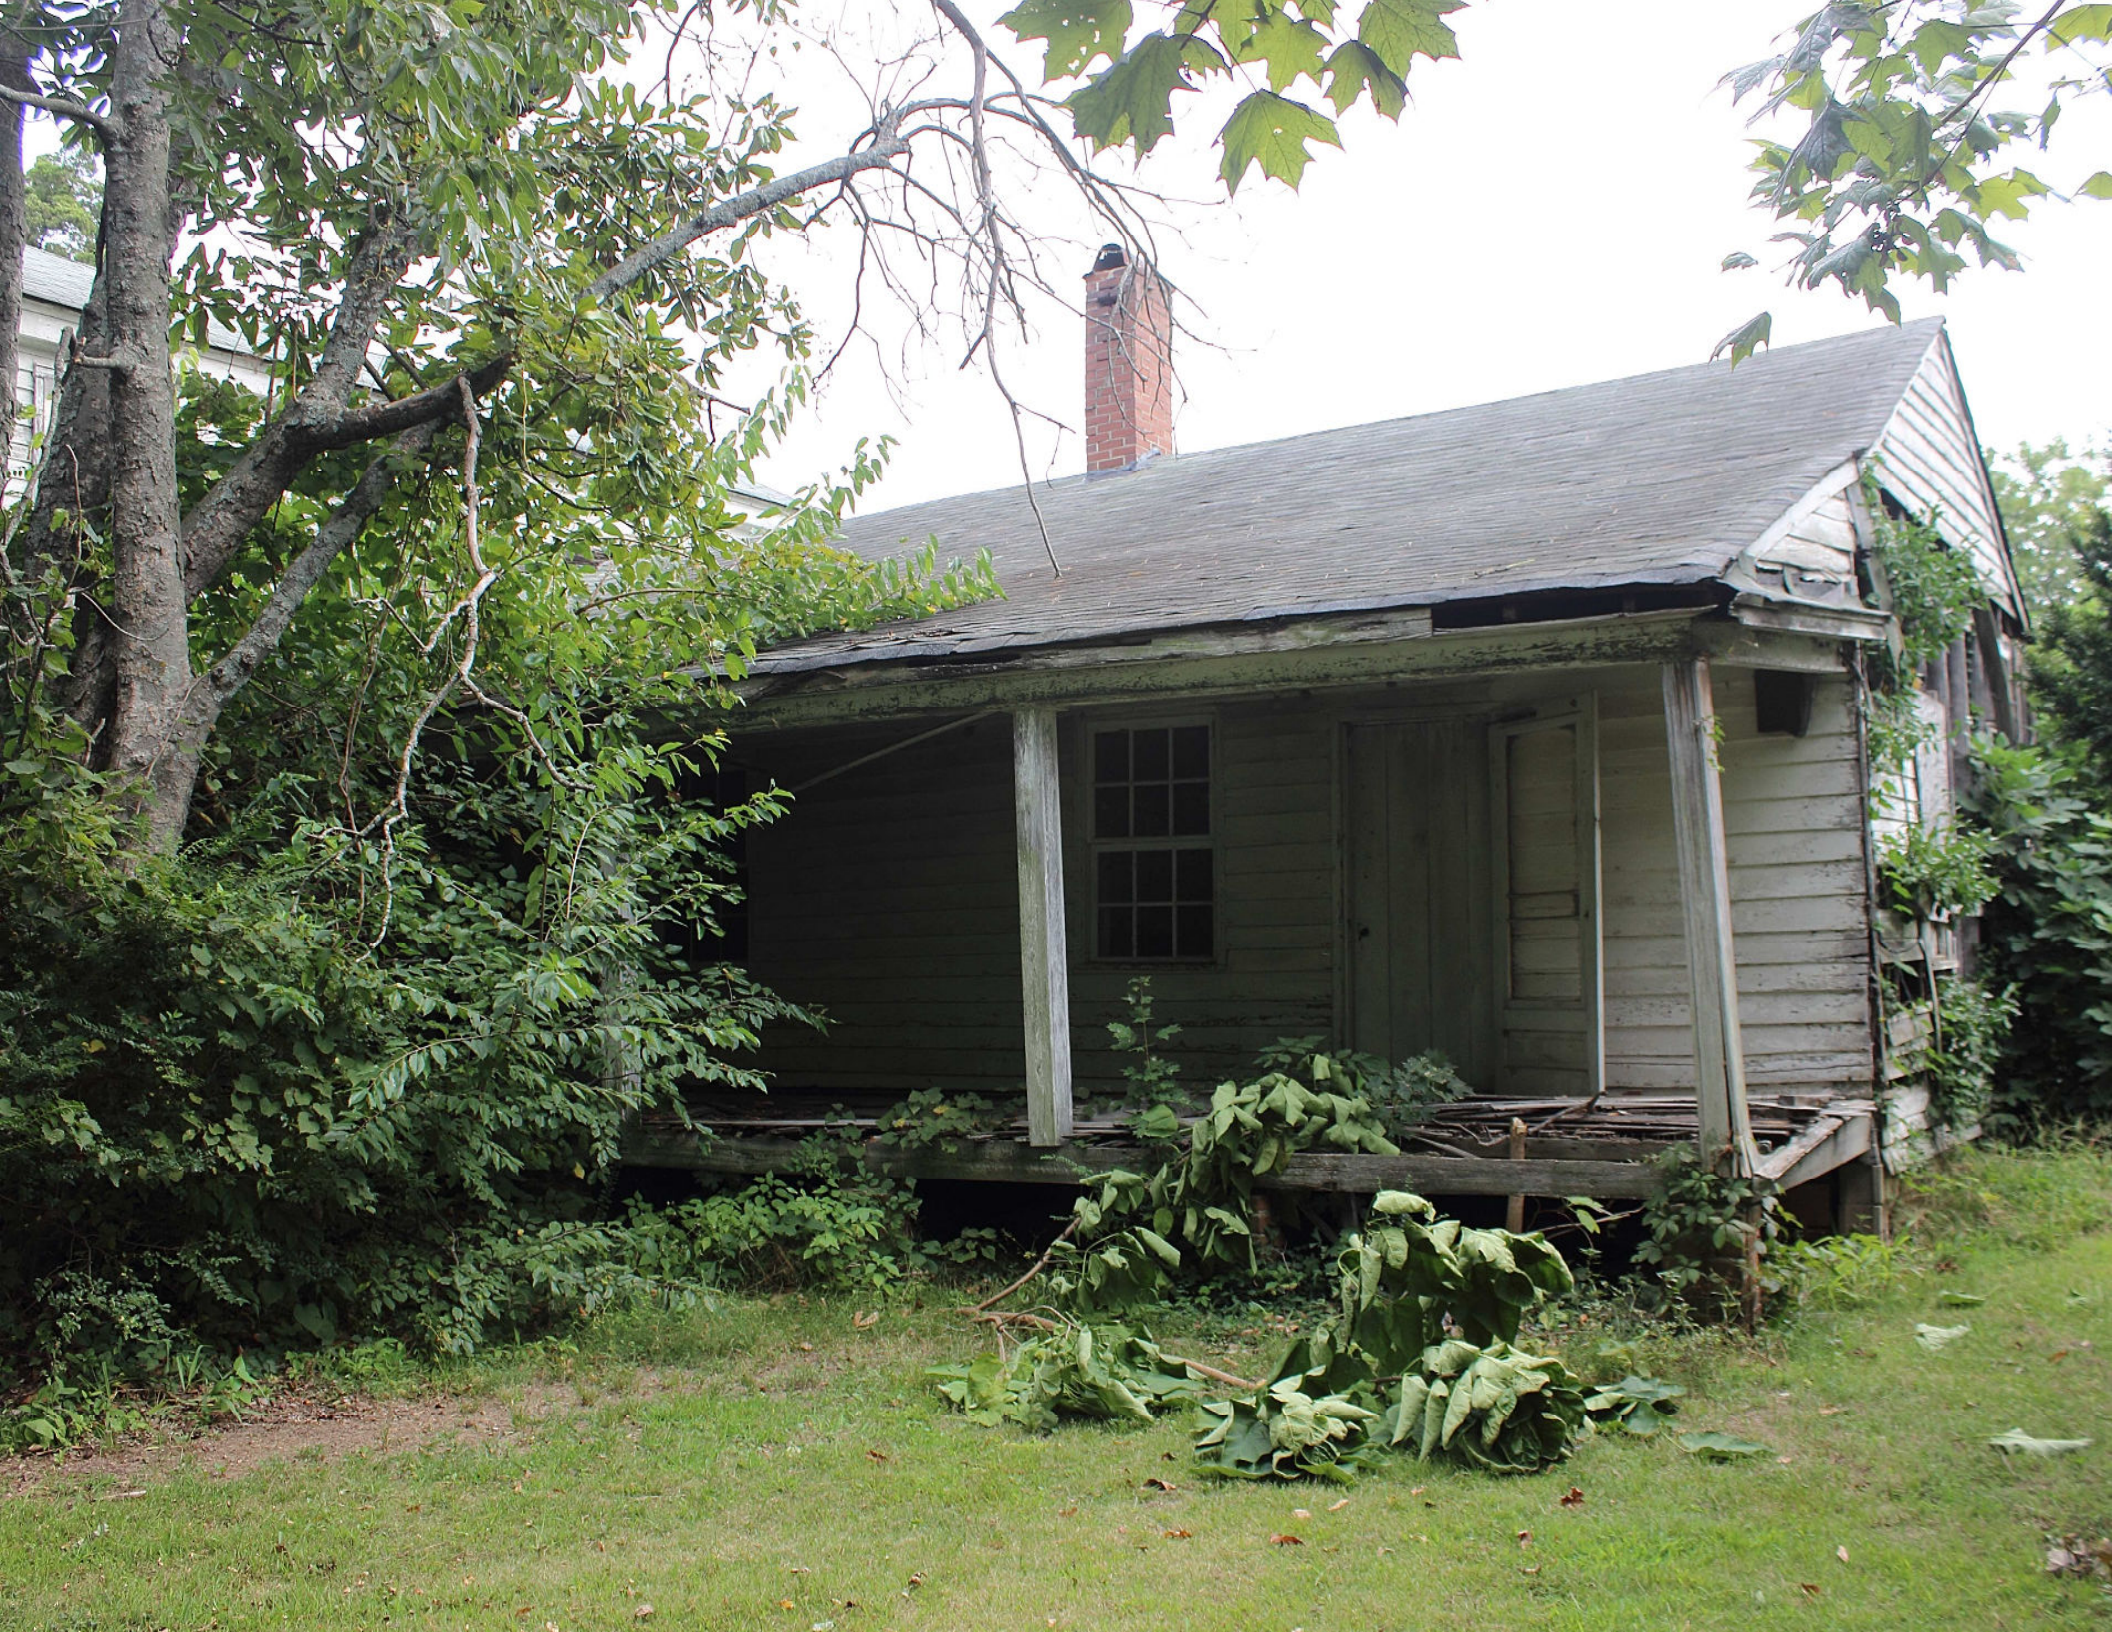
5 of 12: West elevation of ell, facing north-east

The western elevation of the ell portion of the home contains four openings (see photo 5). Two historic wood six-over-six sash windows are located in the center of the elevation. There is one original wood door located at the northern end in the original portion of the ell, a second door is located at the southern end, which opens to the kitchen added in circa 1910.

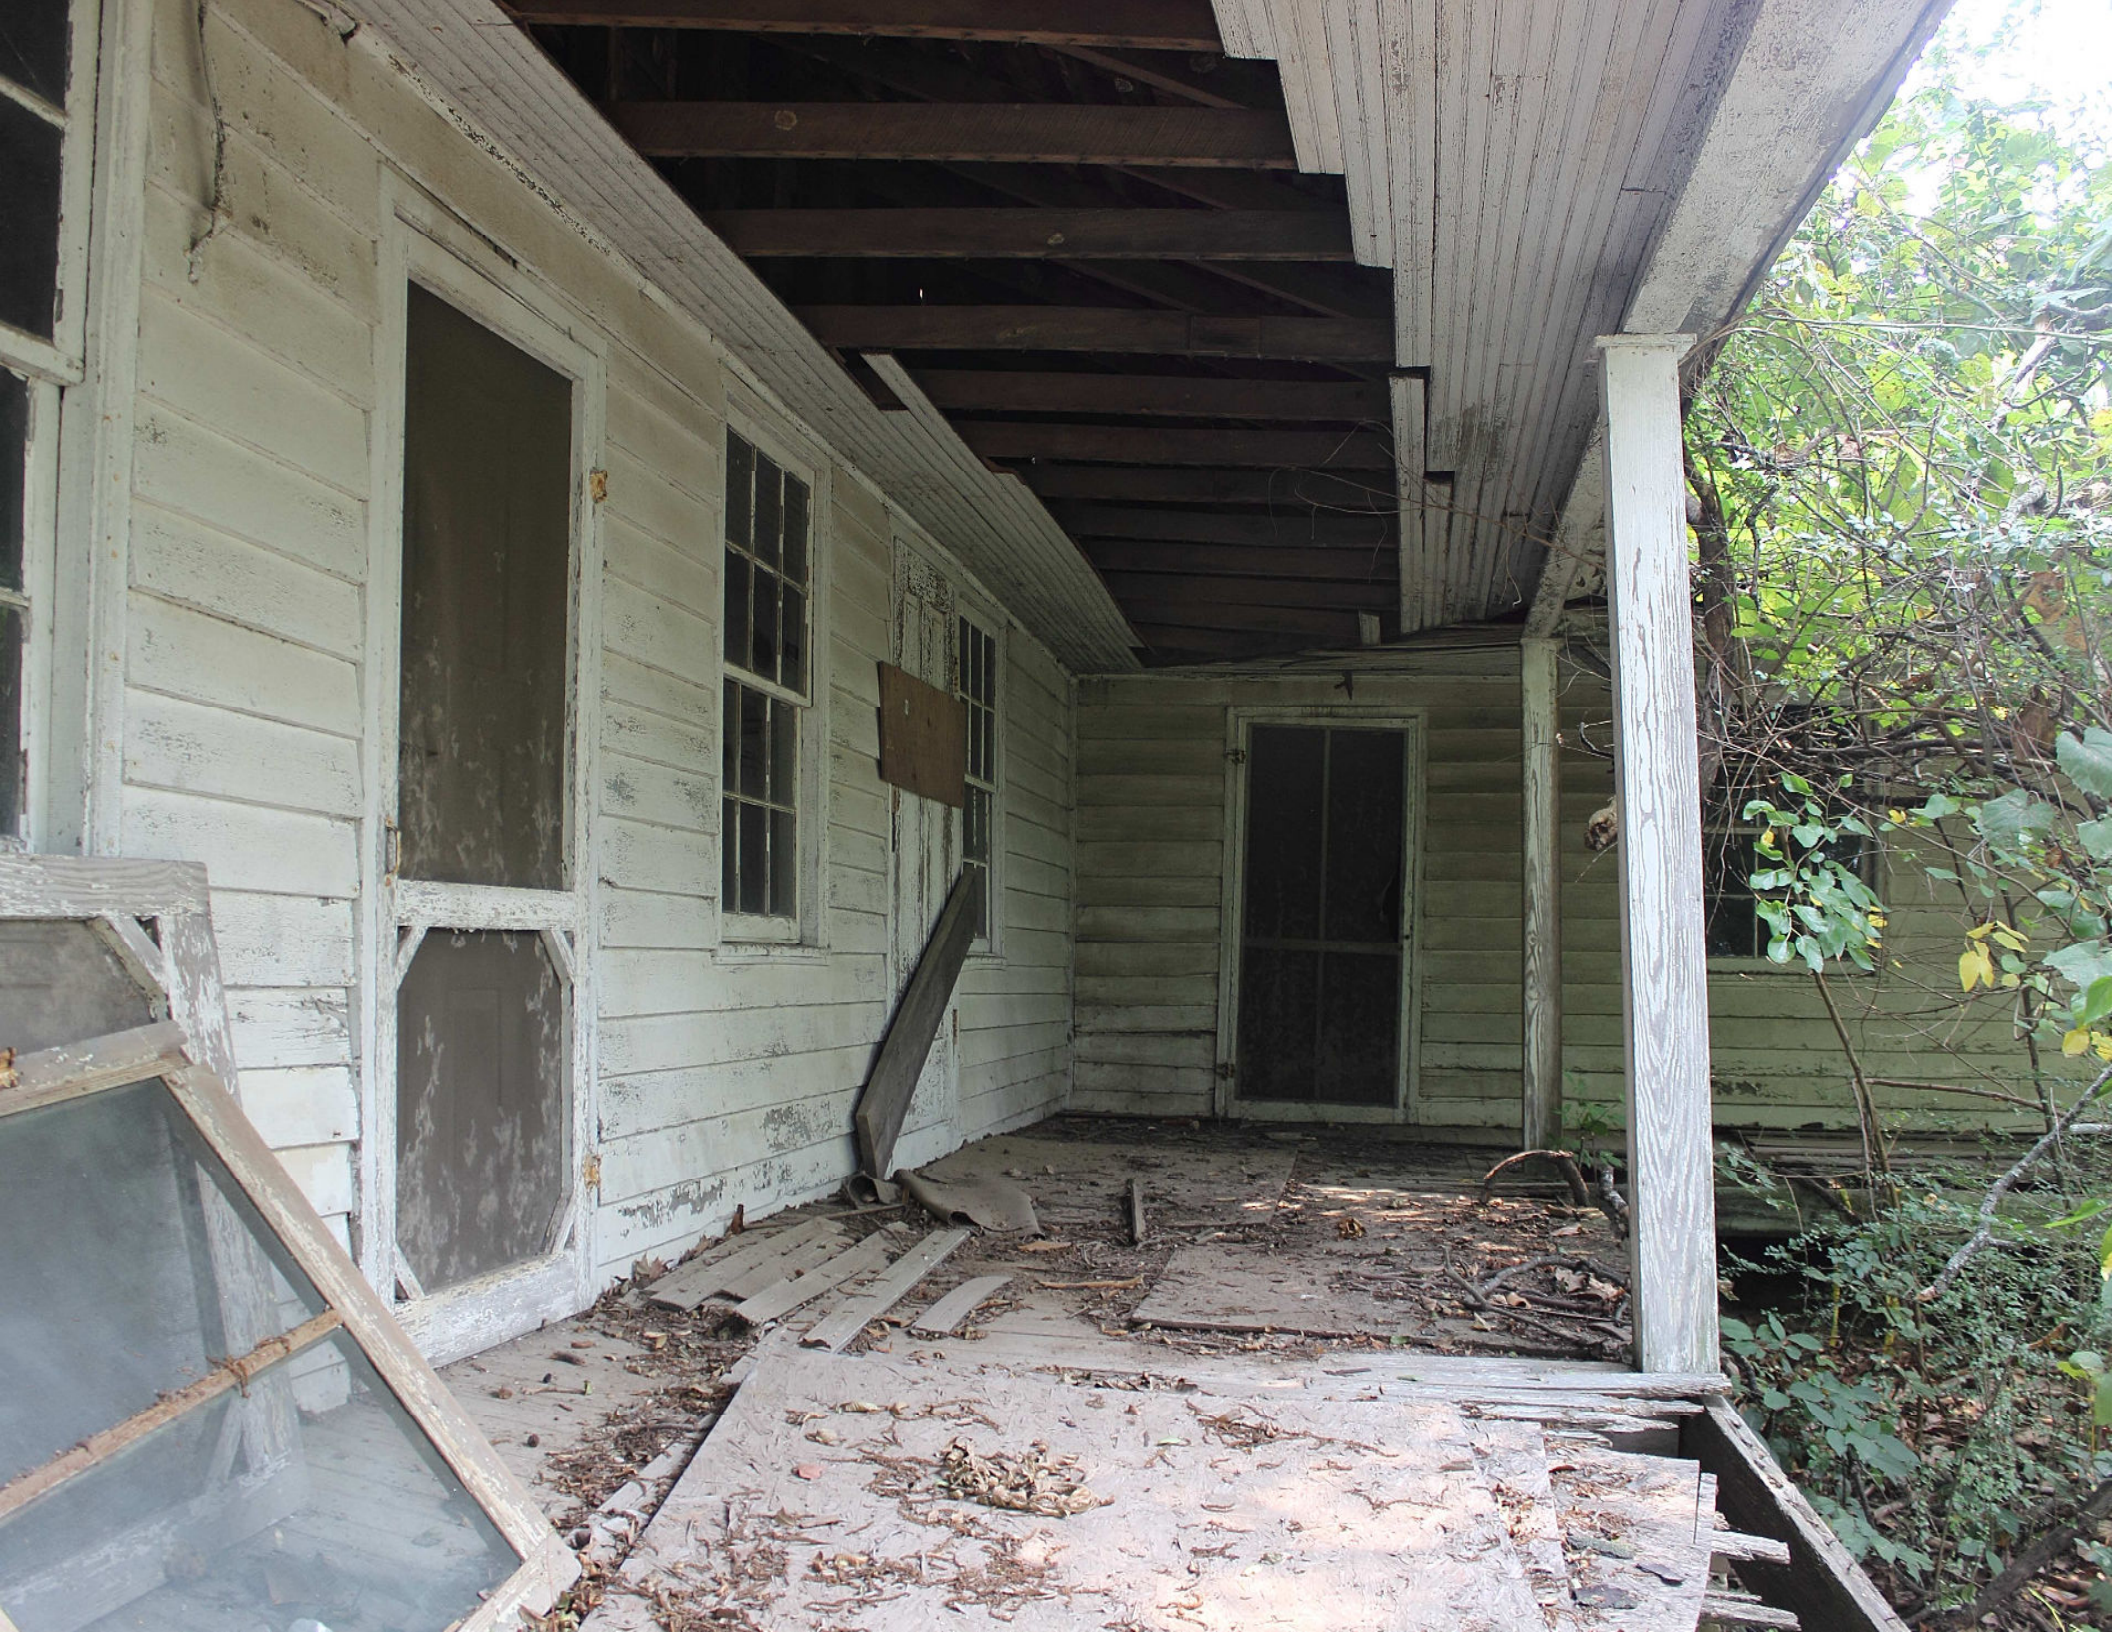
6 of 12: Rear porch, facing east

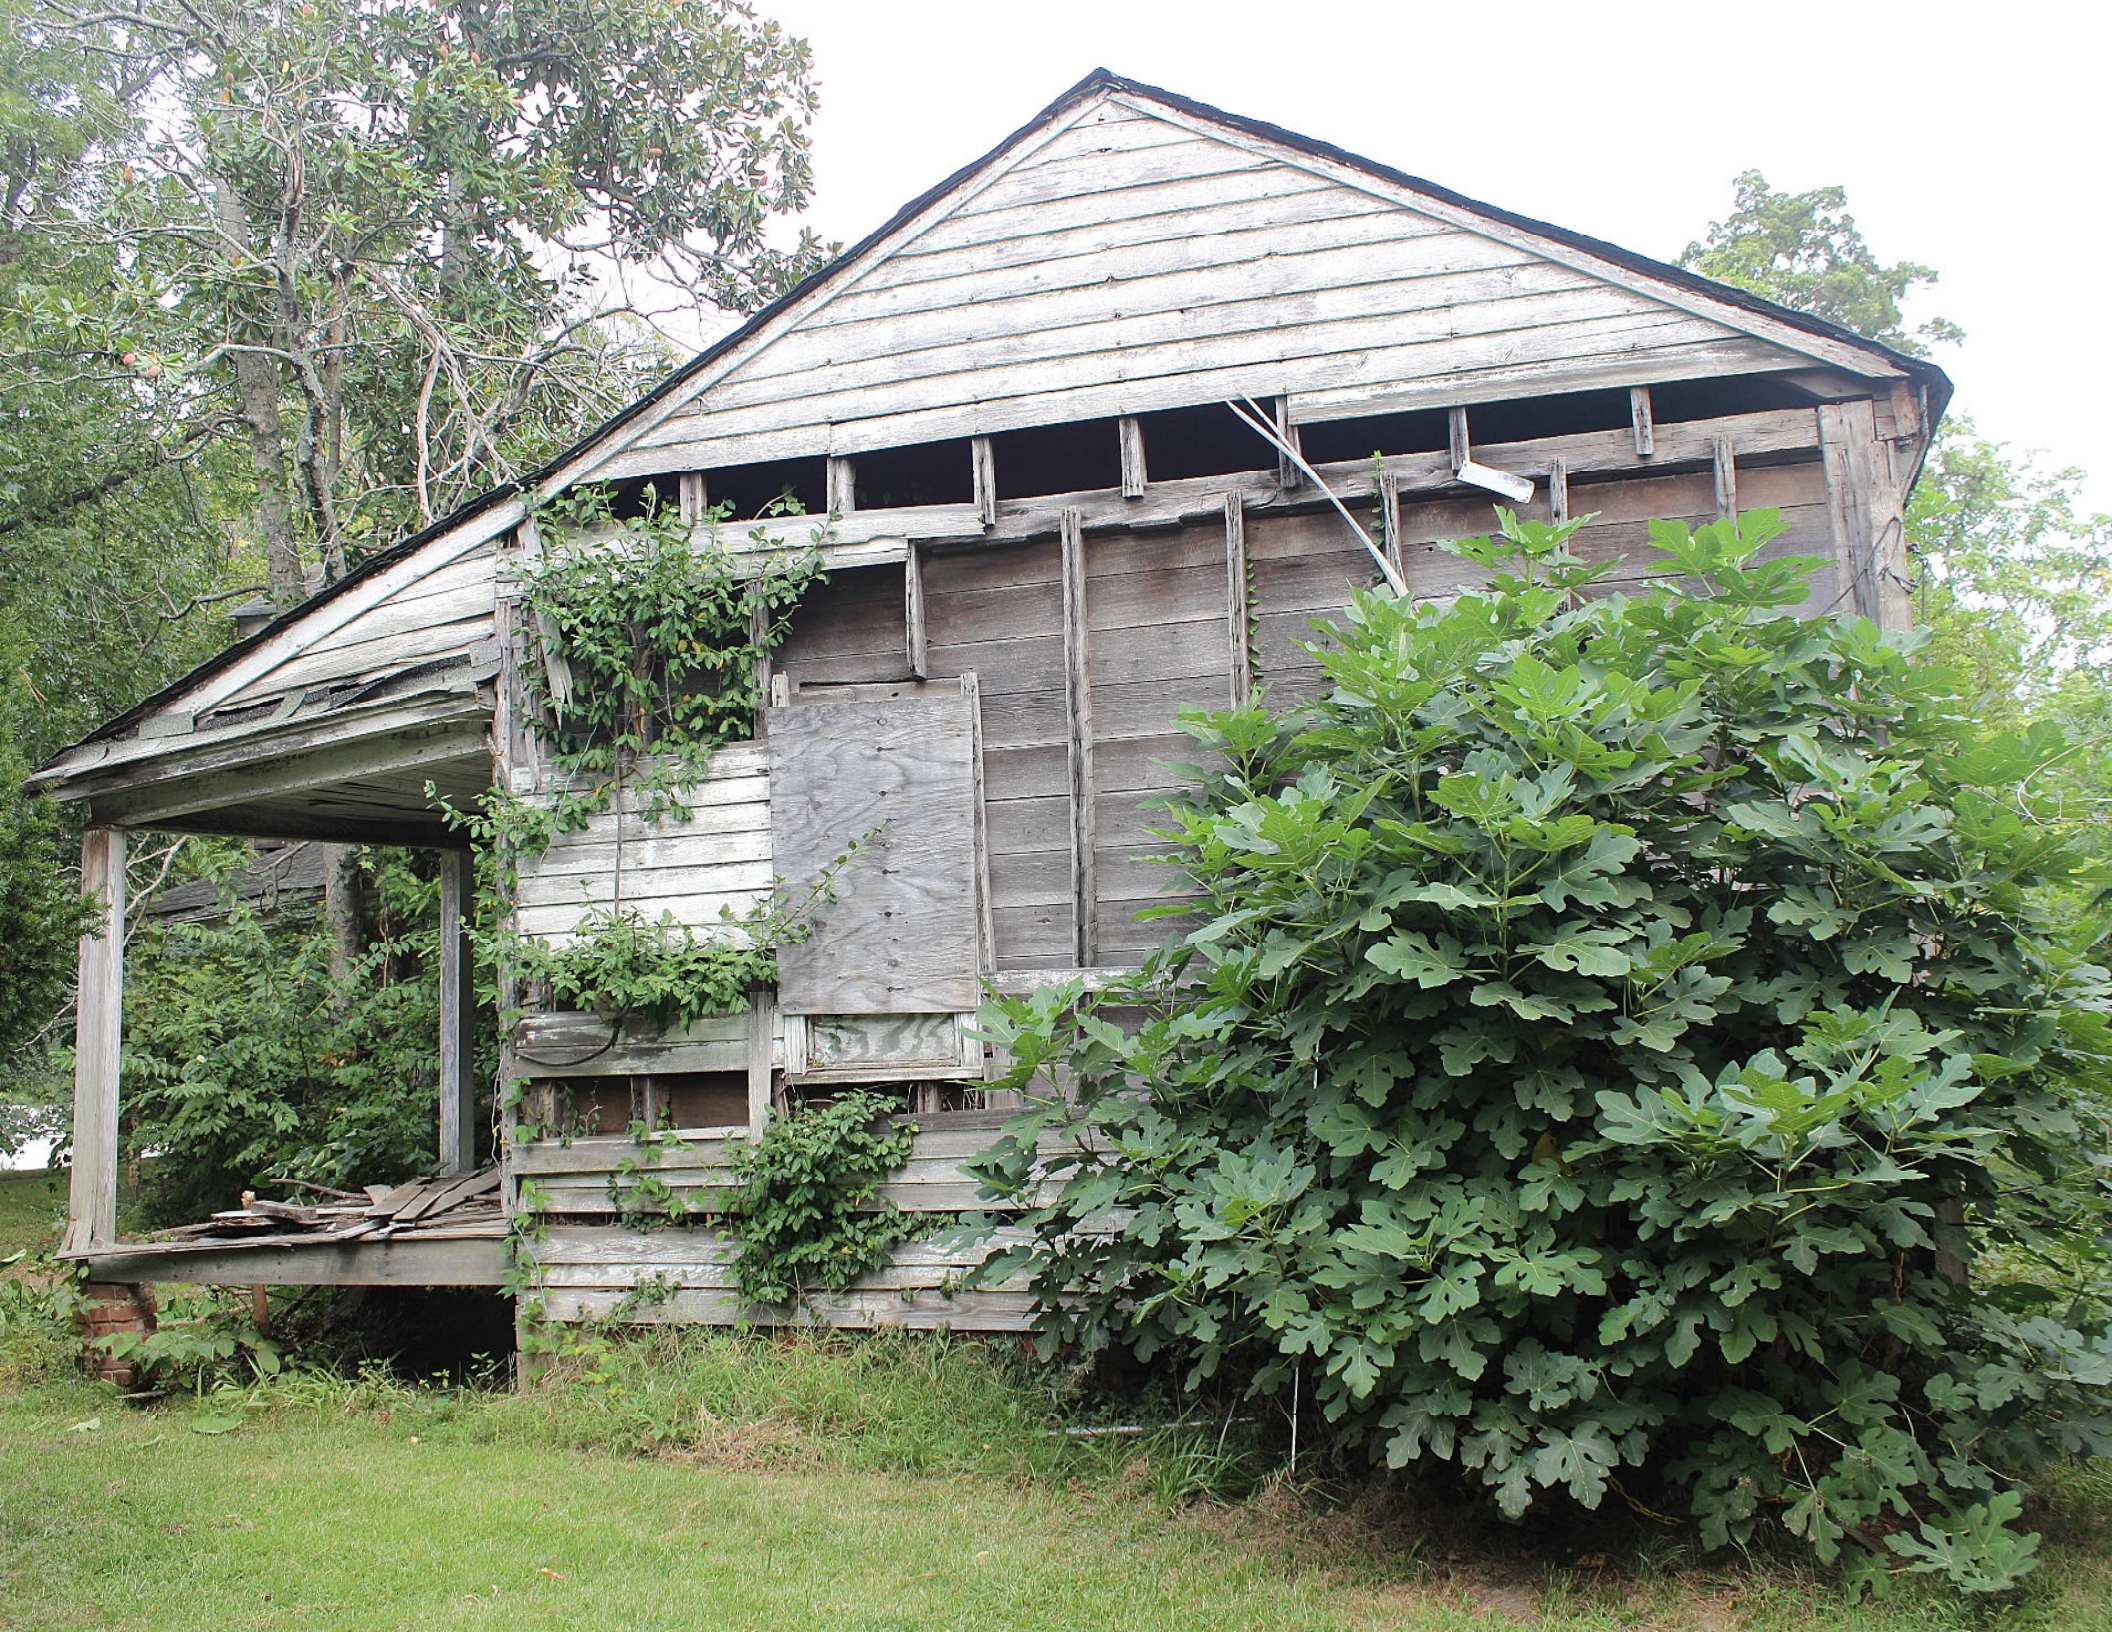
7 of 12: South elevation (ell), facing north

The exterior is in a substantial state of disrepair. Siding is missing in several locations, most prominently on the southern elevation of the ell portion (see photo 7). The mortar in the brick
