National Register of Historic Places Registration Form

Historic name Miller, Henry, House

Street & number 106 Cape Road

The Henry Miller House, circa 1843, is a two story, side gabled, wood frame I house with a one-story ell creating an “L” shaped footprint. Located at 106 Cape Road, Bloomfield, Missouri, the house has a medium pitch asphalt shingle roof with an exterior chimney on the east elevation and five evenly spaced windows on the second level of the façade (north elevation). The first level of the façade has seven openings; five windows located directly below the windows on the second level, and a door located between the first two windows on both the east and west ends of the façade. The original wood windows and doors on both levels of the north elevation are intact behind the plywood coverings. The house was used as a residence continually from the time it was constructed until approximately 1979 and has been vacant ever since. An addition extending the original one-story ell portion of the home was constructed in approximately 1910. The house was wired for electricity during this time and the current wood clapboard siding was added as well. Originally, the house sat

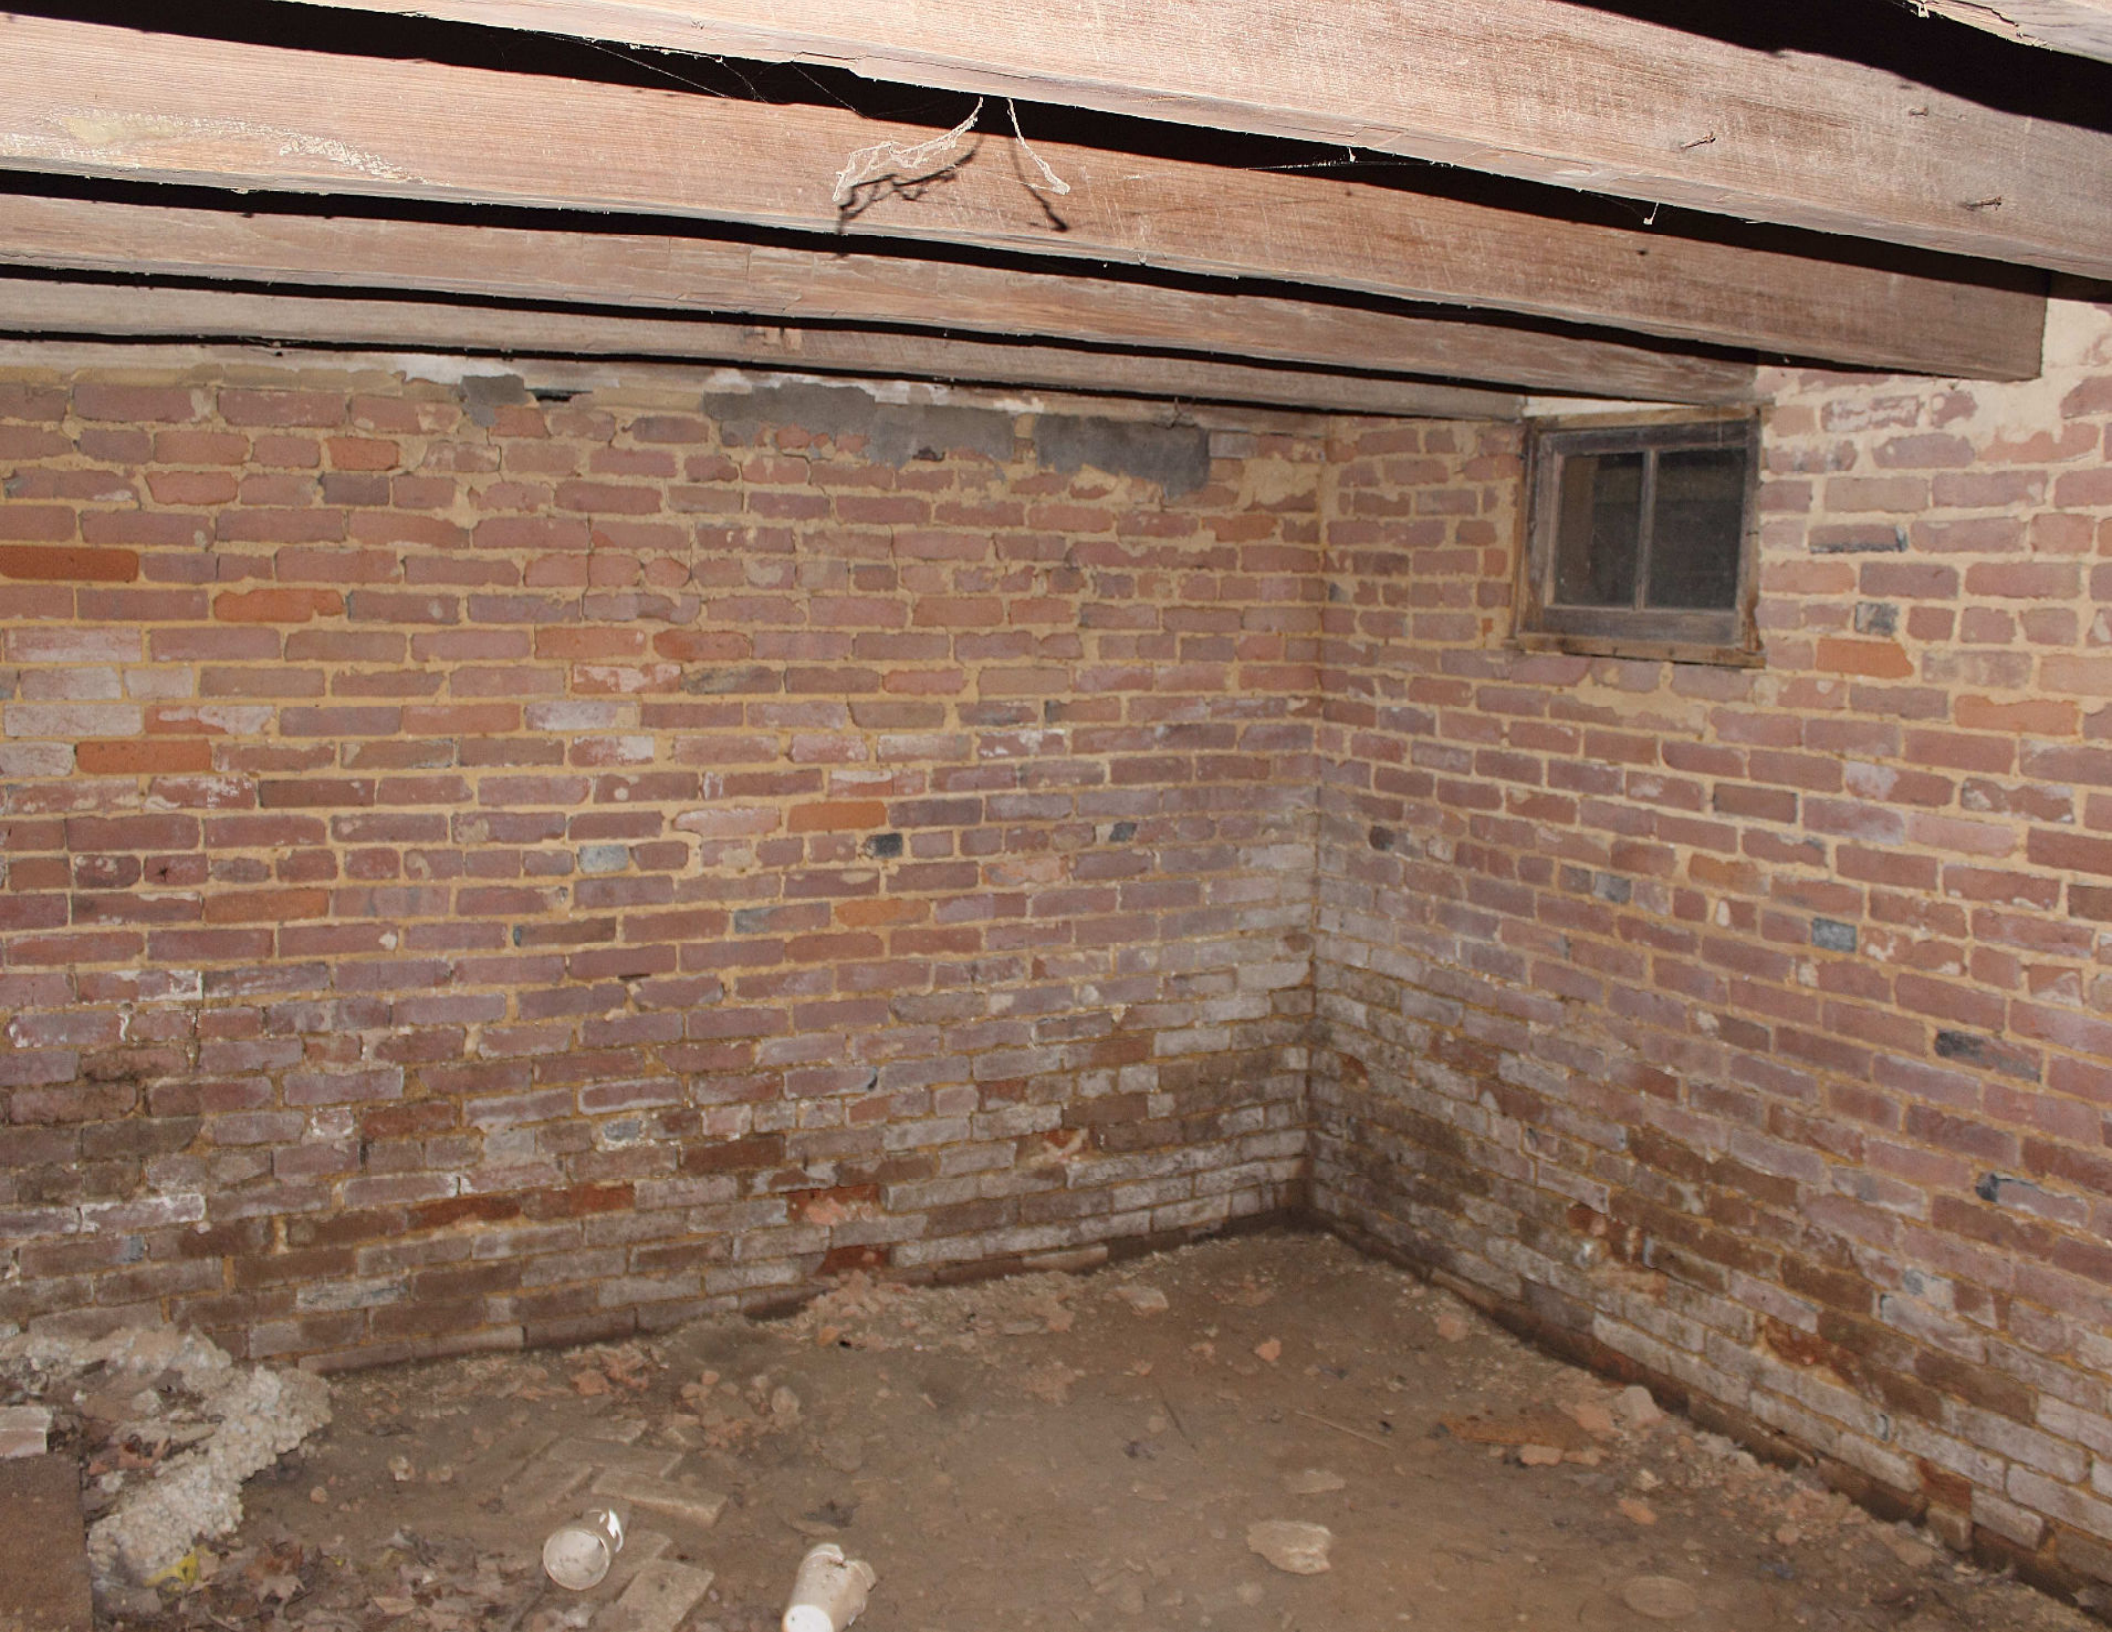
12 of 12: Interior of cellar, facing south-east

The cellar is constructed of brick and is original to the house (see photo 12). The entrance to the cellar, located on the western elevation of the house, was replaced most likely in the 1950s. The cellar is approximately 12 feet by 12 feet and 6 ½ feet high and has two openings for windows on both the north and south walls. The openings suggest that the original foundation to the house was open, which would allow the cellar to be properly ventilated. There are also remnants of brick flooring. There is some damage to the cellar: a large hole in the eastern wall and the southern wall has buckled. The original hand hewn cypress floor joists are visible from the cellar and are in excellent condition.
