National Register of Historic Places
Registration Form

historic name Ozark Courthouse Square Historic District

state Missouri code MO county Christian code 043 zip code 65721

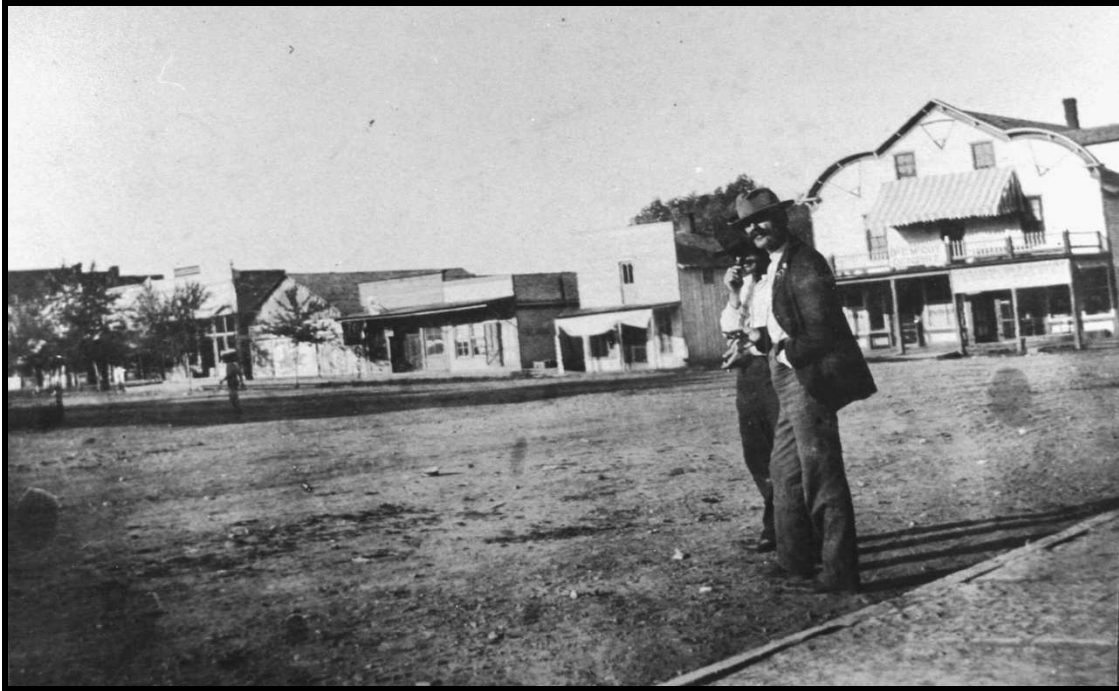
Figure 1. West side of square, Second & Church streets, viewing WSW, (photo c. 1890s).

mercantile until the late 1920s when the Central Hotel, located to the north on the corner of North Second and West Church streets, burned and relocated in the 115/117 building (the original Central Hotel can be seen in Figures 1, 2, and 16).

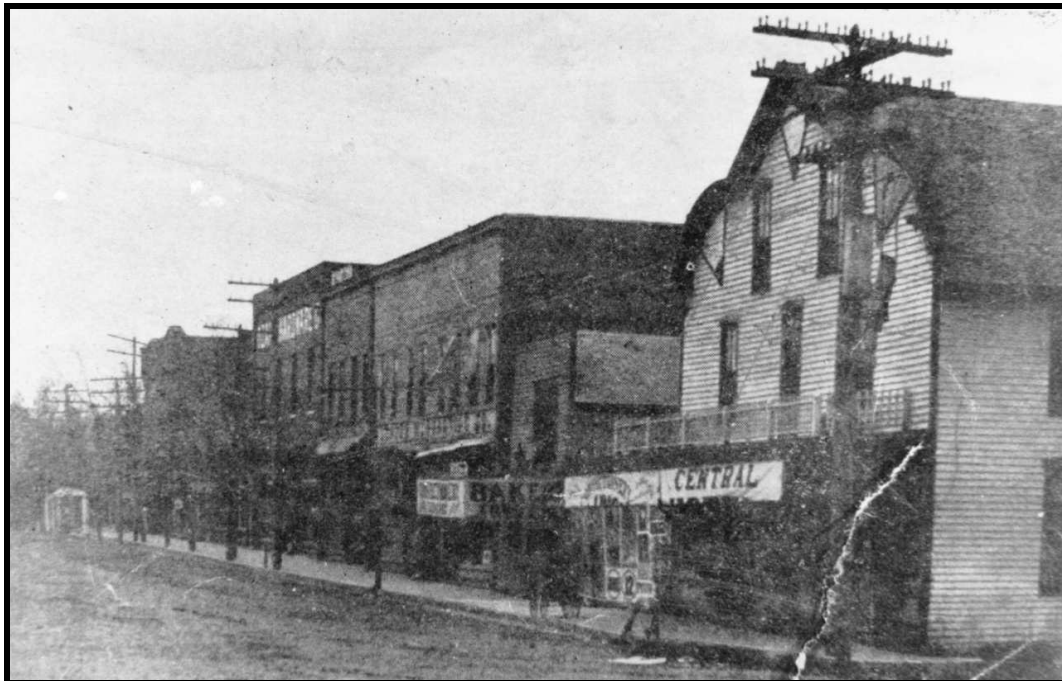
Figure 2. West side of square viewing SSW, c. 1906 (109/111,113, & 115/117 Second Street in center).

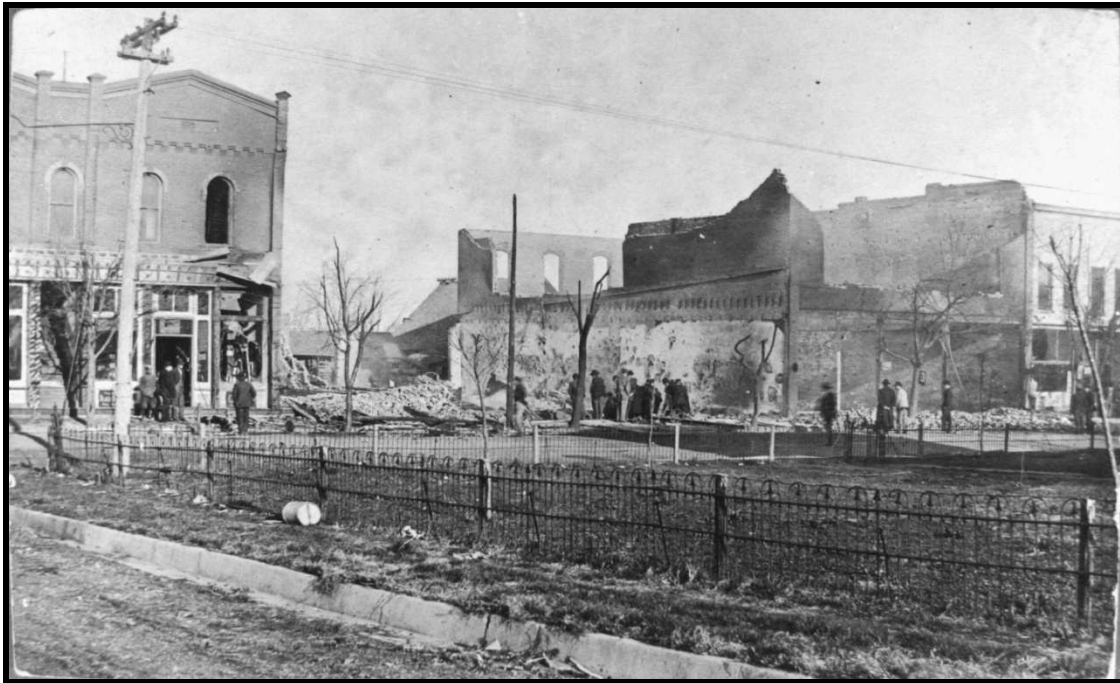
Figure 5. West side square viewing WNW, c. 1909-1910 fire destroyed 105 & 107,
And gutted 109/111 Second Street (photo c. 1910).

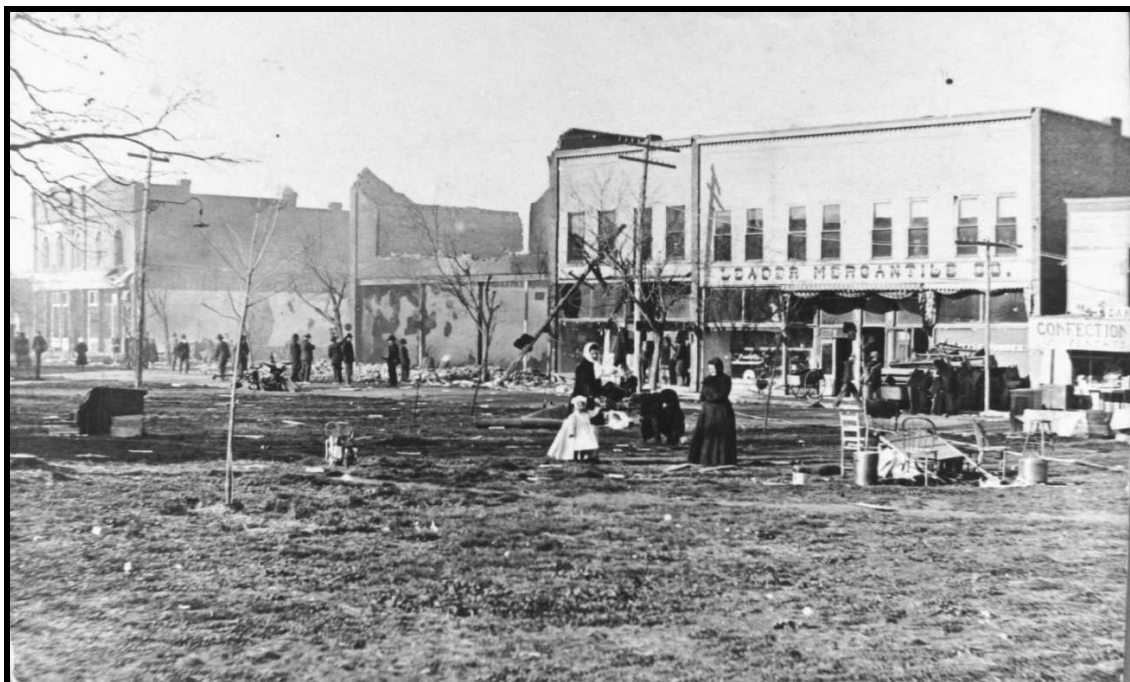
Figure 6. West side of square viewing SW, after c. 1909-1910 fire destroyed
105 & 107 and gutted 109/111 Second Street (photo c. 1910).

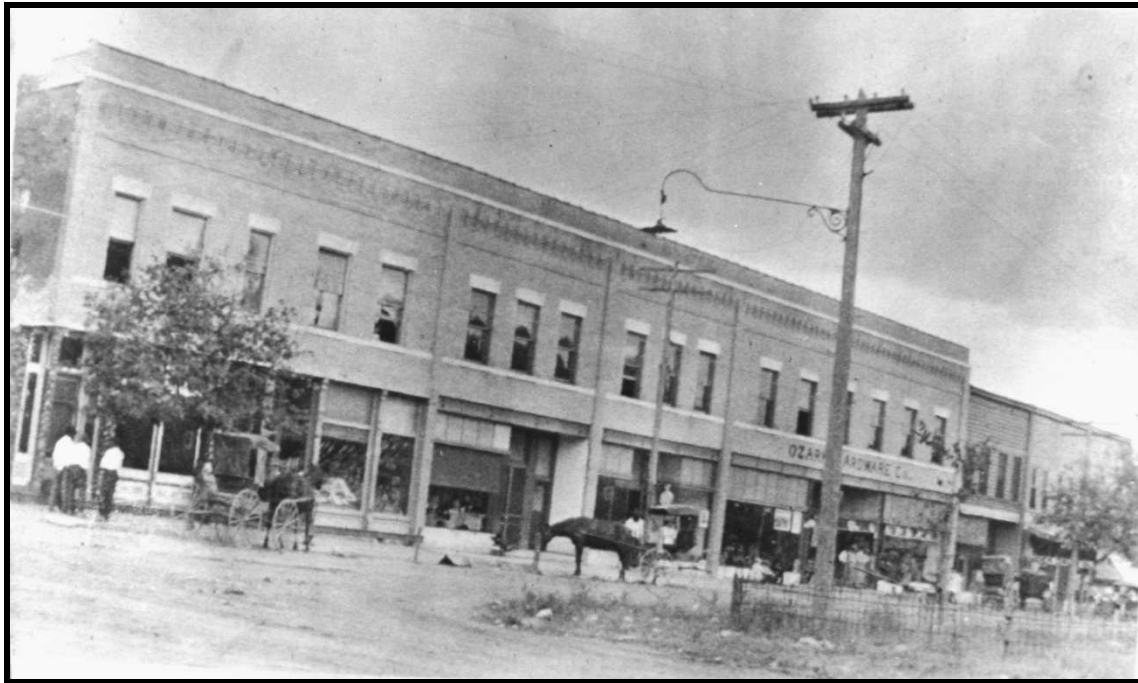
Figure 7. West side square (101-111 South Second Street) viewing WNW with new unified façade constructed after fire c. 1909-1910 (113 & 115/117 North Second Street at far right) (photo c. 1910).

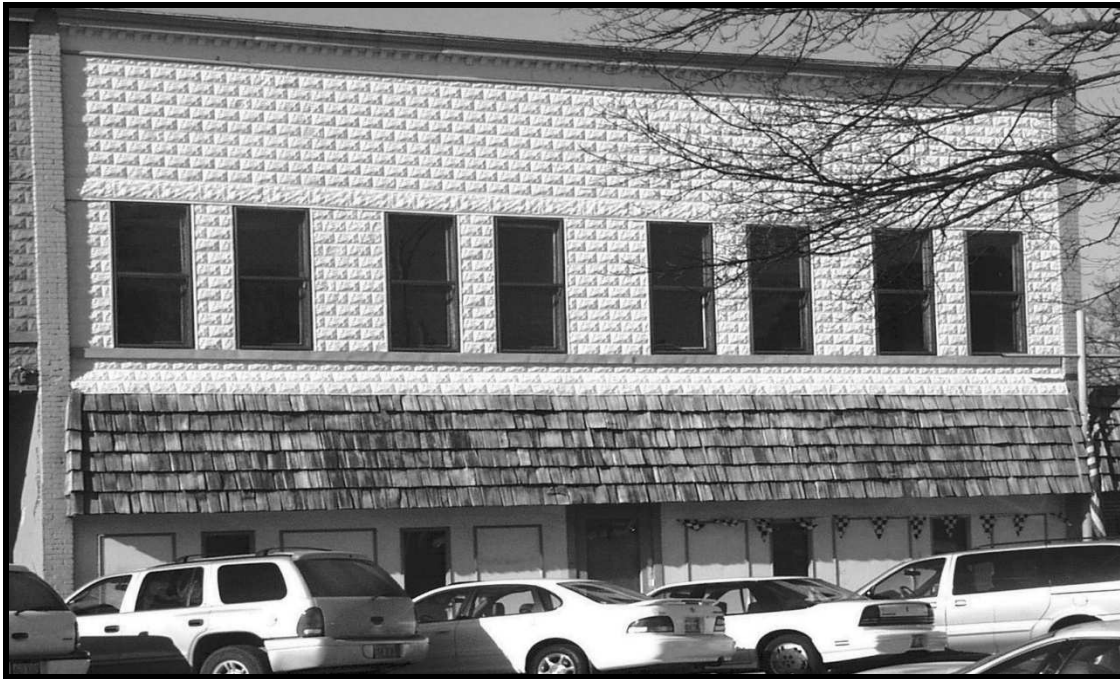
Figure 11. 115-117 North Second Street viewing WNW, (Before rehab, c. 1990s).

wide bays with a central entry accessing each bay, and a central stair that accesses the second floor. The first-story façade and storefront were formerly concealed beneath modern siding material, but were re-exposed circa 2005 (Figure 11); this rehab project entailed removing all non-historic materials which revealed the historic storefront in its entirety. The project then consisted of merely cleaning, painting, and glass replacement, for all historic materials were intact, as was confirmed by a historic photograph (Figure 10). The second story façade has an embossed metal sheathing in a stone-faced block design, based on historic photographs, the same as the adjacent building on left at 113 North Second Street, as described above.

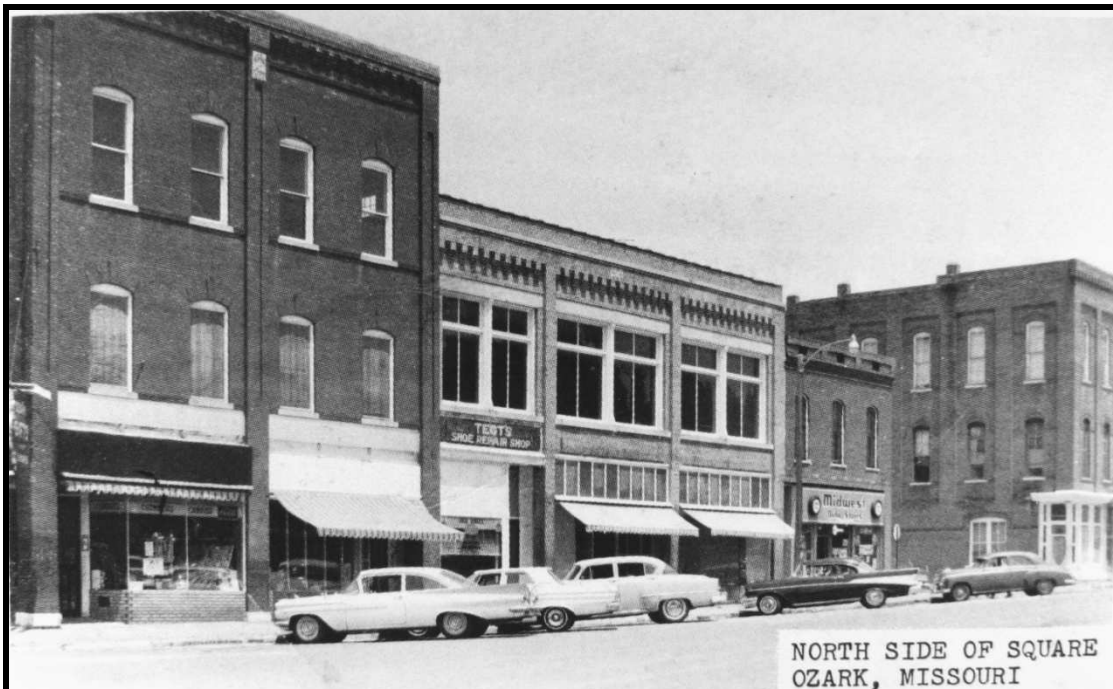
Figure 16. North side of square viewing NE, c. 1965.

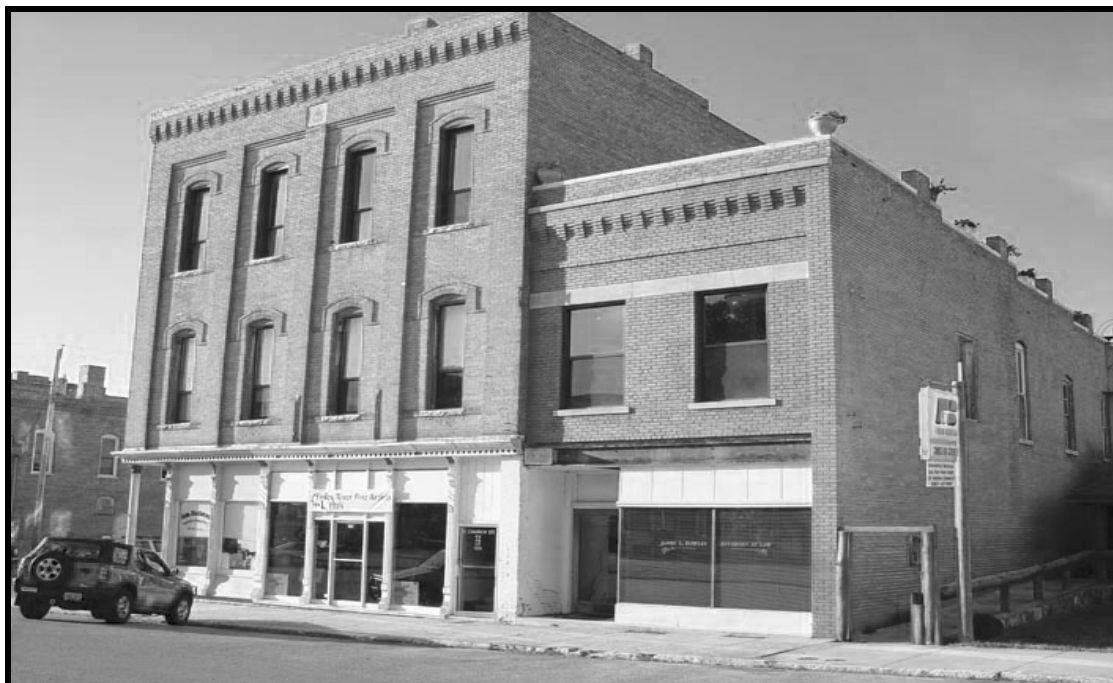
Figure 20. Northeast side of square viewing NW, 101-103 & 127 East Church Street before rehab, c. 2000.

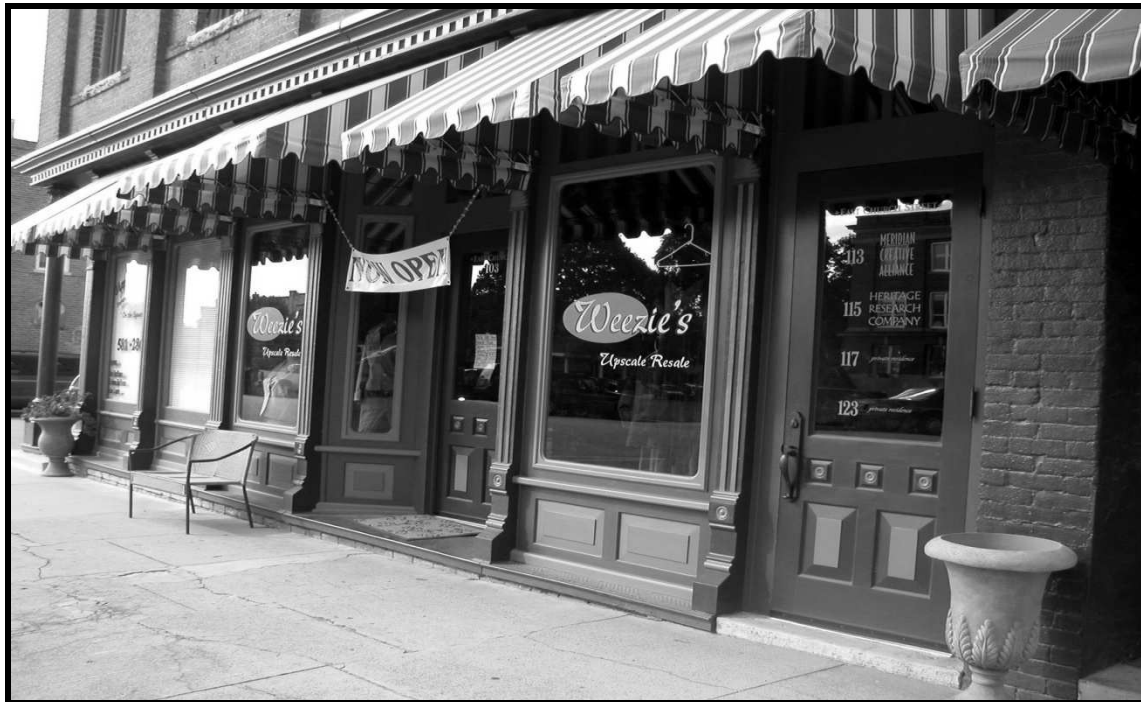
Figure 21. Restored storefront detail, 101-103 East Church (photo c. 2004).

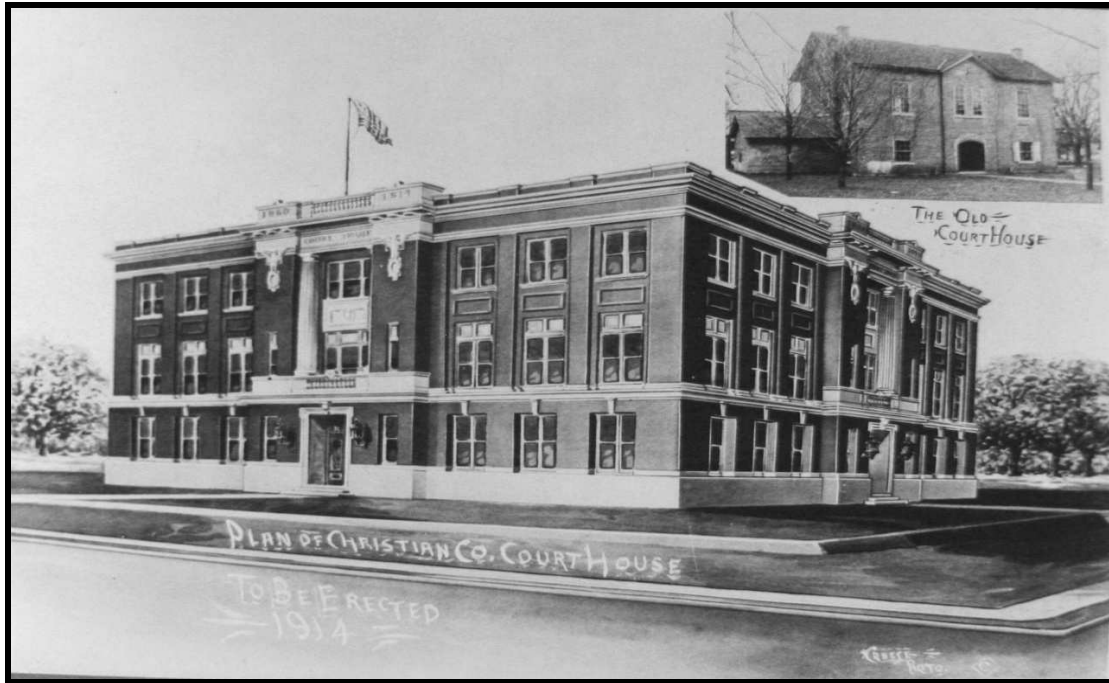
Figure 23. Rendering of courthouse building c. 1913.

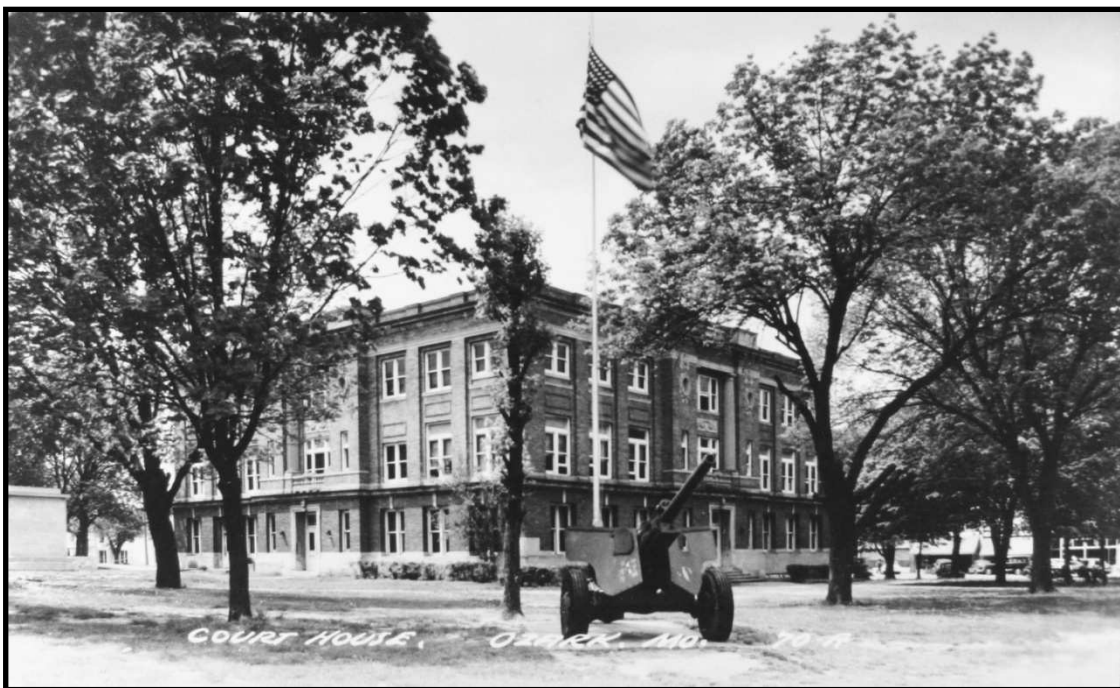
Figure 24. Courthouse viewing SW, prior to door & window replacements (photo c. 1960s).

Each entry porch is framed by an entablature of cast stone; the double-doors and undivided full-span transoms are metal replacements. The second and third stories of each projected elevation contain paired windows that are flanked by cast stone column pilasters spanning both stories. Cast stone balustrades occur in front of the second-story windows and again above the third-story cornice; a rectangular bas relief is set between the second and third story windows. Within the projected entrance façades, the entry is flanked by a one-over-one window, and a more narrow version occurs just above in the second story, then directly above in the third-story is a pair of inoperable oval windows that are framed by a decorative cast stone garland with an eagle perched above, wings spread.

The remaining fenestration pattern of each elevation consists of paired one-over-one single hung replacement aluminum windows, three sets on either side of the entrance elevation. The windows in the third story are notably shorter than those of the other levels, but this appearance is due to the loss of the original design in the second-story windows when they were recently replaced (c. 1980s). Historic

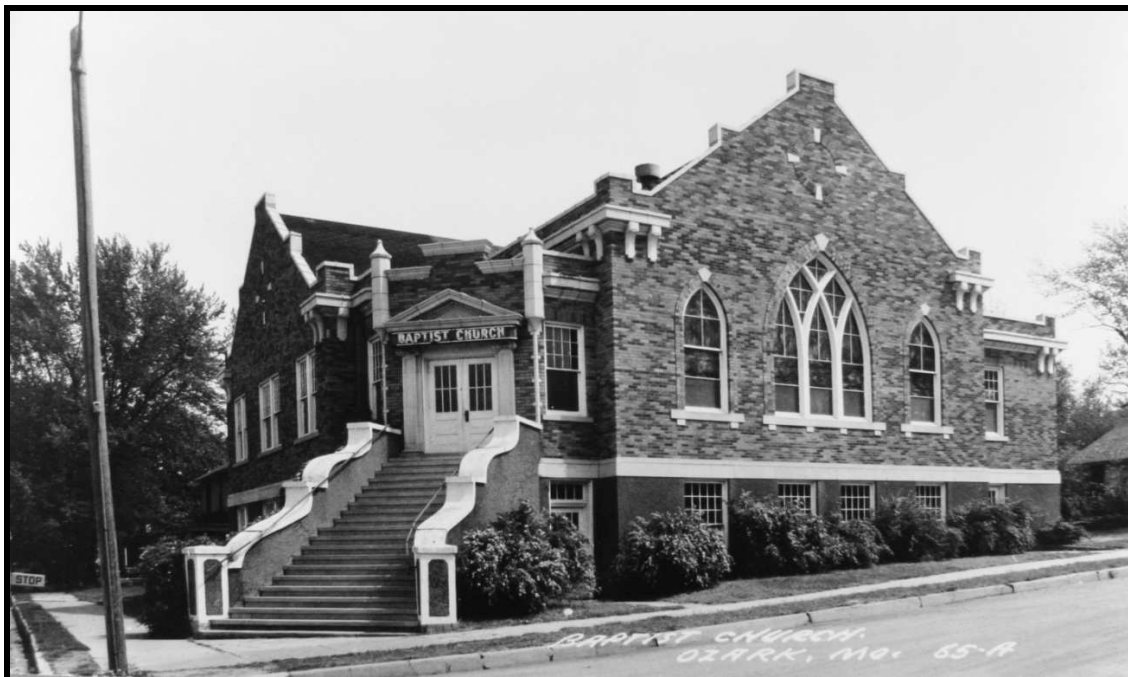
Figure 26. Baptist Church building, 201 East Church Street viewing NE (photo c. 1960s).

201 East Church Street, First Baptist Church (1919): Contributing. This is a massive two-story religious building of brick masonry on a concrete foundation. The roof is a parapeted cross gabled design. It occupies the northeast corner of the square so that each gable faces a prominent street while the grand corner entrance staircase faces courthouse square. The ground level story is concrete with stucco covering. Entry to sanctuary is on southwest corner, accessed by concrete steps rising to the second story doorway. The double entry has a triangular cast stone pediment and is flanked by pilasters. Decorative features include cast stone turrets to either side of primary entry, and a curved concrete walled stair. Cut stone lines the parapets and the wall corners have bracketed cornices. The building suffered a major fire circa 1937, the roof destroyed but the walls remained intact (Figure 25). It was fully restored as seen in Figure 26, as recorded in the 1960s.
