**ARCHITECTURAL/HISTORIC INVENTORY FORM**

1. Survey No. SC-AS-012-0001		2. Survey Name: Reconnaissance Level Survey of Historic Downtown Wentzville	
3. County: St. Charles		4. Address (Street No.) 102	Street (name) East Third Street
5. City: Wentzville	Vicinity: <input type="checkbox"/>	6. UTM:	
8. Historic name (if known):		9. Present/other name (if known):	
10. Ownership: <input type="checkbox"/> Private <input type="checkbox"/> Public		11a. Historic use (if known): DOMESTIC/single dwelling	11b. Current use: DOMESTIC/single dwelling
5. City: Wentzville		7. Township/Range/Section:

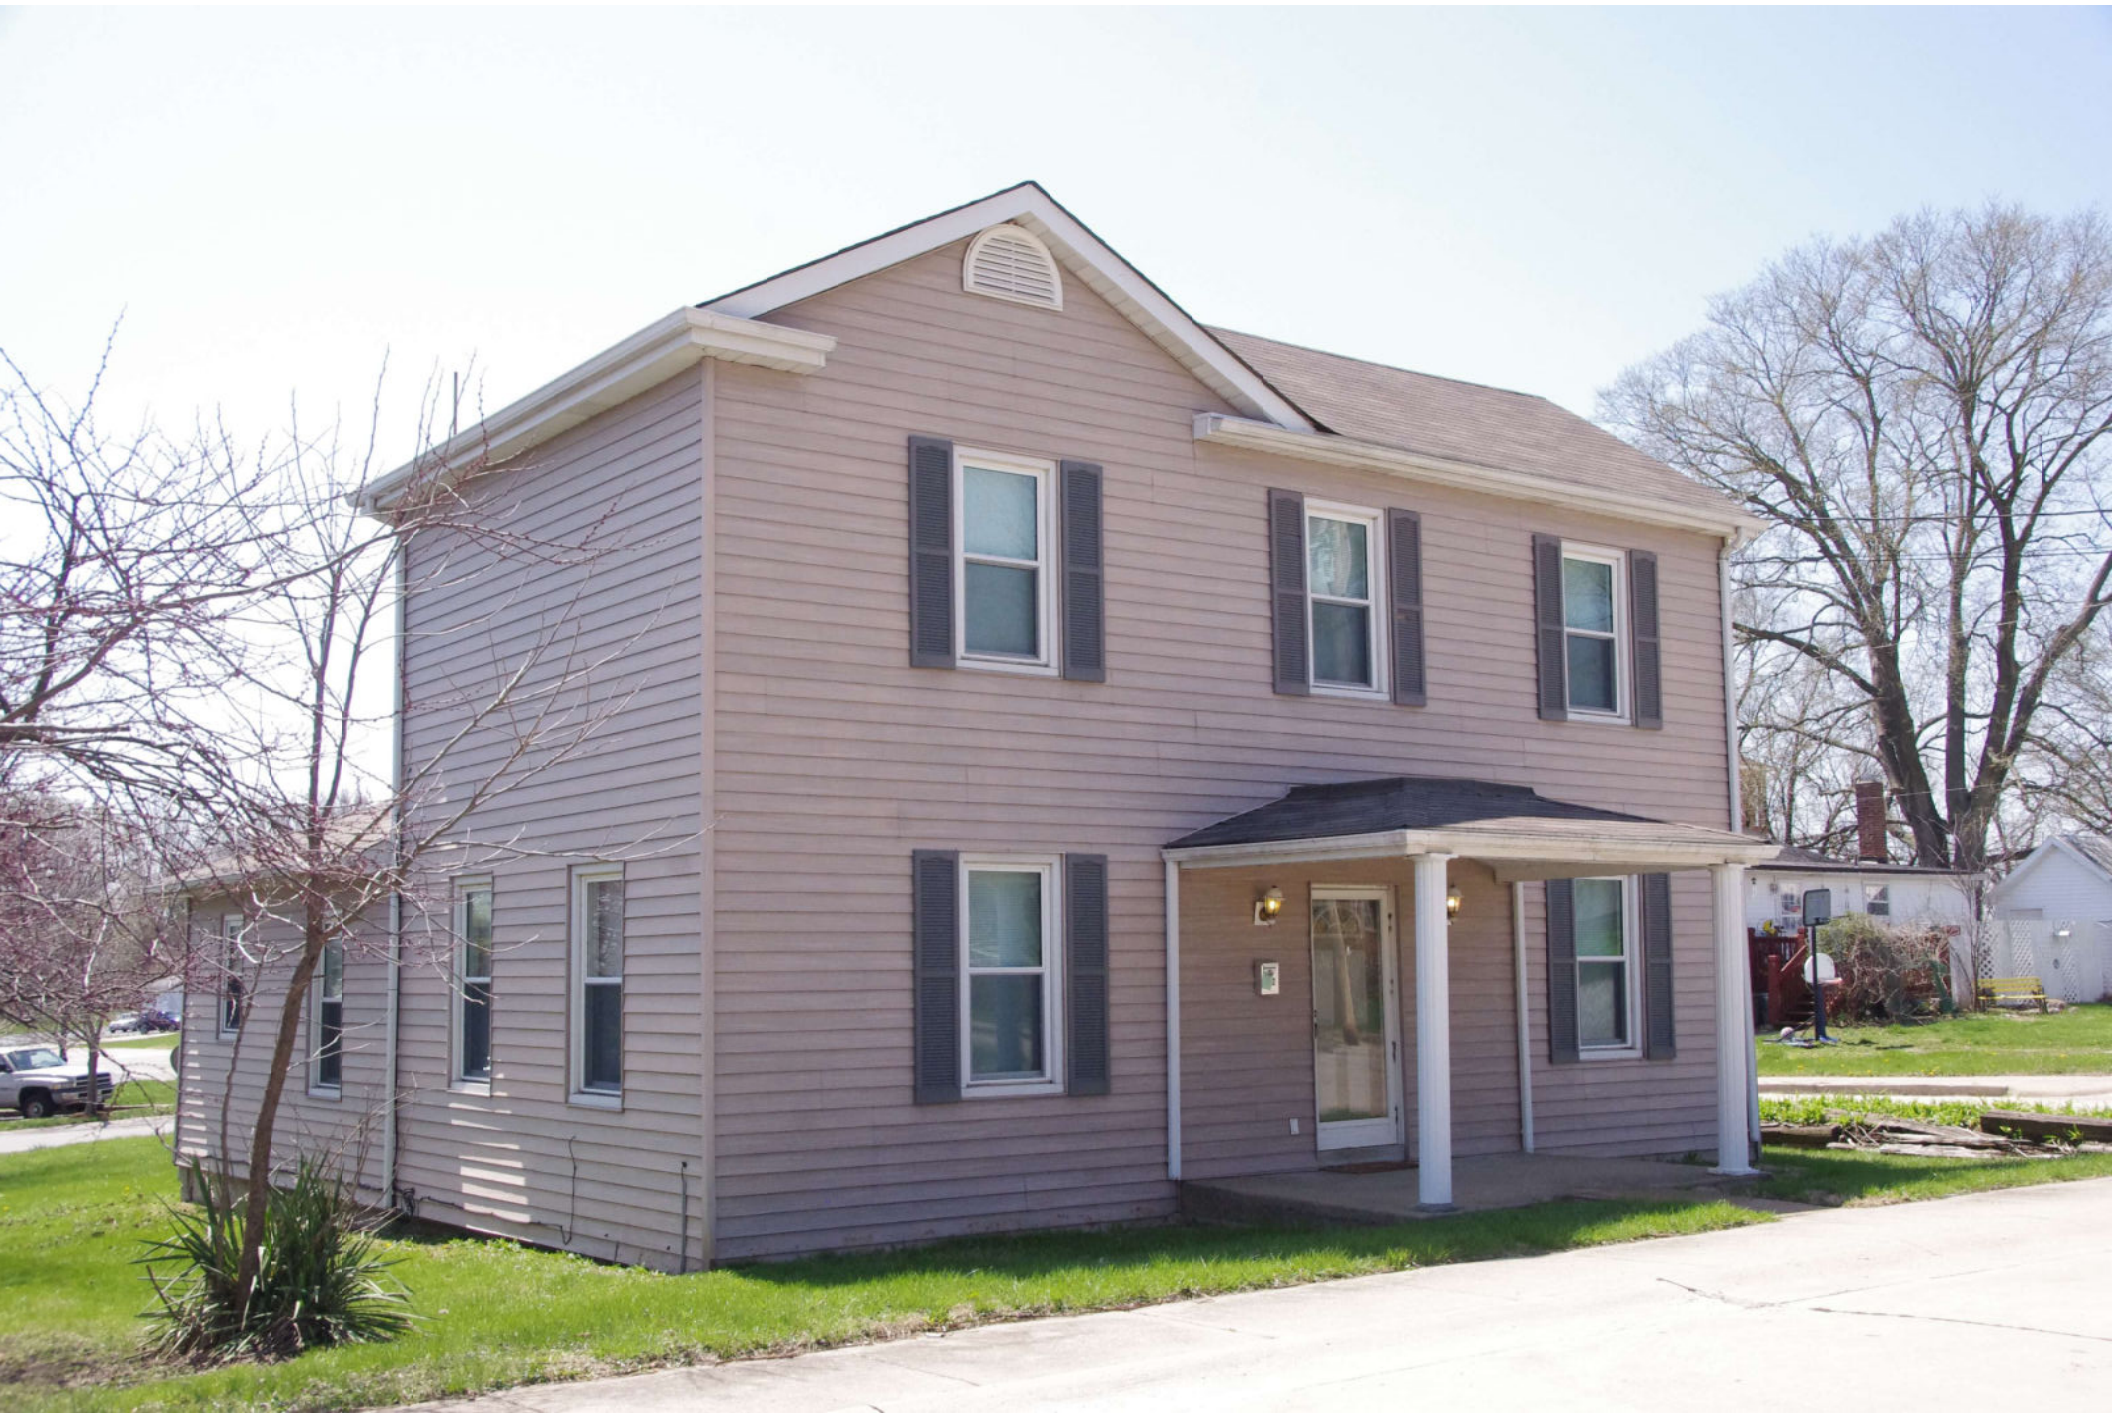
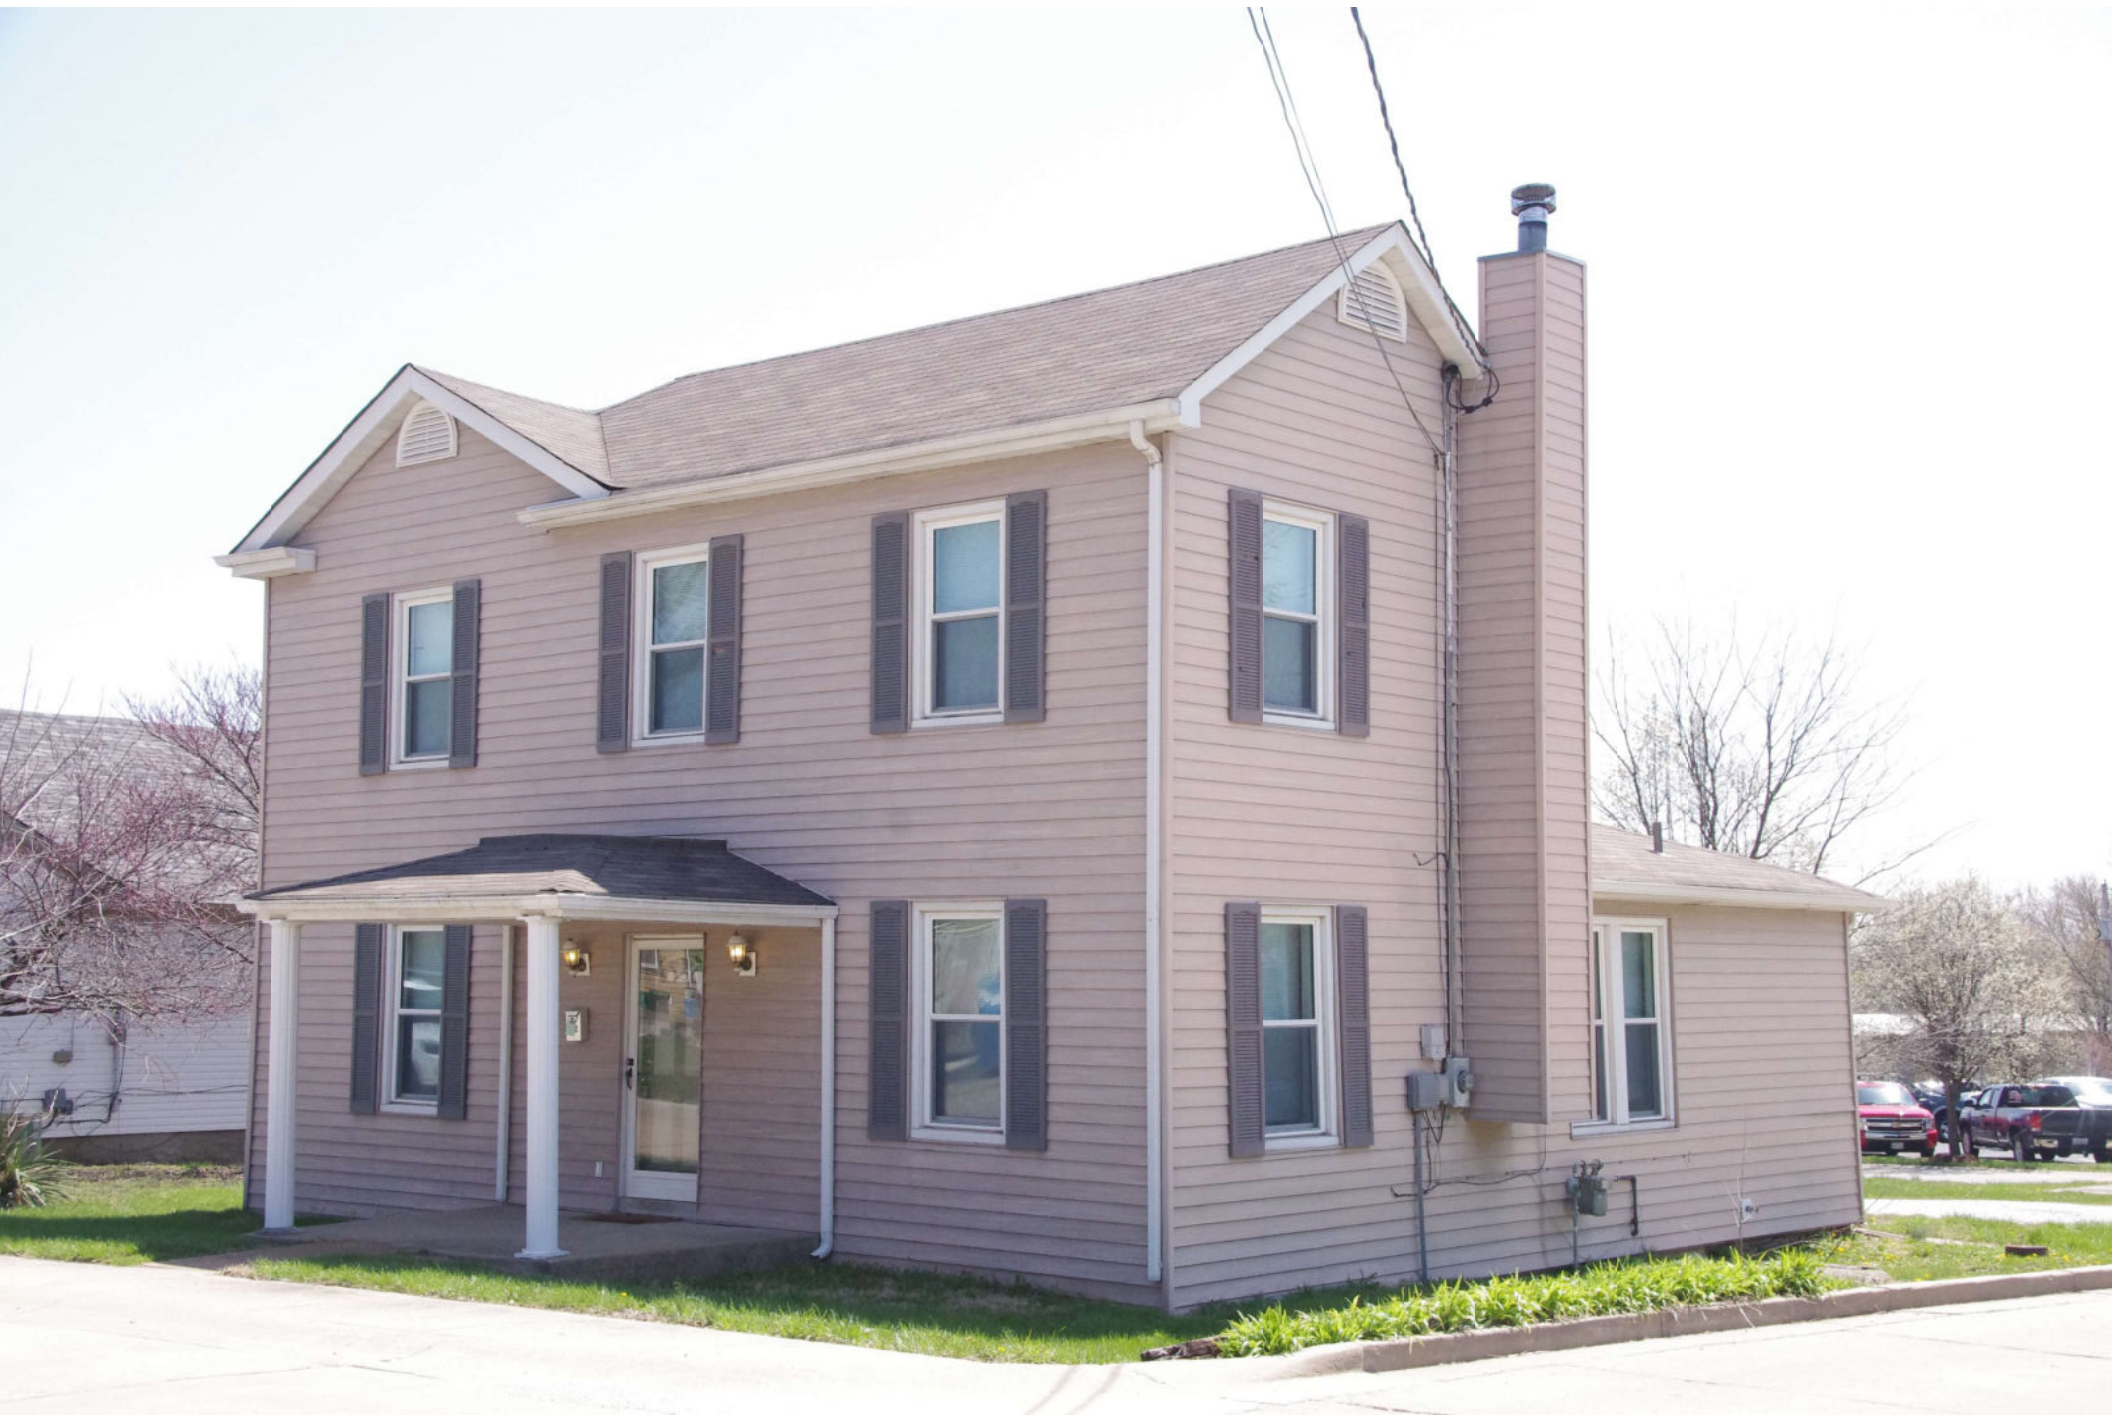
This is a two-story cross gabled house with a central hipped open porch supported by replacement, round columns with a concrete slab at grade. The wood door with fan light and four panels is centered on the first level. The outer bays on the first level and three bays on the second level all contain one-over-one vinyl sash windows. The gable contains a half round vent. The front facing gable has a broken pediment motif created by the soffit returns. On the rear is a hipped roof, one story wing that appears on the 1927 fire insurance map. There is a nonhistoric, vinyl clad chimney on the west elevation.

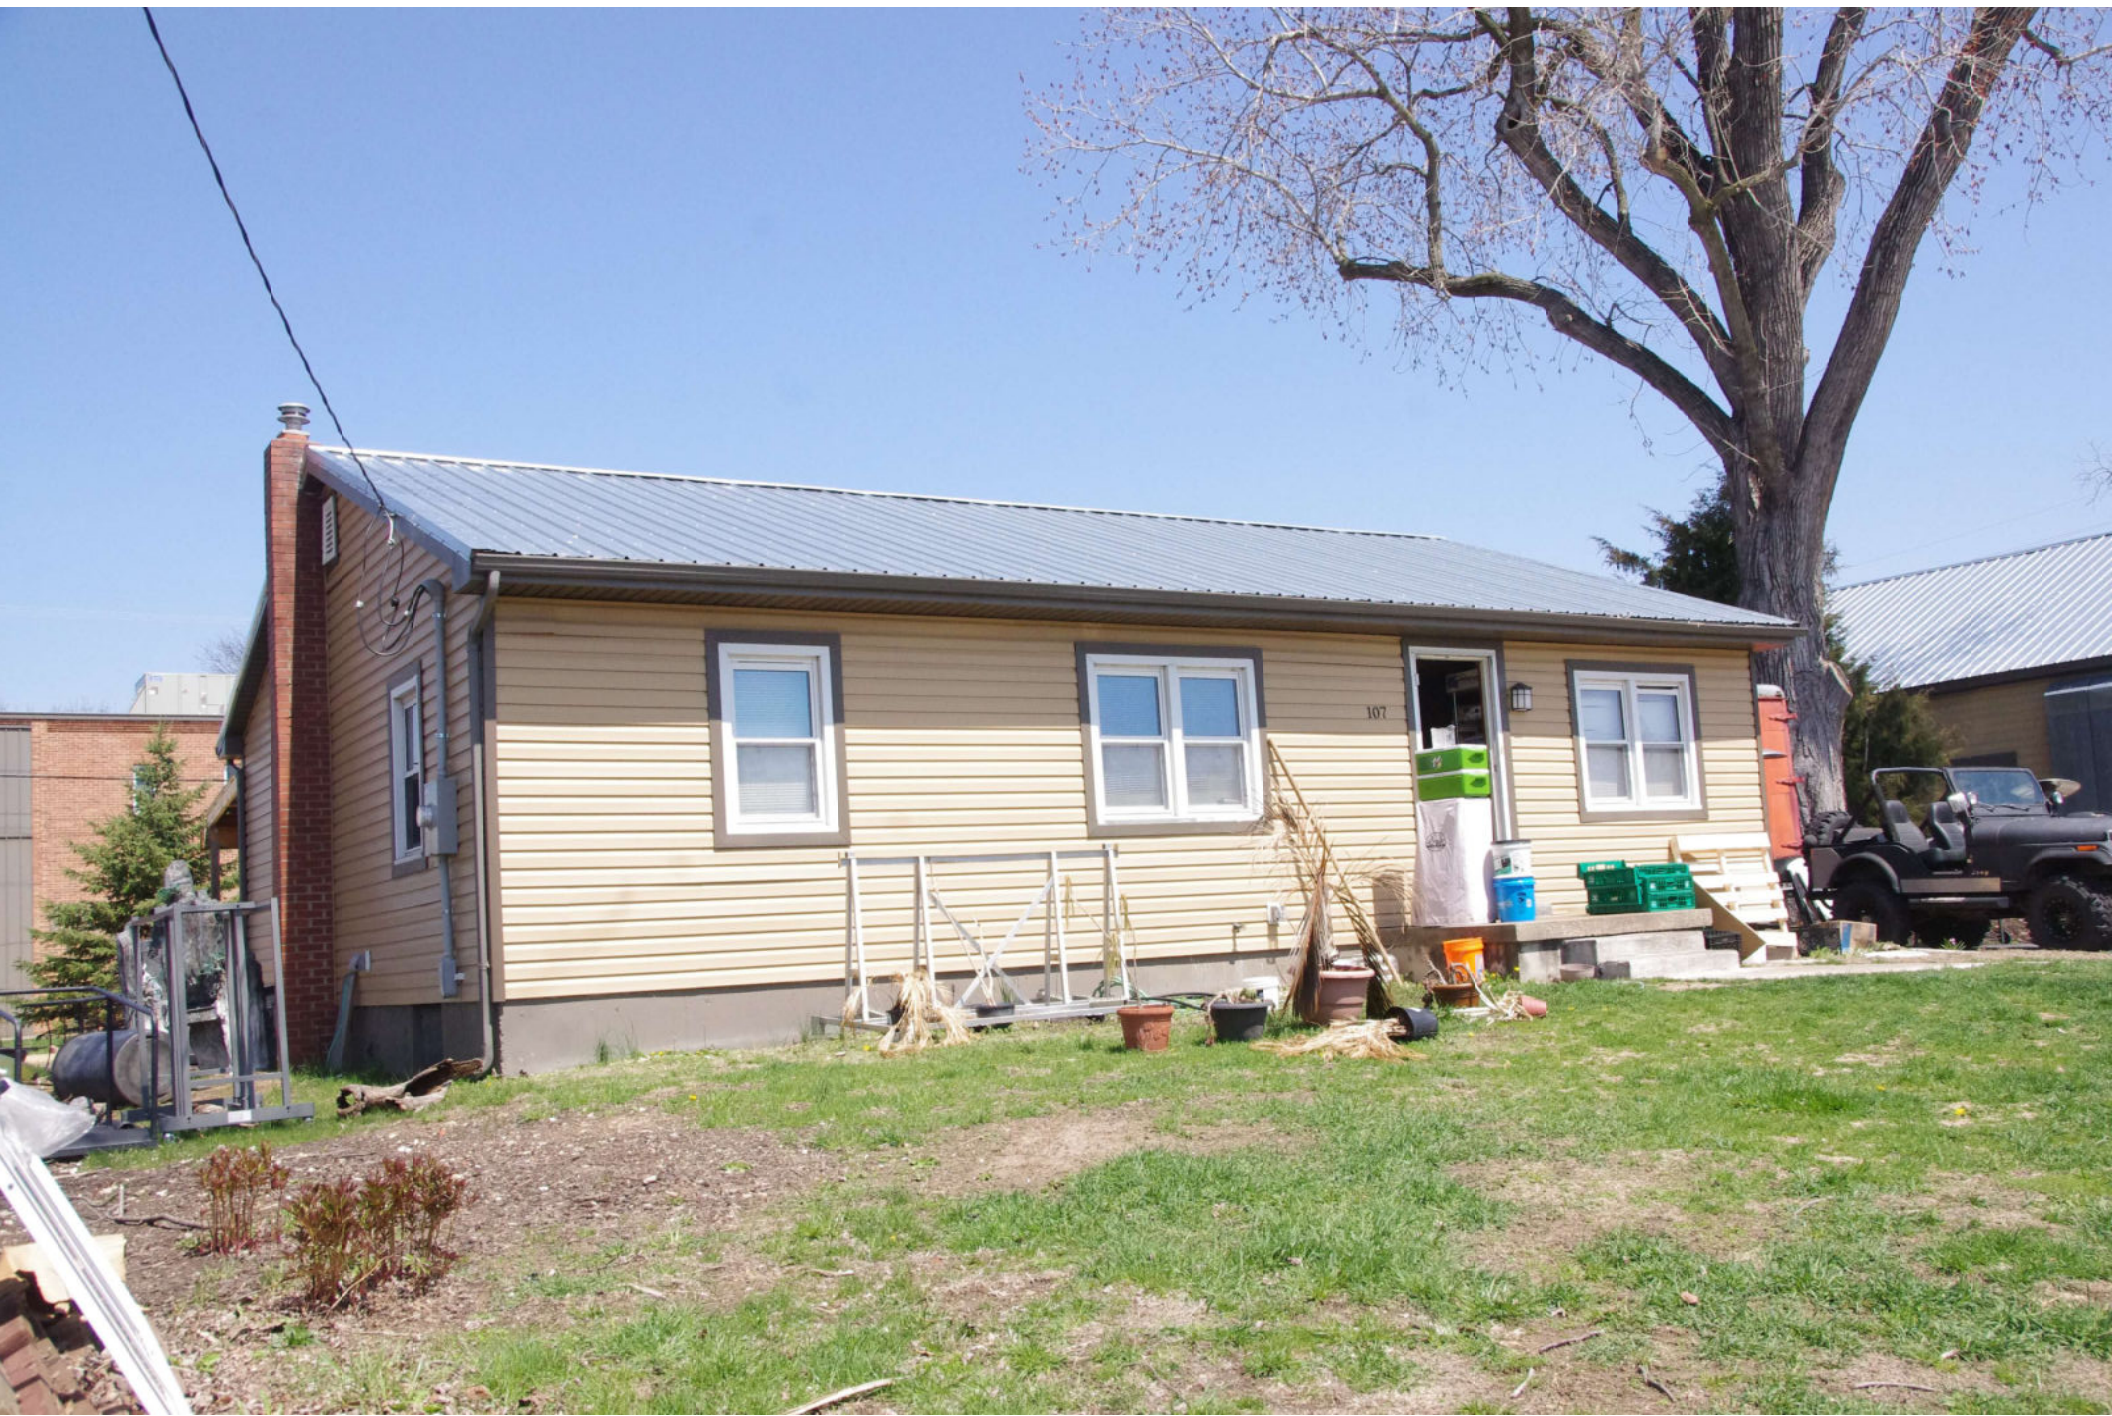
This resource is a one-story, side gabled house with vinyl siding and metal roof. The façade is divided into four bays with the fanlight and four panel door located east of center, flanked on both sides by paired one-over-one vinyl sash windows. The western bay contains a single one-over-one vinyl sash window. There is a shallow concrete stoop in front of the entry.

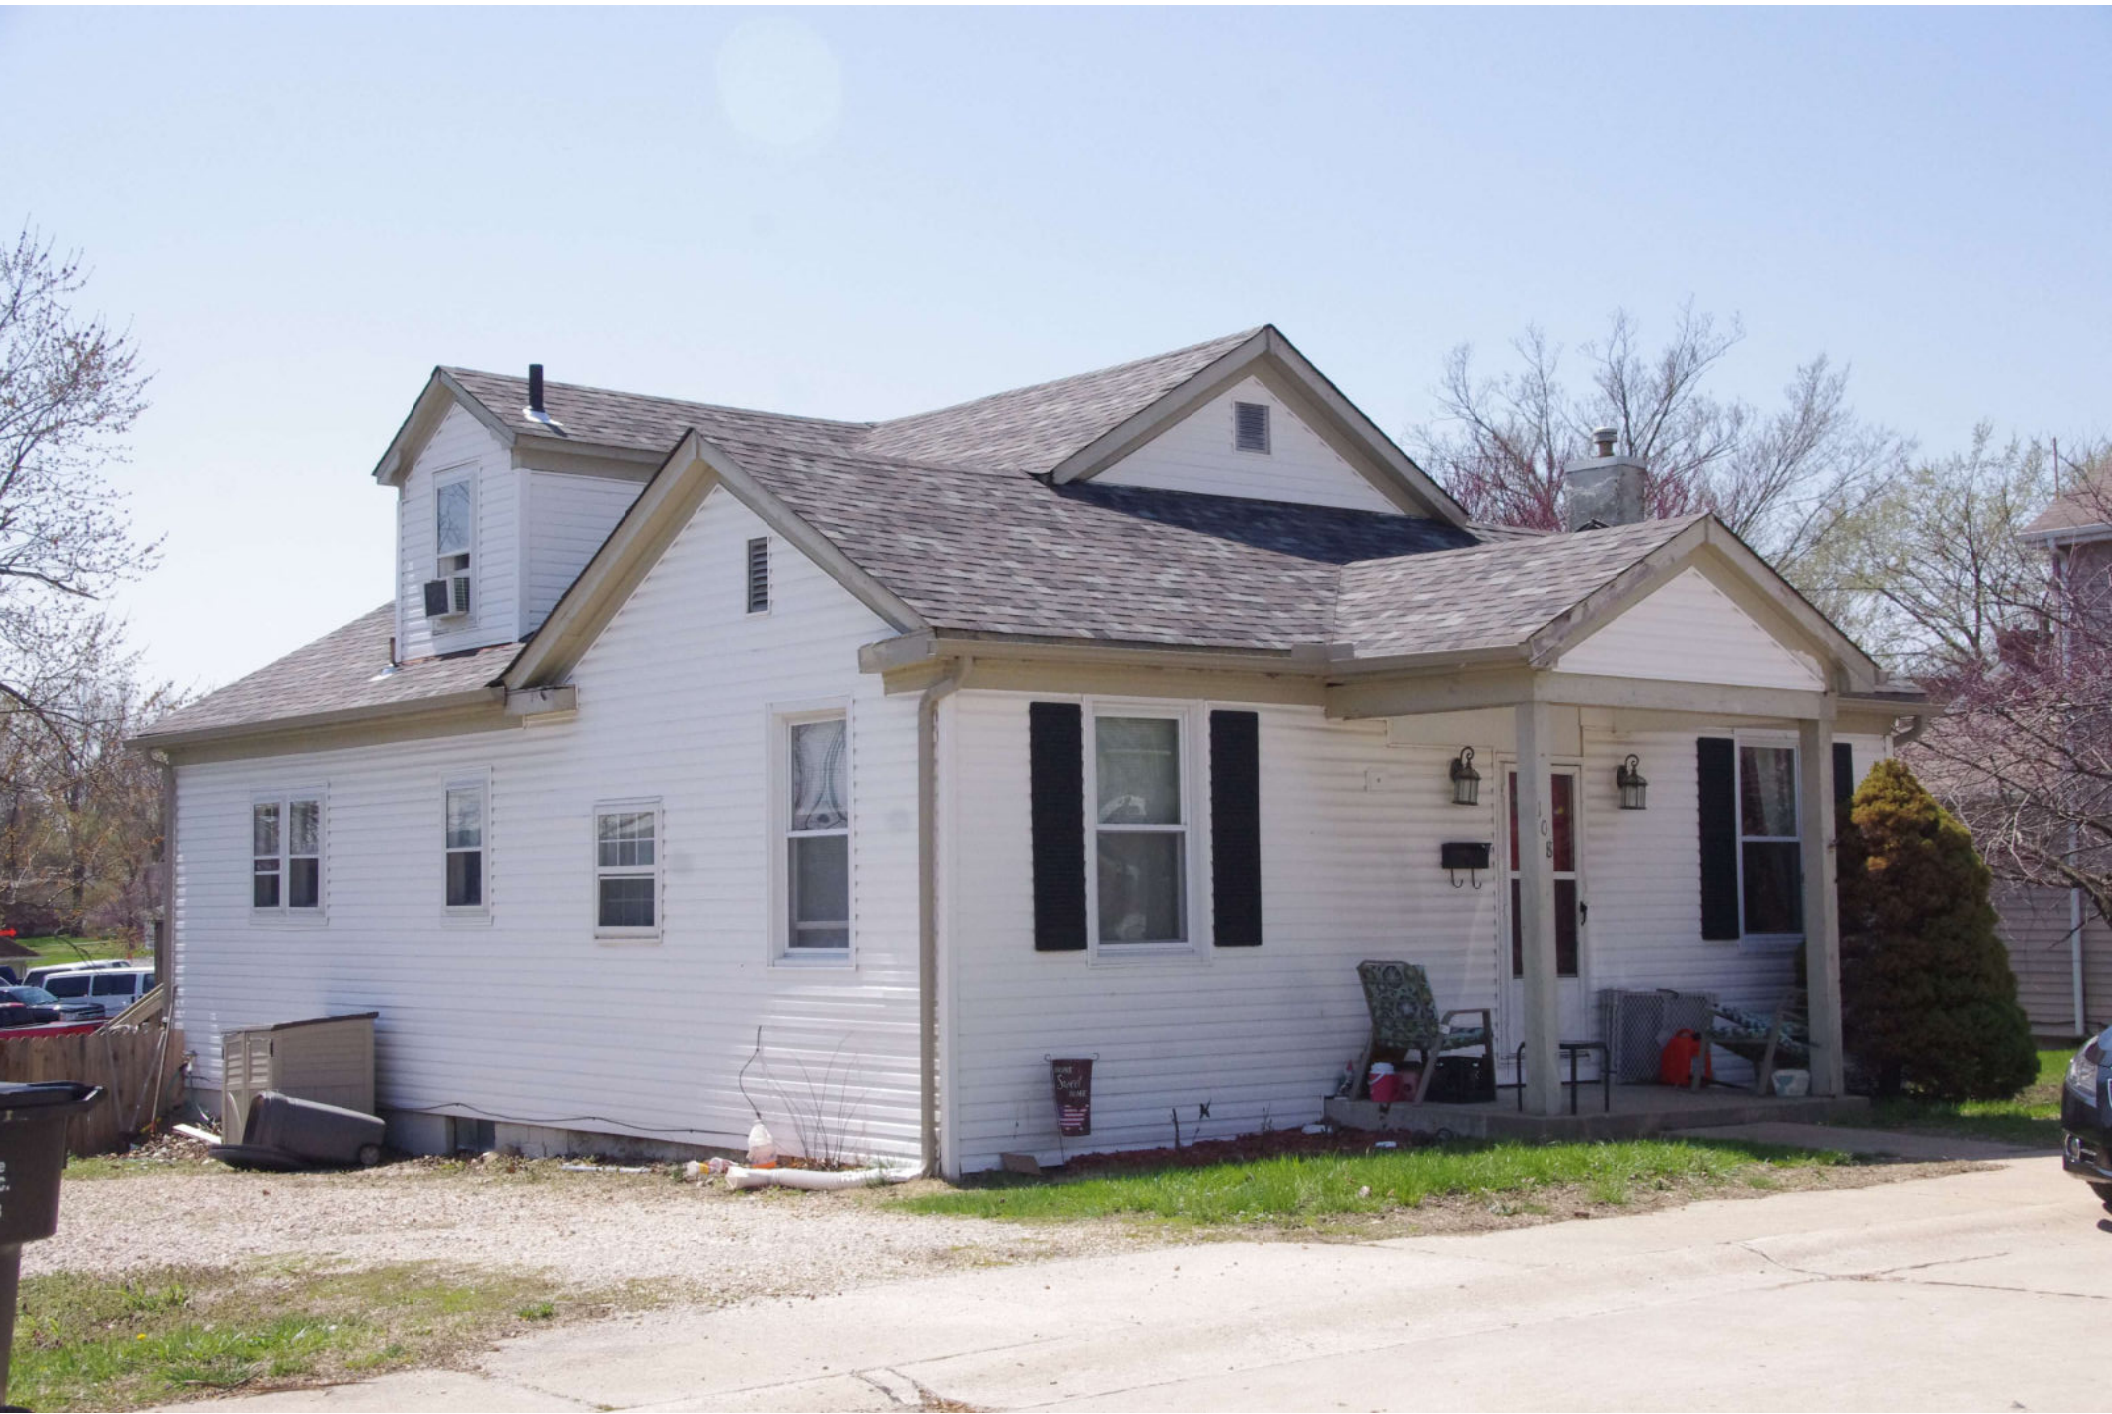
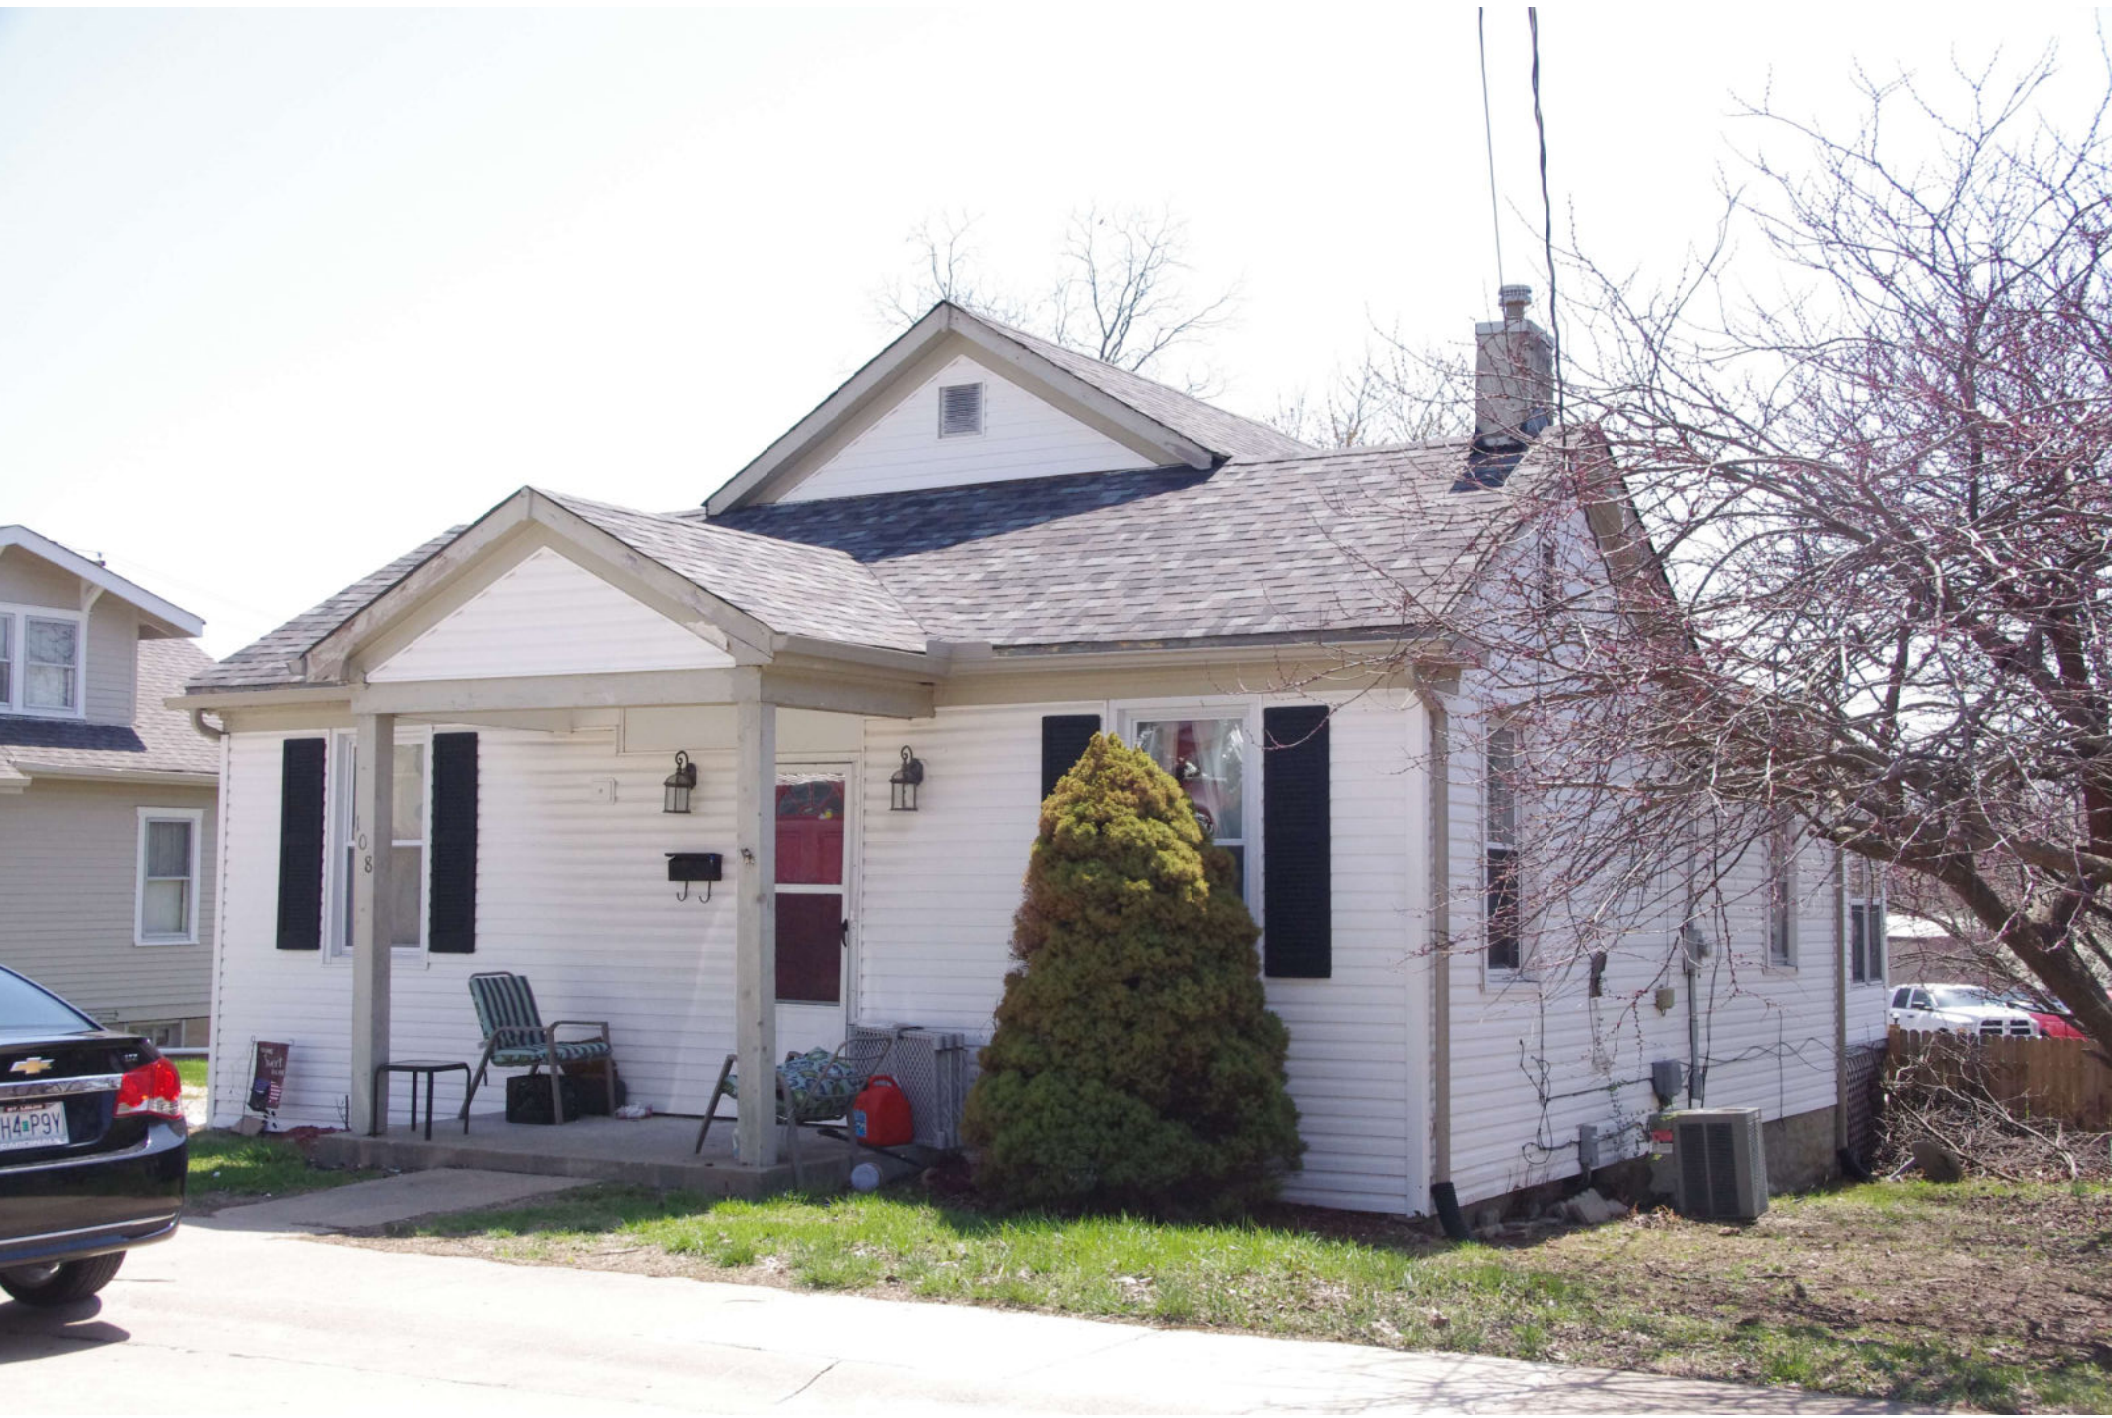
This is a one-and-a-half story house with a cross gable roof and vinyl siding. The gabled open porch is centered on the façade and supported by replacement square corner posts resting on a grade level concrete pad. The door is a fanlight, four panel door. On either side of the entry porch, the outer bays contain one-over-one vinyl sash windows with vinyl faux shutters. Centered at the ridge is the triangular gable end of the rear addition, a 1.5 story, cross gabled wing that has an additional one story gabled wing on the rear. The additions look to be older and are difficult to date given the replacement windows and vinyl siding. There is a gabled dormer on the east elevation.

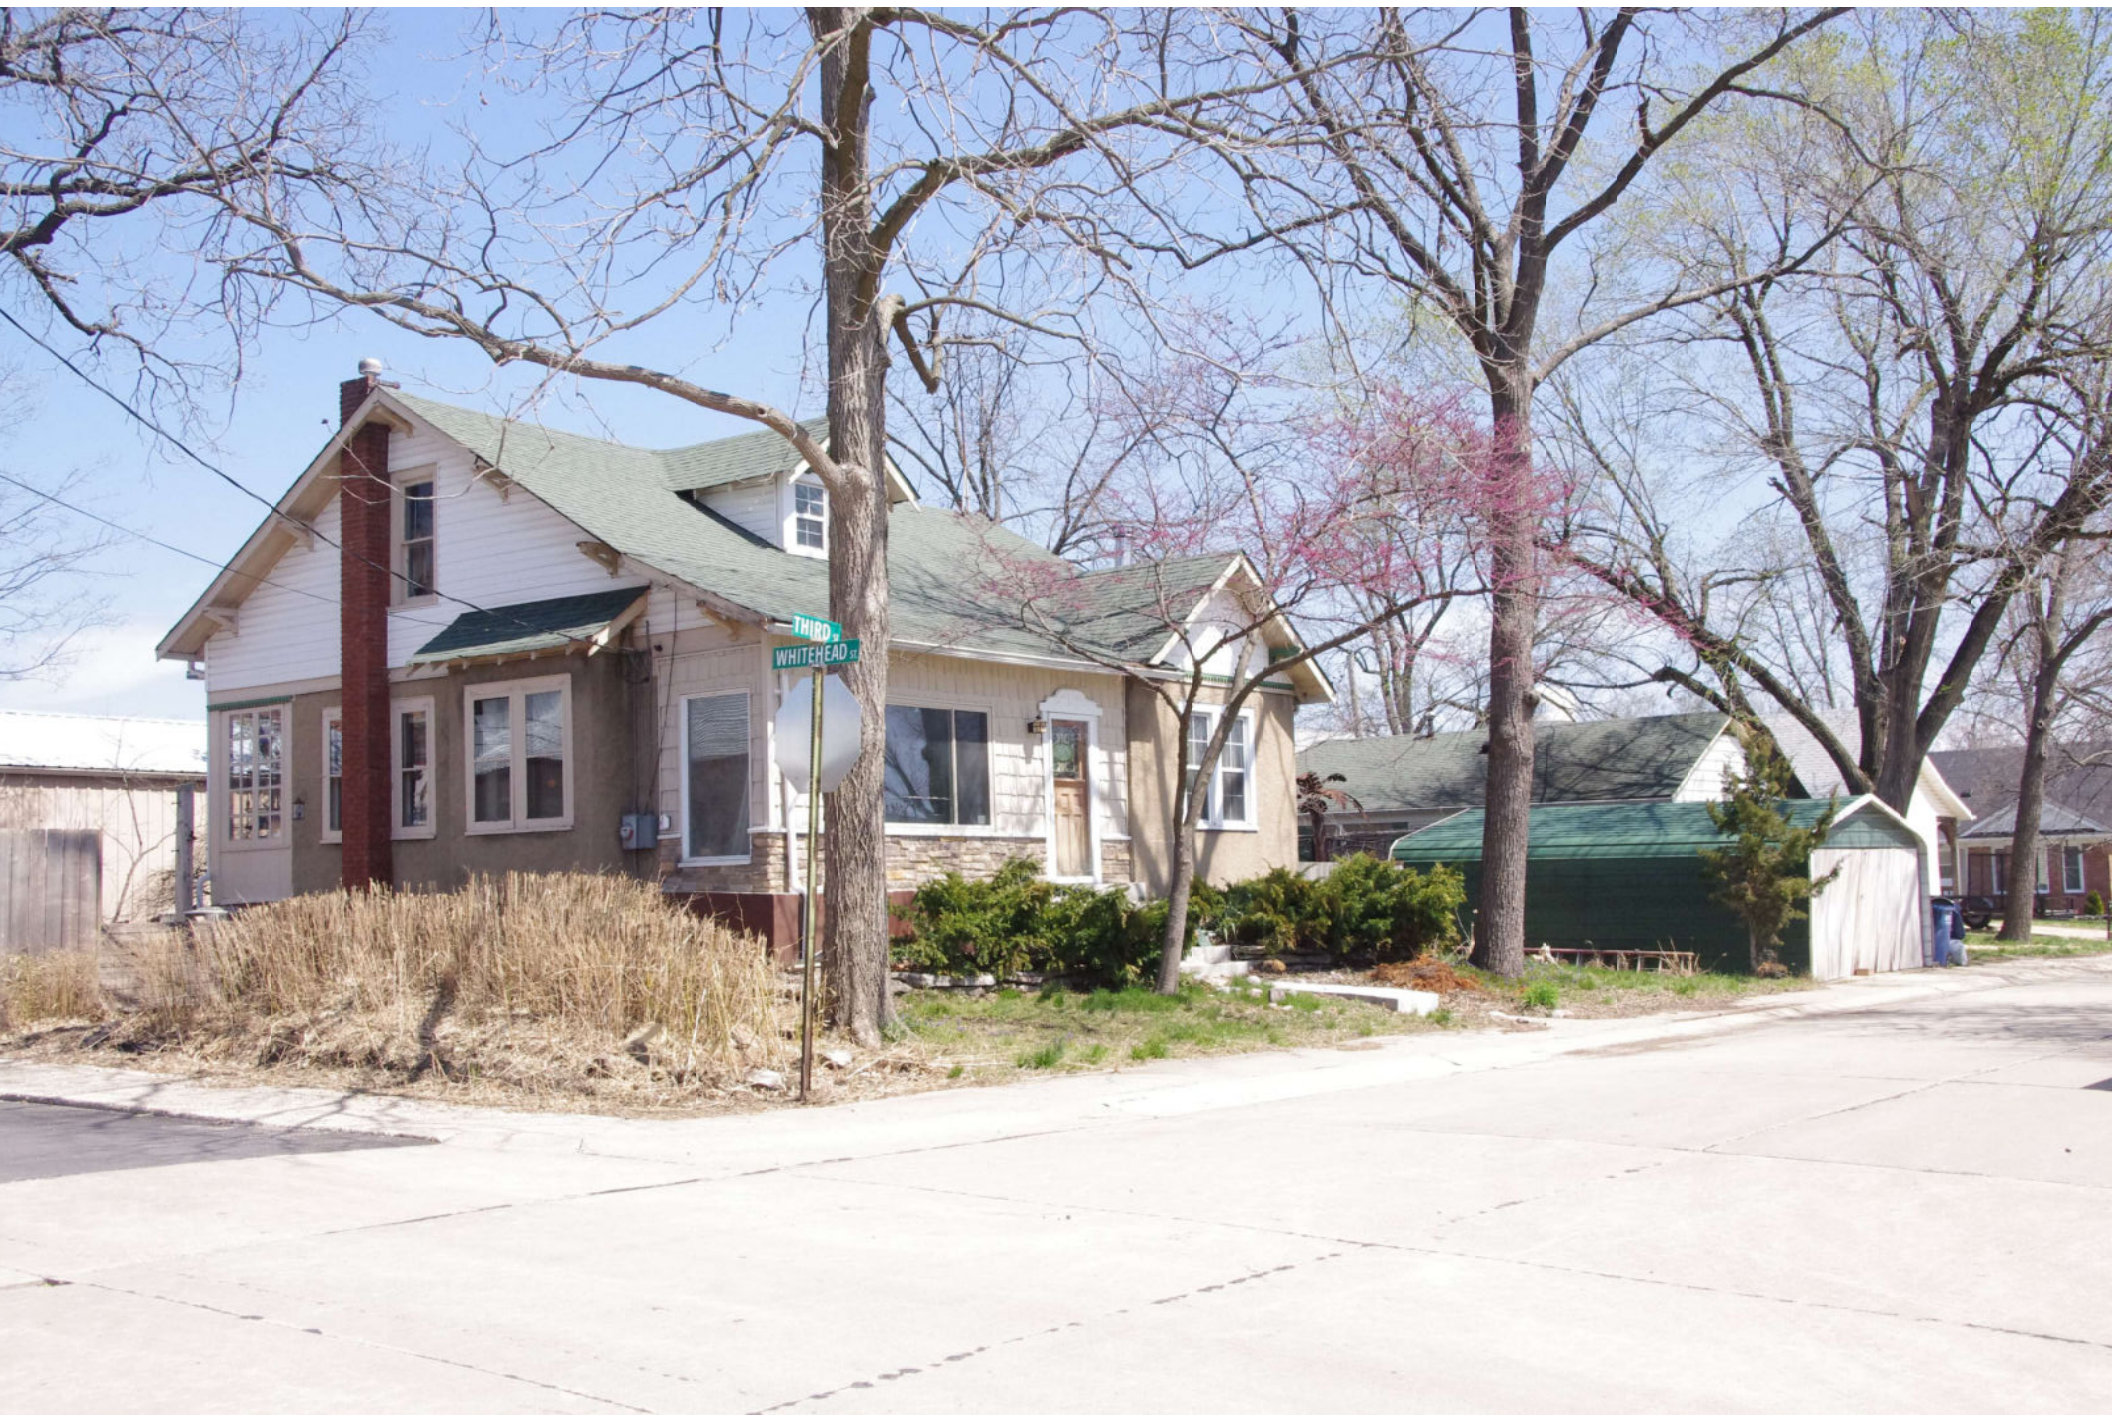
This was originally a smaller Craftsman bungalow with a side gabled roof that extended over the front porch in the west half of the façade while the east half was a cross gabled bay. It retains the wide eaves with knee brace supports and the rafter tail extensions, both characteristic of Craftsman designs. It retains the original stucco walls on the main level, but the original siding on the gable ends and dormers has been covered with vinyl siding. The one-and-a-half story gable and wing house has undergone several different renovations, including enclosing the front porch with cedar shake shingle siding over the stacked sandstone veneer that extends up to picture windows, which stylistically was seen in 1960s Ranch houses. The entry door was relocated to the west end of this enclosed wall (near the center of the façade), although the door may be original to the house since it is a quarter light with three vertical panel door, typical of Craftsman designs. The gable on the east end of the facade includes vinyl fish scale shingles (a recent renovation, not characteristic of Craftsman designs) above paired four-over-four replacement sash windows. The gabled dormer located above the porch also has replacement paired four-over-four windows, but there are some of the original one-over-one wood sashed windows on the house, including some of the original wooden storm windows.
